2023 Annual Facility Performance Review Report

Duck Pond Operations Tailings Management Facility

Teck Resources Limited

Reference No. 23595269-001-R-Rev0-4100

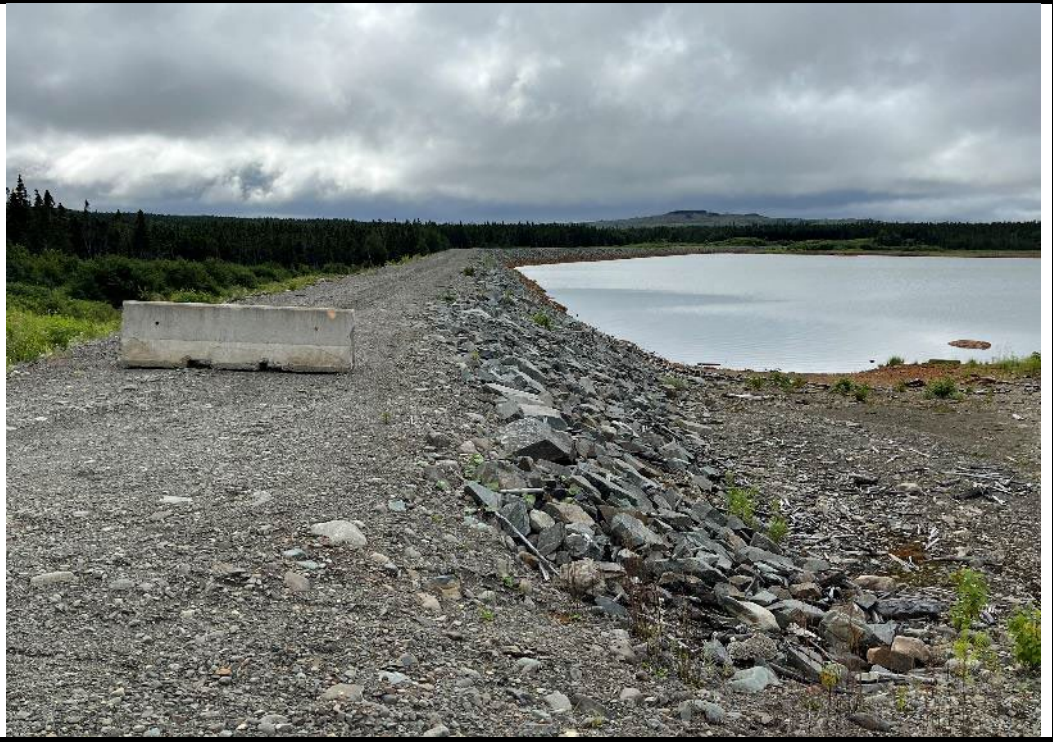
Photograph 2

Dam A upstream slope and
crest looking south from Sta.
0+800.

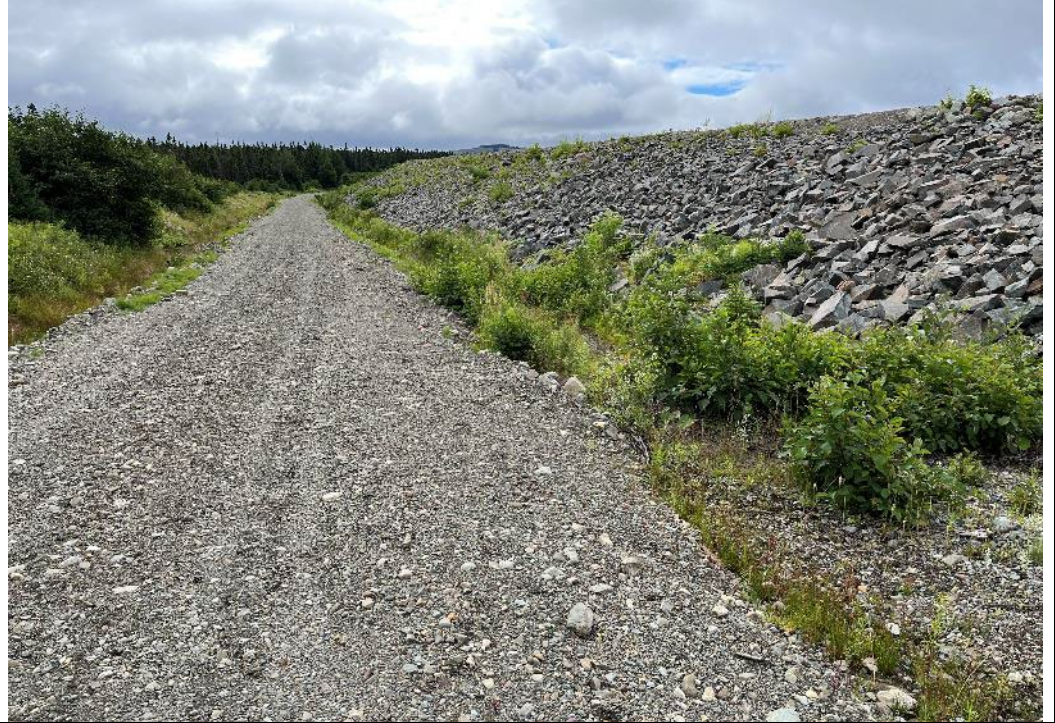
Photograph 3

Downstream slope of Dam A at 0+700.

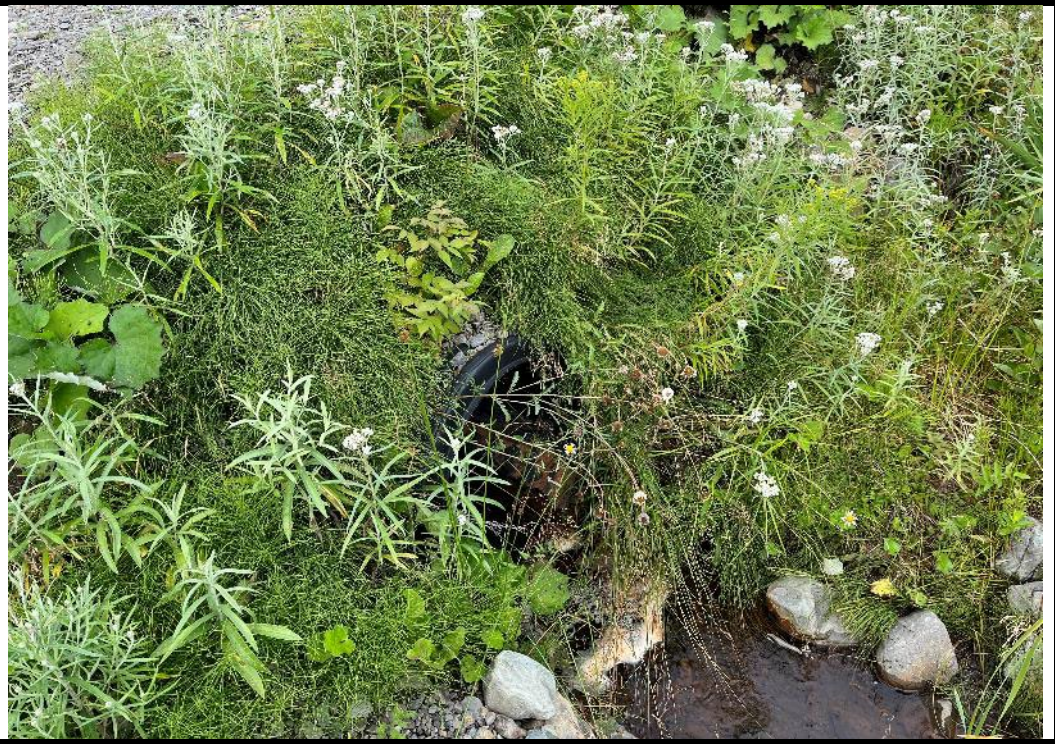
Photograph 4

Discharge from culvert beneath access road downstream of Dam A.

The flowrate was consistent with previous rates.

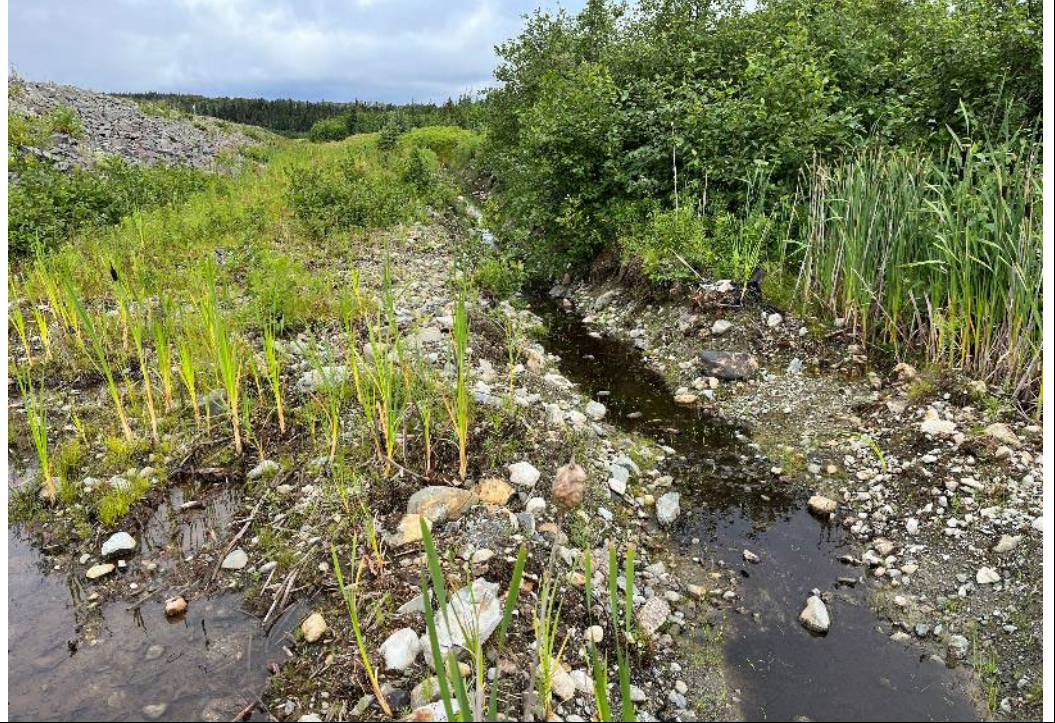
Photograph 7

Downstream toe of Dam A at Sta. 0+150. The collection ditch was cleared and the ditch was deepened in 2022 to improve drainage.

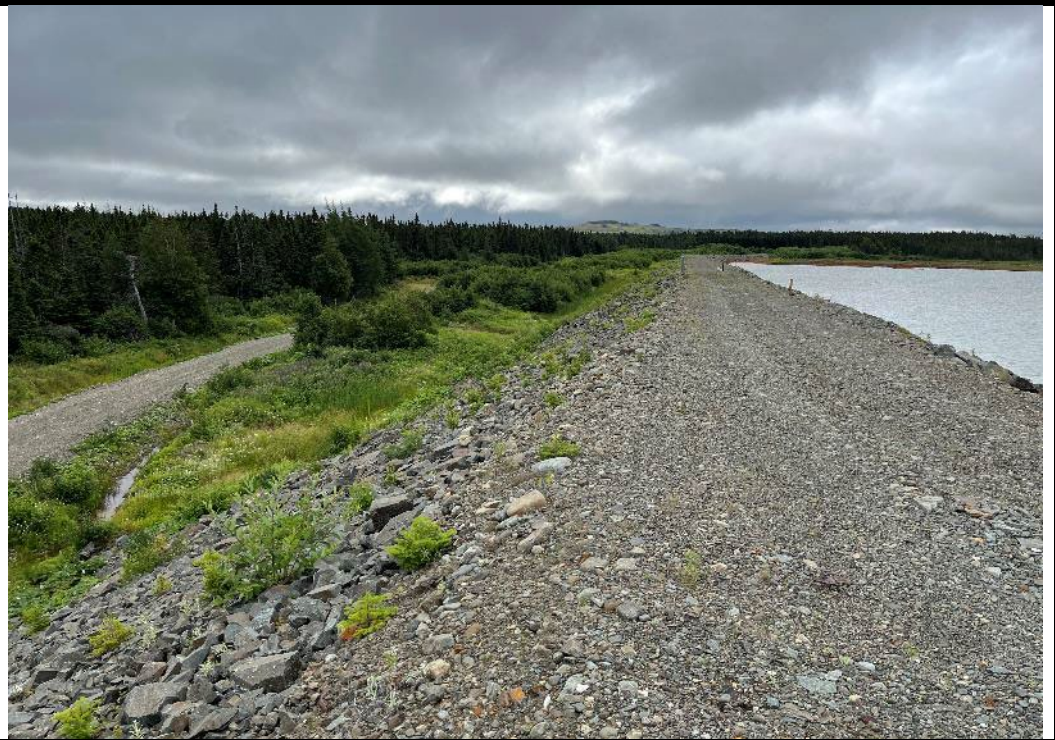
Photograph 8

Downstream slope of Dam A at Sta. 0+600 looking south.

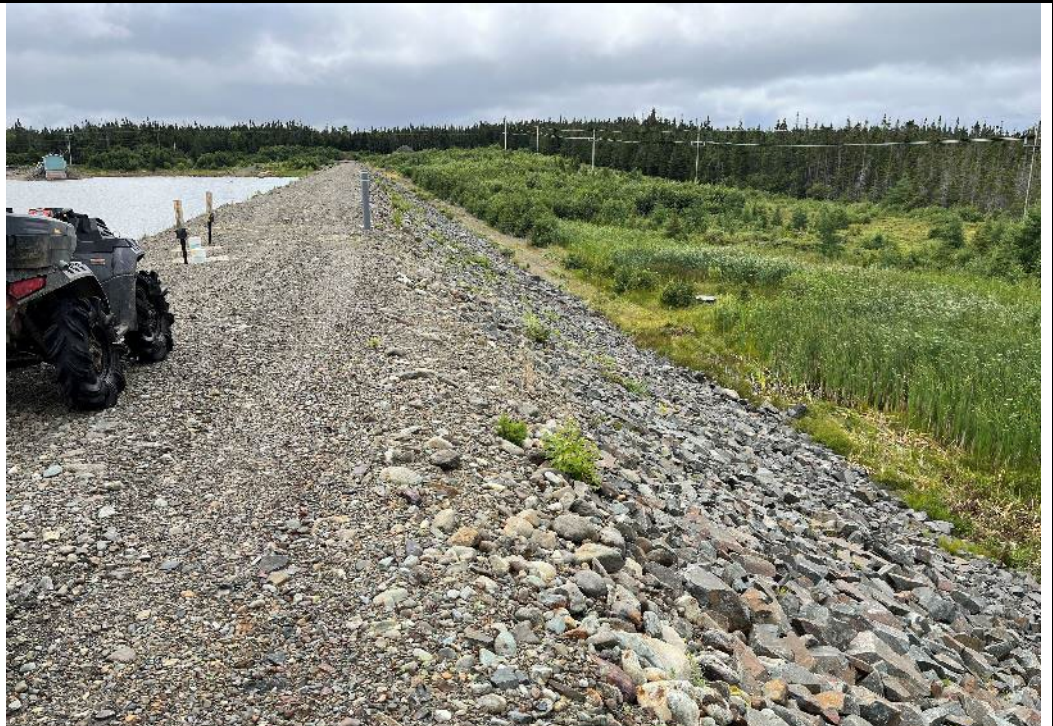
Photograph 3

Dam B crest and downstream slope looking south from Sta. 0+200.

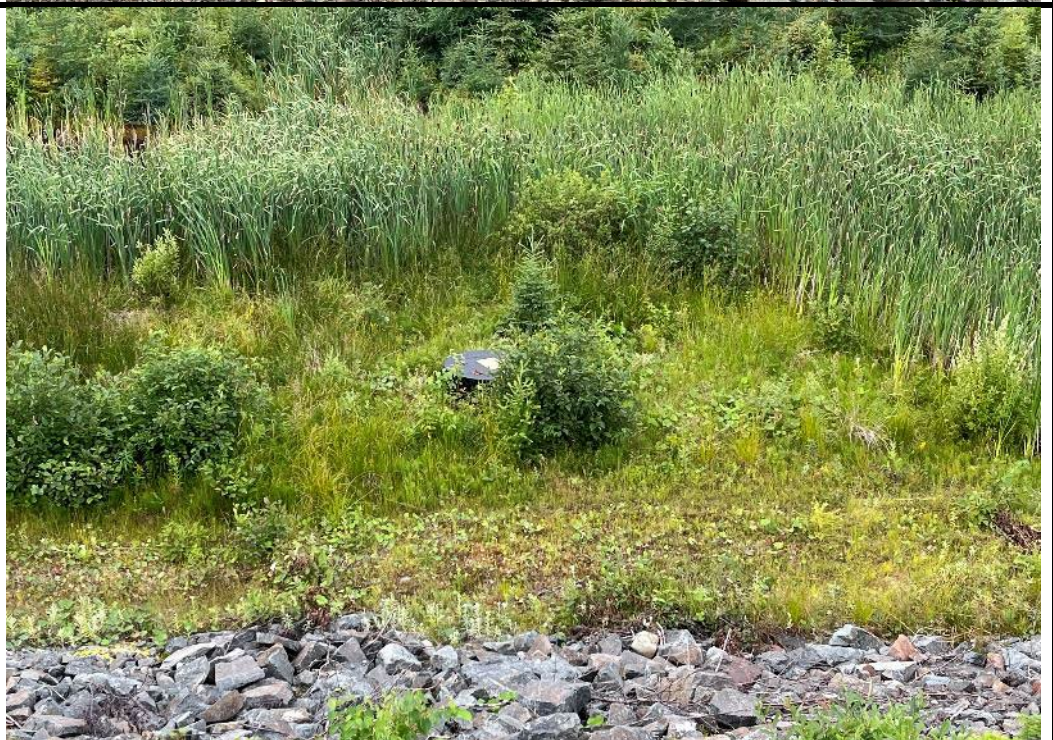
Photograph 4

Similar to previous years, a ponded area was observed at the toe near Sta. 0+250, adjacent to the seepage collection sump. The water coming out from the downstream shell accumulates in this pond before discharging between two overburden spoil piles into a channel that flows towards the Polishing Pond. The downstream toe area and pond have become overgrown with vegetation making seepage monitoring difficult, however, it appears the water is clear (i.e., free of sediment) with some signs of iron staining in the small pond. It was also observed that the channel leading towards the Polishing Pond has become partially blocked with vegetation and sediment accumulation. Teck should clear the downstream toe area of vegetation and clear the channel towards the Polishing Pond. The seepage rate, as observed at the access road downstream of Dam B was consistent with observations in previous years and the seepage reports to the Polishing Pond.

Downstream toe and Dam B seepage collection sump. Seepage and local runoff accumulate at this location and then migrate through the wetland and channel towards the Polishing Pond.

Dam B	2023-04	Overgrown vegetation at the downstream toe of Dam B and sediment accumulation in the channel leading towards the Polishing Pond is limiting the ability to monitor seepage and causing ponding at the toe.	Clear the downstream toe area of vegetation and clear the channel towards the Polishing Pond of sediment to provide better observation of seepage conditions.	New item. To be completed before the end of 2025.	3
Dam C	2023-05	During replacement of the discharge weir intake structure in 2022, rip rap on the upstream slope of Dam C was disturbed.	Place additional rip rap on the upstream slope of Dam C adjacent to the intake structure to reinstate original conditions.	New item. To be completed prior to 2024 AFPR site visit.	3
Internal Berm 2	2023-06	Haul traffic crossing Berm 2 at the north abutment in 2022 has caused about 0.15 m of displacement to the crest.	Teck shall repair the crest once placement of mining impacted soils is complete in the TMA.	New item. To be completed prior to 2024 AFPR site visit.	3

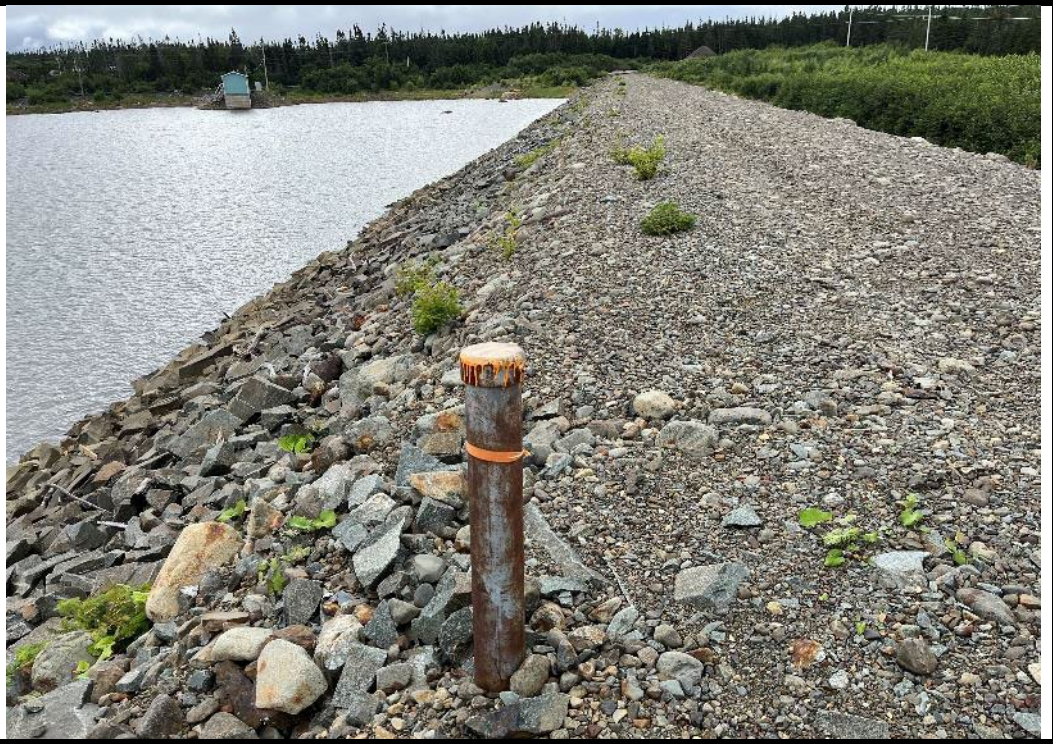
Photograph 6

Surface casing over the Dam B settlement plate located at Sta. 0+300 on the upstream edge or crest.

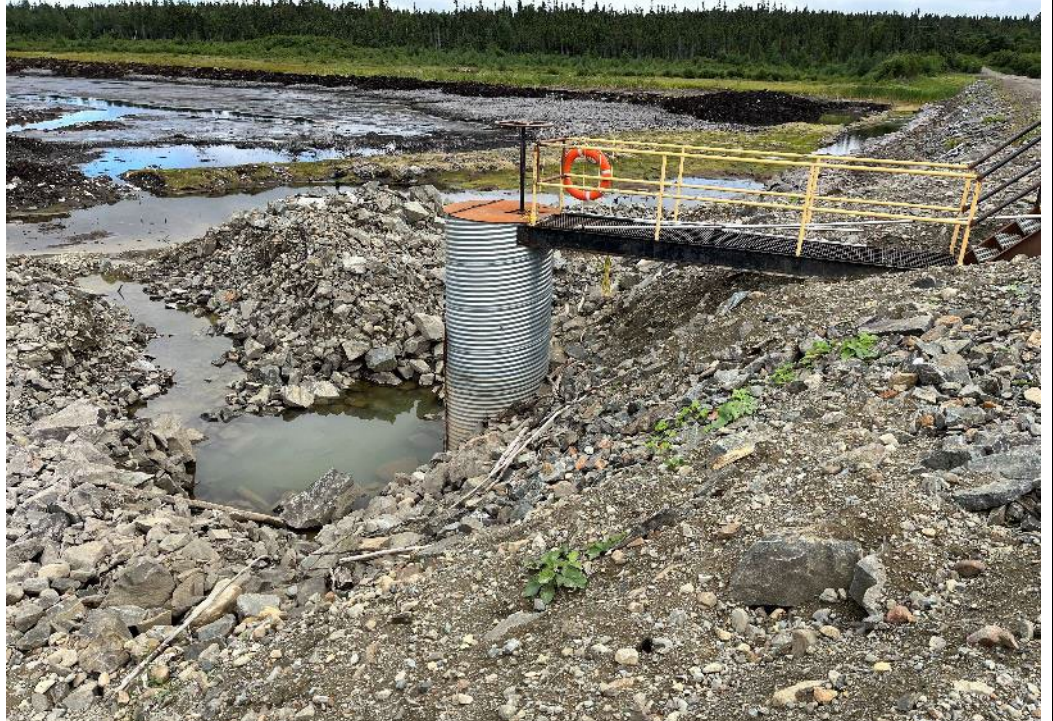
Photograph 3

Dam C decant tower inlet. The tower was replaced in 2022.

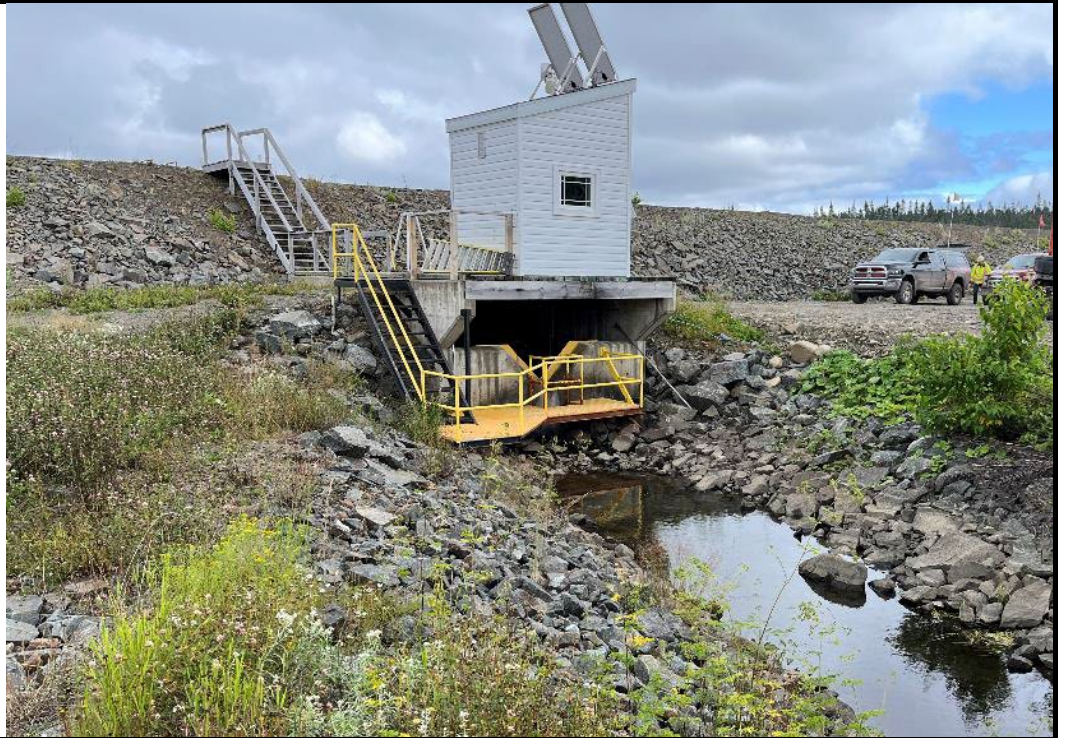
Photograph 4

Dam C hydraulic control structure. New stairway installed in 2022 to improve access to the v-notch weir.

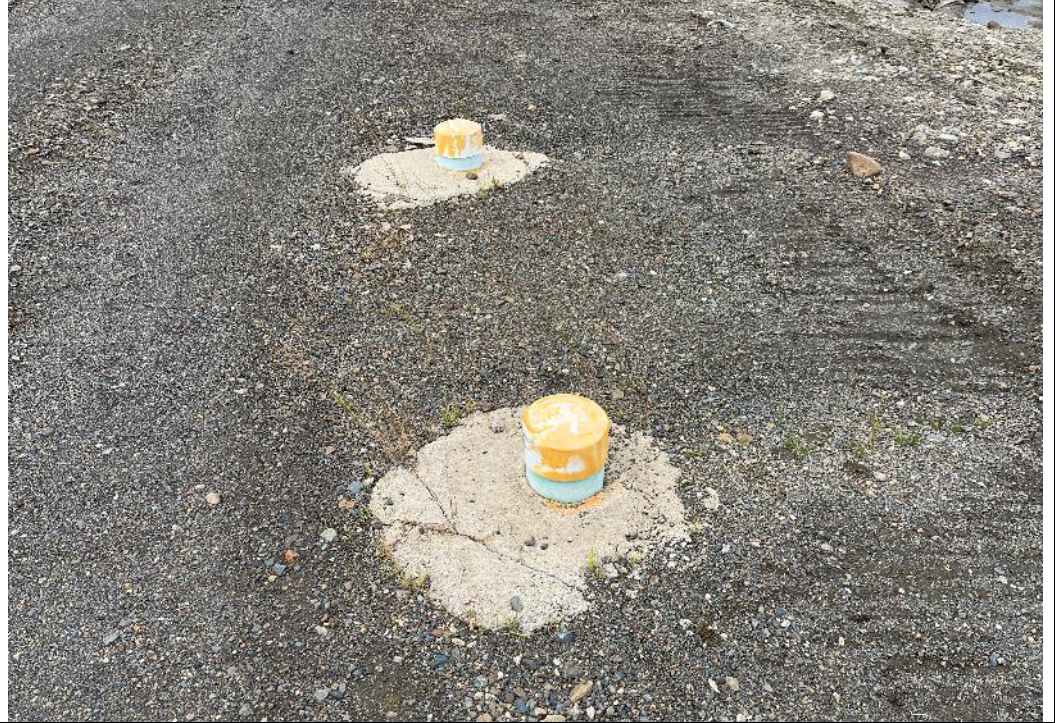
Photograph 5

Piezometer surface casings on the crest of Dam C at Sta. 0+200 (raised in 2019).

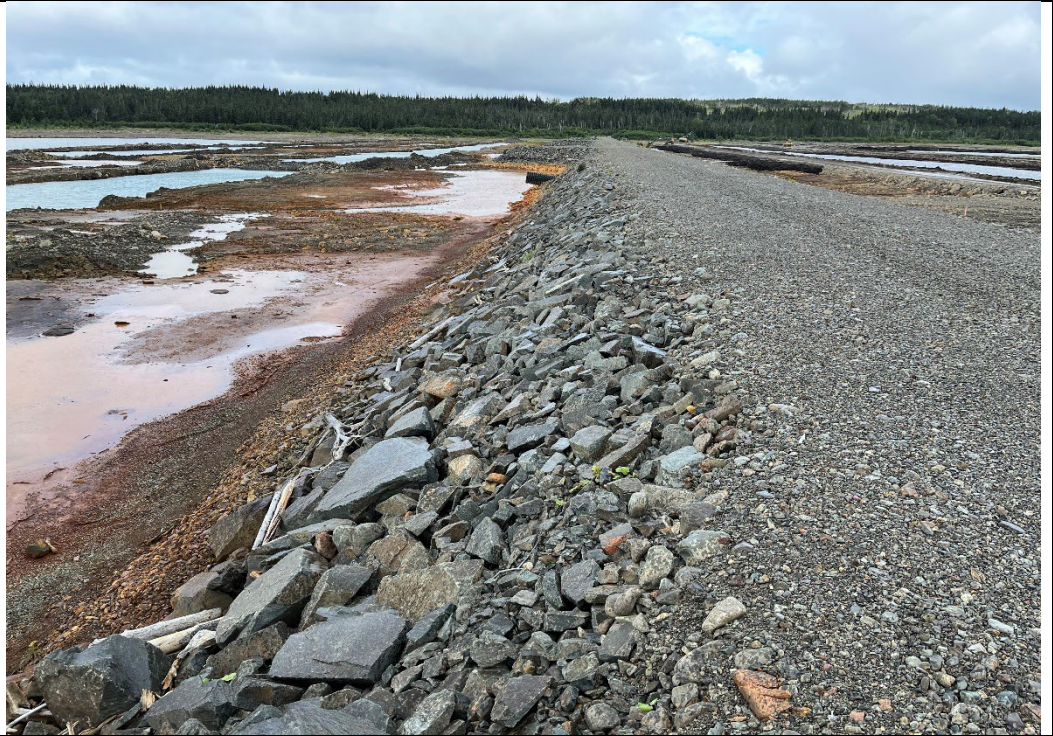
Photograph 4

Berm 2 looking north from south abutment. HDPE culvert connecting Cells 2 and 3 is observed through the berm in the background.

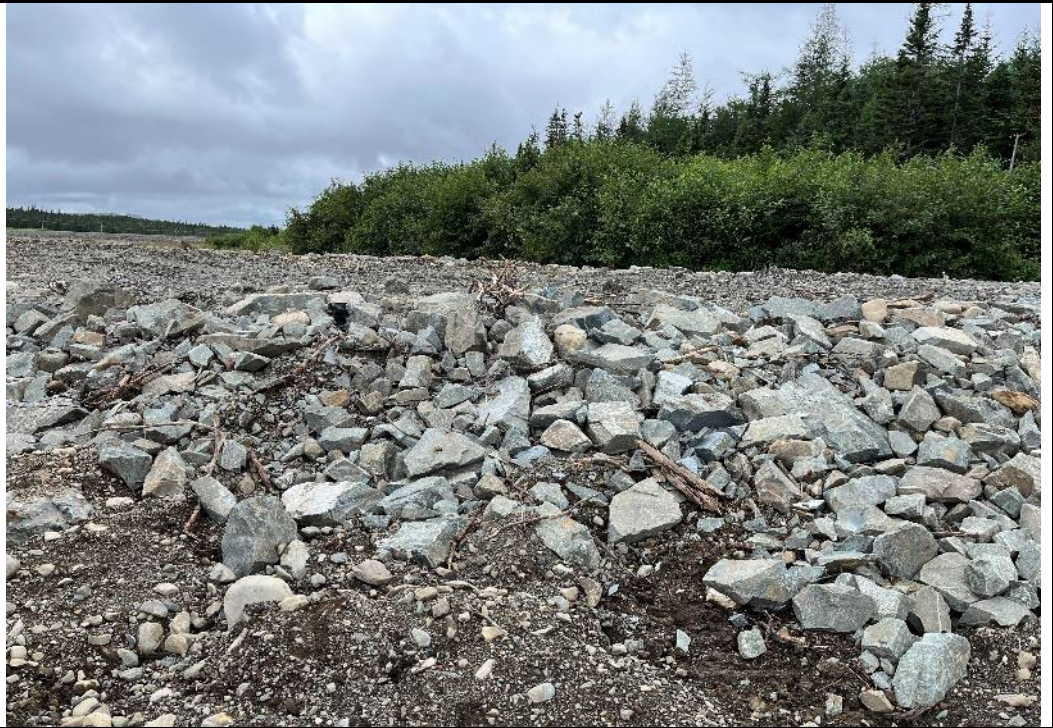
Photograph 9

North abutment of Berm 3 that was repaired in 2023 following 0.15 m of displacement from haul trucks.

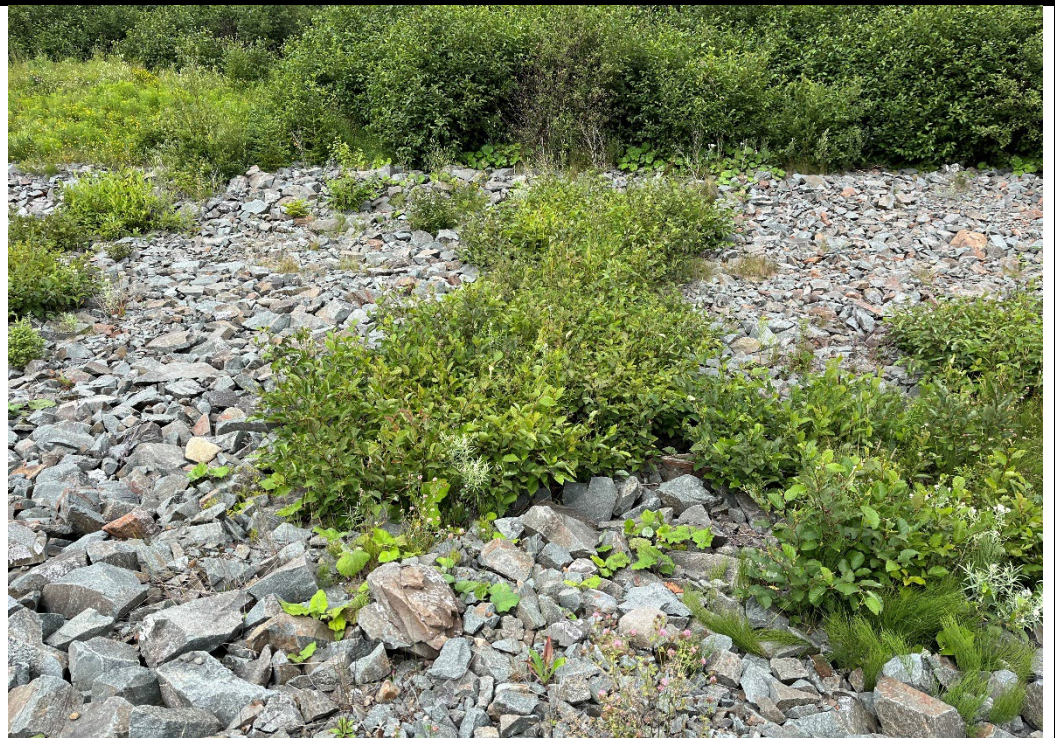
Photograph 2

Dam C Emergency Spillway concrete sill becoming overgrown with vegetation.

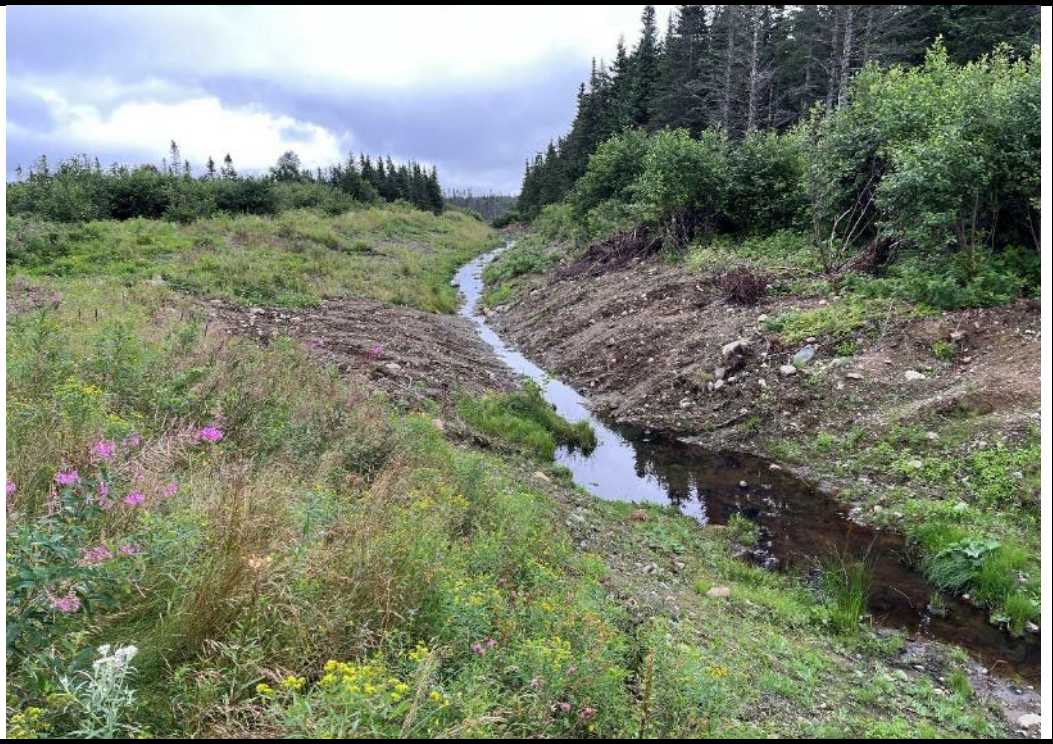
Photograph 4

Diversion Ditch A2 at Sta. 0+350 looking east. Culvert and berm were removed from this section of the ditch in 2023.

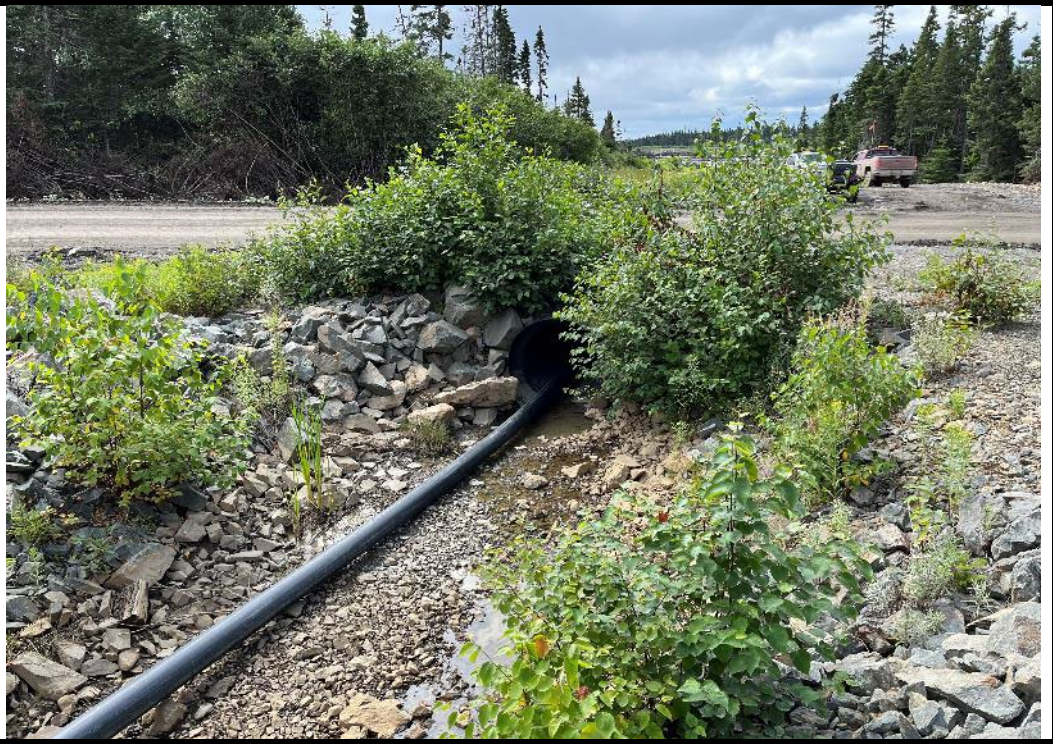
Photograph 2

Culvert inlet on Discharge Ditch at Sta. 0+225. The culvert was temporarily sleeving the Polishing Pond Dewatering pipeline.

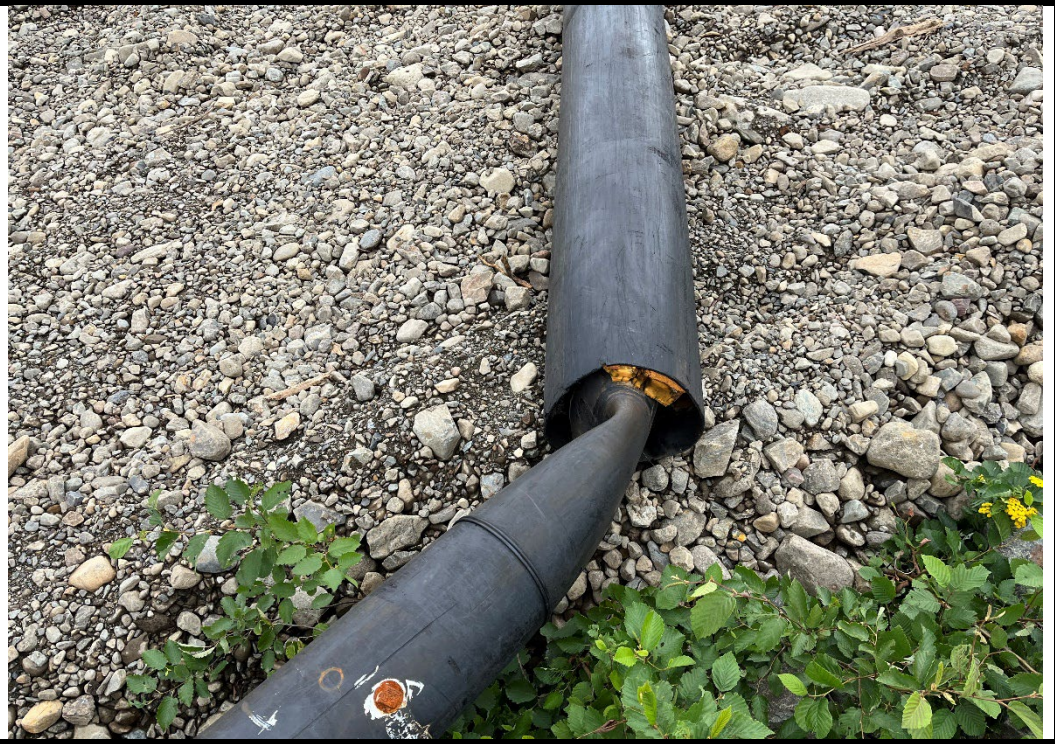
Photograph 6

Structure	ID Number	Deficiency or Non-Conformance	Recommended Action	Status	Priority ^(a)
Pipelines	2023-08	The water treatment pipeline near the south abutment of Berm 3 was observed to be bent and crimped.	The pipeline should be straightened or replaced to maintain flow capacities.	New item. To be completed prior to 2024 AFPR site visit.	3

Water treatment pipeline at south abutment of Berm 3 has become pinched and should be straightened to maintain flow capacity.
