# **2023 ANNUAL FACILITY PERFORMANCE REPORT - LOUVICOURT**

**TECK RESOURCES LTD.**

**WSP Canada Inc.**

CA0005174.2774 RA-Rev0-TSF Inspection 2023

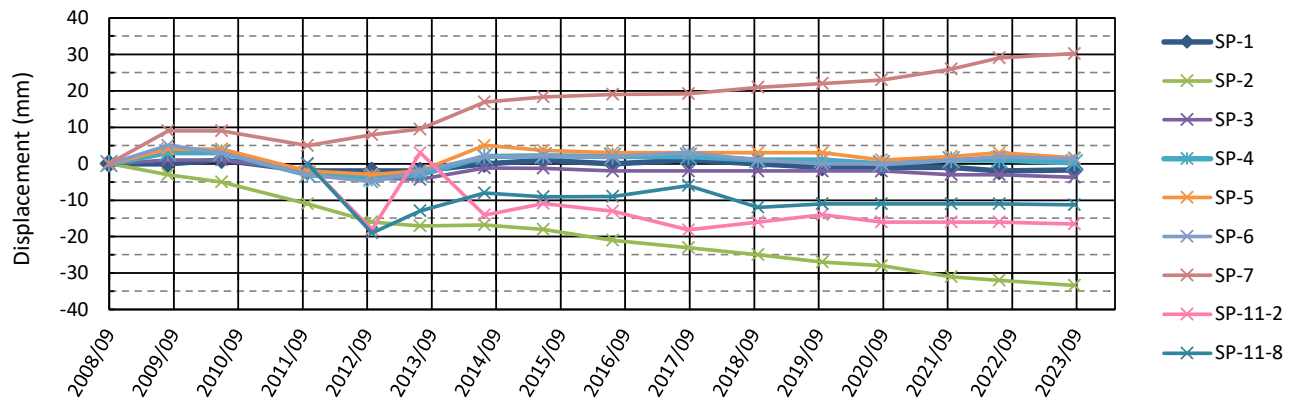
**Figure 5 : Vertical Displacement of the Survey Monuments at Dam 1**

- SP-2 (crest), located in the center part of Dam 1D, shows the maximum downward total displacement along Dam 1, i.e., 33 mm, and an incremental movement of 1.4 mm relative to 2022. This settlement point shows consistent minor downward displacement. This settlement point shows a pattern of annual downward displacement of about 2 to 3 mm per year since 2008. Historical data indicates that the total settlement since the installation of this settlement point in 1993 is in the order of 0.7 m and that the ongoing settlements are likely caused by secondary consolidation (KCB, 2011).

- SP-7 at Dam 1A shows a pattern of year-over-year increase of elevation of the crest. This is inconsistent with the remainder of the instruments which show patterns of movement that are as expected, as shown on figure 5 after the text. This may suggest that SP-7 is subject to frost heave, which would in turn suggest that the installation is faulty. If frost heave is confirmed, that calls into question the reliability of all of the readings, since even a reading showing downward movement may actually be under-reporting the movement. If this trend continues, it may be required to replace this instrument. We note that SP-7 is located near the south end of Dam 1A where the embankment is very small and where the foundation conditions are either till or bedrock – so we would not expect ongoing movements.

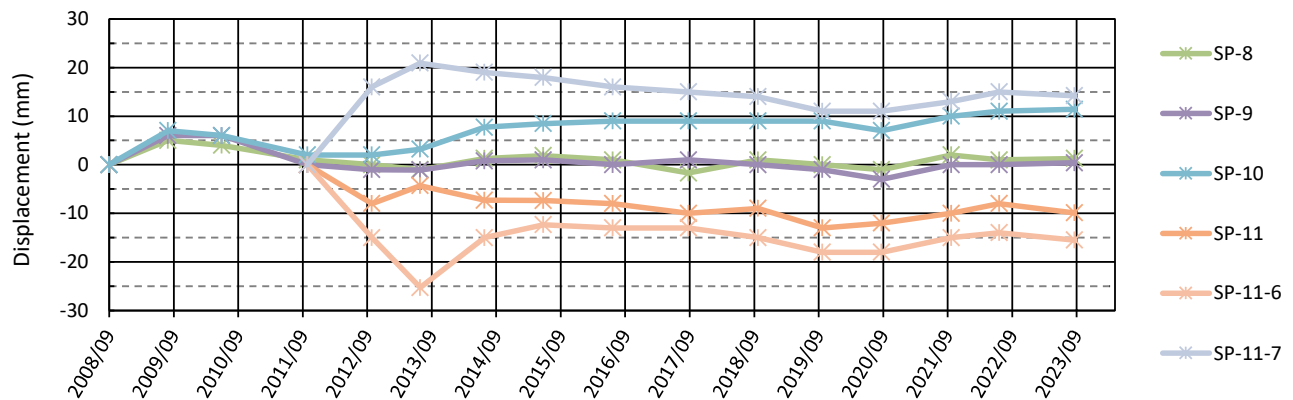
**Figure 6 : Vertical Displacement of the Survey Monuments at Dam 2**

- SP-11-6 (berm), located in the center of the south half of Dam 2B, shows the maximum downward total displacement along Dam 2 (i.e., 16 mm). No historical data prior to 2011 exist for this monitoring point. The settlement point does not show a pattern of annual downward displacement, though 1.5 mm was observed since the 2022 survey, but this is within the stated accuracy.

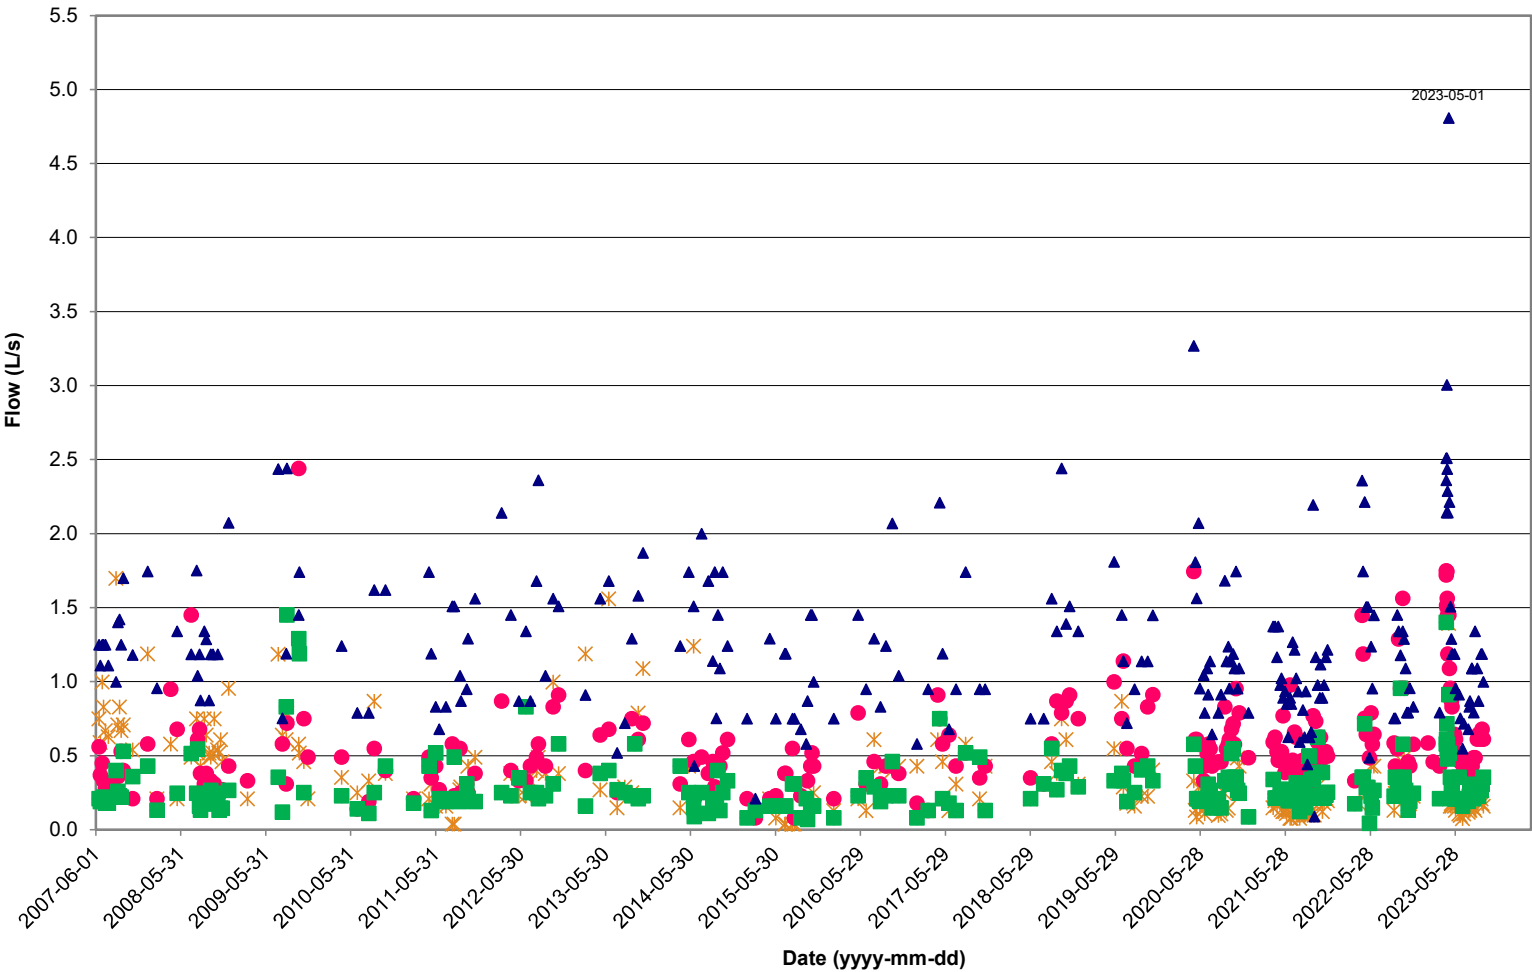
FIGURE 8

It is noted that some of the seepage flows from the embankments are not captured in the V-notch-weir network. Nonetheless, the seepage rates remain low and no pattern of increasing seepage flow is discernable (Figure 8). This is therefore considered to be within the expected range and does not indicate a dam safety concern. Two additional V-notch weirs are scheduled to be installed in 2024, one at Dam 2B and one at Dam 4B.

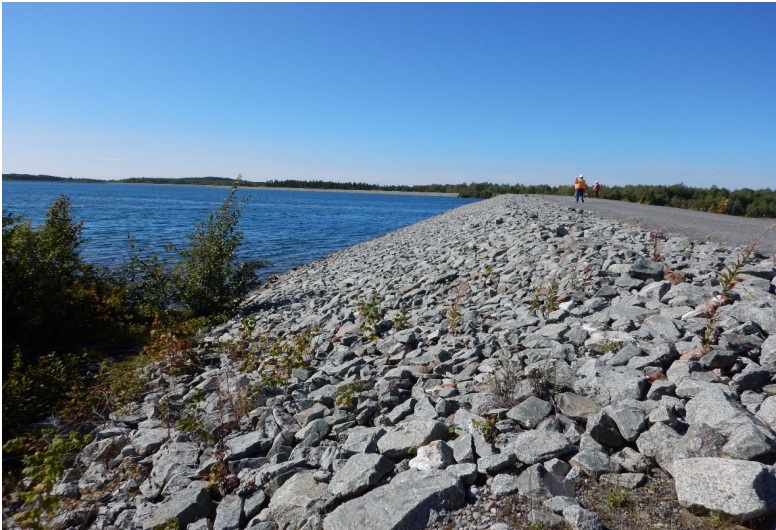
- The riprap on the upstream berms of Dams 1A through 1D, which was repaired with new riprap in 2019 and 2022 (Photographs 1 and 2) was unchanged from the previous inspection.

Photo 1 : Dams 1D – View of the upstream slope with riprap replaced.

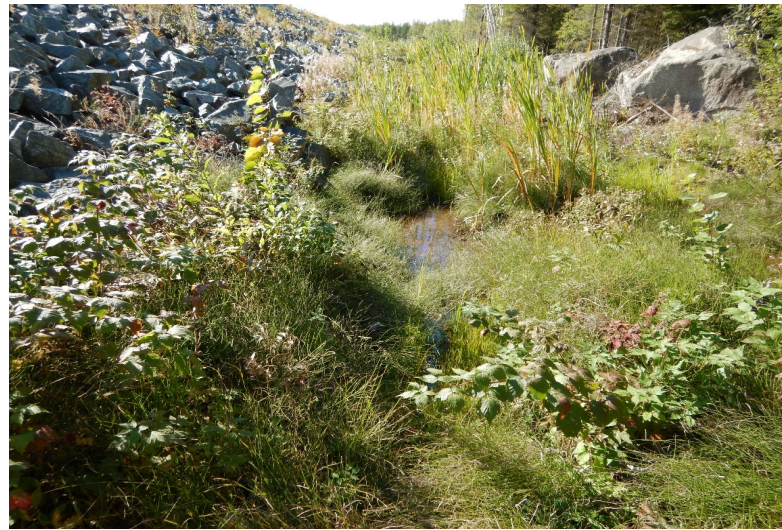
- Ponding water was observed at the toe of Dams 1A to 1E generally at the same locations as last year. Ponded water with little to no observable flow was visible near the toe of Dams 1A to 1C and 2B (Photograph 3). Seepage volumes did not appear significantly different than that under typical conditions; however, disturbance from tree removal equipment during 2022 has resulted in some ponding areas that were not readily visible in the past (Photographs 4 and 5). The locations of current and historic seepage points are presented on Figure 1.

Photo 3 : Ponded water with little to now observable flow at toe of Dam 1C. Similar flows occur on Dams 1A and 1B.

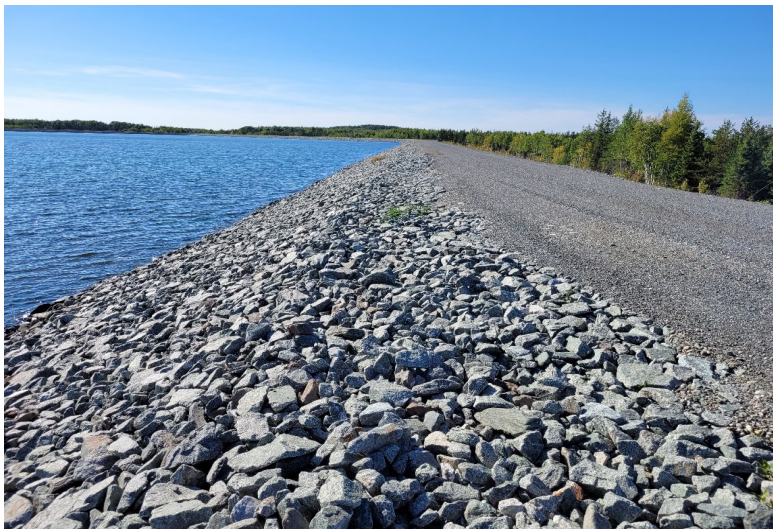
Photo 2 : Dams 1D – View of the upstream slope with riprap replaced. traffic gravel was placed on the crest.

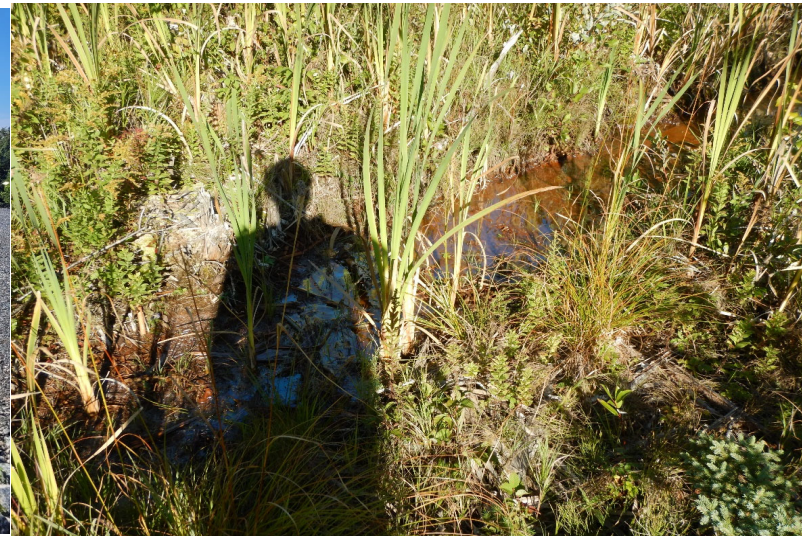
Photo 4 : Tree removal process resulting in ponded water at the toe of dam 1C

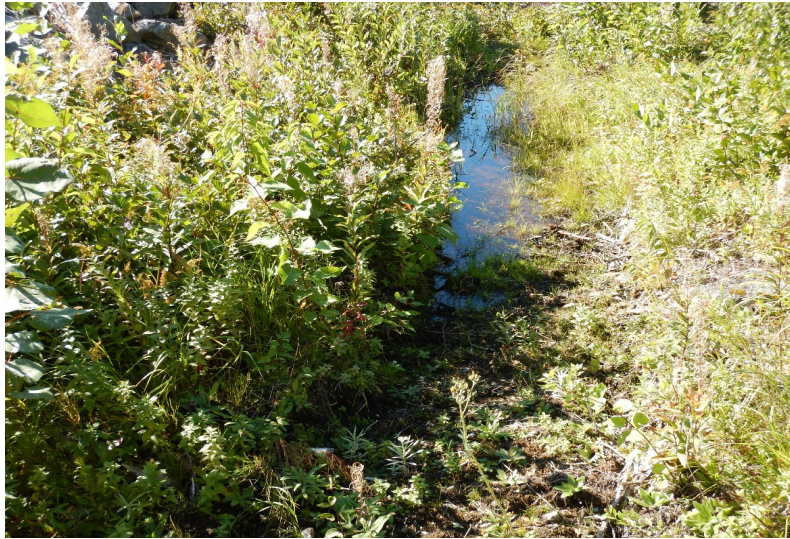
Photo 5 : Area of ponded water at the toe of Dam 1C, due to disturbance by tree removal equipment.

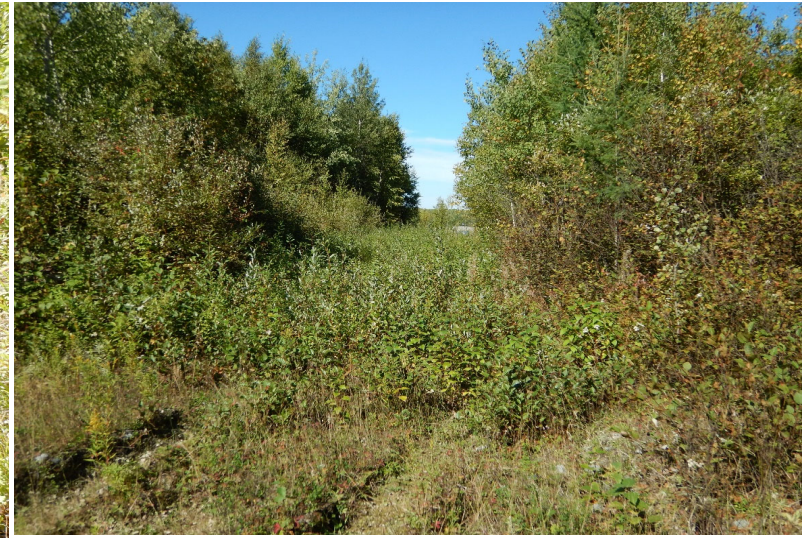
- The emergency spillway located between Dams 1D and 1E (denoted as the second emergency spillway of the TSF) was in good condition with limited vegetation growth. Vegetation in the downstream channel was cleared in 2022 (Photographs 6 and 7) and has historically been cleared every 2 years. This, it will likely require clearing again in 2024.

Photo 7 : View of downstream channel of second emergency spillway. Vegetation was controlled in 2022 and will require management in future.

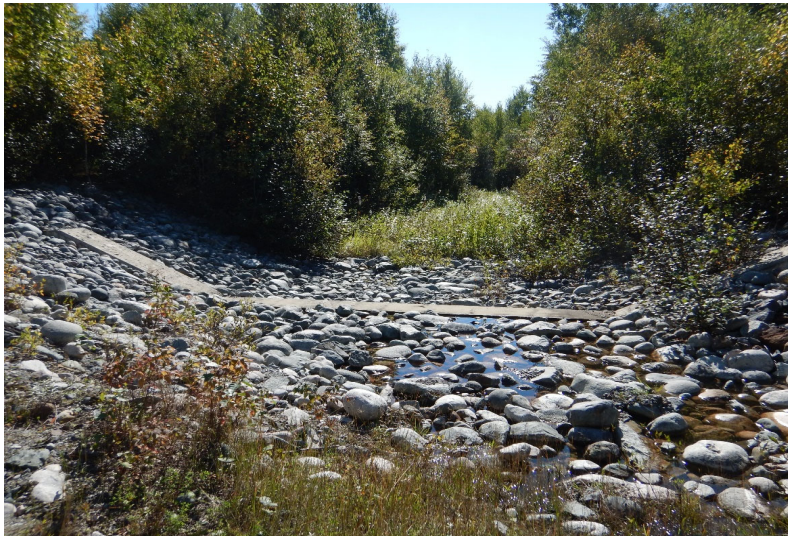
Photo 6 : Concrete weir of the second emergency spillway between Dams 1D and 1E at the TSF with approach channel in background. Good condition.

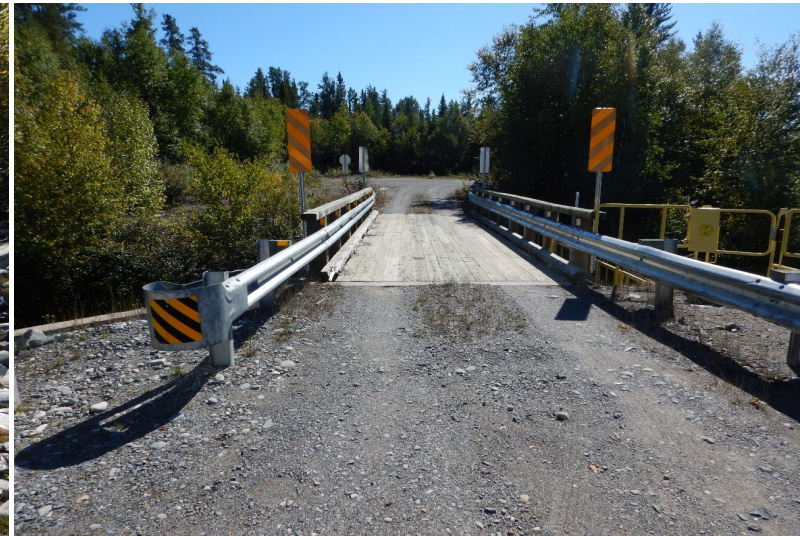
- The access bridge close to the TSF spillway was rehabilitated in 2018 and appears in good condition and unchanged from last year's inspection (Photograph 8).

Photo 8 : General view of the site access bridge. Unchanged from 2022.

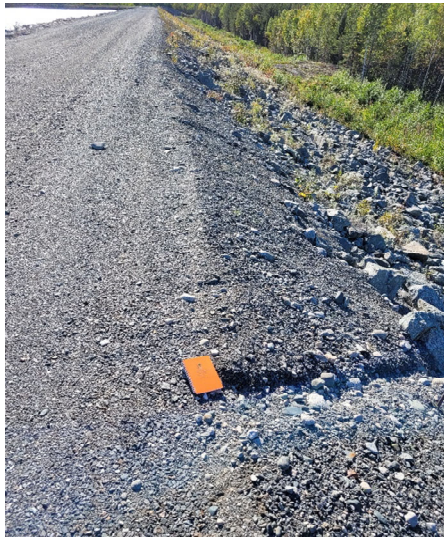
- Crest erosion was nominal (Photograph 9), and evidence of crest erosion repair was observed (Photograph 10).
- Vegetation at the downstream toe of Dams 1A, 1B and 1C was removed in 2022, resulting in improved visibility for inspection purposes (Photograph 11).

Photo 9 : Dam 1B - Minor crest erosion features will require maintenance in future.

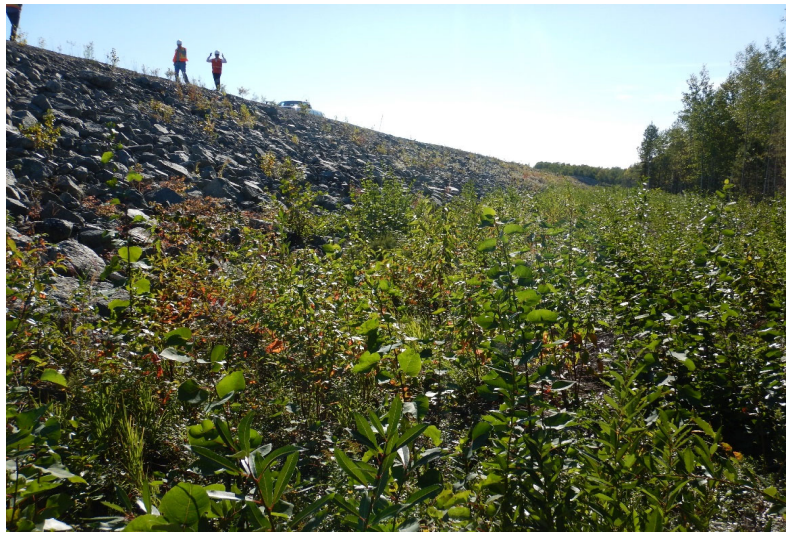
Photo 11 : Downstream slope of Dam 1B. Note trees have been removed for ease of access.

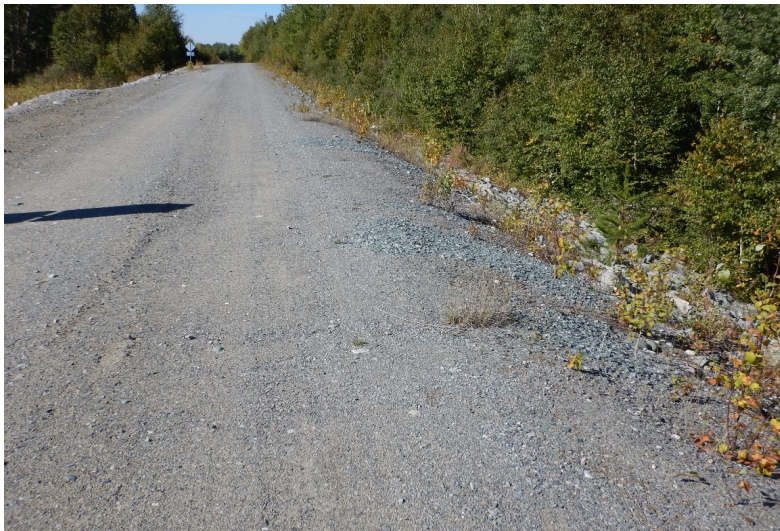
Photo 10 : Erosion features that have been infilled on the downstream shoulder of Dam 1E.

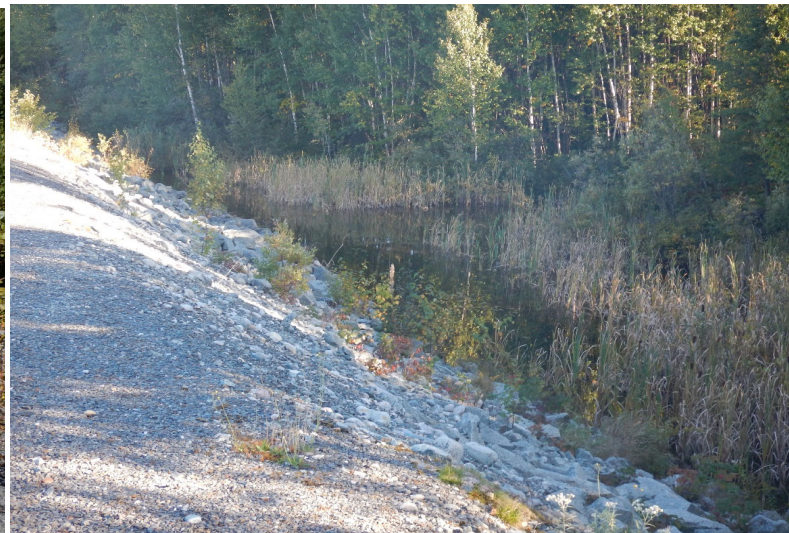
- Some stagnant water and low seepage were observed at the toe of Dam 2B representing the seepage points labelled 8 through 10, and reporting to V-notch 1 and V-notch 2 flow similar to previous years. The seepage water was clear.
- Stagnant water is observed at the toe of Dam 2B (Photograph 12). The extent of ponding appeared similar to that of 2022; it is noted that this area represents a zone where the natural topography drains towards the dam toe such that some accumulation at this location is expected.

Photo 12 : Dam 2A - Stagnant water at toe of Dam 2B.

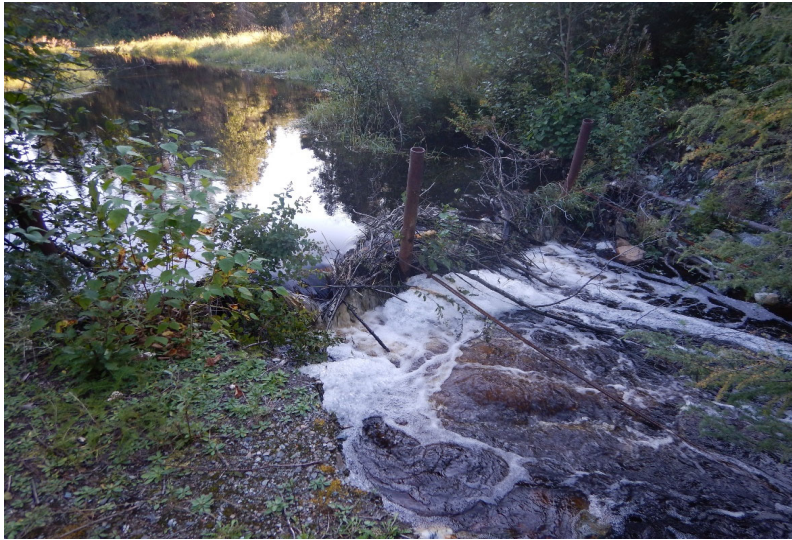
- The culverts, which are located across Unnamed Creek, just north and west of the tailings pond, and which were cleared of debris in 2019, were blocked again during 2023, which caused the flow to breach the adjacent road/earth fill just to the north of the culverts (Photograph 13). This breach location is in turn subject to beaver activity. The partial beaver blockage represents a condition which could change/deteriorate quickly and further, which renders this local access road impassable. Whereas these conditions are not currently impacting the stability of the TSF dams, this area should continue to be monitored in the event that water ponding approaches the TSF infrastructure.

Photo 13 : Unnamed Creek to the west of Dam 2B. Access road fill has been breached due to beaver blockage of culverts immediately to the west.

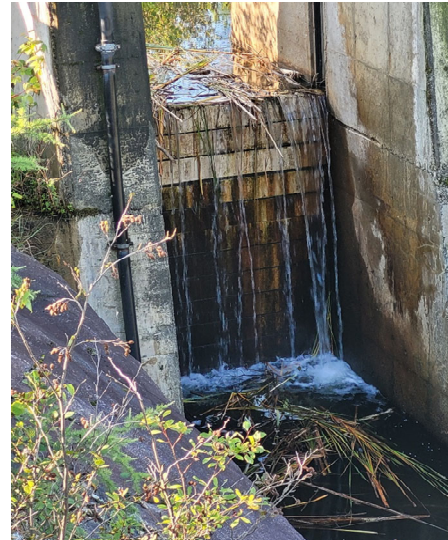
- Significant debris in the main spillway at Dam 4B observed during the 2022 inspection has been removed (Photograph 15). Although some reeds and grasses are visible in the spillway, no evidence of significant beaver activity was found at the time of the inspection. This area continues to be susceptible to beaver blockage, however, and should be monitored closely.

Photo 15 : Main spillway at Dam 4B - Significant debris observed during the 2022 inspection has been removed

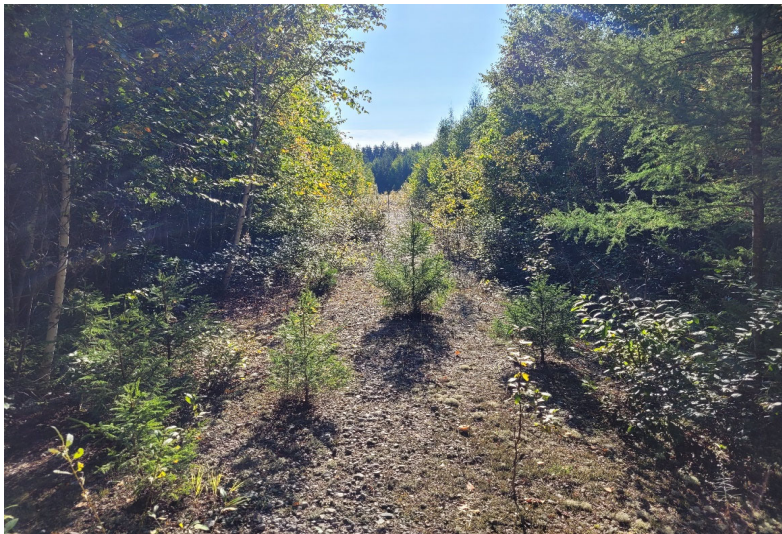
Photo 14 : Trees are continuing to encroach on the side slopes and crest of the Dam 4A embankment

- Trees are continuing to encroach on the side slopes and crest of the Dam 4A embankment (Photograph 14). These trees should be removed. A general rule is to remove any tree or shrub when the diameter of the trunk exceeds 50 mm. Given that Dam 4A does not impound water under normal operating conditions, clearing of the toe areas of this dam is not required.

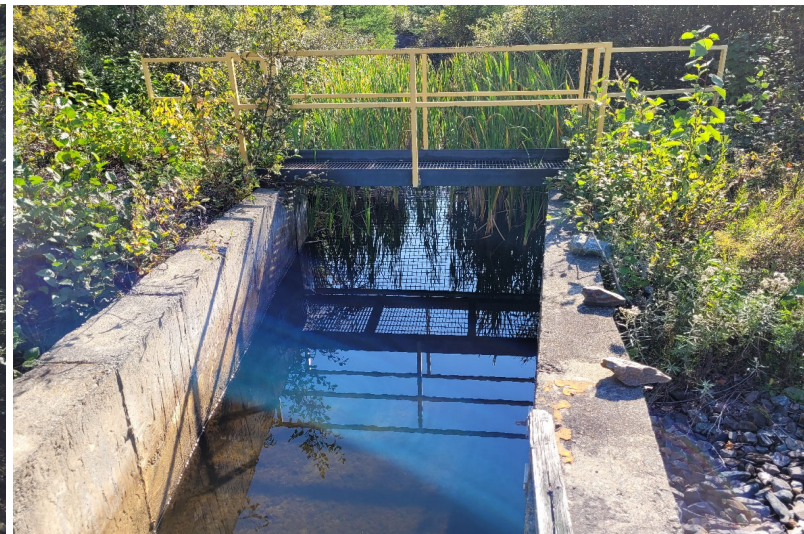
Photo 16 : outflow channel from the spillway to the Parshall flume contains significant vegetation

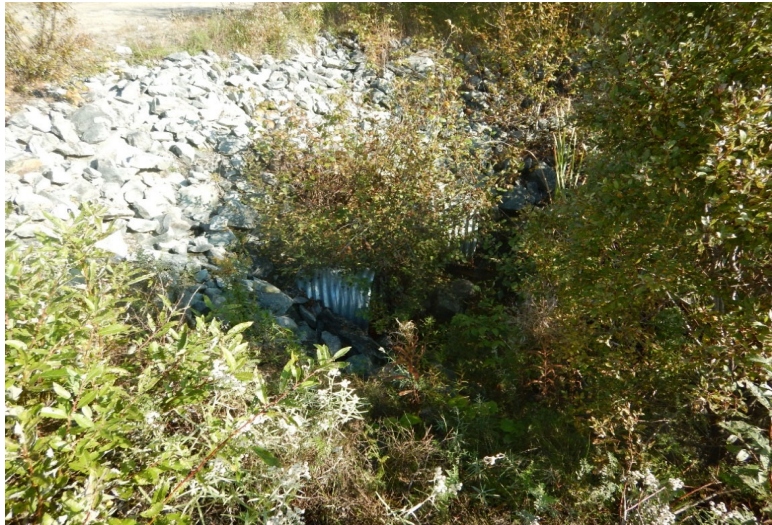
Photo 17 : Culverts at the final effluent point were clear although some limited vegetation is present upstream

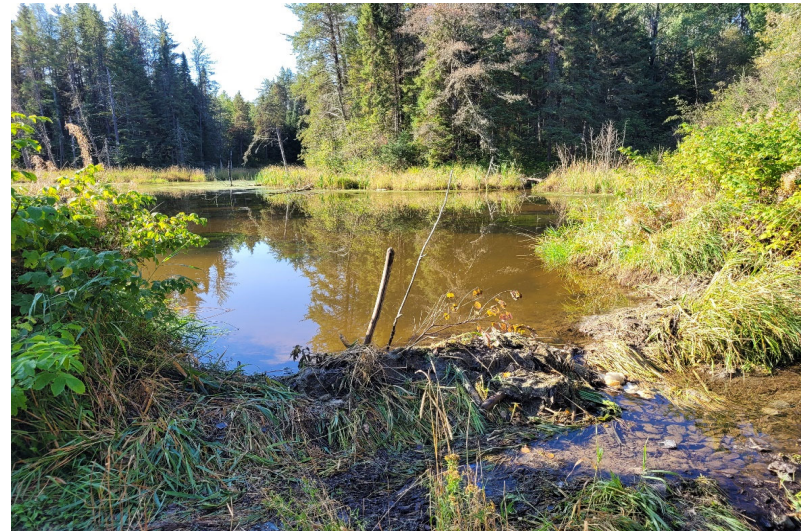
- Beaver activity historically observed at the toe of Dam 4B was not actively occurring (Photograph 19).

Photo 19 : Beaver activity historically observed at the toe of Dam 4B is not actively occurring. Continued monitoring is required.

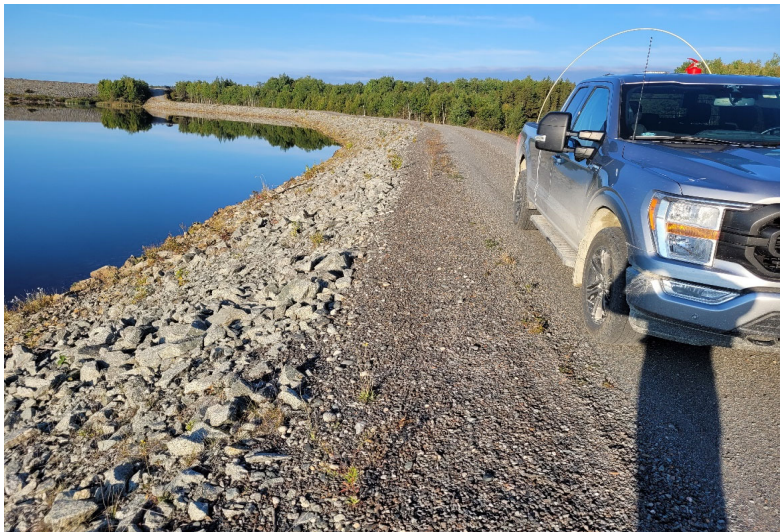
- The Dam 4B crest was generally in good condition (Photograph 18) and essentially unchanged from 2022. Survey monuments are visible. No noticeable changes were visually apparent (i.e., damage) to the survey monuments. Some general maintenance should be applied to remove excess geotextile which is exposed to the west of the emergency spillway.

Photo 18 : Dam 4B Crest unchanged from 2022.
