# **Teck Metals Ltd.**

## **Pinchi Lake Mine Tailings Storage Facility**

### ***2023 Annual Facility Performance Review***

September 7, 2023

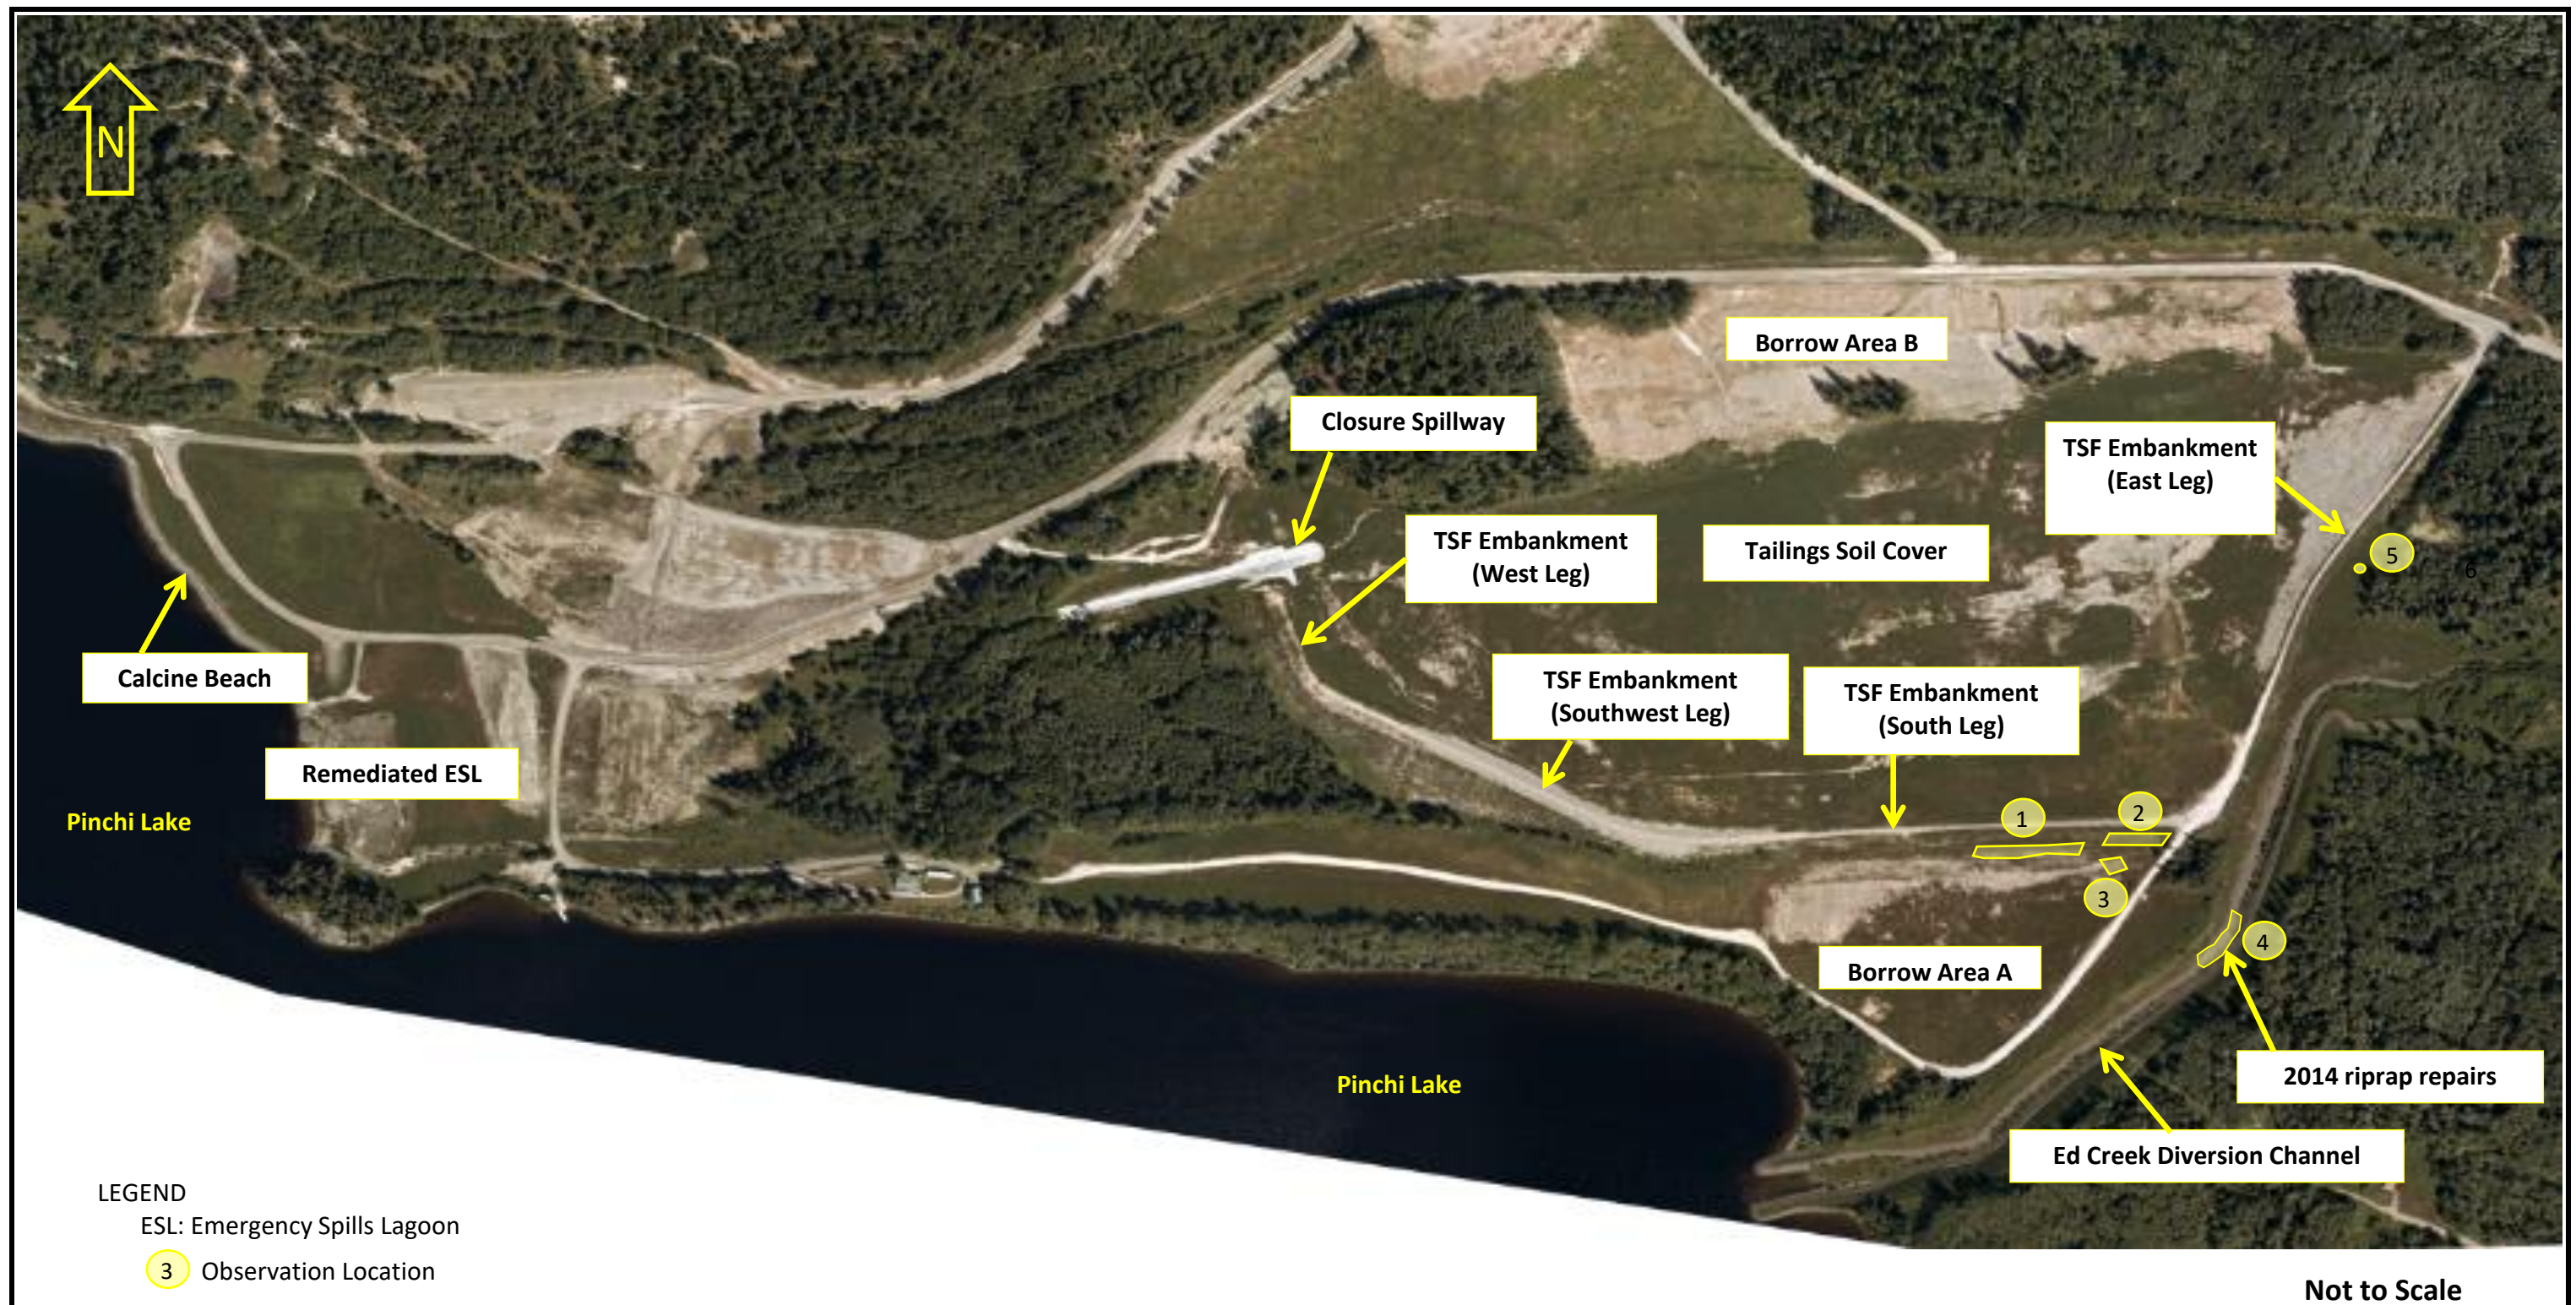
Klohn Crippen Berger</div></div>	PINCHI LAKE MINE TSF 2023 ANNUAL FACILITY PERFORMANCE REVIEW	
		TITLE	
		JUNE 2023 OBSERVATION LOCATIONS	
		PROJECT No. M07728A39	FIG No. 4.1

- Cracks were observed on the slope from 2013 to 2017 (Location 1 in Figure 4.1) and in 2020 (Location 2 in Figure 4.1). Measurements of crack movements were taken from 2015 to 2018 using metal rods installed on either side of the cracks (Photo II-29), but these measurements showed no ongoing movements and were discontinued in 2019. The cracks are no longer visible due to vegetation growth and are not a TSF safety concern. Nevertheless, this area will continue to be monitored during routine inspections as per the OMS Manual.
- The toe of the borrow area slope was generally dry, with one area of wet ground observed in the northeast corner (Location 3 in Figure 4.1; Photo II-30); similar wet areas have been observed since 2011 and are believed to be associated with groundwater unrelated to the TSF.

- The riprap along a small section of the channel (Location 4 in Figure 4.1; Photo II-36), where a depression had formed in the riprap surface, was replaced in 2014. This riprap appeared to be in good condition.

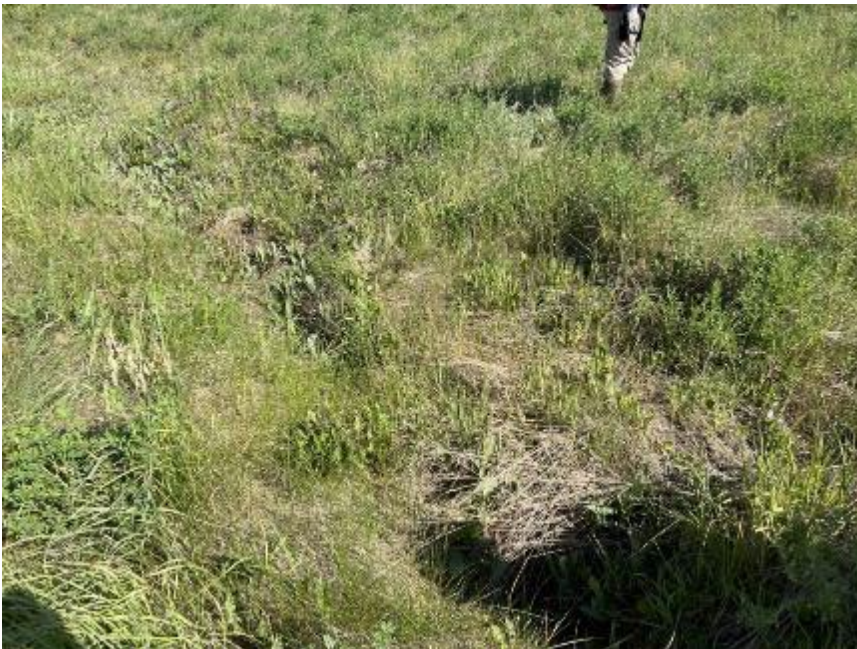
- The Tailings Impoundment was observed from the embankment crest, and by walking 150 m north from the southwest leg across the soil cover.
- There was no standing water in the Tailings Impoundment at the time of inspection. No water was observed at the entrance to the Closure Spillway (see Photos II-19 and II-20 in Appendix II). There is a drainage channel on the cover that directs flow from east to west towards the Closure Spillway. No standing water was observed in the channel.
- The soil cover on the tailings is covered in grass (Photos II-1 to II-3, II-8, and II-10). No signs of erosion, large ponds, or deformation of the cover were observed. There are local low areas in the cover with no signs of erosion or exposed tailings (Photo II-2); these have likely been present since construction.

**Photo II-2**      **Tailings Impoundment – Local depression on cover. No signs of erosion or standing water in low spot**

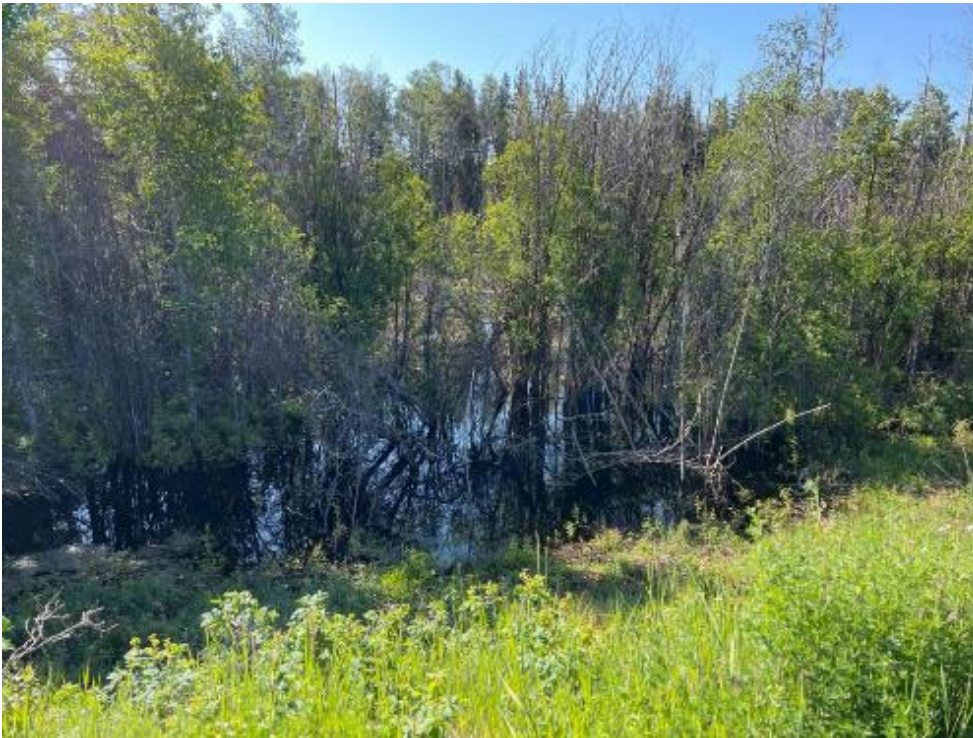
- A pond was observed in the trees near the toe of the east leg of the TSF Embankment (see Figure 1.2 for location; Photo II-5) as in previous inspections. This pond is located near a drainage channel that was shown on historical drawings of the TSF (see Appendix IV) and labelled “runoff channel.” The channel ran parallel to the main Ed Creek channel, and was historically reported to join up with Ed Creek just inside the TSF. The pond appears to collect local runoff, and it now drains through a channel to the south and through a culvert into Ed Creek Diversion Channel. The pond level was slightly higher than was observed during inspections prior to 2021 due to the beaver dam noted below.

**Photo II-5      TSF Embankment – East leg, pond near toe**

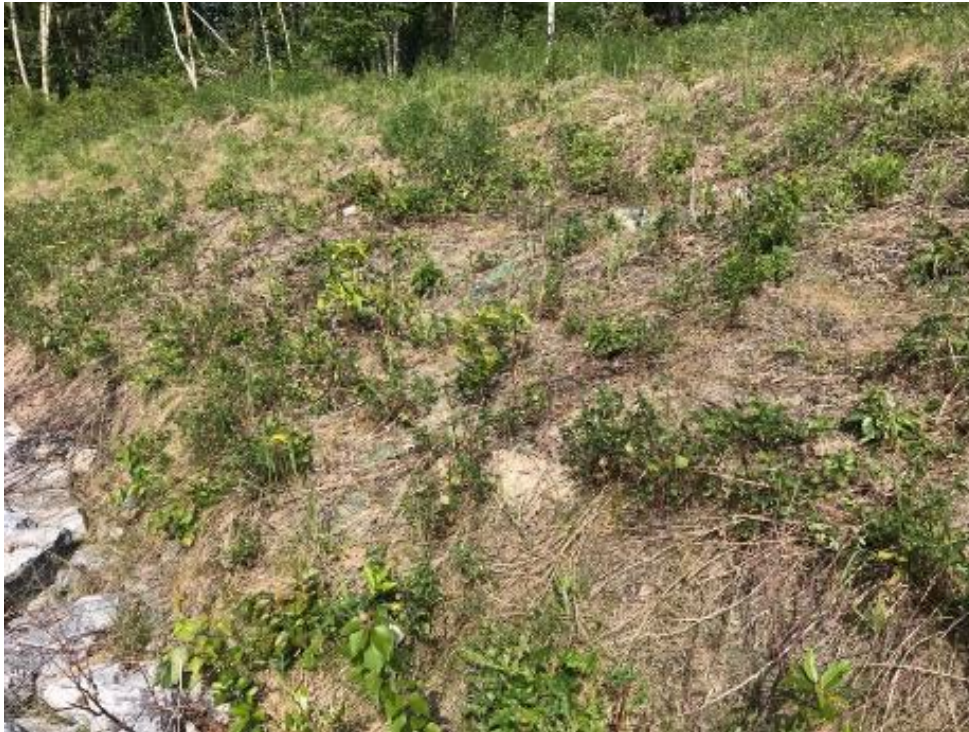
**Photo II-23    Closure Spillway – Slump feature looking north on right bank of spillway;  
no recent movement**

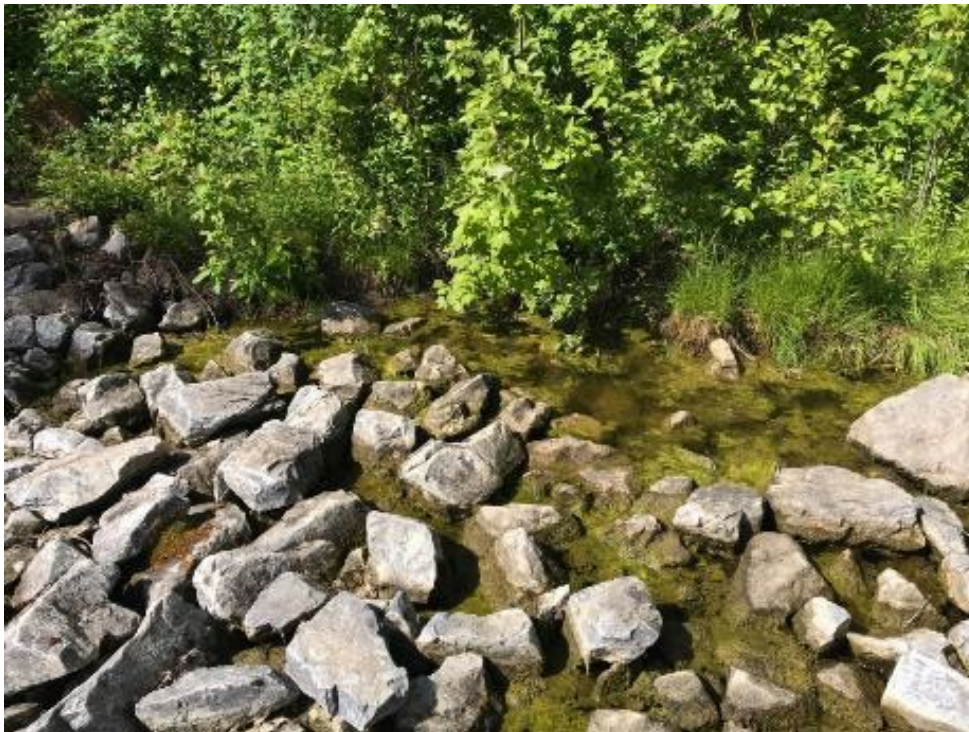
**Photo II-24    Closure spillway – Pond at downstream end of riprap**

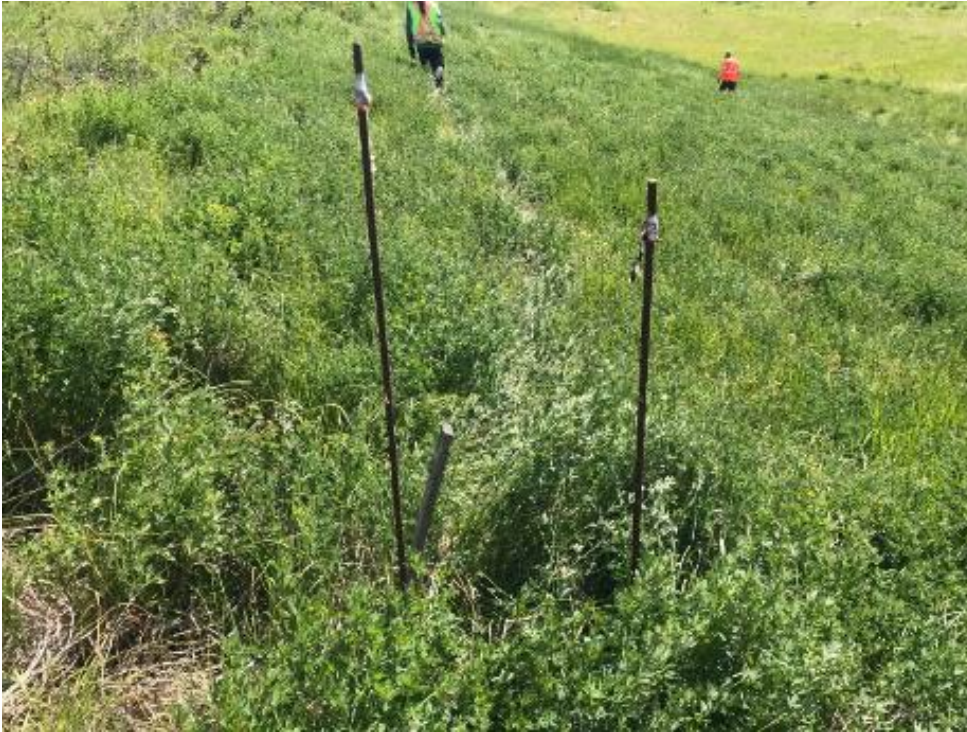
**Photo II-29 Borrow Area A – Crack monitoring rod**

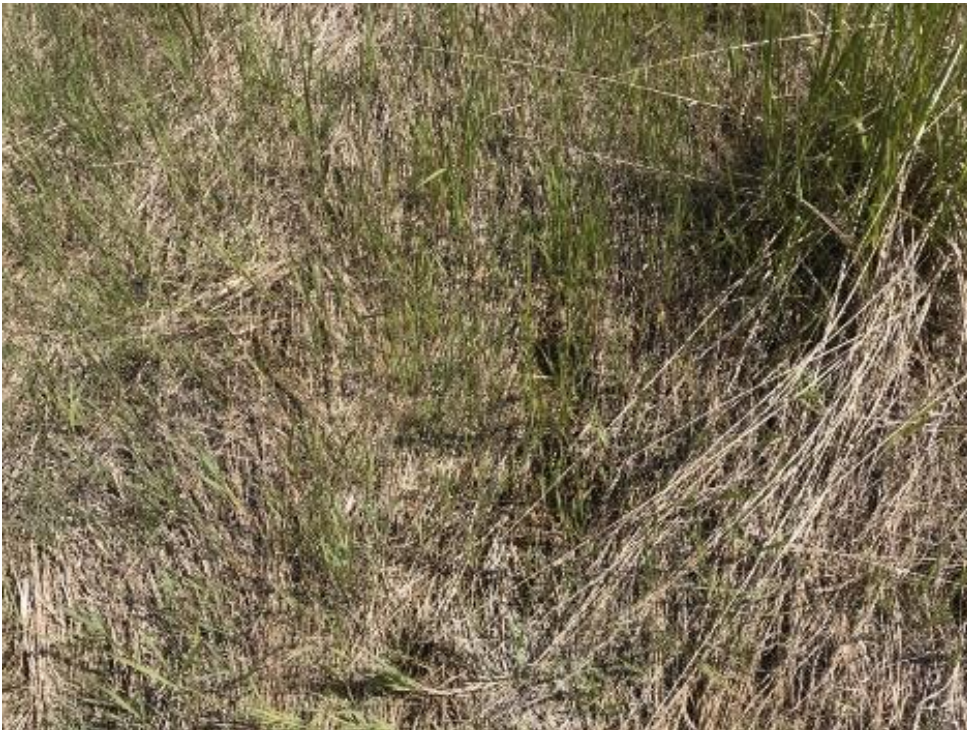
**Photo II-30 Borrow Area A – Wet spot in northeast corner**

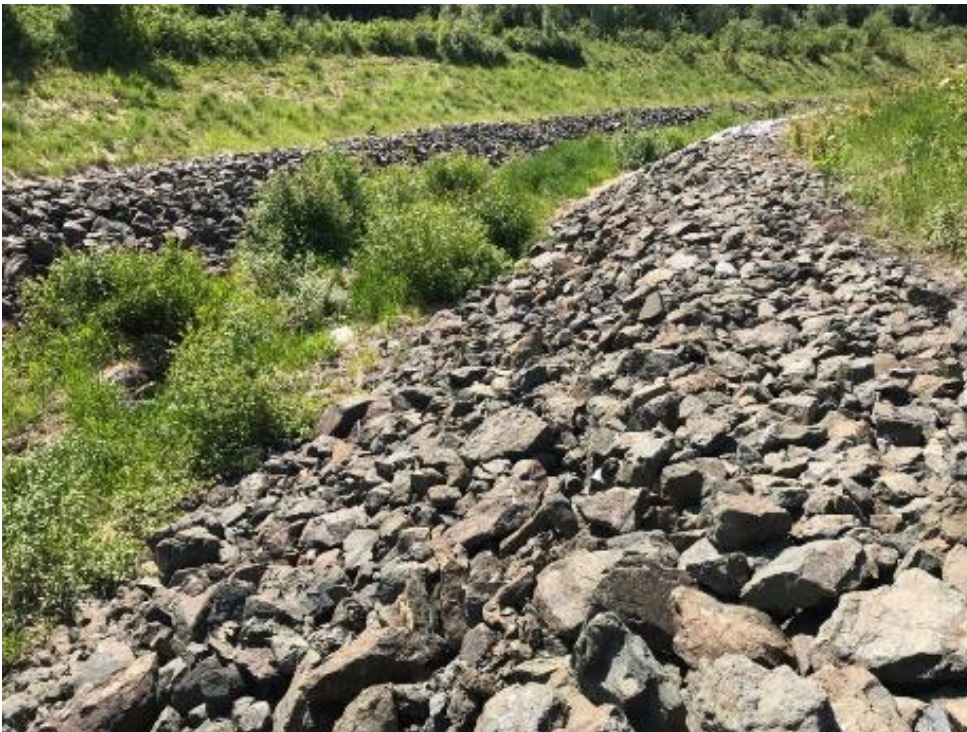
- Vegetation in Ed Creek Diversion Channel has grown to over 1.5 m height in some areas (Photo II-34). This is not currently a TSF safety concern. However, the vegetation management plan recommends vegetation clearing prior to the vegetation exceeding 1.5 m height (Spectrum 2017).

**Photo II-34 Ed Creek Diversion Channel – Looking downstream from between second and third bends**

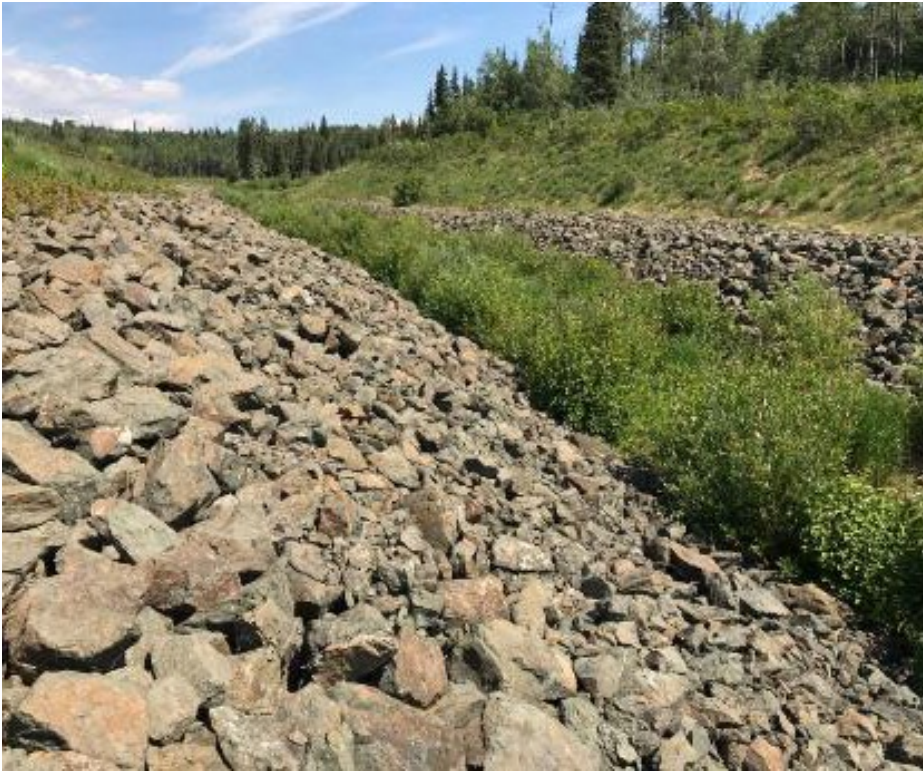
**Photo II-35** Ed Creek Diversion Channel – Vegetation in channel, looking upstream from between second and third bends

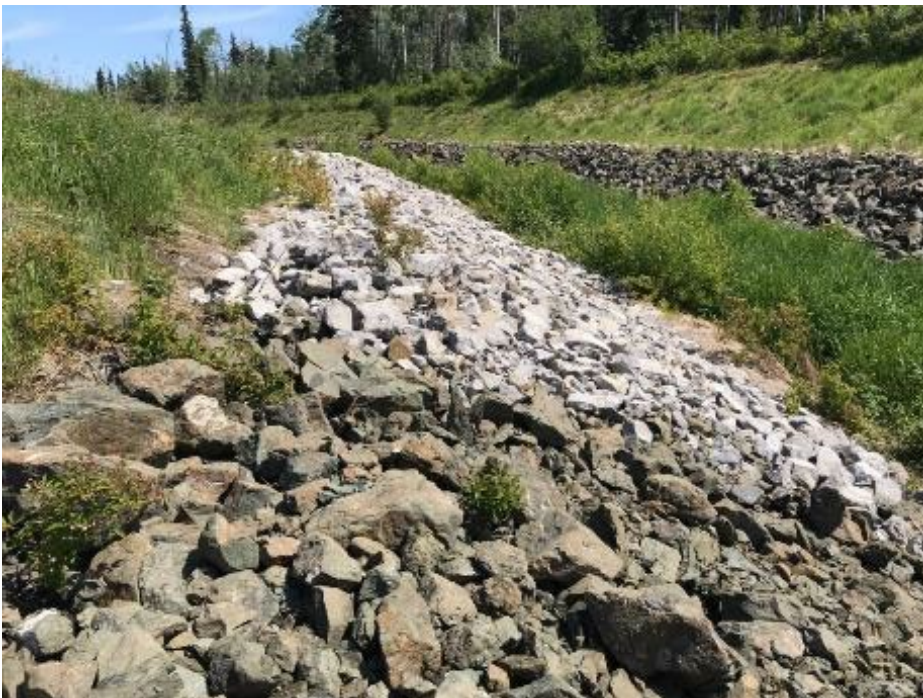
**Photo II-36** Ed Creek Diversion Channel – Looking upstream from near second bend. Light coloured area of riprap was replaced in 2014 and is in good condition

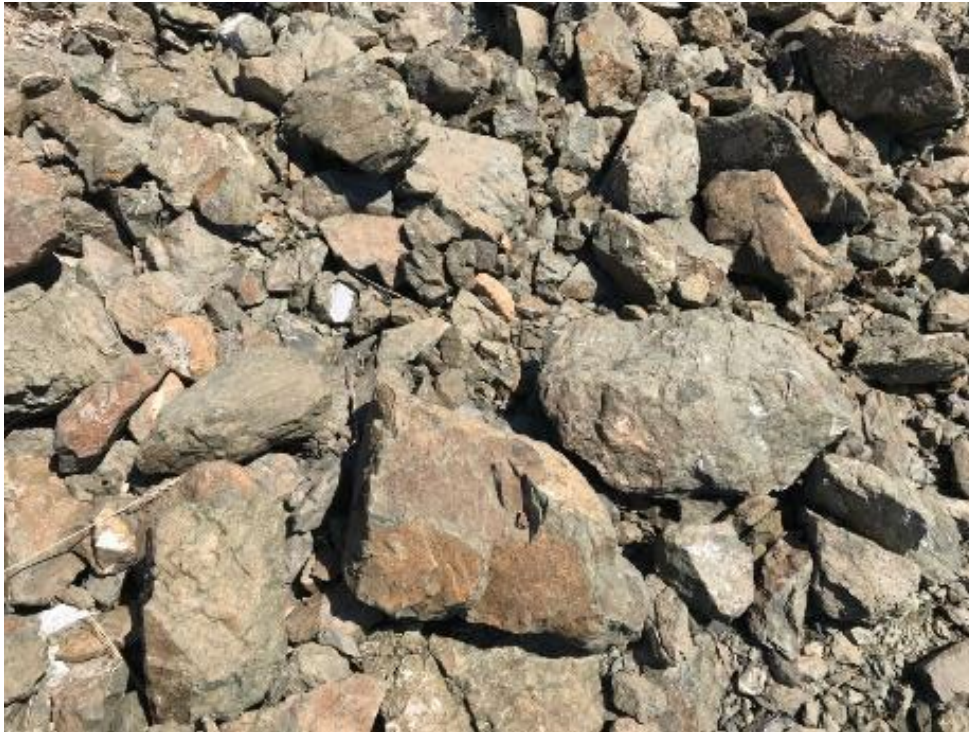
- Previous AFPR reports have noted that the riprap along some areas of the Ed Creek Diversion Channel is weathering and breaking up (Photo II-37). The condition of the riprap appeared similar to previous inspections. Degradation of the riprap is discussed further in Section 5.4.

**Photo II-37**    **Ed Creek Diversion Channel – Riprap on right bank, showing weathering and breakage**

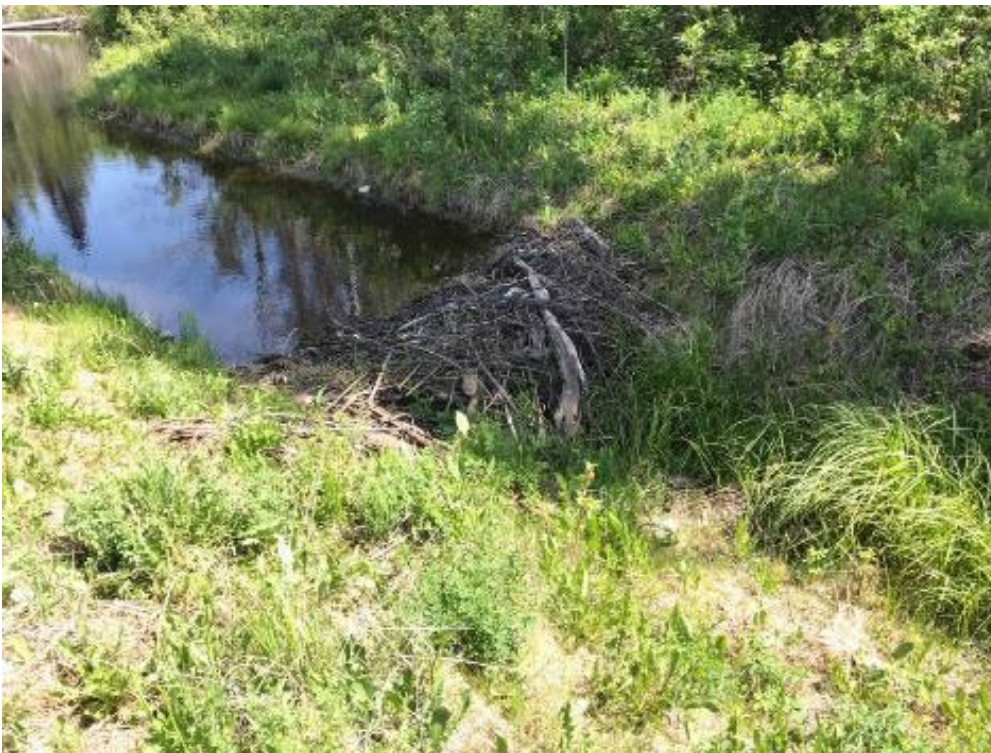
- A beaver dam was previously observed during the 2022 AFPR inspection in the channel south of the pond described above (see Location 5 in Figure 4.1). During the Fall 2022 routine inspection in October, Ecofor noted that the dam was removed (Ecofor 2022). During the Spring 2023 routine inspection, Ecofor observed that a new beaver dam (<1 m high) was re-established in approximately the same location (EcoFor 2023; see Location 5 in Figure 4.1; Photo II-44). The beaver dam is not a TSF safety issue and can remain in place.

**Photo II-44 Beaver dam and pond near East Leg toe, looking north**

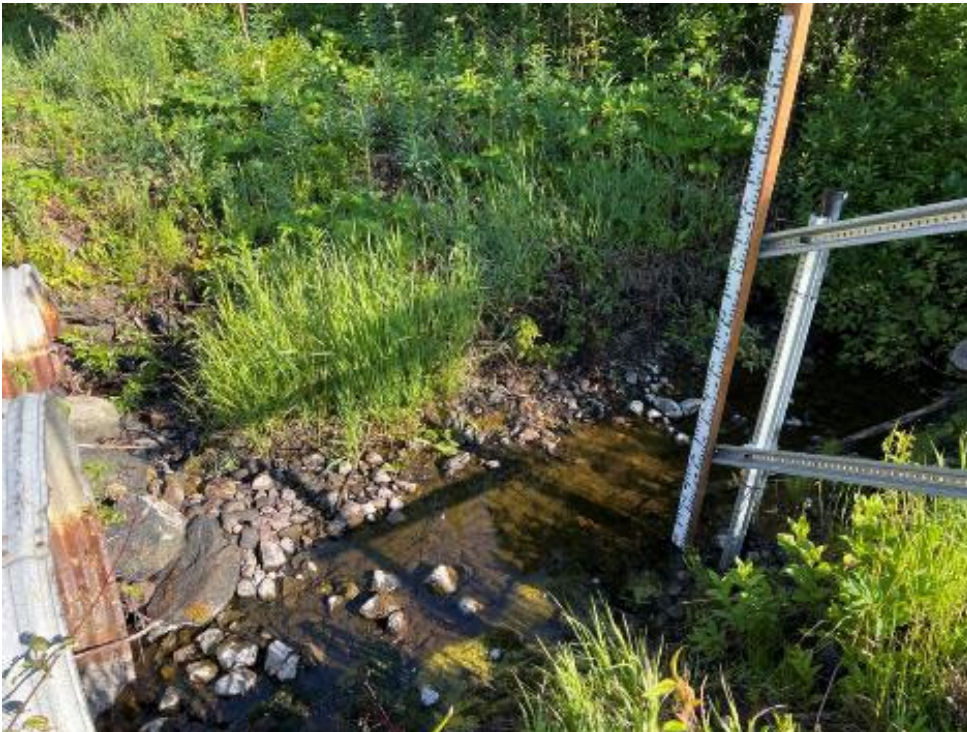
- There are two culverts on Ed Creek under Pinchi Lake Road approximately 300 m east of the mine gate (see Figure 1.2 for location and refer to Photos II-45 and II-46). Flow was observed in the east (left) culvert, with a water depth of 3 cm at the inlet.
- Vegetation was cleared around the culverts in October 2022.
- During the May 2023 inspection, Ecofor observed the west (right) culvert to have corroded holes at the bottom of the culvert allowing water to drain through to the bottom before reaching the outlet (Ecofor 2023). This is not an immediate concern, but options to upgrade the culverts are being considered as part of plans to address the degradation of Ed Creek Diversion Channel riprap. In the meantime, the culverts should continue to be inspected.

**Photo II-45 Inlet of Ed Creek culverts under Pinchi Lake Road**
