Teck Metals Ltd.

Pine Point Mine Tailings Impoundment Area

2023 Annual Facility Performance Report

December 2023

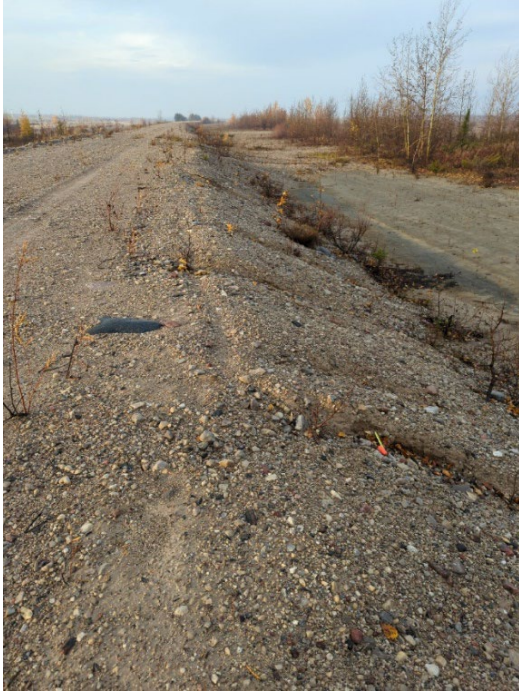
- **Downstream Slopes and Toe:** Good condition. No signs of erosion requiring maintenance, slope instability, or seepage.
 - ◆ Erosion rills are present on many of the downstream slopes. The rilling is a surficial feature that is not a dam safety concern. The rilling has not retrogressed into the dyke crests and does not require maintenance at this time.

Photo I-1 **South Dyke – looking west, rills on upstream slope (Location 1)**

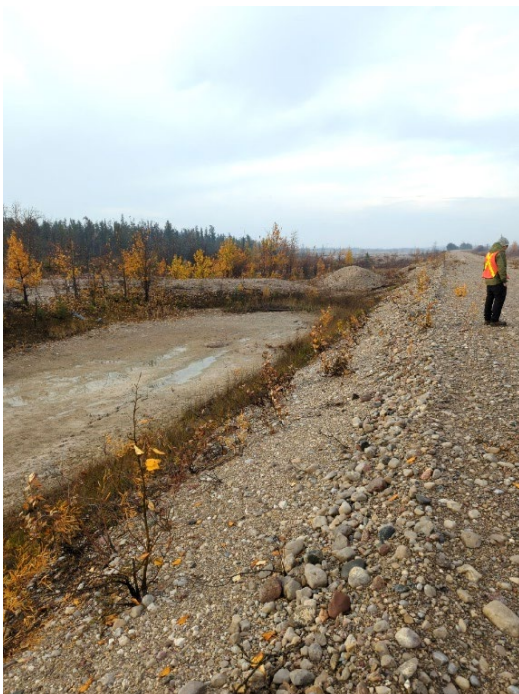
Photo I-2 **South Dyke – looking southwest, South Dyke toe, dry where typically have ponded water (Location 2)**

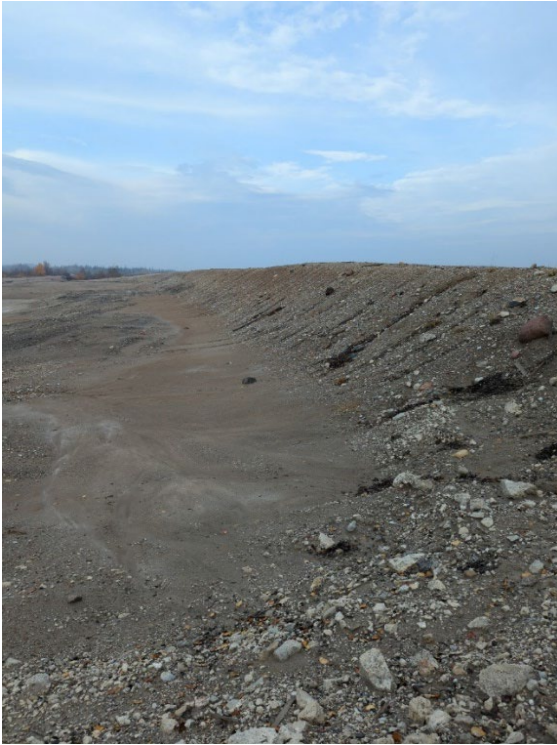
Photo I-3 South Dyke – looking west, rills on downstream slope (Location 3)

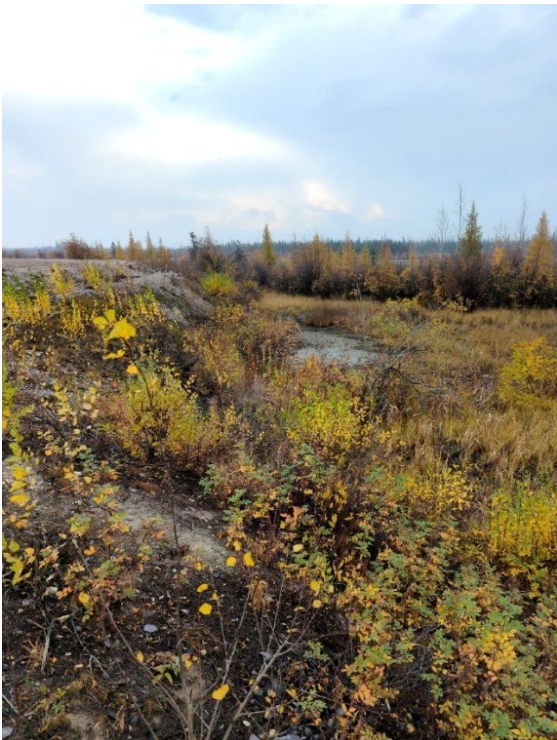
Photo I-4 South Dyke – looking southeast, ponds at the downstream toe drier than typical (Location 4)

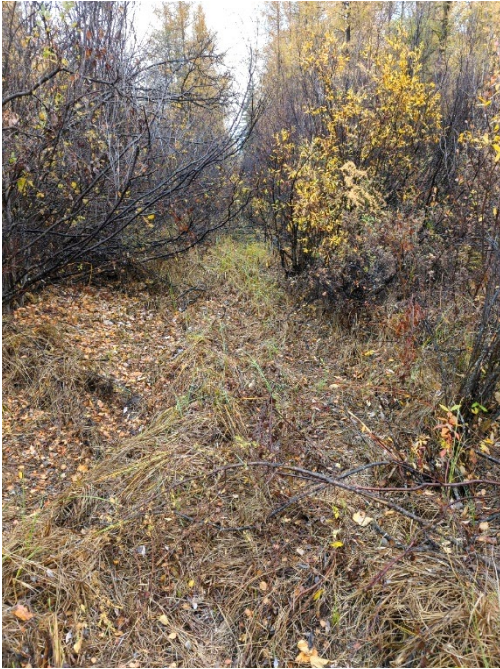
Photo I-5 South Dyke – looking east, view upstream from southwest access road culvert inlet (Location 5)

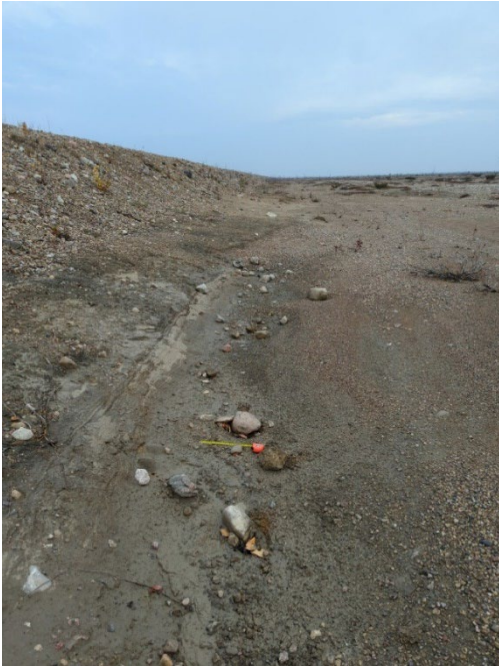
- **Upstream Slope:** Good condition. No signs of slope instability.
 - ◆ Evidence of surface water flow along the surface of the tailings next to portions of the West Dyke's upstream slope.

Photo I-6 **West Dyke – looking east, surface water runoff on tailings surface channelized along upstream slope (Location 6)**

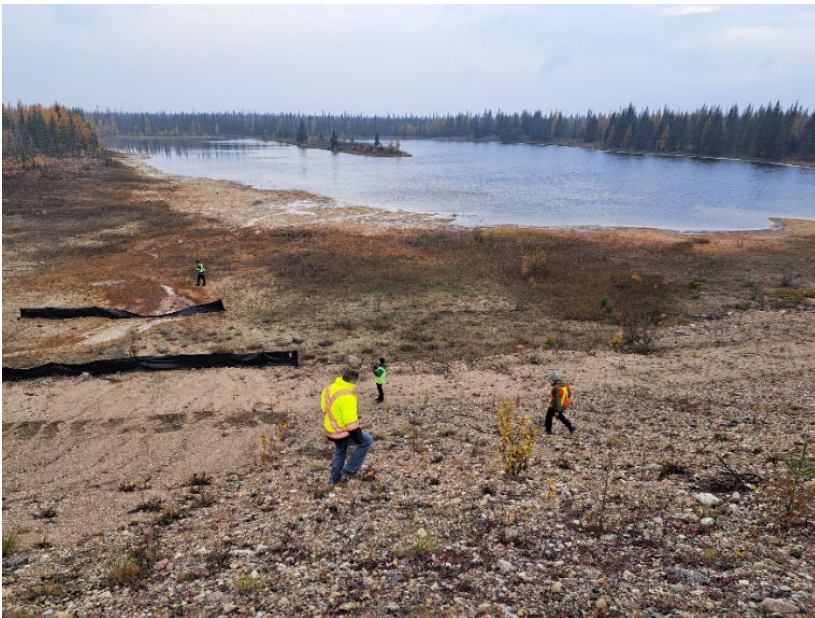
Photo I-10 West Dyke – looking west, downstream slope with silt, low water levels in pond (Location 10)

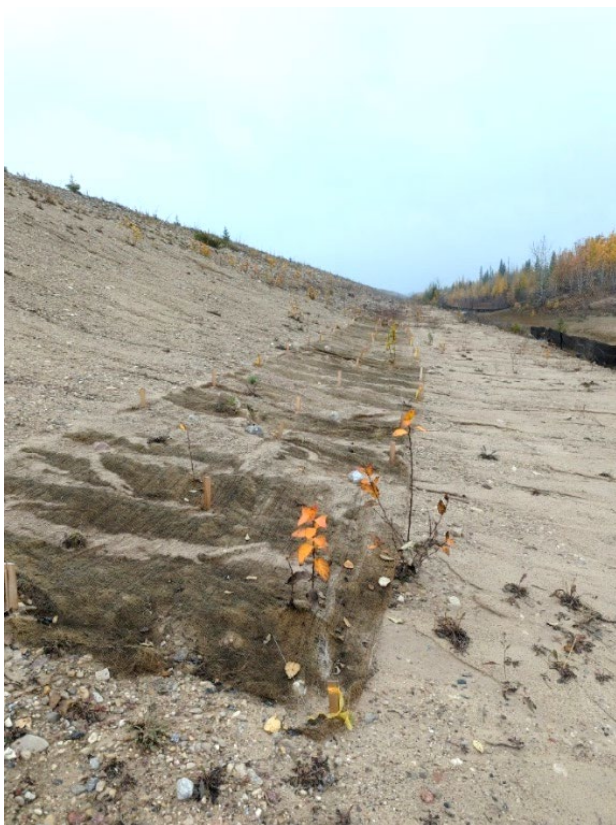
- ◆ The silt fencing and coconut mats installed on the West Dyke in fall 2022 to prevent release of fines appear to be performing as intended.
 - ◆ The water levels in the permanent ponds downstream of the dykes (Sta. 1+00, 20+00, 44+00, 47+50, 62+00) were lower than normal, indicating dry conditions. Where ponded water was present near the toe of the dykes, it was clear.

Photo I-11 West Dyke – looking south, downstream slope and coconut matting installed October 2022 (Location 11)

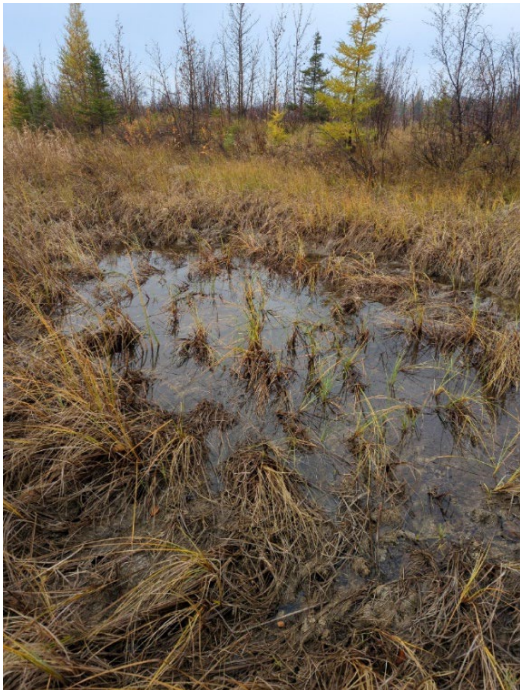
Photo I-13 **North Dyke – looking north, clear ponded water downstream from dyke (Location 13)**

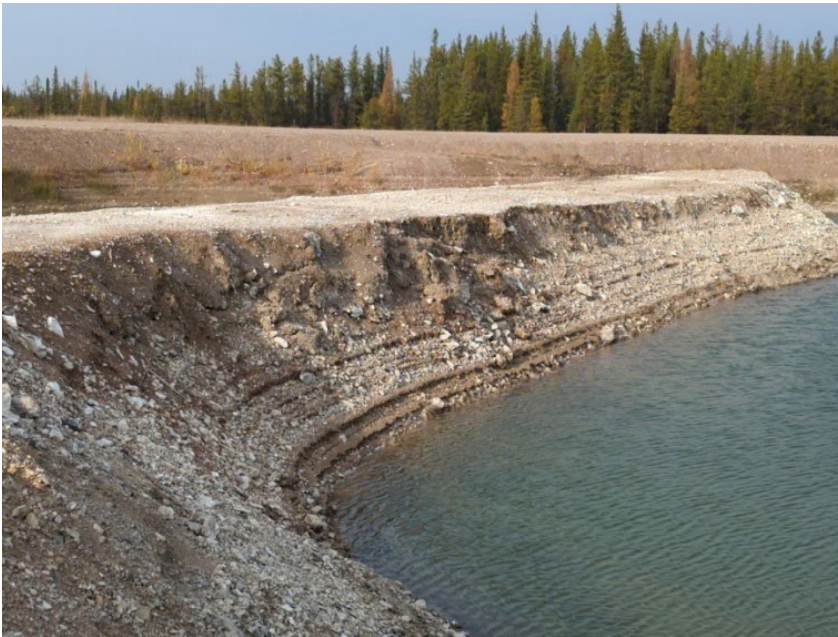
- **Spillways:** Good condition. No signs of erosion, cracking, or obstructions.
- **Polishing Pond:** Active erosion in the top 1 m of Finger Dyke 3 (westernmost dyke). Wave-cut erosion of the internal slope of the North Dyke within the Polishing Pond; however, the elevation of the erosion is below the natural ground downstream of the North Dyke toe and therefore is not a concern for dam safety.

Photo I-19 Polishing Pond – looking north, Finger Dyke 3, active erosion near crest (Location 19)

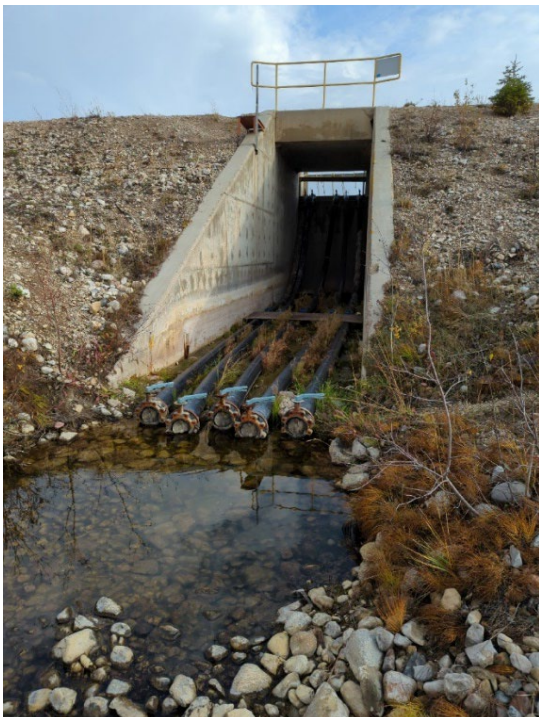
Photo I-23 Polishing Pond Spillway – looking south, spillway outlet, syphons not active, clear flow downstream at the spillway outlet (Location 23)

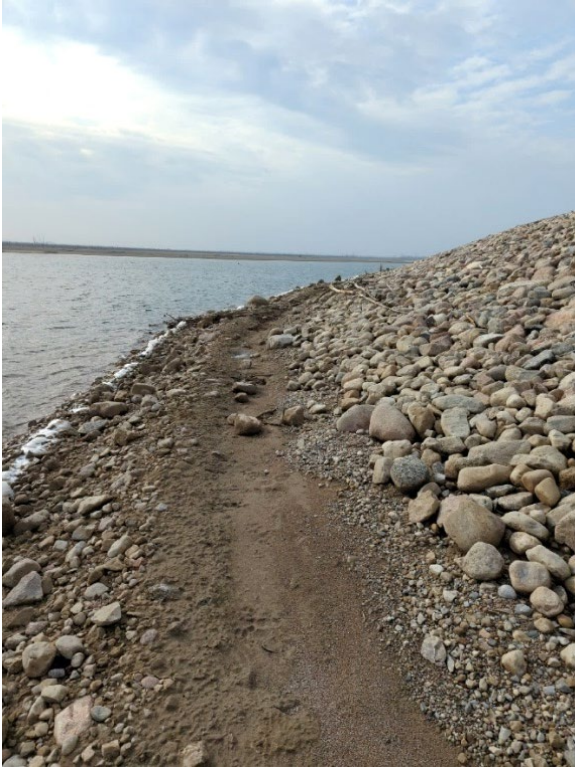
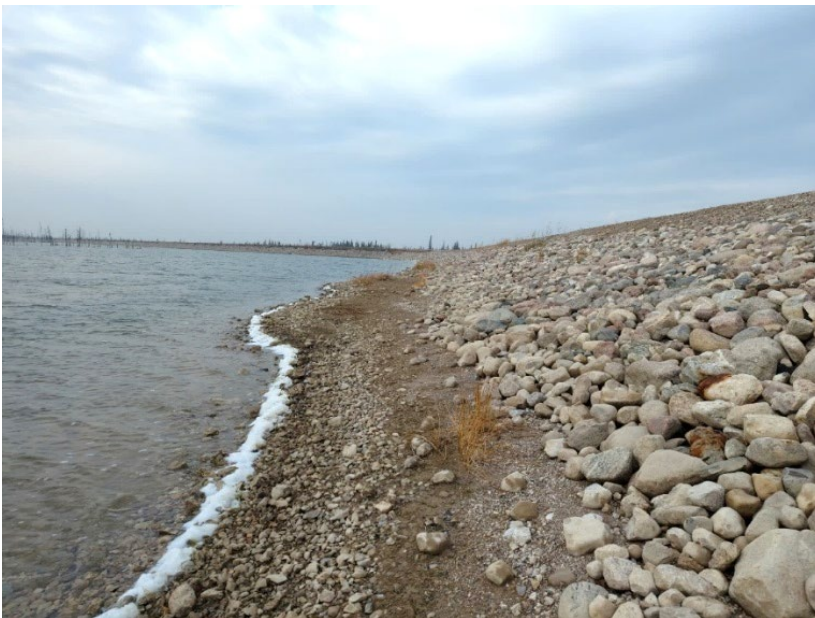
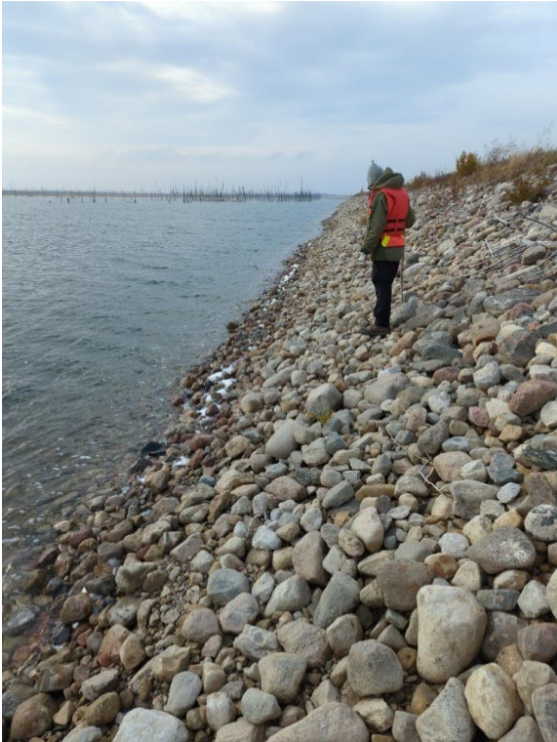
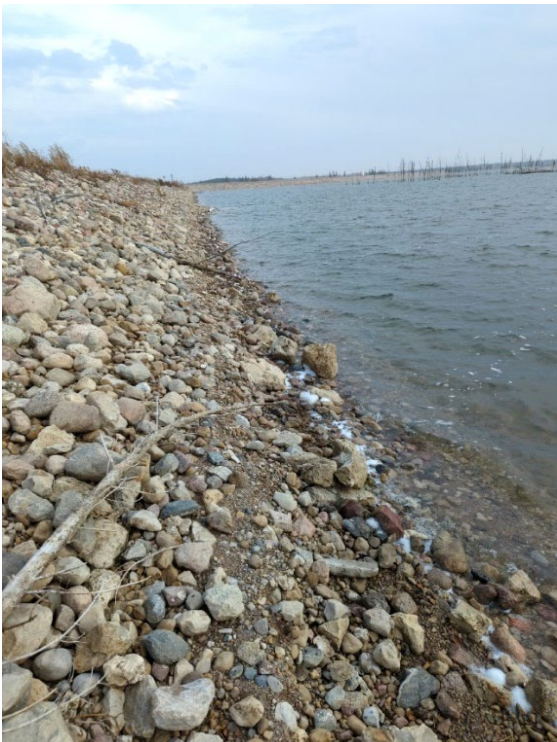
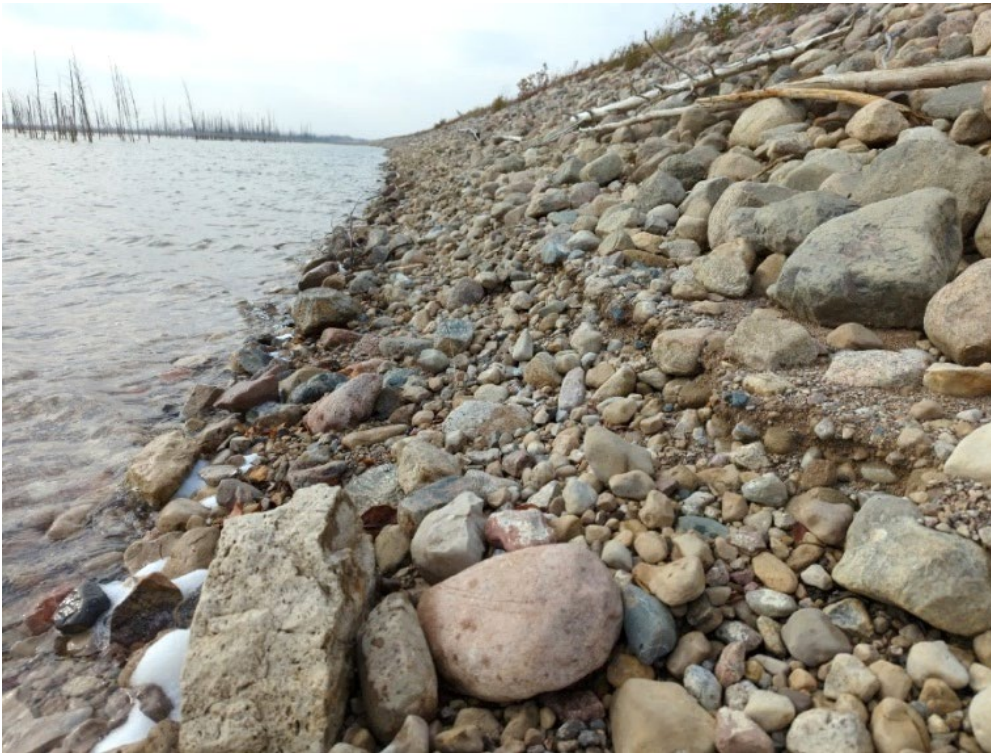
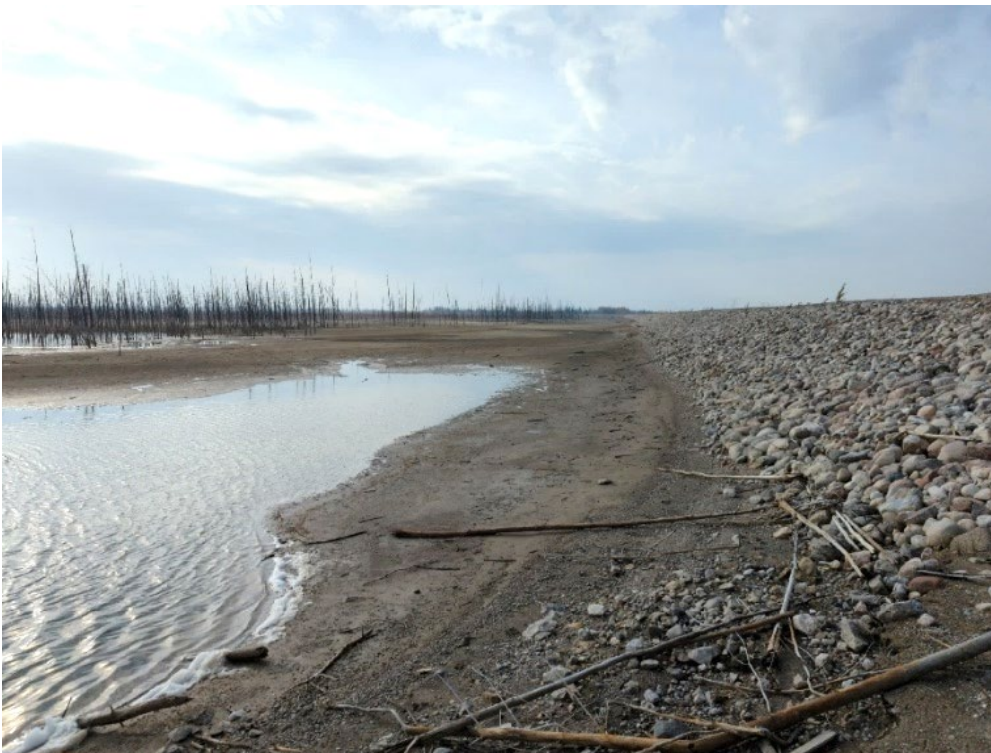
- ◆ The AFPR site visit included walking the length of the upstream slope of the North Dyke to observe the performance of the erosion protection (Appendix II). A small, wave-cut erosion scarp less than 30 cm high was observed along some portions of the North Dyke upstream slope. However, since the erosion scarp appears to be a surficial feature in a sand and gravel material, maintenance is not required at this time. KCB recommends that an inspection of the North Dyke upstream slope be conducted by the EoR every three years at a low-water level. This inspection should include walking the length of the upstream slope of the North Dyke along the low-water level.

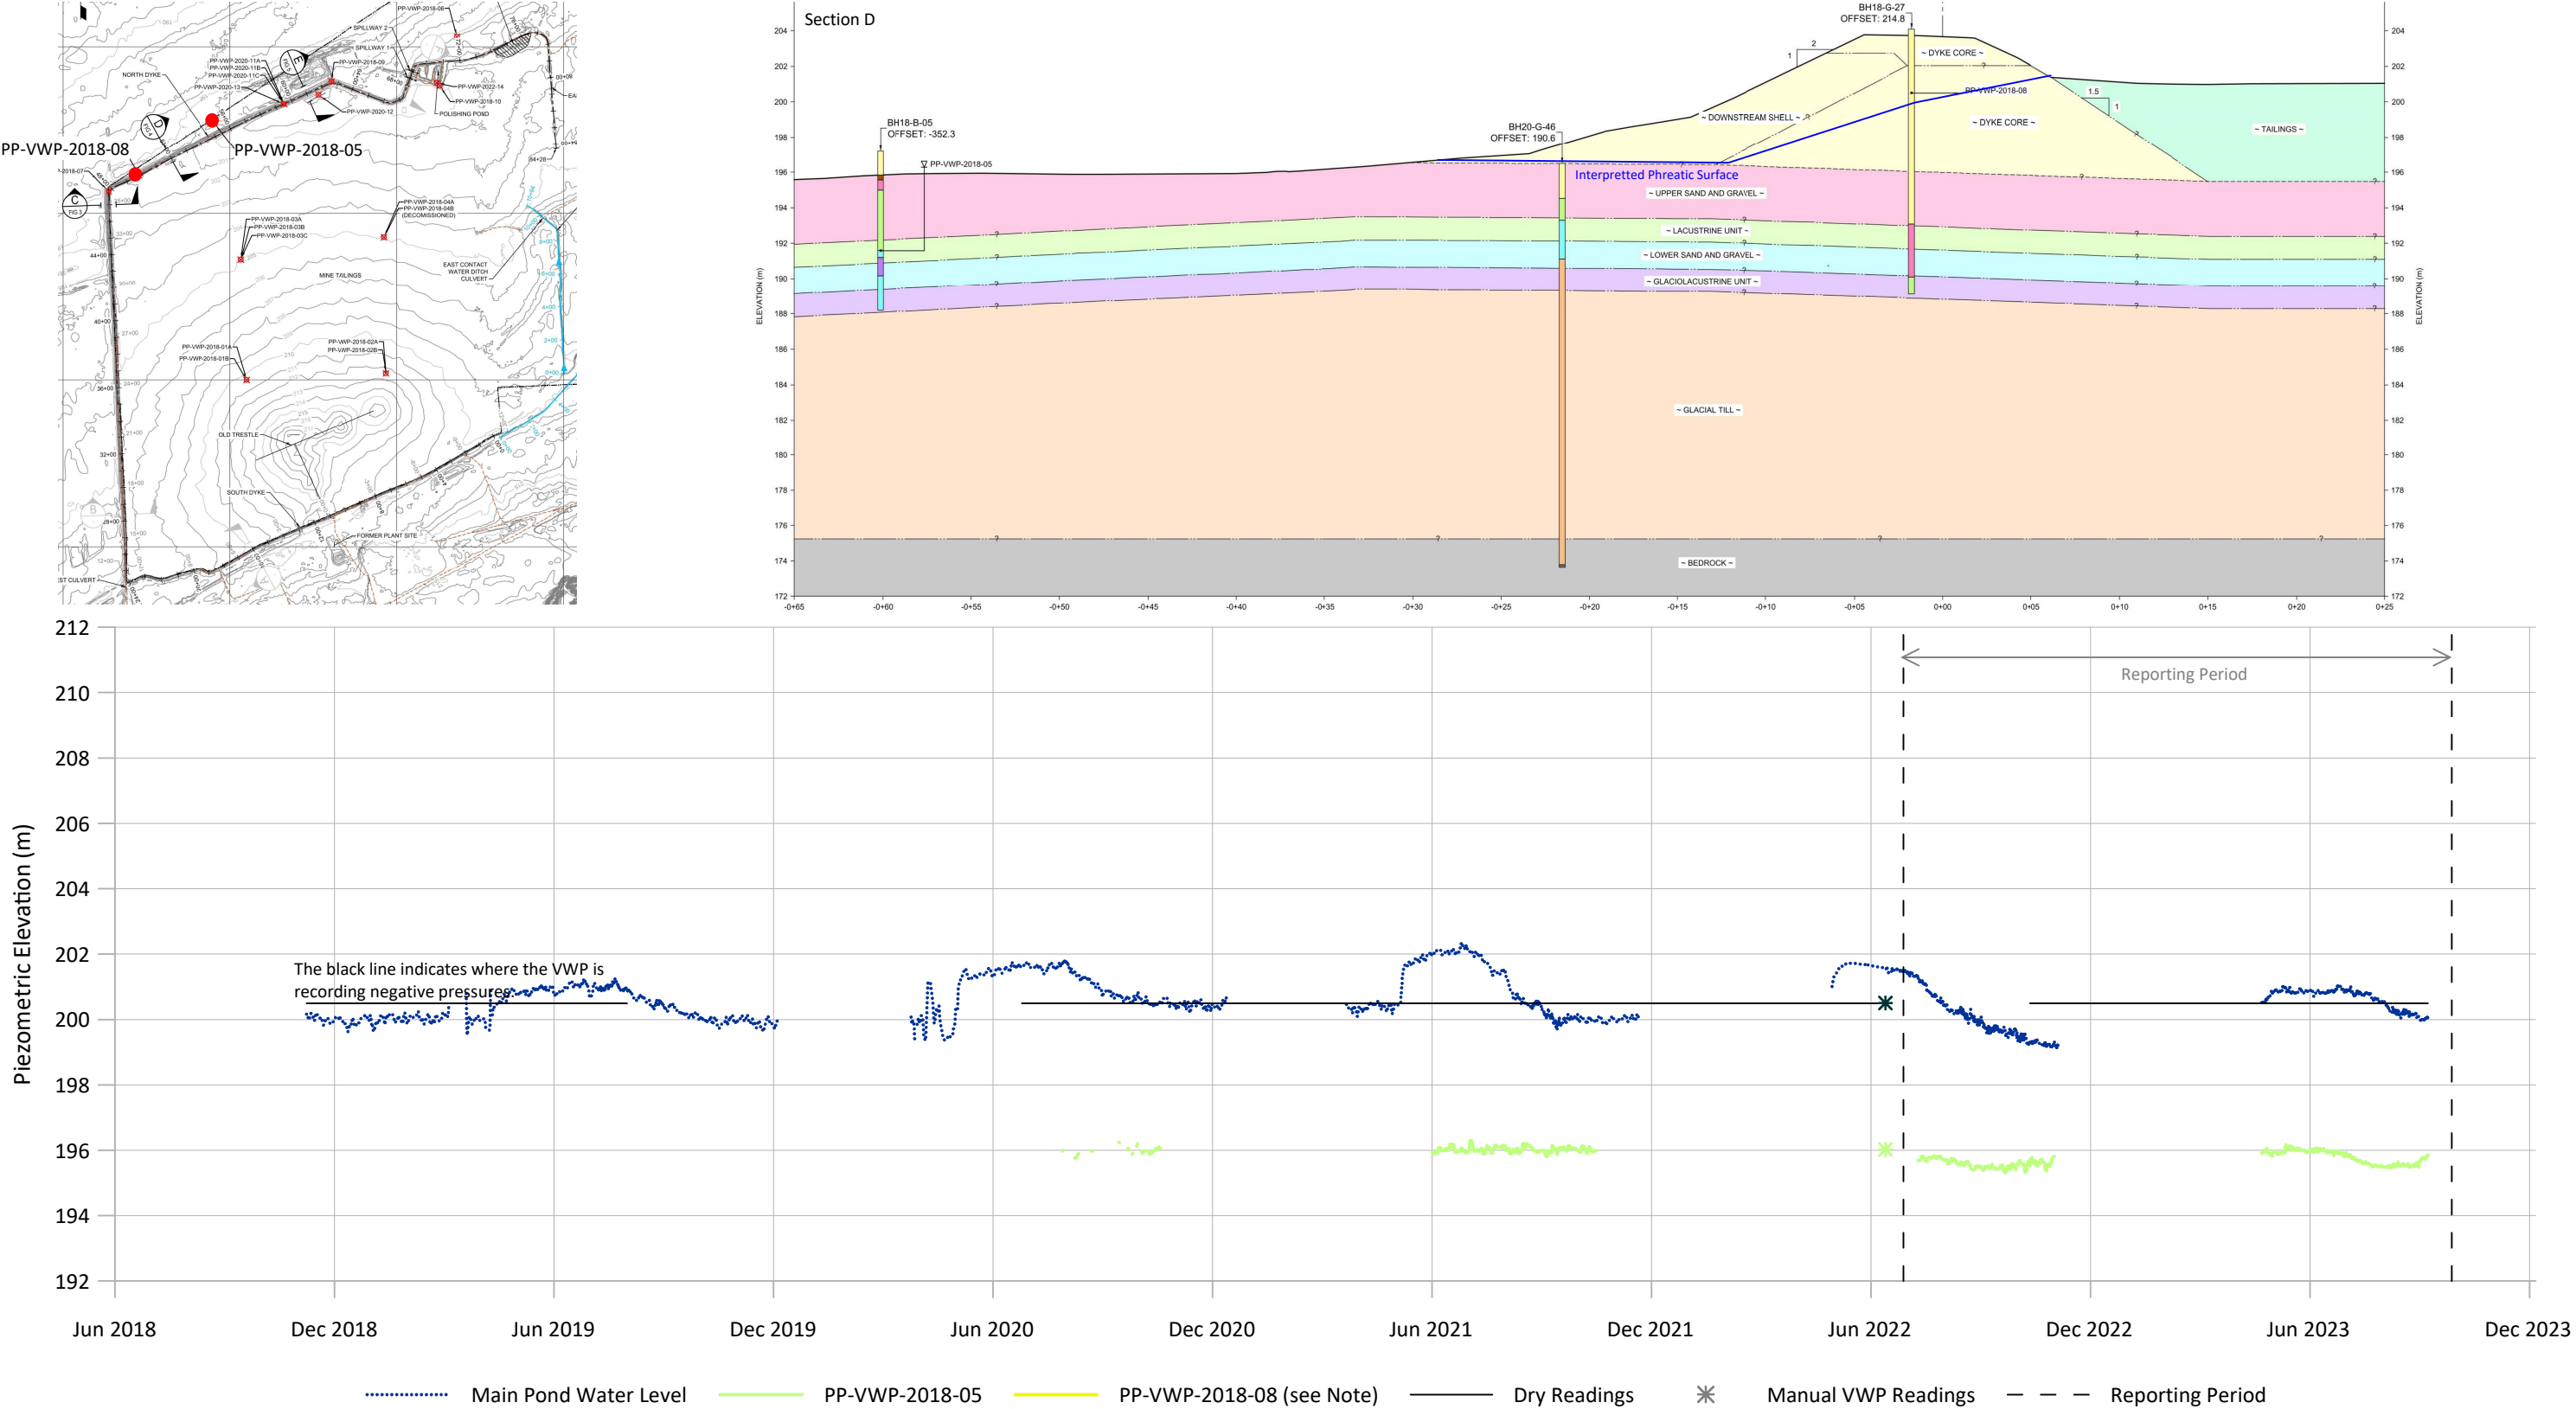
Figure III-4 PP-VWP-2018-05 and PP-VWP-2018-08

Note: PP-VWP-2018-08, all historic and current readings indicate the VWP is dry.
