# **Teck Coal Limited**

## **Quintette Coal Operations**

### ***2017 Dam Safety Inspection***

### ***Shikano North Tailings Dam***

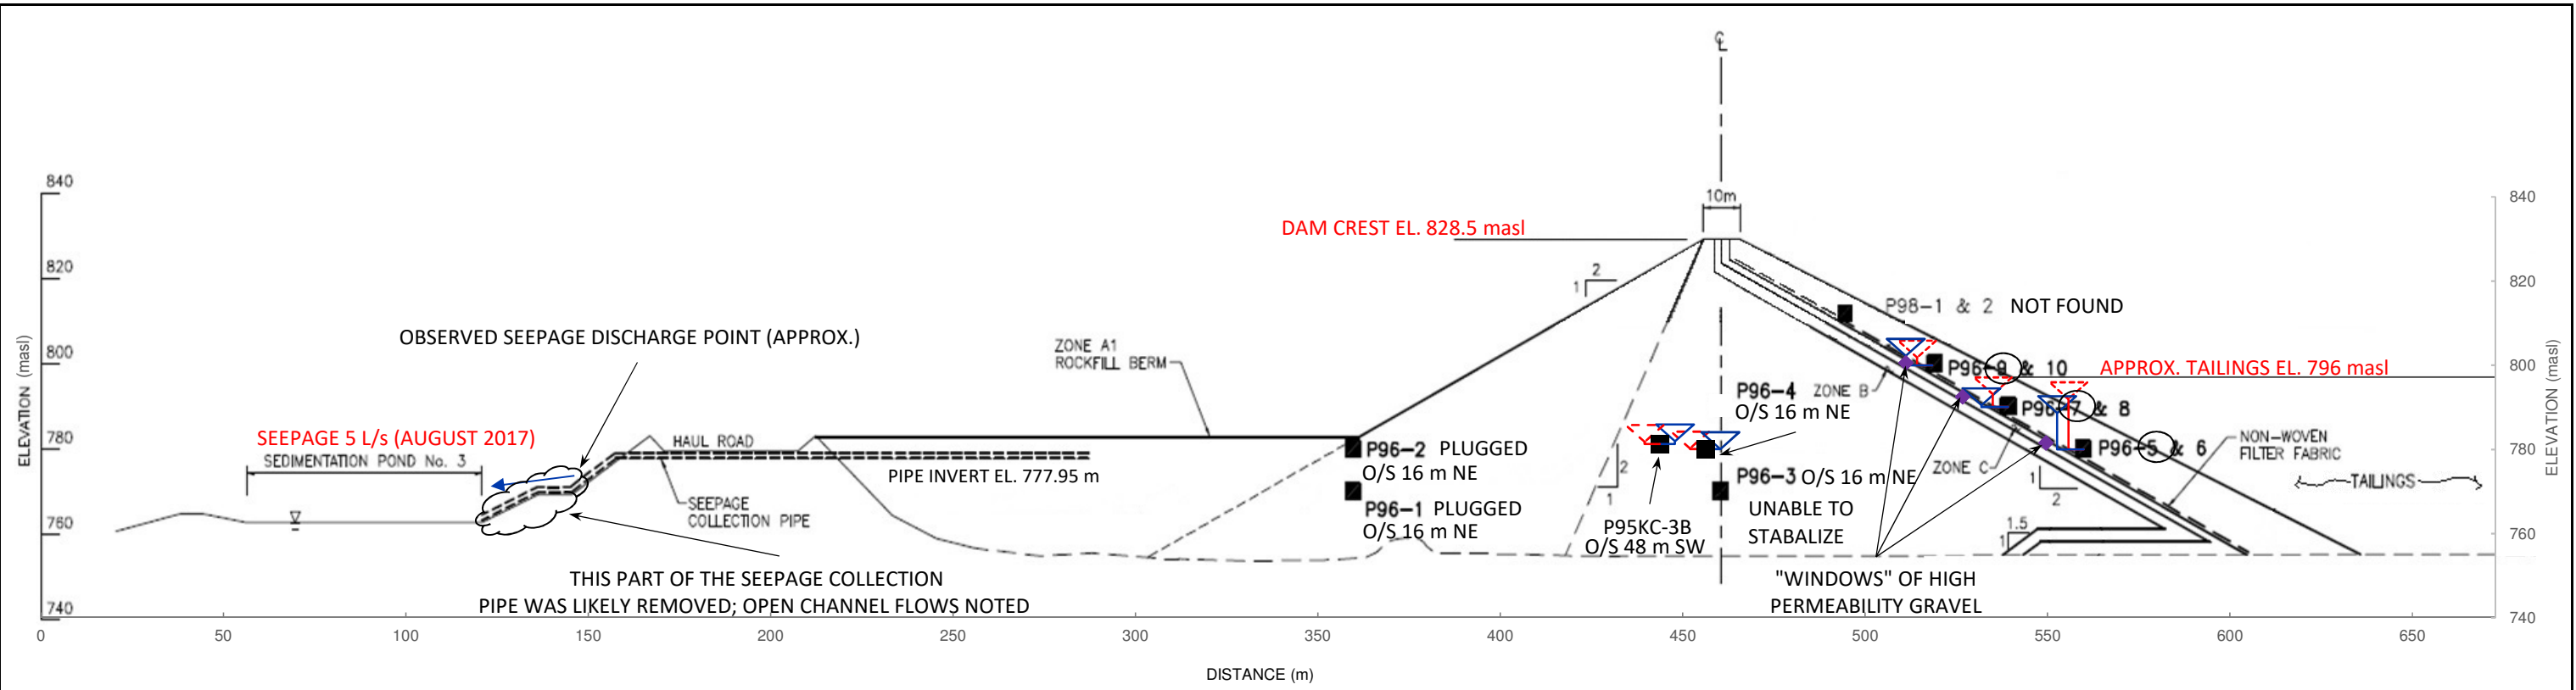
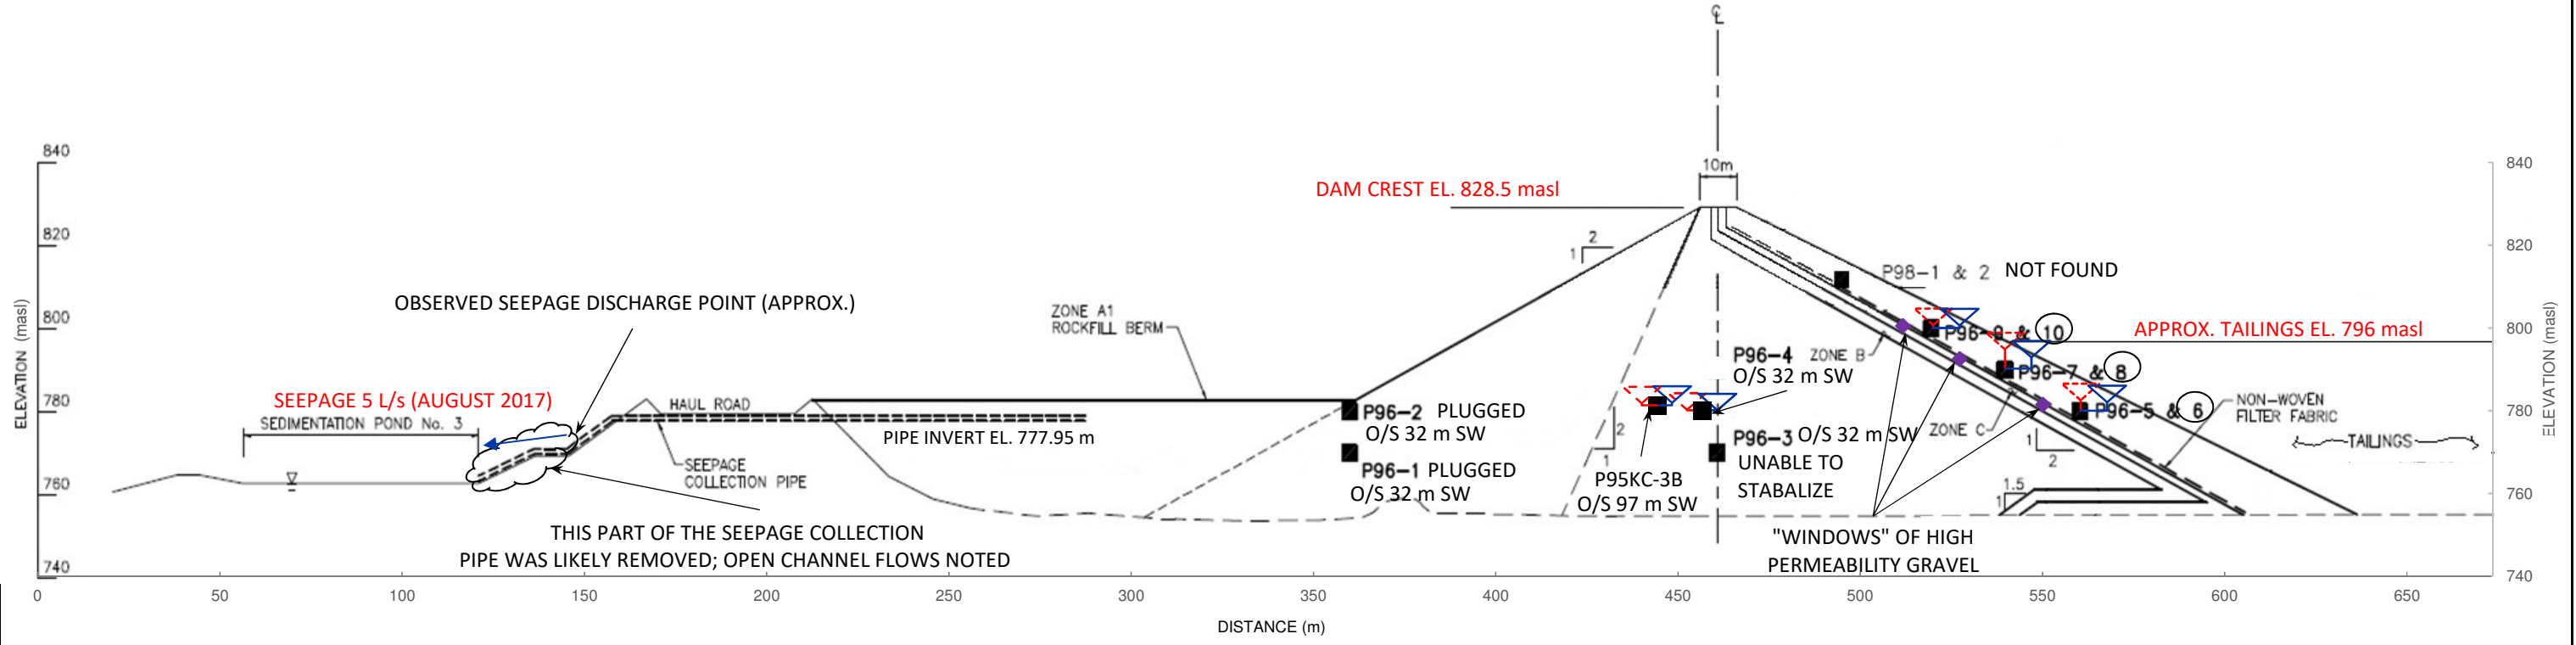
- ◆ P96-4 instrument cable was noted as plugged in KC (1999a) and the instrument continued to give unreasonable reading (+34 psi) in 2017, so it has been disregarded. P96-4 cable was suspected to have been switched with P96-3 in 2016 and in earlier years. P96-3 (before being relabelled to P96-4 in 2017) has been recording approximately 0.1 m of water head above the instrument tip (i.e., El. 770.1 masl), which appears to be lower than the perforated CSP seepage collection pipe (i.e., pipe El. 778 masl as shown in Figure 2). In addition, P96-4 reported tip elevation was incorrectly shown in the as-built drawing D-16003 (Appendix II), which shows the tip elevation at approximately 790 masl instead of installed El. 780.1 masl (KC 1999b). After the revision of P96-4's tip elevation and the labelling between P96-3 and P96-4, the 2017 water elevations recorded by P96-4 were between El. 780.1 m and 780.2 m (Figure 2), which are consistent with the CSP elevation. P96-3 is now being reported as "Unable to Stabilize" (Figure 2).

- ◆ P95KC-3A was not found; Teck managed to find P95KC-3B after it has been reported as "not found" in previous DSI reports. The instrument location and its water levels are shown in Figure 2.

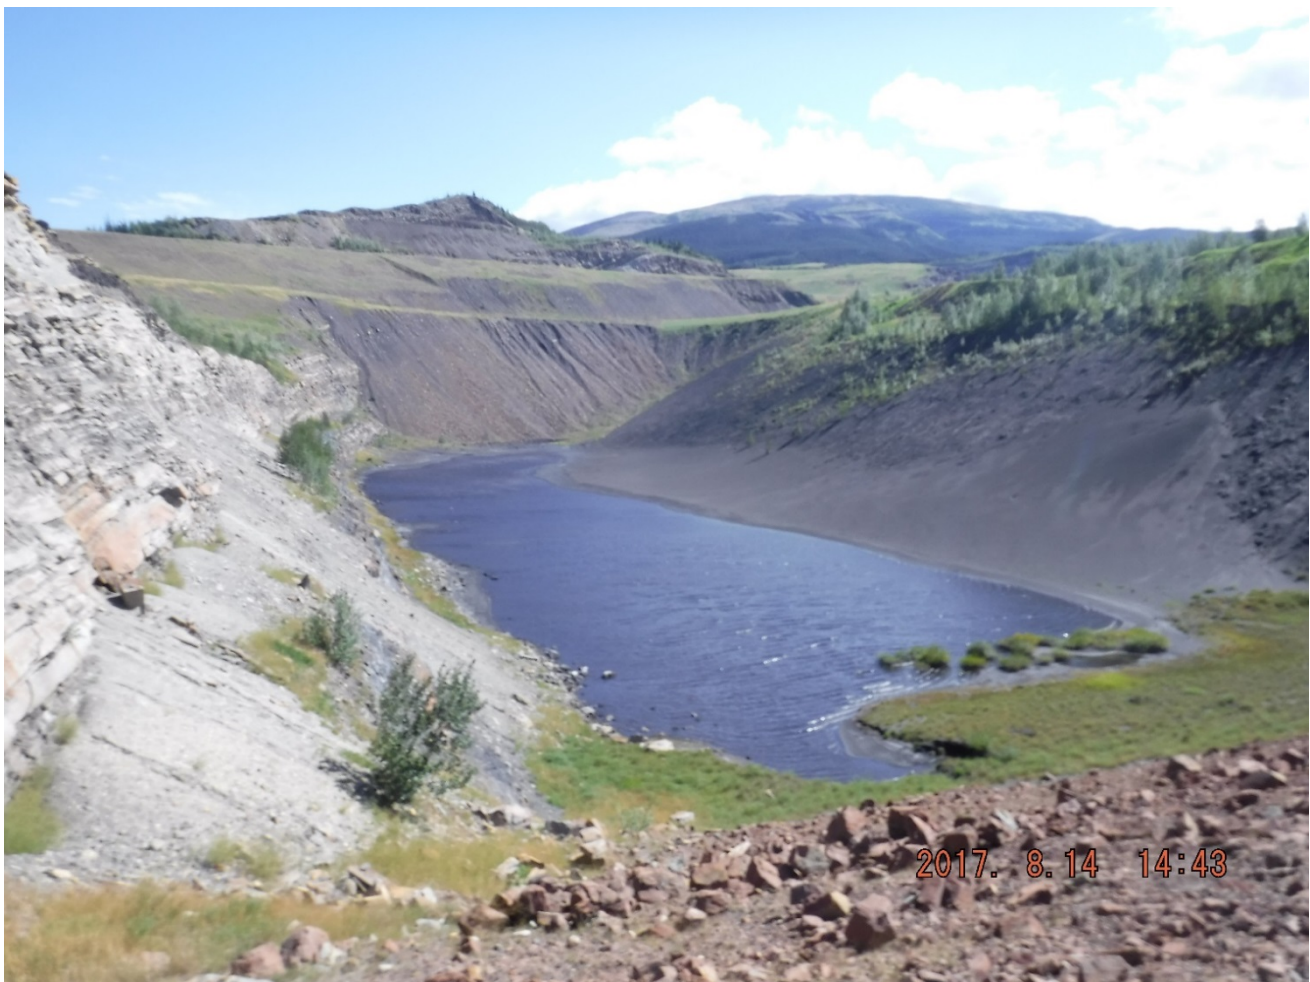
**Photo I-1      Pond and basin from the northeast abutment - looking upstream (south)  
(SNTD-2017-01)**

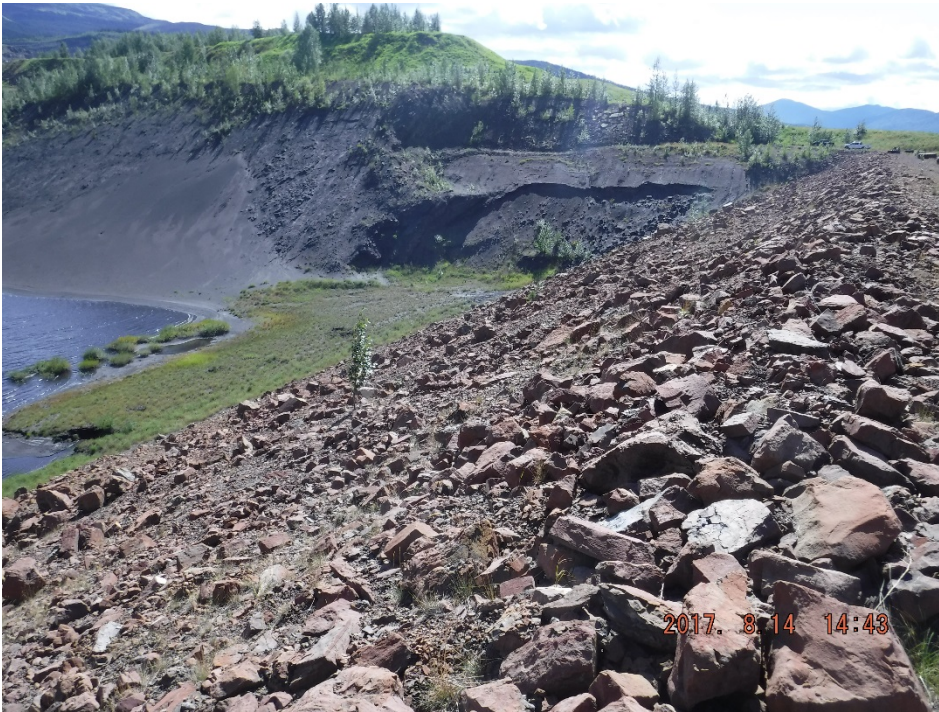
**Photo I-2 Upstream slope – looking southwest. No sign of erosion or movement (SNTD-2017-01)**

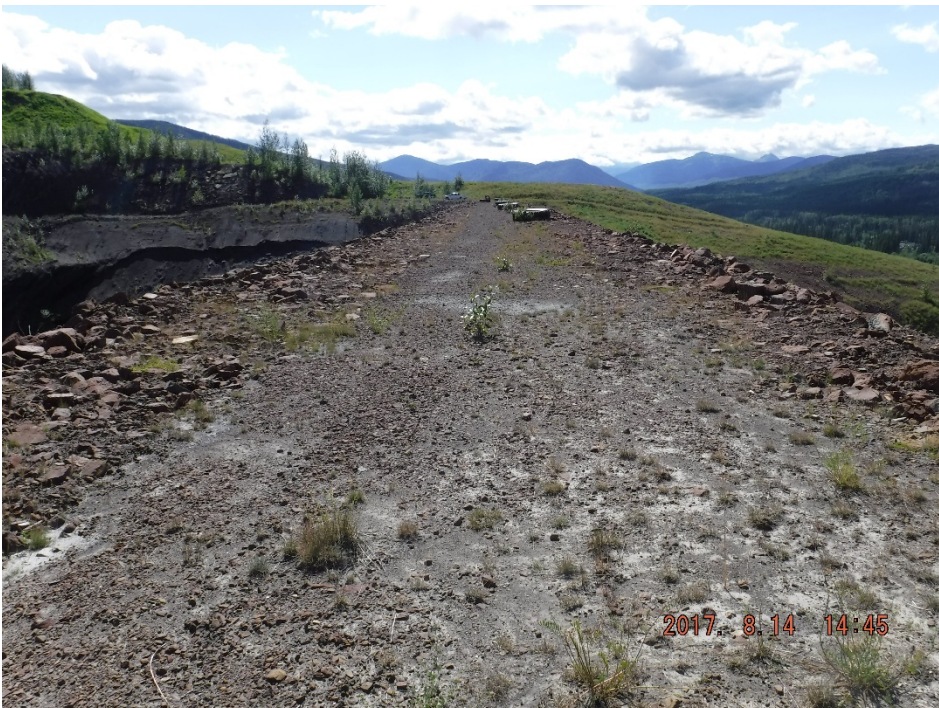
**Photo I-3 Dam crest from east abutment – no sign of movement or settling (e.g., sinkholes, cracks, slumping) (SNTD-2017-02)**

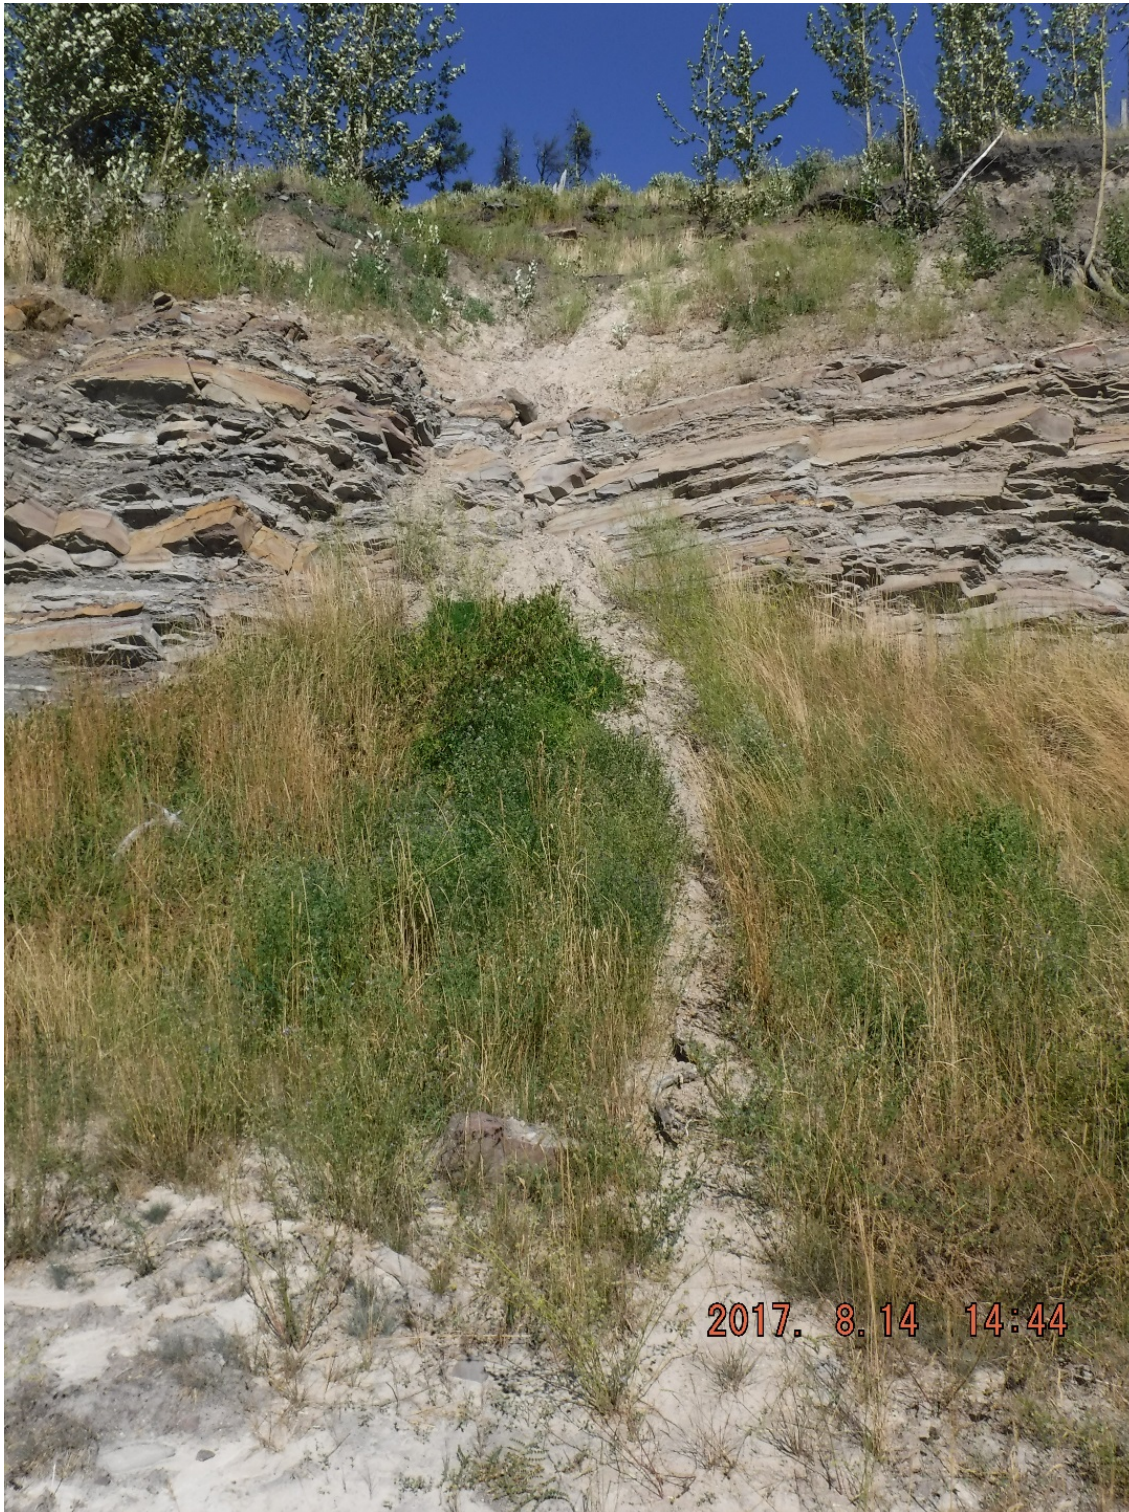
**Photo I-4 East abutment – minor ravelling of material from slope above onto the crest – appears to be in the same condition as previous year (SNTD-2017-02)**

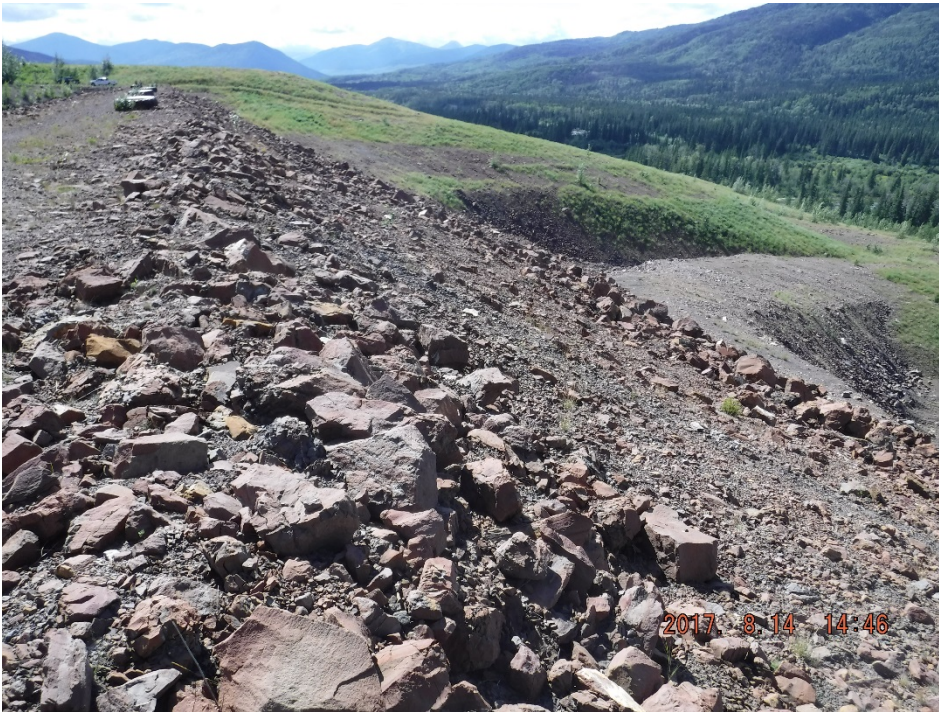
**Photo I-5 Downstream slope – looking southwest. No sign of erosion or significant movement (SNTD-2017-03)**

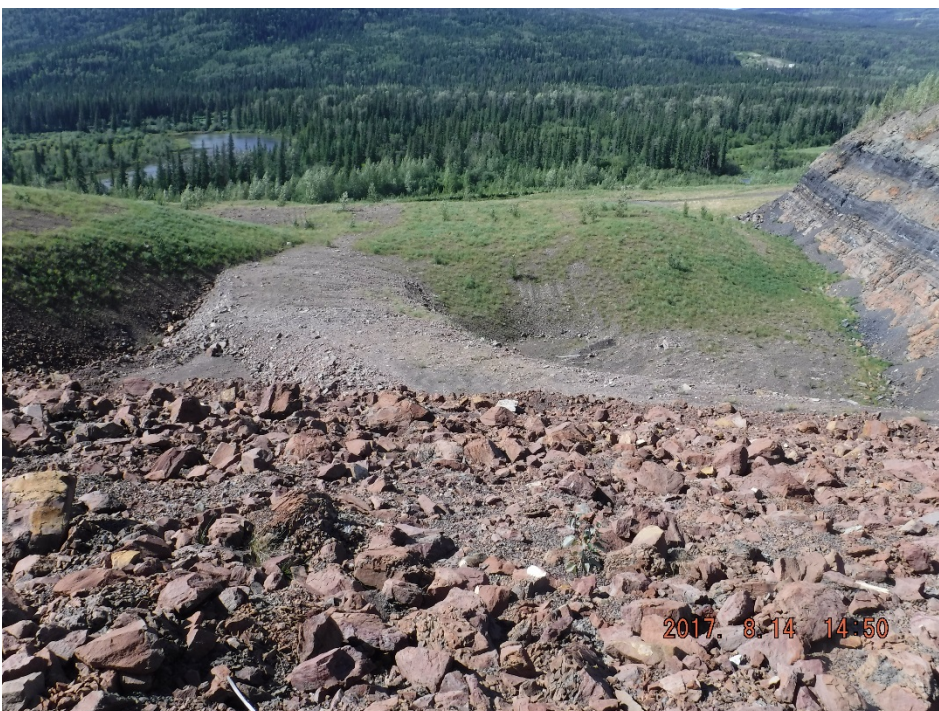
**Photo I-6 Downstream slope taken from mid-length of the crest – slope appears to be in good condition (SNTD-2017-04)**

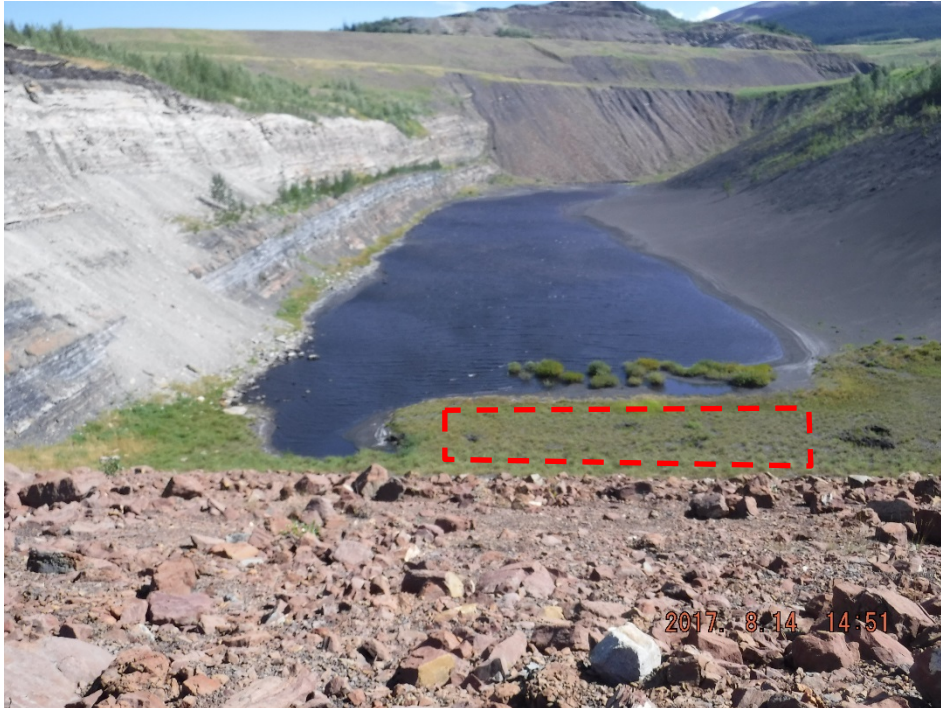
**Photo I-7 Upstream slope taken from mid-length of the crest – slope appears to be in good condition. General area where sinkholes are observed is shown in red box (SNTD-2017-05)**

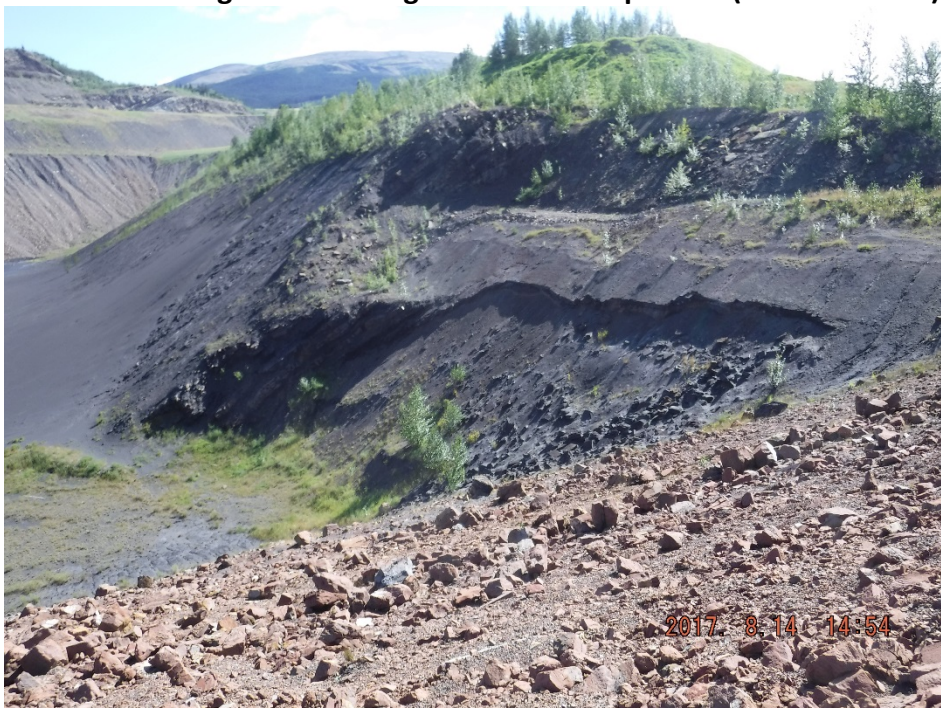
**Photo I-8 West abutment, continued ravelling of shale slope upstream of abutment. No significant change from 2016 inspection (SNTD-2017-06)**

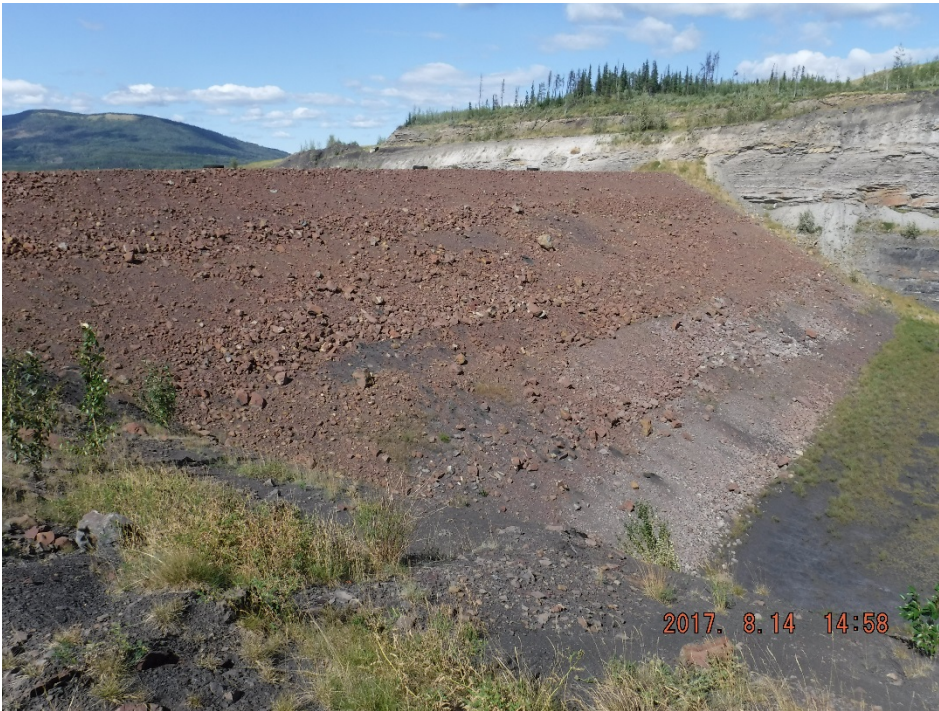
**Photo I-9 Upstream slope taken from the west abutment – looking northeast. Slope appears to be in good condition with no significant sign of erosion or movement (SNTD-2017-07)**

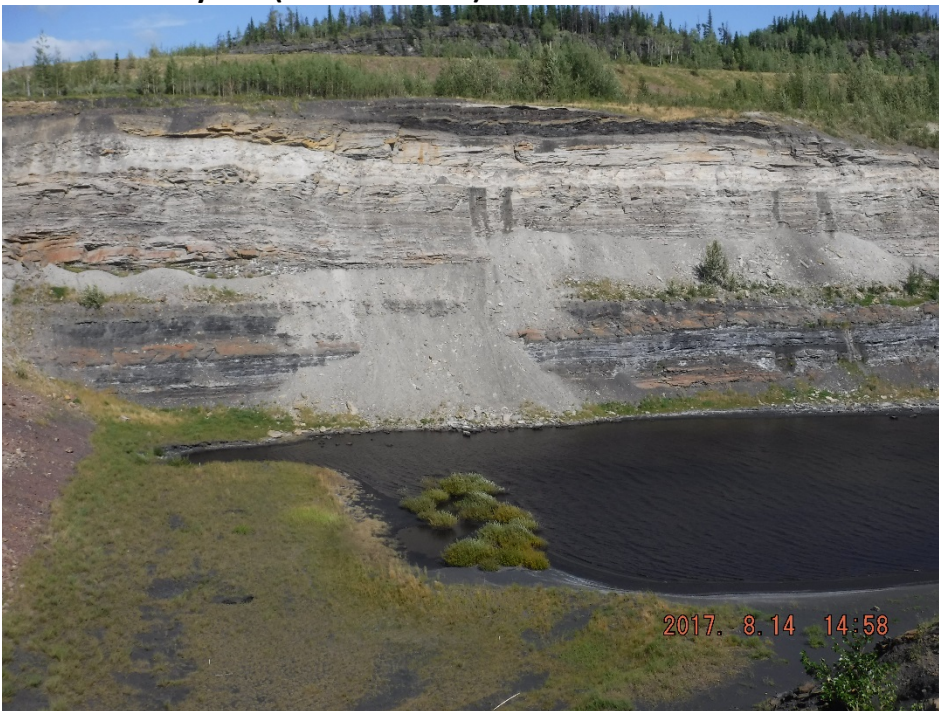
**Photo I-10 North abutment – looking northeast; erosion appears unchanged from previous years (SNTD-2017-07)**

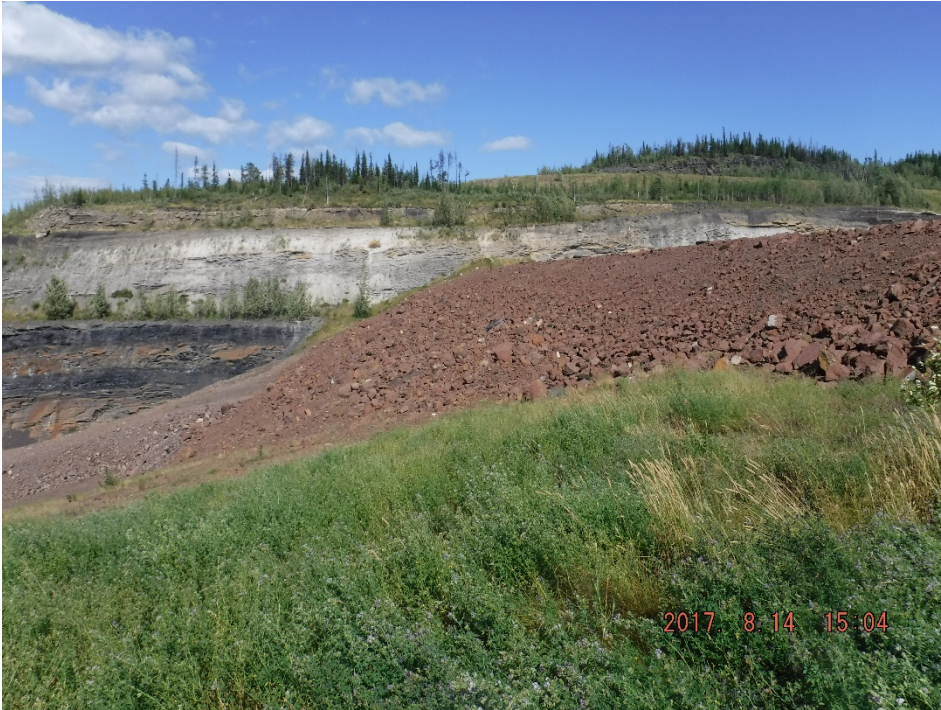
**Photo I-11** Downstream slope taken from west abutment – looking northeast; no sign of erosion or movement (SNTD-2015-08)

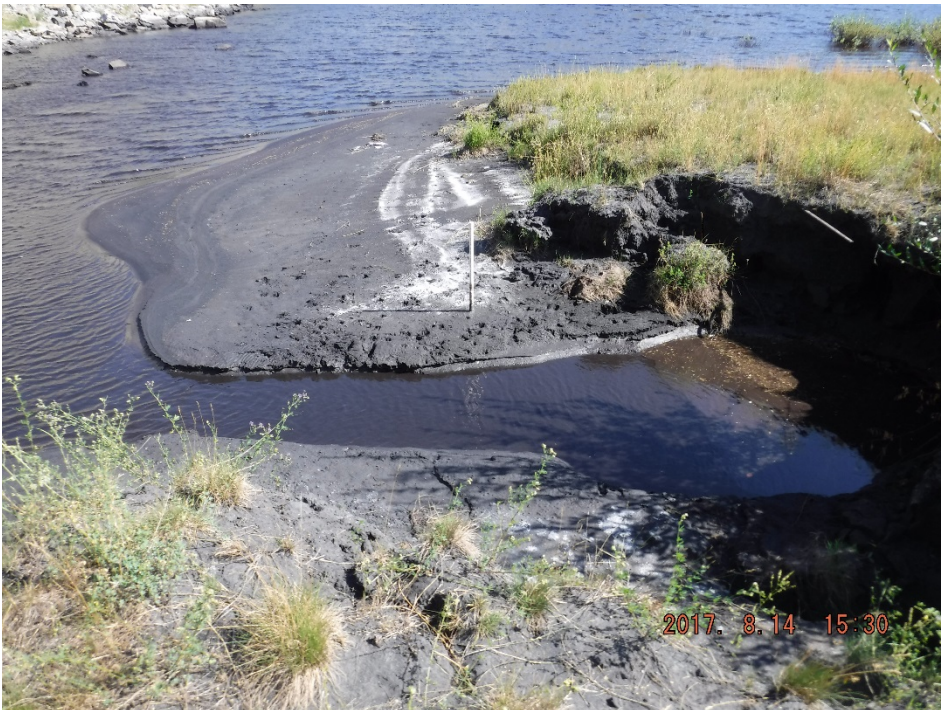
**Photo I-12** Drainage channel inside the impoundment (SNTD-2017-09)

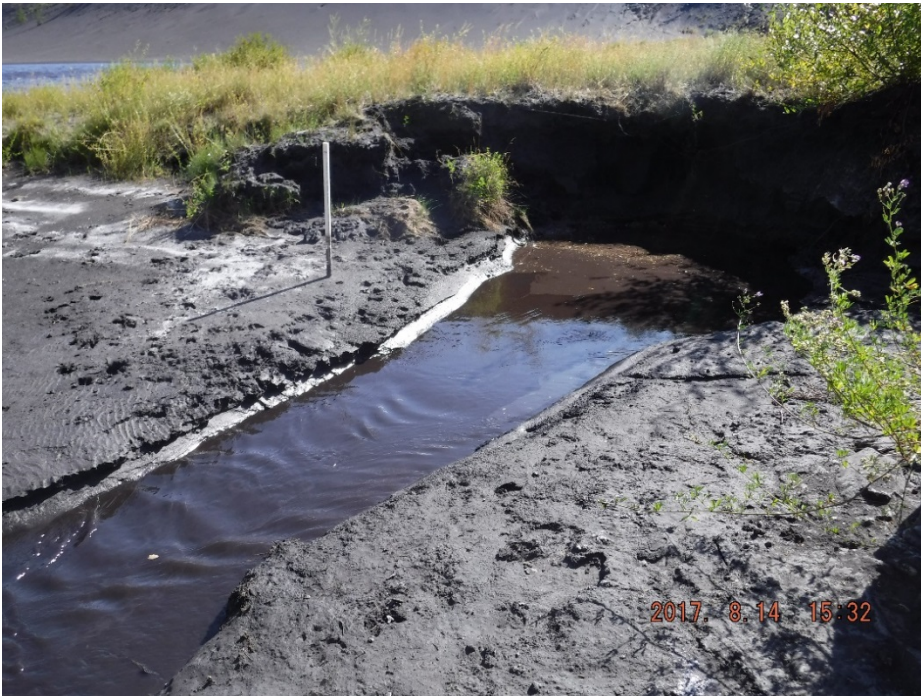
**Photo I-13** Offshoot of main drainage channel from the tailings pond to the upstream face of the SNTD; signs of slumping within tailings around the channel. (SNTD-2017-09)

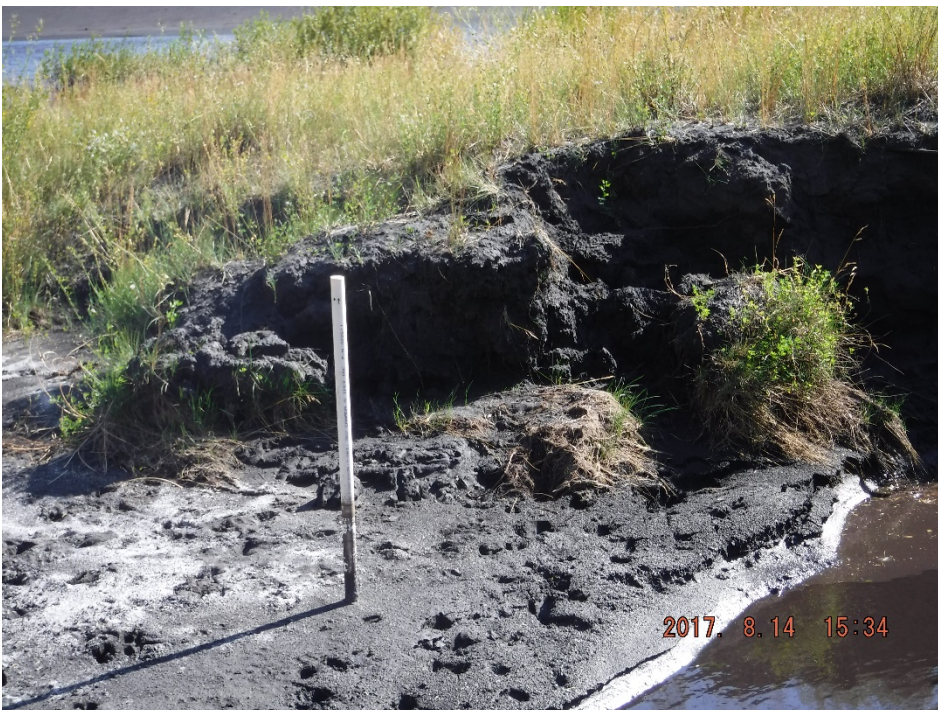
**Photo I-14** Offshoot of main drainage channel – closeup view of the slumping (SNTD-2017-10)

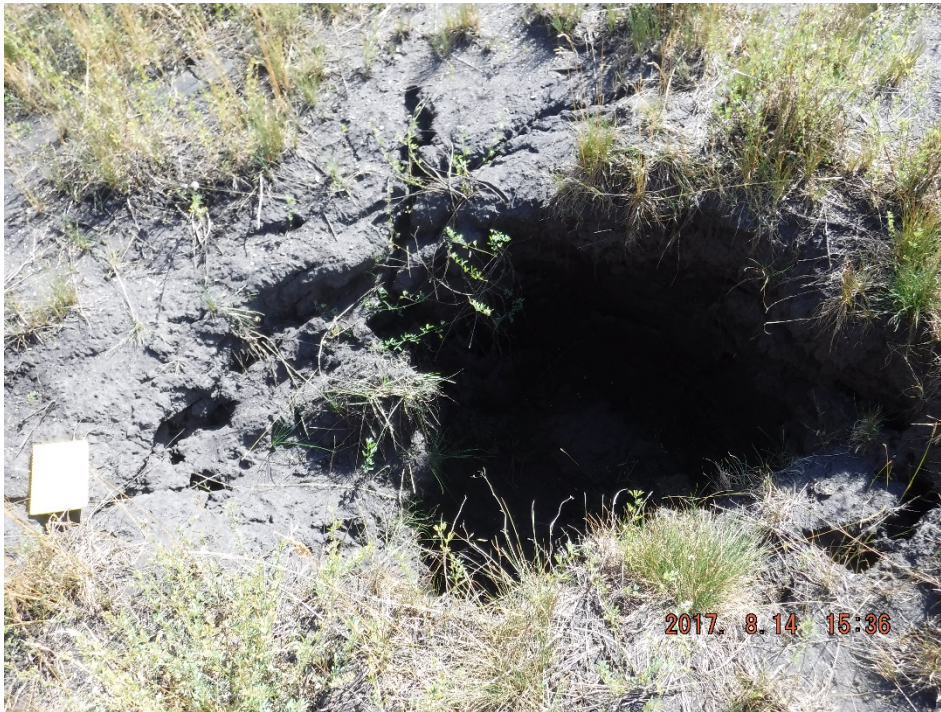
**Internal Erosion and Piping:** Several sinkholes have been observed on the tailings beach since 2010 DSI inspection but when they started to form is not known. They are most likely a local condition where tailings are migrating into the upstream coarse rockfill shell or into the “windows” of high permeability fill, but not through the internal filters. The “windows” of high permeability was a design modification introduced during the construction to encourage seepage flow through the dam as the fine filter had a permeability lower than expected. If piping of tailings were to occur, the probability of triggering a dam failure is very low.

**Photo I-15 Sinkhole 1 – first observed in 2016. Approximately 1.2 m x 1.9 m x 1.0 m deep (SNTD-2017-11)**

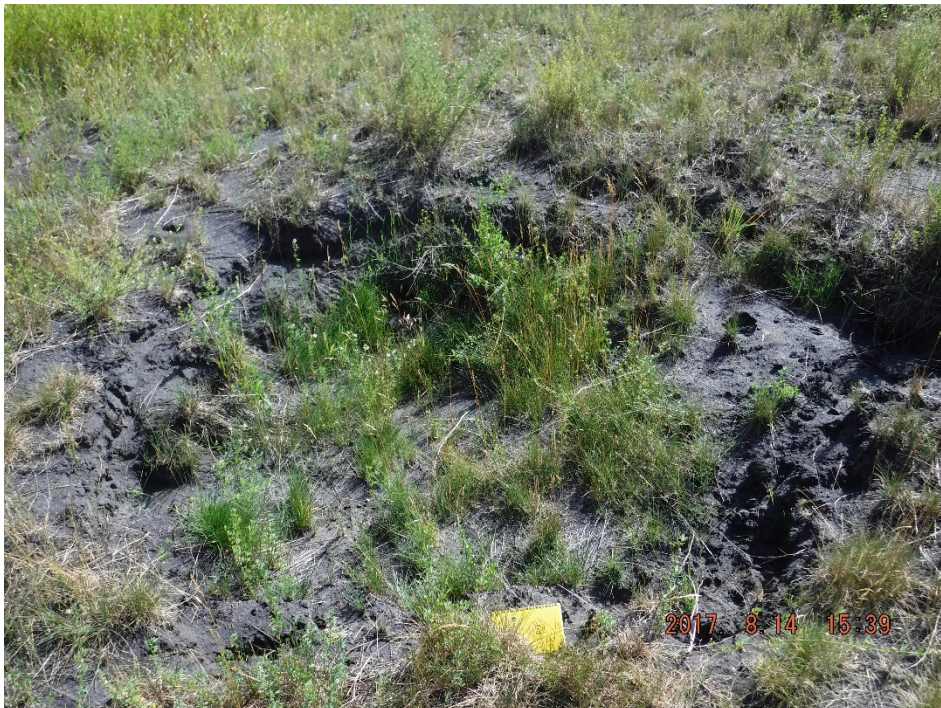
**Photo I-16 Sinkhole 2 – approximately 3.1 m x 2.8 m x 0.6 m deep (SNTD-2017-12)**

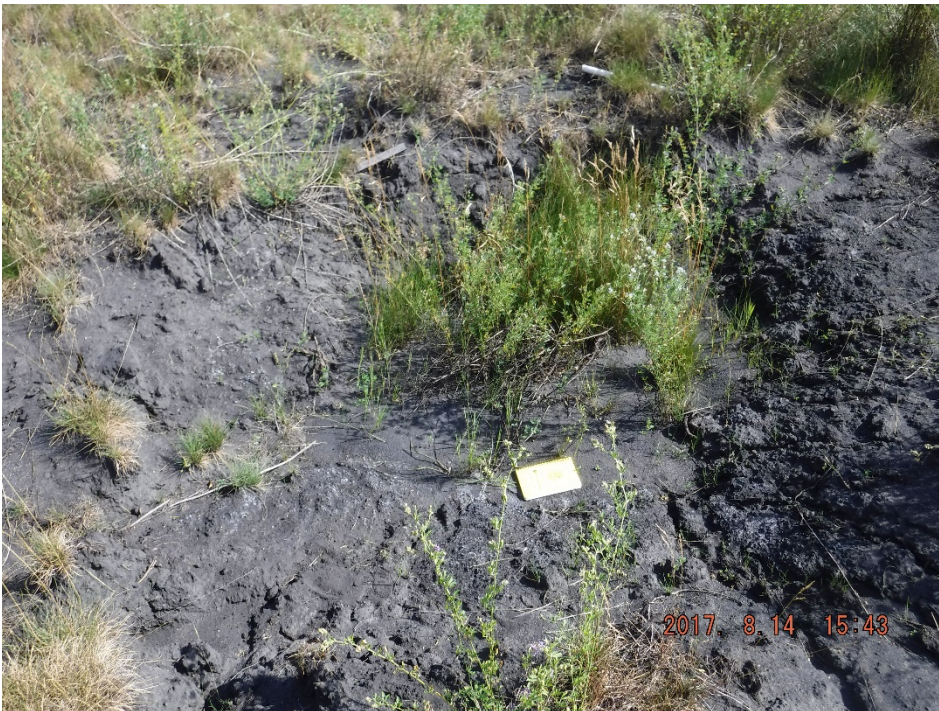
**Photo I-17 Sinkhole 3 – approximately 2.5 m x 2.3 m x 0.5 m deep (SNTD-2017-13)**

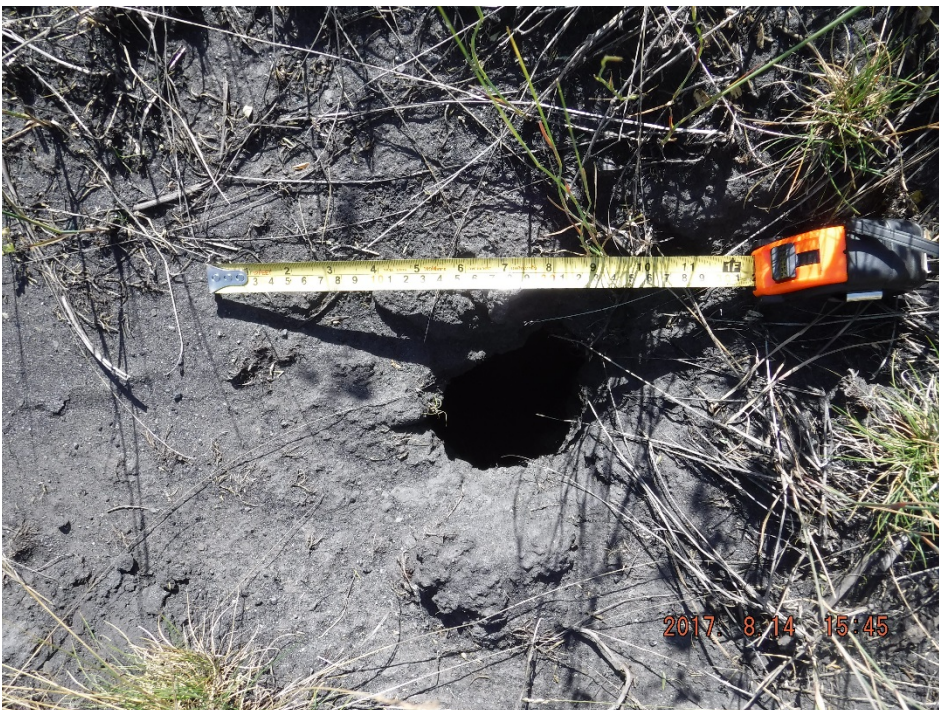
**Photo I-18 Sinkhole 4 – was not observed in 2016. Approximately 0.2 m x 0.1 m x 0.7 m deep (SNTD-2017-14)**

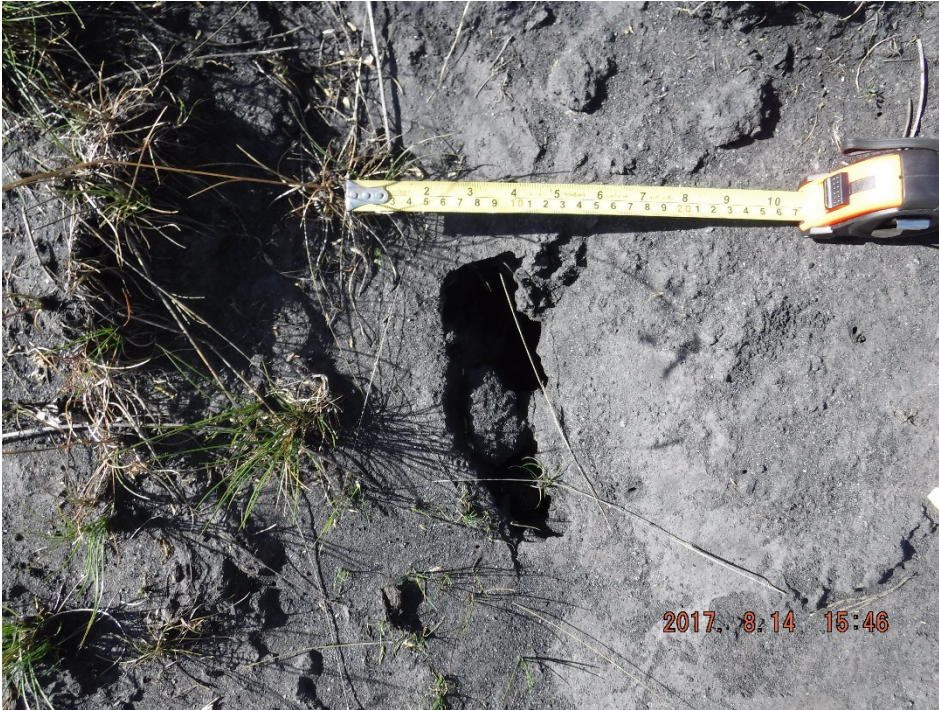
**Photo I-19 Sinkhole 5 – was not observed in 2016. Approximately 0.2 m x 0.1 m x 0.2 m deep (SNTD-2017-15)**

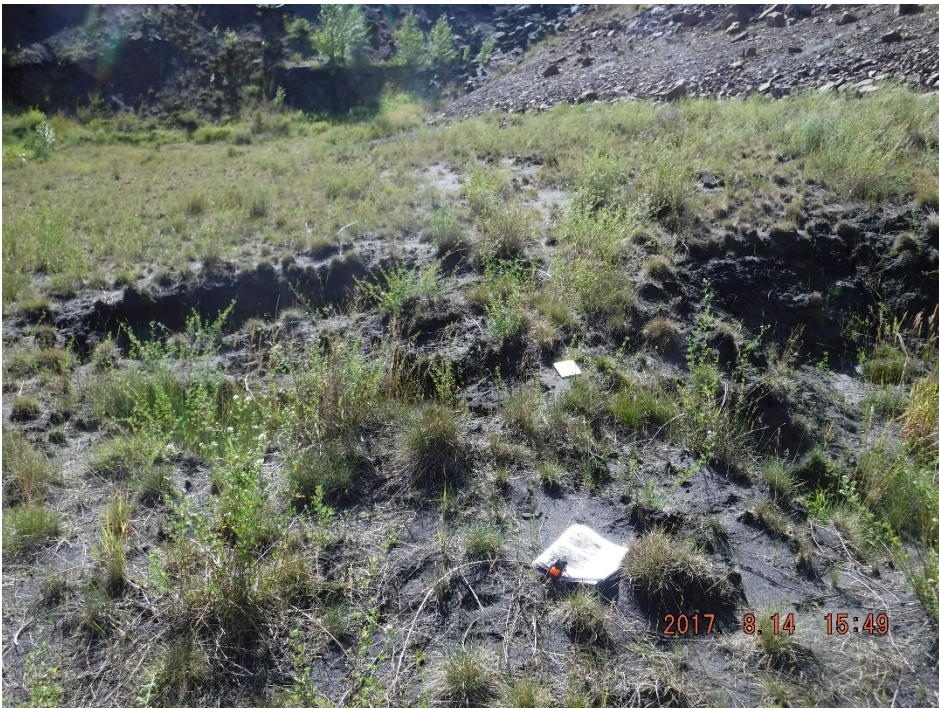
**Photo I-20 Sinkhole 6 - cluster of three sinkholes (STND-2017-16)**

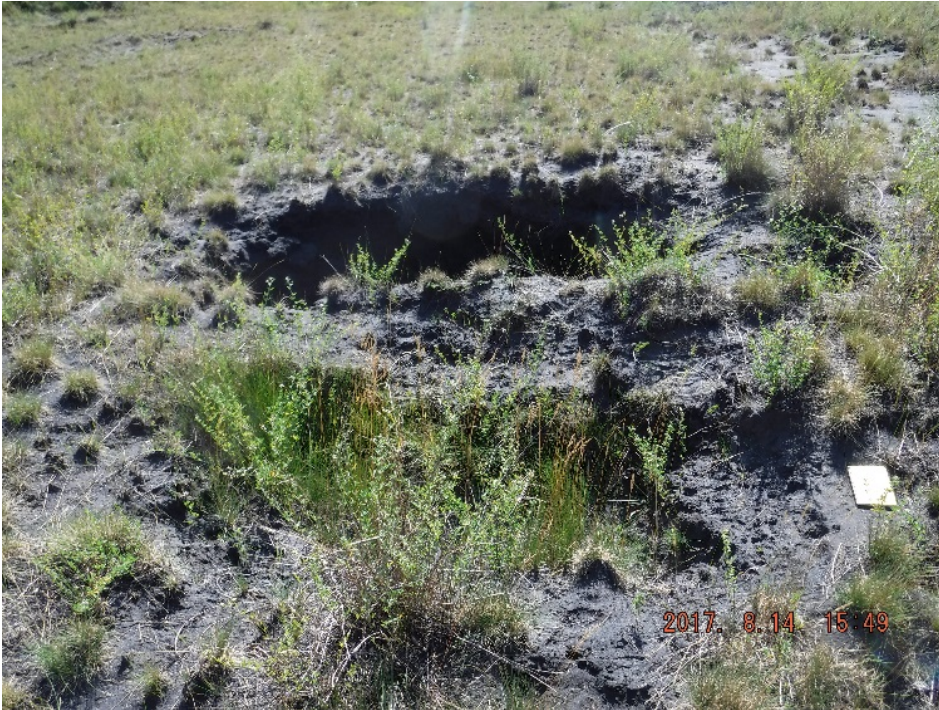
**Photo I-21 Sinkhole 6 - partial view of sinkhole cluster. Approximately 1.2 m x 1.3 m x 0.5 m deep (SNTD-2017-16)**

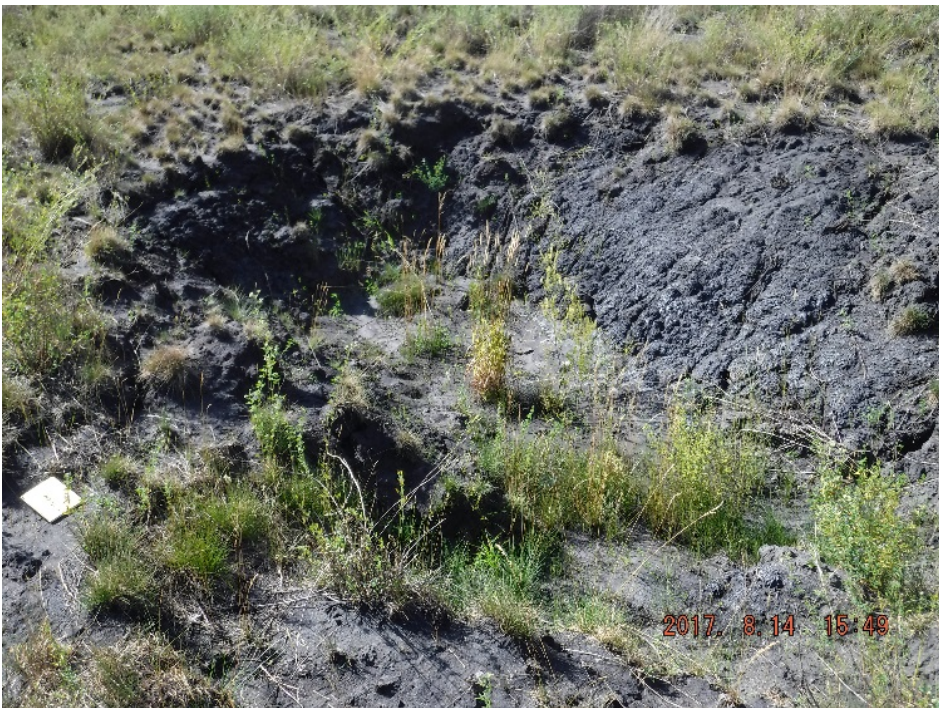
**Photo I-22 Sinkhole 6 - partial view of sinkhole cluster. Approximately 3.5 m x 6.7 m x 0.9 m deep (SNTD-2017-16)**

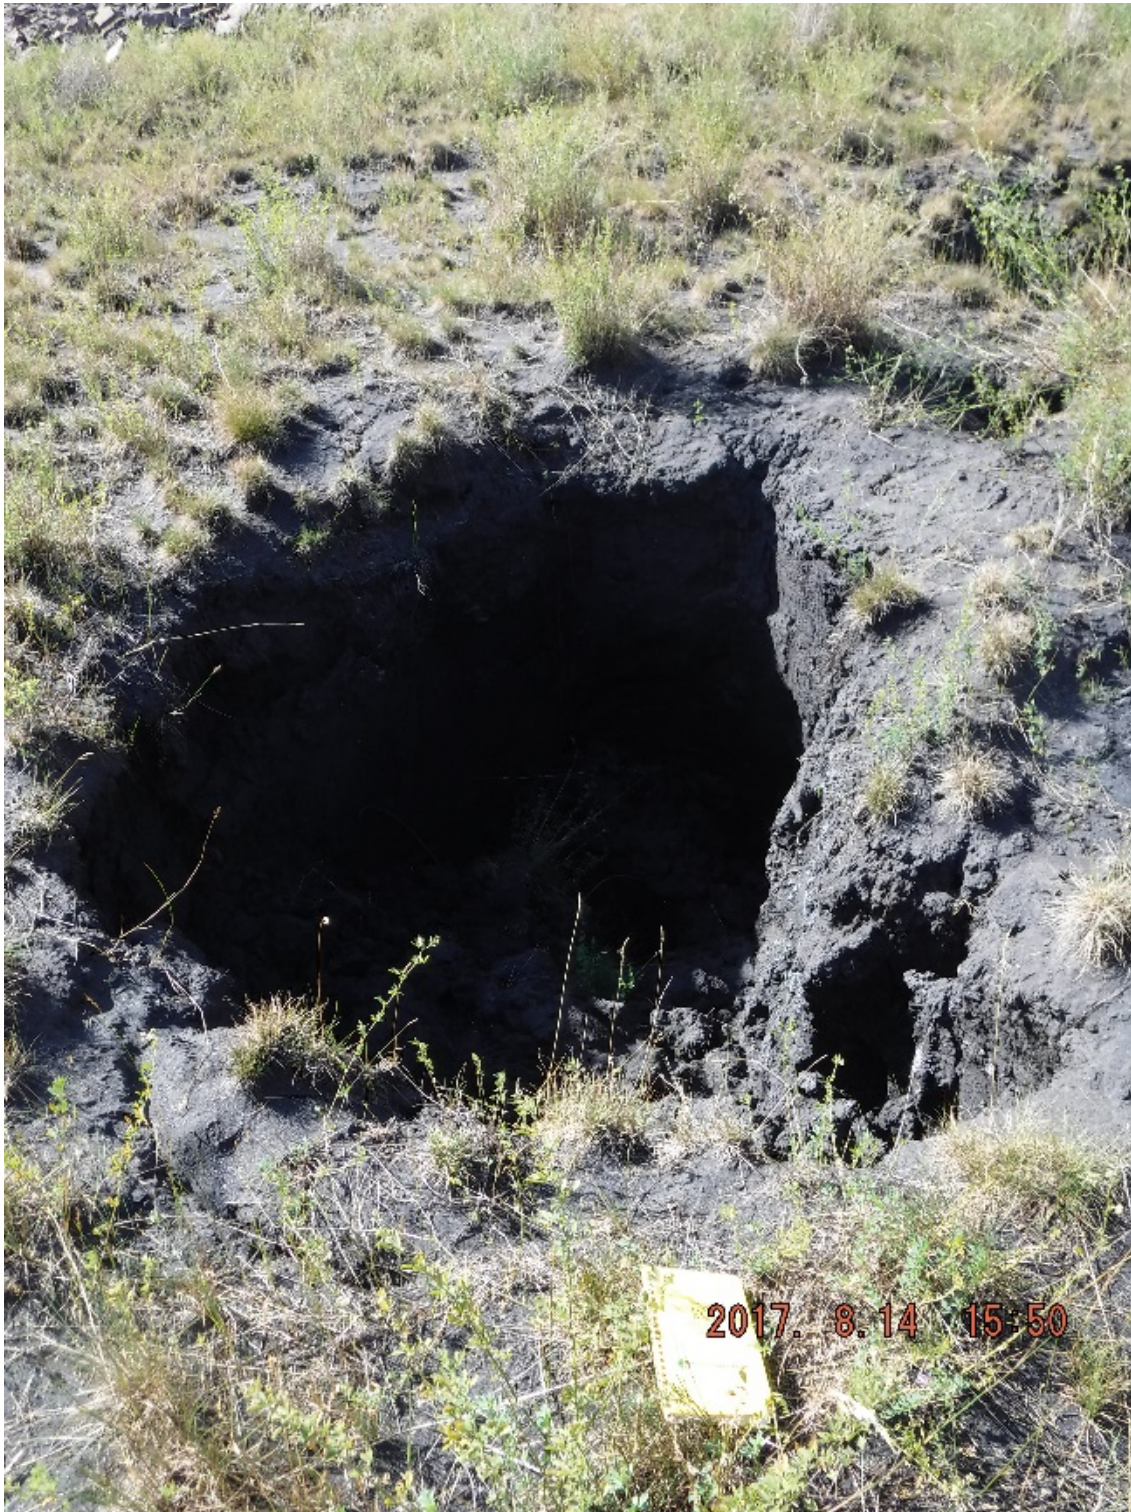
**Photo I-23 Sinkhole 6 - partial view of sinkhole cluster. Approximately 1.9 m x 3.2 m x 1.9 m deep (SNTD-2017-16)**
