# **Teck Coal Limited**

## **Quintette Coal Operations**

### ***2017 Dam Safety Inspection***

### ***Shikano North Tailings Dam***

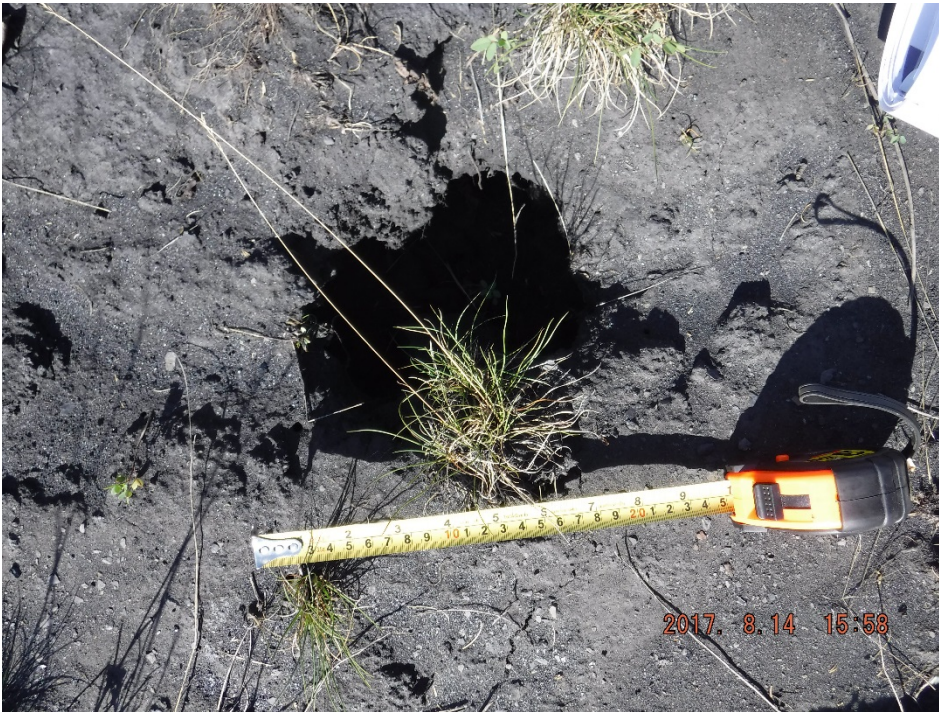
**Photo I-24 Sinkhole 7 – was not observed in 2016. Approximately 0.2 m x 0.2 m x 0.2 m deep (SNTD-2017-17)**

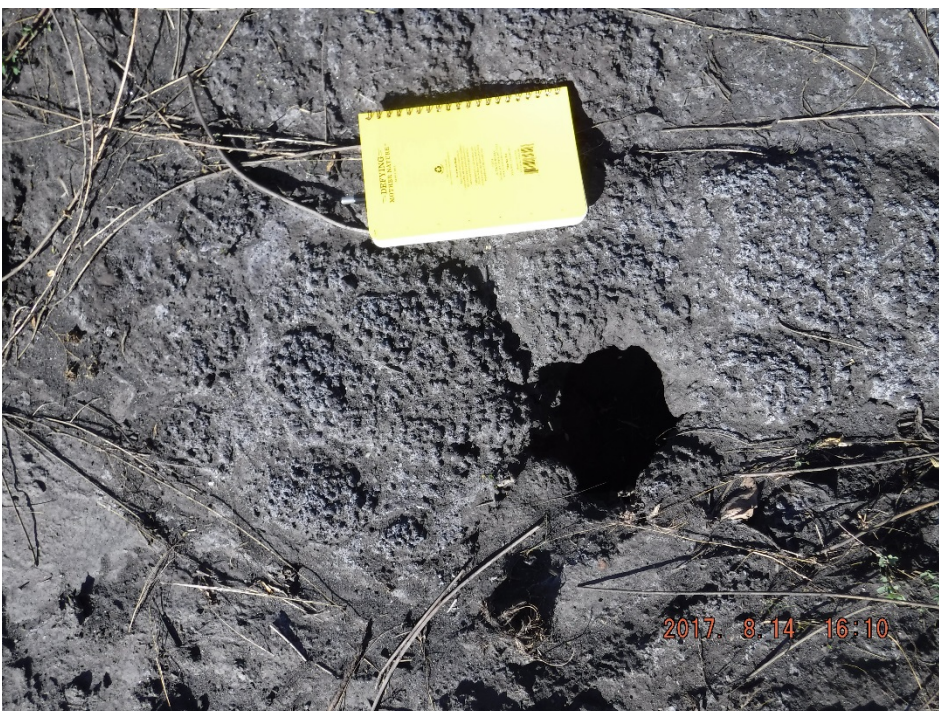
**Photo I-25 Sinkhole 8 – was not observed in 2016. Approximately 0.1 m x 0.2 m x 0.2 m deep (SNTD-2017-18)**

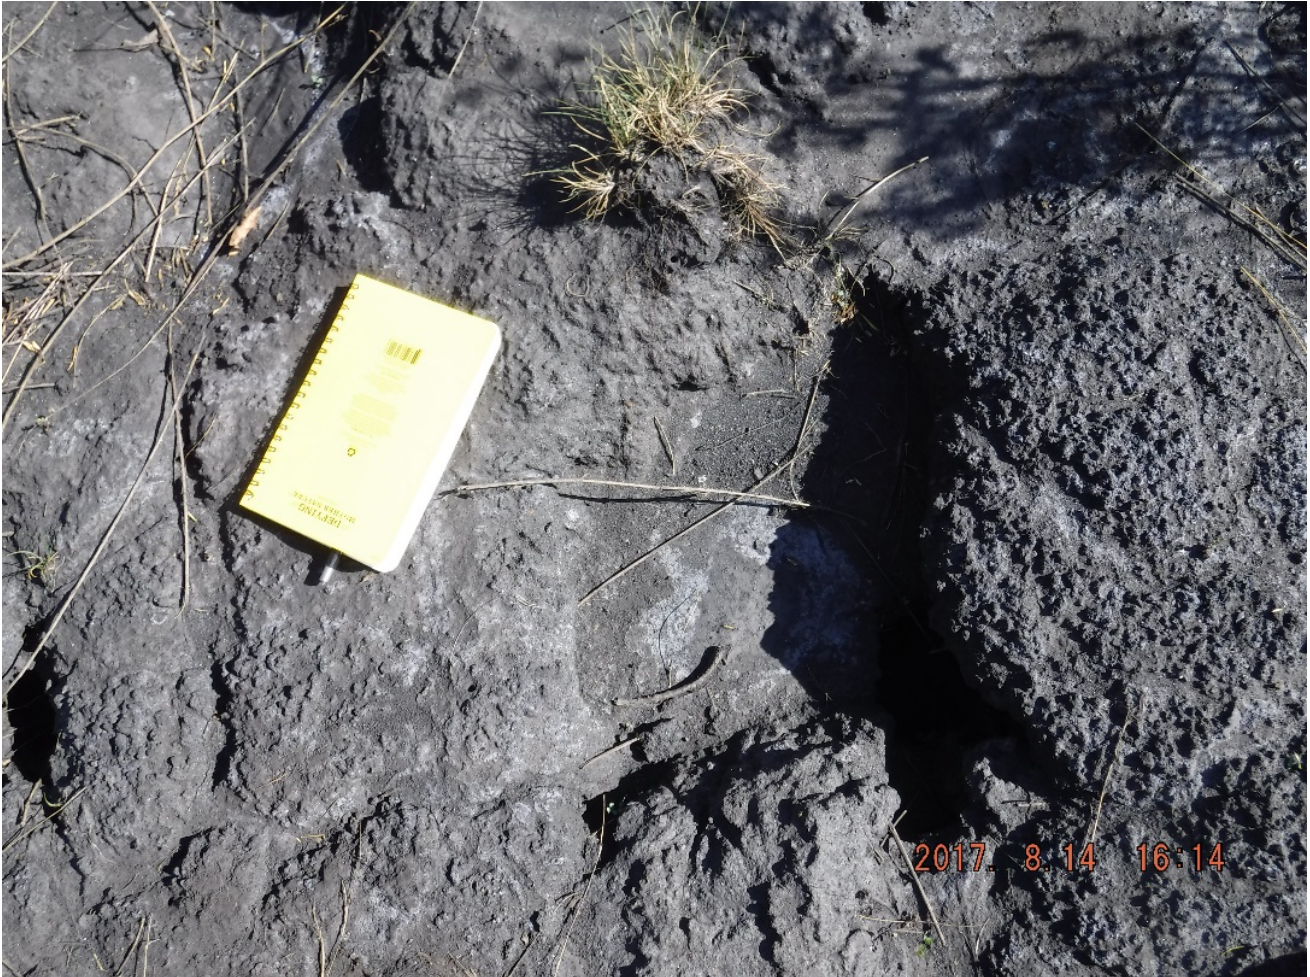
**Photo I-26 Sinkhole 9 – first observed in 2016. Approximately 0.1 m x 0.1 m x 0.1 m deep (SNTD-2017-20)**

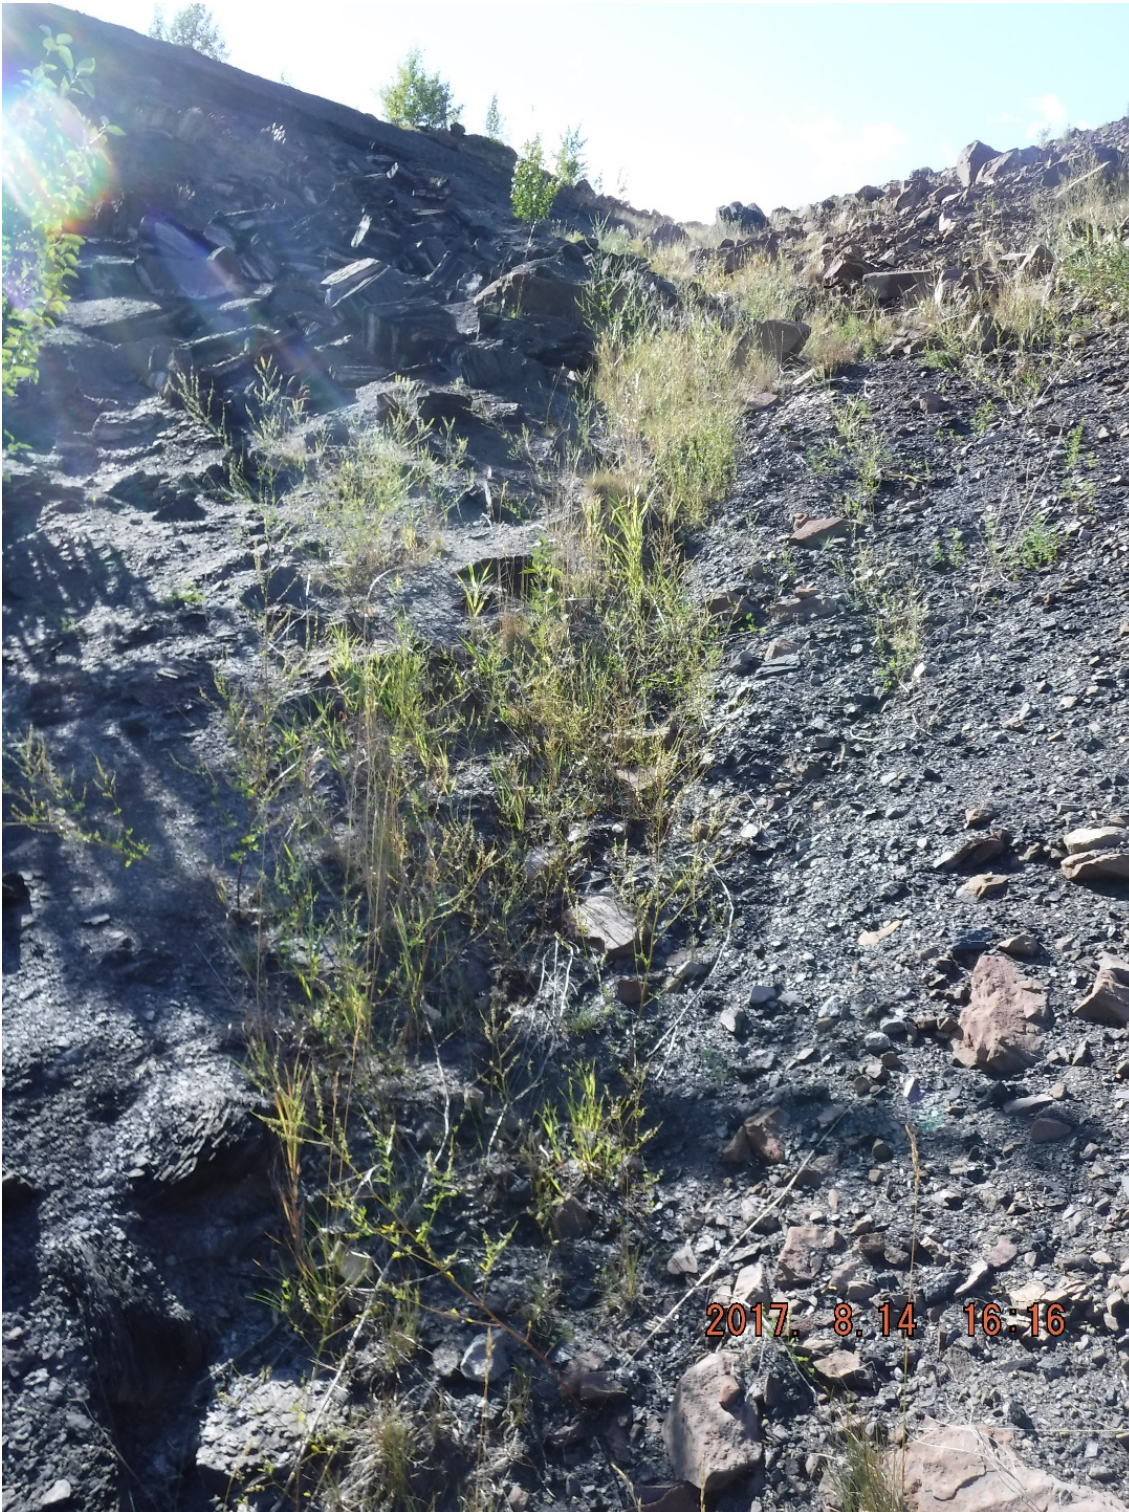
**Photo I-27** SNTD west abutment - upstream contact with the Shikano pit west wall – small erosion gully noted (SNTD-2017-21)

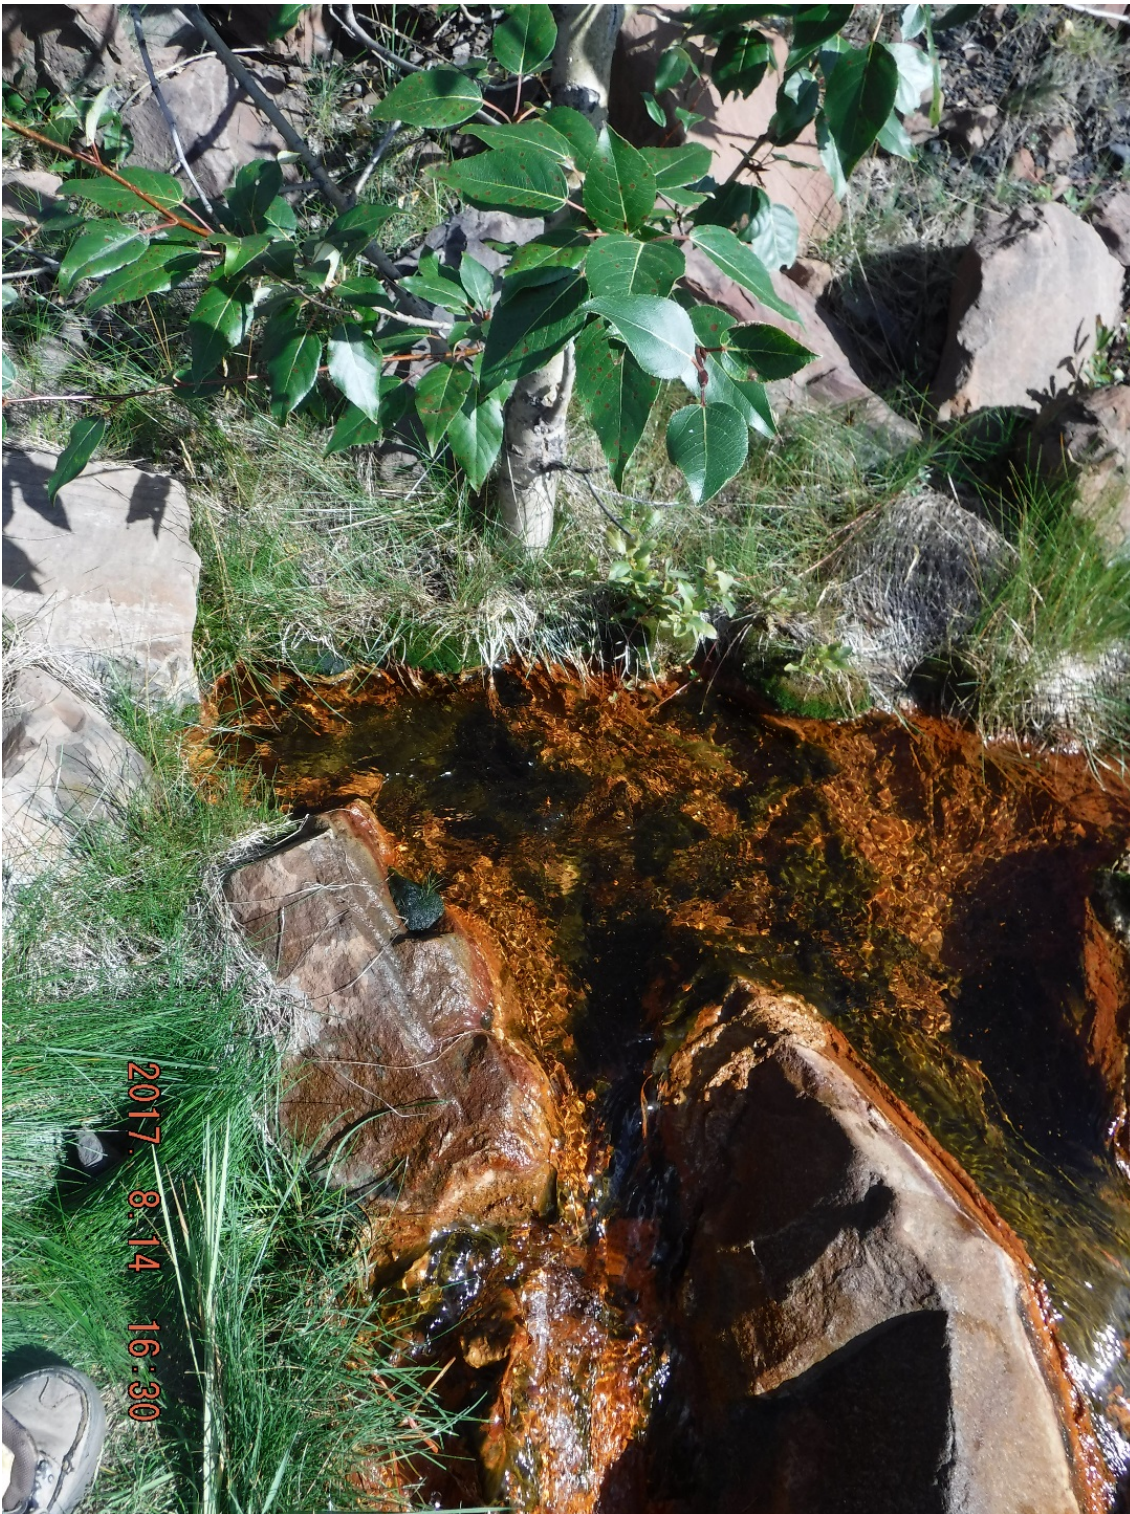
**Photo I-28 Seepage from low level outlet downstream of the dam (SNTD-2017-22)**

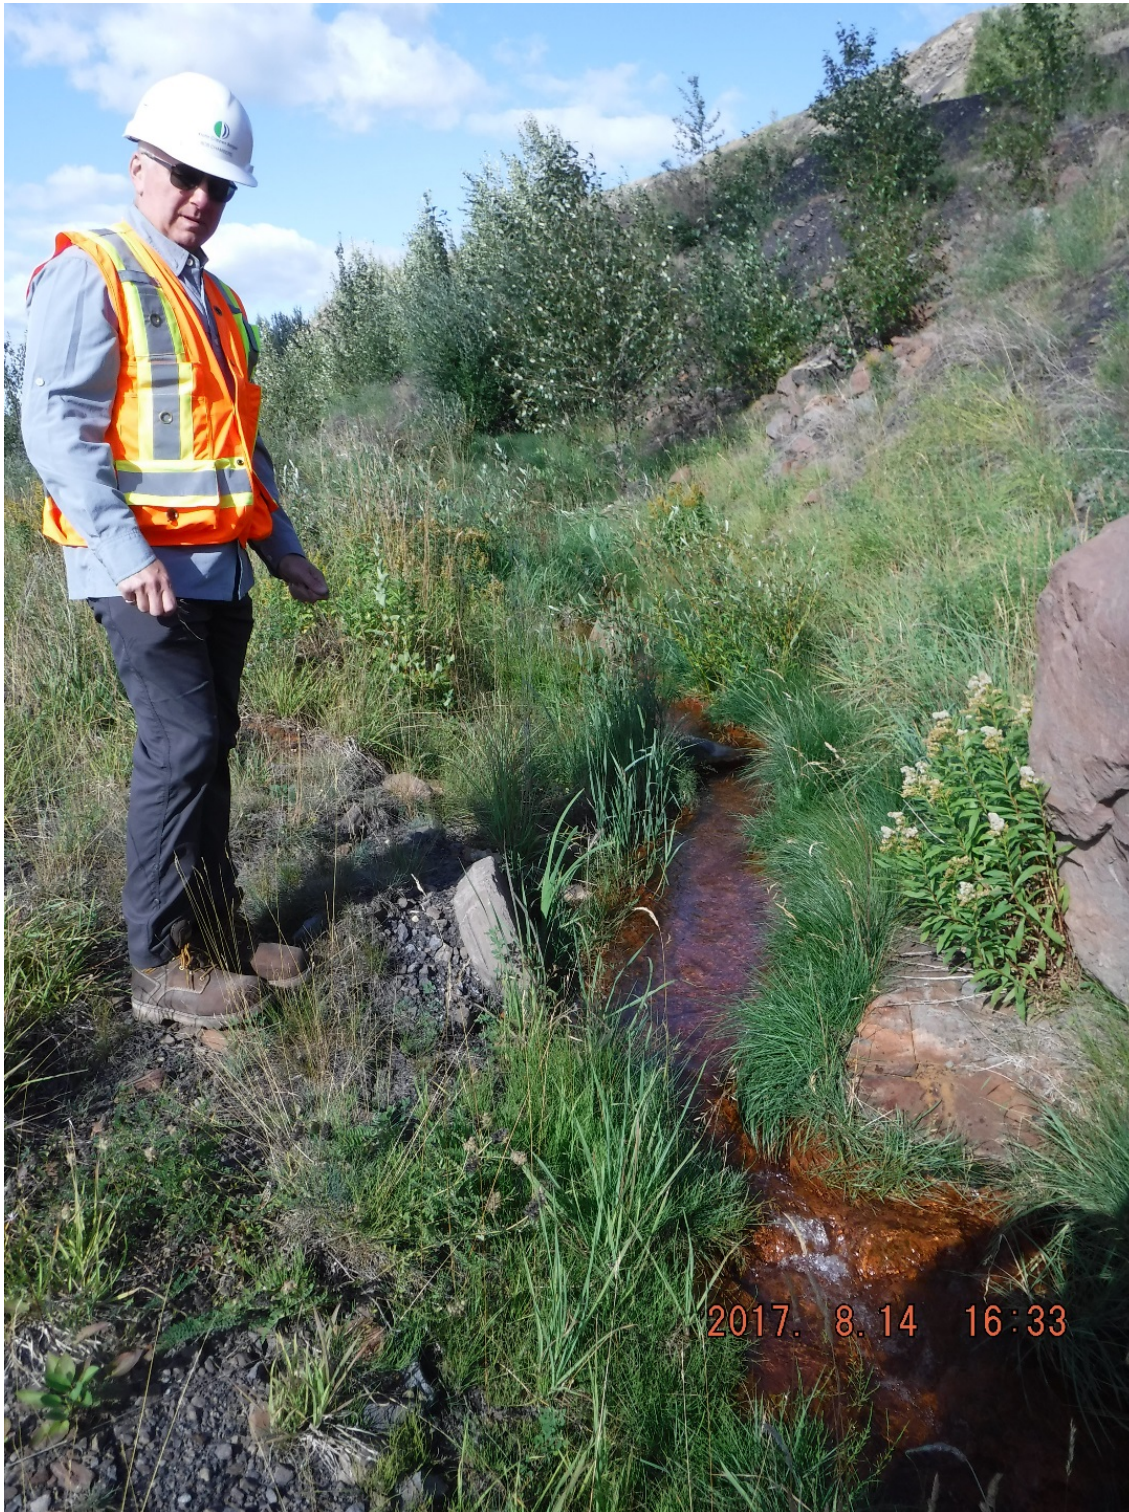
**Photo I-29 Seepage channel, which flows into Sediment Pond S3 – flow estimate: 5 L/s (SNTD-2017-23)**

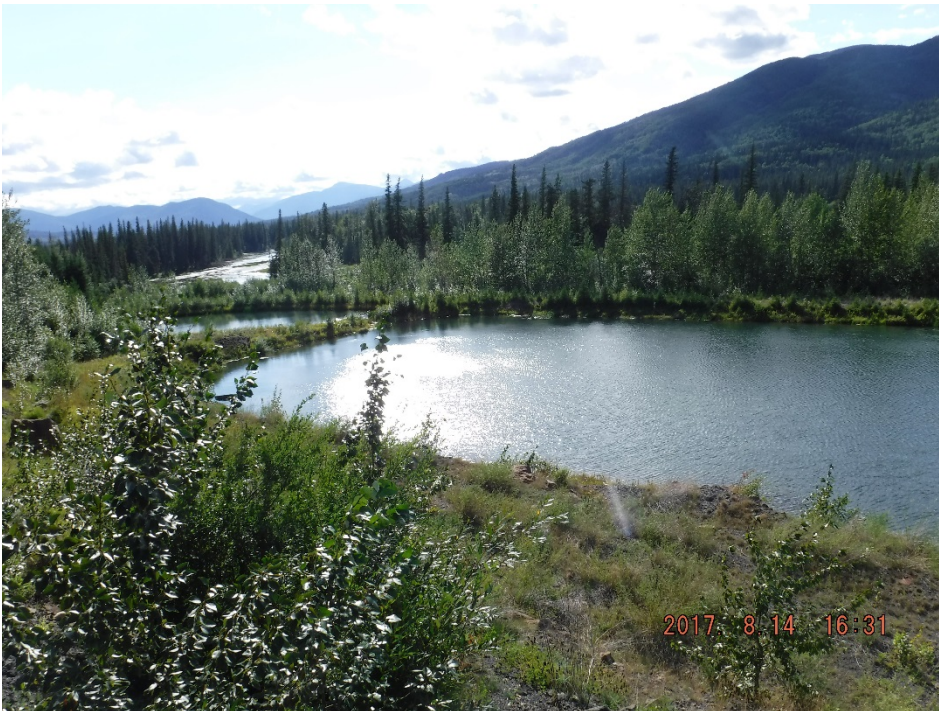
**Photo I-30 Sediment Pond S3 (SNTD-2017-23)**

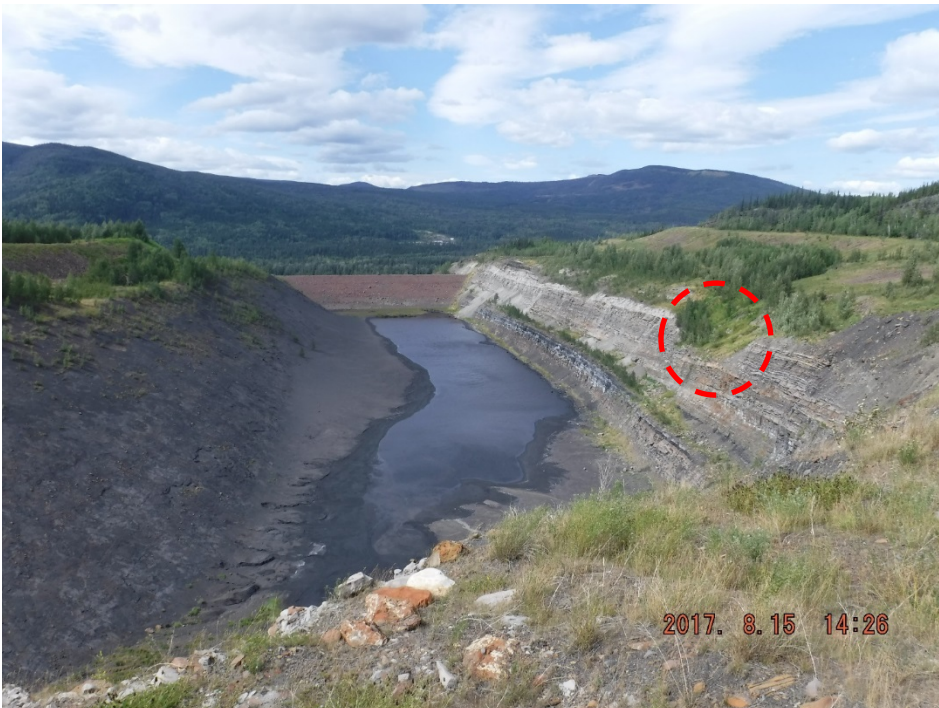
**Photo I-31 Shikano North Tailings Dam – looking south. Historic slumping failure circled with red dash line. No significant change since 2012 (SNTD-2017-24)**

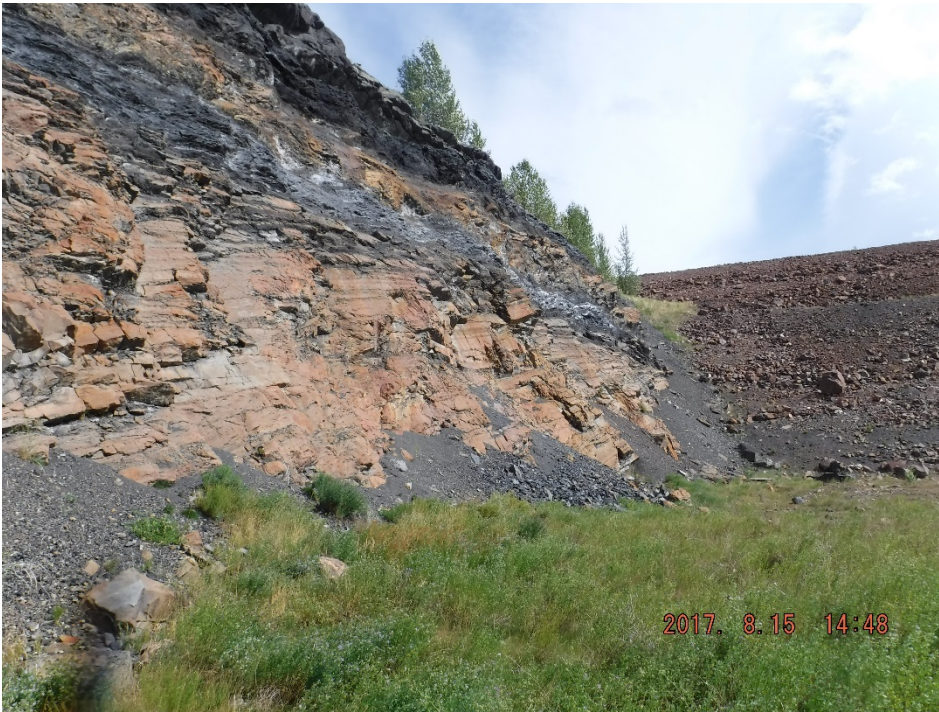
**Photo I-32** Downstream east abutment – looking southeast. No change in condition from previous year (SNTD-2017-25)

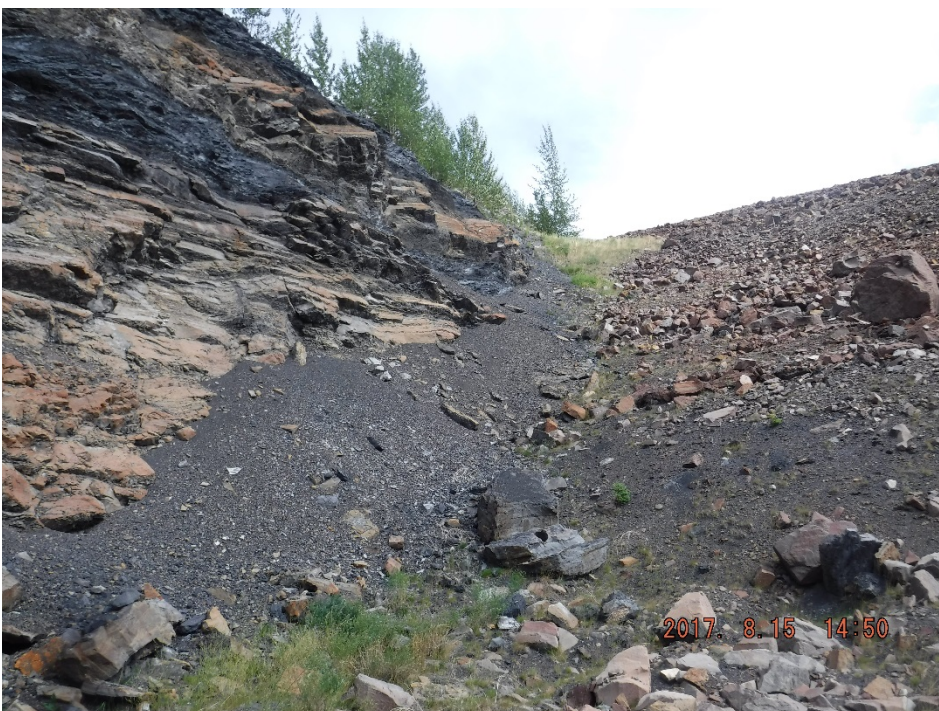
**Photo I-33** Downstream contact with east abutment – no change in condition from previous year (SNTD-2017-26)

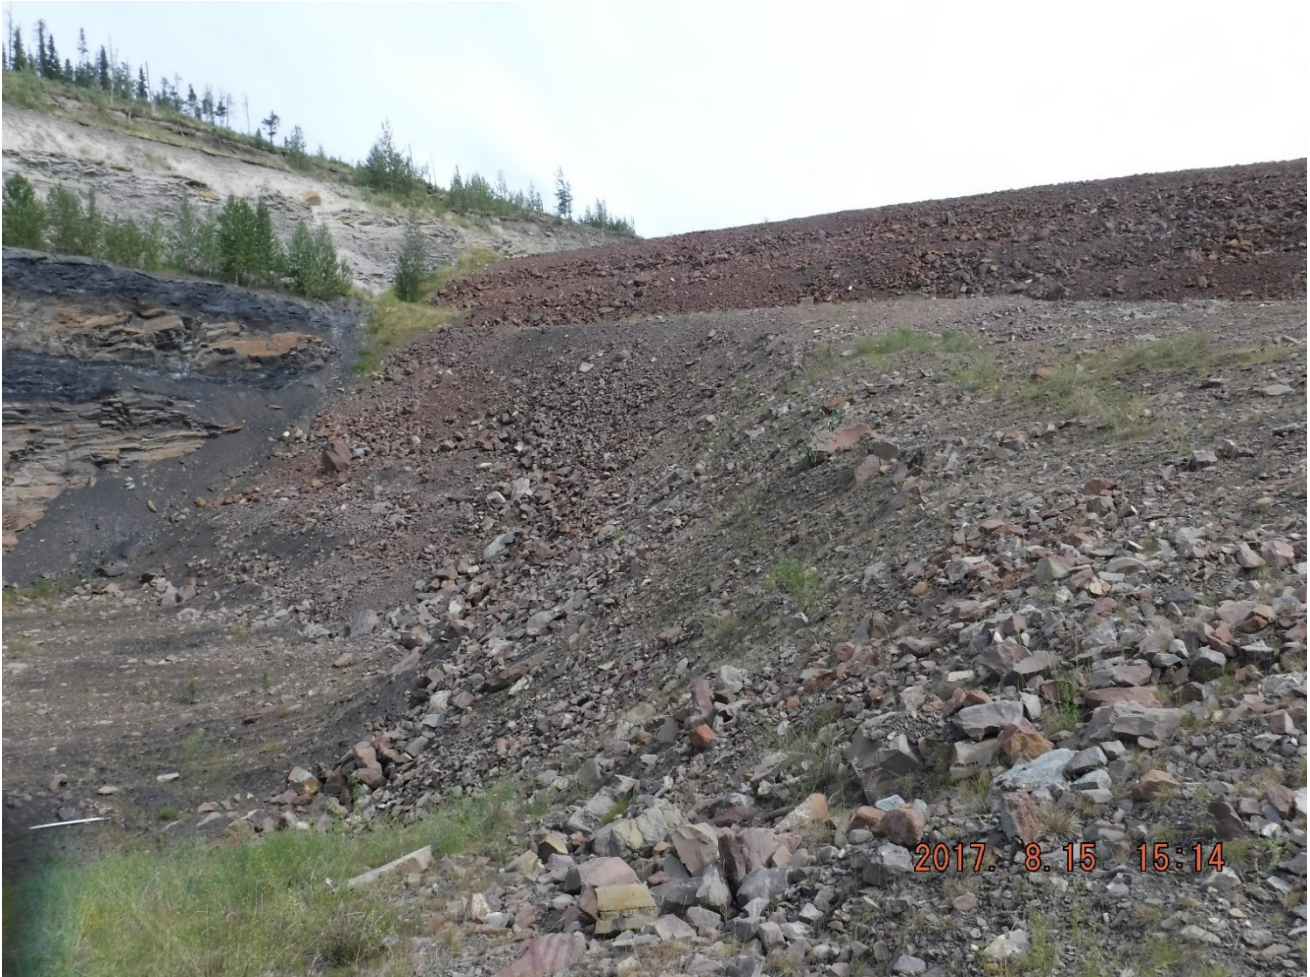
**Photo I-34** Downstream, access ramp and downstream slope – no significant sign of erosion or movement (SNTD-2017-27)
