# **Teck Coal Limited**

## **Quintette Coal Operations**

### ***2017 Dam Safety Inspection***

### ***Plantsite Tailings Dam***

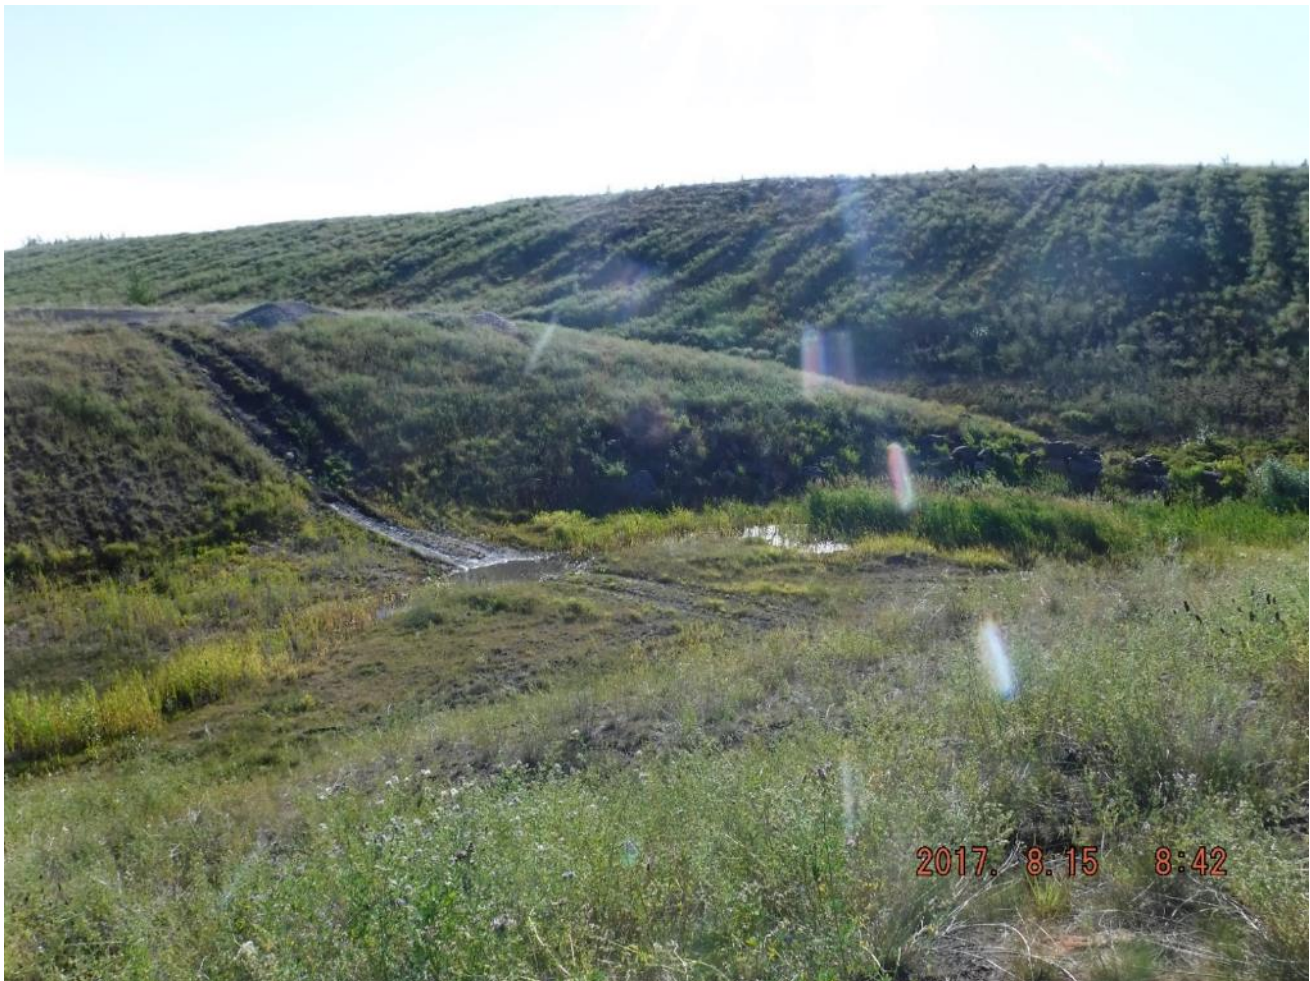
**Photo I-2      Spillway channel - viewed from the embankment looking north along the channel – channel is well vegetated but no obstruction observed (PTD-2017-01)**

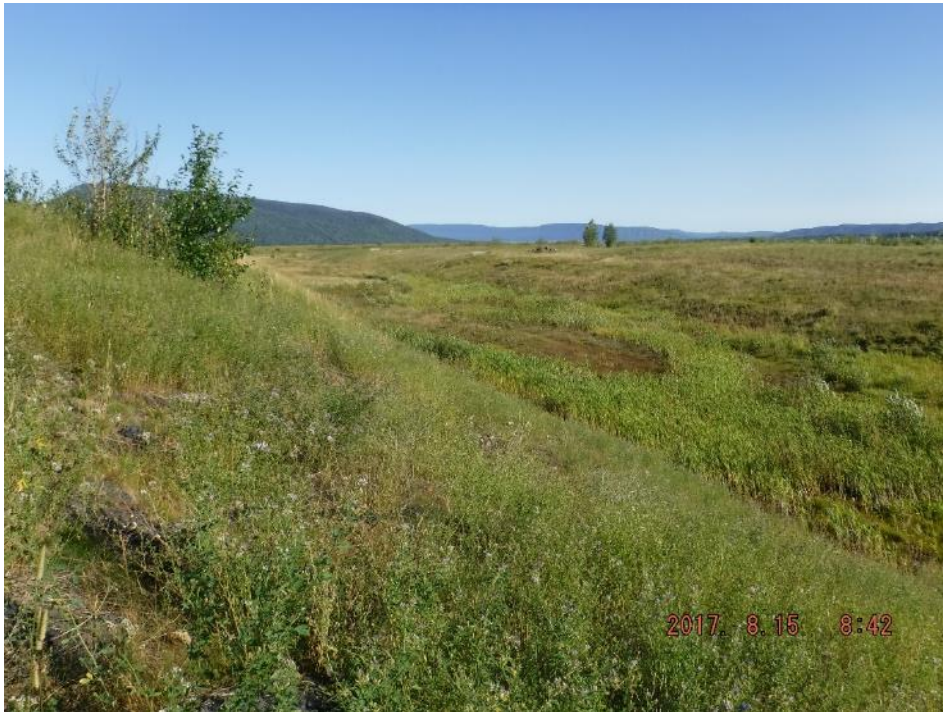
**Photo I-3      Looking northwest toward the inlet (PTD-2017-02)**

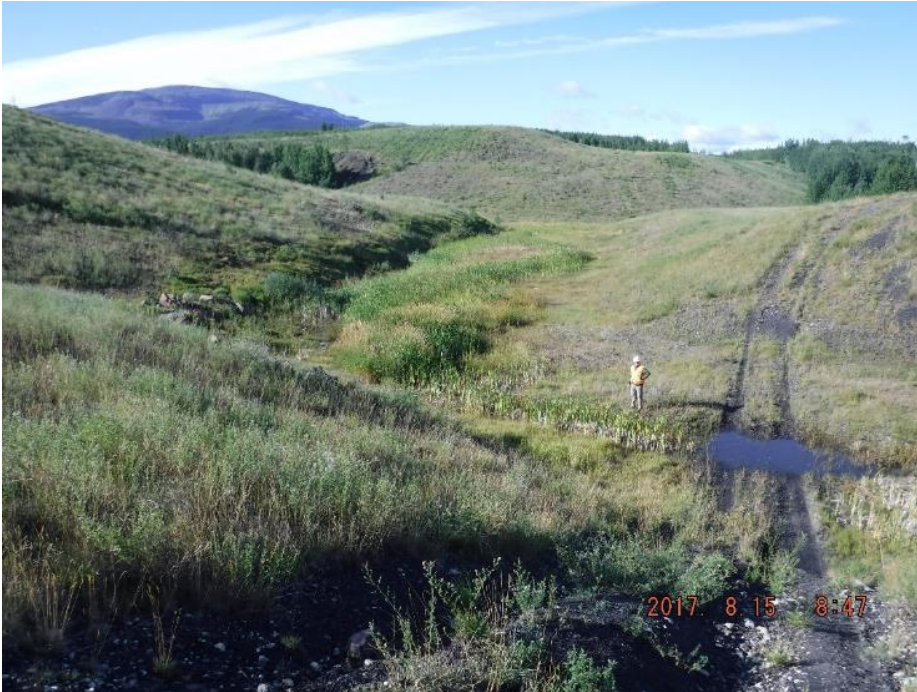
**Photo I-5** Spillway channel – viewed from inside the PTD impoundment looking northwest along the channel. Channel is well vegetated but no obstruction observed; (PTD-2017-03)

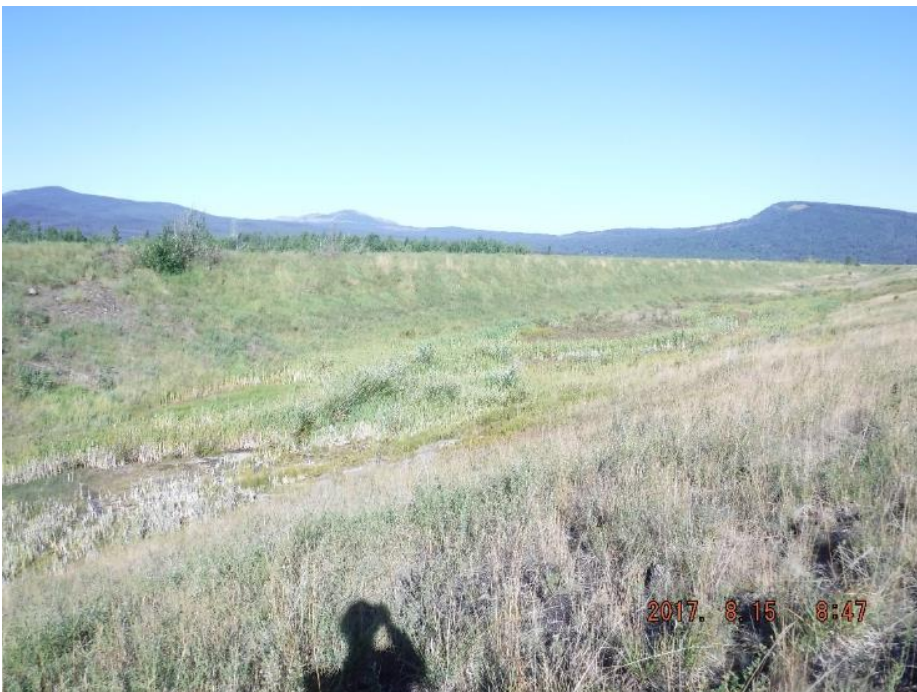
**Photo I-6 Overview of outlet channel – looking southwest toward discharge point into M17 Creek. (PTD-2017-04)**

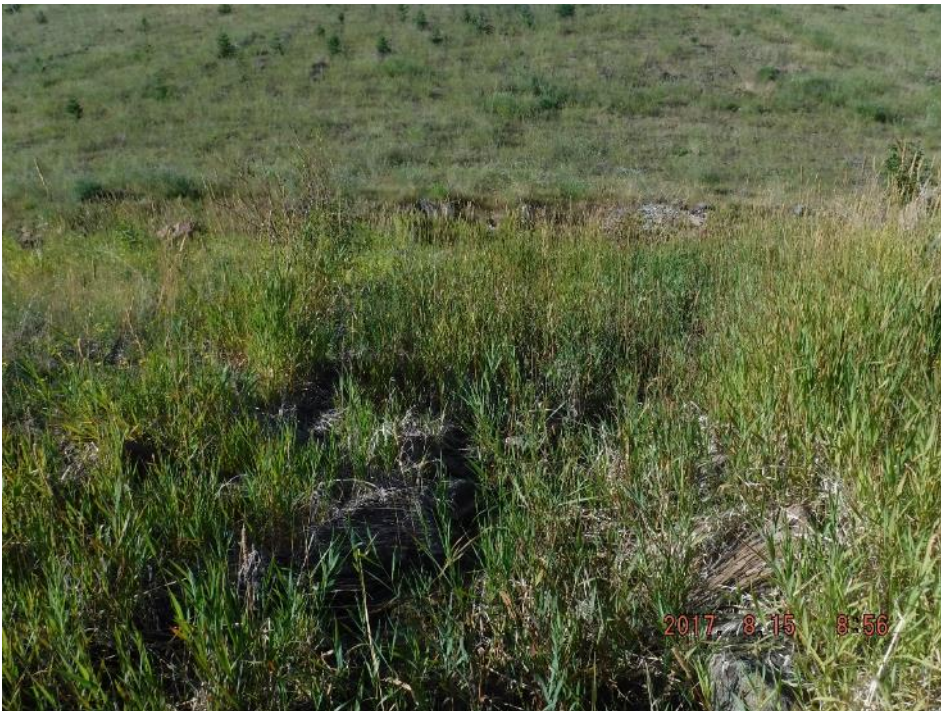
**Photo I-8**      **Spillway discharge point into M17 Creek – minor flow observed but could not be estimated due to the vegetation (PTD-2017-05)**

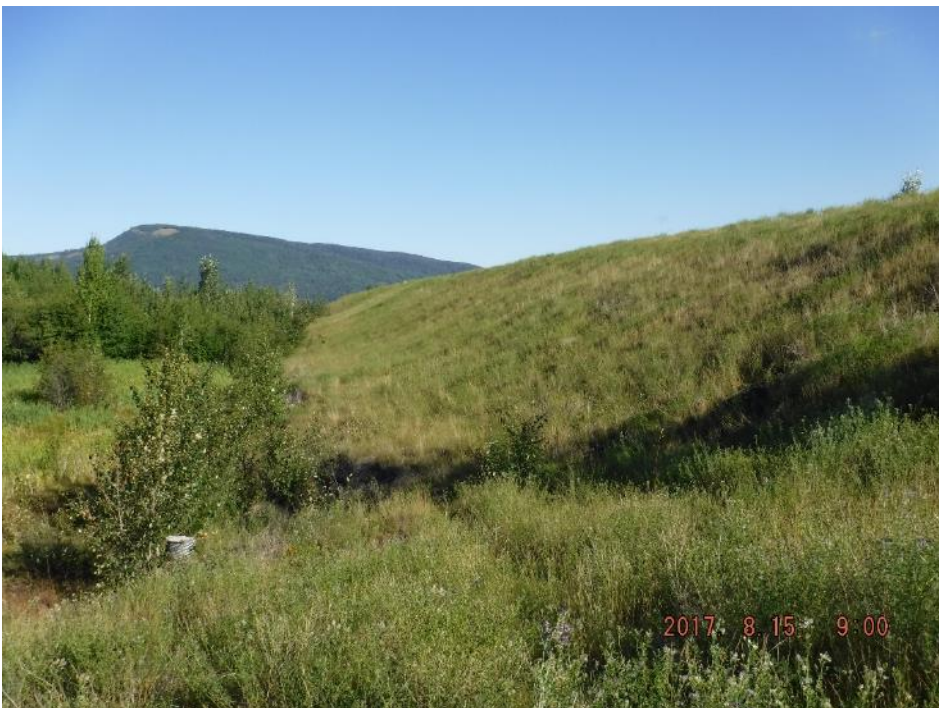
**Photo I-10** Looking northwest at a wet area downstream of PTD toe – no apparent change in condition from previous year (PTD-2017-07)

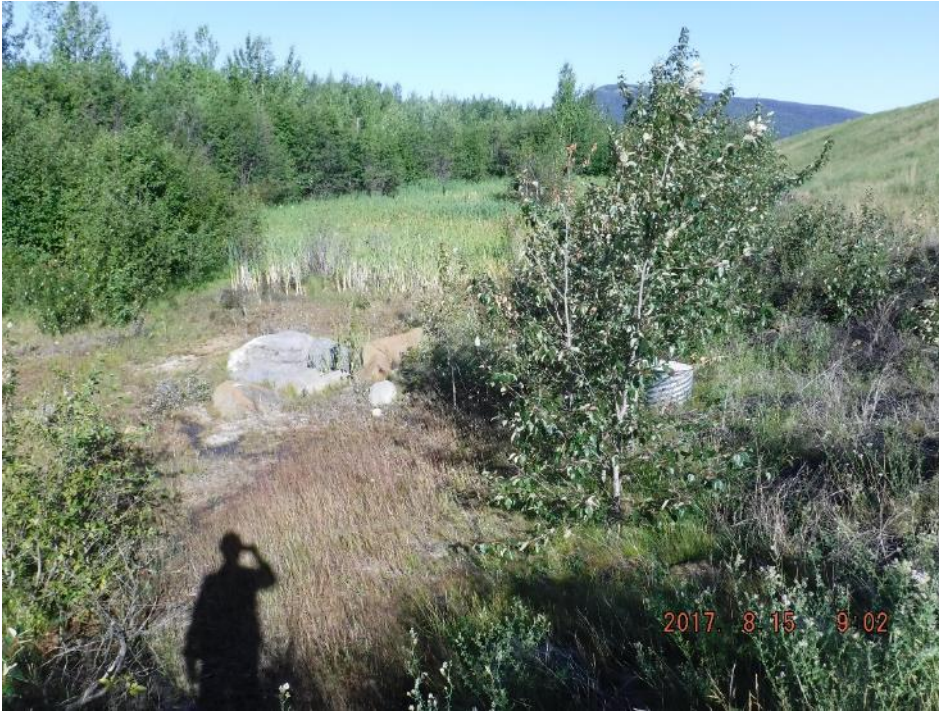
**Photo I-11** Closeup view of the wet area downstream of PTD toe. Algae buildup in pond (PTD-2017-08)

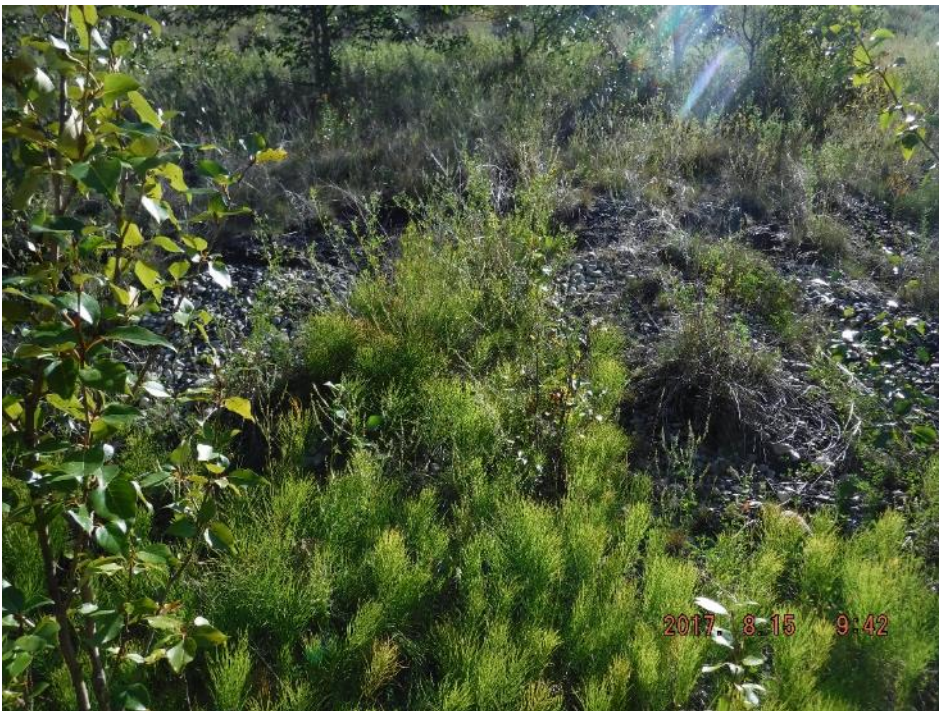
**Photo I-14** Closeup of the boggy area at the finger drain outlet – water observed on the surface (PTD-2017-10)

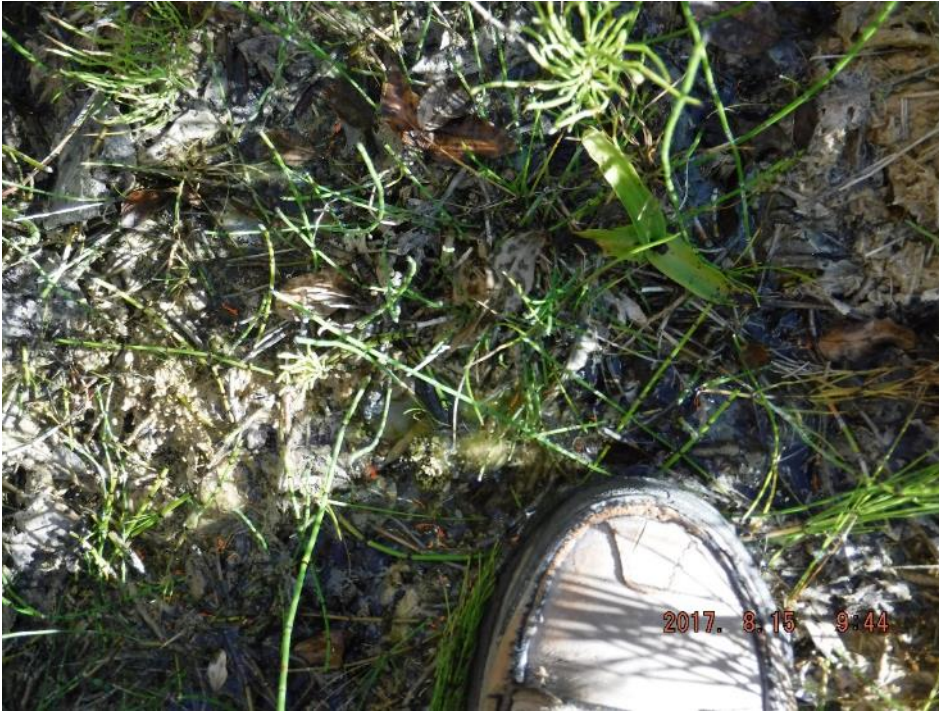
**Photo I-15** Finger drain at the PTD toe – little to no flow observed (PTD-2017-11)

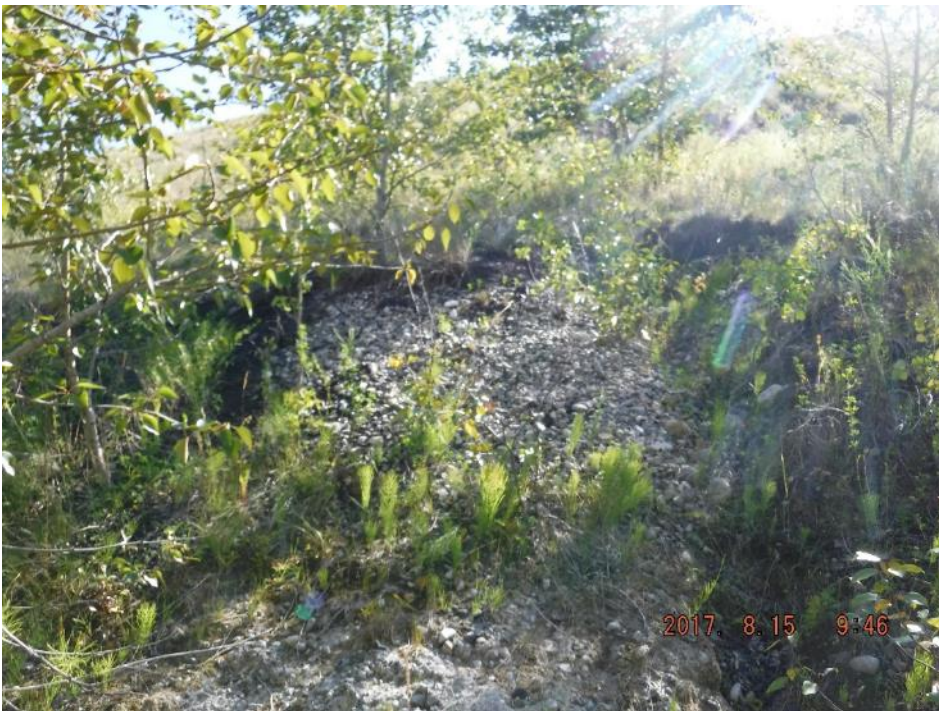
**Photo I-16 Finger drain at the PTD toe – <1 L/min flow (PTD-2017-12)**

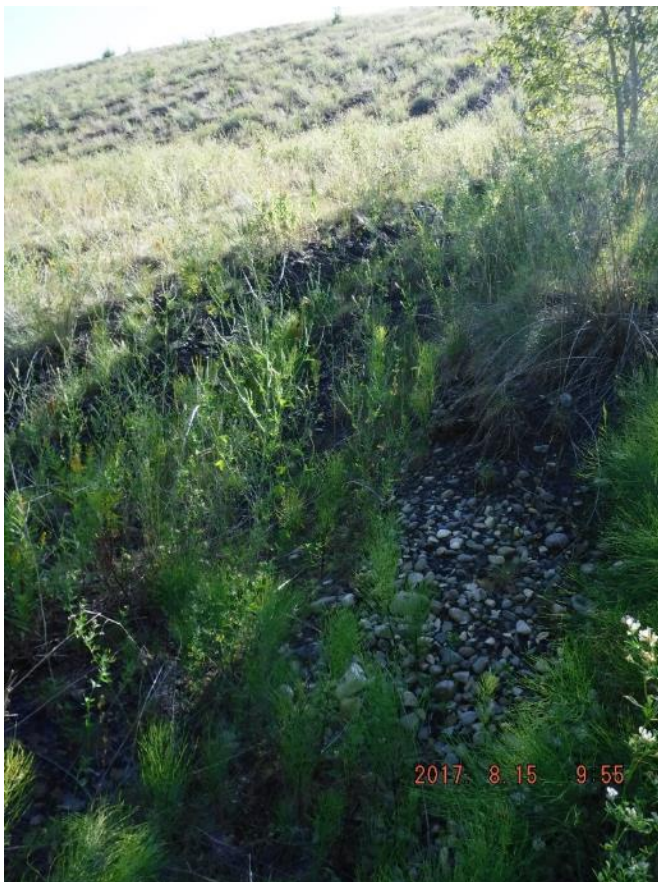
**Photo I-18 Seepage Collection Pond – located west of the PTD which discharges into M17B Creek. No sign of erosion, distress, or discernable discharge noted (PTD-2017-14)**

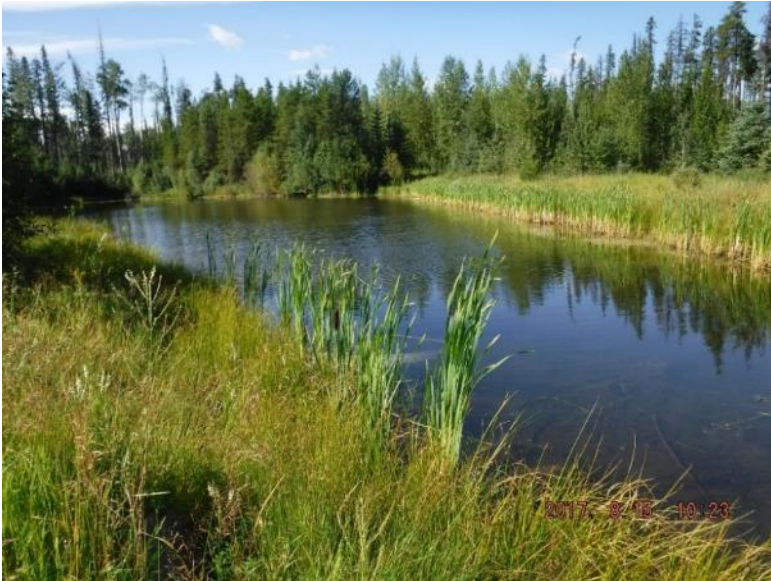
**Photo I-19 PTD Seepage Collection Pond – Beaver Dam noted obstructing the outlet area of the pond (PTD-2017-15)**

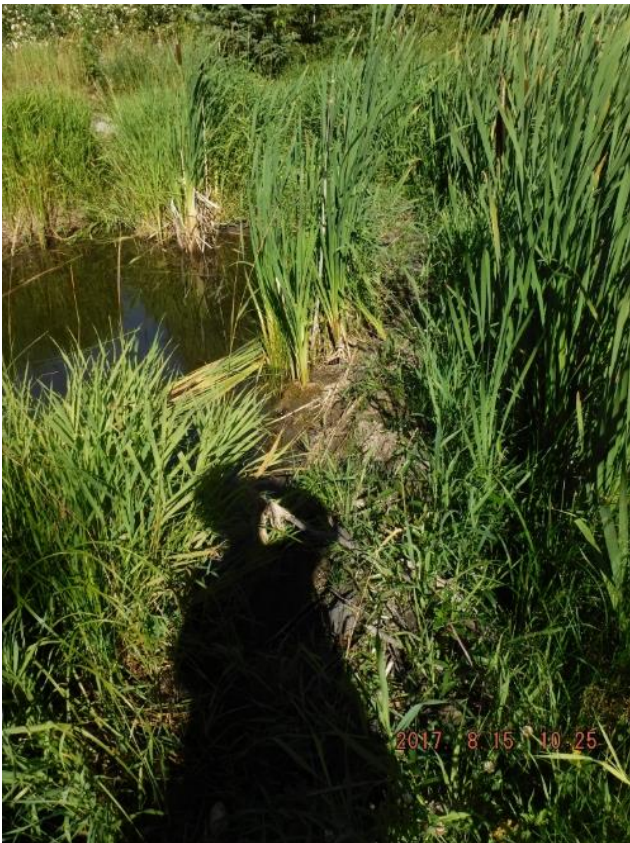
**Photo I-20     Seepage Collection Pond – no sign of distress (PTD-2017-16)**

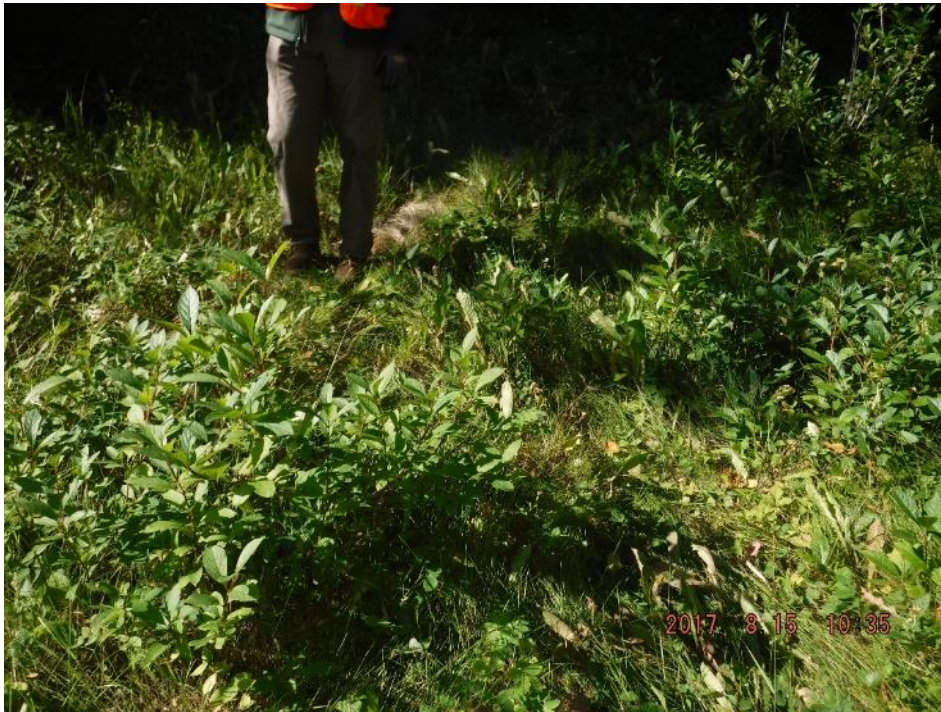
**Photo I-25** Outlet channel of the Sedimentation Pond – ponded area appears to be smaller than previous year; no discharge noted (PTD-2017-20)

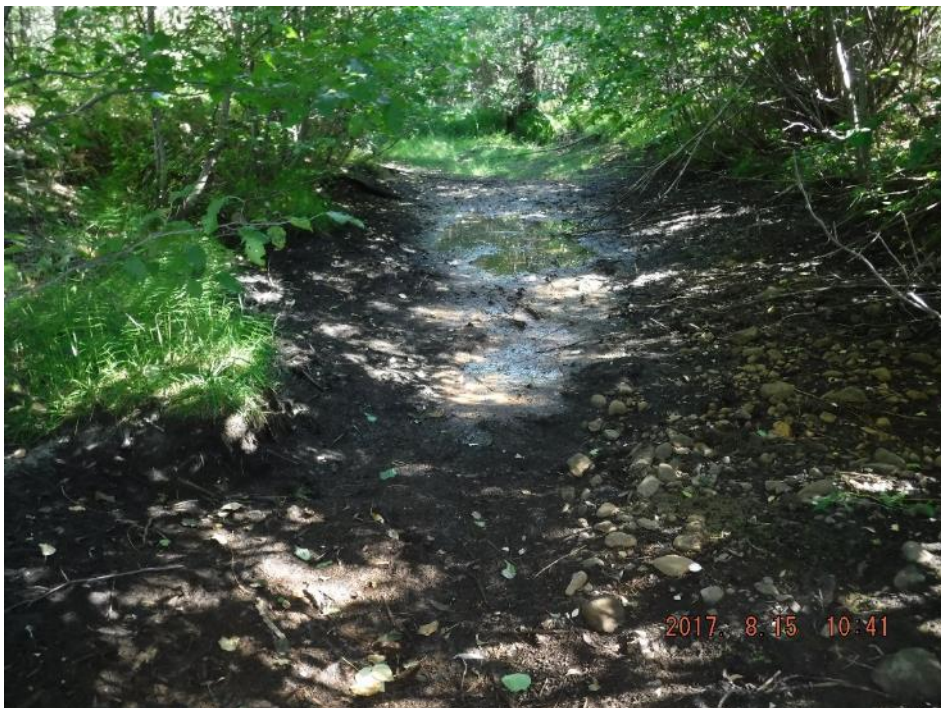
**Photo I-26** Typical finger drain wrapped with geotextile – wet ground downstream of the drain outlet noted (<1 L/min flow) (PTD-2017-21)

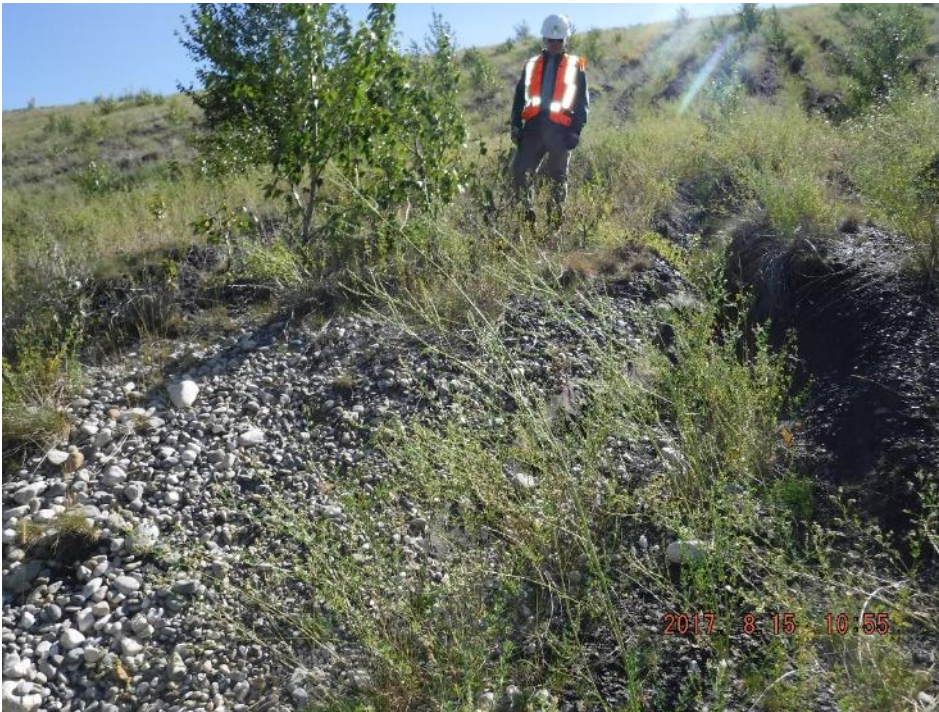
**Photo I-27** Closeup of small flow (<1 L/min) downstream of the finger drain outlet (PTD-2017-21)

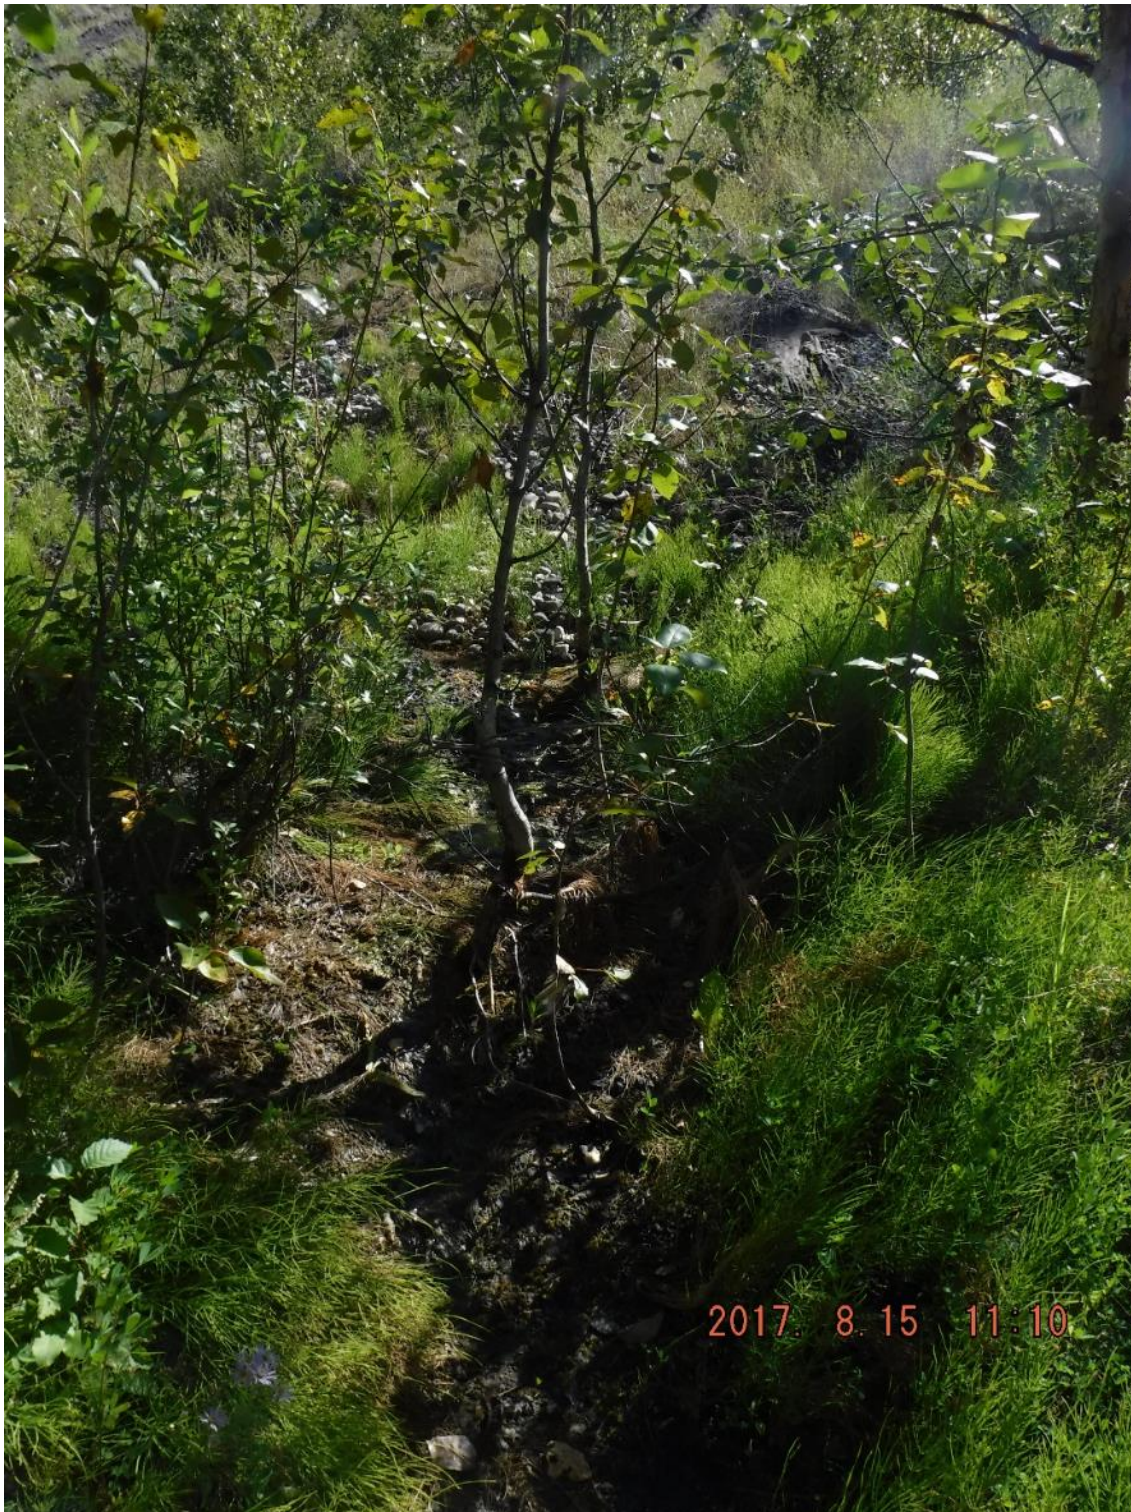
**Photo I-29** Flow noted coming from downstream toe adjacent to a finger drain - flow was estimated 1 L/min (PTD-2017-23)

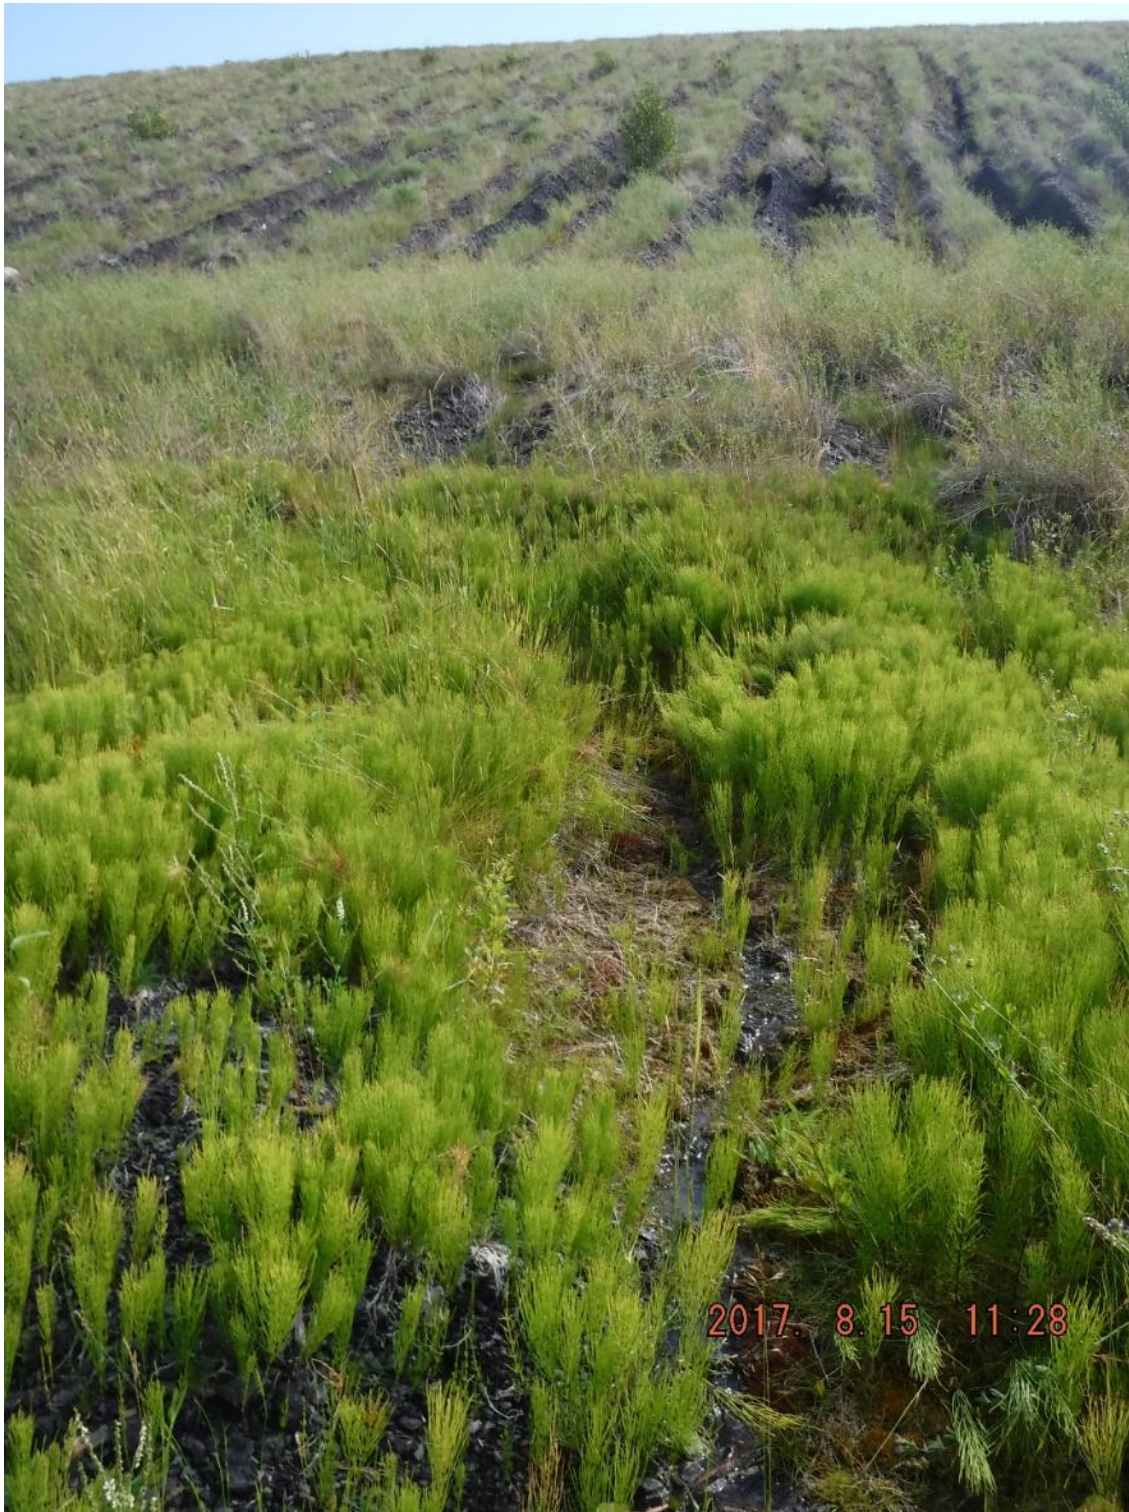
**Photo I-30**    **Flow noted coming from finger drain – flow was estimated 3 to 5 L/min**  
**(PTD-2017-23)**

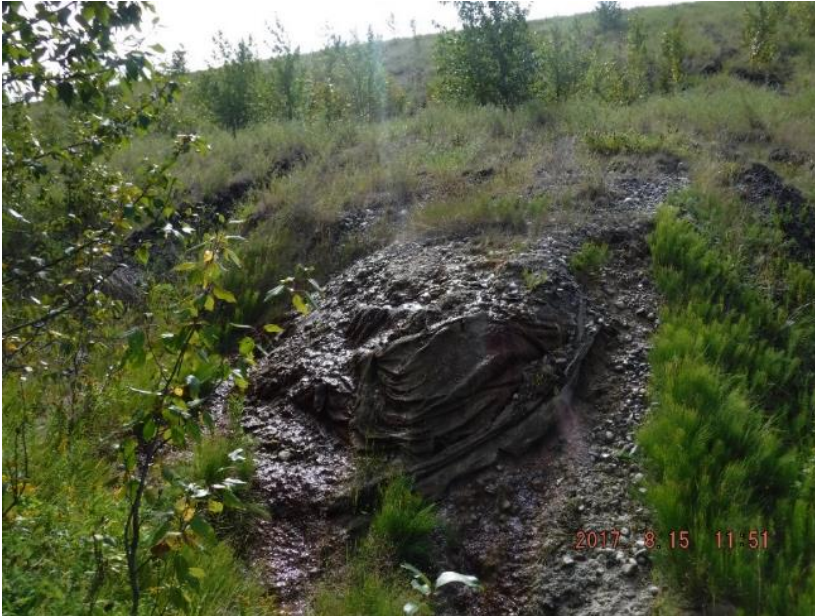
**Photo I-34 Finger drain with geotextile – flow was estimated 0.5 L/min (PTD-2017-26)**

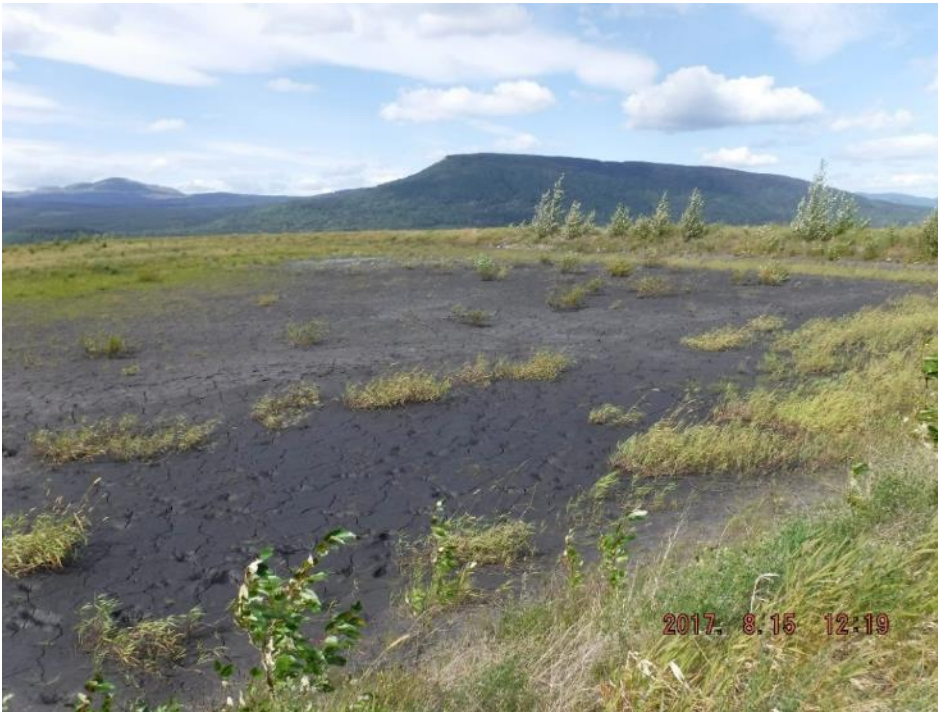
**Photo I-38** Standing at the PTD's northwest corner looking southwest into the impoundment – no sign of distress (PTD-2017-30)

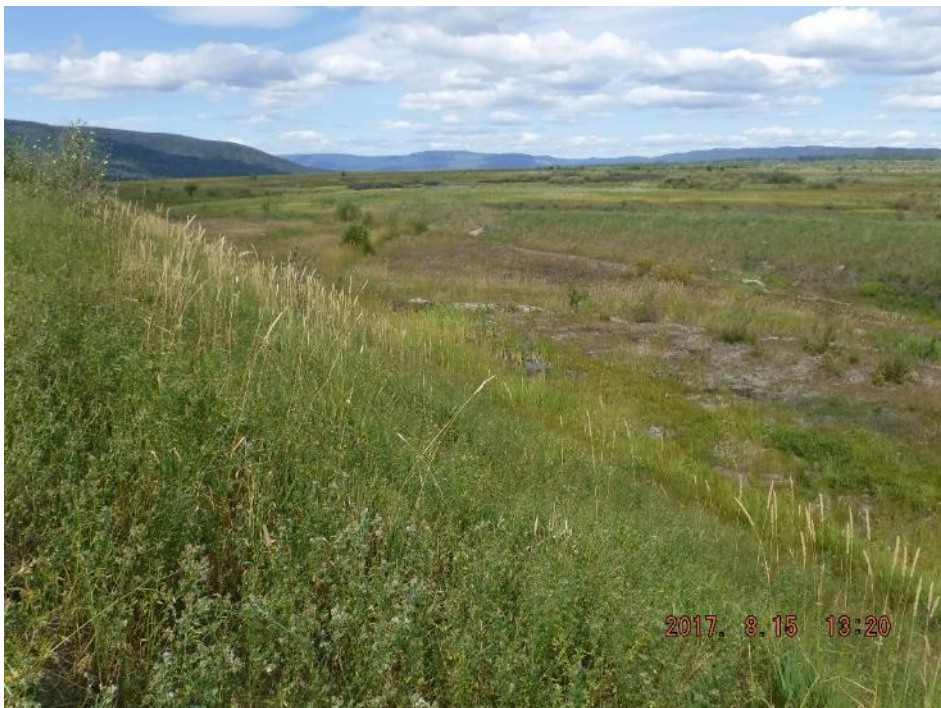
**Photo I-53** Standing inside the spillway channel looking north at deteriorating riprap and ponded area inside local depressions inside the channel (PTD-2017-43)

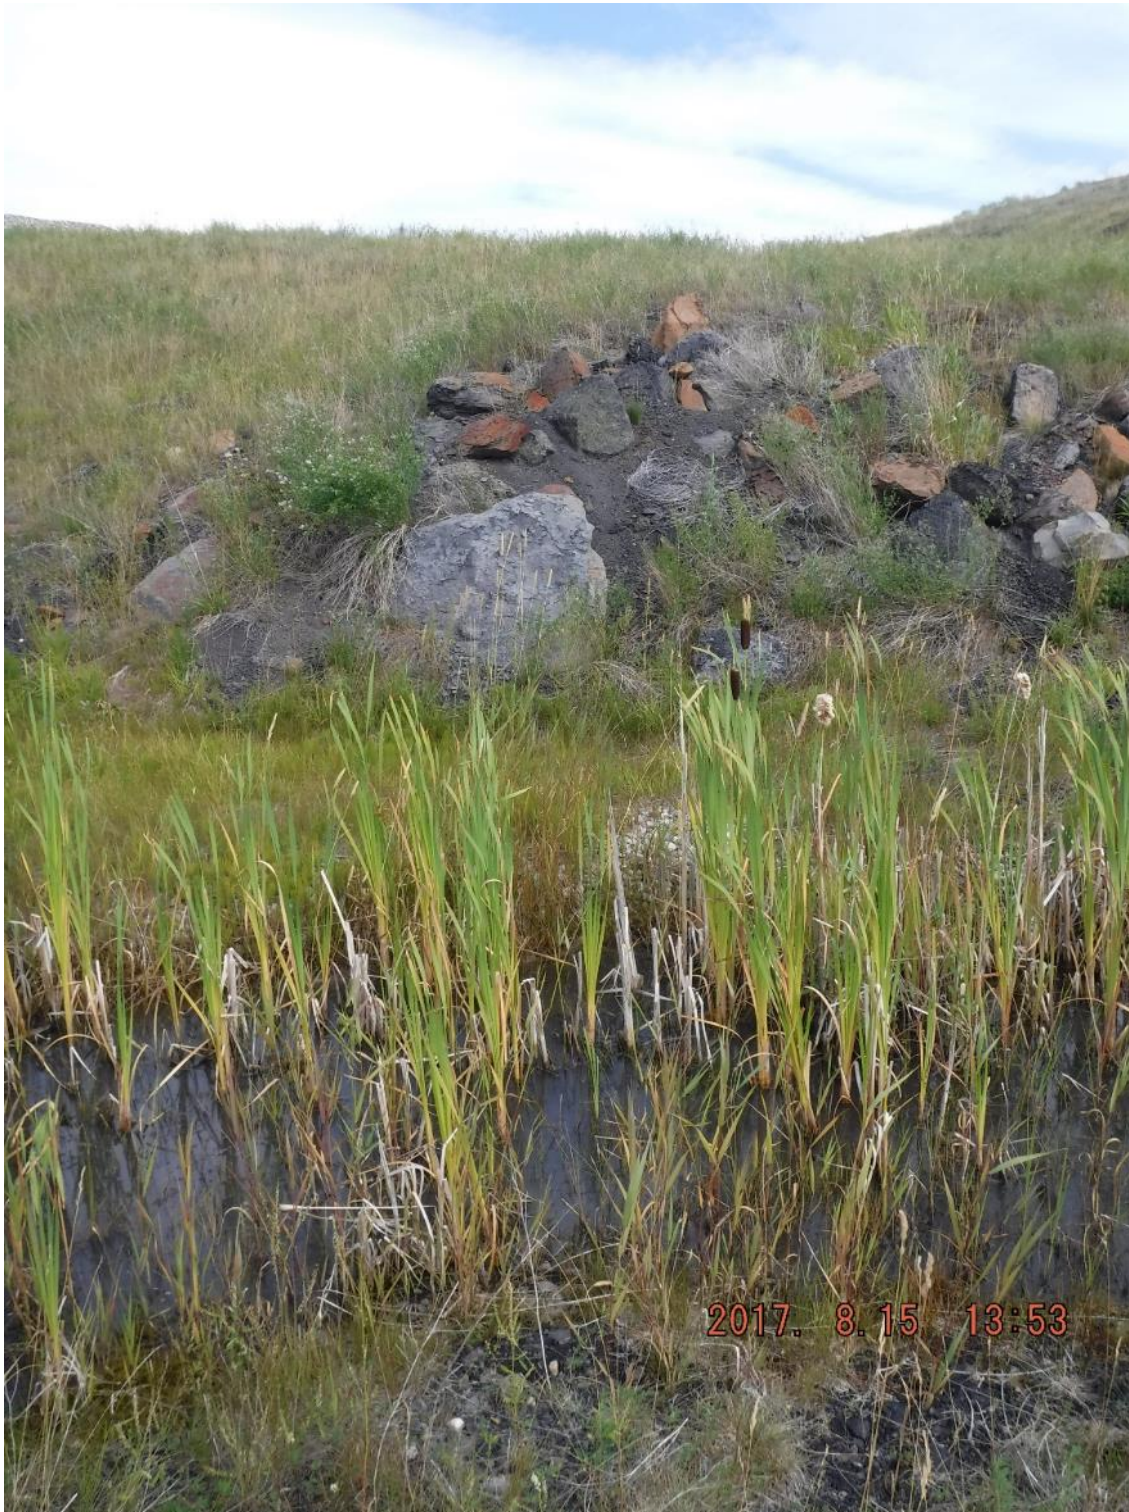
**Photo I-54 Closeup of the slaking riprap (PTD-2017-43)**

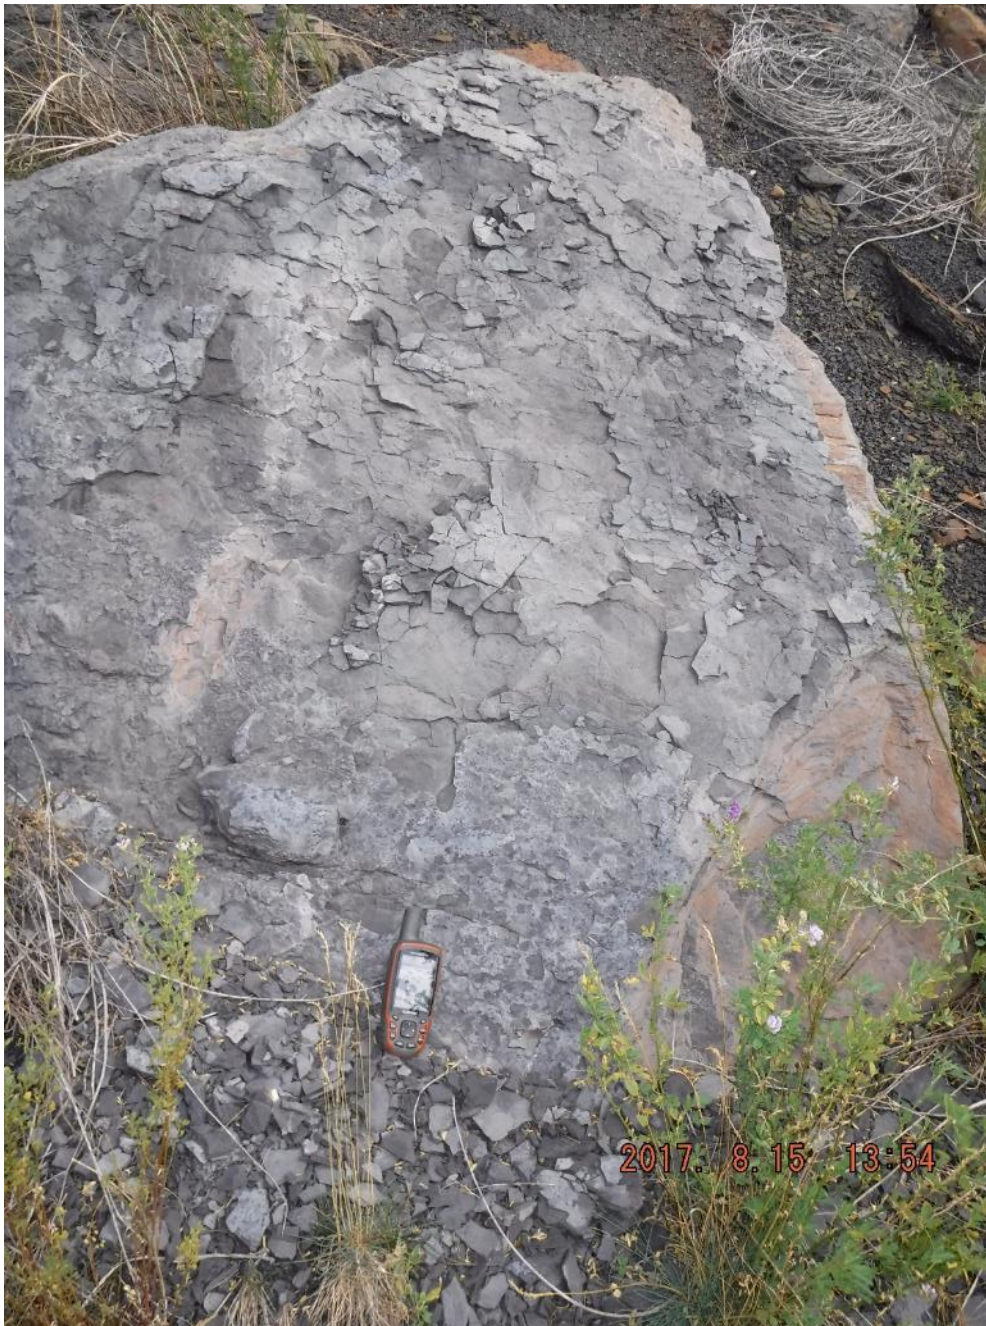
**Photo I-55** Standing inside the spillway channel looking east at deteriorating riprap and a small channel behind the riprap with flow of <2 L/min (PTD-2017-44)

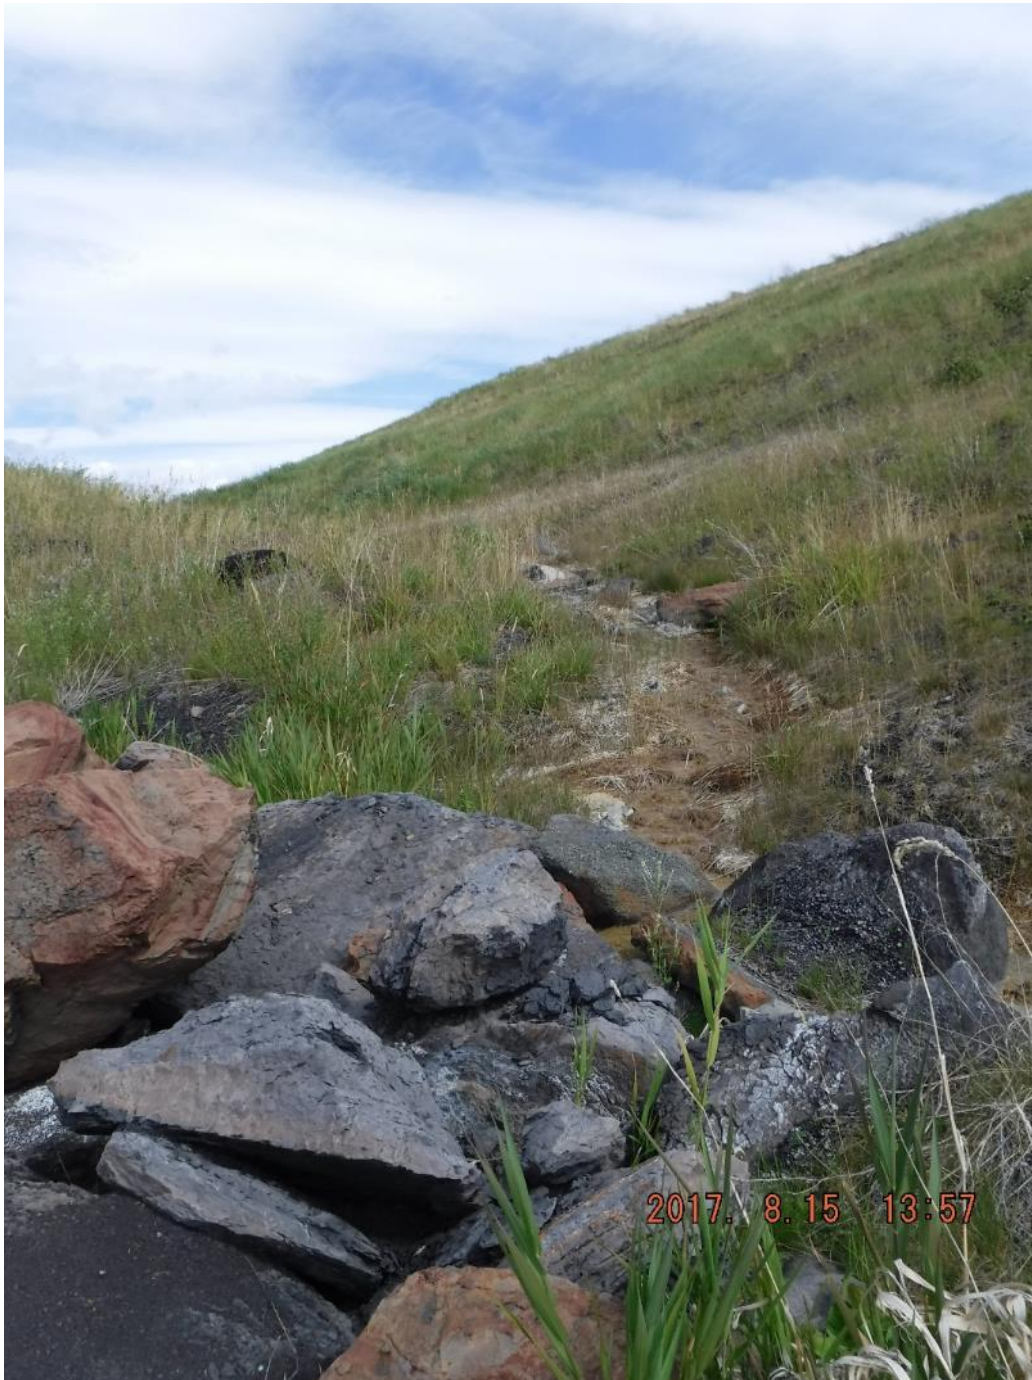
**Photo I-56      Closeup of the deteriorating riprap (PTD-2017-44)**

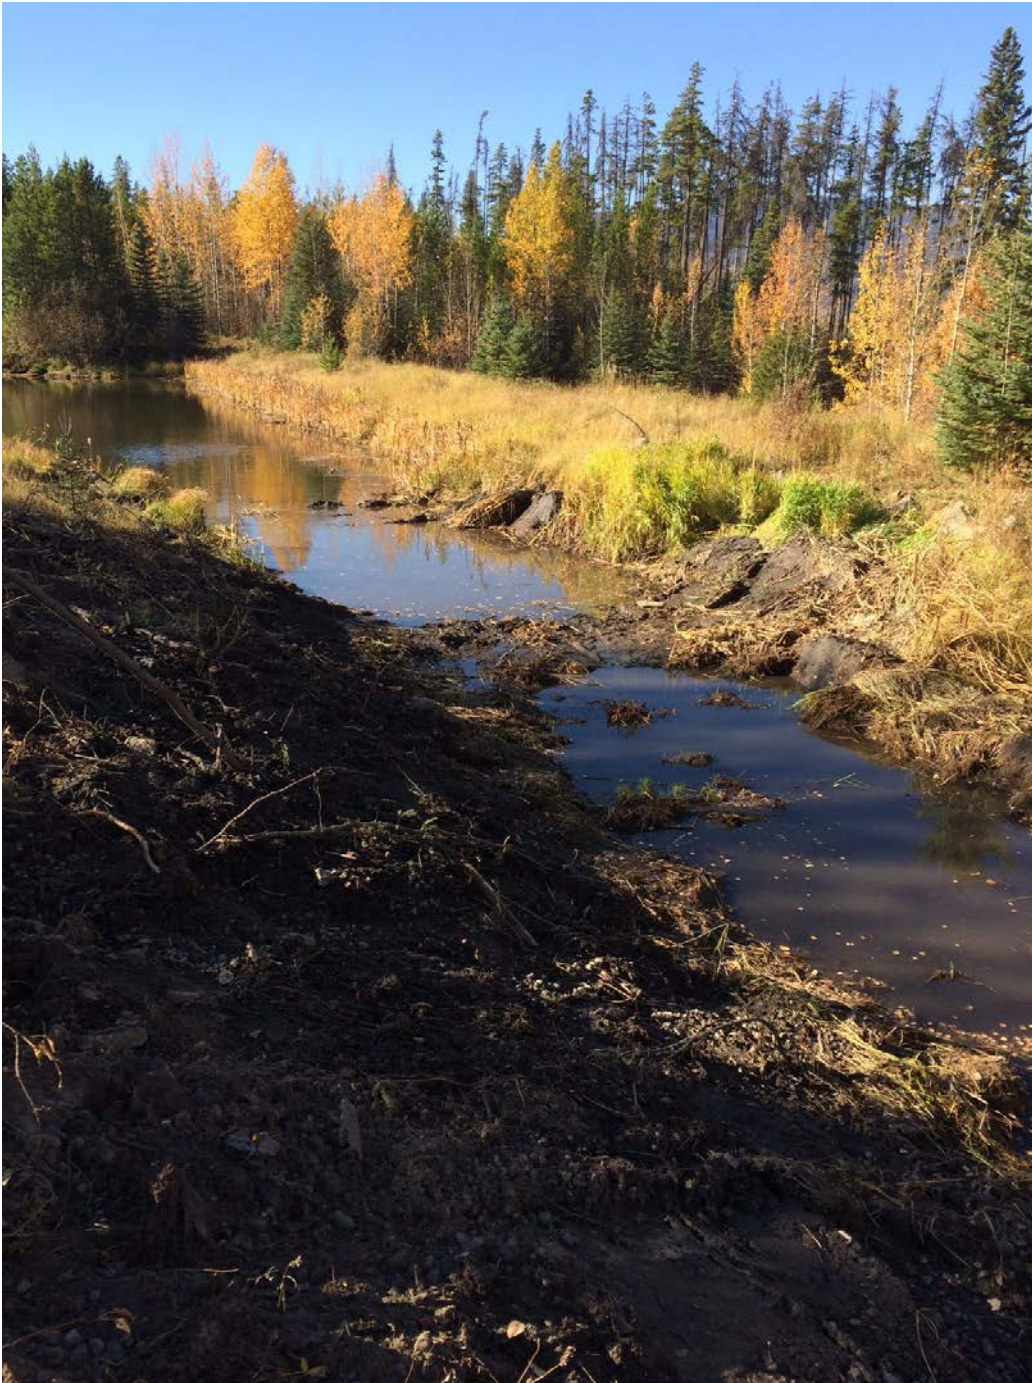
**Photo I-58**    **Teck removed beaver dam and vegetation at the Seepage Collection Pond in October 2017 – looking northeast (near waypoint PTD-2017-15)**

- Replaced 4 pneumatic piezometer fittings on August 14<sup>th</sup> (refer to Section 4.3.3.1 for more details); and
- Cleared beaver dam obstructing the flow in the outfall channel of the Seepage Collection Pond on October 3<sup>rd</sup> (Photos I-57 and I-58).
