Teck Metals Ltd.

Sullivan TSF 2023

Annual Facility Performance Report

March 26, 2024

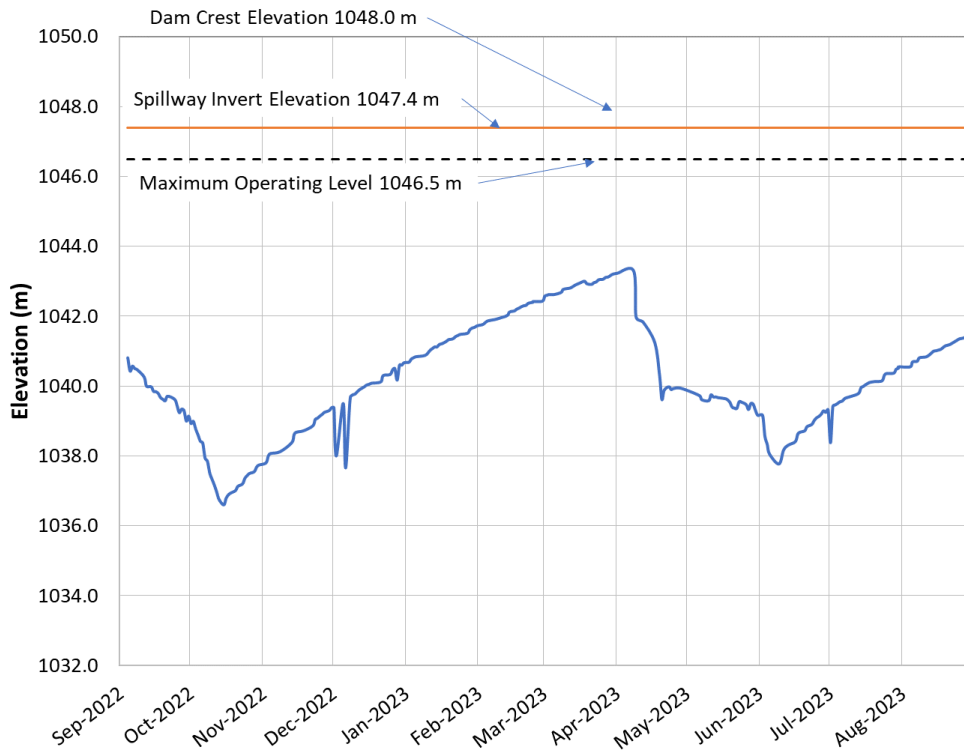
Figure 3.2 ARD Pond Level 2022 – 2023

Based on the pond water levels, the maximum level observed during the reporting period was El. 1043.3 m, which occurred on April 1, 2023. This is 3.2 m lower than the maximum operating level (MOL) and is 4.1 m below the spillway invert elevation. There was no water discharged from the ARD Pond spillway to the Iron Pond during the water balance reporting period. The spillway has never discharged since the ARD pond was constructed.

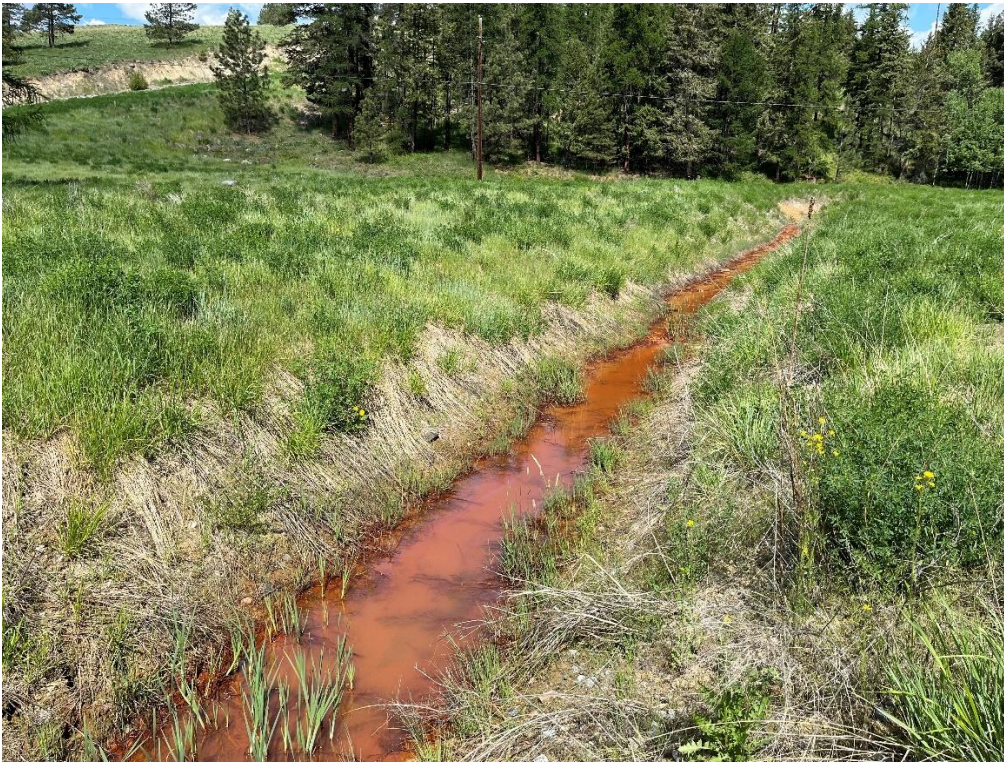
Photo II.15 Upstream of Weir #4

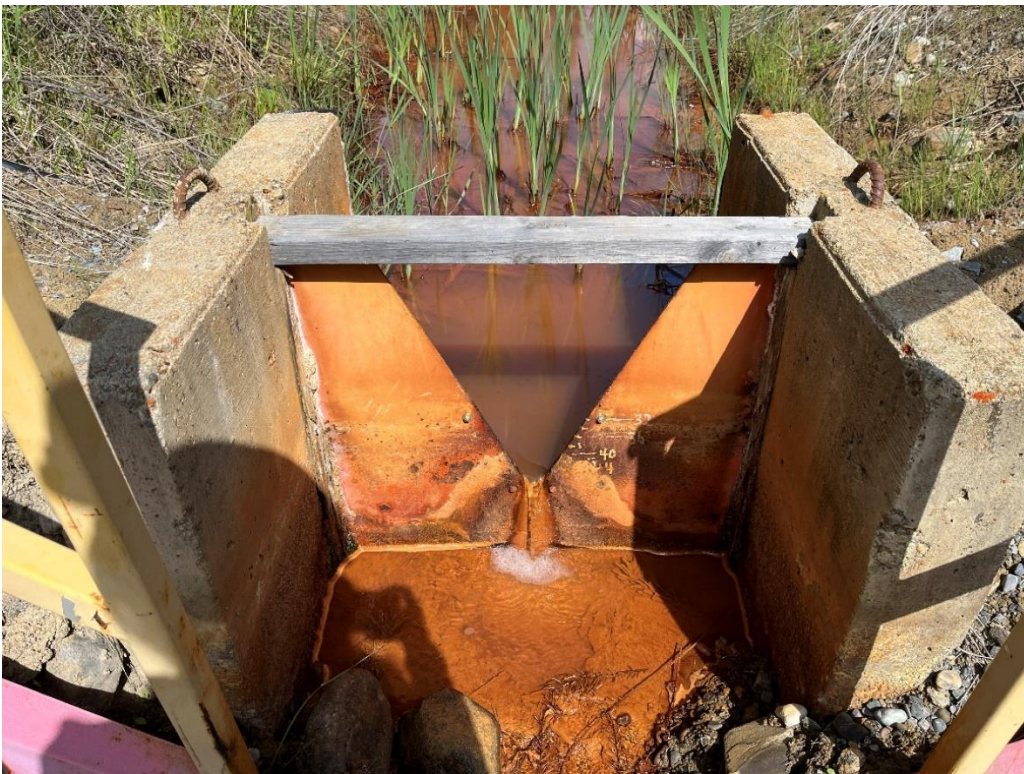
Photo II.16 Weir #4 worn notch
