## Sä Dena Hes Mine, Yukon Territory 2017 Dam Safety Inspection

SRK Consulting (Canada) Inc.  
December 2017

Project No: 1CT008.065

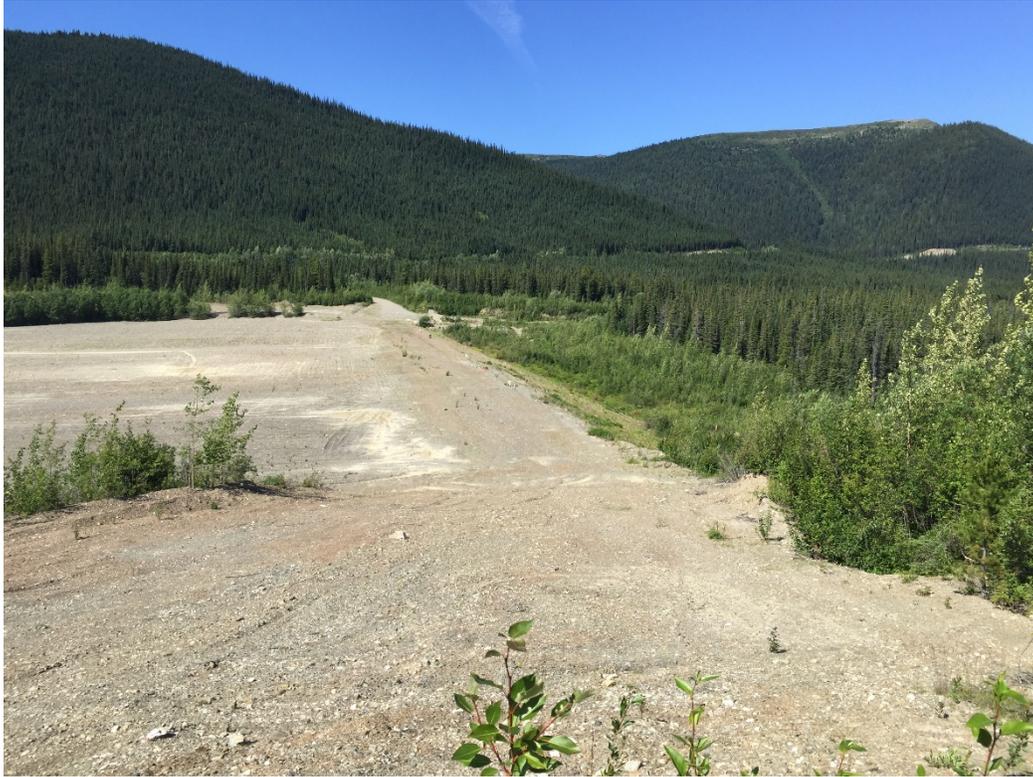
The crest of the North Dam (Photo 1), is in good condition. It shows no signs of deformation or abnormal settling. The downstream slope of the dam (Photo 2) shows no signs of surficial movement or erosion nor is there any sign of bulging at the downstream toe. Oversized trees observed during a previous dam safety inspection in 2015 had been removed in accordance with the routine maintenance specified in the OMS manual.

Photo 1: North Dam Crest looking west

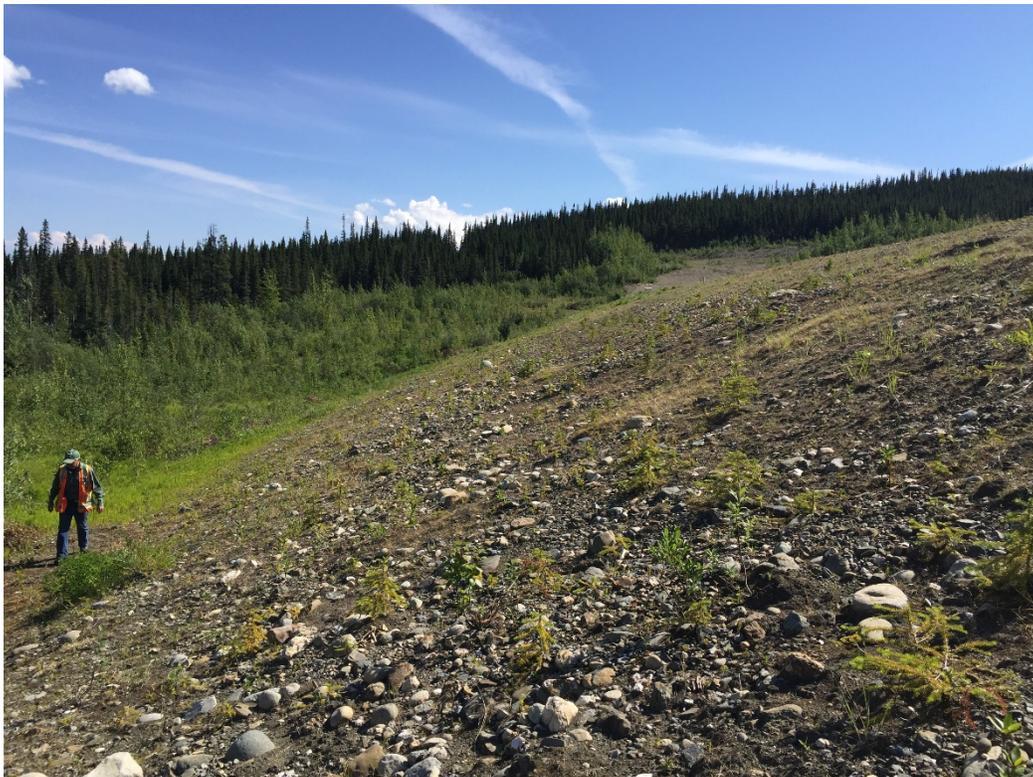
Photo 2: Downstream slope of the North Dam. Oversized trees have been removed

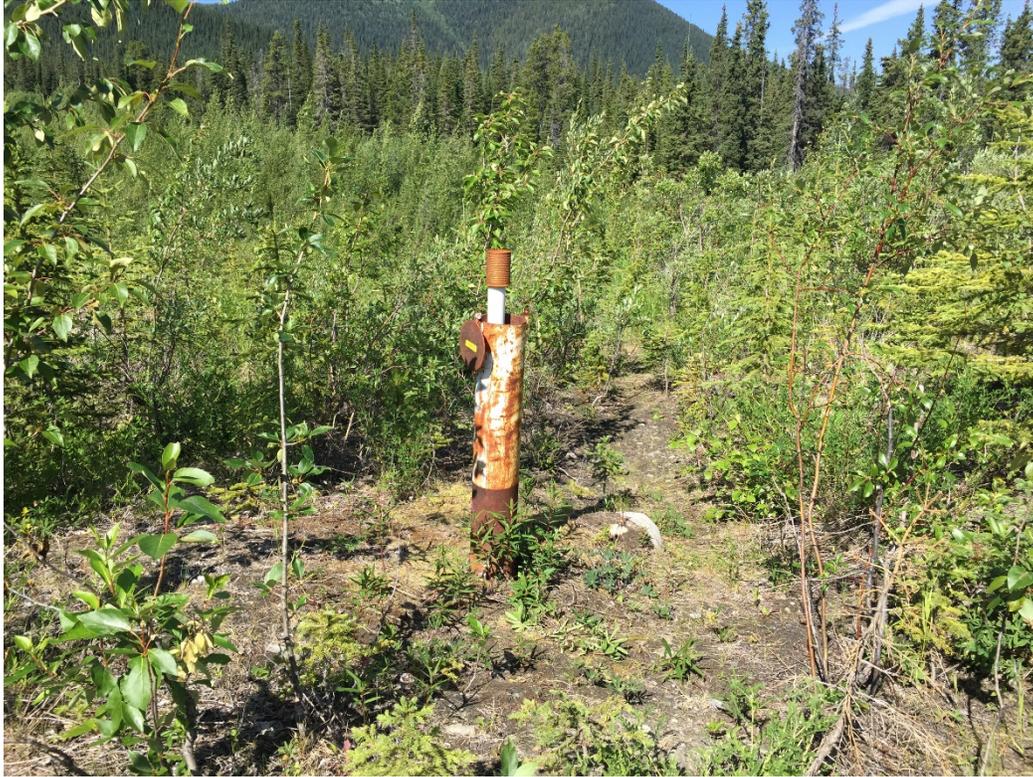
The piezometers and settlement gauges (Photos 3, 4 and 5) on the North Dam are in good condition and continue to function as designed. The orange coloured piezometer caps provide visible identification for the monitoring team. Piezometer 4A at the toe of the dam has not been updated with the new caps, and the steel protective cap has settled over time below the top of the PVC pipe.

Photo 3: North Dam Piezometer at toe NDW 4A

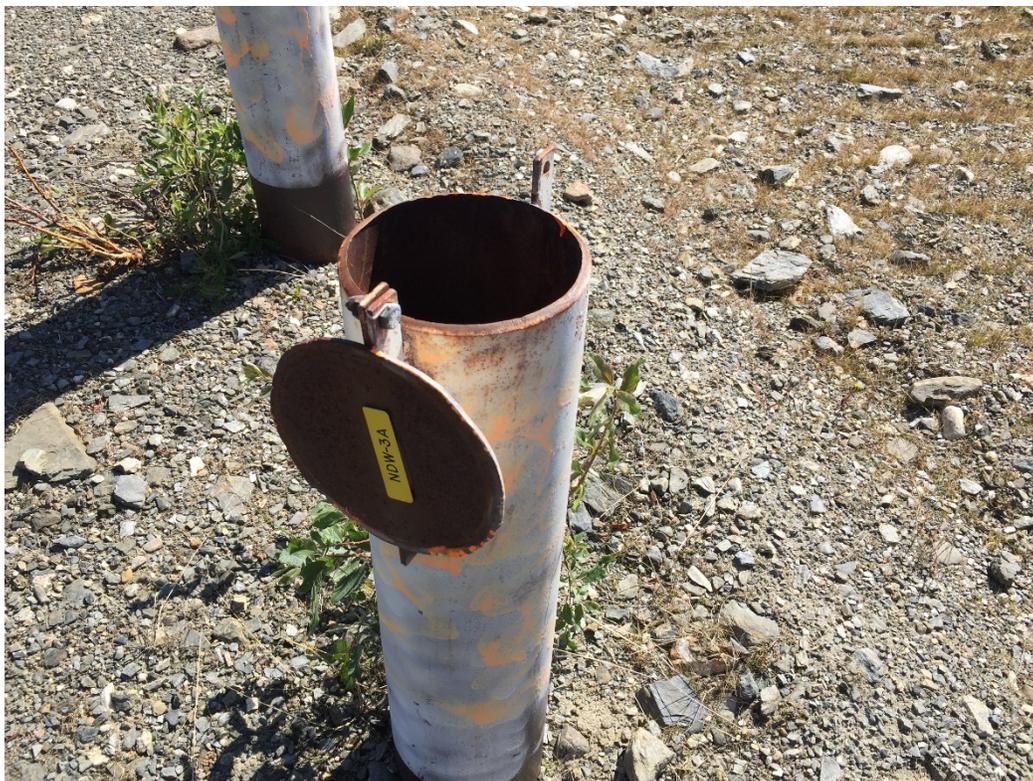
Photo 4: Well cover on NDW 3A

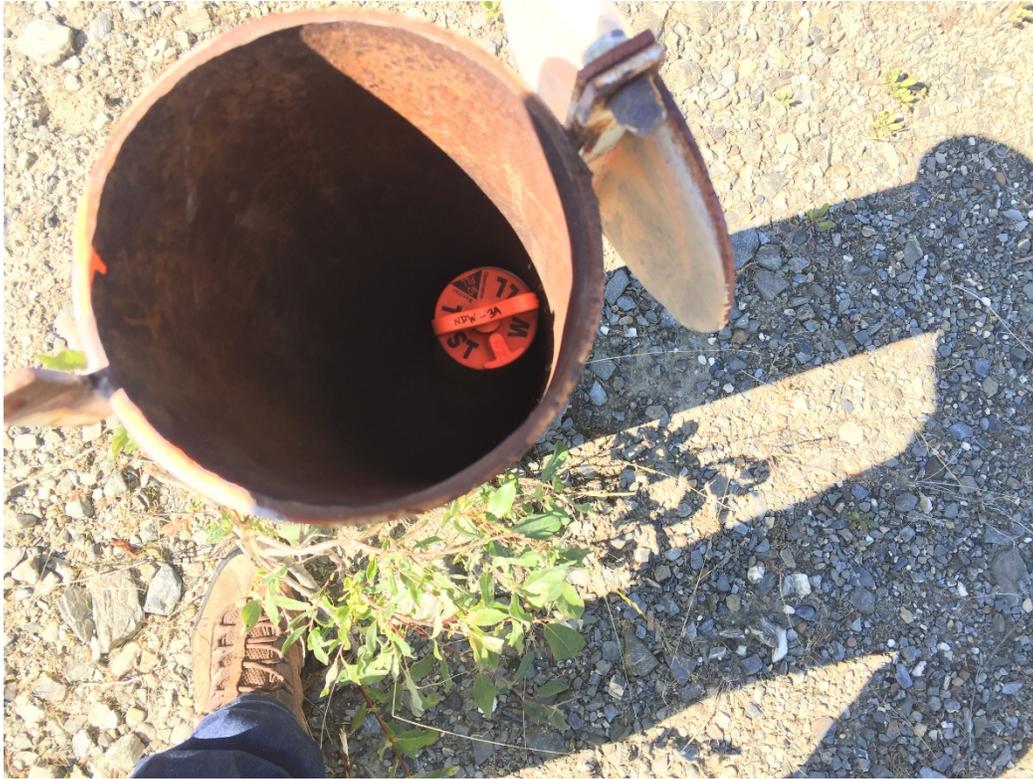
Photo 5: Plastic cap on the Piezometer NDW3A

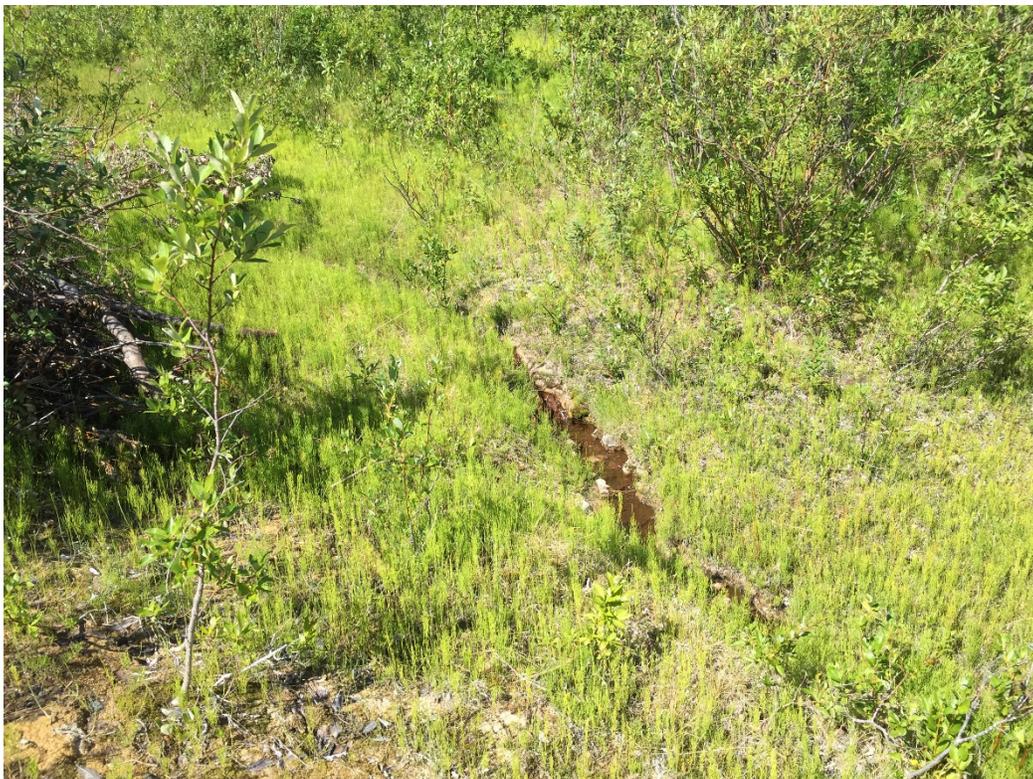
Along the downstream toe of the North Dam there is an 80 m long seepage zone (Photo 6). Seepage from this zone is collected at a monitoring station referred to as MH-02 and is a combination of groundwater discharge from the surrounding hillsides to the west and minimal seepage flow from the impoundment. The monitoring station consists of a 6-inch diameter steel pipe (Photo 7) embedded in sandbags. It was noted that the pipe had rotated and was not functioning as designed. Photo 8 shows the redundant slope displacement monitoring pins, which have survived the elements.

Photo 6: Hillside Seepage at toe of North Dam

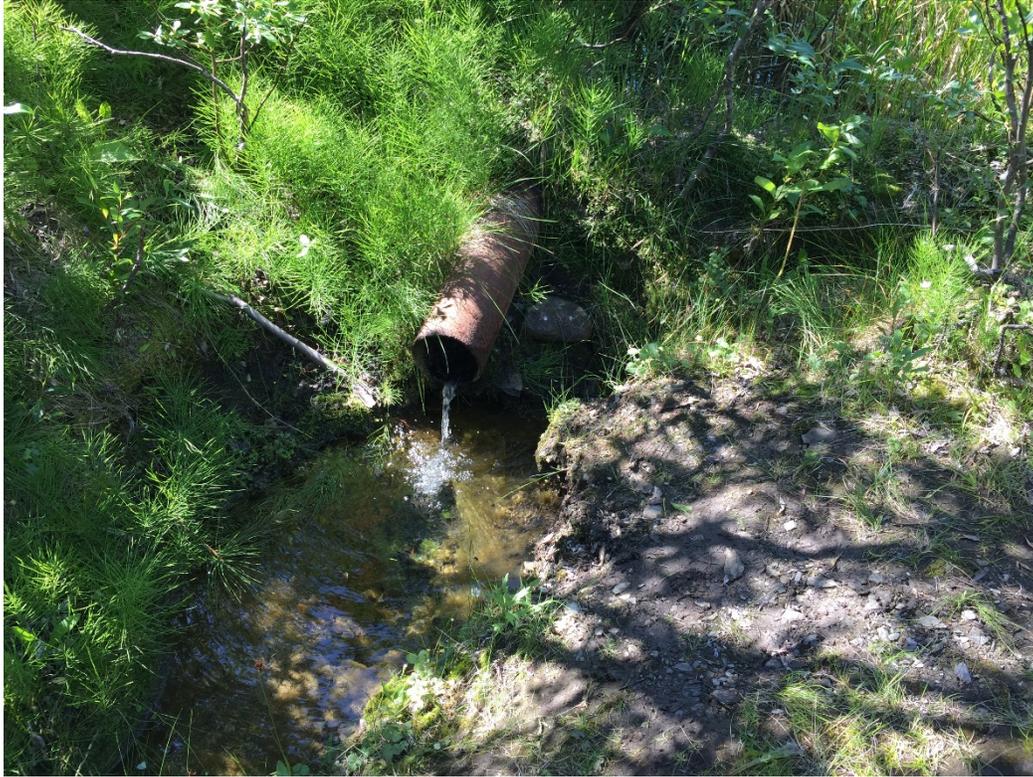
Photo 7: rotated pipe weir at MW 02

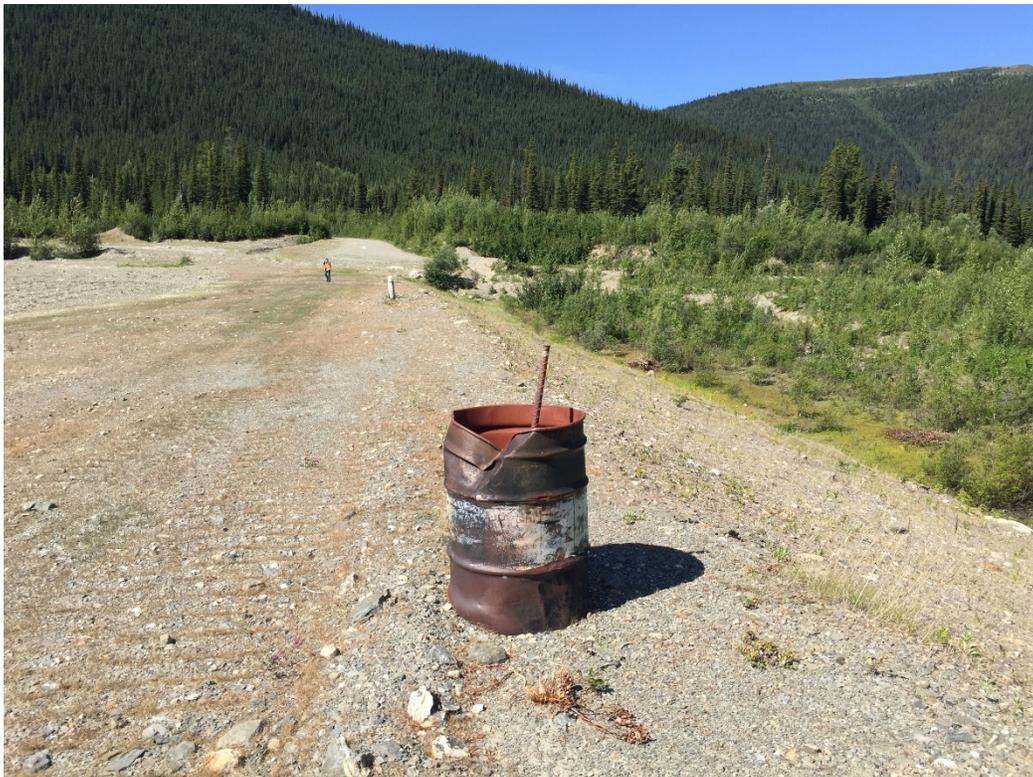
Photo 8: Slope Displacement pin on north edge of Dam (redundant)

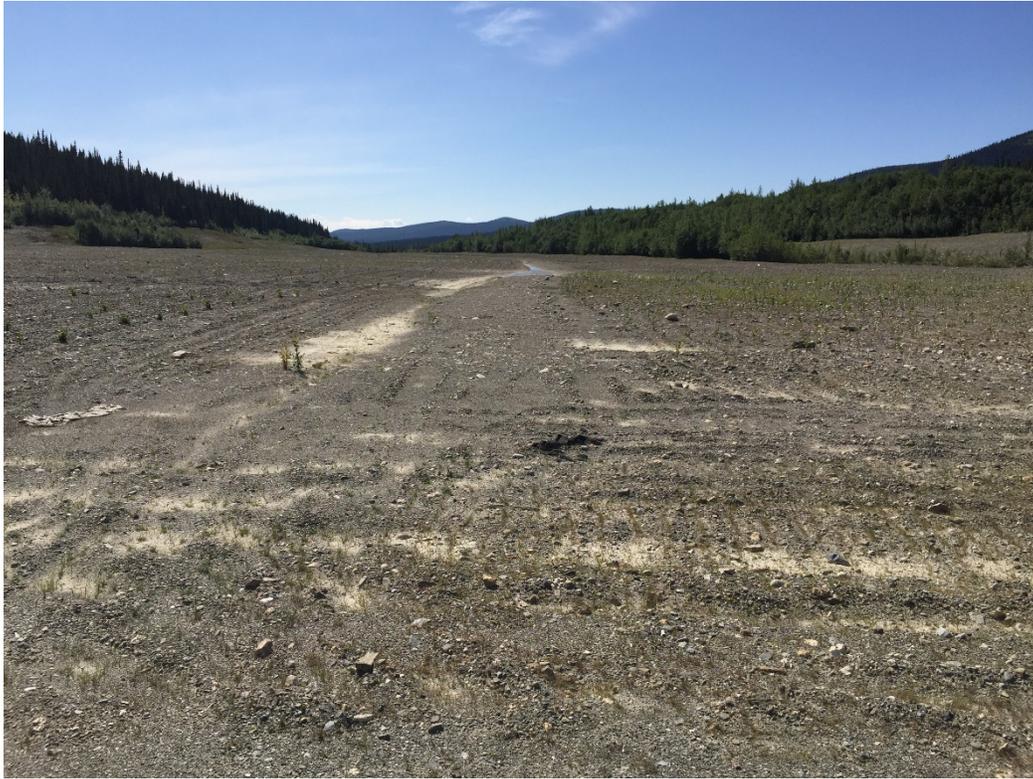
Photo 9: View looking south of drainage swale on tailings till cover

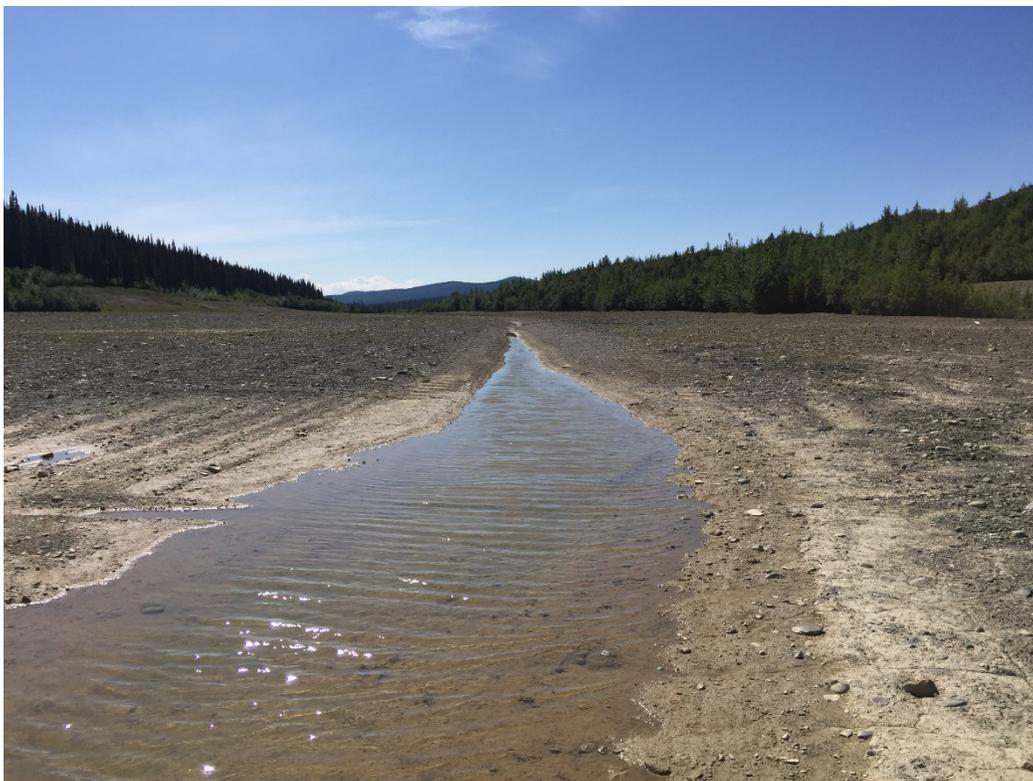
Photo 10: water in drainage swale draining south

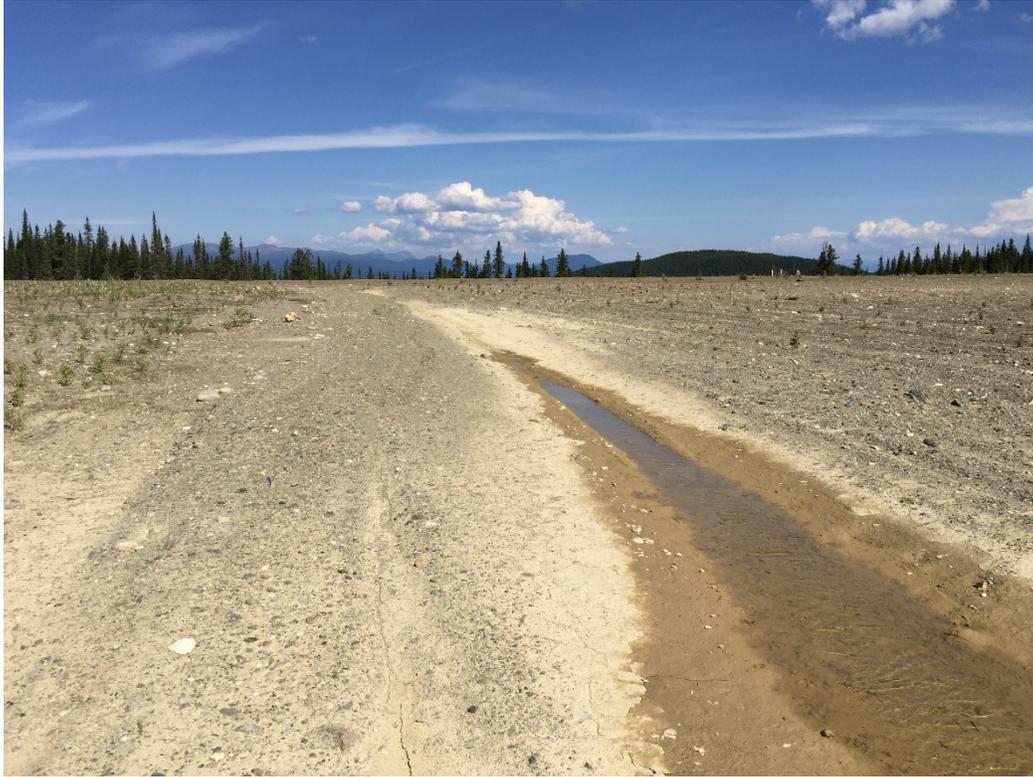
Photo 11: Drainage channel looking north

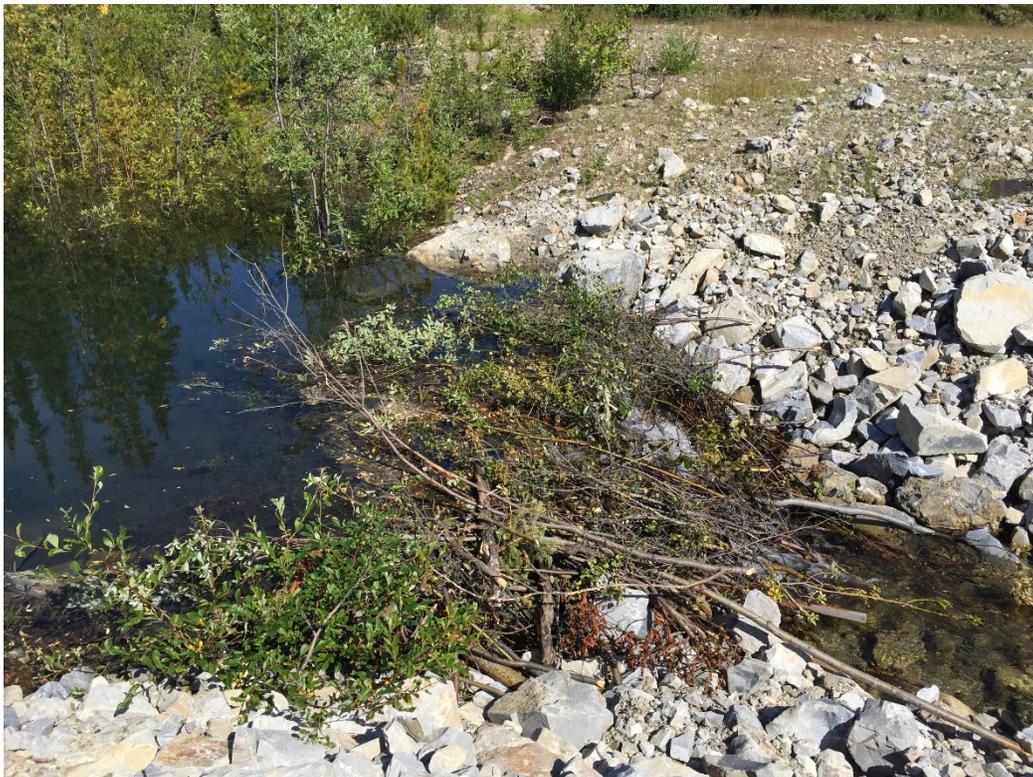
The riprapped channel conveys the North Creek over the location of the decommissioned North Creek Dyke. It was noted at the inlet of the channel that beavers had built a dam (Photo 12). Photo 13 shows a view downstream of the channel. At the outlet of the channel (Photo 14) some of the riprap has been dislodged by the flow, exposing a small area of the underlying filter fabric. This was noticed during last year's inspection and it has not deteriorated. The channel remains stable and no remediation is required. Photo 15 shows a view looking upstream along the channel.

Photo 12: Beaver dam at inlet to North Creek crossing

Structure	ID No.	Deficiency or Non Conformance	Applicable Regulatory or OMS Reference	Recommended Action	Priority (Teck 2014)	Recommended Deadline/ Status
North Creek Channel	2017-1	Beaver Dam at inlet to channel		Remove beaver dam in channel	3	End of 2017 / Completed July 27 Closed
Pipe Weir at MW-02	2017-2	6-inch pipe has rotated raising ponded water		Reconstruct weir to stabilise	3	End of 2017 / Completed July 27 Closed

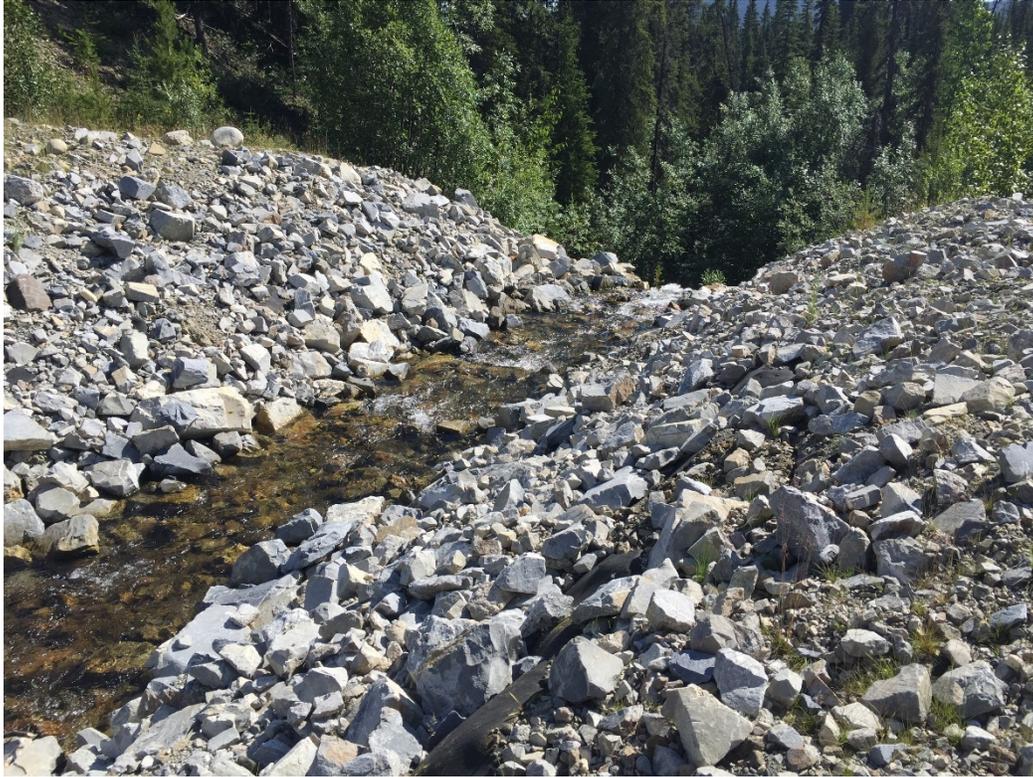
Photo 13: North Creek Crossing

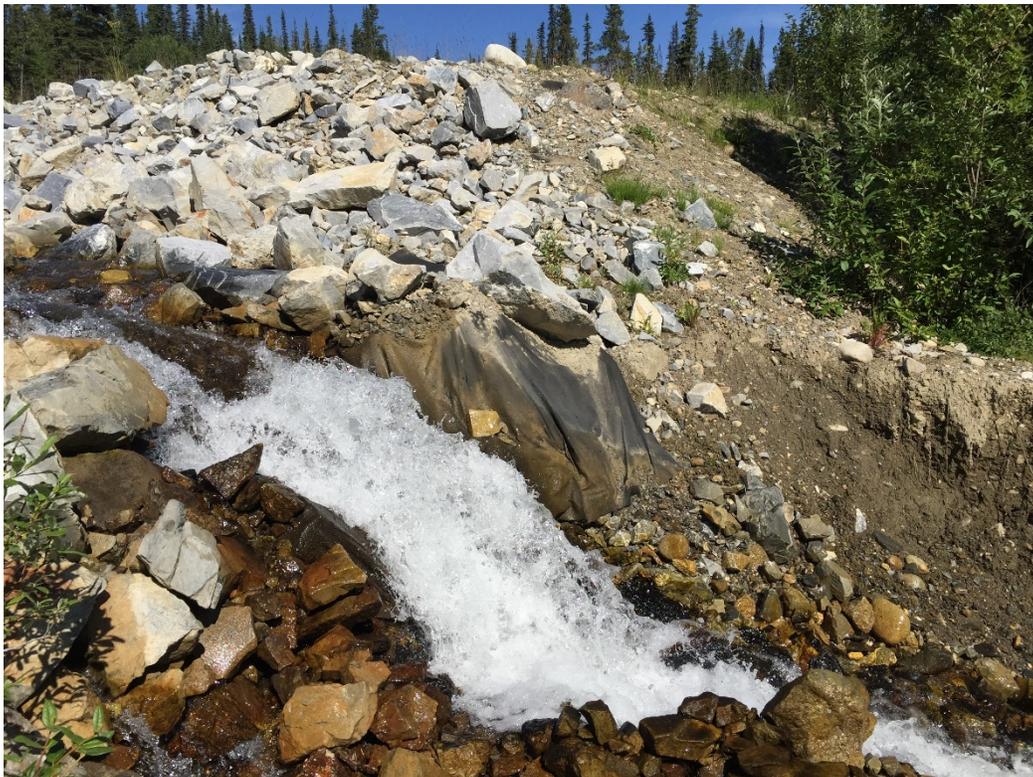
Photo 14: Outlet of North Creek crossing

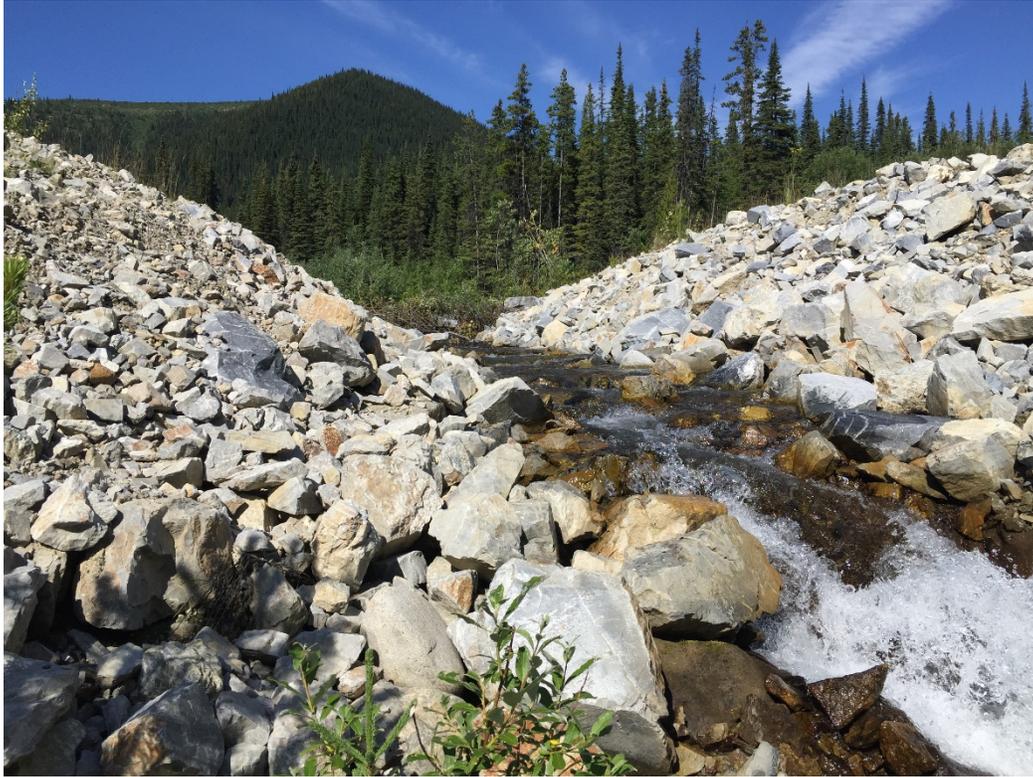
Photo 15: View looking upstream of the North Creek Dyke

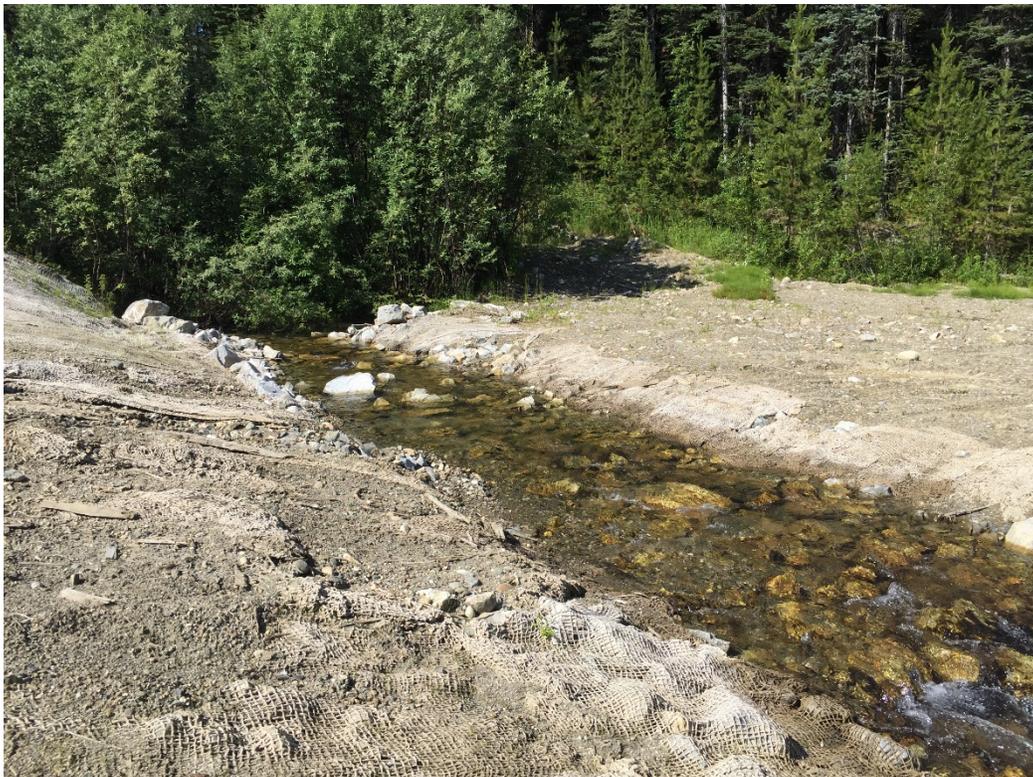
Photo 16: Second Crossing of North Creek

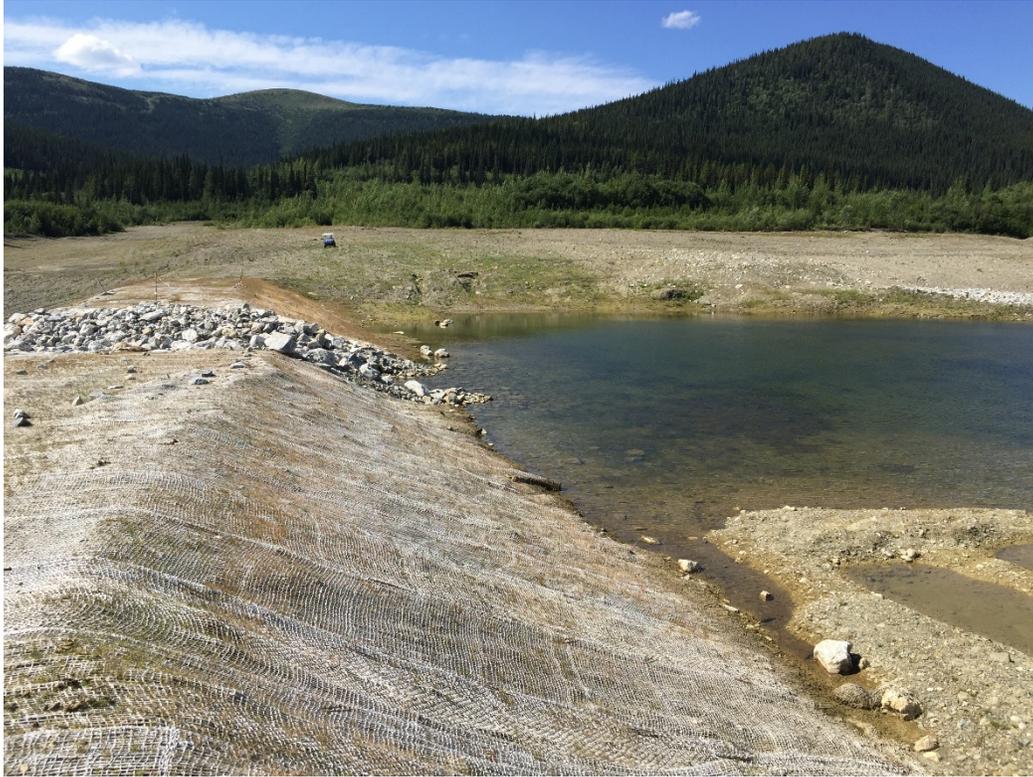
Photo 17: View looking west of the SRS and sediment pond

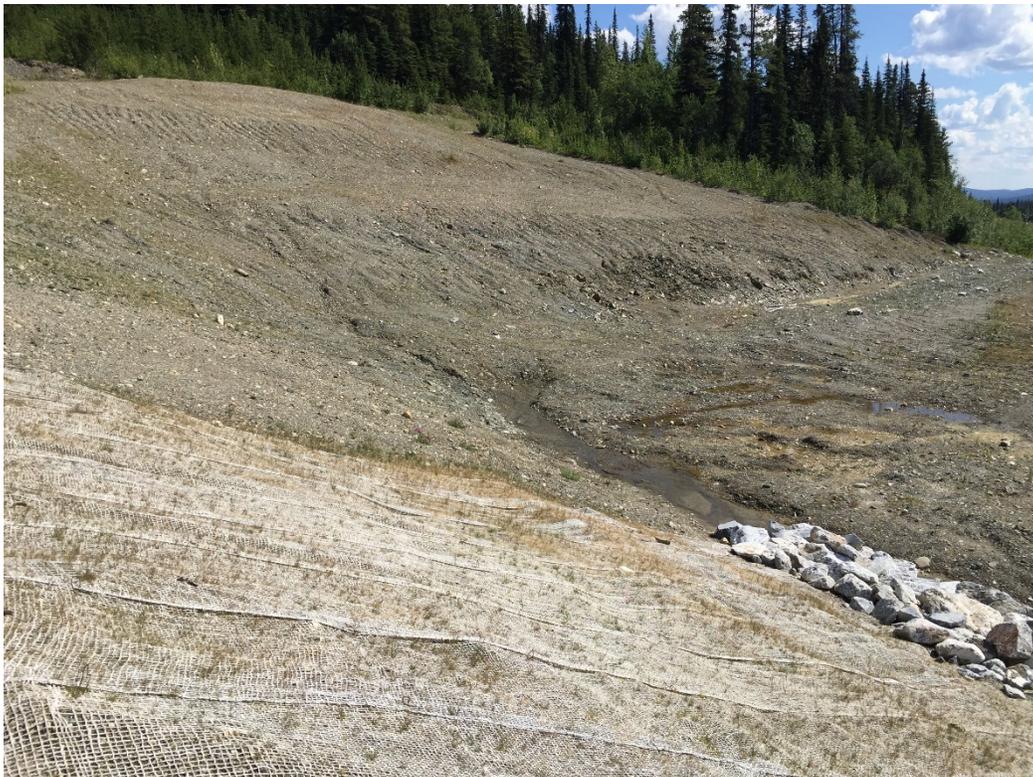
Photo 18: Hillside seepage along D/S toe of dyke

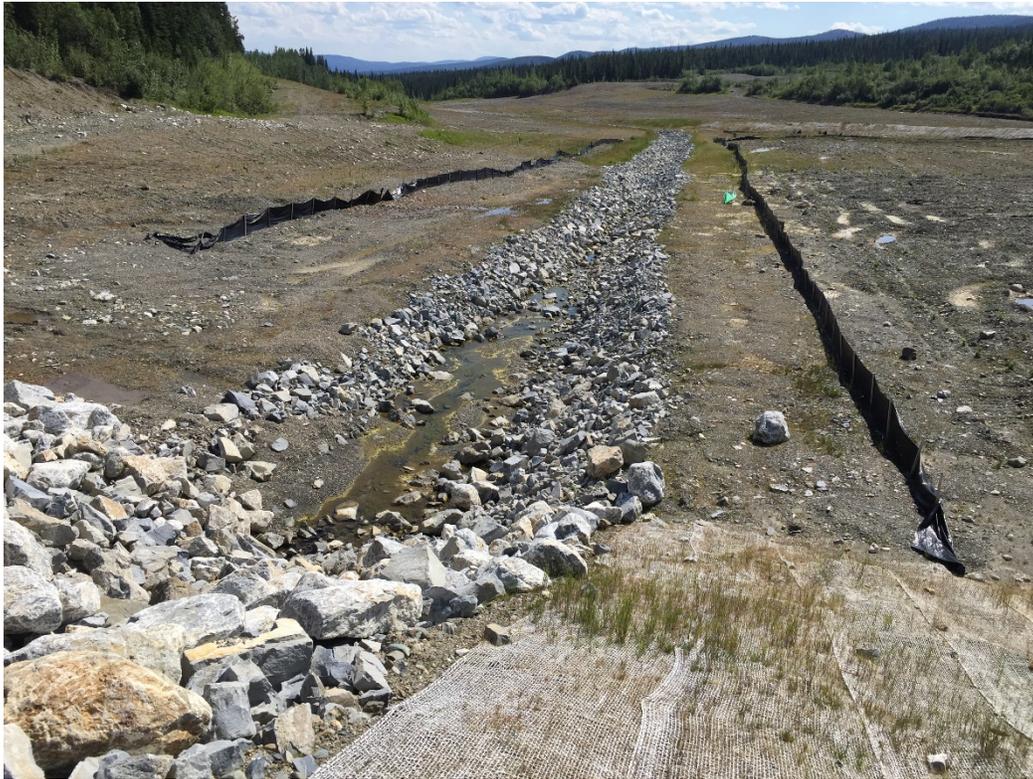
Photo 19: View of the south channel looking south from the SRS Dyke

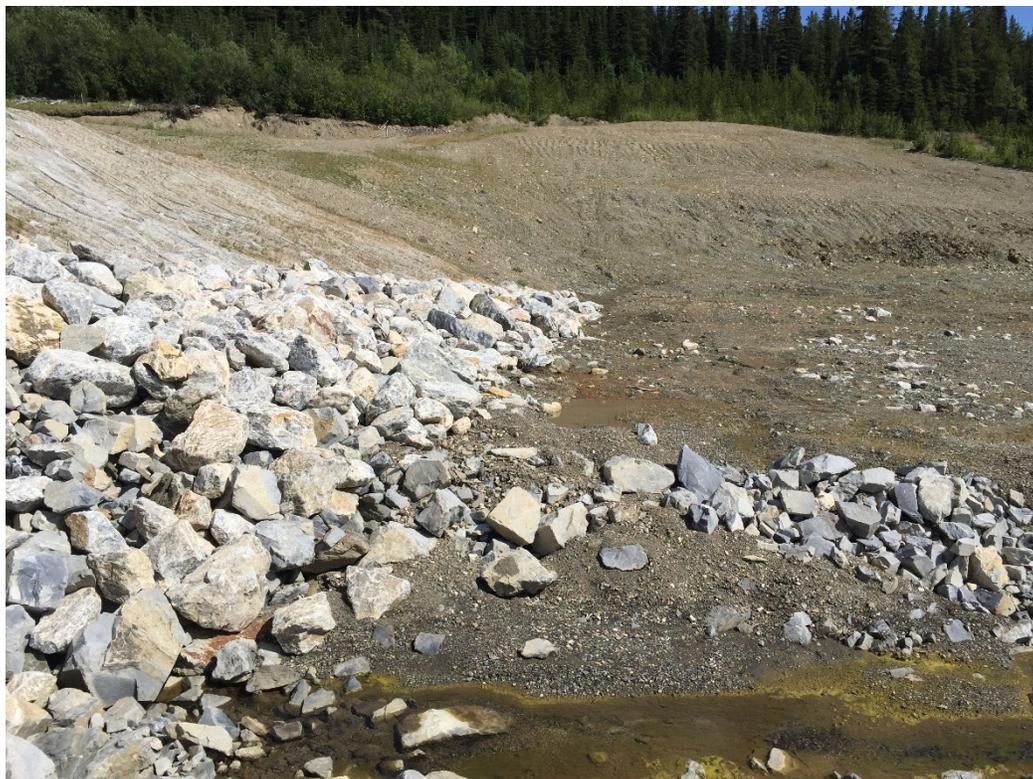
Photo 20 shows the riprap buttress along the toe of the dyke. A small boil was noted (Photo 21) at the toe of dyke which was also noted during last year's inspection. The activity is minor and no remediation is required.

Photo 20: View looking east of the riprap buttress along the D/S toe of the SRS dyke

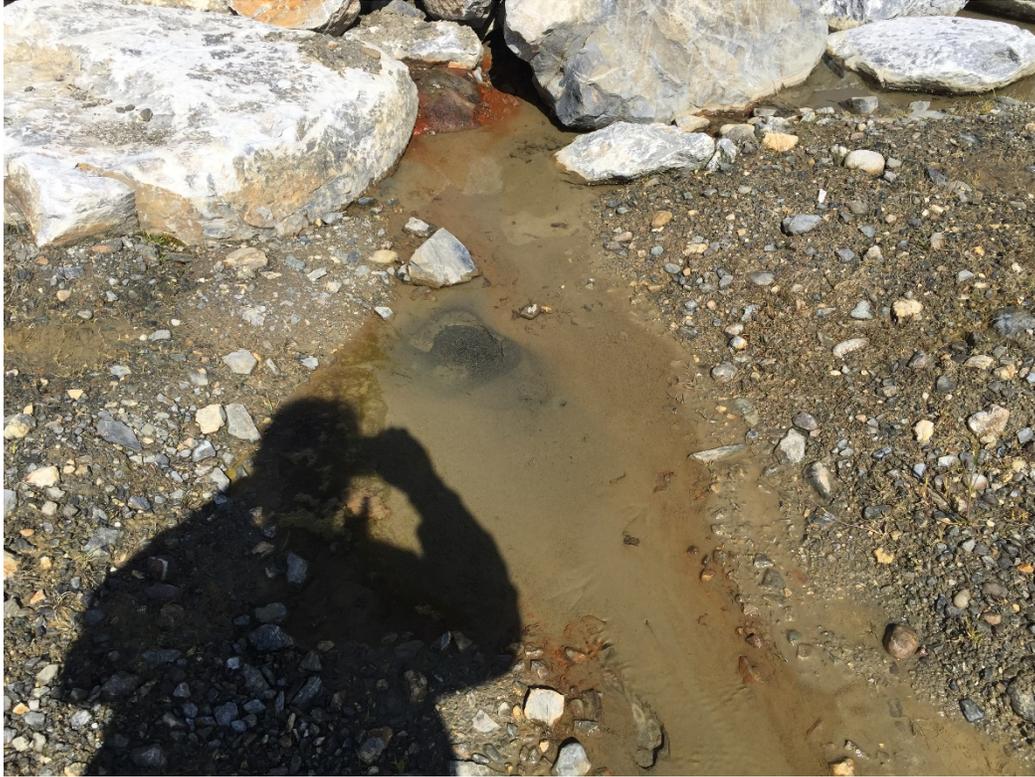
The pond behind the SRS has a maximum depth of about 1.5 m and the overall hydraulic gradient through the structure is low and corresponds to no piping potential. The seepage through the dyke is barely measurable. There is one small boil that has been noted at the downstream toe of the SRS dyke, but no loss of fines detected.

Photo 21: Single boil at toe of the SRS dyke

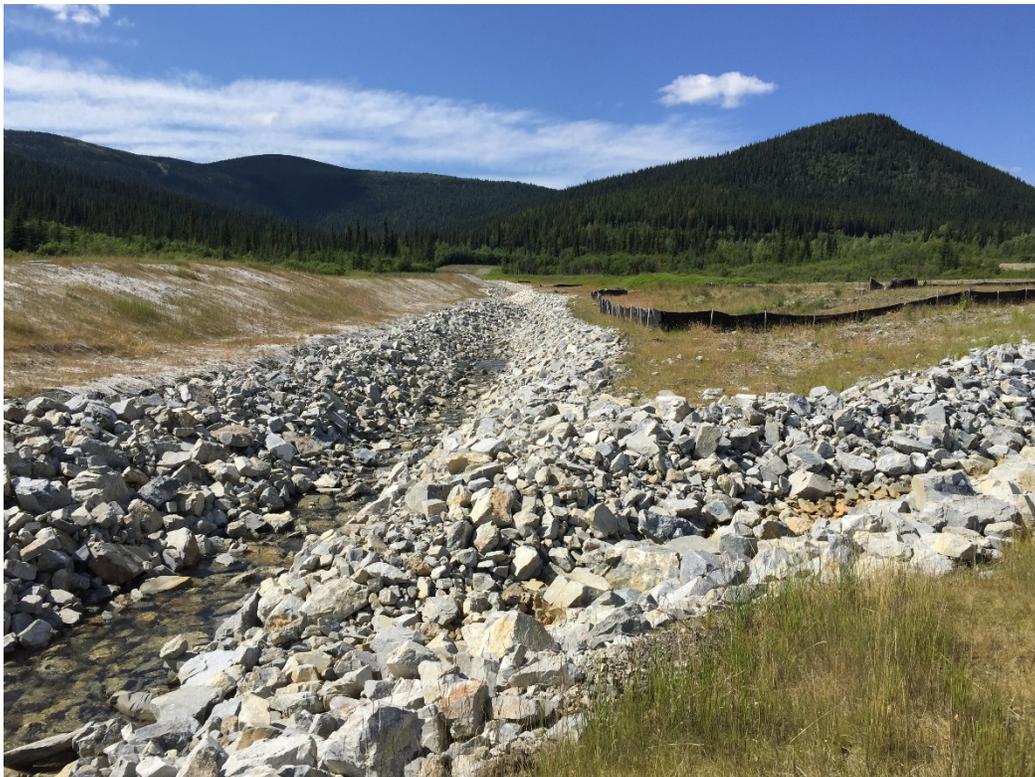
Photo 22: View upstream of the Camp Creek channel

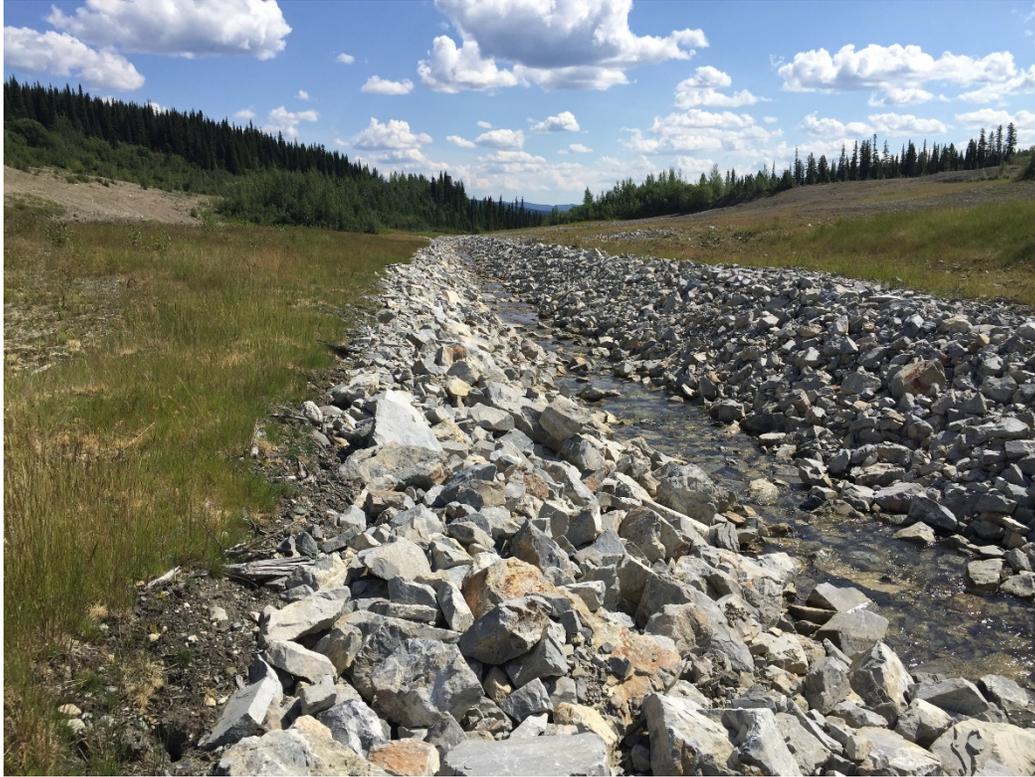
Photo 23: View south of the Camp creek drainage channel

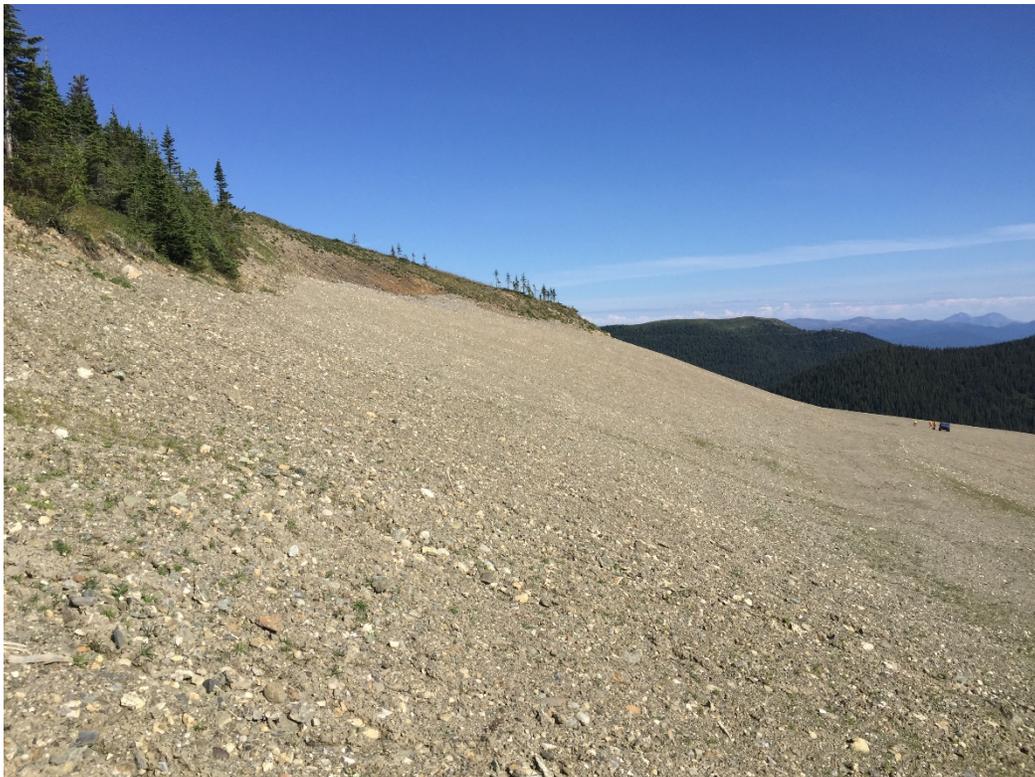
SRK inspected the resloped Main Zone and Jewelbox waste dumps (Photo 24 and Figure 12). It was noted that at the toe of the dumps, there was evidence of some erosion (Photos 25 and 26). While the erosion does not impact the stability of the dumps, SRK recommended that marked stakes be installed at the base of the erosion to monitor the erosion trend over time. Teck has installed the stakes and they will be inspected in 2018.

Photo 24: Regraded slopes of Jewelbox waste rock dump

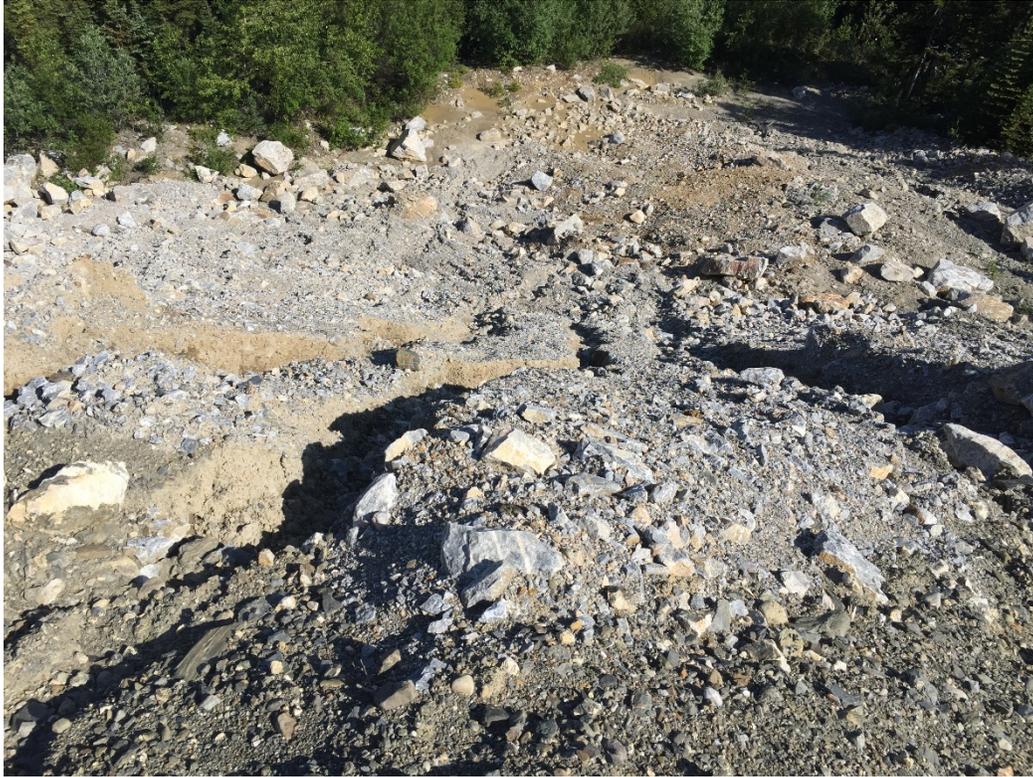
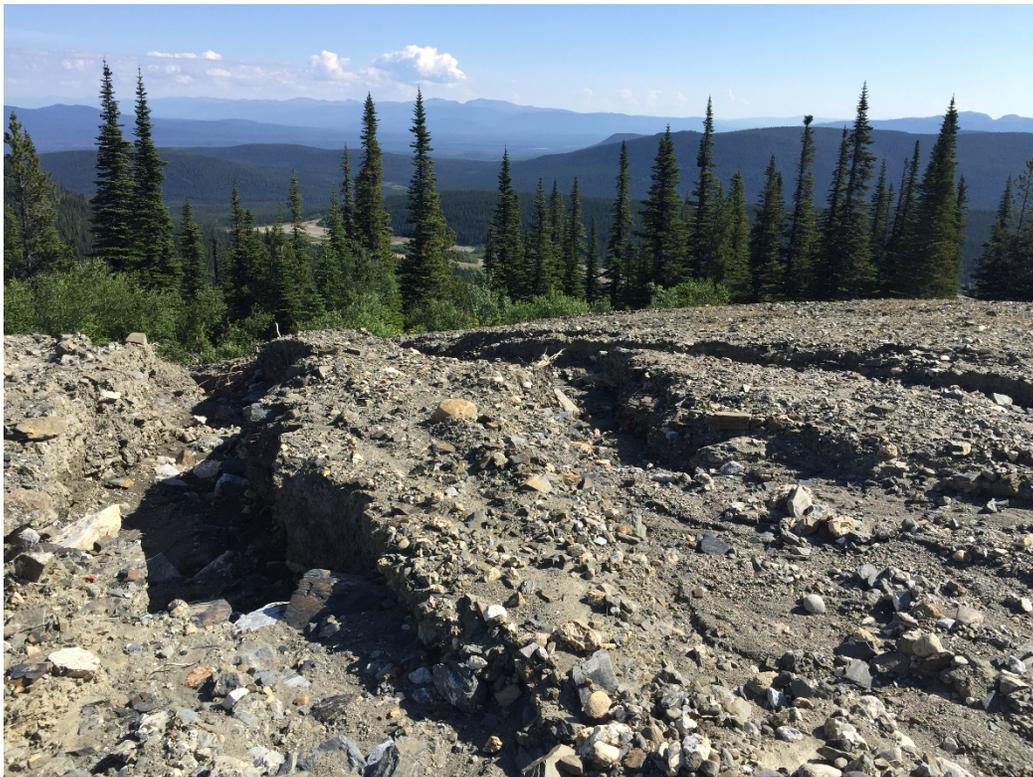
Photo 25: Erosion gullies at toe of Jewelbox Waste rock dump

Photo 26: erosion gullies at toe of Jewelbox waste rock dump

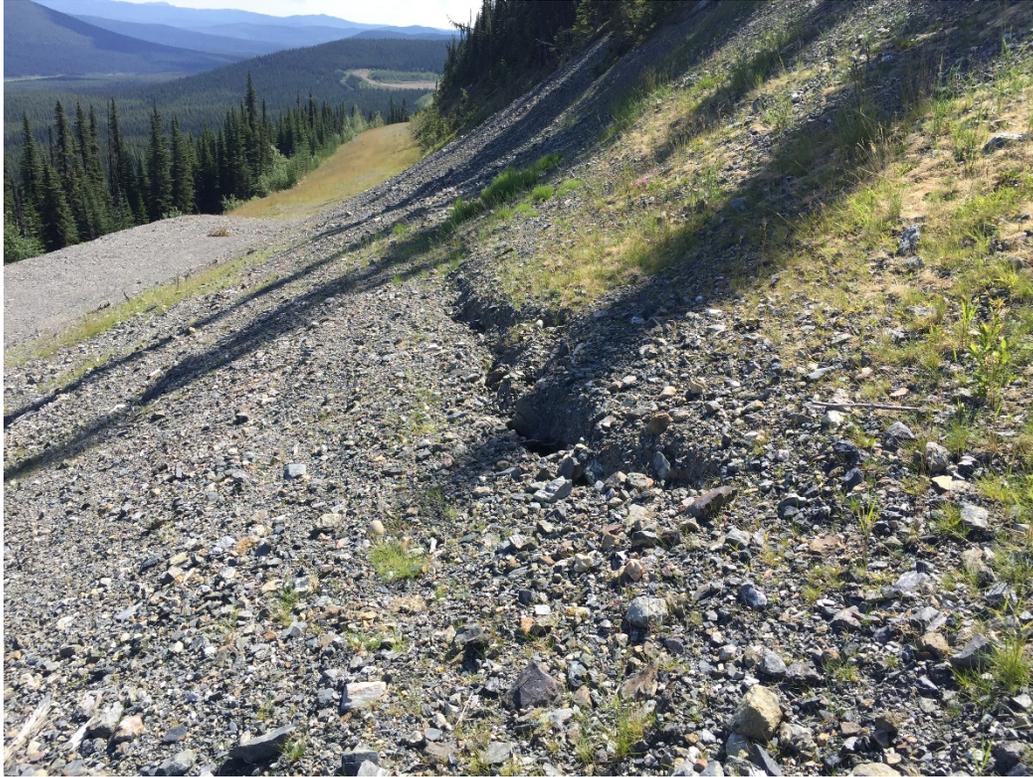
Minor settlement of the fill that was placed over the 1200 portal was noted (Photo 27). This settlement is to be expected and no remediation is required.

Photo 27 minor subsidence on the slope of the backfill at Portal 1200 on Burnick
