## **Teck Resources Limited**

**Bullmoose Mine**

**Bullmoose Tailings Dam**

2020 Annual Summary of Tailings Facility Performance

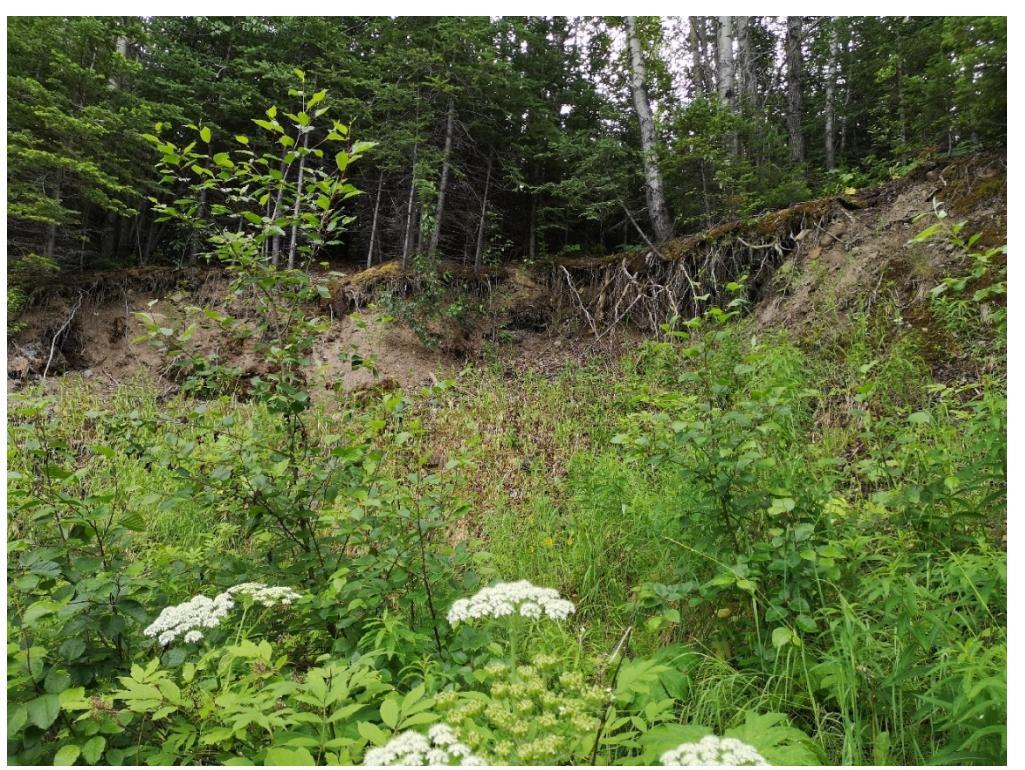
Historical Slope Failure on Natural Slope South of Impoundment: A historical slope failure is present in the natural slope on the south side of the impoundment (Photo II-30). The failure is also visible in photographs from previous annual reports (Teck 2013a, KCB 2011, KCB 2014a, and KCB 2020a) indicating this has been present since at least 2010. The slide mass is overgrown with vegetation including small trees. Comparison of photographs between 2010 and 2020 does not indicate any visually identifiable changes. This feature is not a risk to the dam safety.

Photo II-30 Historical landslide upslope of BTD (BTD-2020-16)

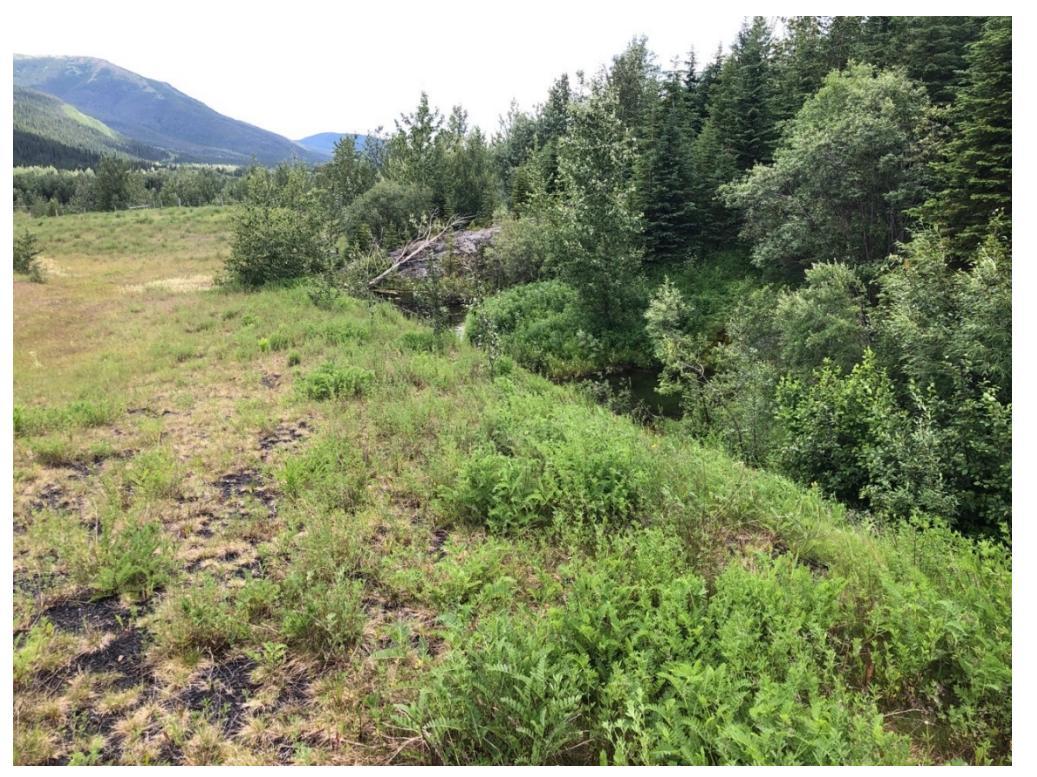
- Right Abutment: Good condition. No signs of significant erosion or displacement of the natural slope. Vegetation is well established at the abutment and along the abutment/downstream slope contact. There is a small channel running along the Right Abutment towards the toe which is unchanged from the 2018 condition (Photo II-32).

Photo II-32 Small channel along right abutment, looking east (BTD-2020-17)

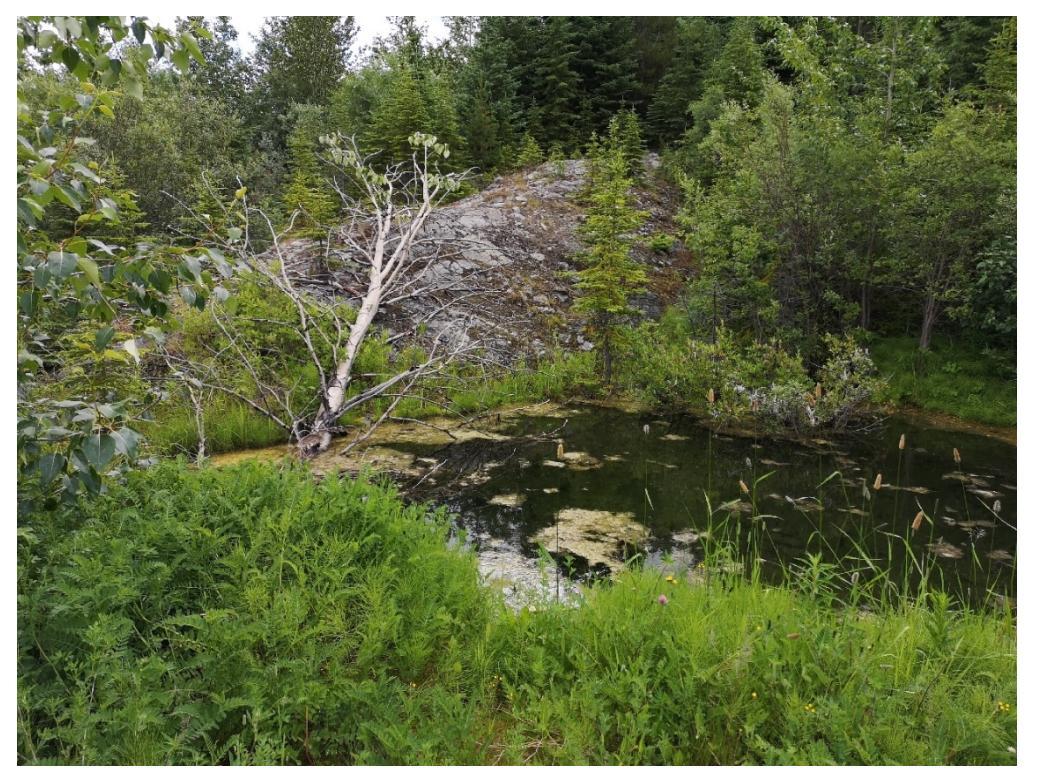
- A small erosion gulley was observed at the toe near the Right Abutment (Photo II-35). The gulley was first observed in 2017; in 2020, dimensions appeared similar to observations to previous DSIs (approximately 0.2 m to 0.3 m wide, 0.1 m deep and 10 m to 15 m long). The likely cause was concentrated local flow during spring freshet. This feature continues to be monitored and inspected for signs of change during routine visual inspections and annual site visits.

- Shallow rills were observed on the downstream slope. The rills appear to be stable based on comparison with previous photographs.
  - The existing rills and gulley do not represent a dam safety concern. On-going surface erosion represents a maintenance issue as part of long-term closure.

Photo II-35 Erosion gulley at toe of dam (BTD-2020-19)

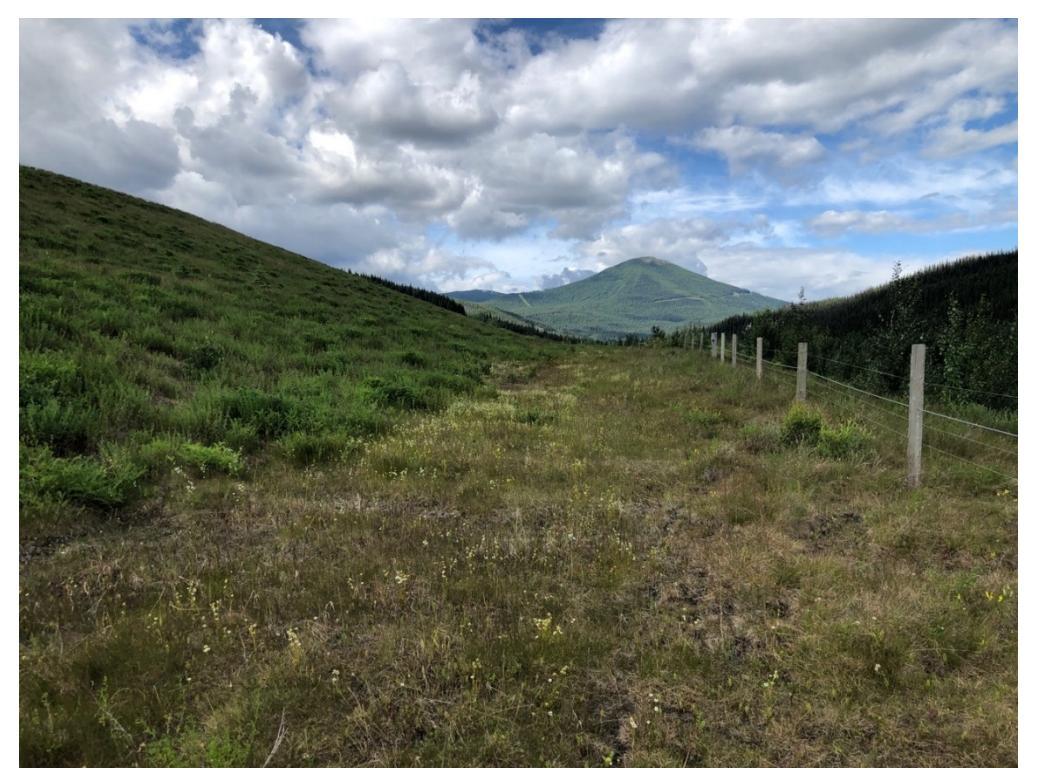
- A small wet area was noted near the toe of the north arm of the BTD during the annual site visit (Photo II-45), which was first noted in 2019. There were no signs of seepage emerging from the downstream slope, and the wet area is believed to be due to ponding from snowmelt from the slopes.

Photo II-45 Wet spot noted near dam toe. Same spot noted from previous year (BTD-2020-24)

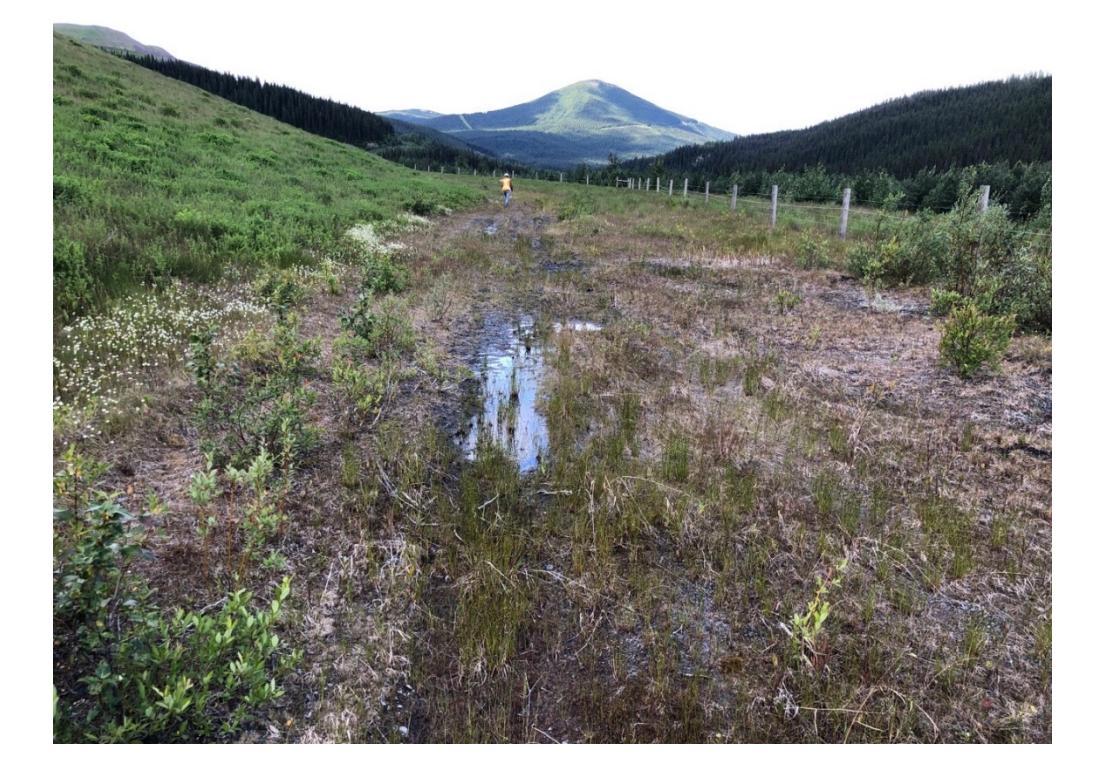
Photo II-46 Downstream slope of dam, minor rilling (BTD-2020-25)
