REPORT

2020 Annual Dam Safety Inspection for 2 Pit and 3 Pit Tailings Storage Area

Teck Coal Limited, Fording River Operations

Reference No. 20136981-2020-220-R-Rev1-2000

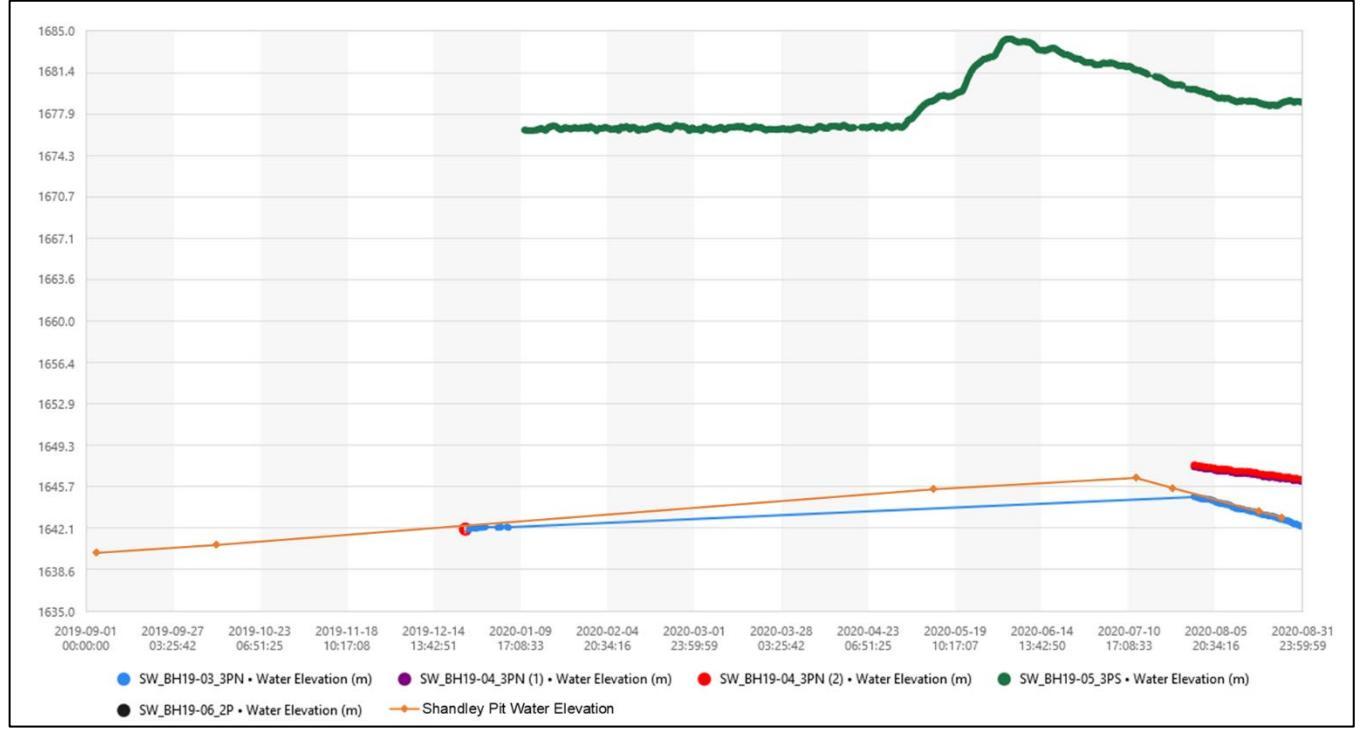
Chart 2: 3PN and 3PS Vibrating Wire Piezometer Groundwater Elevations and Shandley Pit Water Elevation from 1 September 2019 to 31 August 2020

In 3PN, pore water pressure in the tailings was observed to fluctuate in response to water level in Shandley Pit. Piezometric data for the reporting period are shown in Chart 2, along with the Shandley Pit water elevation for comparison.

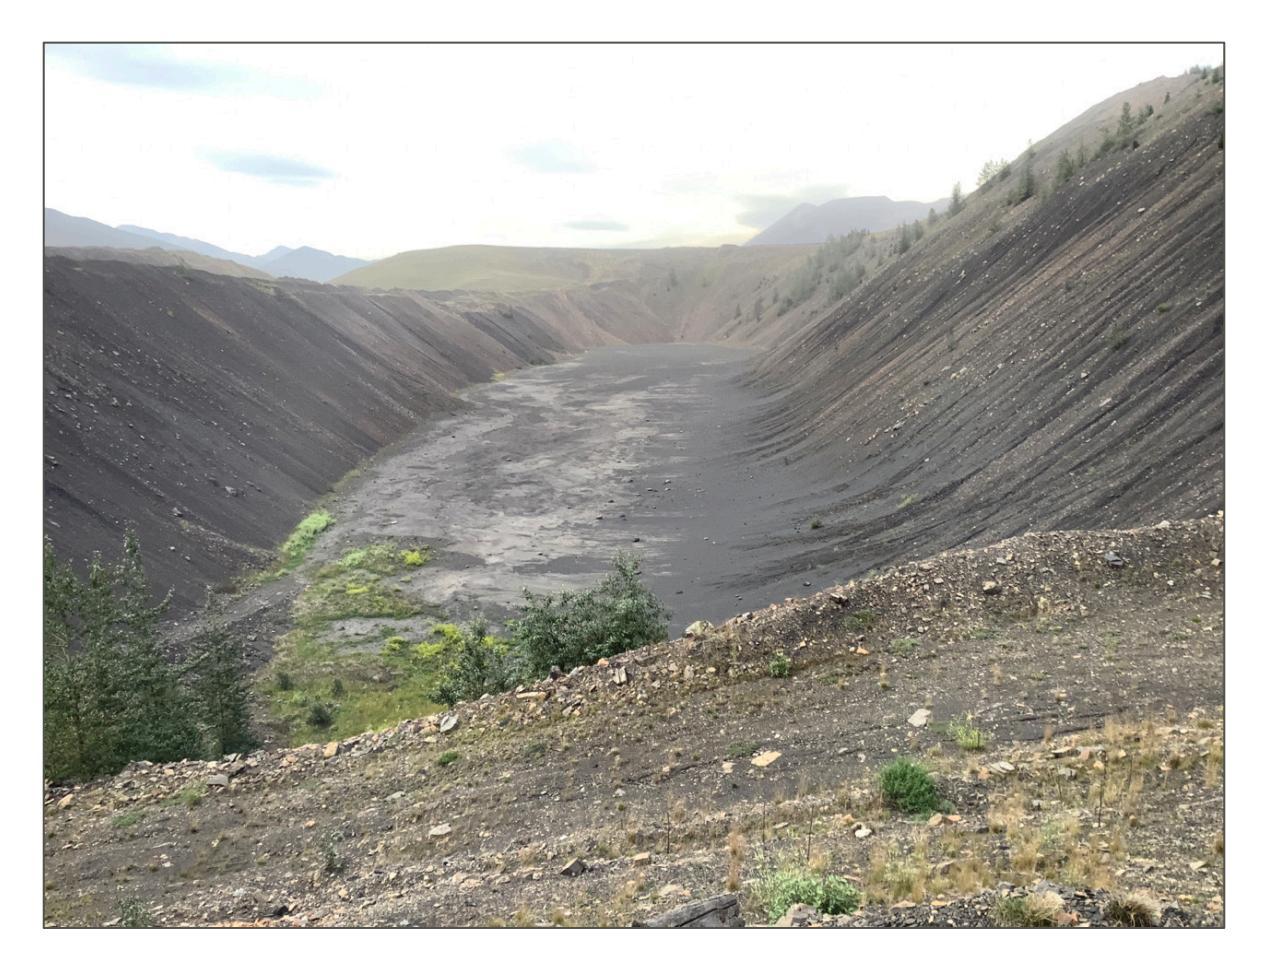
2020 Annual Dam Safety Inspection for 2 Pit and 3 Pit Tailings Storage Area PHOTOGRAPH A-1 20 August 2020

2 Pit overview, looking southeast.

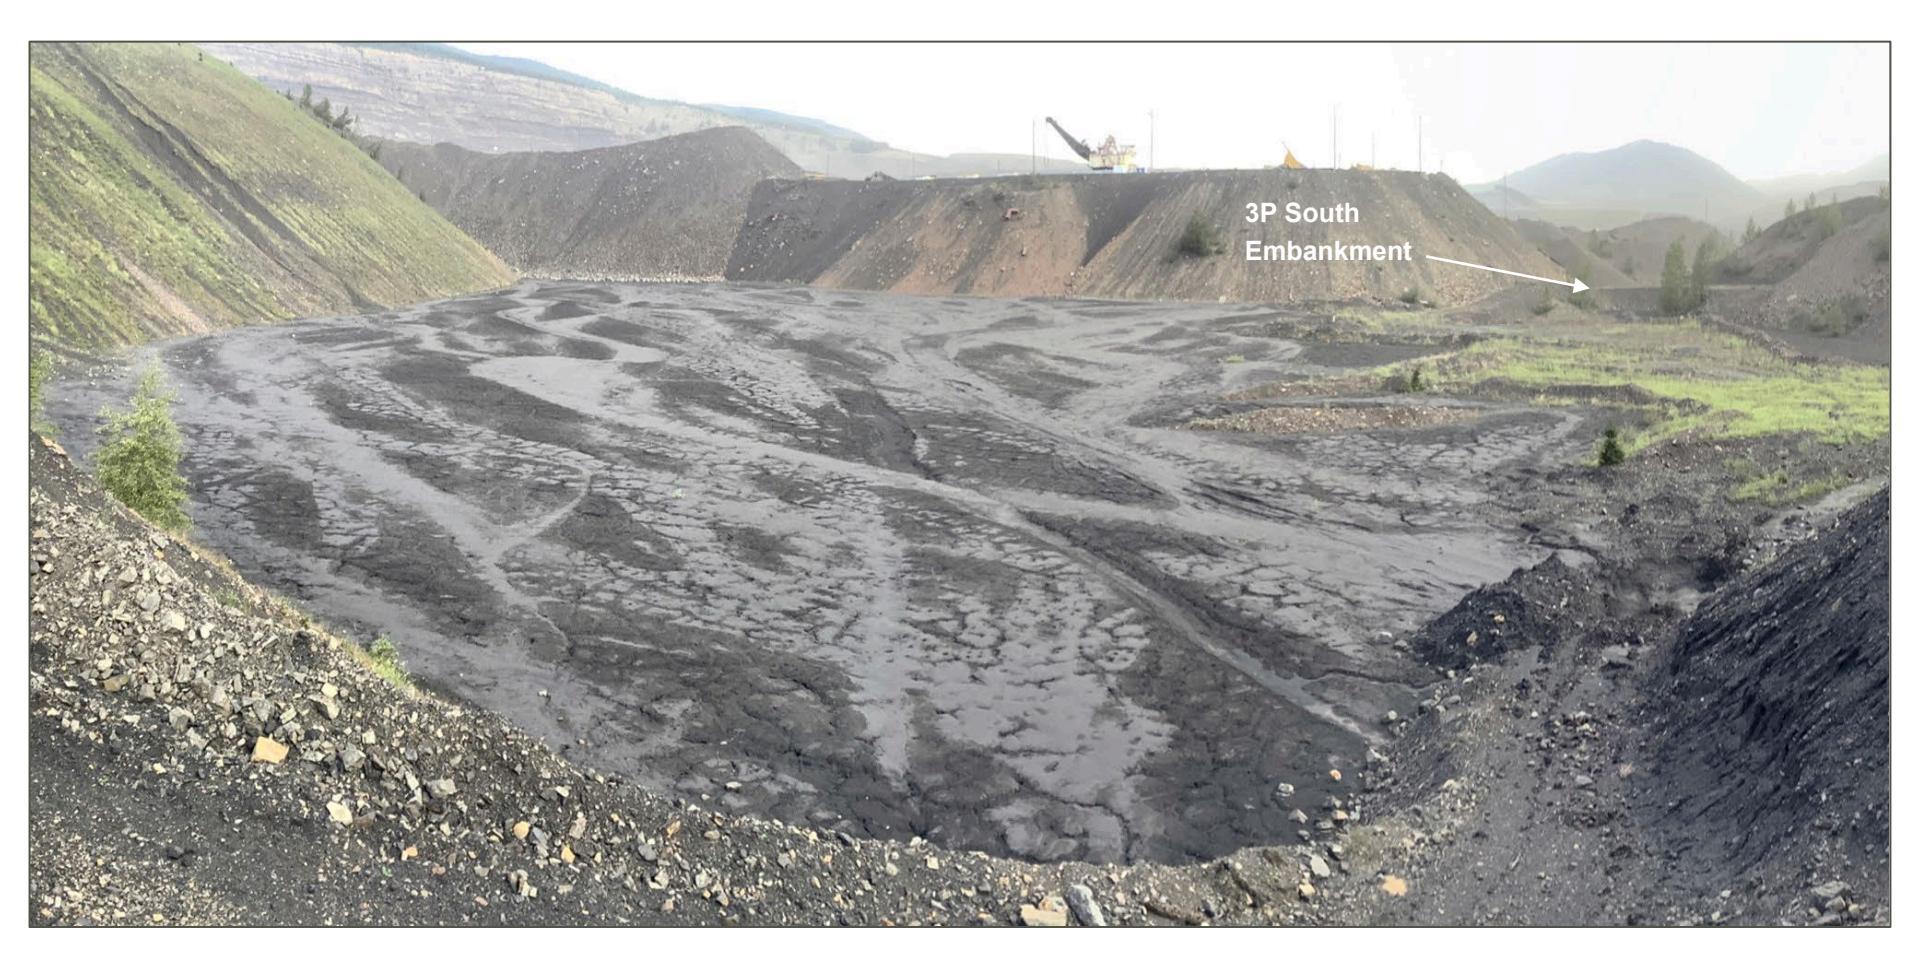
2020 Annual Dam Safety Inspection for 2 Pit and 3 Pit Tailings Storage AreaPHOTOGRAPH A-220 August 2020

3 Pit South overview, looking northwest.

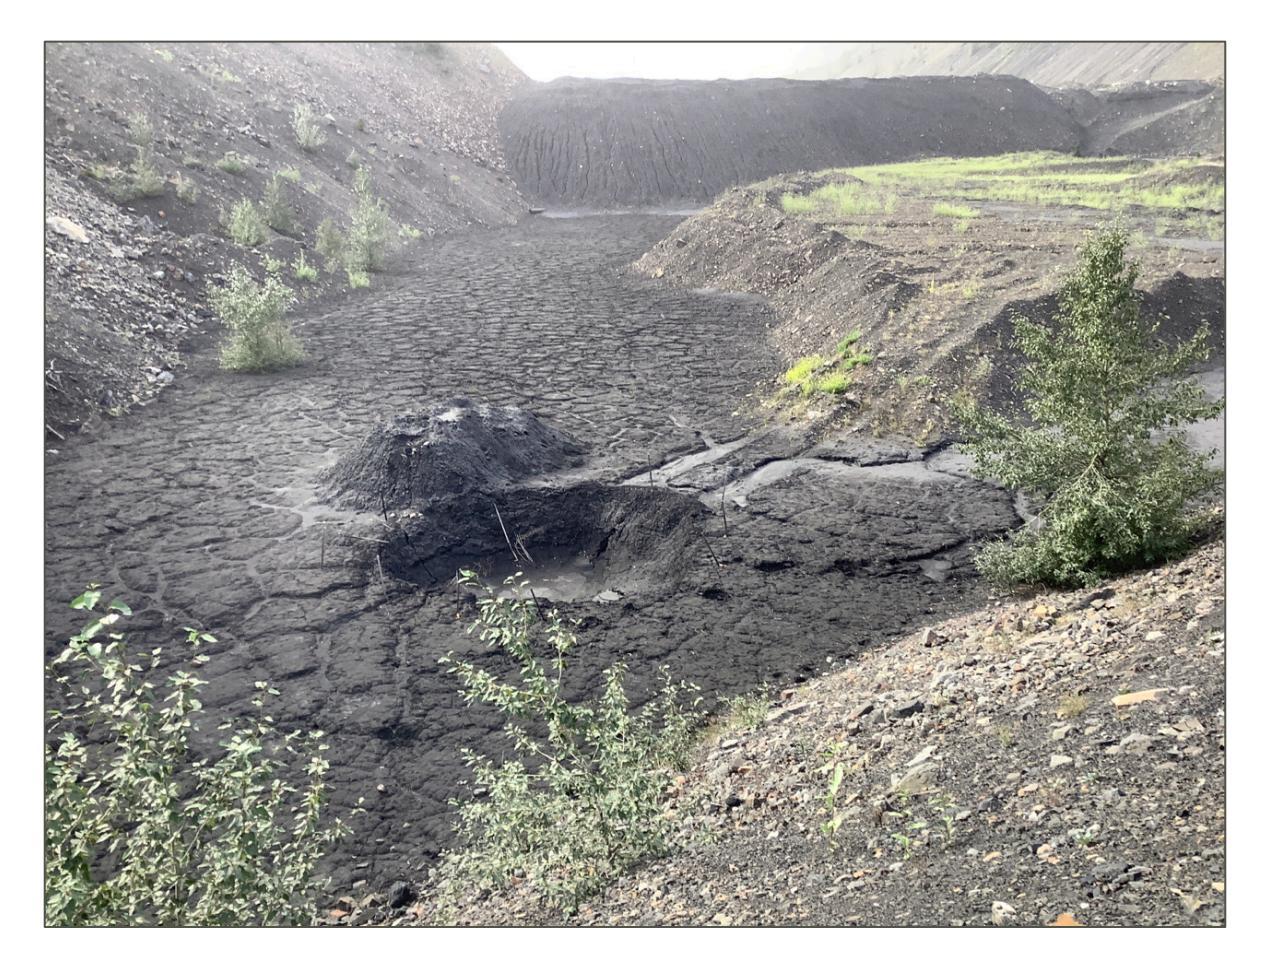
2020 Annual Dam Safety Inspection for 2 Pit and 3 Pit Tailings Storage Area PHOTOGRAPH A-3 20 August 2020

3 Pit South desiccated tailings surface and dry conditions observed in pit upstream of 3 Pit South Embankment, looking south.

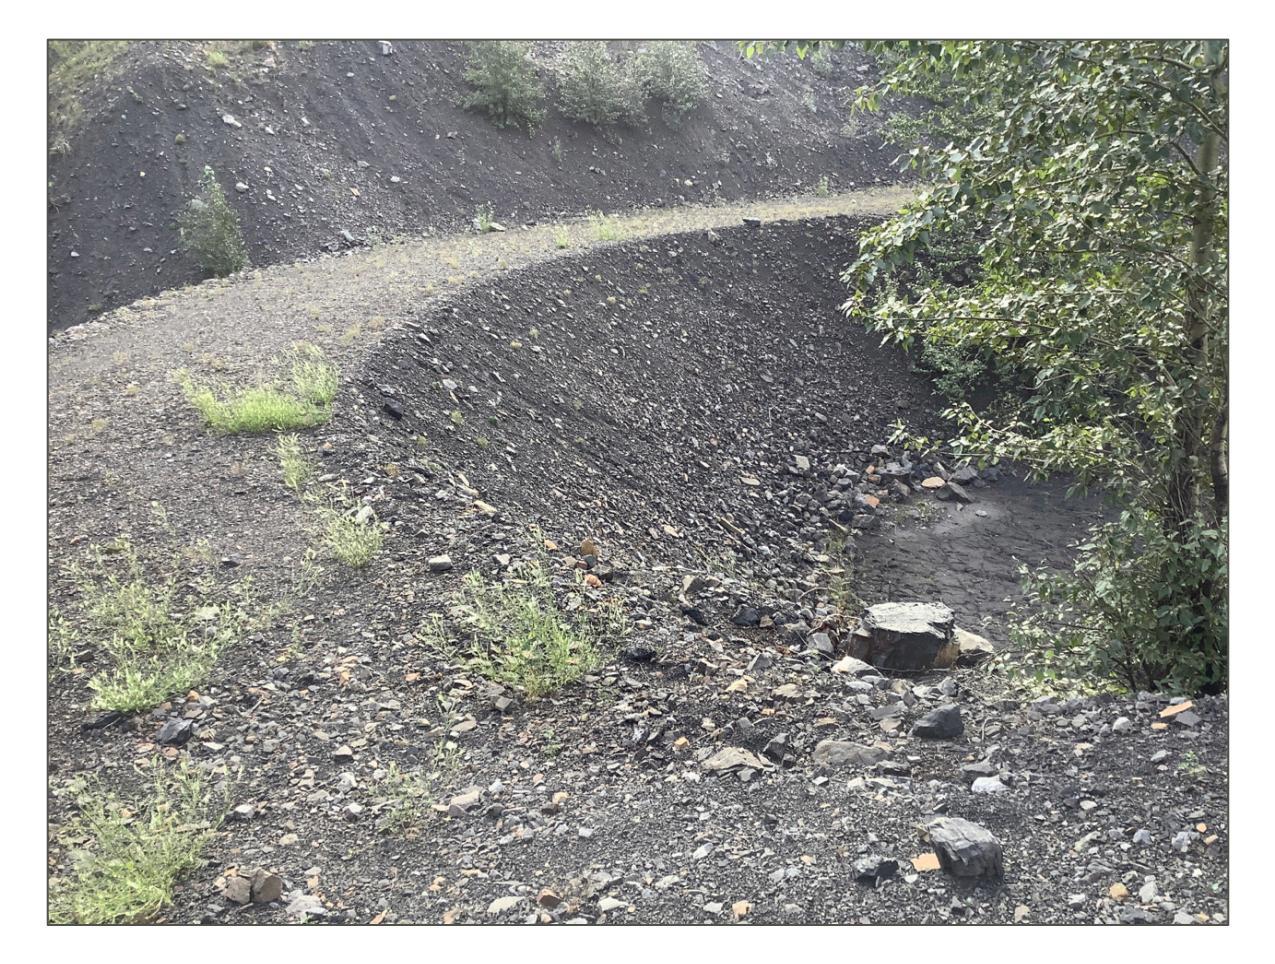
2020 Annual Dam Safety Inspection for 2 Pit and 3 Pit Tailings Storage Area PHOTOGRAPH A-4 20 August 2020

3 Pit South Embankment crest and upstream slope, looking east.

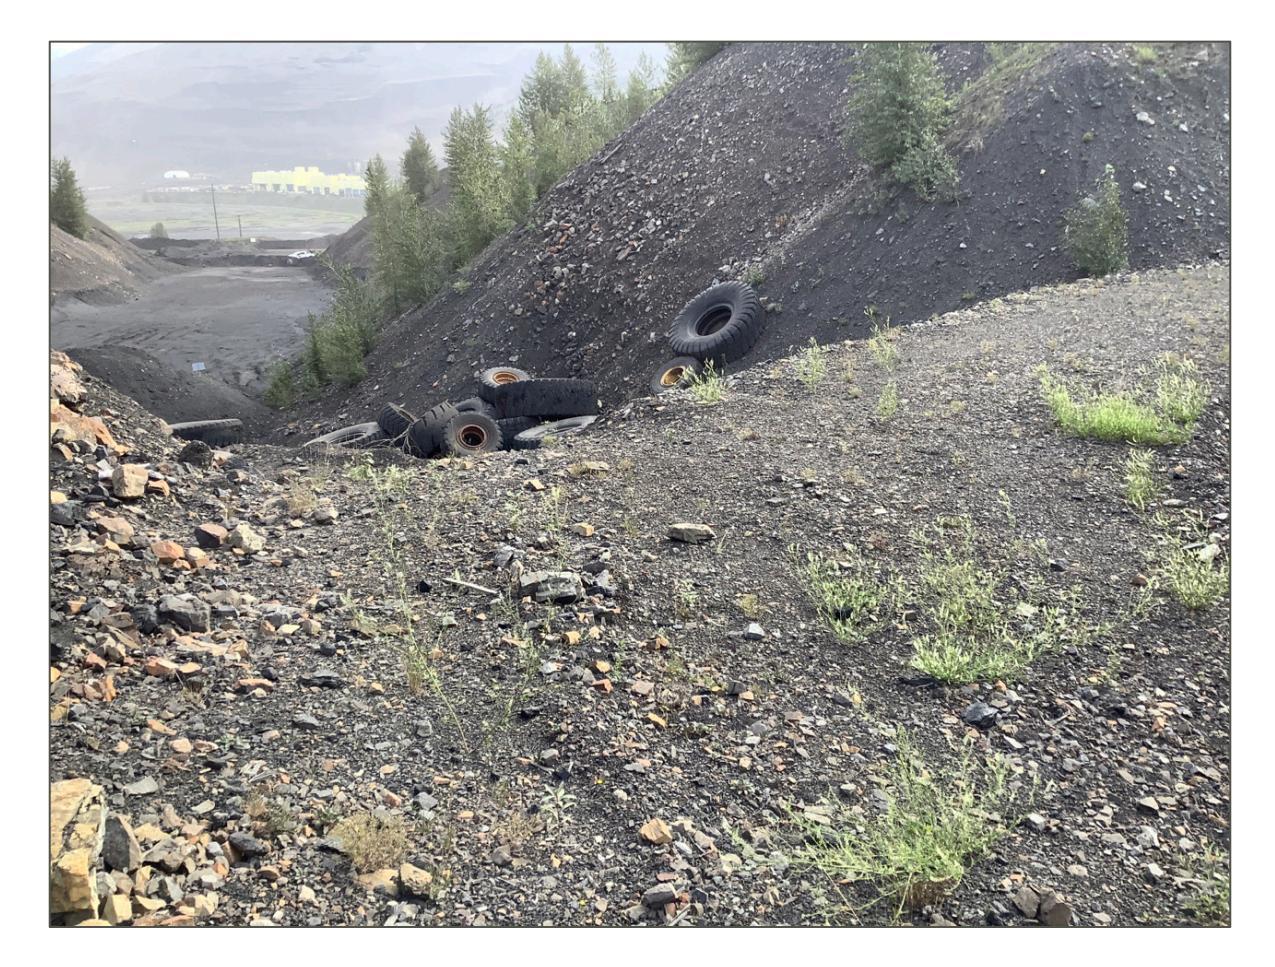
2020 Annual Dam Safety Inspection for 2 Pit and 3 Pit Tailings Storage Area PHOTOGRAPH A-5 20 August 2020

3 Pit South Embankment crest and downstream area, looking northeast.

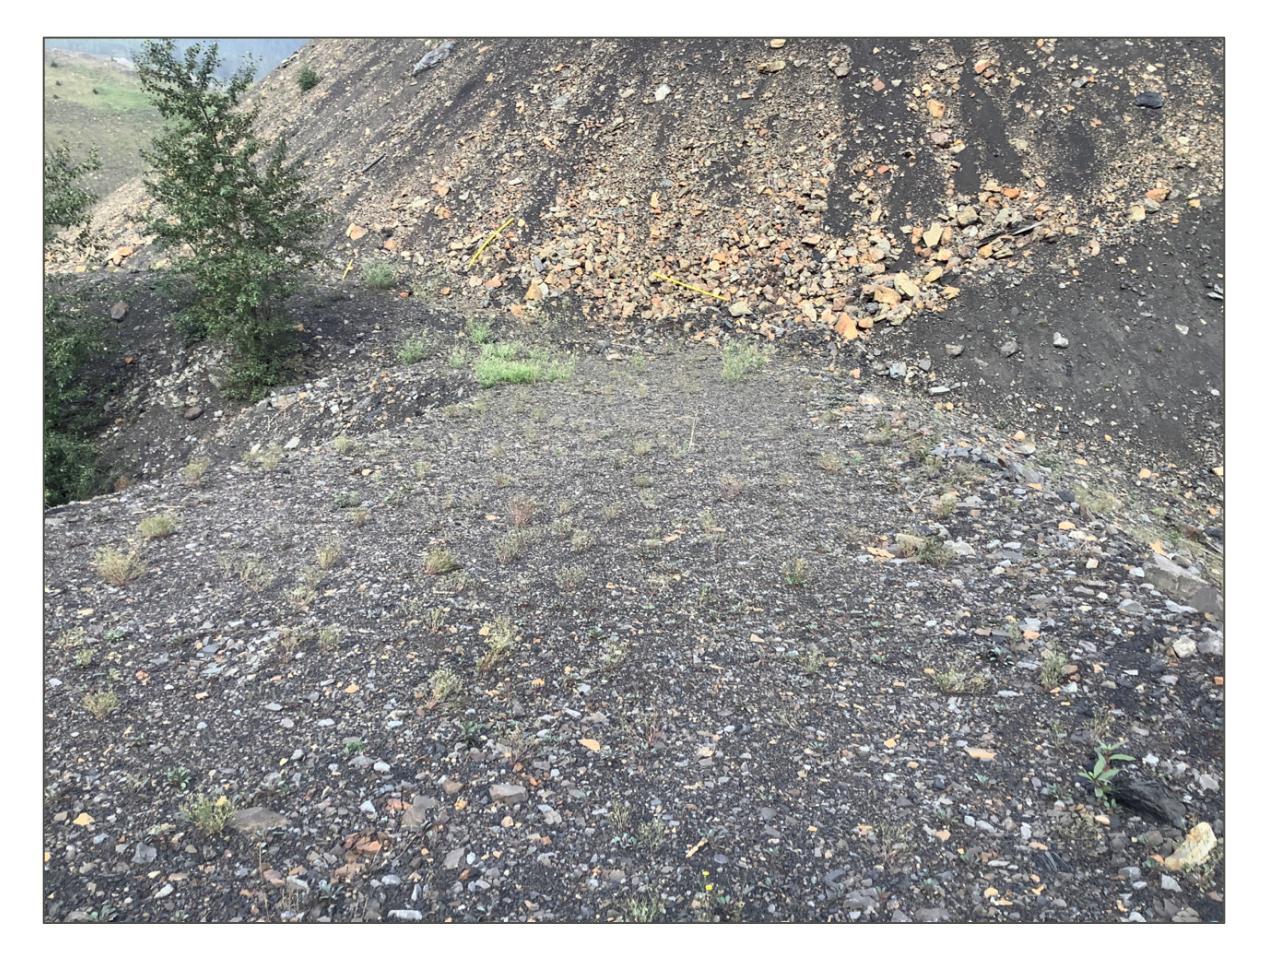
2020 Annual Dam Safety Inspection for 2 Pit and 3 Pit Tailings Storage Area PHOTOGRAPH A-6 20 August 2020

3 Pit South Embankment crest at south abutment, looking west.

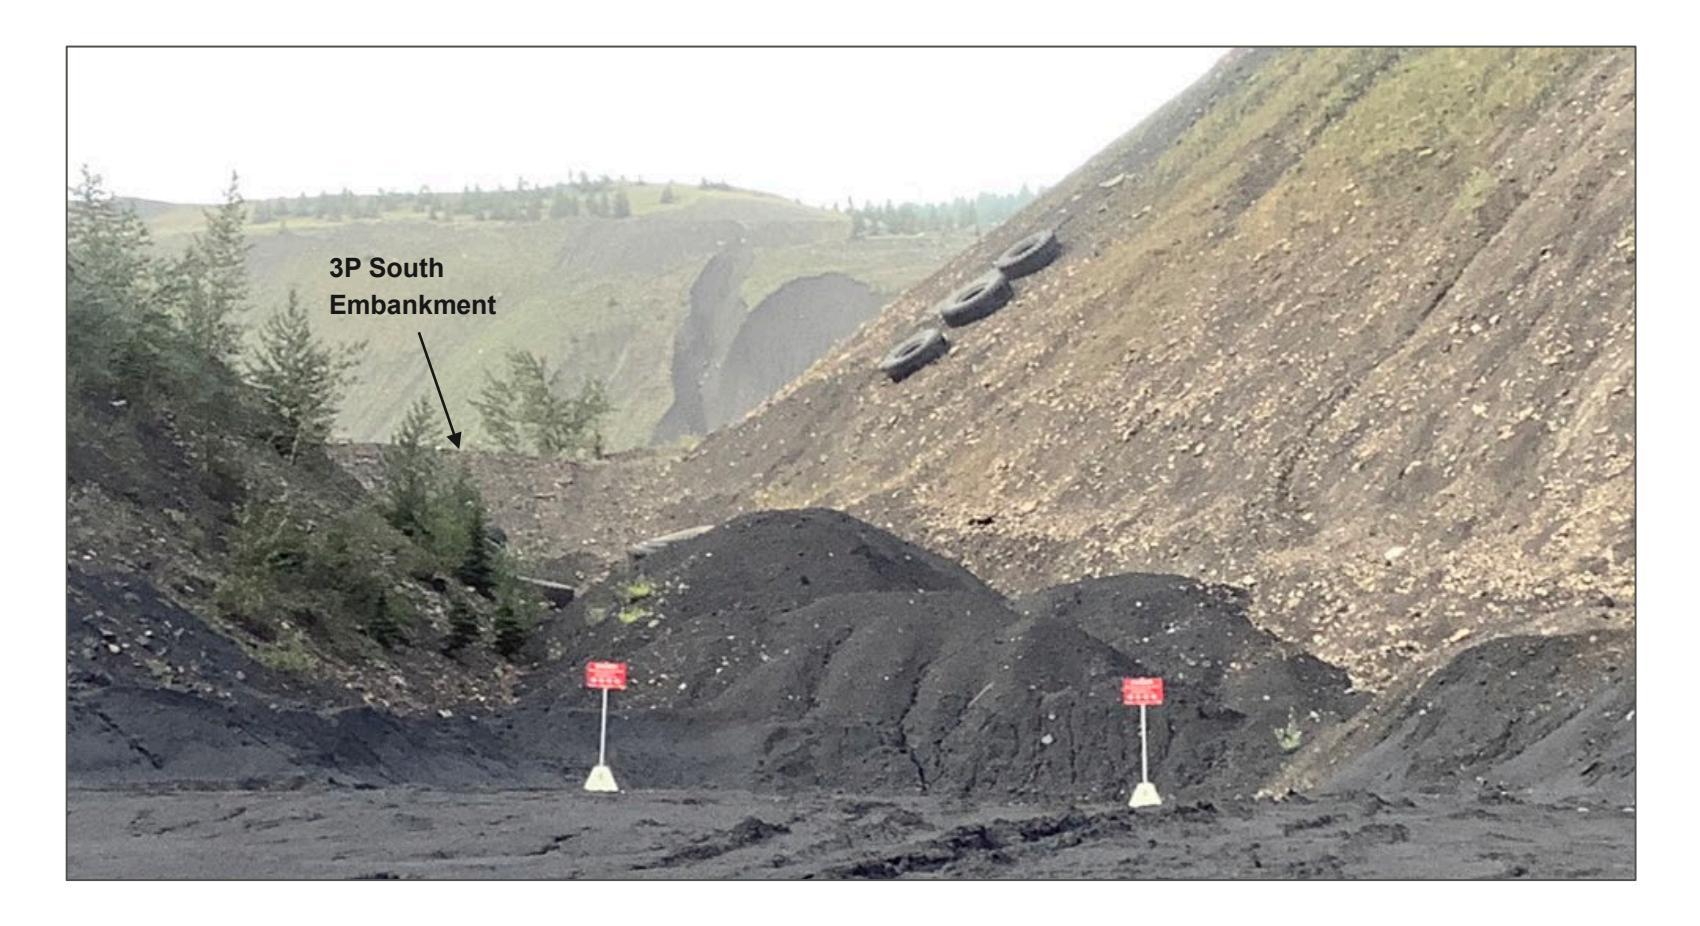
2020 Annual Dam Safety Inspection for 2 Pit and 3 Pit Tailings Storage AreaPHOTOGRAPH A-720 August 2020

3 Pit South Embankment view from coal stockpile area downstream, looking southwest. Tailings area notifications signs at downstream limit of embankment.

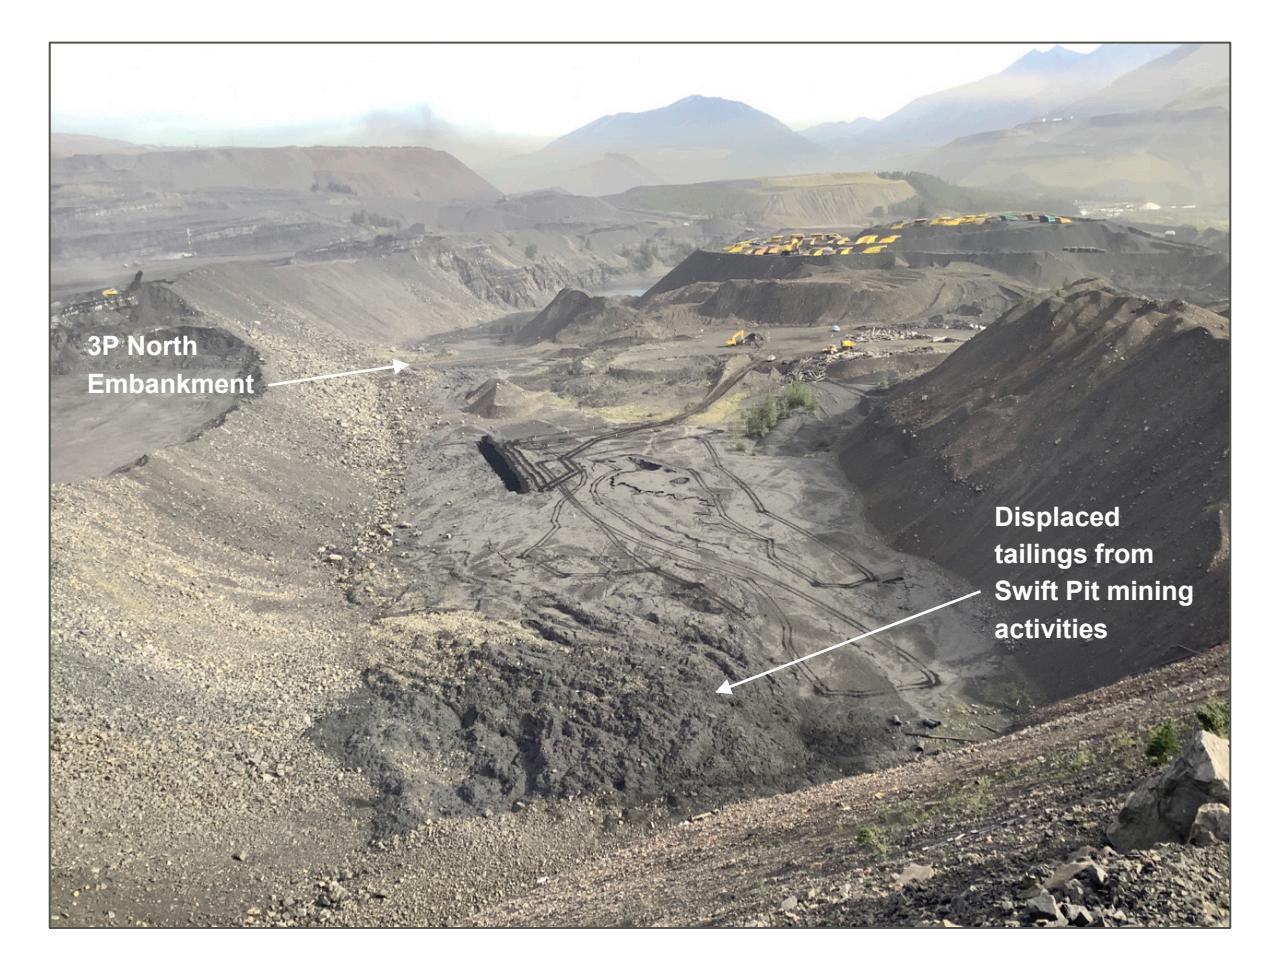
2020 Annual Dam Safety Inspection for 2 Pit and 3 Pit Tailings Storage AreaPHOTOGRAPH A-820 August 2020

3 Pit North overview, looking north.

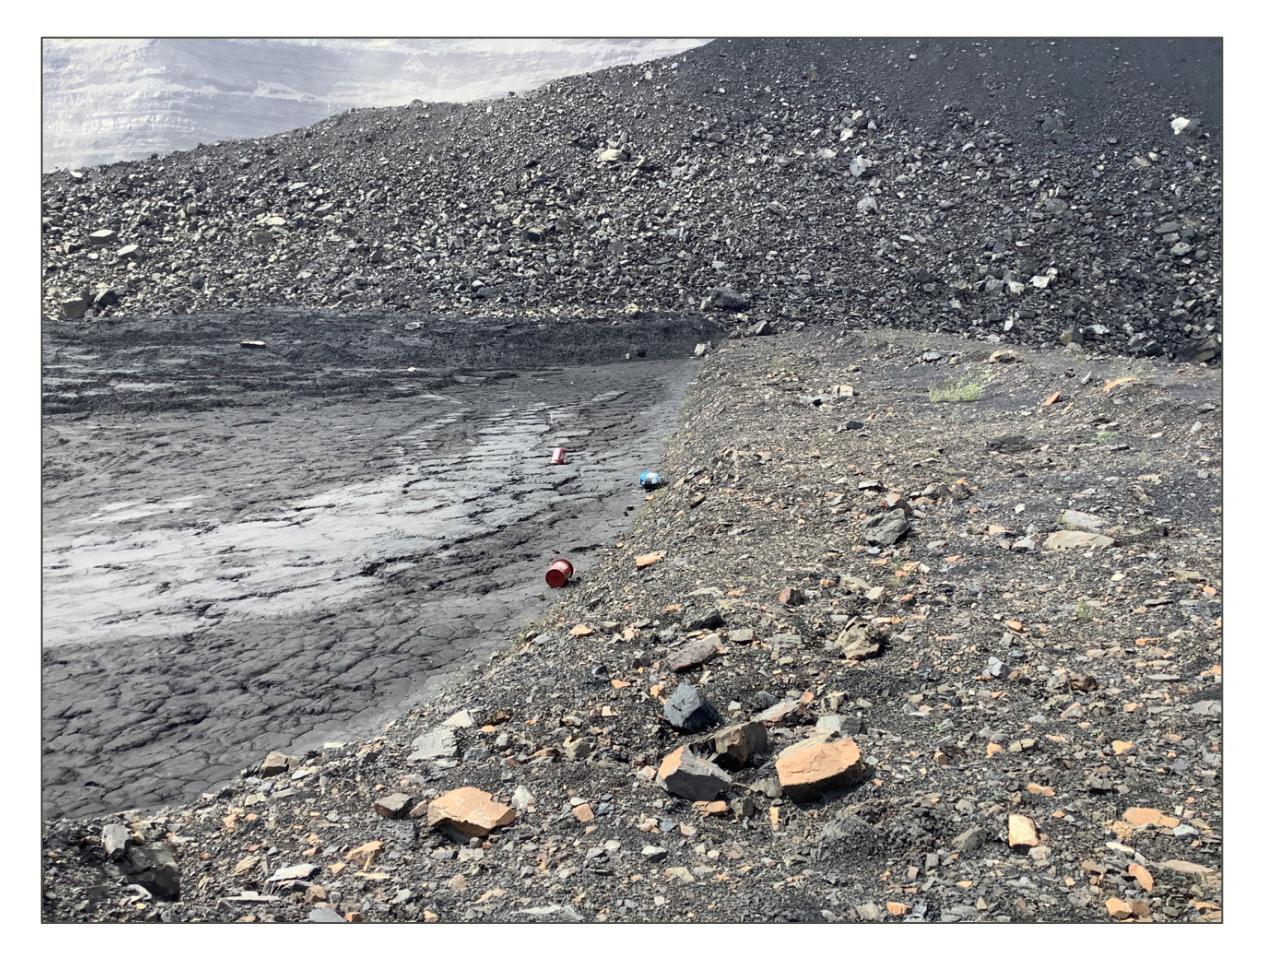
2020 Annual Dam Safety Inspection for 2 Pit and 3 Pit Tailings Storage Area PHOTOGRAPH A-9 19 August 2020

3 Pit North Embankment crest and upstream slope, looking west.

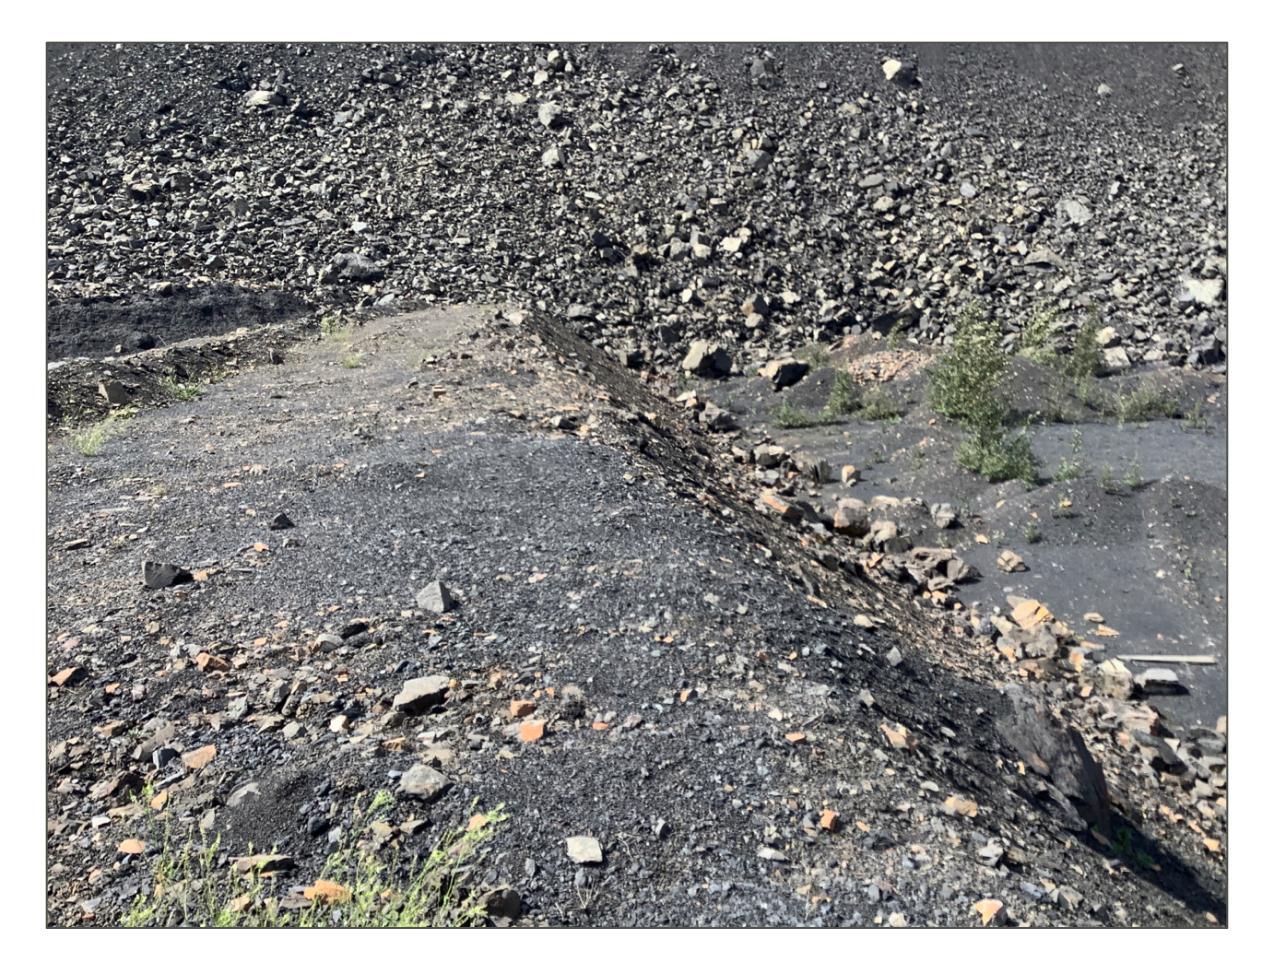
2020 Annual Dam Safety Inspection for 2 Pit and 3 Pit Tailings Storage Area PHOTOGRAPH A-10 19 August 2020

3 Pit North Embankment crest and downstream slope, looking west.

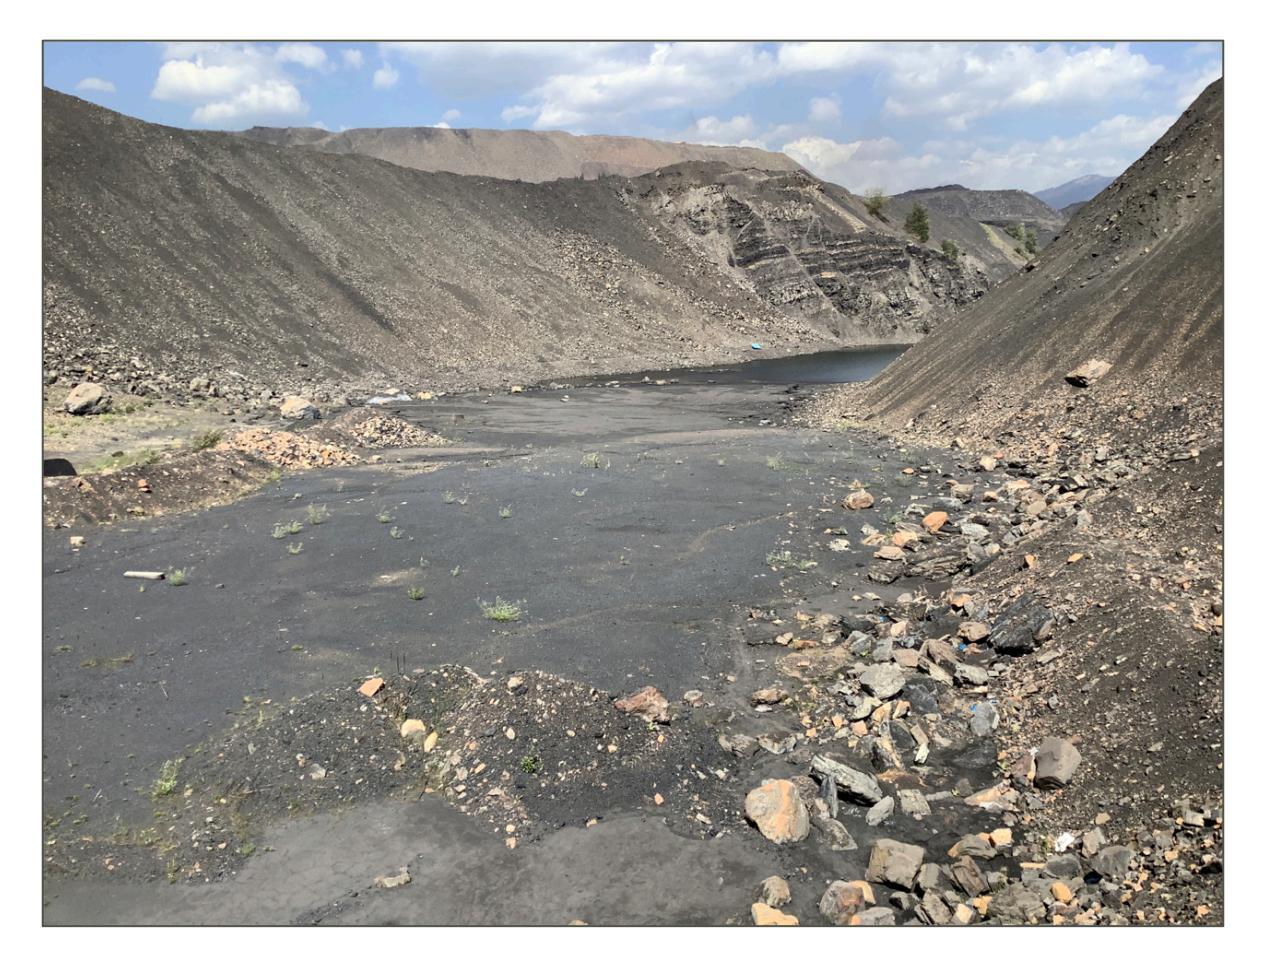
2020 Annual Dam Safety Inspection for 2 Pit and 3 Pit Tailings Storage Area PHOTOGRAPH A-11 19 August 2020

View to north downstream of 3 Pit North Embankment crest showing Shandley Pit pond.
