REPORT 2021 Annual Facility Performance Report

Greenhills Operations Tailings Storage Facility

Reference No. 21452085-2021-204-R-Rev1-3000

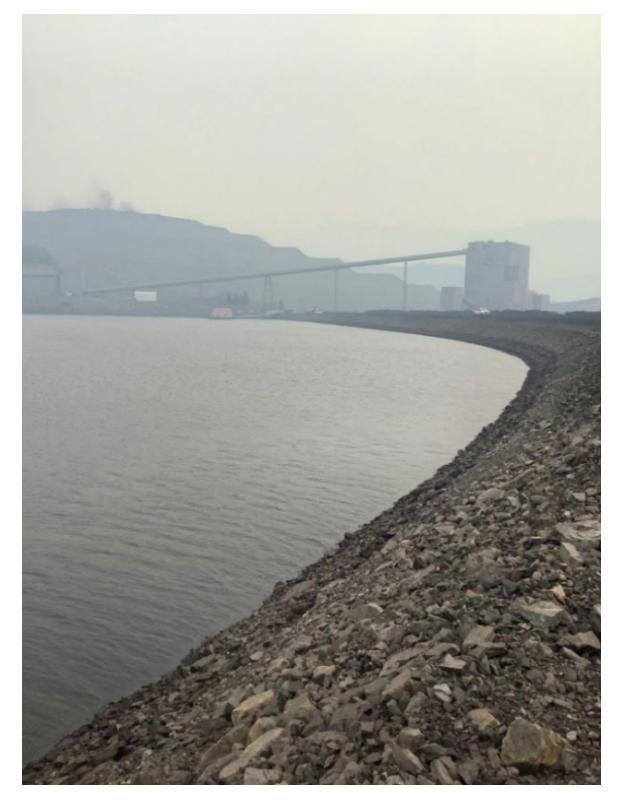
Photograph 8: Main Tailings Dam – Minor Erosion along Upstream Crest; Looking Northeast, 16 August 2021

Erosion rills, gullies, and minor localized depressions, noted on the MTD and WTD during monthly inspections during the operational period were repaired during the 2021 embankment raise construction.

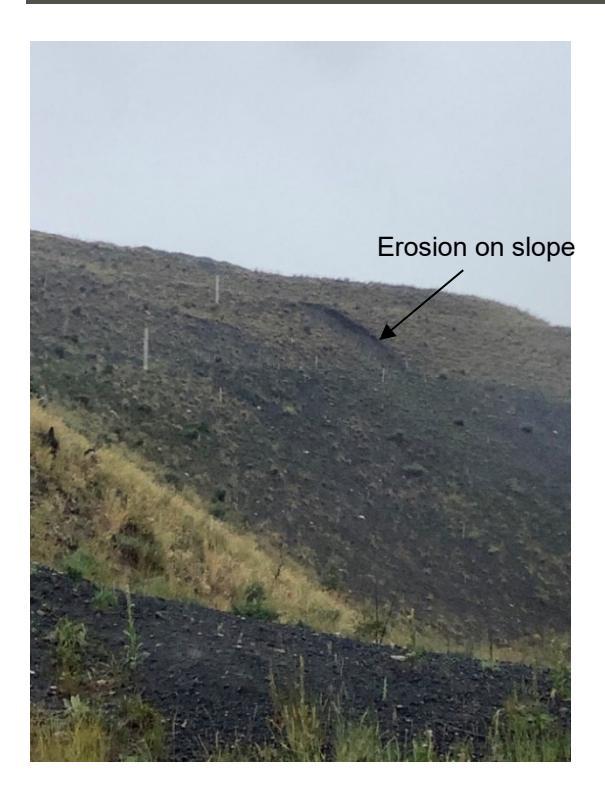
Photograph 13: Site C Coarse Coal Refuse Facility – Erosion on Downstream Slope; Looking North, 17 August 2021

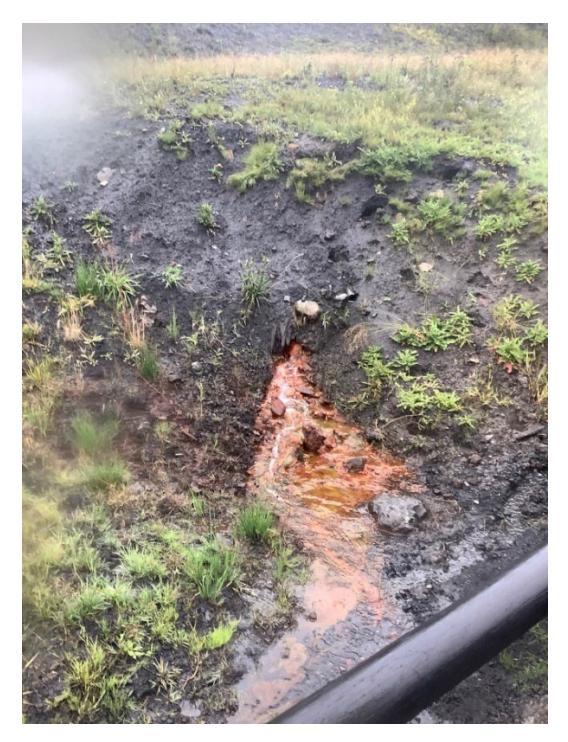
During the 2021 site visit, it was observed that flow in the WTD seepage collection channel and seepage from the MTD was clear and free of visible suspended solids. Seepage rates during the reporting period were within normal operating conditions, and visual observations were not indicative of conditions attributable to internal erosion.

Photograph 15: Site C Coarse Coal Refuse Facility – Rock Drain Discharge and Seepage from Main Tailings Dam; Looking Northeast, 17 August 2021

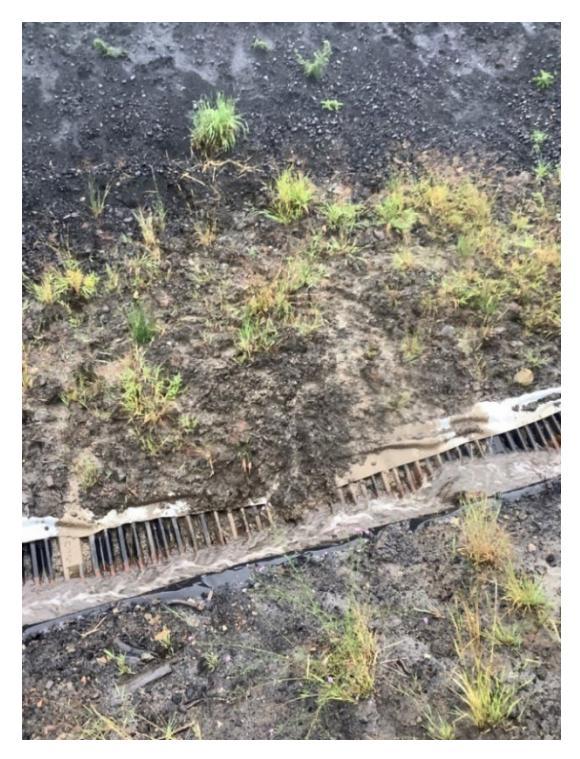
Photograph 19: Site C Coarse Coal Refuse Facility – Sediment Blocking Smart Ditch; Looking North, 17 August 2021
