# **Teck Highland Valley Copper** Partnership

## 2021 Annual Facility Performance Report

Bethlehem No.1 Tailings Storage Facility

March 2022

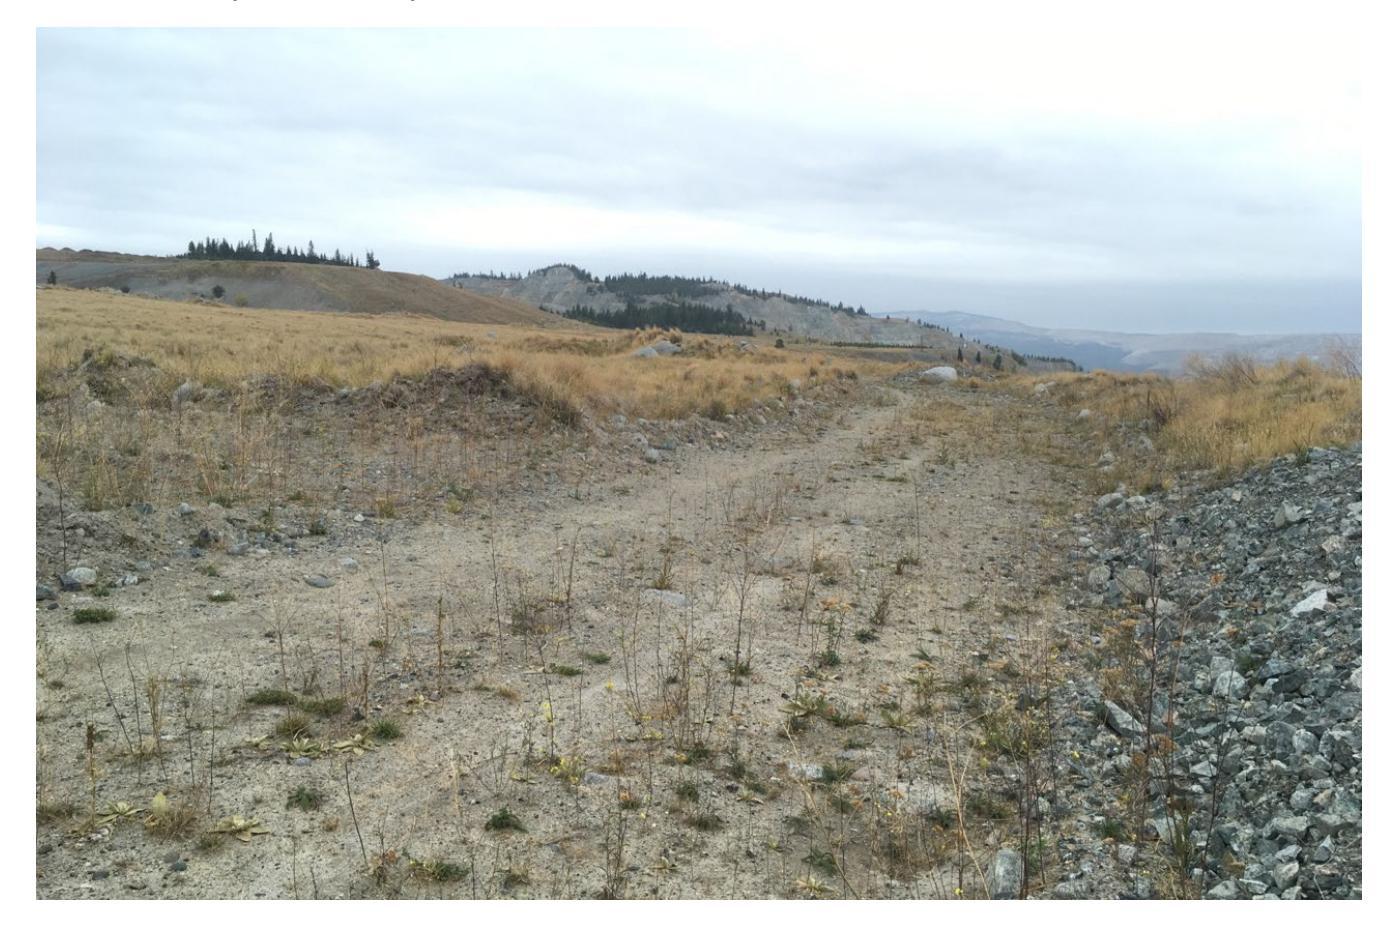
# Photo I-A-1 Dam No. 1 crest road. No evidence of erosion or depression was observed (BTH-2021-01)

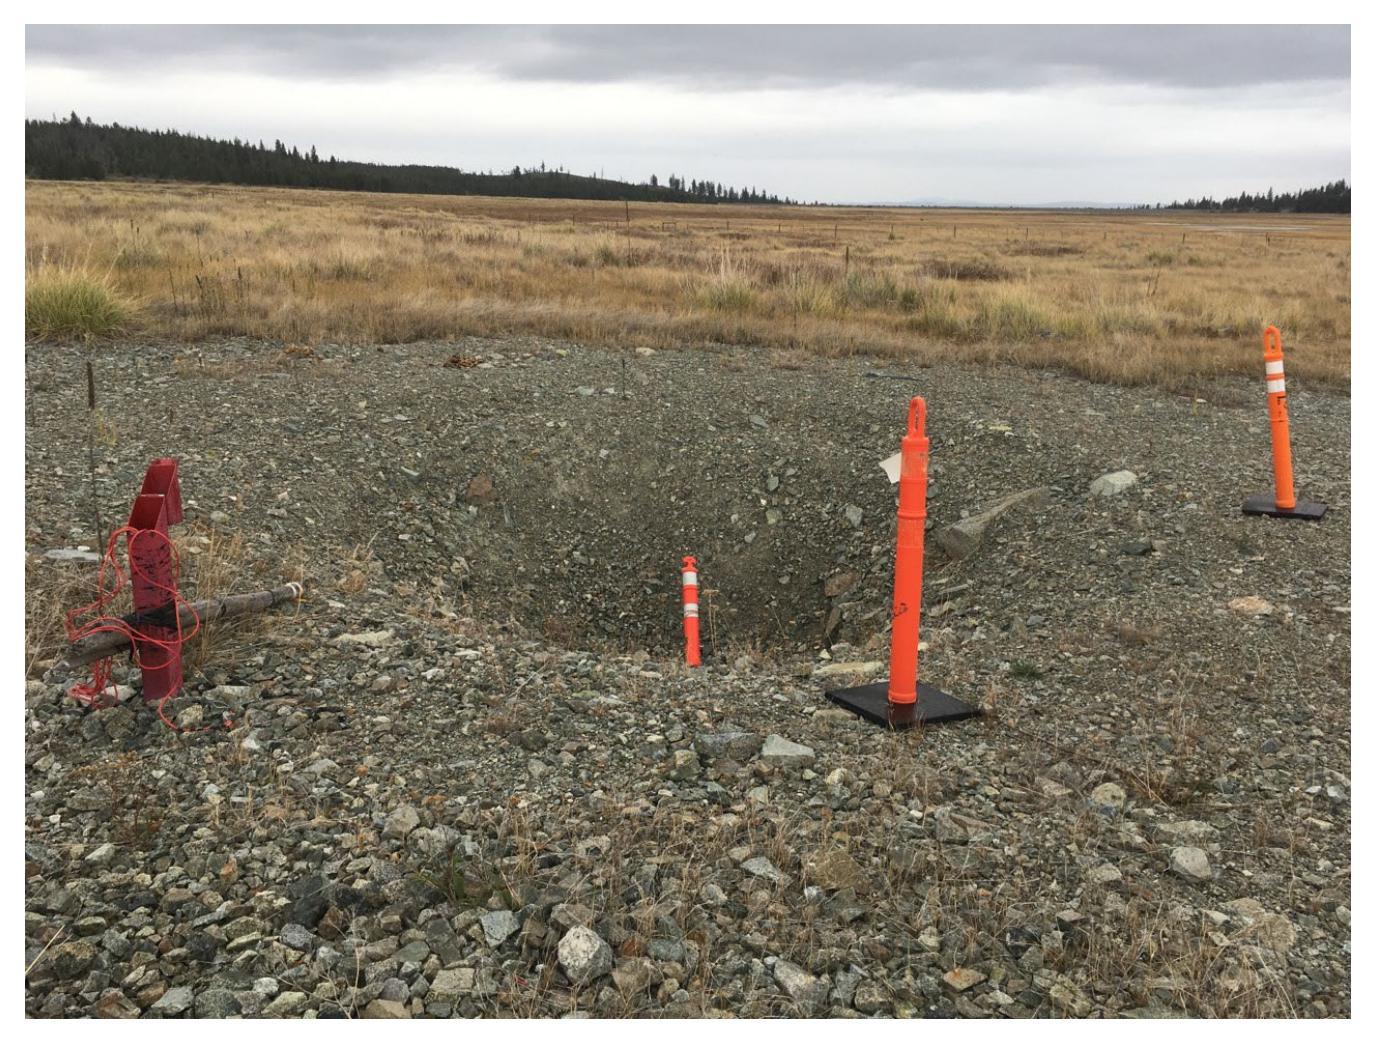
# Photo I-A-2 Bethlehem sinkhole on tailings beach, no visual change from previous visual observations (BTH-2021-03)

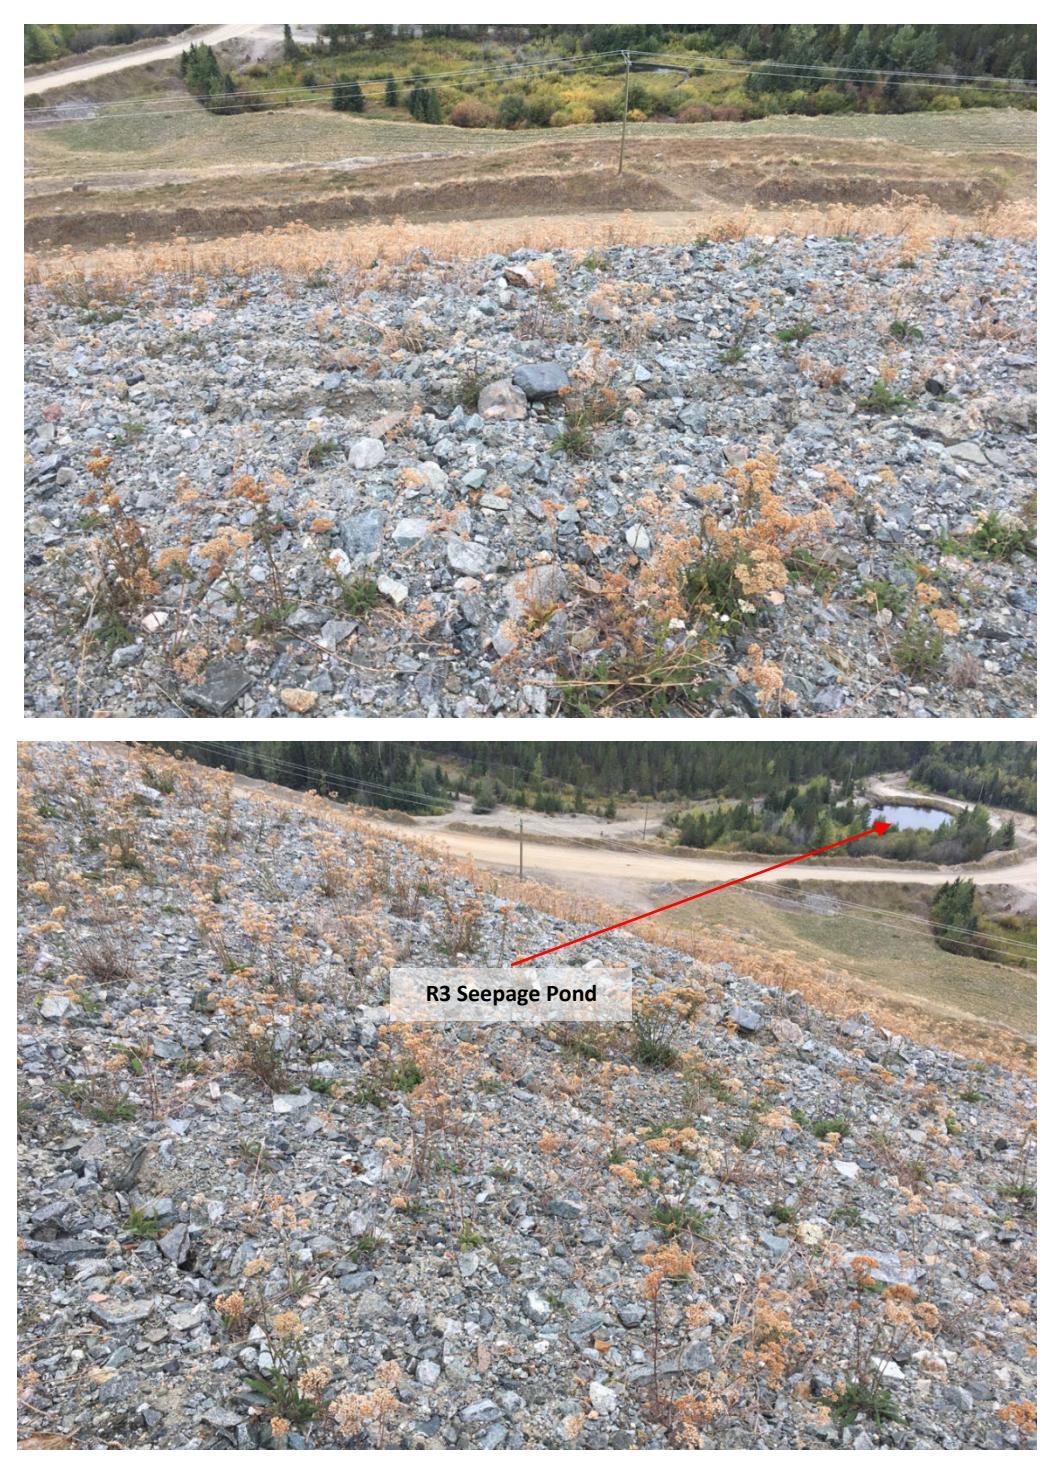
Photo I-A-3 Overview of downstream slope and toe area and of previously documented erosion area. Similar to the previous AFPR the cracking remains filled, indicating area has been inactive (BTH-2021-02)

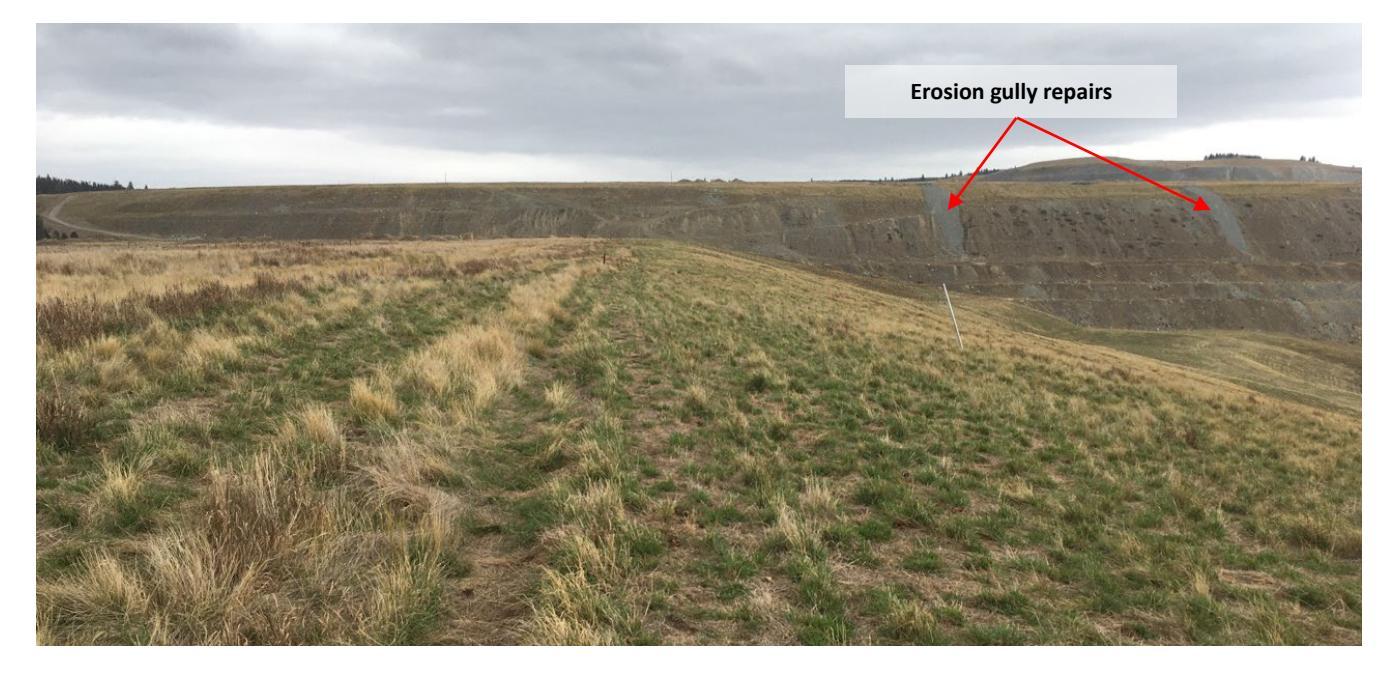
# Photo I-A-4 Overview of downstream slope and toe from Trojan Dam. No new erosion areas were observed, and previous repairs are holding up well (BTH-2021-04)

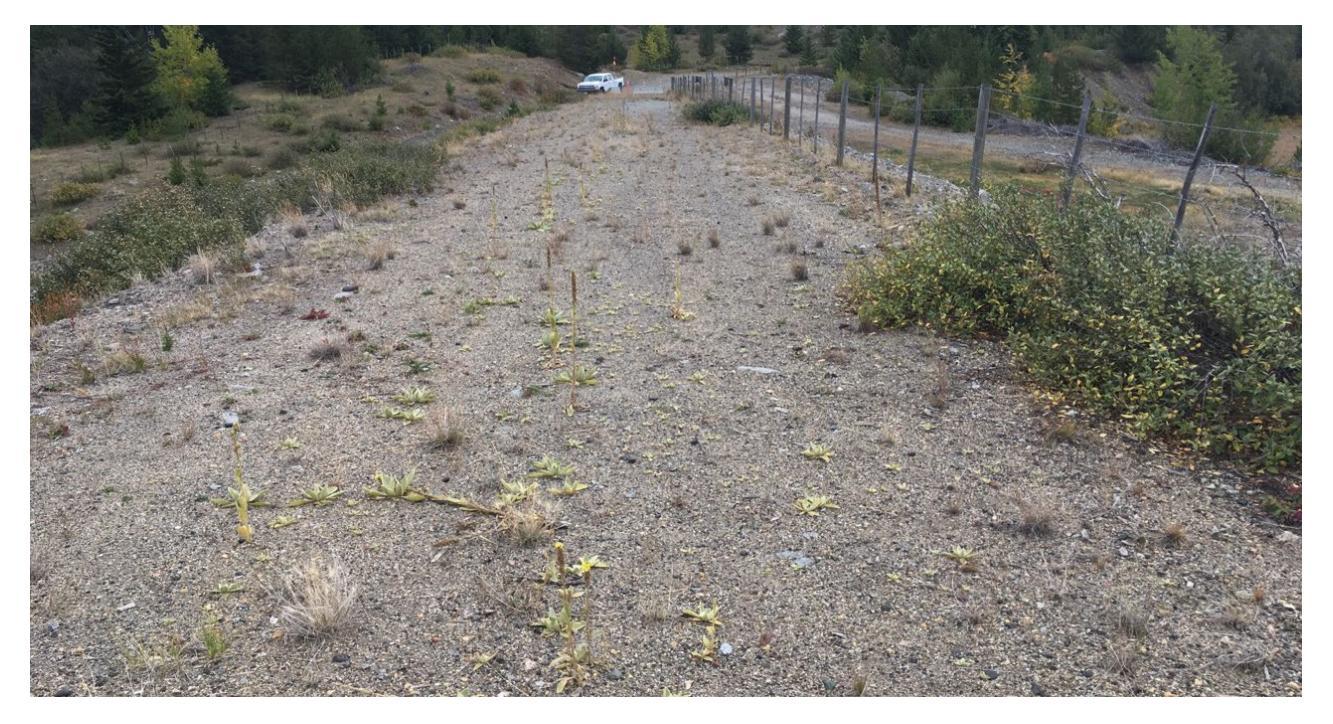
Photo I-B-3 Overview of dam crest, looking towards right abutment. No sign of erosion or depression was observed (BTH-2021-06)

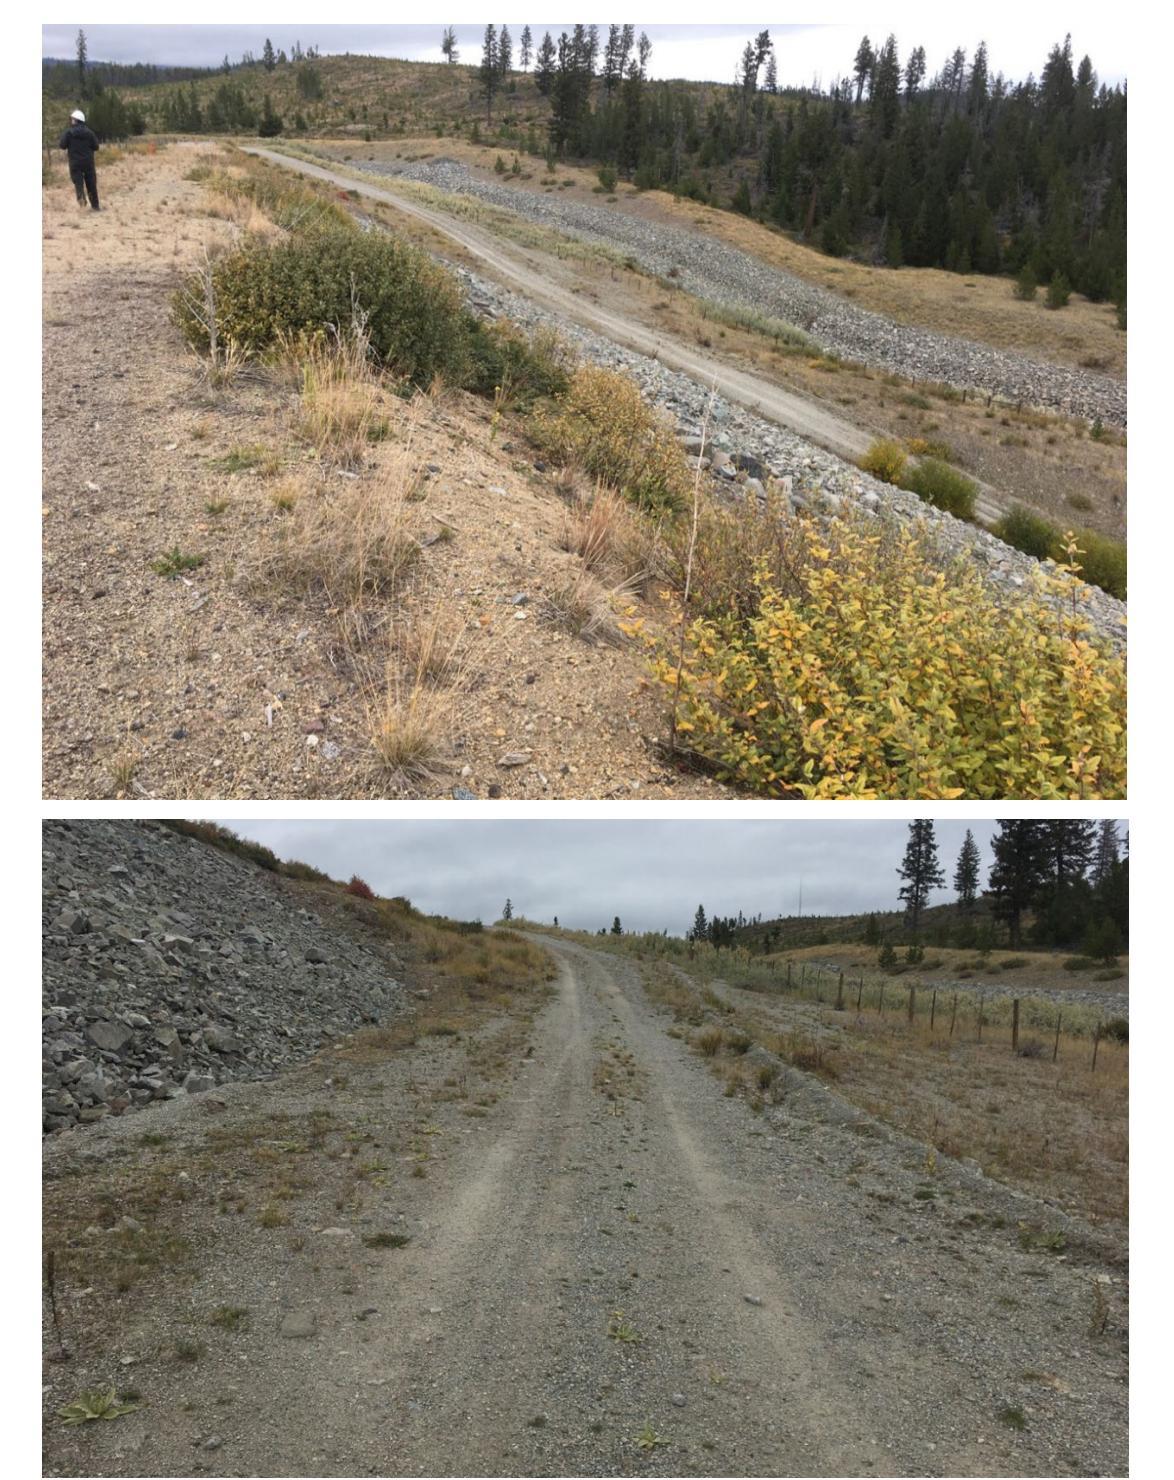
# Photo I-B-5 View of left abutment. No sign of erosion or unusual condition (BTH-2021-07 and BTH-2021-08)

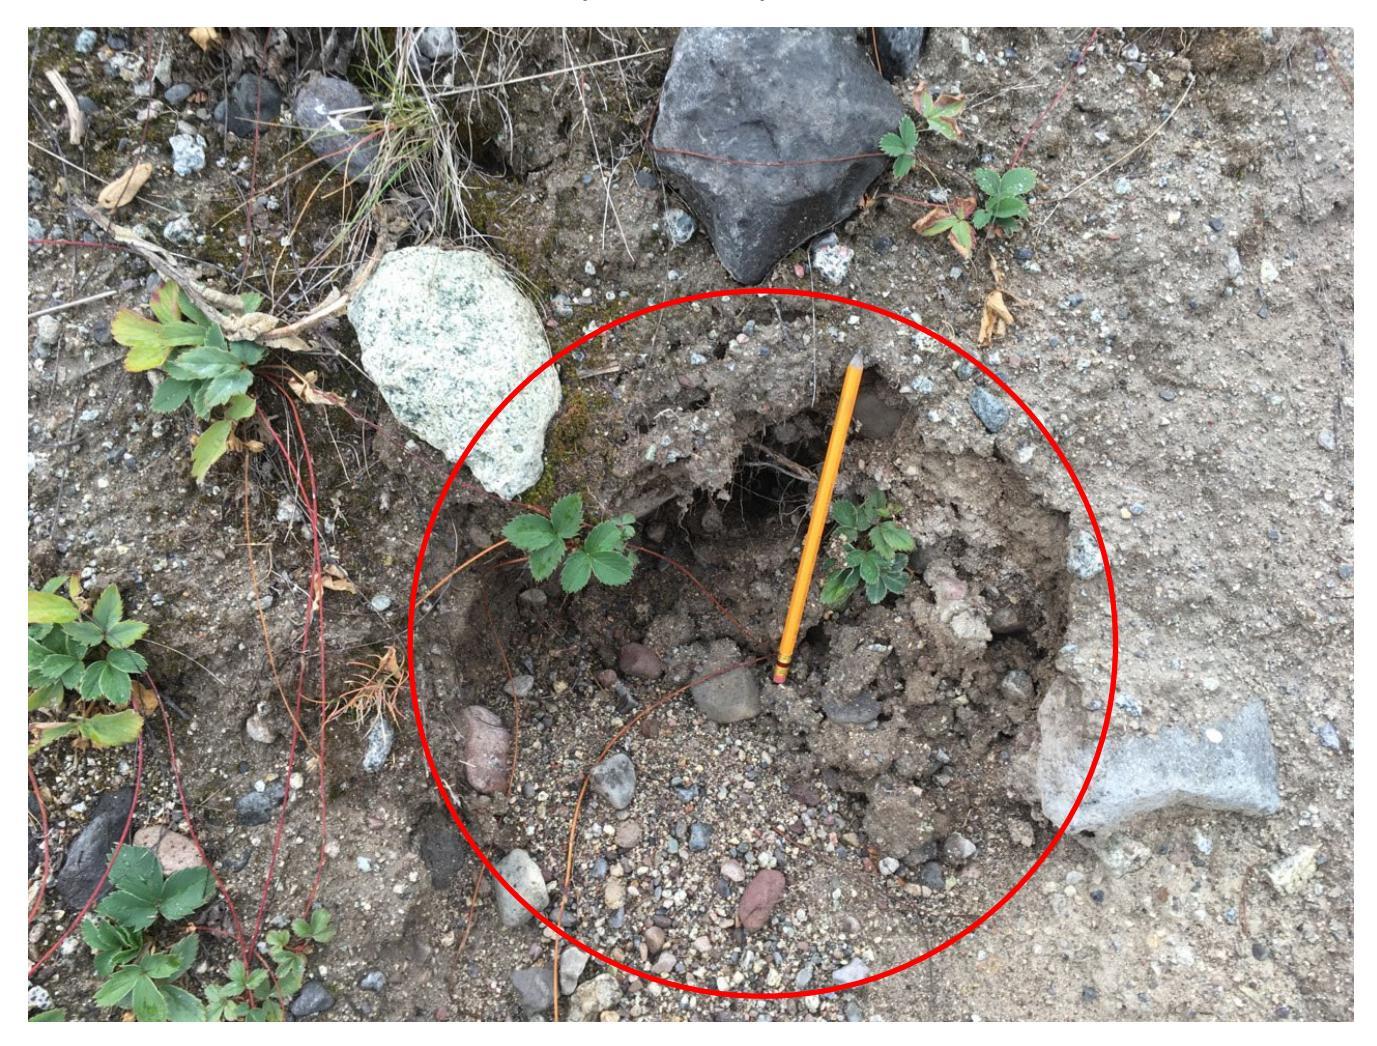
- Animal burrows on the downstream slope of Bose Lake Dam (glacial till zone) were visited by KCB and Mr. Aaron Sangha (HVC). The outstanding recommendation (BD-2020-01) has been closed based on the following:

Photo I-B-6 An animal burrows observed at the downstream slope near the left abutment. HVC reviewed the burrow patterns, and the separation between the downstream and upstream slopes is more than 3x the expected burrow depth even under extreme flood conditions, and the pond level is not predicted to reach the elevation where the burrows are observed (BTH-2021-09)

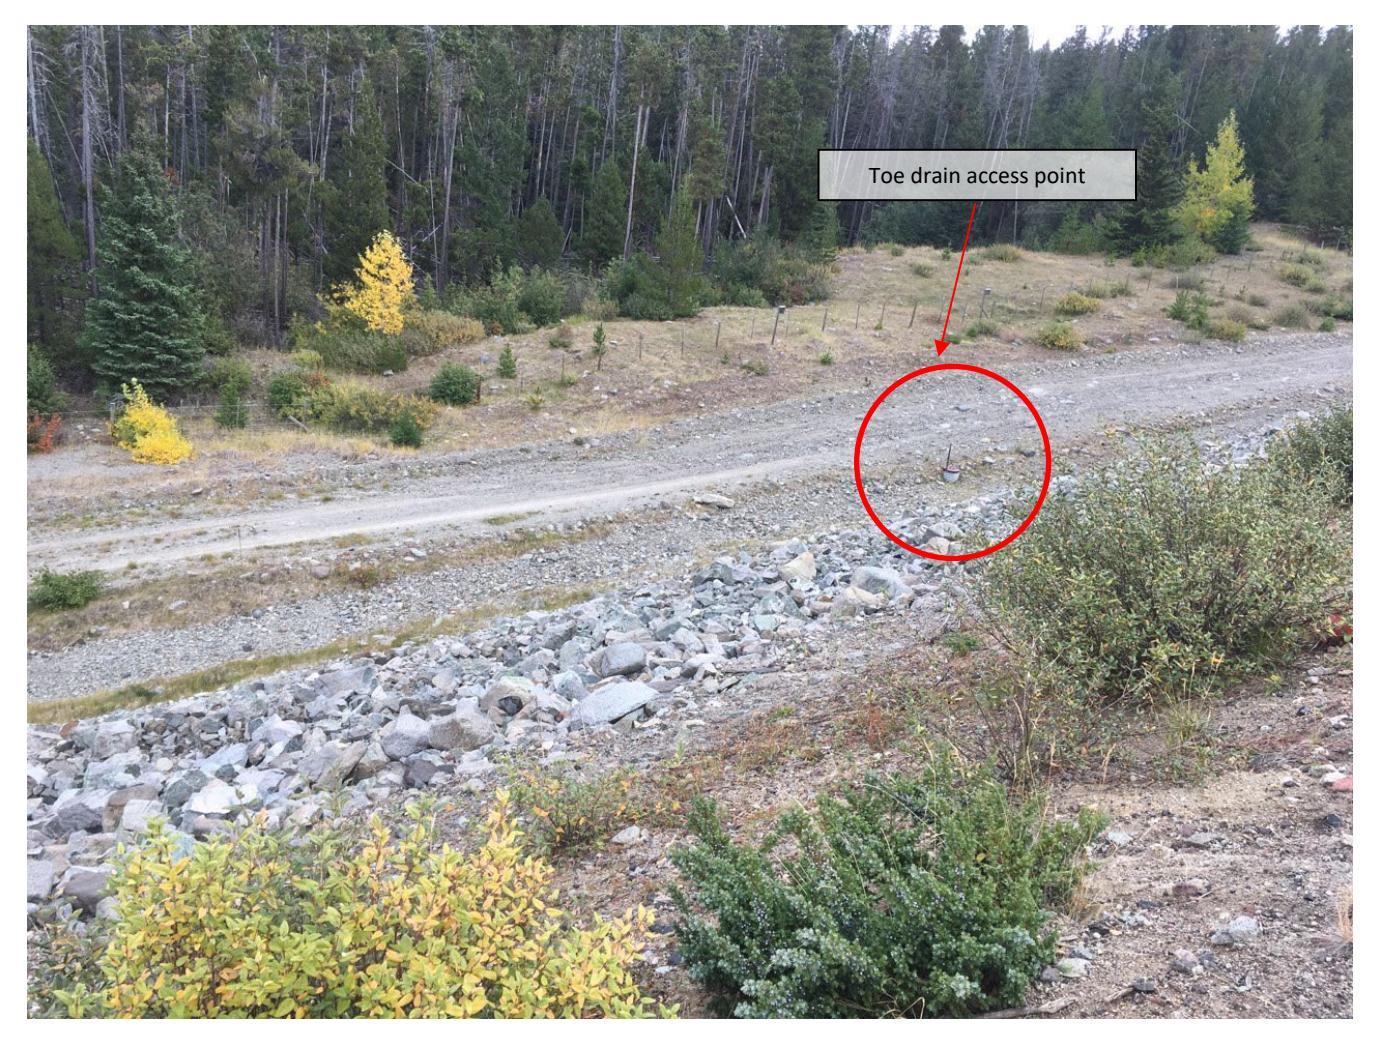
# Photo I-B-8 Upslope extent of toe drain along abutment. Toe drain access point is visible. Cap is sealed (BTH-2021-06)

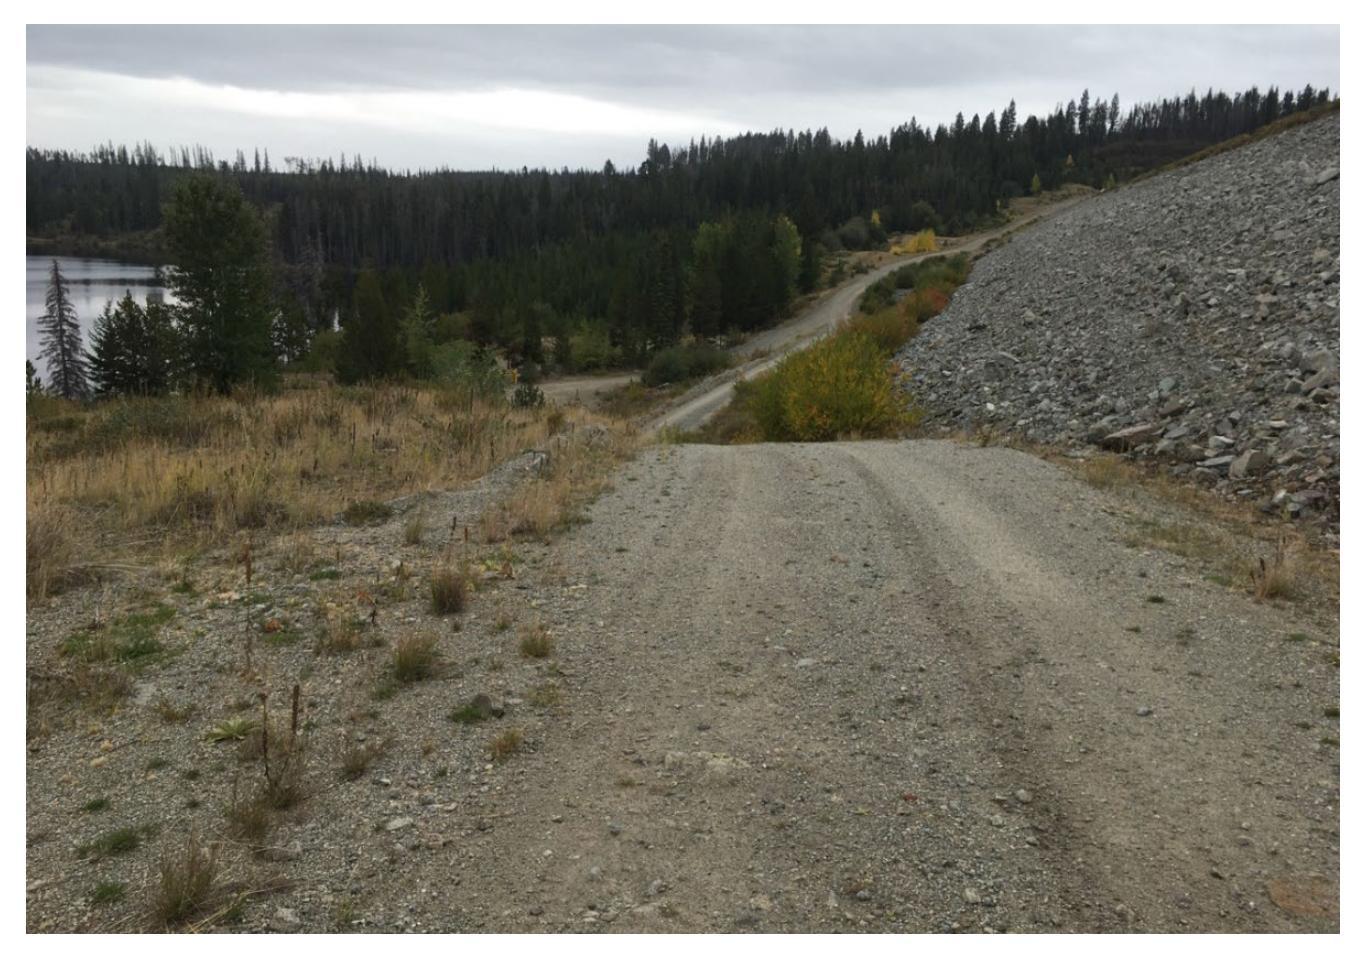
Photo I-B-9 View of downstream slope. Vegetation cover over lower portion of slope identifies the segment of downstream slope comprised of glacial till fill. No erosion of slope (rock or glacial till) was observed (BTH-2021-08)

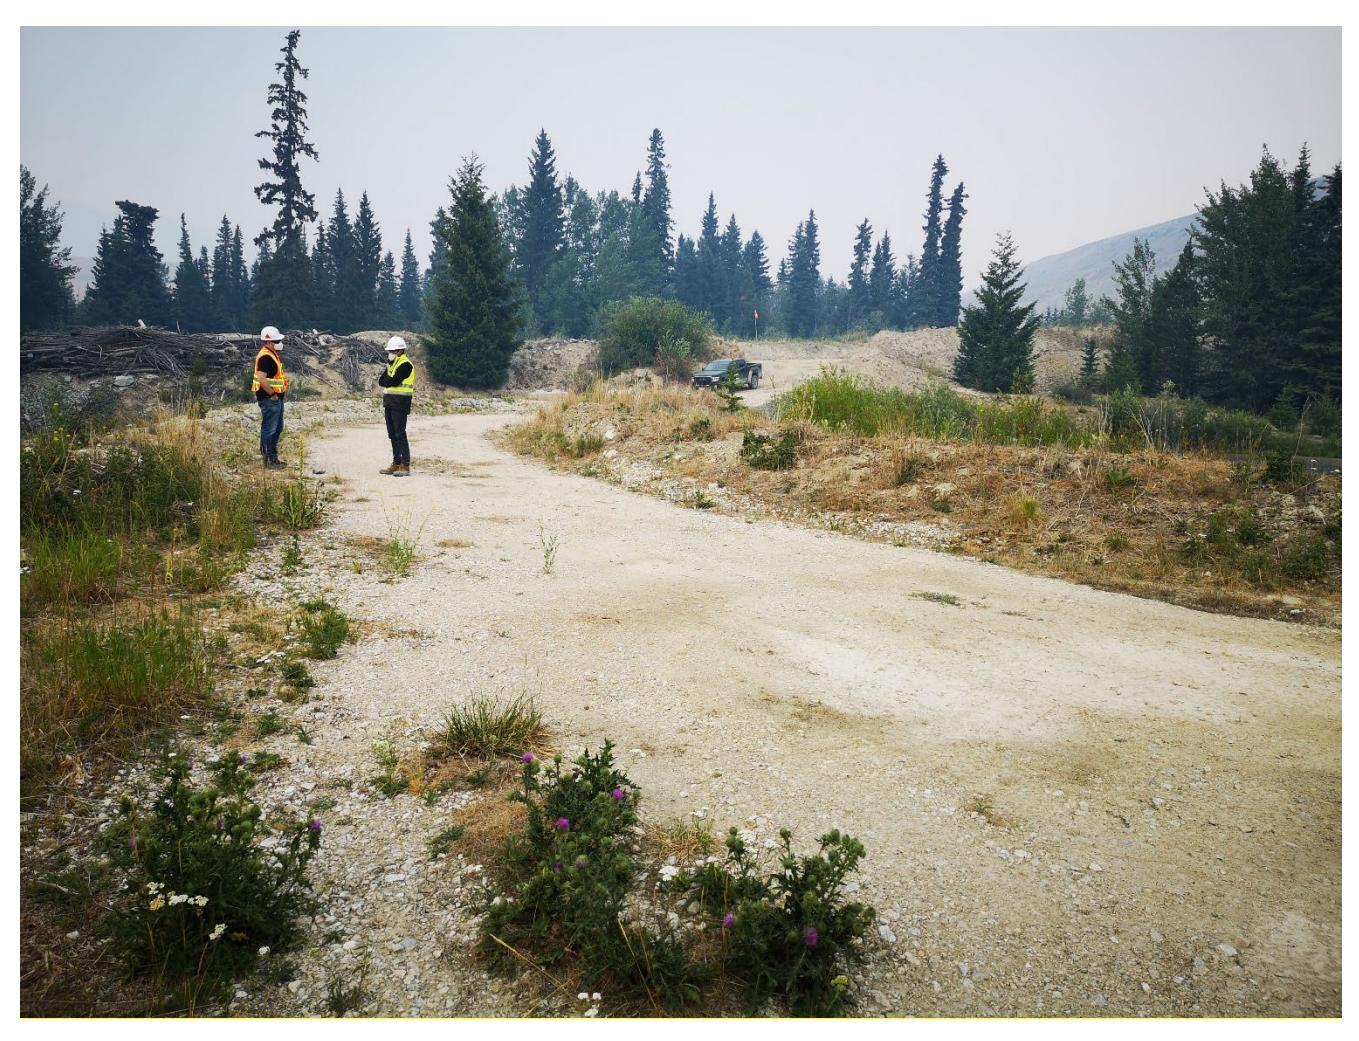
# Photo I-C-2 R3 Seepage Pond dam crest. No cracking or no sign of distress was observed (BTH-2021-14)

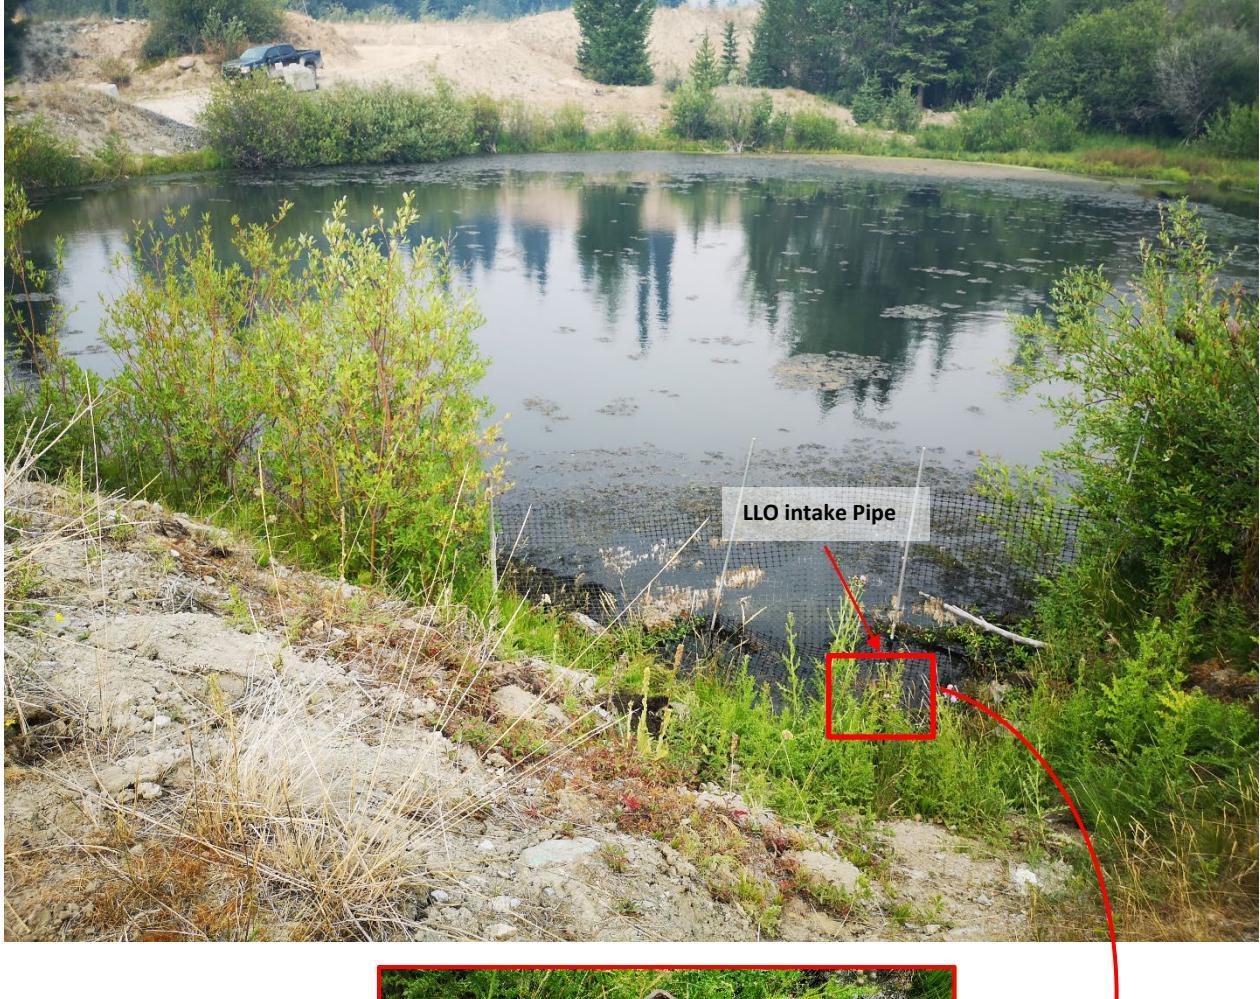
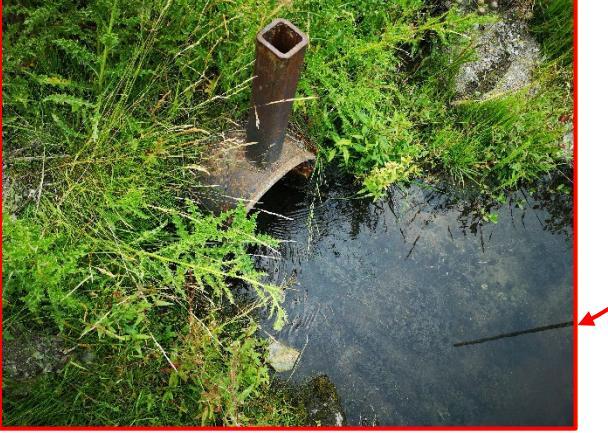
Photo I-C-3 View of R3 Seepage Pond and debris mesh for Low-Level Outlet (LLO). Clear water was flowing at the time of the site visit. The debris mesh is clogged below and above water. This does not impact ability to route the Inflow Design Flood but could be part of routine maintenance (BTH-2021-15)

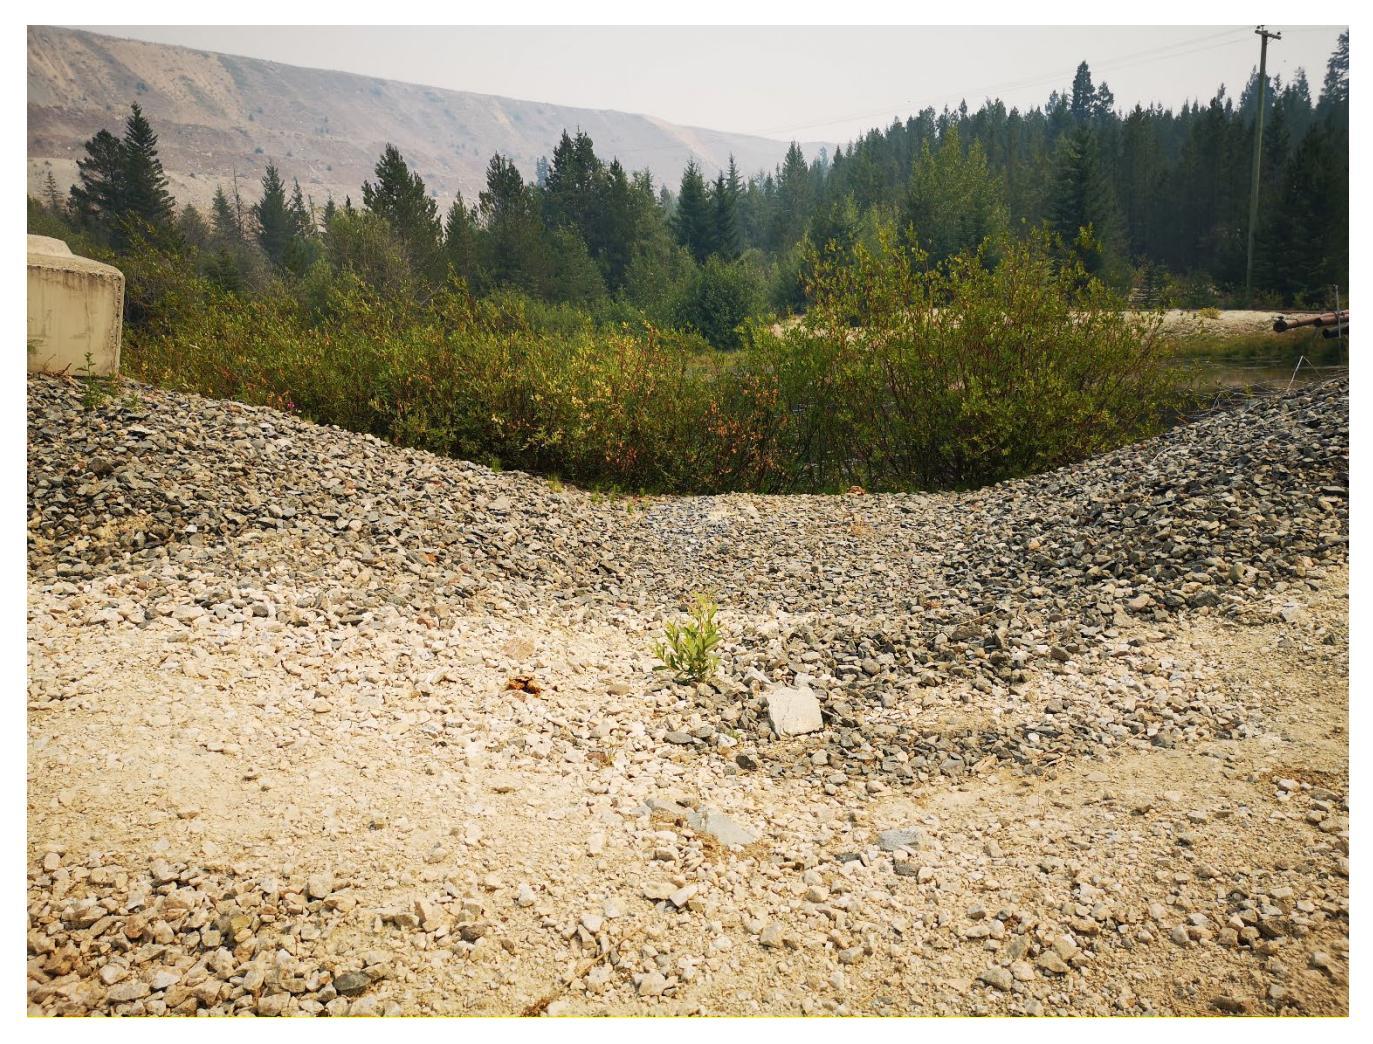
Photo I-C-4 View of spillway inlet, looking upstream. Vegetation to be cleared from inlet. Lockblock removed in 2020 (BTH-2021-16)
