Teck Highland Valley Copper Partnership

2021 Annual Facility Performance Report

7-Day Pond Tailings Storage Facility

March 2022

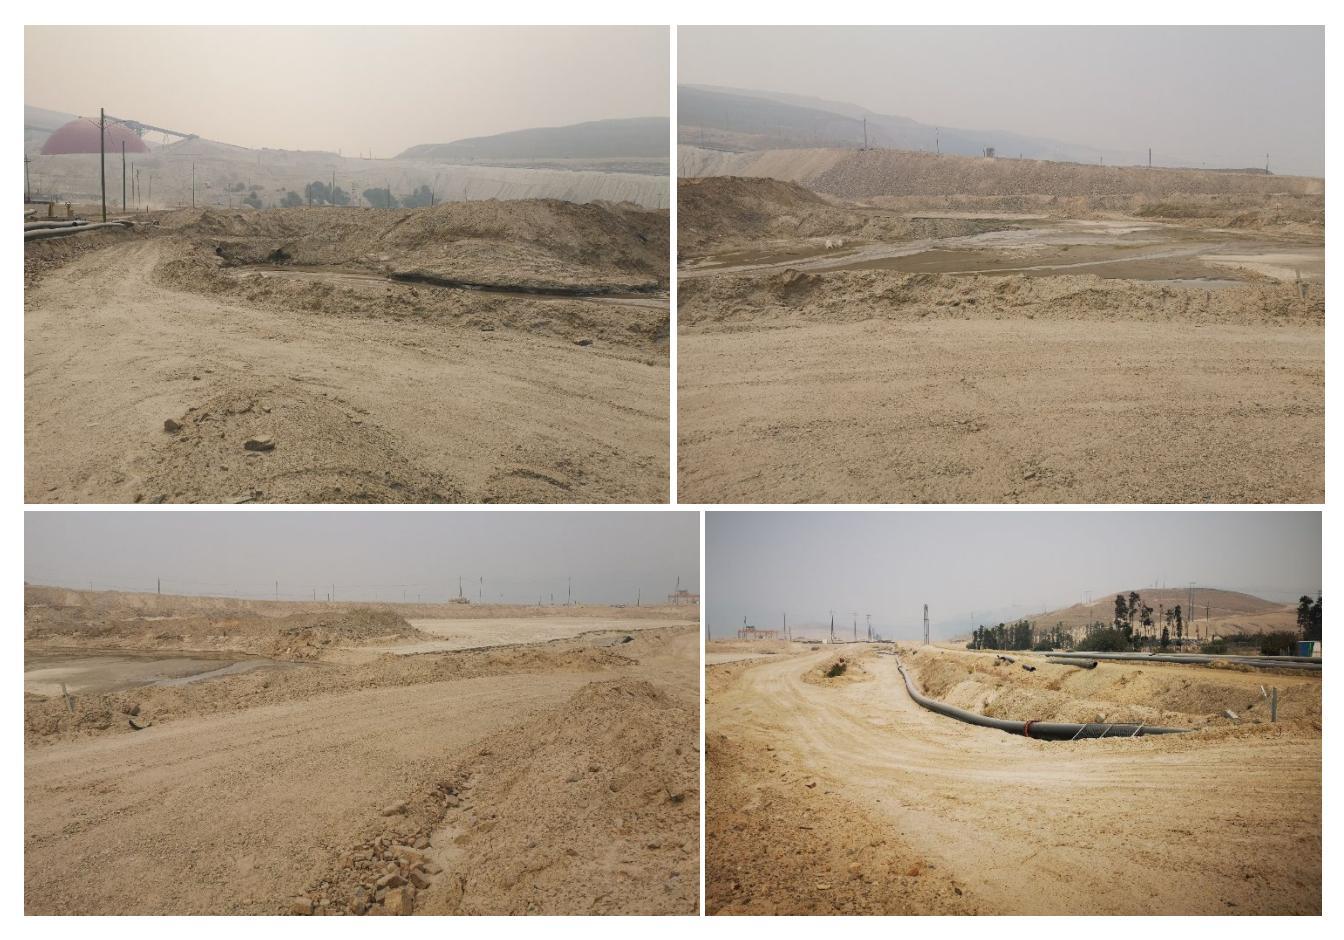
- Crest: The haul road which forms the crest of the dam around 7-Day Pond TSF was in good physical condition. No indicators of significant concern were observed (e.g., cracking, slumping) (Photo I-1 and Photo I-2).
- Upstream and Downstream Slopes: Upstream slopes were in good physical condition. The upstream slopes were not vegetated, but no indicators of significant concern were observed (e.g. animal activity, cracking, slumping, surface erosion features). The visible parts of the downstream slope of the haul road forming the east containment of the impoundment were in good physical condition (Photo I-3).
- **Tailings Beach and Pond**: Impoundment was being excavated at the time of the site visit and there was no pond. No tailings deposition was in place (Photo I-1).
- **Outflow Pump**: Had not been installed at the time of the site visit.
- Seepage: None observed.

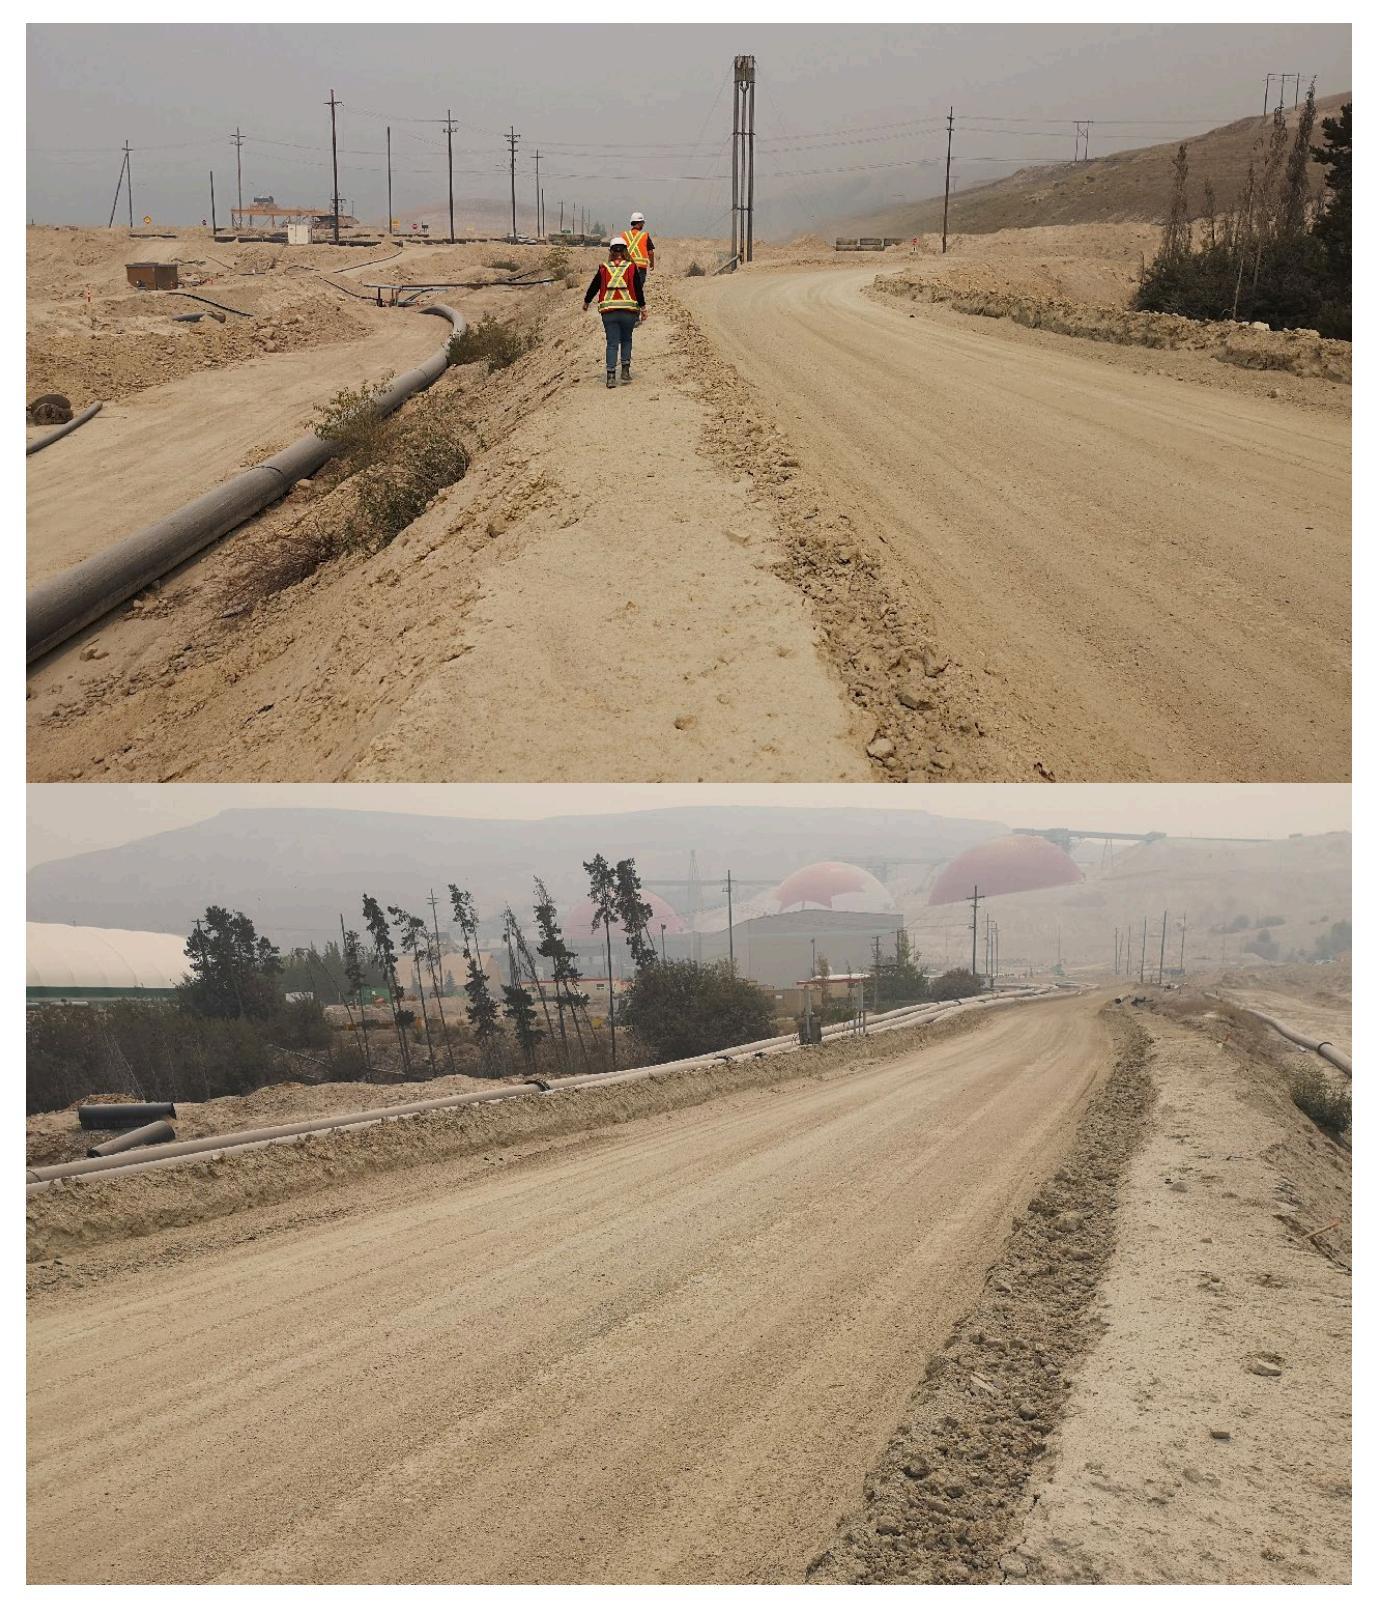
Photo I-2 7-Day Pond crest (SDP-2021-02)

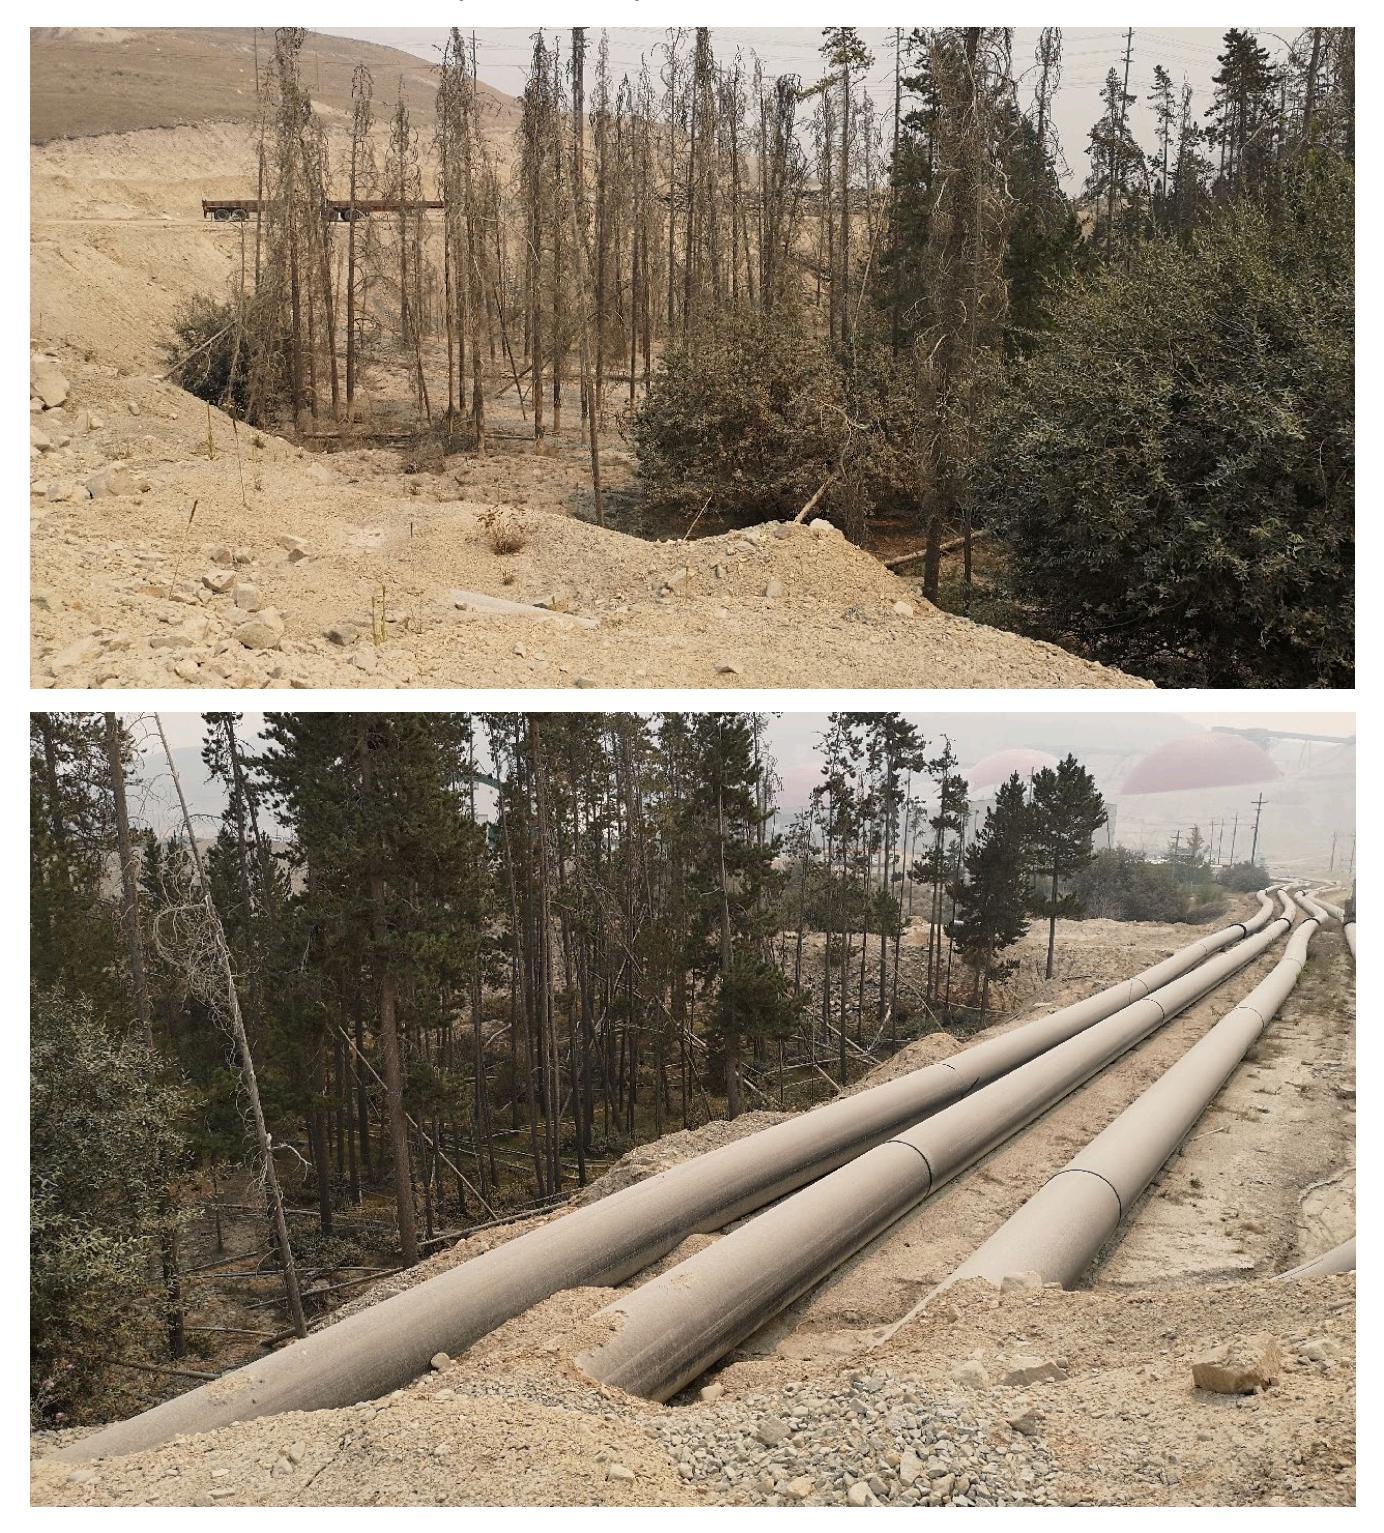
Photo I-3 Treed area downstream (D/S) of 7-Day Pond retaining berm formed by east perimeter access road and water pipelines along downstream side of east perimeter access road crest (SDP-2021-03)

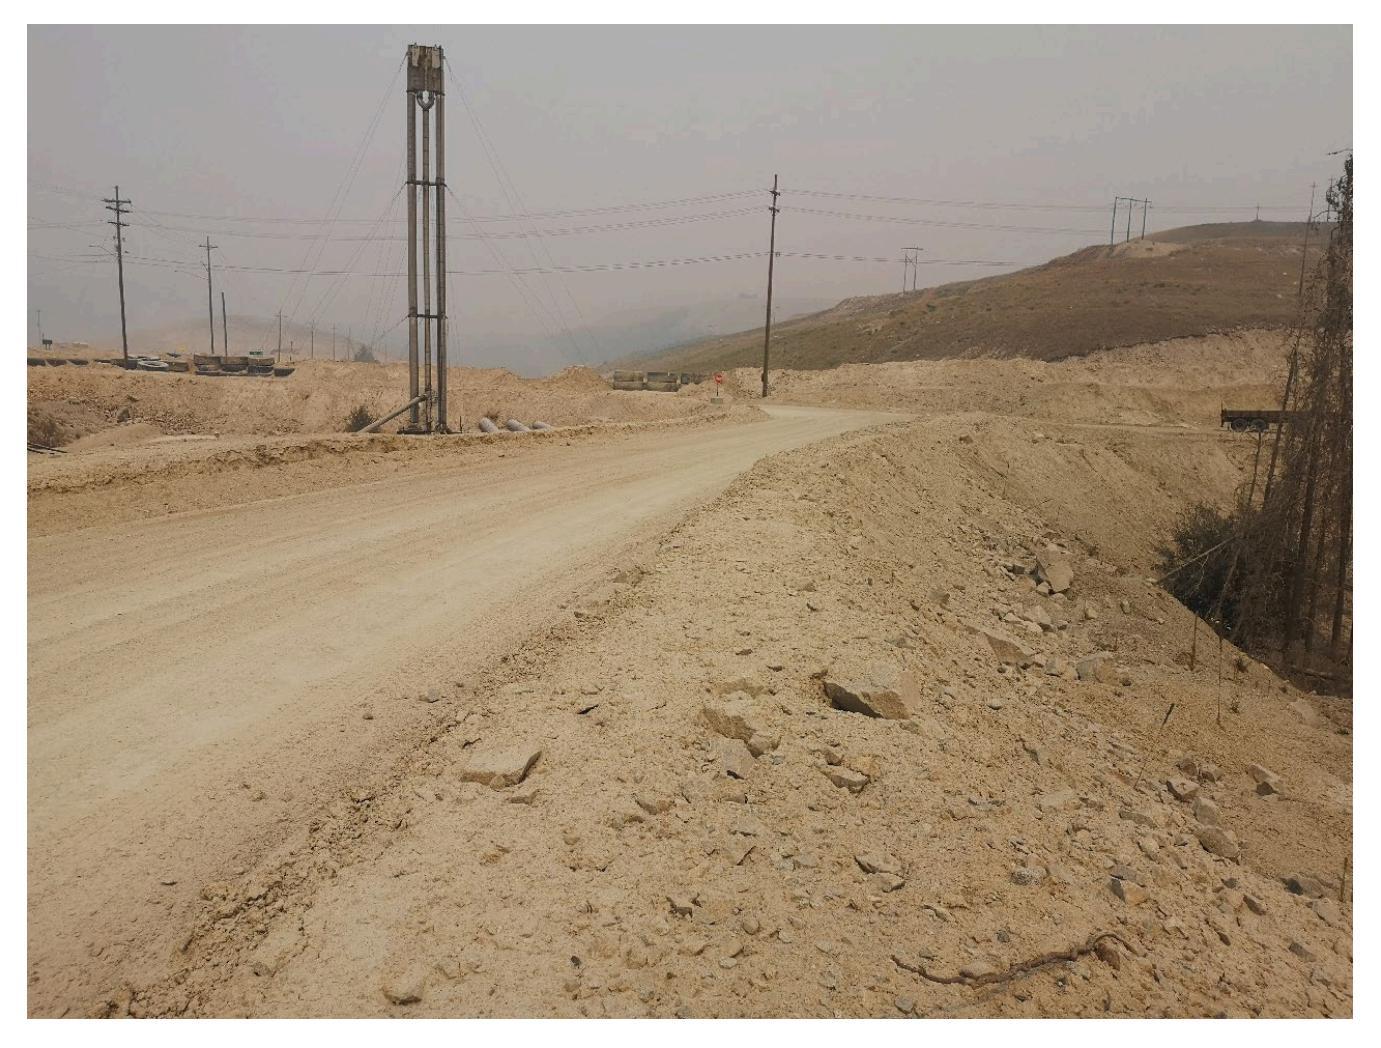
Photo I-4 7 Day Pond east perimeter access road. Structure within TSF impoundment is part of permanent dewatering-pump system (SDP-2021-03)
