Teck Highland Valley Copper Partnership

2021 Annual Facility Performance Report

Trojan Tailings Storage Facility

March 2022

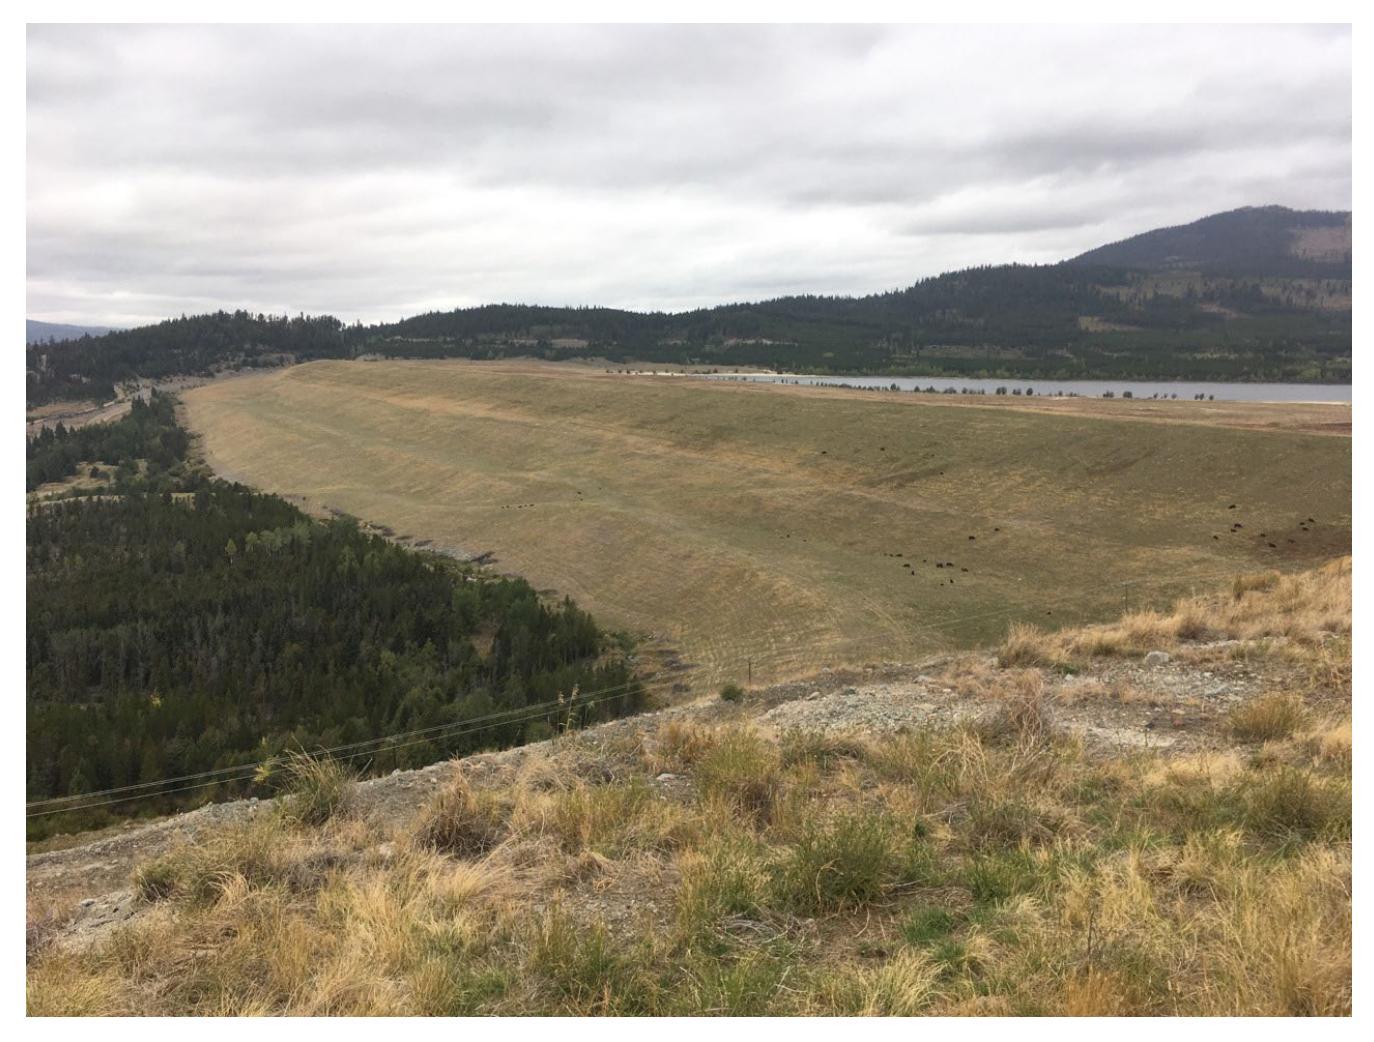
Photo I-A-1 Overview of Trojan Tailings Pond and Trojan Dam downstream slopes from the Bethlehem Dam crest. No visible erosion or scour (TRJ-2021-01)

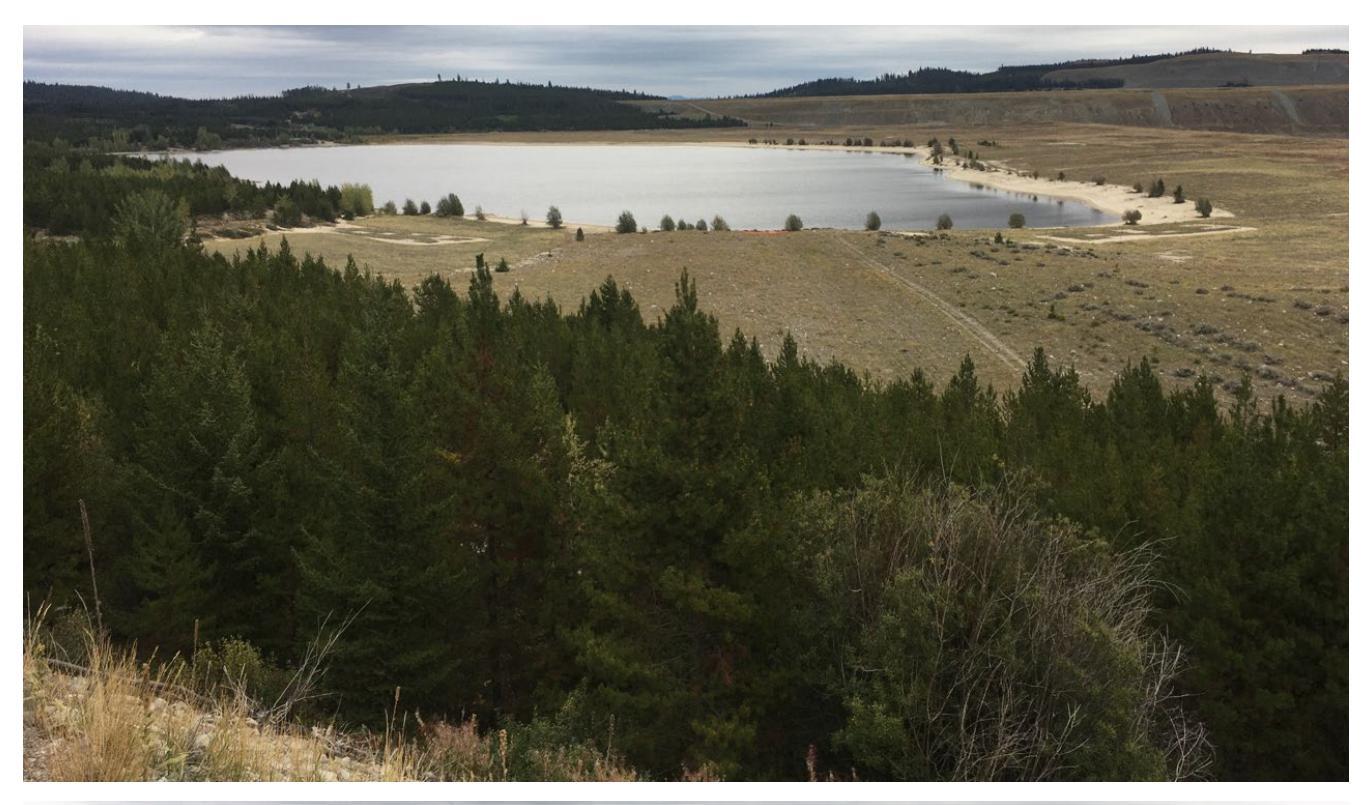
Photo I-A-2 Overview of Trojan Tailings Pond and tailings beach from Trojan Diversion Channel (TRJ-2021-02)

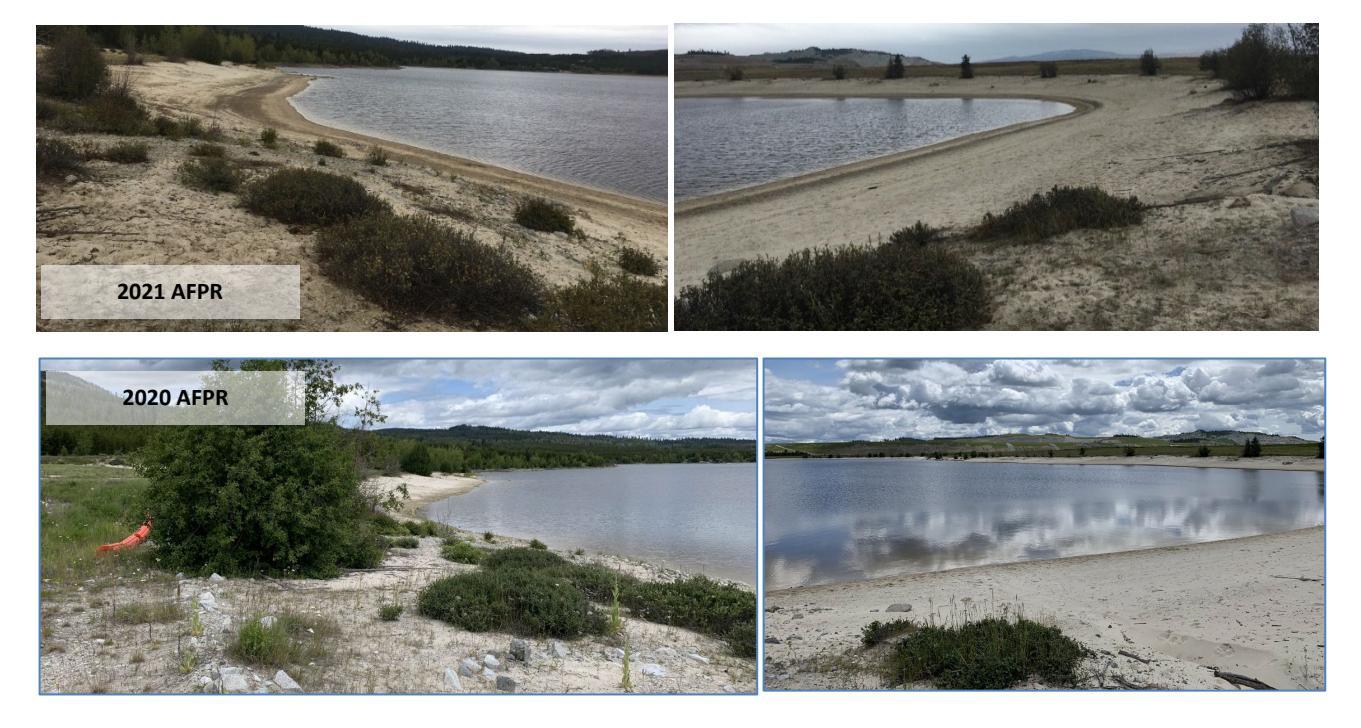
Photo I-A-3 Overview of Trojan Tailings Pond. Sand beach is exposed. Spillway inlet is visible. Debris boom is secured (TRJ-2021-03)

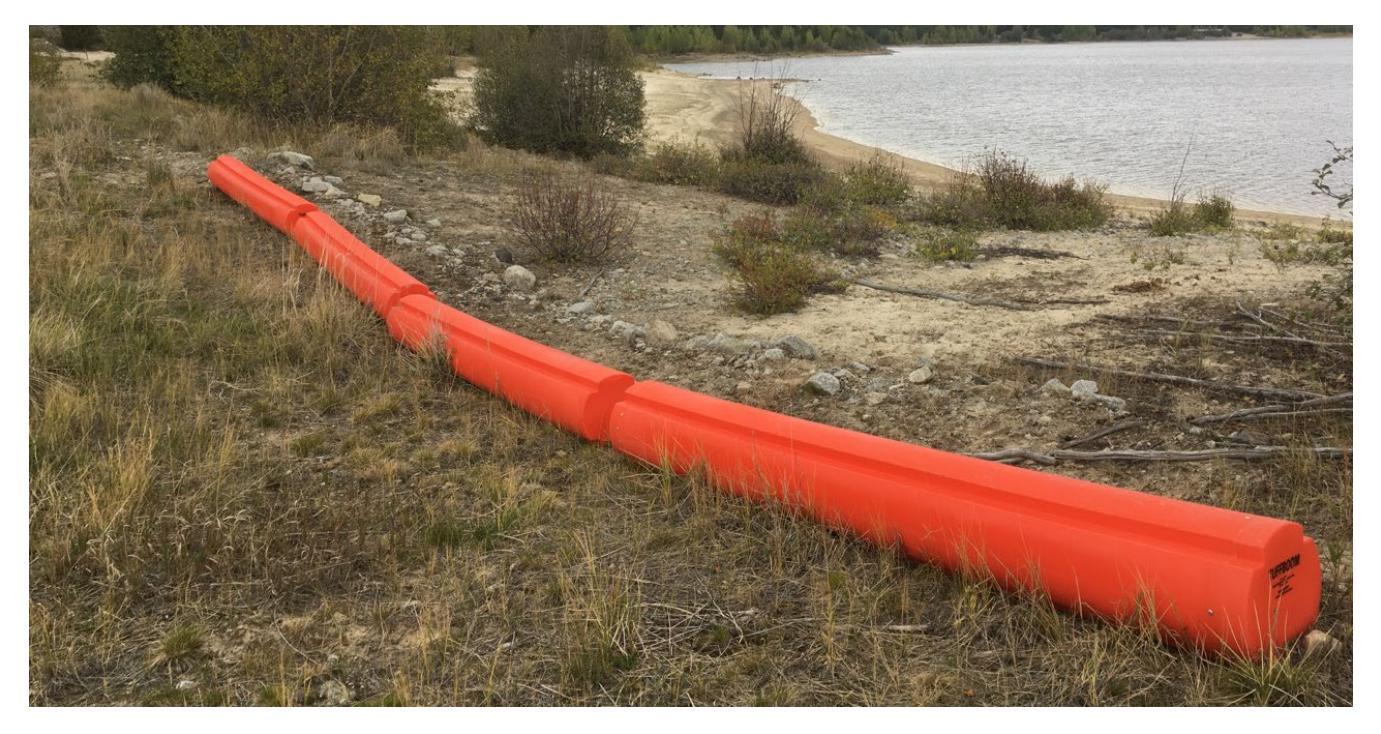
Photo I-A-4 Trojan spillway inlet. Approach channel is clear and debris boom is secured. (TRJ-2021-03)

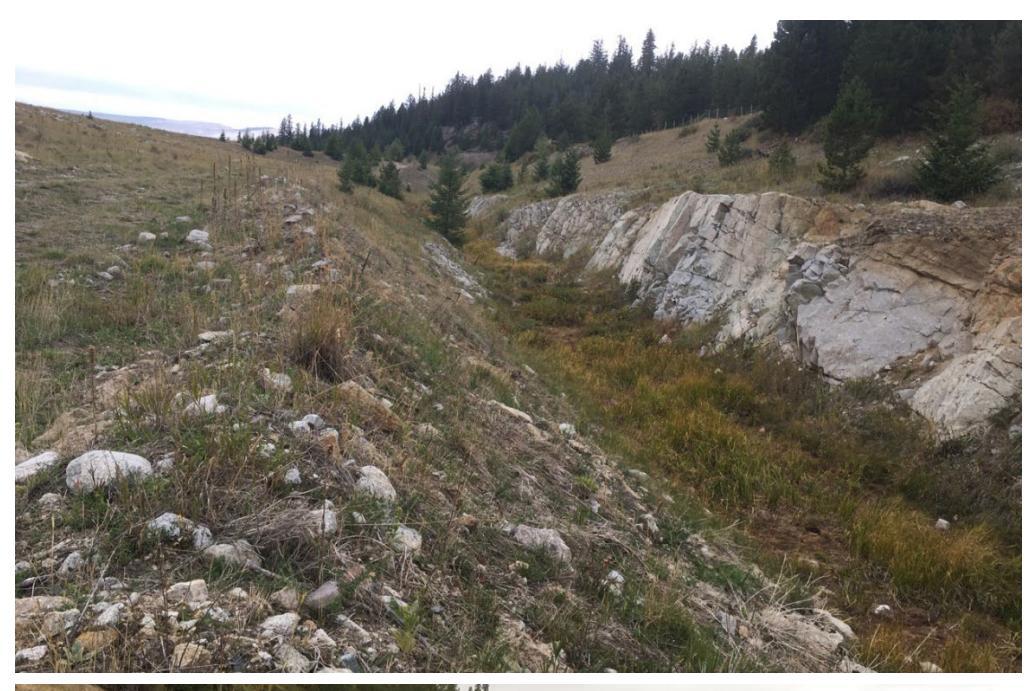
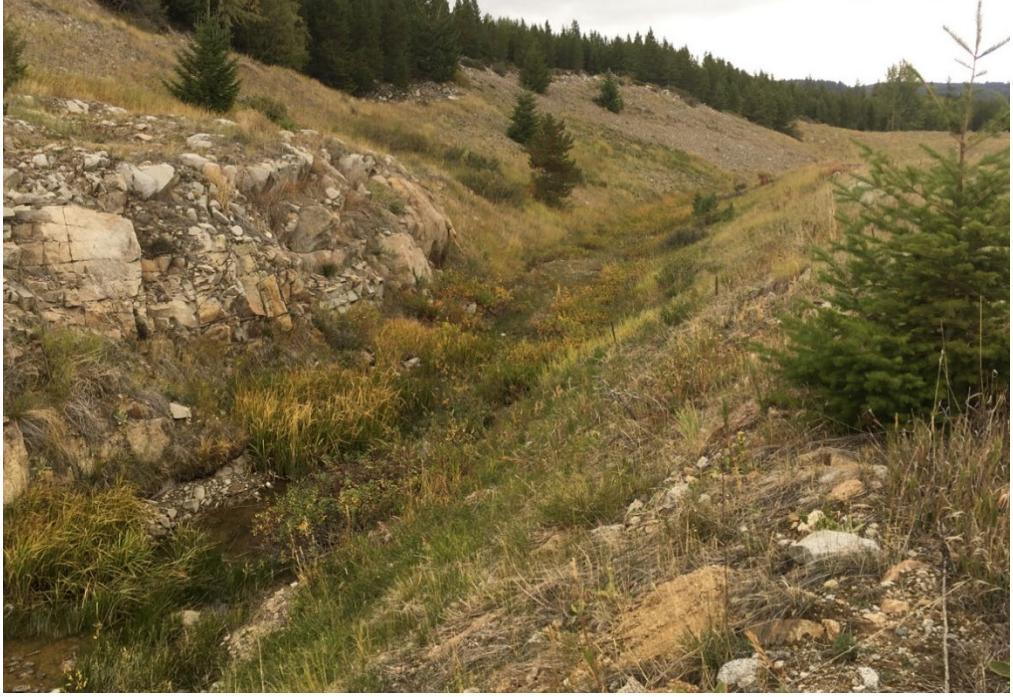
Photo I-A-6 Overview of upper segment of spillway, downstream of approach channel, looking toward southwest (top photo) and looking toward northeast (bottom photo). No sign of weathering/disruption of riprap was observed. No evidence of sloughing of cut slopes was observed. Channel is heavily vegetated with shrubs and bushes. In December 2020, THVCP received permit approvals to clear vegetation so the work can be included in routine maintenance.

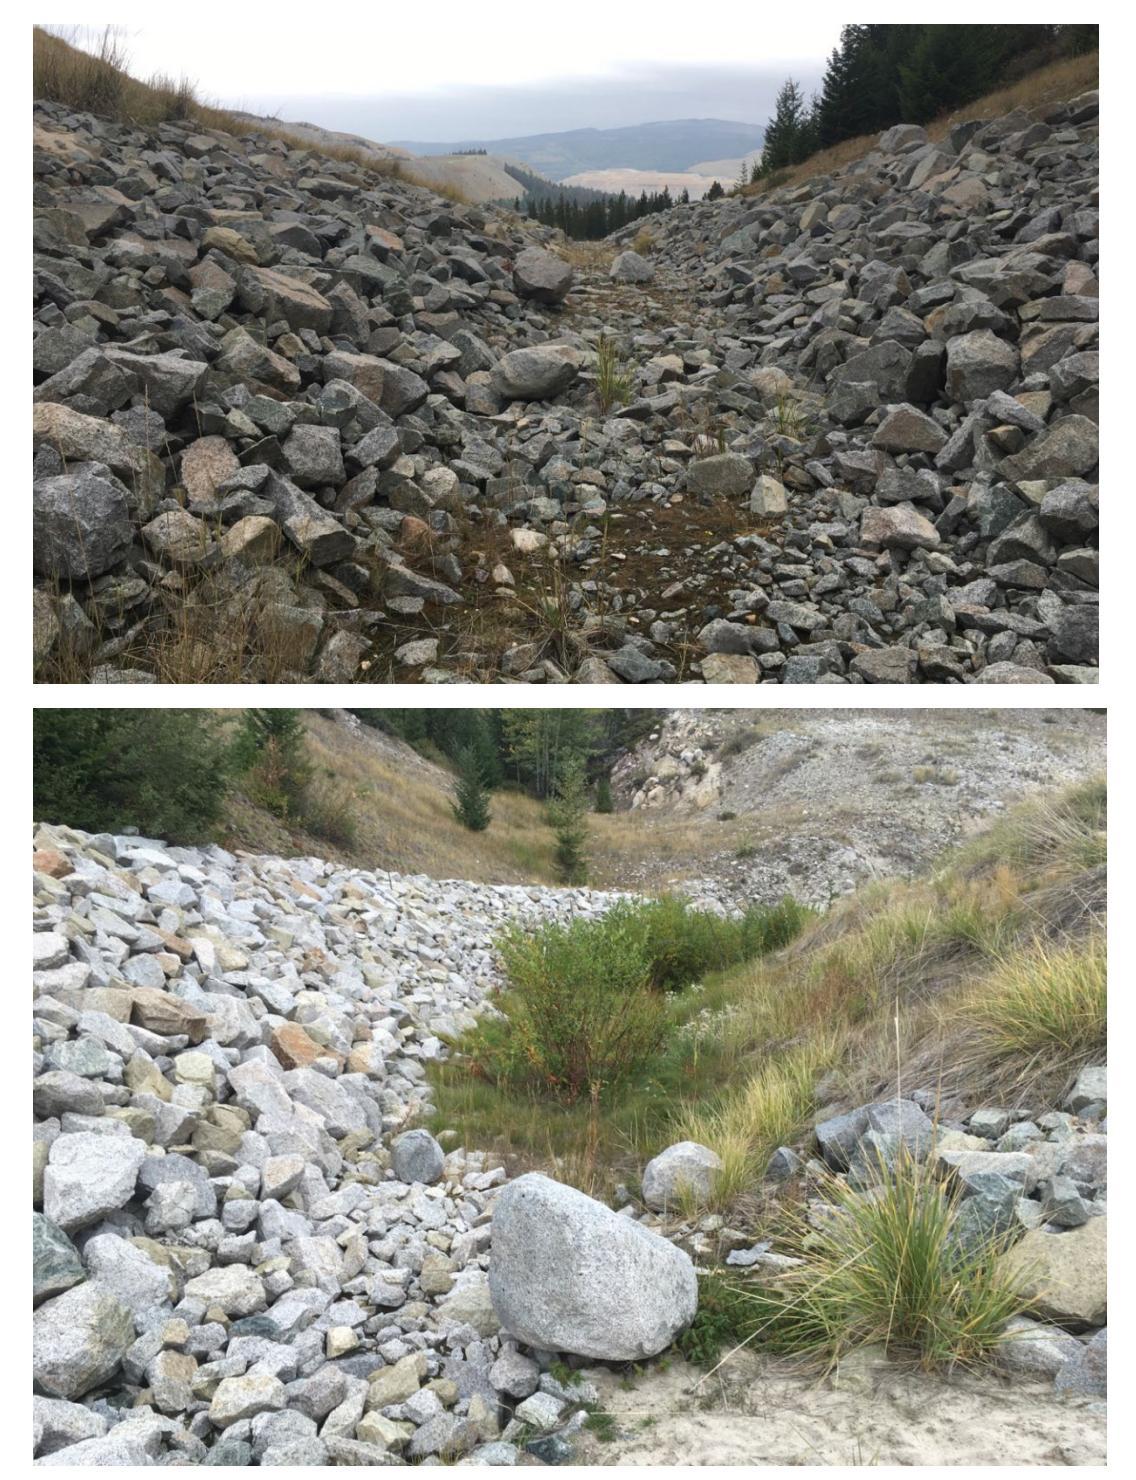
Photo I-A-7 Spillway channel, downstream of rock chute, near transition to riprap segment, looking toward south (top) and looking north (bottom). Minor vegetation and sediment accumulation but would not significantly impact flood capacity as it would be washed away by spillway flows prior to peak discharge- (TRJ-2021-05)

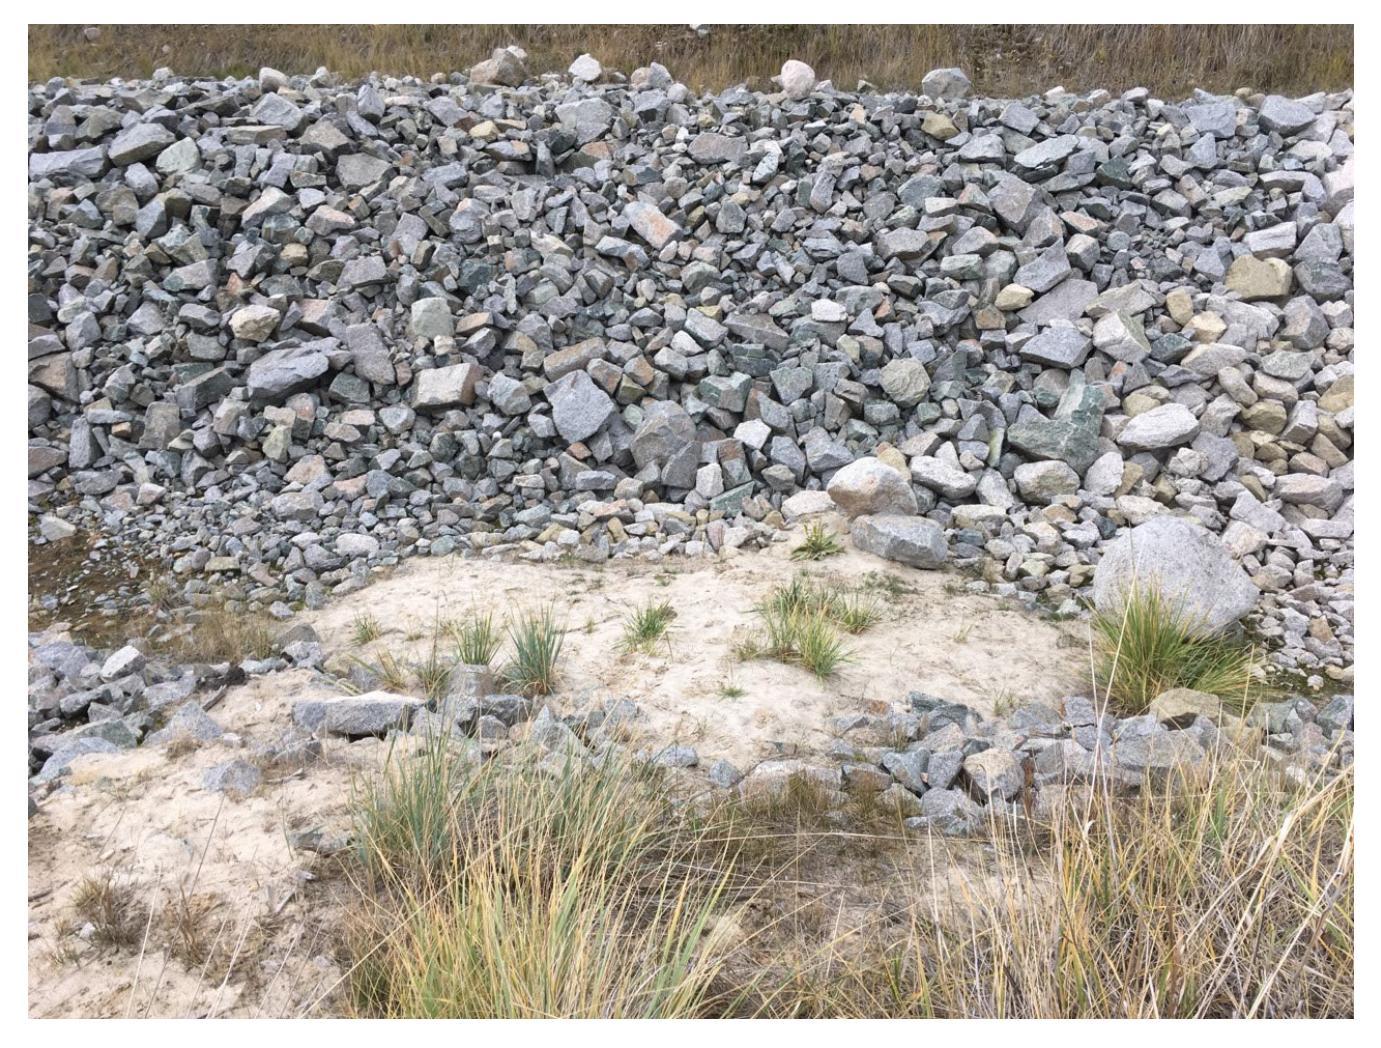
Photo I-A-8 Sand on the base of the spillway, not visual change from previous site visit. Sand appears to have been placed/deposited on top of riprap, suggesting this is not related to piping/seepage. No active seepage faces. This is not a dam safety concern. (TRJ-2021-05)

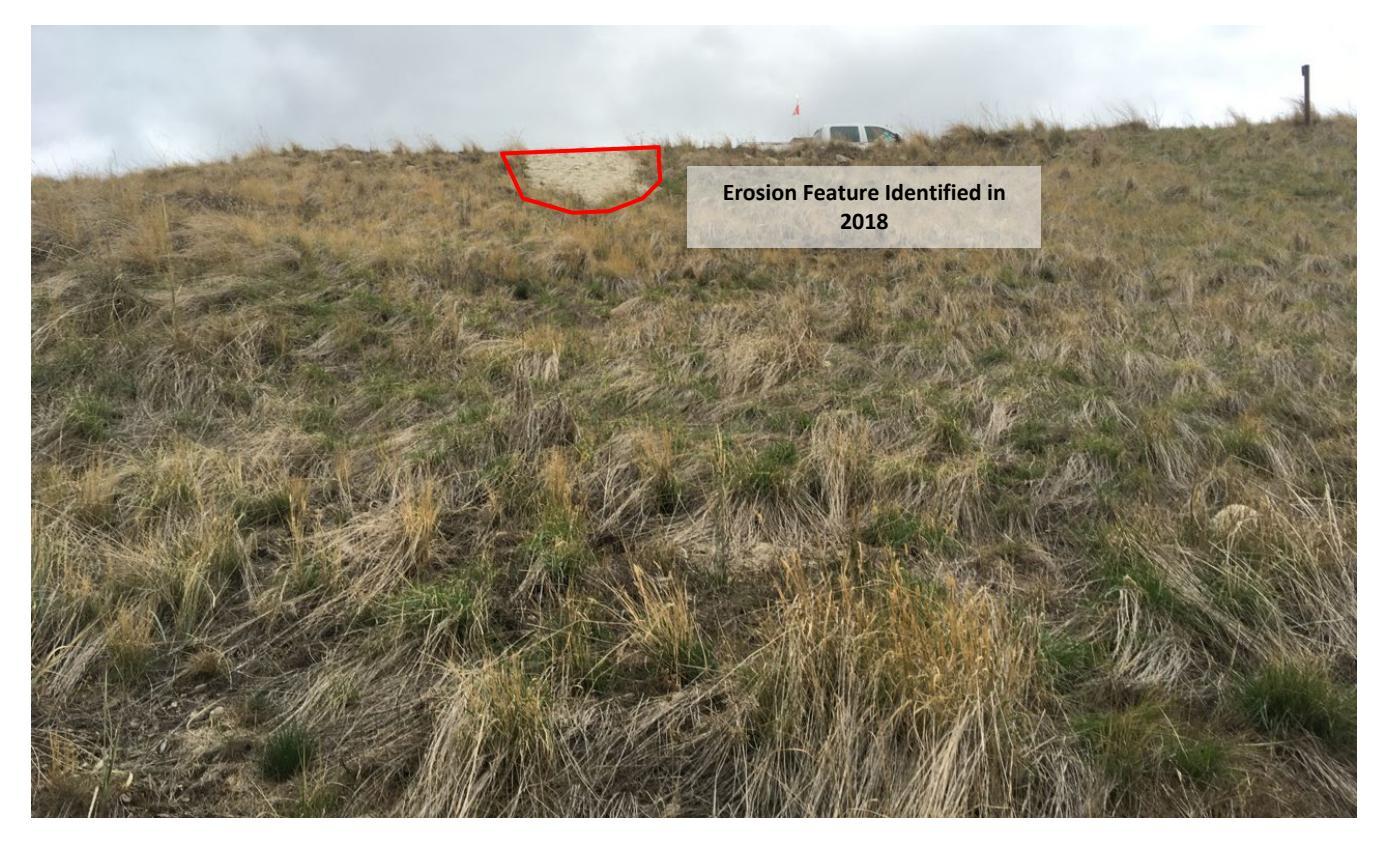
Photo I-A-9 Surface erosion / scour feature near western edge of crest. No visual indication of scour developing further since HVC regraded area (in 2019) to divert water away from this point. No additional follow up required. (TRJ-2021-05)

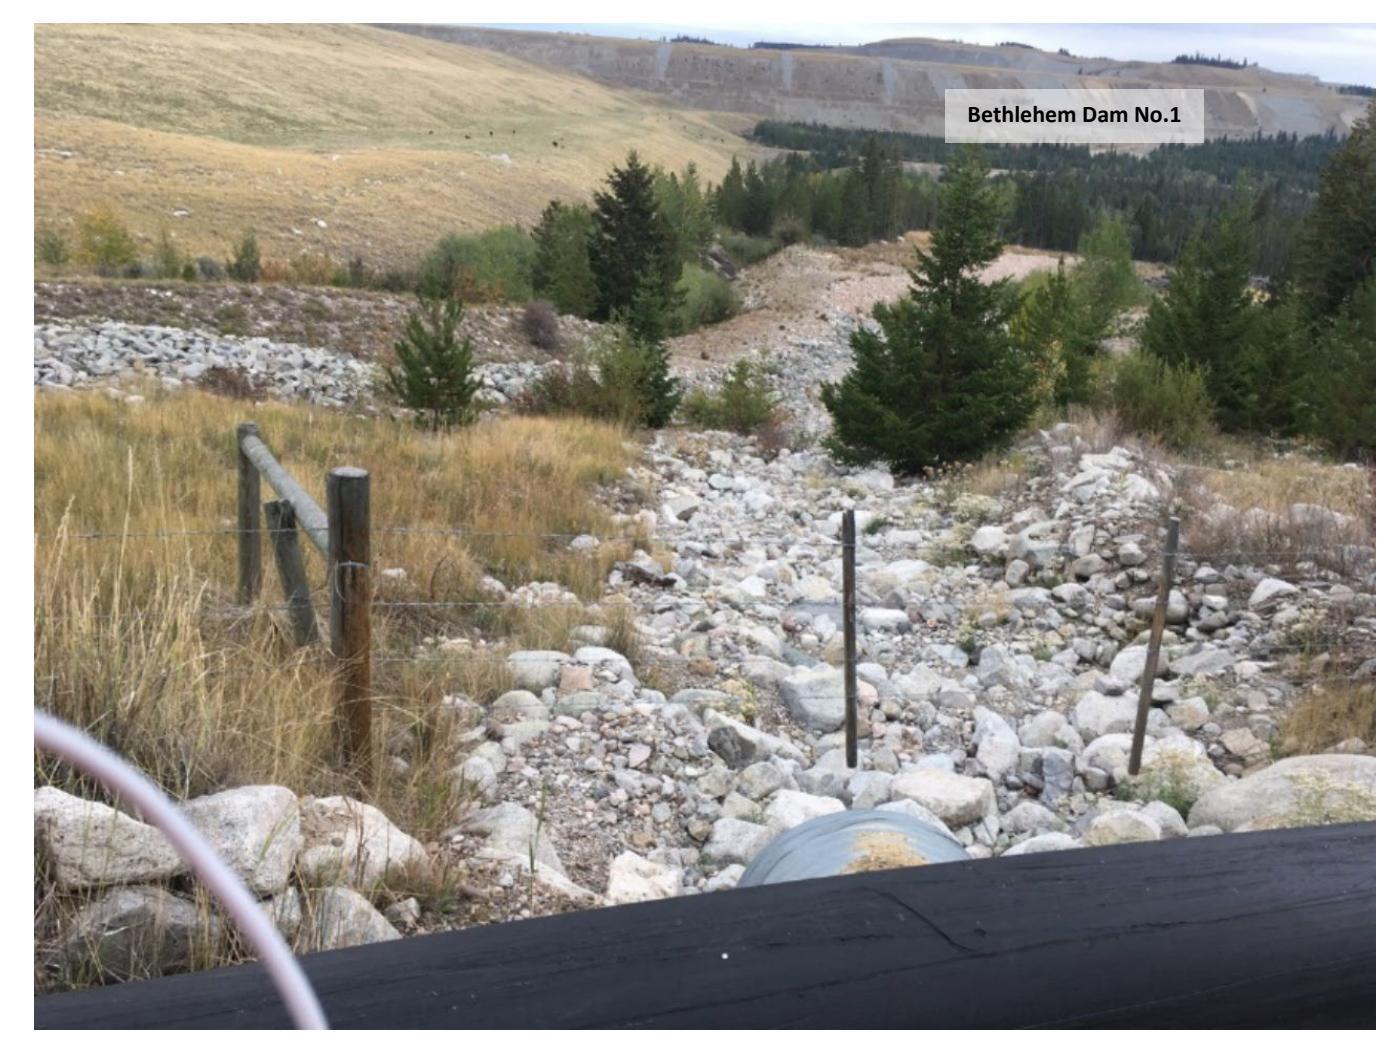
Photo I-A-10 Overview of extension to Trojan Dam spillway channel, built in 2018, at the toe of the right abutment. Channel in foreground is surface channel that drains into, but is not part of, the spillway channel (TRJ-2021-06)

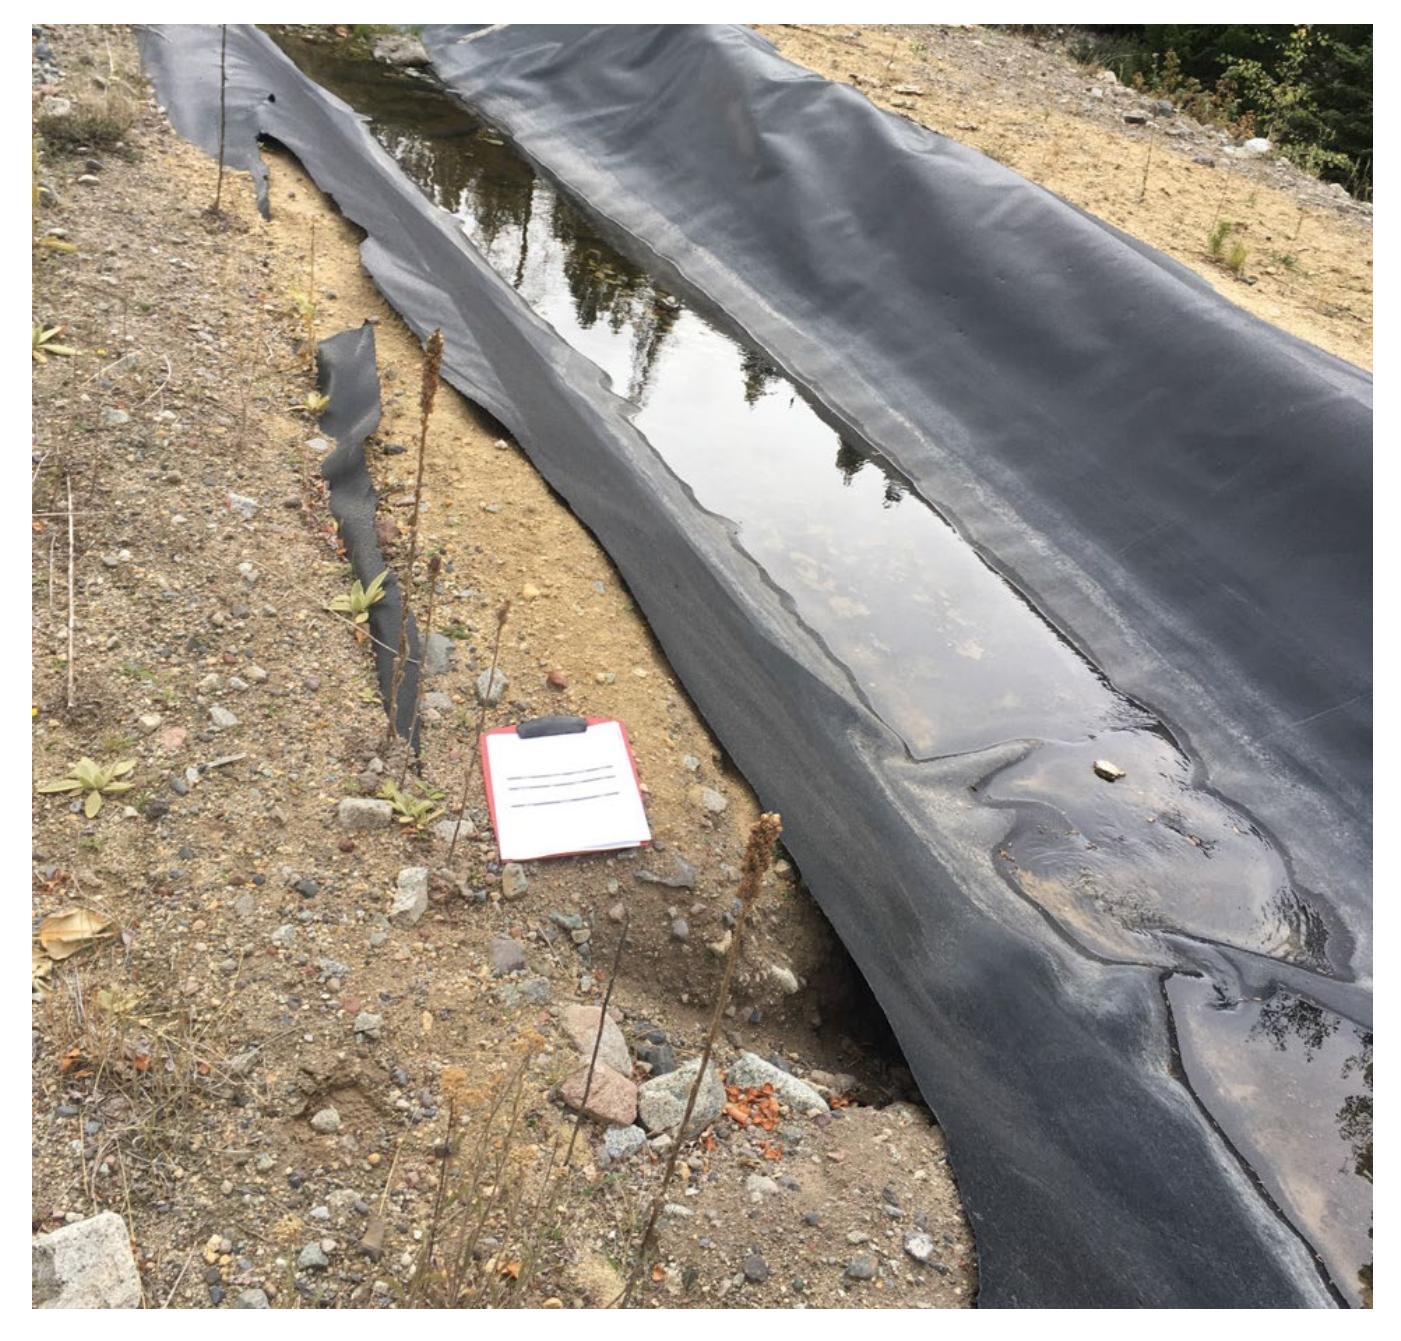
Photo I-A-11 Example of liner damage observed along Trojan Diversion ditch. Not a dam safety issue but should be repaired as part of general maintenance activities. (TRJ-2021-07)

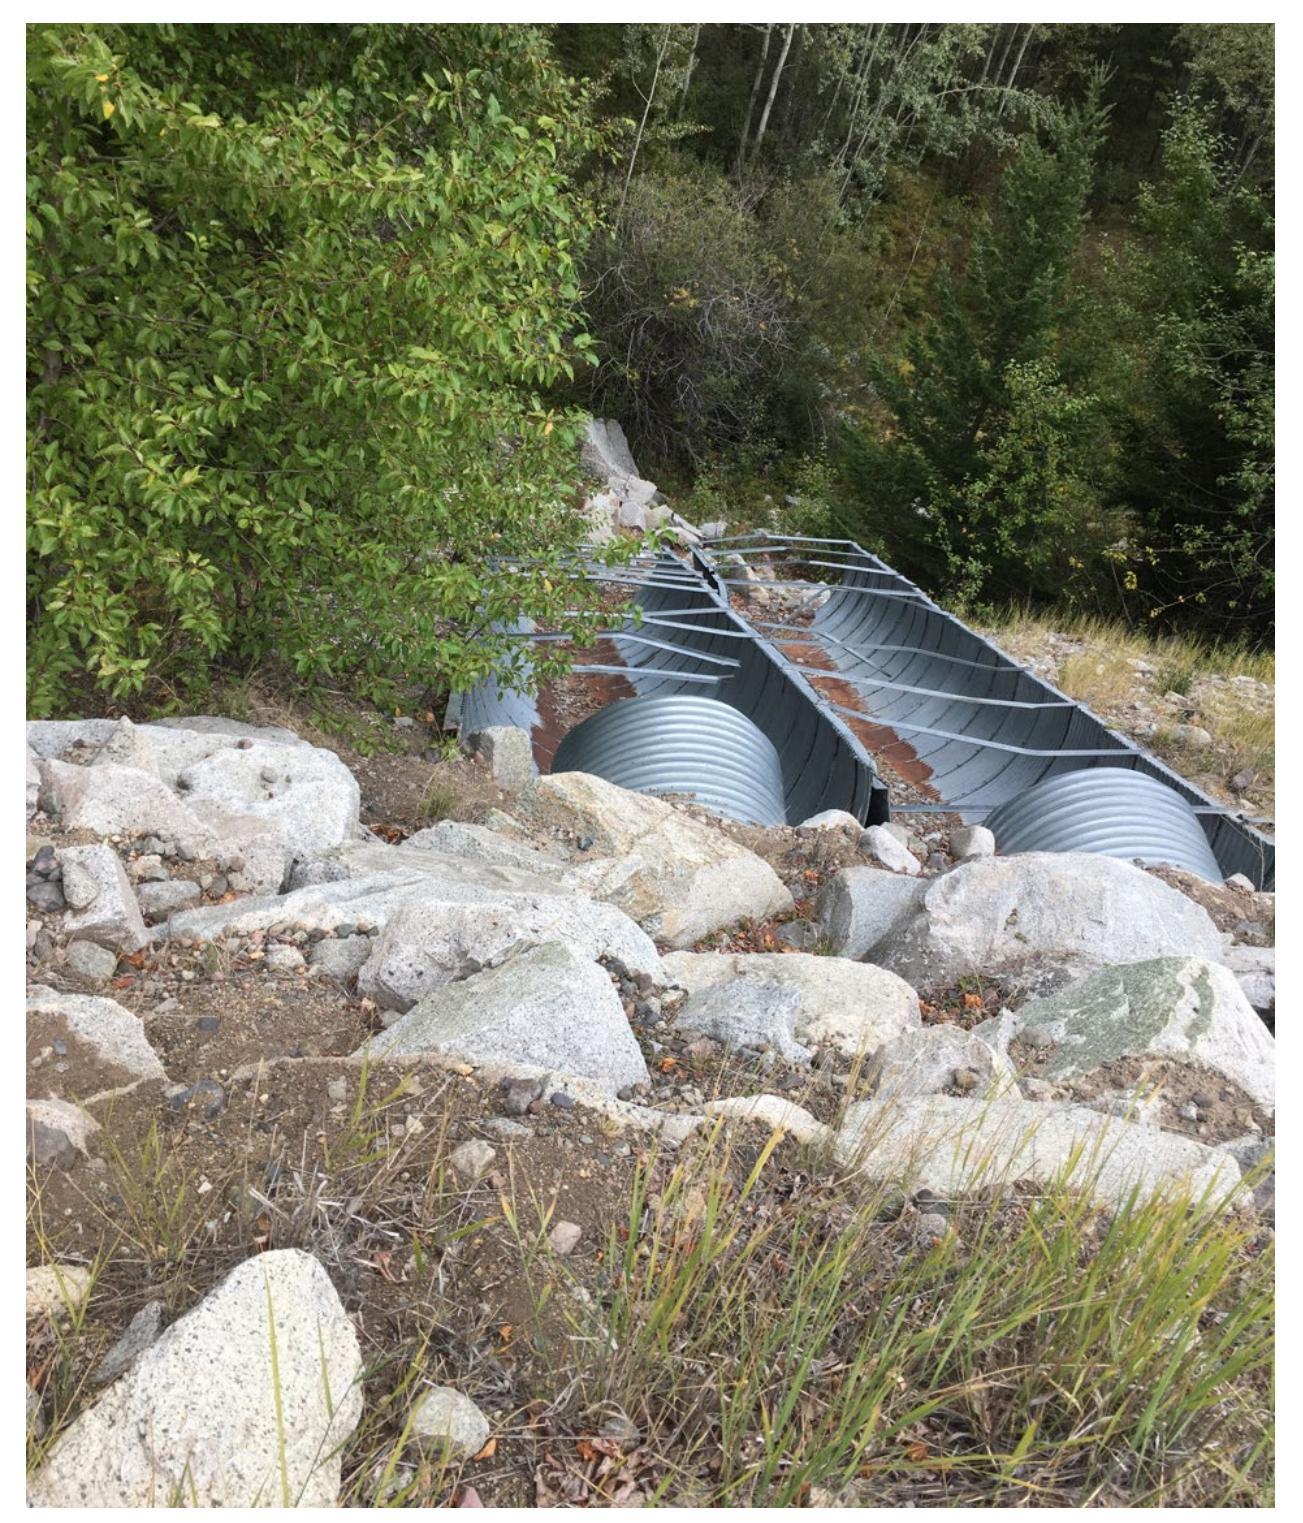
Photo I-A-12 Trojan Diversion Ditch (TRJ-2021-07)

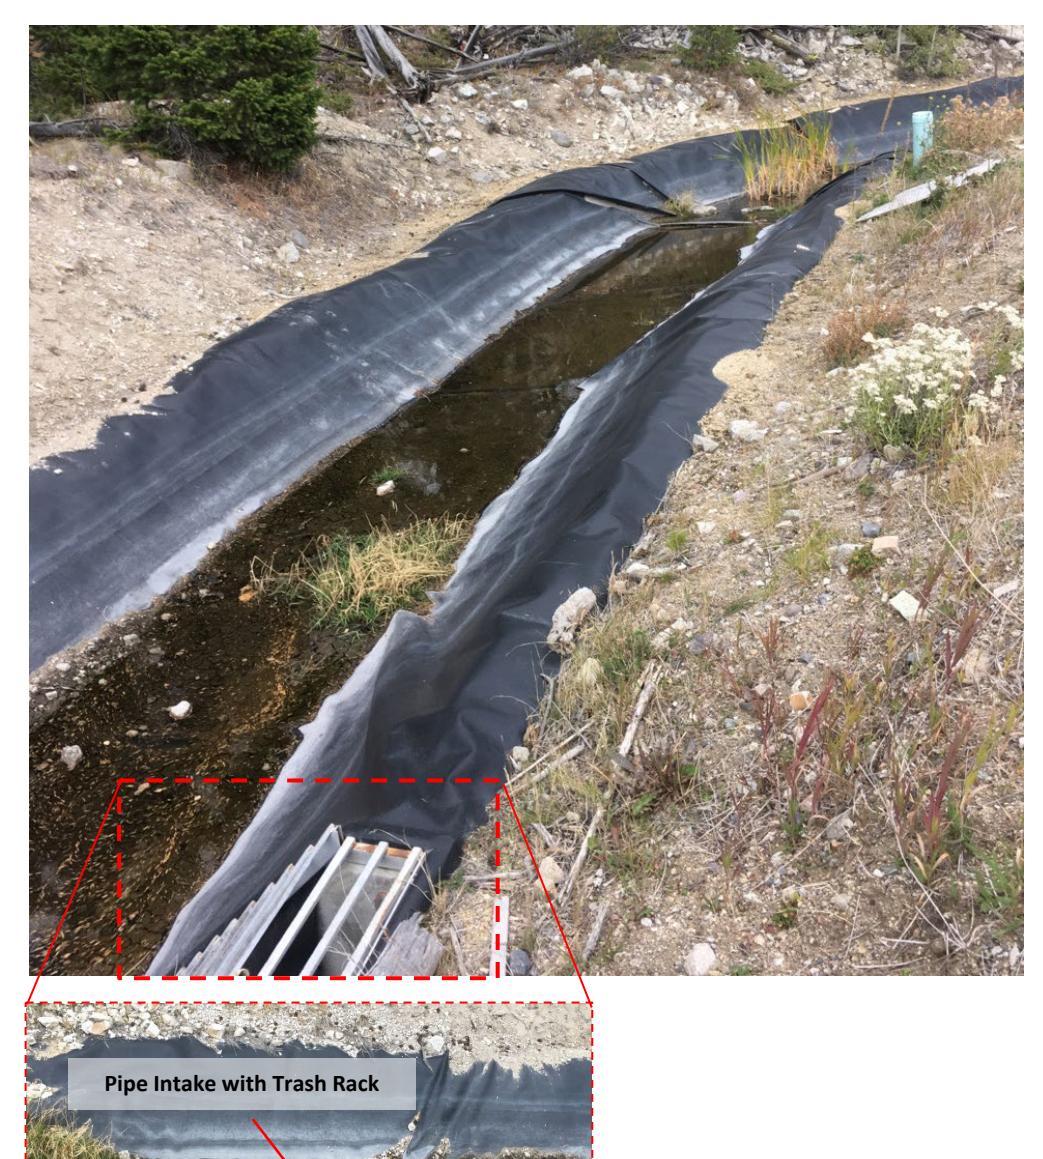
Photo I-A-13 Water flowing at the pipe intake southwest of Trojan TSF. Outlet valve here is open. Gate has minor debris accumulation. No flow bypassing diversion (i.e. flowing further downstream of channel). (TRJ-2021-08)

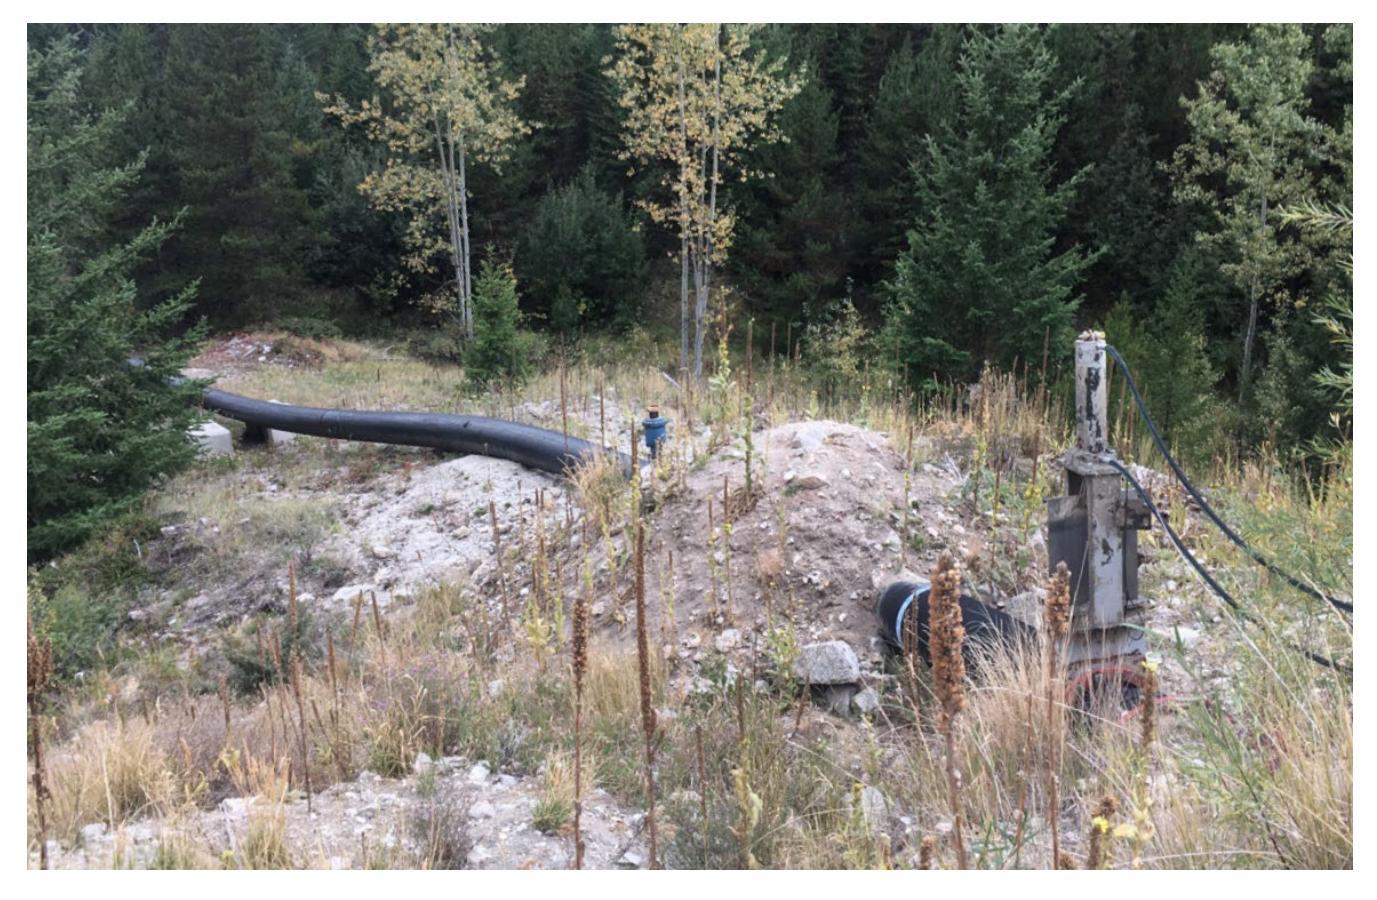
Photo I-A-14 Upstream potion of Trojan Diversion Pipeline, near discharge from Trojan Diversion, well supported with no leaks observed. Water discharging / valve open. (TRJ-2021-08)

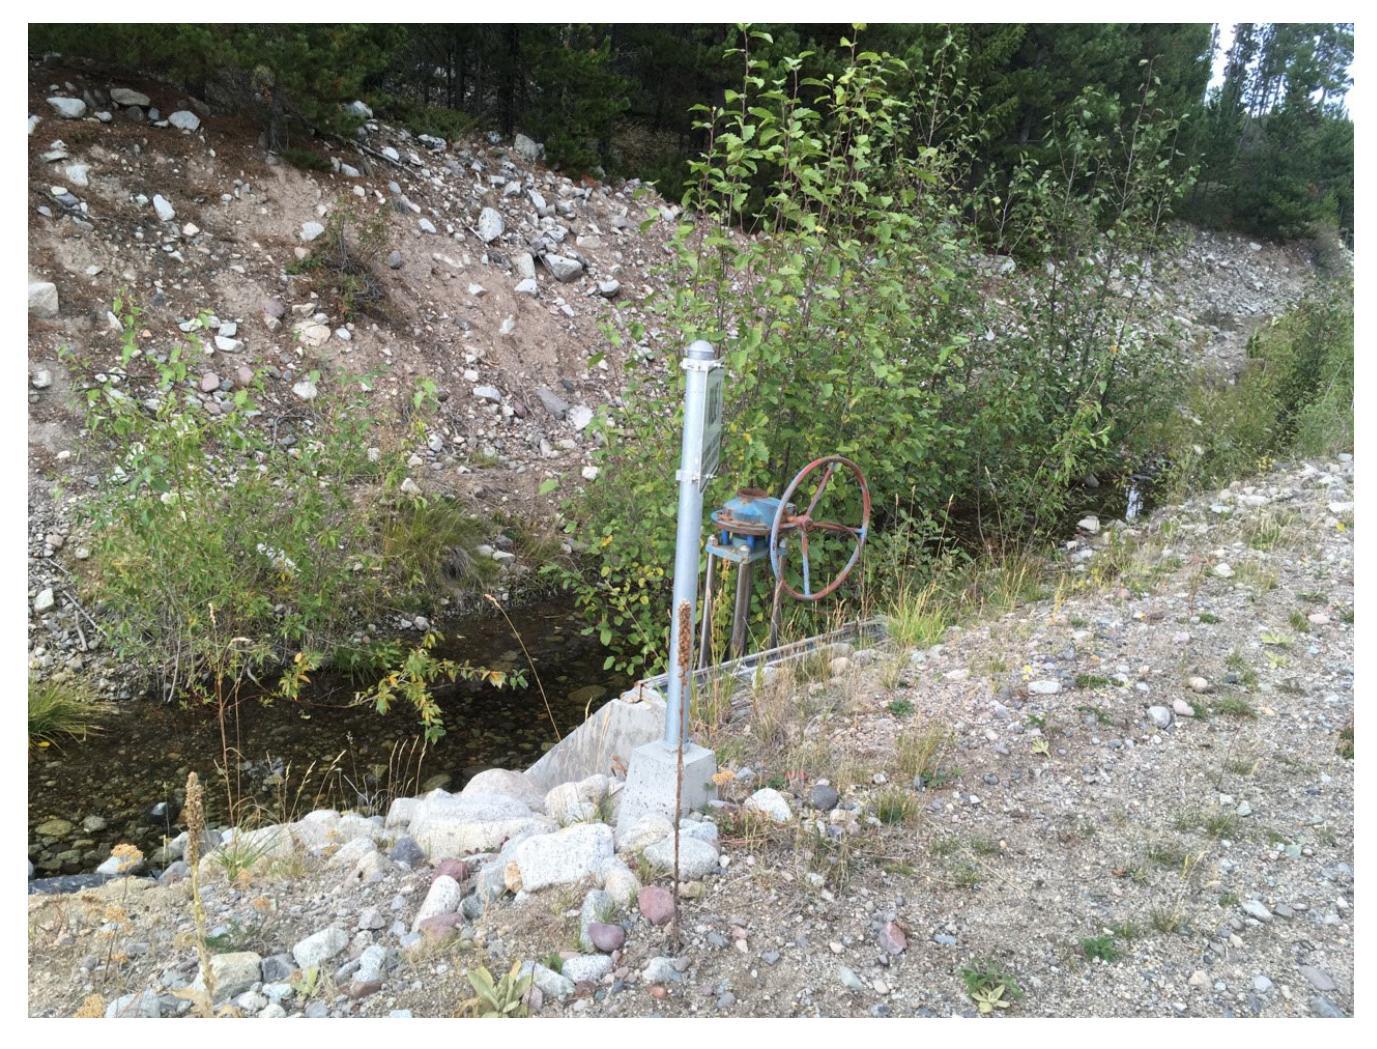
Photo I-A-15 Trojan Diversion Valve 1 was closed (no flow into impoundment) and locked. Valve is located at the transition of unlined channel to lined channel. (TRJ-2021-09)

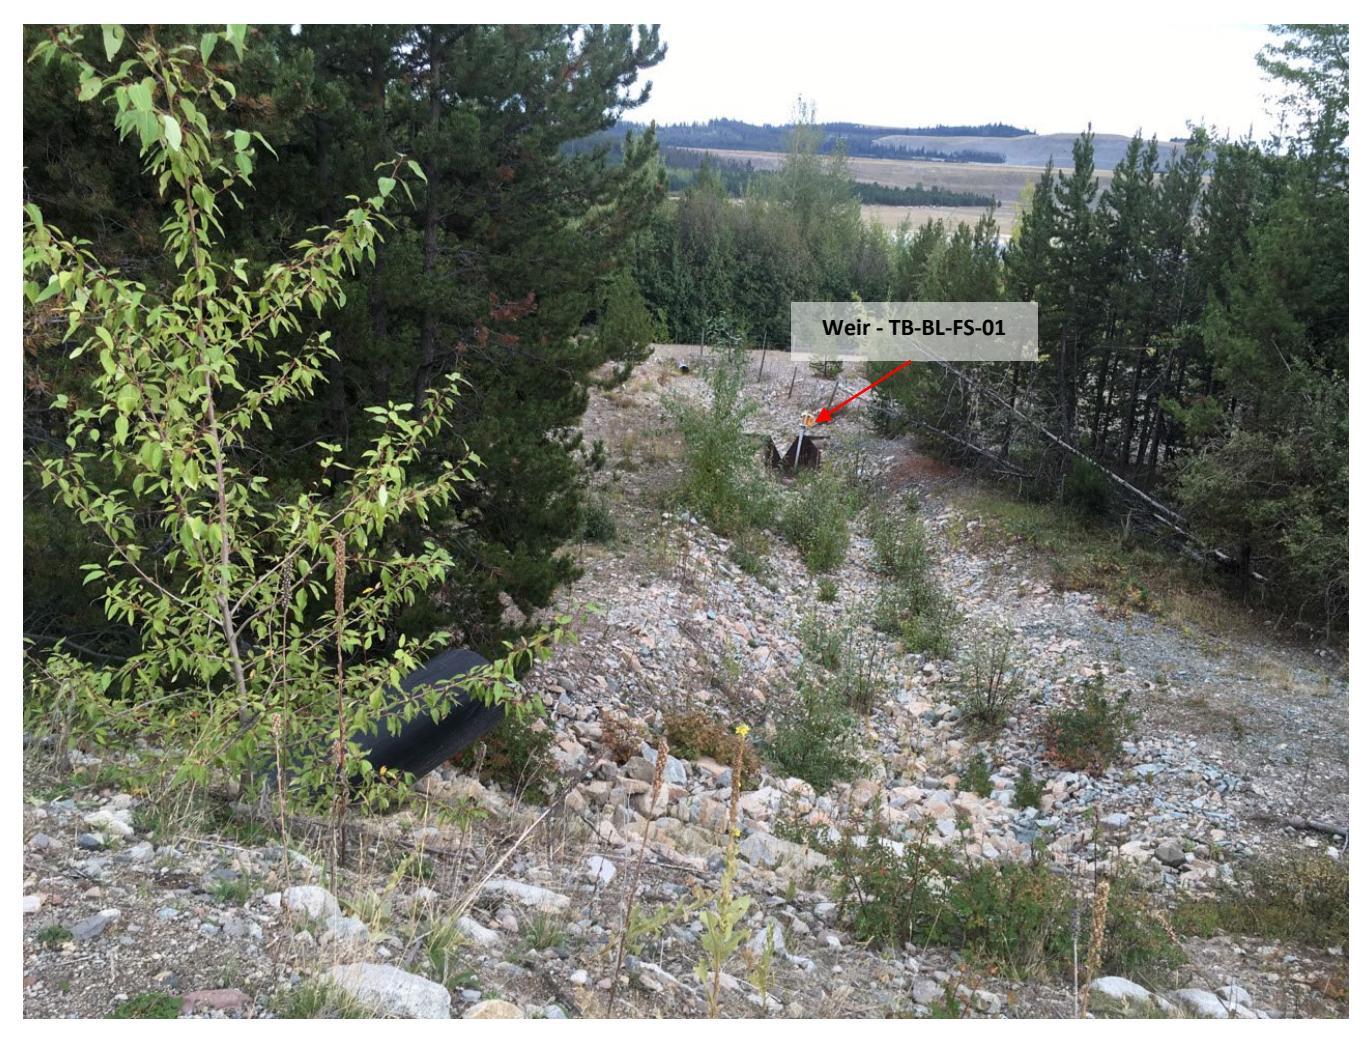
Photo I-A-16 Open channel downstream of Trojan Diversion Valve 1. Valve 1 was closed during the site visit and there was no discharge from Trojan Diversion Valve 1 Pipe into the impoundment. No sign of excessive scour or erosion damage. (TRJ-2021-09)

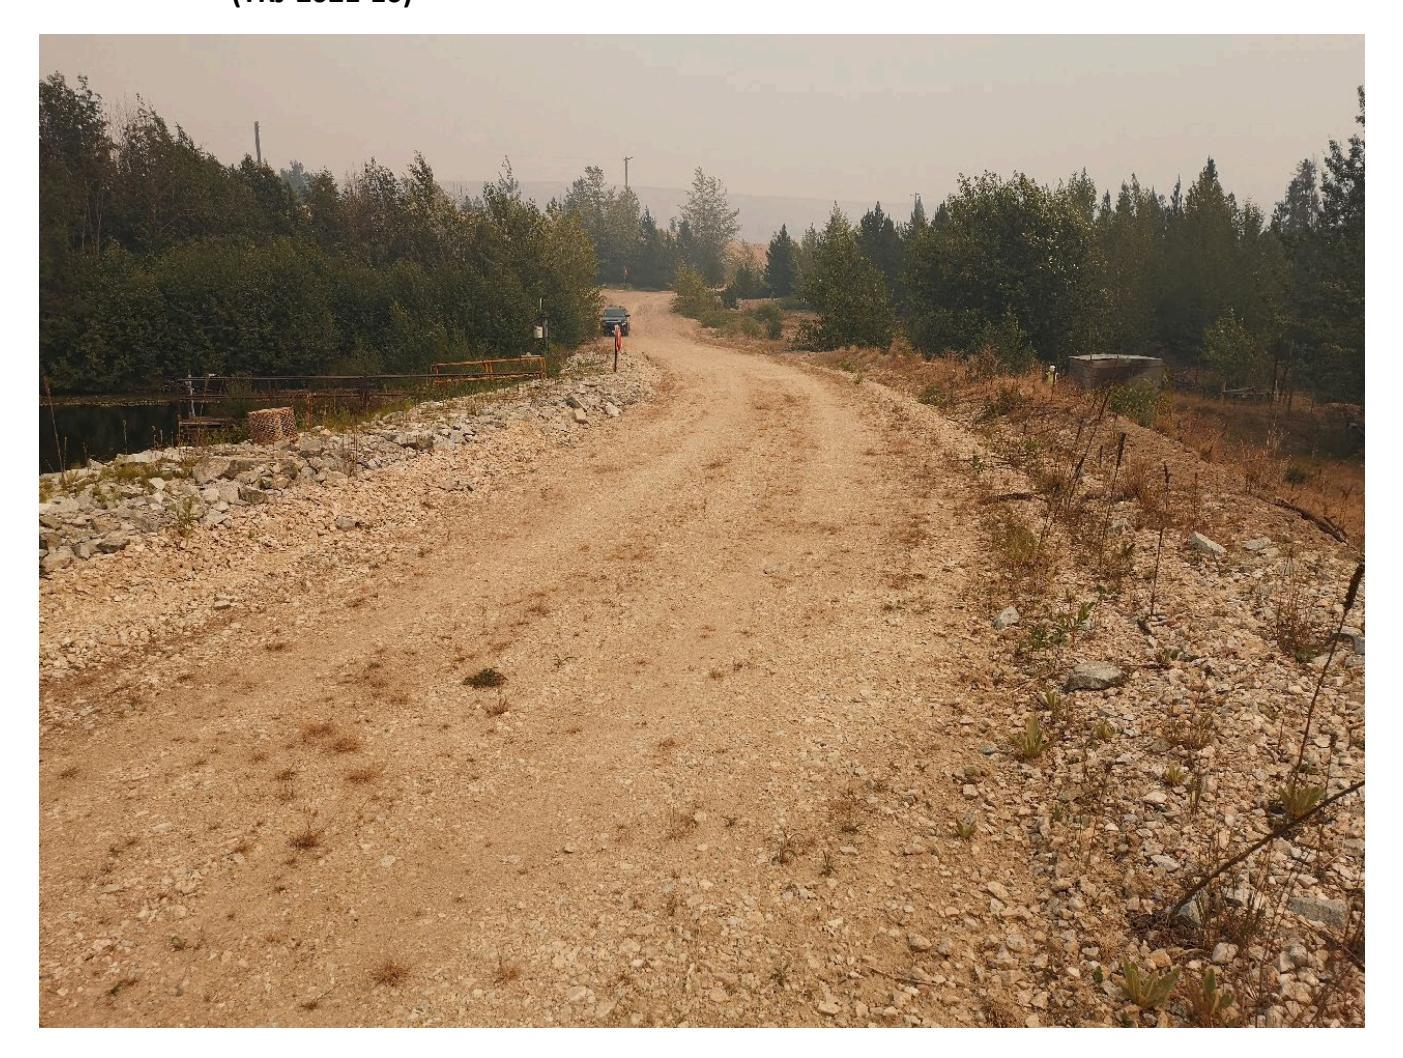
Photo I-B-1 Overview of R4 Seepage Pond Dam crest and downstream slope looking towards left abutment (TRJ-2021-10)
