Teck Highland Valley Copper Partnership

2021 Annual Facility Performance Report

Trojan Tailings Storage Facility

March 2022

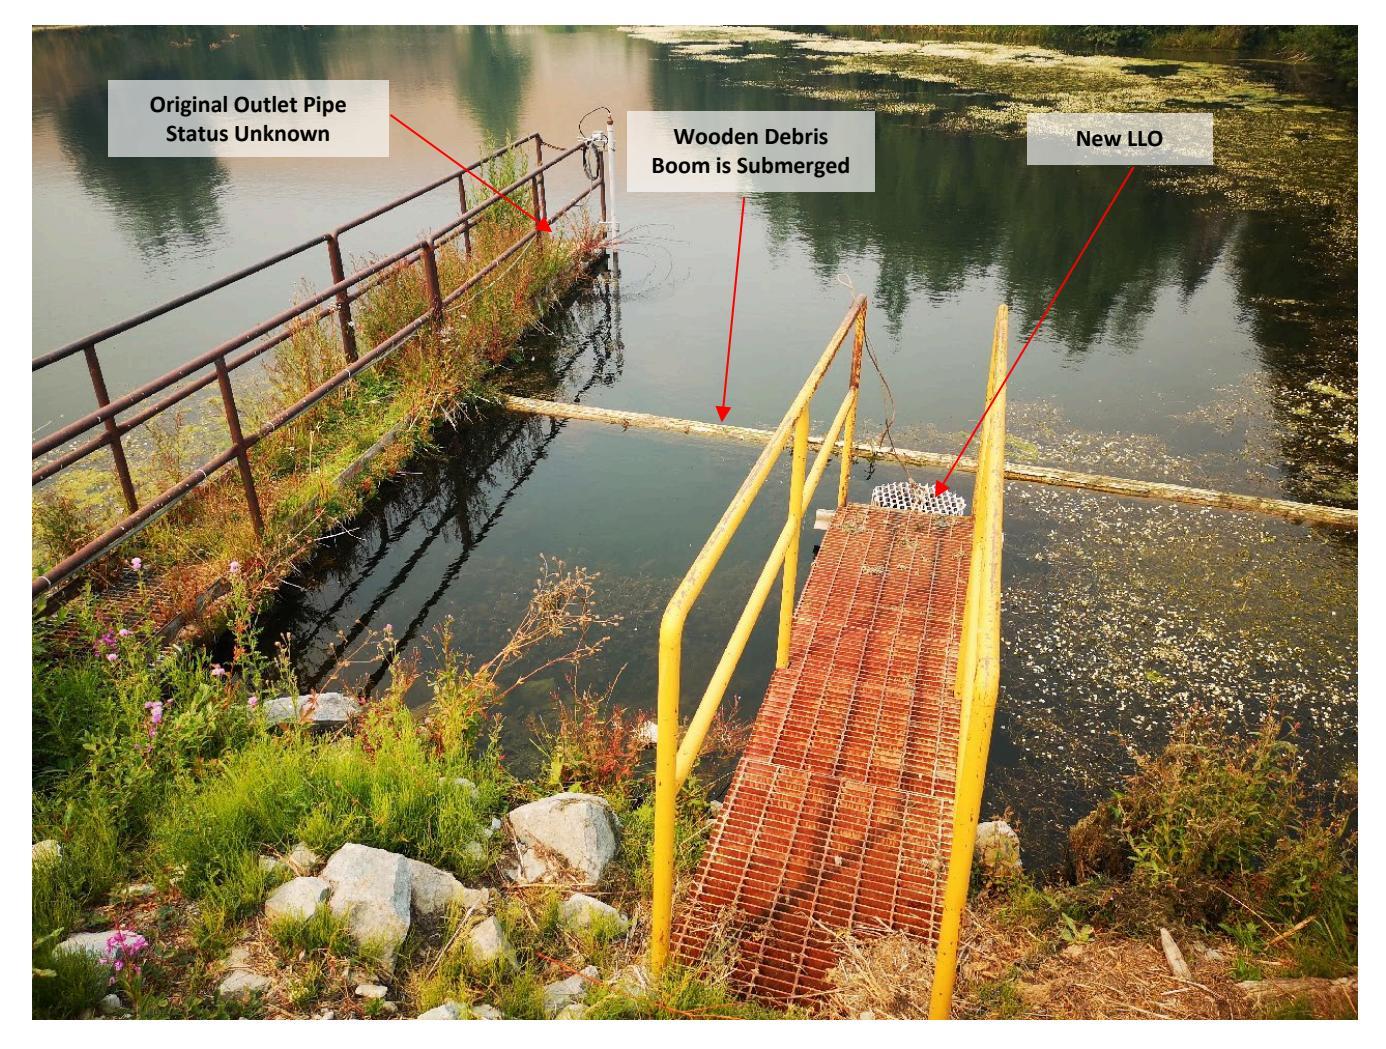
Photo I-B-3 Overview of the pond and low-level outlet (LLO) to Witches Brook via Lower Trojan Dam (TRJ-2021-11)

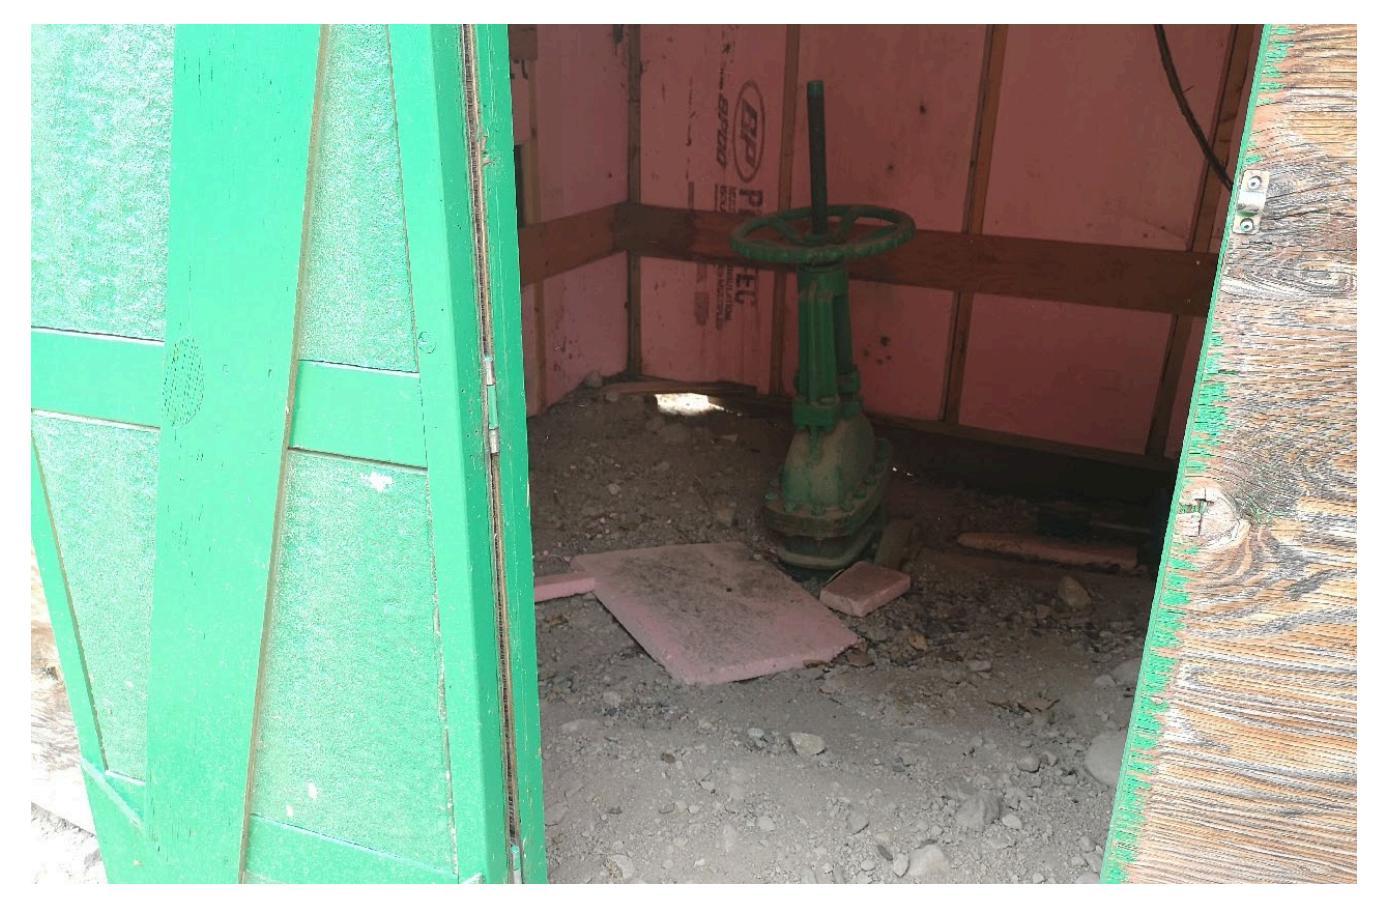
Photo I-B-4 Low Level Outlet valve in shed downstream of toe. The valve cannot be hand turned. The need to close the valve is not a critical control for the structure but HVC may want to fix the valve for routine operations (TRJ-2021-12)

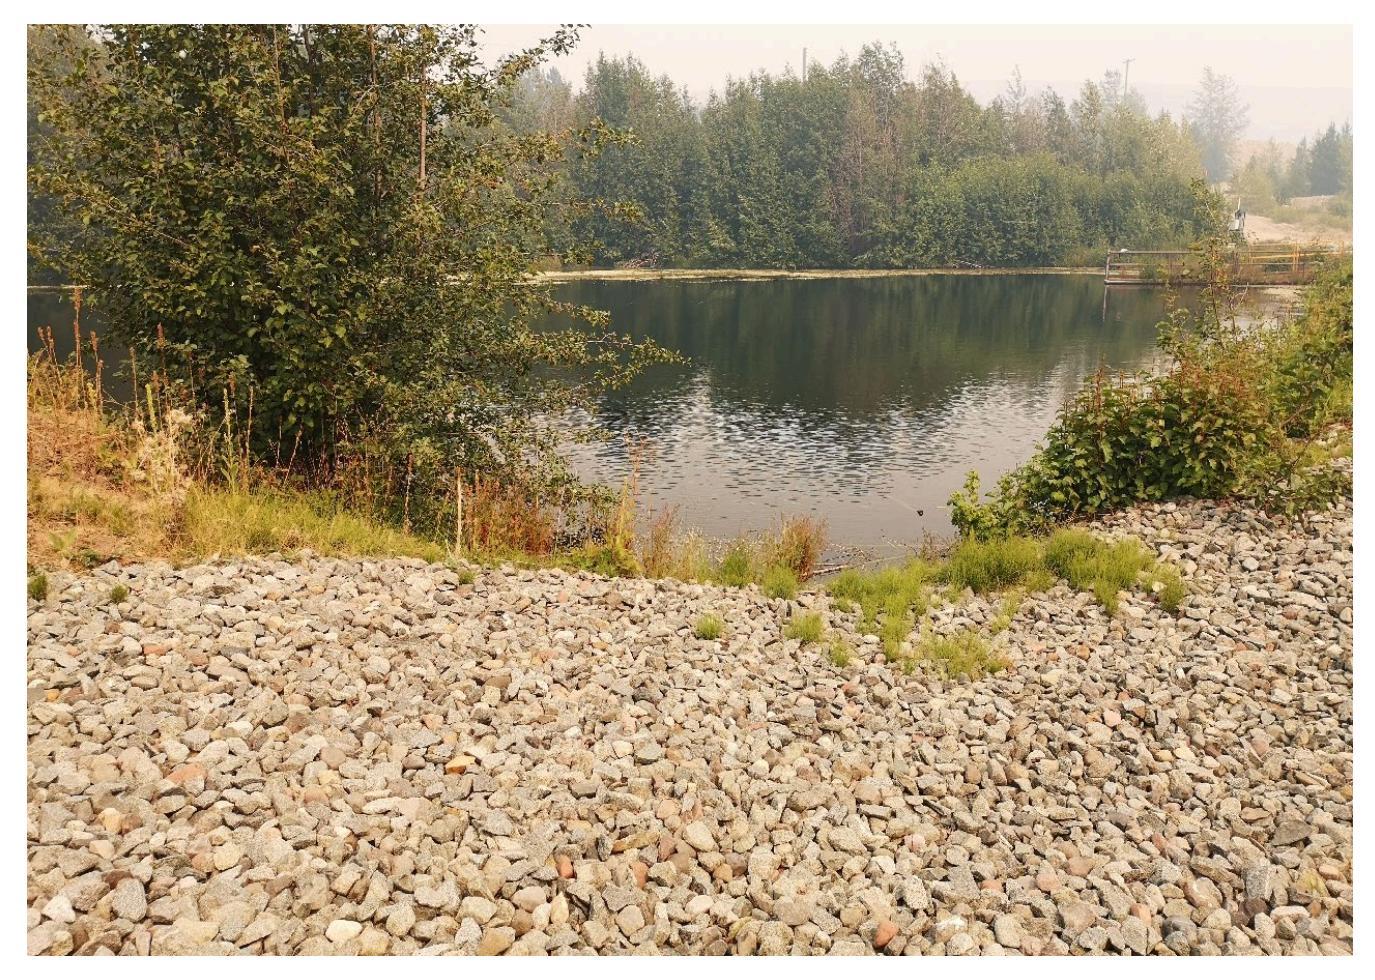
Photo I-B-5 Overview of pond and spillway inlet – Spillway inlet is clear of debris (TRJ-2021-13)

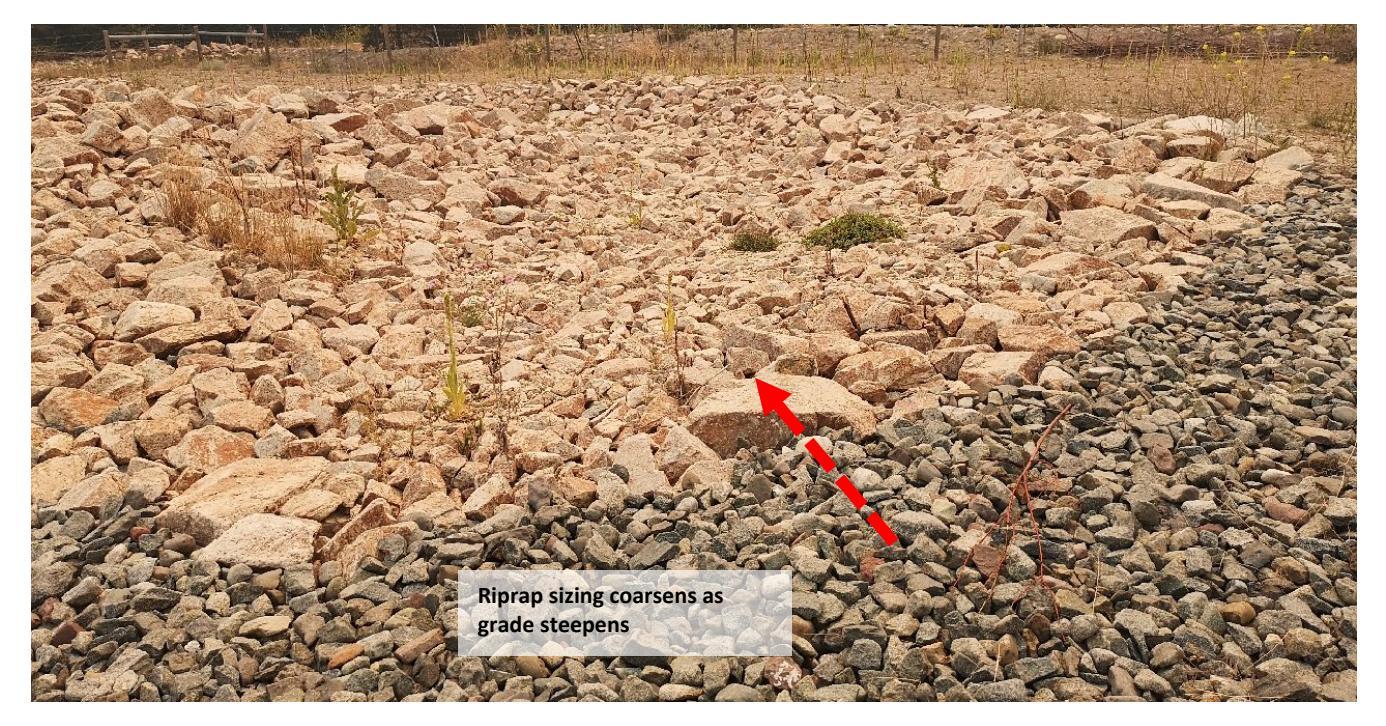
Photo I-B-6 Spillway Channel (TRJ-2021-13)

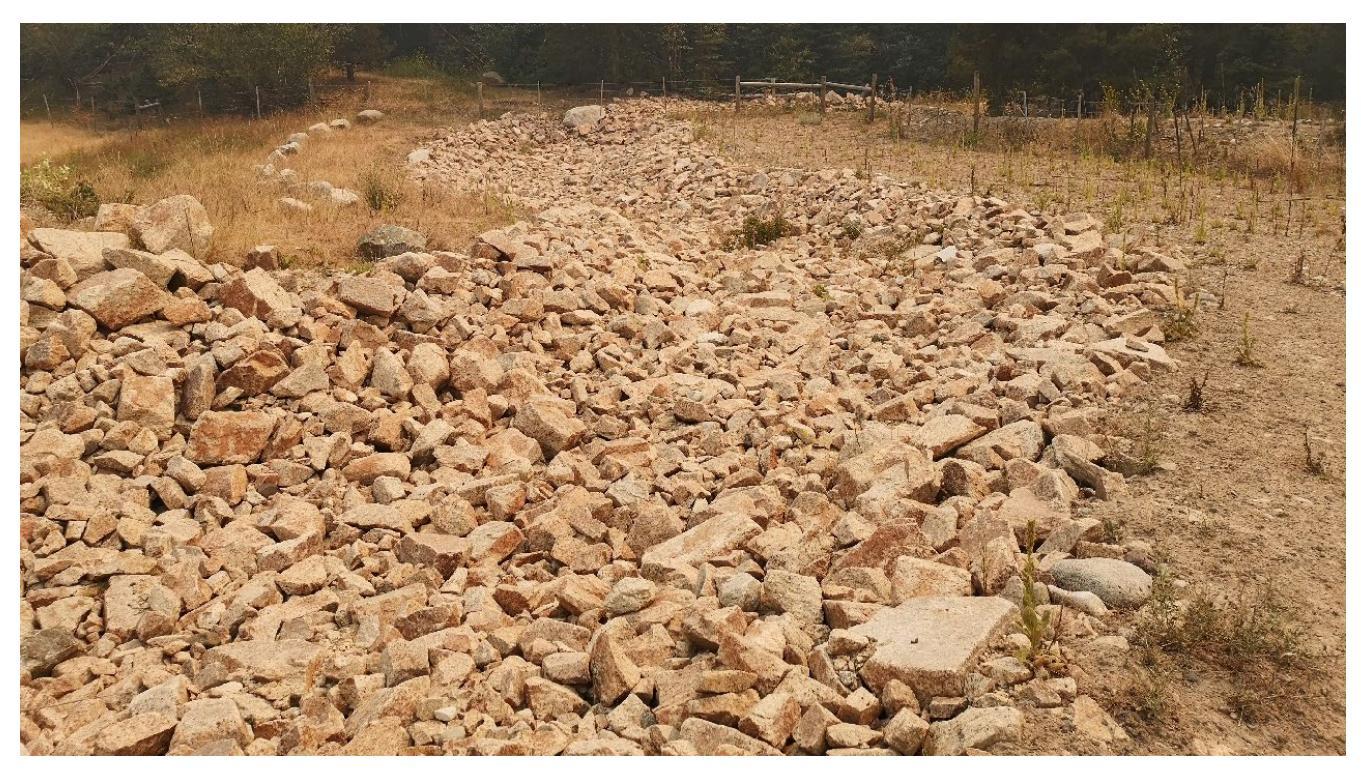
Photo I-B-7 Spillway Channel (TRJ-2021-13)

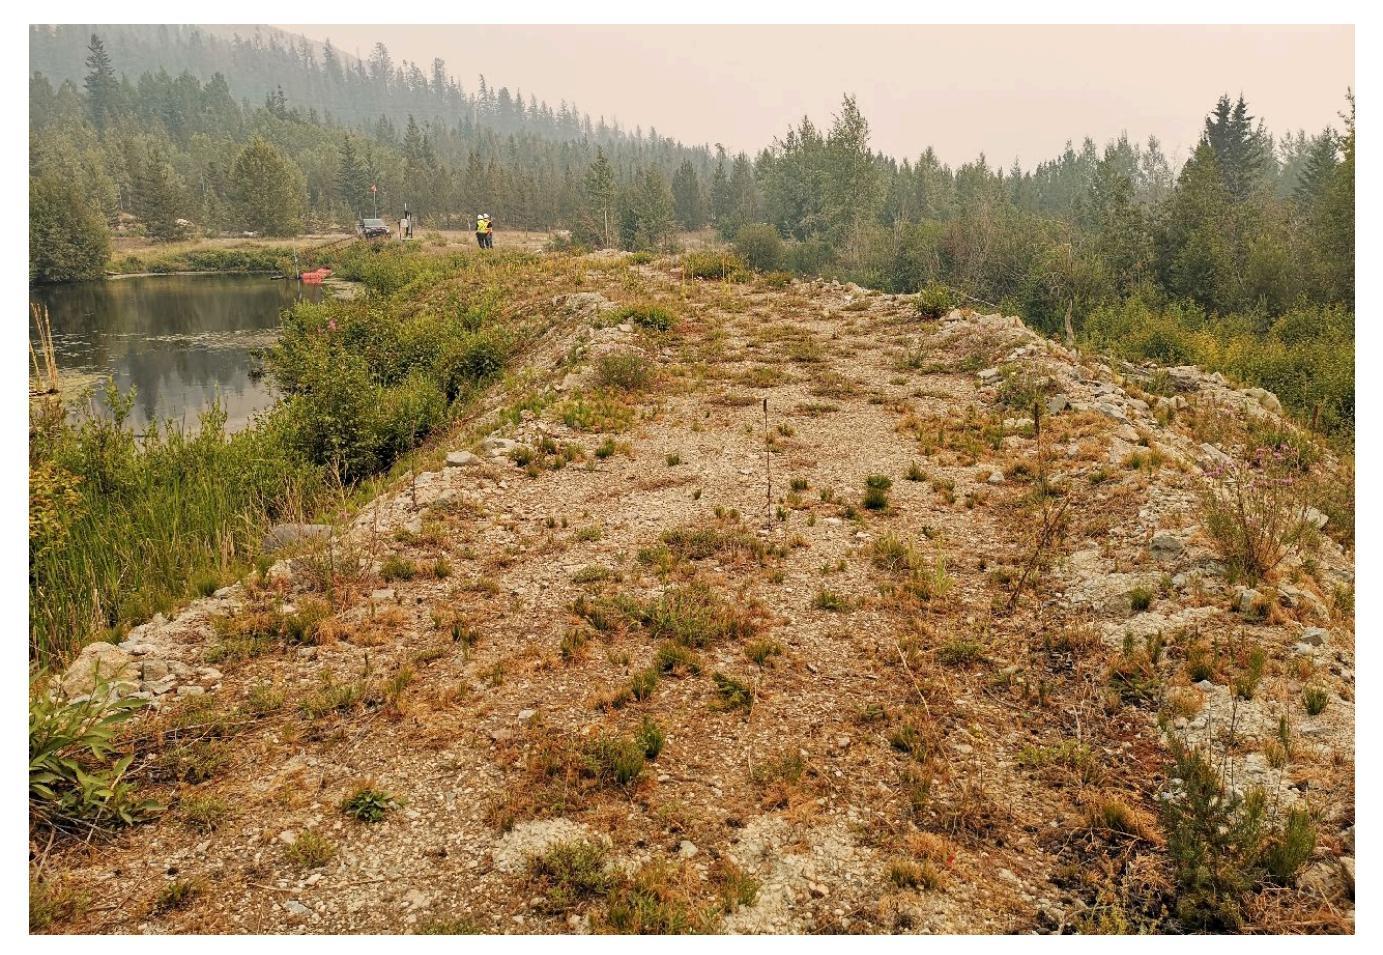
Photo I-C-1 Overview of Lower Trojan Dam crest from right abutment. Crest is uneven and appears to be sloped (rises from left abutment to right abutment) (TRJ-2021-14)

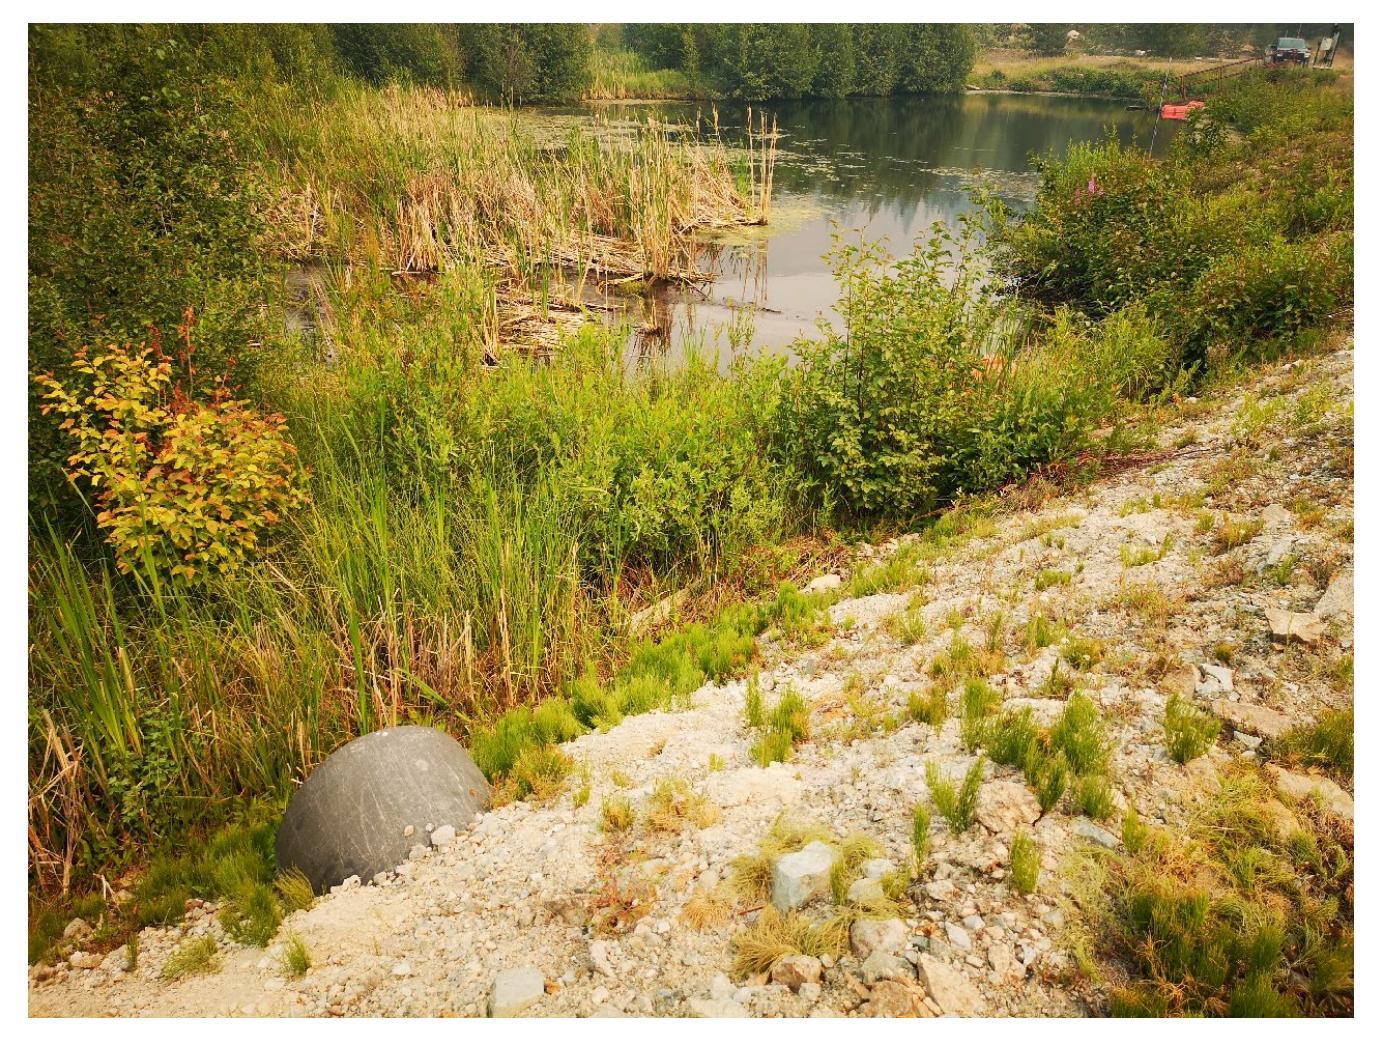
Photo I-C-2 Upstream slope near right abutment with overflow pipe through the dam. Heavy vegetation present in front of the pipe inlet which should be cleared (TRJ-2021-15)

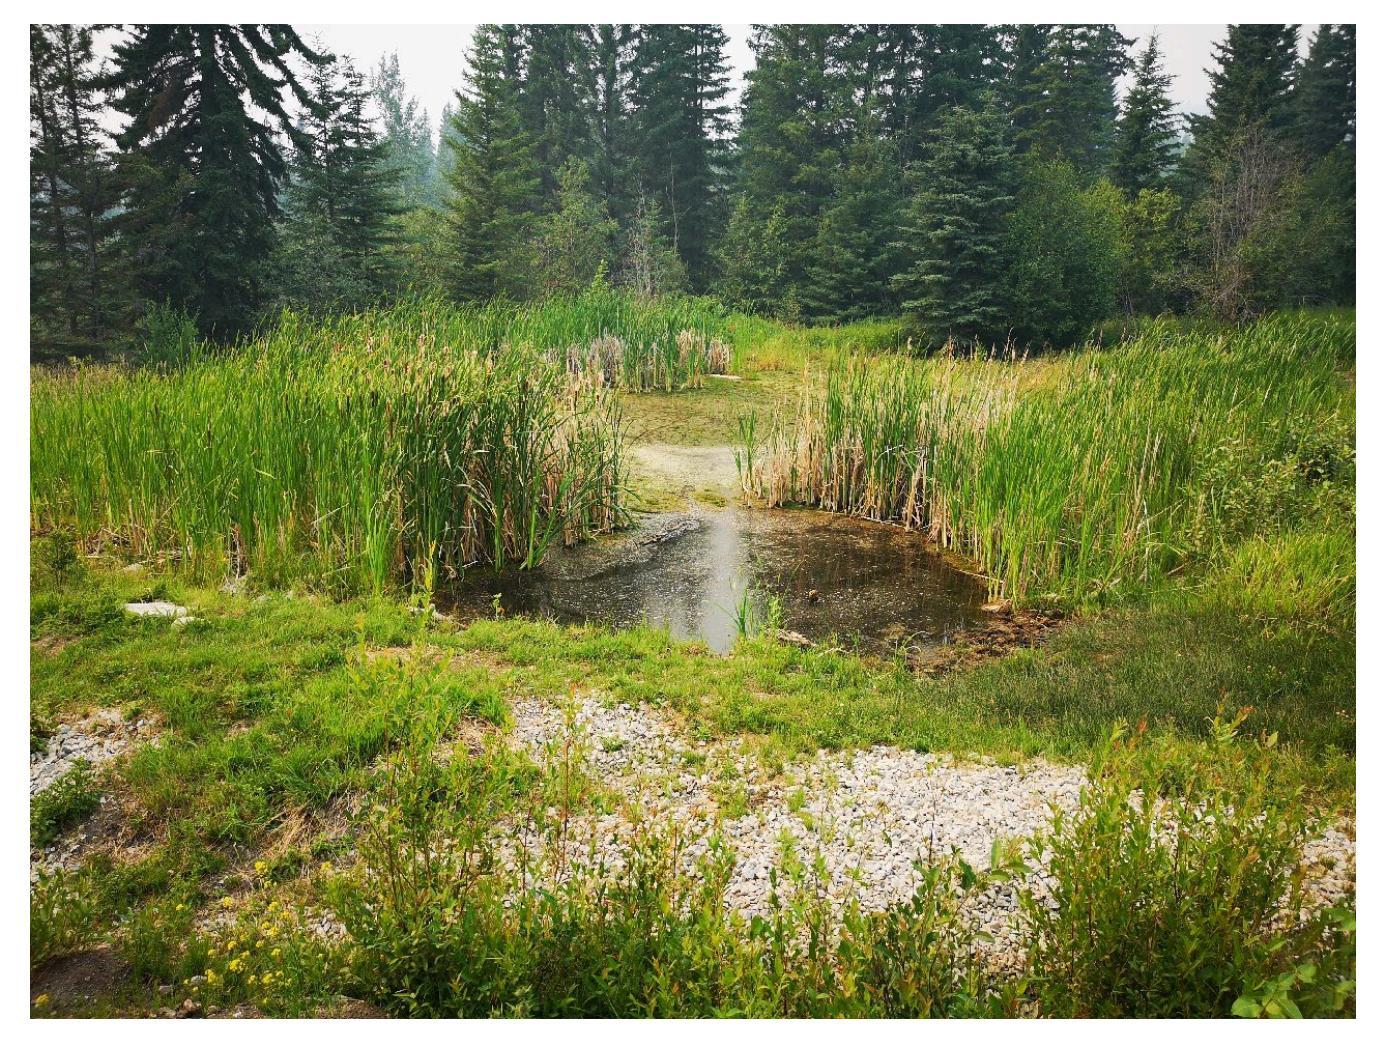
Photo I-C-3 Lower Trojan Dam Pond upper basin (TRJ-2021-16)

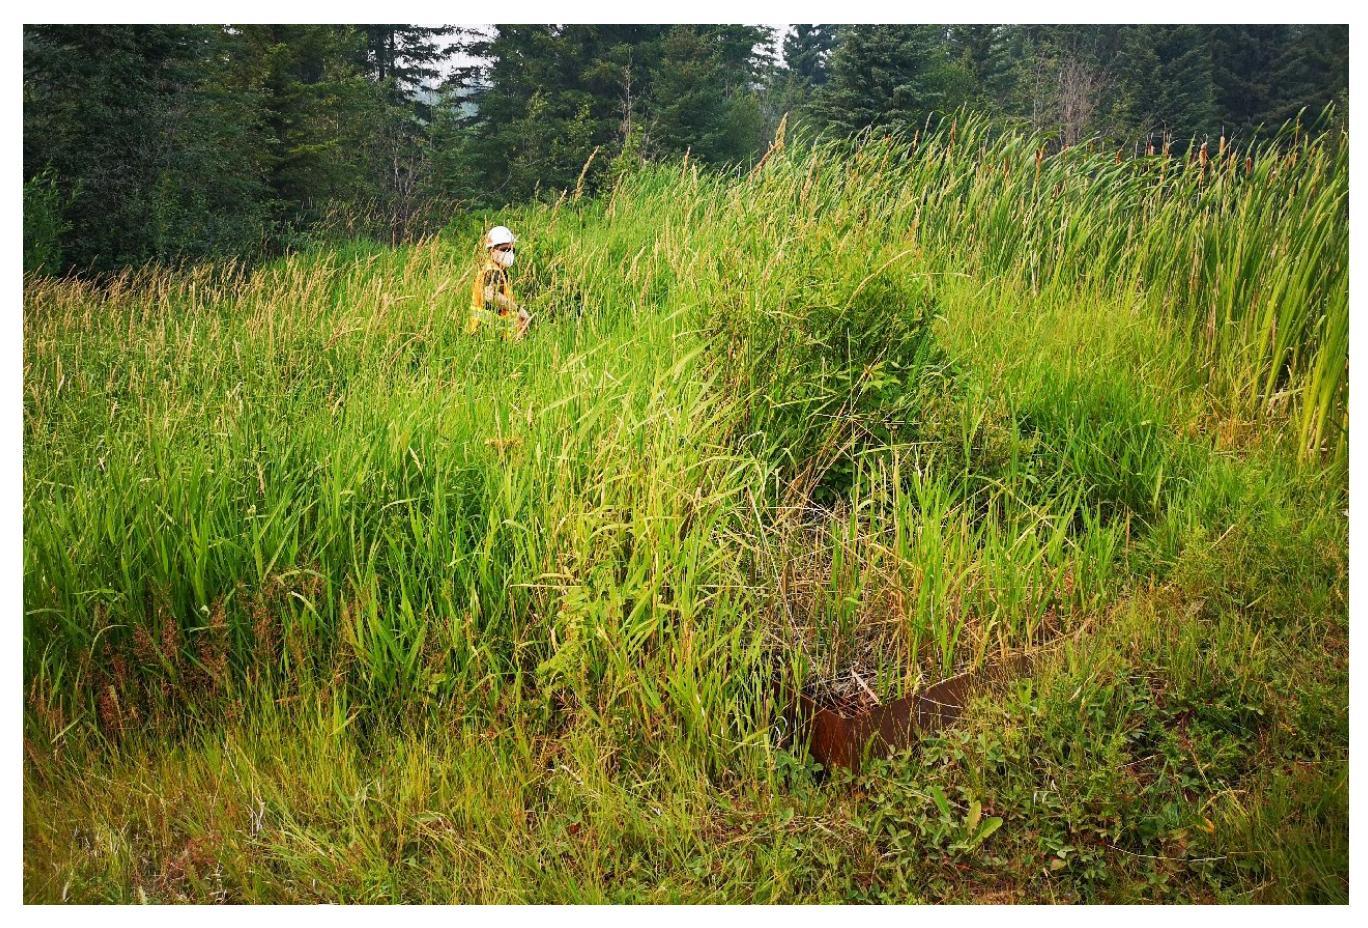
Photo I-C-4 Outlet which appeared to connect the upper basin to the lower basin at Lower Trojan Pond. There were no sounds or visual observations of flow from the outlet. During the site visit, flow from upper basin was reporting to lower basin via overland flow. (TRJ-2021-17)

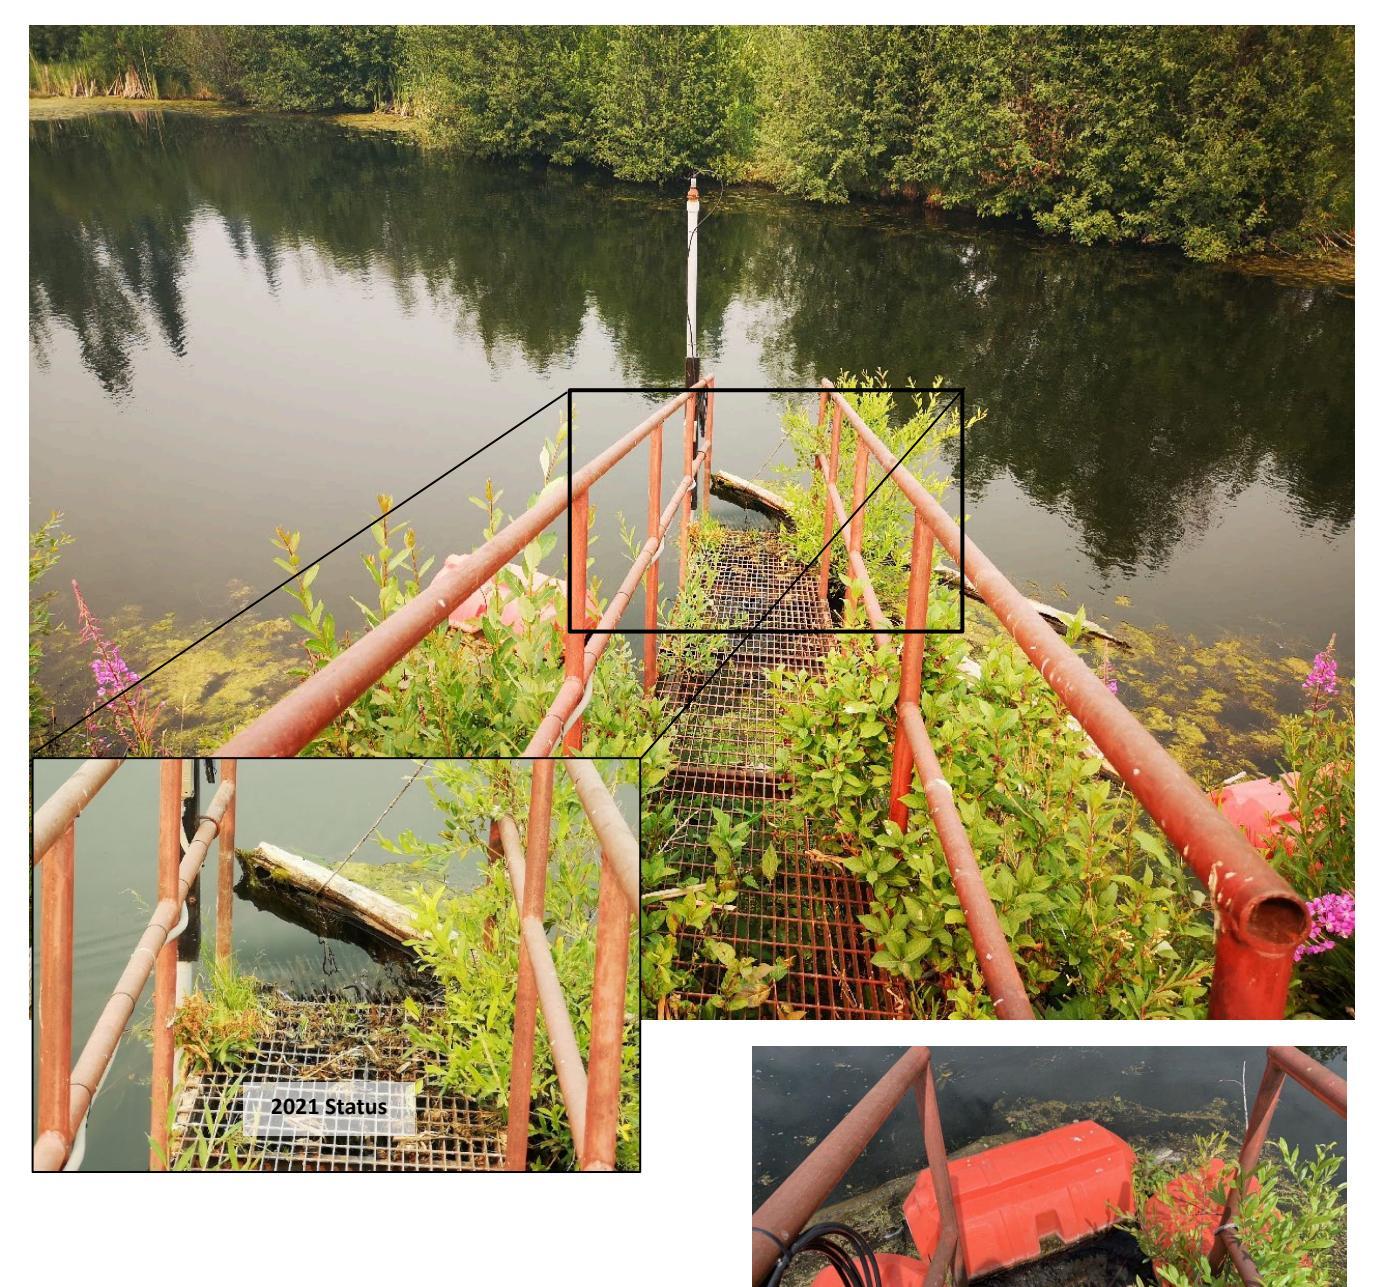
Photo I-C-5 Low-Level Outlet (LLO) inlet. Accumulated debris on trash rack was cleared and the debris boom put back in place by HVC as part of routine maintenance following the 2020 AFPR. (TRJ-2021-18)

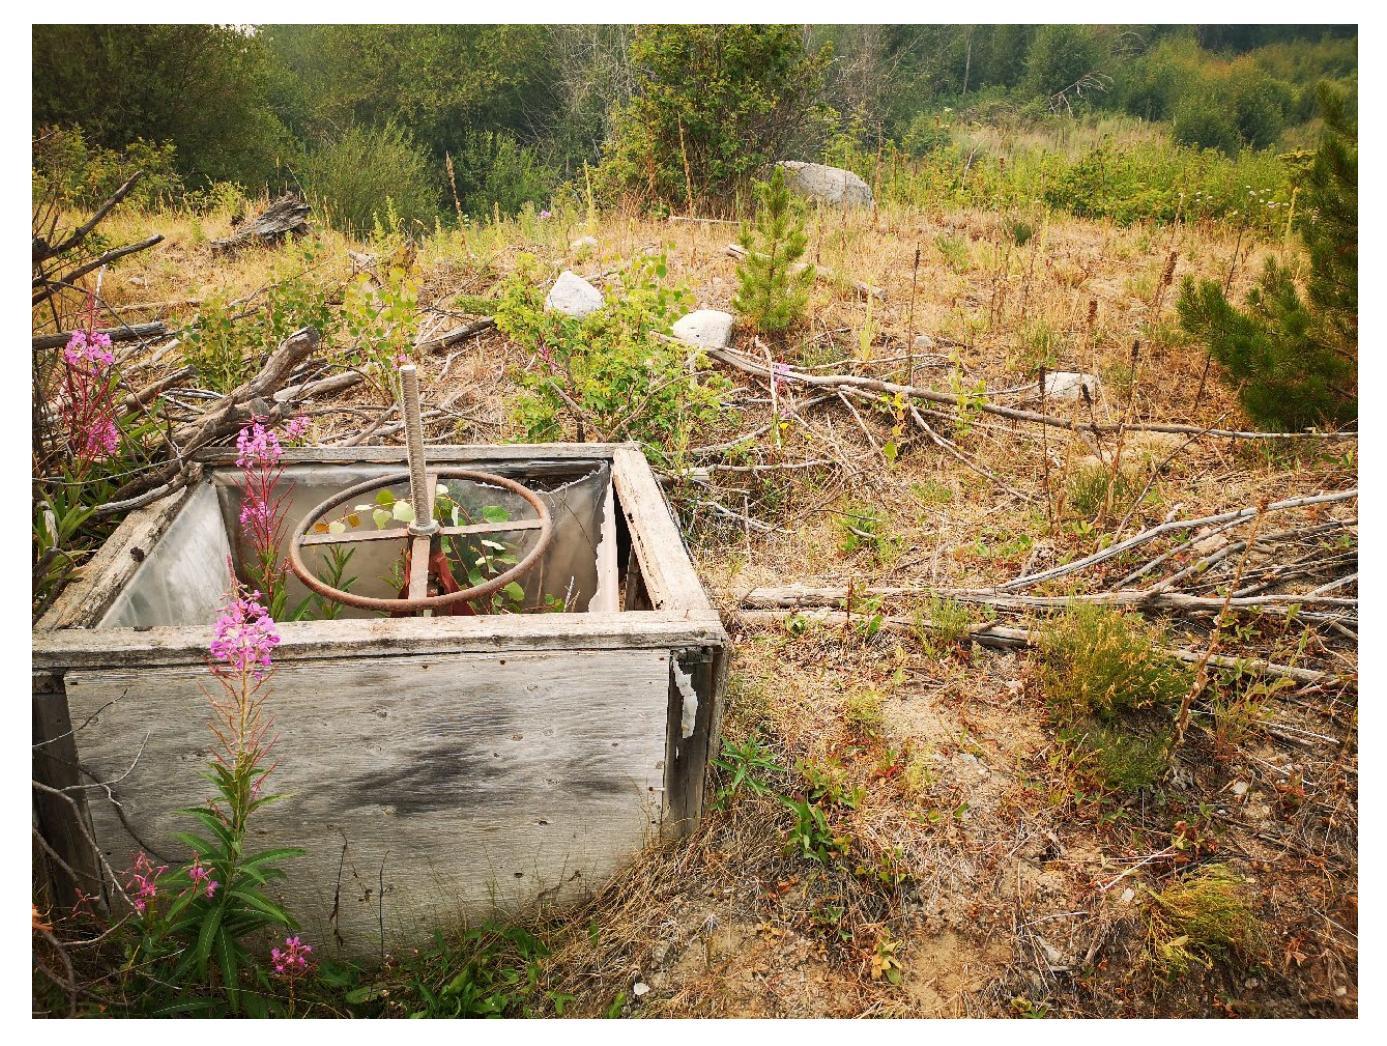
Photo I-C-6 Low-Level Outlet (LLO) valve can be hand operated (TRJ-2021-19)
