Teck Metals Ltd.

Pinchi Lake Mine Tailings Storage Facility

2021 Annual Facility Performance Review

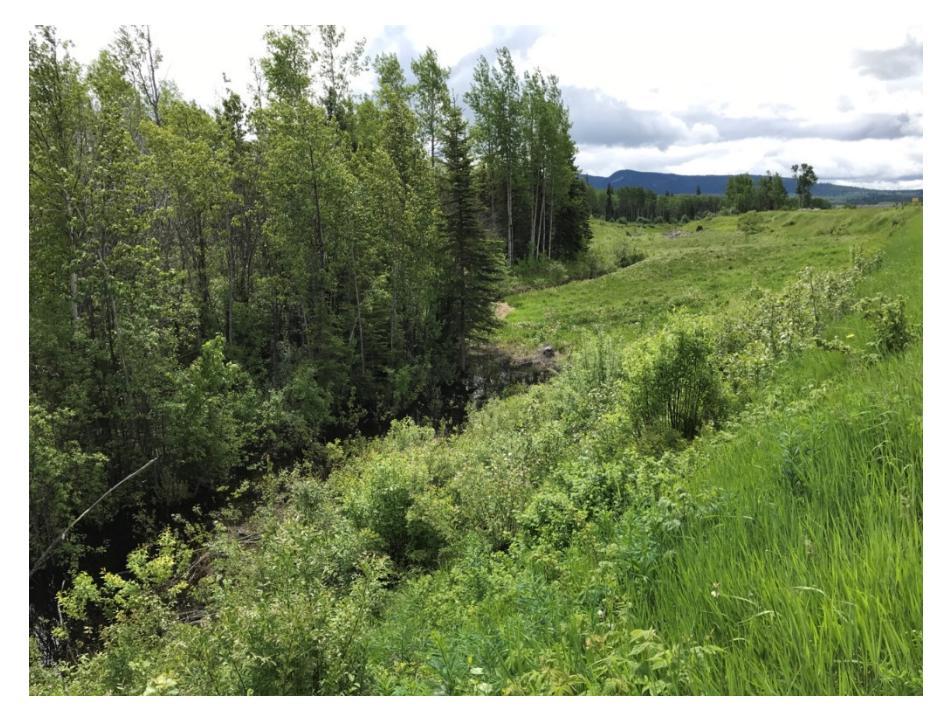
- The embankment slopes were covered with grasses and small shrubs. Some bushes have regrown on the east leg downstream slope since this area was cleared in fall 2019, and are exceeding 1.5 m height in some areas (see Photo II-1 and Photo II-13). This does not present an immediate concern for embankment safety, but note that the vegetation management plan recommends clearing vegetation greater than 1.5 m height from the embankment slopes (Spectrum 2017).

Photo II-1 TSF Embankment – East leg, looking south. Note vegetation.

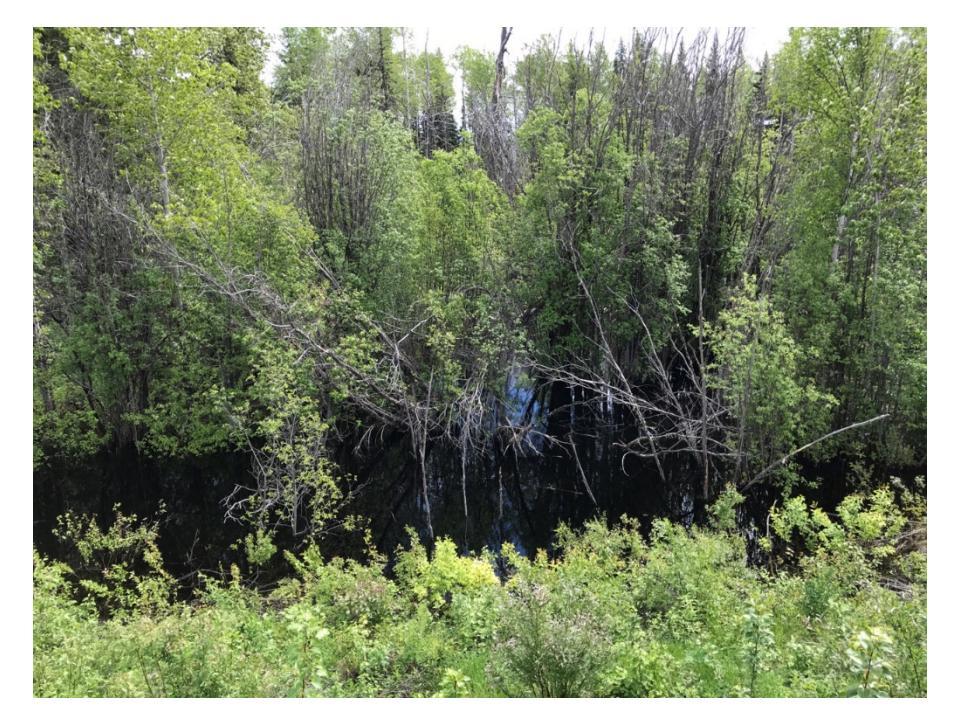
- A pond was observed in the trees near the toe of the east leg of the TSF Embankment (see Figure 1.2 for location; Photo II-2) as in previous inspections. This pond is located near a drainage channel that was shown on historical drawings of the TSF (see Appendix IV) and labelled "runoff channel." The channel ran parallel to the main Ed Creek channel, and apparently once joined up with Ed Creek just inside the TSF. The pond appears to collect local runoff, and it drains through a channel to the south and through a culvert into Ed Creek Diversion Channel. The pond level was slightly higher than in previous inspections due to the beaver dam noted below.

Photo II-2 TSF Embankment – Pond near toe of east leg.

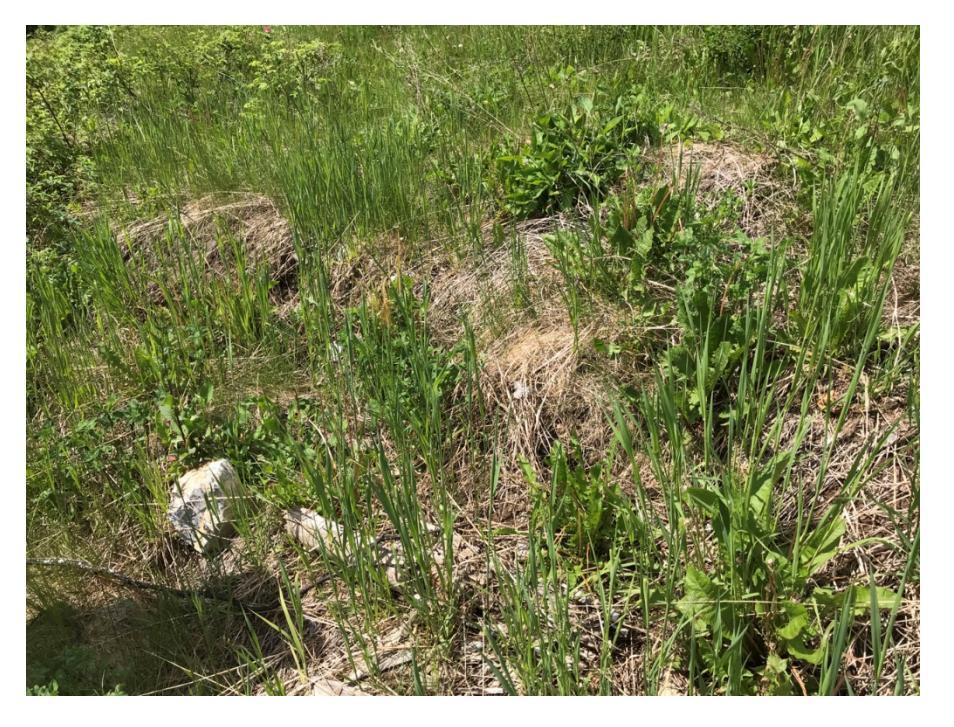
- A small slump in the slope above the riprap on the right (north) side of the spillway channel has been noted in inspections since 2014 (Location 1 in Figure 4.1). The slump area was covered in grass and the head scarp was only visible at close range (Photo II-23). The upstream side of the slump is about 90 m downstream of the embankment centreline. The condition of the slump has not noticeably changed in the last seven years, and it is not expected to impact the TSF Embankment or the performance of the Closure Spillway.

Photo II-23 Closure Spillway – Head scarp of slump above right bank.

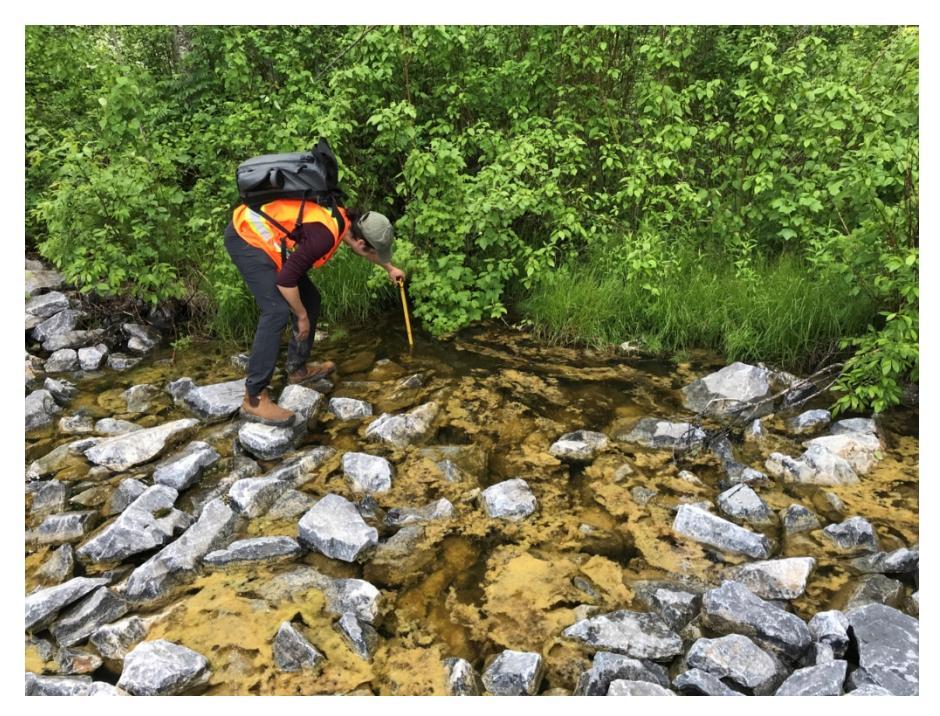
Photo II-24 Closure spillway – Pond at downstream end of riprap.

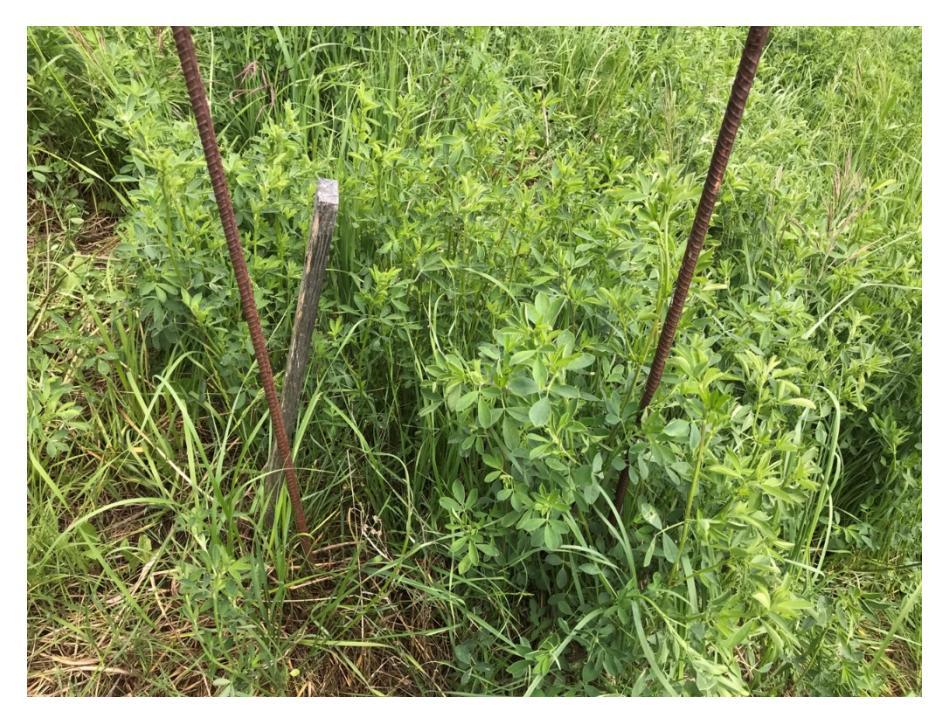
- Cracks were observed on the slope from 2013 to 2017 (Location 3 in Figure 4.1) and 2020 (Location 4 in Figure 4.1). Measurements of crack movements were taken from 2015 to 2018 using metal rods installed on either side of the cracks (Photo II-30), but these measurements showed no ongoing movements and were discontinued in 2019. The cracks are no longer visible due to vegetation growth, and are not a TSF safety concern. Nevertheless, this area will continue to be monitored during routine inspections as per the OMS Manual.

Photo II-30 Borrow Area A – crack monitoring rod location 103 (crack not visible).

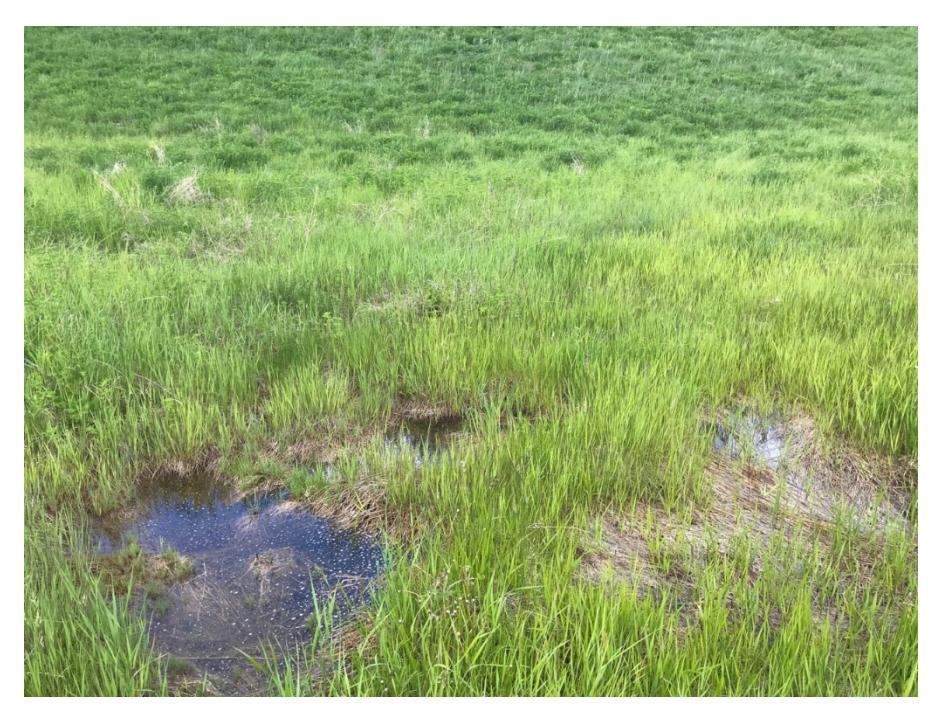
- A few small areas of wet ground and ponding were observed starting in the northeast corner of the borrow area and moving slightly downhill to the west along the toe of the slope for 150 m (Location 5 in Figure 4.1; Photo II-32). The largest pond was about 0.5 m wide and a few centimetres deep. Similar wet areas have been observed since 2011, and they are believed to be associated with groundwater unrelated to the TSF. Outside of these wet areas, the ground on the slope and along the toe was dry.

Photo II-32 Borrow Area A – Wet ground and ponding in northeast corner.

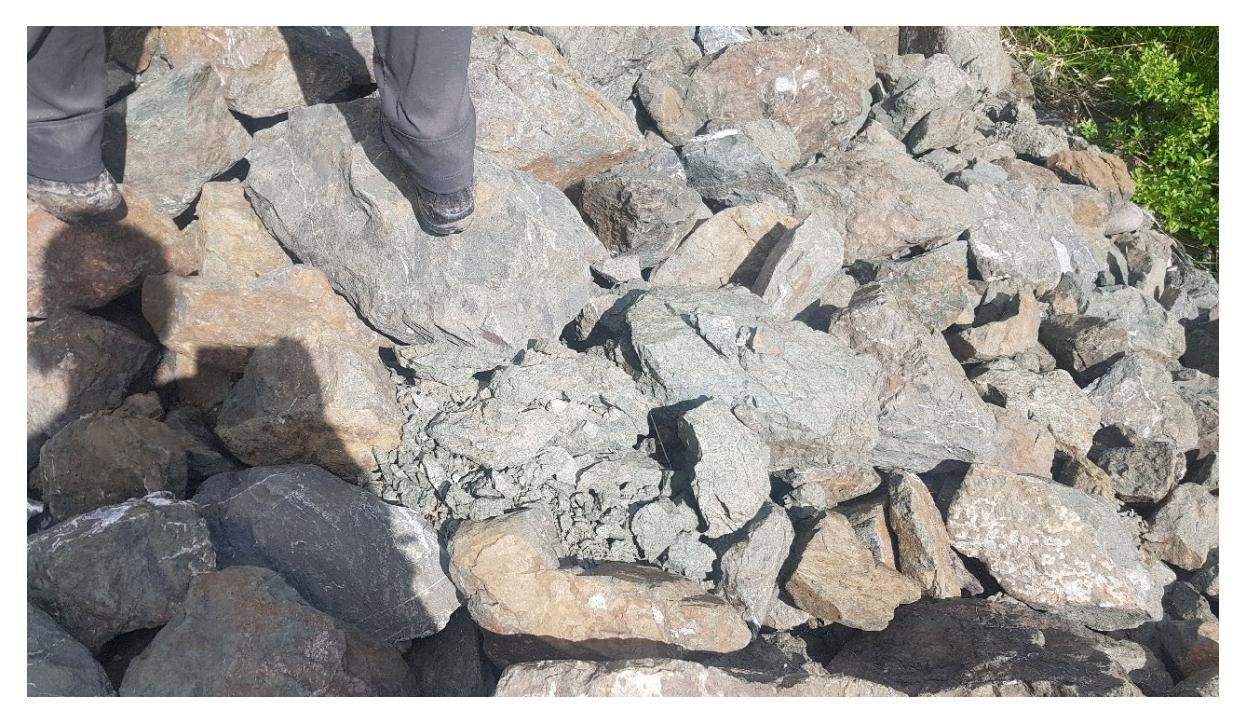
Ed Creek Diversion Channel was designed to convey the 1000-year flood event without erosion damage, but gradual weathering and breakage of the riprap has reduced its capacity. A portion of the channel is approximately 10 m from the TSF Embankment, and damage to the riprap during an extreme flood event could initiate gradual erosion of the channel towards the embankment. This is addressed through surveillance and maintenance, and erosion would not be allowed to progress to the point where it could undermine the toe of the embankment. Options for remediating the channel are also being investigated, including replacing the riprap and possibly realigning the channel away from the TSF.

Photo II-35 Ed Creek Diversion Channel – Riprap on right bank, showing weathering and breakage.

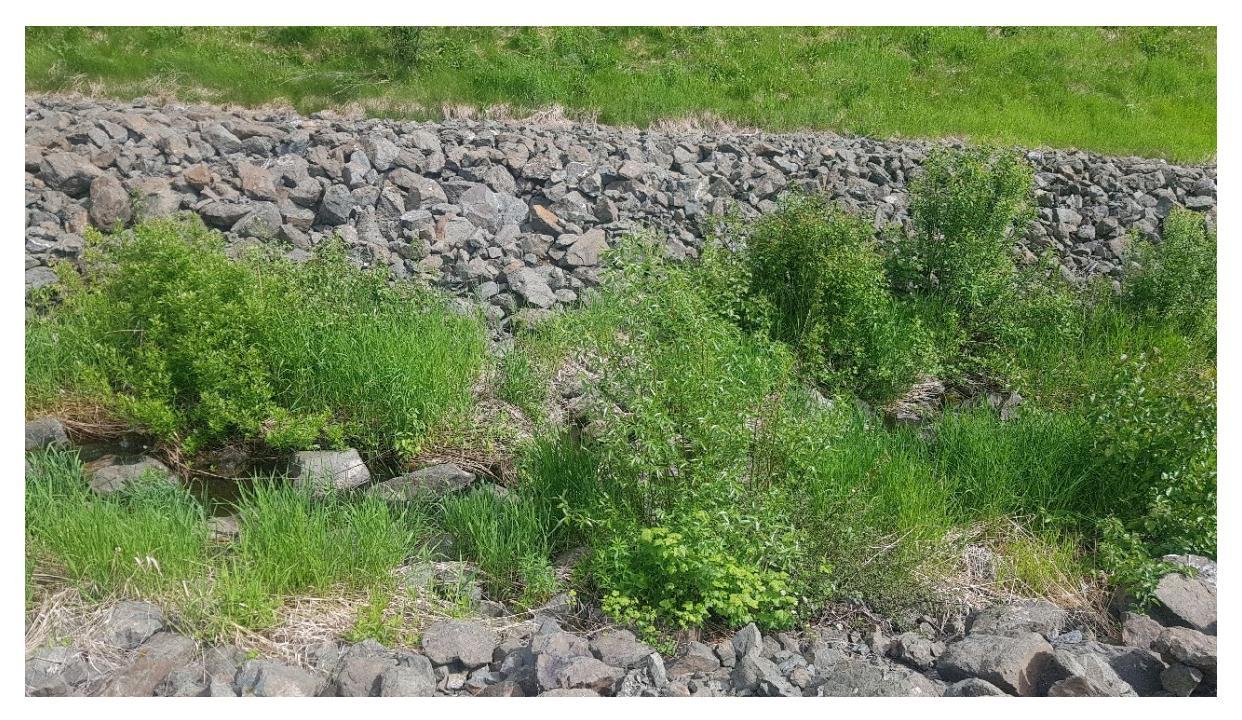
- Vegetation growth at the base of Ed Creek Diversion Channel is over 2 m high in some areas (Photos II-34, and II-36 to II-43). This is not currently considered to be a TSF safety concern. However, the vegetation management plan recommends vegetation clearing prior to vegetation exceeding 1.5 m in height (Spectrum 2017).
- Previous annual performance reports have noted that the riprap along some areas of the Ed Creek Diversion Channel is weathering and breaking up (Photo II-35). The condition of the riprap appeared similar to previous inspections. Degradation of the riprap is discussed further in Section 5.5.
- The riprap along a small section of the channel (Location 6 in Figure 4.1; Photo II-39), where a
 depression had formed in the riprap surface, was replaced in 2014. This riprap appeared to be
 in good condition.

Photo II-38 Ed Creek Diversion Channel – Vegetation in channel.

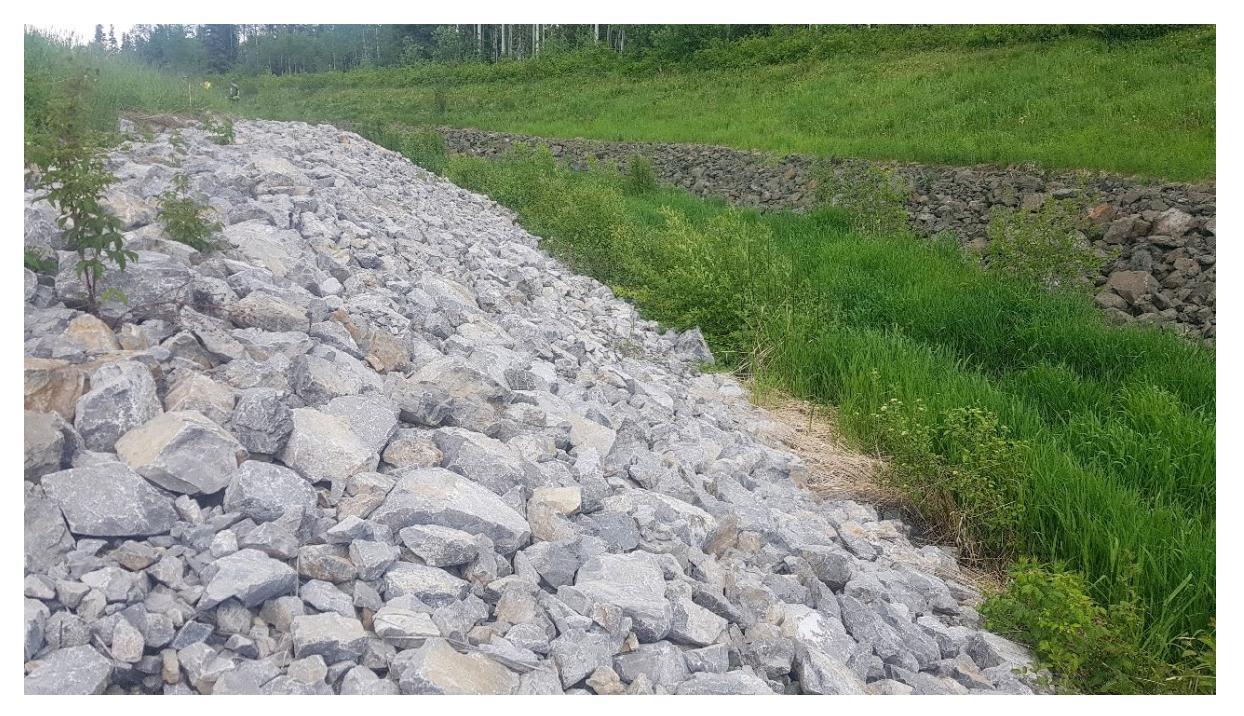
Photo II-39 Ed Creek Diversion Channel – looking upstream from near second bend. Light coloured area of riprap was replaced in 2014 and is in good condition.

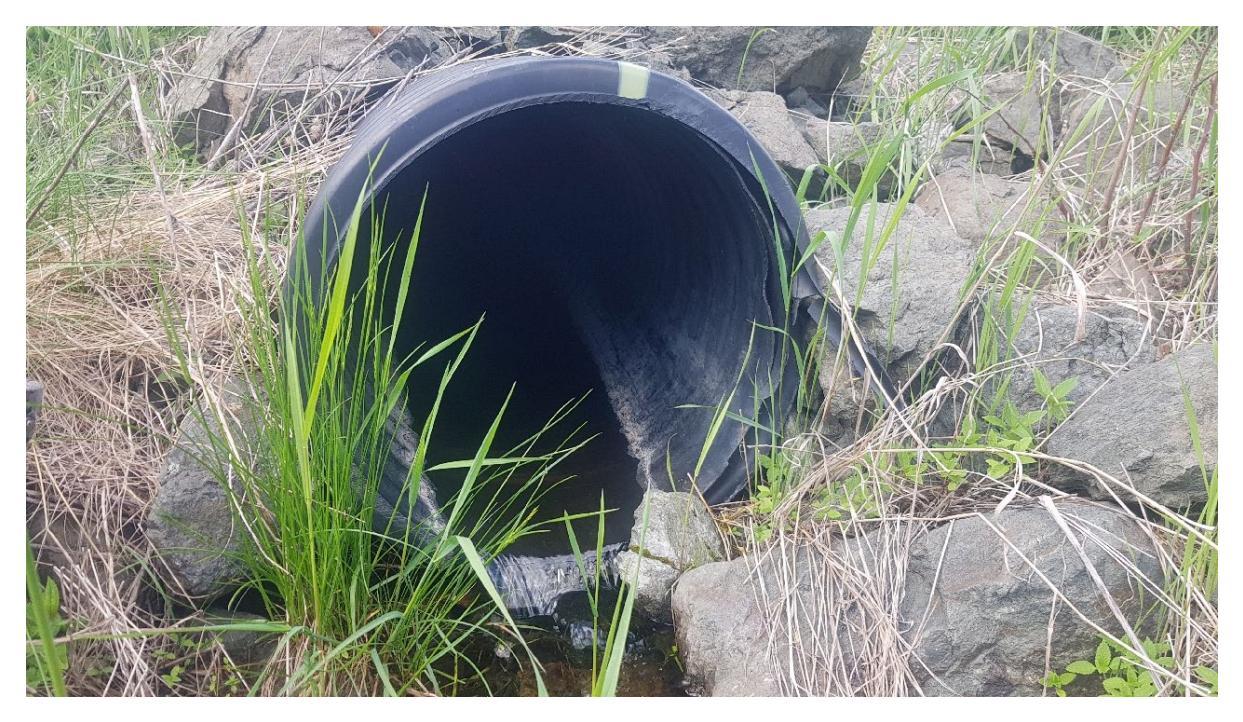
Photo II-45 Inlet of 460 mm culvert on north bank of Ed Creek Diversion Channel. There is minor vegetation upstream of the inlet.

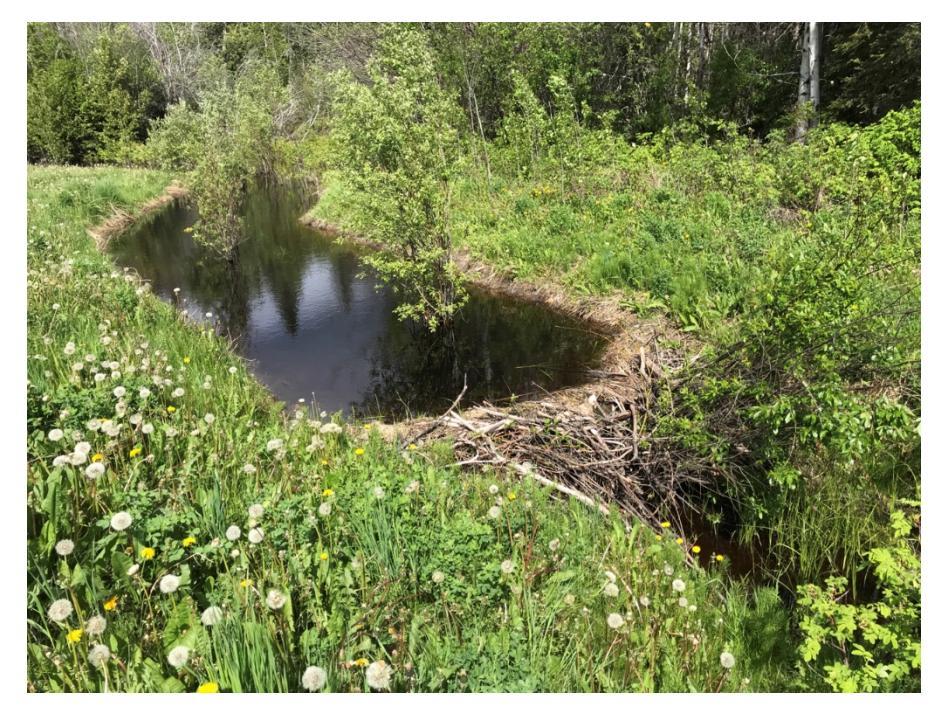
- A small beaver dam (0.8 m high) was observed in the channel south of the pond described above (Location 7, Photo II-47). Although this beaver dam is not currently an embankment safety issue, it is prudent to remove it to discourage beaver activity in the area.

A small beaver dam was observed downstream of the TSF Embankment east leg in a local drainage channel. This is not a safety concern for the TSF, but the beaver dam should be removed to discourage beaver activity in the area.

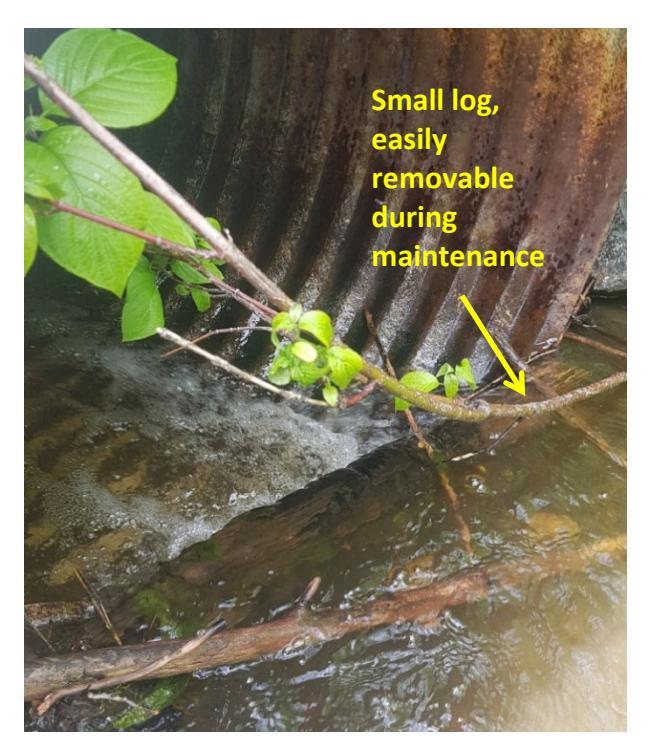
- There are two culverts on Ed Creek under Pinchi Lake Road approximately 300 m east of the mine gate (see Figure 1.2 for location and refer to Photos II-48 to II-51). Flow was observed in both culverts, with a water depth of 110 mm at the east culvert inlet and a water depth of 70 mm at the west culvert inlet.
- There was no vegetation in front of the culvert inlets. However, there was a small log partially blocking a portion of the west culvert (Photo II-49), which is not an immediate concern.

Photo II-49 Small log partially blocking invert of west culvert under Pinchi Lake Road.
