Teck Resources Limited

Quintette Coal Operations

2021 Annual Facility Performance Review

Plantsite Tailings Storage Facility and Plantsite Seepage Collection Pond Dam

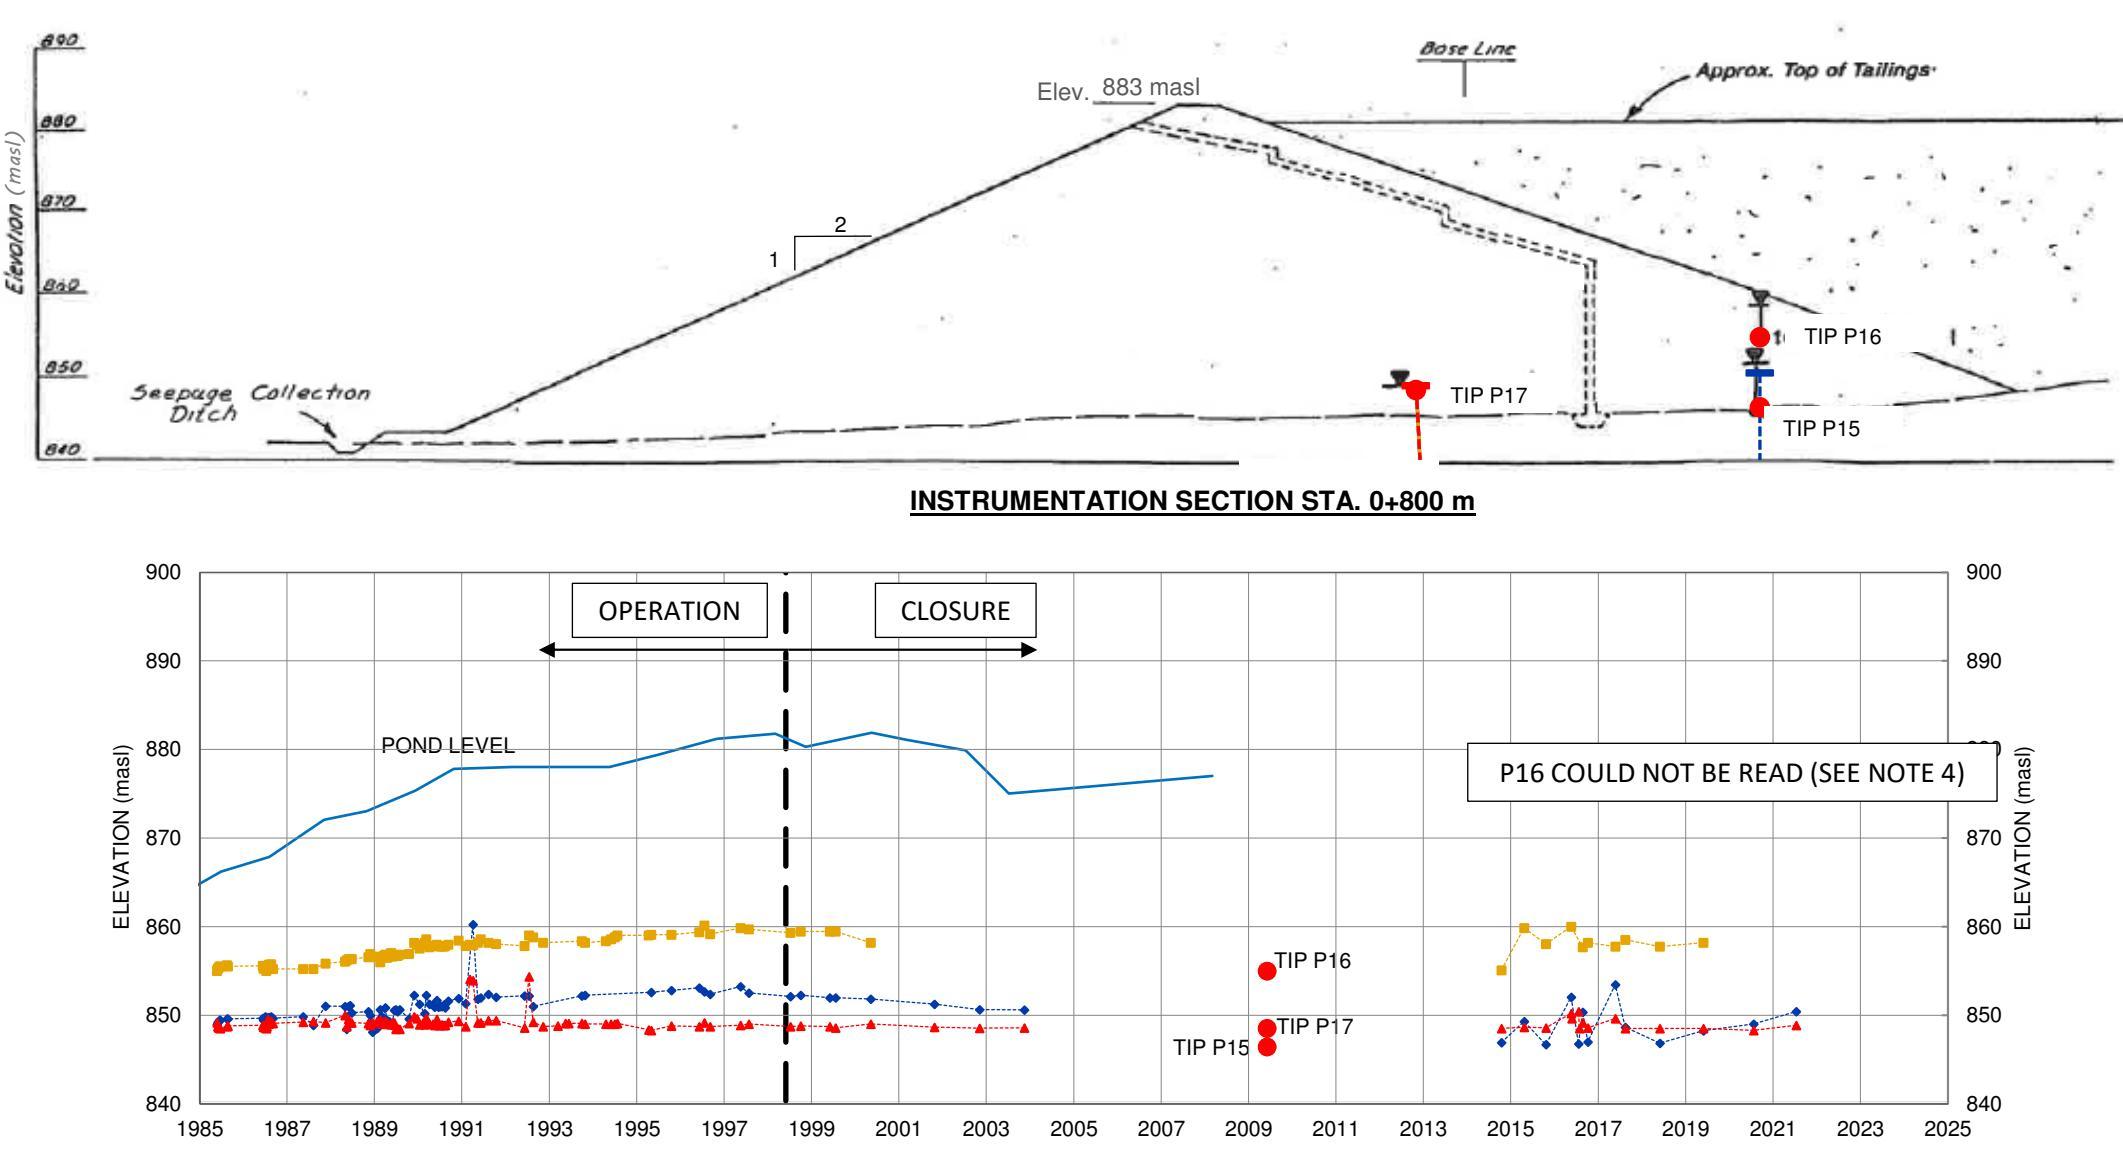
- All piezometer readings are below the established threshold values, and no changes to thresholds are required.
- In general, piezometers showed similar or slightly lower water levels compared to 2020 readings, except P15 at Sta. 0+800 which shows a gradual increasing trend over the last three years. Despite the trend, the piezometer reading is 3.5 m below the threshold level and is within the range of post-operations readings observed in this instrument.

- Piezometer P16 could not be read because of a build-up of mineral deposits on the instrument tip. The tip should be replaced as part of routine maintenance, however this is not a concern given that P15 and P17 remain functional and are located along the same instrument section.

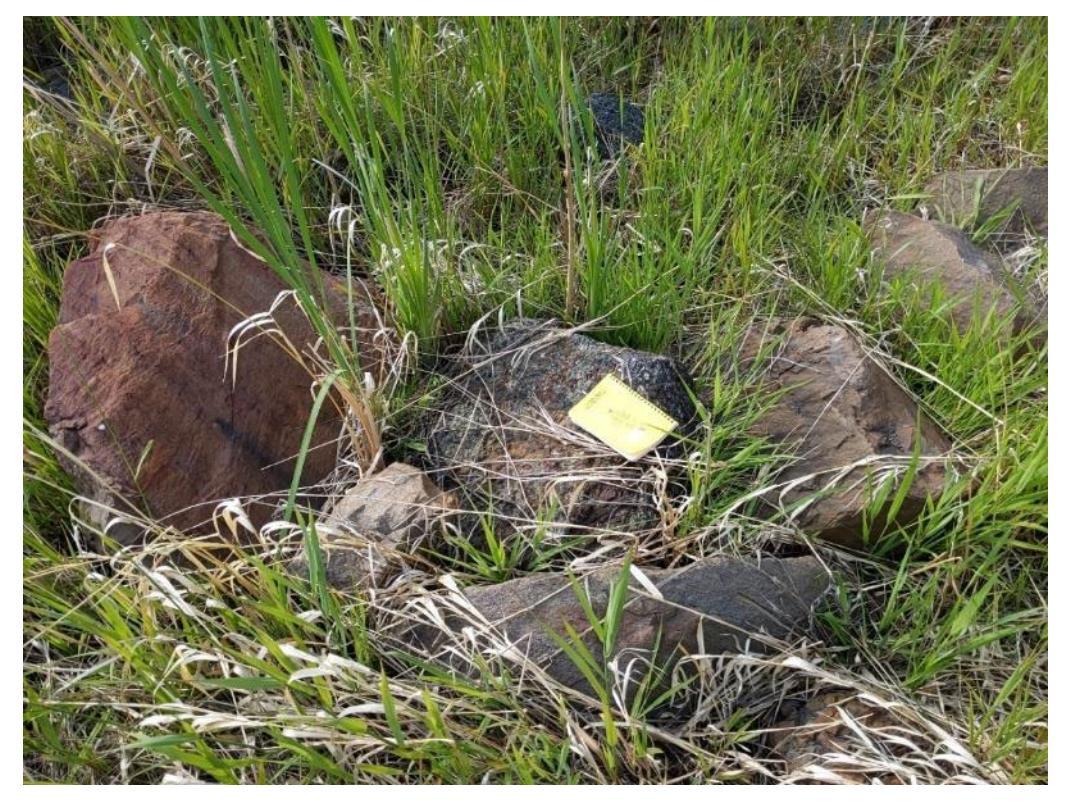
- Closure Spillway Channel: Good condition. The vegetation cover, primarily grasses and bushes, is well-established. No signs of erosion or scouring were noted. The riprap on the natural slope bank continues to show signs of particle breakdown but is not considered a dam safety concern at this time.

Photo I-15 PTD Spillway riprap (PTD-2021-06)

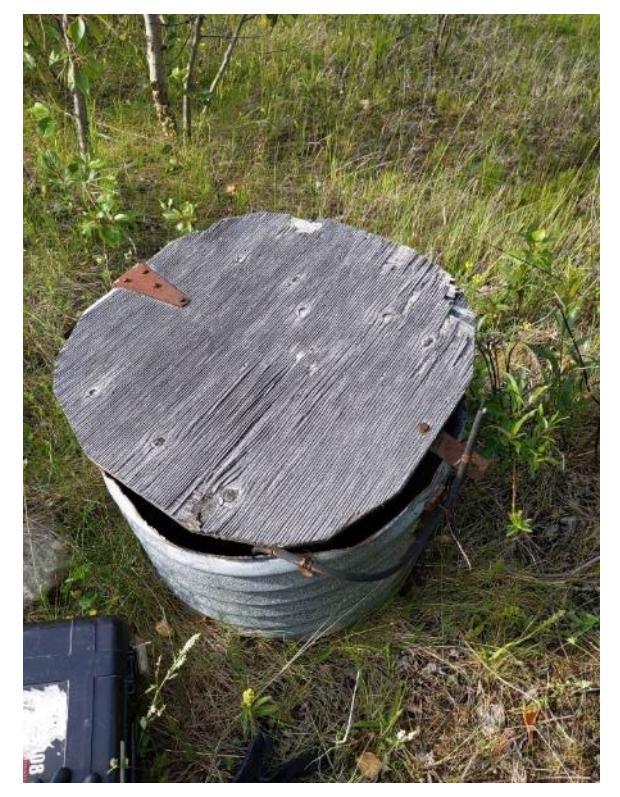
Photo I-18 Piezometer at downstream toe missing tip (PTD-2021-08)

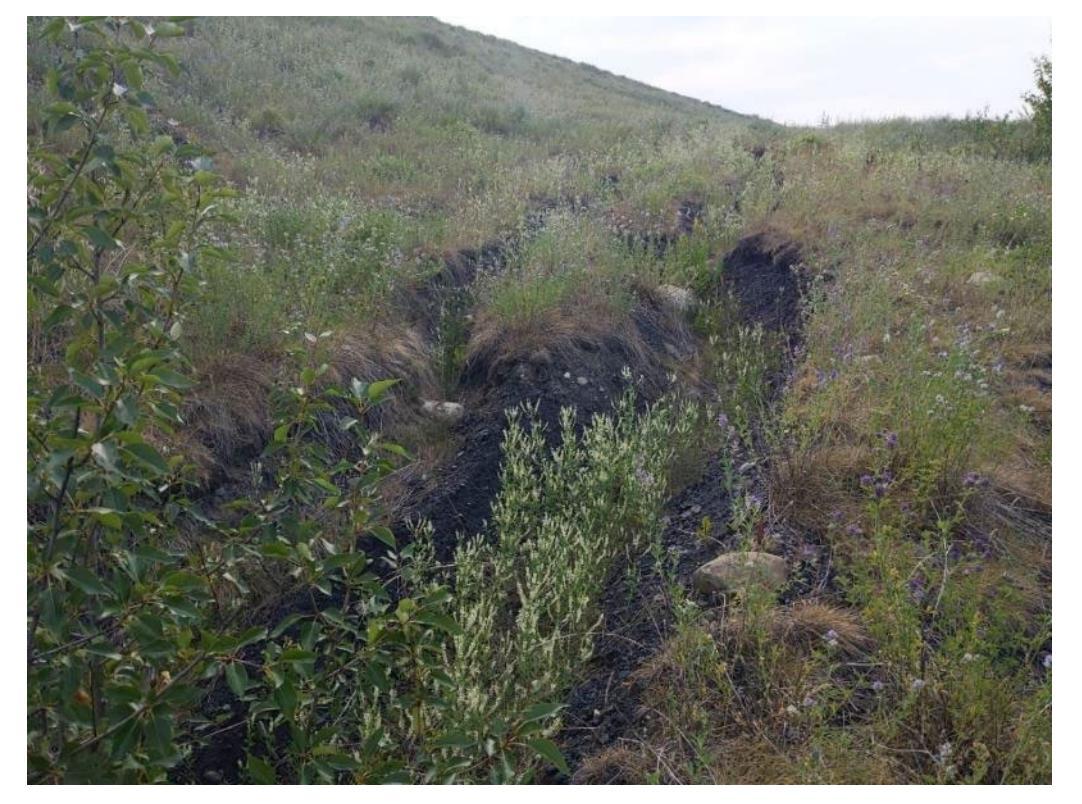
Photo I-19 Erosion gulley at the toe – looking southeast (PTD-2021-09)

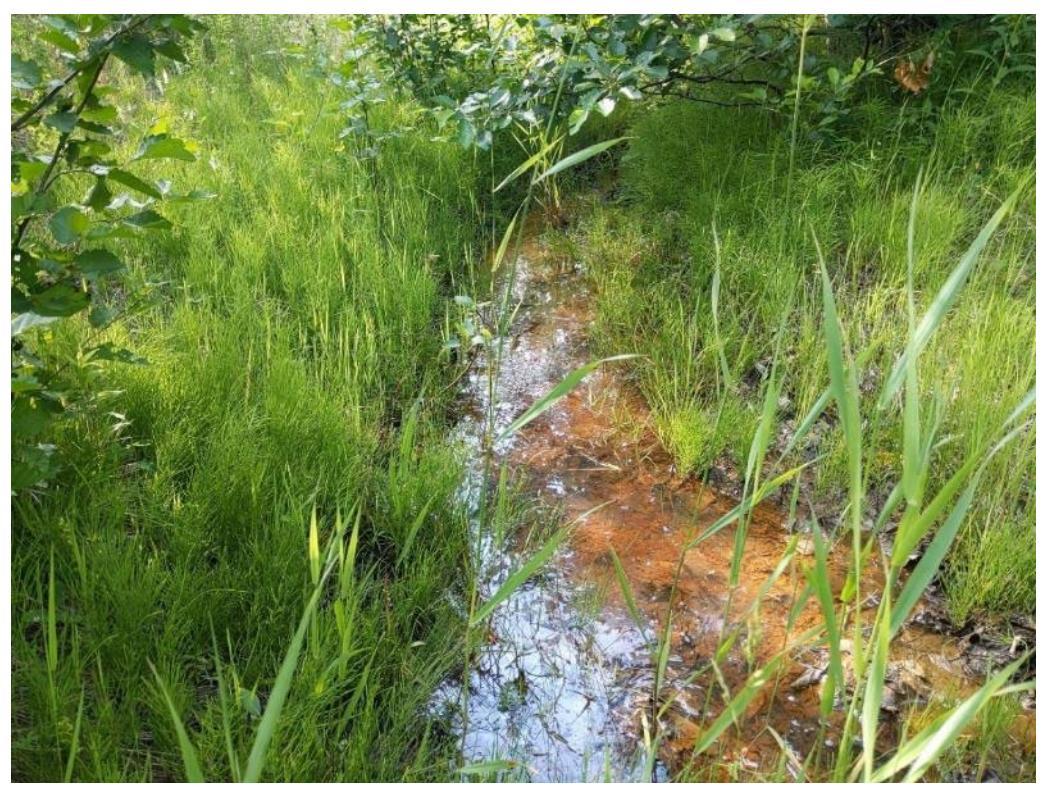
Photo I-20 Shallow ponded water in Seepage Collection Ditch (PTD-2021-10)

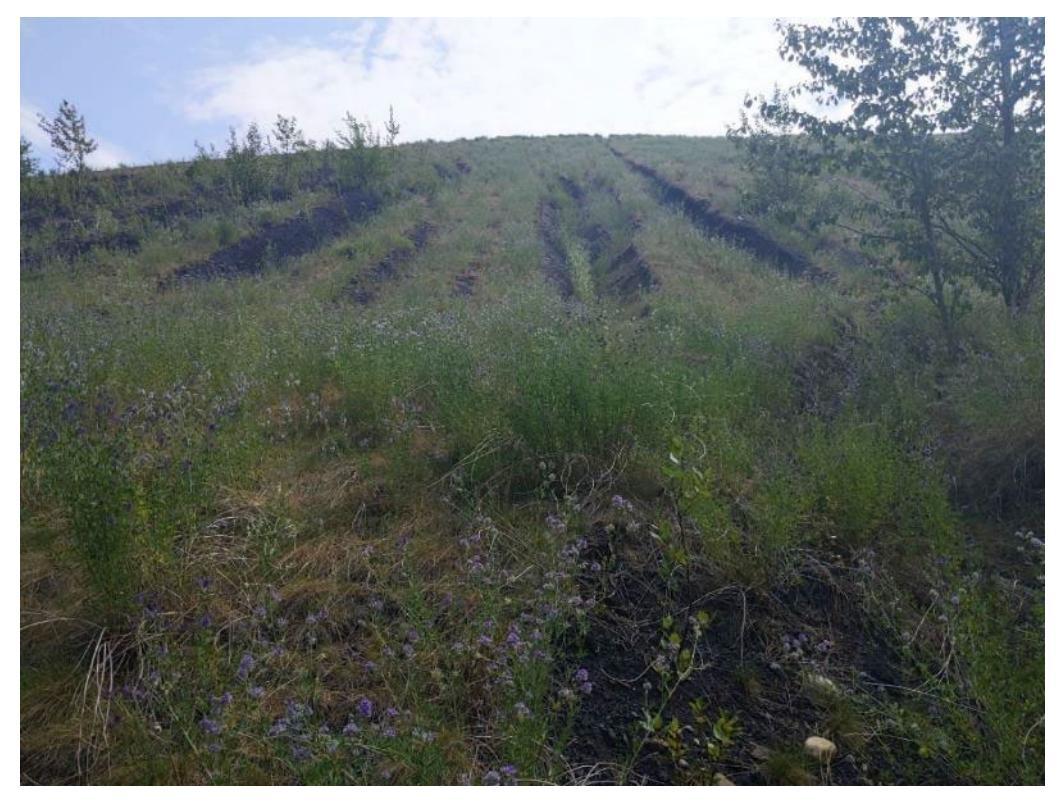
Ongoing rill erosion has been observed on the slope of the PTSF since operations ceased. The rills are up to 1 m deep in some cases, however they have not impacted the crest. The rills are observed during routine inspections for signs of change. Photographs are taken from selected locations and compared to previous site visits. Rill monitoring locations and photographs are included in Appendix II.

Photo I-29 PTD Downstream Slope erosion rills – looking east (PTD-2021-18)

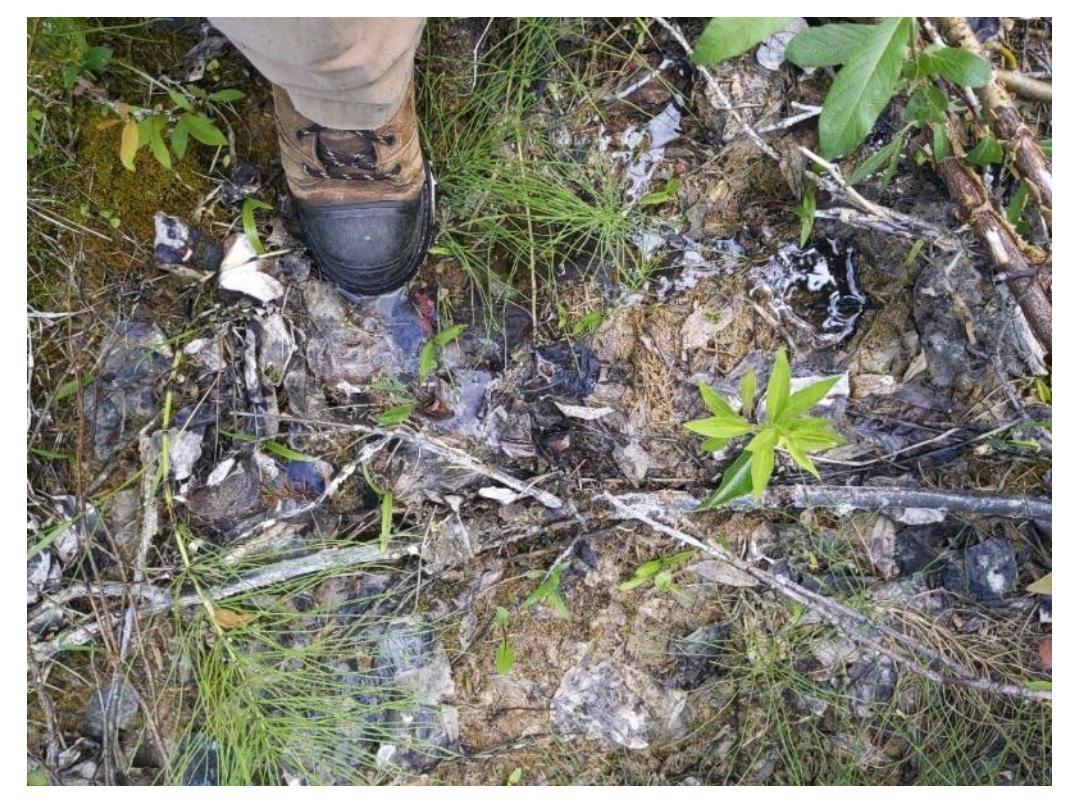
- Closure Spillway Outlet to M17 Channel: Good condition. Vegetation is well established. No signs of obstruction or debris blocking the outlet.
- **Seepage**: Minor seepage was observed from the finger drains at several locations along the toe. Where seepage was flowing from the finger drain, the water was clear.

Photo I-33 Seepage daylighting at toe of north wingwall (PTD-2021-22)

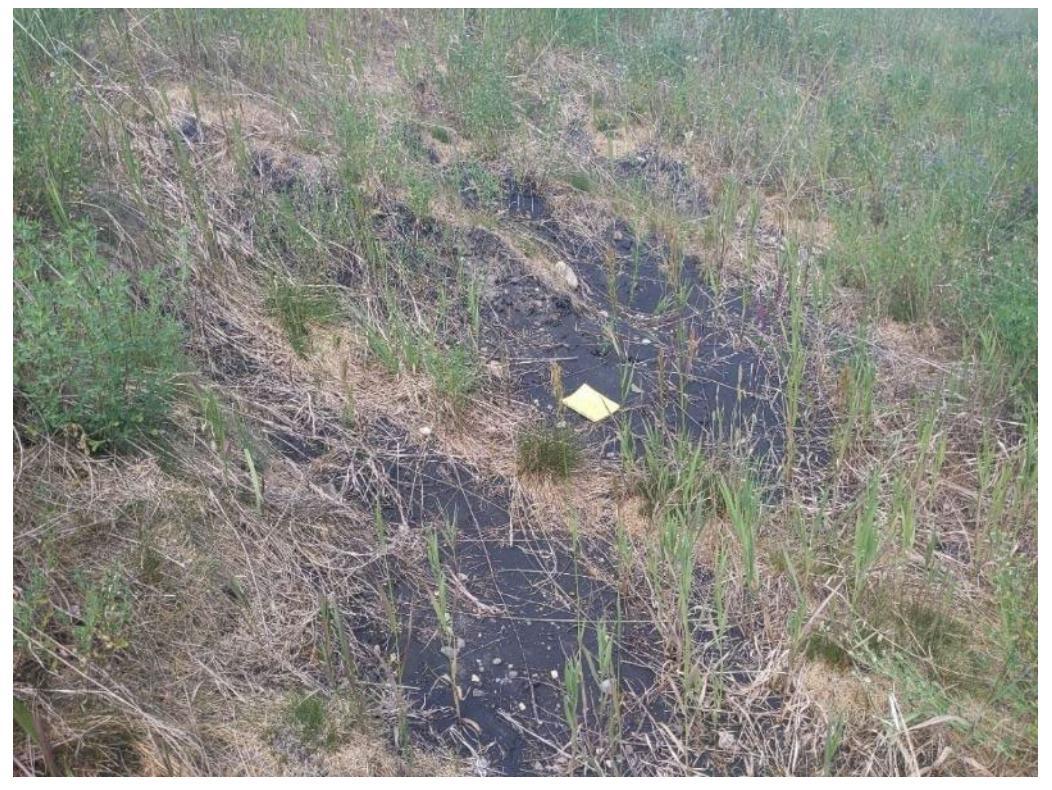
- Downstream Slope and Toe: Good condition. No signs of cracking, sloughing, slumping, seepage, excessive vegetation, or animal activity. The minor depression on the east embankment slope observed in 2018, which was attributed to animal activity, did not show signs of change. This feature is not considered a dam safety concern. Rilling was observed on the downstream slope, similar to previous site visits; however, there was no visually discernable change in rill size. Refer to Section 4.6 for discussion of rill erosion and Appendix II for rill photographs.

Photo I-40 Depressions on Embankment Slope, presence of a spoil pile adjacent to the depressions suggests that these were caused by animal activity (PTD-2021-29)
