Teck Highland Valley Copper Partnership

2023 Annual Facility Performance Report

Highmont Tailings Storage Facility

March 2024

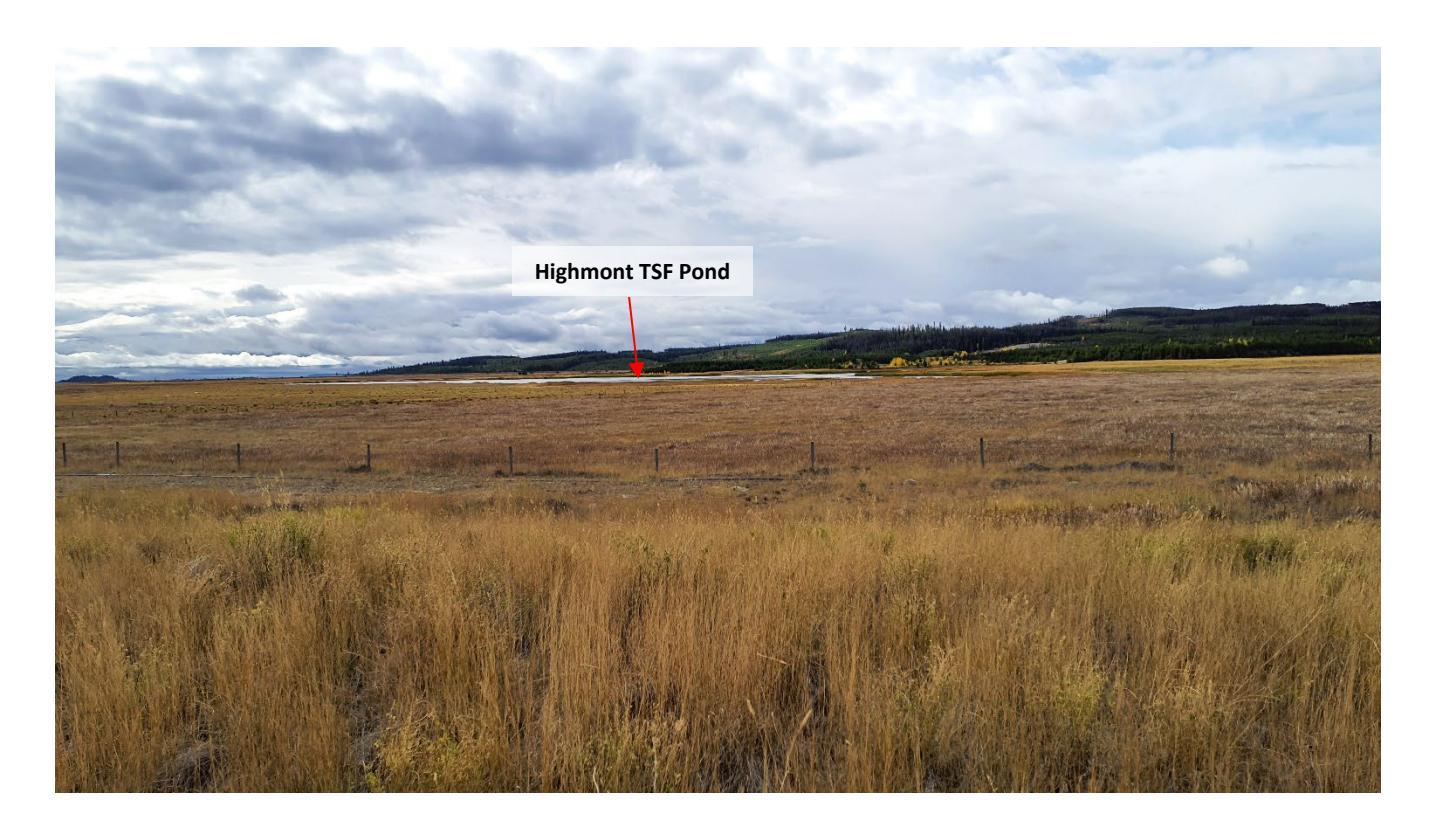
Photo I-A-2 View of tailings impoundment and beach from East Dam (HGH-2023-02)

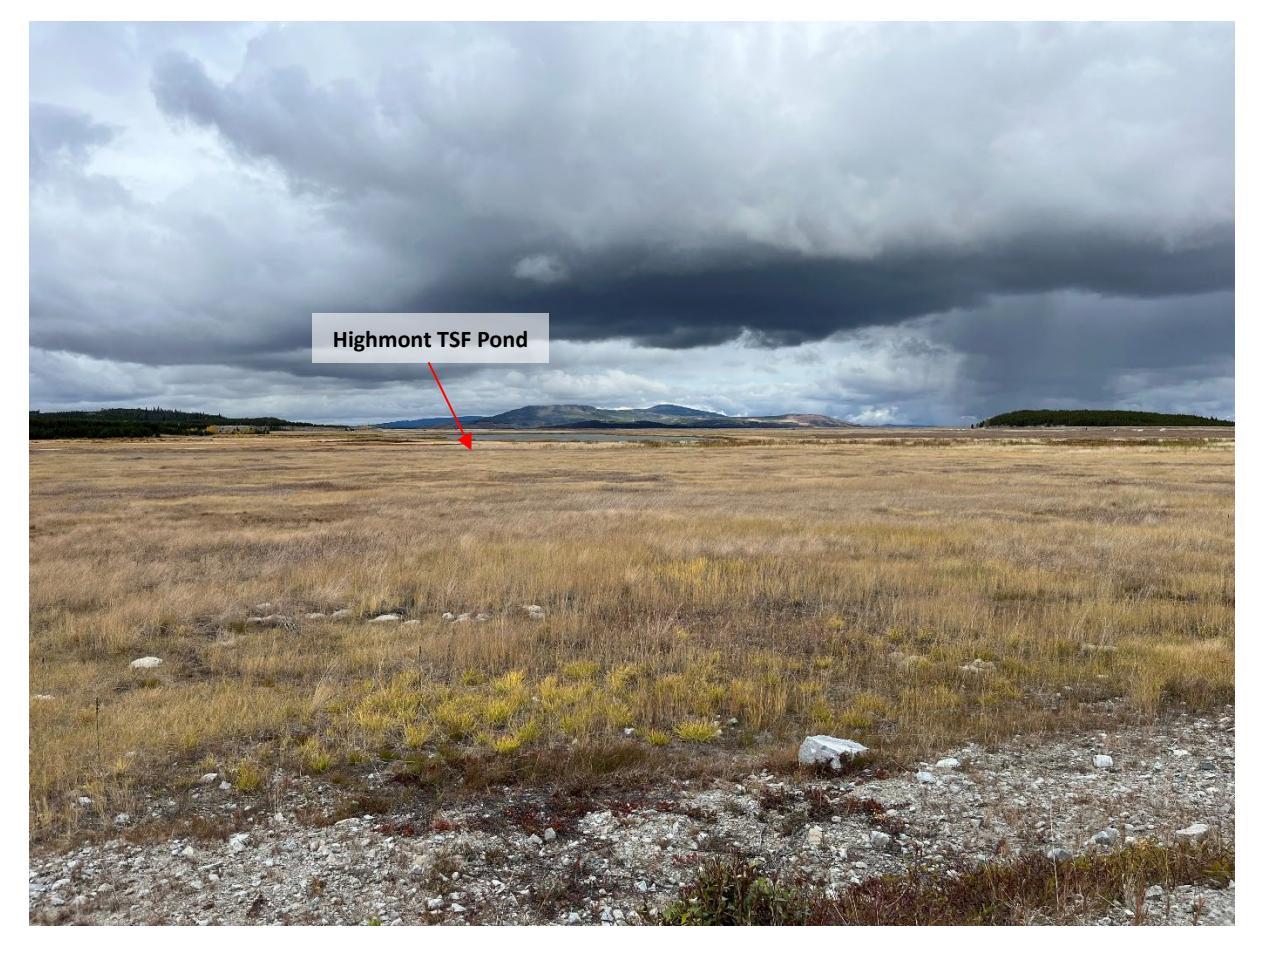
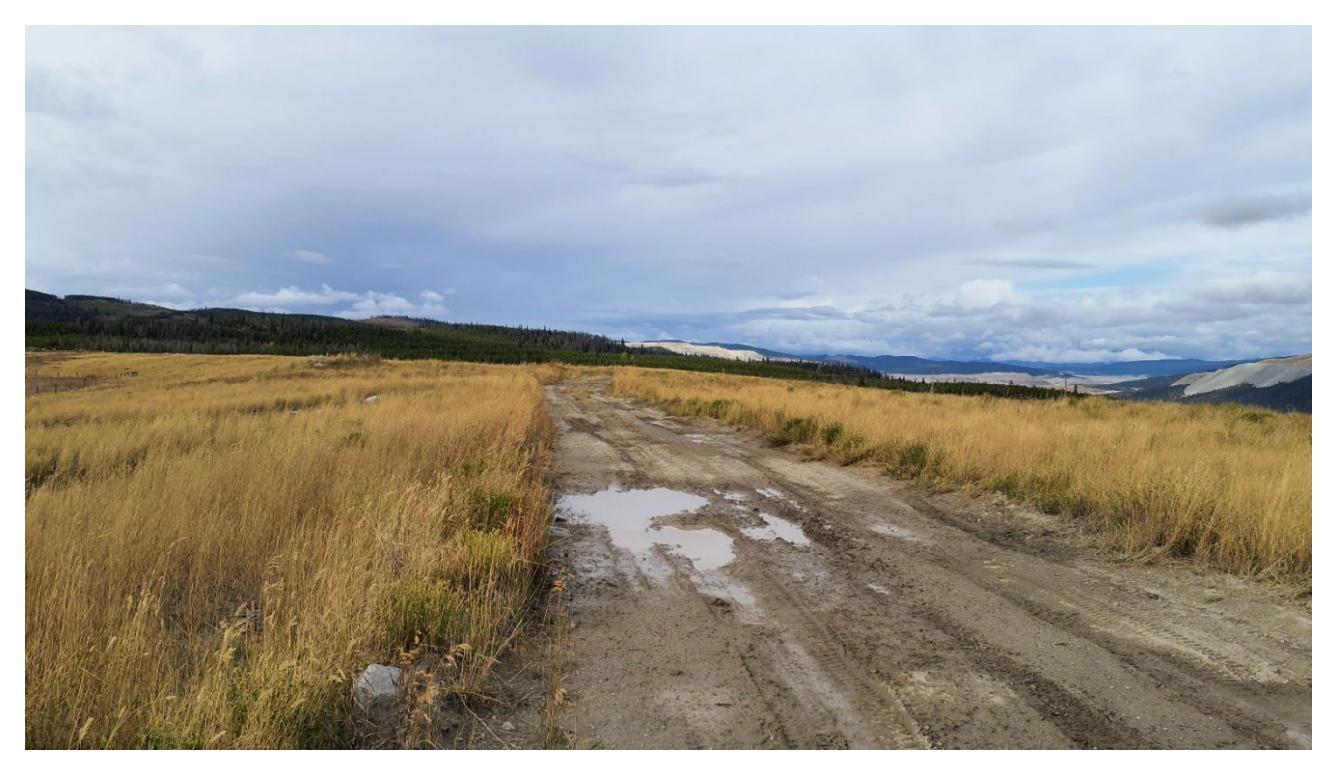
Photo I-A-4 View of North Dam crest looking west and east respectively. Crest is in good condition. No signs of distress, settlement, or depression (HGH-2023-01 and HGH-2023-04)

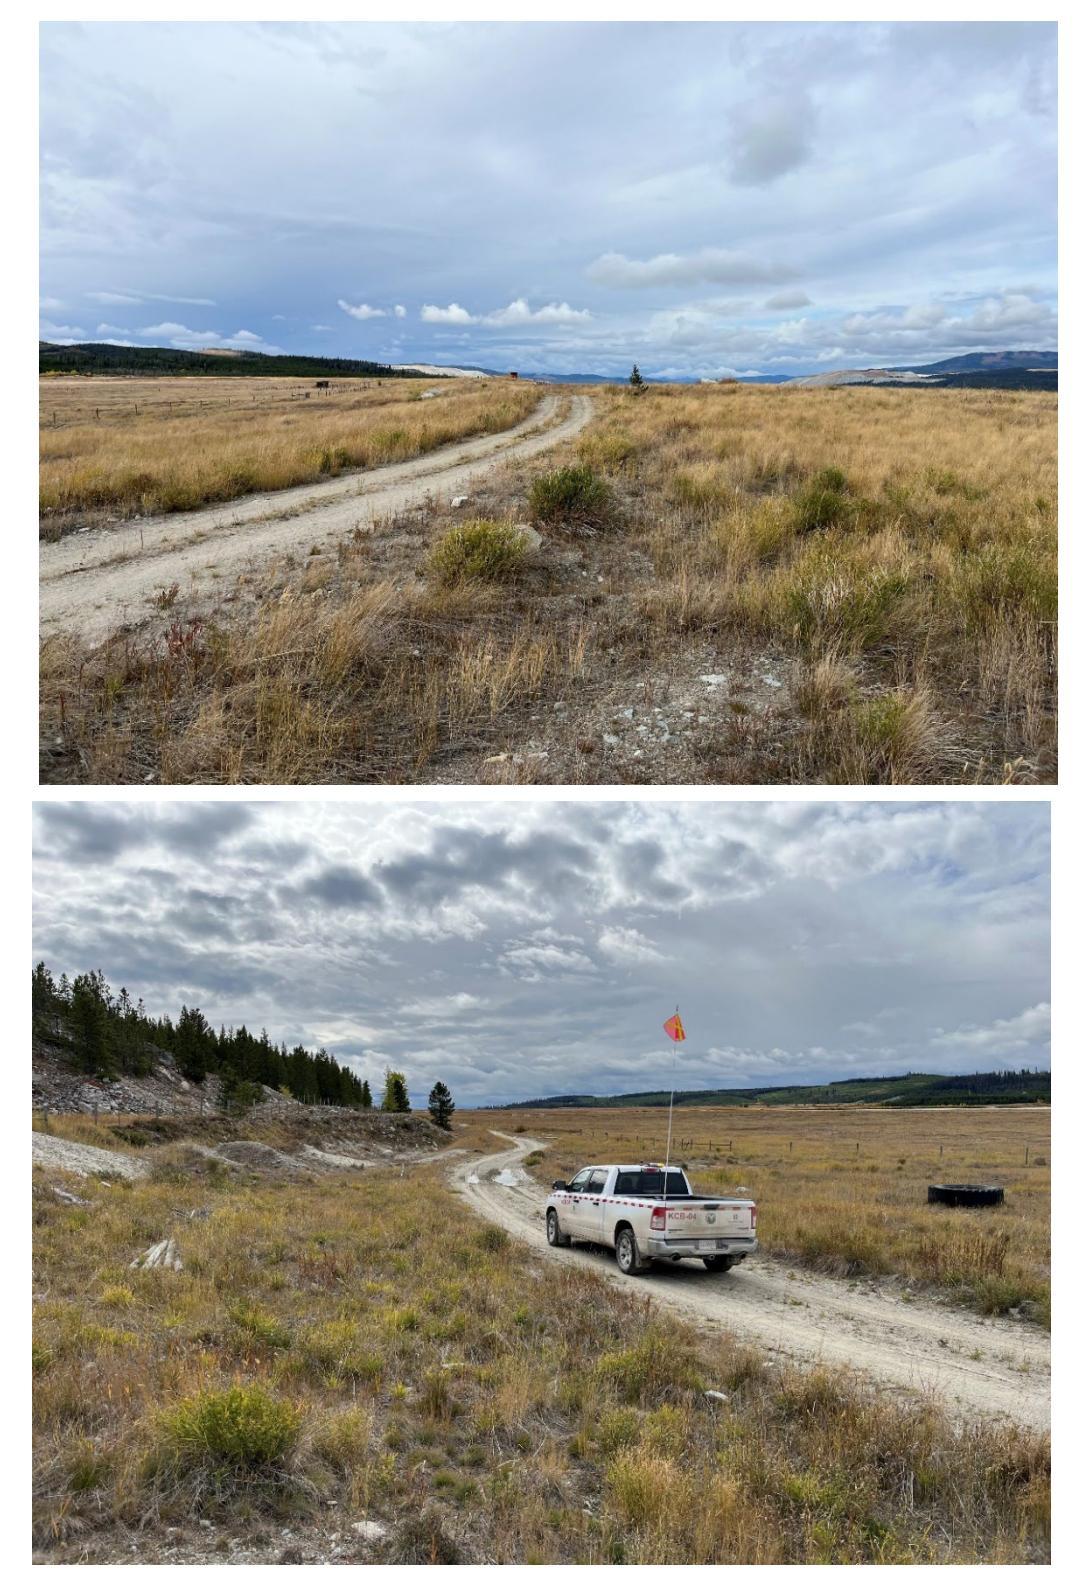
Photo I-A-6 View of East Dam crest looking north and south respectively. Crest is in good condition. No signs of deformation or distress were observed (HGH-2023-02)

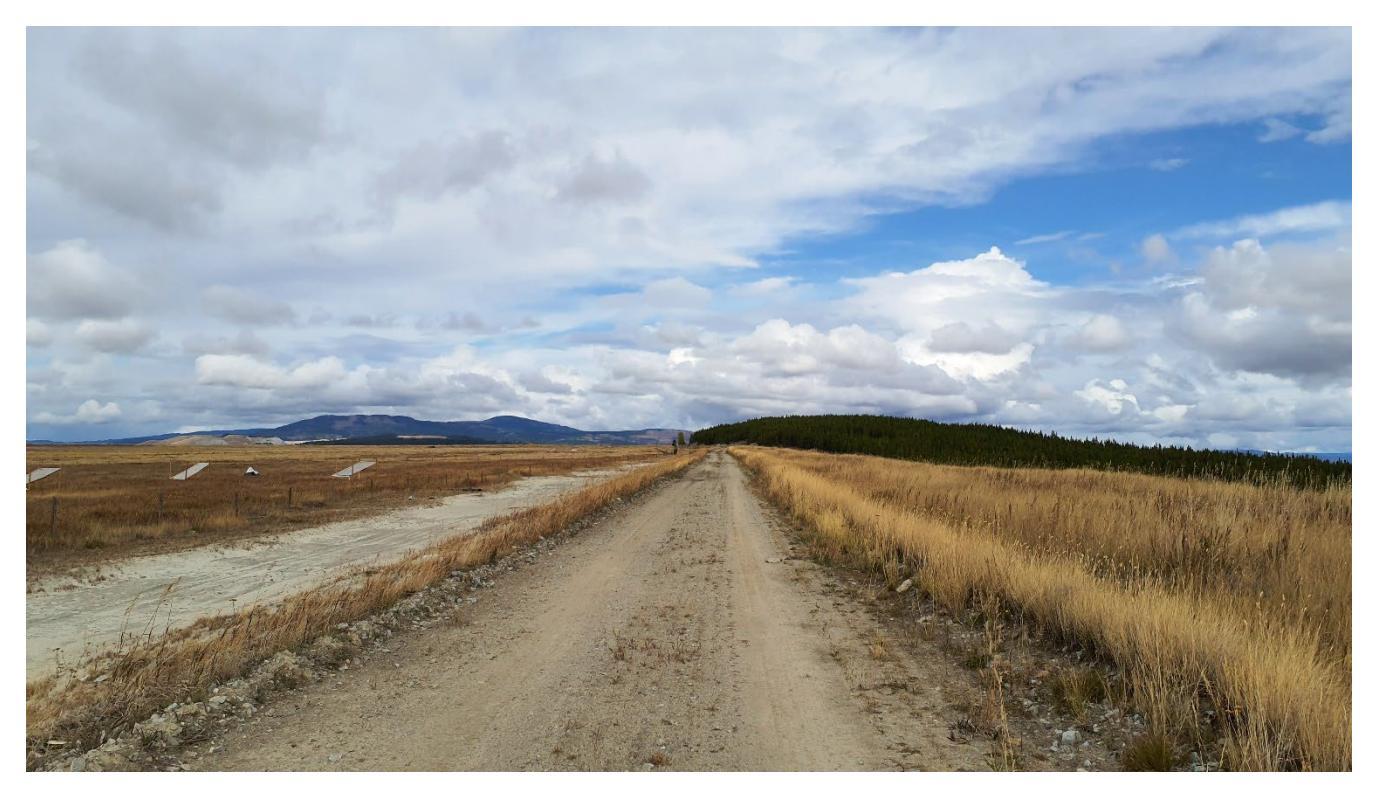
Photo I-A-7 View of North Dam downstream toe and S8 Pond. No signs of distress or deformation were observed (HGH-2023-06)

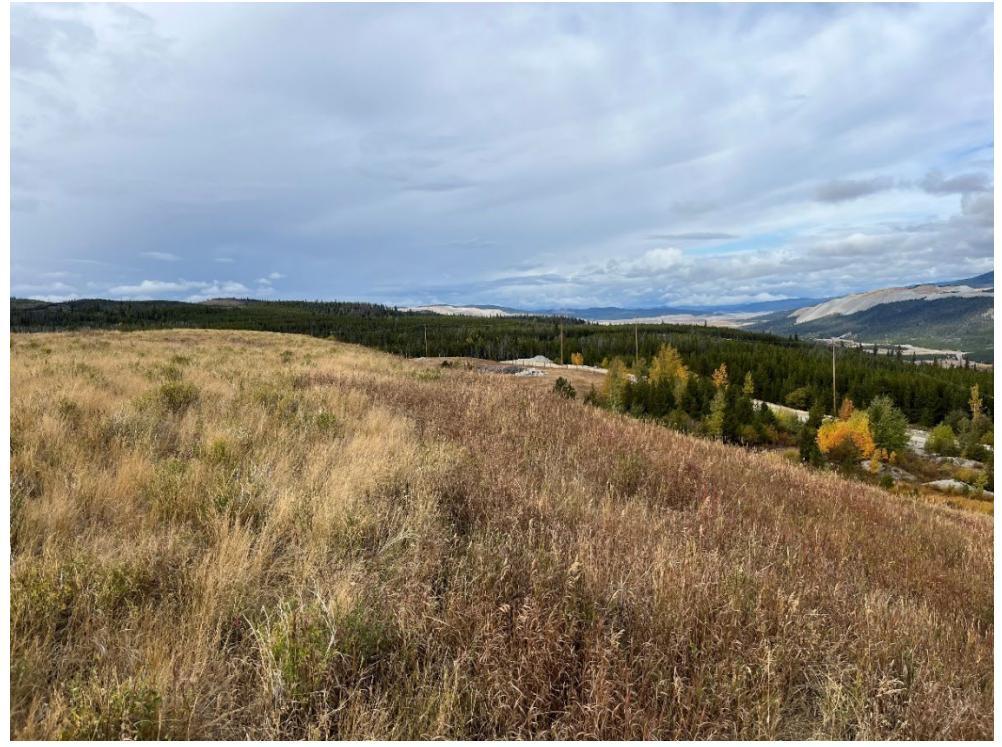
Photo I-A-9 East Dam downstream slope. Slope is vegetated and in good condition (HGH-2023-07)

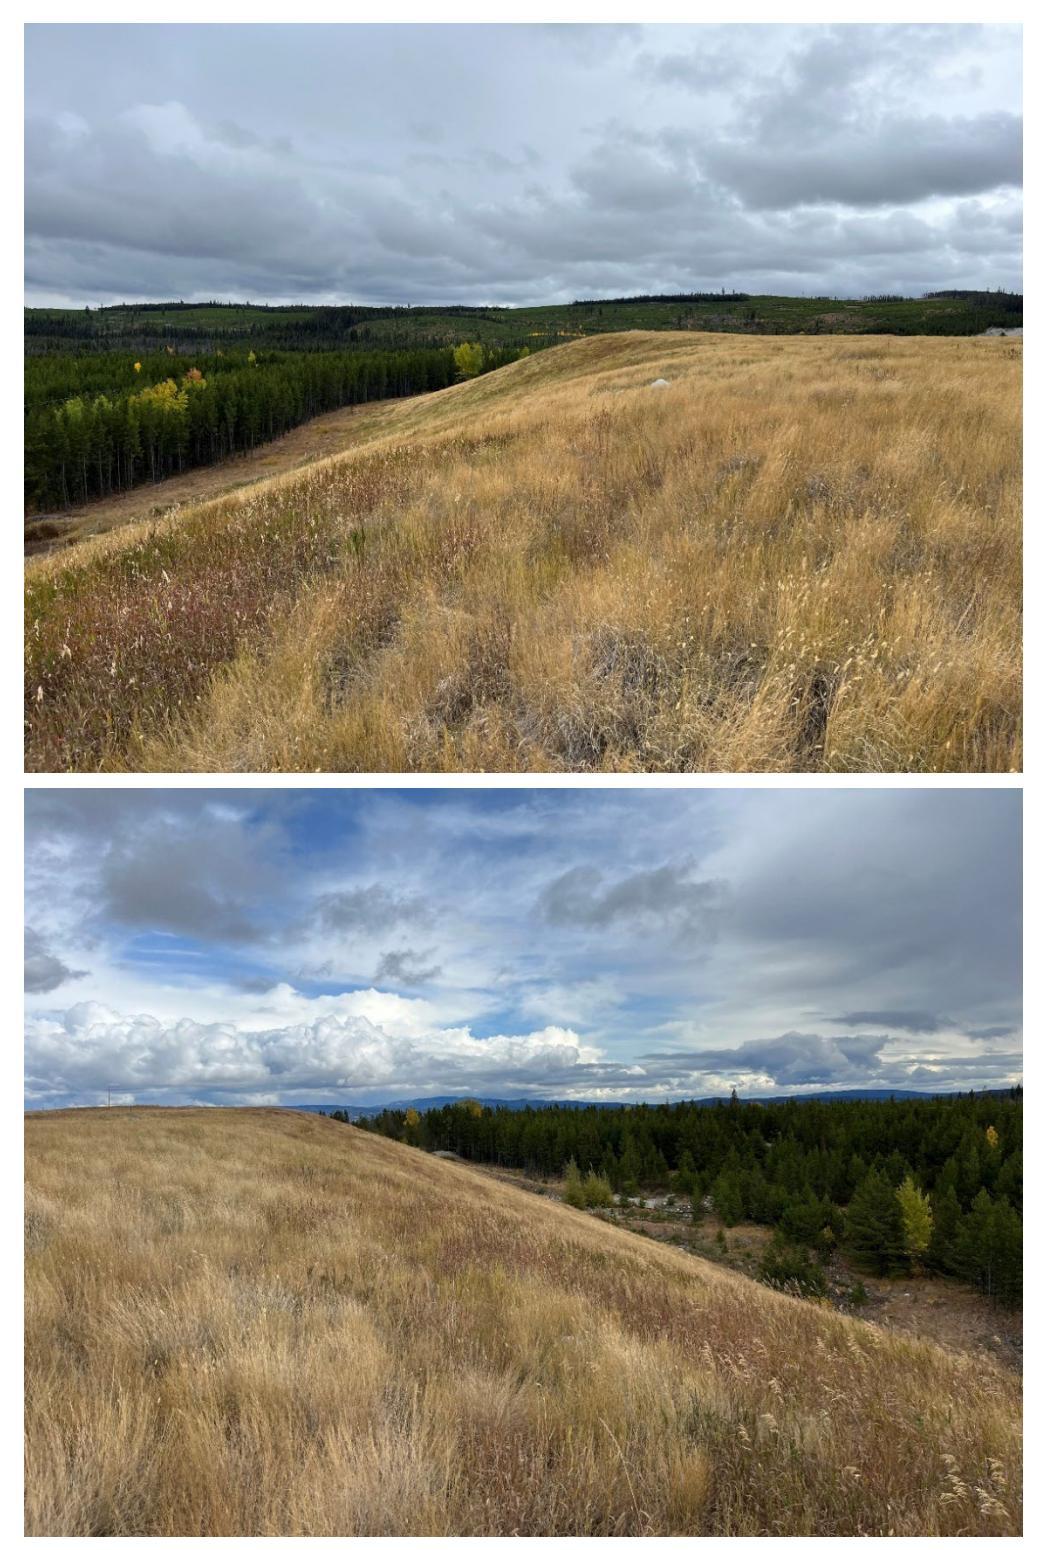
Photo I-A-11 View of South Dam downstream slope and S3 pond. Slope is vegetated and in good condition (HGH-2022-08)

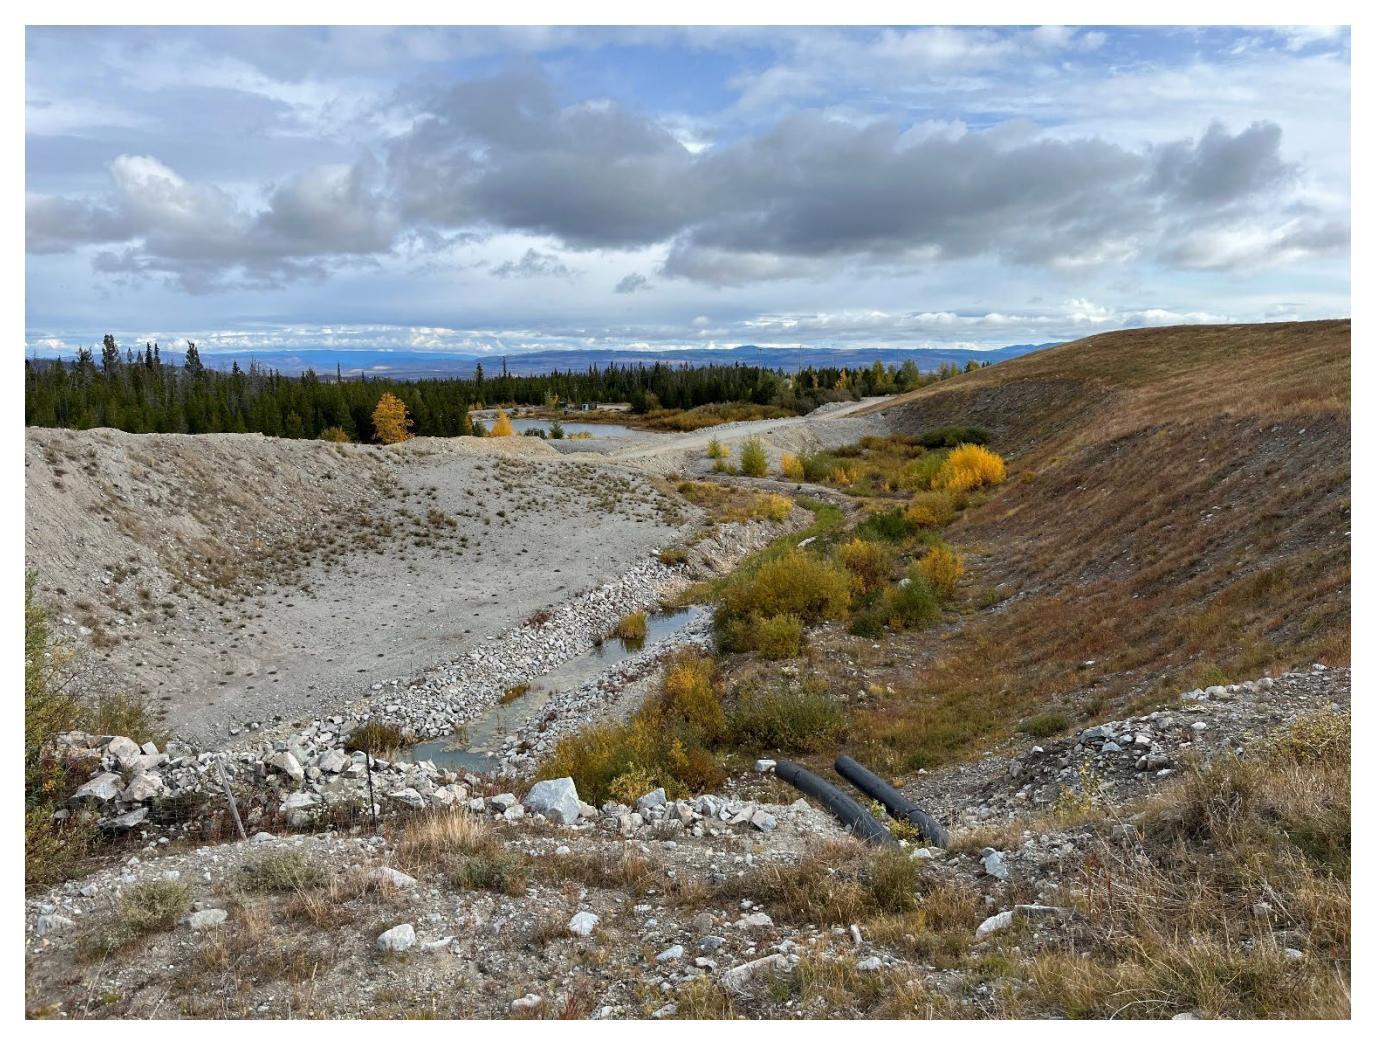
Photo I-A-19 Spillway channel downstream of spillway chute. Water is ponded downstream of spillway drop, which is typical (HGH-2023-18)

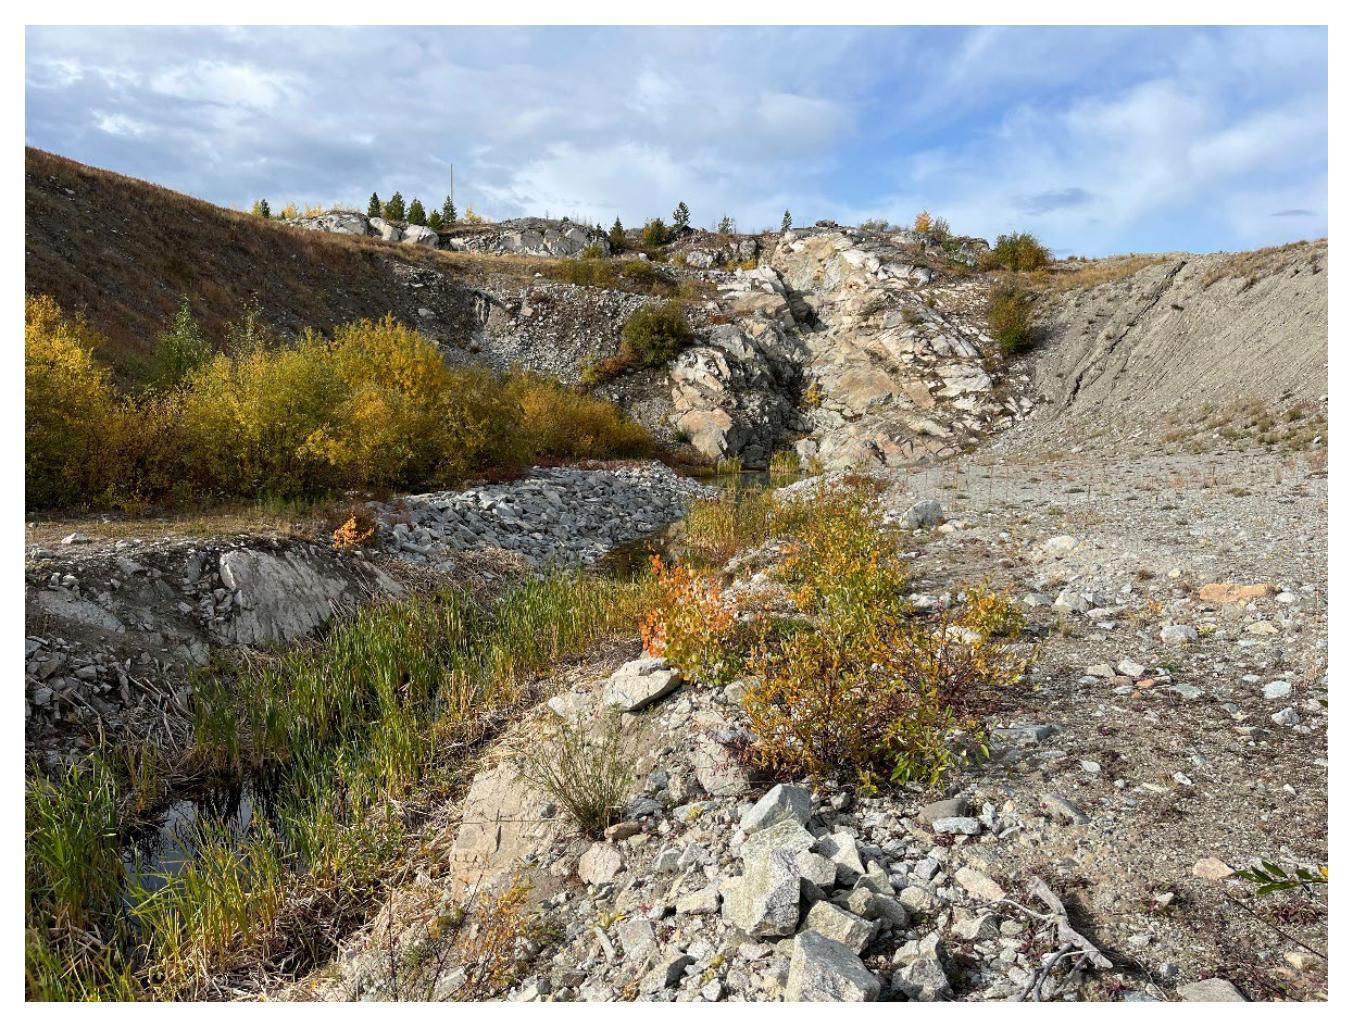
Photo I-A-20 View of spillway channel downstream of S2 Pond road at the toe of the North Dam. Gass observed in channel is typical of this time of the year and does not require further action beyond routine maintenance specified in OMS Manual (HVC 2022) (HGH-2023-17)

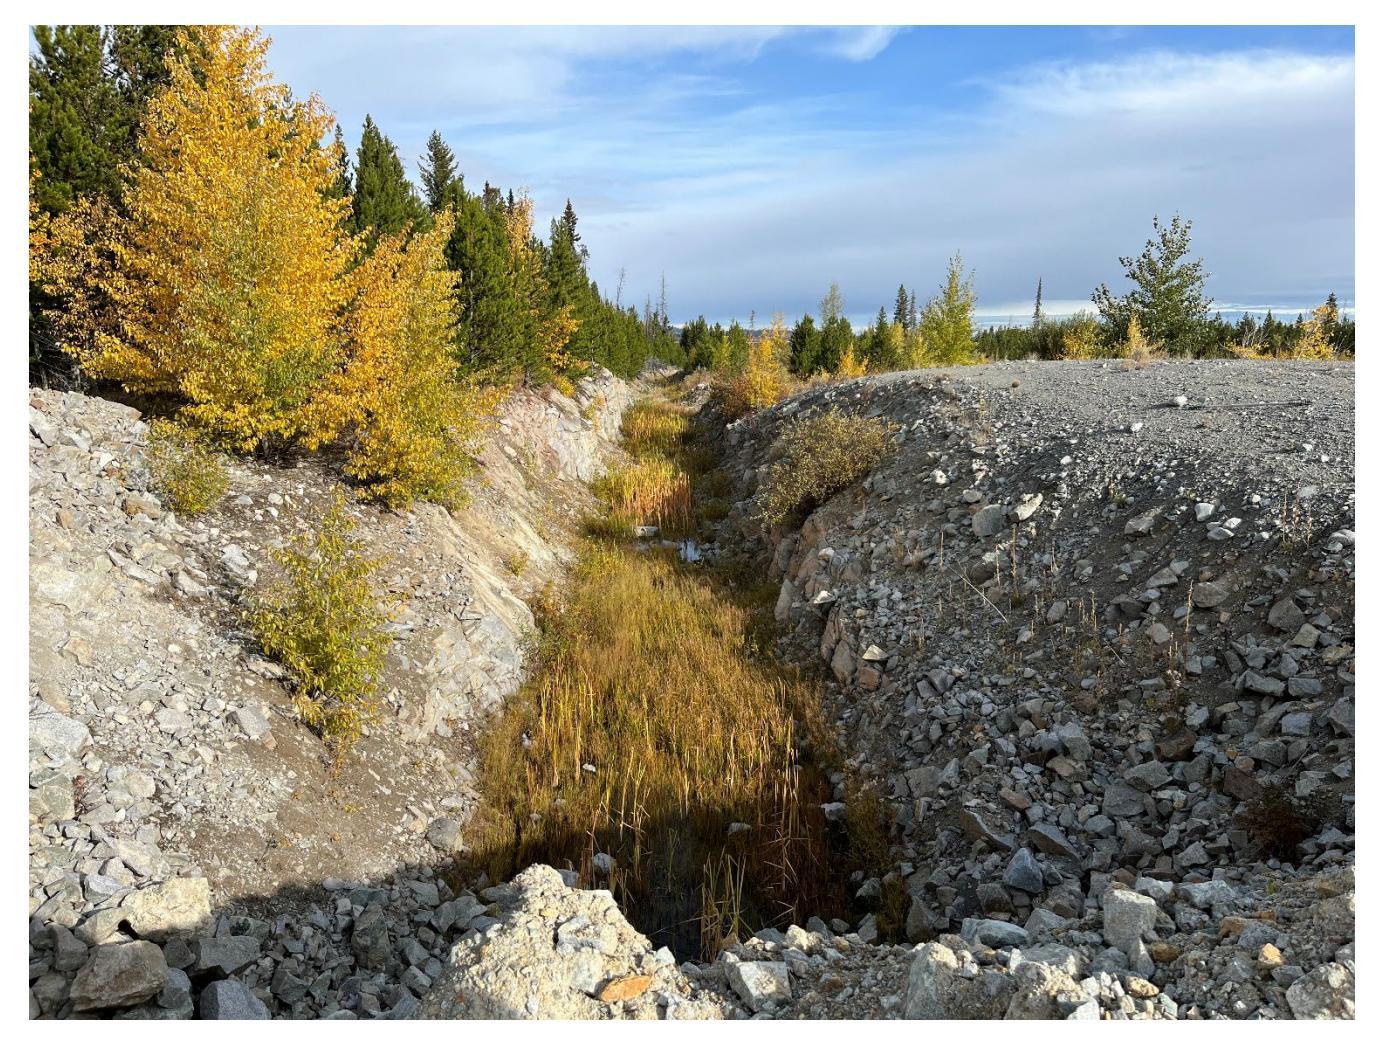
Two new recommendations were identified (Table 2) during the 2023 AFPR. One was to clear the Highmont TSF spillway culverts, downstream of the dam, that were partially obstructed during the road regrading work. If a major flow goes through the culverts before they are cleared, water would back up at the toe of the dam and would not affect the water levels in the impoundment. Additionally, the road profile is built to overtop and redirect water to the spillway, if needed. The second is to update the OMS Manual with changes introduced by the revisions to the PE-376 permit issued during the review period.

Photo I-A-21 North Dam toe access road crossing culvert (downstream of road). Culverts are partially blocked; see AFPR recommendation HD-2023-01 (HGH-2023-17)

ID No.	Applicable Reg. or OMS Reference	Recommended Action	Priority ⁽¹⁾	Recommended Deadline				
	Highmont TSF							
HD-2023-01	Maintenance	The Highmont Spillway culverts crossing the S2 Pond road, at the toe of the North Dam, are partially blocked due to the road regrading works. Culverts should be cleared.	3	Q3 2024				
HD-2023-02	OMS Manual	Update OMS Manual with changes introduced by the PE- 376 changes.	3	Q1 2025

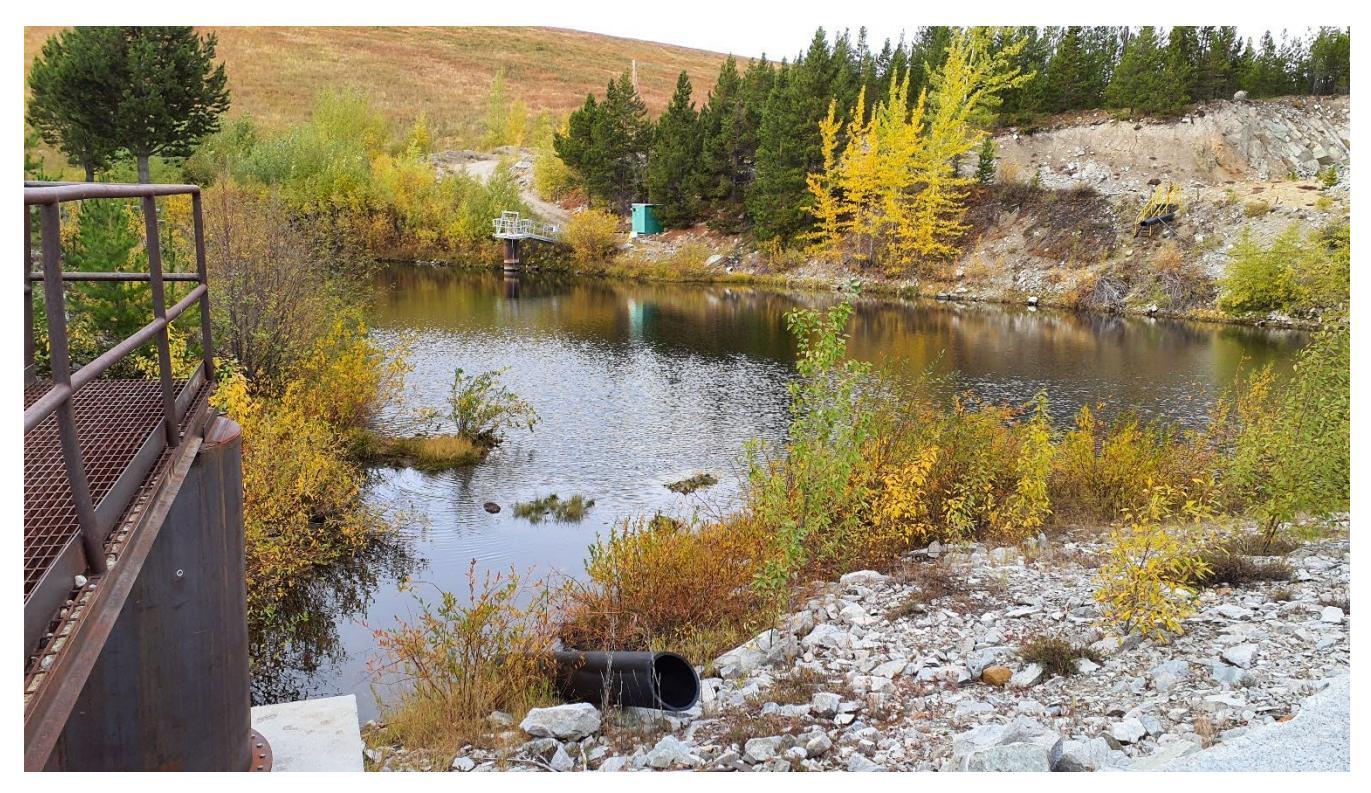
Photo I-B-4 S1 Pond: LLO to the left of spillway intake. Water was flowing into the LLO at the time of the site visit (HGH-2023-23).

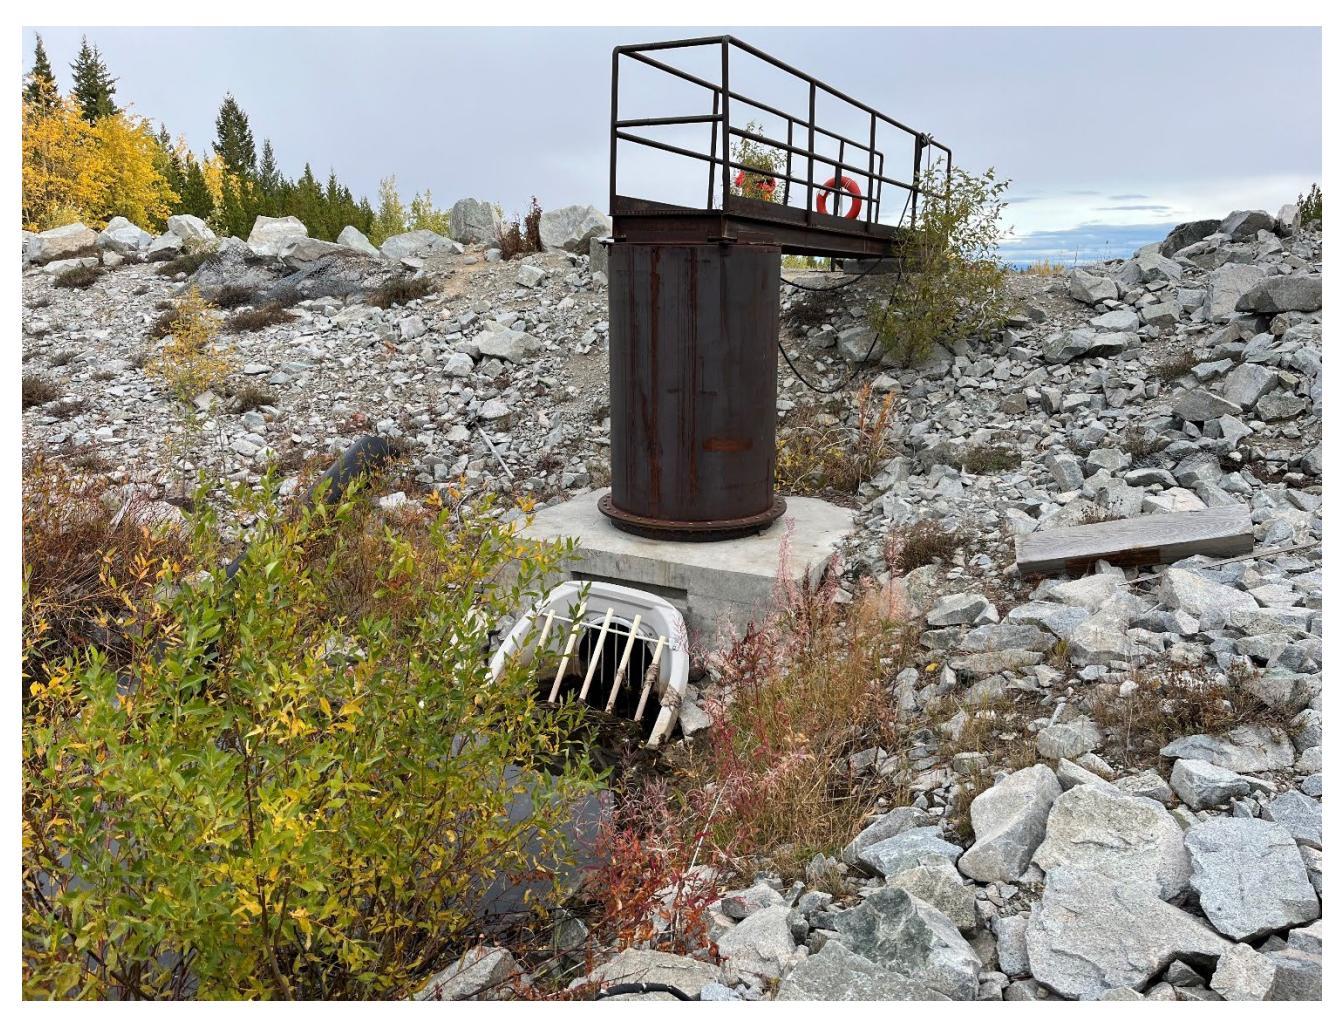
Photo I-B-5 S1 Pond: Spillway channel and pipe intake looking downstream. Channel is clear of vegetation and no sign of obstruction was observed at the pipe intake (HGH-2023-24).

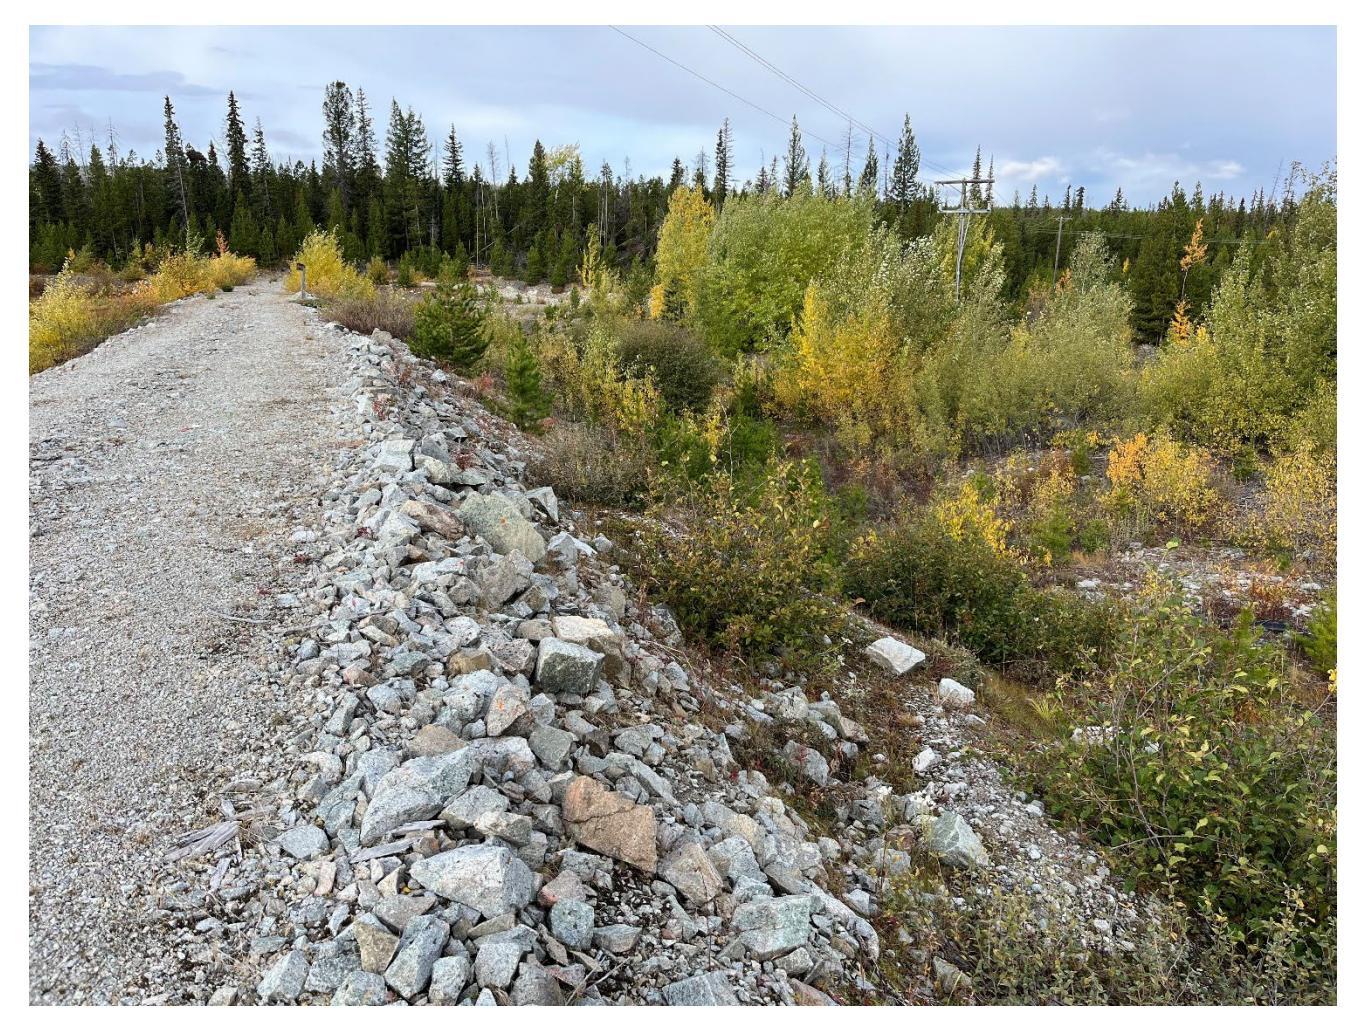
Photo I-B-7 S2 Pond: View of downstream slope. Slope is in good condition (HGH-2023-26).

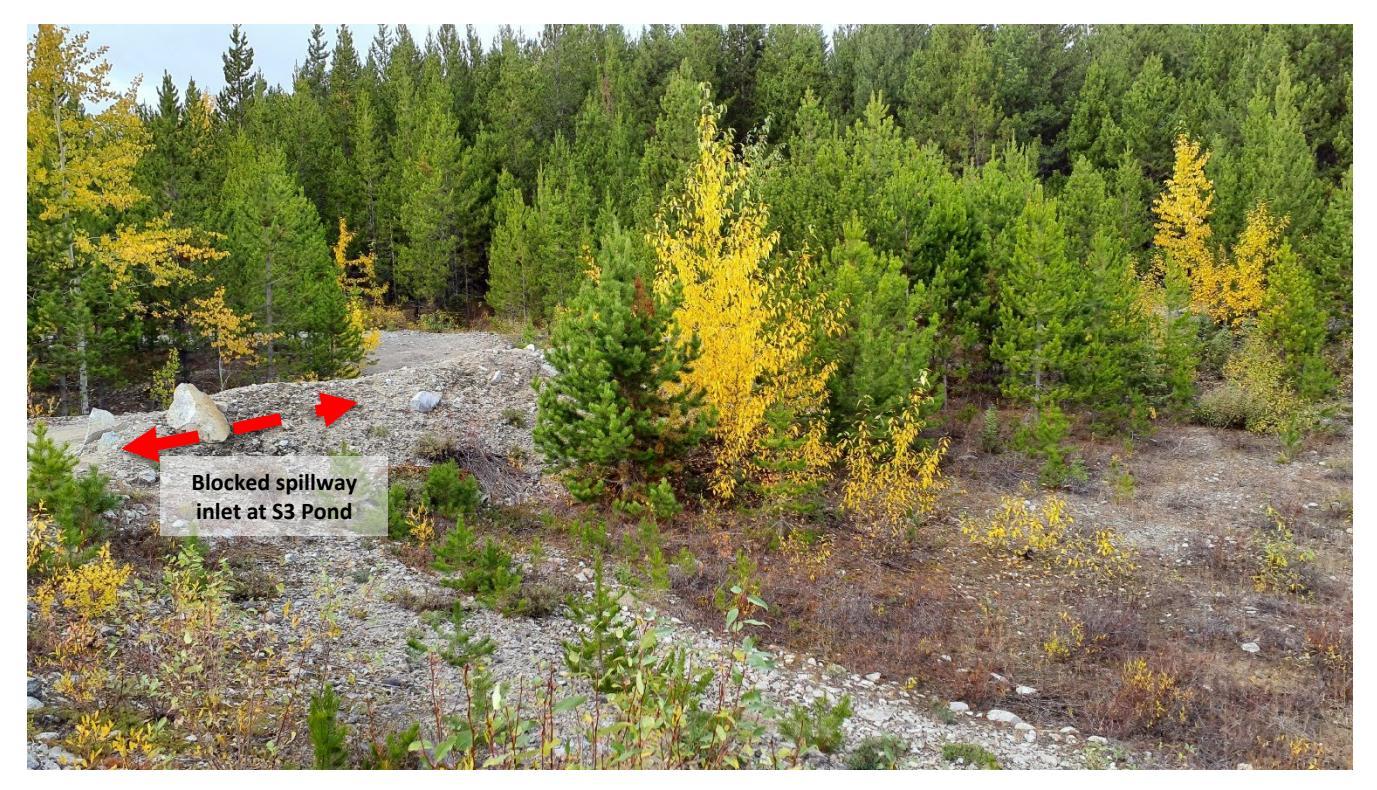
Photo I-B-16 S3 Pond: View of blocked spillway inlet at right abutment (HGH-2023-30).

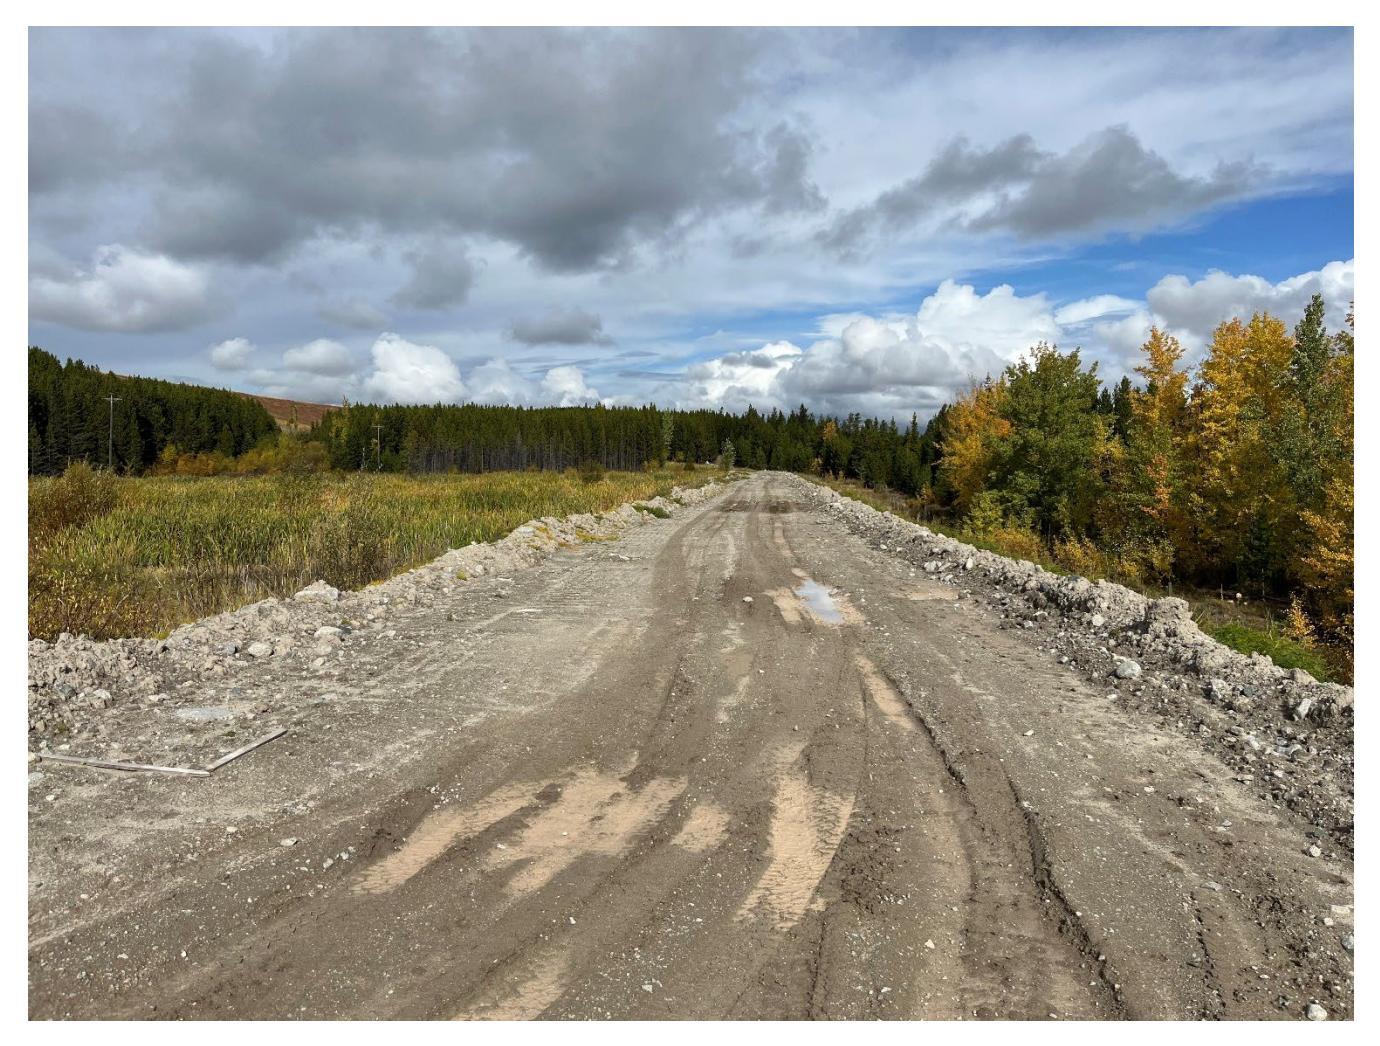
Photo I-B-17 S5 Pond: Overview of crest; in good condition (HGH-2023-32).

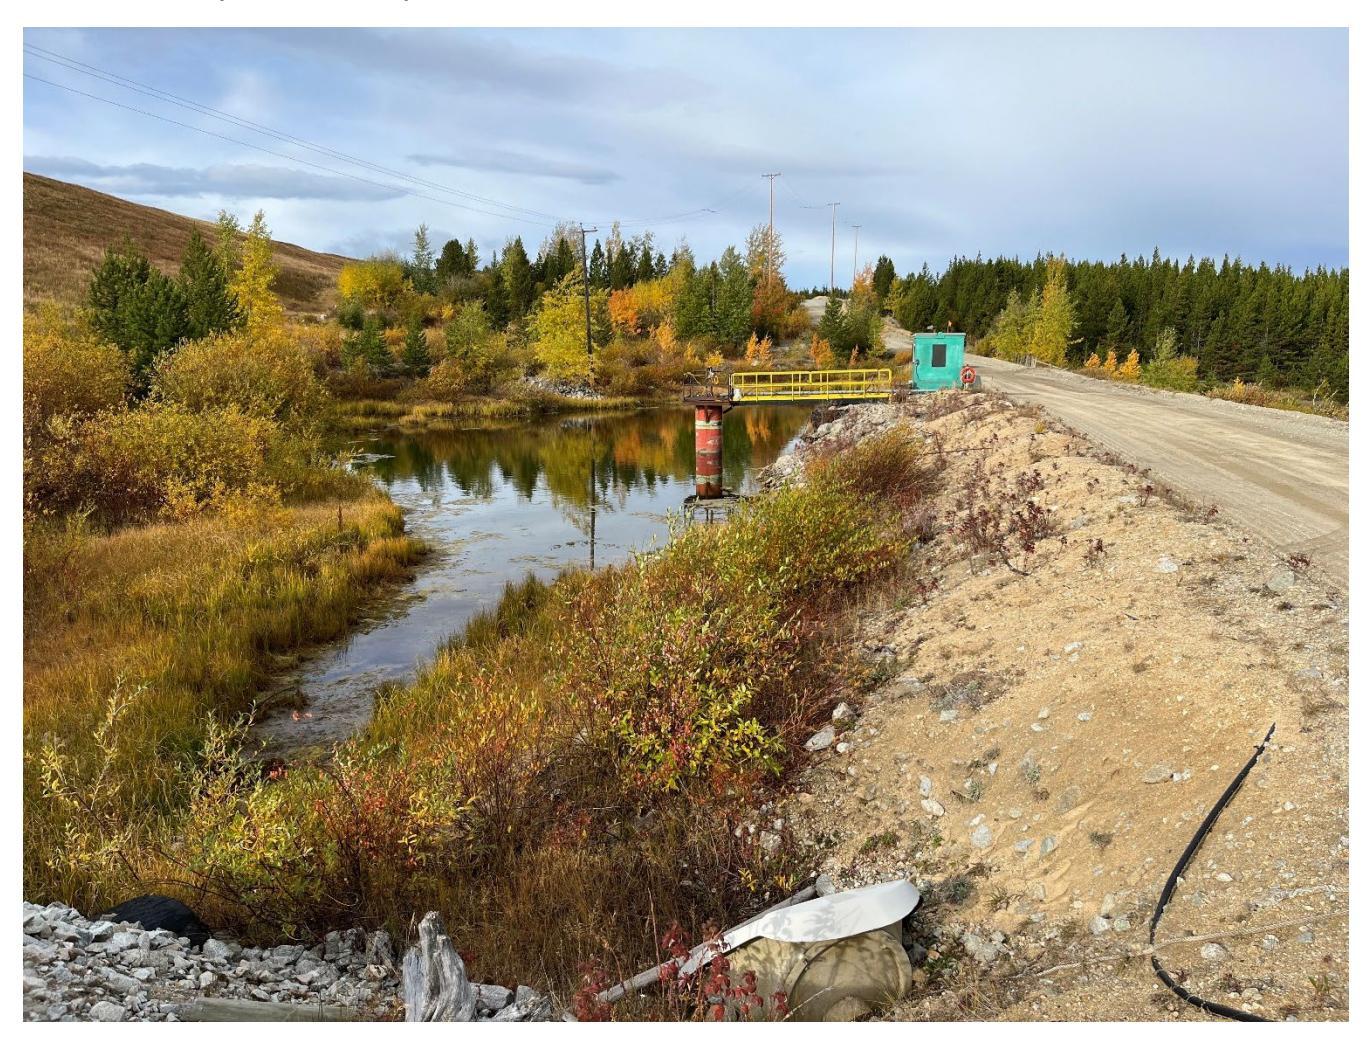
Photo I-B-25 S8 Pond: Overview of overflow pipe trash rack. Rack is clear of debris. Current water level is below the invert (HGH-2023-39).
