# Teck Highland Valley Copper Partnership

# **2023 Annual Facility Performance Report**

**Trojan Tailings Storage Facility**

March 2024

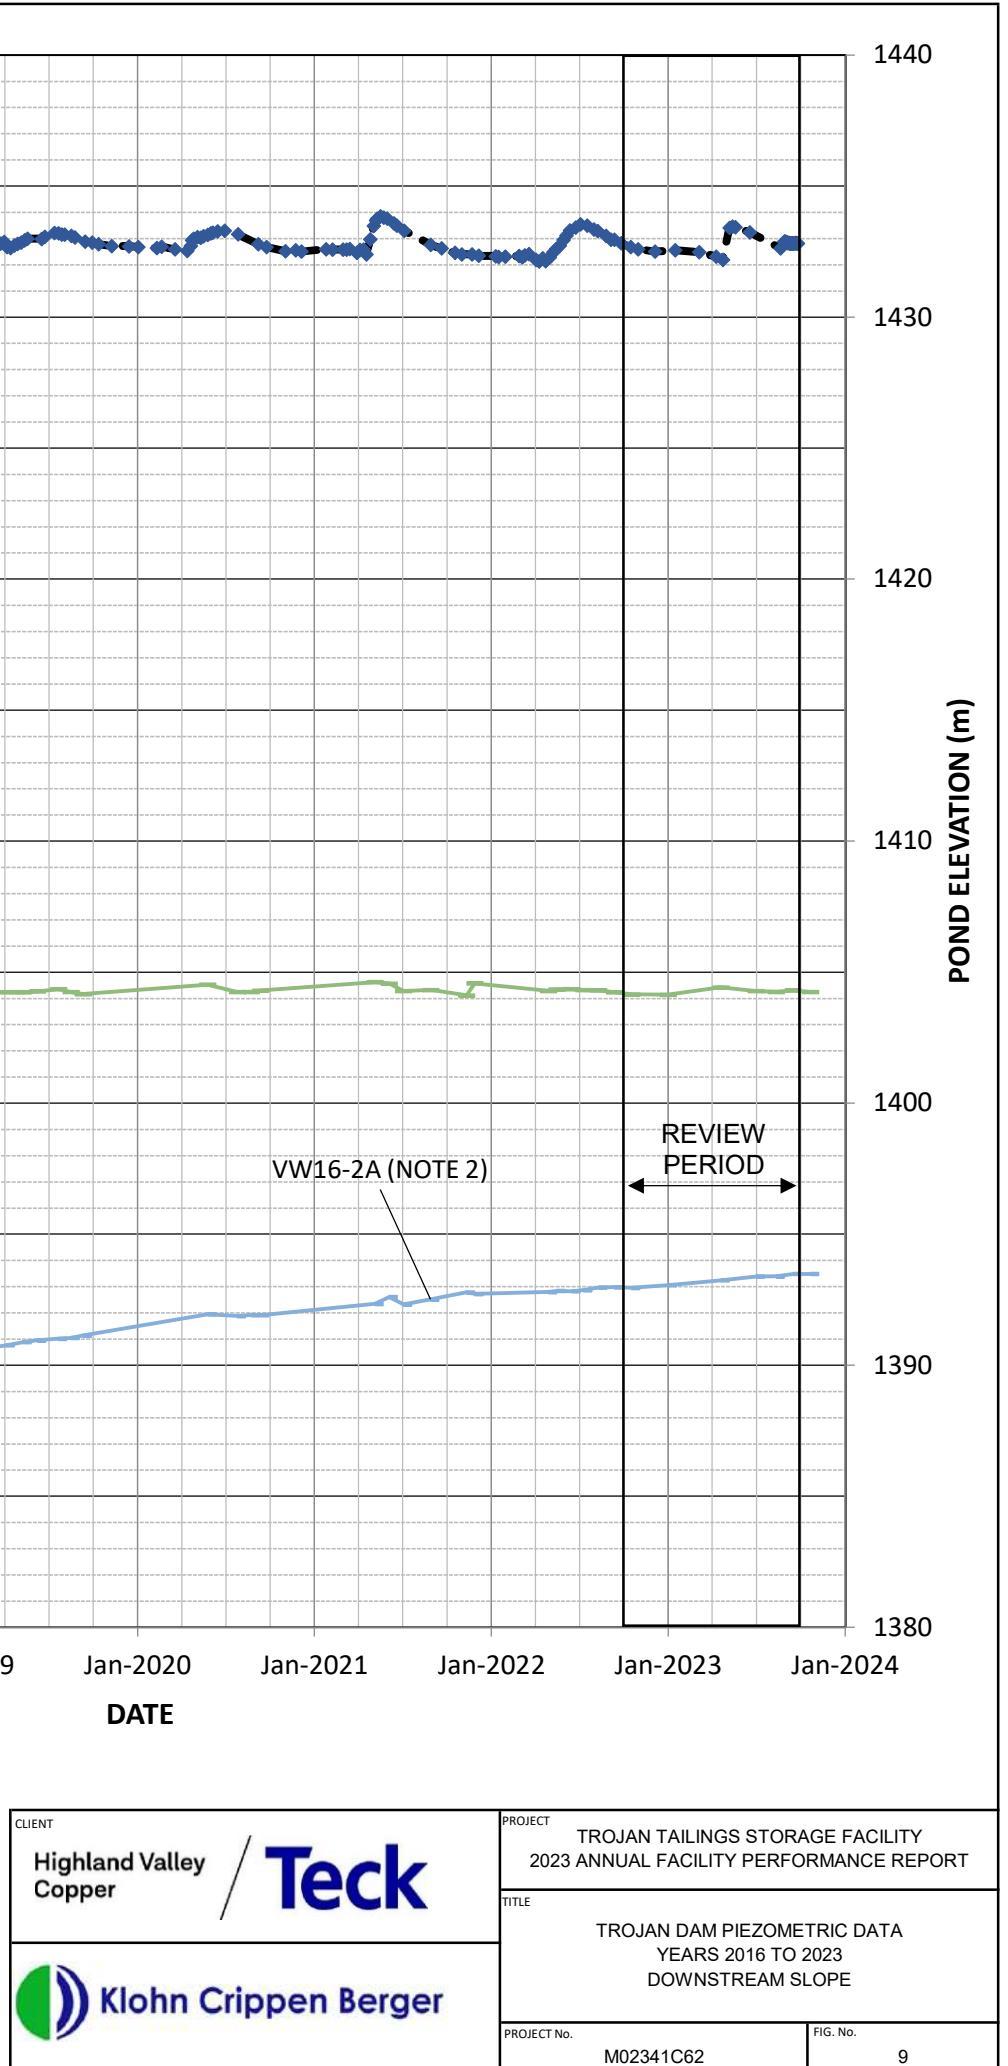
- Piezometer VW16-2A exceeded the Notification Level threshold value during the review period. This piezometer has been measuring a continued rise since installation in 2017. The rate of rise has been attenuating. The current piezometric level and threshold value are set below the level assumed in stability analysis. Piezometric rise is not a dam performance concern and the threshold is set so the reading is reviewed periodically as the instrument reading levels off. A revised threshold was defined for the 2024 update to the OMS Manual based on the rate of rise observed over the past 2 years:

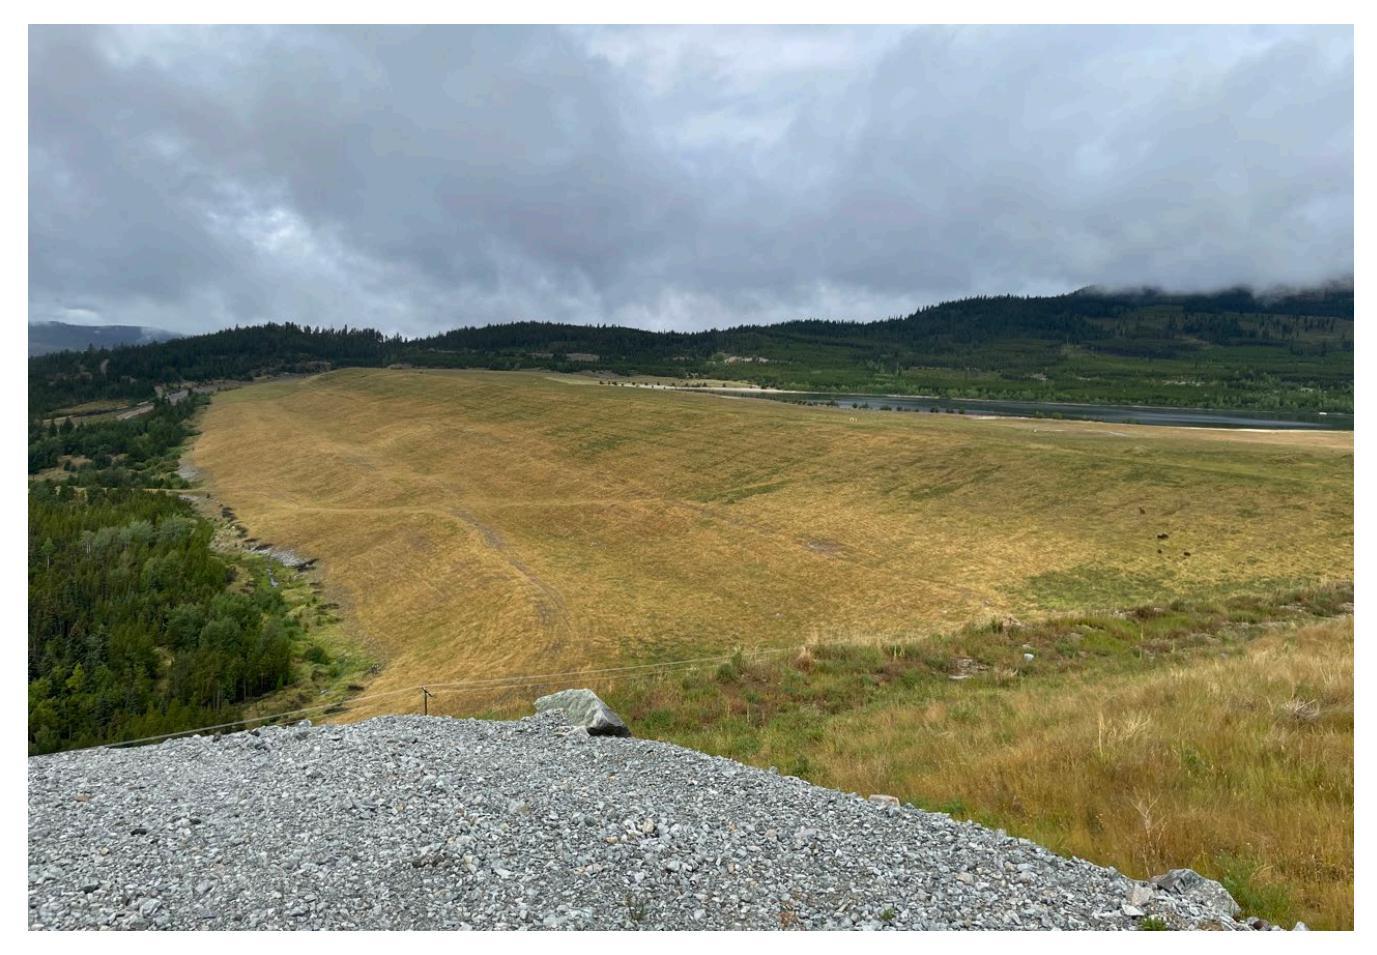
### Photo I-A-1 Overview of Trojan Dam downstream slopes from the Bethlehem Dam No. 1 crest. No observations of visible erosion or scour (TRJ-2023-01)

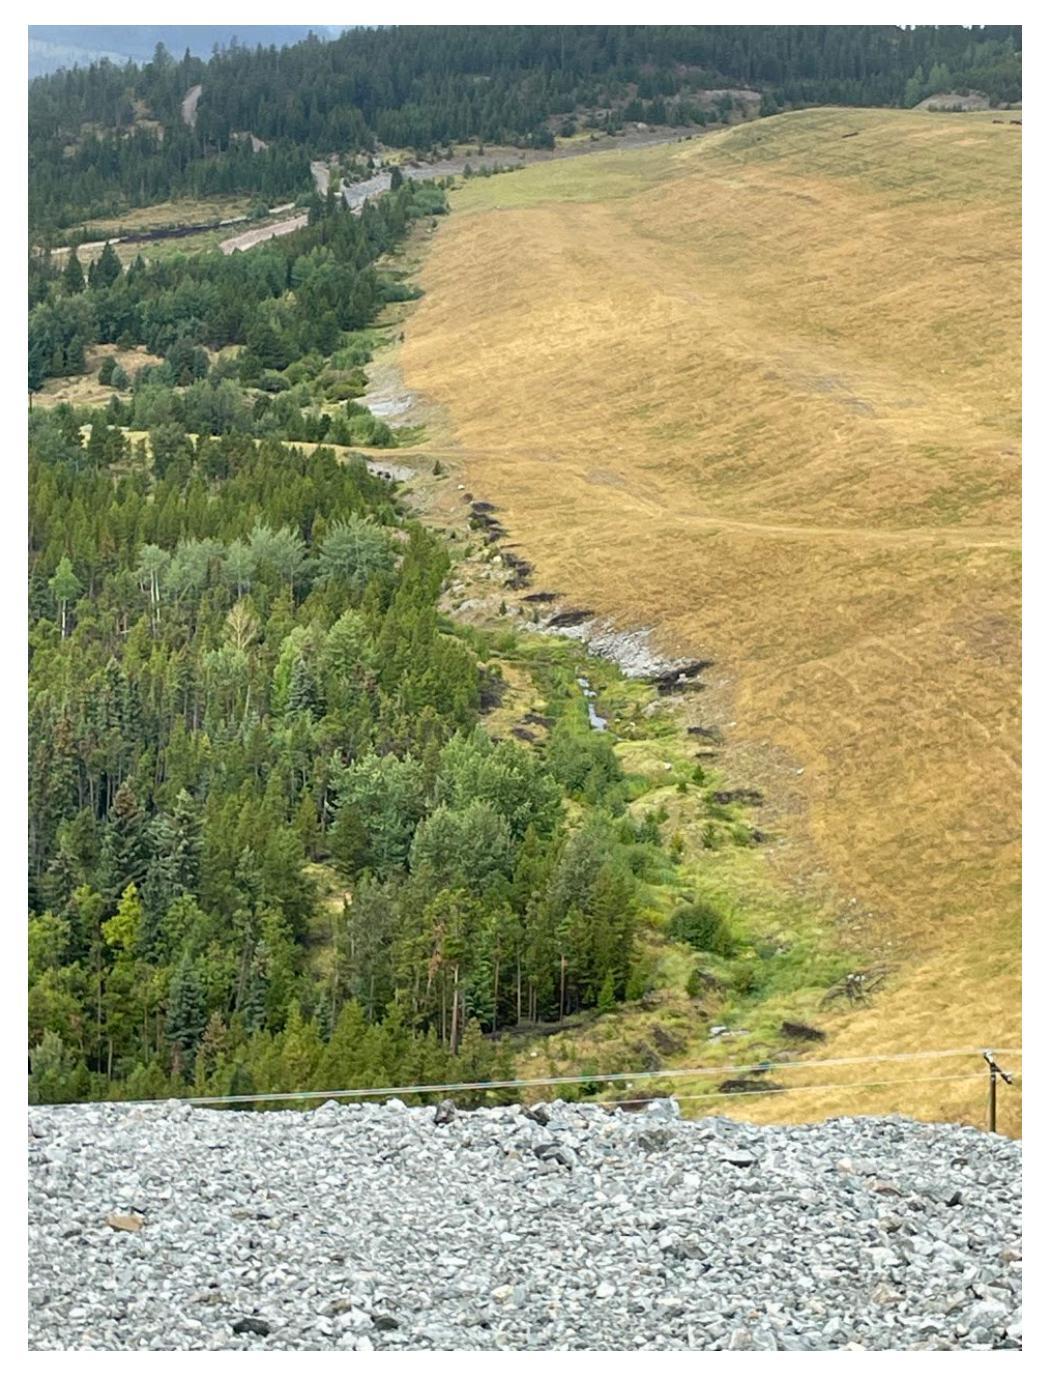
Photo I-A-2 Overview of Trojan Dam toe. No observations of visible erosion or significant change from the 2022 inspection (TRJ-2023-01).

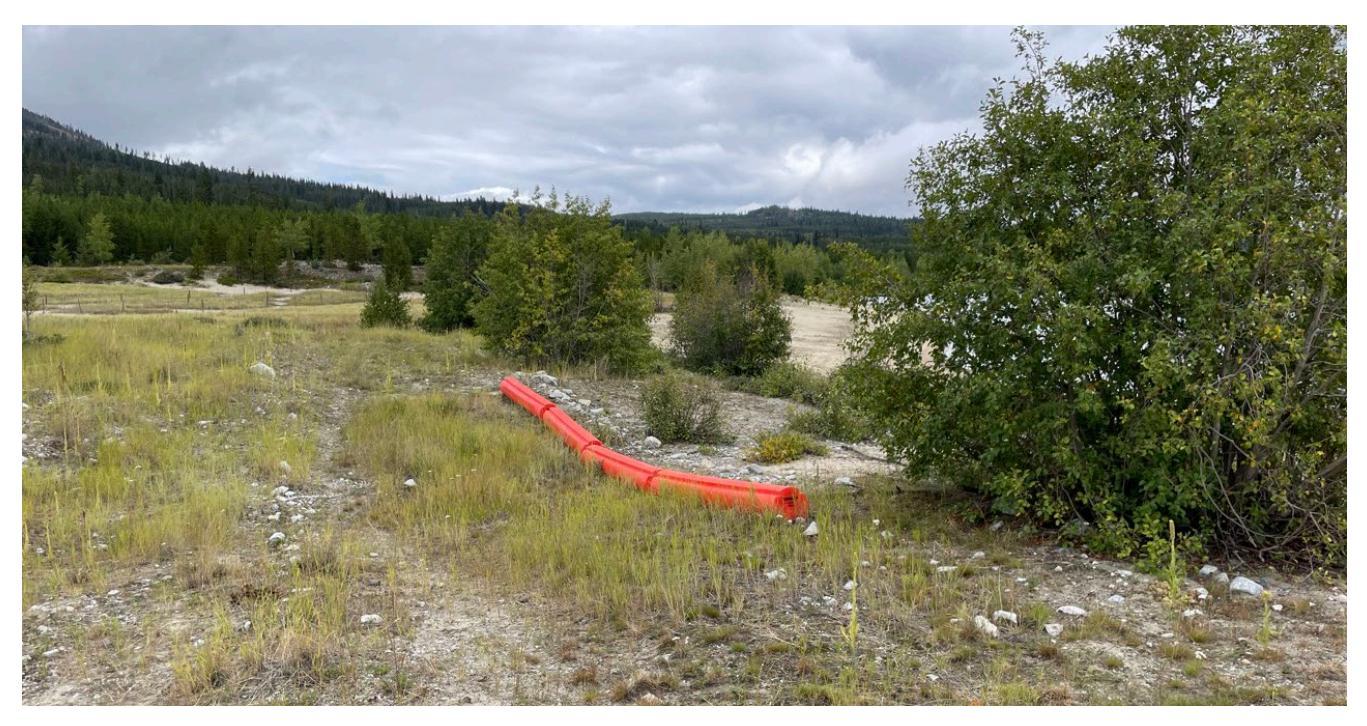
Photo I-A-6 Trojan spillway inlet with debris boom secured and in good condition (TRJ-2023-04).

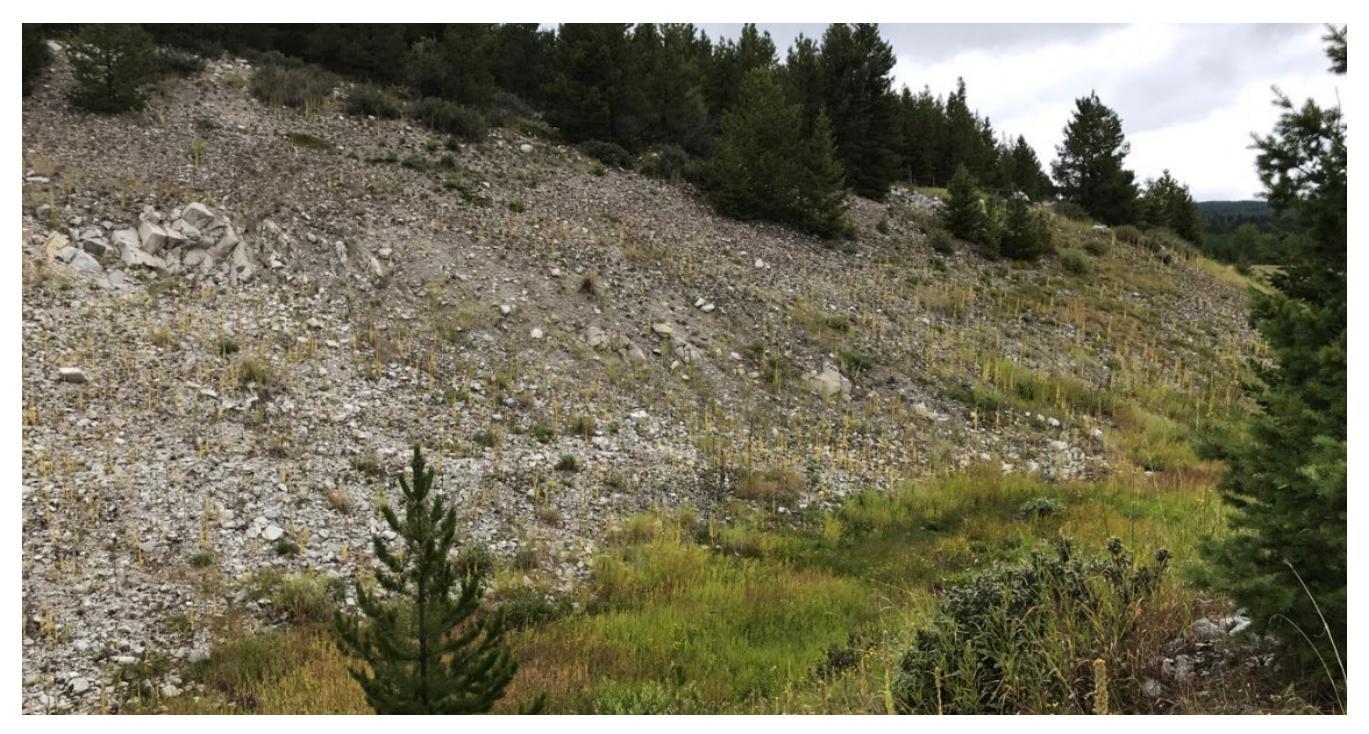
Photo I-A-9 Upper segment of spillway channel, excavated through Glacial Till. Vegetation growth was cleared following site visit (TRJ-2023-05).

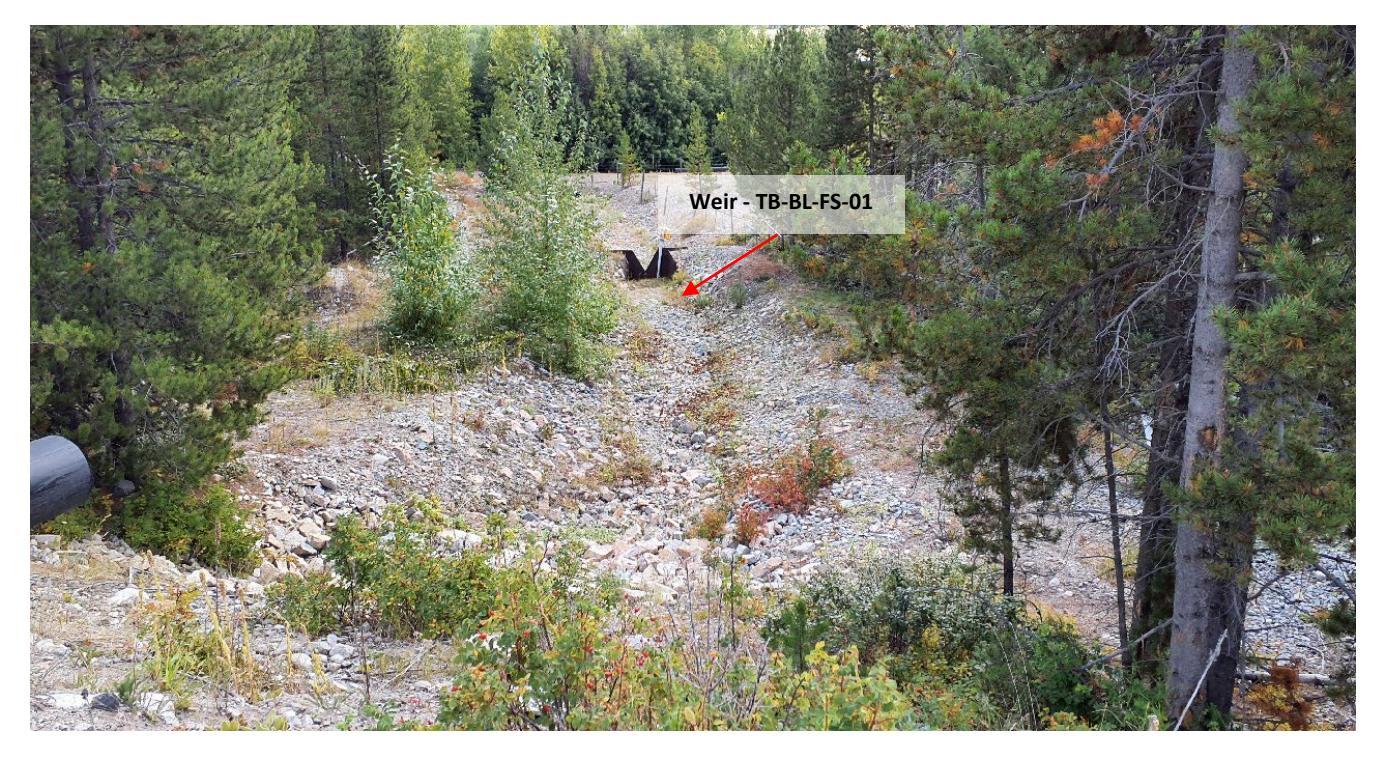
## Photo I-A-13 Open channel downstream of Trojan Diversion Ditch Valve 1. No sign of excessive scour or erosion damage. Weir measures flows into impoundment (TRJ-2023-09).

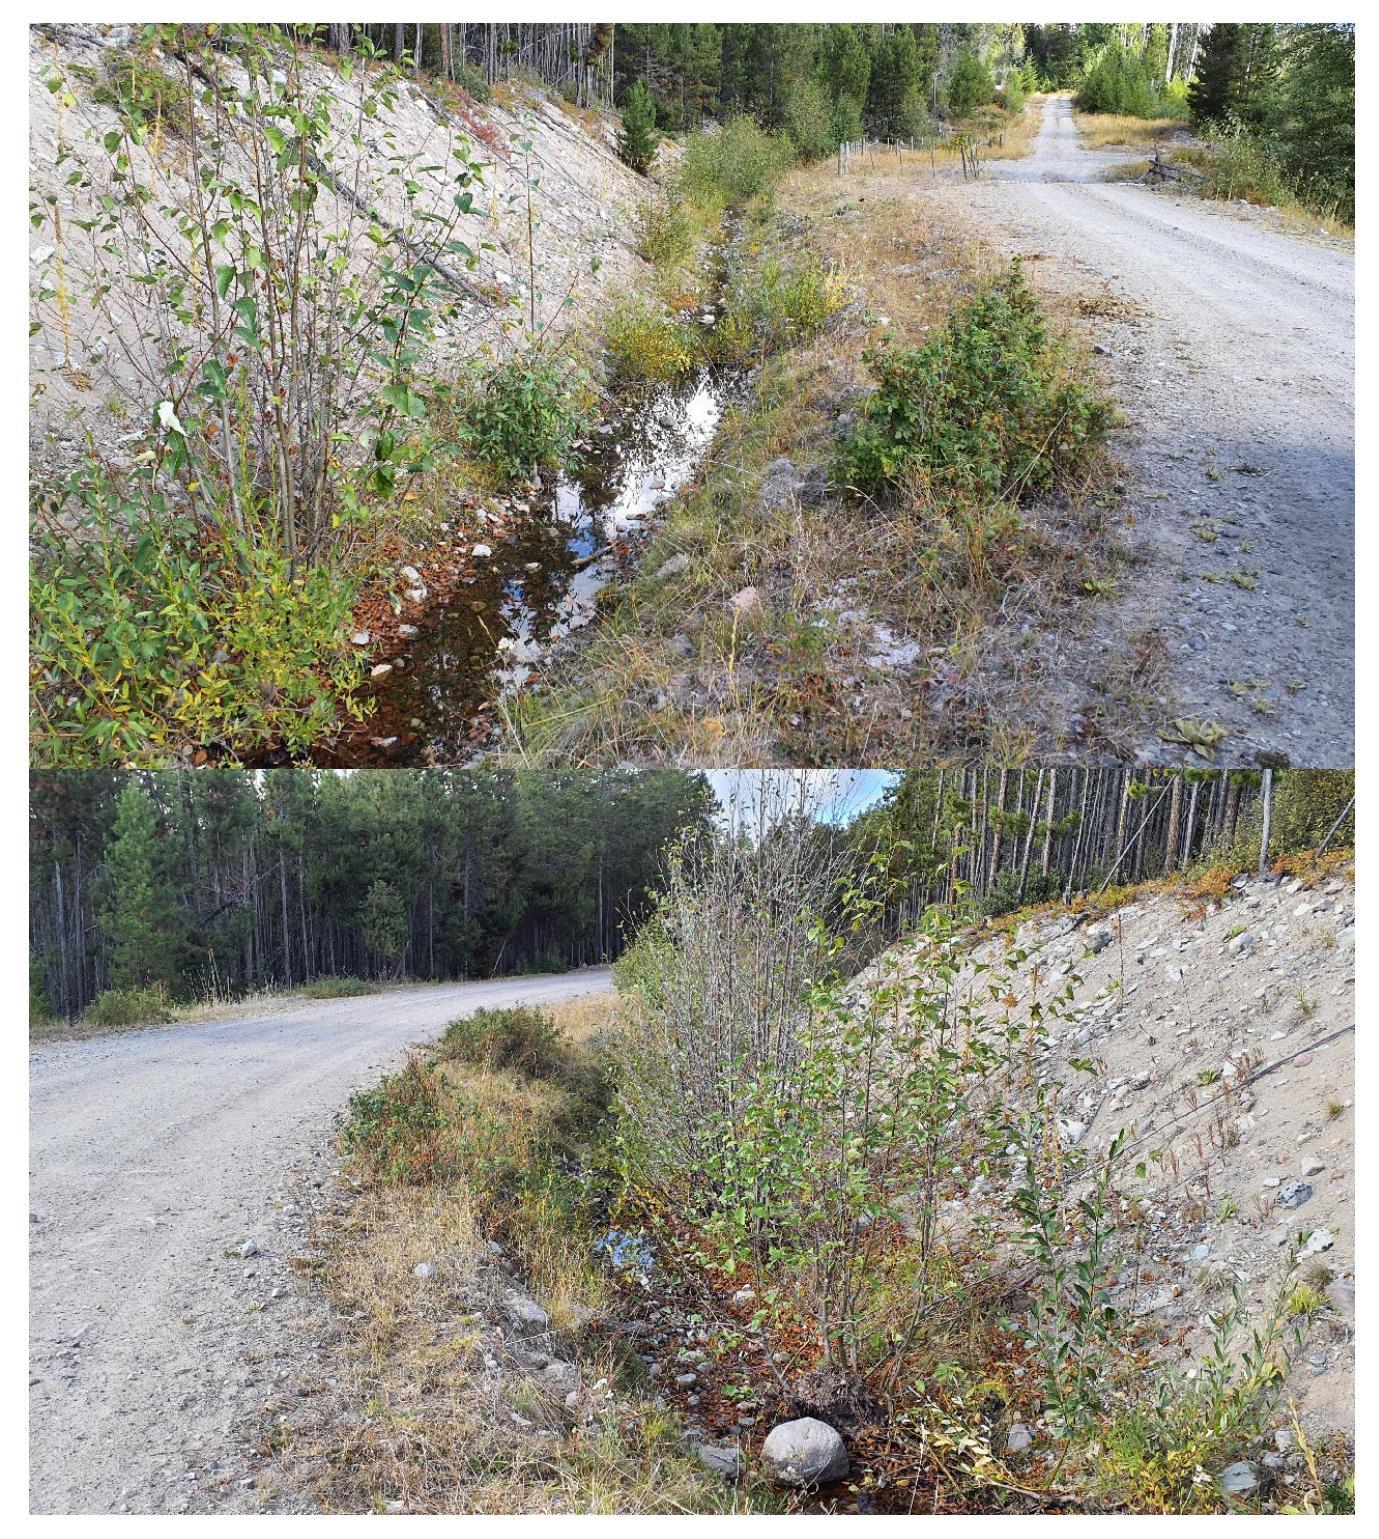
# Photo I-A-14 Trojan Diversion Ditch in the segment that has no geomembrane liner. Vegetation growth along channel does not impact dam safety (TRJ-2023-10).

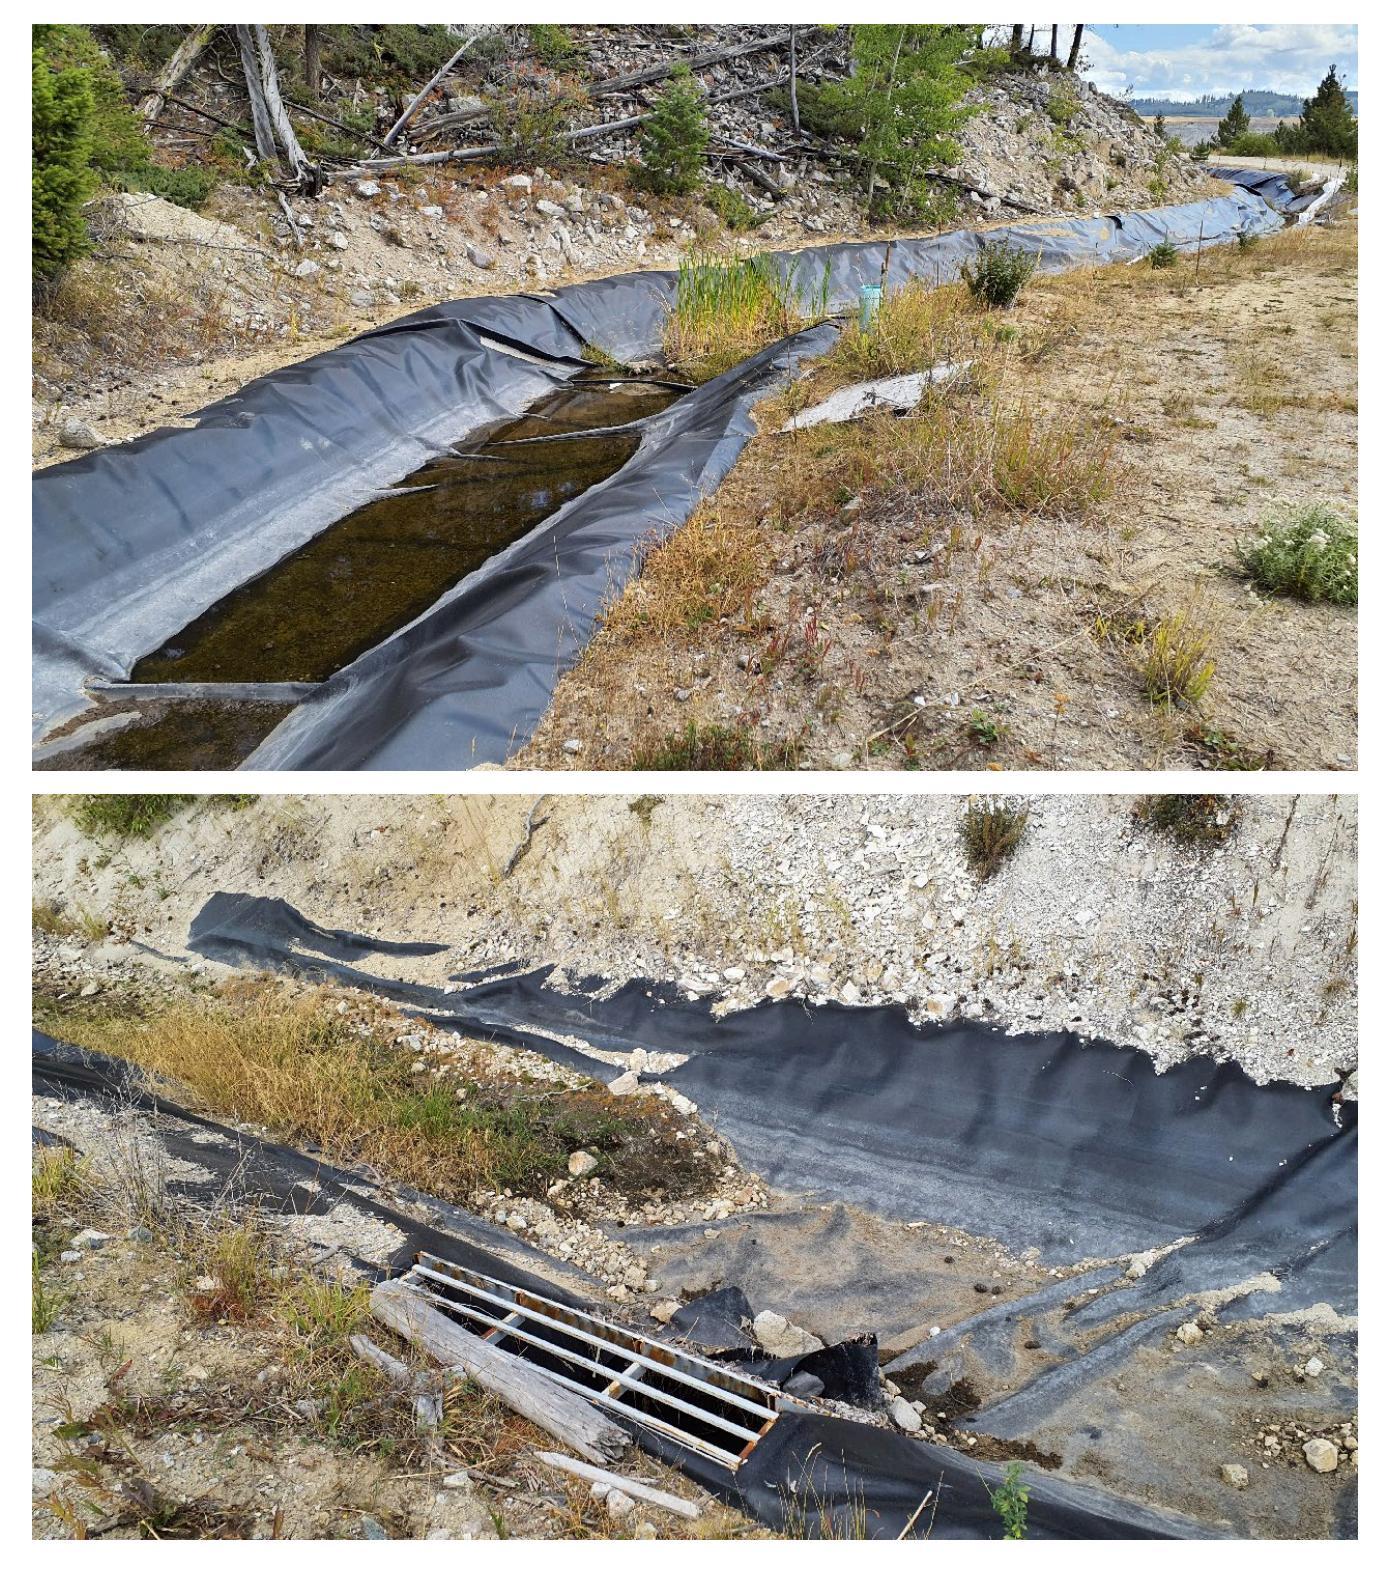
# Photo I-A-15 Water ponded in the Trojan Diversion Ditch, near inlet to Trojan Diversion Pipeline, but no discharge. Gate has minor debris accumulation (TRJ-2023-08).

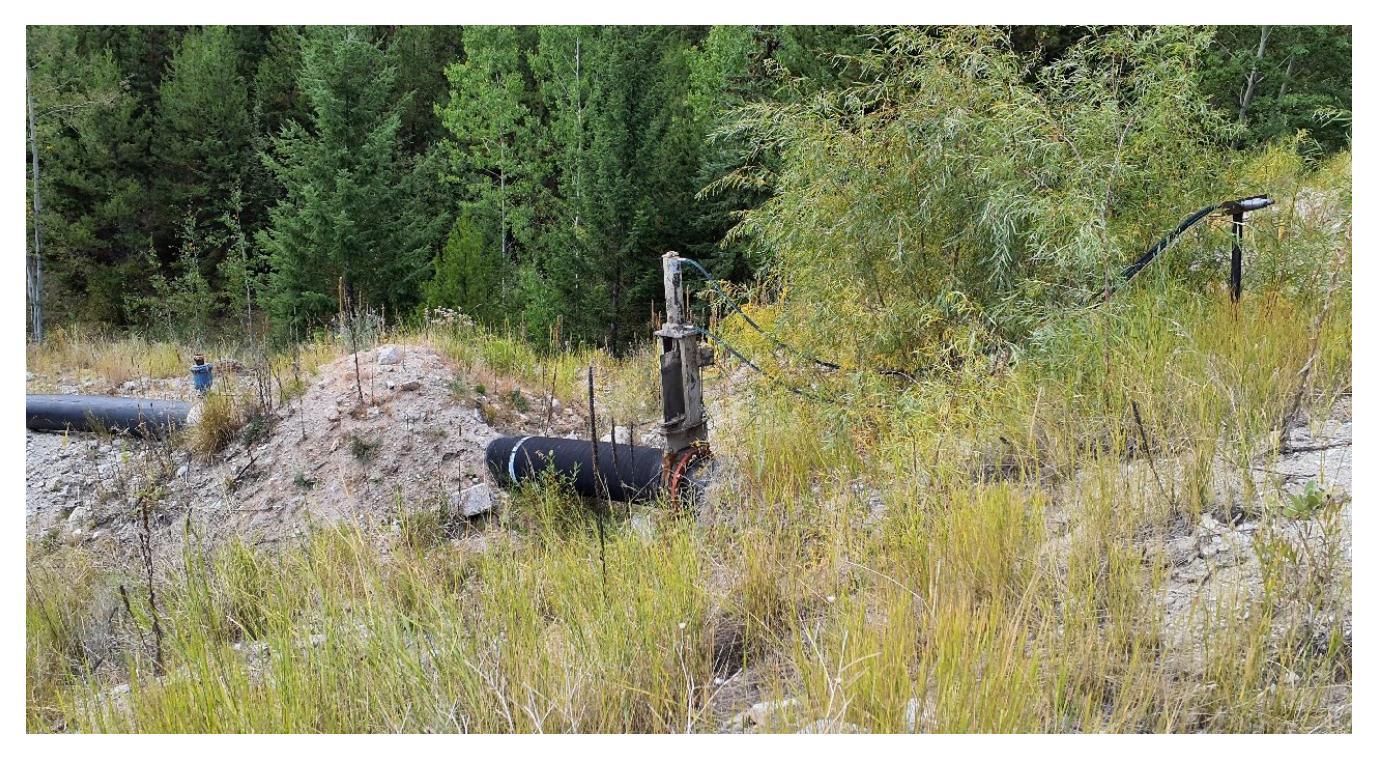
# Photo I-A-16 Upstream portion of the Trojan Diversion Pipeline, near discharge from the Trojan Diversion Ditch, well supported with no leaks observed (TRJ-2023-08).

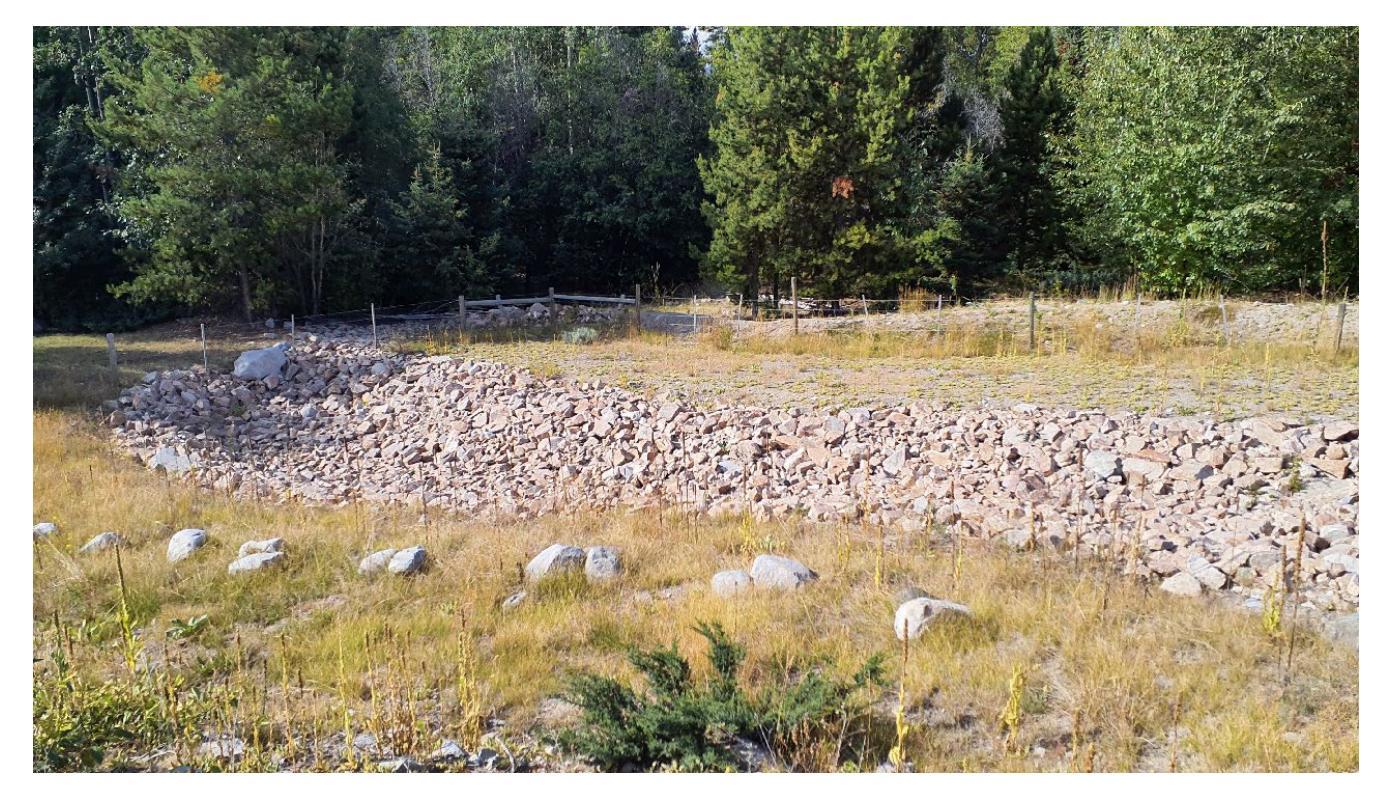
Photo I-B-6 Spillway inlet clear of vegetation, debris or obstruction (TRJ-2023-14).

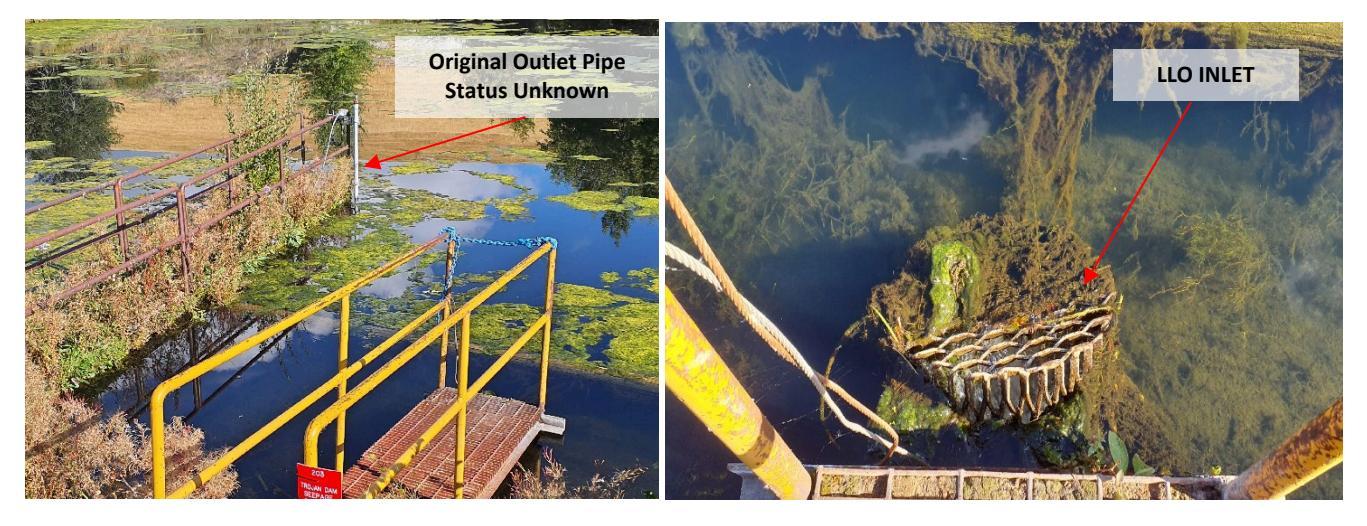
Photo I-B-8 Overview of the pond and LLO inlet. The log-boom was partially submerged and KCB suggested this be replaced and HVC are planning to do so. There was debris accumulated on LLO inlet that was cleared as part of routine maintenance (TRJ-2023-12).

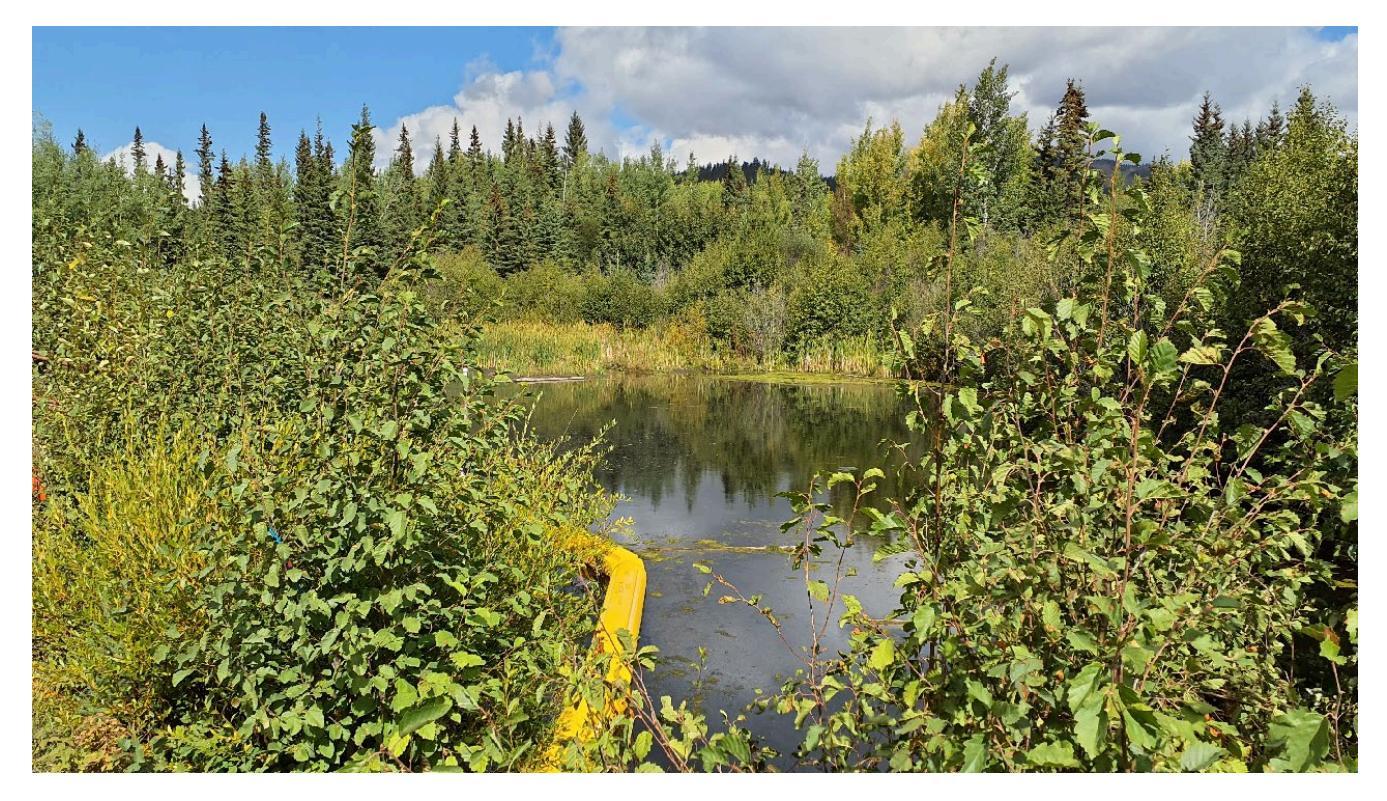
## Photo I-C-1 Overview of Lower Trojan Dam reservoir, prior to vegetation clearing. Replaced debris boom visible (TRJ-2023-15).

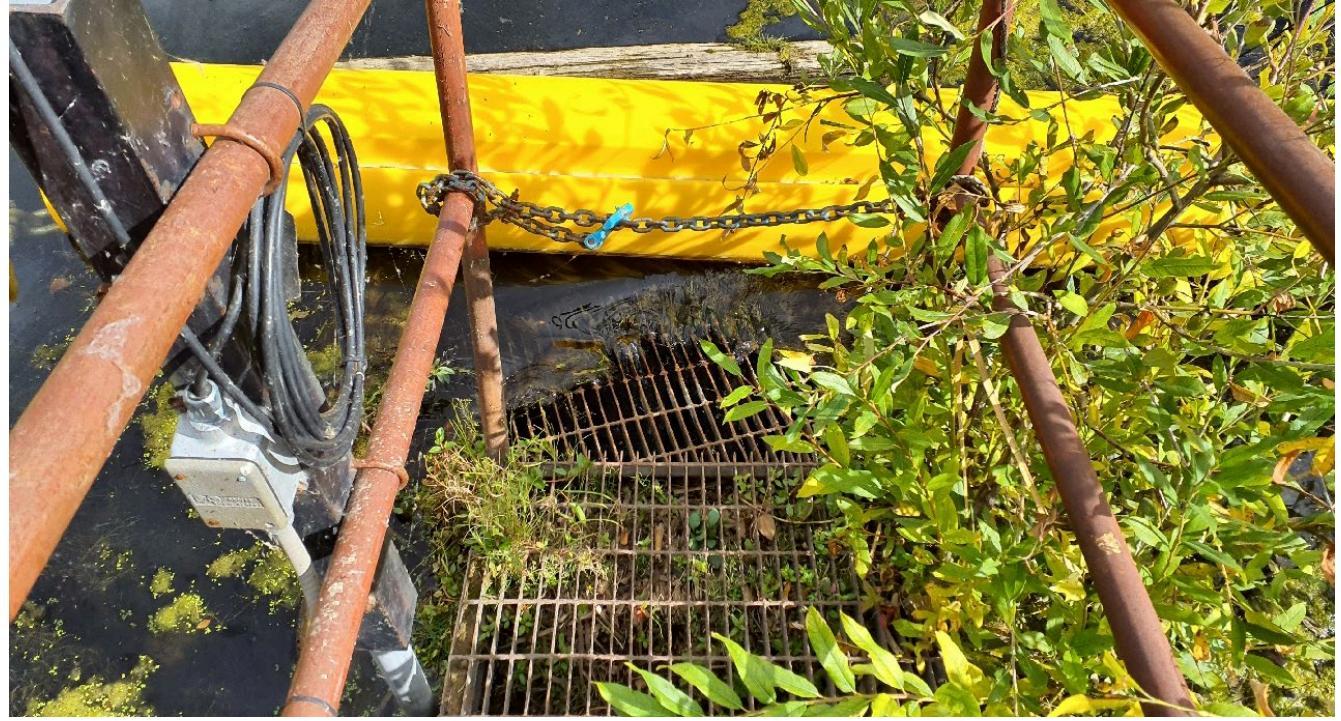
# Photo I-C-10 Low-Level Outlet inlet, prior to vegetation clearing. HVC installed a new debris boom to protect the intake of LLO (TRJ-2023-15).
