Teck Highland Valley Copper Partnership

2023 Annual Facility Performance Report

7-Day Pond Tailings Storage Facility

March 2024

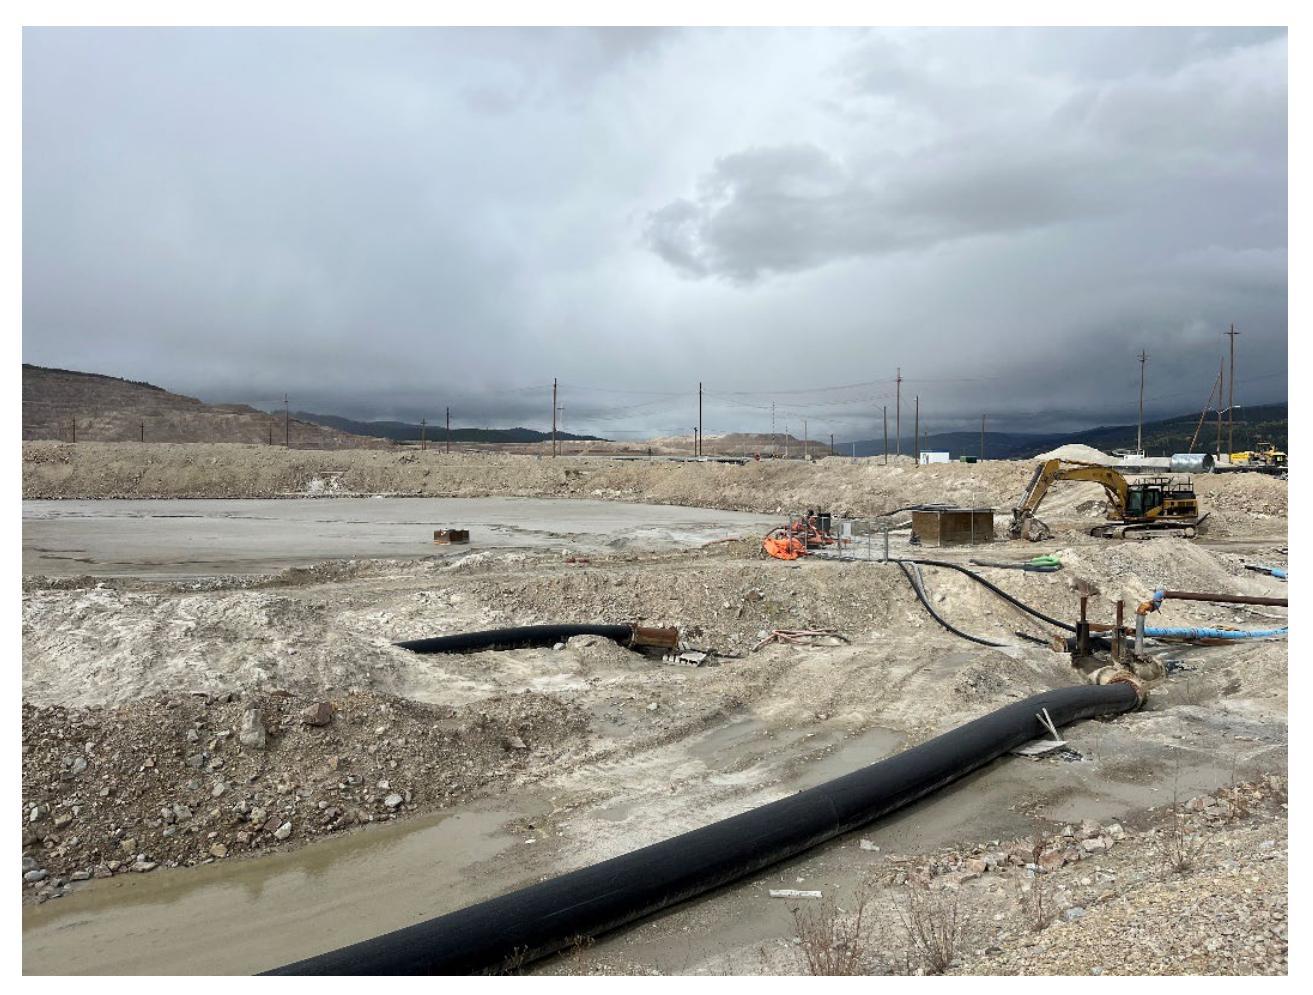
- Crest: The haul road that forms the crest of the dam around 7-Day Pond TSF was in good physical condition. No indicators of significant concern were observed (e.g., cracking, slumping) (Photo I-1 and Photo I-2).
- Upstream and Downstream Slopes: Upstream and downstream slopes were in good physical condition. They were not vegetated, and no indicators of significant concern were observed (e.g., animal activity, cracking, slumping, or surface erosion features).
- Tailings Beach and Pond: Impoundment had a visible beach as well as ponded water near the outlet. The v-notch weir near the inlet was buried by tailings, and the east flank trench was filled with tailings and water (Photo I-1).
- **Outflow Pump**: Fixed pumping system operational.
- Seepage: None observed.

Photo I-2 East Berm (SDP-2023-02)
