Beaverdell Tailings Storage Facilities – 2023 Annual Facility Performance Report

Teck Resources Limited, Beaverdell Mine

Reference No. CA0007697.0438-003-R-Rev0

February 27, 2024

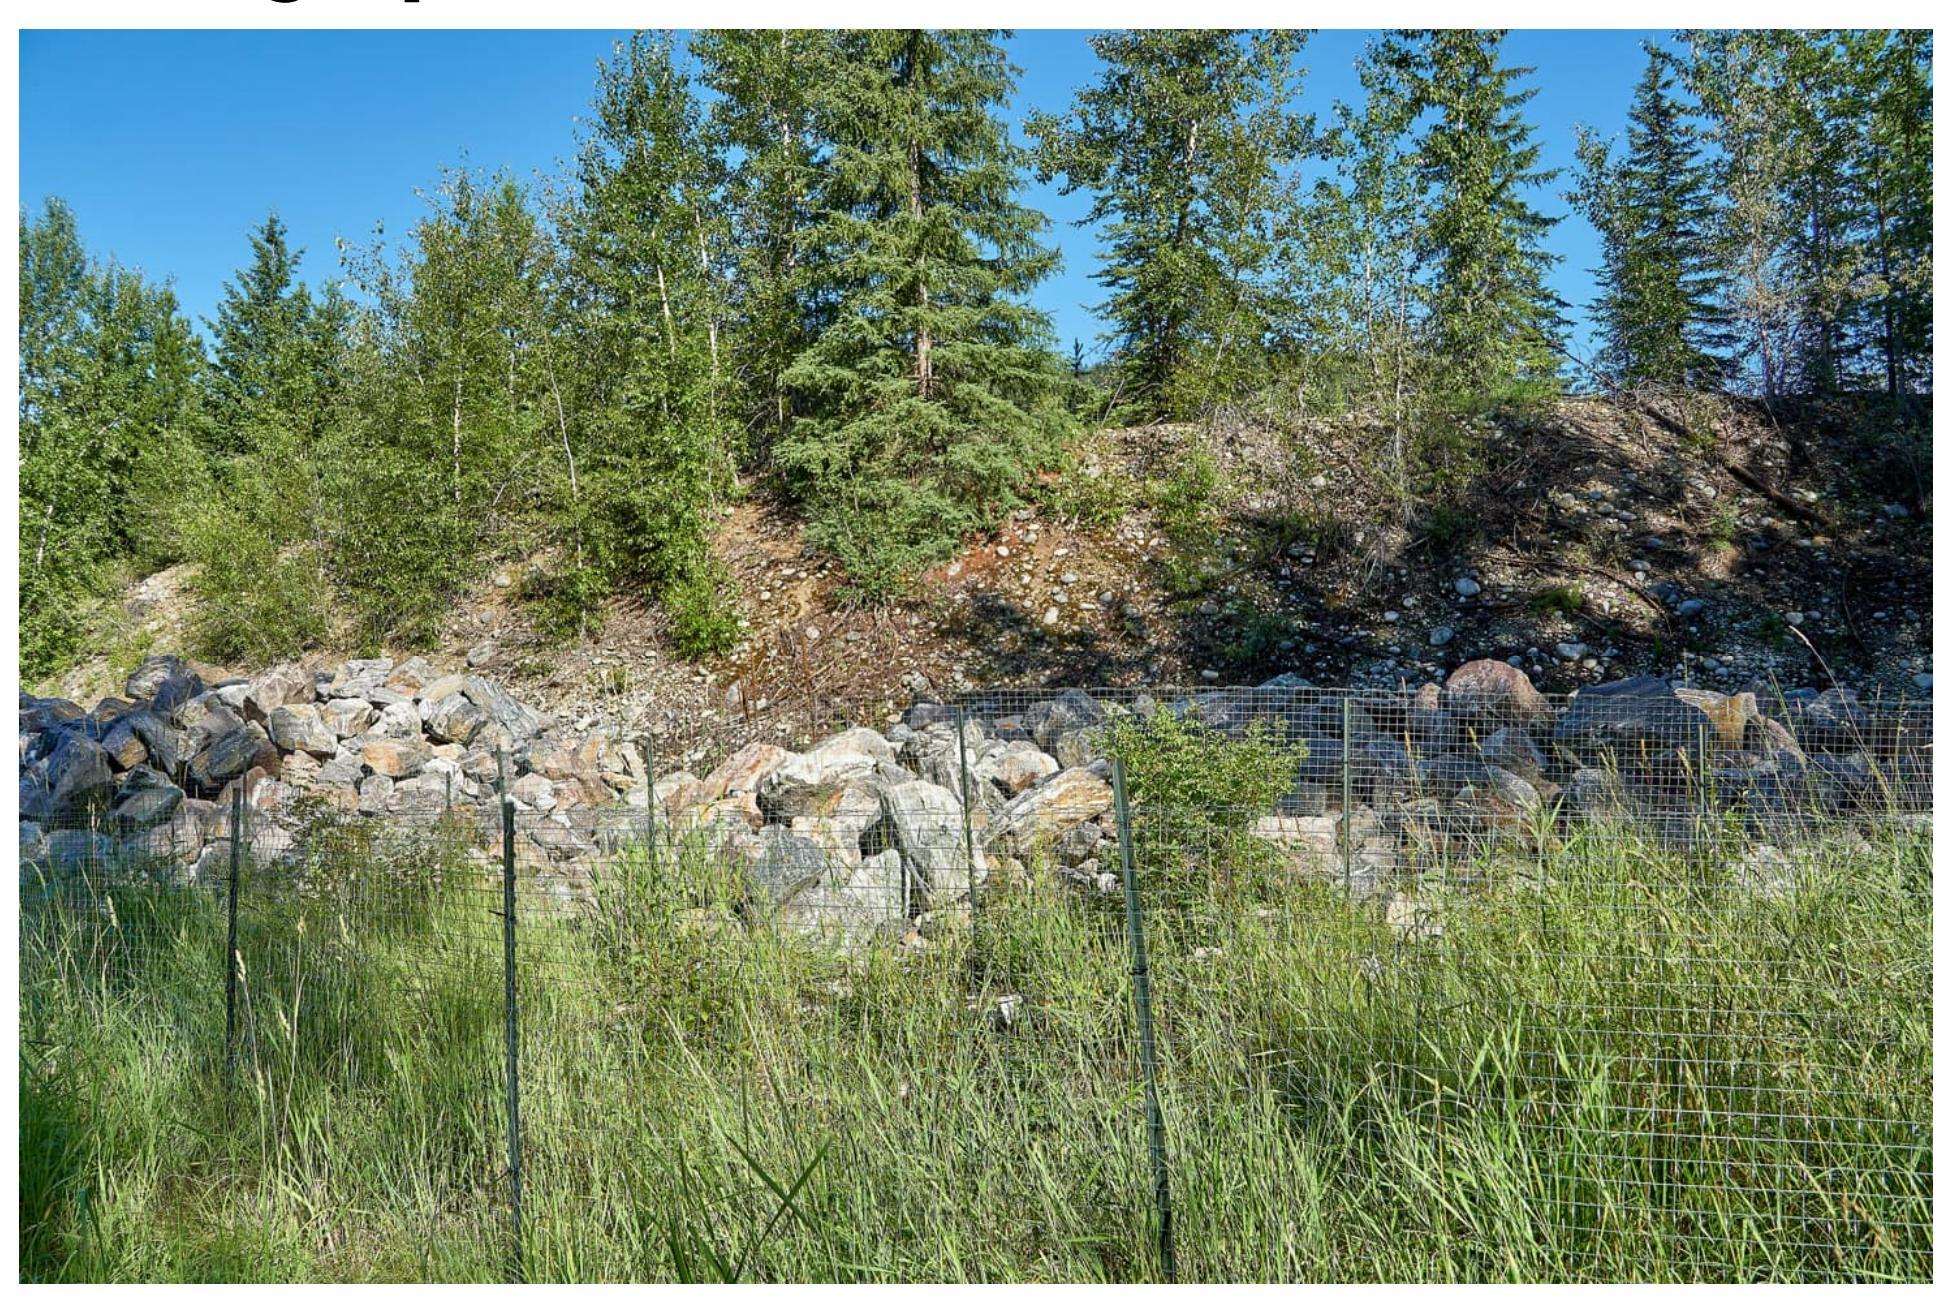
Photograph #1: "Downstream slope and toe of Cell 4"

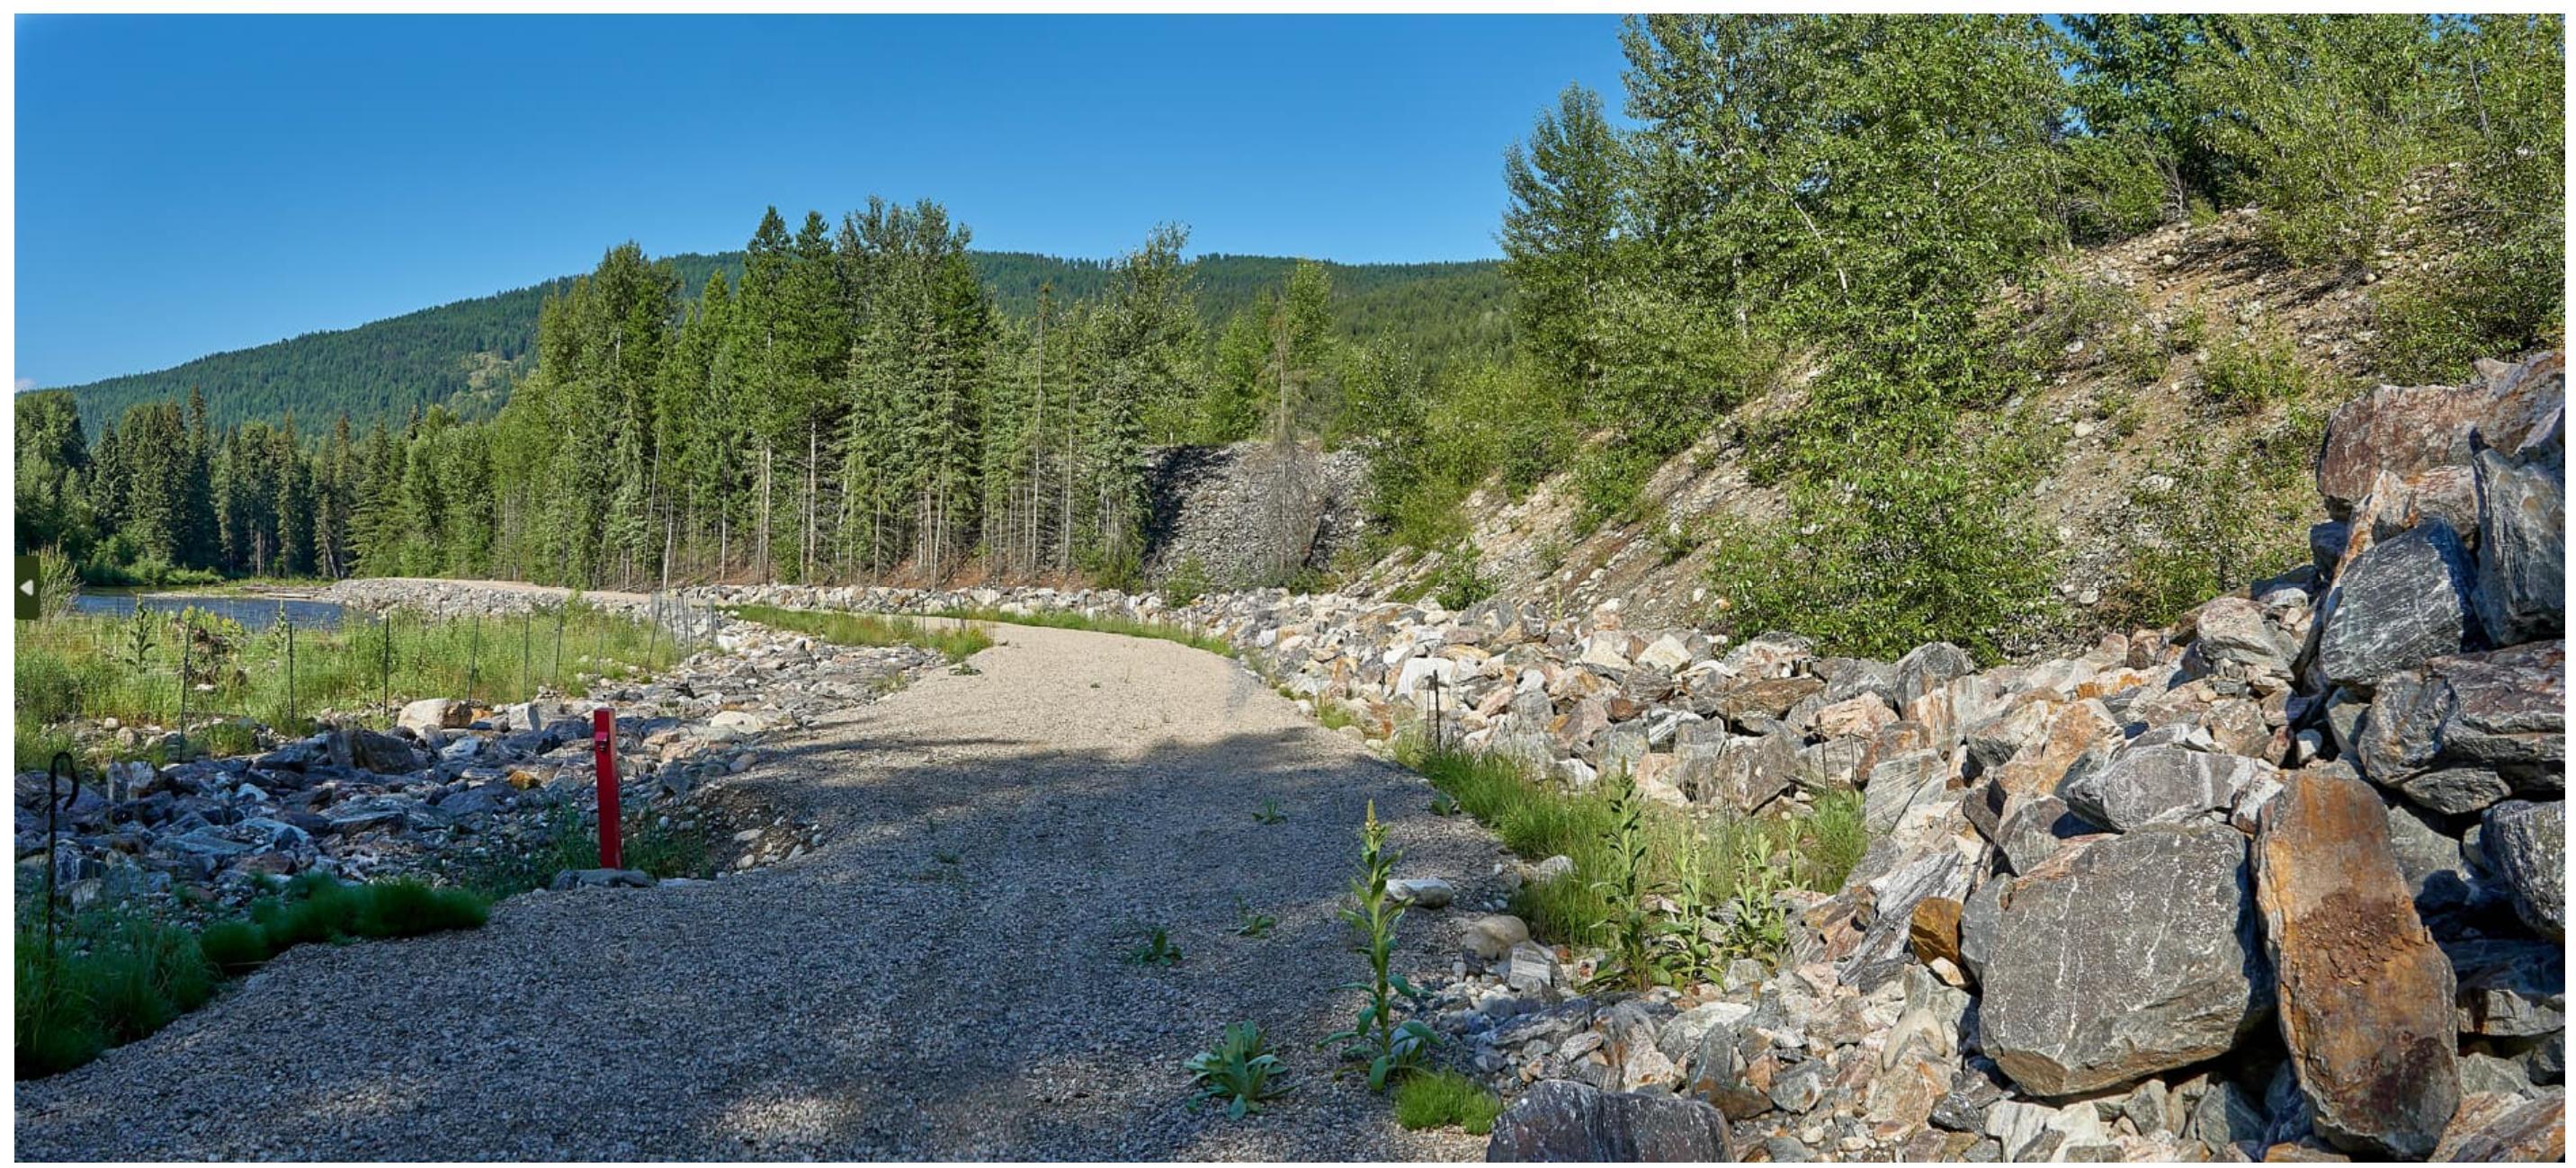
Photograph #2: "Downstream slope and toe of Cell 4, riprap and West Kettle River"

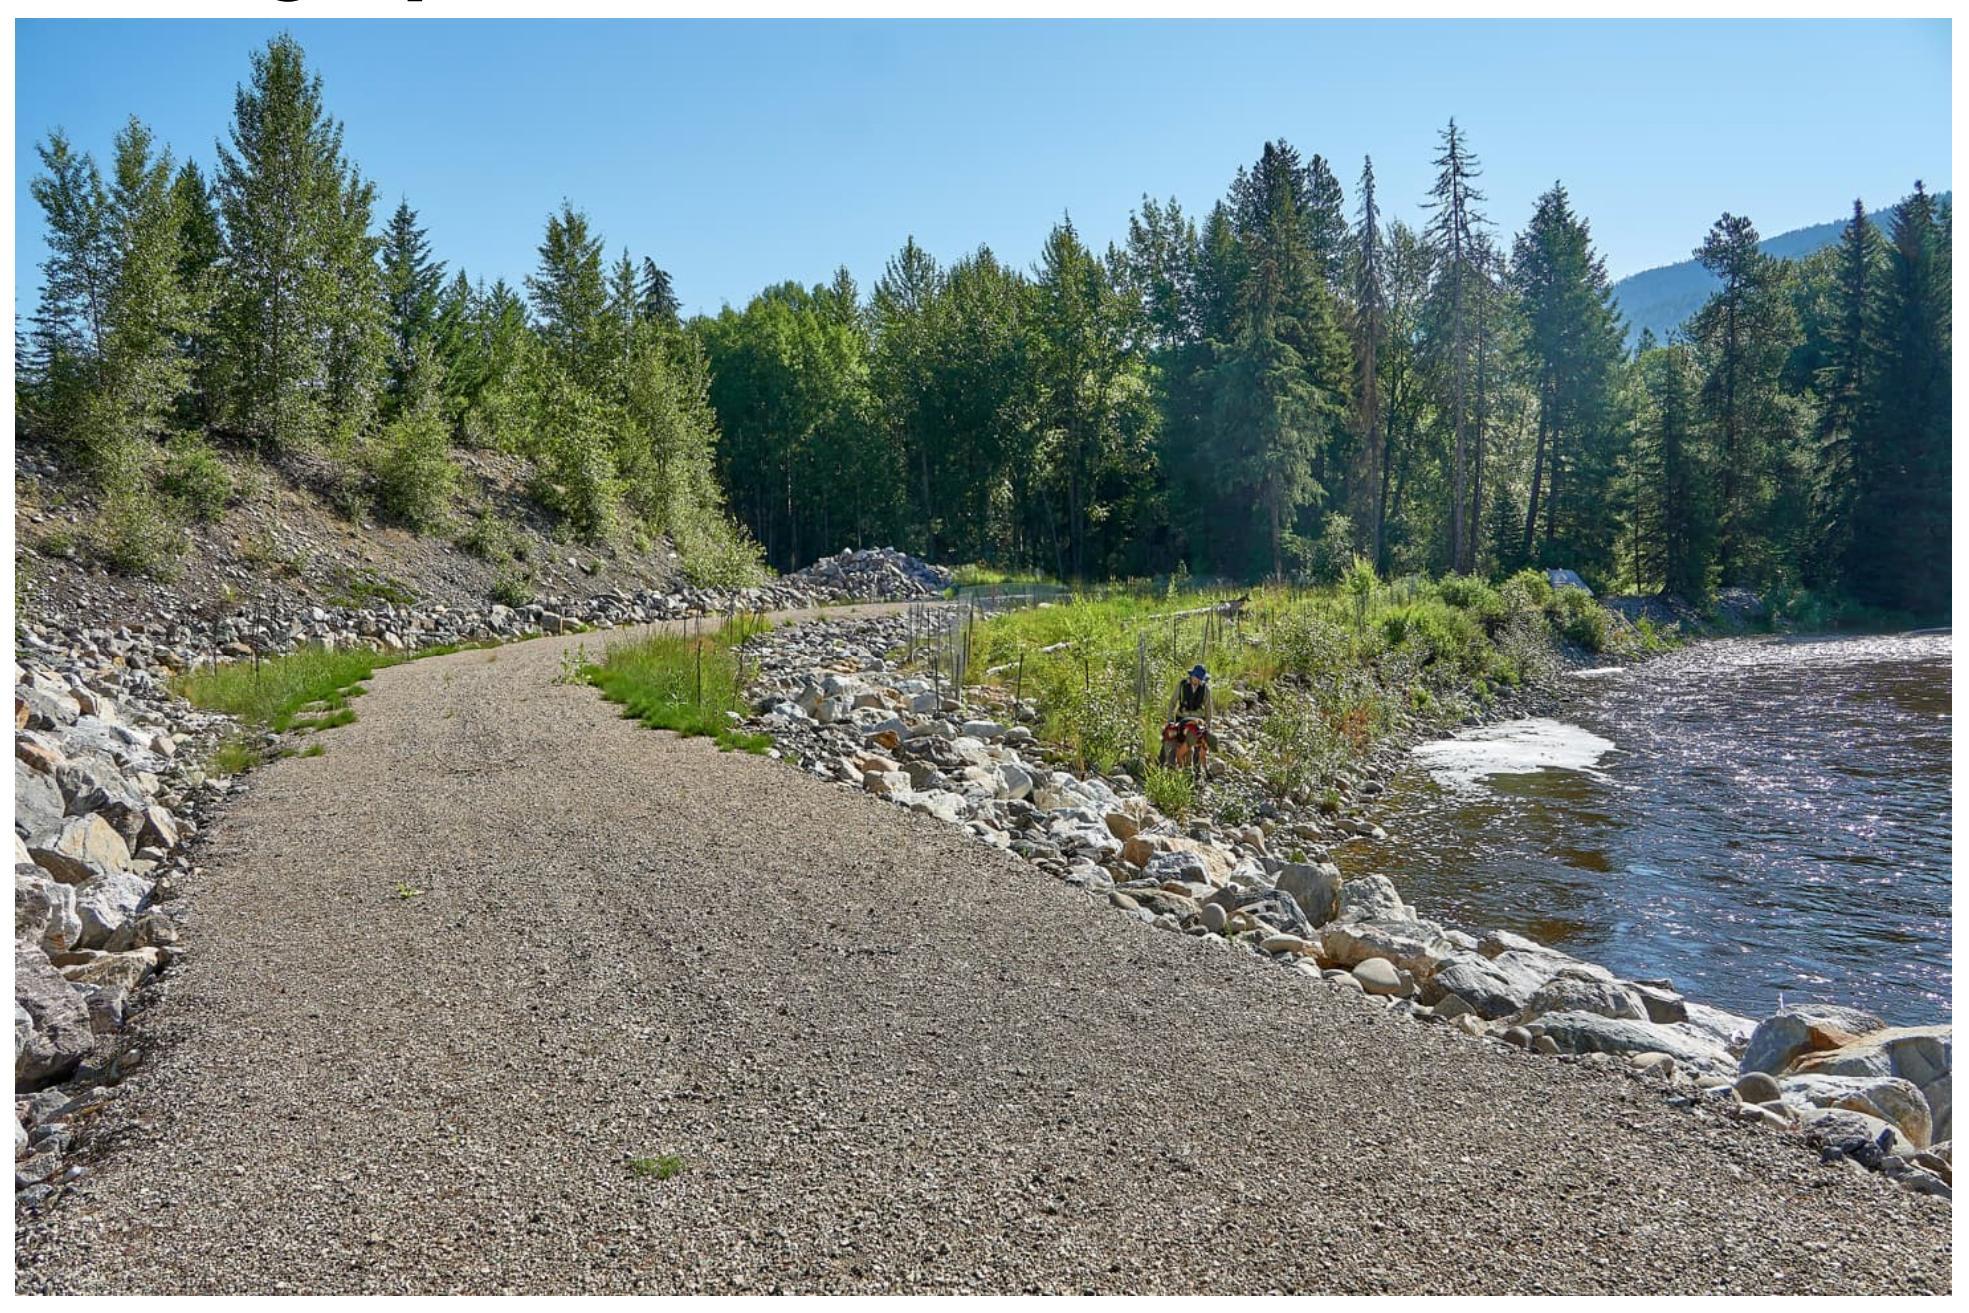
Photograph #3: "Downstream slope and toe of Cell 4, riprap and West Kettle River"

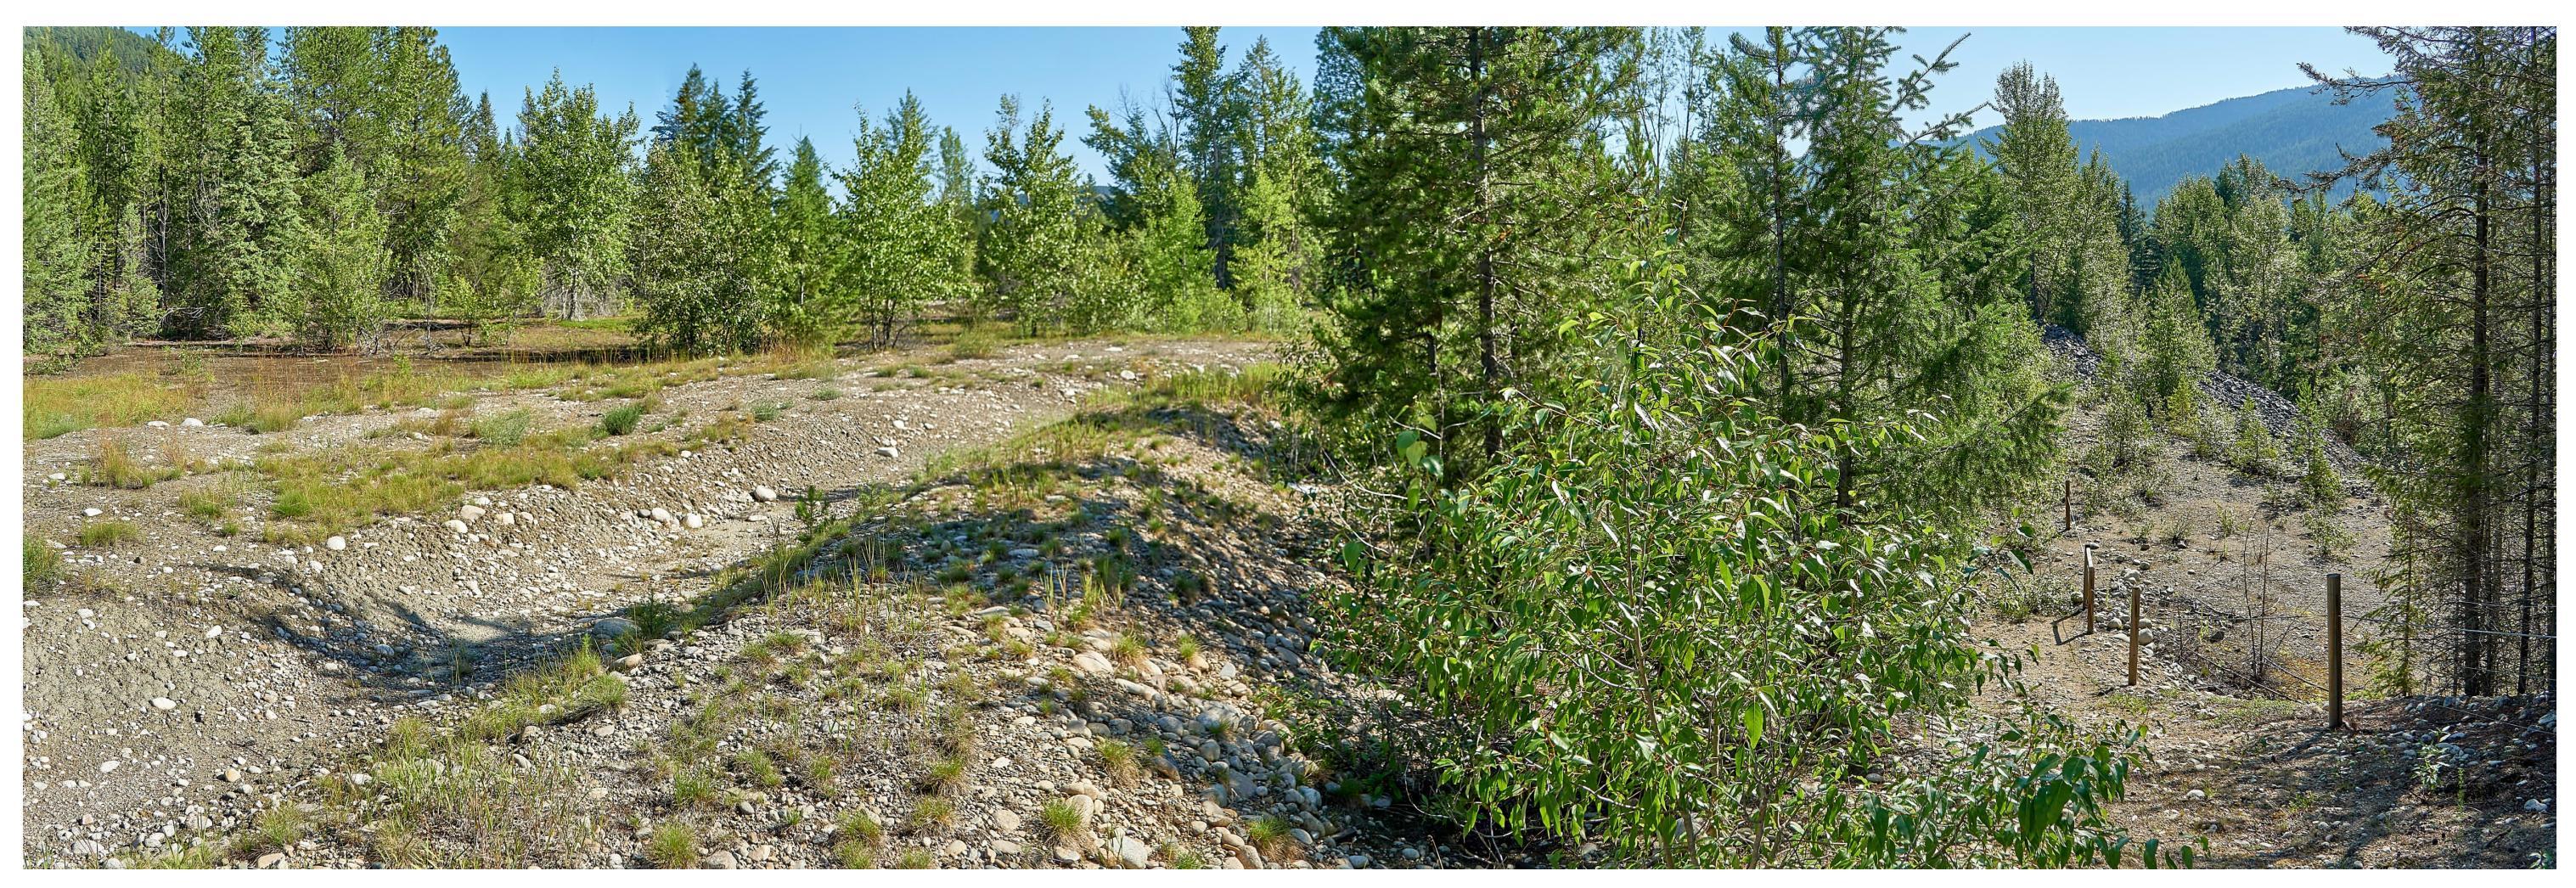
Photograph #4: "Drainage ditch along the crest of Cell 1"

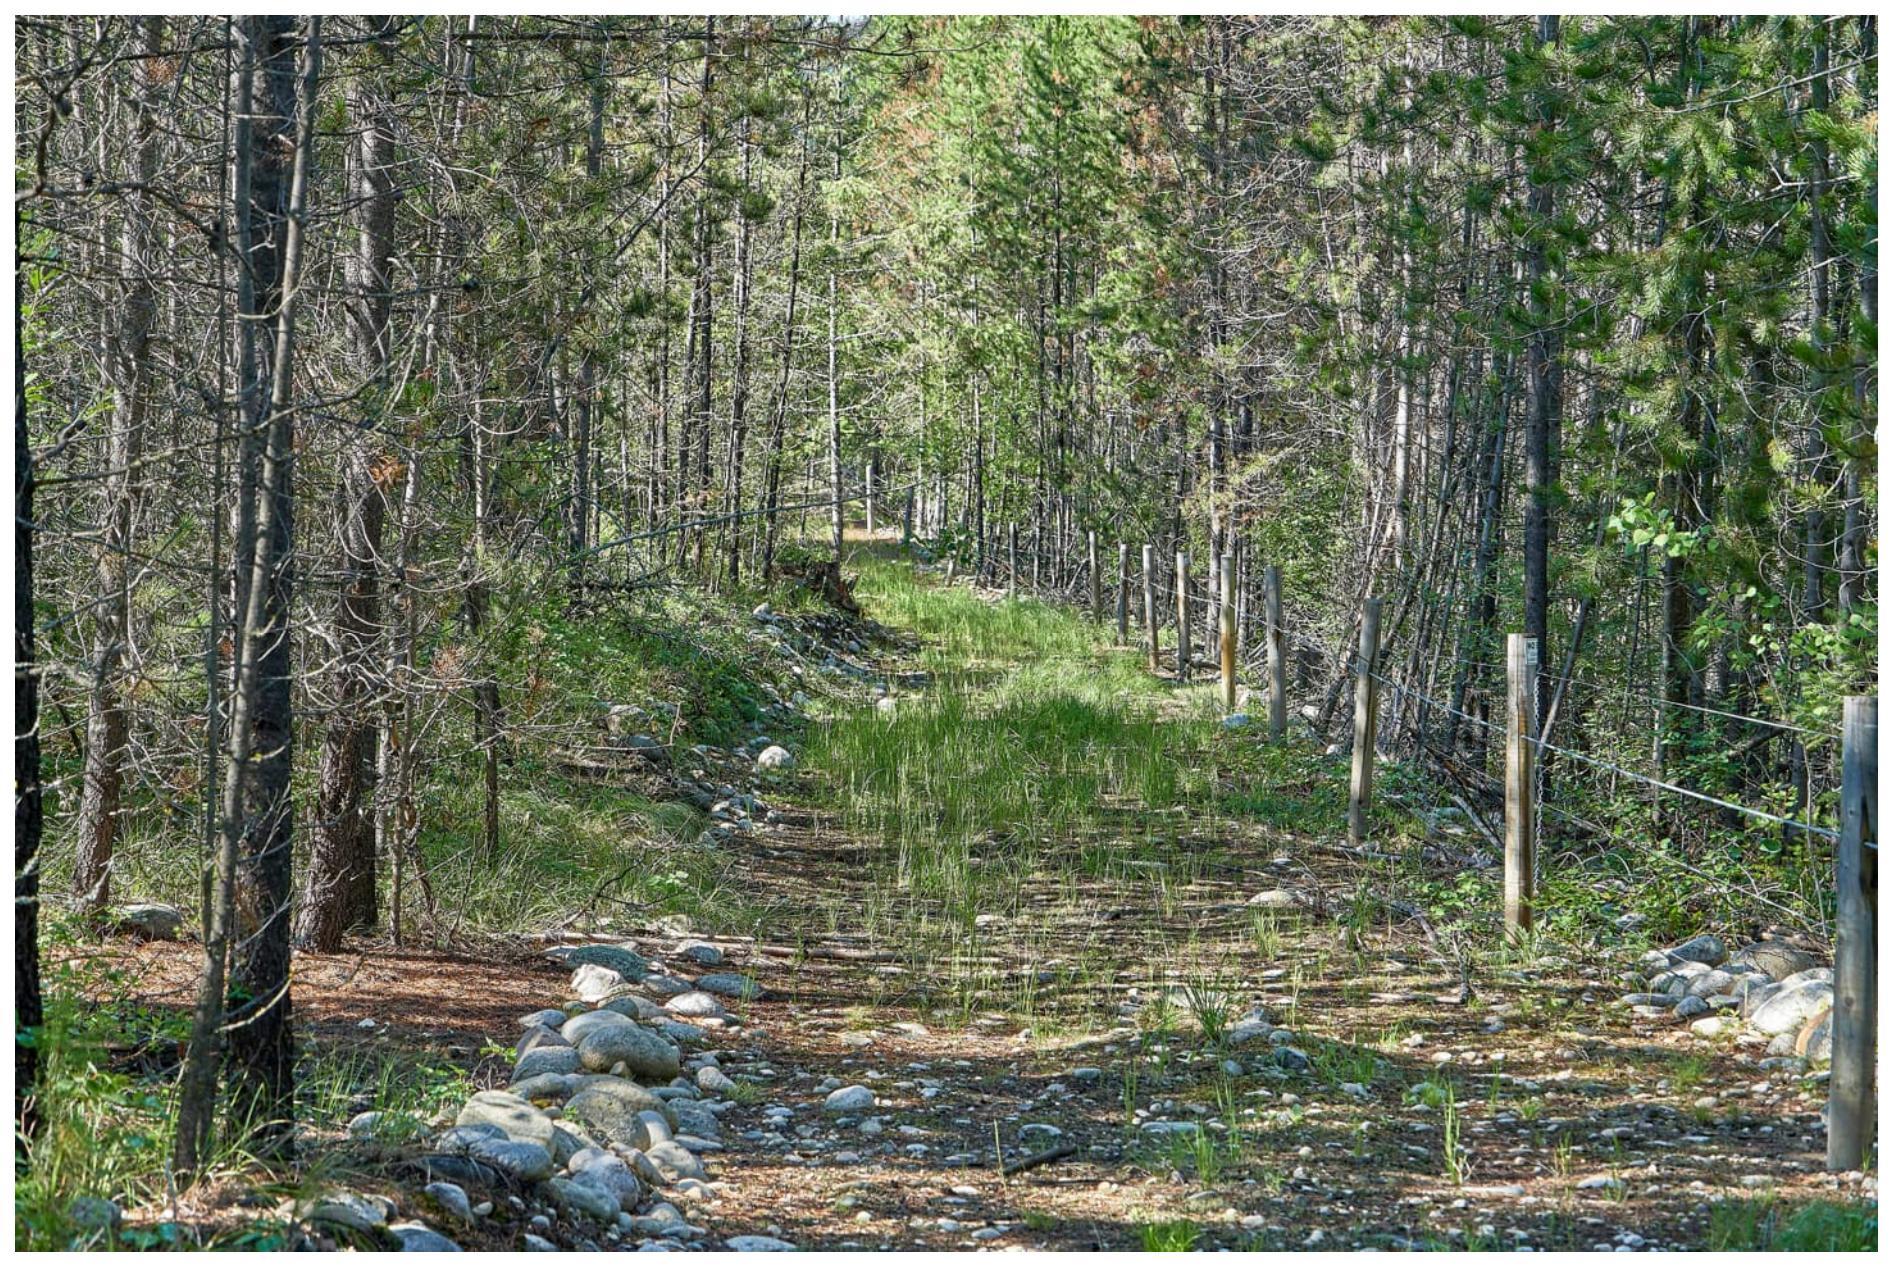
Photograph #5: "Crest adjacent to Cell 2"

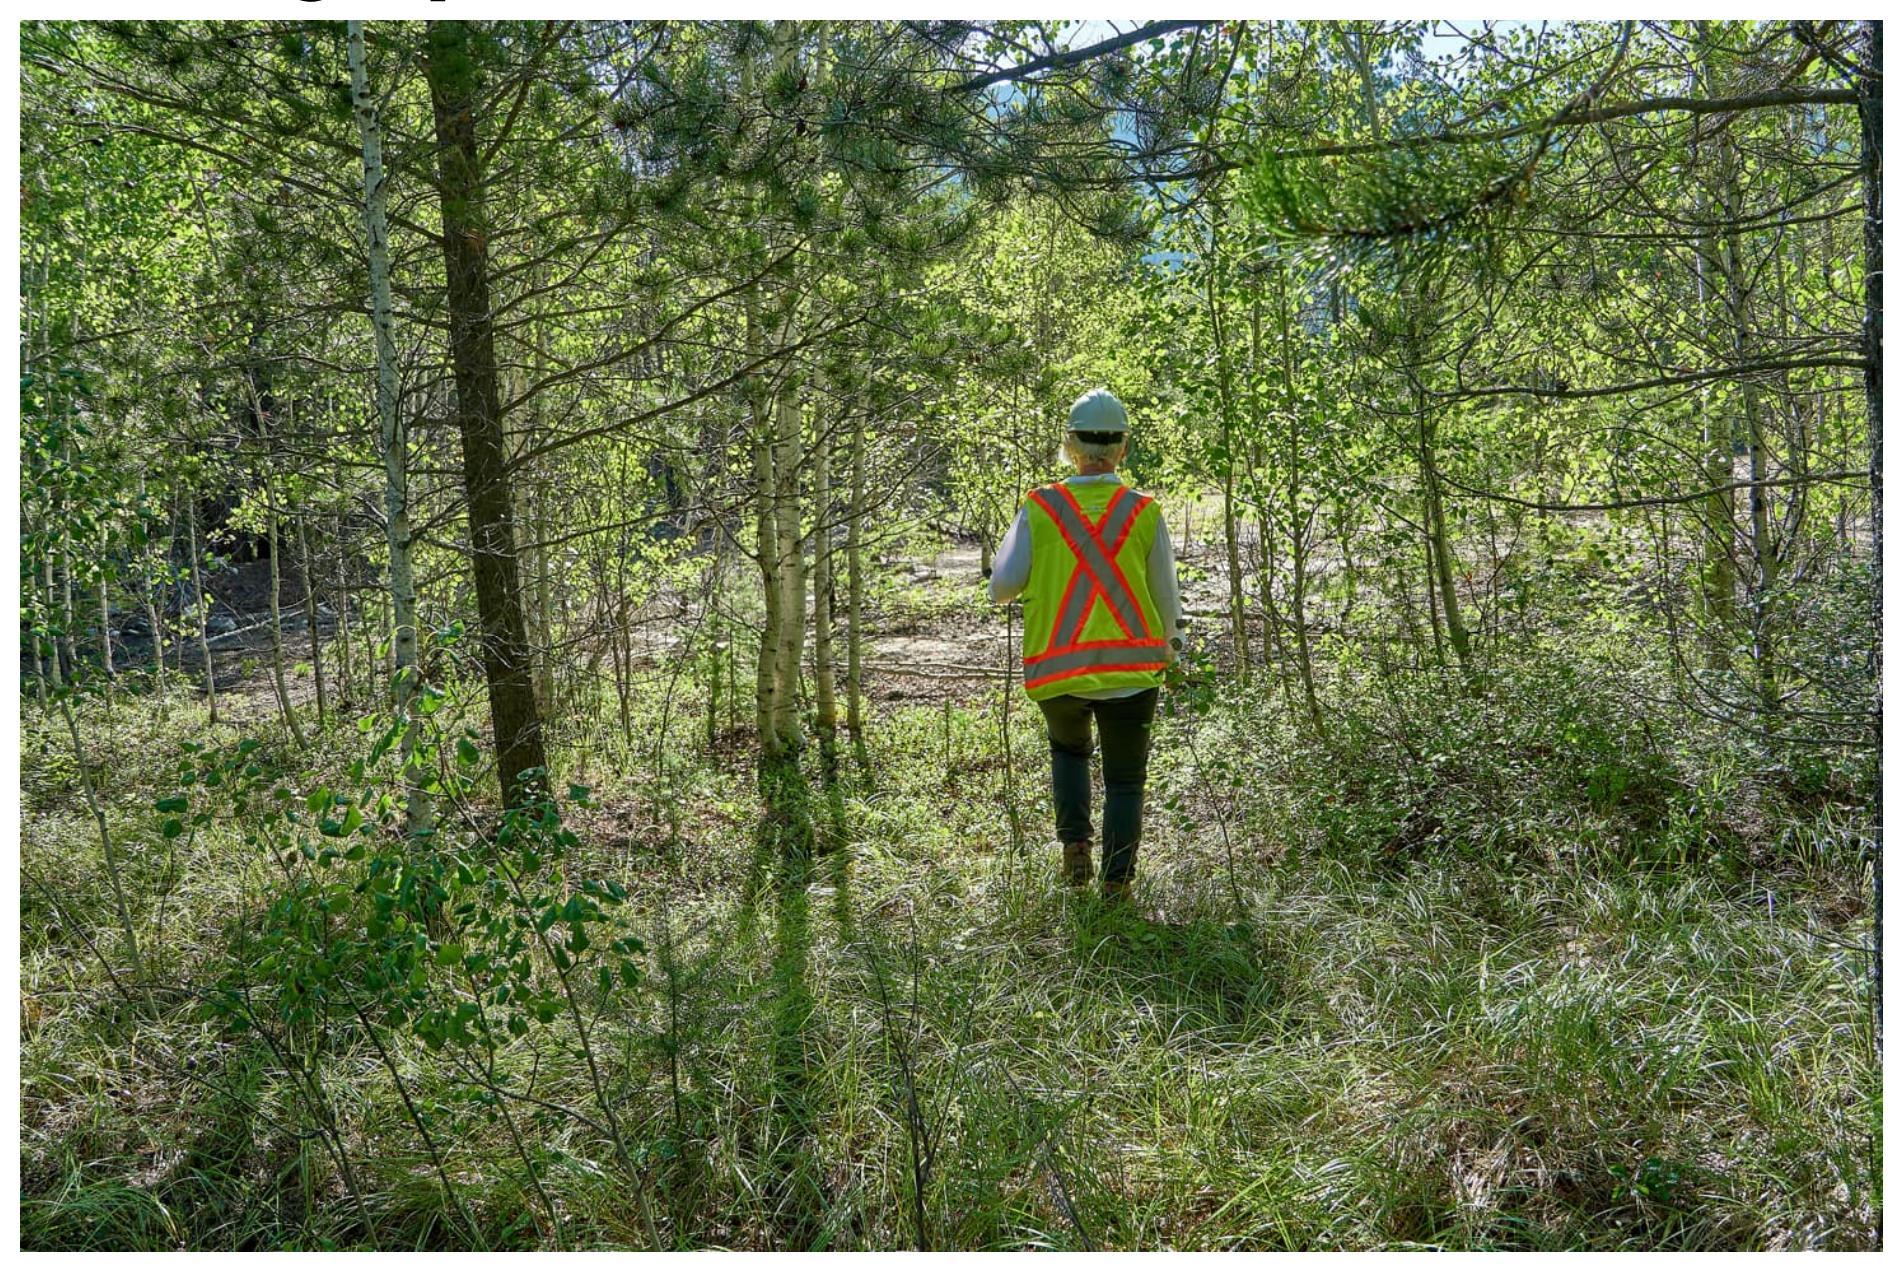
Photograph #6: "Vegetation cover on Cell 2"

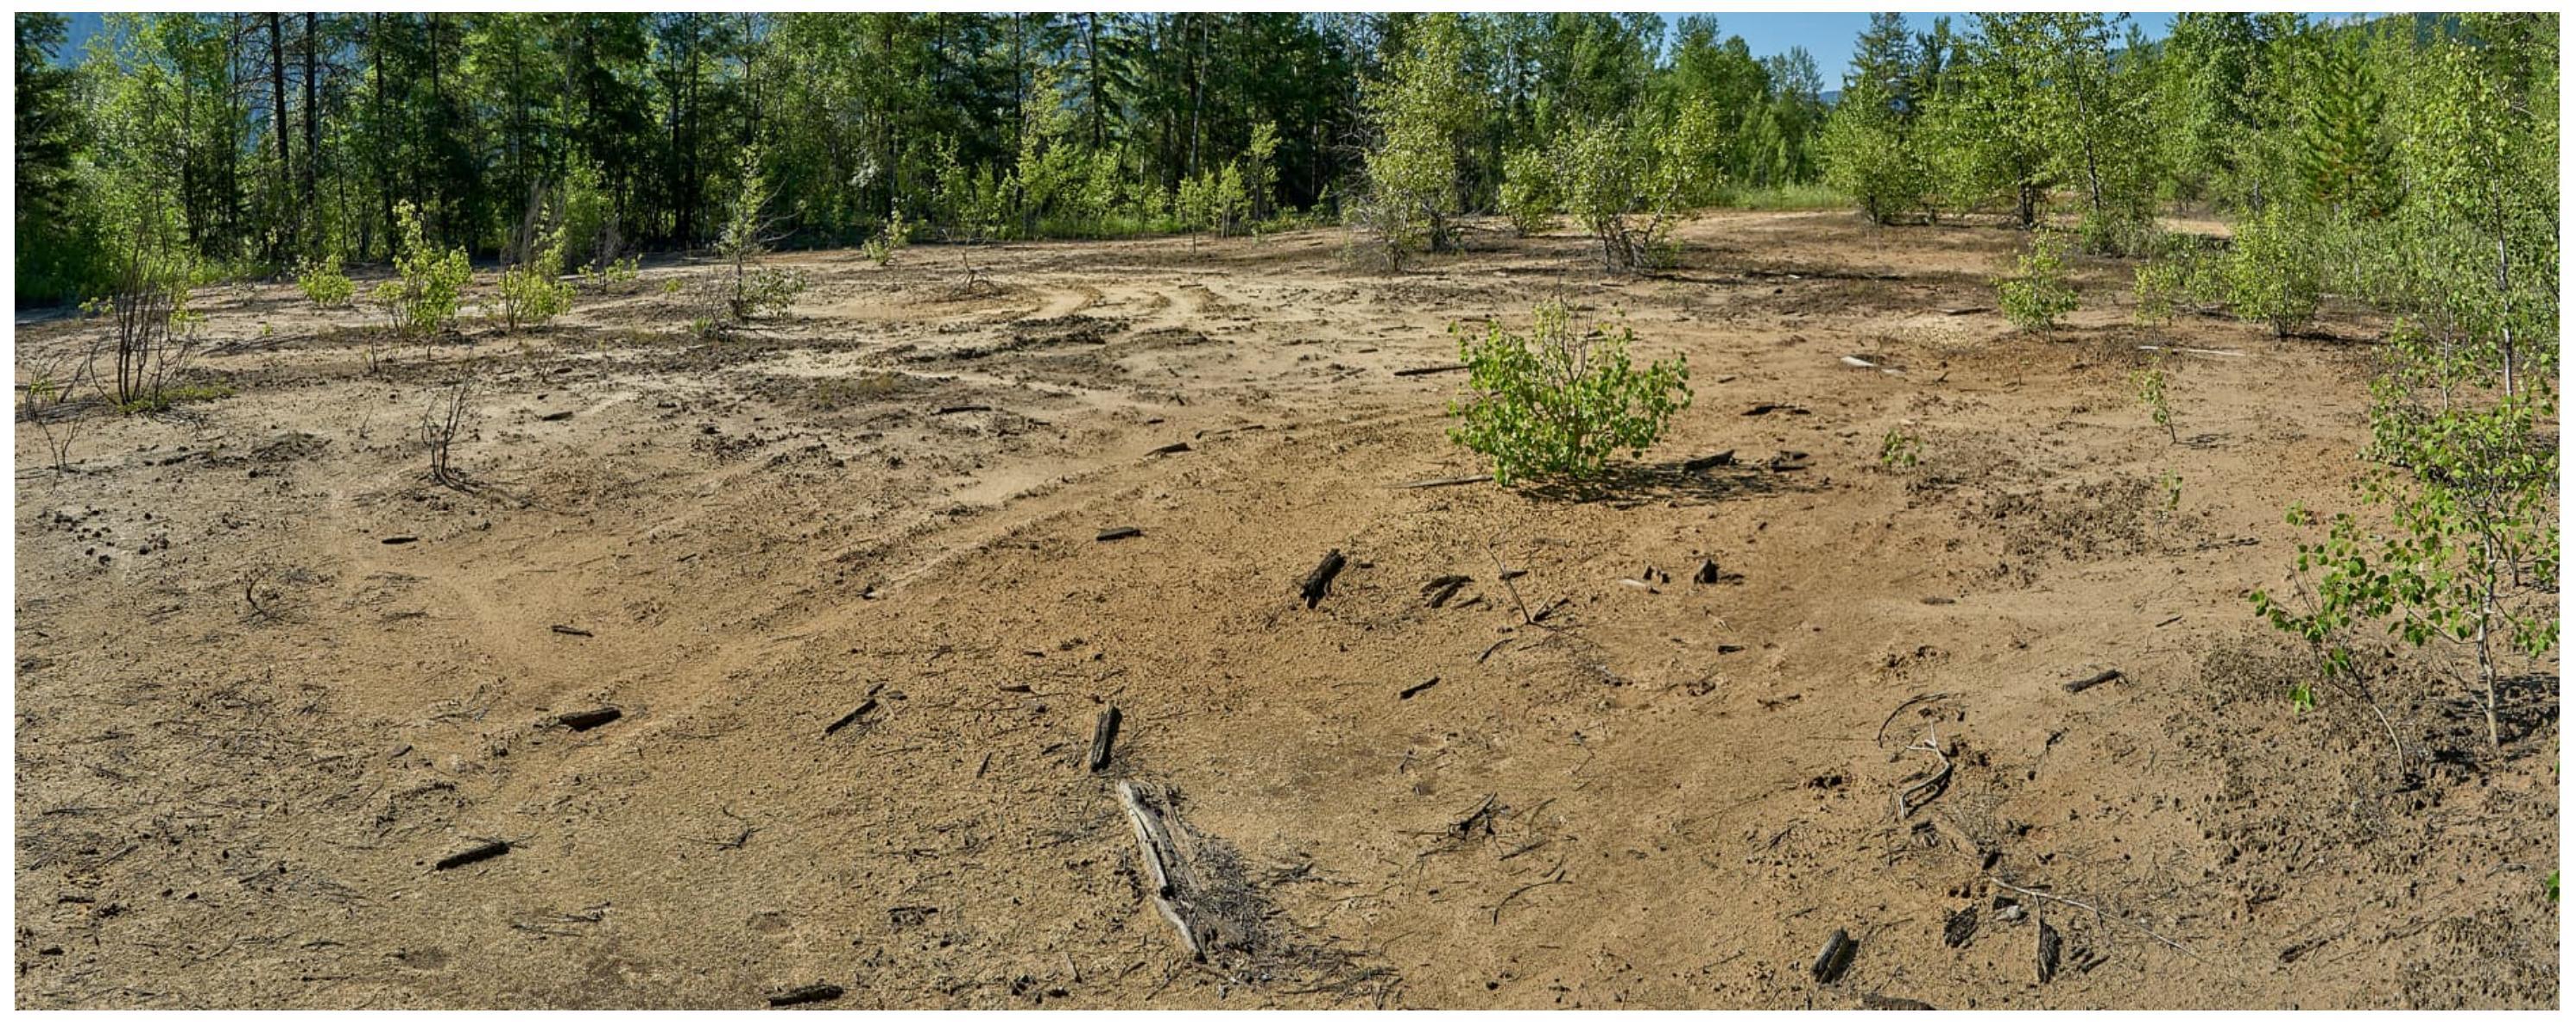
Photograph #7: "Cell 1 tailings surface"

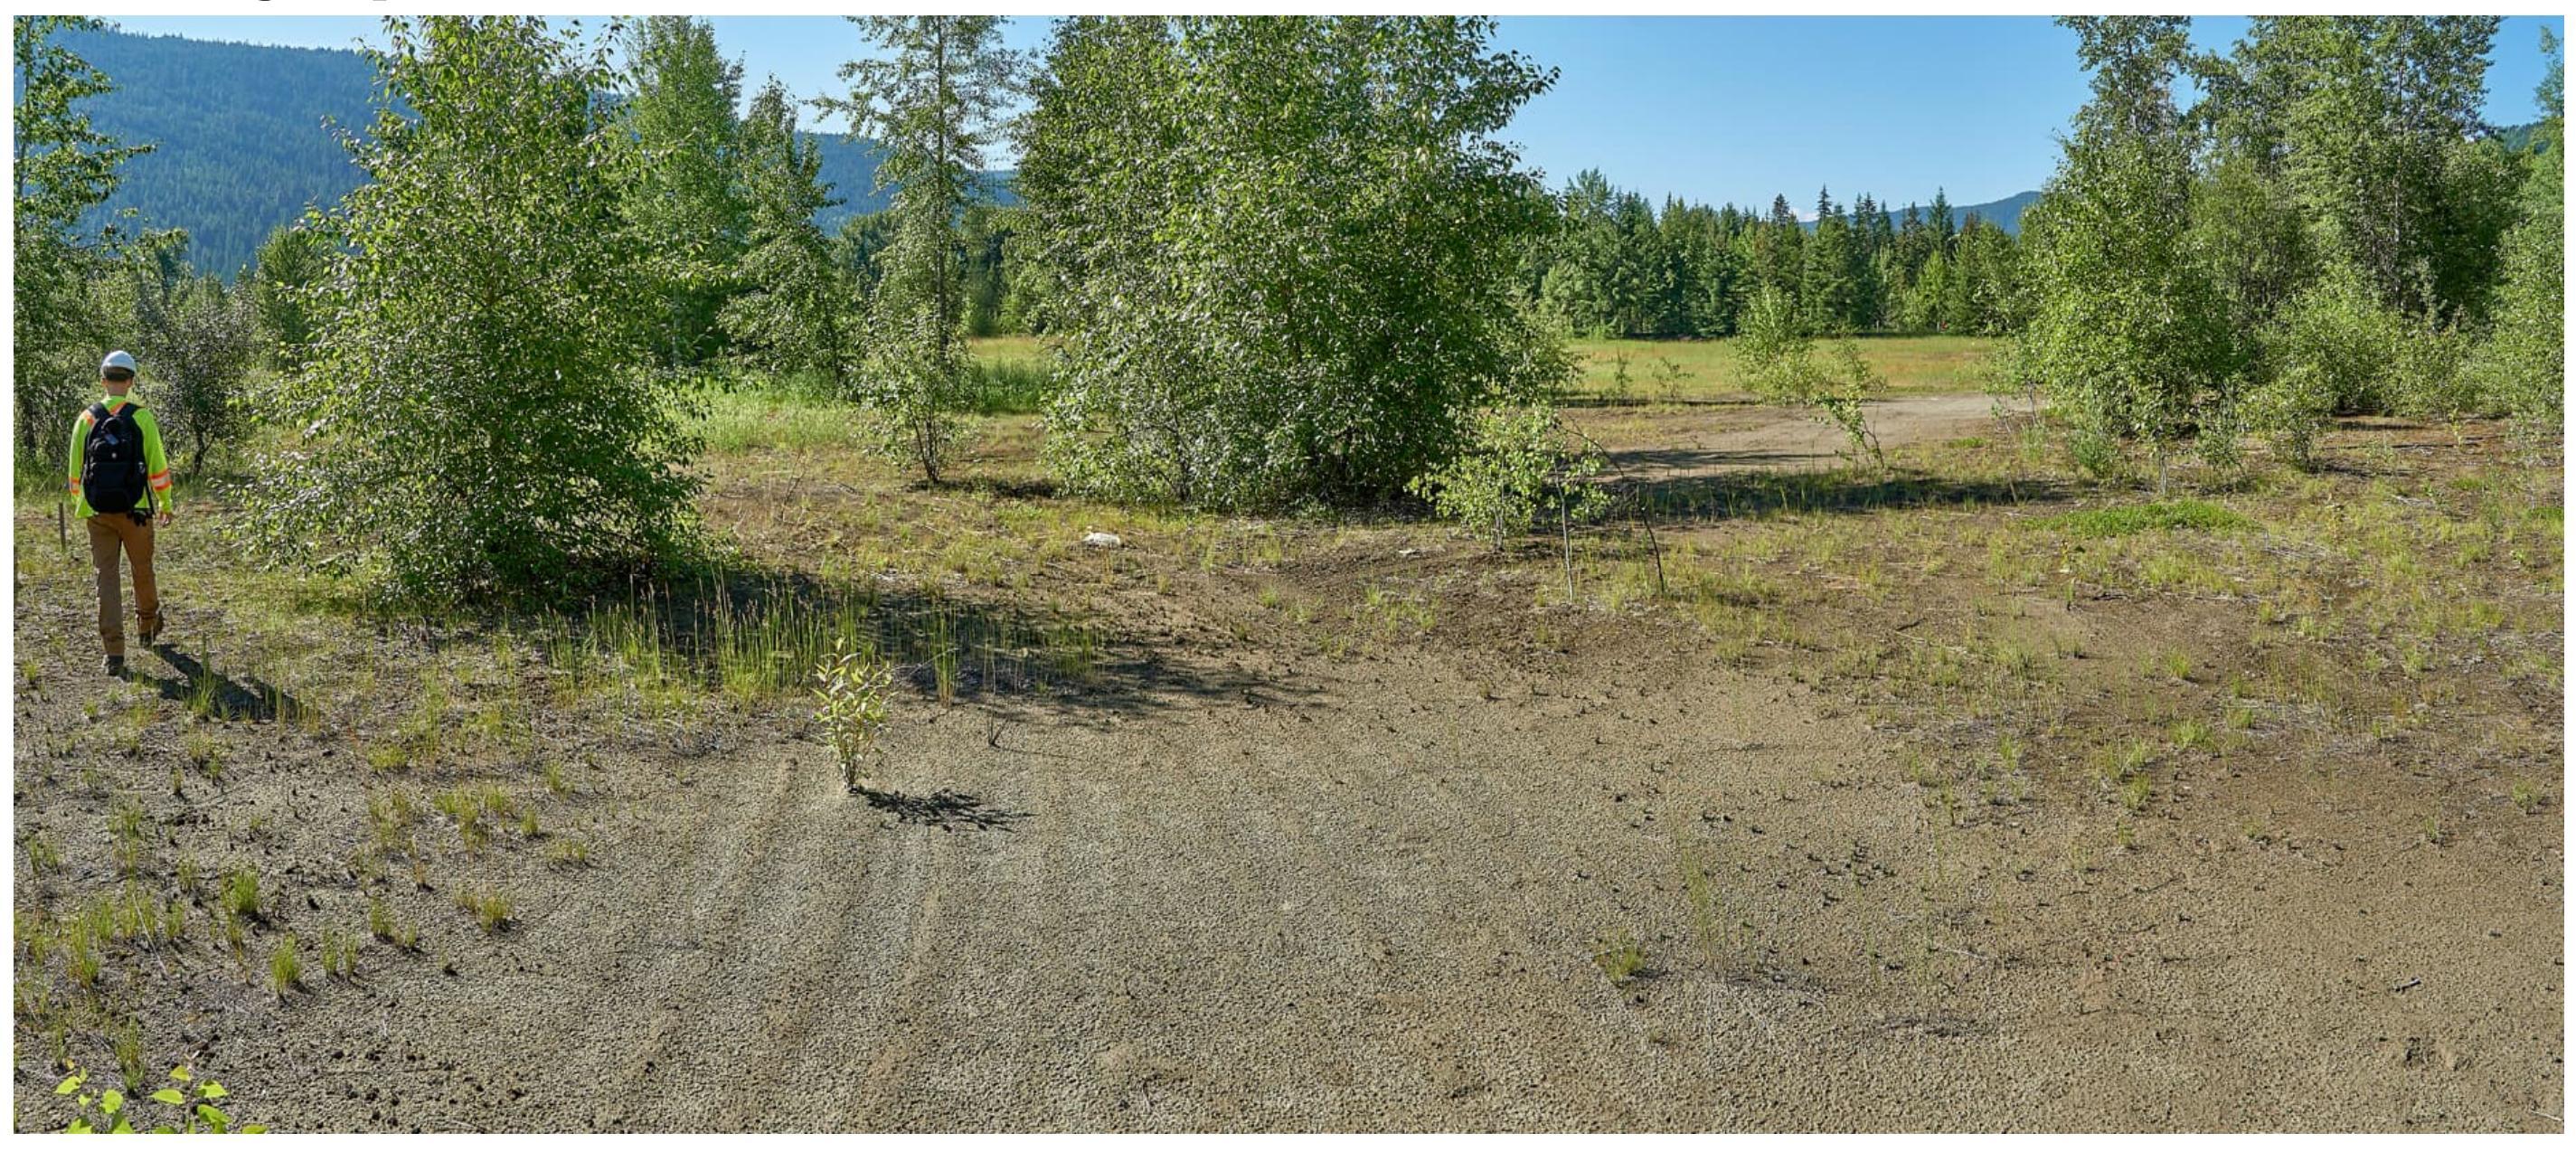
Photograph #8: "Cell 5 tailings surface"
