Beaverdell Tailings Storage Facilities – 2023 Annual Facility Performance Report

Teck Resources Limited, Beaverdell Mine

Reference No. CA0007697.0438-003-R-Rev0

February 27, 2024

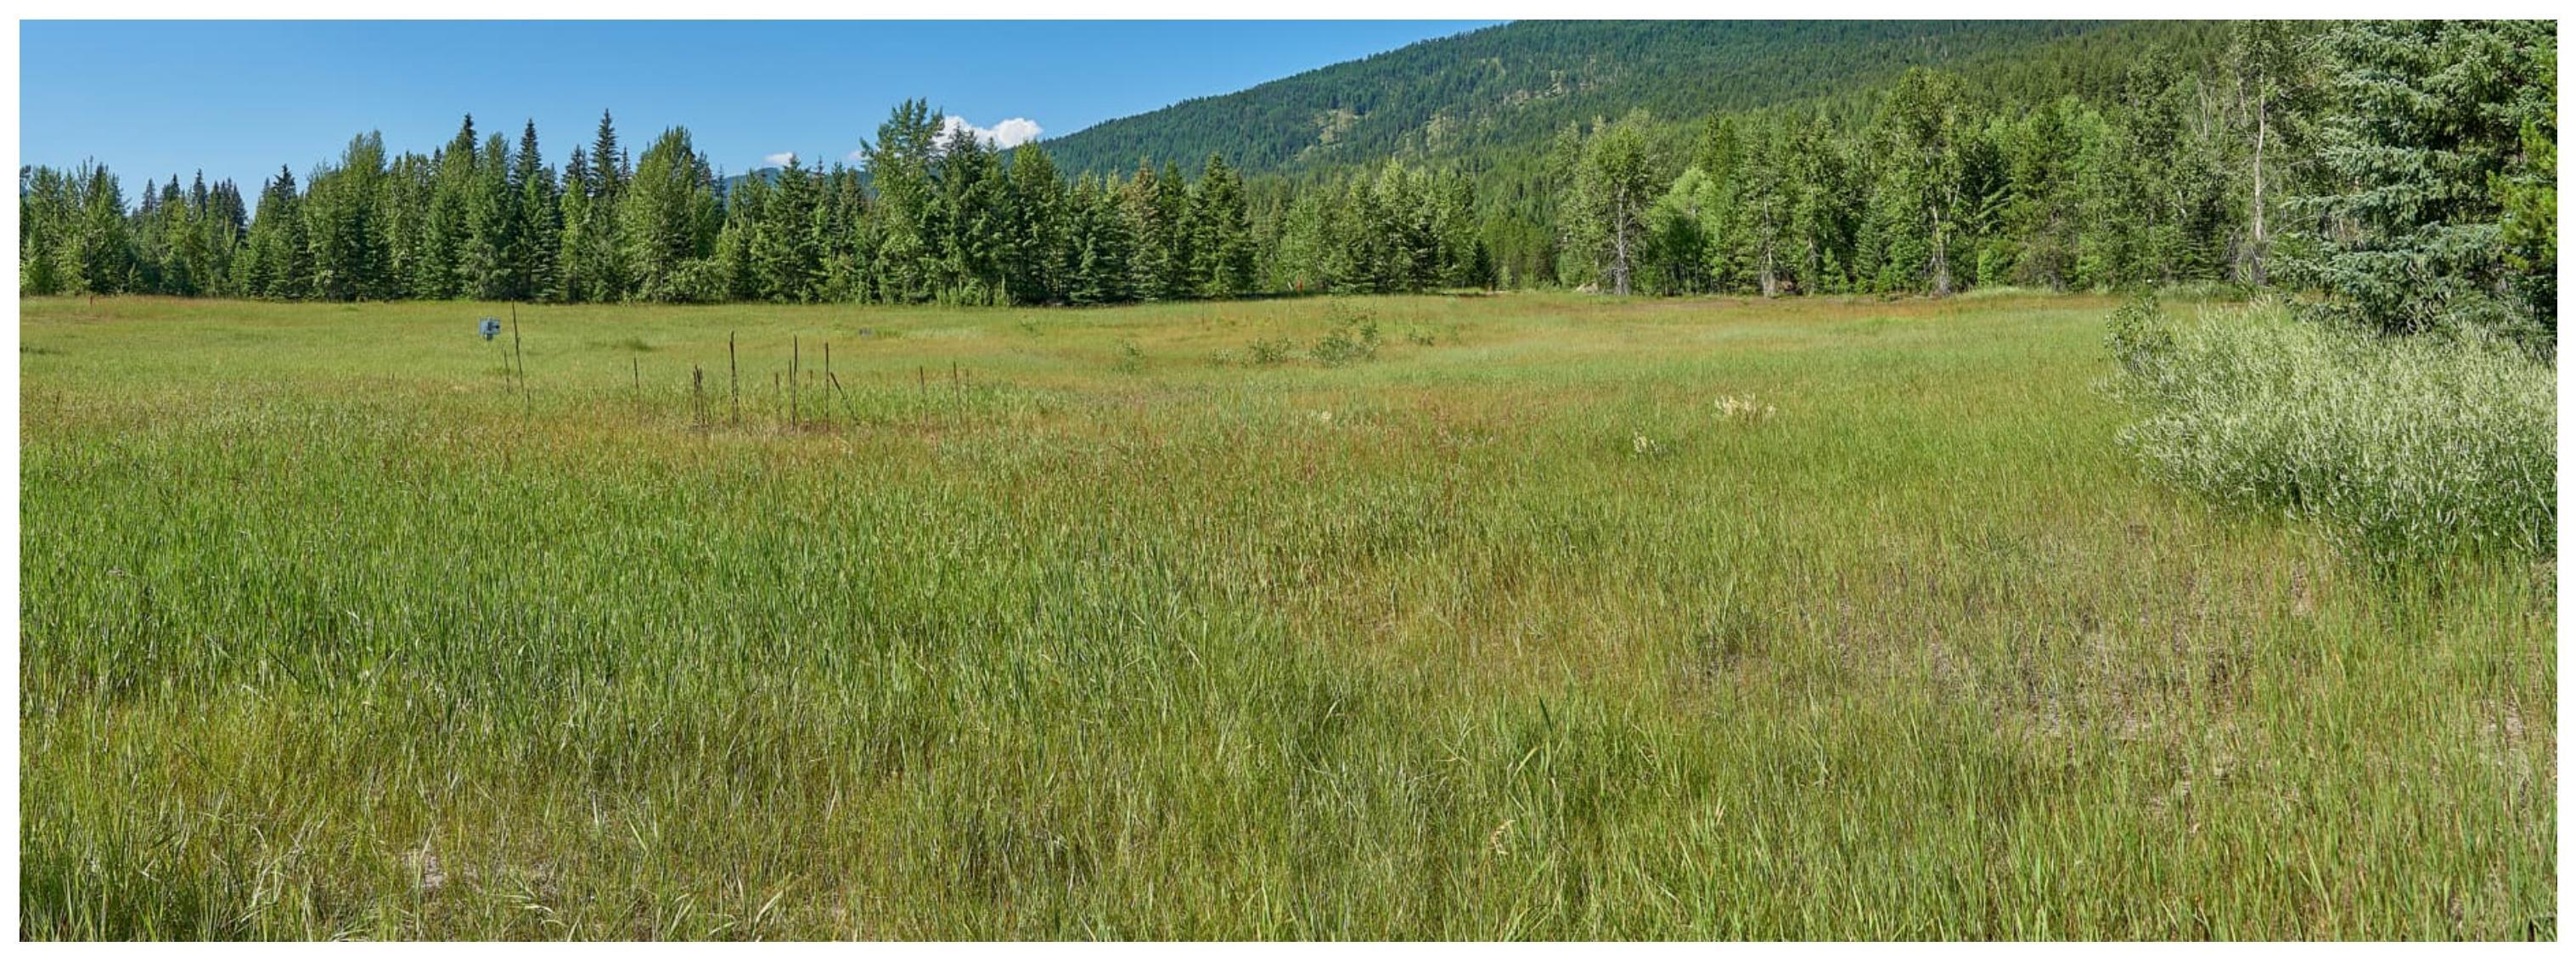
Photograph #9: "Cell 5 tailings surface"

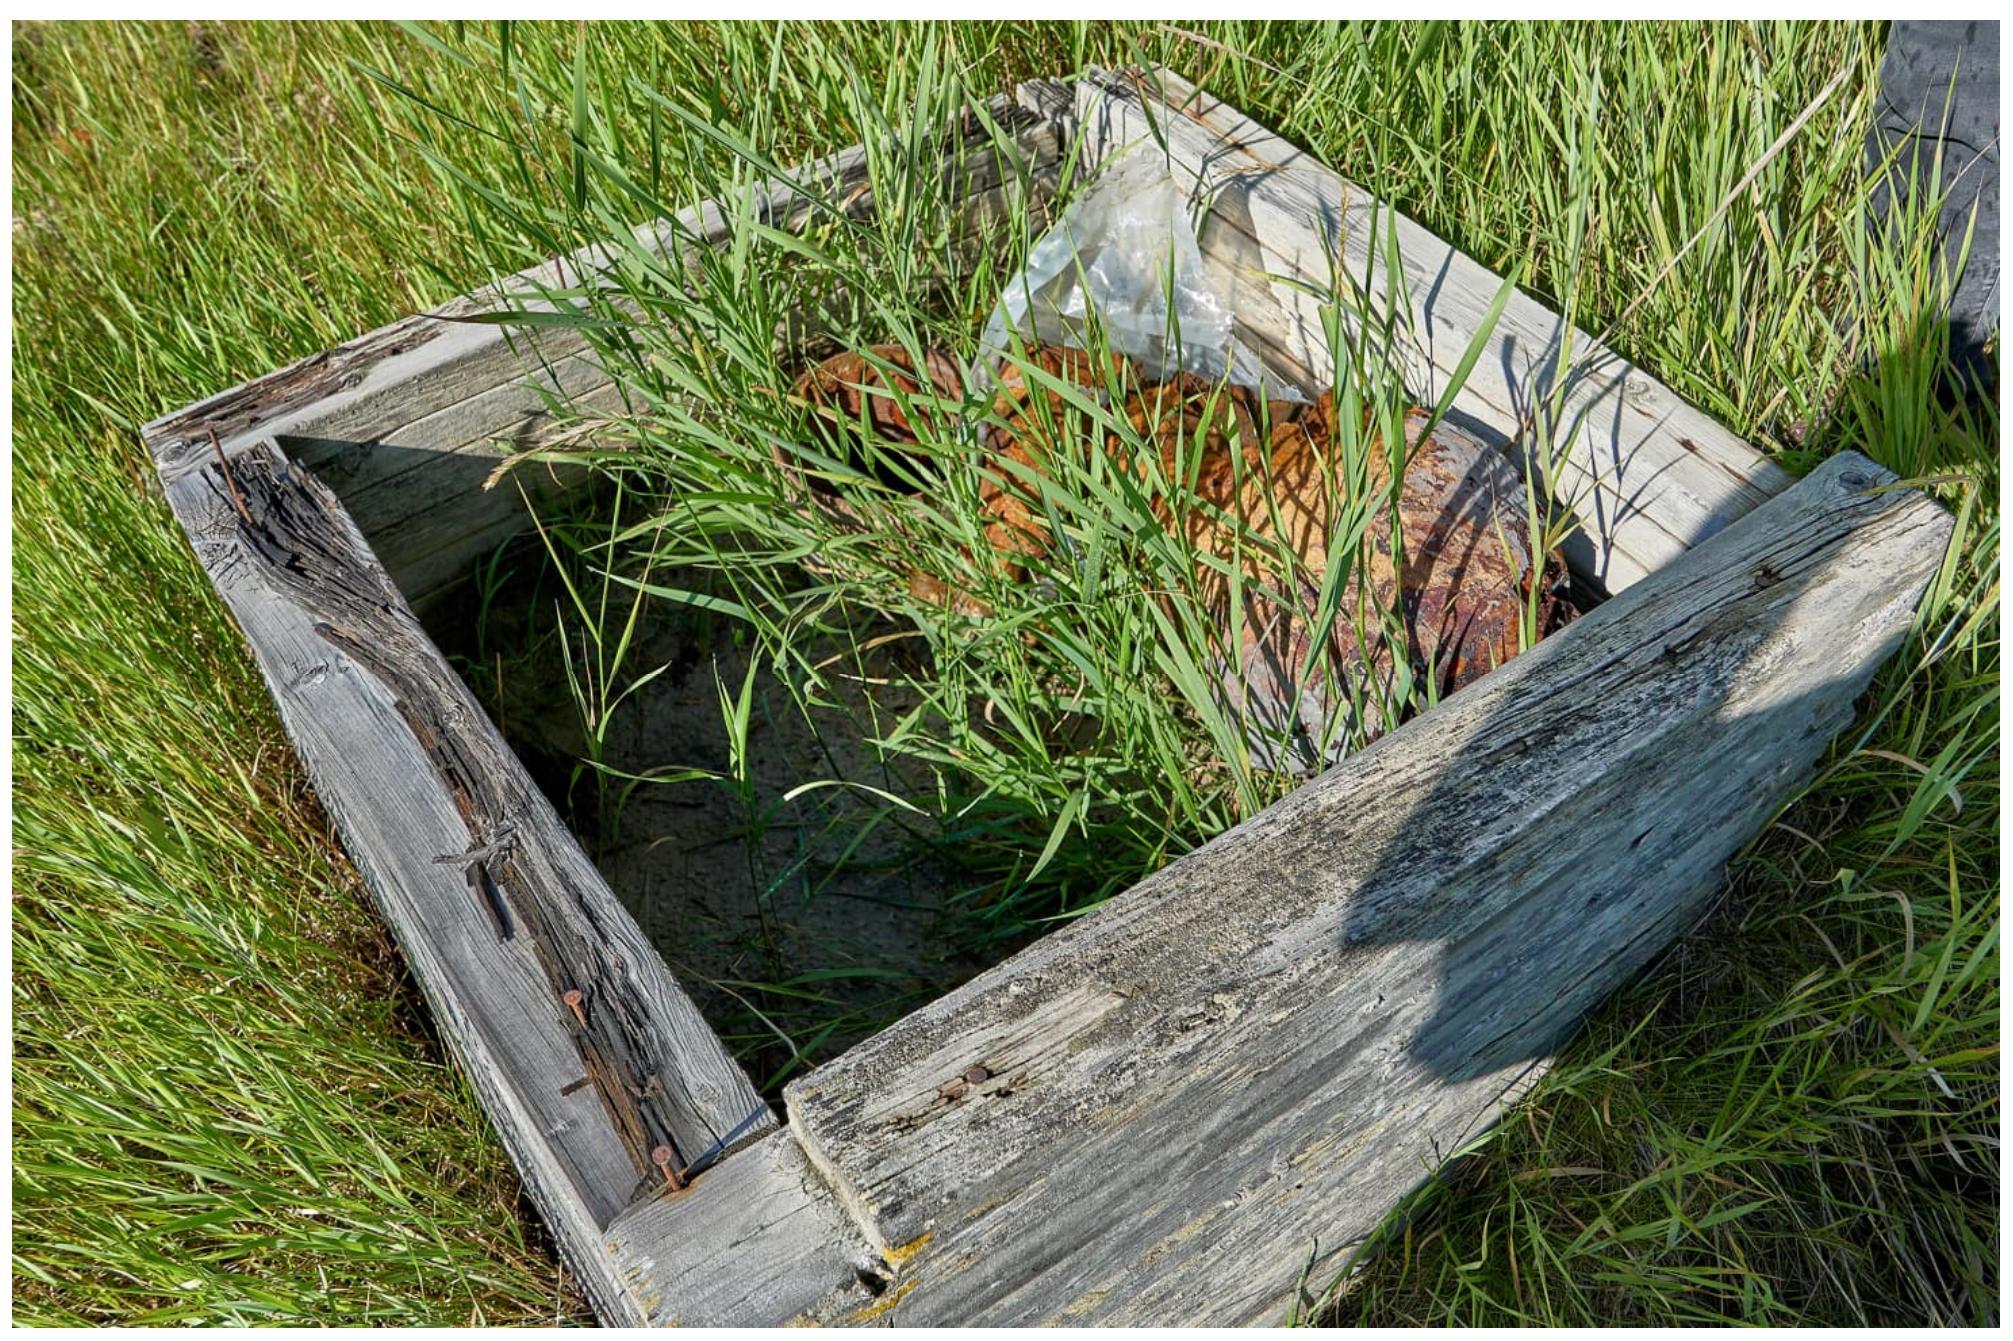
Photograph #10: "Decant in Cell 5"

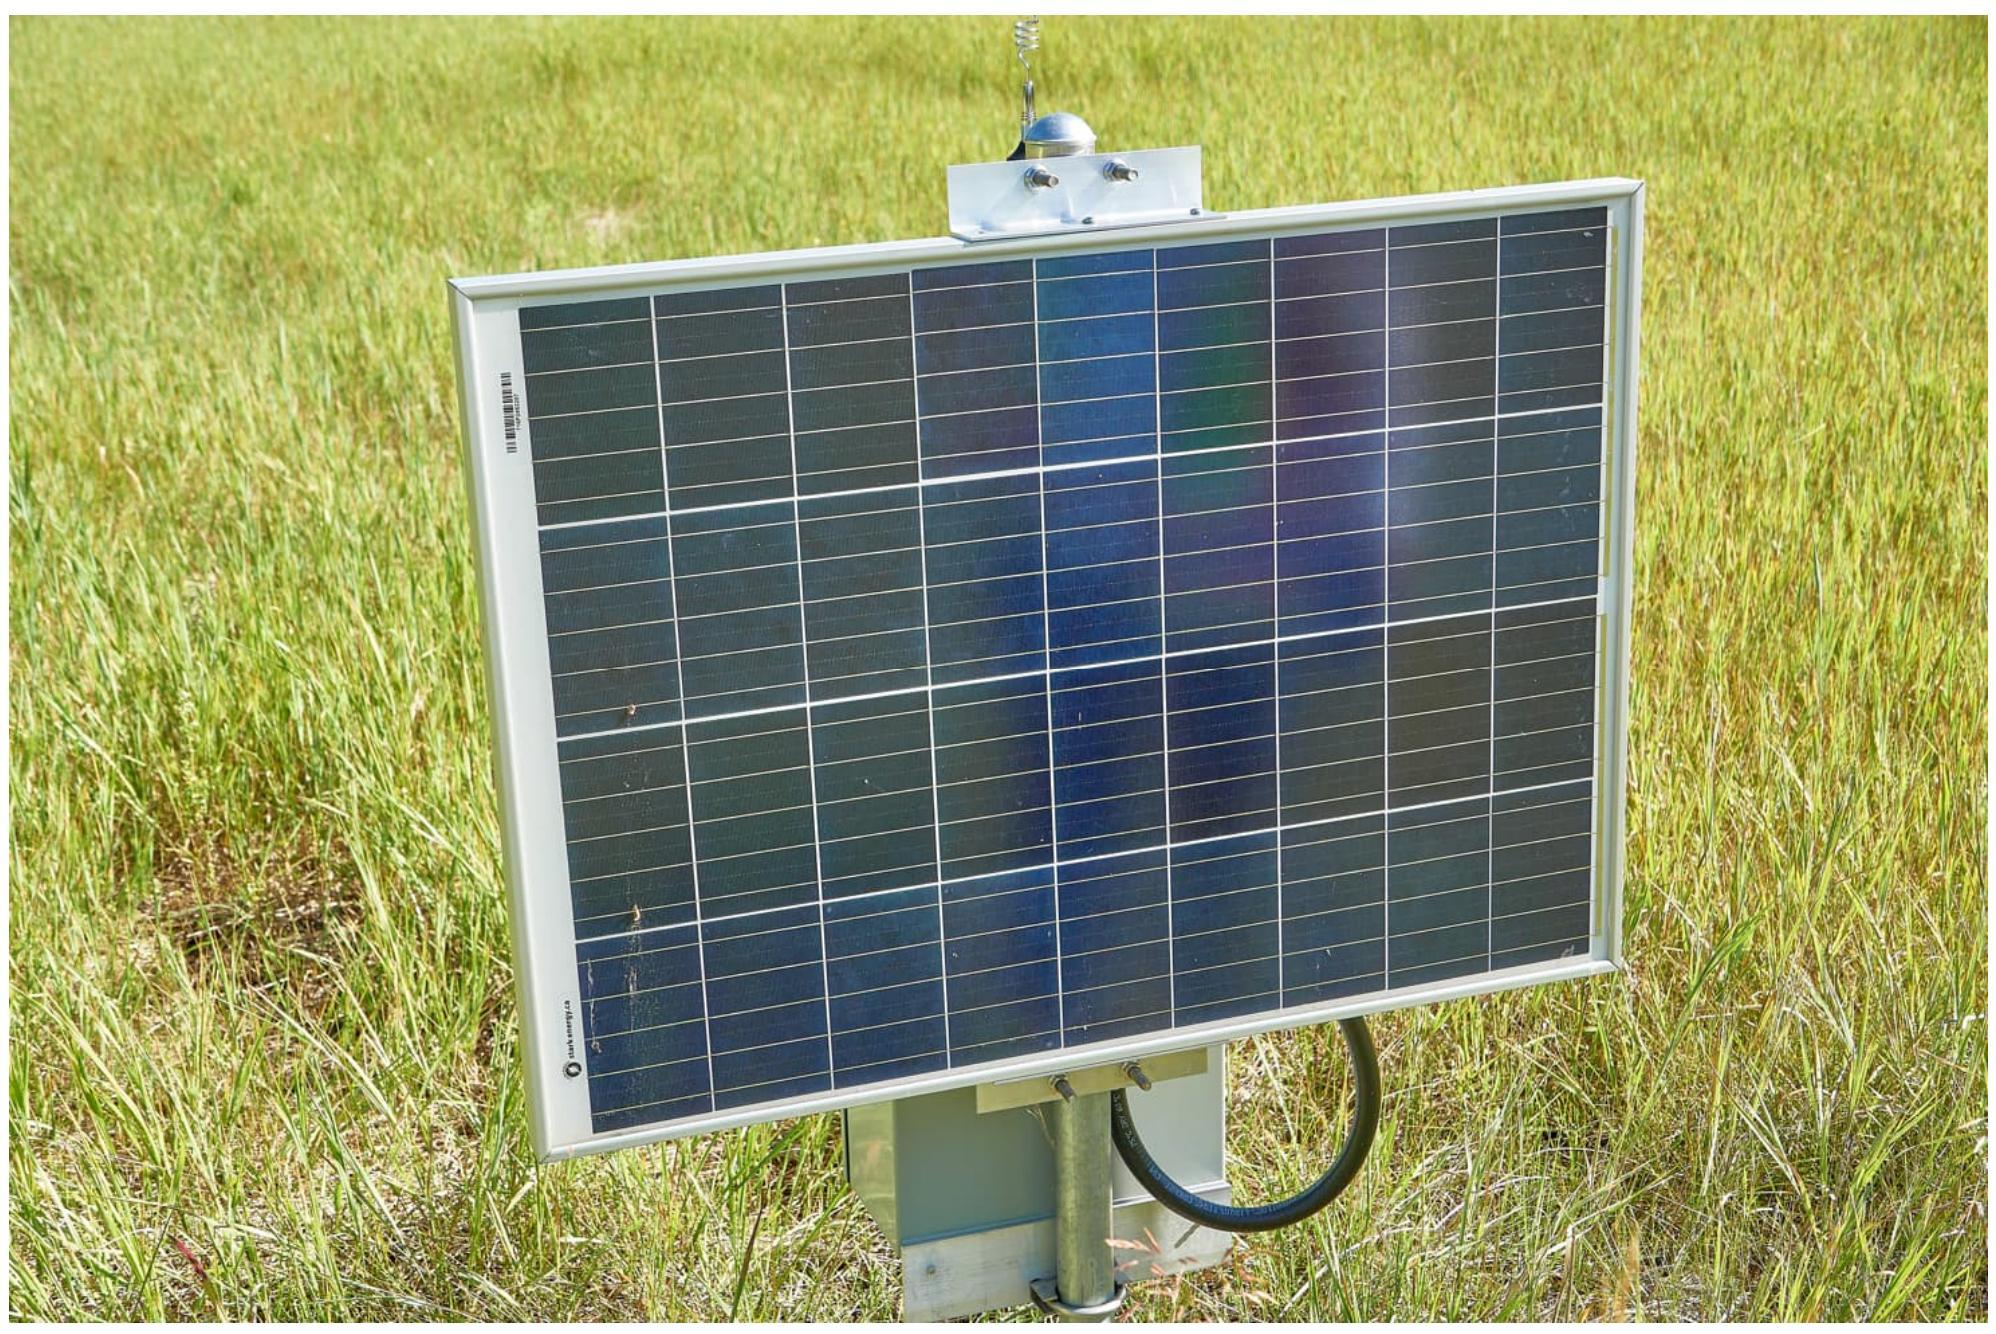
Photograph #11: "Repeater in Cell 5"

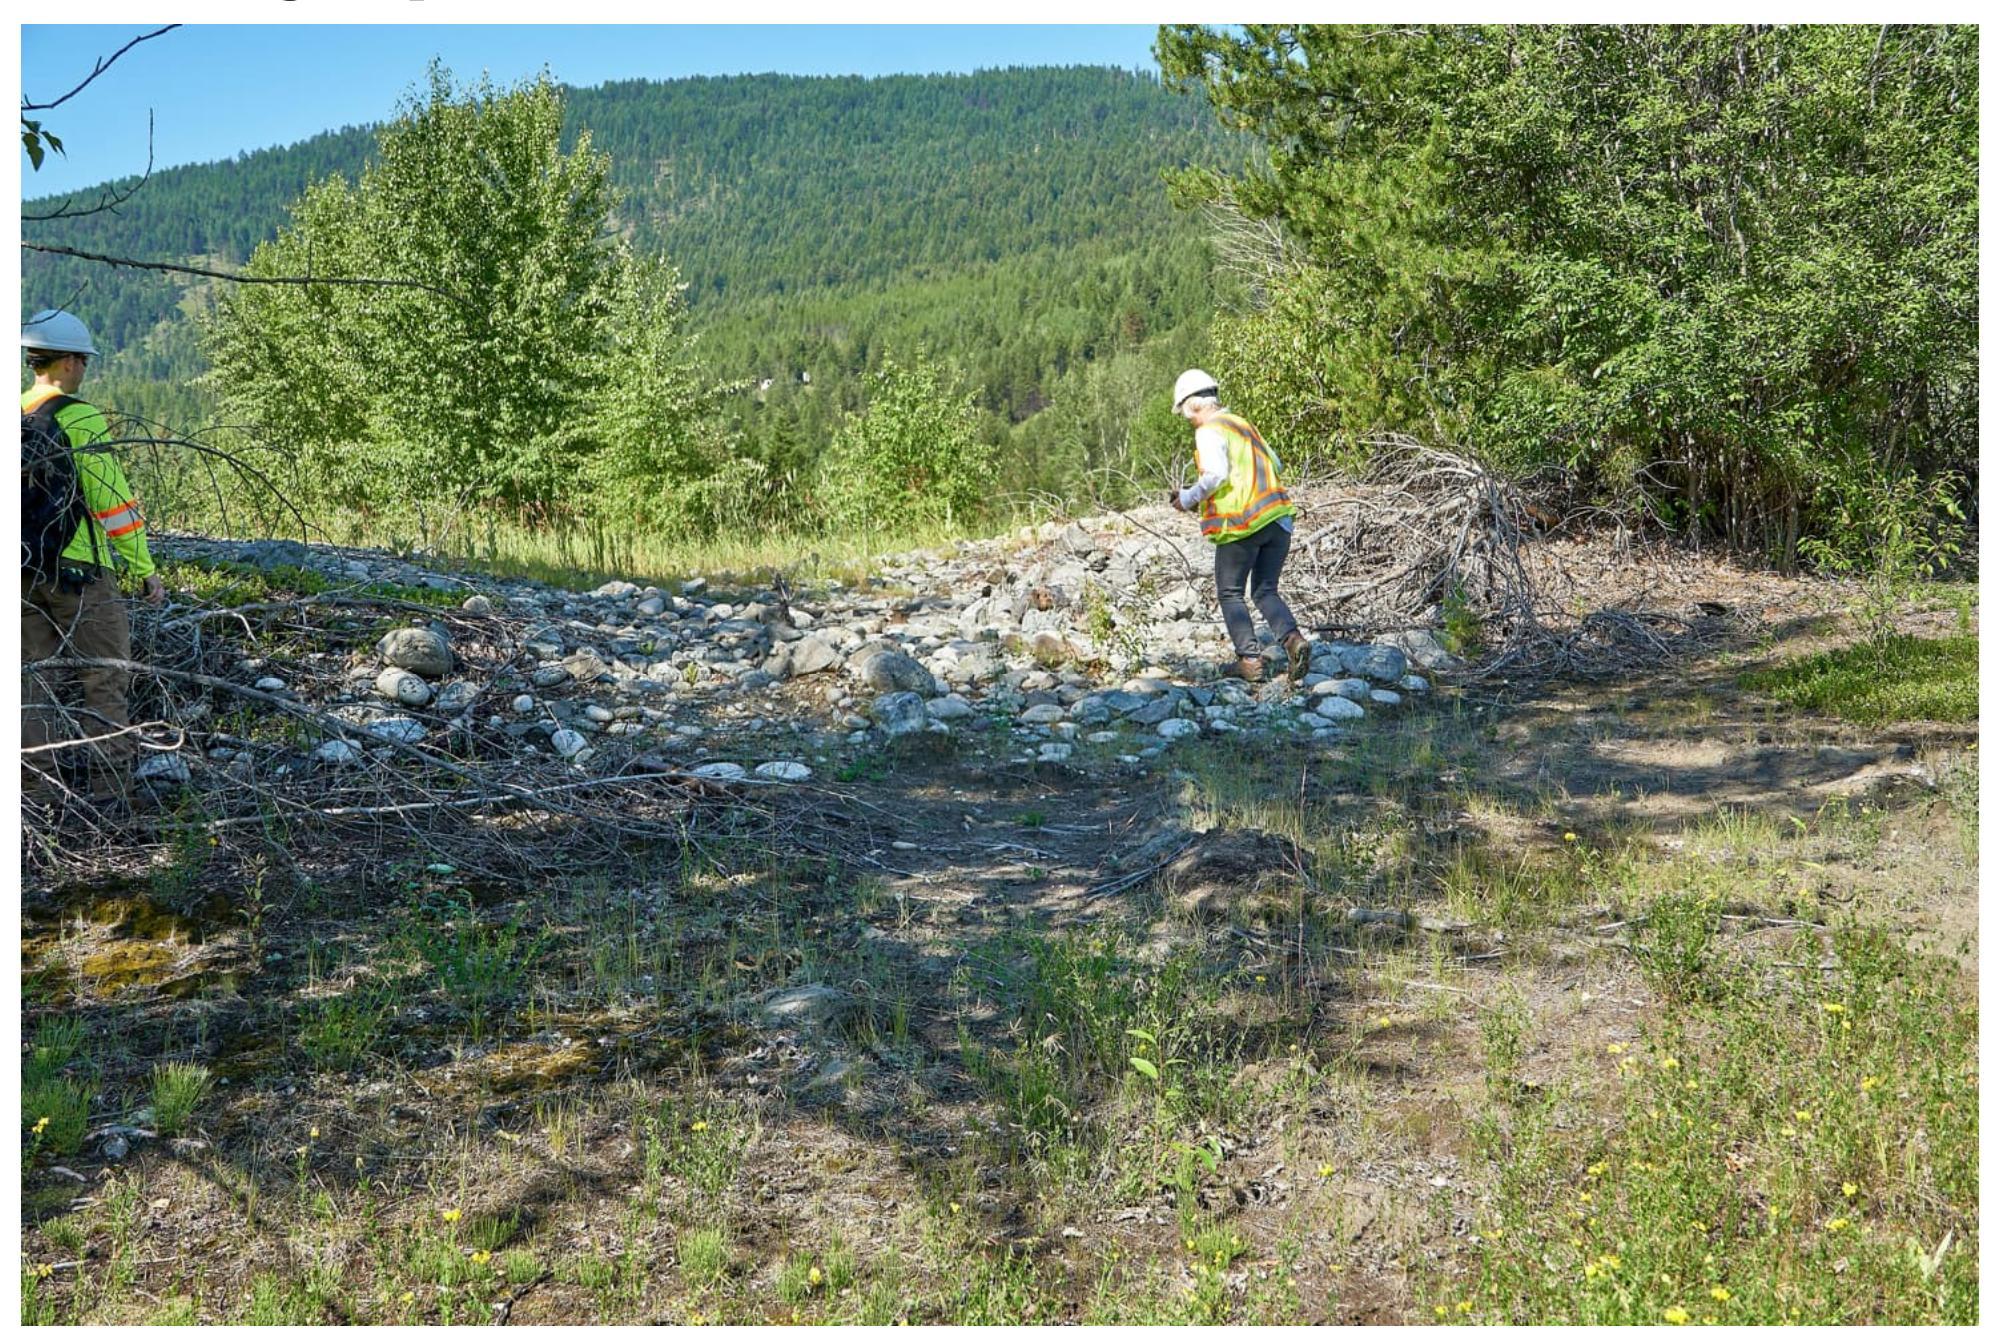
Photograph #12: "Overflow structure between Cell 5 and Cell 4"

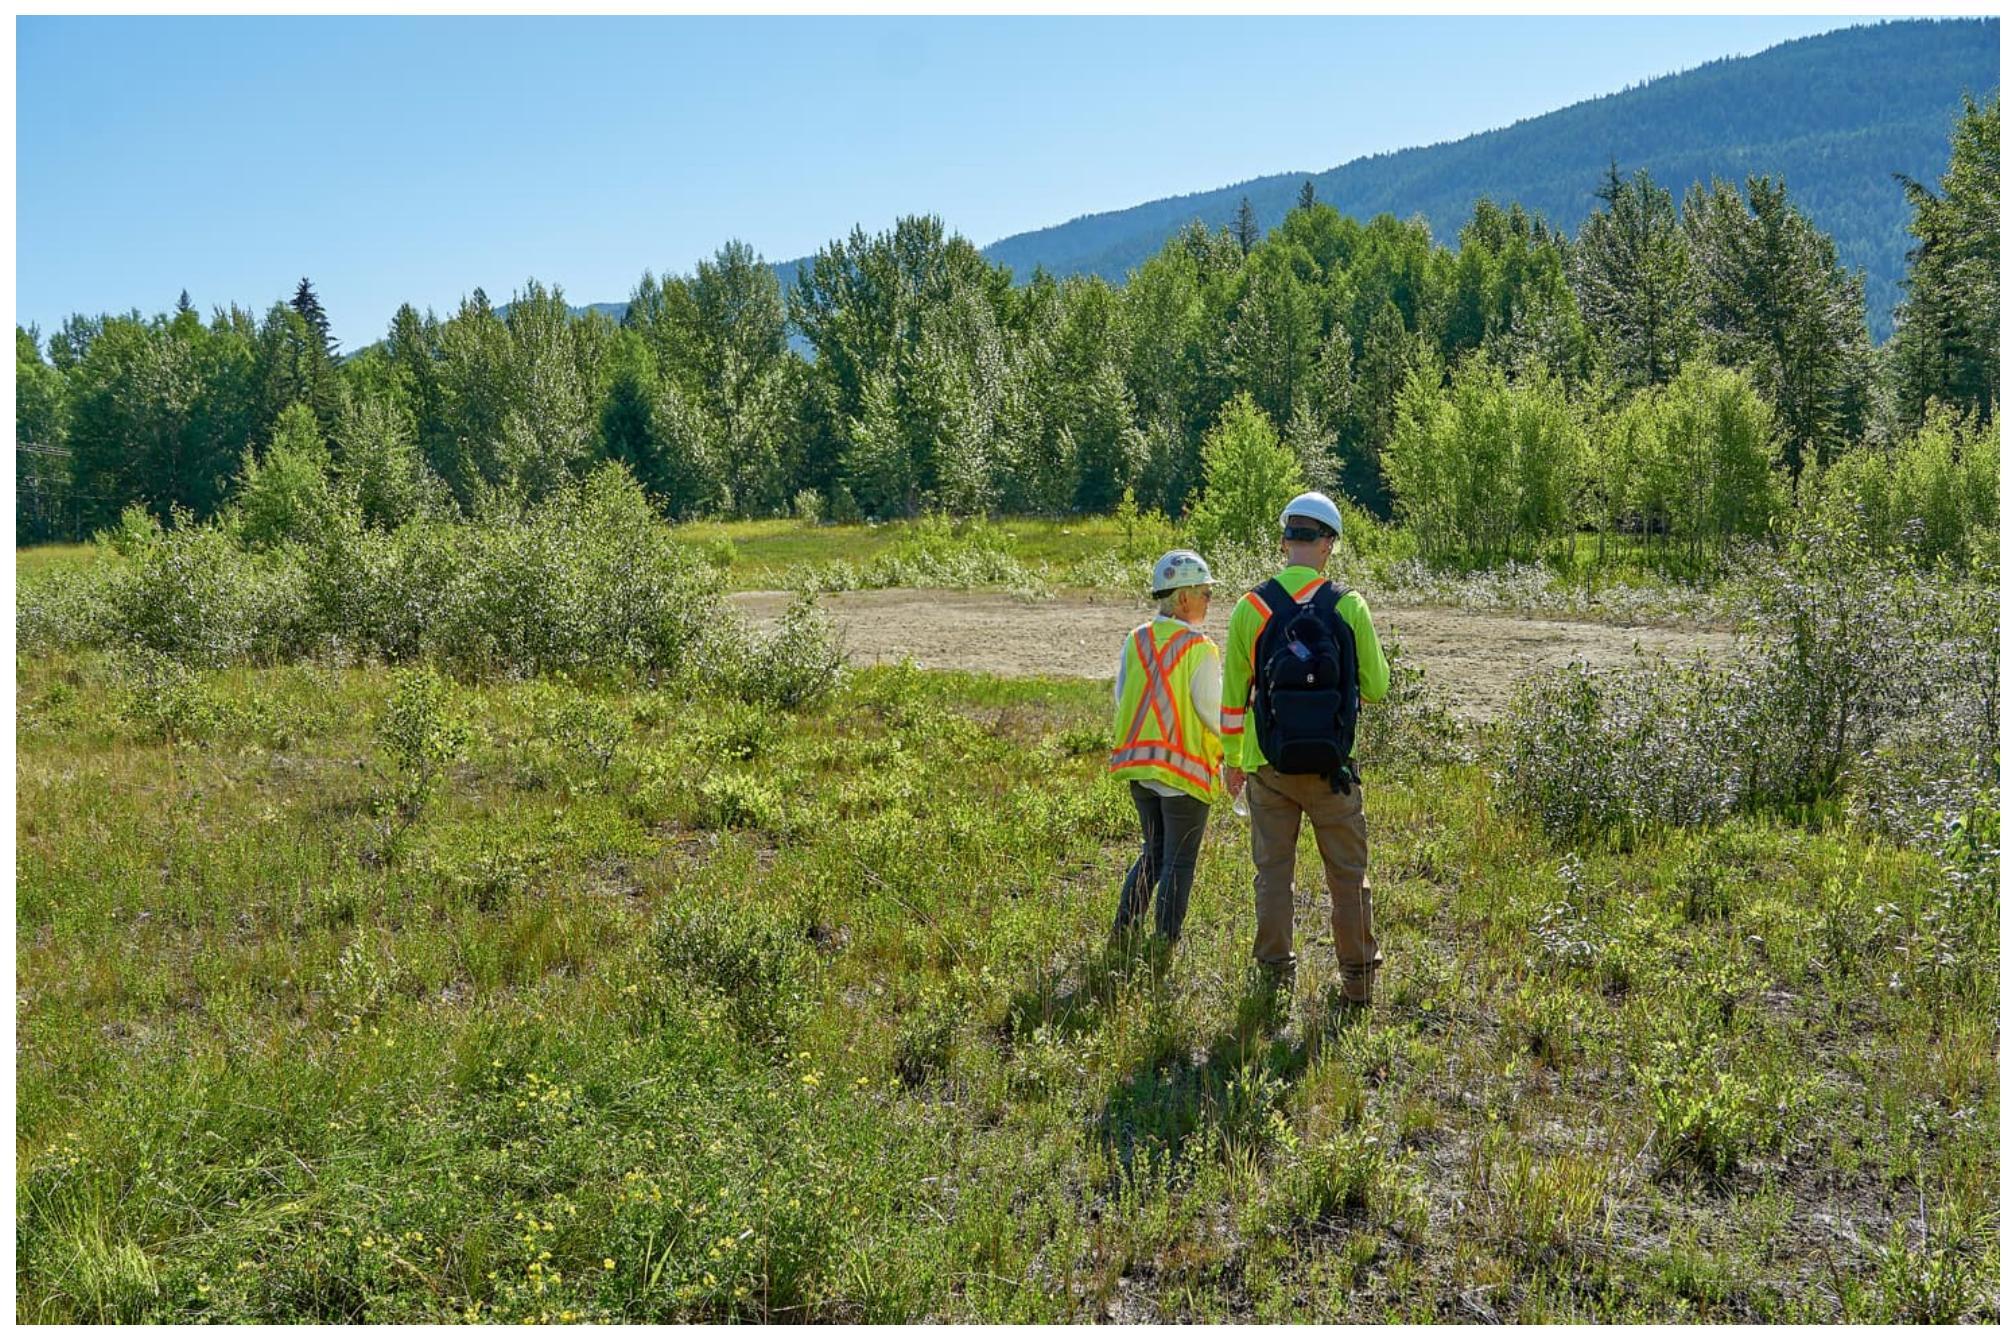
Photograph #13: "Dry pond in Cell 4"

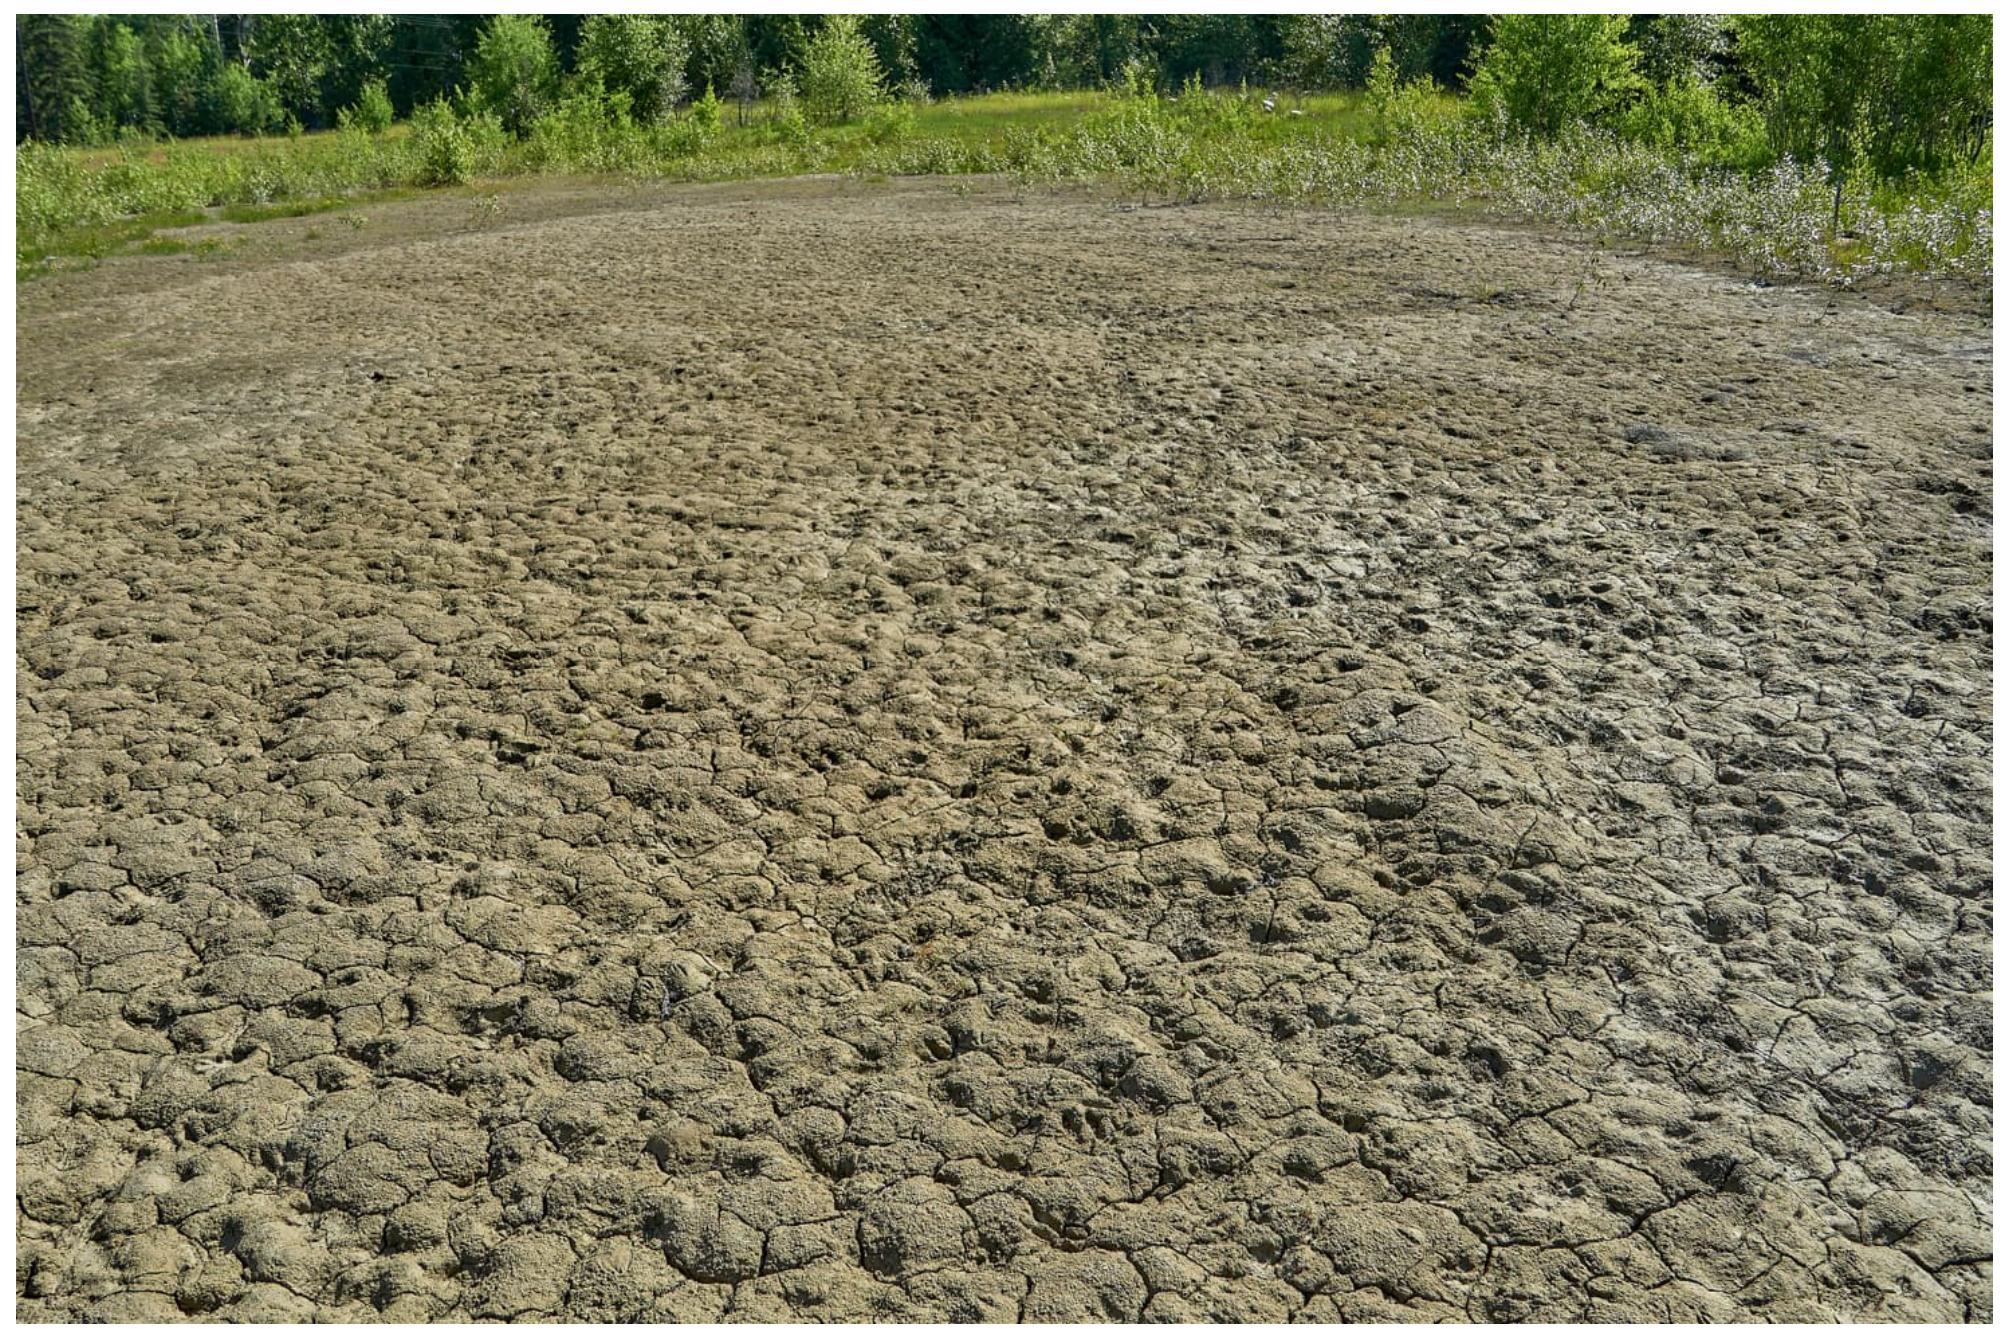
Photograph #14: "Surface of dry pond in Cell 4"

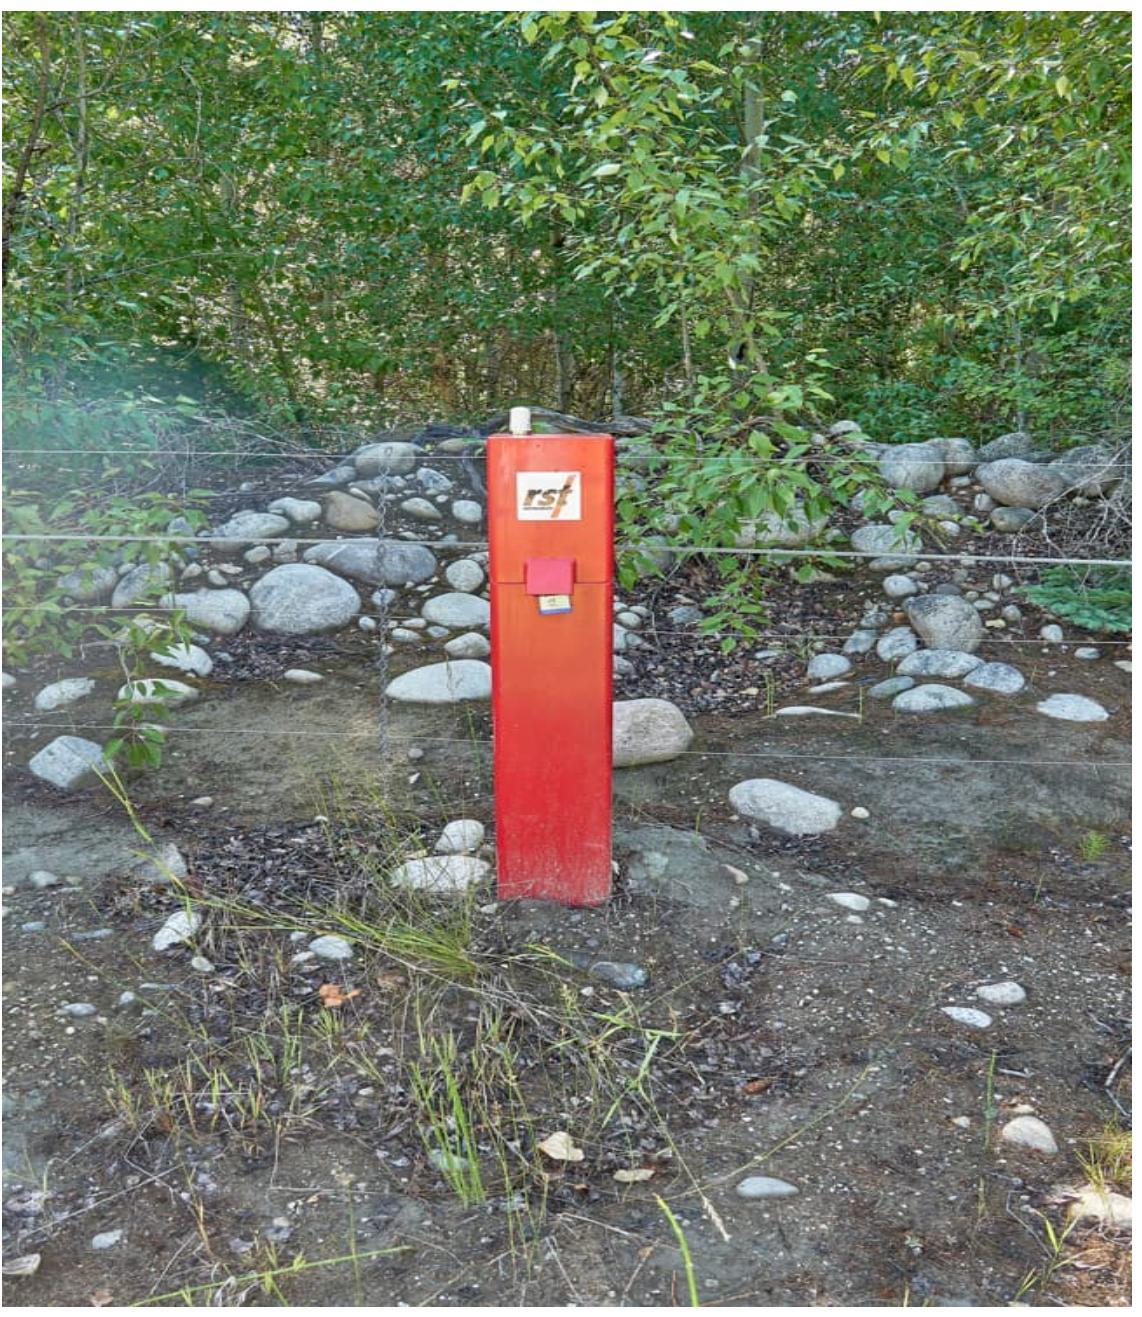
Photograph #15: "Piezometer adjacent to Cell 4"

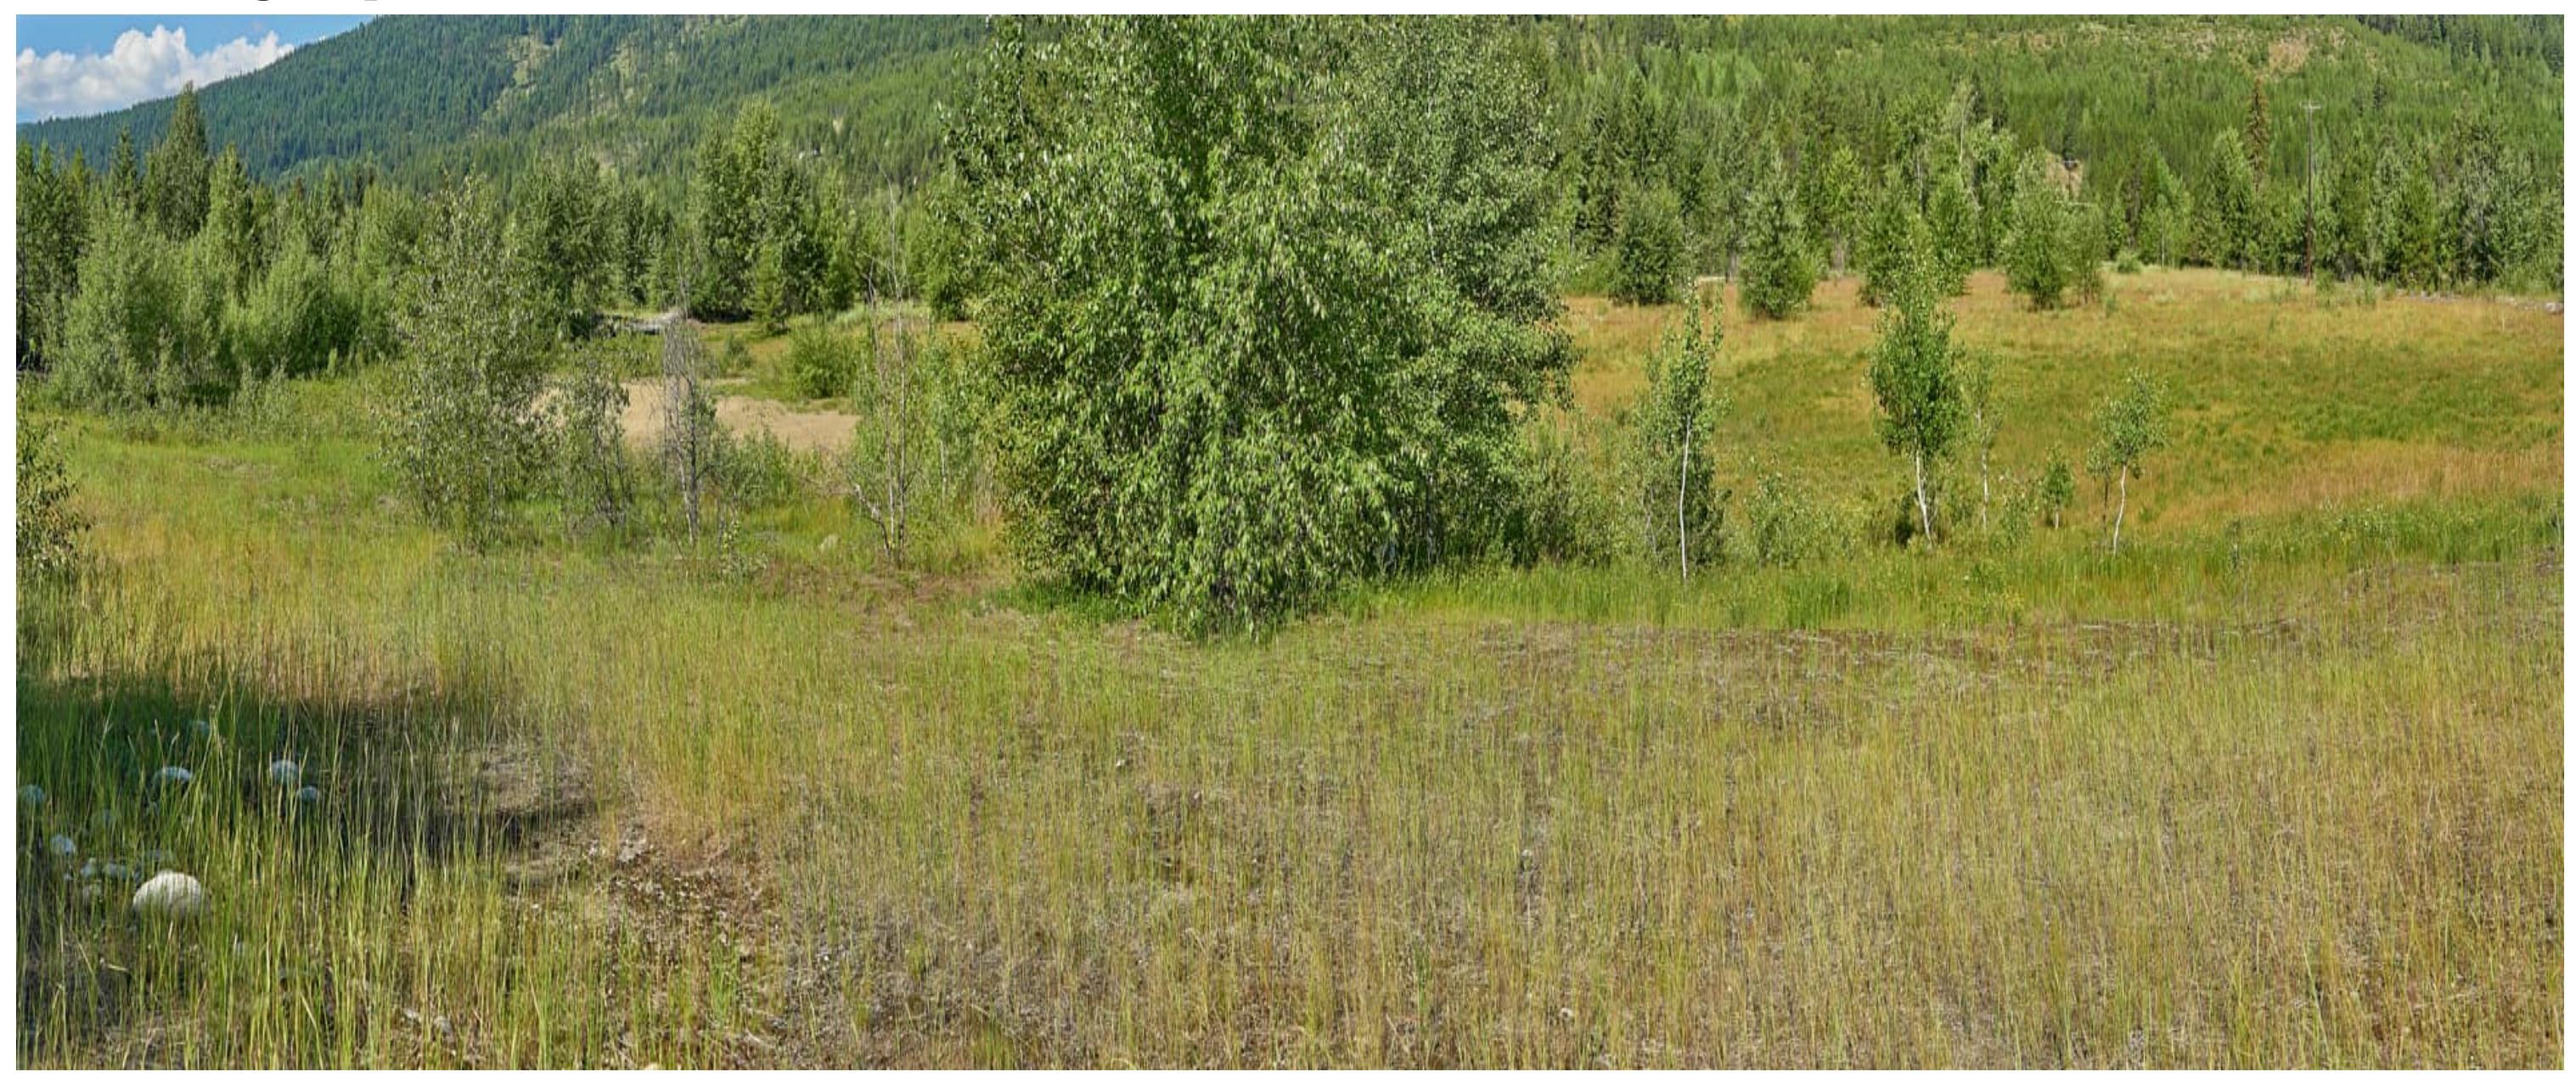
Photograph #16: "Cell 4 tailings surface"

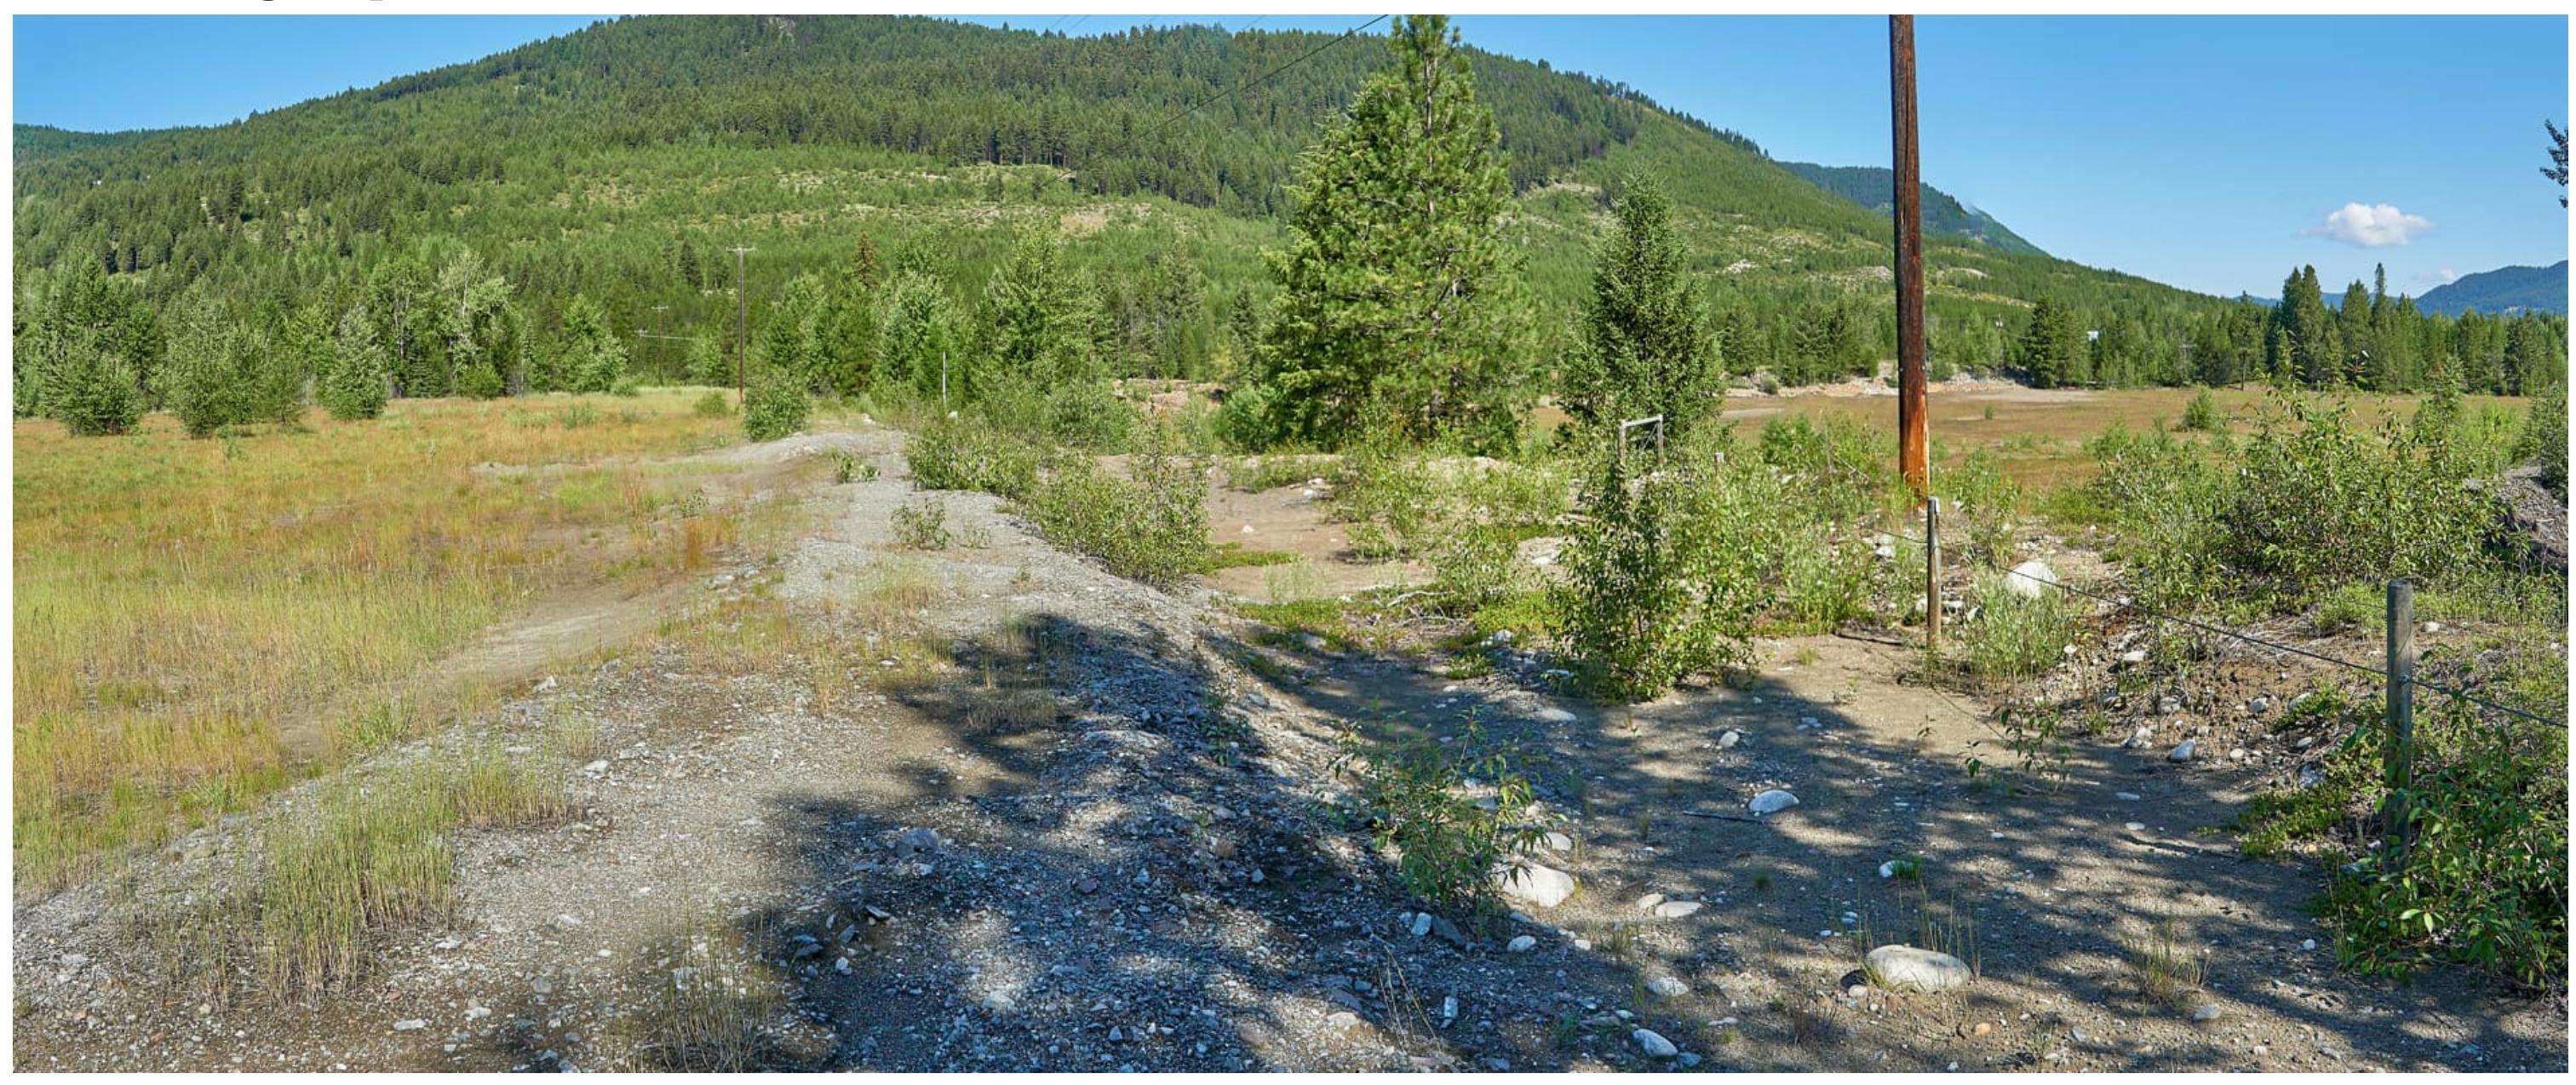
Photograph #17: "Internal dike between Cell 4 and Cell 3"
