Beaverdell Tailings Storage Facilities – 2023 Annual Facility Performance Report

Teck Resources Limited, Beaverdell Mine

Reference No. CA0007697.0438-003-R-Rev0

February 27, 2024

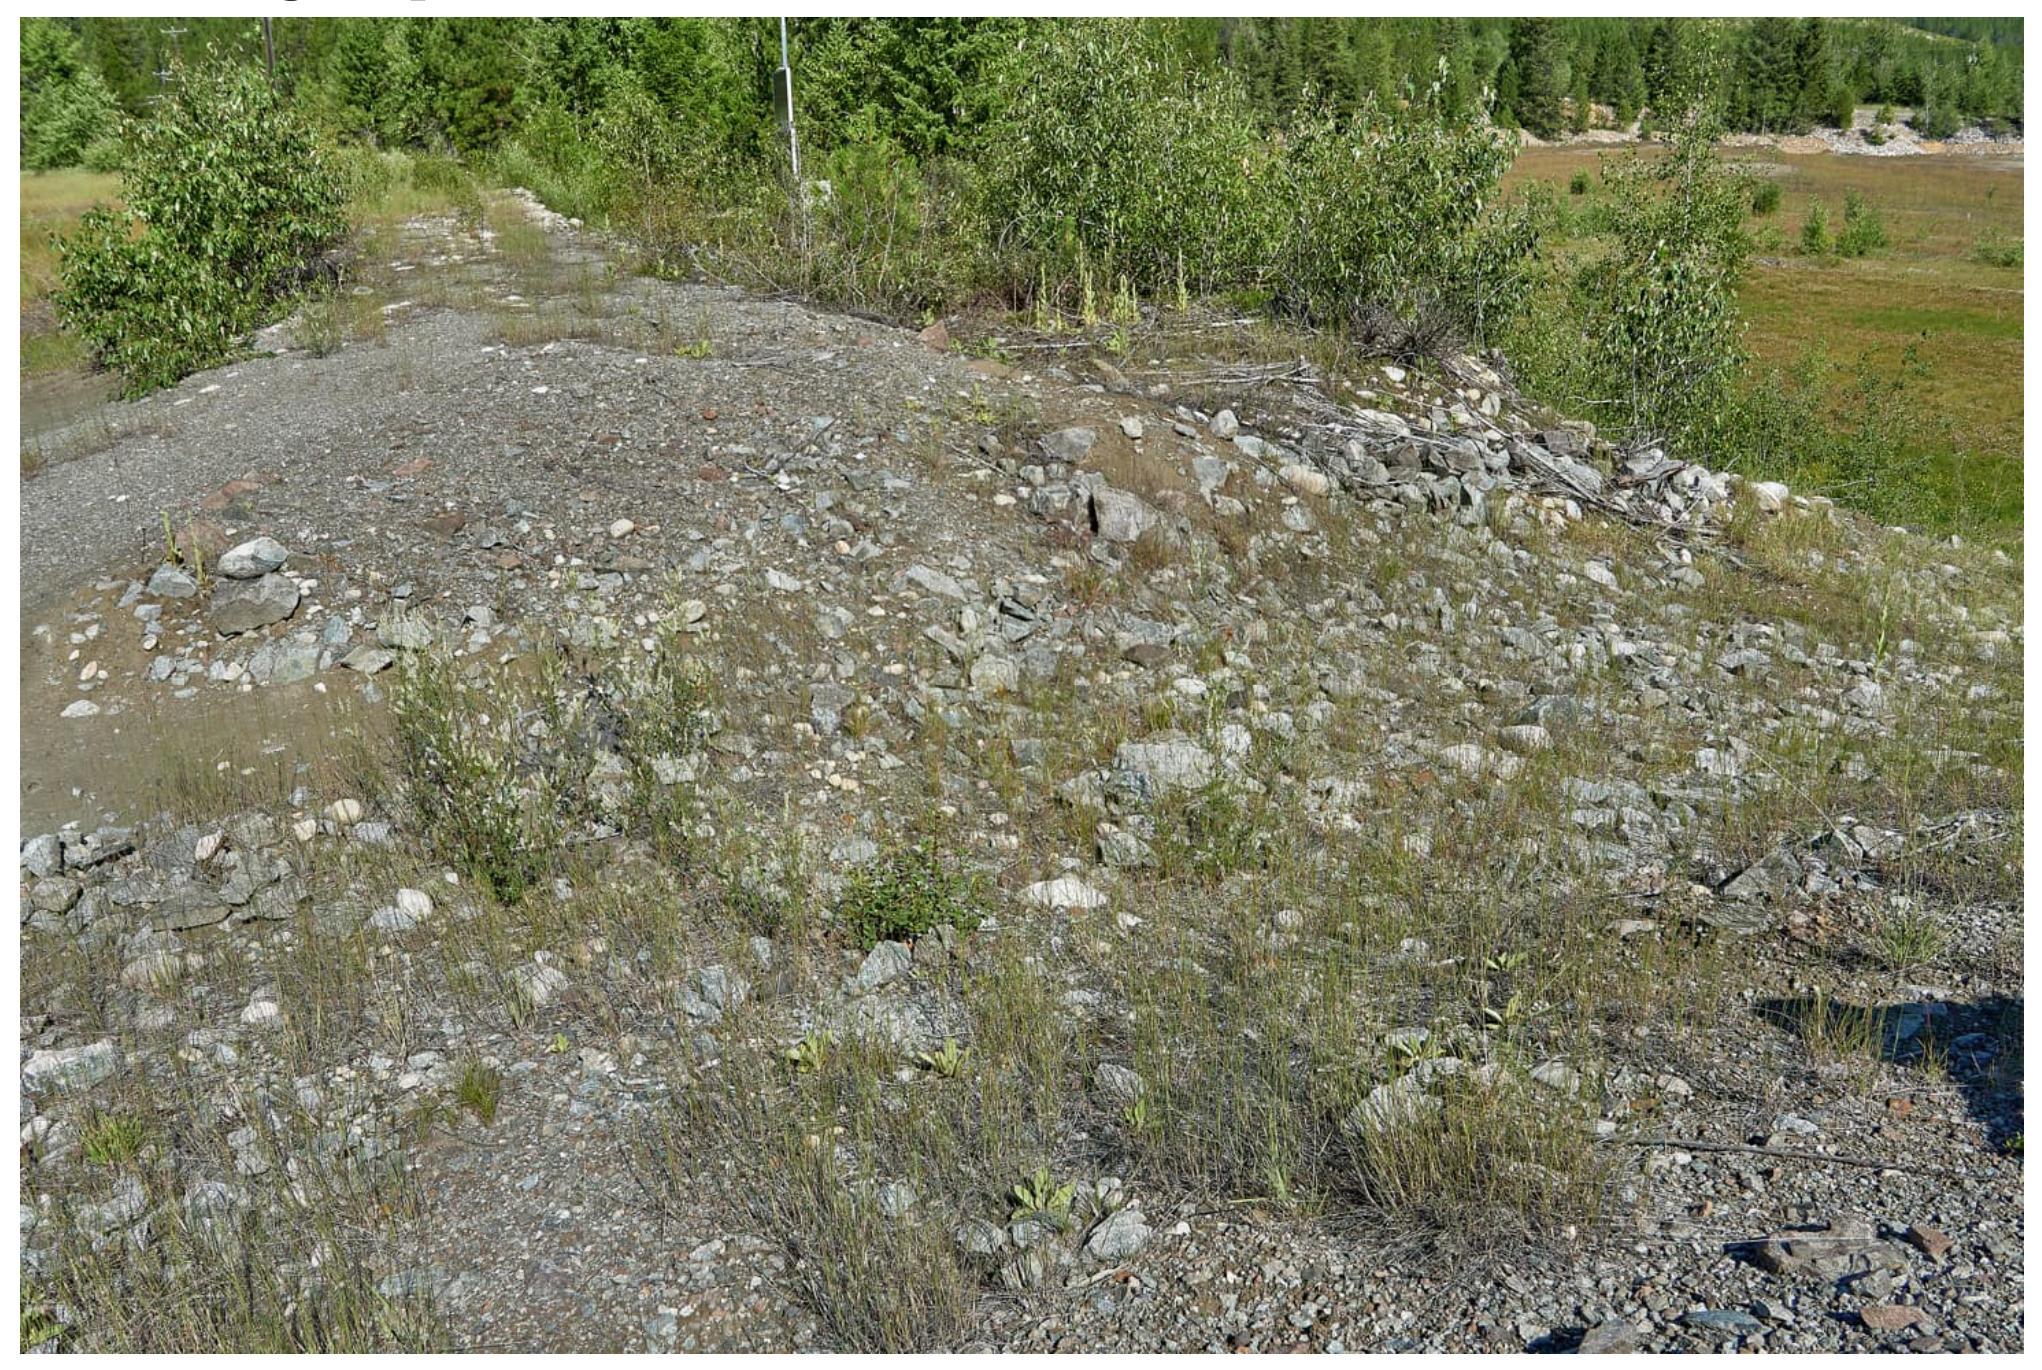
Photograph #18: "Overflow structure between Cell 4 and Cell 3"

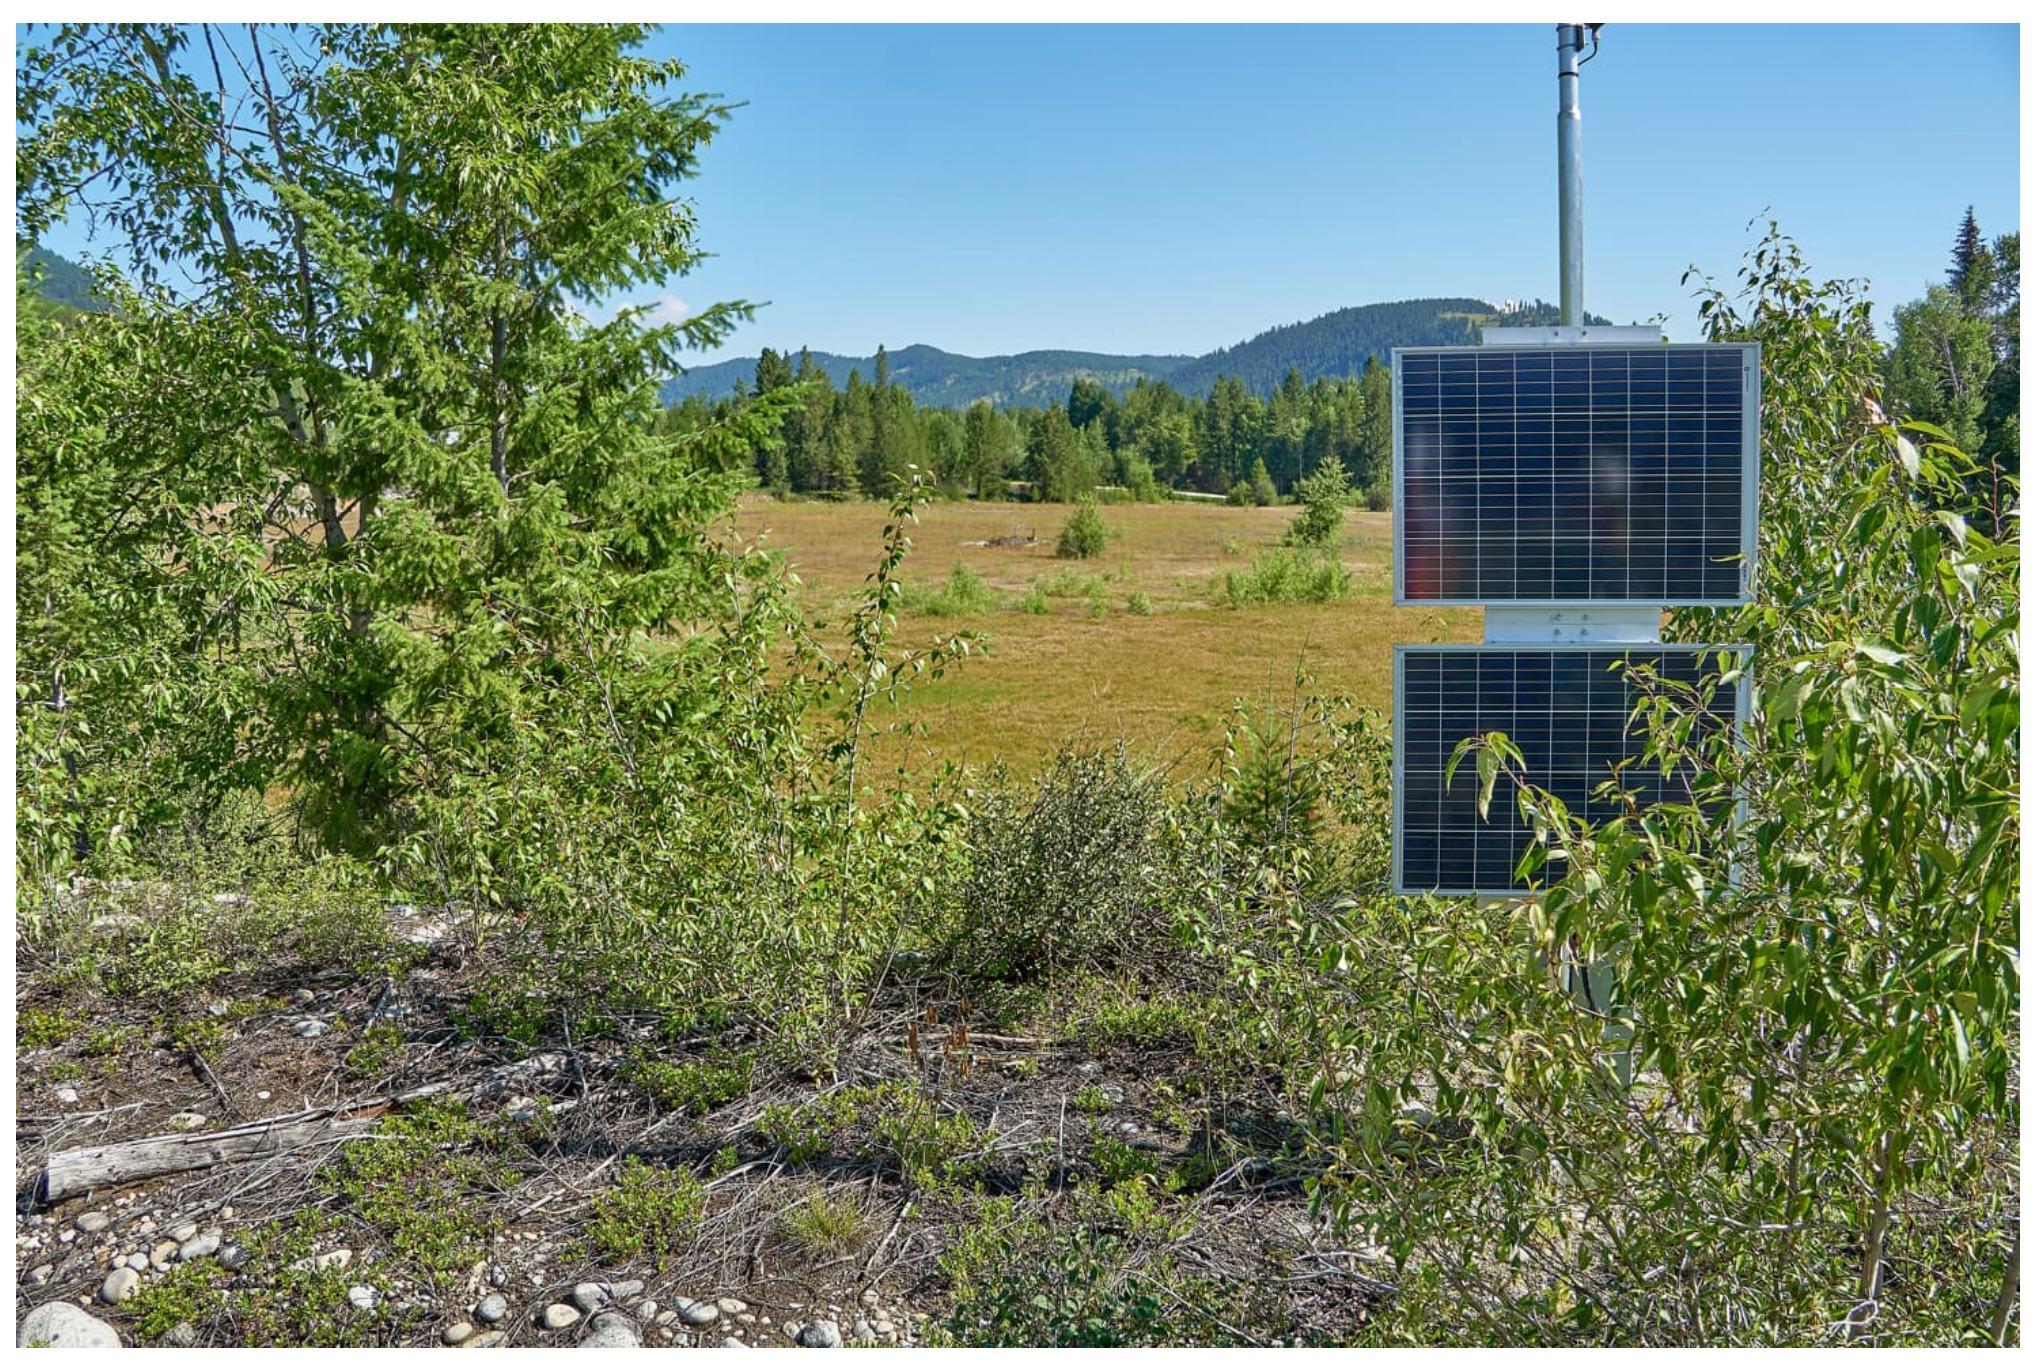
Photograph #19: "Instrumentation hub"

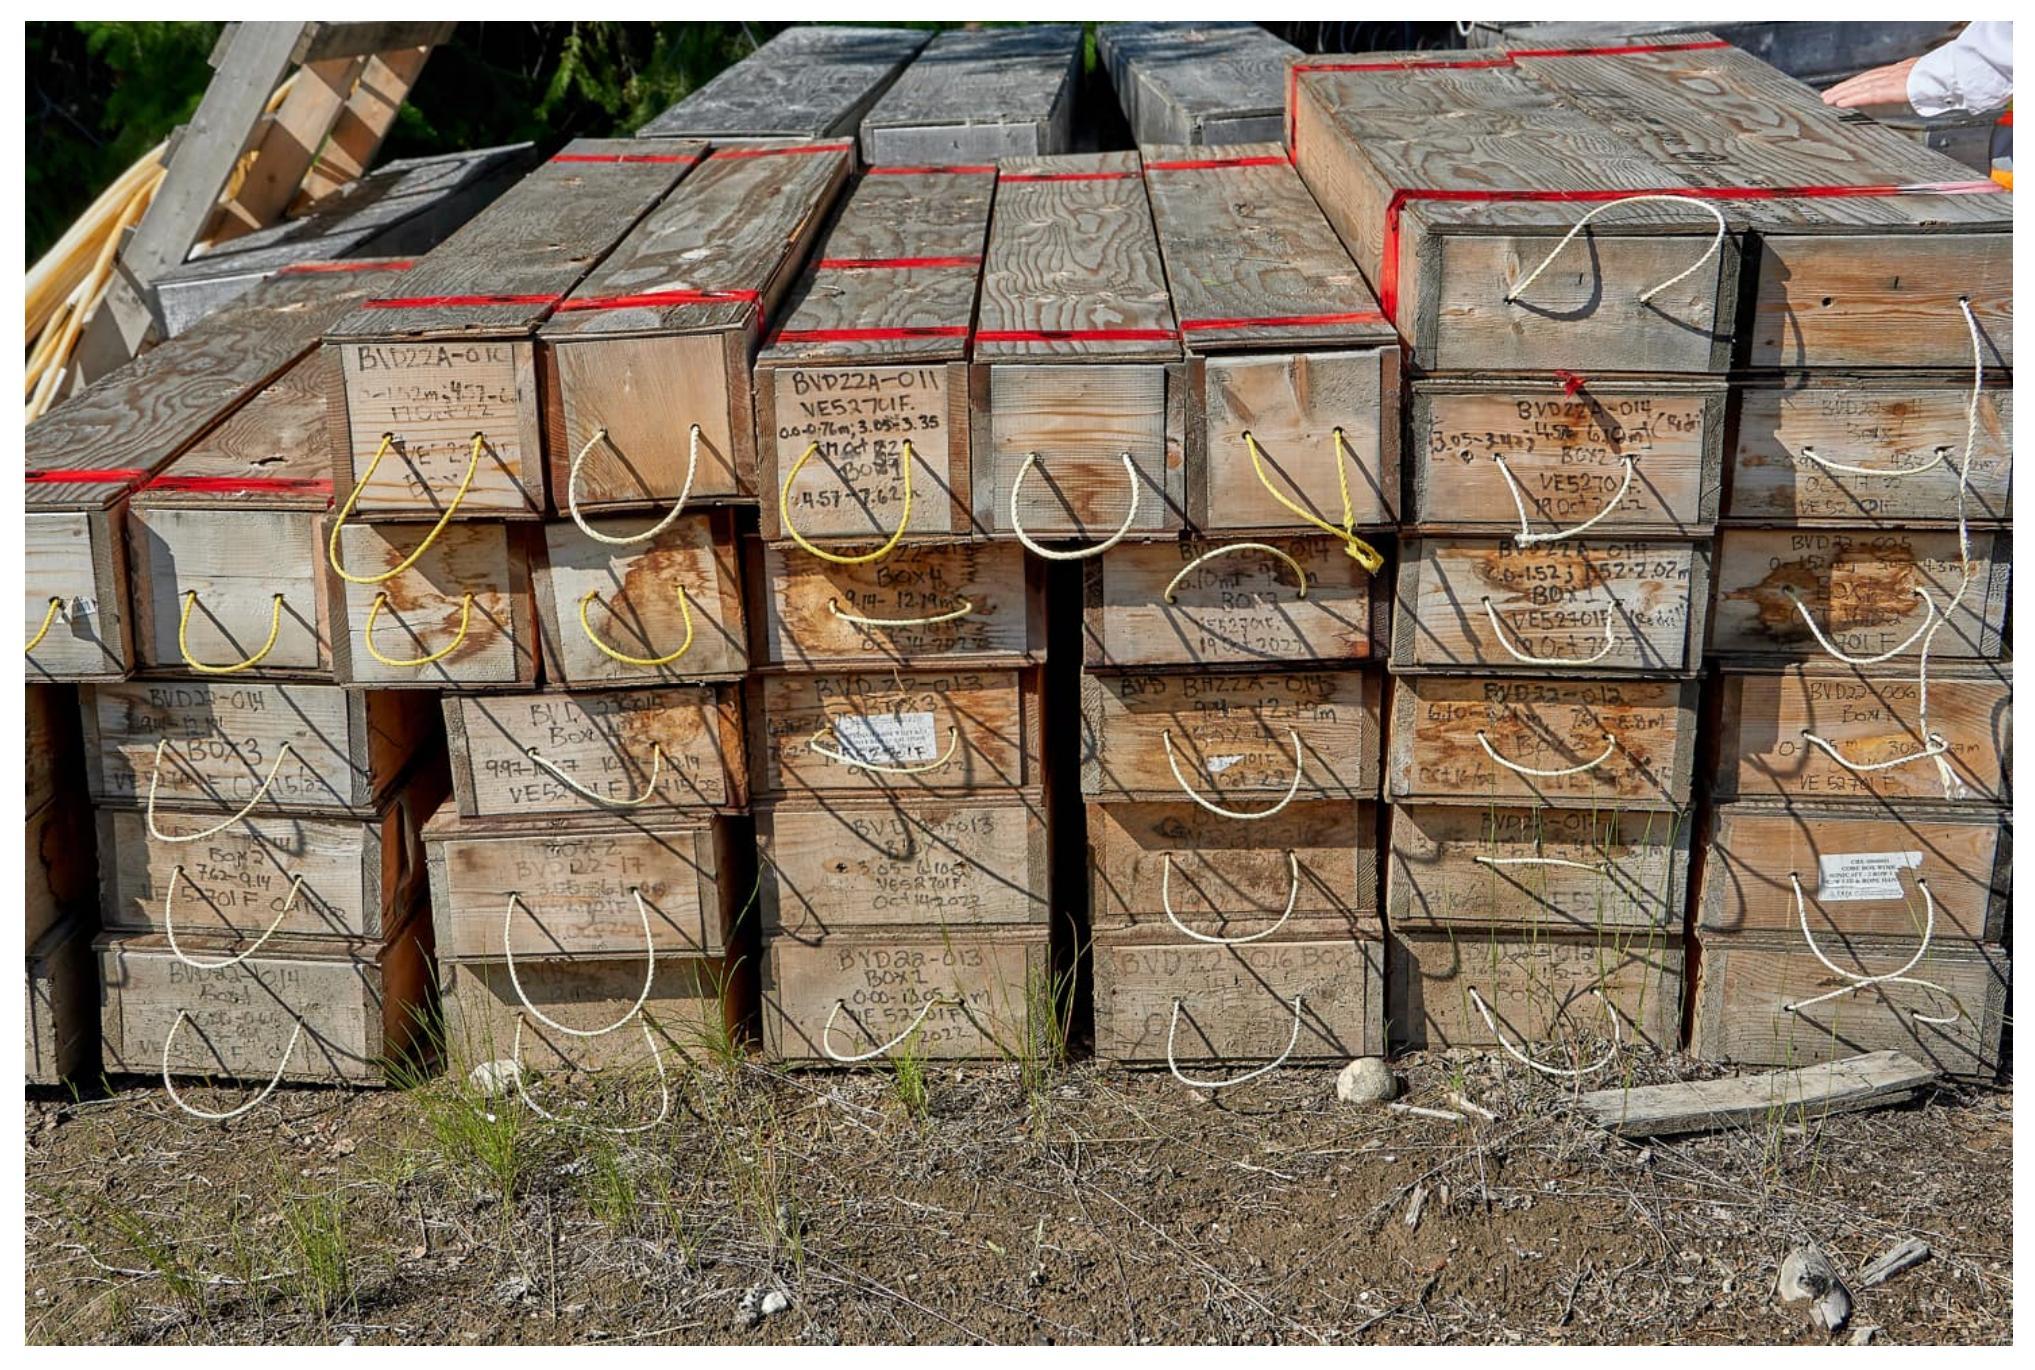
Photograph #20: "Core boxes from piezometer installation"

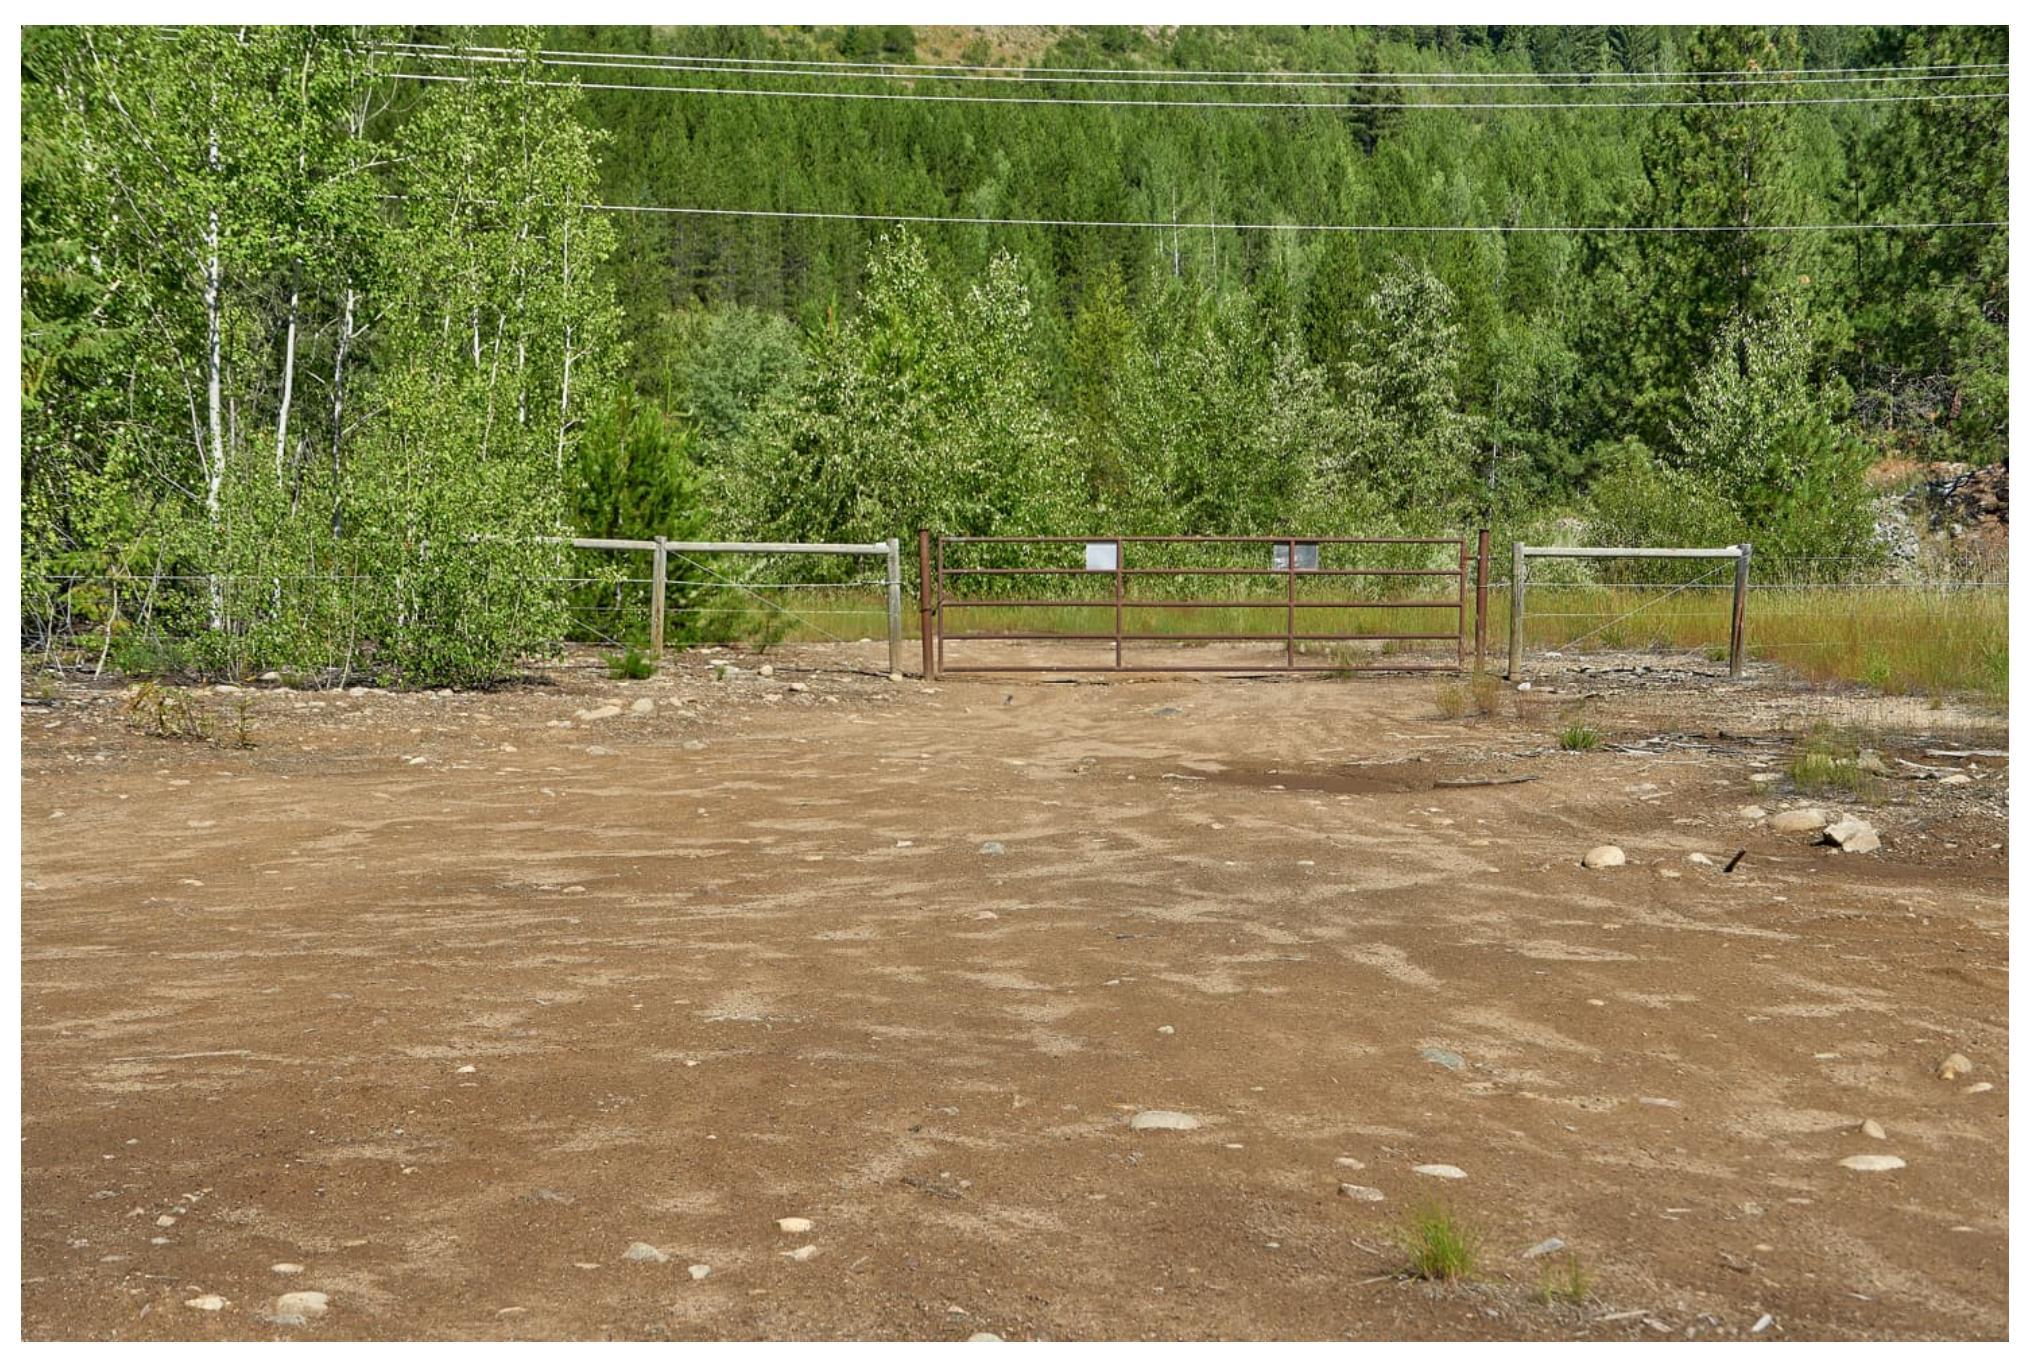
Photograph #21: "Locked gate at SW corner of Cell 3"

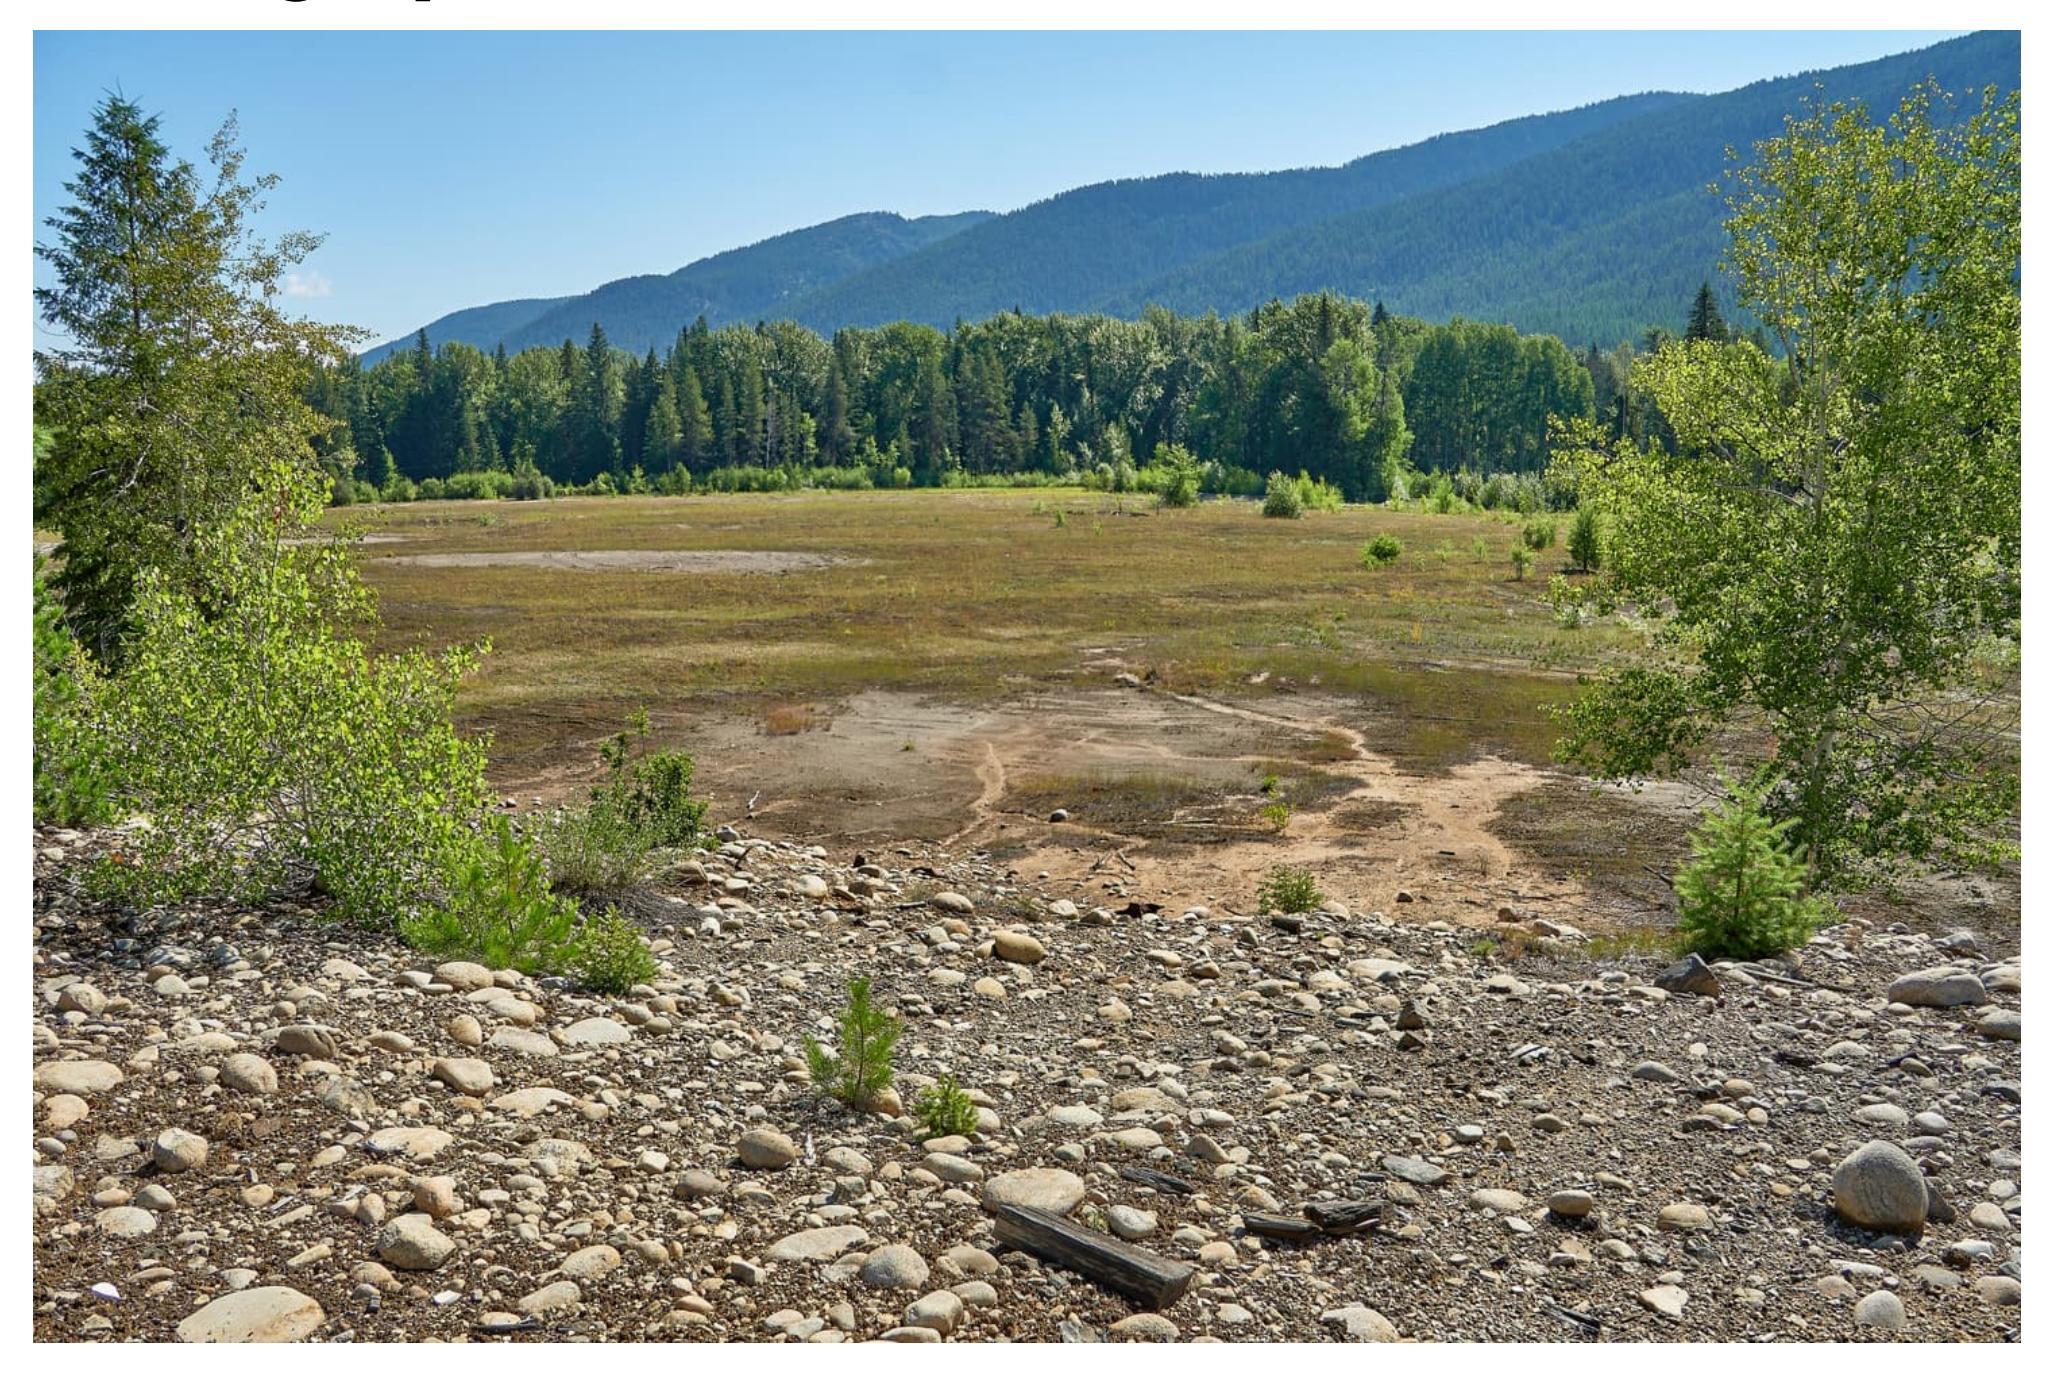
Photograph #22: "Cell 3 tailings surface"

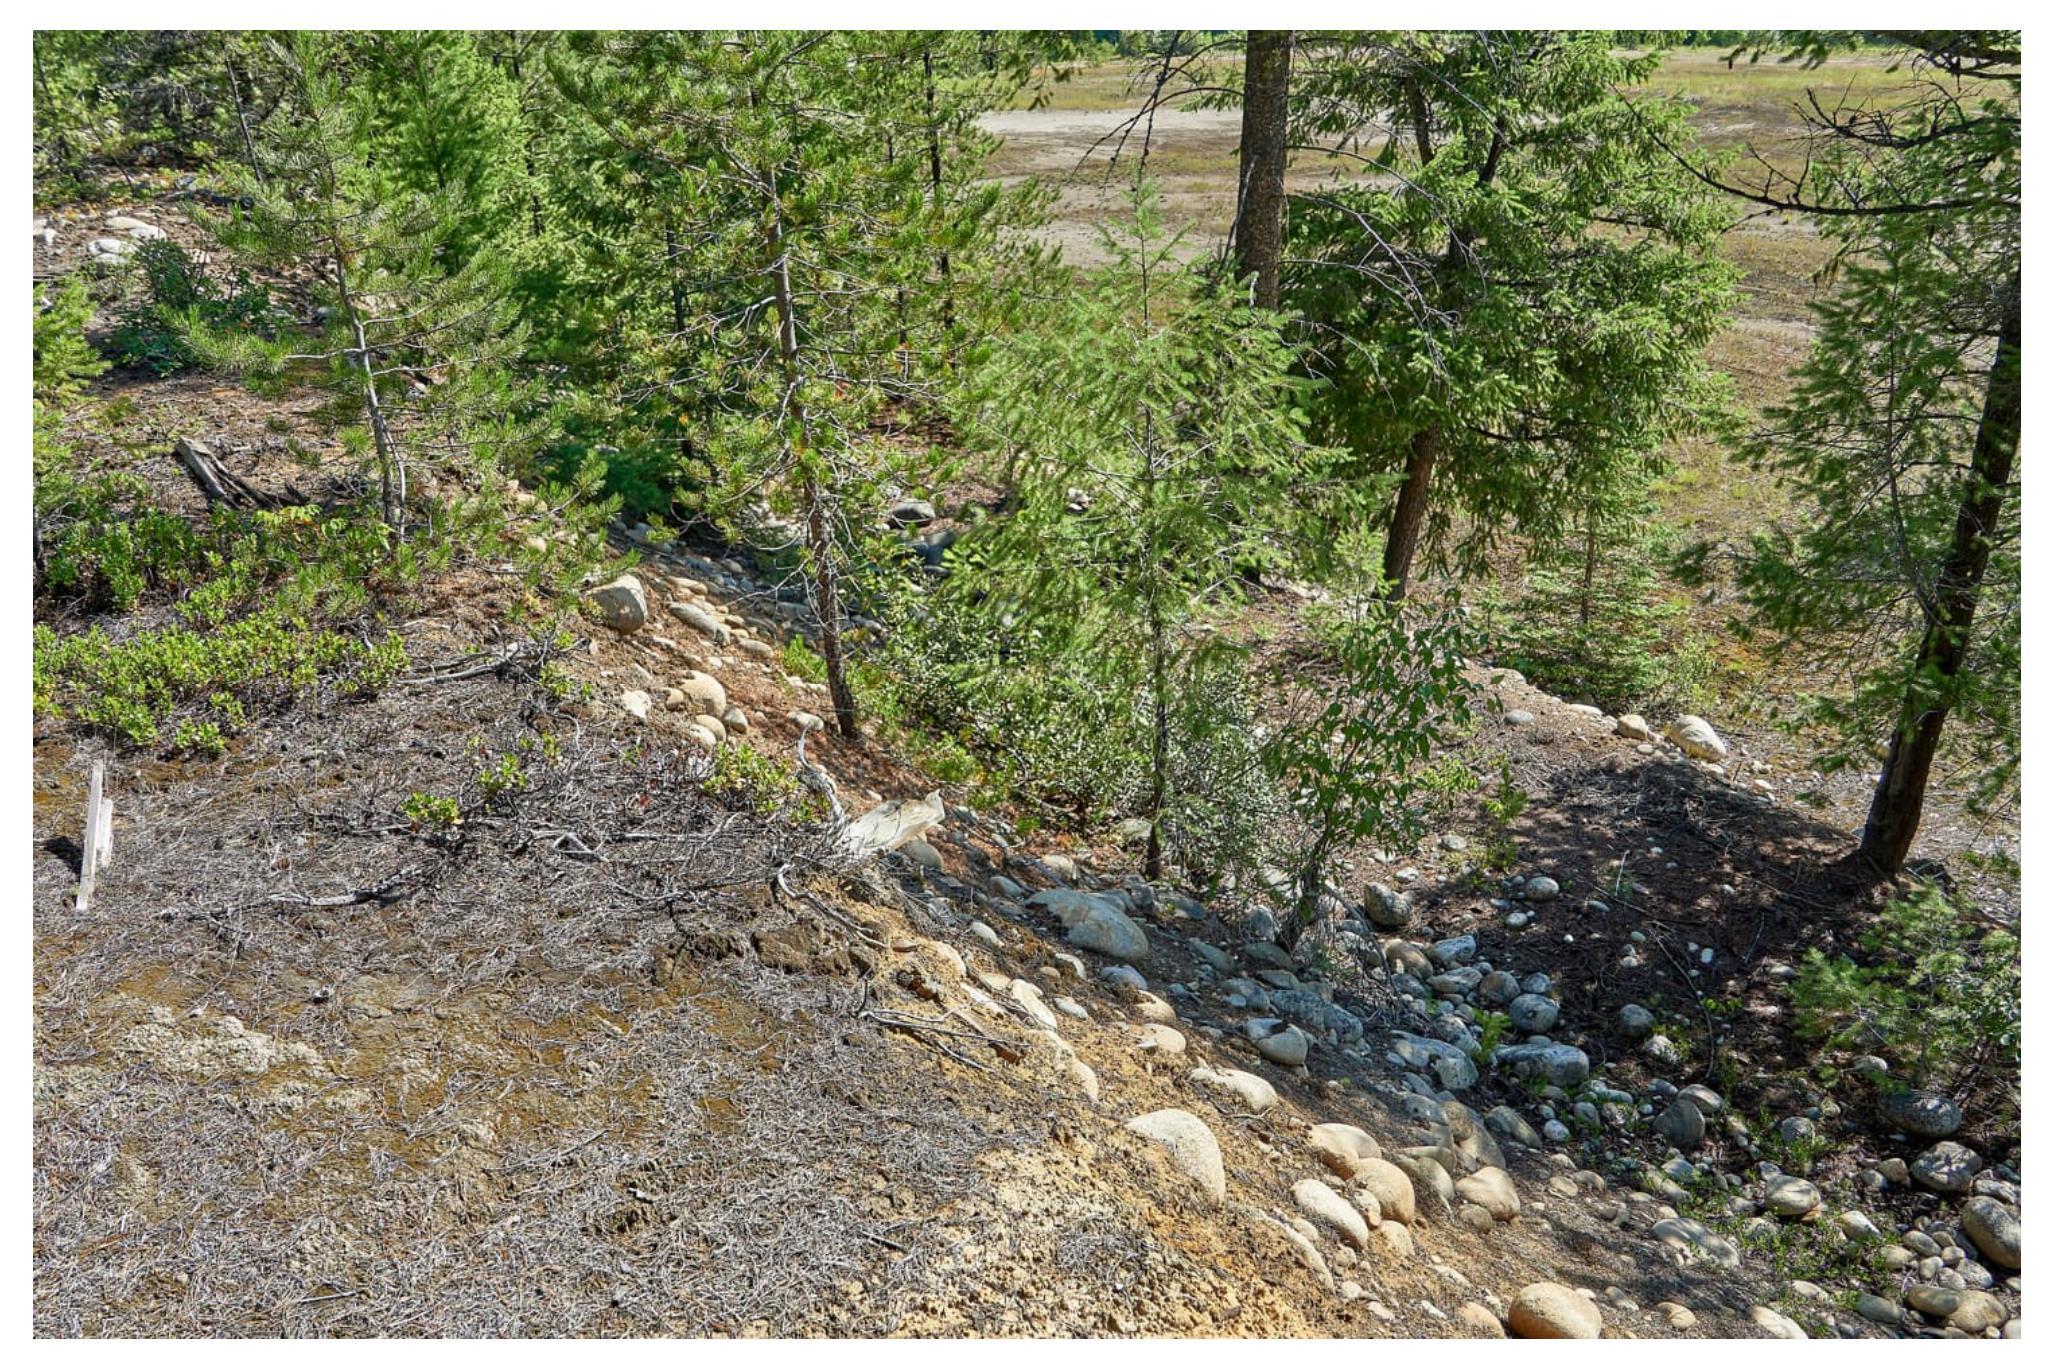
Photograph #23: "Slope of internal dike between Cell 4 and Cell 3"

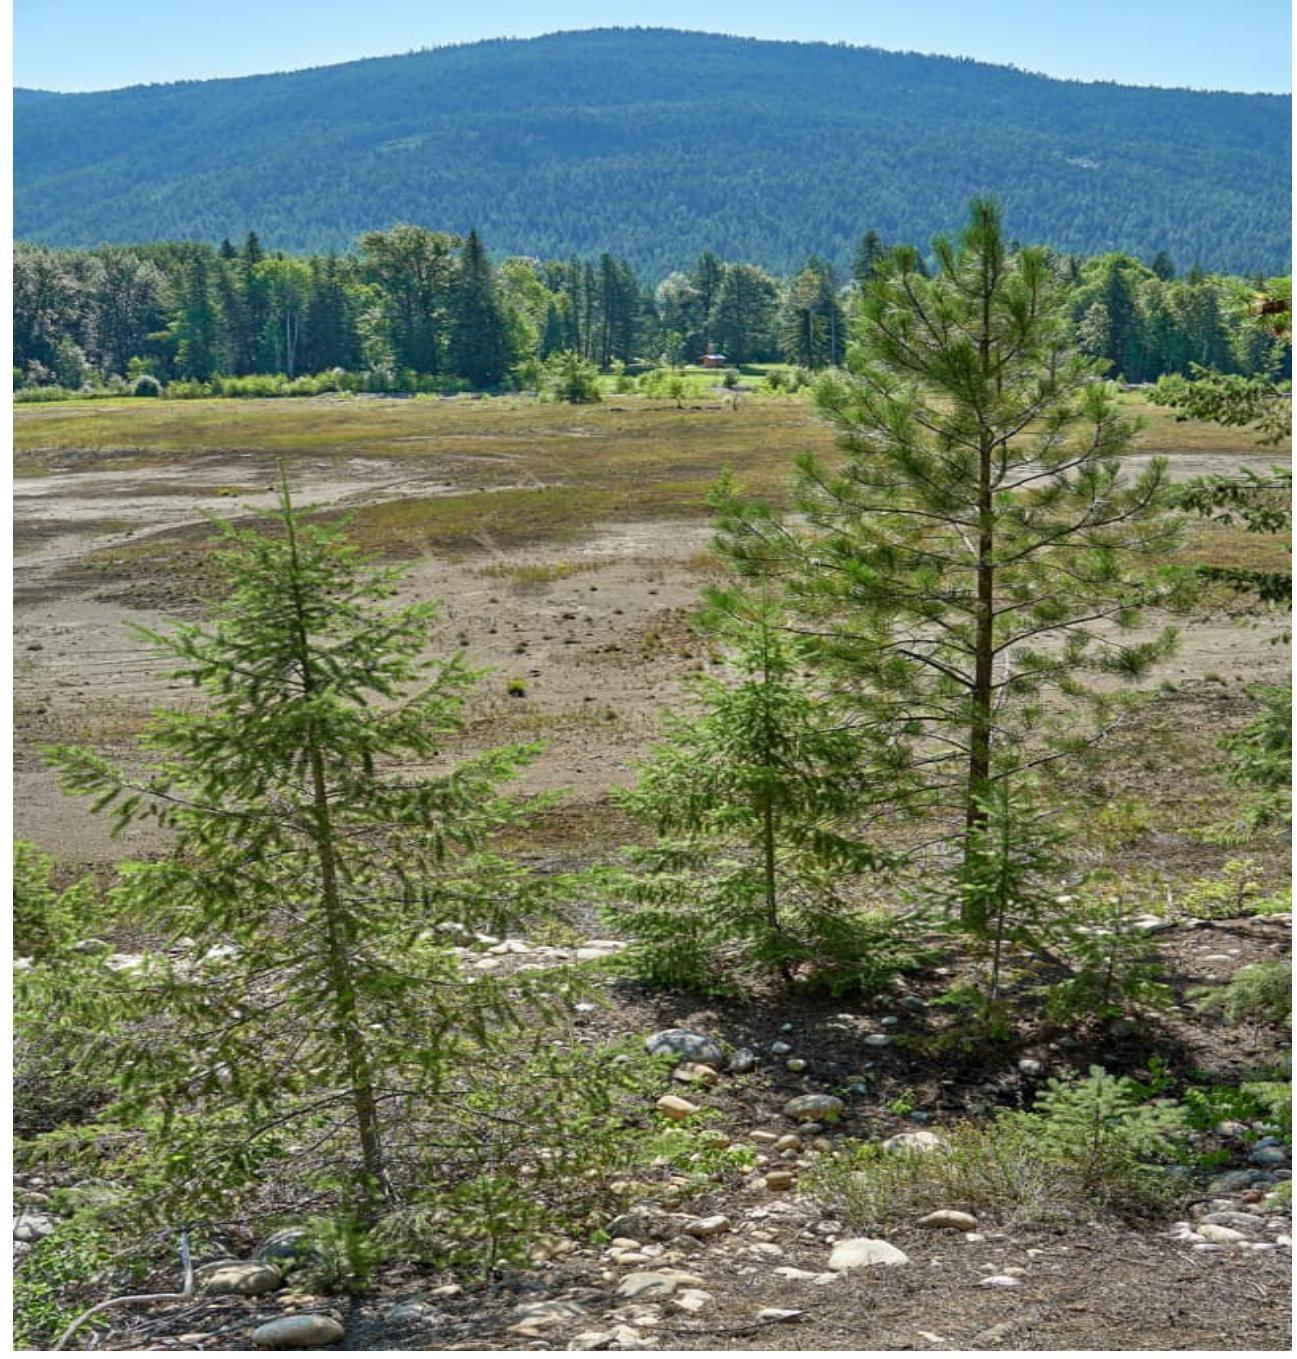
Photograph #24: "Cell 3 tailings surface"

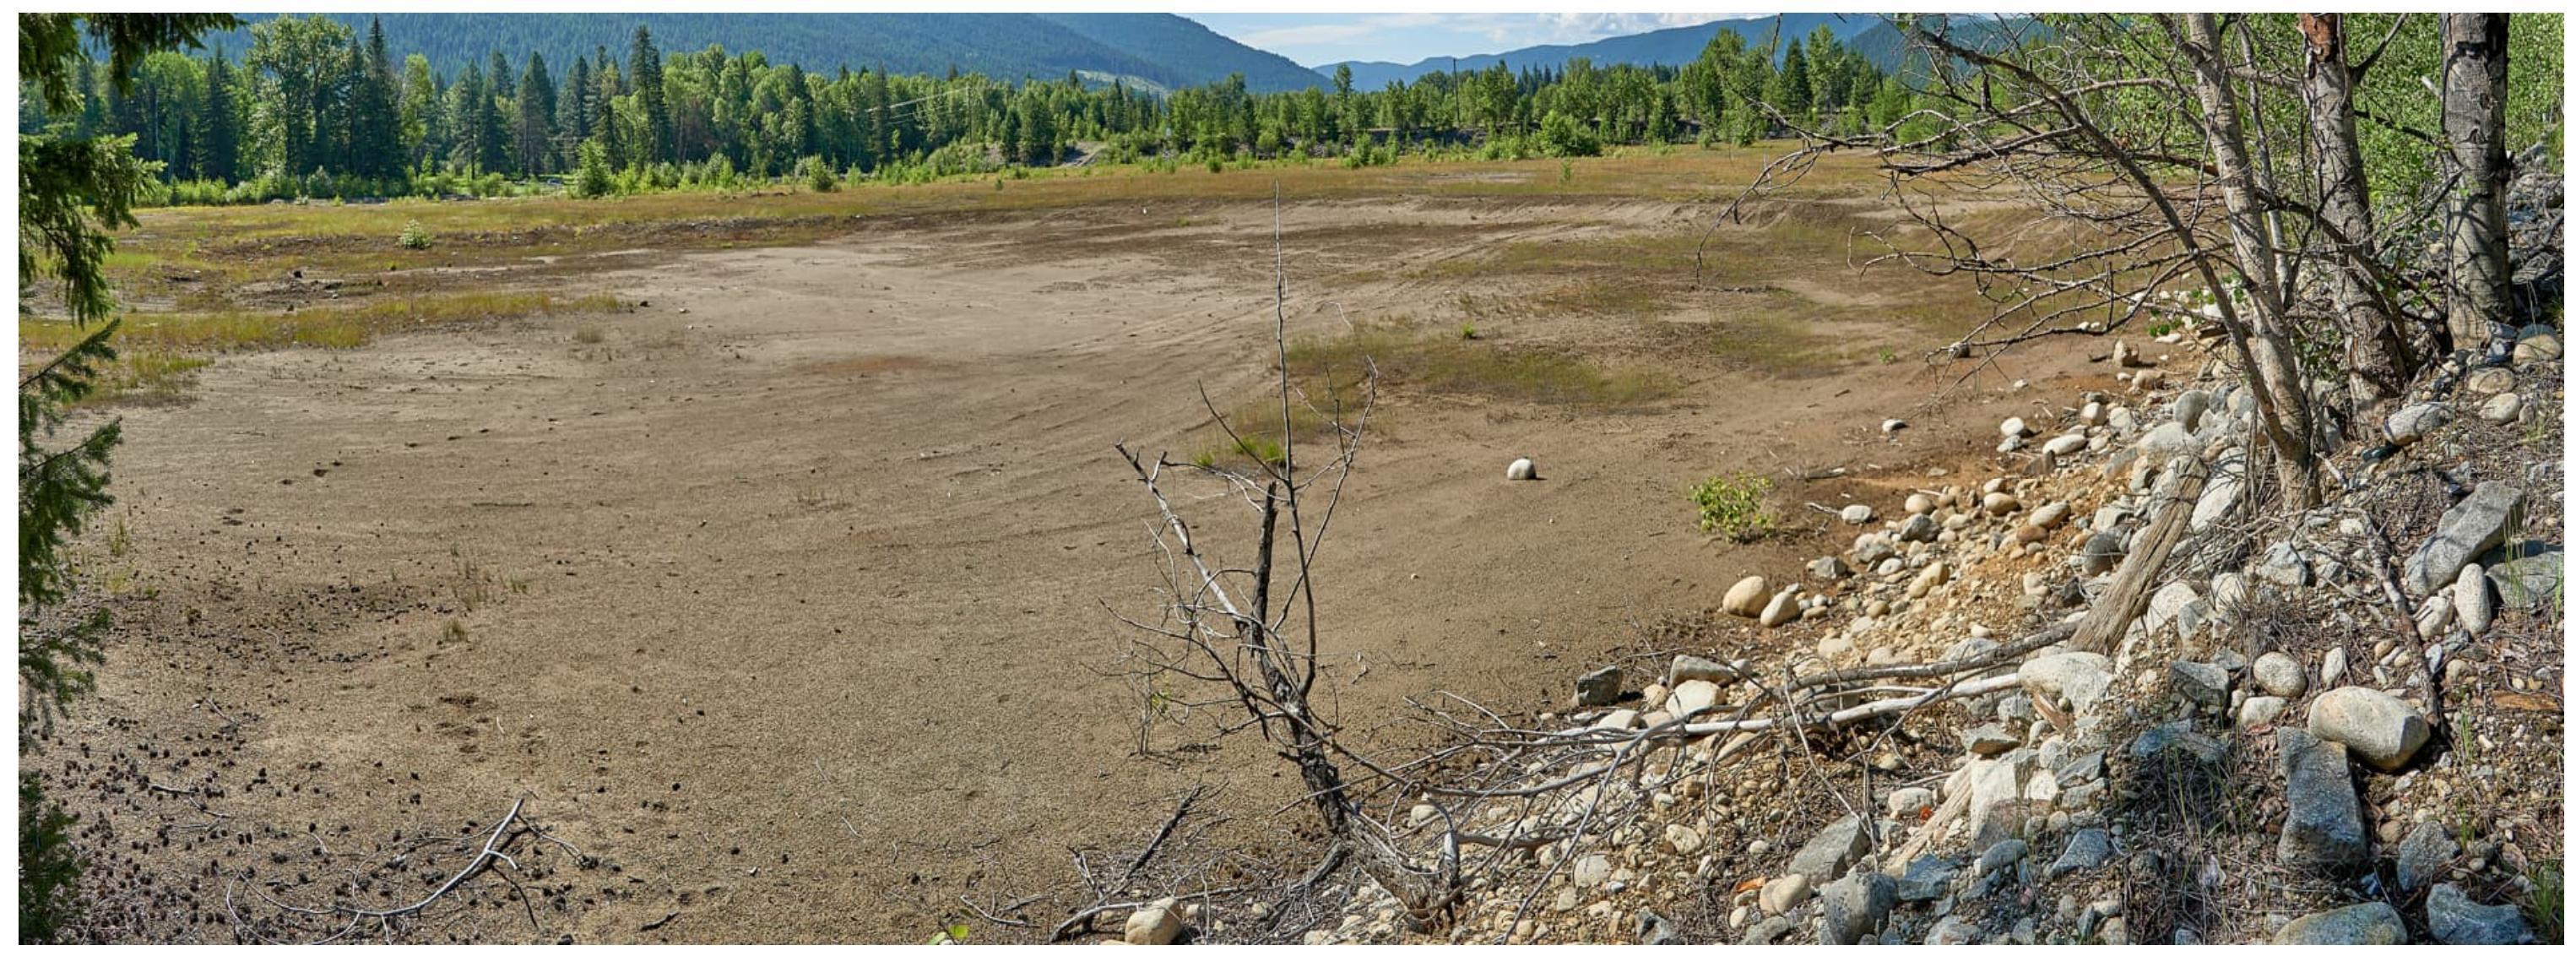
Photograph #25: "Cell 3 tailings surface"

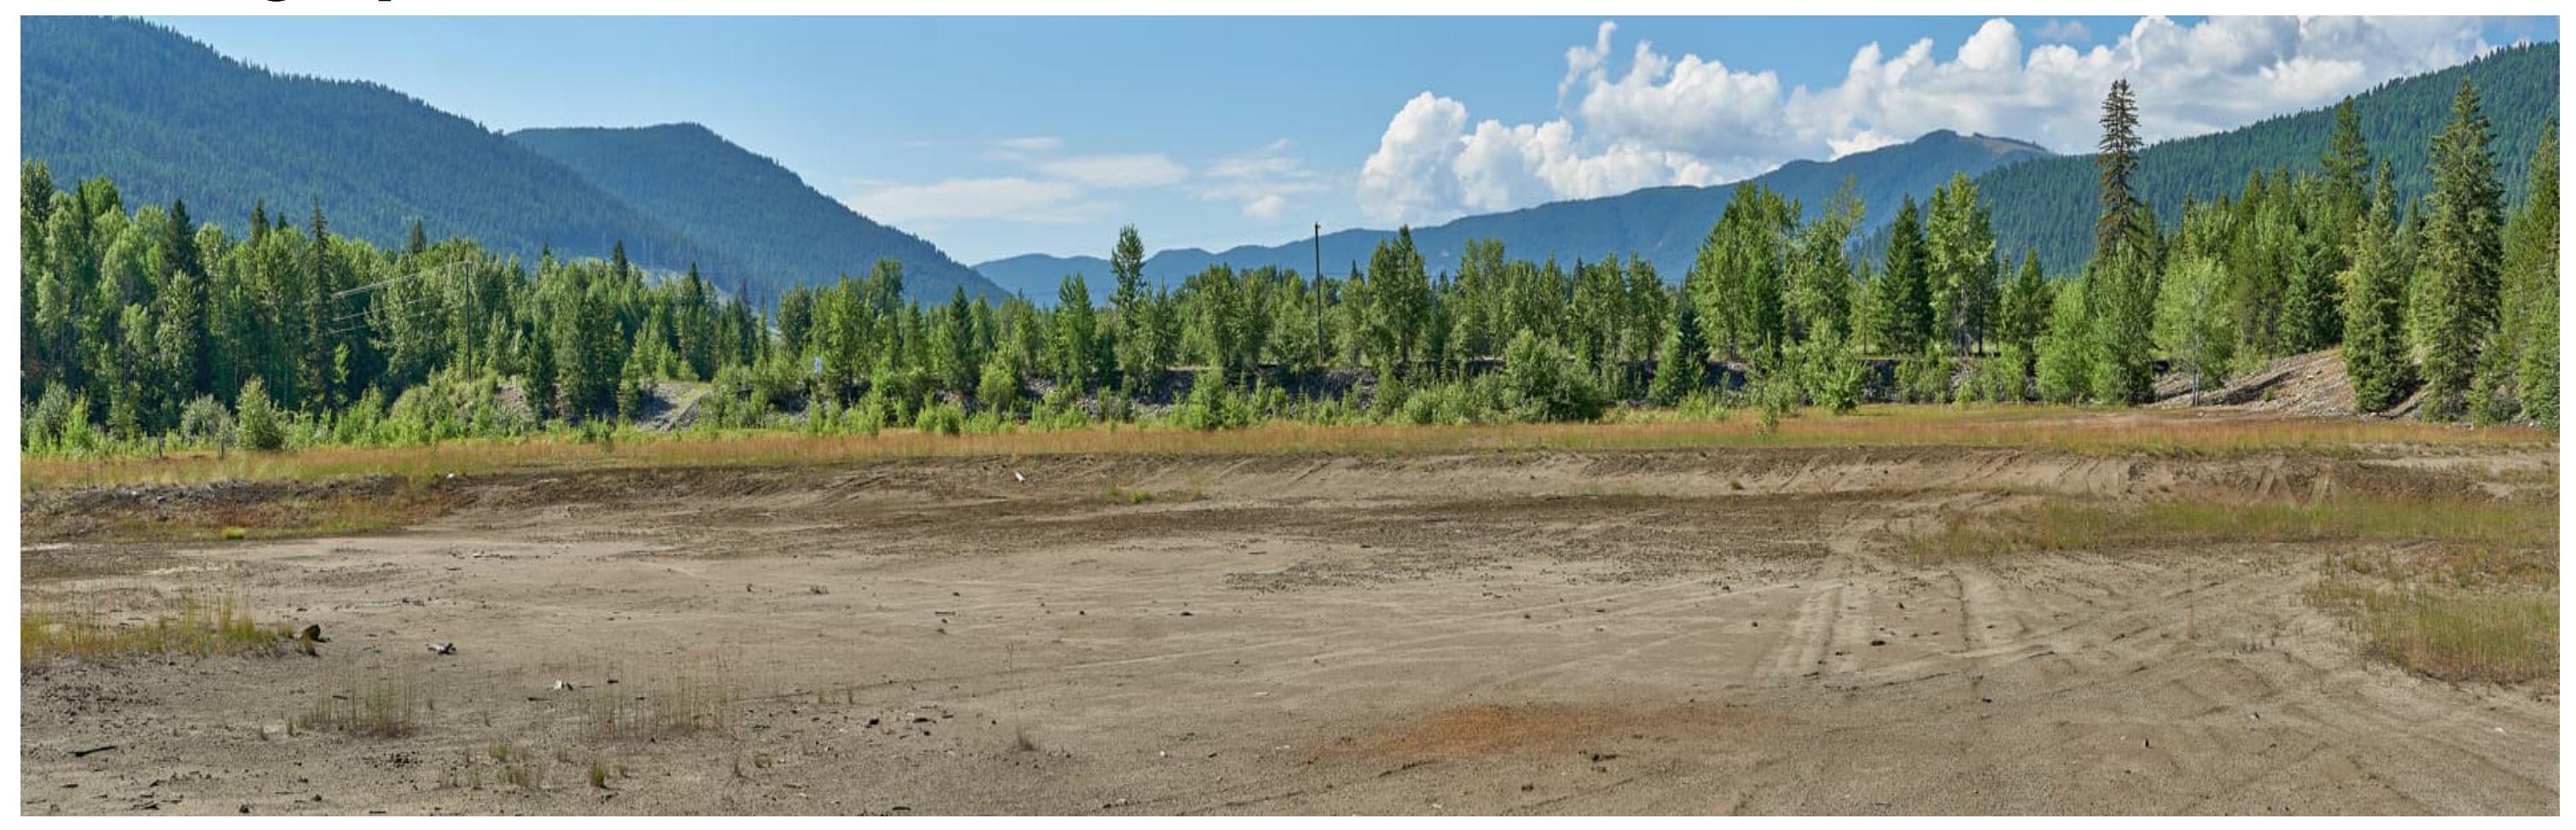
Photograph #26: "Cell 3 tailings surface"
