Beaverdell Tailings Storage Facilities – 2023 Annual Facility Performance Report

Teck Resources Limited, Beaverdell Mine

Reference No. CA0007697.0438-003-R-Rev0

February 27, 2024

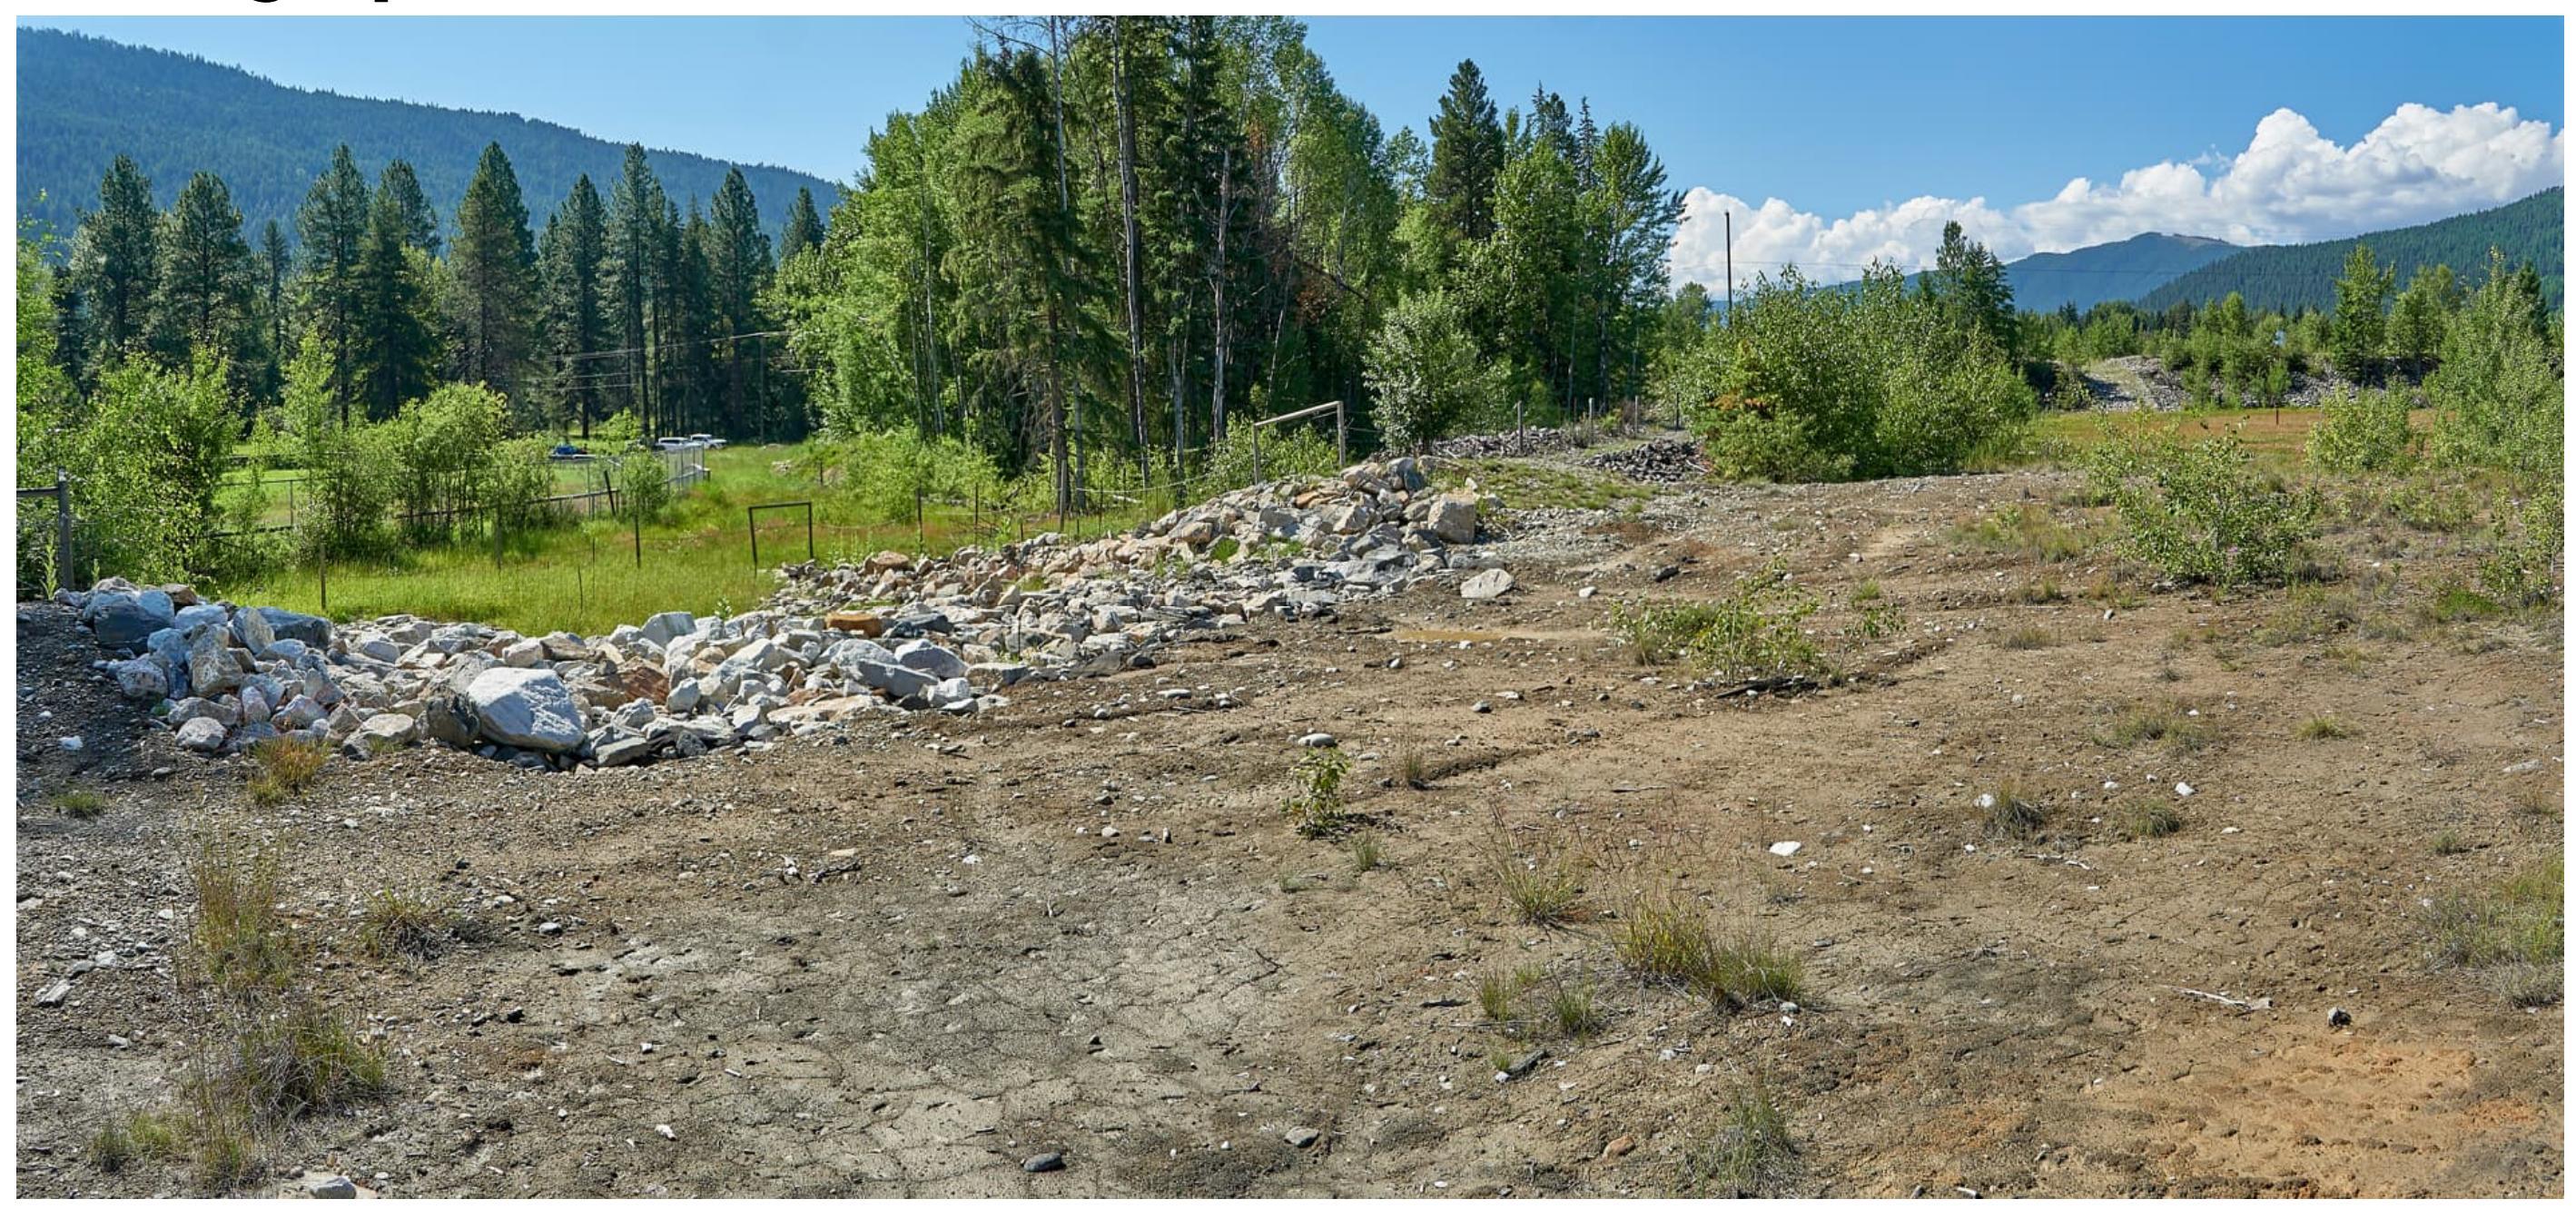
Photograph #27: "Cell 3 spillway "

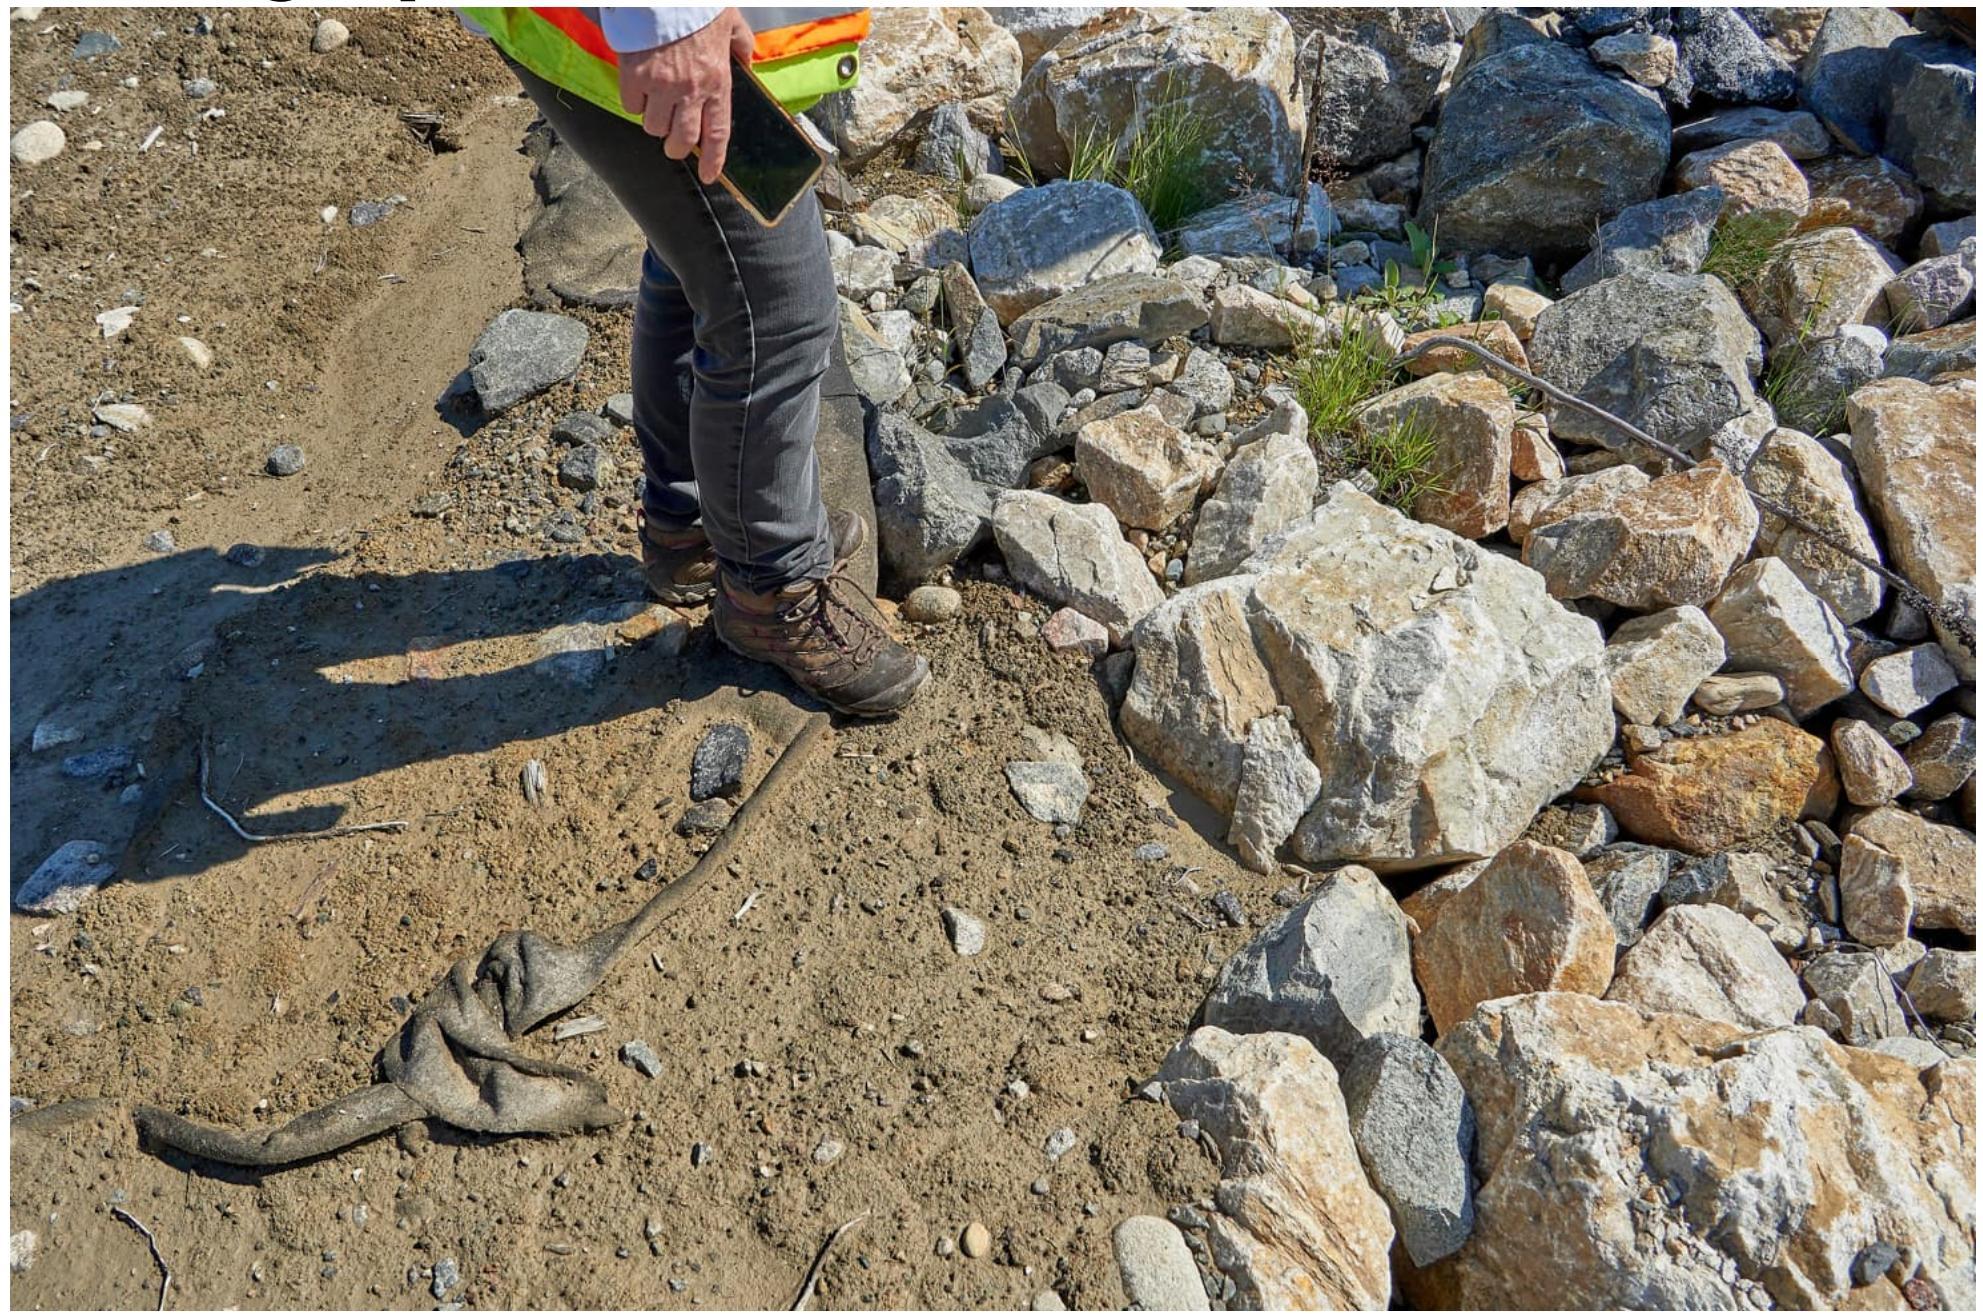
ID Number	Deficiency or Non-conformance	Applicable Regulation or OMS Manual Reference	Recommended Action	Priority
2023-01	In Cell 3, tailings are present at the level of the spillway invert. If the spillway becomes active, tailings could be transported downstream.		Evaluate measures to minimize transport of tailings downstream of the Cell 3 spillway and develop a design for the preferred option by Q4 2024. A follow-up recommendation will then be added to this registry to implement the selected measures.	2

Photograph #28: "Interface between tailings and Cell 3 spillway"

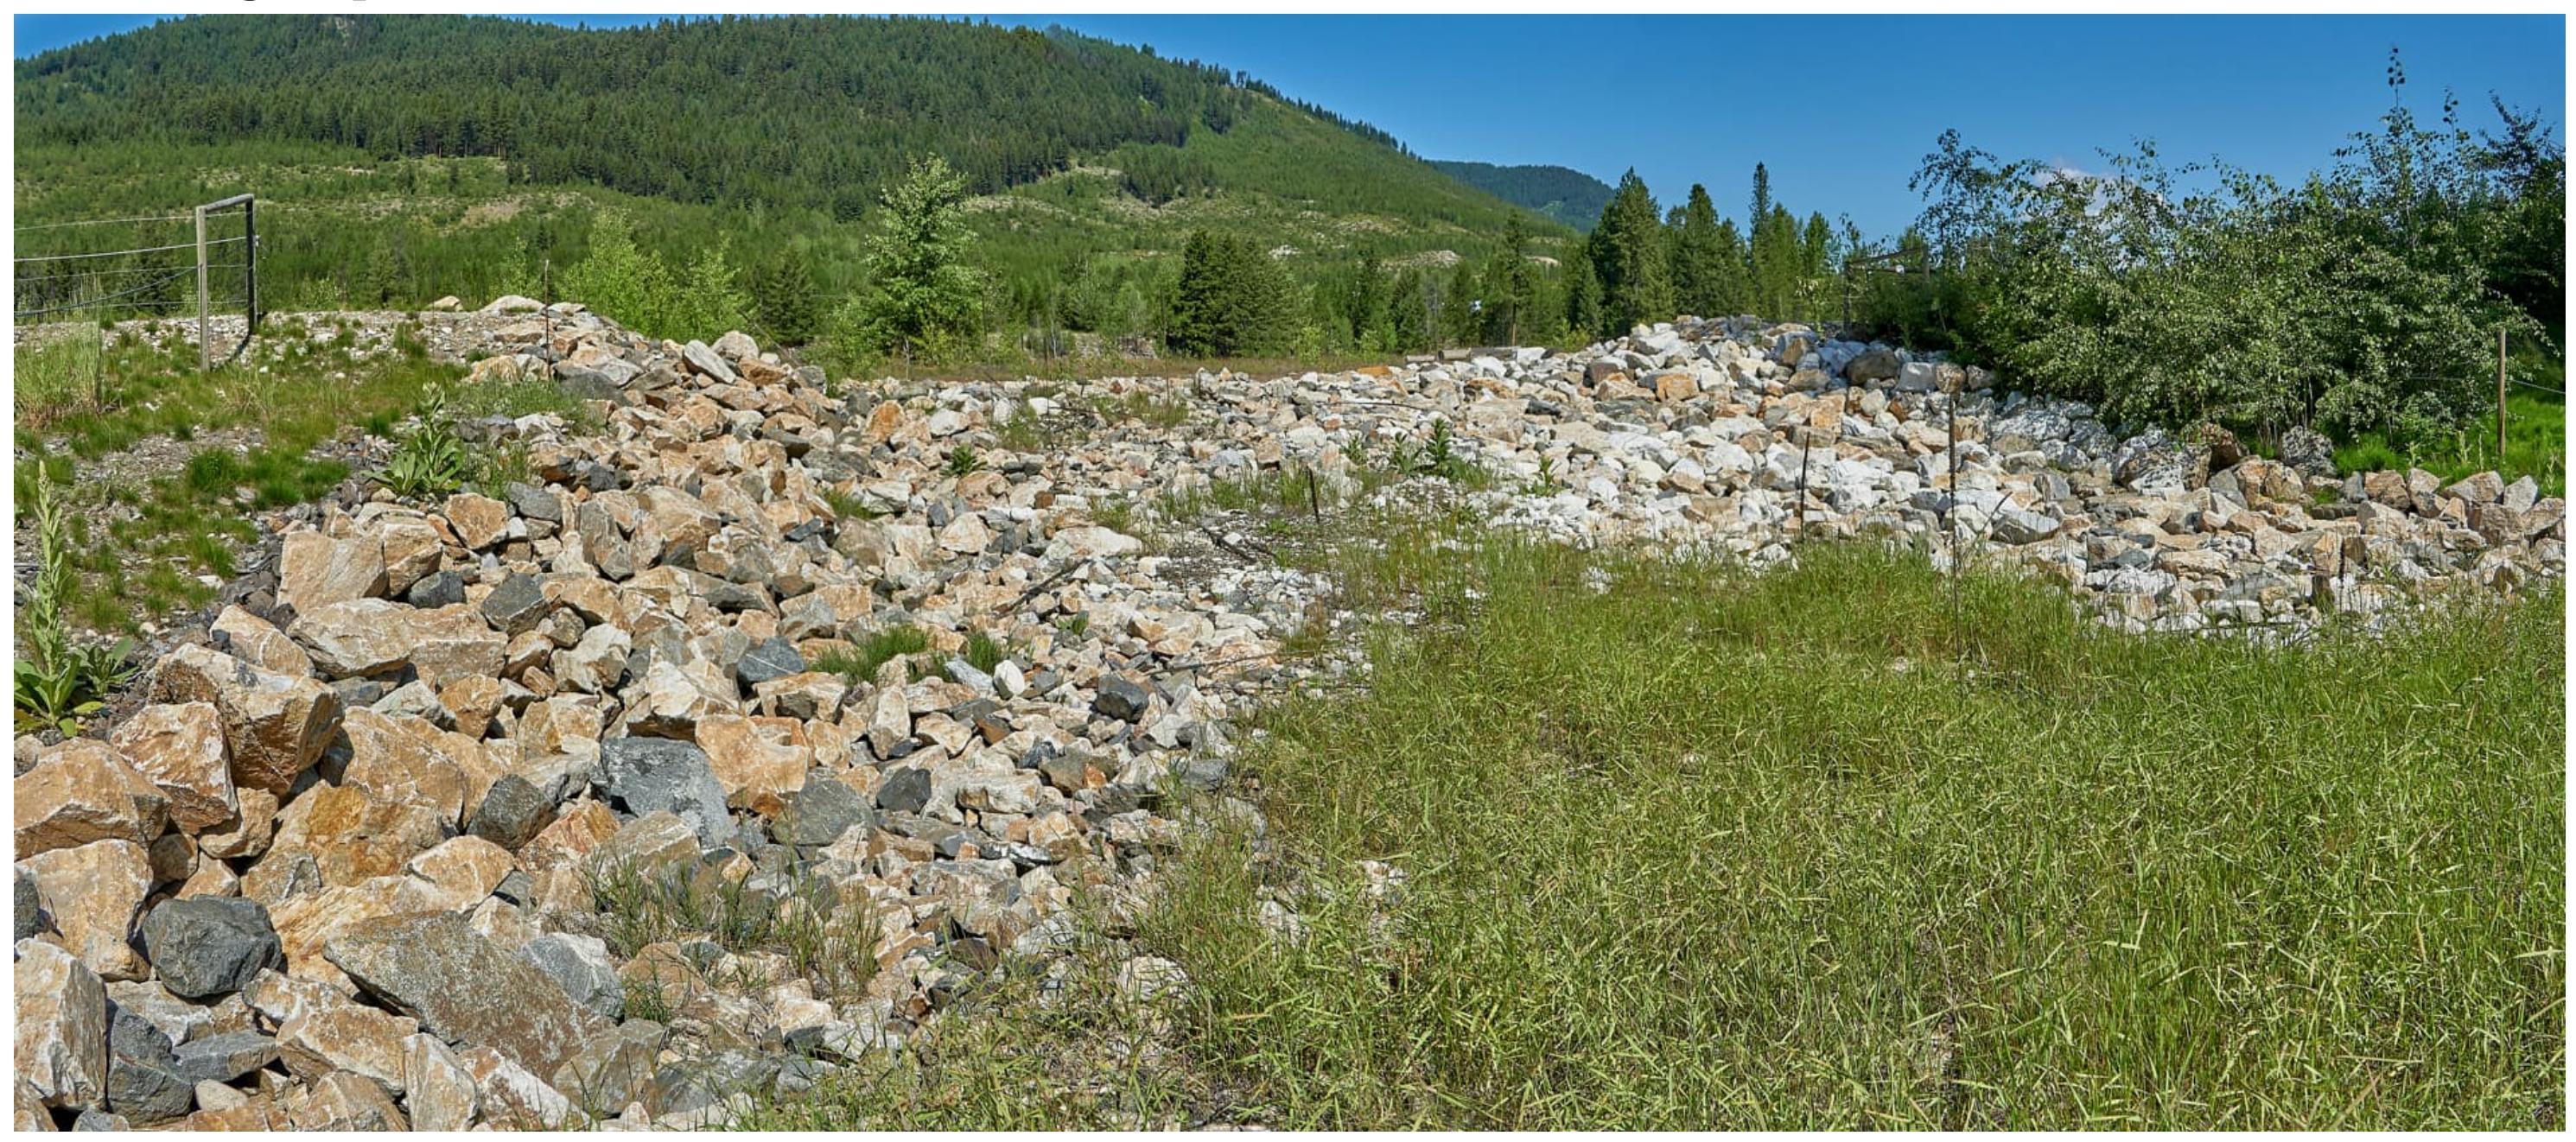
Photograph #29: "Cell 3 spillway"

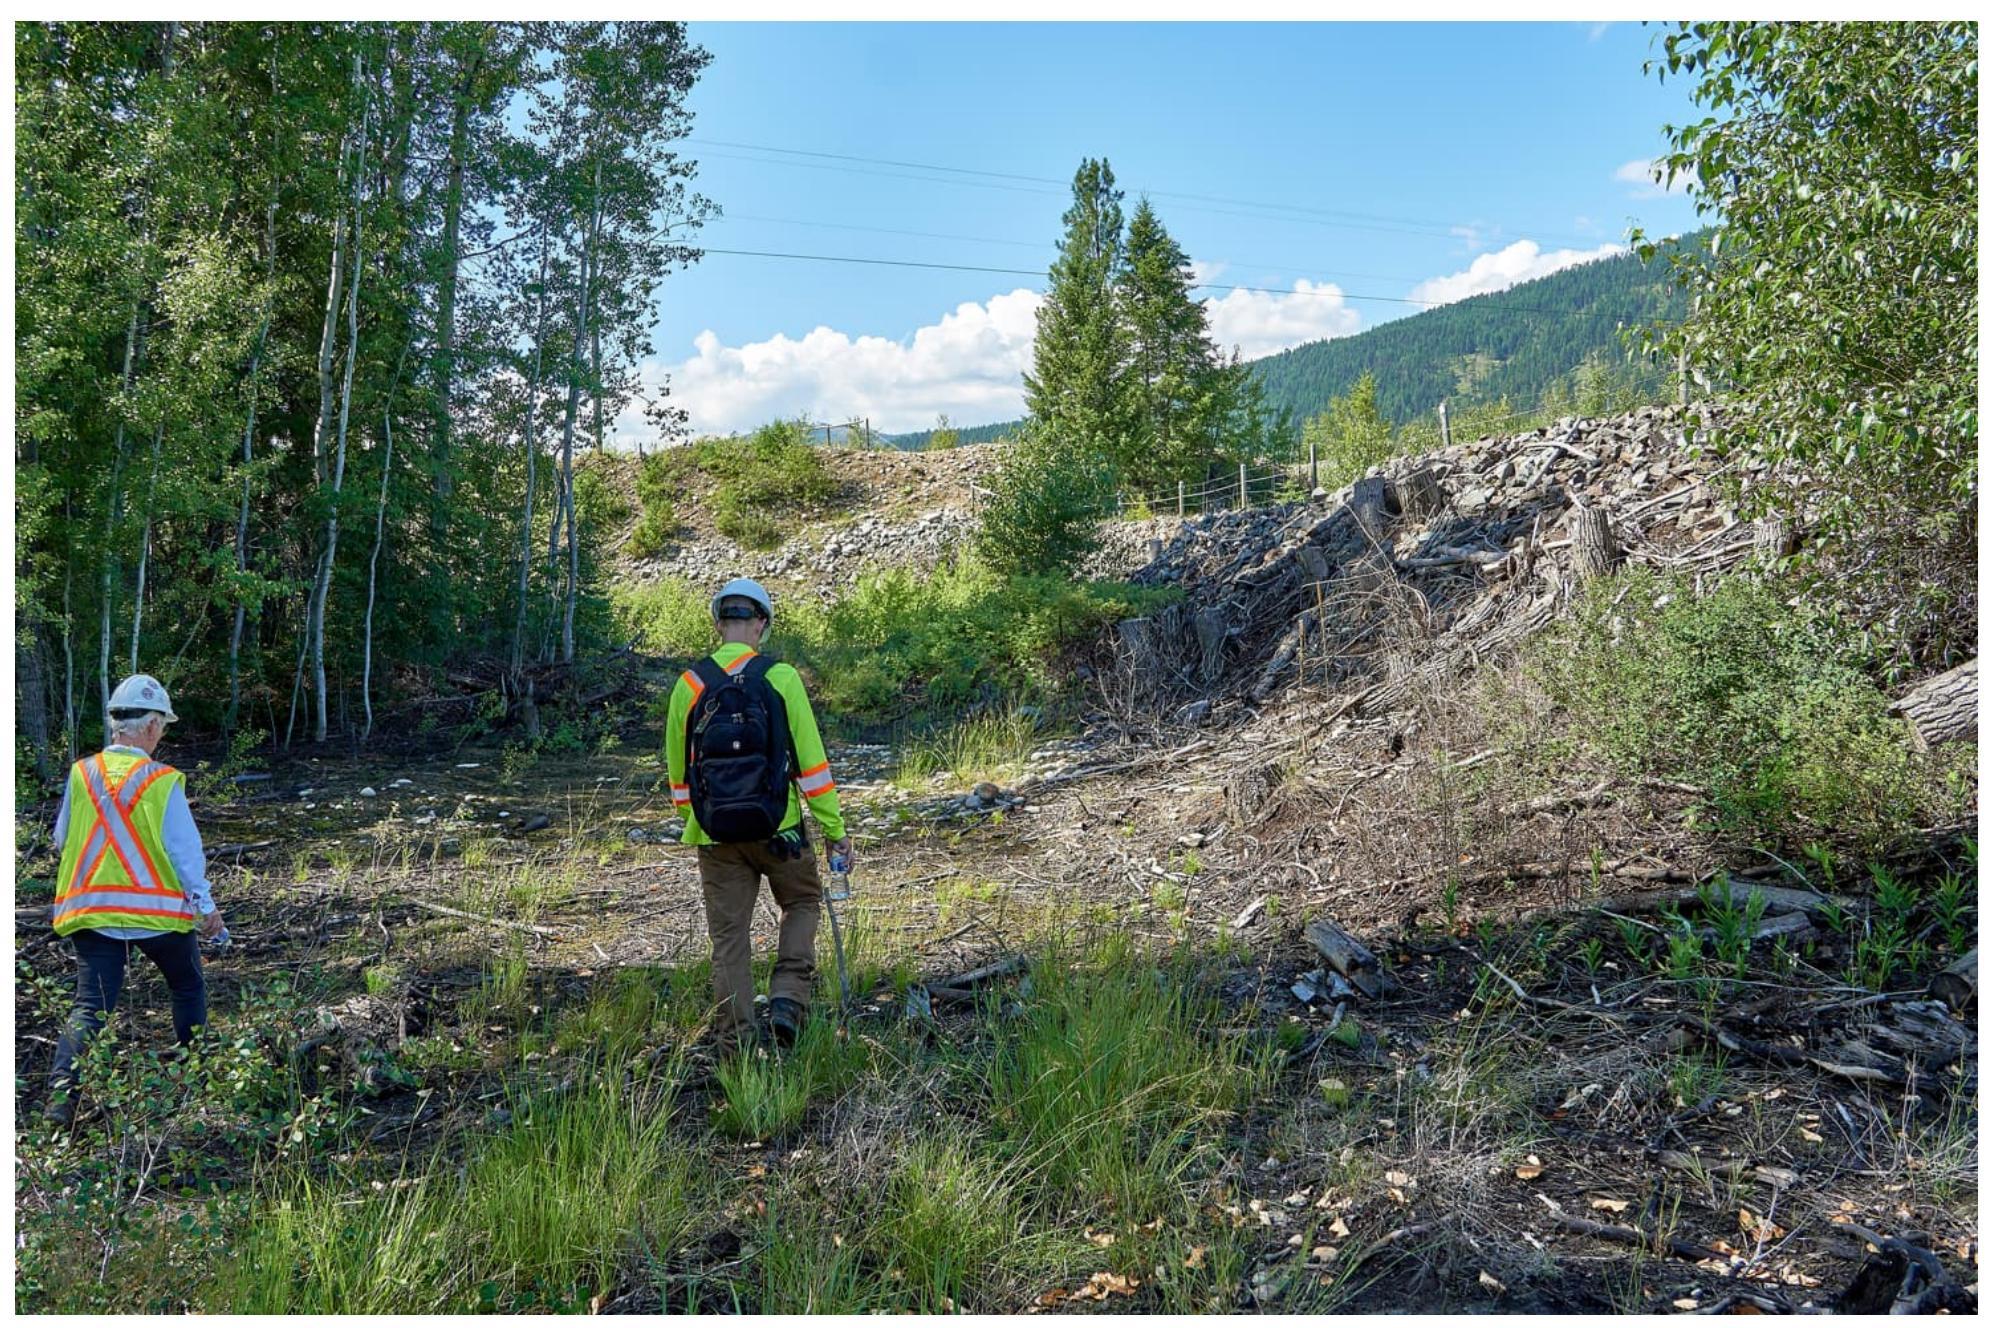
Photograph #30: "Downstream slope at Cell 3/4 boundary"

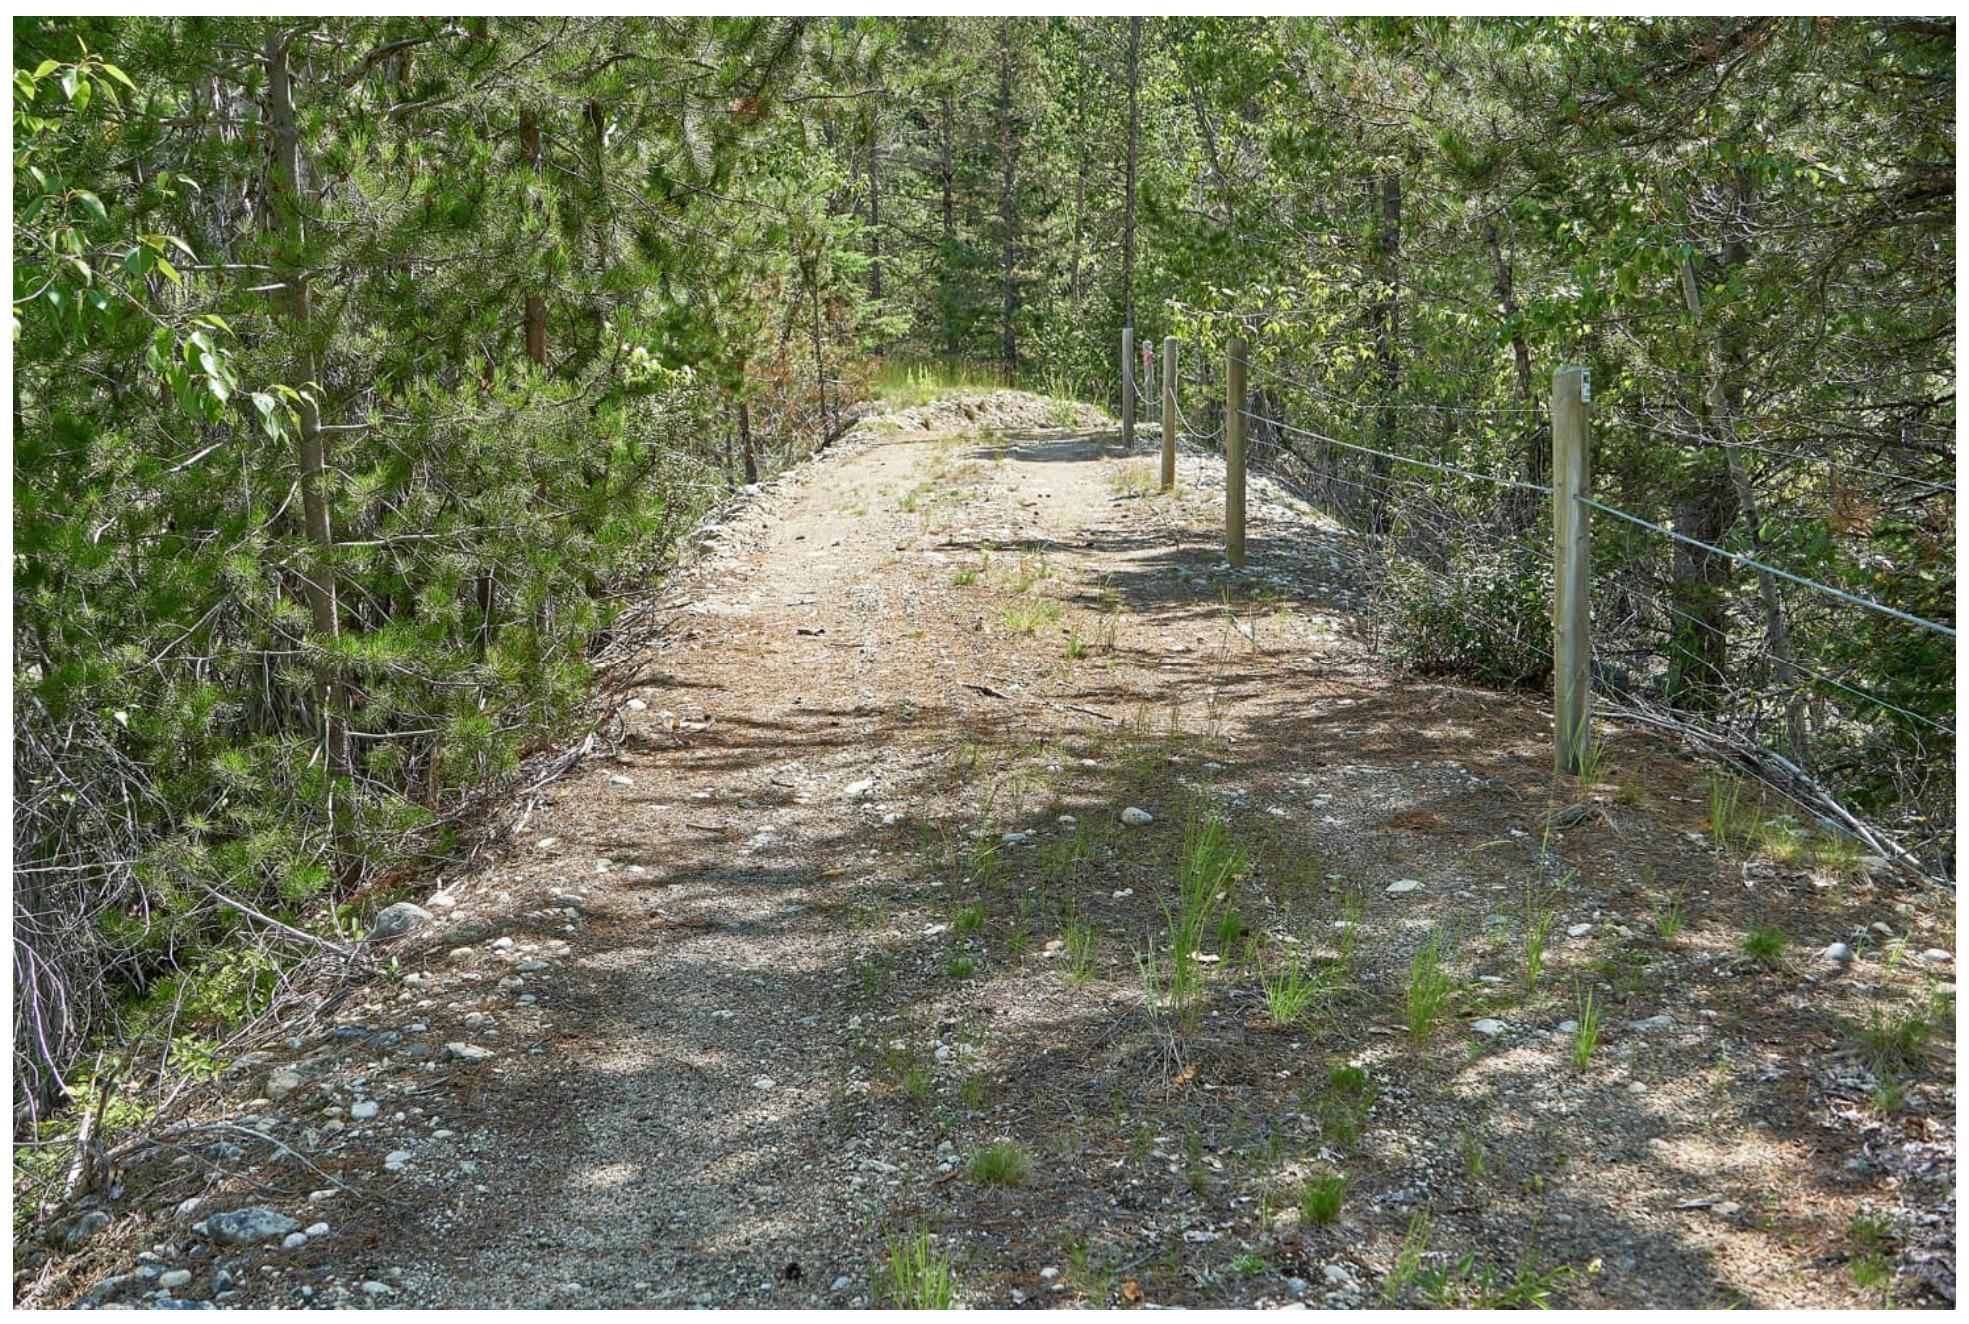
Photograph #31: "Cell 6 crest"

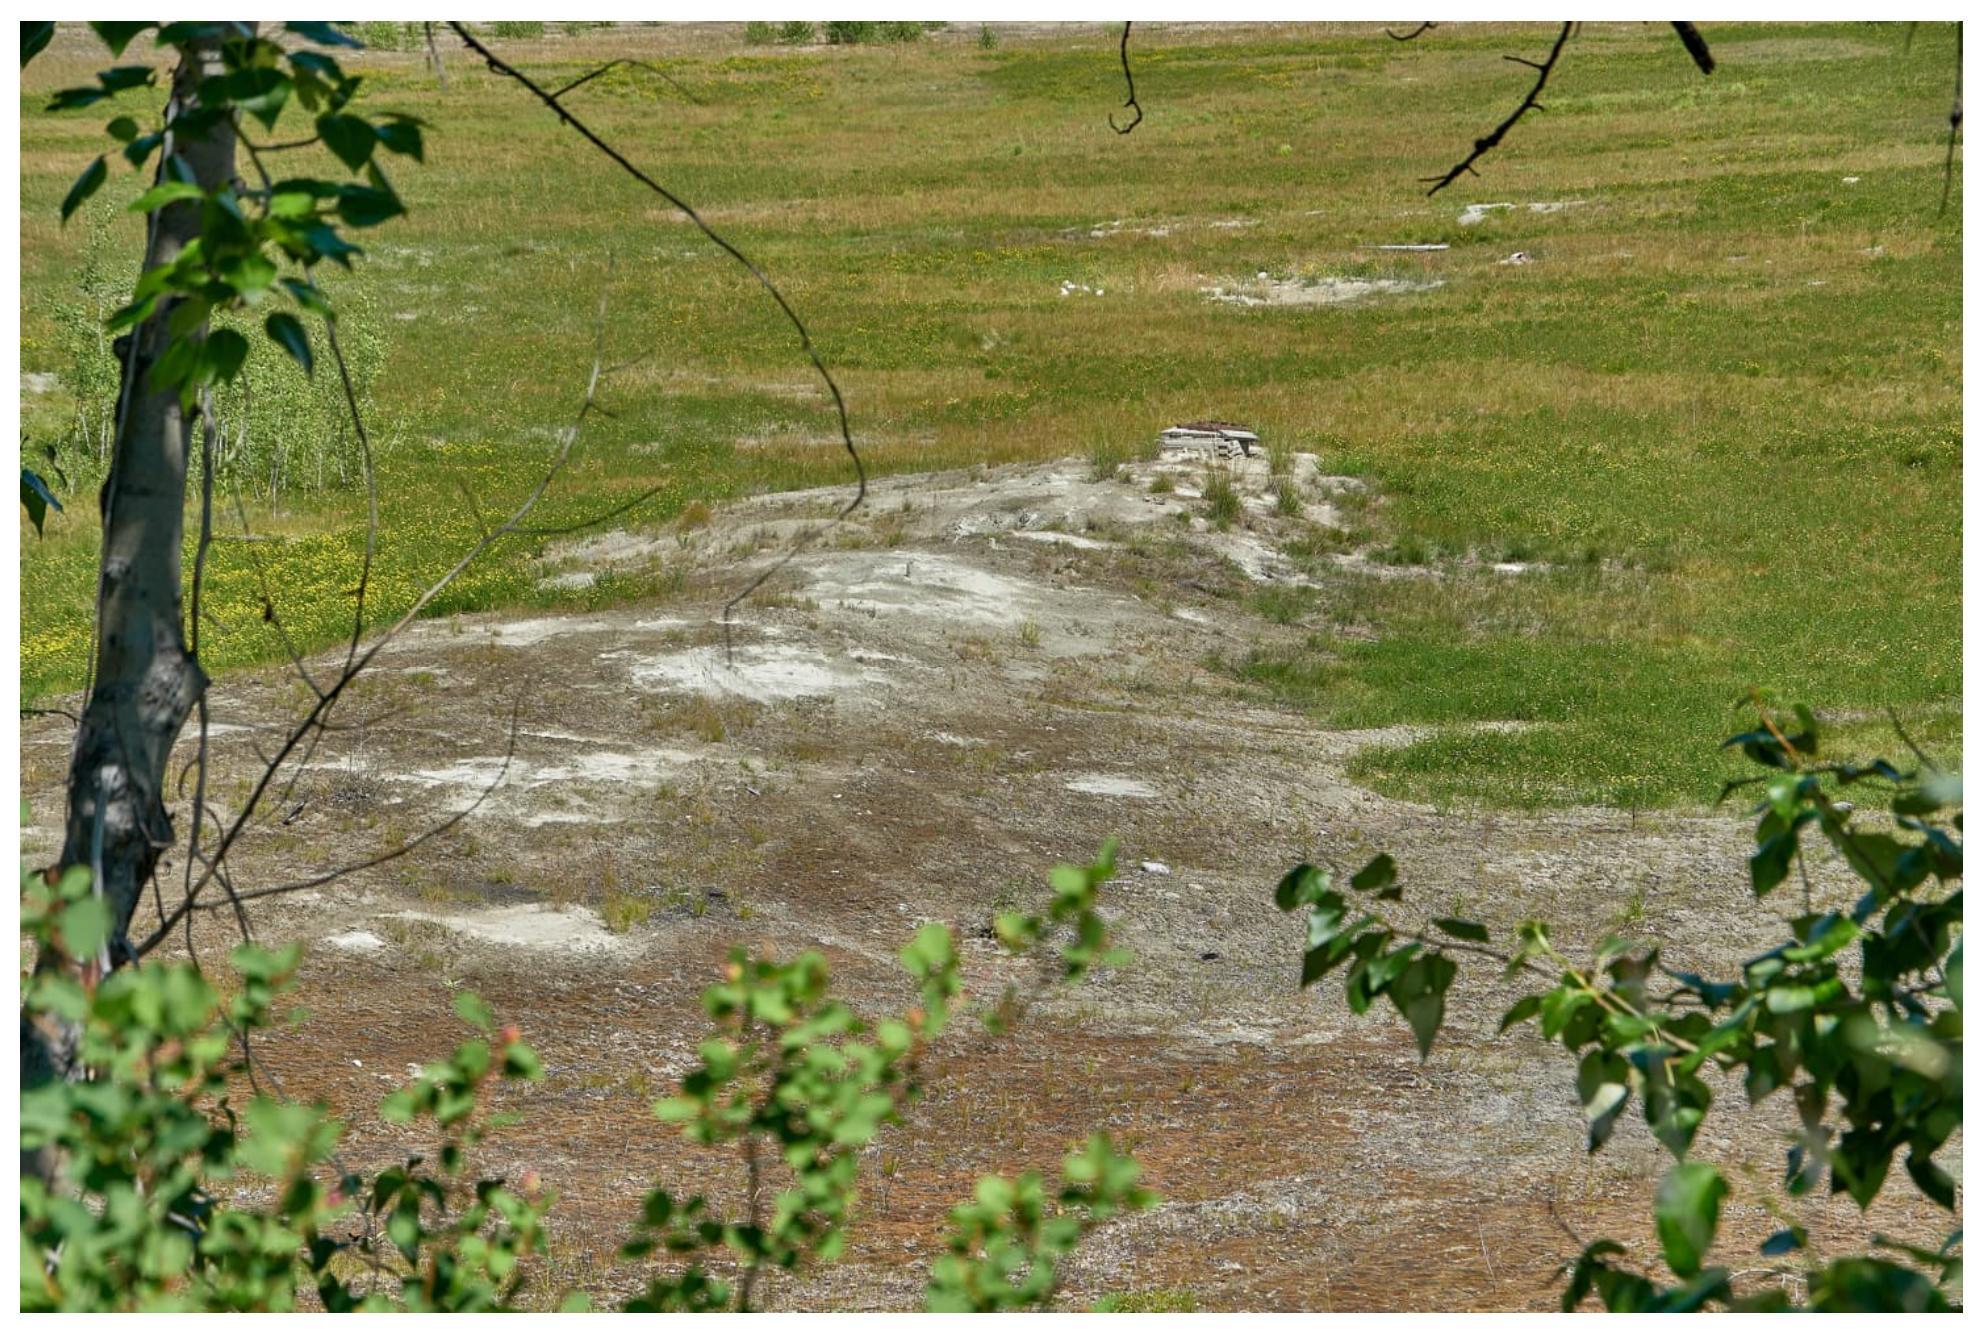
Photograph #32: "Cell 6 decant structure"

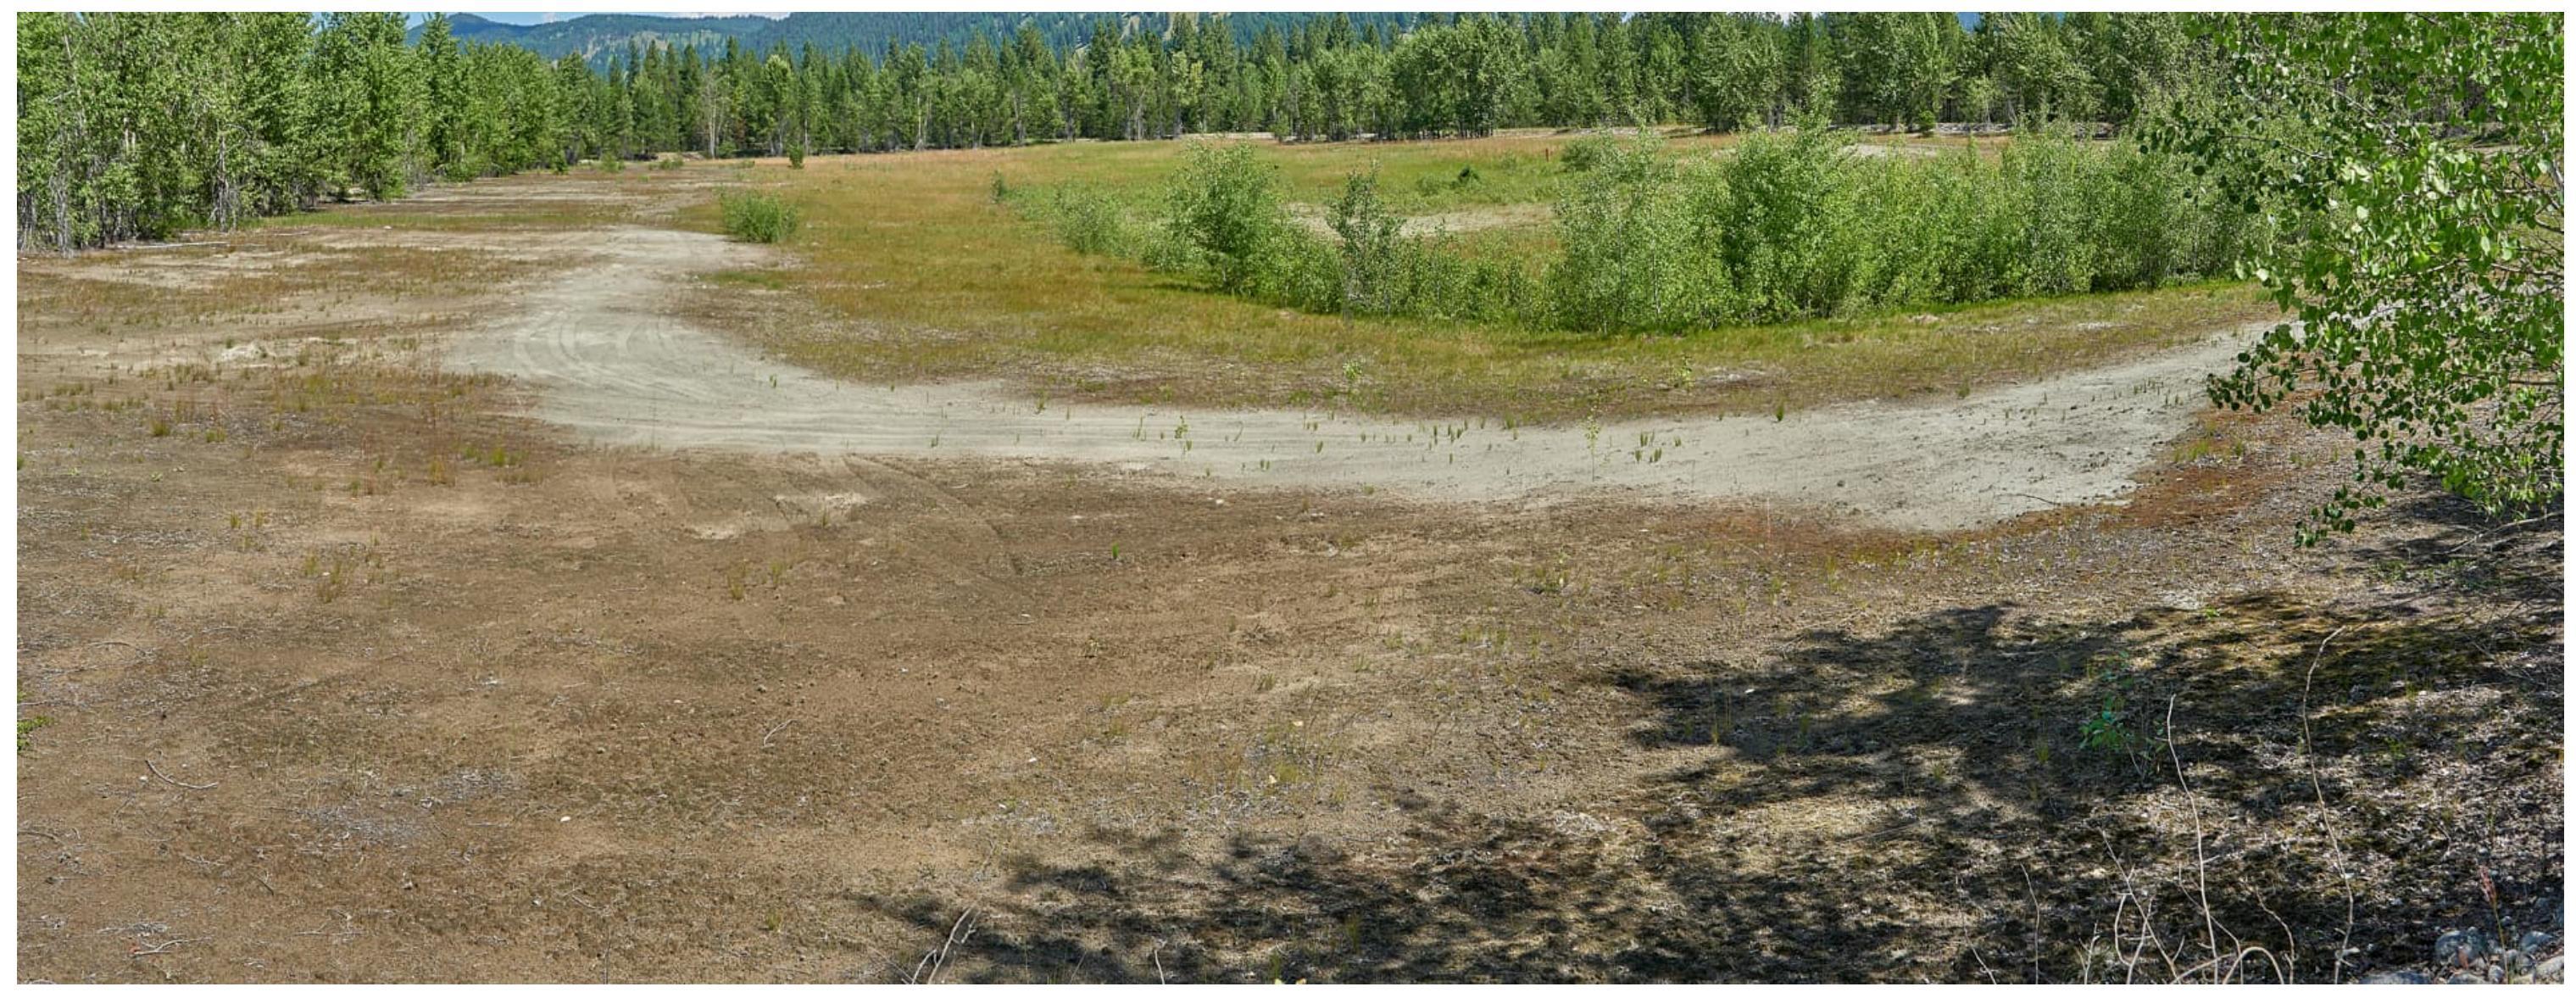
Photograph #33: "Cell 6 tailings surface"

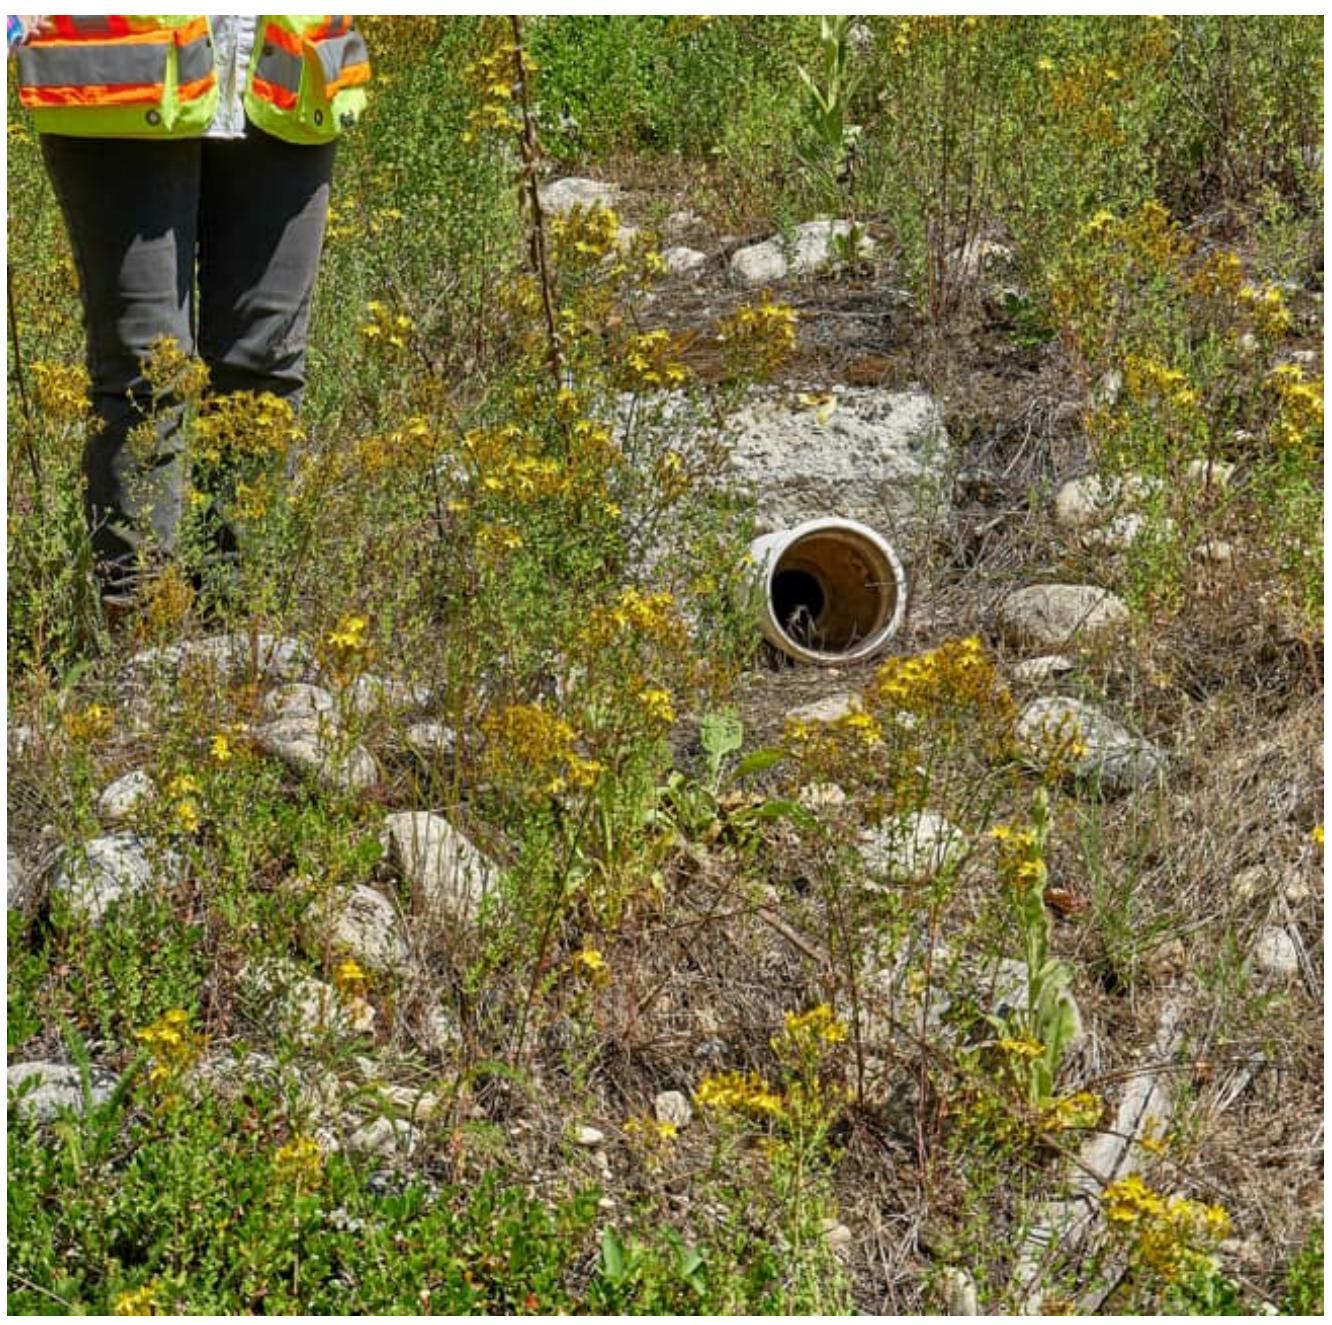
- Sinkholes or subsidence of the tailings surface were not noted, though the entire tailings surface was not observable from the embankments.
- The outlet pipe for the Cell 6 decant was dry.

Photograph #34: "Cell 6 decant outlet"

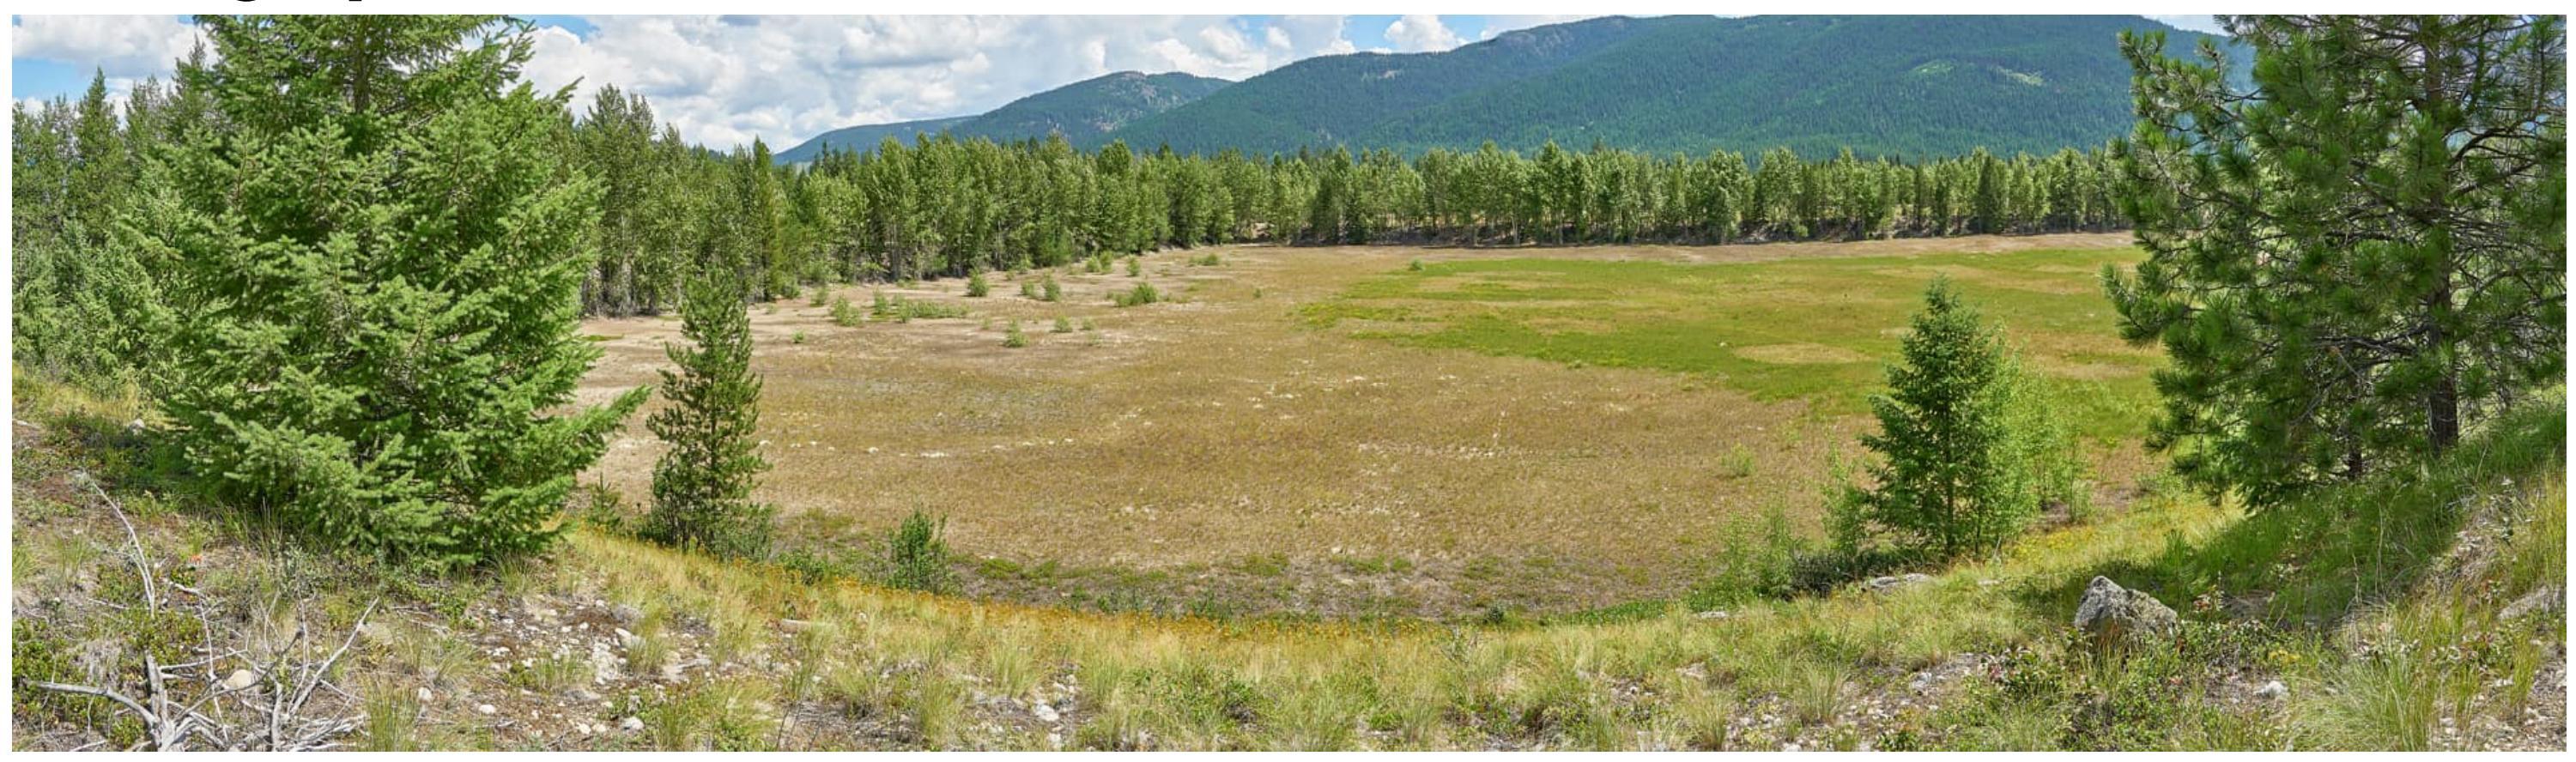
Photograph #35: "Cell 7 tailings surface"
