# 2021 Annual Facility Performance Review

## *Swift South Spoil Co-management Facilities*

Reference No. 21456080-2021-256-R-Rev0-500

25 March 2022

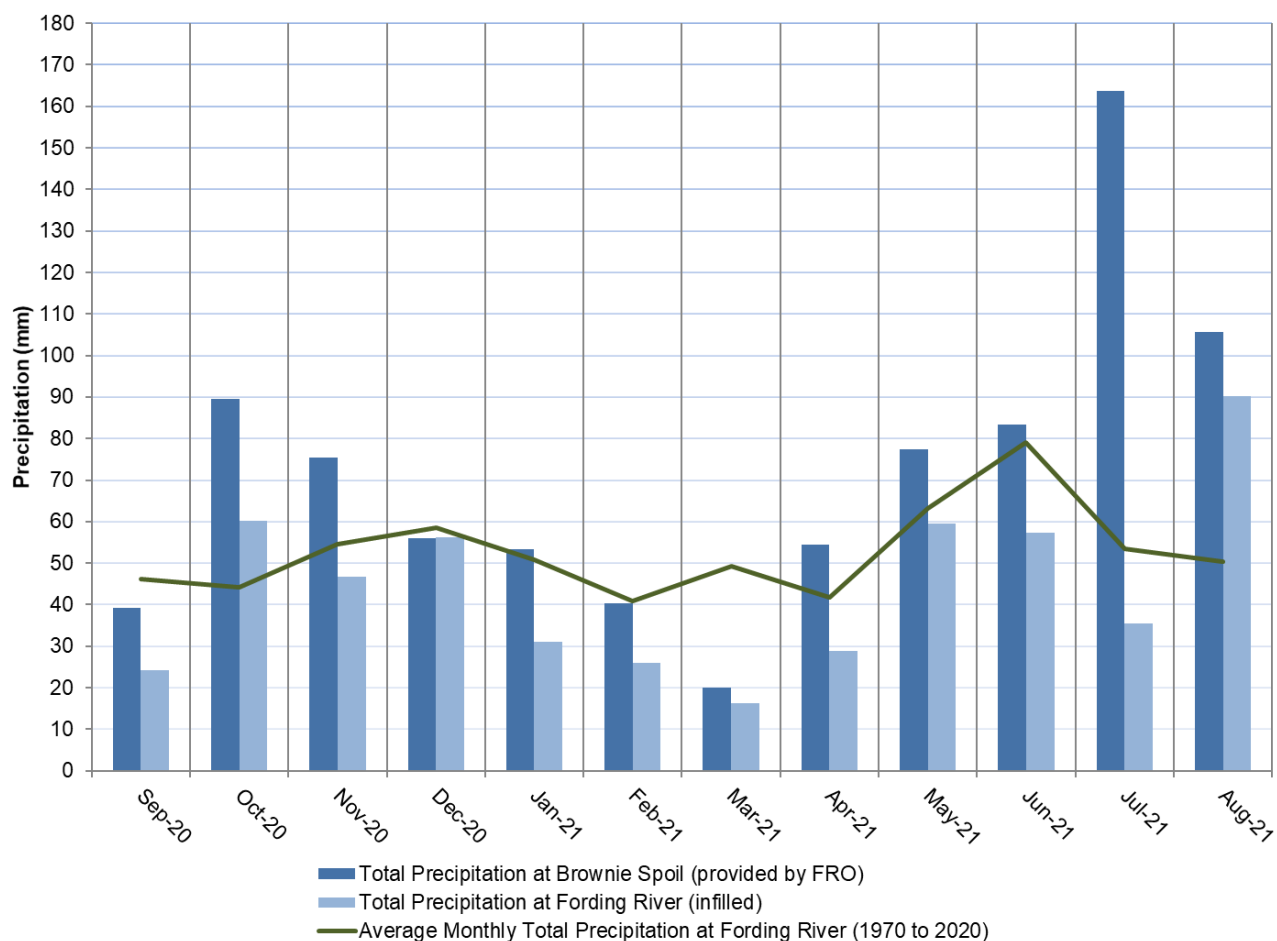
**Chart 1: Monthly Precipitation Data from 1 September 2020 to 31 August 2021**

The precipitation data in Table 4 indicate the annual precipitation used for the Fording River (infilled) dataset from 1 September 2020 to 31 August 2021 was lower than the long-term average of 632 mm, whereas the corresponding annual precipitation received at the Brownie Spoil weather station was higher than the long-term annual average. A similar observation could be made from Chart 1, where the total monthly precipitation data used in the Fording River (infilled) dataset were lower than the long-term average and the total monthly precipitation data recorded at the Brownie Spoil weather station were generally at or higher than the long-term average except for the following time periods:

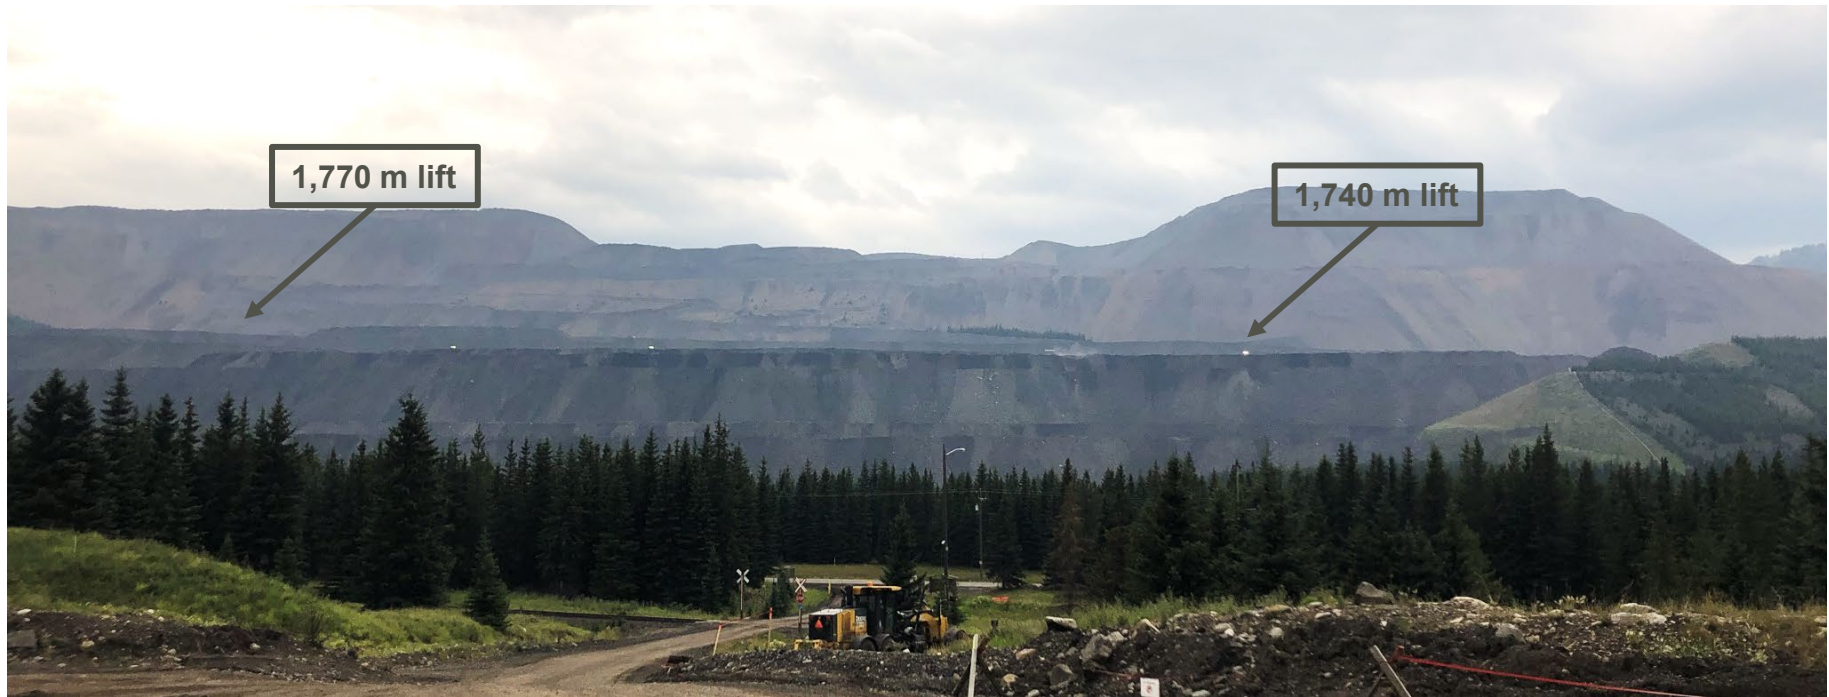
### PHOTOGRAPH A-1

Swift South Spoil containing CMFs, overview, looking west.

- Based on visual inspections collected on site, the Swift South Spoil CMFs appeared safe with no deficiencies that require immediate action (Photograph A-1).
- The platforms of the constructed lifts were in good condition with relatively flat surface and no observed cracking (Photographs A-2 and A-3).
- Water was ponding on the compacted surface of the Swift South Spoil CMFs. This was observed to be relatively unchanged over the three-day site visit despite no precipitation (Photograph A-4).
- Domestic waste was observed in the 1,740 lift of the southern CMF (Photograph A-5).
- Construction of the northern Swift South Spoil CMF facility was occurring at the 1,740 lift. Construction was proceeding in accordance with design. (Photograph A-6).

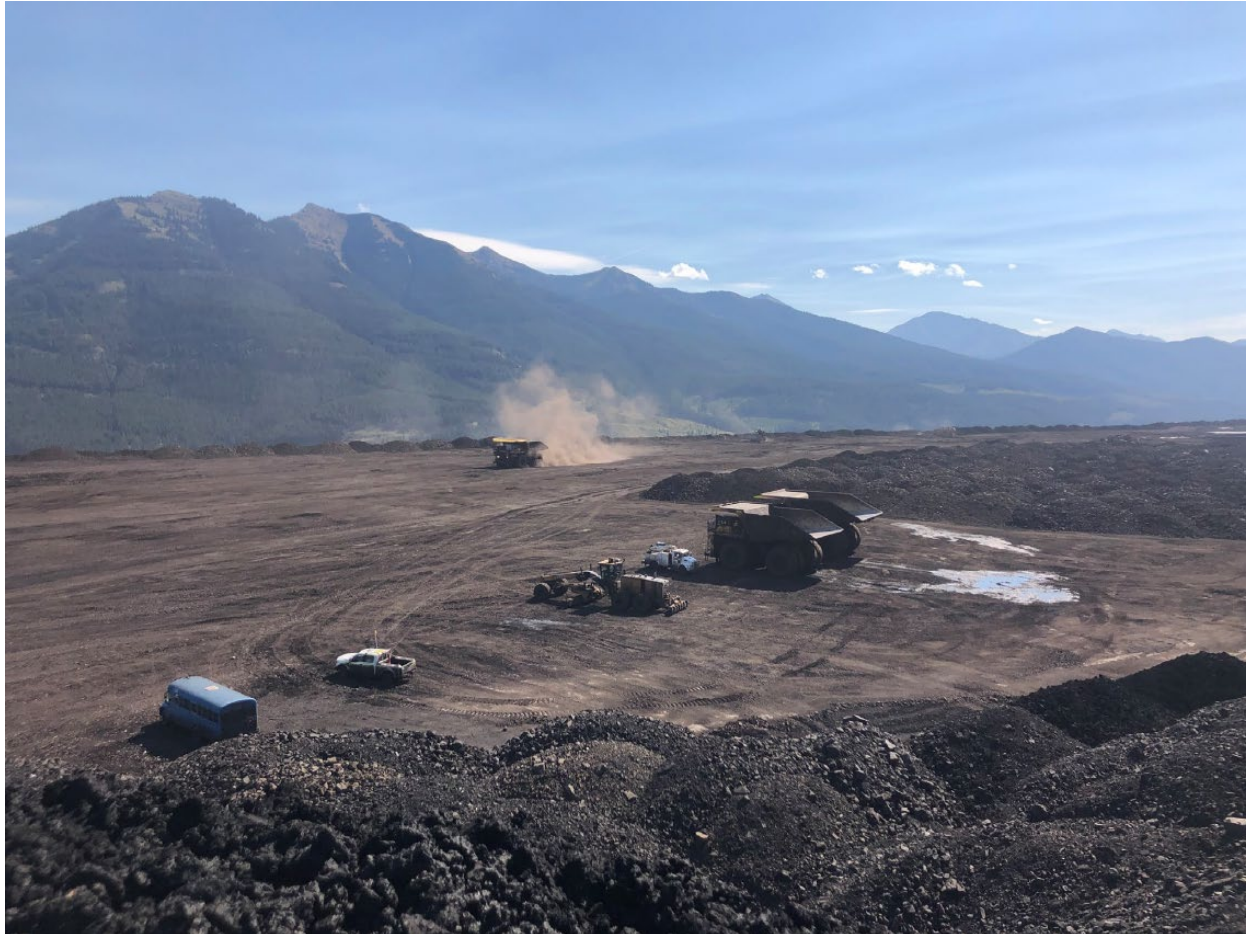
### PHOTOGRAPH A-2

Advancing face of the 1,740 m lift of the southern Swift South Spoil CMF, looking southeast.

INSPECTION ITEM	PHOTO	OBSERVATIONS, COMMENTS & OTHER DATA
1. Platform Conditions		
1.1 Crest Elevation	A-2, A-3	Material was being placed on the 1,740 m lift of the northern CMF (maximum crest height of 1,755 m). Material had been placed to a maximum crest height of 1,770 m on the southern CMF and no placement was occurring at the time of the site visit.

2. Slope Face		
2.1 Slope Angle	A-2	37 deg. Overall interlift at 2 horizontal:1 vertical
2.2 Signs of Erosion	-	No signs of erosion were observed or reported. The facility is encapsulated after construction of each lift.

3. Toe		
3.1 Slope Angle	A-2	37 deg. Overall interlift at 2 horizontal:1 vertical
3.2 Signs of Erosion	-	No signs of erosion were observed or reported. The facility is encapsulated after construction of each lift.

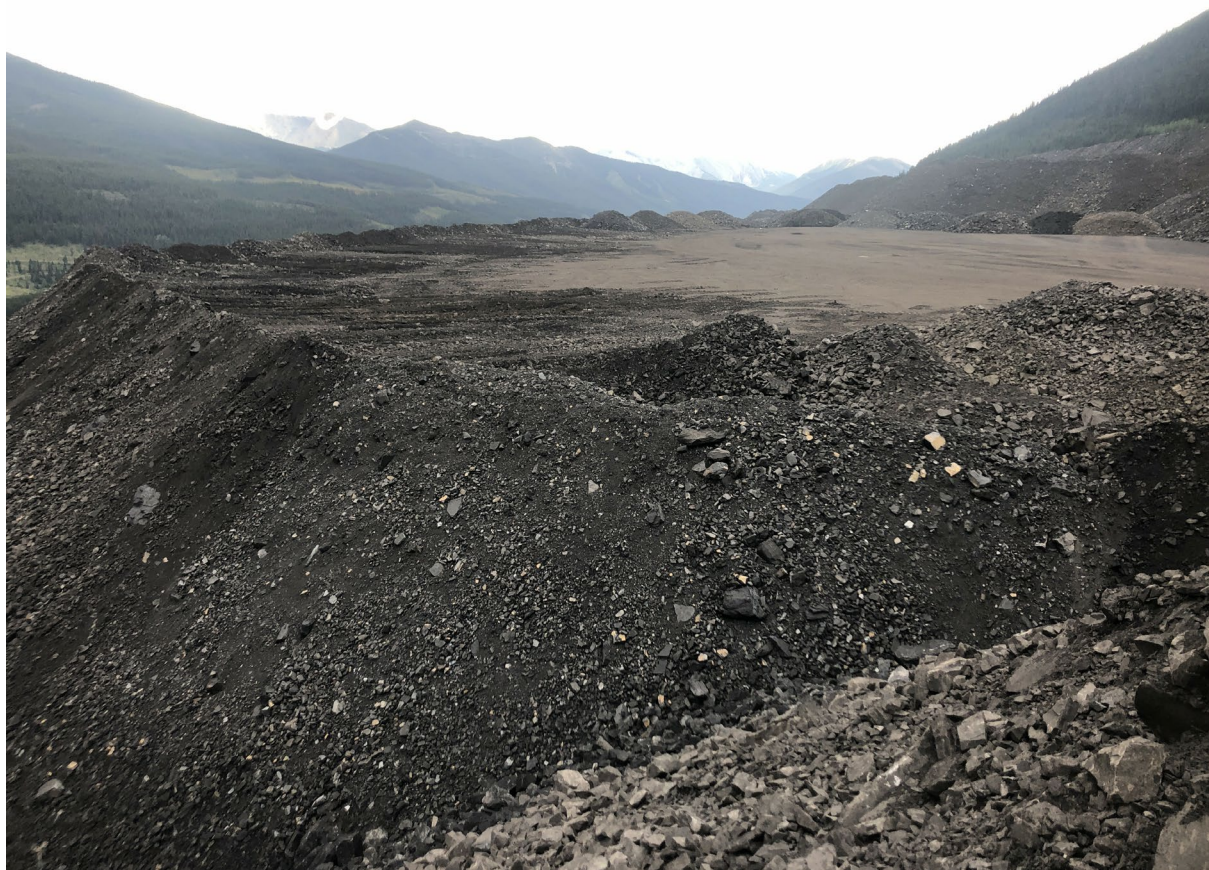
### PHOTOGRAPH A-3

Advancing face of the 1,740 m lift of the southern Swift South Spoil CMF, looking south. The surface of both the northern and southern CMFs looked similar.

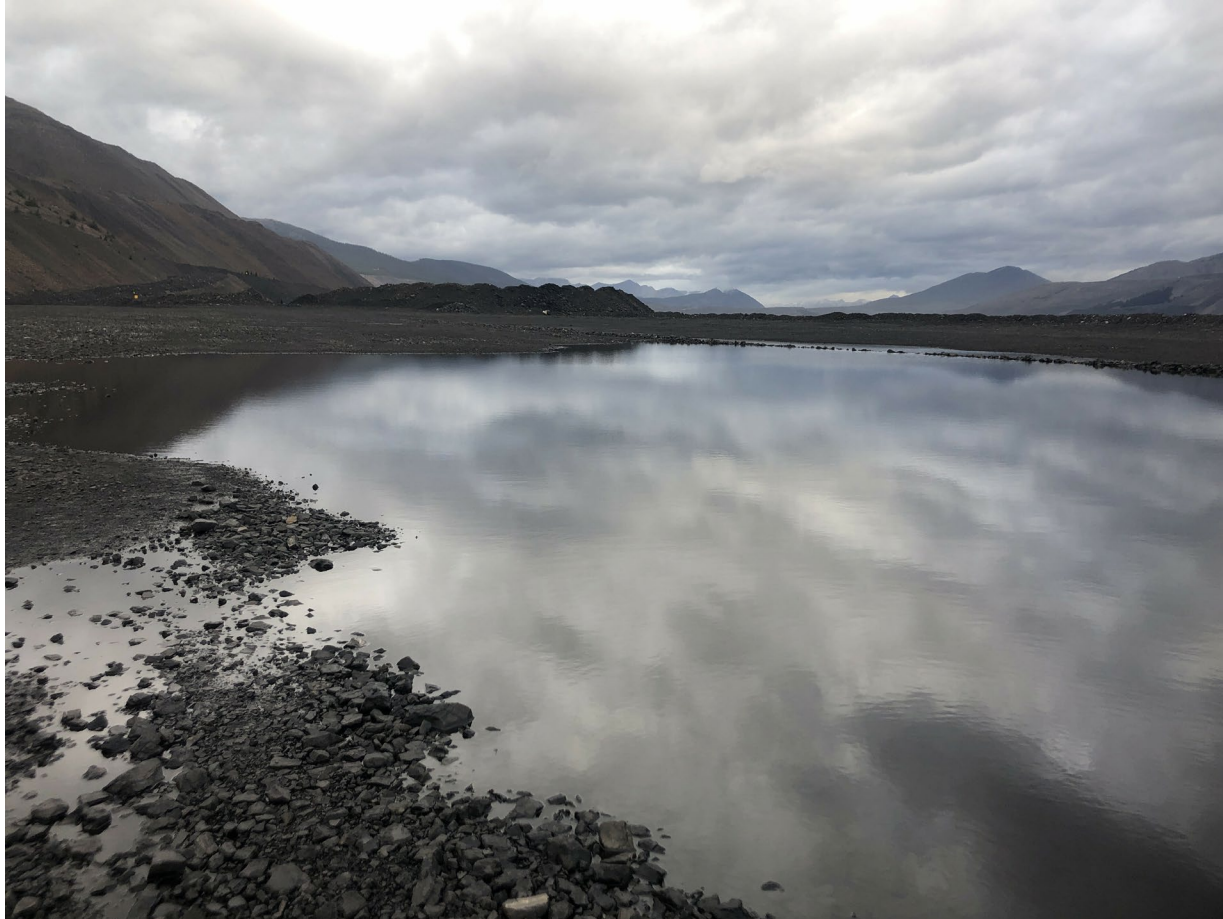
### PHOTOGRAPH A-4

Ponding water on 1,770 m lift of the southern Swift South Spoil CMF. This ponding was largely unchanged for three days with no rain. Looking northeast.

1.6 Lateral Movement	-	No lateral movement was observed or reported.
1.7 Other Unusual Conditions	A-4	Ponding water was observed on the 1,770 m lift of the southern Swift South Spoil CMF. This water was observed to have been ponding unchanged for three days.

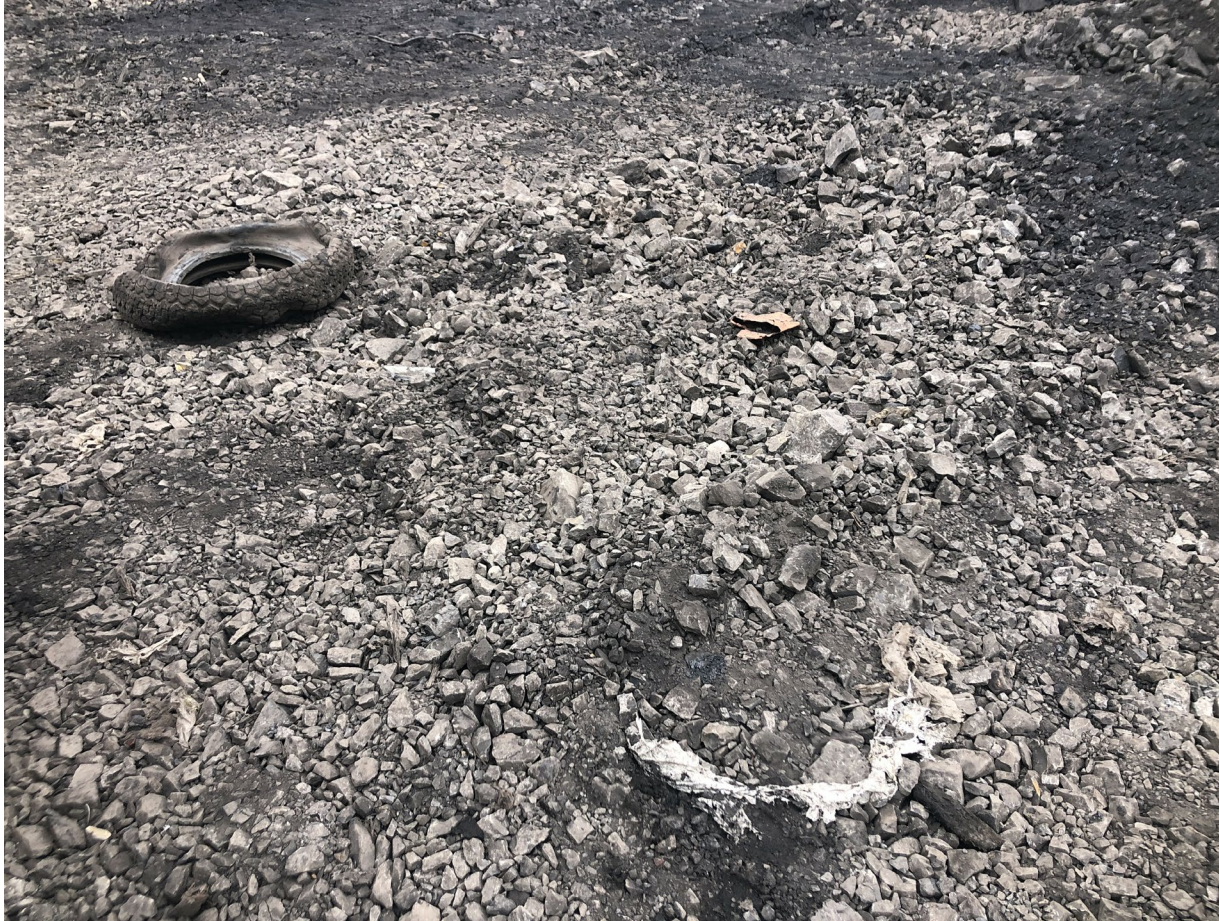
### PHOTOGRAPH A-5

Surface of the 1,740 m lift of the southern Swift South Spoil CMF, showing domestic waste incorporated into the placed CMF material. Looking northeast.

ID Number	Deficiency or Non-conformance	Applicable Regulation or Guideline	Recommended Action	Priority	Recommended Timing for the Action
2021-01	Unapproved material placed in CMFs	n/a	Assess and document the impact of deviation due to unapproved domestic waste placement in the southern Swift South Spoil CMF.	3	Q3 2022

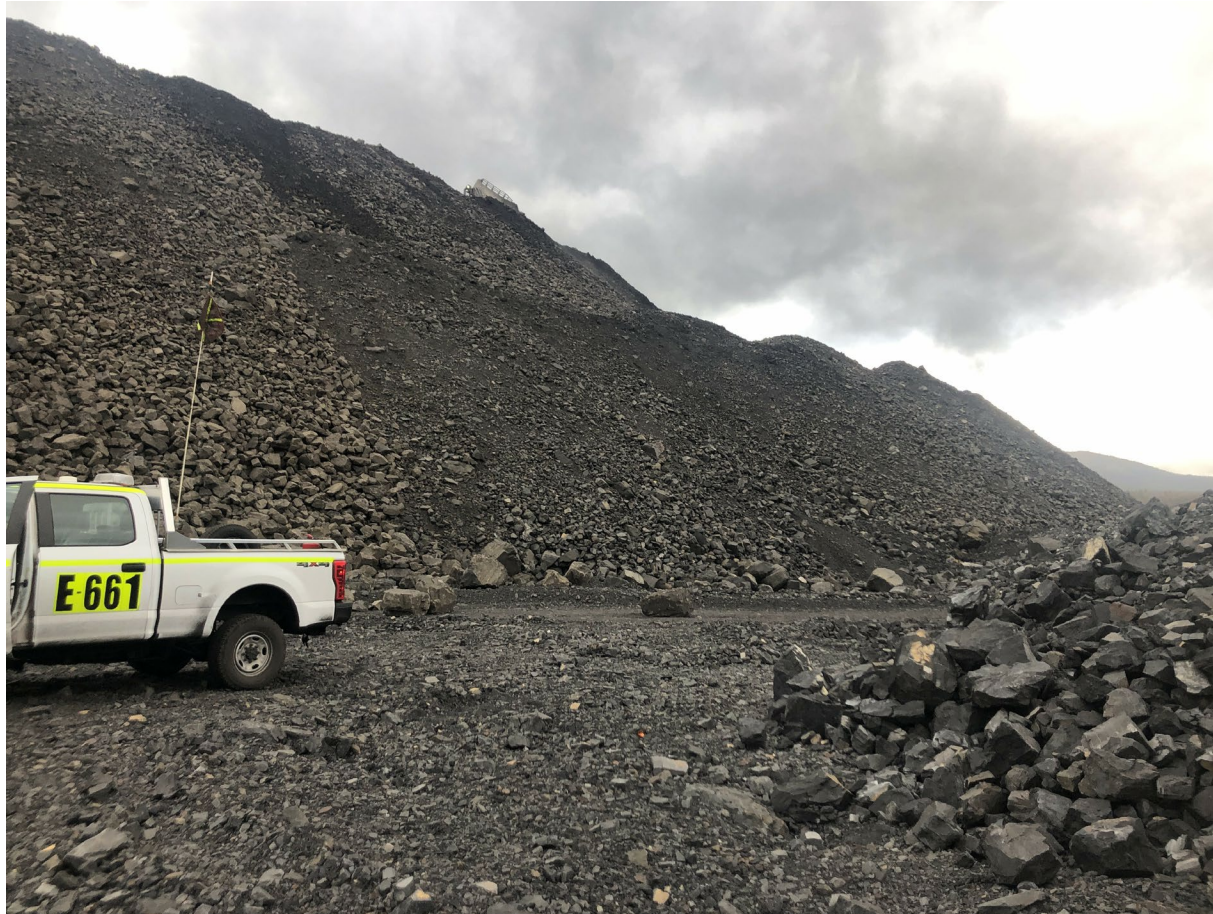
### PHOTOGRAPH A-6

Haul truck dumping off the 1,740 m lift onto the 1,710 m lift on the northern Swift South Spoil CMF, looking west. The northern CMF was being actively constructed at the time of the site visit.
