EARLY COPPER PRODUCTION RESULTS FROM VALE'S HYDROMETALLURGICAL CESL REFINERY

Jennifer Defreyne¹, Tobias Cabral²

¹ Cominco Engineering Services Ltd. (CESL) ² Companhia Vale do Rio Doce (Vale)

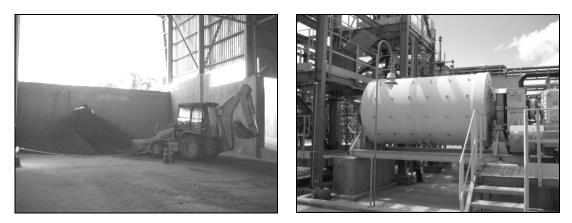
Concentrate feed is received at the UHC plant battery limits (Figure 1) and is subjected to a light regrind in a ball mill (Figure 2) to increase the surface area of the minerals.

Figure 1: Concentrate Handling

Figure 2: UHC Ball Mill

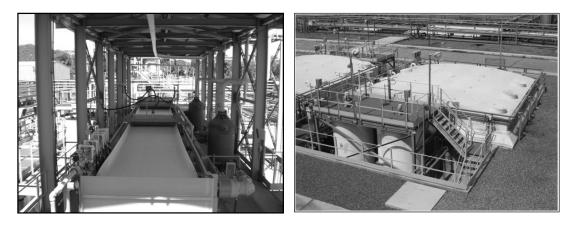
The autoclave final product slurry is discharged continuously through a pressure letdown system. Steam is vented from these tanks, reducing the temperature of the slurry to below boiling. Additional cooling of the discharge slurry is required prior to thickening and filtration; this is achieved by recycling the cooled thickener overflow to mix with the hot autoclave discharge slurry. The cooled autoclave discharge slurry is thickened and filtered (Figure 3). Copper is removed from the autoclave leach liquor by solvent extraction before it is recycled through the evaporator and returned to the autoclave. The evaporator is used to maintain the plant water balance, removing water at a rate of approximately $1.5 \text{ m}^3/\text{hr}$. The leach filter cake, containing oxidized copper, hematite and elemental sulphur is washed on the belt filter to confine the chloride catalyst to the PO circuit. The washed cake is then repulped with recycled raffinate from solvent extraction (Figure 4) prior to atmospheric leaching. The slurry pH is controlled to a pH of 1.5 using raffinate in the reactor train to efficiently leach the copper from the PO filter cake.

Figure 3: Autoclave Slurry Belt Filter

Figure 4: SX Mixer-Settler

The pregnant leach solution (PLS) from the atmospheric leach is purified using two-stage countercurrent solvent extraction. LIX organic extractant transfers the copper to the electrolyte leaving all of the impurities in the raffinate which is then recycled back to the leach.

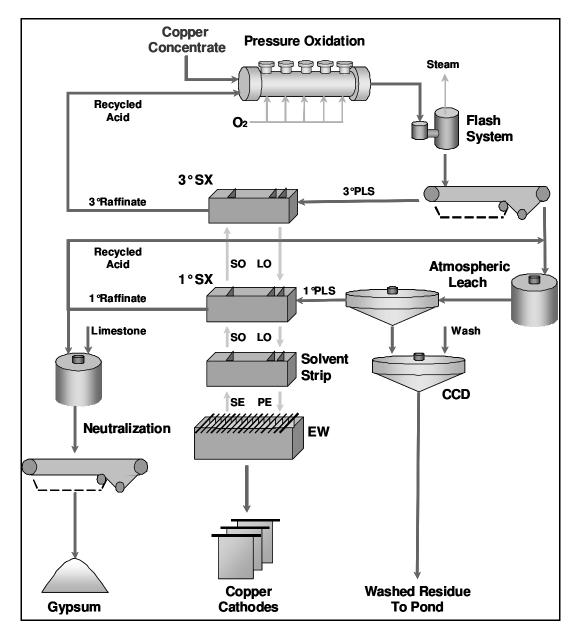
Figure 5: Simplified Process Flow Diagram

The main solid waste streams from the plant are the final washed leach residue and gypsum. The final washed leach residue contains the elemental sulphur, hematite and any precious metals present in the concentrate. Figure 5 below shows a simplified version of the UHC process flow diagram.

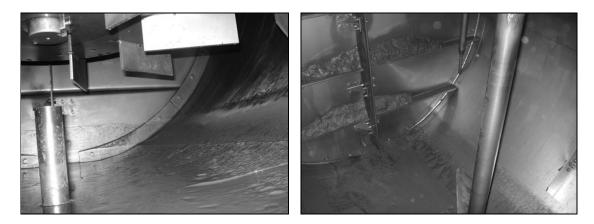
The first autoclave inspection occurred after approximately one month of consistent operation. There were no signs of wear or undesirable solids accumulation found in the autoclave Figure 6 and 7).

Figure 6: 1st Autoclave Inspection Compartment 1 Figure 7: 1st Autoclave Inspection Compartment 5

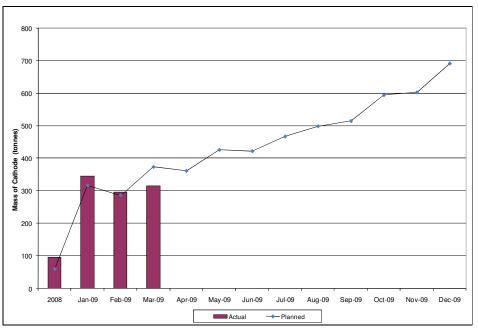
Figure 15: UHC Cathode Production

Figure 15 shows the copper cathode production at UHC from December 2008 through March 2009 compared against the monthly ramp-up target.

Between December 1, 2008 and March 31, 2009, just over 1000 tonnes of copper cathode has been produced. Thus far in 2009, the plant has averaged 40% of design.

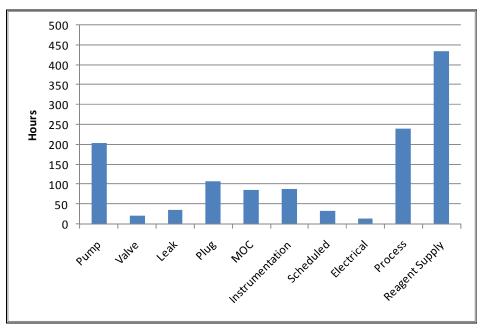
Figure 16: Downtime Sources at UHC

Significant causes for downtime this year are attributable to inadequate reagent supply, process upsets and pump problems as depicted in Figure 16.

Lack of oxygen has been the largest cause of downtime at UHC. The oxygen is trucked from 1000 km away, making it very difficult to schedule deliveries. Although the plant has three days of

oxygen storage onsite, interruption to supply occurs regularly during poor weather and road conditions leading to extended shutdowns.

Process upsets, namely inventory management issues, have also been a large source of downtime. It has been a very interesting learning experience for all involved in the project as to the troubles of maintaining a water balance during the rainy season in northern Brazil. On a few occasions, the plant has been shutdown and the evaporator used to decrease the volume of process solution to a manageable level.

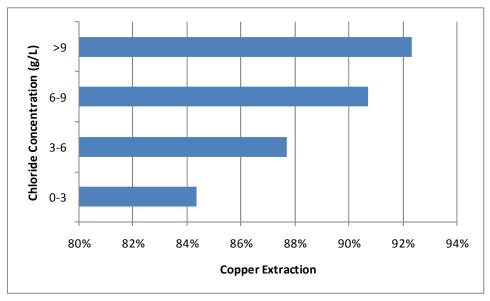
Figure 17: UHC Copper Extraction at Varying Autoclave Chloride Levels

Figure 17 shows the average UHC copper extraction to date at varying chloride levels.

Copper extraction has ranged from 80% to 93% during the first three months of operation. Vale has recognized the importance of controlling the chloride level and it's affect on copper extraction and is focusing on improving the delivery schedule of HCI to site. To minimize future addition requirements, a rigorous sampling campaign will occur in April and May to identify the sources of chloride loss in the plant.
