Report: Data Report for the Tributary Evaluation Program (DRAFT)

**Data Report for the
Tributary Evaluation Program
(DRAFT)**

Prepared For:
Teck Coal Limited
Sparwood, BC

Prepared By:
Minnow Environmental Inc.
Georgetown, ON

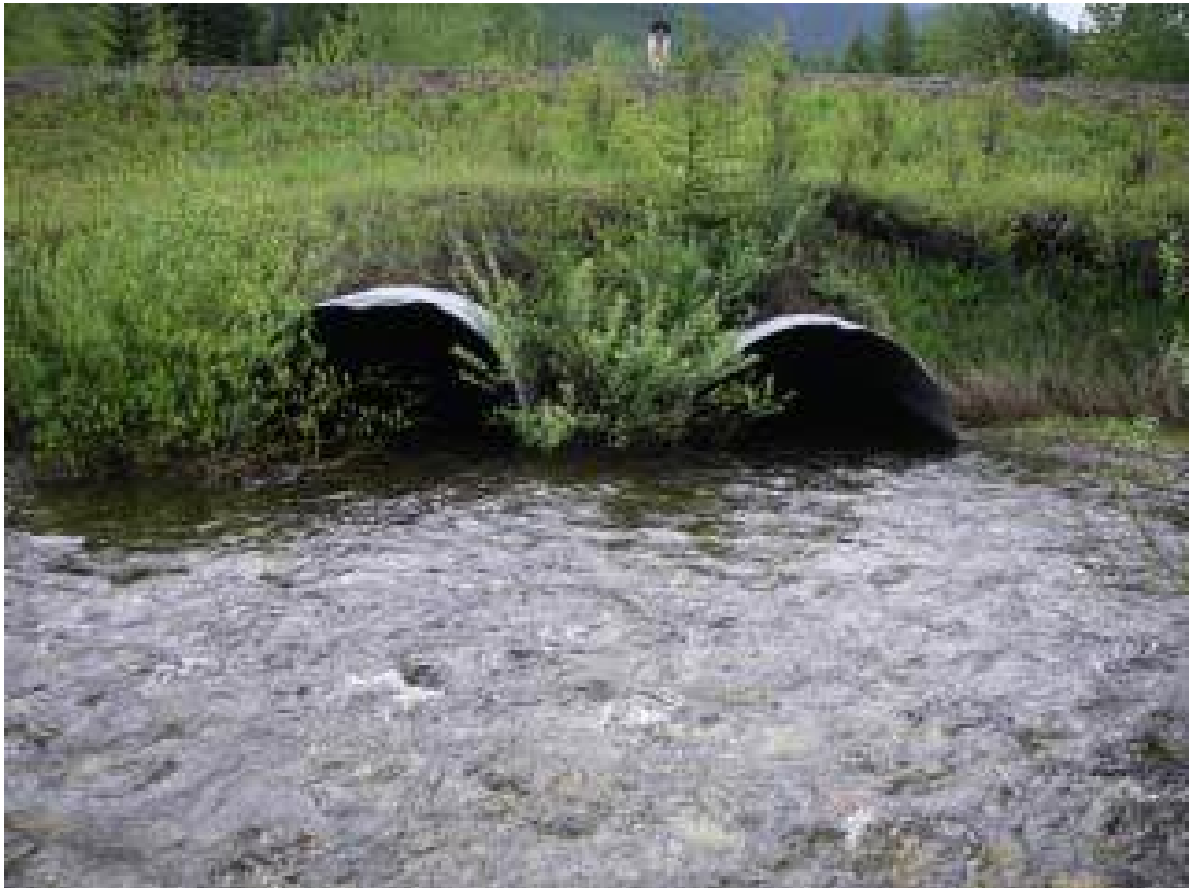
Photo 3.6: Paired culvert crossing under Fording Road in Dry Creek (Teck 2011b).

LCO's Dry Creek flows north from its headwaters to the Fording River. An unnamed tributary (often referred to as the East Tributary), joins Dry Creek from the east about 5 km upstream from the confluence with the Fording River. A railway and two road crossings are located along the lower portion of Dry Creek. The railway and one road crossing are paired culvert crossings (Photo 3.6), whereas the second road crossing is a clear-span bridge.

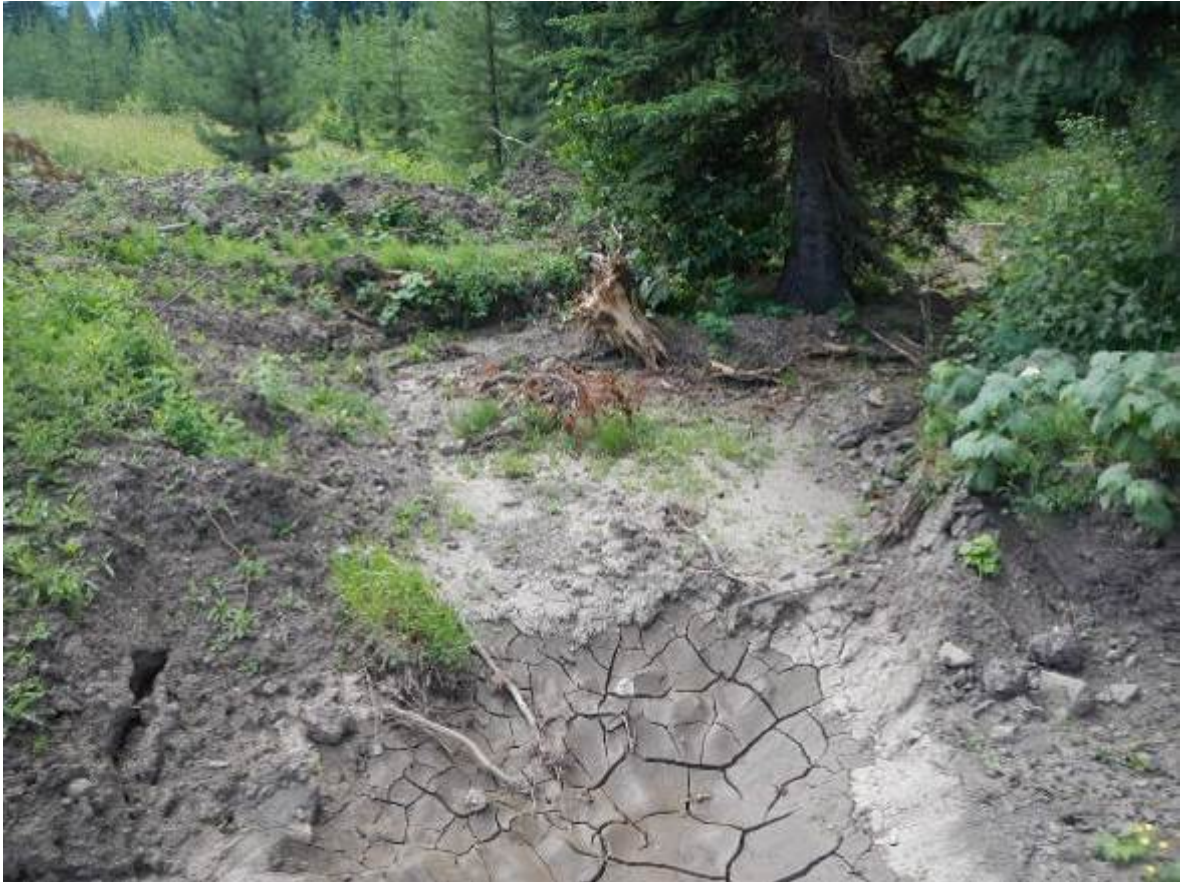
Photo 5.1: Dry creek bed in Branch F Creek (Lotic 2015b).

In September 2013, the creek was characterized as dry from the Elk River to the FSR (Lotic 2015b; Photo 5.1). Additional visits in February 2014, and July 2014 again found the channel dry, so no biological sampling occurred. Branch F Creek has an average gradient of 15.3% and an average channel width of 0.80 m, and there is a gradient barrier (slope greater than 30% for 30 m) located at its confluence with the Elk River (Lotic 2015b). The stream is considered non-fish bearing (Lotic 2015b).

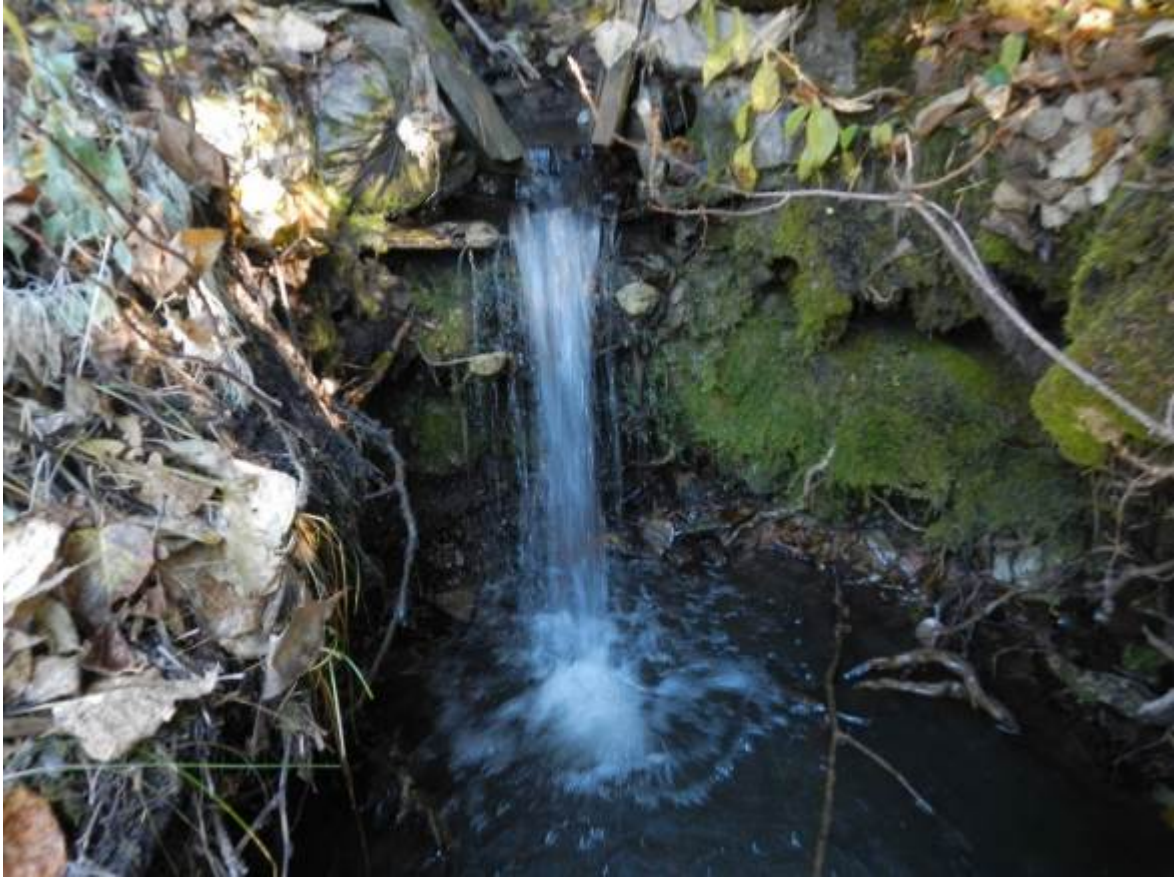
Photo 5.6: One metre tall waterfall on Mickelson Creek upstream from the Round Prairie Forest Service Road (Lotic 2015b).

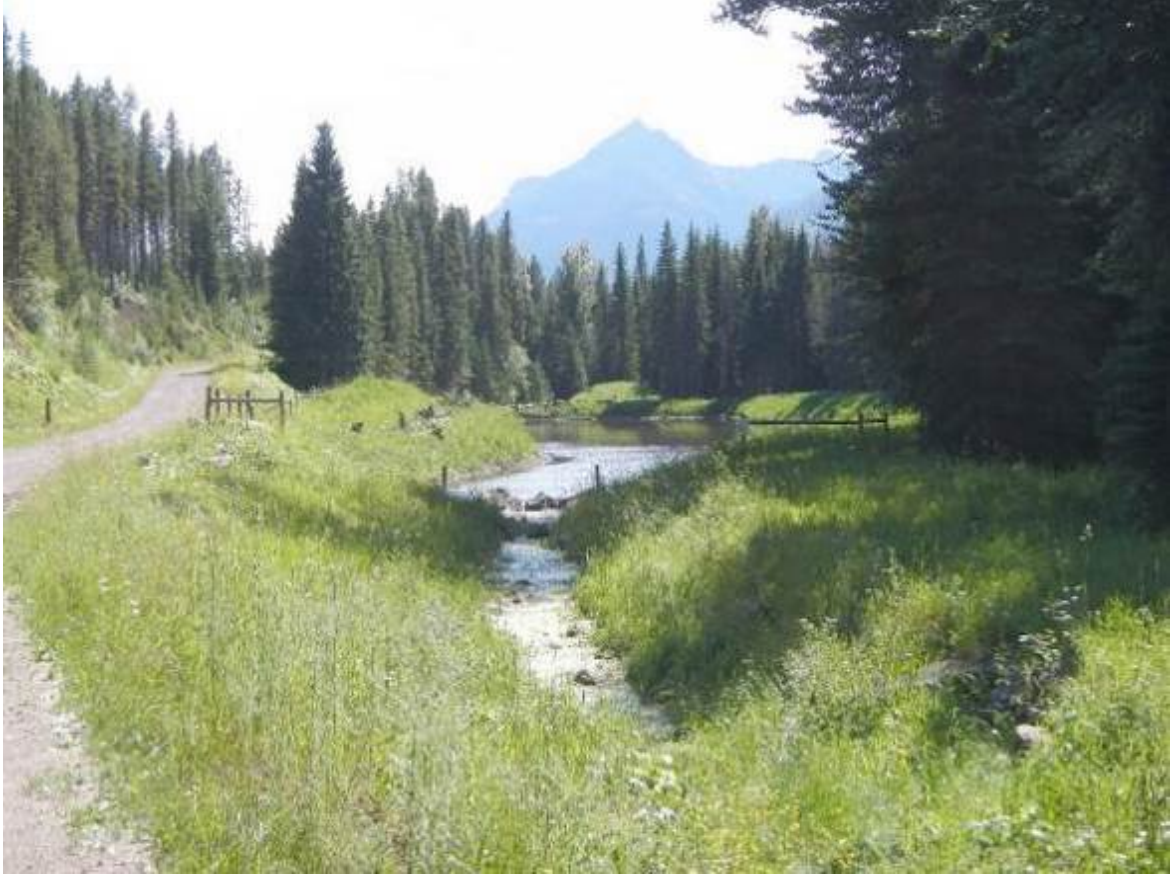
Photo 5.7: Downstream sedimentation pond at Leask Creek (Lotic 2015b).

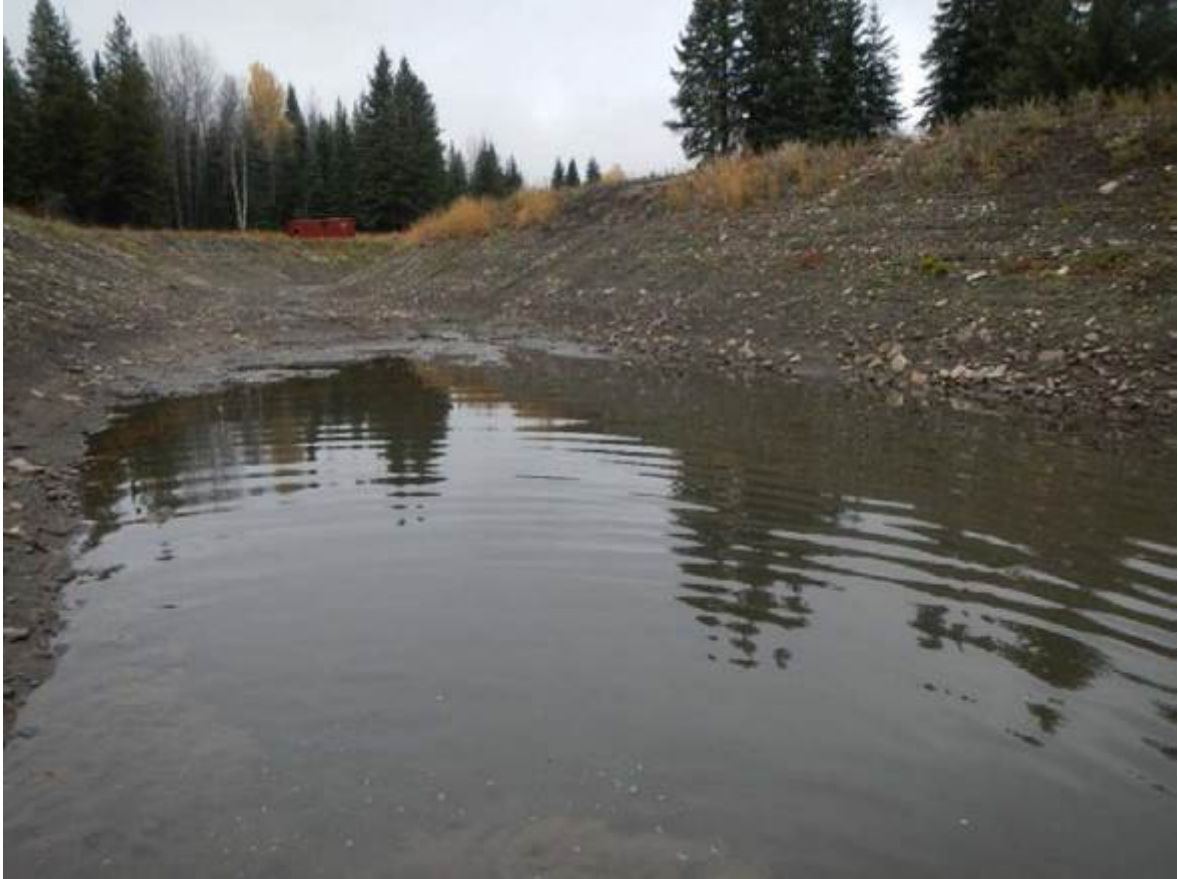
Photo 5.8: Upstream view of downstream sedimentation pond on Wolfram Creek (Lotic 2015b).

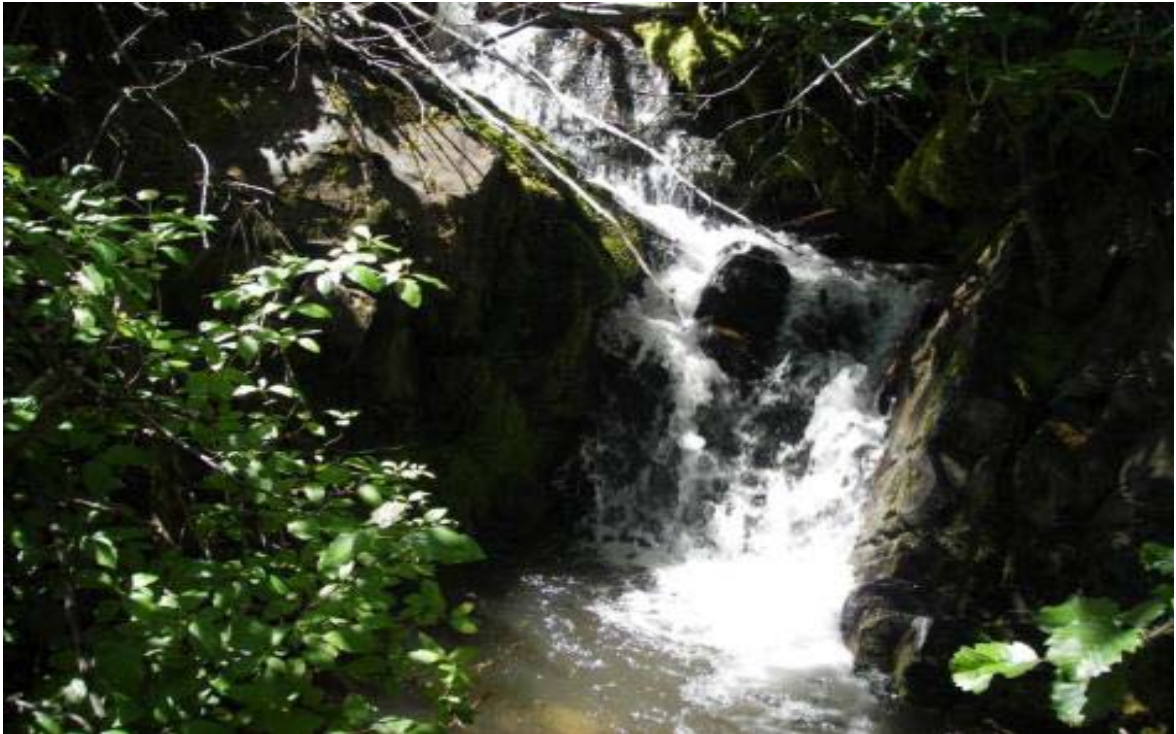
Photo 6.5: First rock-fall barrier to fish movement on Unnamed Michel Creek Tributary (Golder 2015).

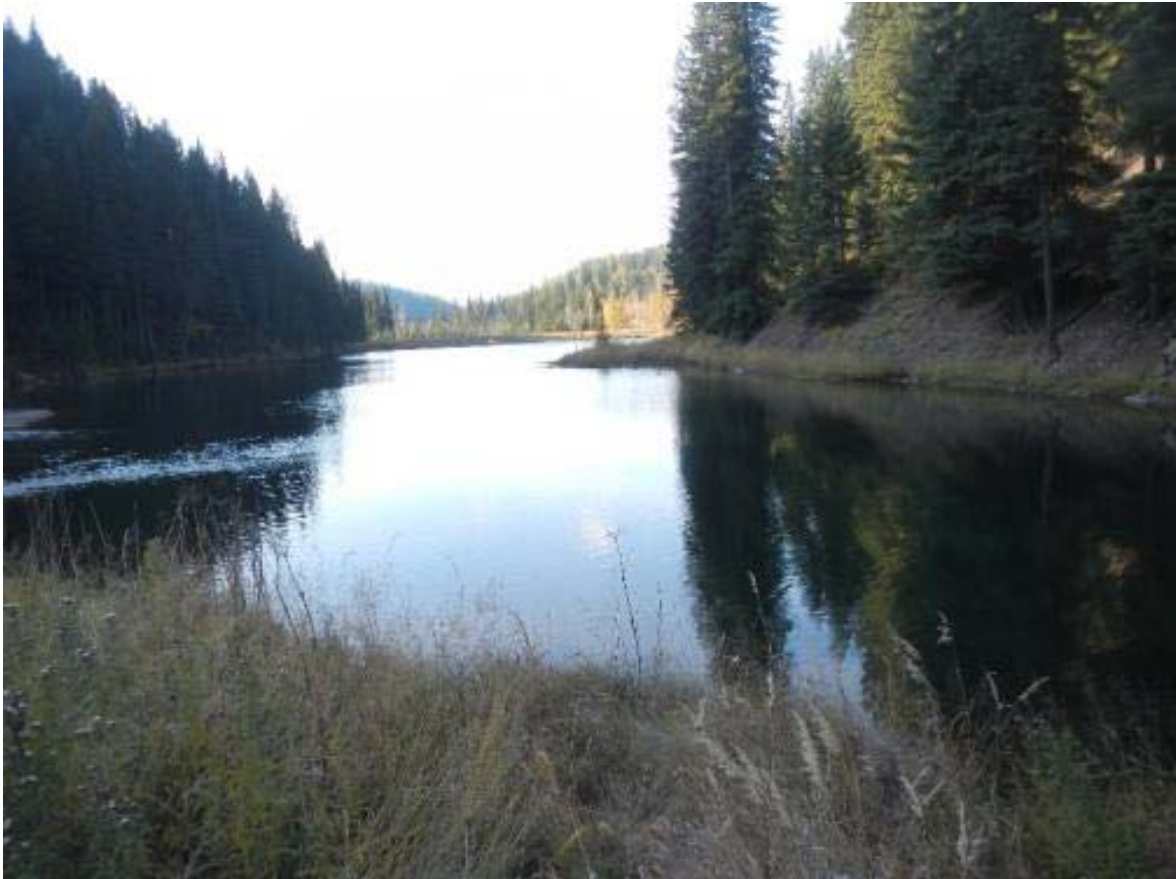
Photo 7.2: Harmer Pond 0.5 km upstream of the confluence of Harmer Creek with Grave Creek (Lotic 2015a).

Harmer Creek flows into Grave Creek and its headwaters, upstream from the confluence with Dry Creek, are not exposed to any direct mining activities. A dam and spillway is located on Harmer Creek, about 0.5 km upstream from the confluence with Grave Creek, is a barrier to upstream fish movement (Lotic 2015a). The dam creates Harmer Pond, which is about 19,000 m² and has a maximum depth of 5 m (Photo 7.2).

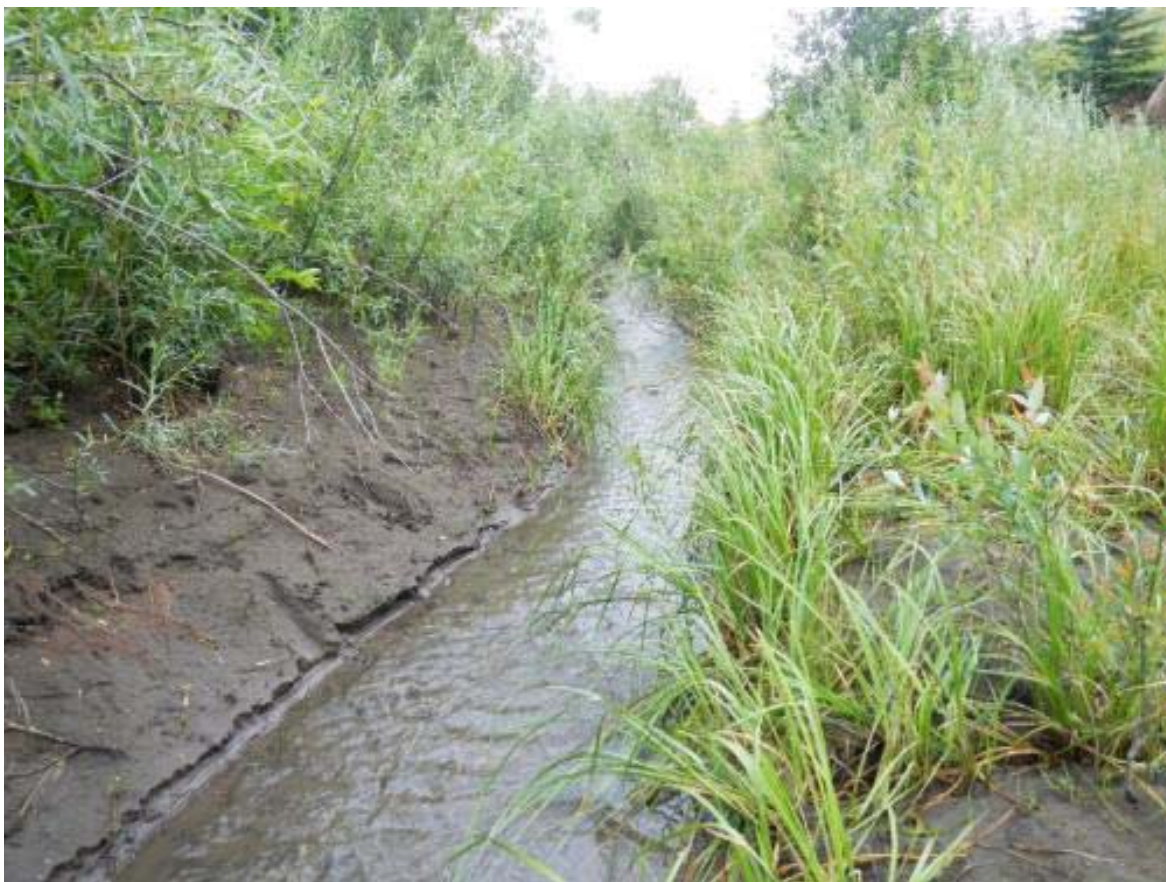
Photo 7.3: Channel habitat in lower Six-Mile Creek (Lotic 2015a).

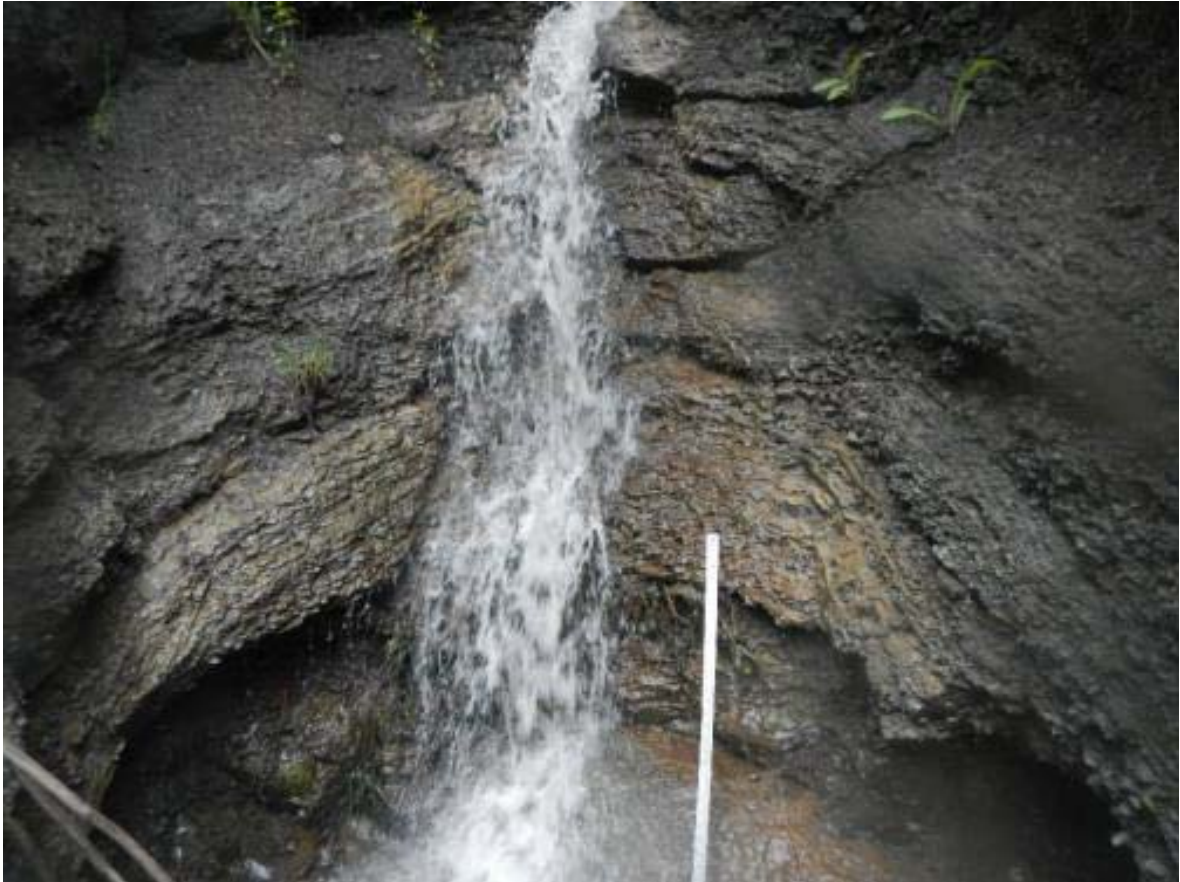
Photo 7.4: View of 2 m tall waterfall at the confluence of Fennelon Creek with the Elk River (Lotic 2015a).
