# **Teck Highland Valley Copper Partnership**

## **2021 Annual Facility Performance Report**

*Highmont Tailings Storage Facility*

March 2022

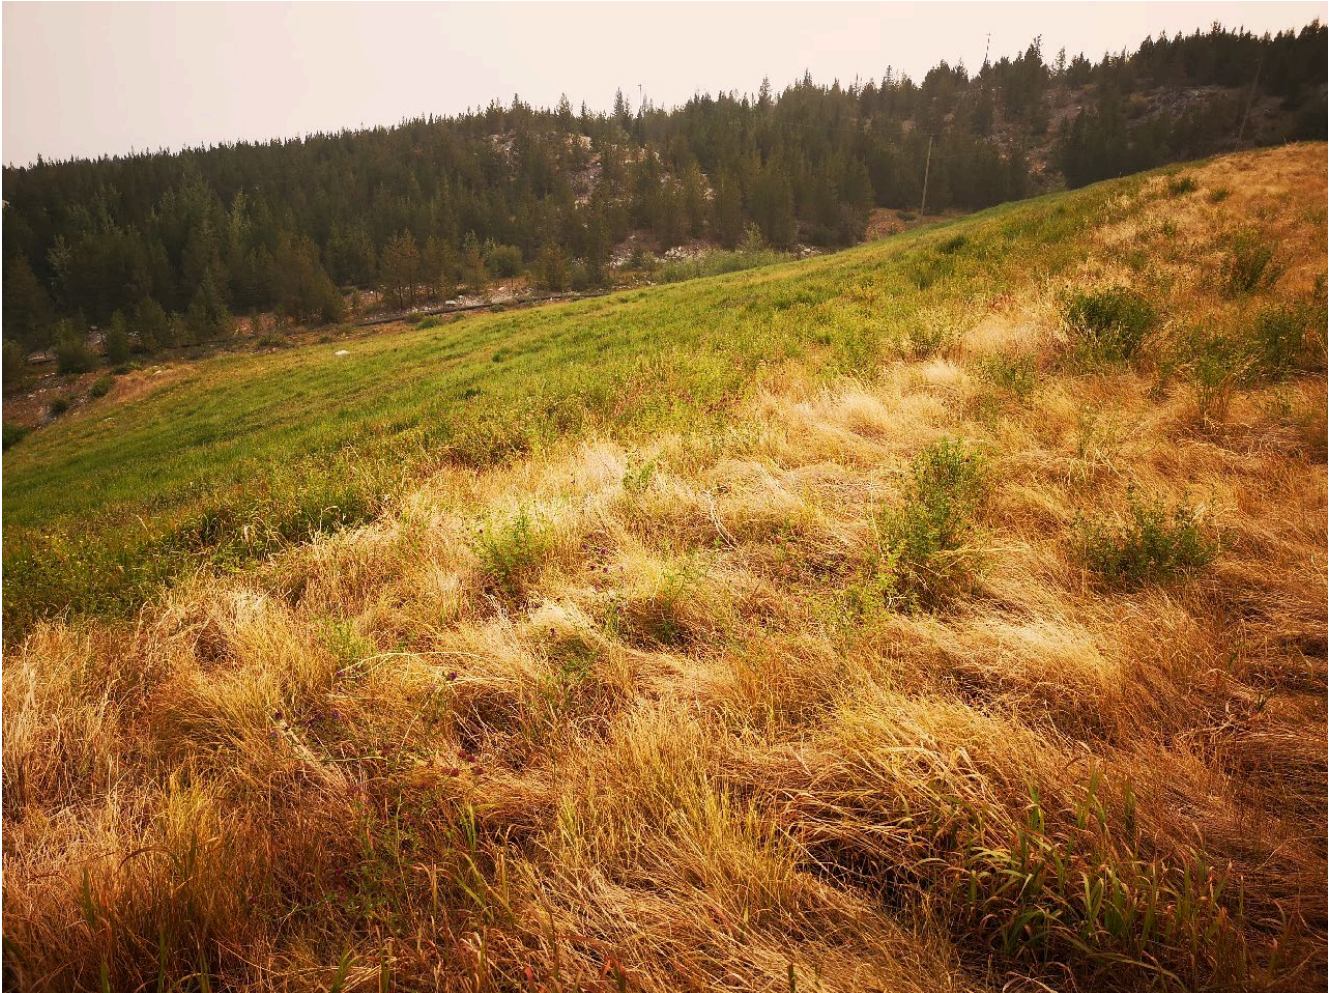
**Photo I-A-10 View of North Dam downstream slope looking east (HGH-2021-06)**

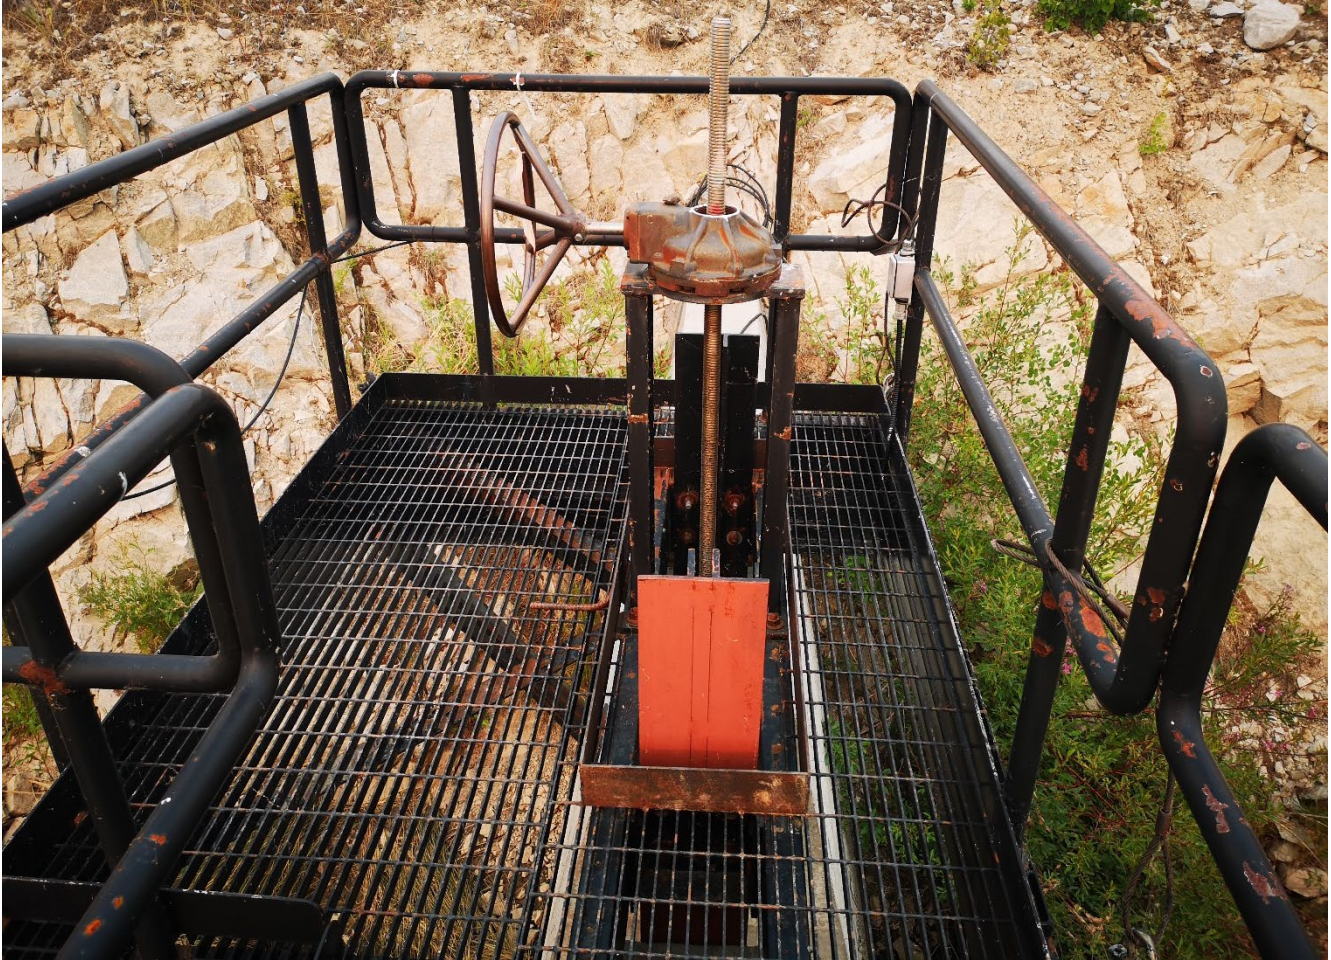
**Photo I-A-21 Spillway flow control gate. Valve is operational and could move up and down (tested for slight movement). Sliding gate is slightly open (HGH-2021-12)**

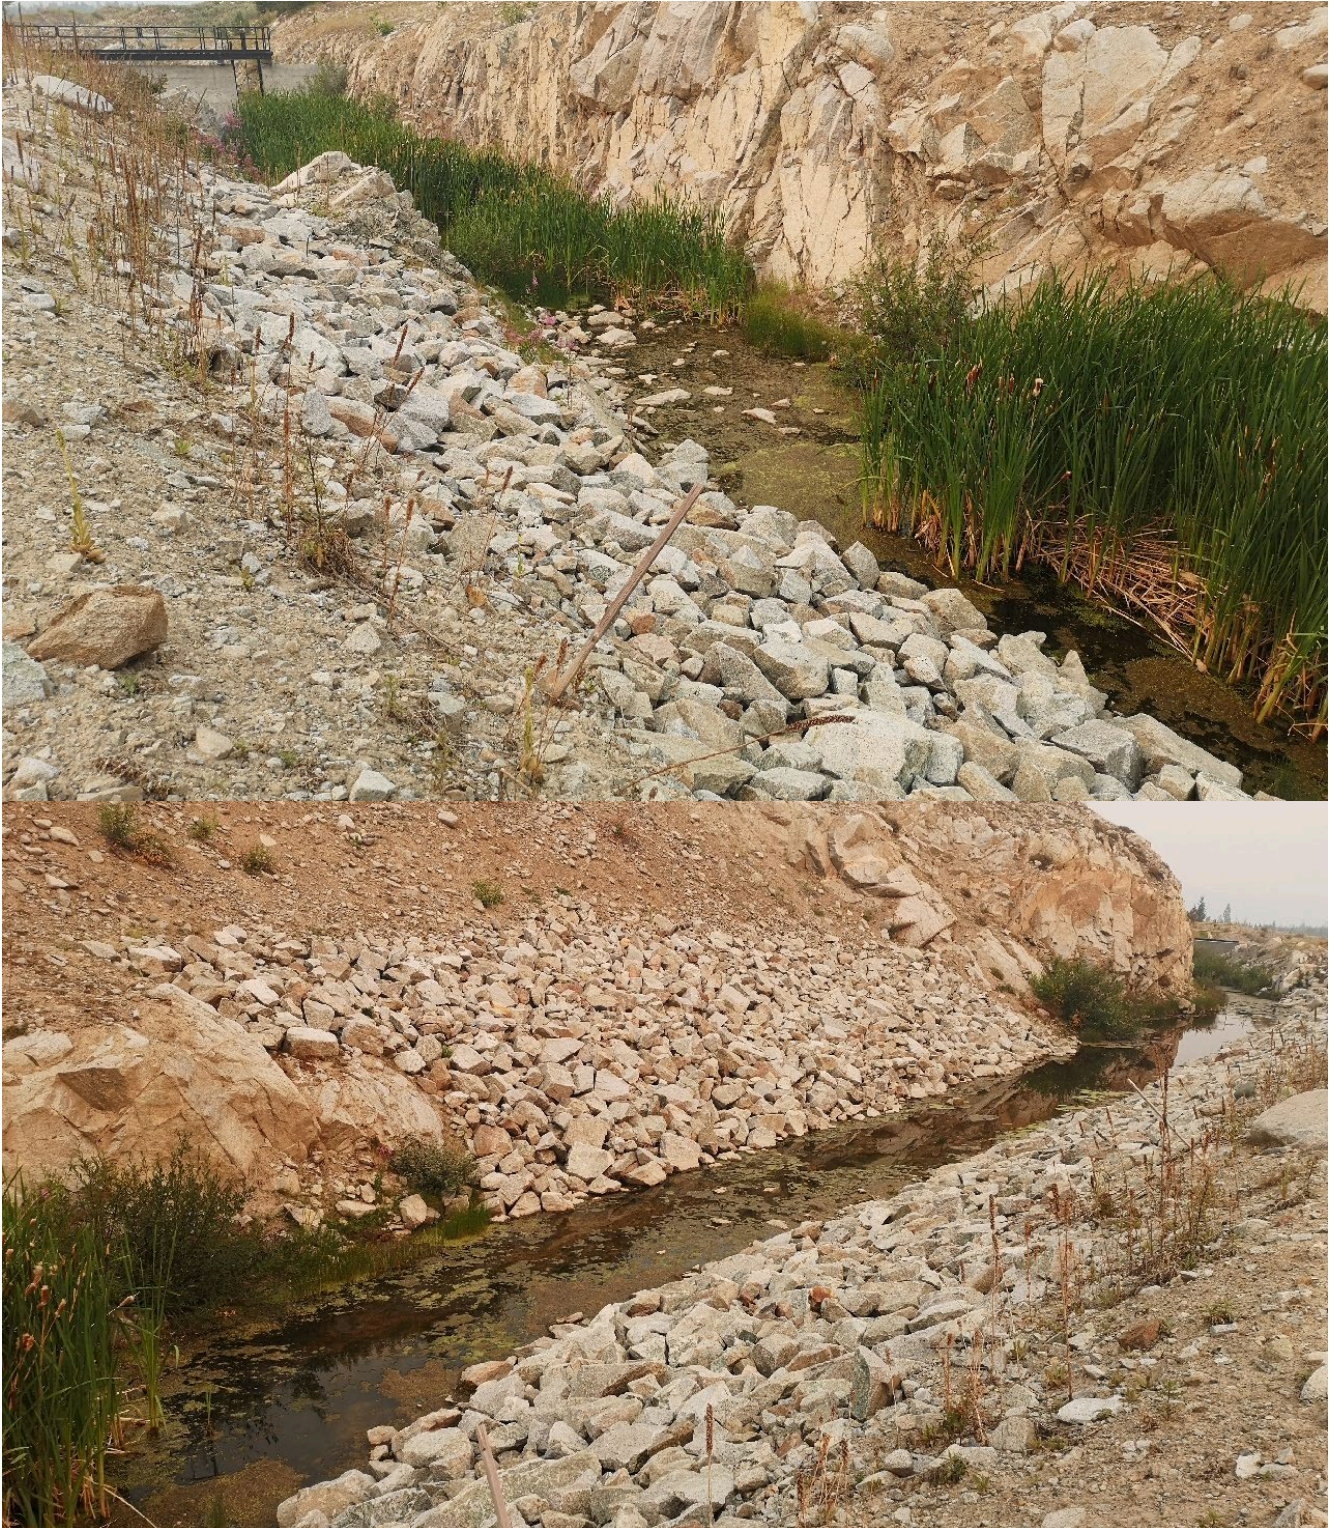
**Photo I-A-22 Downstream area of spillway flow control gate (HGH-2021-13)**

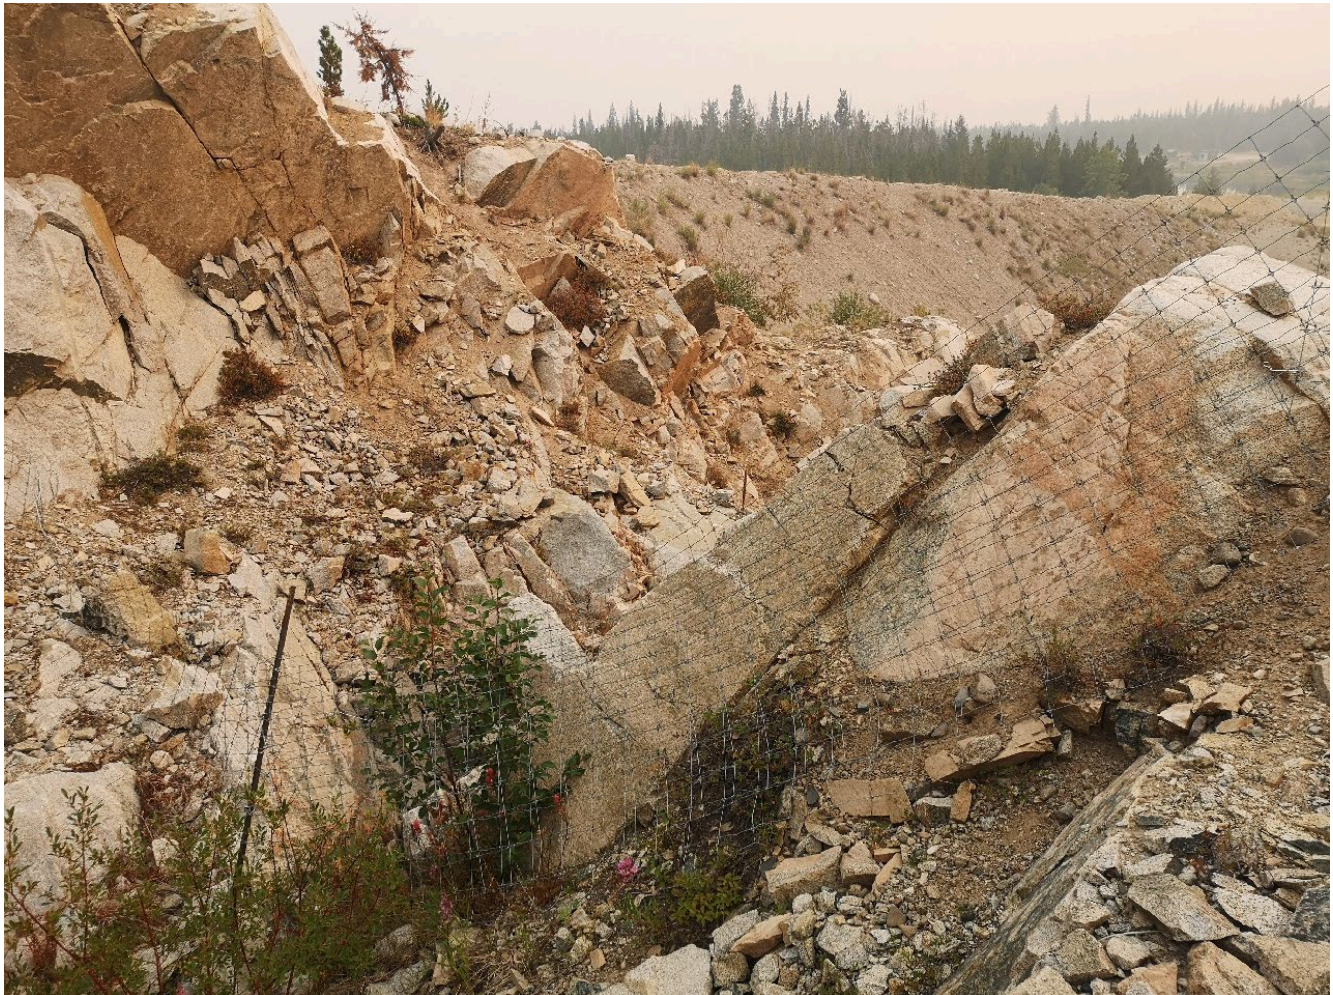
**Photo I-A-26 Highmont Spillway channel upstream of spillway drop (HGH-2021-15)**

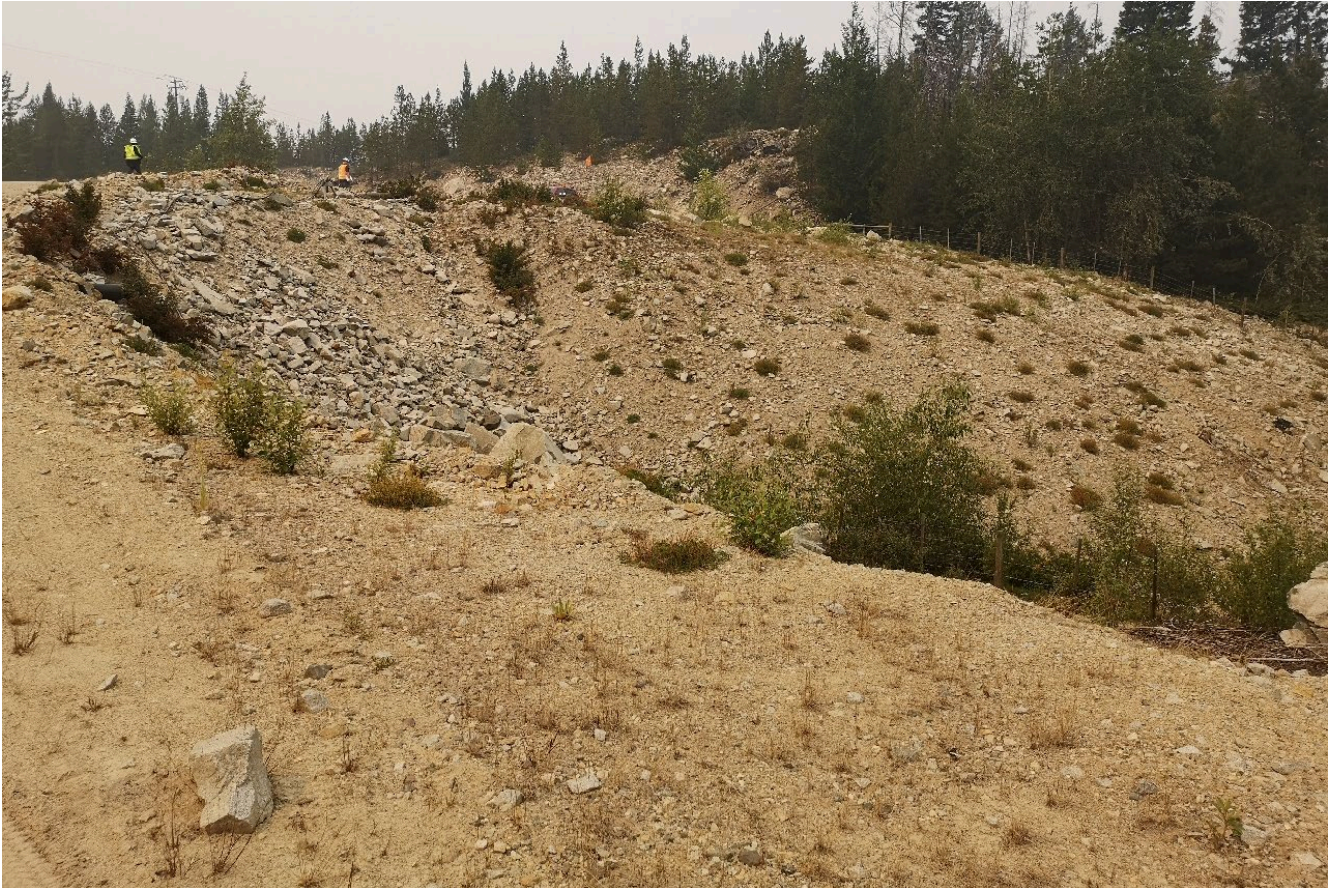
**Photo I-B-2 S1 Pond: S1 Pond dam downstream slope (HGH-2021-19).**

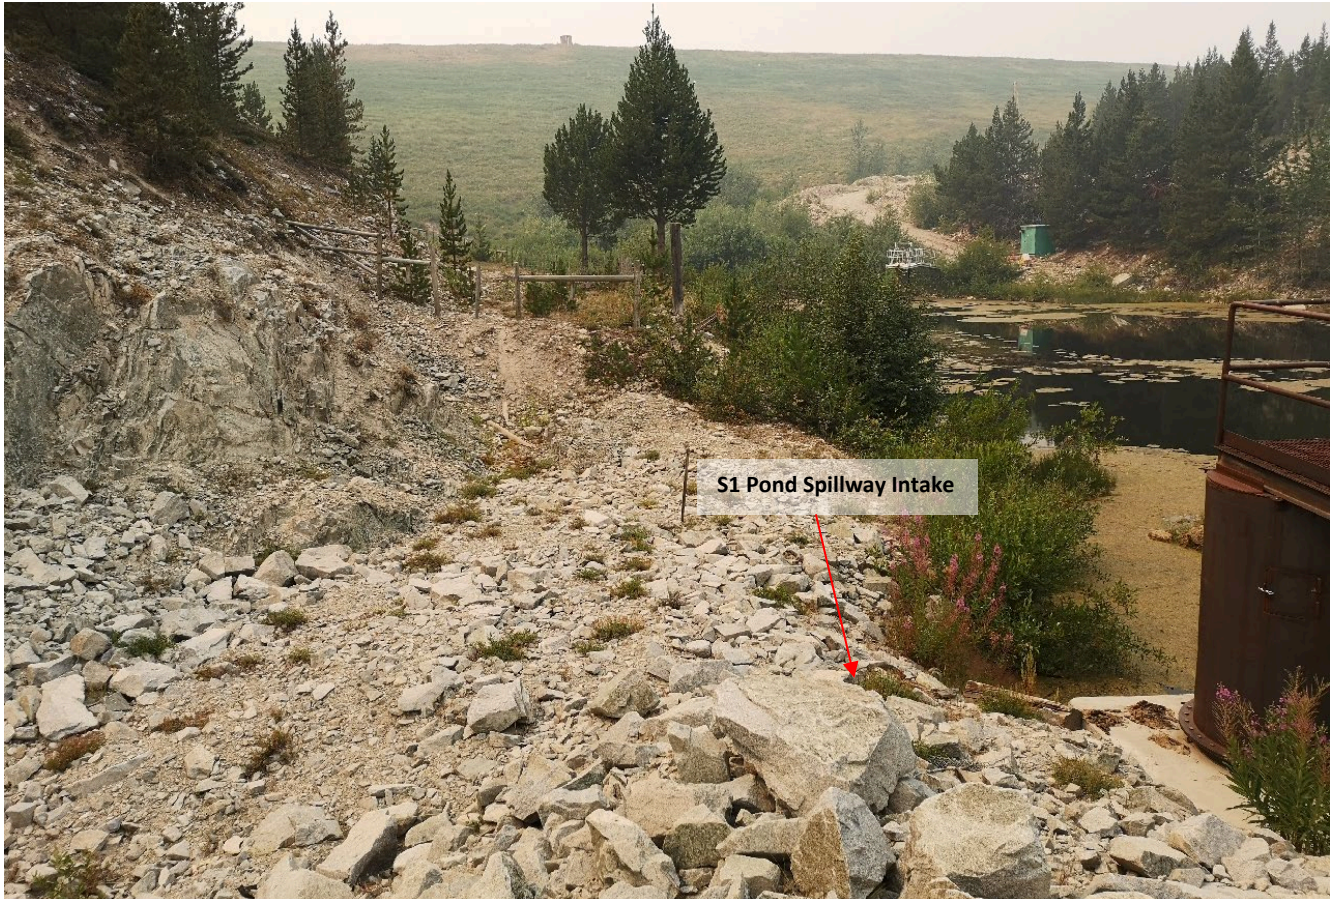
**Photo I-B-3 S1 Pond: View of S1 Pond, spillway intake, and Low-Level Outlet (LLO) (HGH-2021-18).**

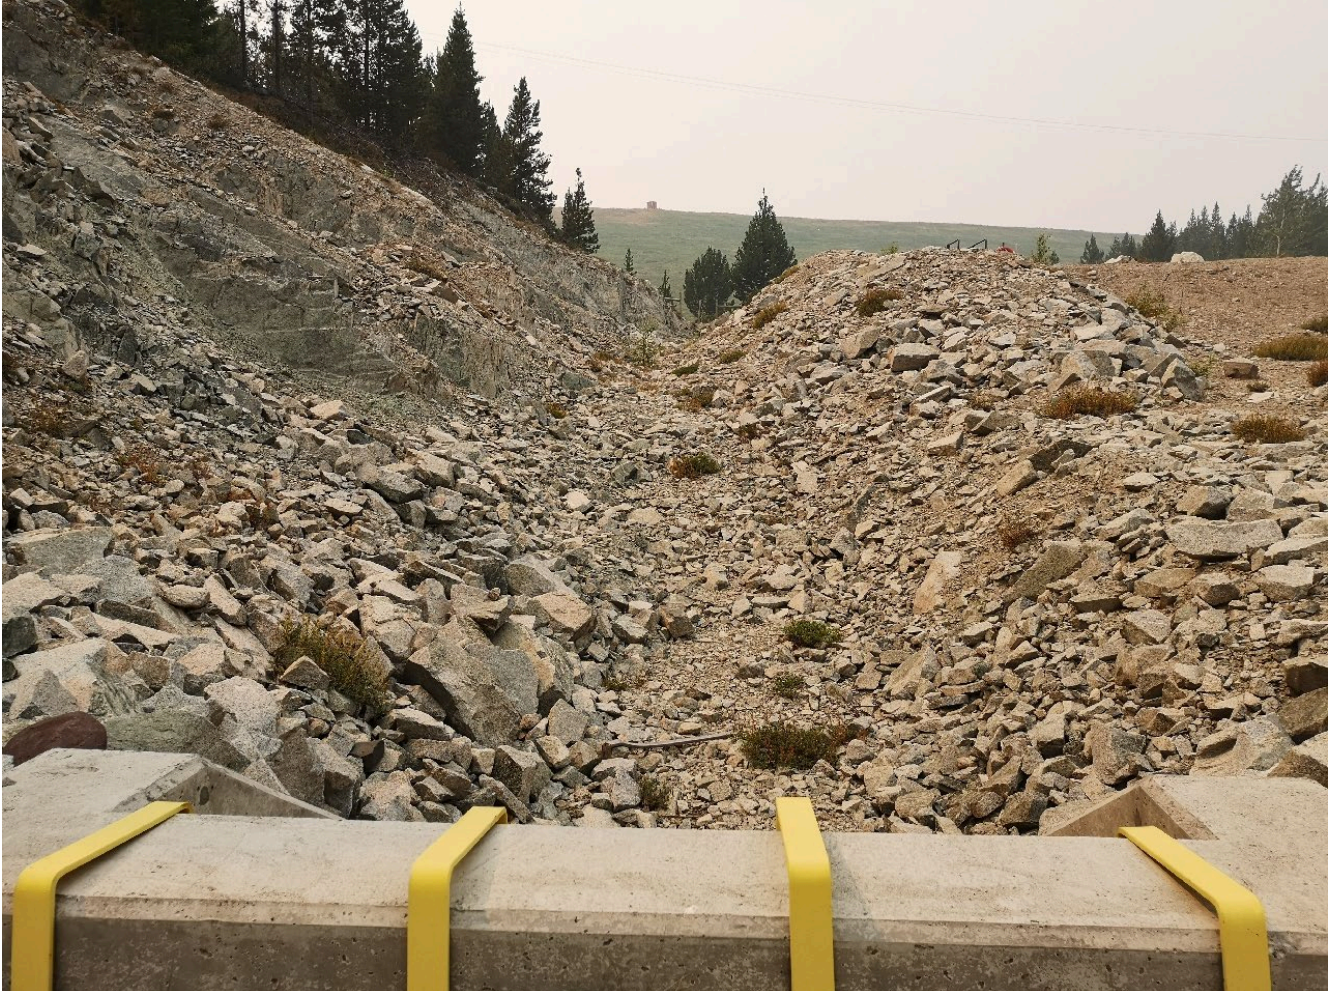
**Photo I-B-6 S1 Pond: Spillway channel upstream of pipe intake, looking toward the pond (HGH-2021-20).**

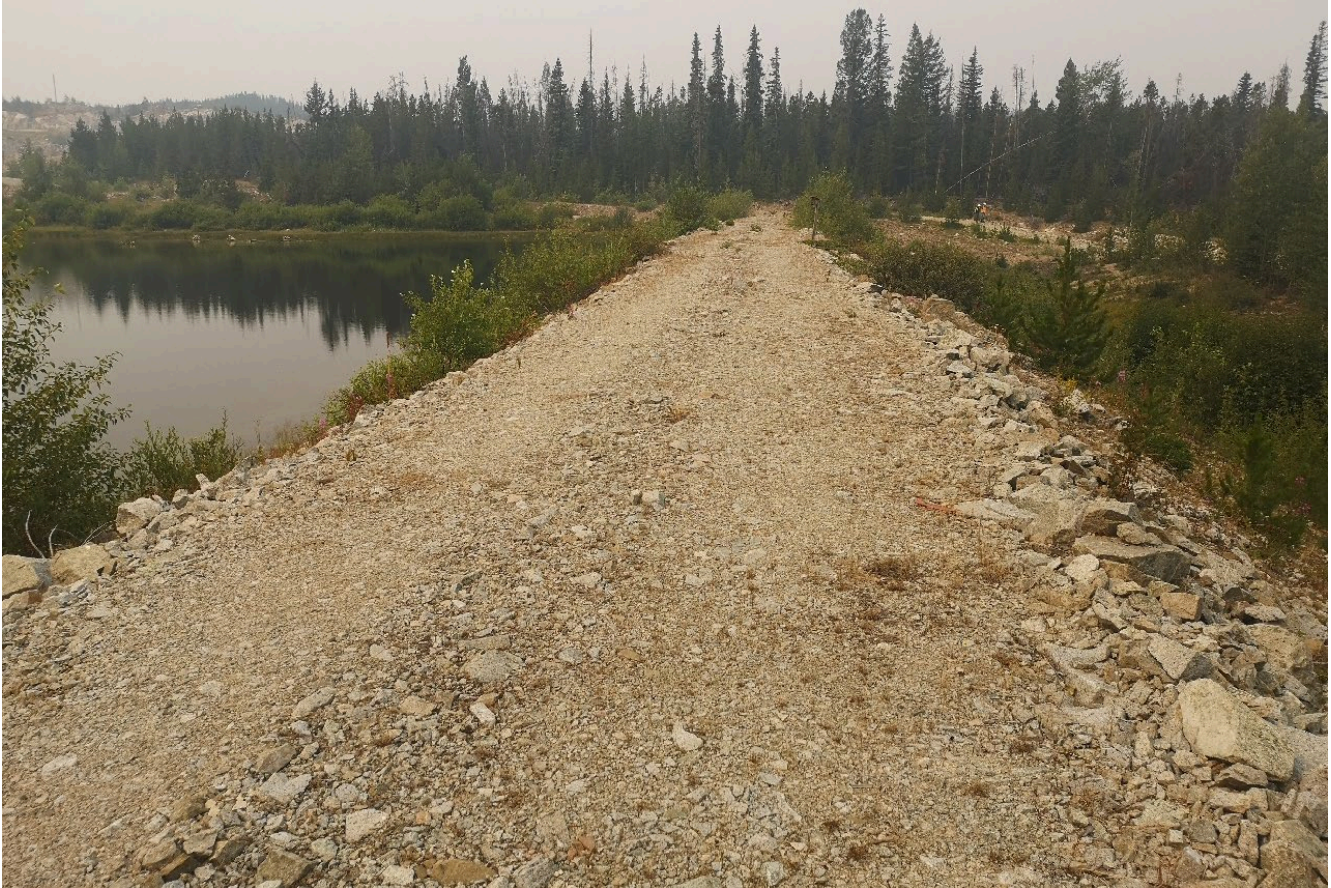
**Photo I-B-7 S2 Pond: View of S2 Pond embankment crest, looking toward left abutment (HGH-2021-21).**

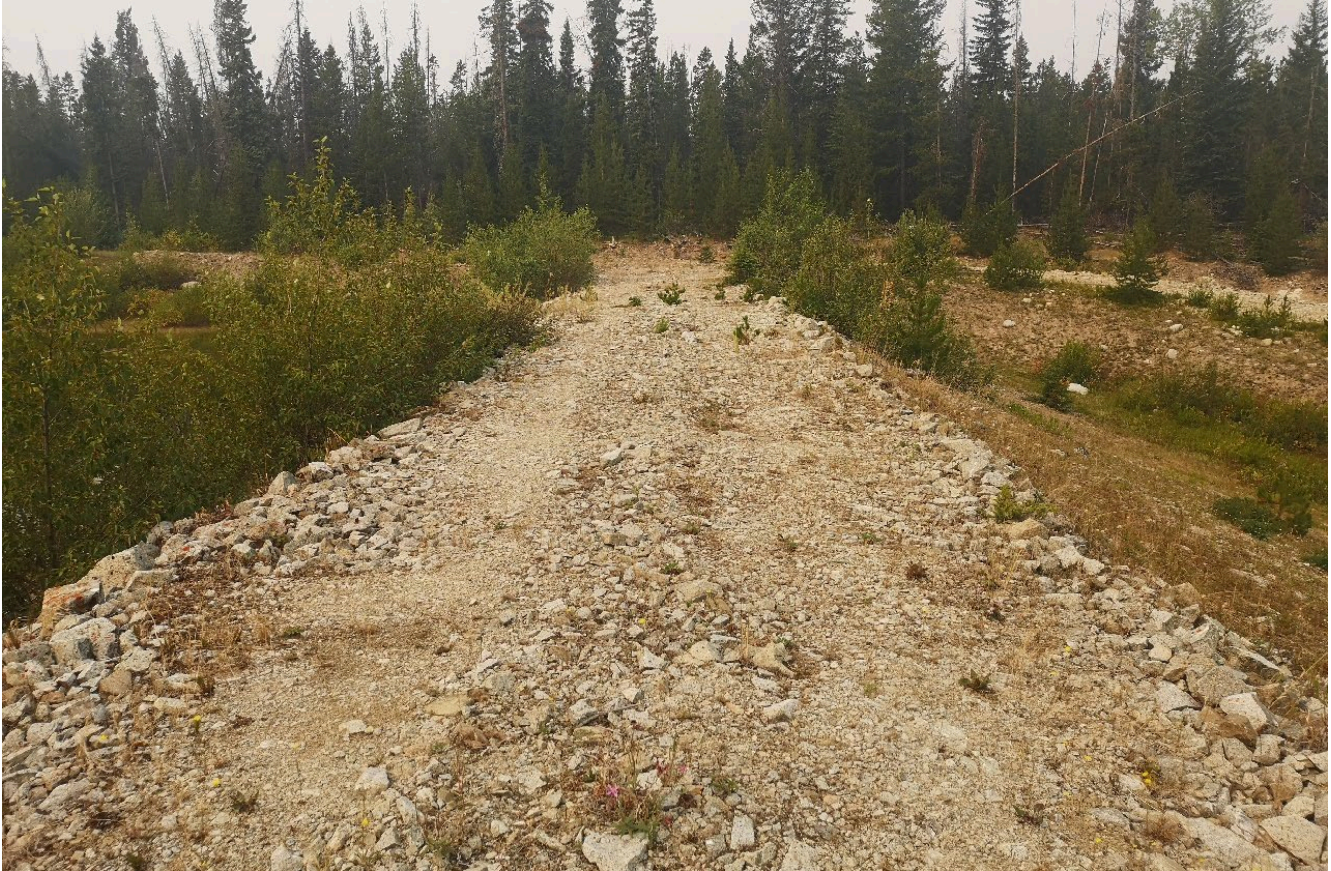
**Photo I-B-8 S2 Pond: View of S2 Pond embankment crest, view from mid dam towards left abutment (HGH-2021-22).**

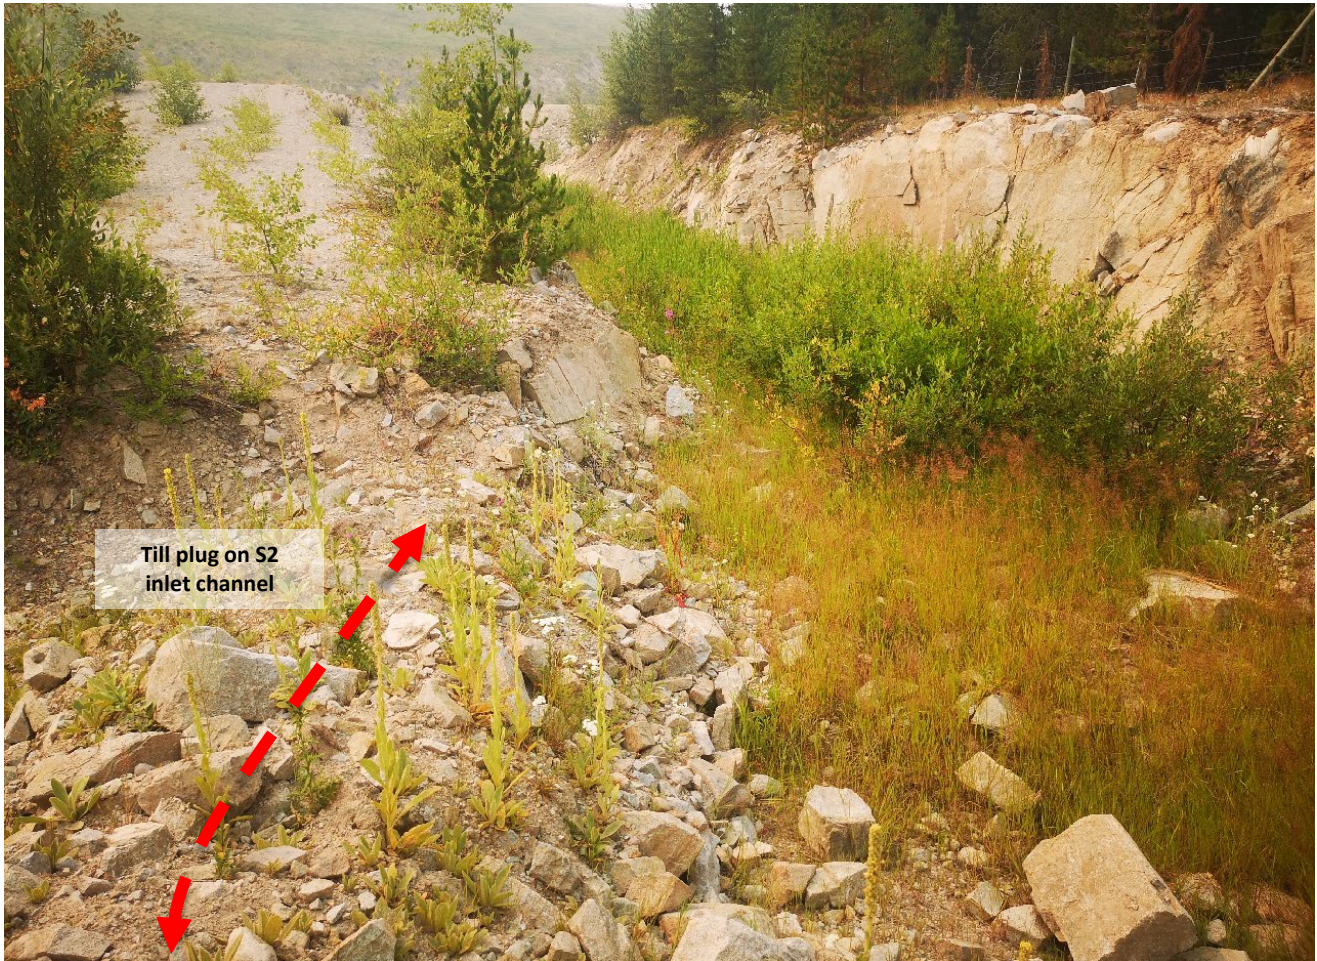
**Photo I-B-13 S2 Pond: Till plug (~1.2 m high and ~ 1m wide) is placed in S2 inlet channel. Highmont TSF Spillway diversion channel is heavily vegetated; needs to be cleared as part of routine maintenance (HGH-2021-24).**

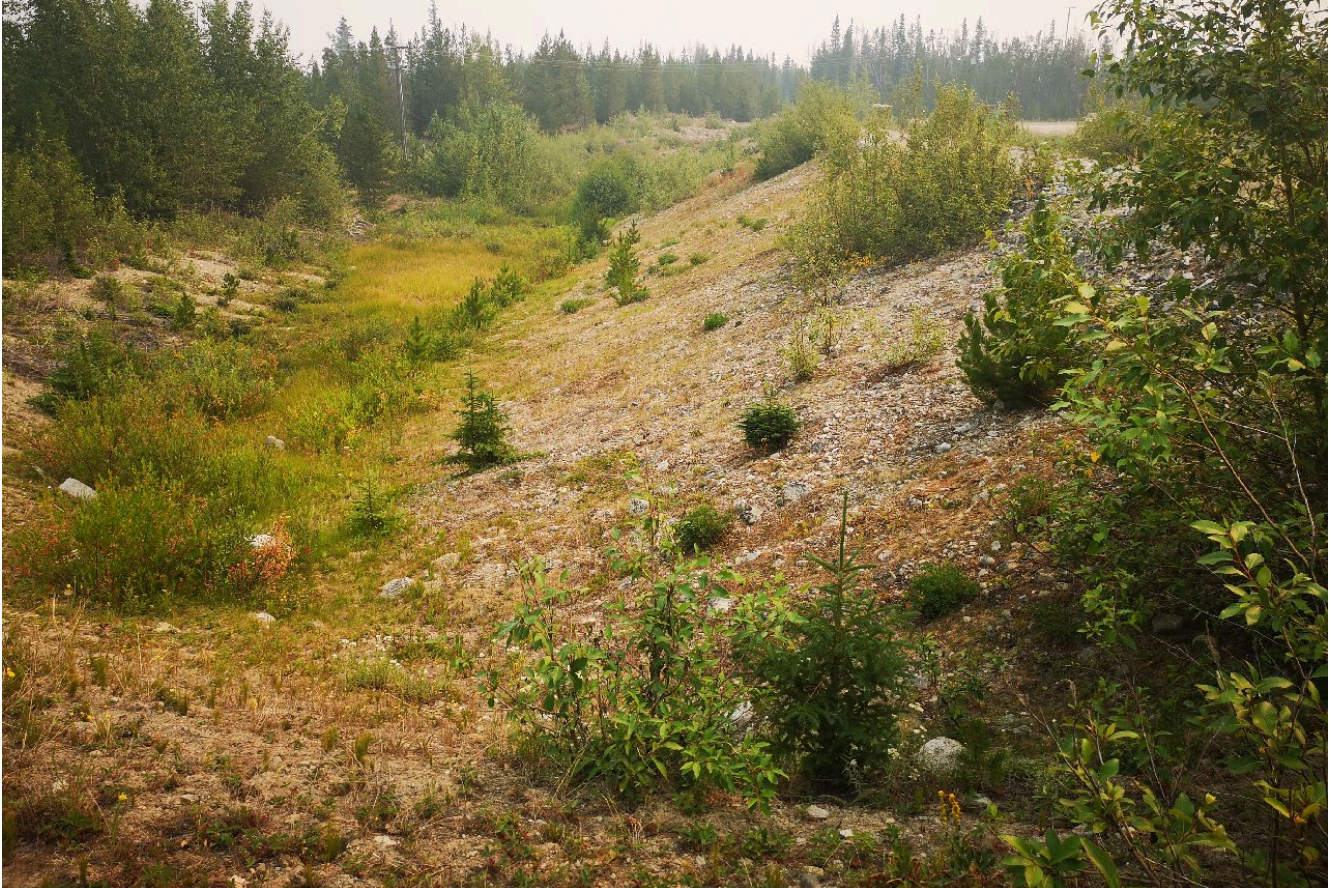
**Photo I-B-16 S2 Pond: Vegetation and signs of recent ponded water at downstream toe (HGH-2021-26).**

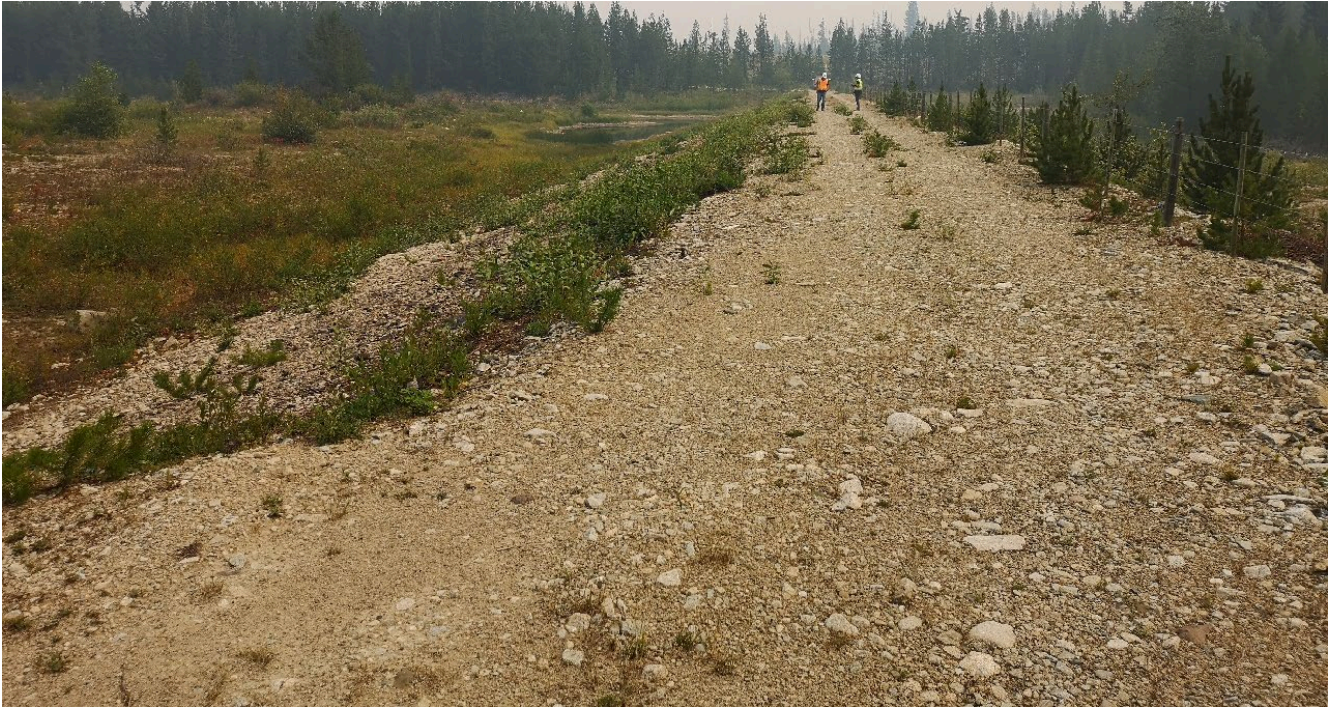
**Photo I-B-17 S3 Pond: Overview of dam crest from right abutment (HGH-2021-27).**

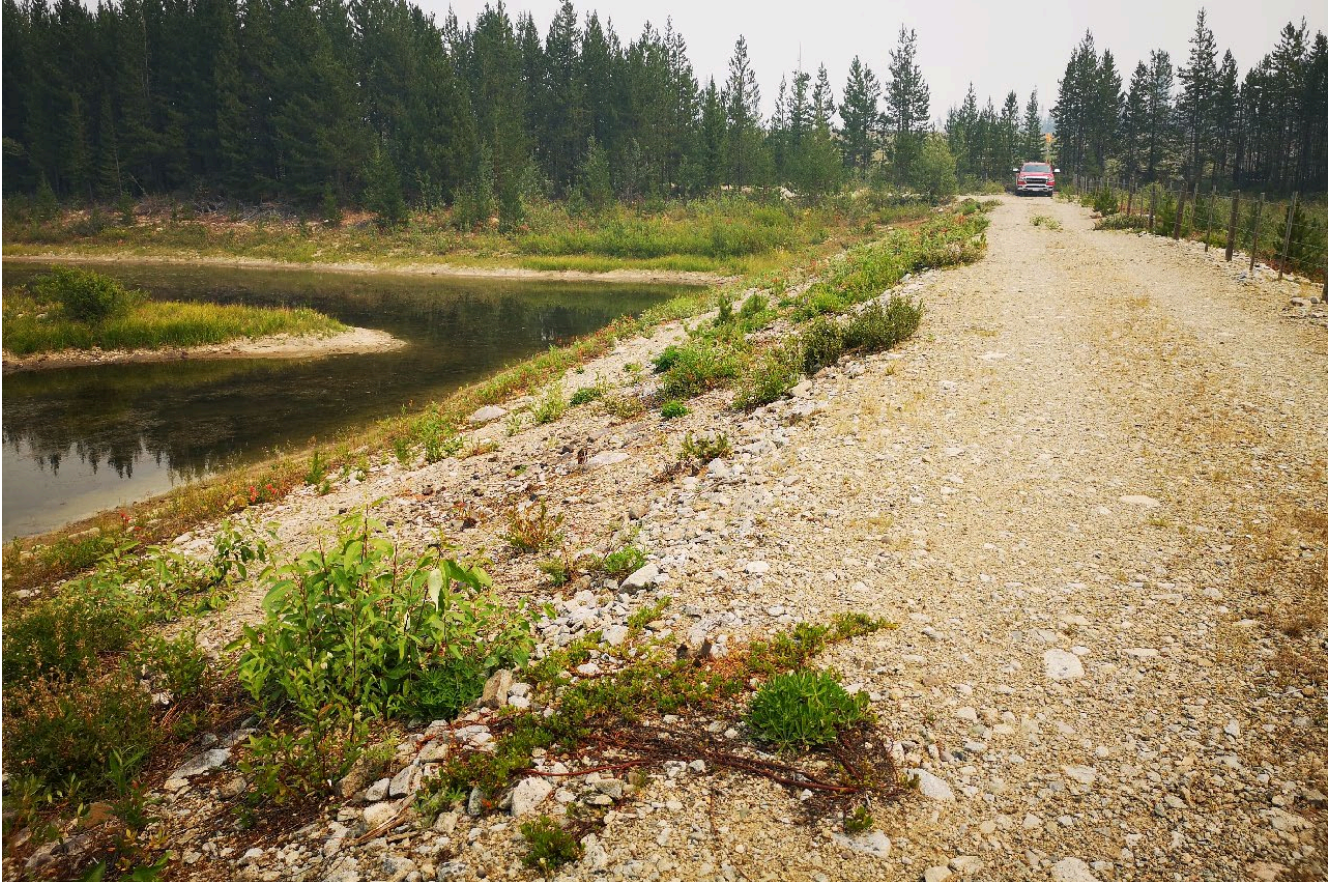
**Photo I-B-18 S3 Pond: Overview of dam crest from mid dam, looking toward left abutment (HGH-2021-28).**

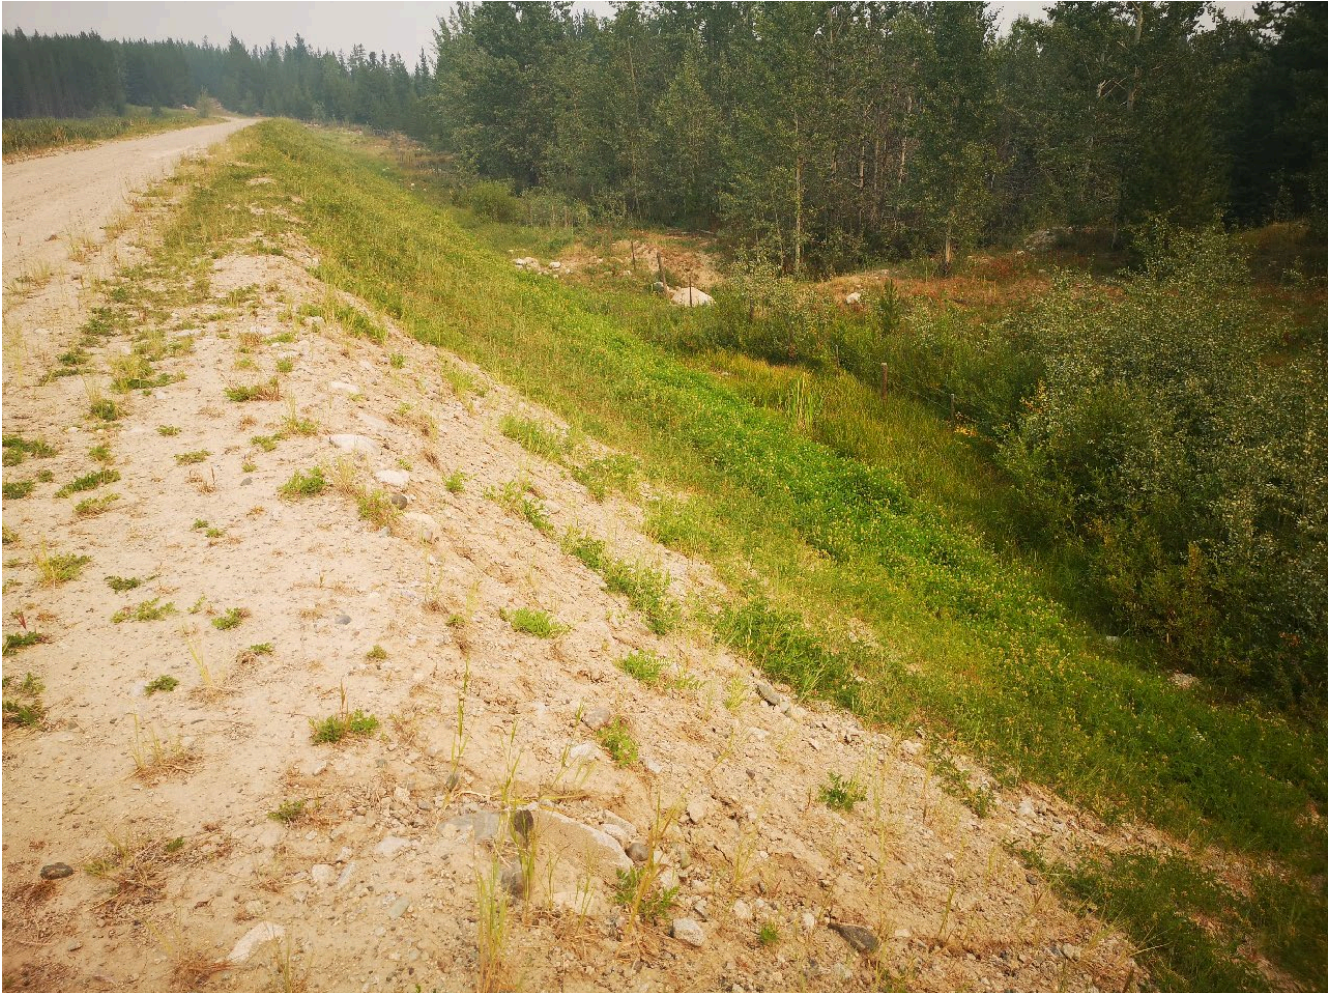
**Photo I-B-29 S5 Pond: S5 Pond north outlet pipe, permanently sealed. Metal plates placed at intake and pipes filled with till in 2015 (HGH-2021-32 and HGH-2021-33).**

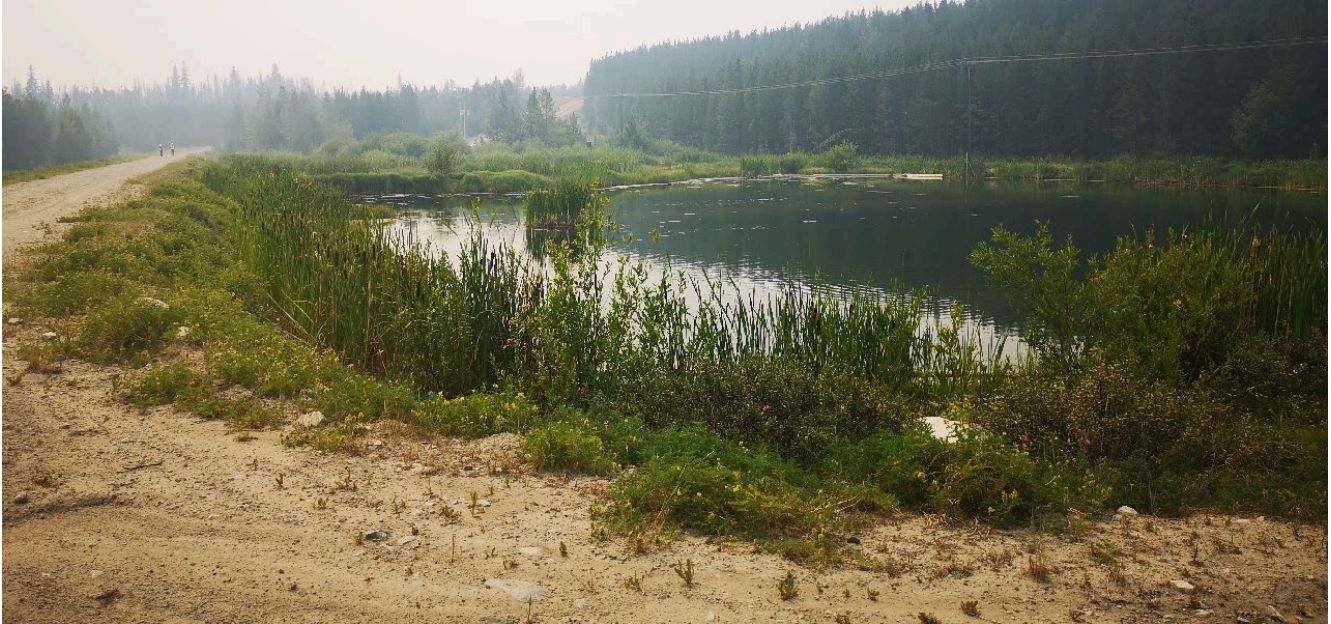
**Photo I-B-30 S5 Pond: Overview of Pumping Sub-cell (HGH-2021-34).**

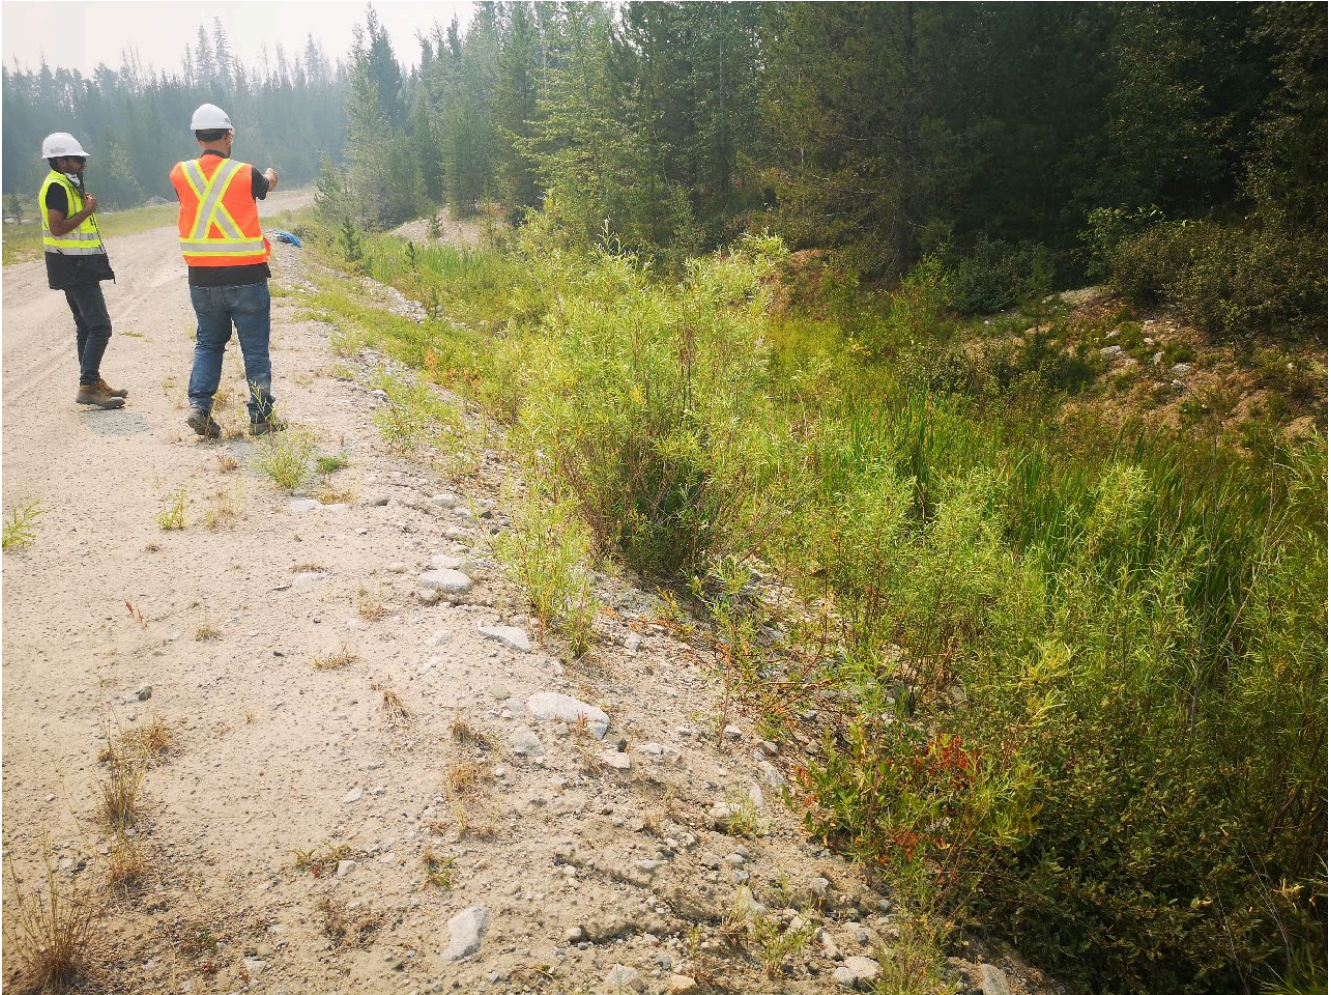
**Photo I-B-33 S5 Pond: Pumping Sub-cell Outlet #2 (South). Metal plates placed at intake and pipes filled with till in 2015 (HGH-2021-35).**

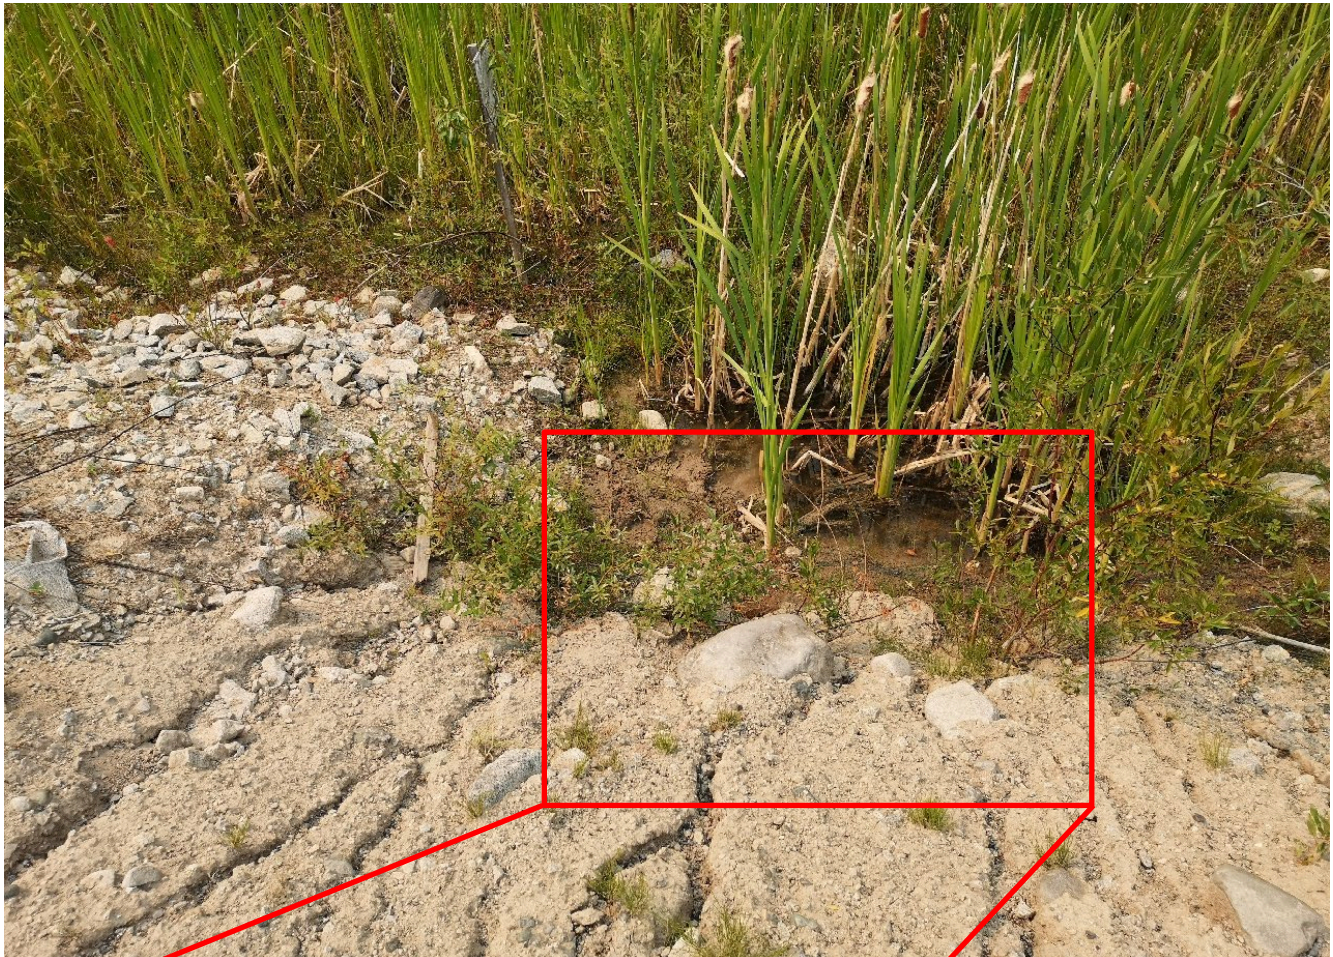
**Photo I-B-36 S5 Pond: Overview of downstream slope and S5 Overflow outlet pipes daylighting at toe, looking east (HGH-2021-36).**

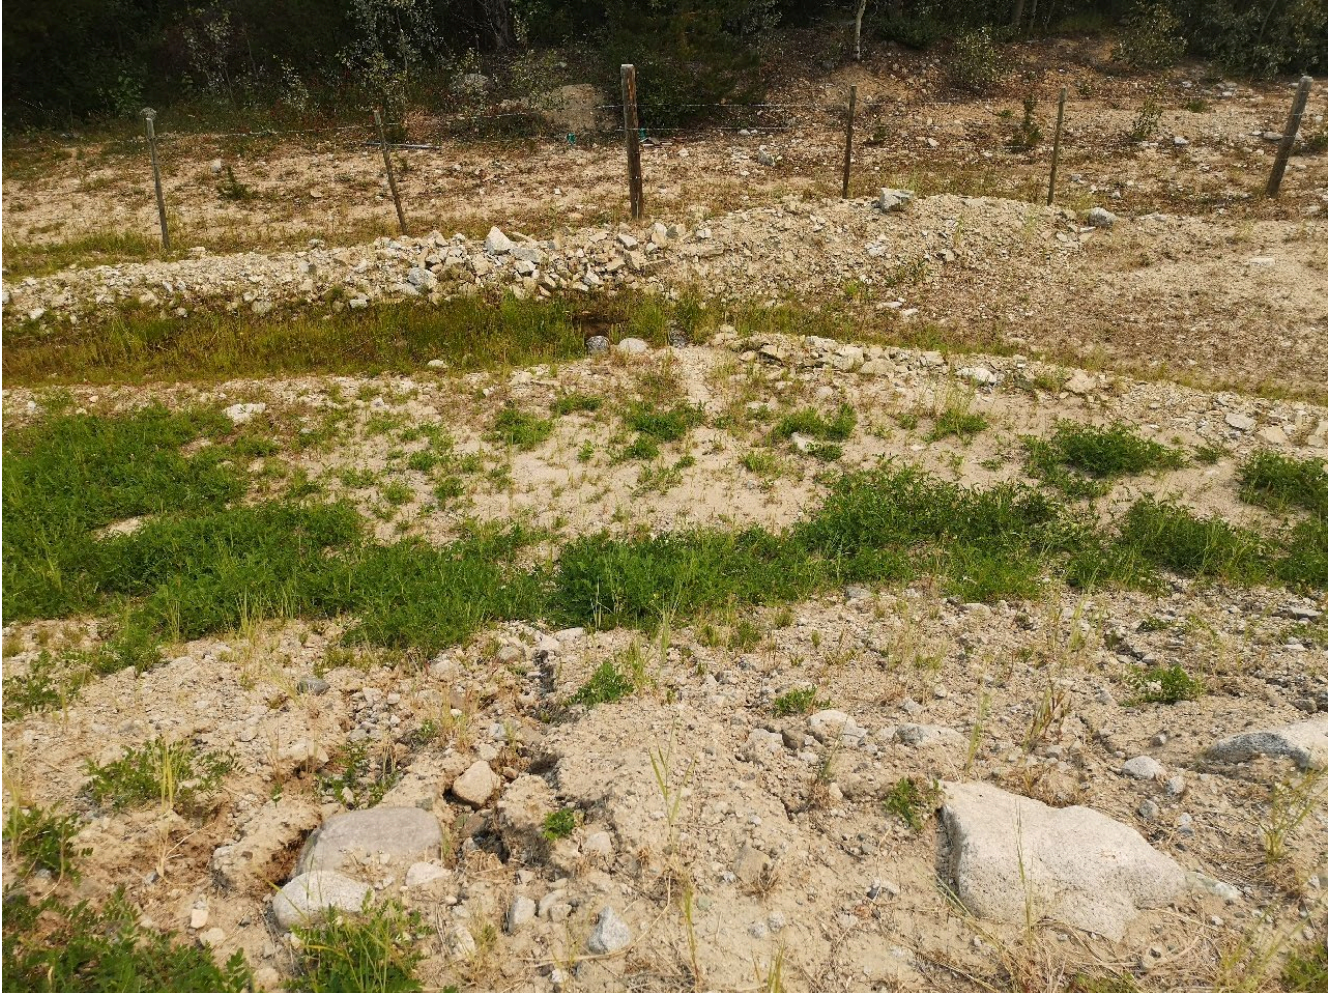
- **Seepage:** Change of vegetation on the downstream toe of the perimeter crest suggests there has been temporary ponding at the toe, likely due to the run-off (Photo I-B-37). No seepage was observed.

**Photo I-B-37 S5 Pond: Downstream toe of perimeter crest. Change of vegetation suggests there has been temporary ponding at the toe likely due to the run-off; no signs of seepage (HGH-2021-31).**
