# **Teck Highland Valley Copper Partnership**

## **2021 Annual Facility Performance Report**

*Highmont Tailings Storage Facility*

March 2022

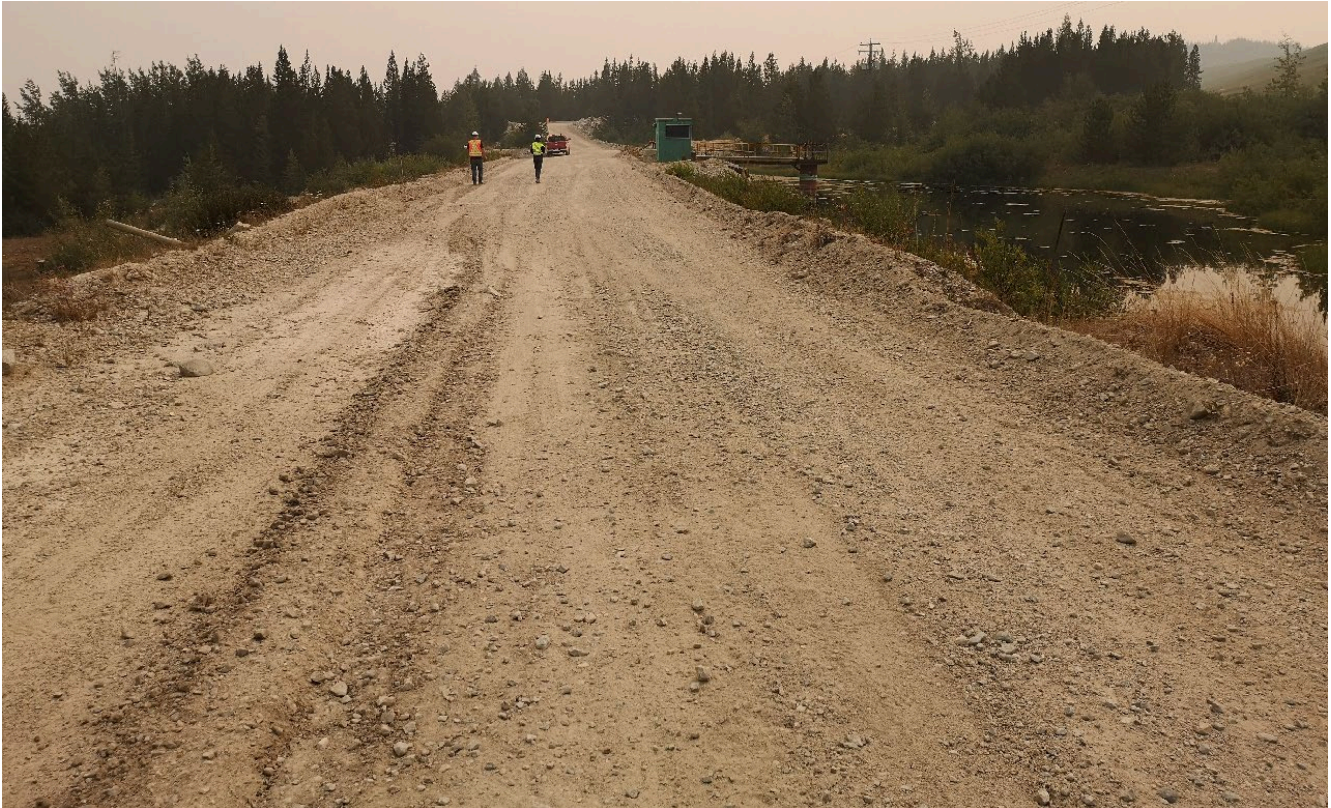
**Photo I-B-39 S8 Pond: View of downstream slope (HGH-2021-39).**

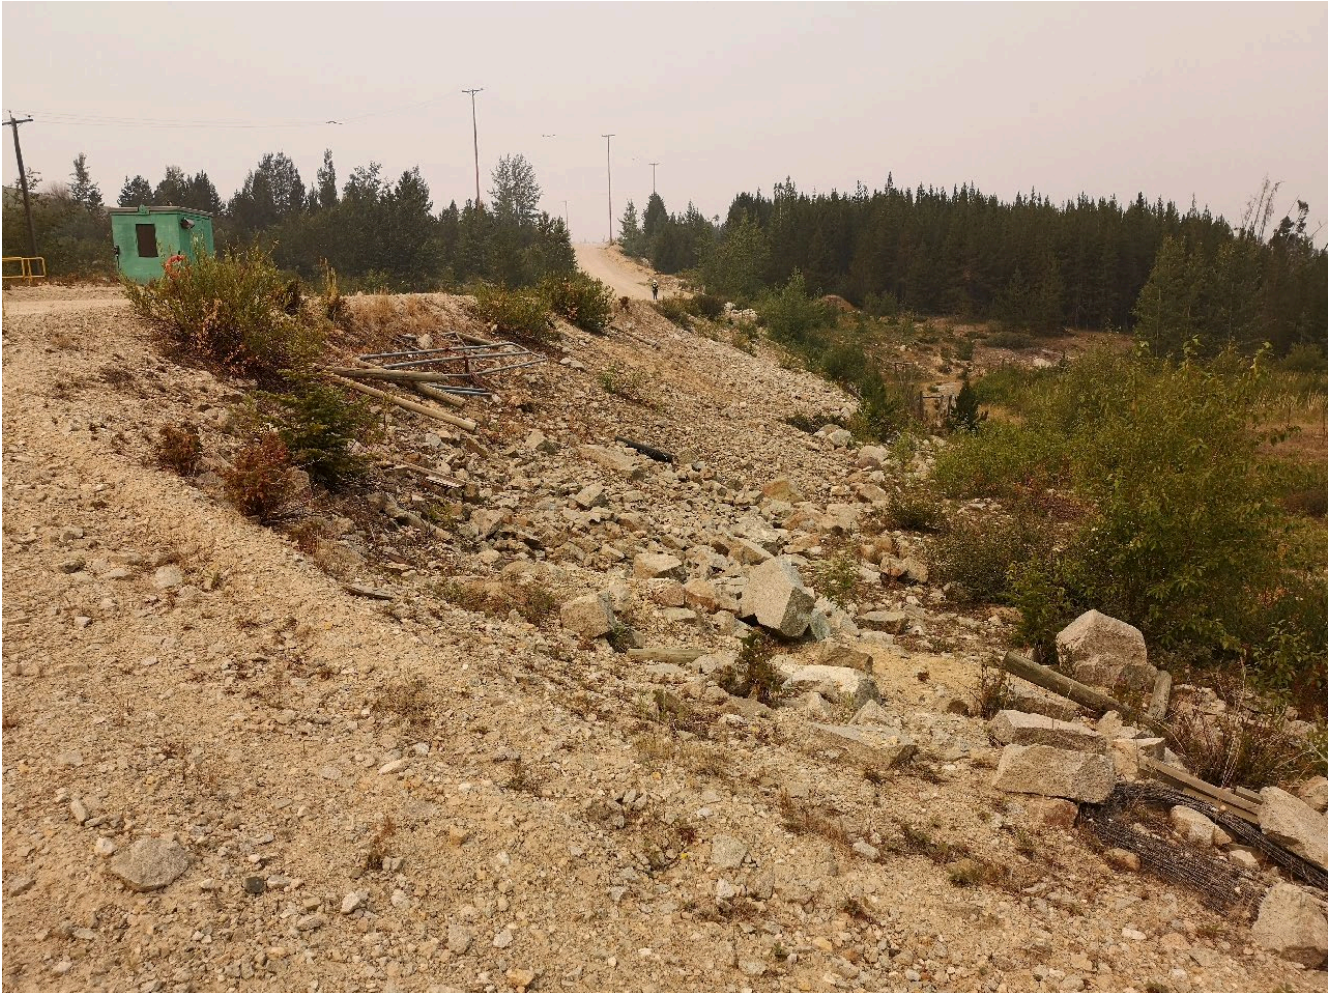
**Photo I-B-40 S8 Pond: View of S8 Pond impoundment. Highmont North Dam downstream slope is visible on right hand side of picture (HGH-2021-38).**

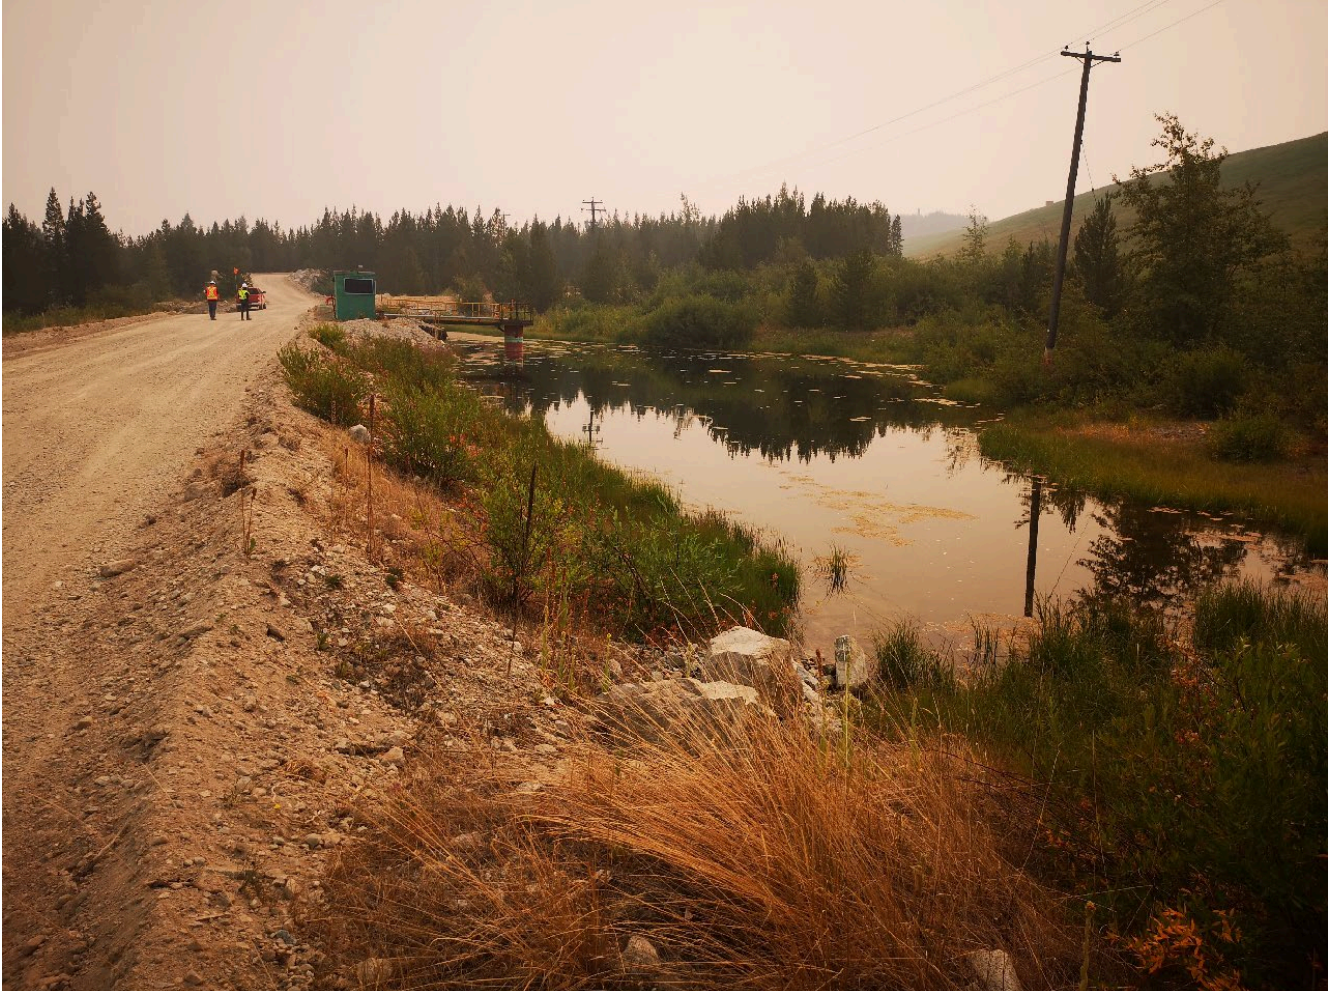
**Photo I-B-41 S8 Pond: View of impoundment, catwalk and outlet pump to S1 Pond (HGH-2021-40 and HGH-2021-41).**

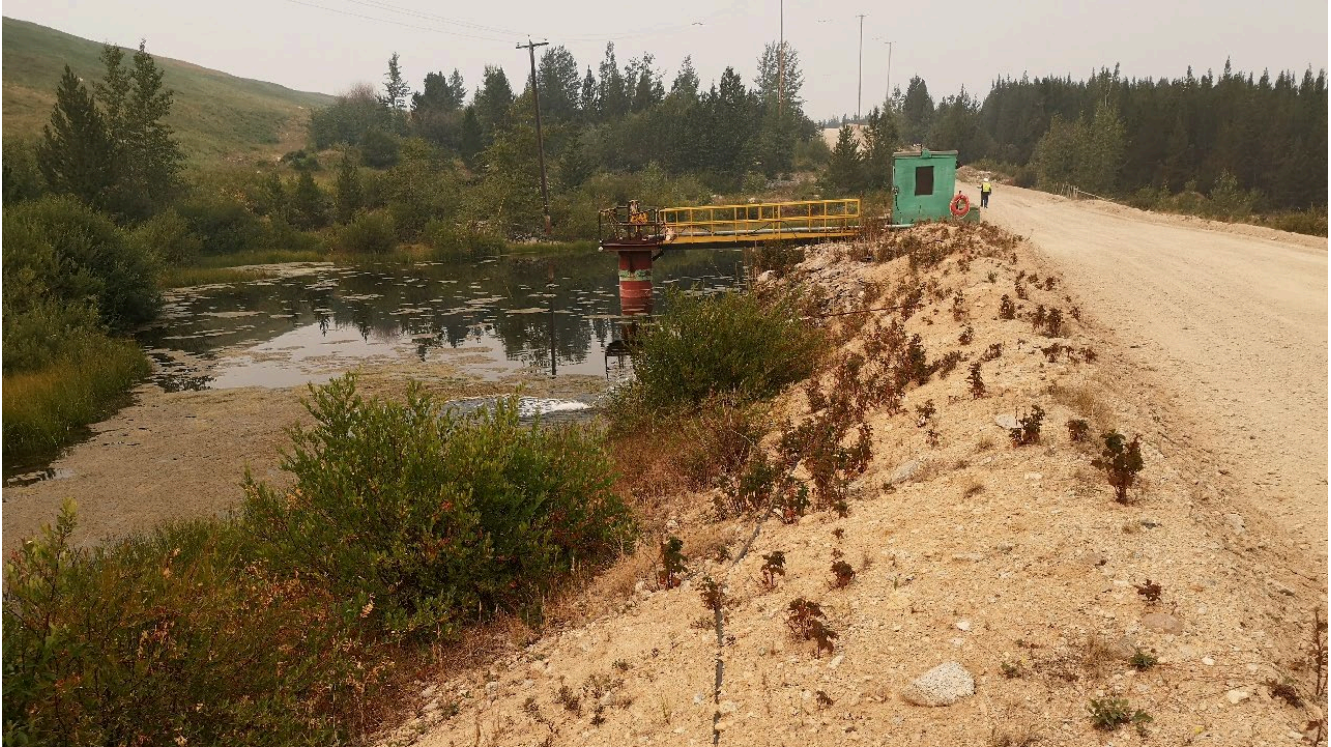
- **Crest:** Good physical condition. No signs of significant erosion, deterioration, displacement, or cracking (Photo I-B-38).
- **Left and Right Abutment:** Good physical condition. No signs of significant erosion, deterioration, displacement, or cracking.
- **Downstream Slope:** Good physical condition. Moderate vegetation throughout slope and large wood debris present. No observed signs of erosion, deterioration, or adverse displacement. (Photo I-B-39).
- **Pond:** At the time of the site visit the pond appeared lower in elevation when compared to the 2020 site visit. Less than 2 m below the crest of the dam (Photo I-B-40 and Photo I-B-41).
- **Spillway:** The outlet pipe was clear of debris (Photo I-B-42).
- **Seepage:** None observed.

**Photo I-B-42 S8 Pond: Overview of overflow pipe trash rack. Rack is clear of debris. Current water level is below the invert (HGH-2021-40).**
