# 2022 Annual Facility Performance Report—Coal Reject Spoils

*Teck Coal Limited, Fording River Operations*

Reference No. 22516328-2022-123-R-Rev0-1800

29 March 2023

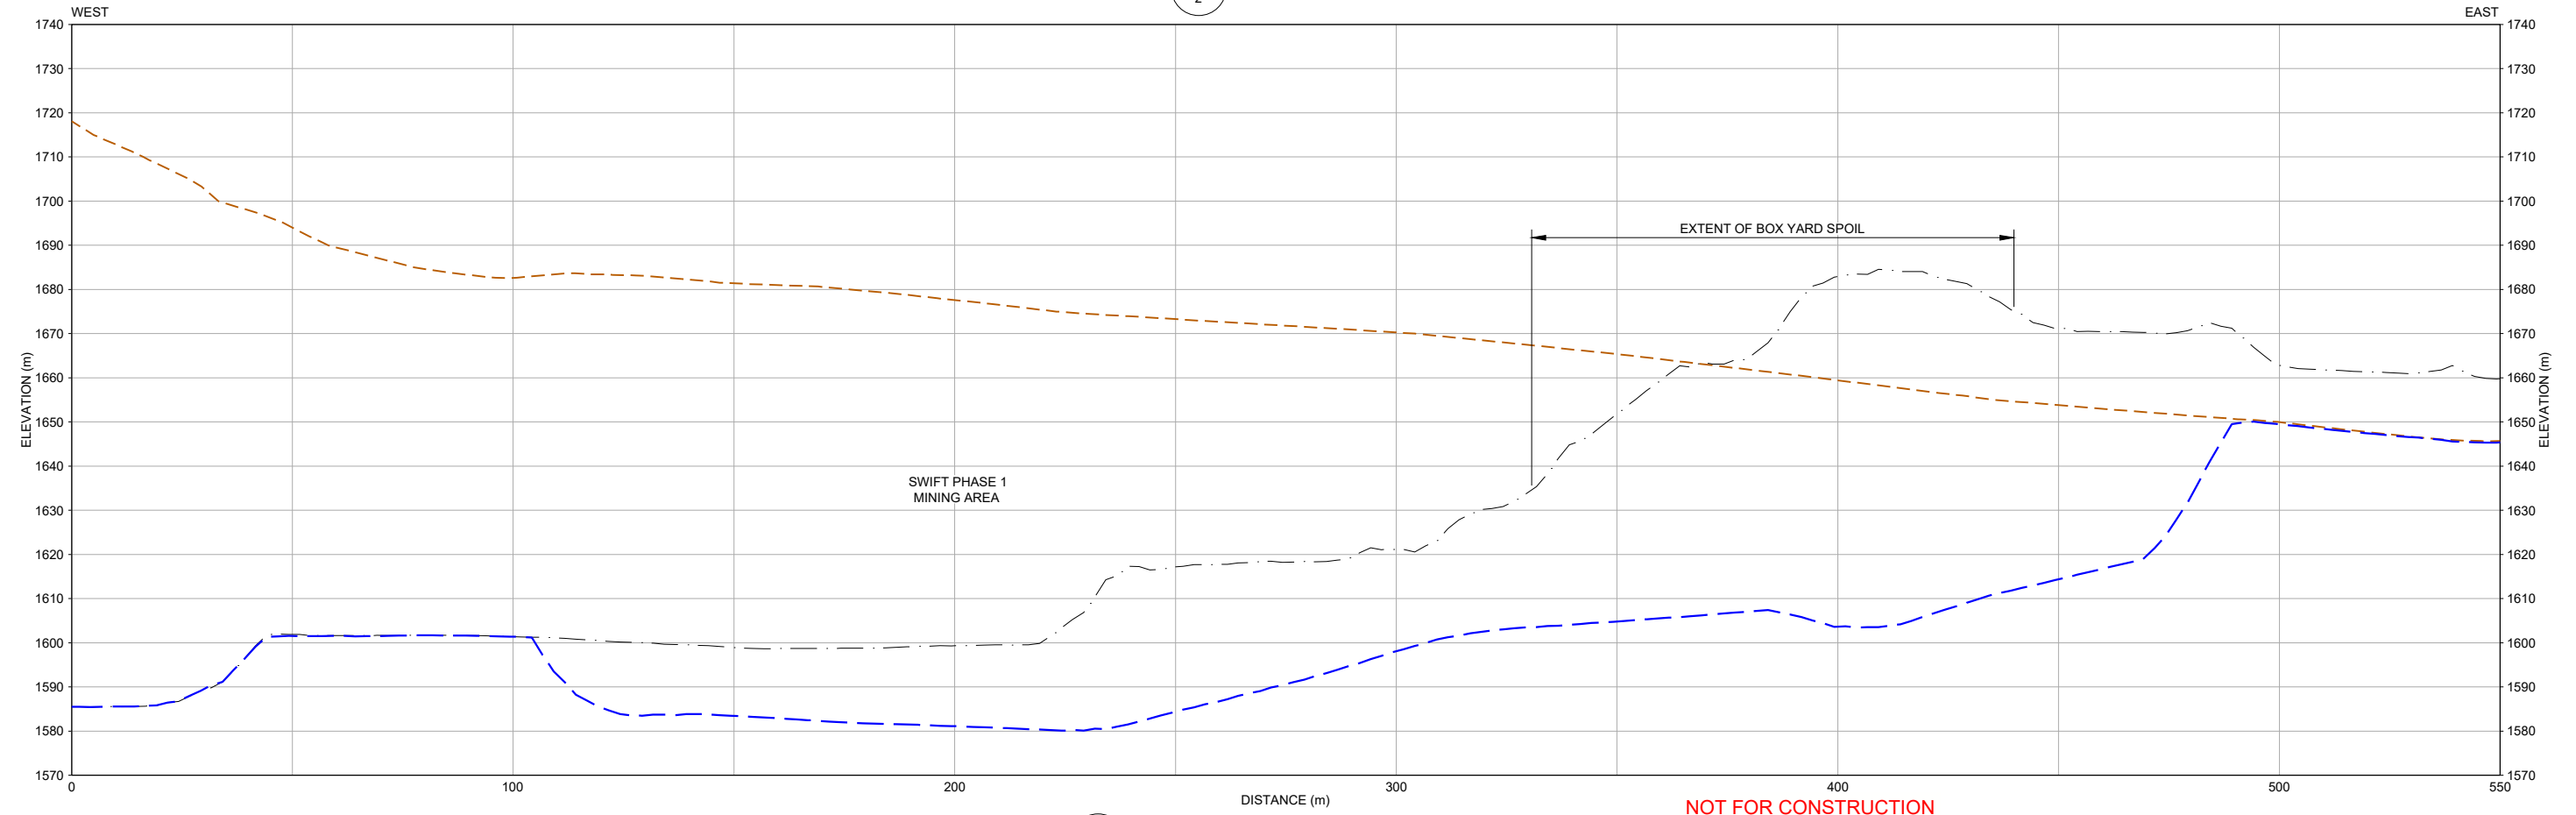
SCALE 1:1,500 m **B** EXTENT OF BOX YARD SPOIL CROSS-SECTION

The remainder of the Box Yard spoil is within the pit wall of the Swift Pit. Sections of the facility are oversteepened from excavation efforts (approximately 0.75H:1V; recommended action 2021-11), with overall slope angles generally 37°.

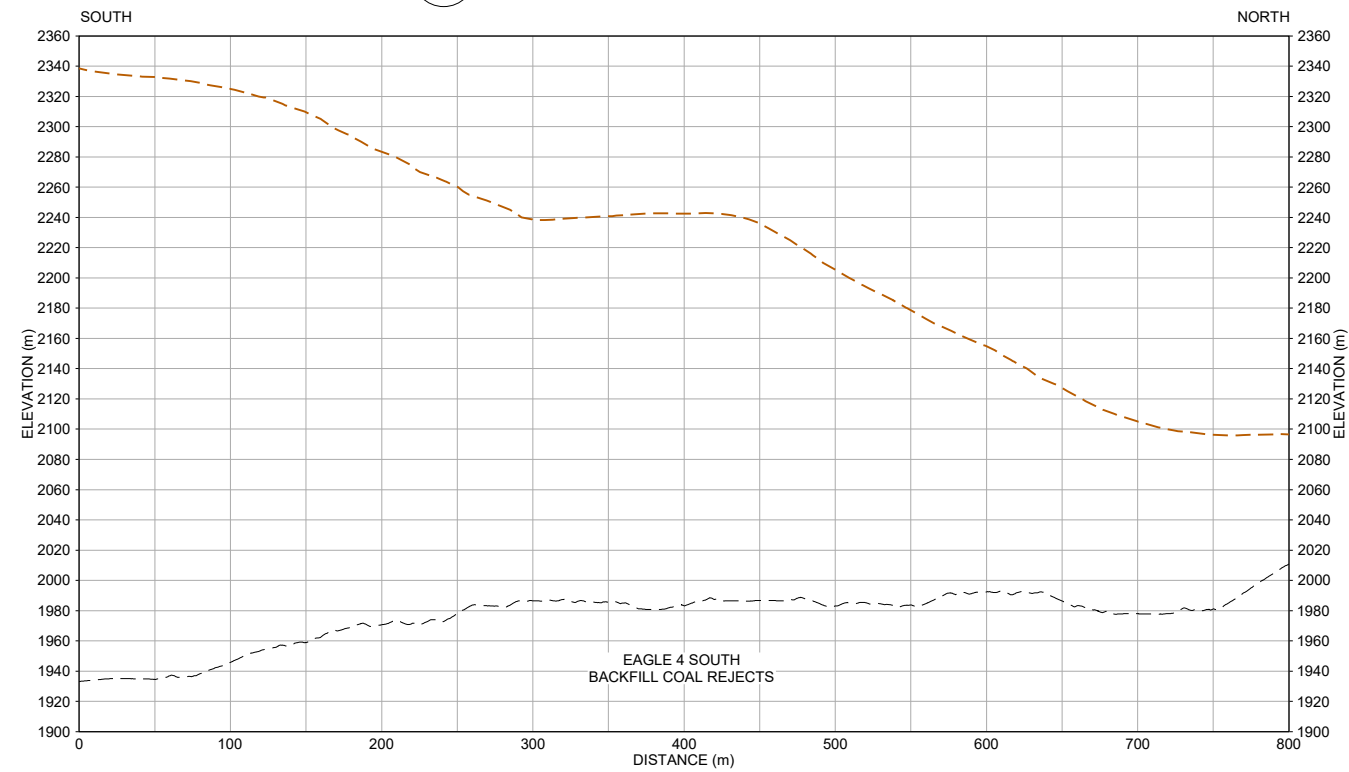
SCALE 1:5,000 m **H** EAGLE 4 SOUTH BACKFILL SPOIL CROSS-SECTION  
3

- Eagle 4 South Backfill—Excavation at the east toe was observed at the time of the site with the excavated slope (up to approximately 10 m high) left in an oversteepened state. This presented an immediate danger to equipment and personnel working in the area (HSRC Section 6.20.2(2)). Following identification, work was halted, and an initial berm placed to block access to the excavation. Teck also identified an alternate source of borrow material and placed an additional berm adjacent to the access road to block access as well as added signage to restrict access. Corrective action to re-slope the excavated toe area is required prior to resumption of operations in this area.

2022-04	Eagle 4 South Backfill	Unauthorized excavation at toe	Unsupported toe could result in local failure, risk to personnel working in the area	Remediation of slope is required prior to the removal of the exclusion zone and commencement of operations in the area.	2	Q2 2023	<b>New Recommendation</b>

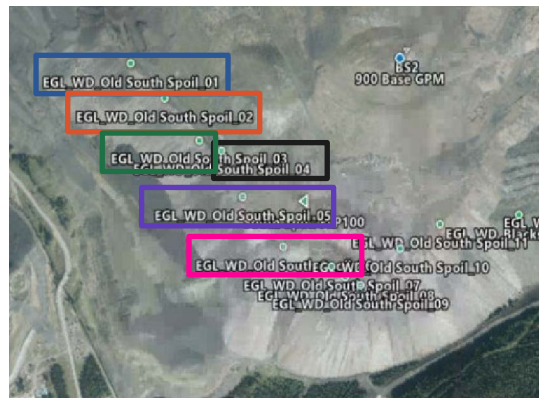
TITLE GPS MONITORING DATA OLD SOUTH SPOIL ABOVE KILMARNOCK / TOE BERM SPOIL	
YYYY-MM-DD	2023-01-23	PROJECT No.	22516328
PREPARED	P. Amini-Mottagh	Phase/Task/Doc.	1000/1800/2022-123
DESIGN	P. Amini-Mottagh	Rev.	0
REVIEW	N. Carrière	SHEET	C-3
APPROVED	J. Steele

Note: EGL\_WD\_Old South Spoil\_01 delta elevation was not properly zeroed initially but was corrected 1 September 2022.
