**2022 Annual Facility Performance Report for
South Tailings Pond and North Tailings Pond**
Teck Coal Limited, Fording River Operations

WSP Canada Inc.

Reference No. 22516328-2022-118-R-Rev0-1300

23 March 2023

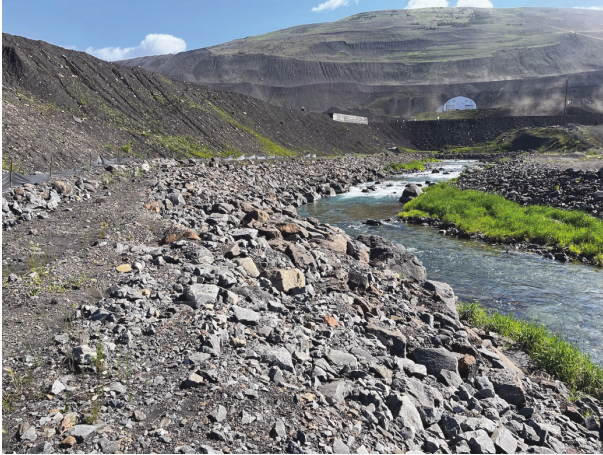
Photo 1: Looking upstream at riprap along the right bank, upstream of the NTP setback riprap.

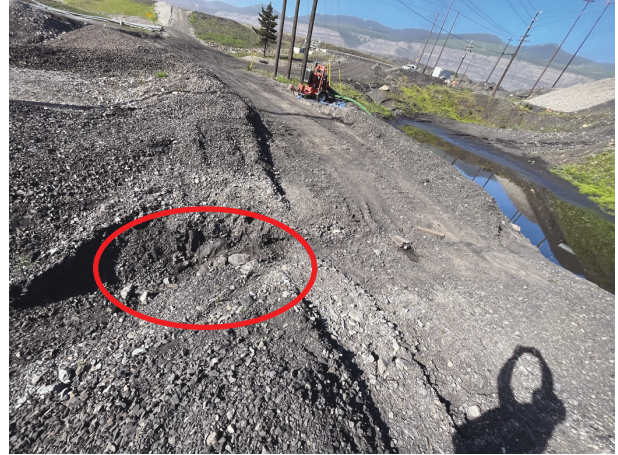
Photo 2: Riprap exposed where NTP Sumps spill from one cell to the next across the setback riprap.

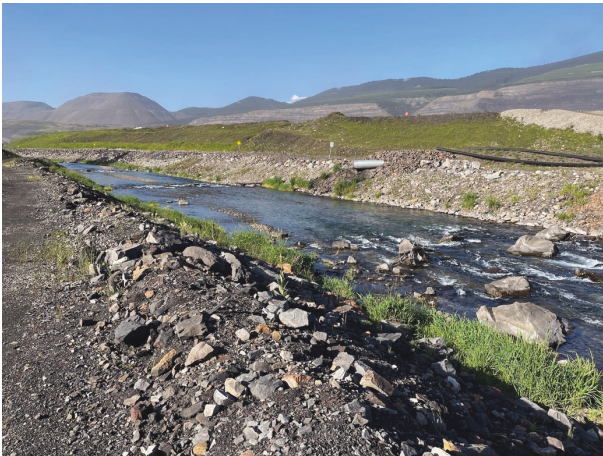
Photo 3: Looking downstream at riprap along right bank (Sta. 0+125)

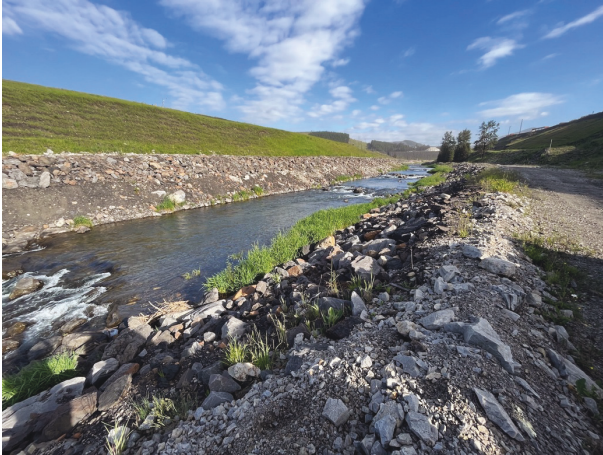
Photo 5: Looking upstream at NTP riprap (from approx. Sta. 0+550)

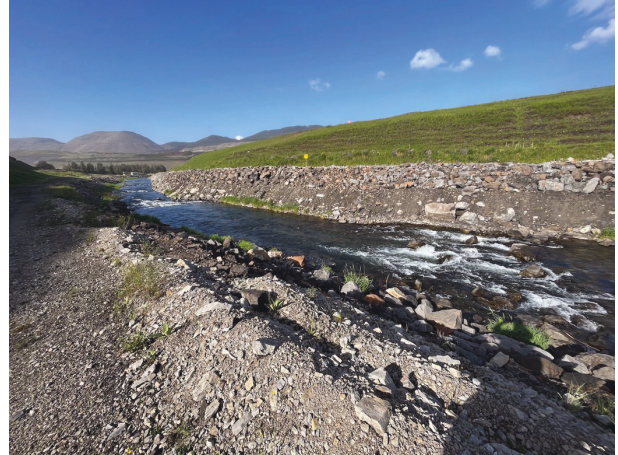
Photo 6: Looking downstream at NTP riprap (from approx. Sta. 0+550)

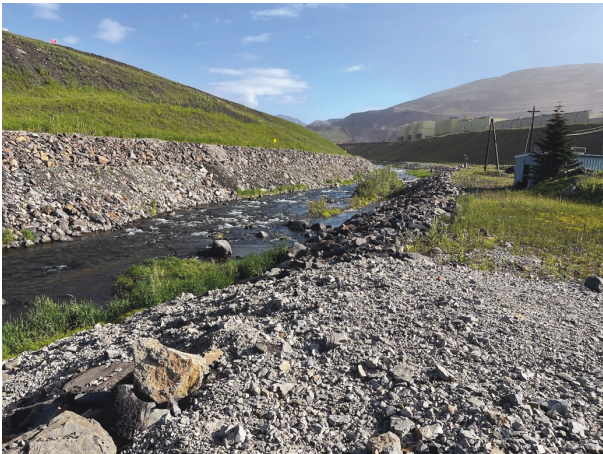
Photo 7: Looking upstream at NTP riprap (from approx. Sta. 0+900)

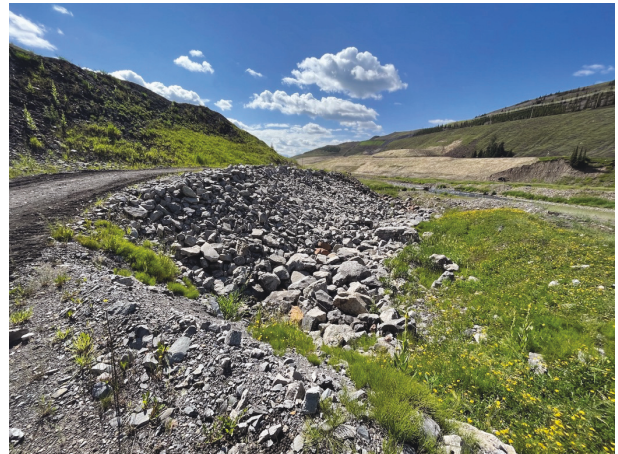
Photo 8: Looking downstream at start of STP riprap (from approx. Sta. 0+250)

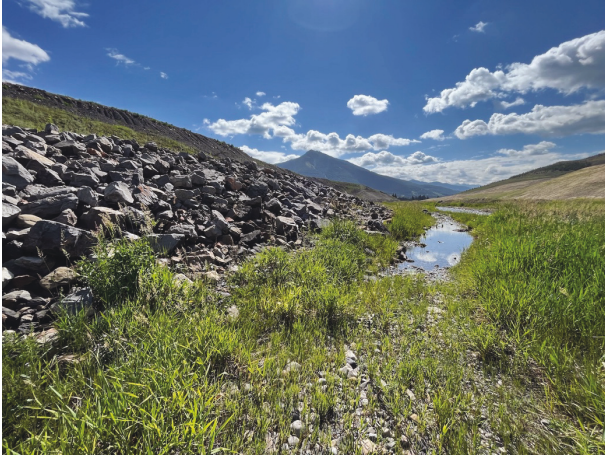
Photo 9: Looking downstream at STP riprap (from approx. Sta. 0+300)

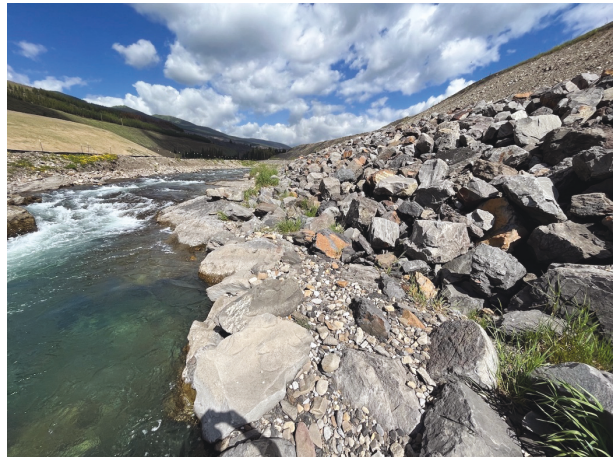
Photo 12: Erosion along the toe apron of the STP riprap at Sta. 0+670 remains the same as 2021

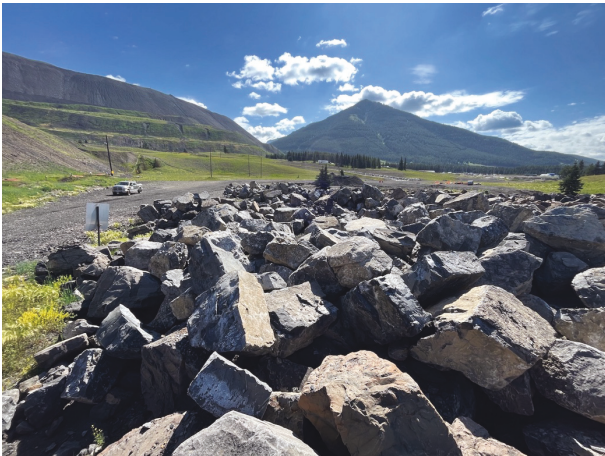
Photo 14: Riprap at emergency riprap stockpile

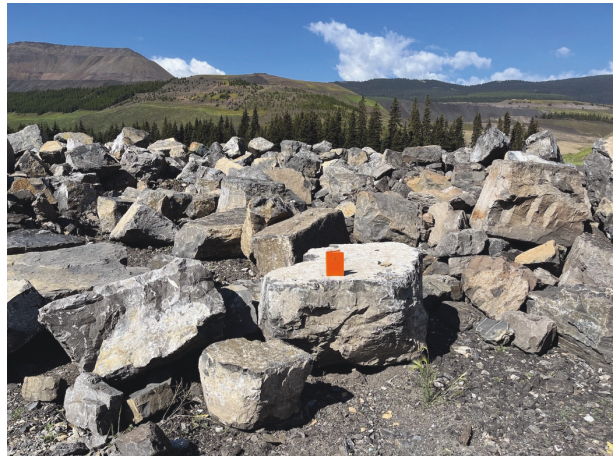
Photo 15: Riprap at emergency riprap stockpile
