Teck Metals Ltd.

Pinchi Mine Lake Tailings Storage Facility

2022 Annual Facility Performance Review

October 2022

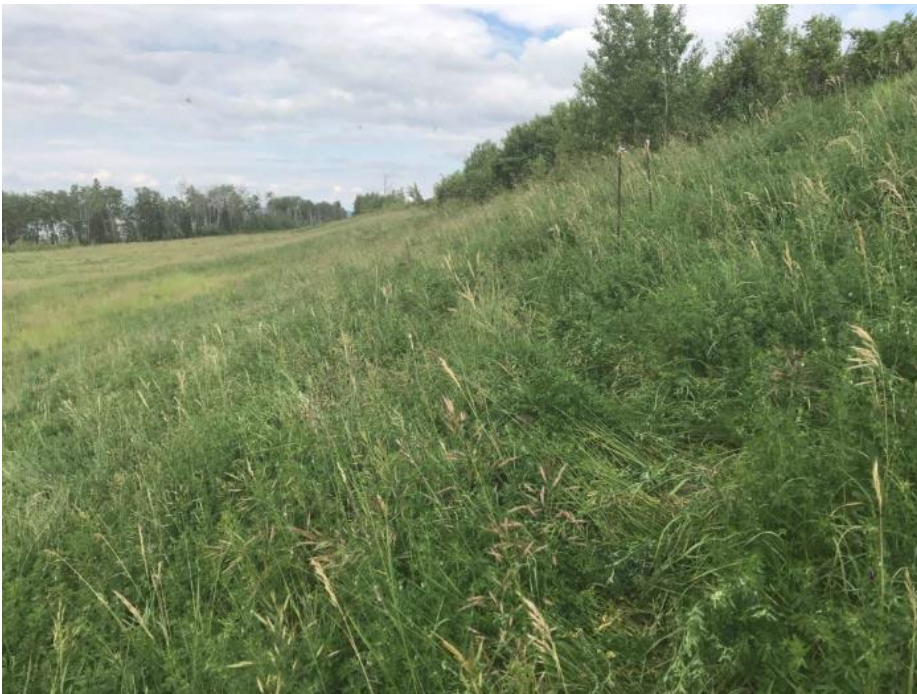
Photo II-28 Borrow Area A – crack monitoring rod location 203

- Cracks were observed on the slope from 2013 to 2017 (Location 1 in Figure 4.1) and 2020 (Location 2 in Figure 4.1). Measurements of crack movements were taken from 2015 to 2018 using metal rods installed on either side of the cracks (Photo II-28), but these measurements showed no ongoing movements and were discontinued in 2019. The cracks are no longer visible due to vegetation growth and are not a TSF safety concern. Nevertheless, this area will continue to be monitored during routine inspections as per the OMS Manual.

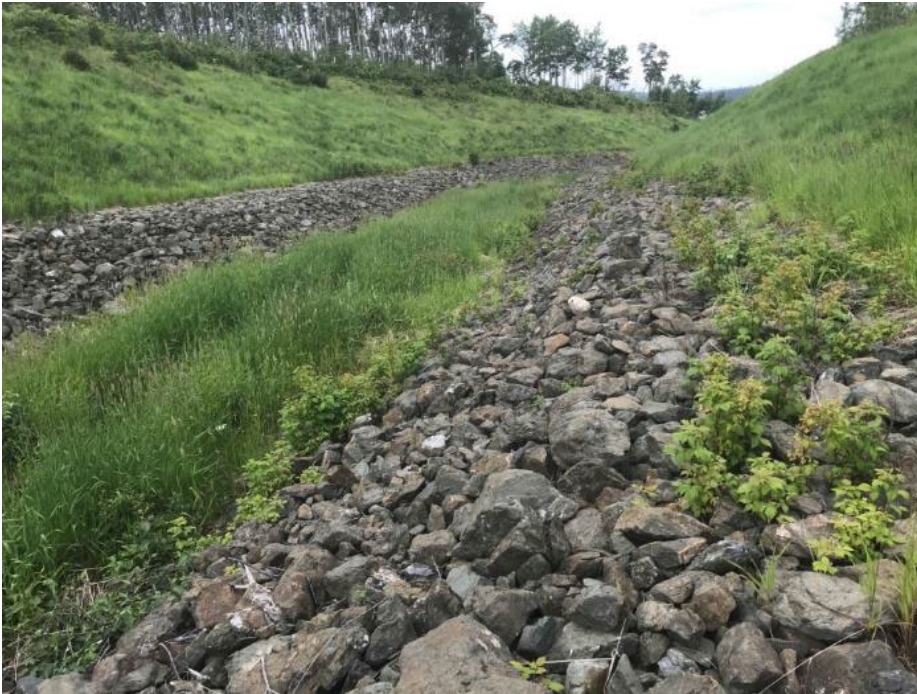
Photo II-34 Ed Creek Diversion Channel – Vegetation in channel, looking upstream from between second and third bends

1. Vegetation was observed throughout the base of the channel, including tall grasses up to 1.5 m height.
2. As noted during previous inspections, riprap along entire diversion channel is deteriorating. Visual inspection suggested there were no significant changes from the condition in recent years.

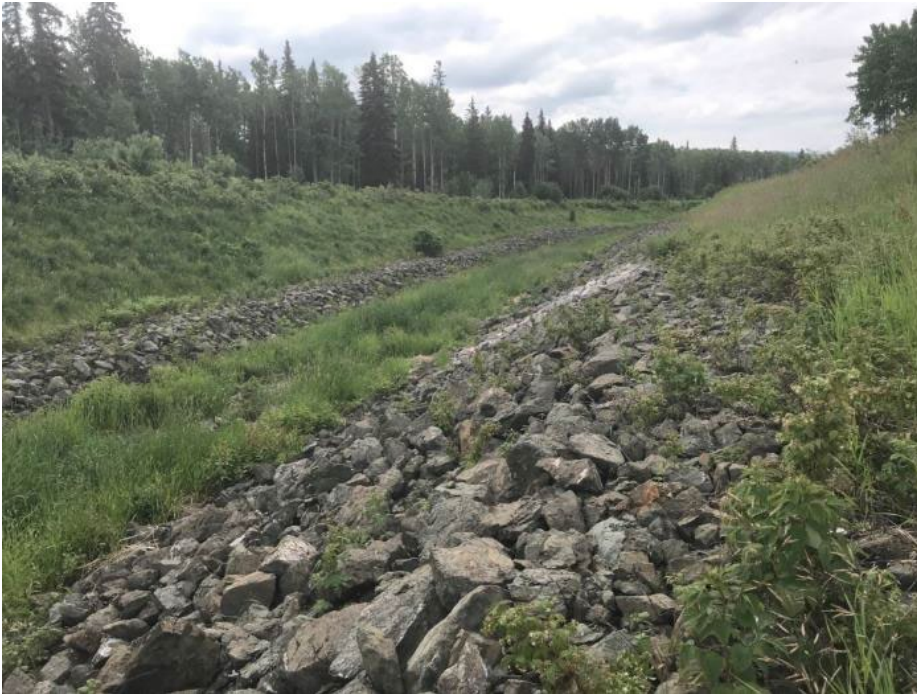
Photo II-38 Ed Creek Diversion Channel – looking upstream from between first and second bends

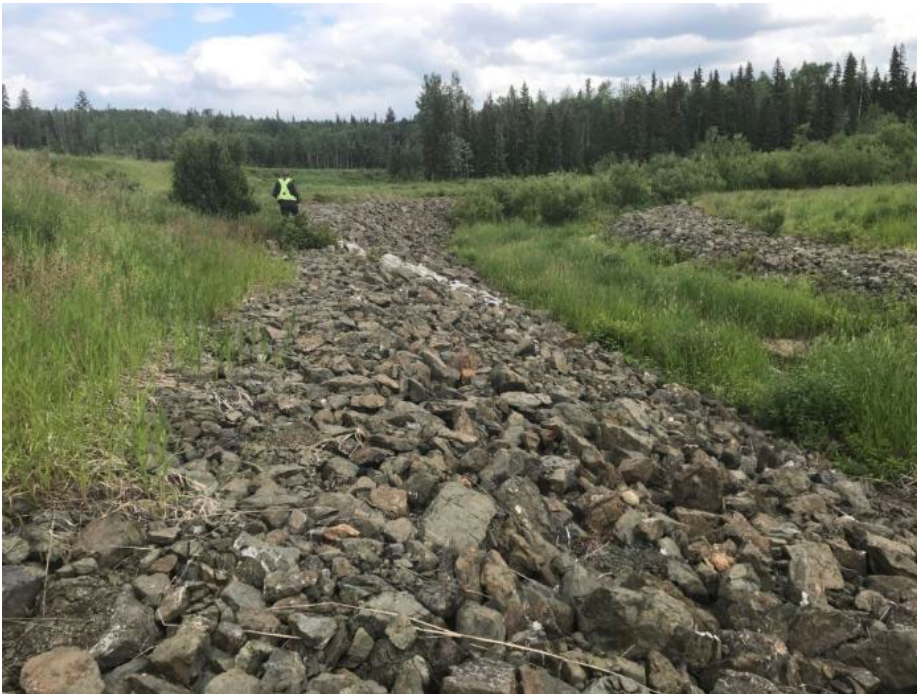
Photo II-39 Ed Creek Diversion Channel – Looking downstream from near first bend

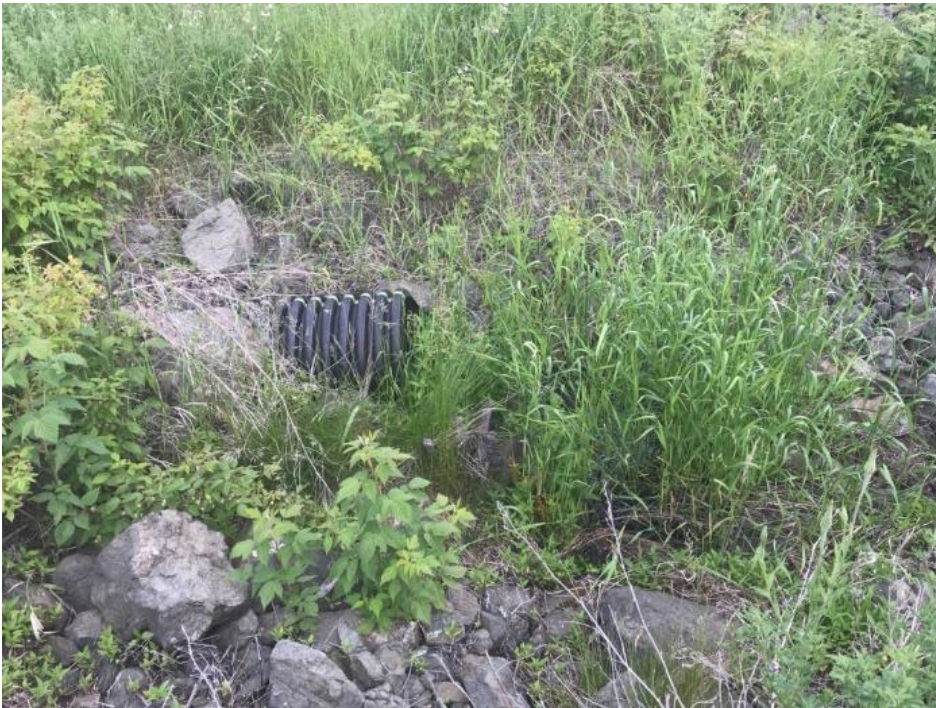
Photo II-41 Inlet of 460 mm culvert on north bank of Ed Creek Diversion Channel. Note vegetation near the inlet

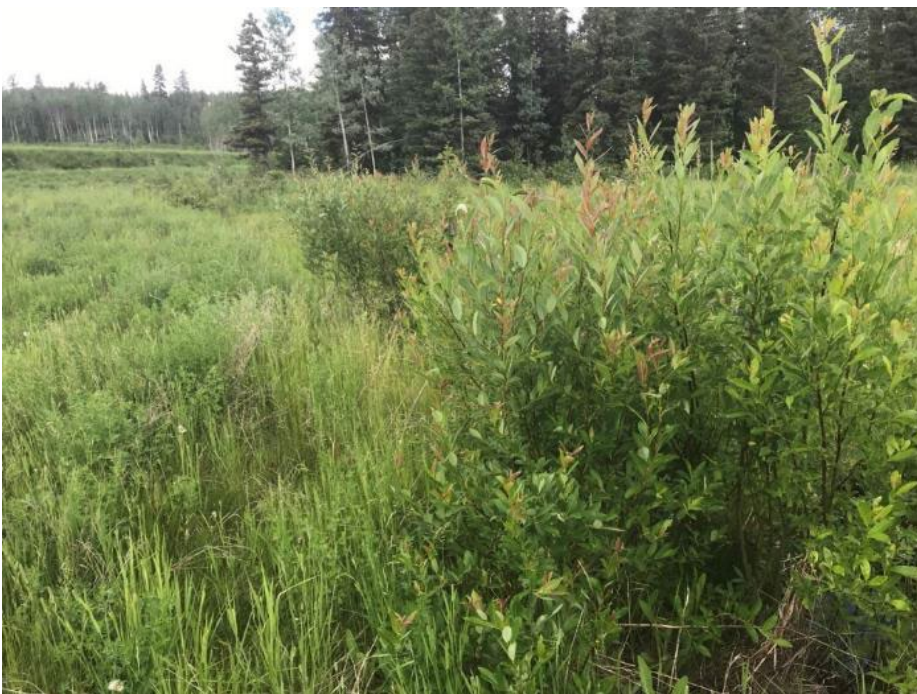
Photo II-43 Ditch north of Ed Creek Diversion Channel, looking south. Ditch is filled with vegetation

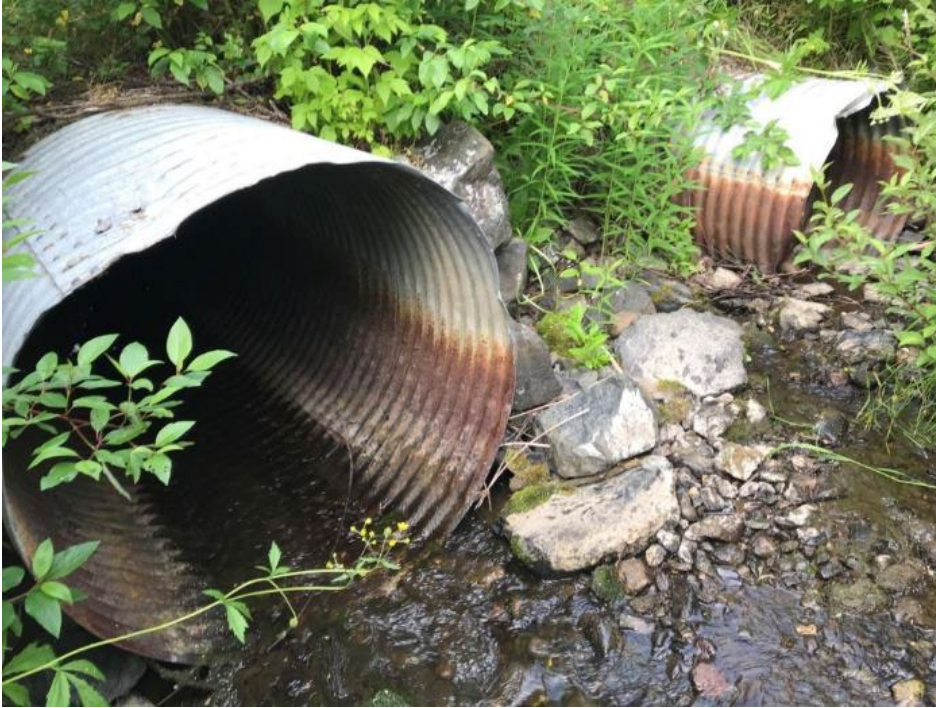
Photo II-46 Flow monitoring station immediately upstream of Pinchi Lake Road culverts

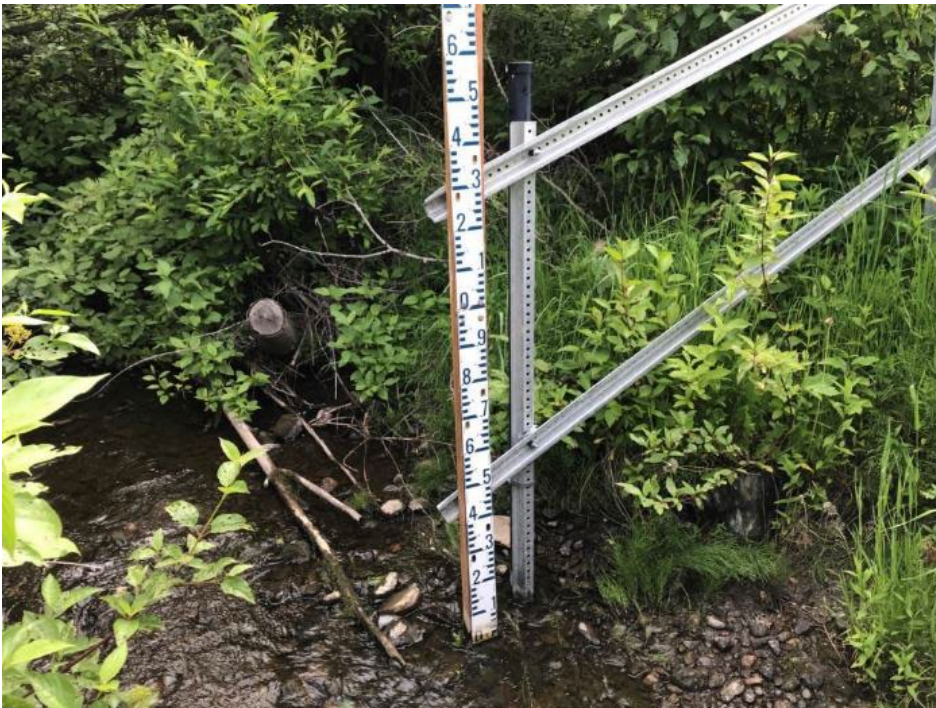
Photo II-47 Looking upstream from inlet of Ed Creek culverts under Pinchi Lake Road

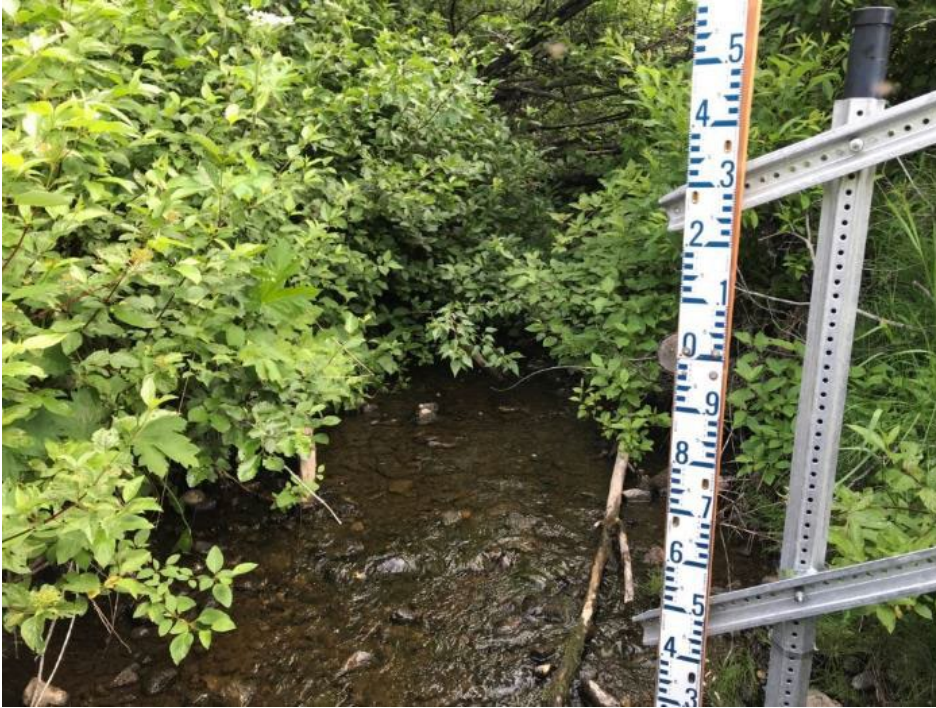
Photo II-48 Outlet of Ed Creek culverts under Pinchi Lake Road
