2022 Annual Facility Performance Review

Sä Dena Hes Mine, Yukon Territory
Teck Resources Limited

SRK Consulting (Canada) Inc. ■ CAPR001928 ■ November 2022

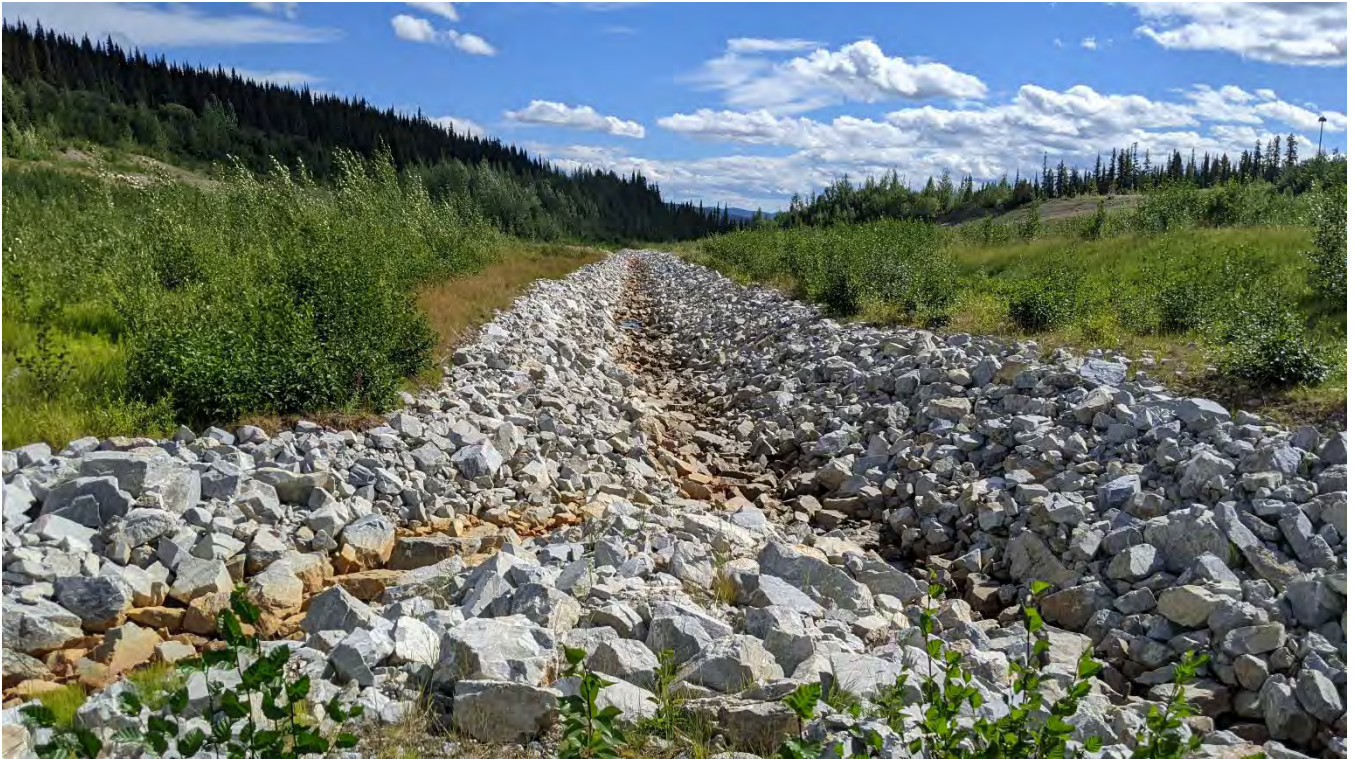
Photo DC-01: Camp Creek looking downstream at the confluence with the South Drainage Channel..

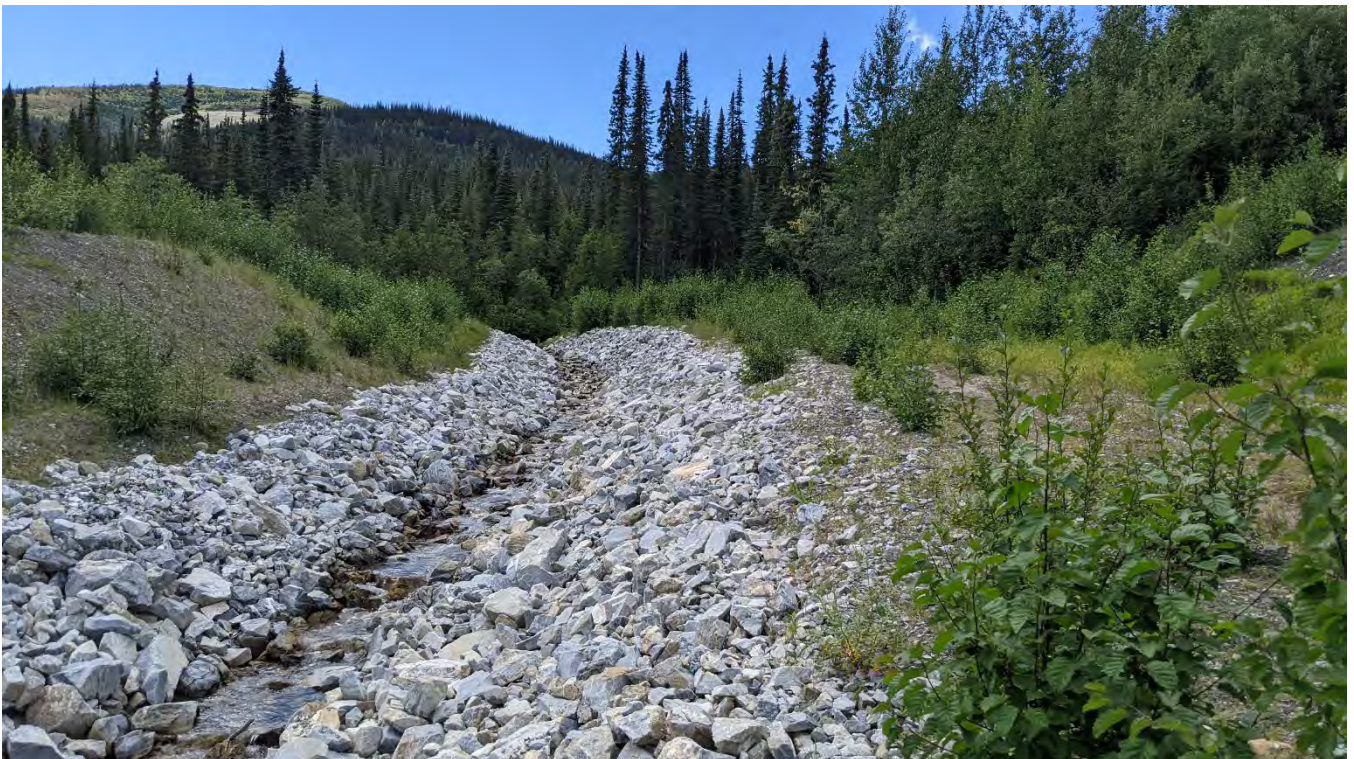
Photo DC-02: Camp Creek looking upstream.

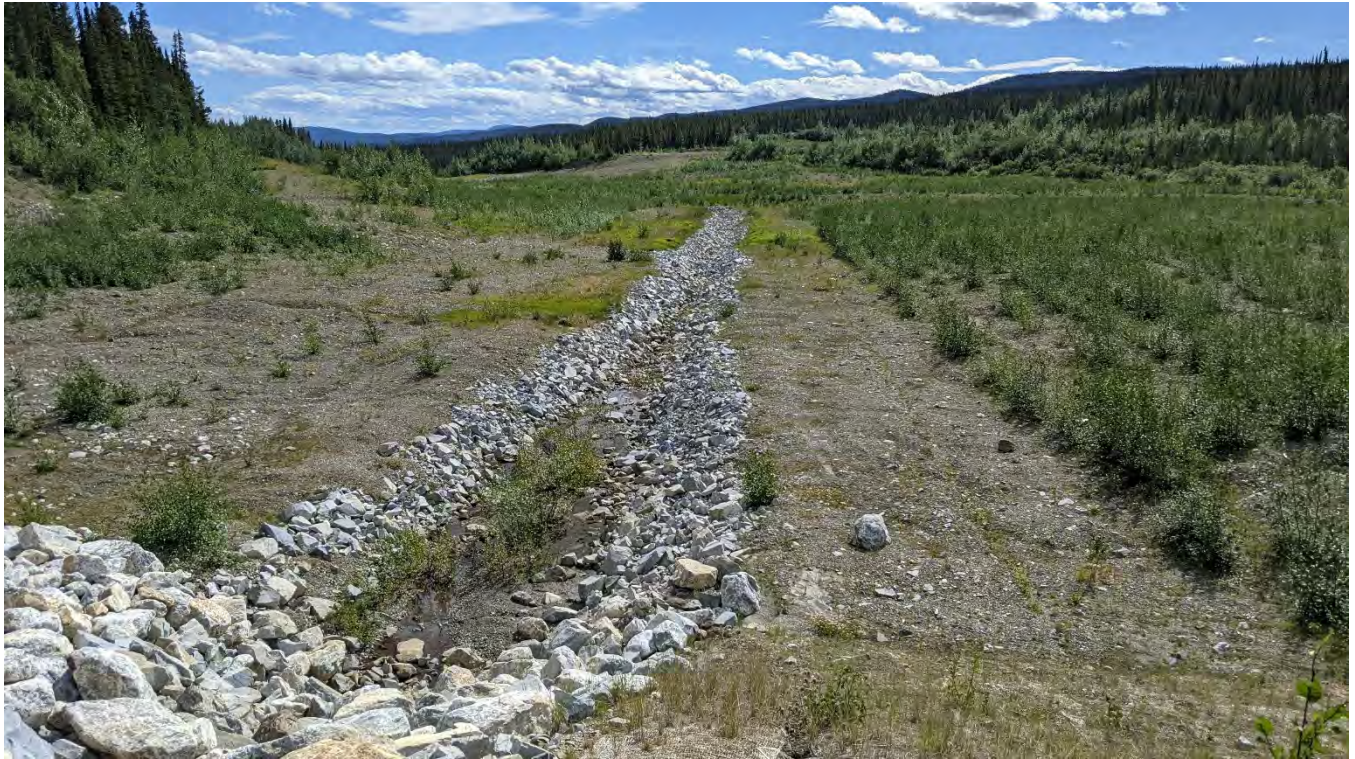
Photo DC-03: Upper end of the South Drainage Channel taken from the SRS Spillway.

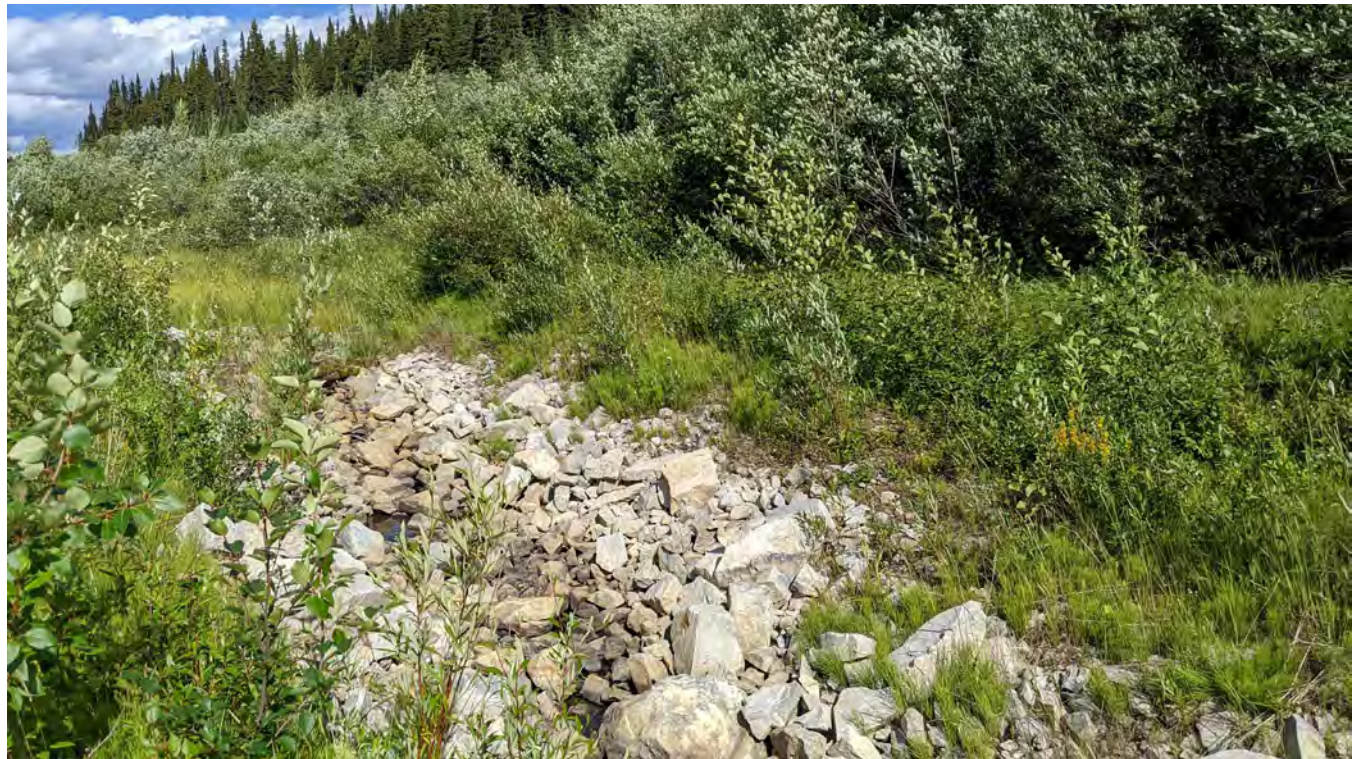
Photo DC-04: North Diversion Channel looking upstream.

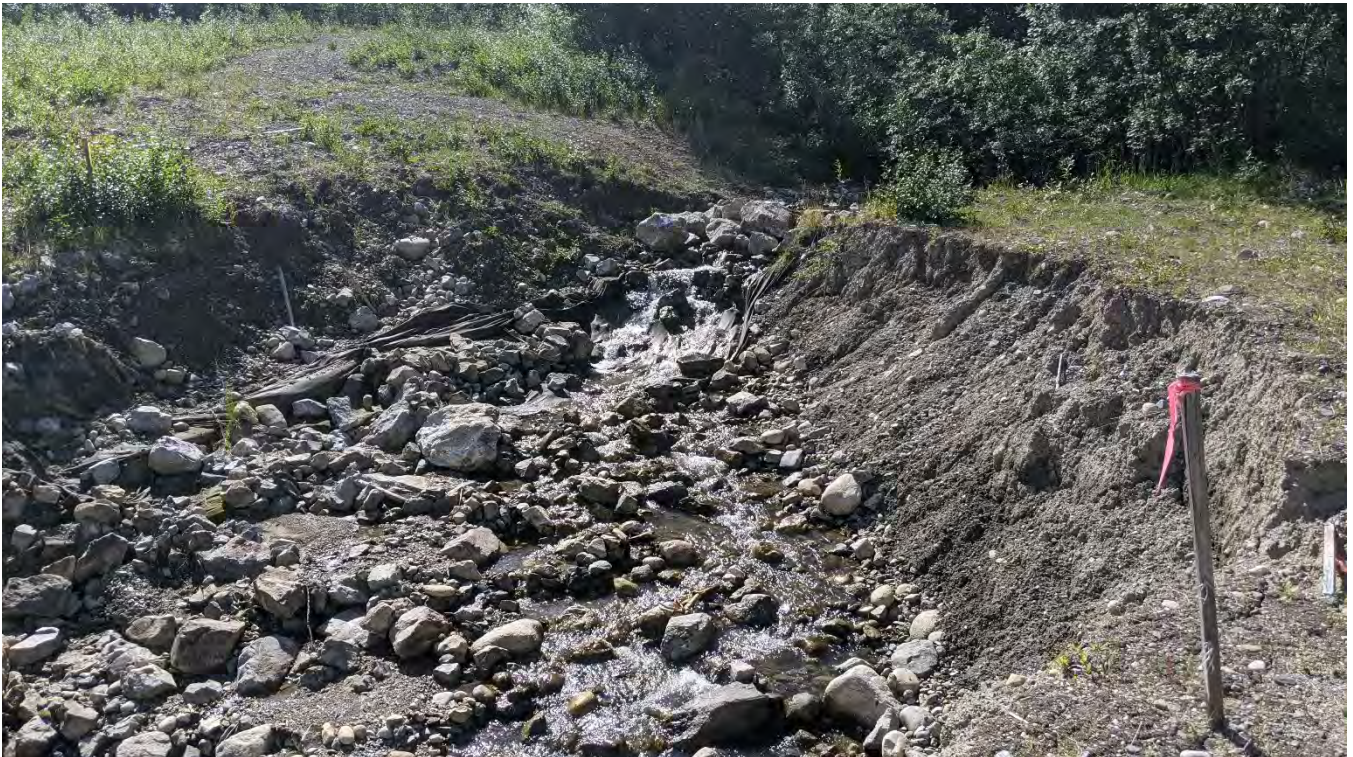
Photo NC-06: On-going channel and bank erosion at the upstream end of the lower decommissioned access road crossing of North Creek to the landfill area.

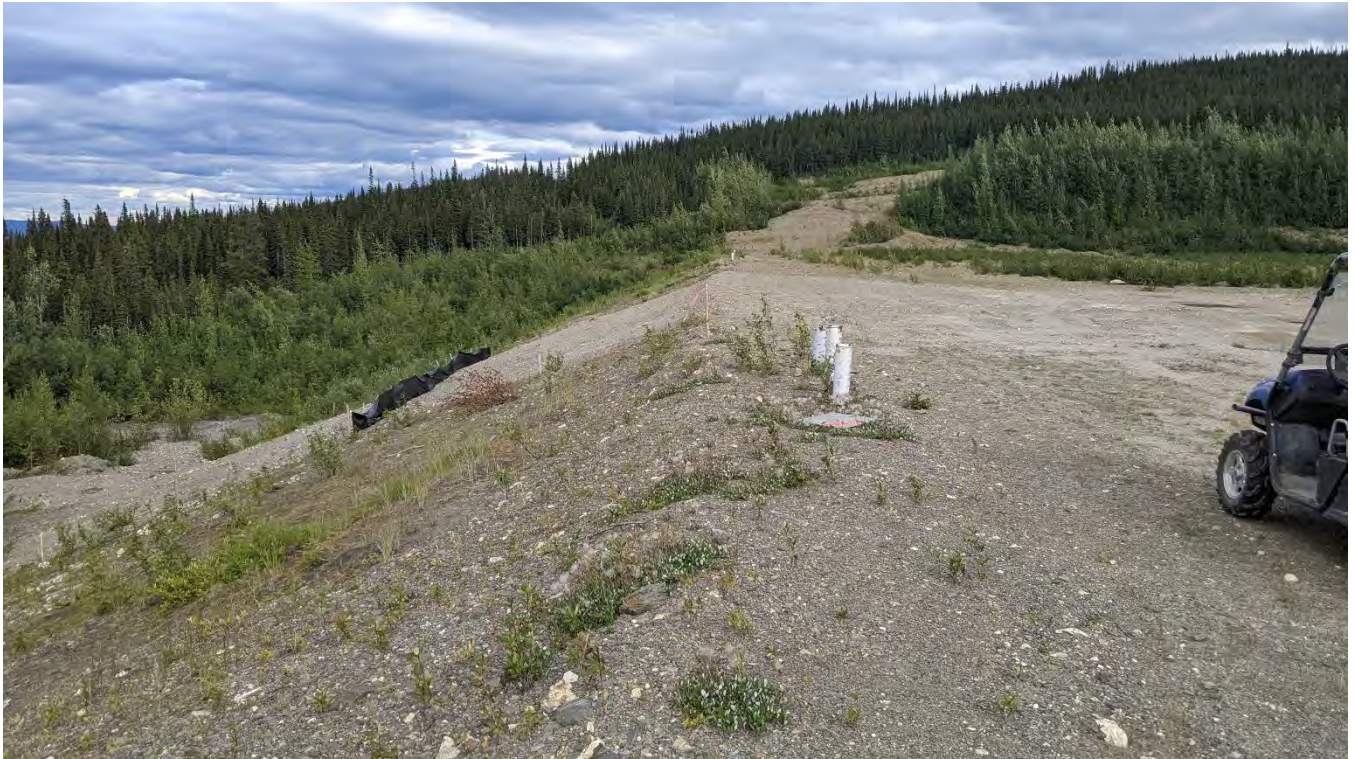
Photo ND-01: North Dam looking east towards the erosion gully repair area.

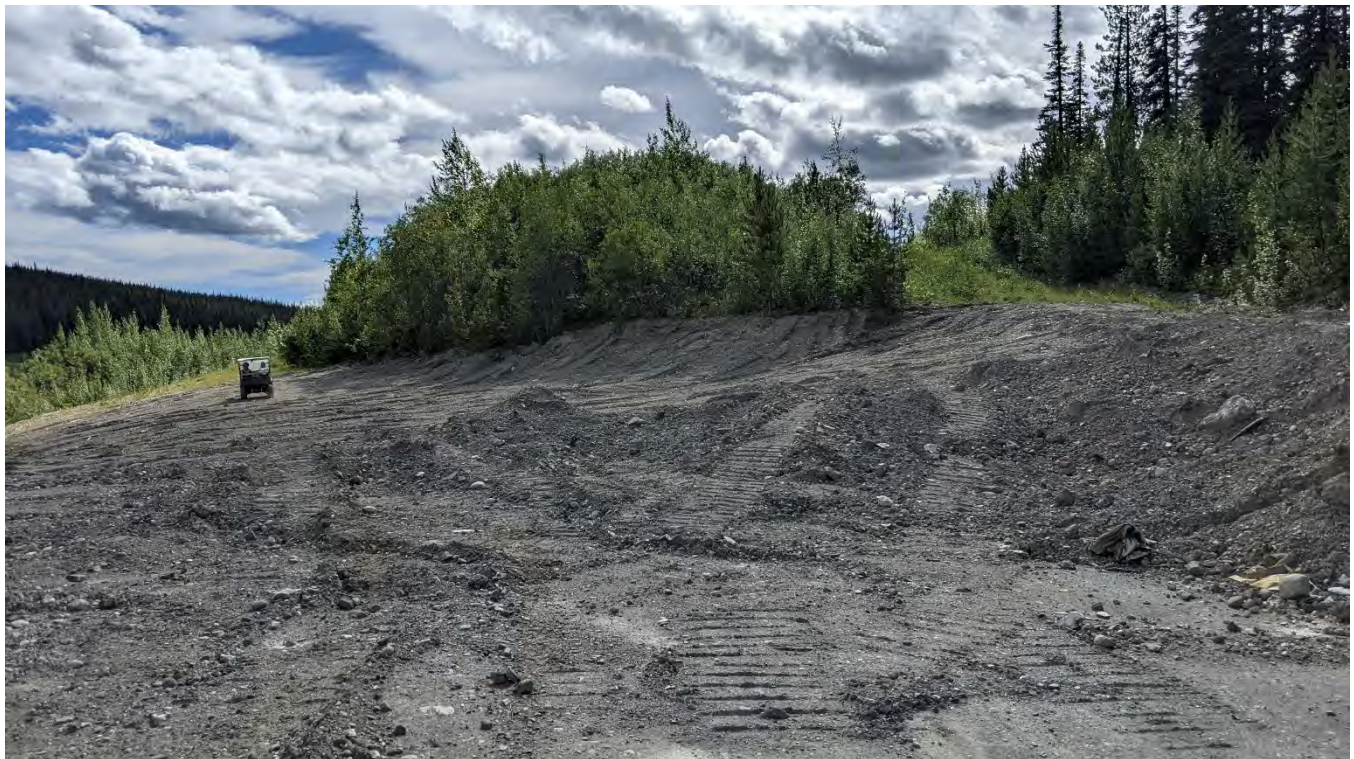
Photo ND-02: Till borrow area used for the North Dam repairs. The borrow slopes have been partially regraded and landformed.

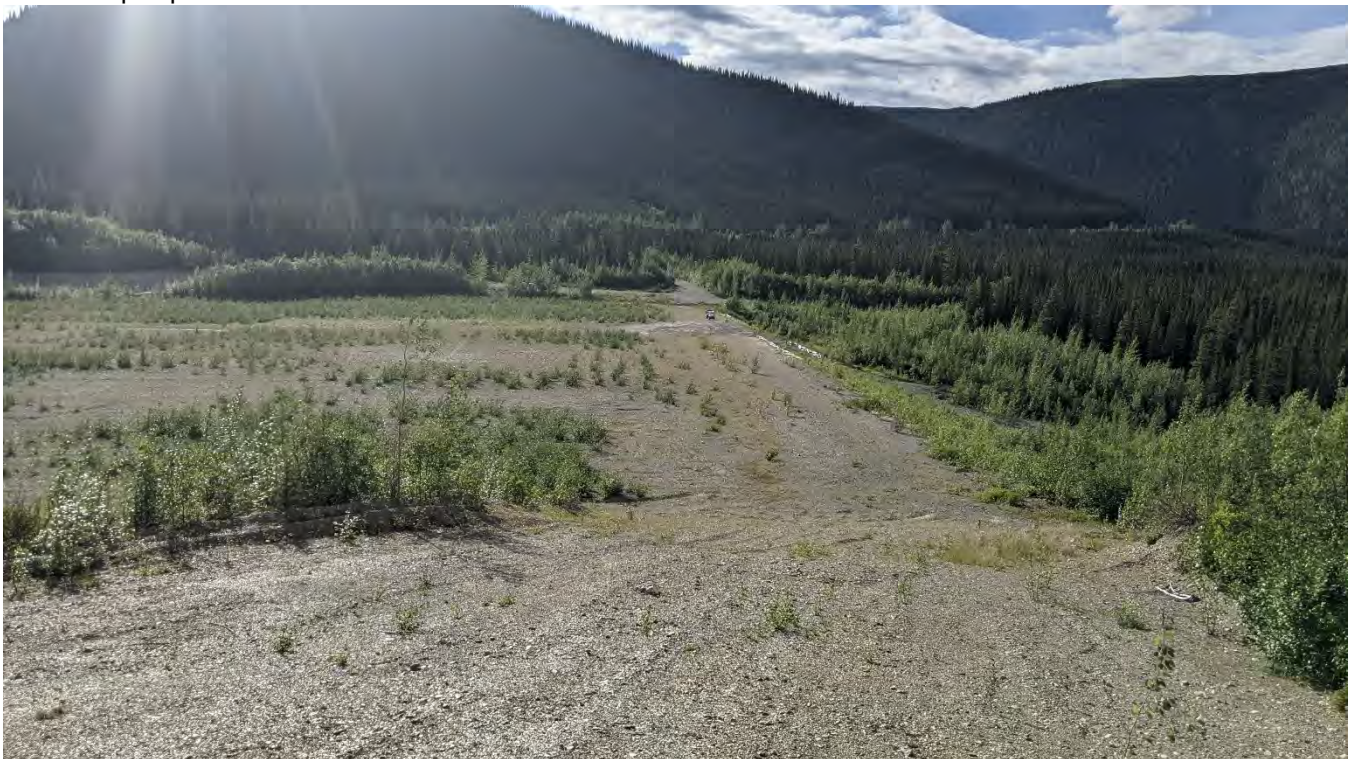
Photo ND-04: North Dam looking west.

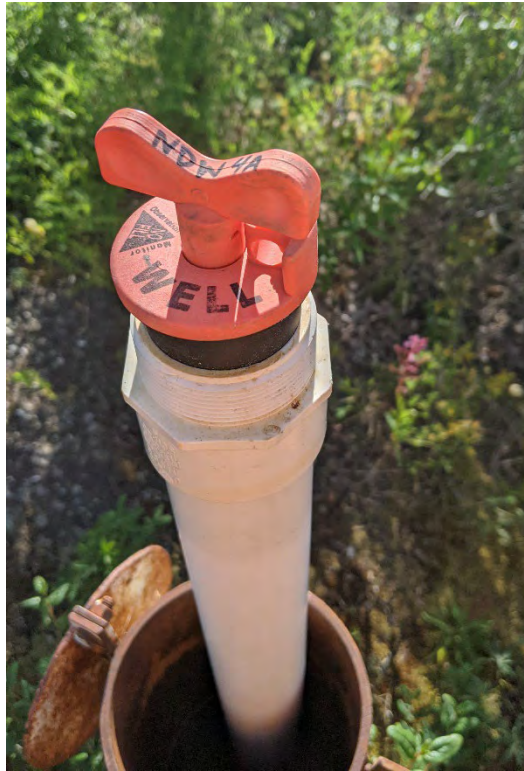
Photo ND-05: Piezometer NDW-4A downstream of the dam toe. The PVC pipe extends above the protective casing.

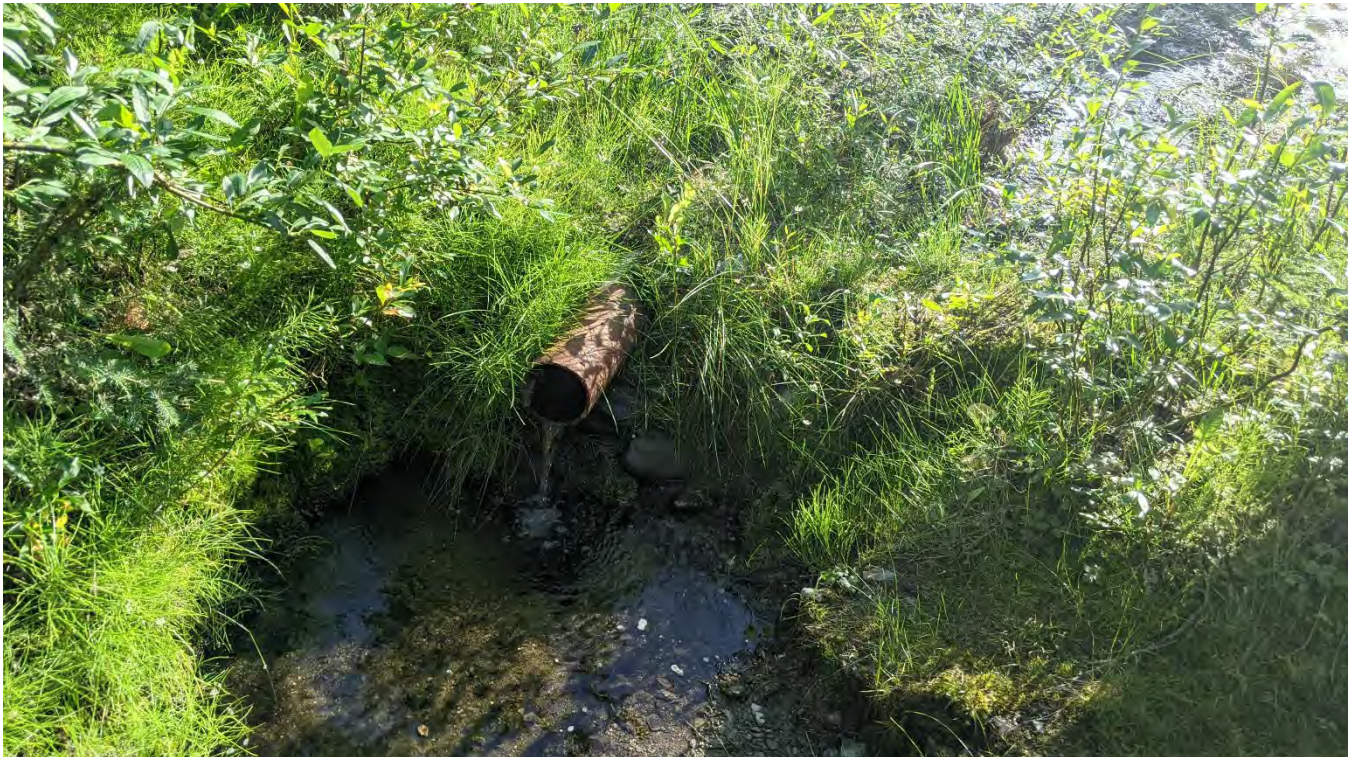
Photo ND-06: MH-02 flow monitoring pipe.

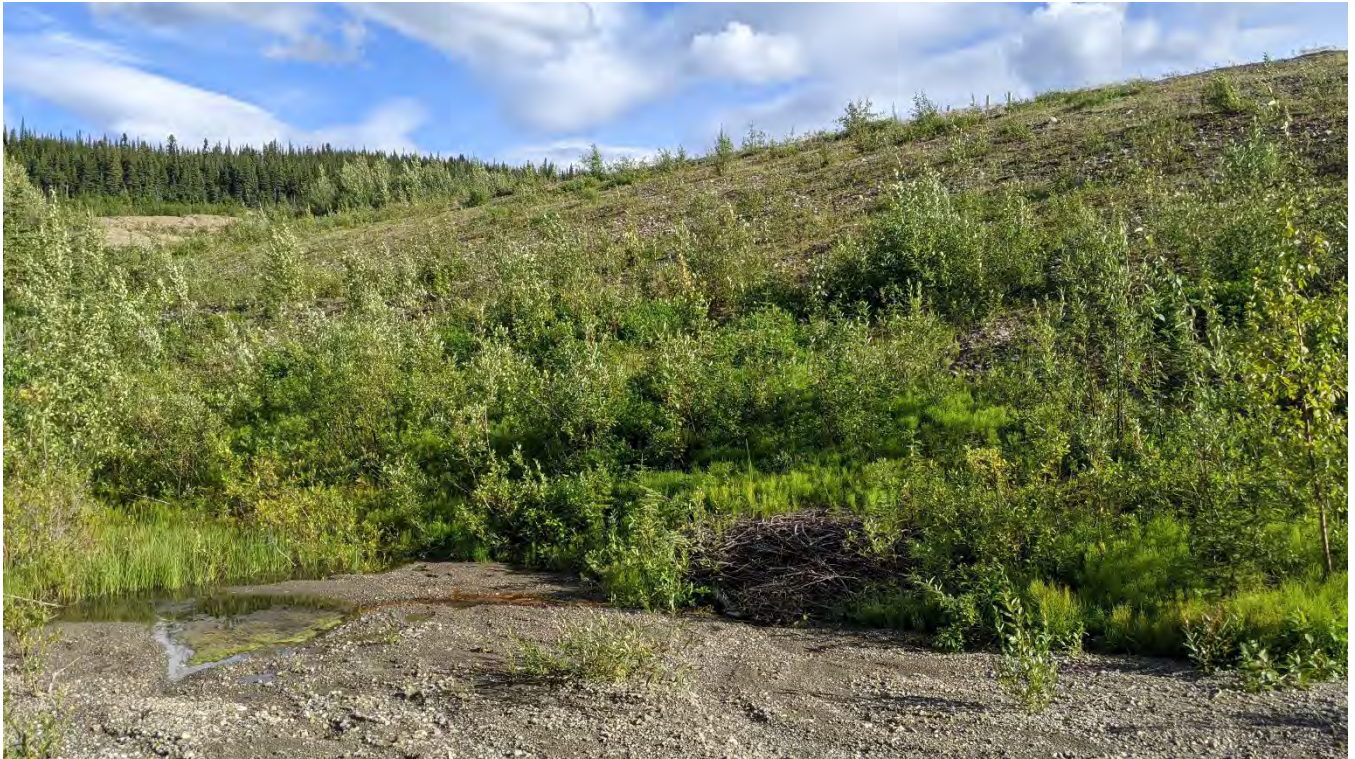
Photo ND-07: Downstream slope of the North Dam looking southeast from the base of the erosion gully repair area.

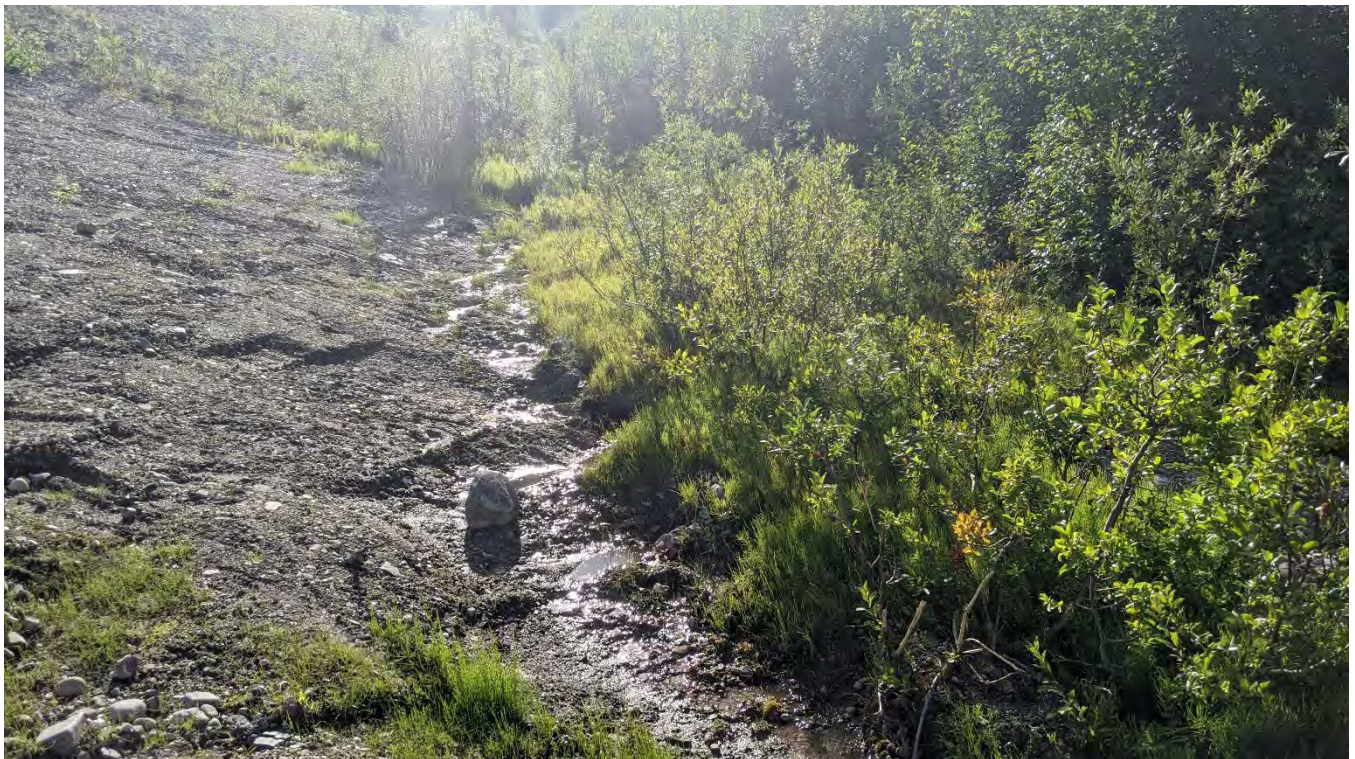
Photo ND-08: Downstream toe of the North Dam looking west at the base of the erosion gully repair area.

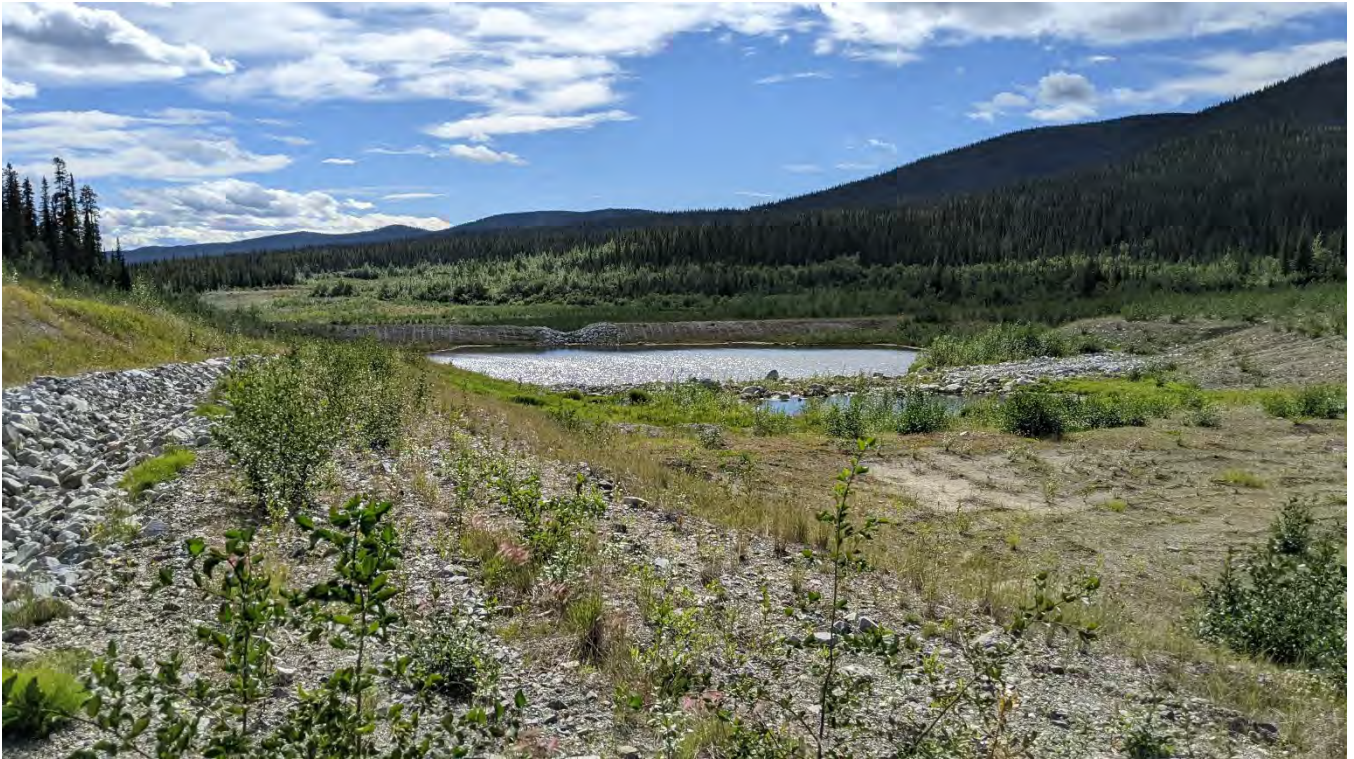
Photo SRS-01: SRS and pond looking south. The North Drainage Channel is located at the left side of the photo.

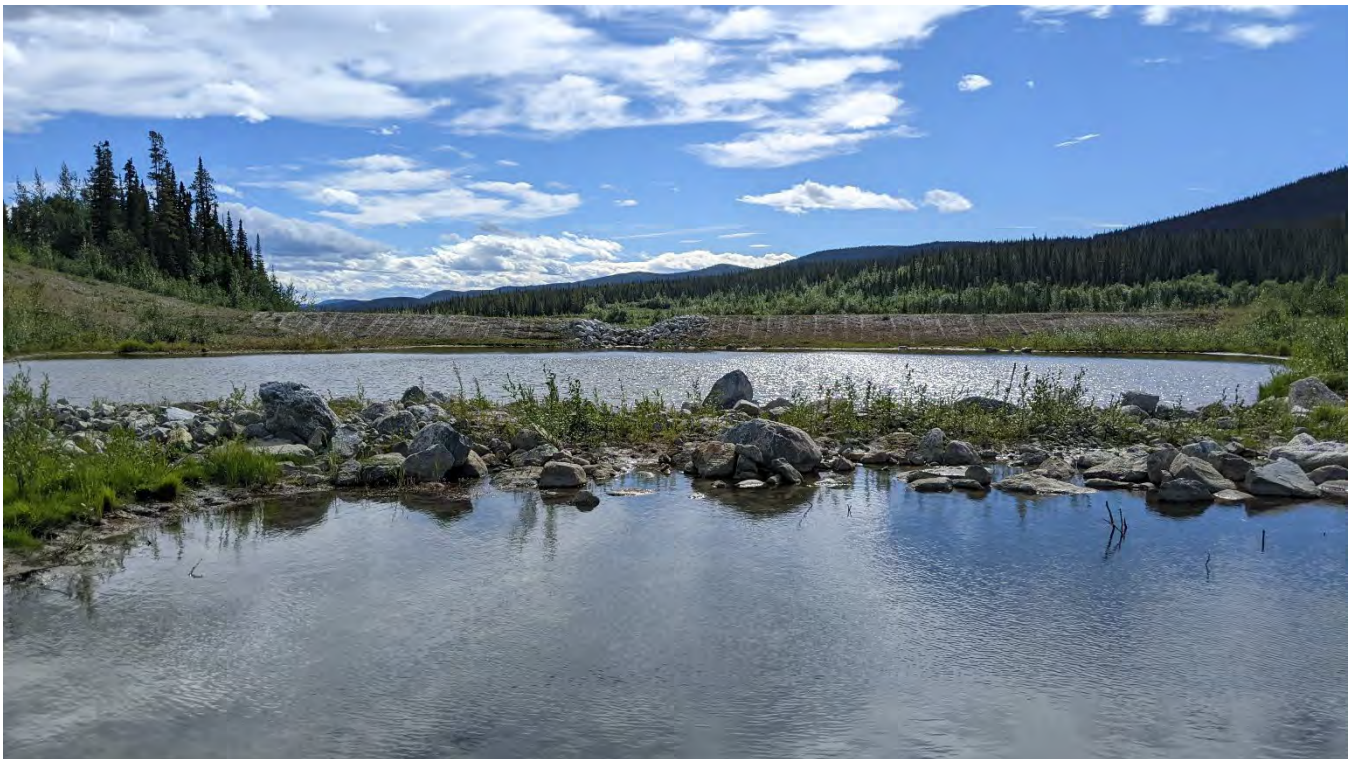
Photo SRS-02: SRS in distance, with the coffer dam in the foreground of the photo.

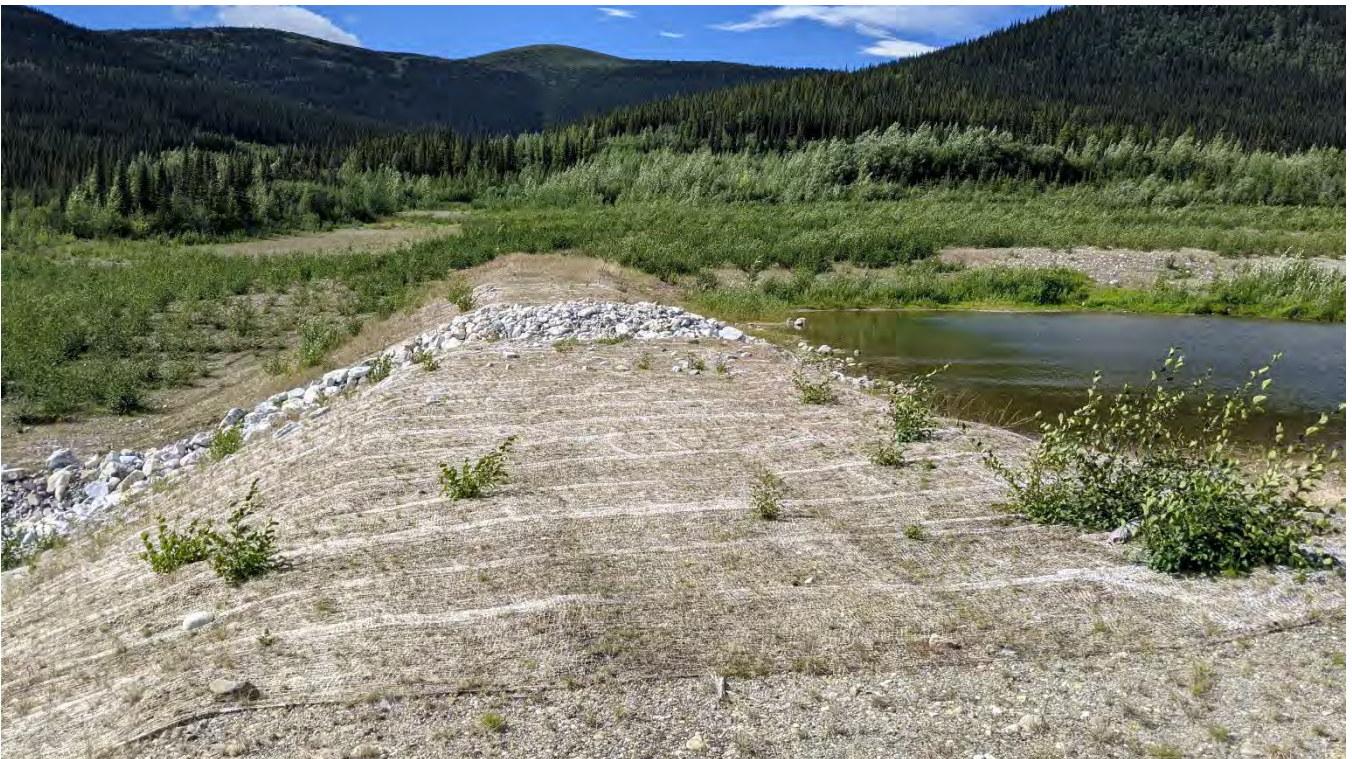
Photo SRS-04: SRS crest looking west from the east abutment.

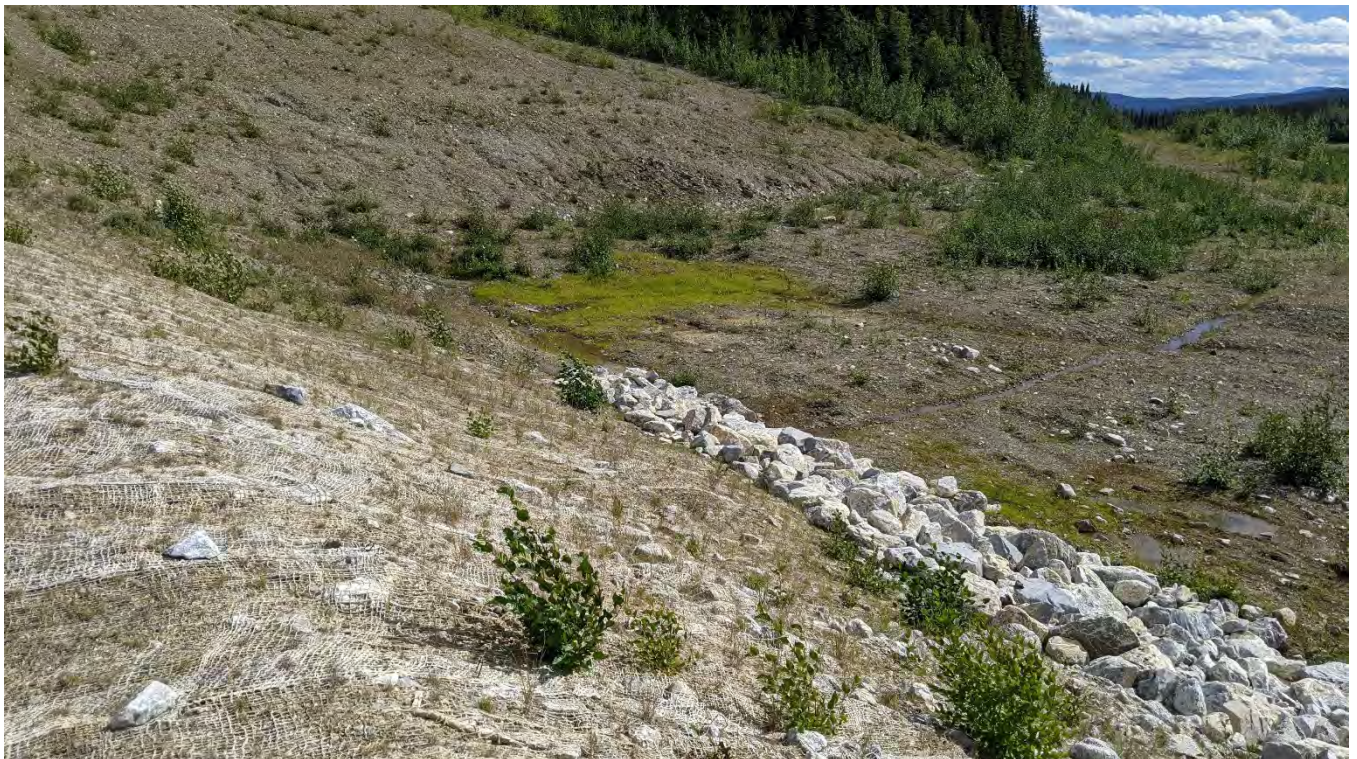
Photo SRS-06: Downstream face of the SRS on the east side of the spillway looking southeast.

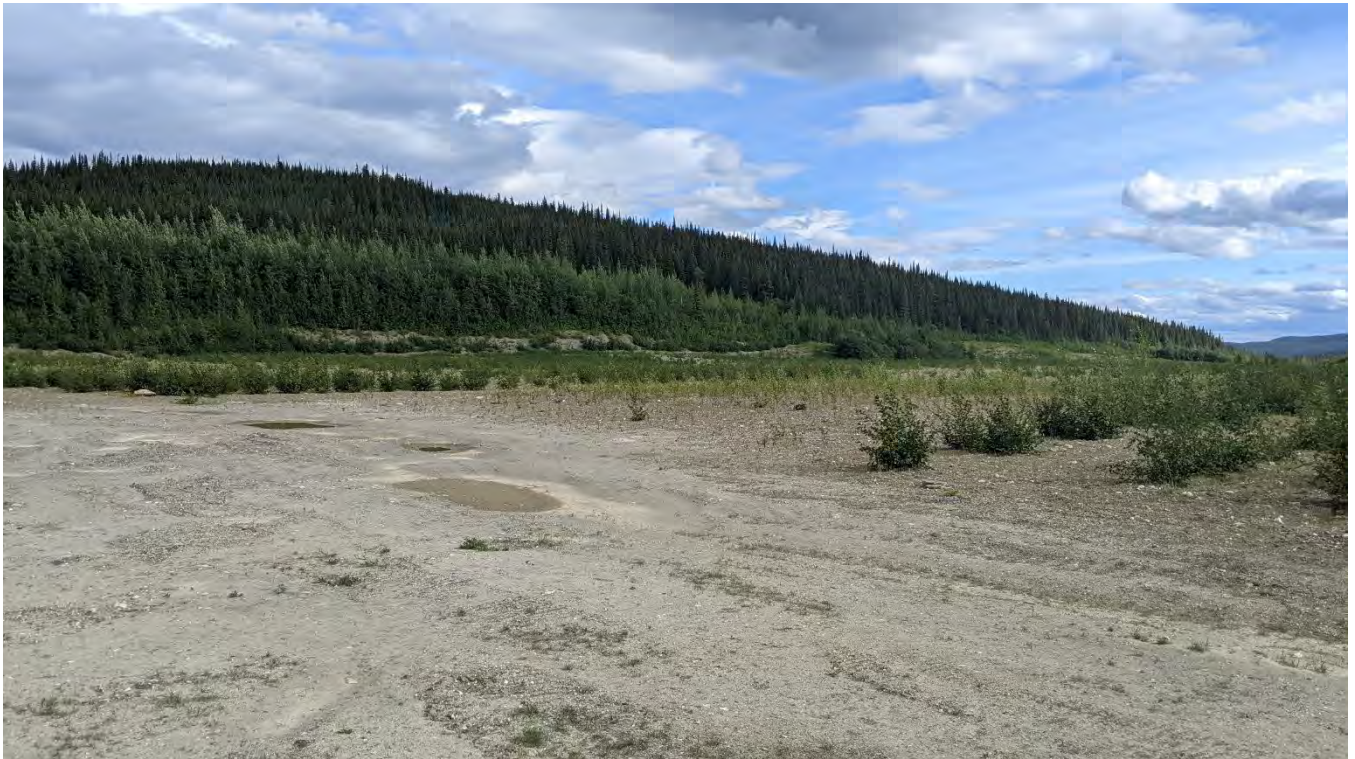
Photo TC-01: North Dam crest and tailings cover south of the erosion gully repair area.

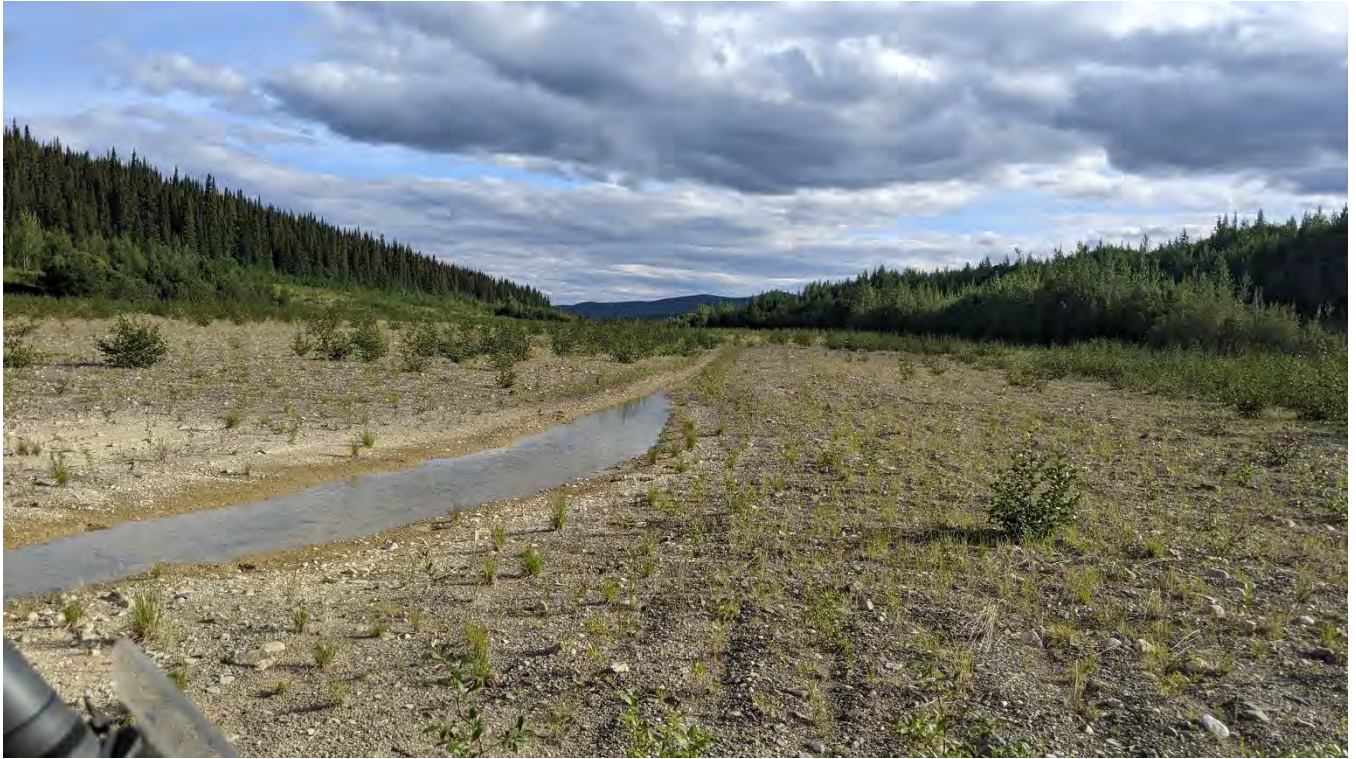
Photo TC-03: Main drainage swale that flows south through the middle of the tailings cover.

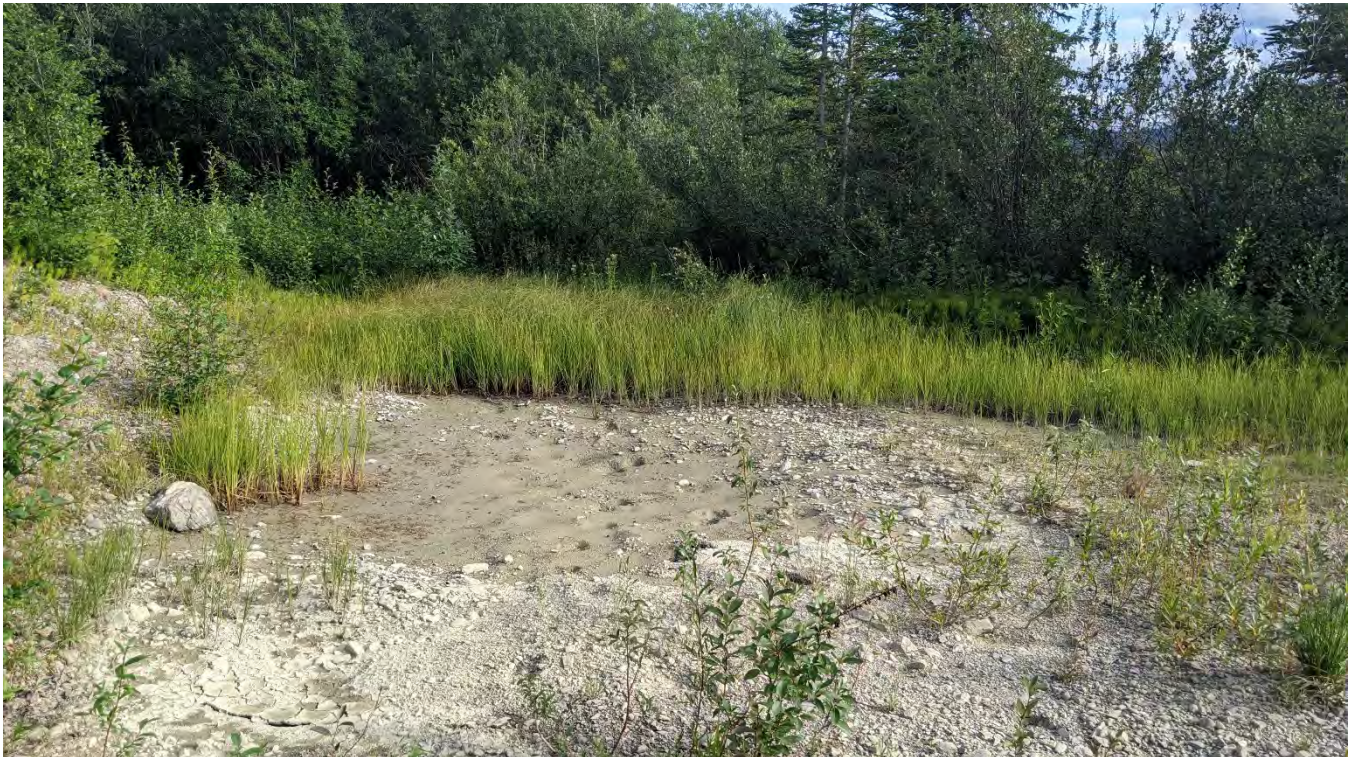
Photo TC-04: Sediment accumulation at the south end of the Northern Tailings Area at the location of the former Coffey Dam (removed).

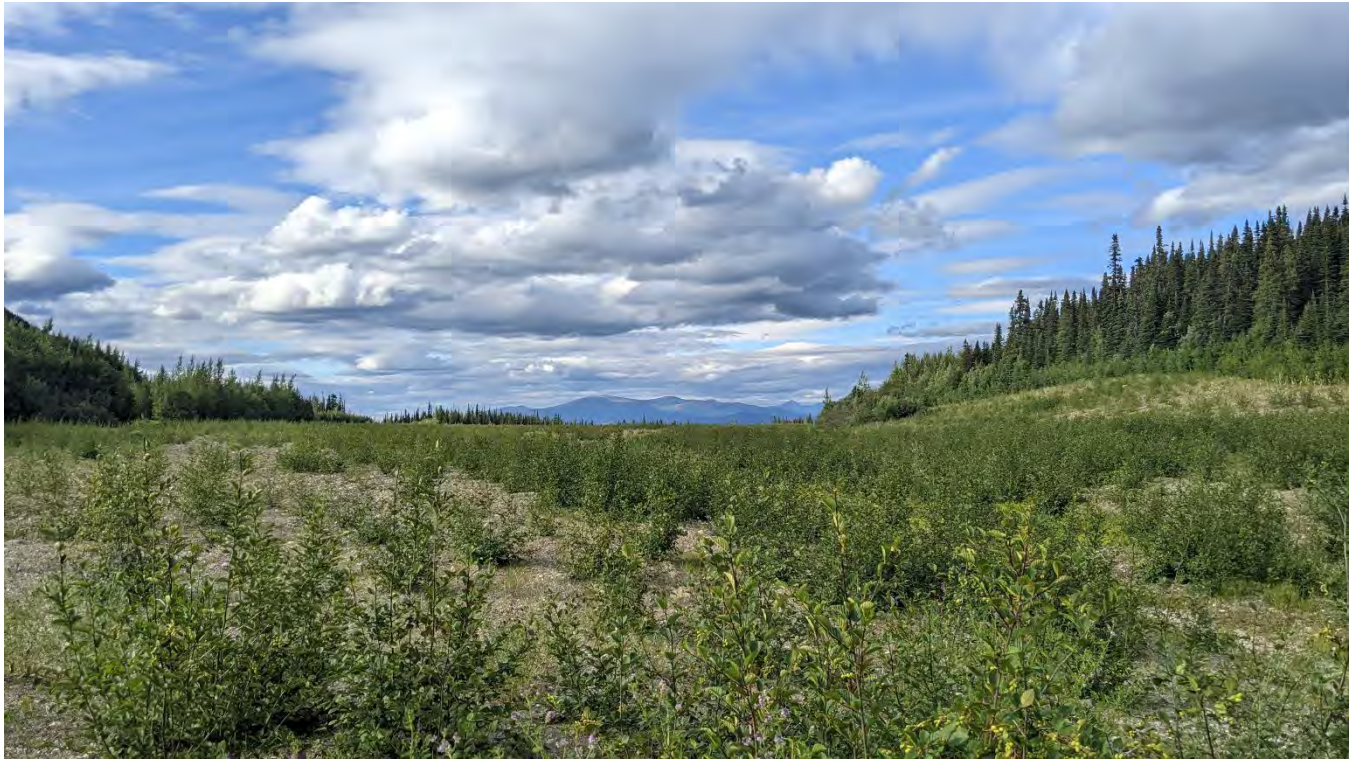
Photo TC-05: Tailings cover looking north.

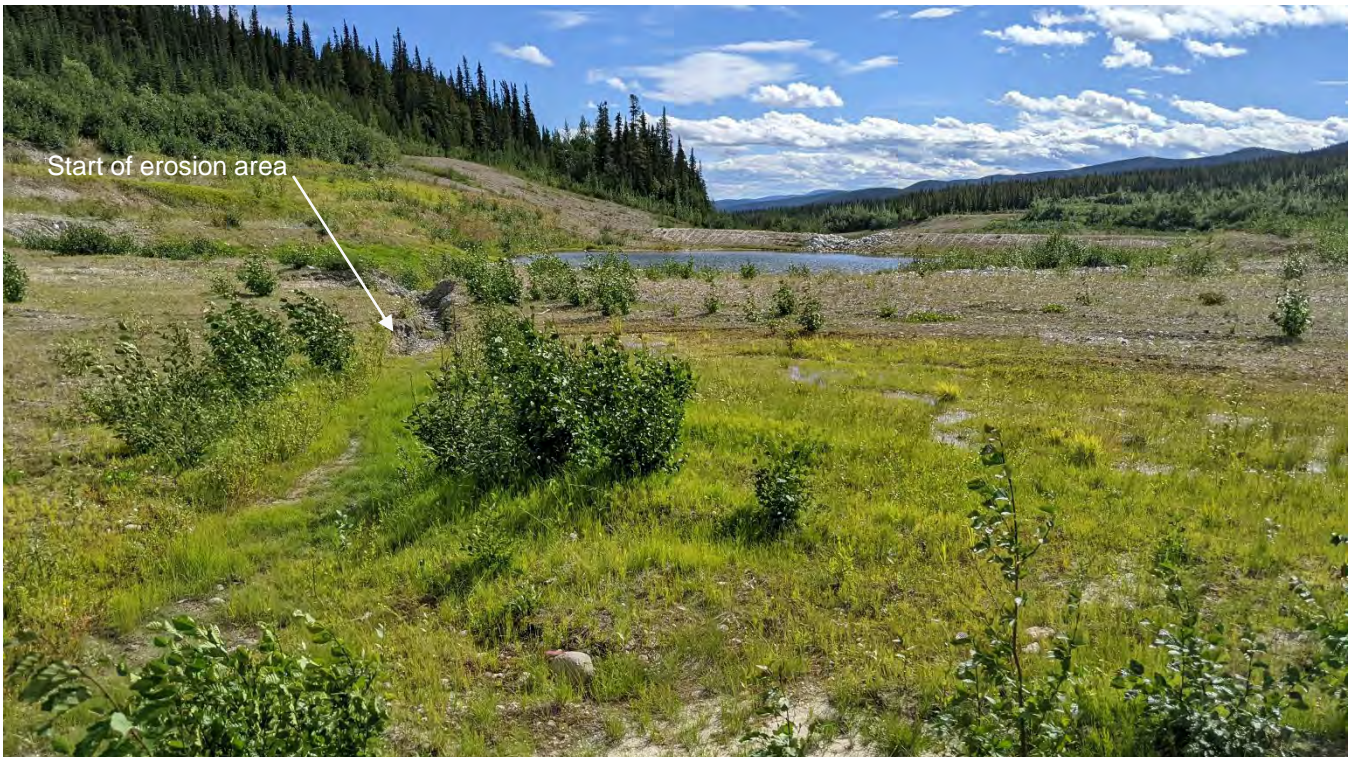
Photo TC-08: Reclamation cover looking south towards the SRS and the start of the erosion gully.

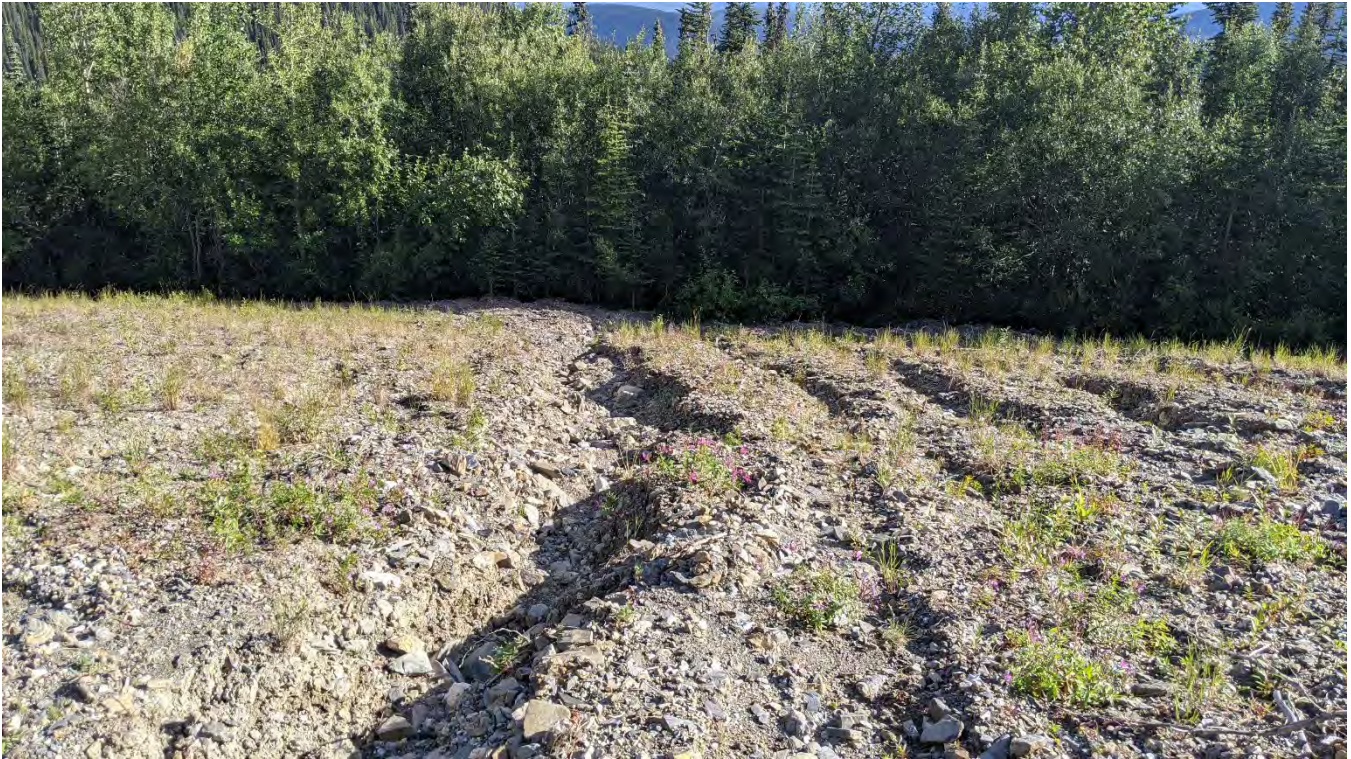
Photo WR-01: Rill and gully erosion across the decommissioned access road to the Jewelbox Waste Rock Dump.
