2022 Annual Facility Performance Review

Sä Dena Hes Mine, Yukon Territory
Teck Resources Limited

SRK Consulting (Canada) Inc. ■ CAPR001928 ■ November 2022

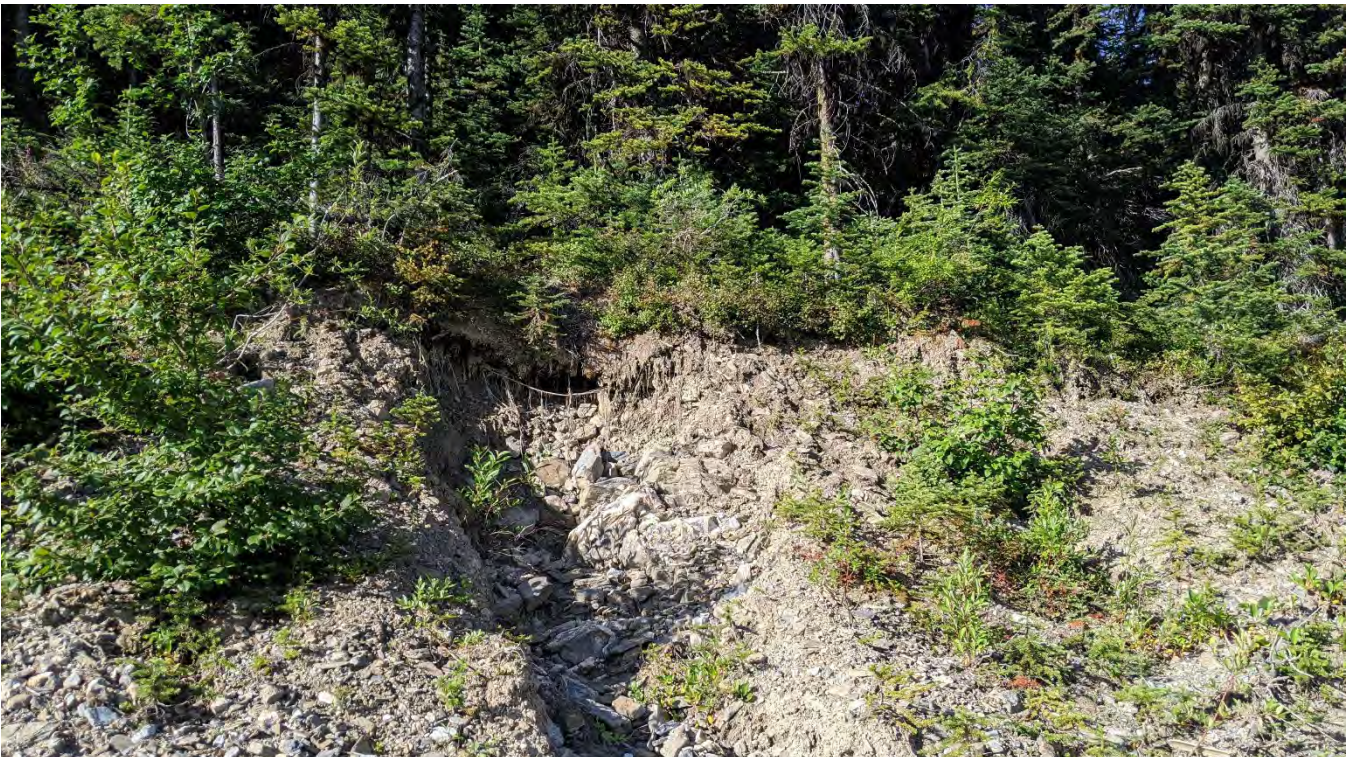
Photo WR-02: Erosion gully across the decommissioned access road to the Jewelbox Waste Rock Dump.

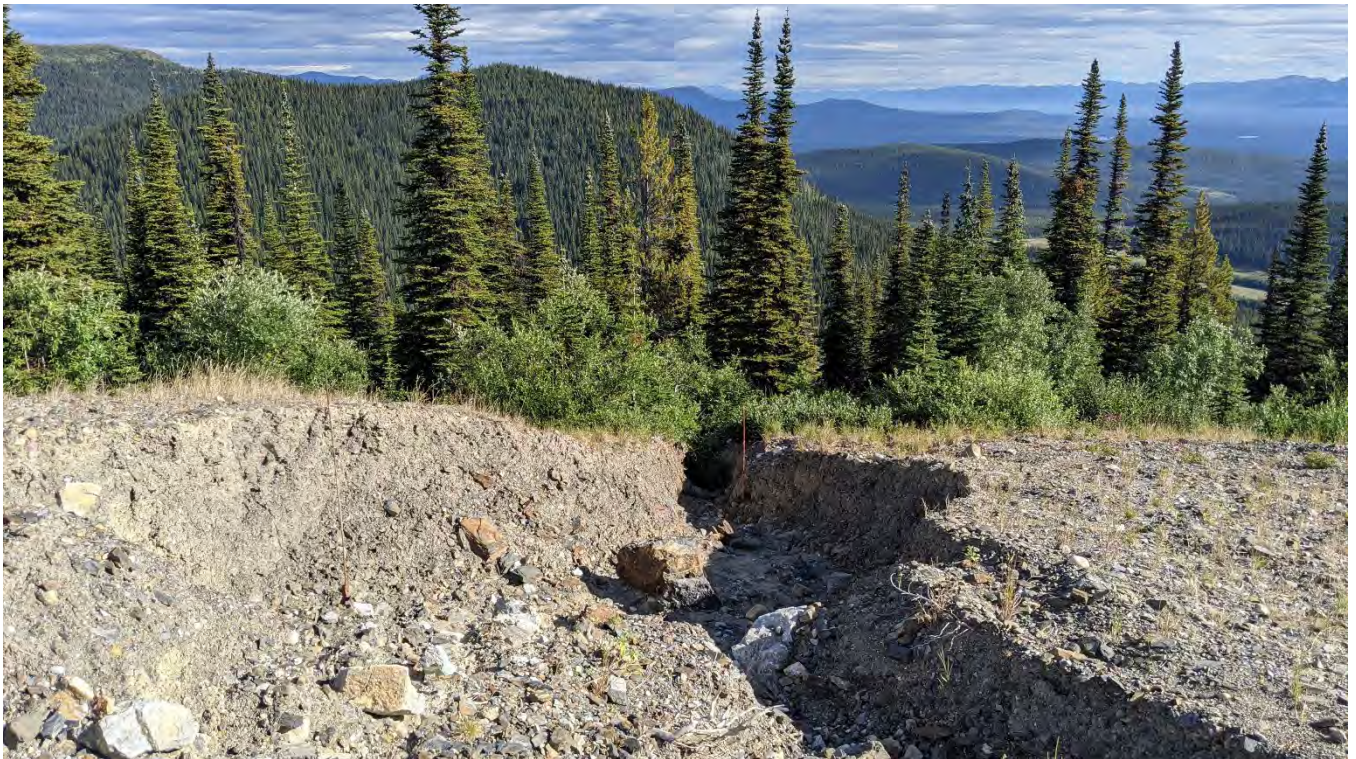
Photo WR-04: Erosion gully at the base of the Jewelbox Waste Rock Dump looking downslope. The gully has eroded down to bedrock.

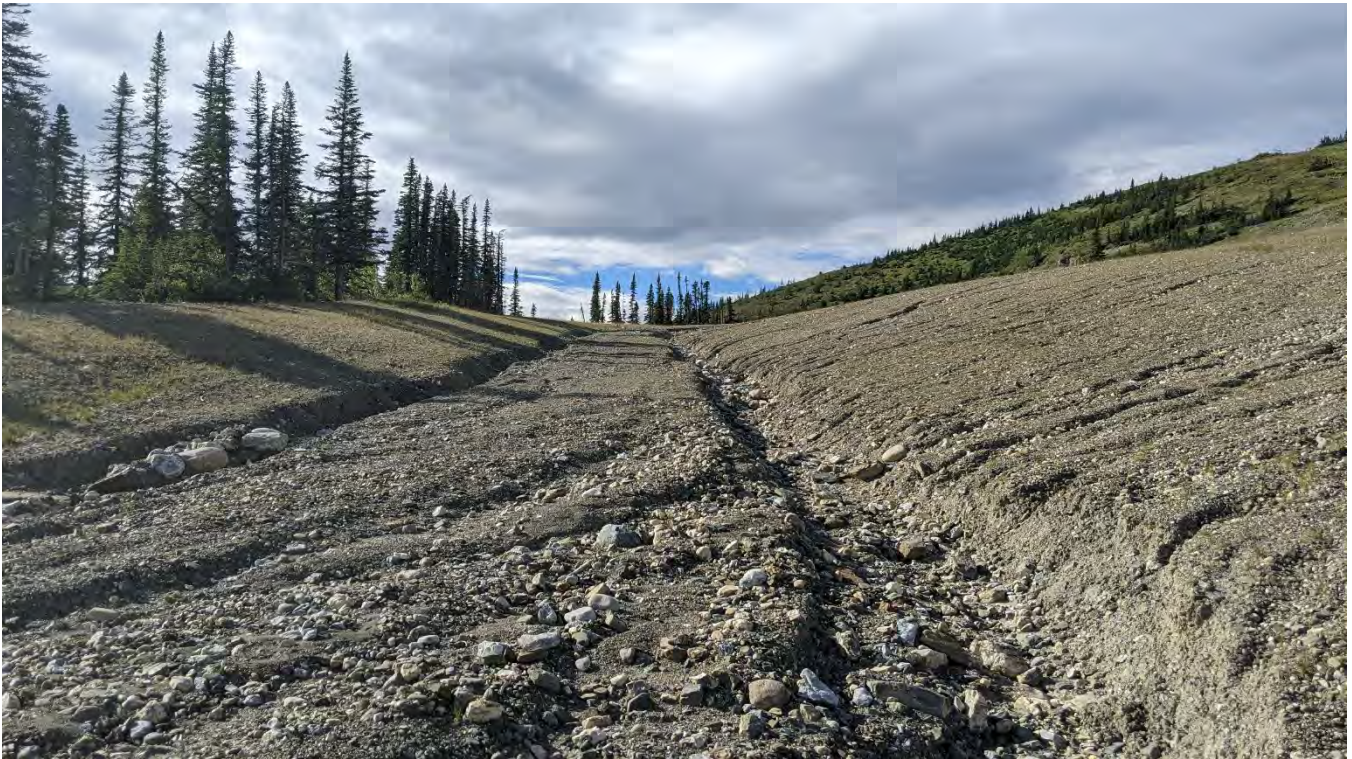
Photo WR-05: Erosion gully at the base of the Jewelbox Waste Dump looking upstream.

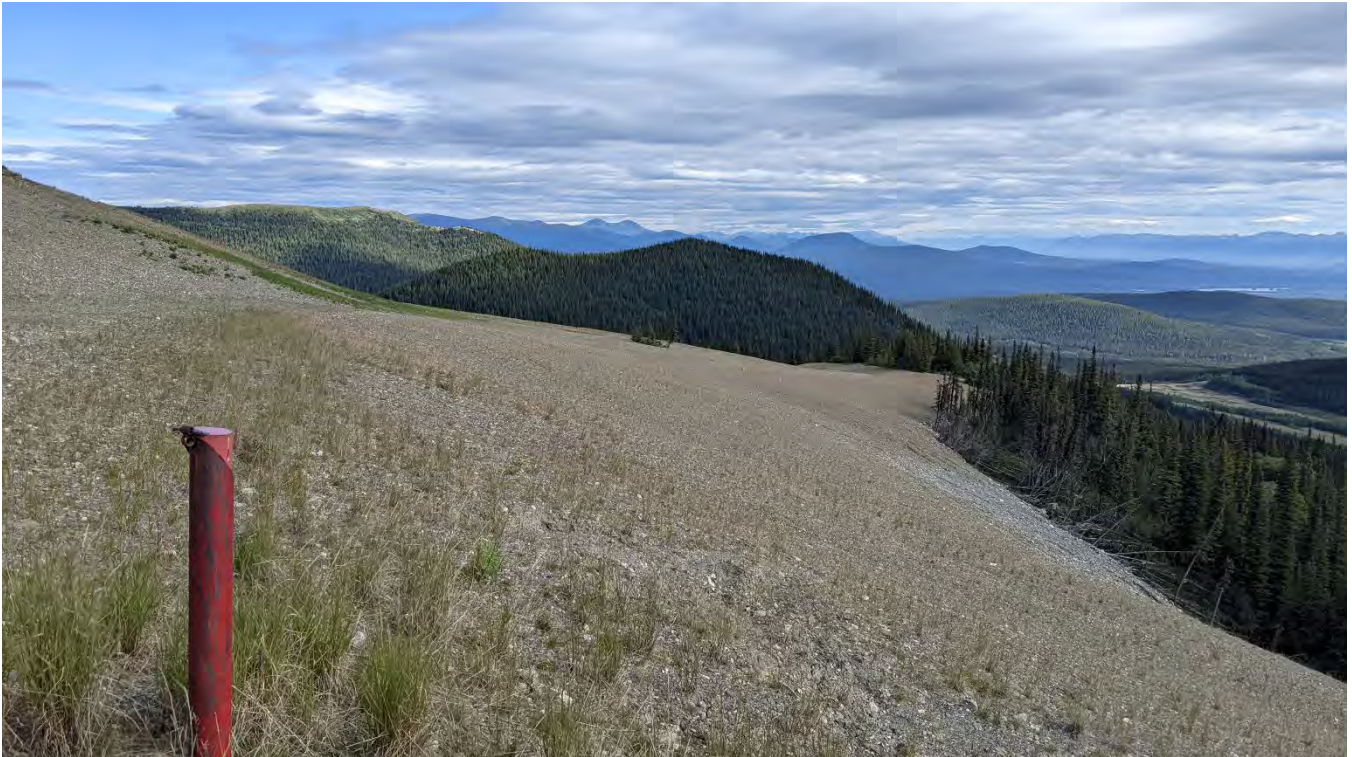
Photo WR-07: 1408 Portal Waste Rock Dump looking north.

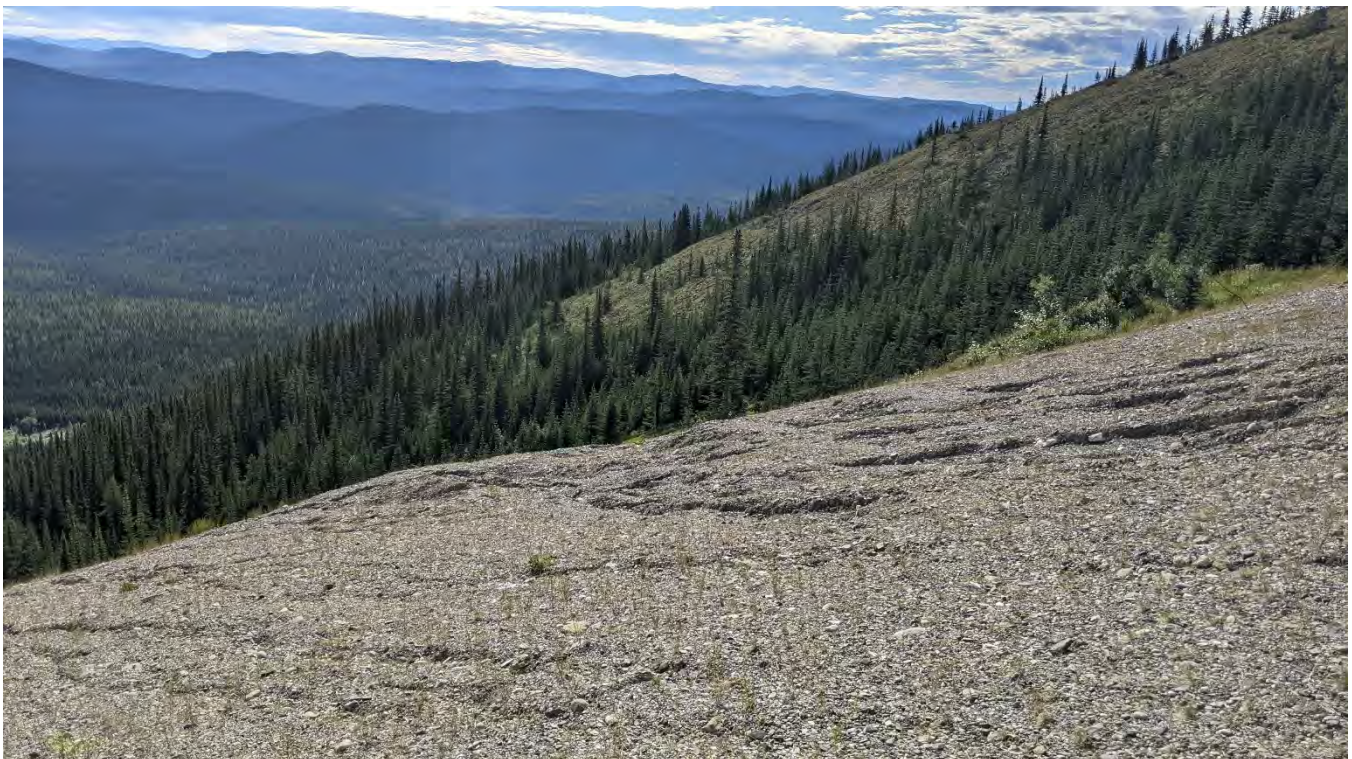
Photo WR-08: Surficial slumping near the south end of the 1408 Portal Waste Rock Dump

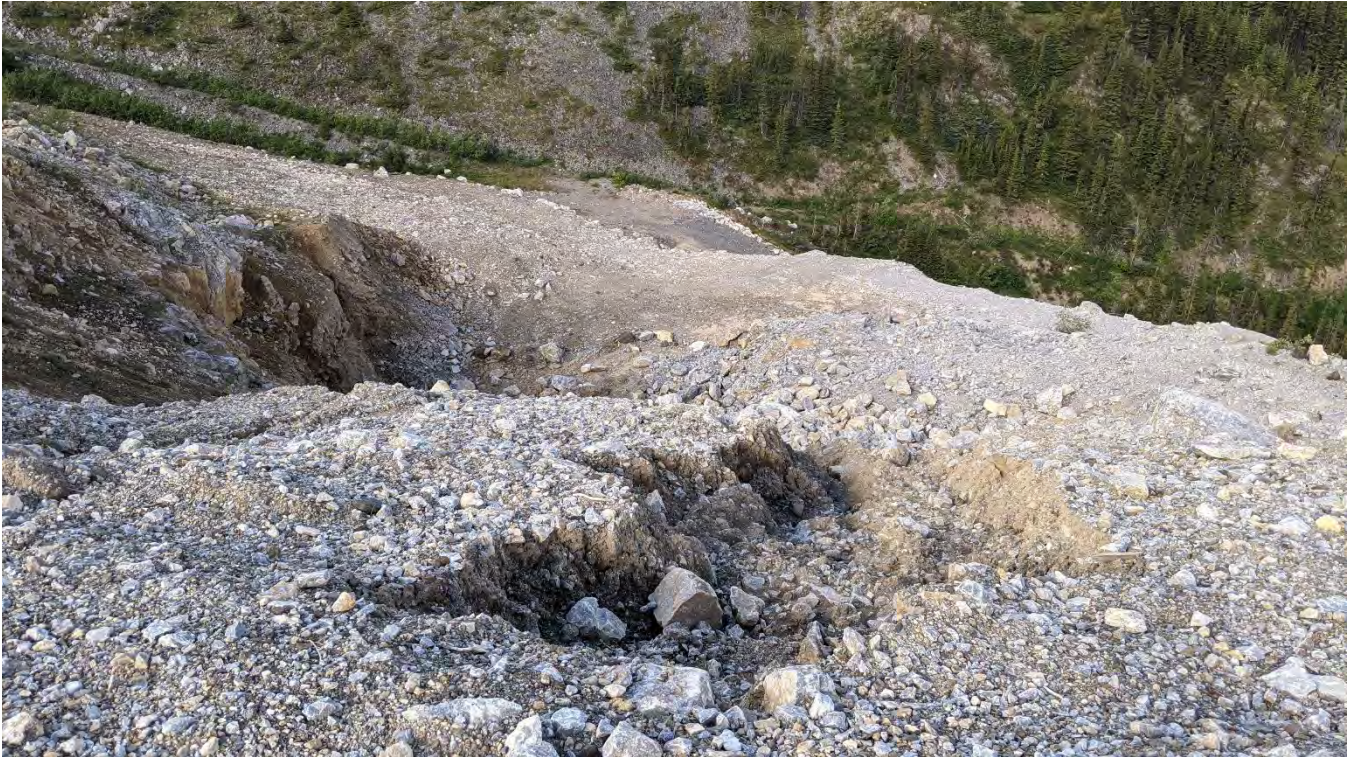
Photo WR-15: Erosion gully down the Main Zone Waste Rock Dump above the 1380 Portal.

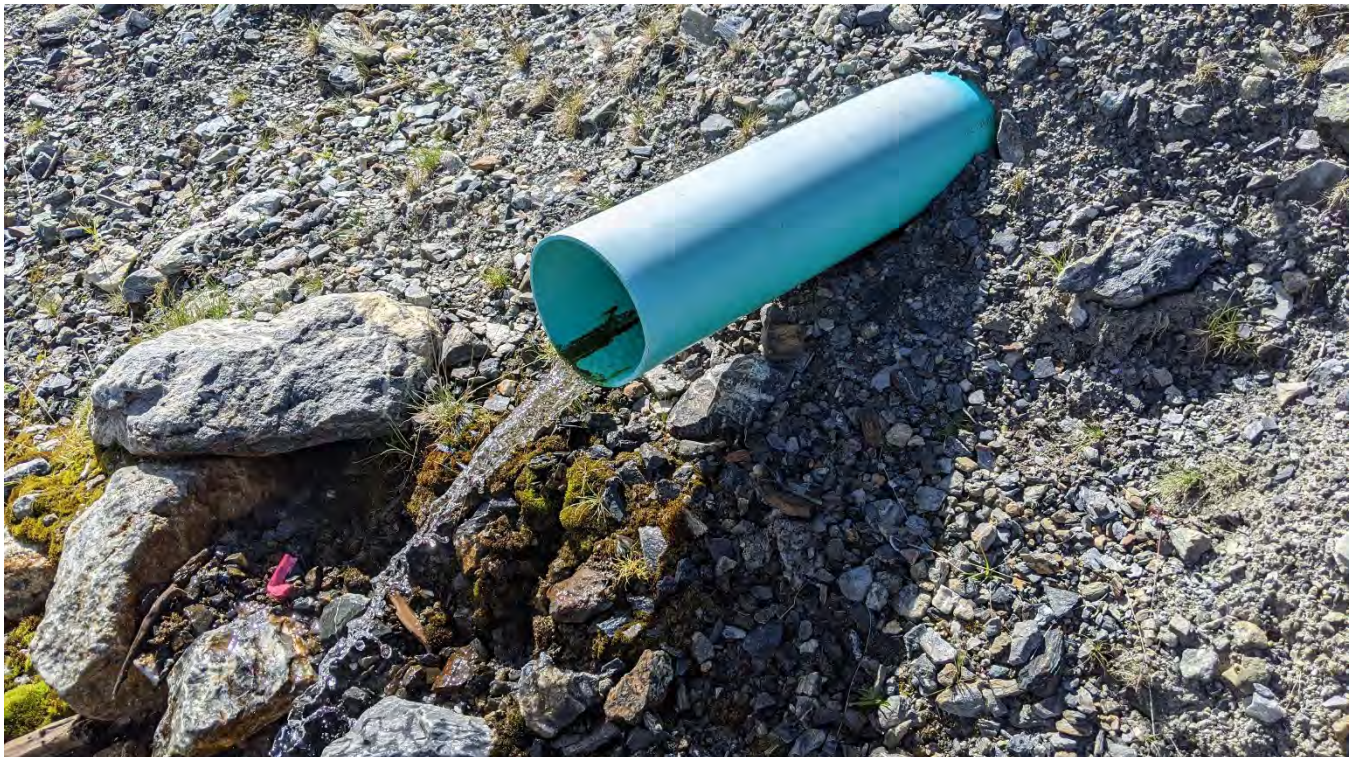
Photo WR-18: 1200 Portal drainpipe.

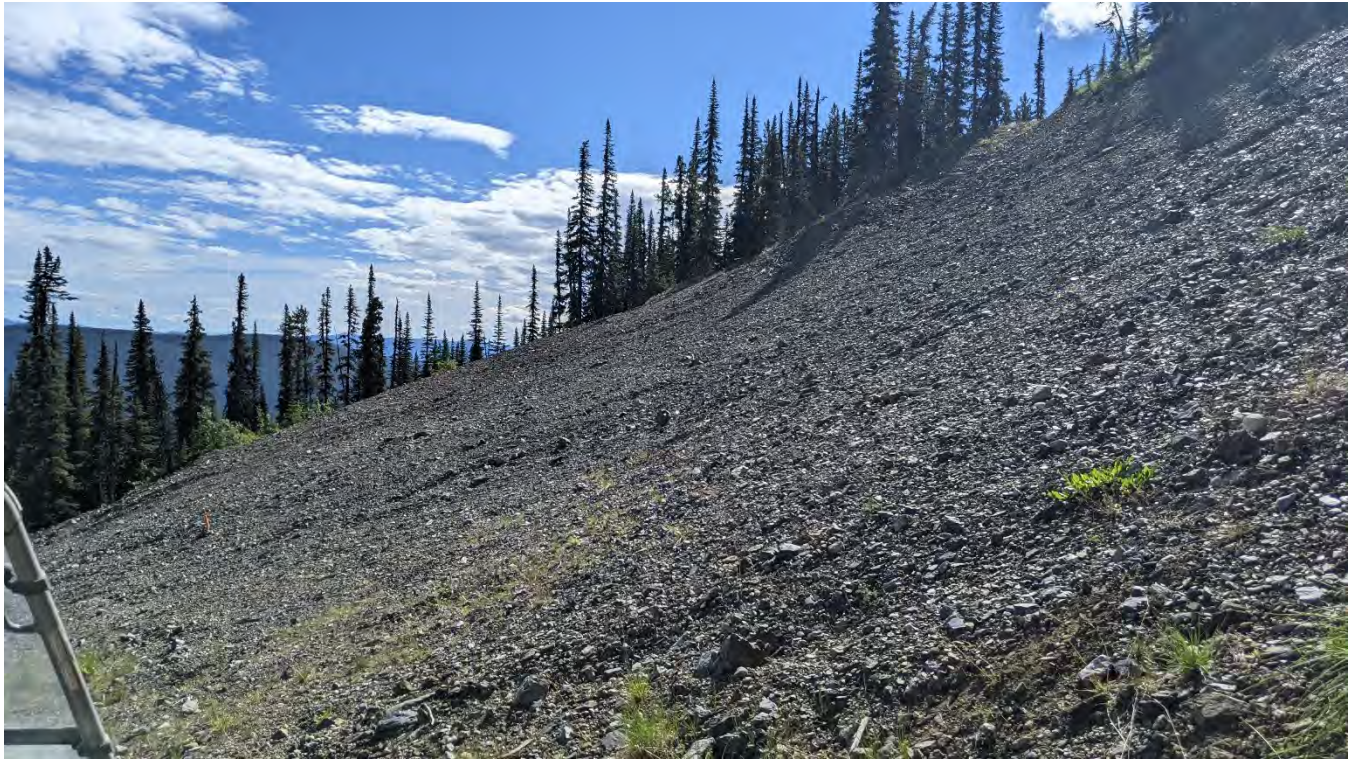
Photo WR-19: Regraded 1300 Portal Waste Rock Dump and 1300 Portal area

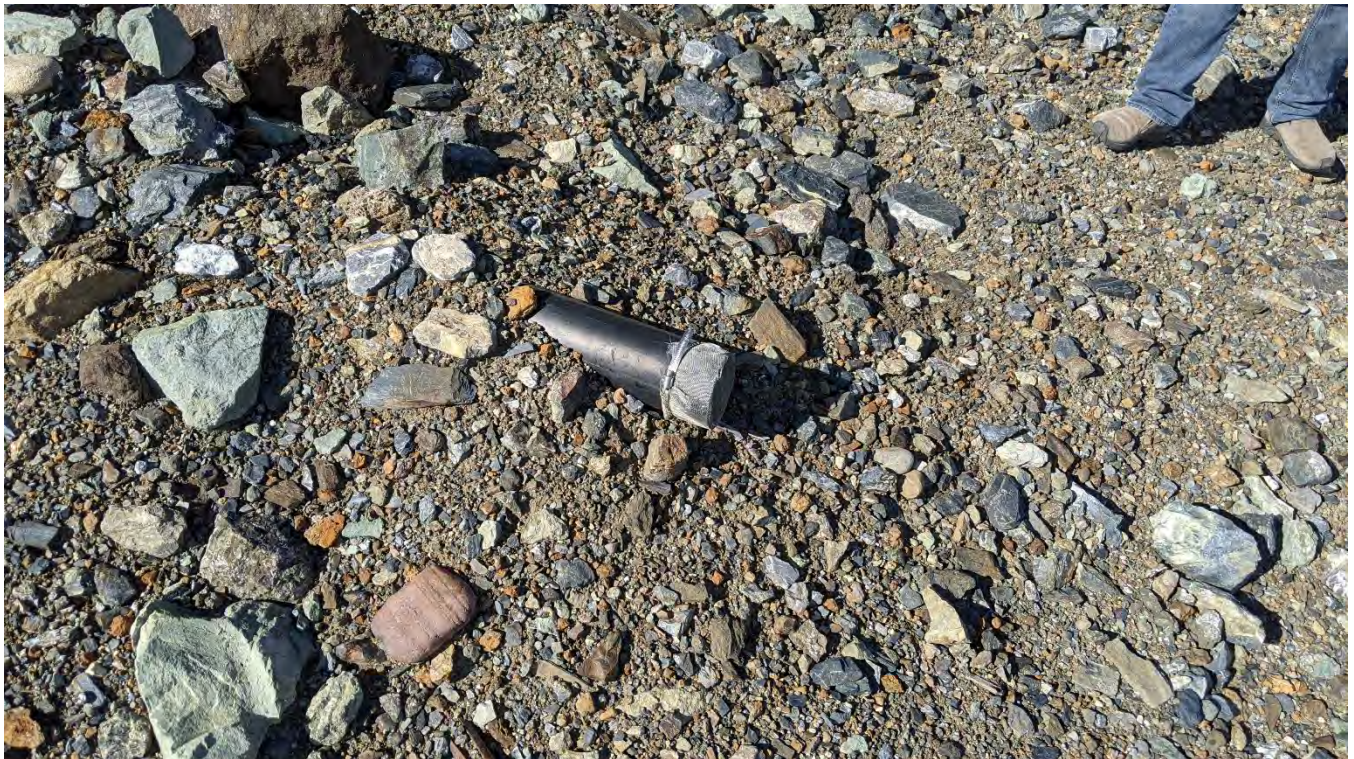
Photo WR-20: 1300 Portal drainpipe.
