2022 Annual Facility Performance Review Summary Report

Tailings Management Facility, Quebrada Blanca 2

Compañía Minera Teck Quebrada Blanca S.A.

Golder Associates S.A.

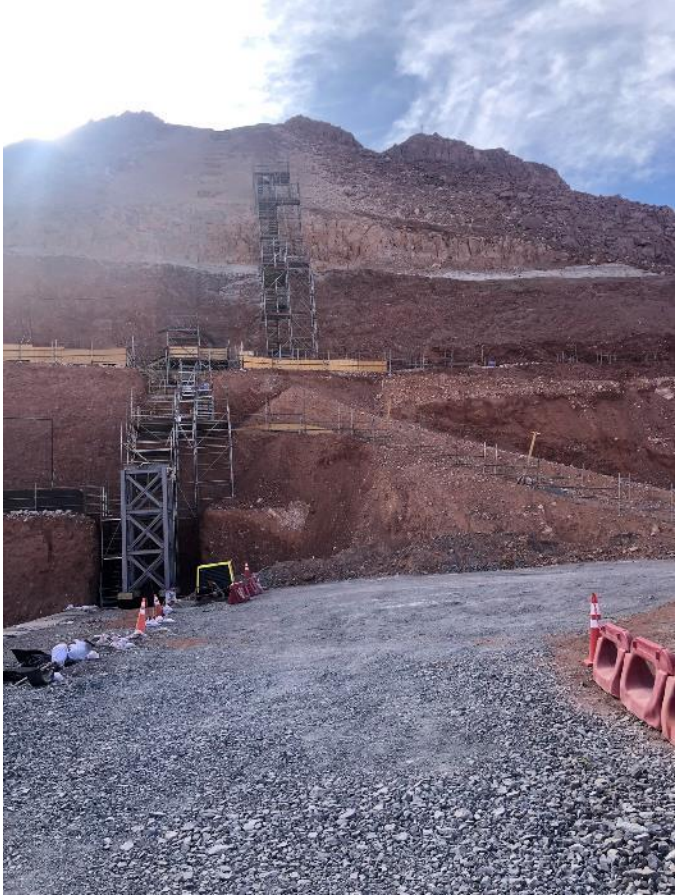
Plate 12: Tailings Distribution System (1442)

- An opportunity was identified for future backfilling of the pipe supports on the east abutment. Rather than placing and compacting sand in the confined space of a pipe support (see Plate 12), the use of lean concrete is to be considered. Use of the bedrock excavation may be made in combination with simple formwork on the outside face. Golder will consider this during the Phase I sand dam detailed design when it begins.

East abutment viewed from starter dam crest

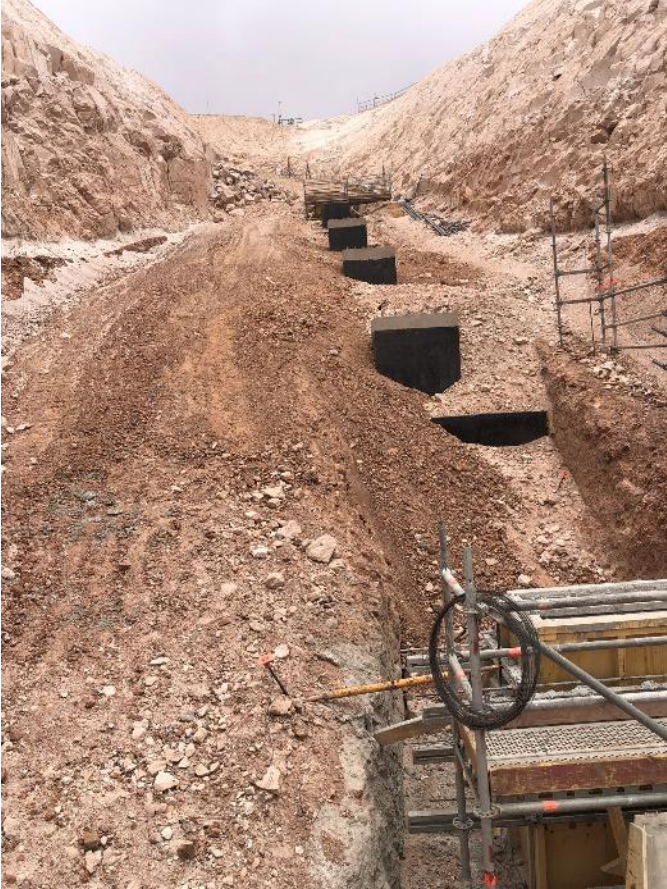
Plate 13: Tailings Distribution System (1442)

East abutment above starter dam crest

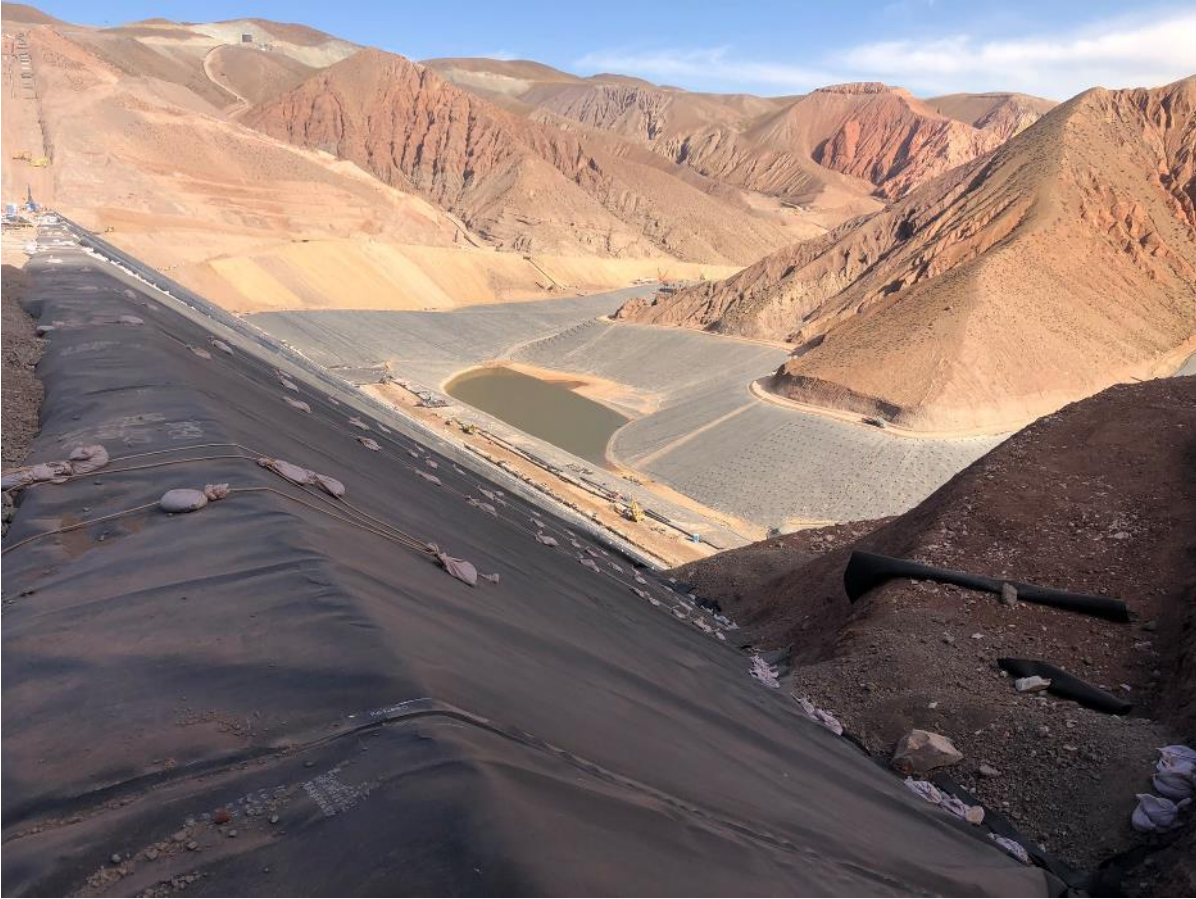
Plate 15: Initial Reclaim Pond (1400)

View from west abutment of starter dam crest

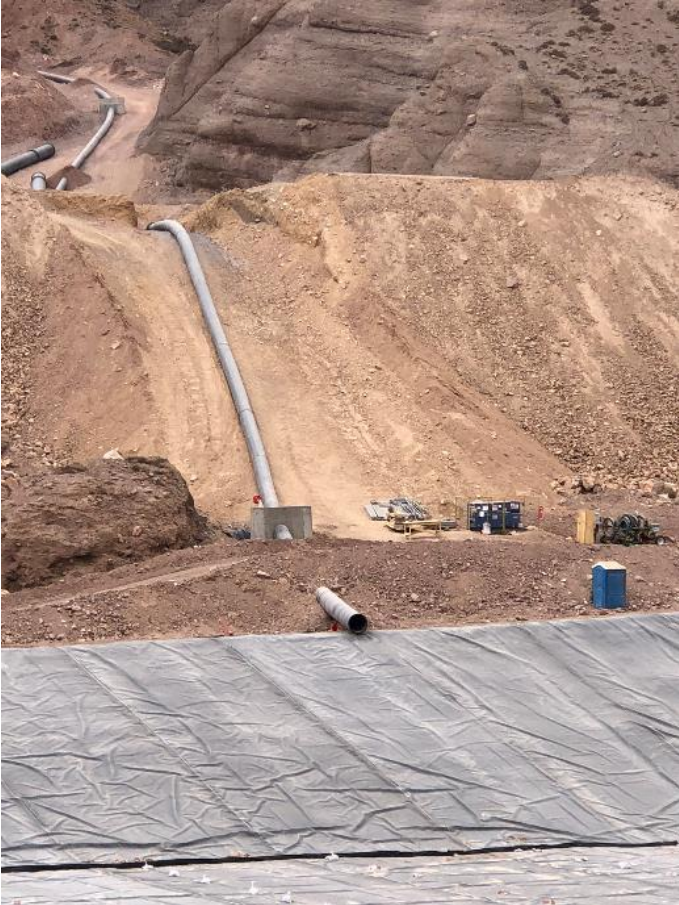
Plate 20: Cyclone Station (1441) & Initial Reclaim Pond (1424)

Outlet of emergency discharge pipeline

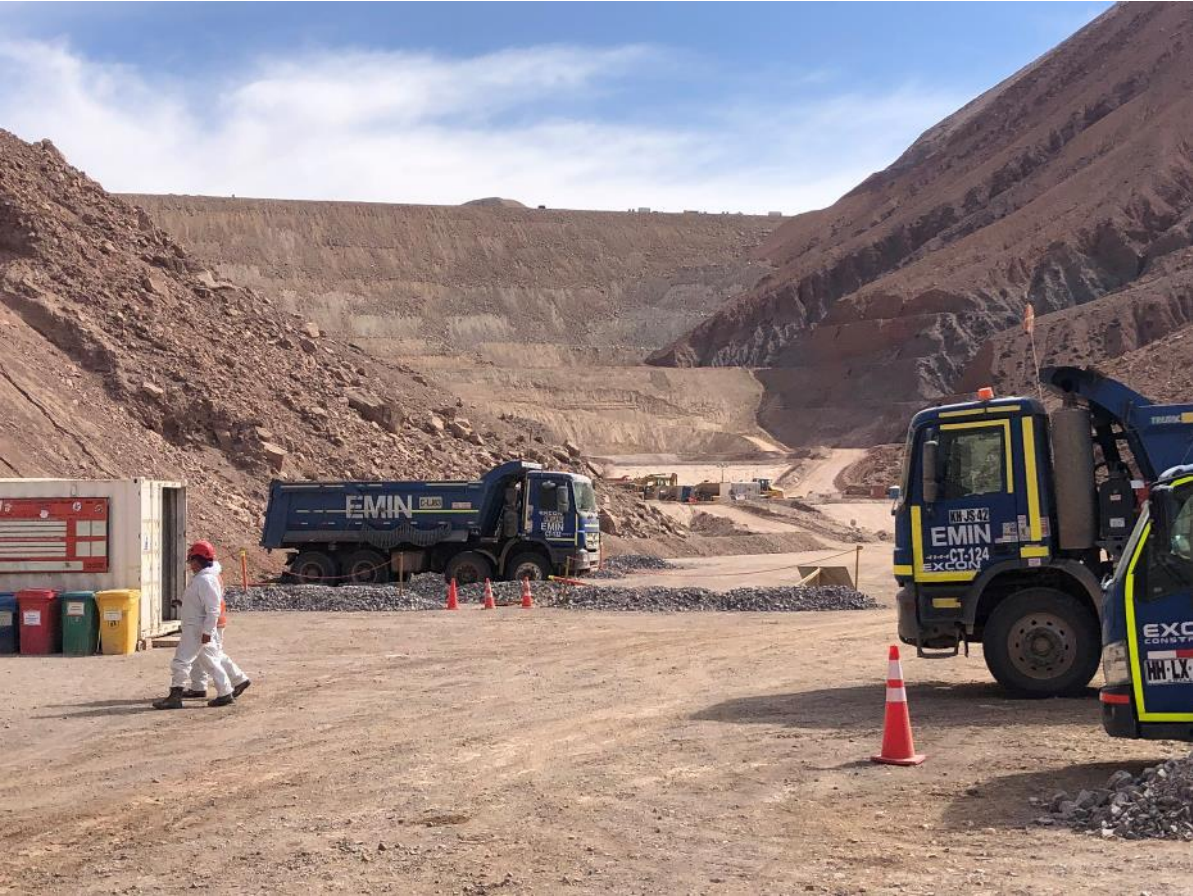
Plate 21: Starter Dam & Downstream Paddock Platforms (1452)

Looking upstream towards starter dam along dam drain

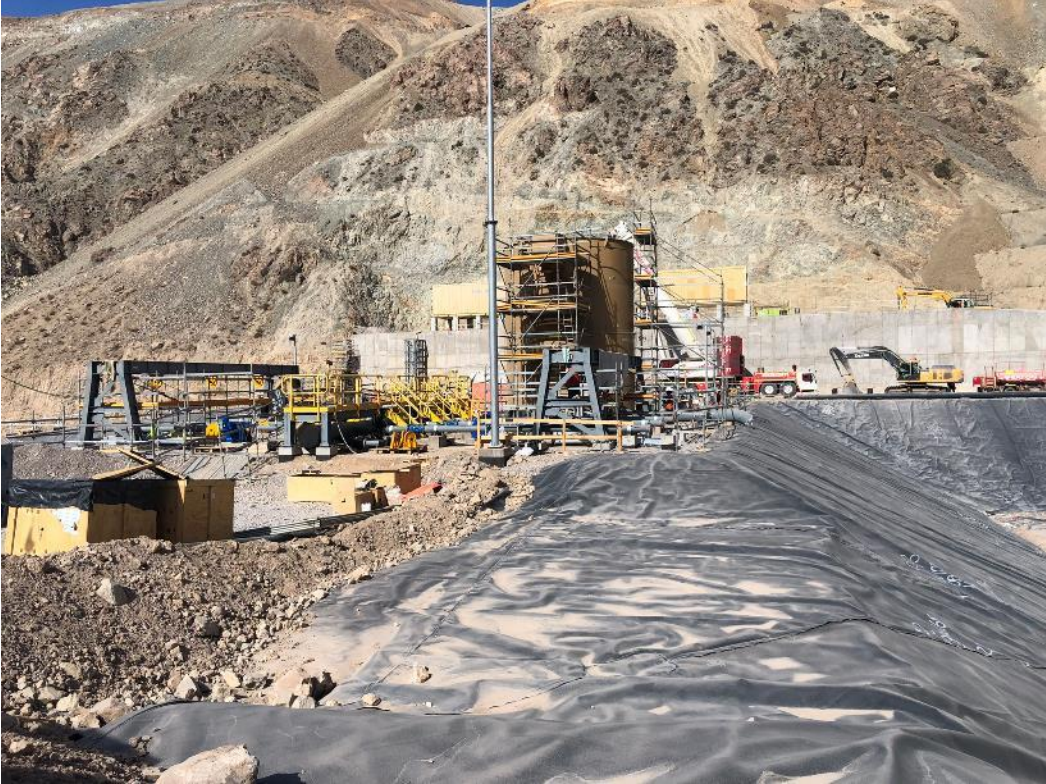
Plate 30: Seepage Collection Ponds (1461)

Central berm & pumping infrastructure

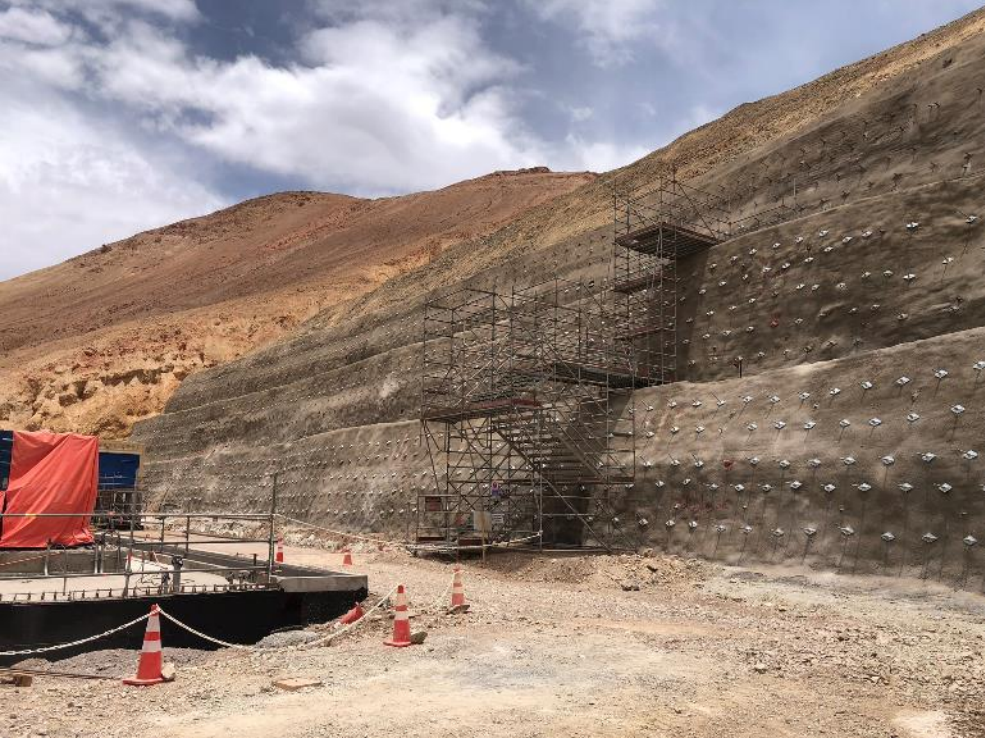
Plate 36: Booster Station No. 2 (1480)

Slope reinforcement measures

12.5	Other Unusual Conditions		x		
13.0 Booster Station No. 2					
13.1	Concern with cut slopes		x	36	Geotechnical instrumentation installation in-progress per design.
