Louvicourt Mine Tailings Storage Facility and Polishing Pond

2019 Dam Safety Inspection

001-19118317-5000-RA-Rev0

25 March 2020

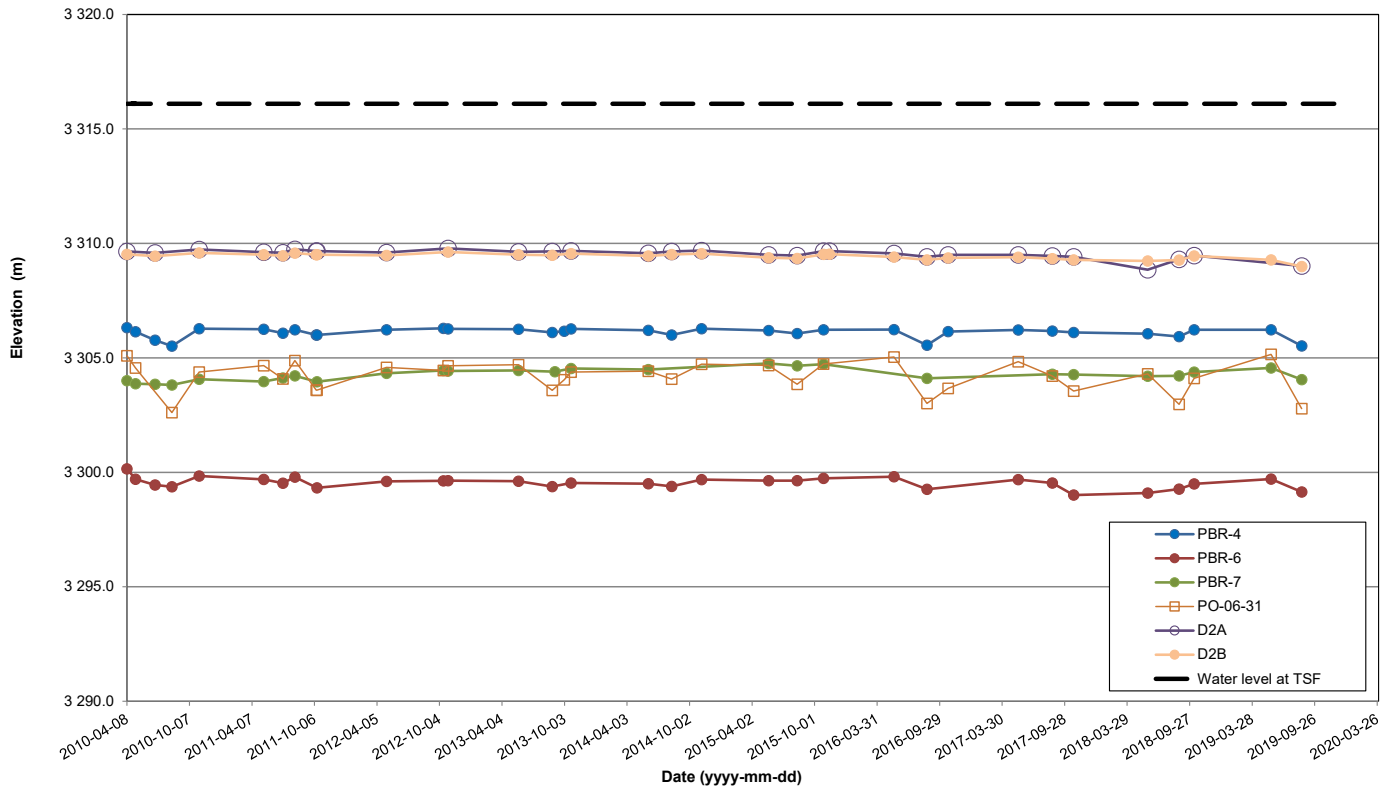
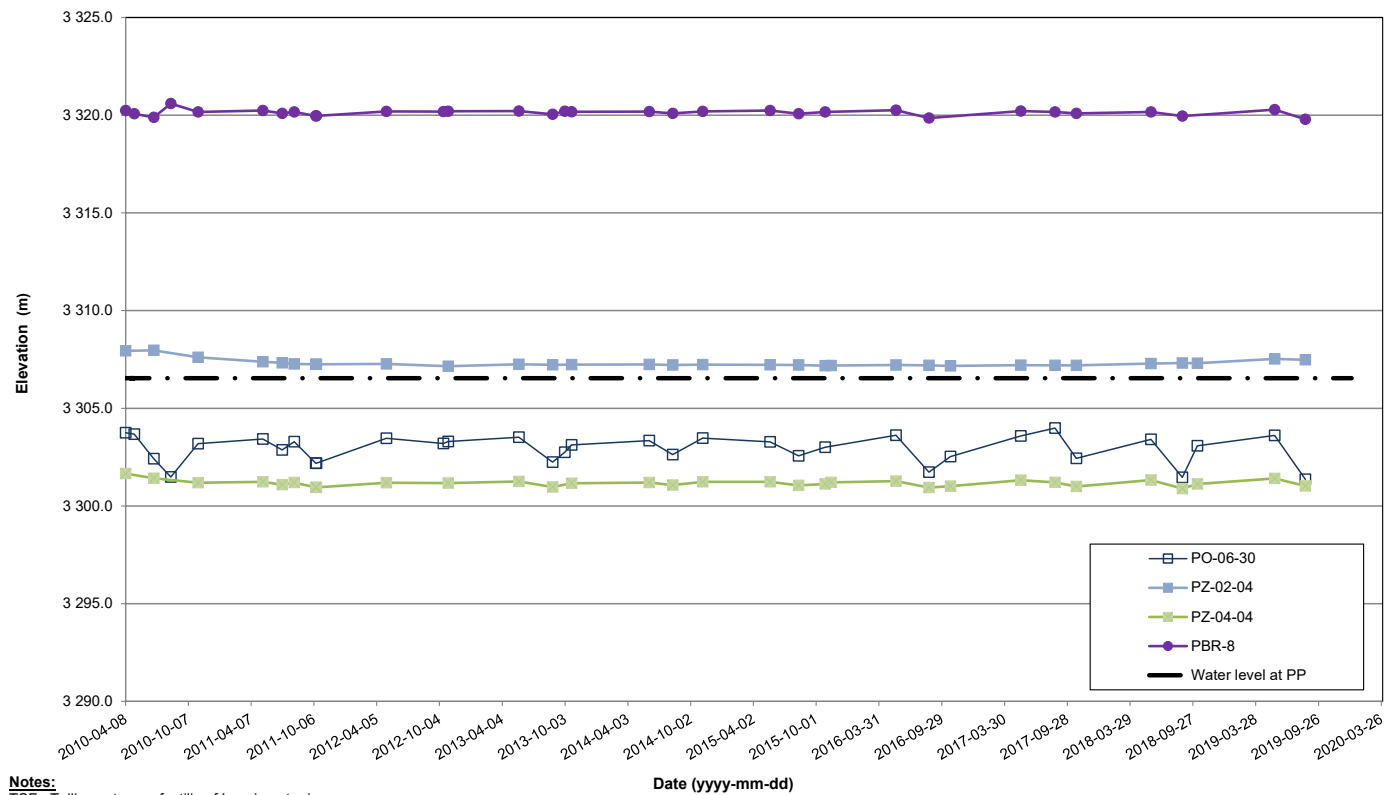
Figure 4: Water Level Measurements - Piezometers (Provided by Teck)

Figure 4 presents available groundwater levels for the dams. A total of four piezometers (PZ-02-04, PZ-04-04, D2A, D2B) are installed on the berms of three different dams. Six other observation wells (PBR-4, PBR-6, PBR-7, PRB-8, PO-06-30, PO-06-31) are located on natural ground, some distance away from the toe of the dams. The position of these wells is shown in Figure 1. Data for 2019 was compiled by Teck (Figure 4). It can be seen that recent values are quite stable for all wells and consistent with previous trends.

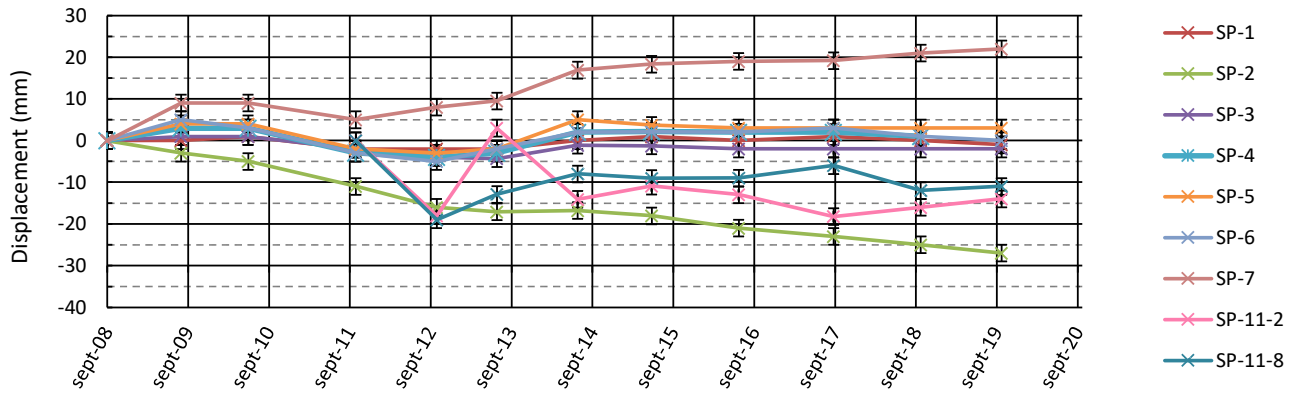
Figure 5 : Vertical Displacement of the Survey Monuments at Dam 1

Since the previous year, the vertical data shows that 2 monuments indicated minor upward movements and 9 monuments had settlements of 2 mm or less (which is the stated survey accuracy). Six monuments showed incremental settlements greater than 2 mm (3, 4 and 7 mm). All monuments show total settlement since installation of 27 mm or less. In order to better assess the settlement data, plots of historical settlement have been prepared as Figures 5 to 7.
