Teck Highland Valley Copper Partnership

2018 Dam Safety Inspection Report

Bethlehem No. 1 Tailings Storage Facility

March 2019

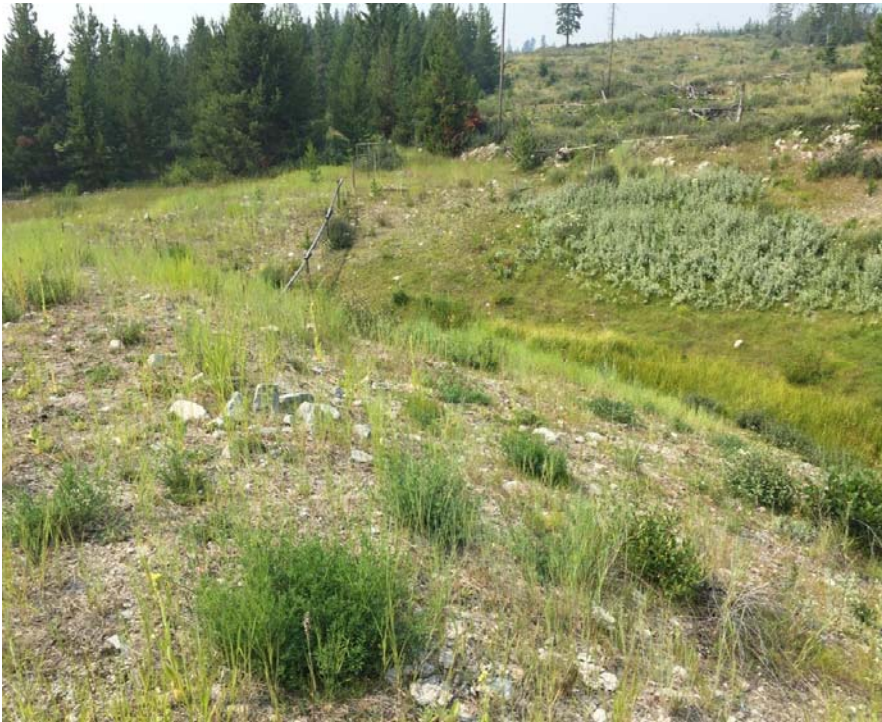
Photo II-B-8 Spillway channel at transition point between inlet and riprap-lined segment, looking southeast (downstream) towards Bose Lake (BTH-2018-12)

1. Similar to the observation during the 2017 inspection, vegetation growth was observed at the upstream portion of the riprap lined channel section near the concrete sill. This growth should be monitored and removed if deemed to be impacting the spillway capacity or riprap integrity.
2. Seepage collection system outlet flowing at approximately 1 L/s.
3. The animal burrowing and minor downstream slope erosion features, noted in the 2017 inspection, were not observed during the 2018 site inspection.

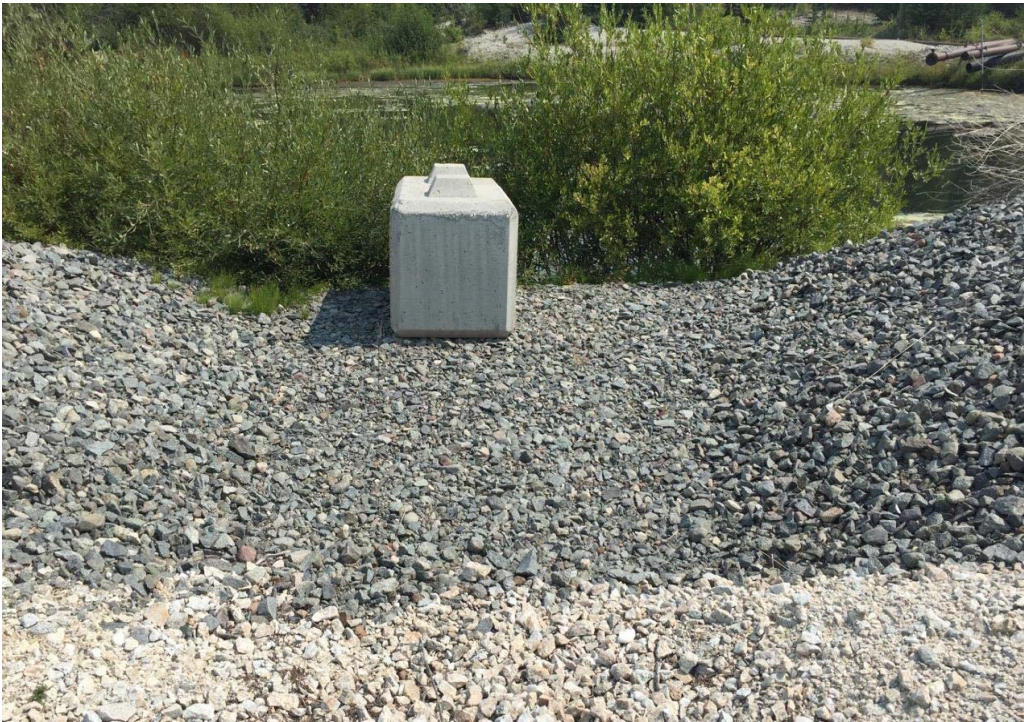
Photo II-C-6 Spillway crossing at right abutment, looking downstream (BTH-2018-22)

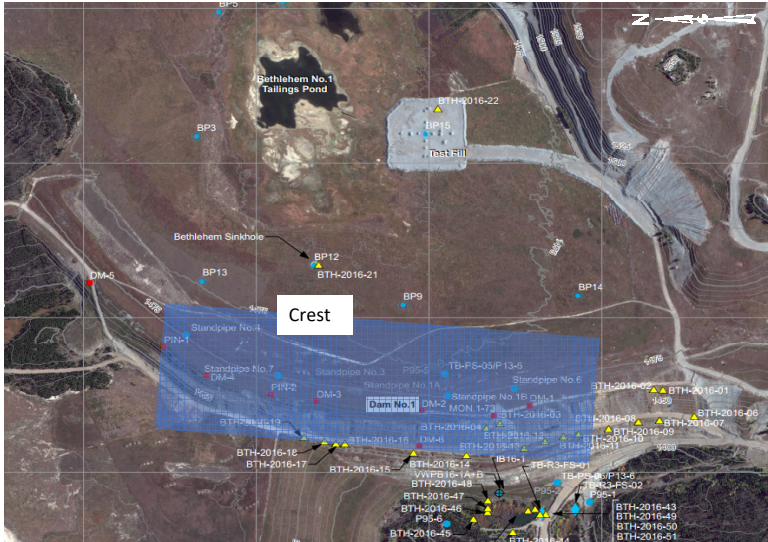
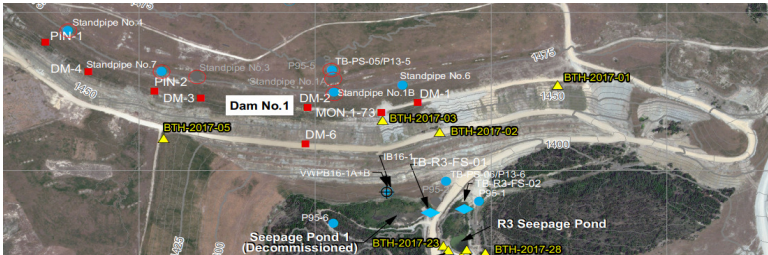
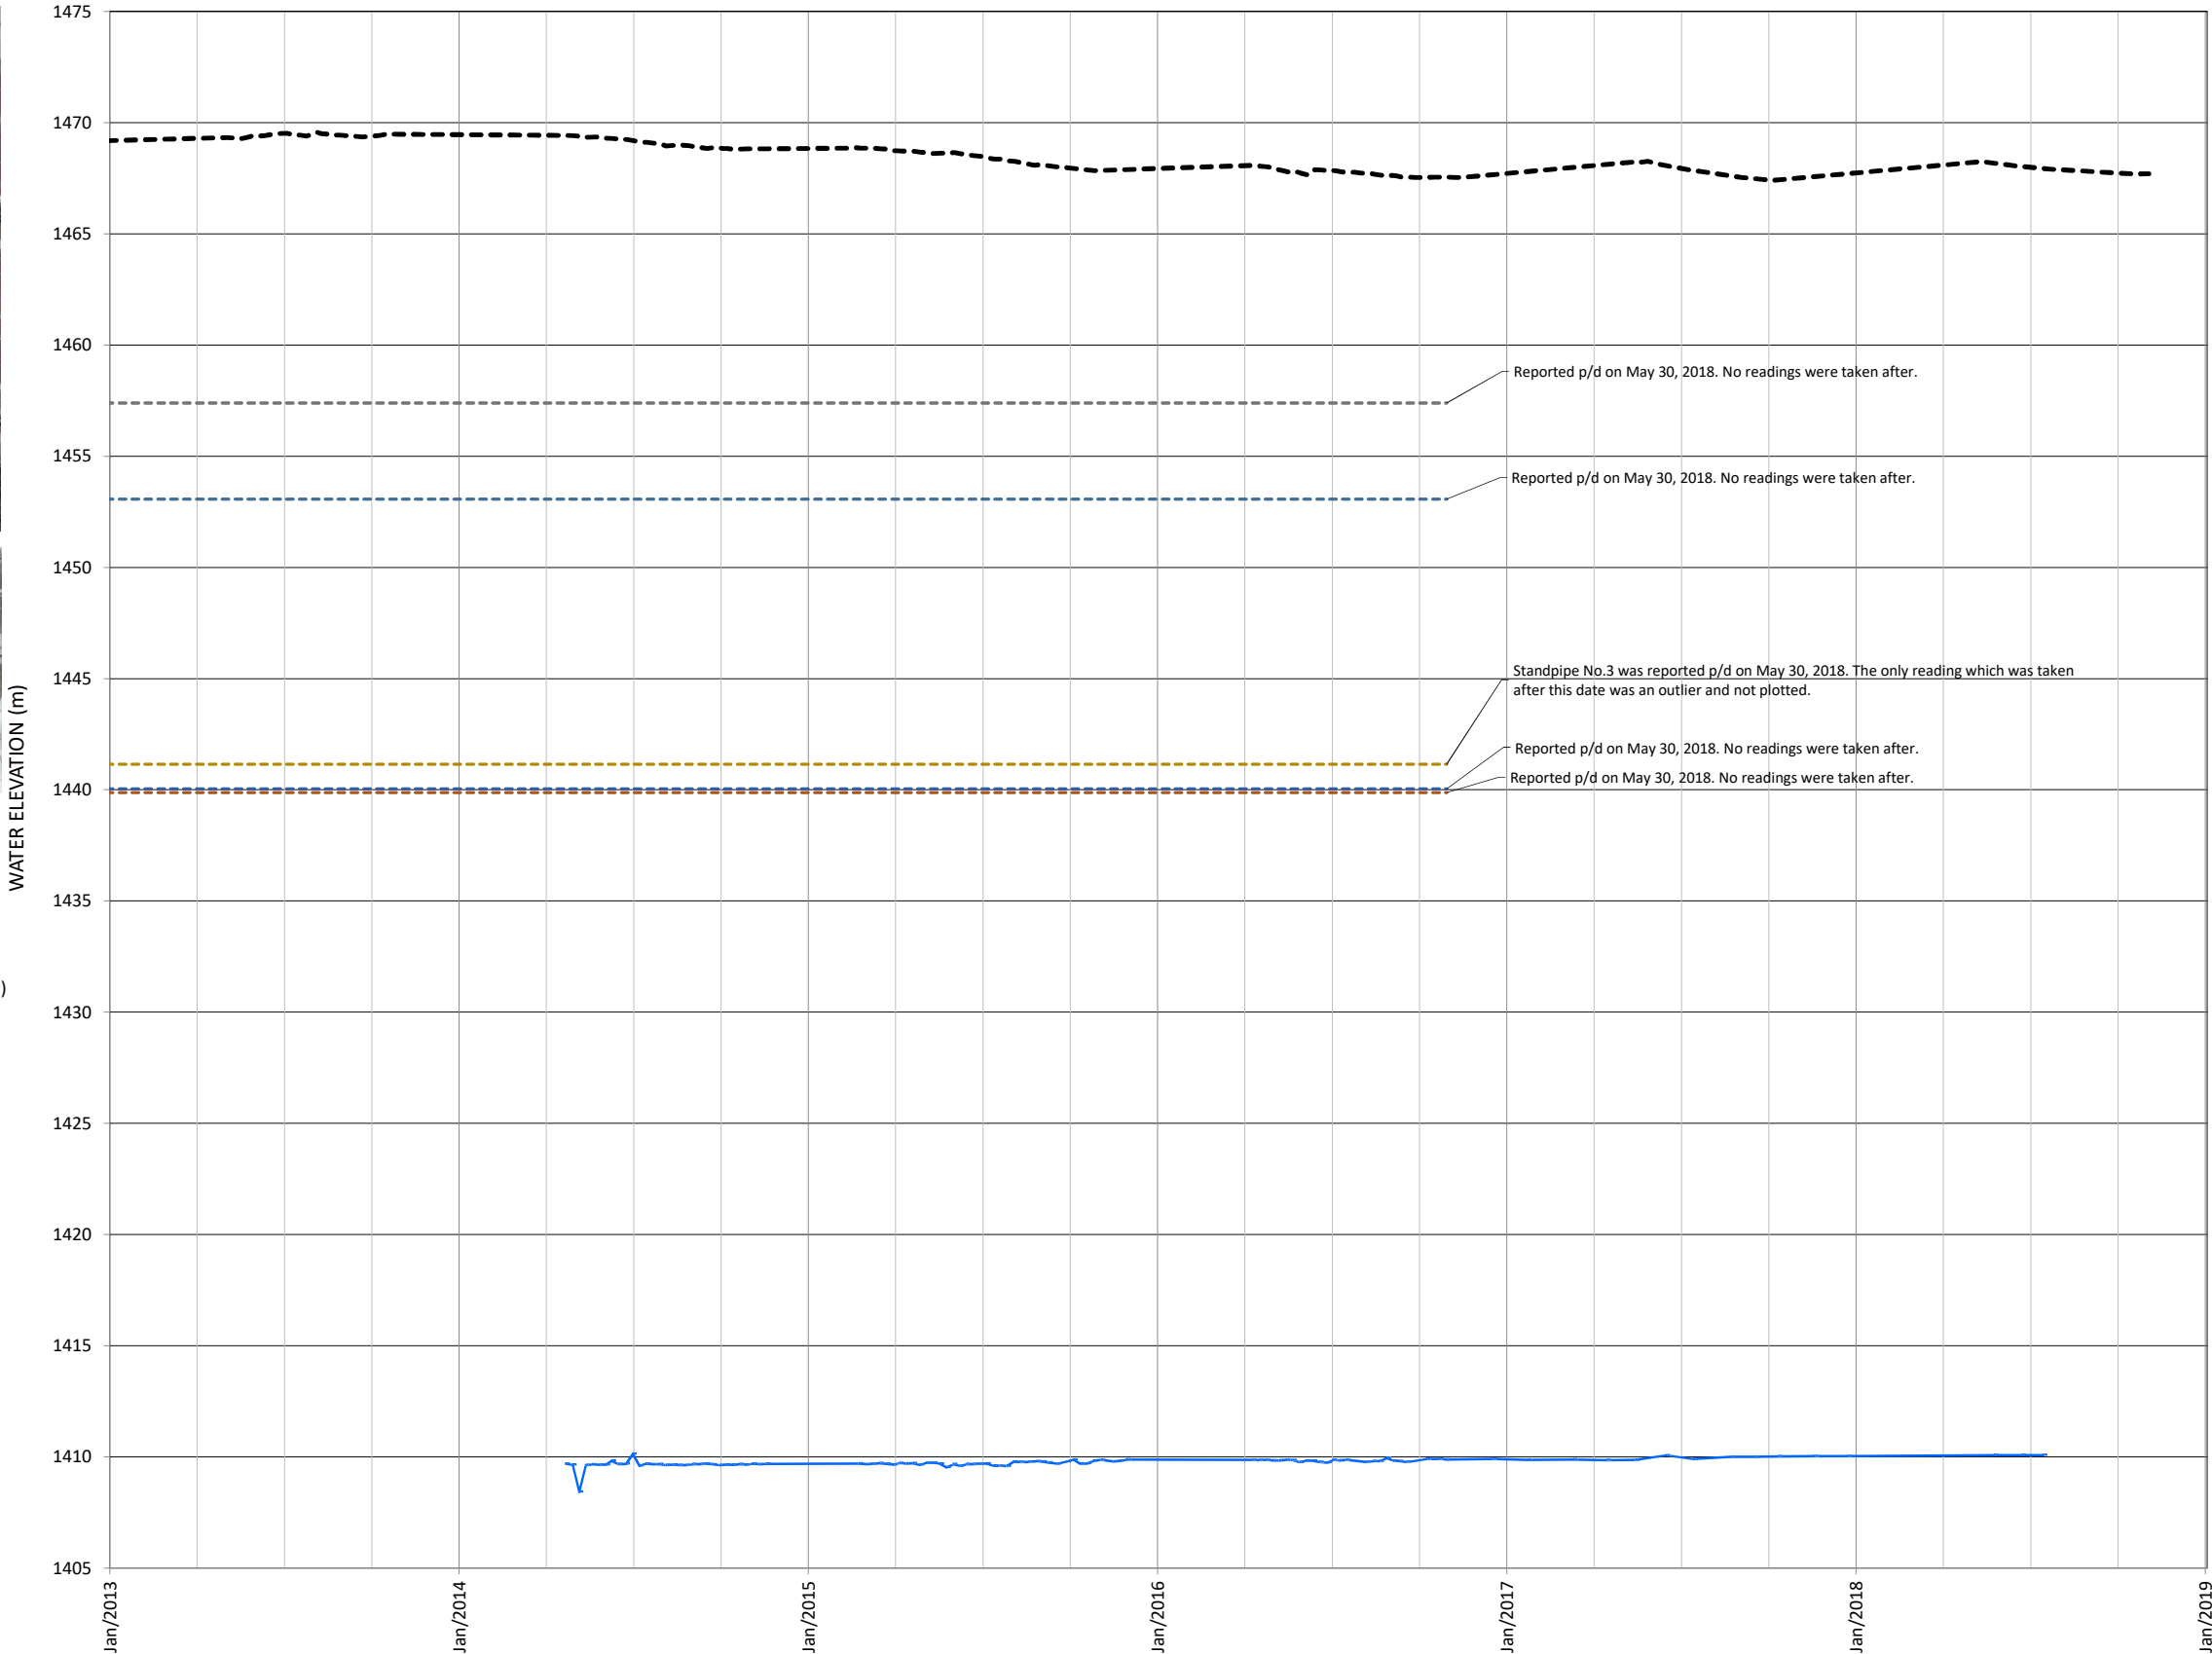
Klohn Crippen Berger</div>	<div>PROJECT No.</div> <div>M02341B43</div>		
	<div>FIG No.</div> <div>IV-2</div>

- STANDPIPE NO. 3 HAS BEEN NOTED AS DRY/PLUGGED IN THE RECORDS AND LIKELY EXPLAINS THE ERRATIC JUMPS IN MEASUREMENTS. HOWEVER A FALLING HEAD TEST CONDUCTED IN 2015 INDICATED THE PIEZOMETER WAS STILL RESPONDING.
- STANDPIPE NO. 6 WAS TESTED IN 2015 AND FOUND TO BE DEFUNCT.
- TIP ELEVATION FROM ORIGINAL LOGS. THE INSTRUMENT WAS SOUNDED IN 2015 AND THE TIP ELEVATION WAS FOUND TO BE EL. 1441.05 m WHICH WAS USED TO SET THE ALERT THRESHOLD.

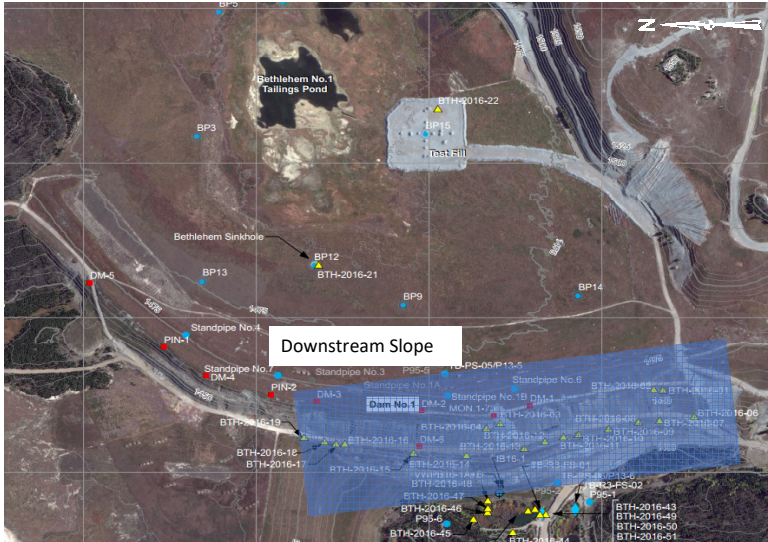
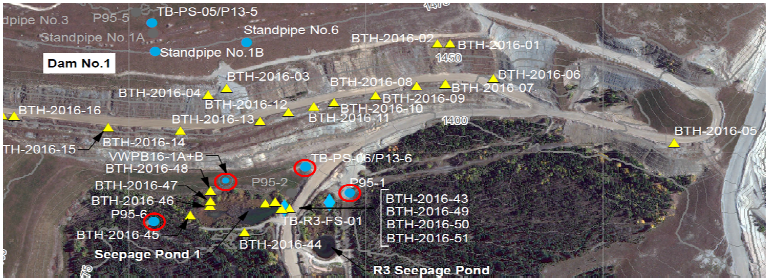
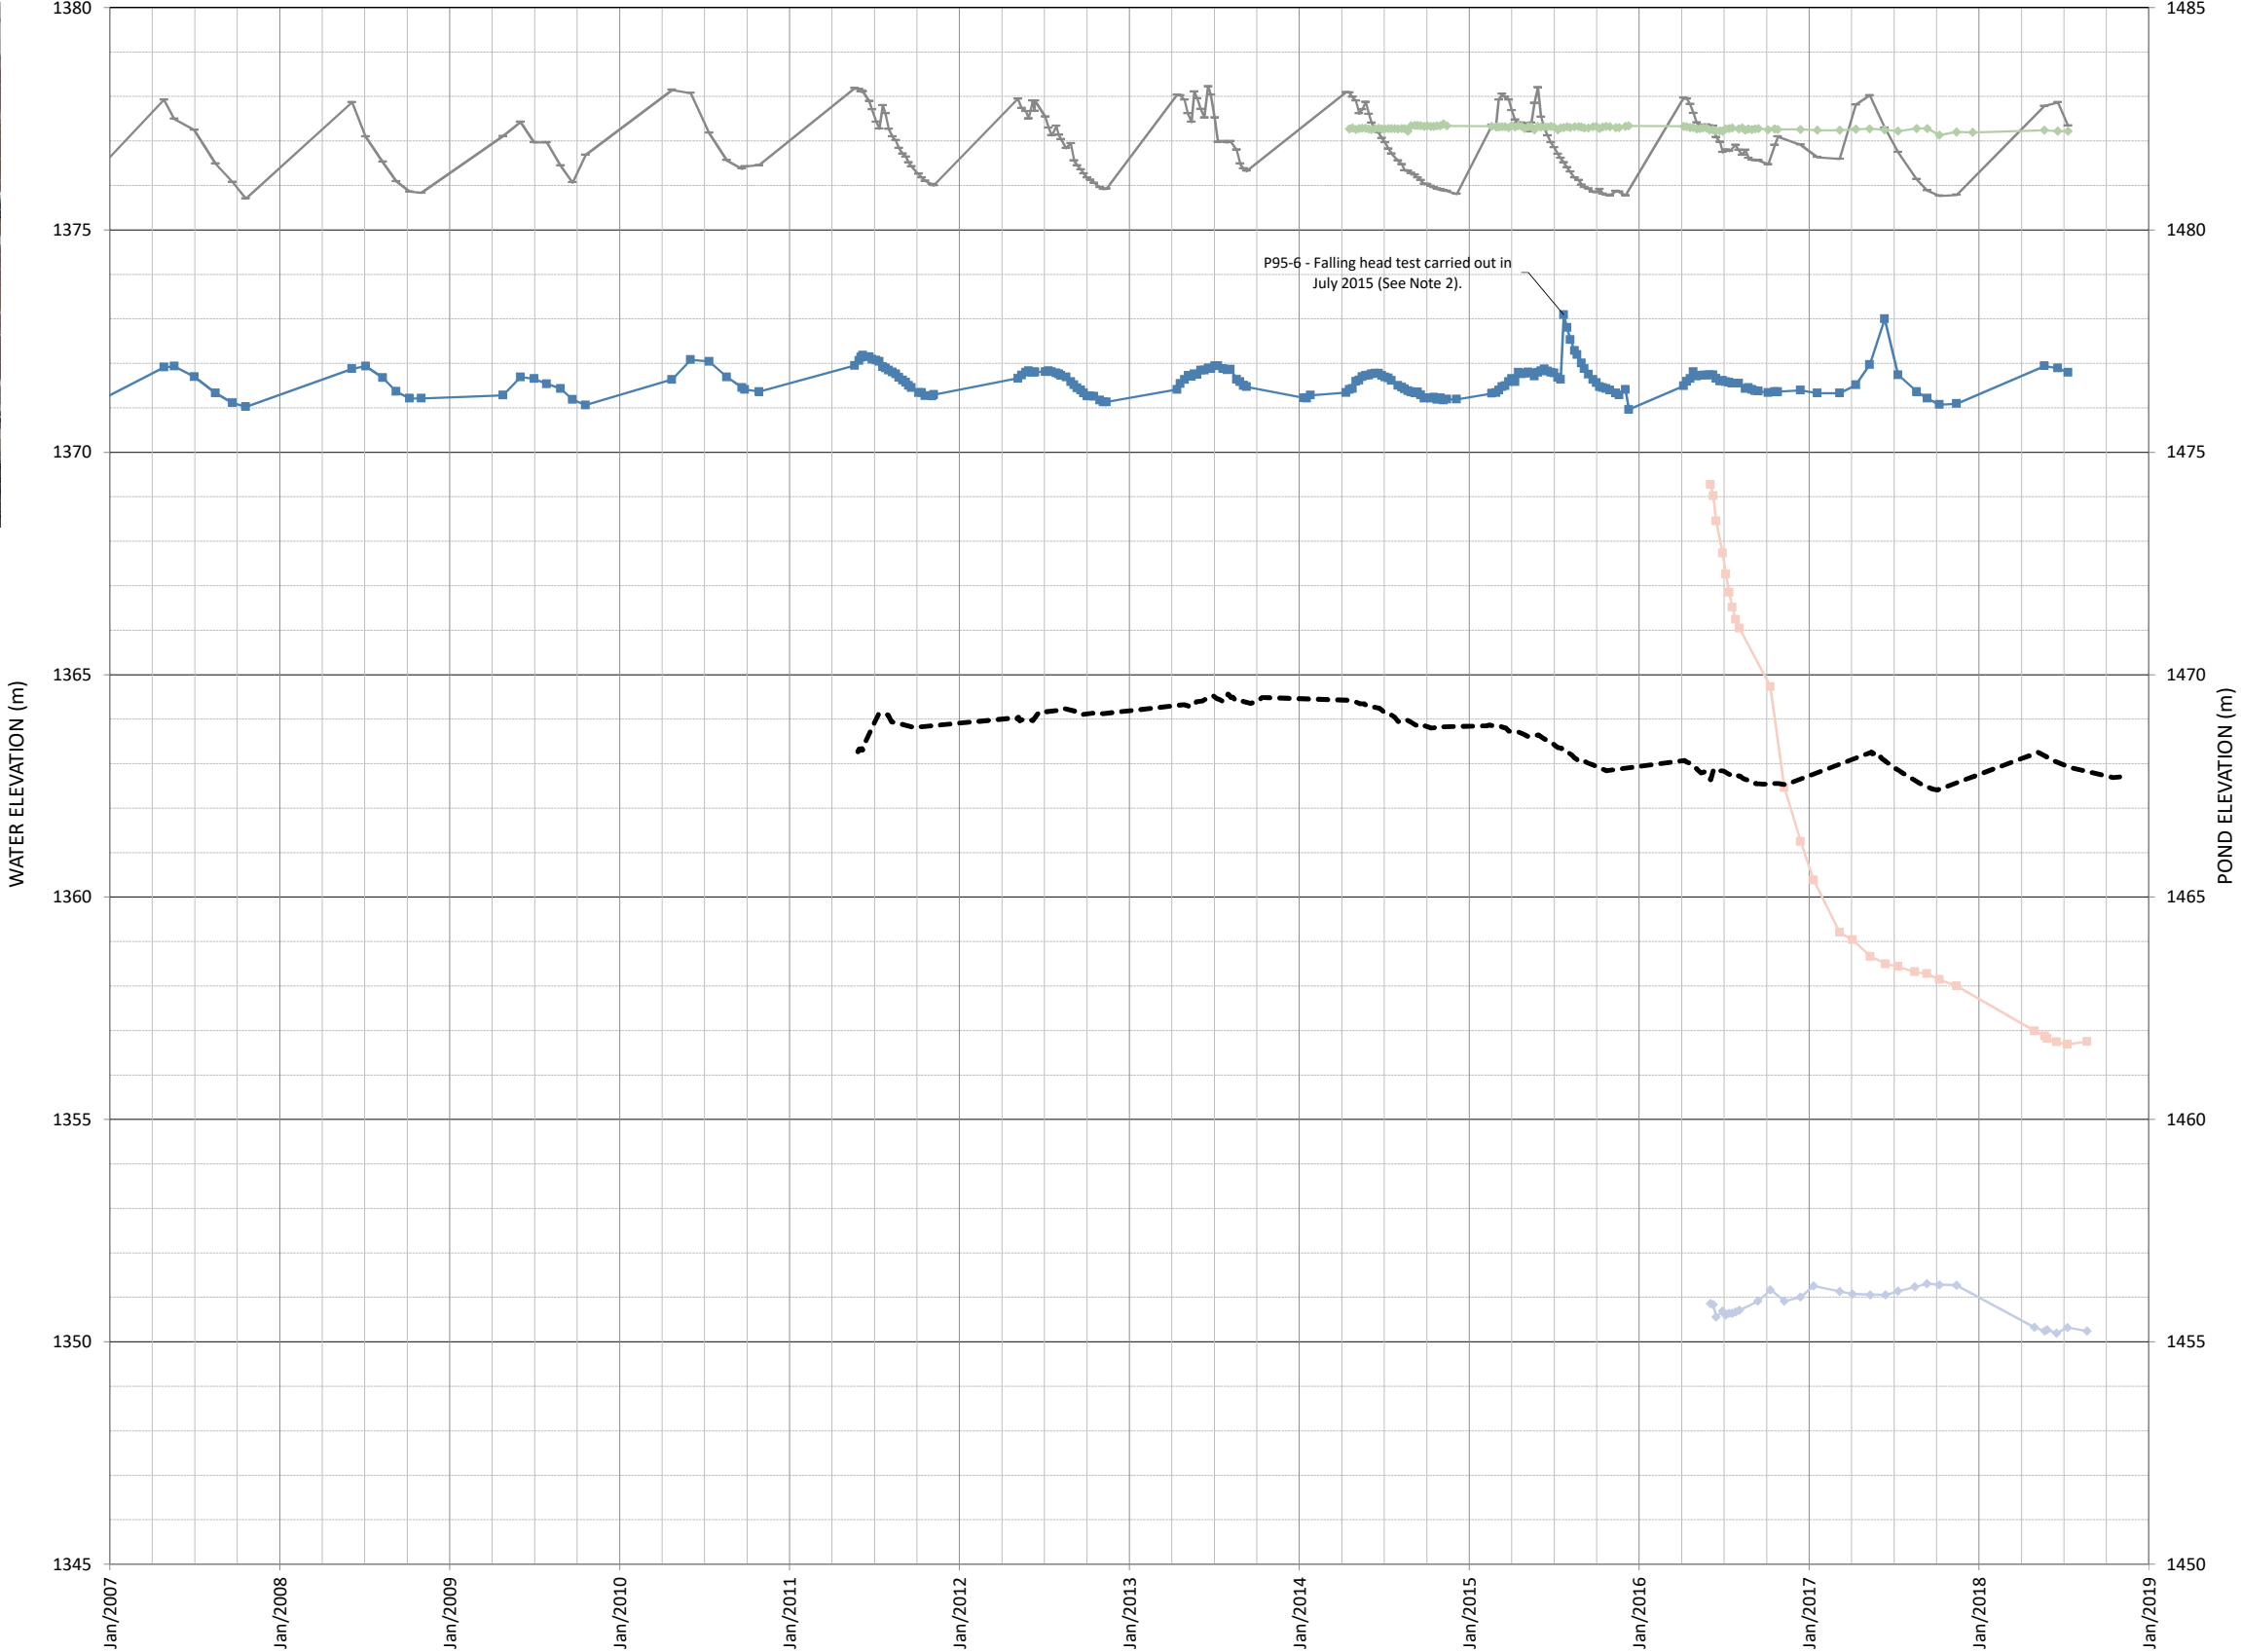
- NOTES:**
- PIEZOMETER WATER ELEVATIONS PLOTTED ON PRIMARY (LEFT) AXIS, POND ELEVATION PLOTTED ON SECONDARY (RIGHT) AXIS.
 - FALLING HEAD TEST CARRIED OUT ON P95-6 DURING JULY 2015 - CAUSE OF SPIKE IN PIEZOMETRIC LEVELS

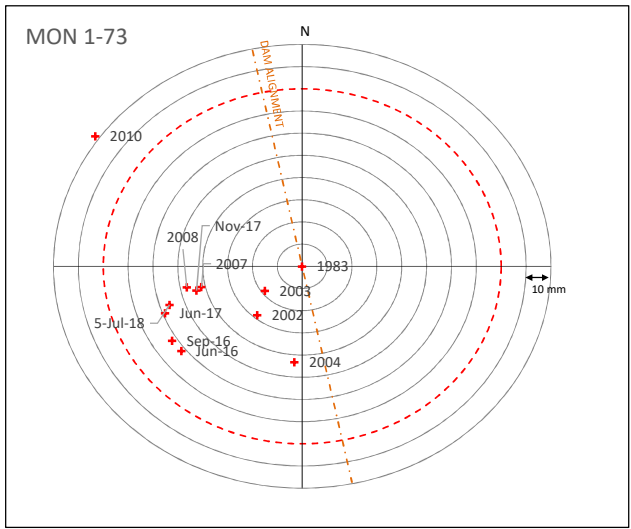
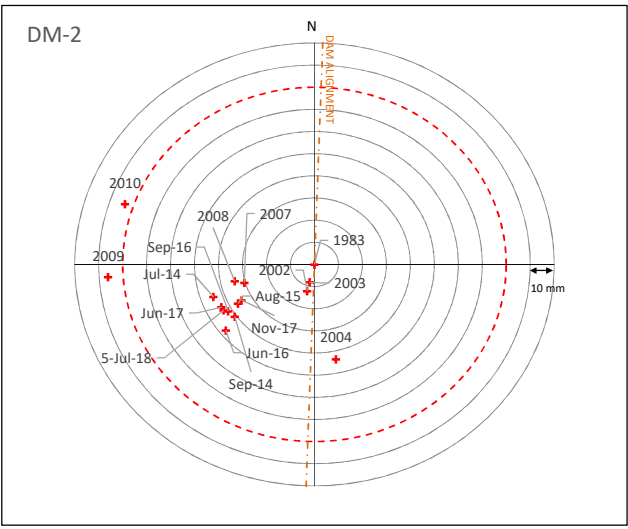
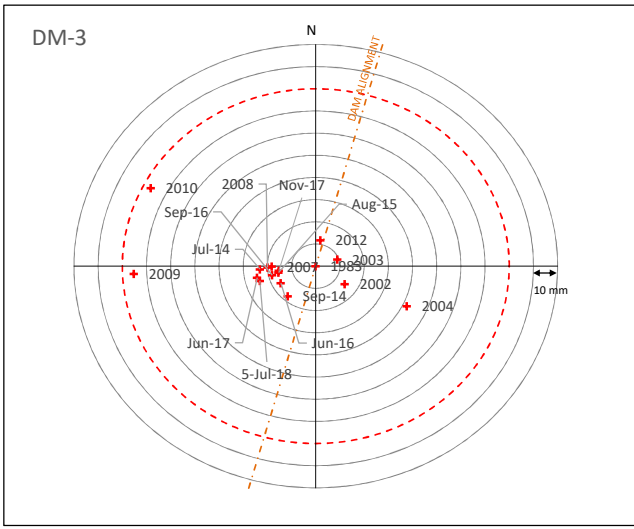
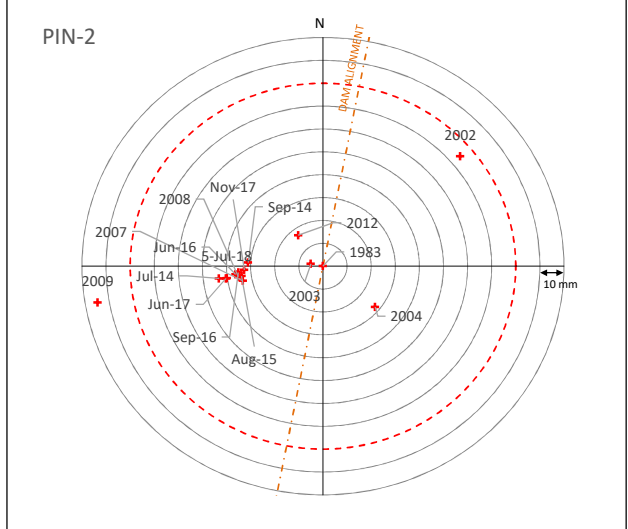
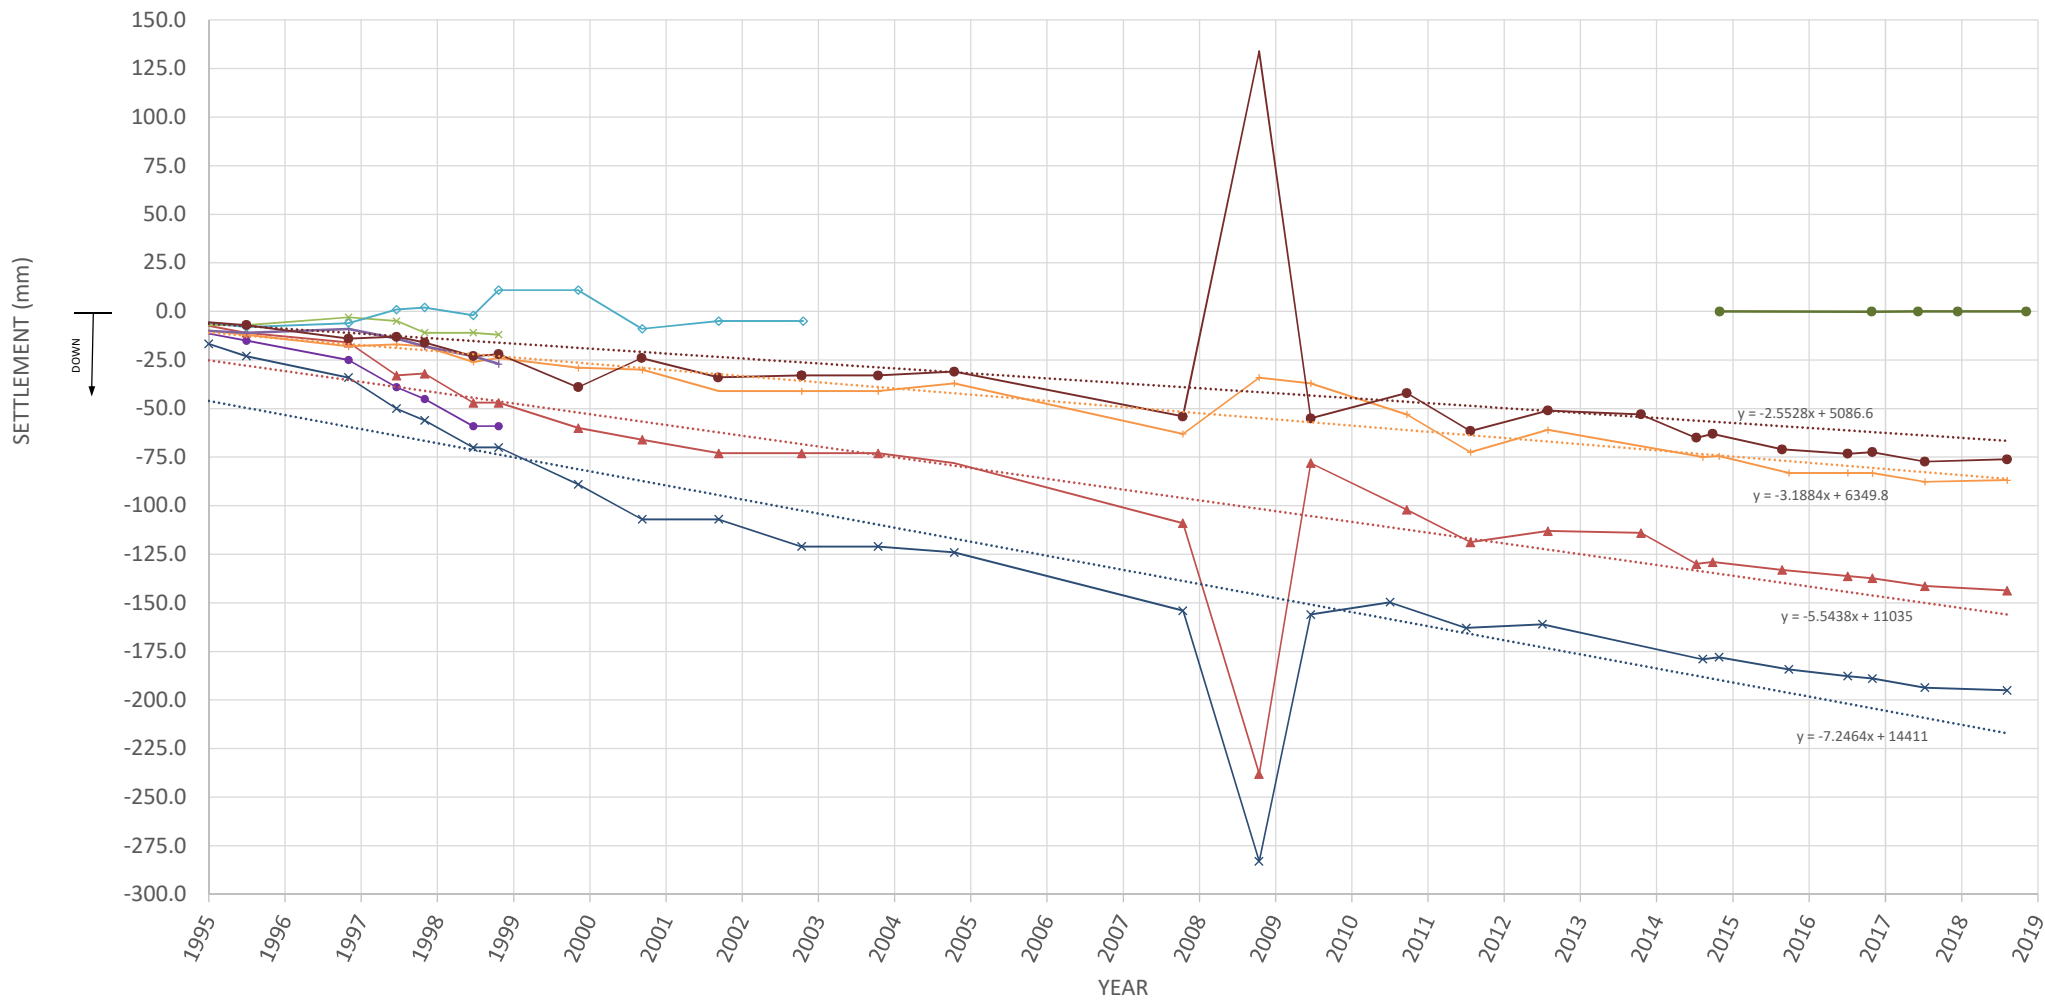
- DAM No. 1 MOVEMENT MONITORING DATA PRIOR TO 1995 NOT SHOWN.
- REFER TO FIGURE 3 FOR MONUMENT LOCATIONS IN PLAN VIEW.
- DM-1, DM-4 AND DM-5 DESTROYED IN 1999.
- DM-6 DESTROYED IN 2002.

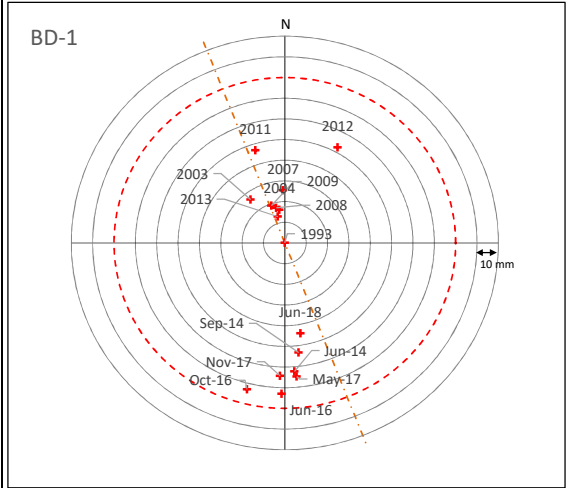
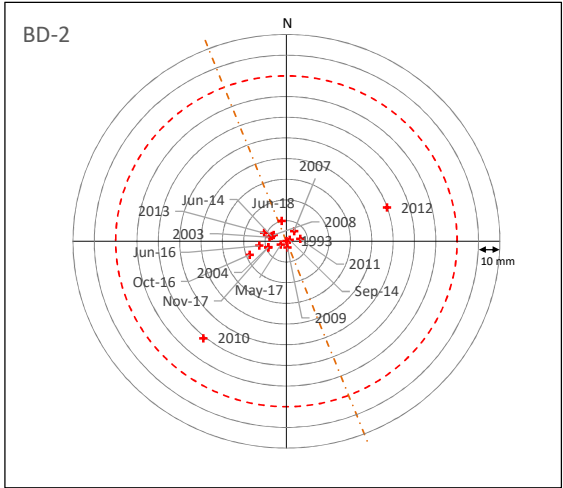
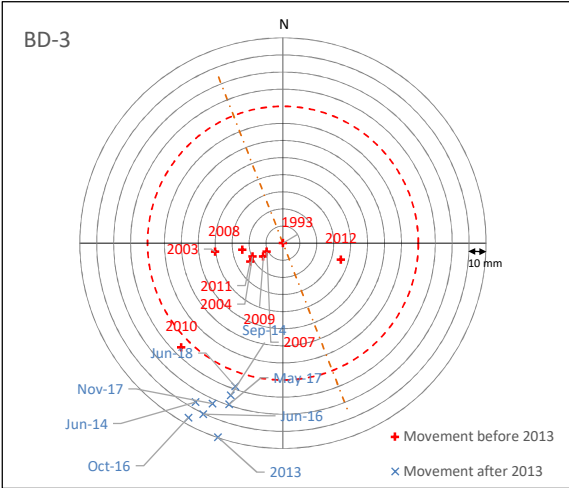
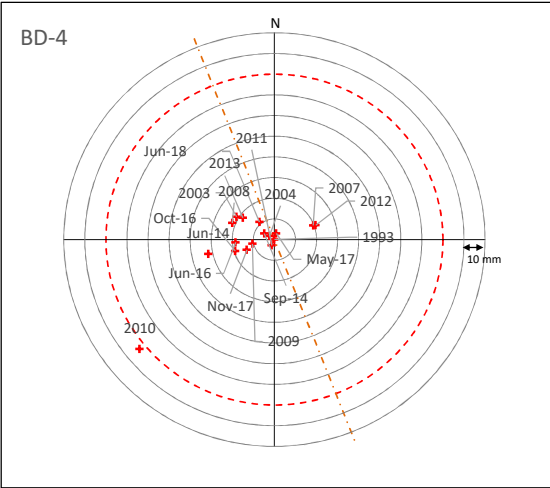
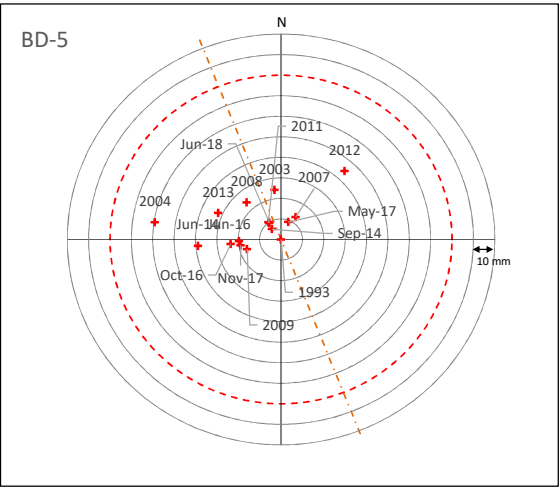
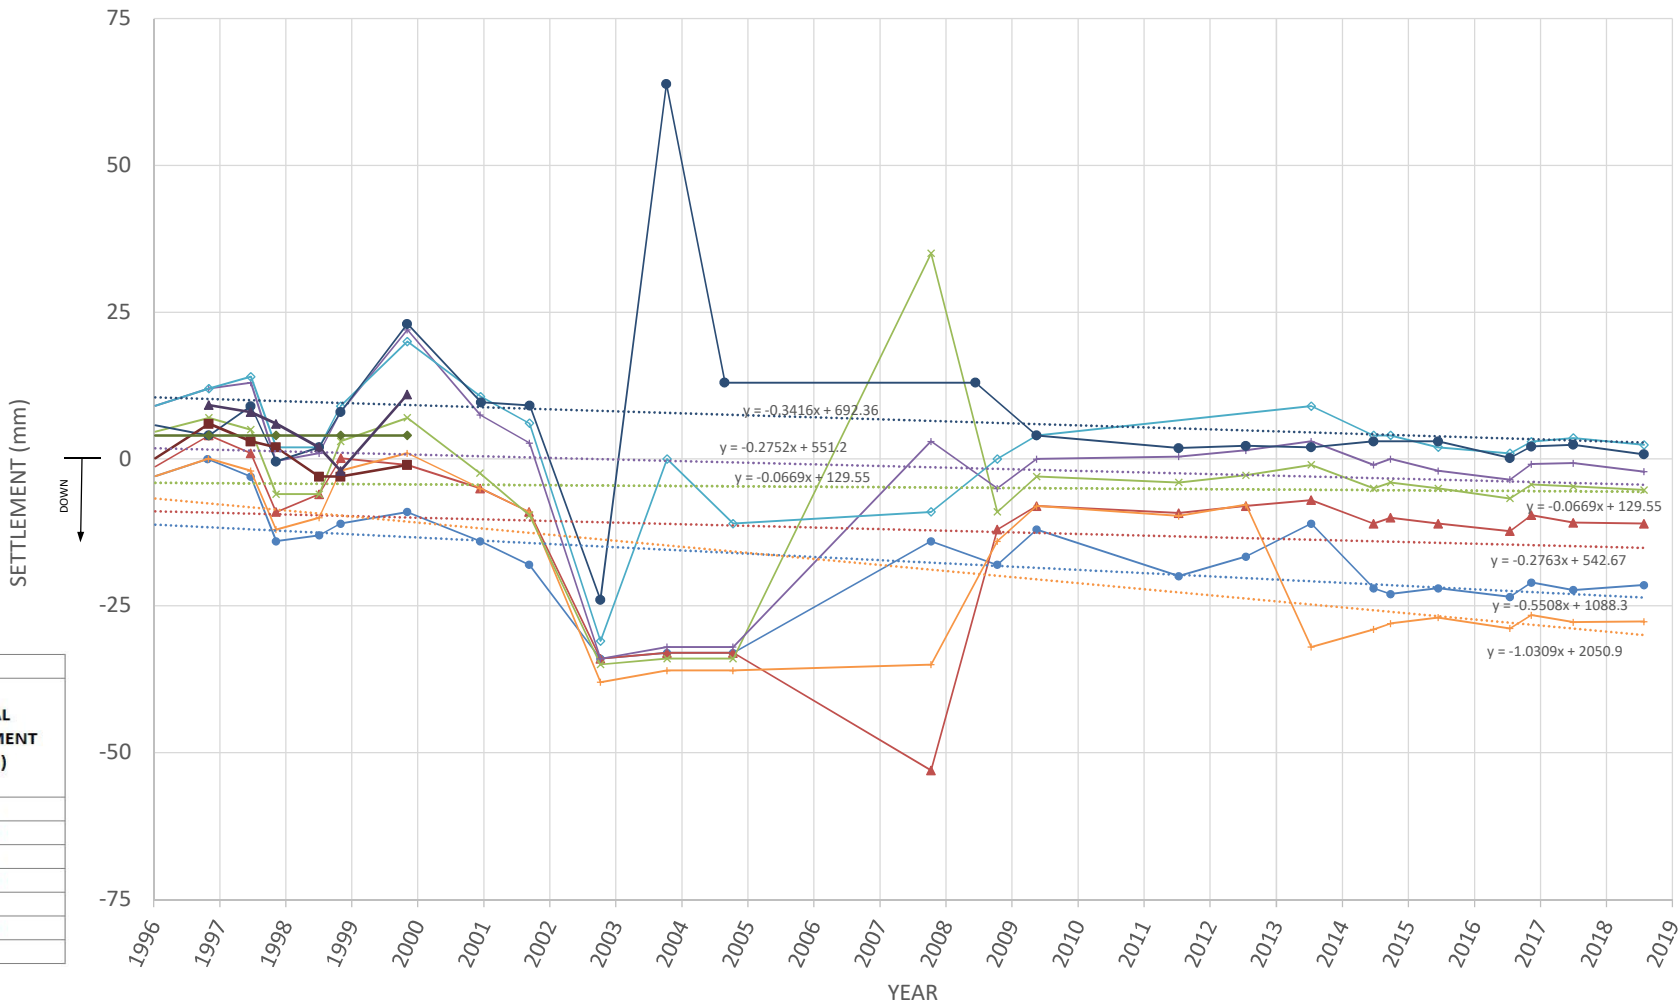
- BOSE LAKE DAM CREST MOVEMENT MONITORING DATA PRIOR TO 1996 NOT SHOWN.
- REFER TO FIGURE 3 FOR MONUMENT LOCATIONS IN PLAN VIEW.
- BD-8, BD-9 AND BD-10 DESTROYED IN 1999 OR 2000.
- BD-1 2010 READING (NOT SHOWN IN PLAN PLOT) LOCATED 1505 mm FROM INITIAL 1993 READING. READING WAS REVIEWED AND FOUND MORE LIKELY RELATED TO SURVEY ERROR THAN DISPLACEMENT.
- BD-5 2010 READING (NOT SHOWN IN PLAN PLOT) LOCATED 294 mm FROM INITIAL 1993 READING. READING WAS REVIEWED AND FOUND MORE LIKELY RELATED TO SURVEY ERROR THAN DISPLACEMENT.
- BD-3 SHIFT BETWEEN PRE AND POST 2013 SURVEYS WHICH COULD BE THE RESULT OF DAMAGE OR SURVEY DATUM. NOT AN INDICATOR OF DAM SAFETY ISSUE.
