# Teck Resources Limited

## Bullmoose Mine

### *2018 Dam Safety Inspection*

### *Bullmoose Tailings Dam*

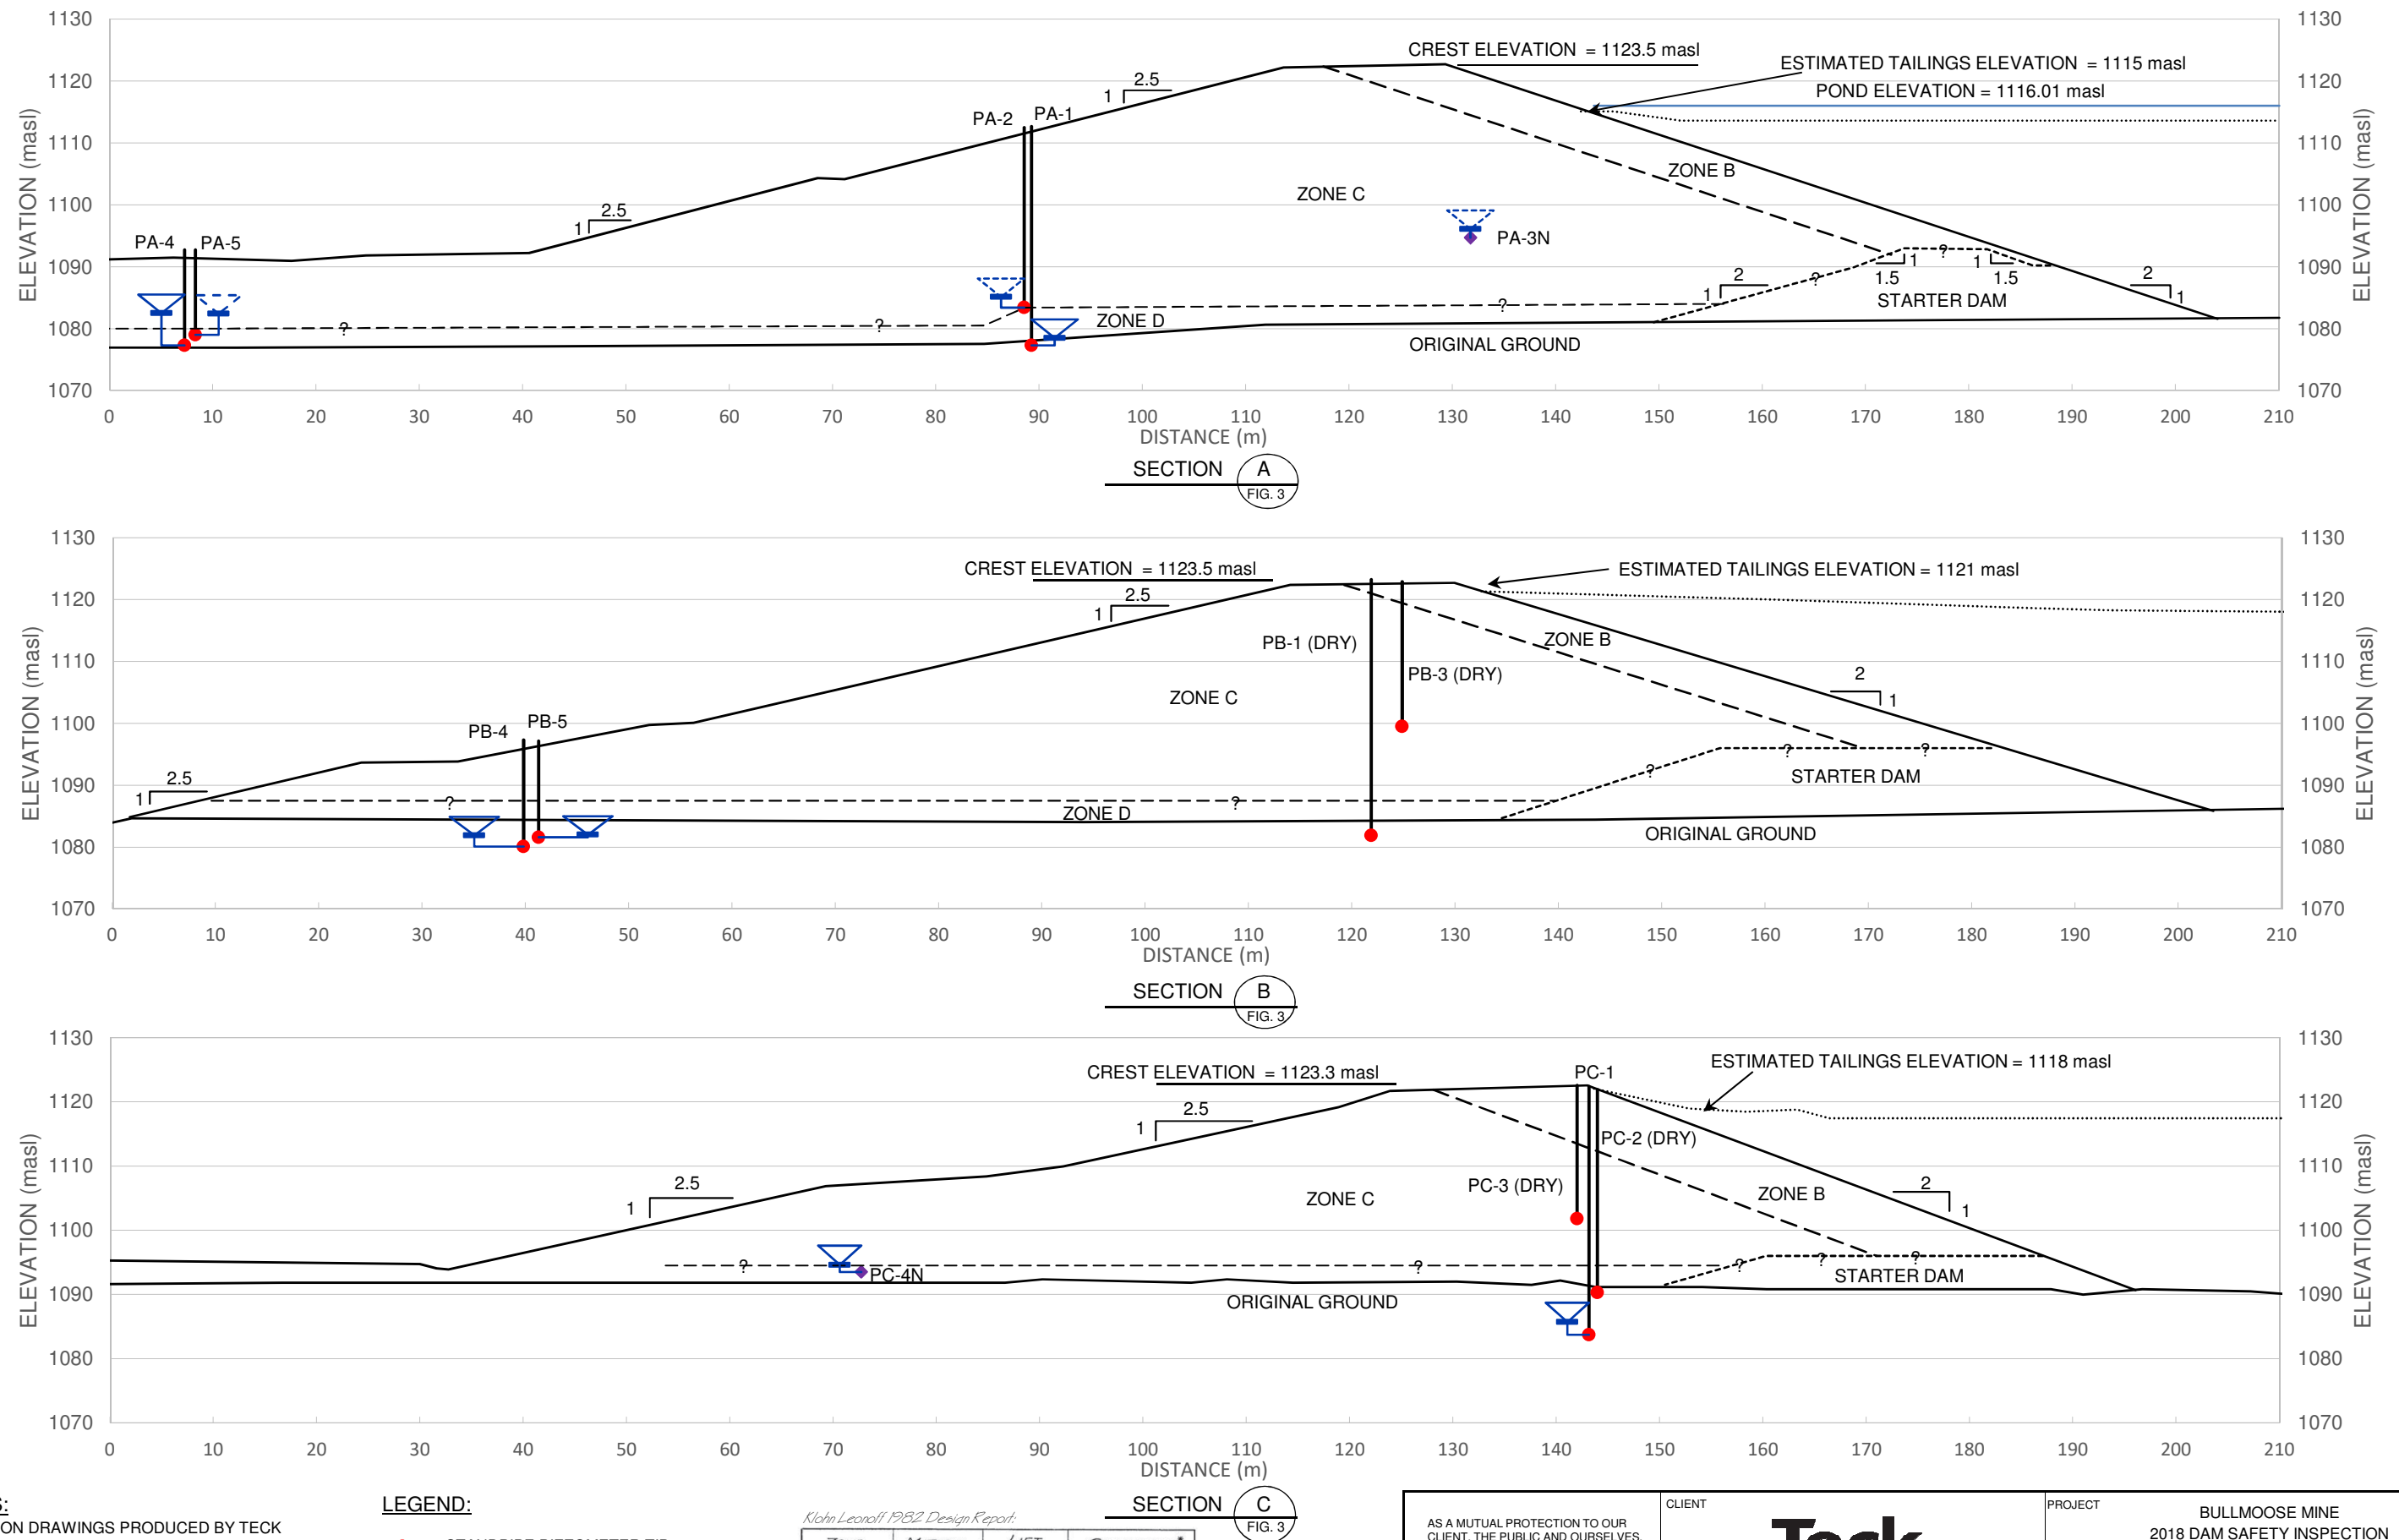
CLIENT <b>Teck</b> 	PROJECT BULLMOOSE MINE 2018 DAM SAFETY INSPECTION	
	TITLE BULLMOOSE TAILINGS DAM INSTRUMENTATION SCHEMATIC SECTIONS A, B AND C	
	PROJECT No. M09893A08	FIG. No. 7

Low pore pressures in the downstream shell of the dam indicate that dam drainage and foundation seepage capacity exceeds flow requirements (see Figure 5). Pore pressures have been stable, and the dam shell is drained with low gradient of approximately 0.04 to 0.05 (KCB 2018c). Operation and construction induced pore pressure responses are no longer observed. Therefore, piezometers monitoring frequency of once per year is sufficient for ongoing monitoring of the structure under “Closure-Passive Care” conditions.

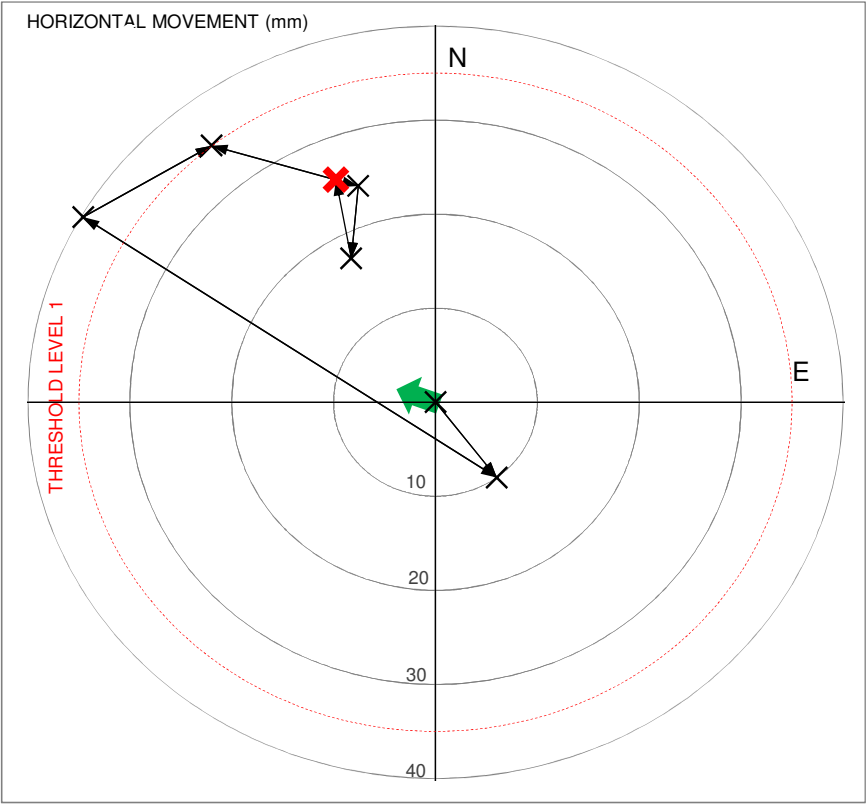
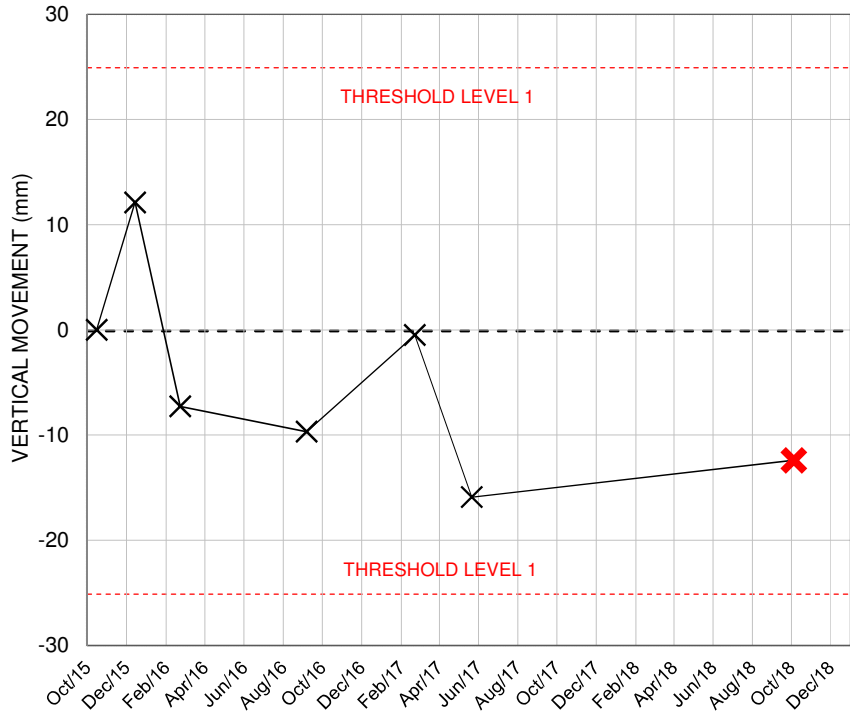
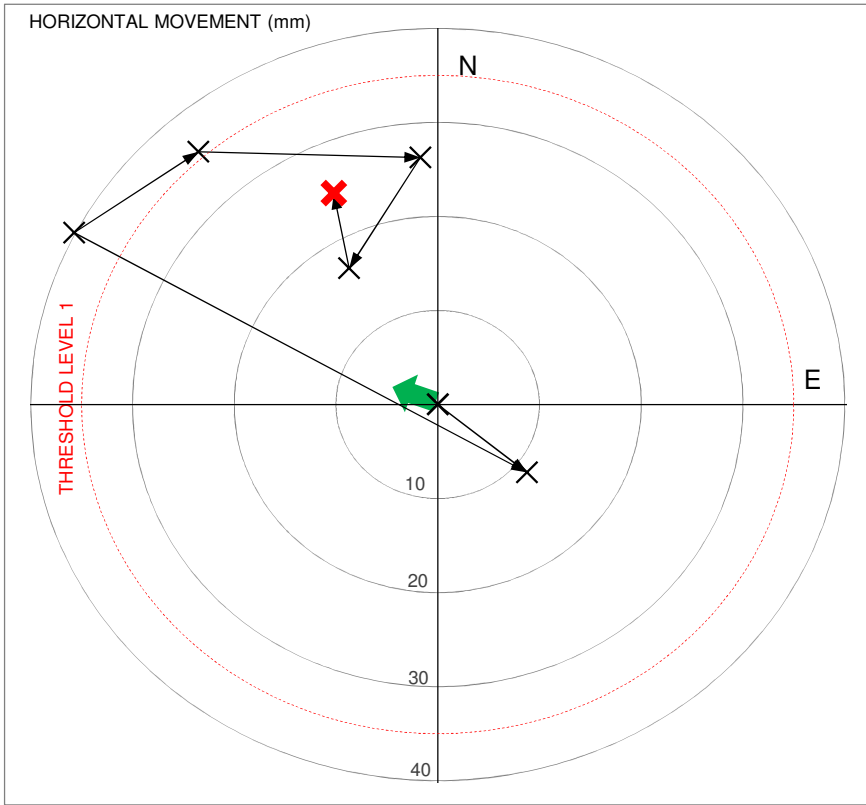
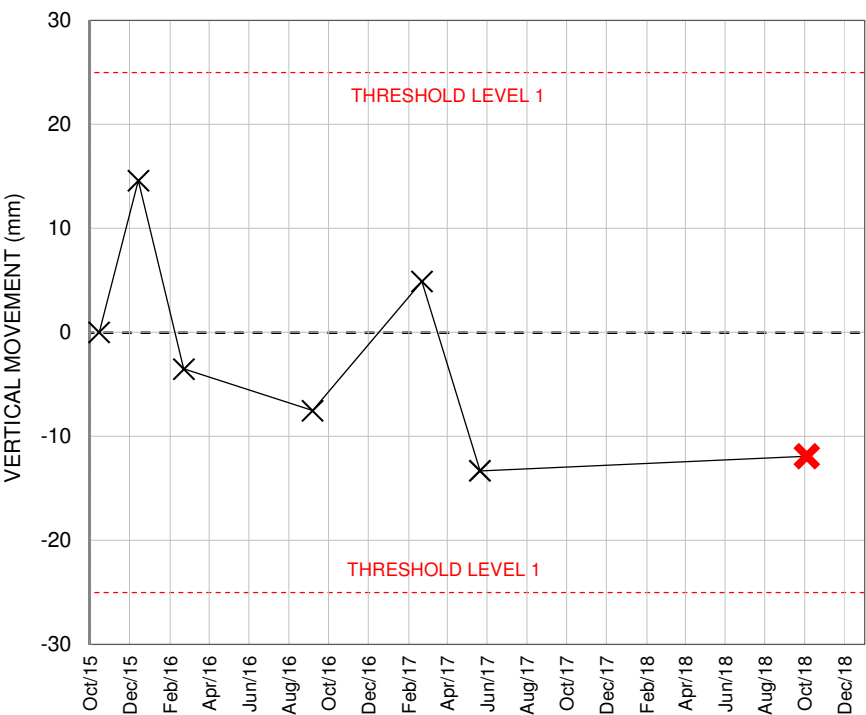
In July 2015, 7 survey monuments were installed on the BTM. Survey readings are summarized in Figure 6. Survey measurements up to 2018 are also shown in Figures 9 through 11. Survey monument QPOs are as follow:

- Thresholds Level 1 were developed based on the maximum observed survey measurement to date plus approximately 20%. The threshold is exceeded if:
  - ♦ Horizontal movement  $\geq 25$  mm from the initial reading.
  - ♦ Vertical movement  $\geq 25$  mm from the initial reading.
  - ♦ Vertical movement  $\geq 15$  mm between successive readings.
  - ♦ Threshold Level 1 values are illustrated in Figures 7 to 9.
- Threshold Level 2:
  - ♦ If there are Threshold Level 1 exceedances at 2 or more monuments on a section.
