REPORT

2018 Dam Safety Inspection for Greenhills Operations, Tailings Storage Facility

Teck Coal Limited, Greenhills Operations

Reference No. 1894290-2018-133-R-Rev0-2000

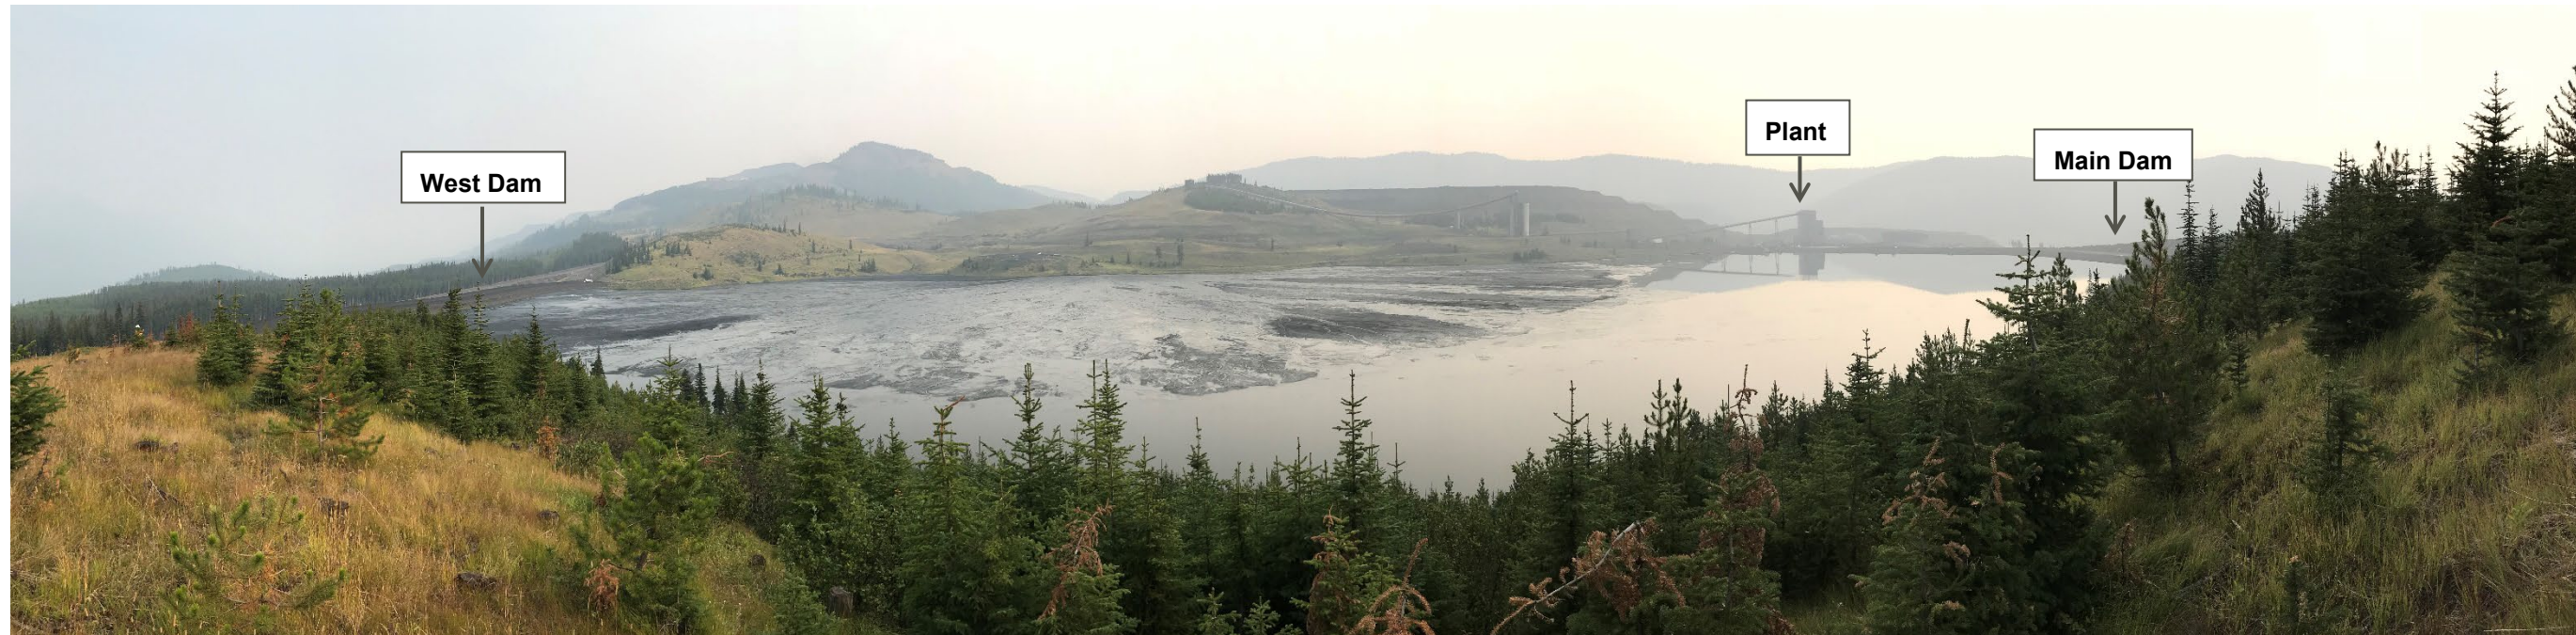
Photograph 1: Overview from rise of natural ground to the south, looking northeast. 15 August 2018.

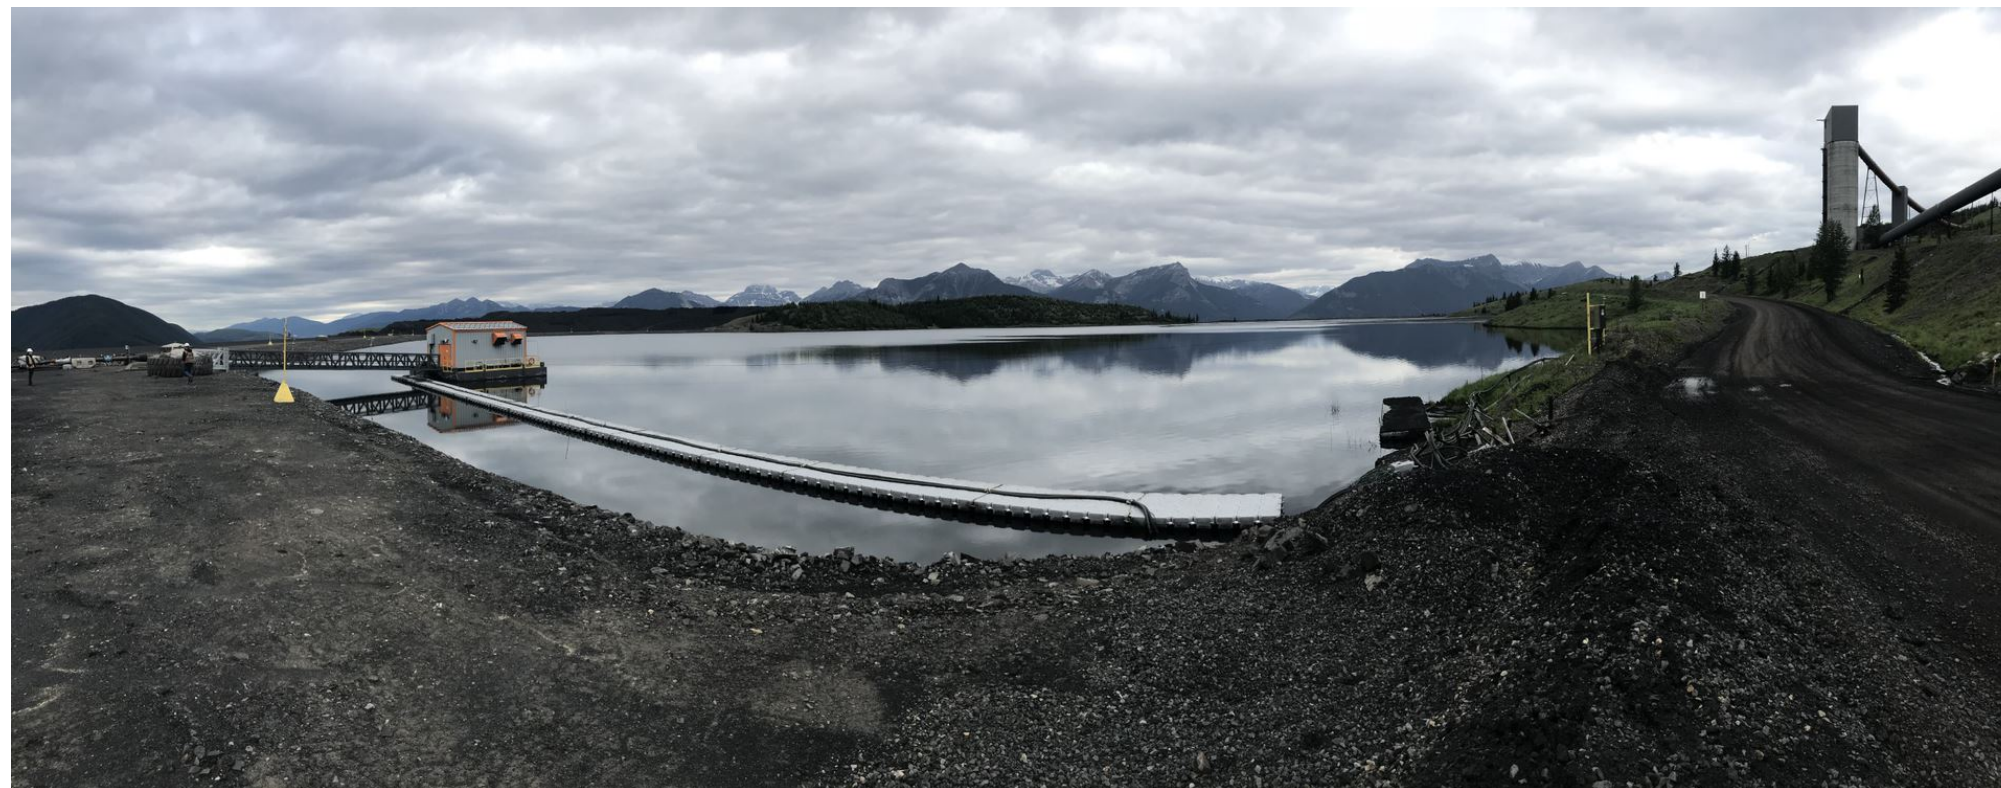
Photograph 2: Main Dam – overview of barge, looking southwest. 18 June 2018.

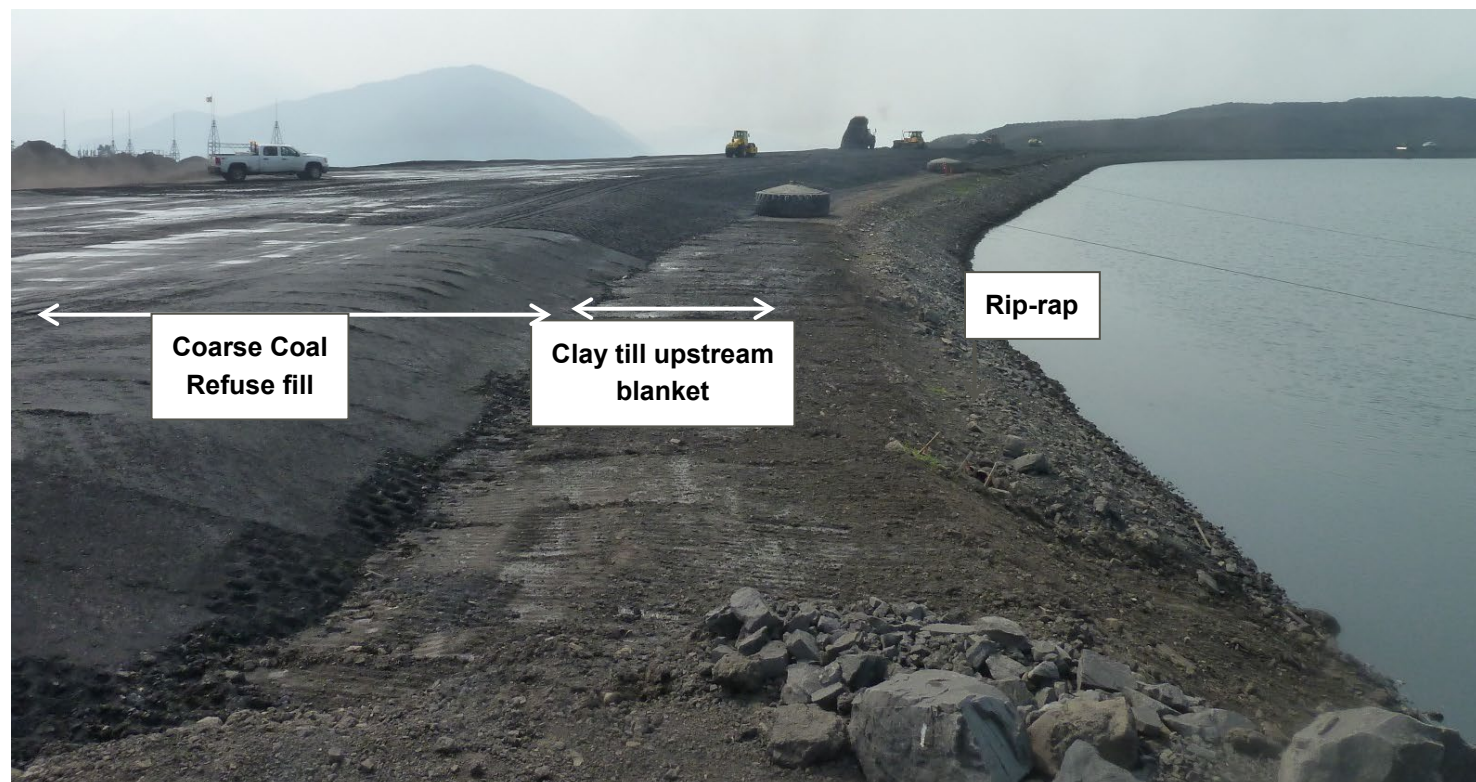
Photograph 4: Main Dam – upstream slope and crest, looking southwest. 15 August 2018.

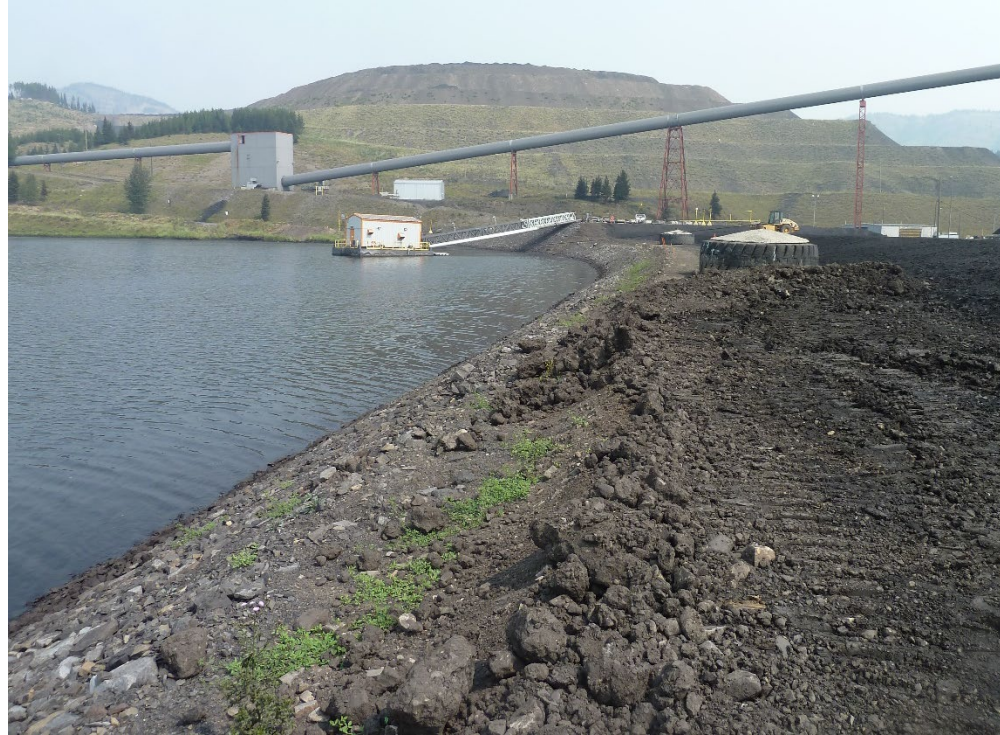
Photograph 5: Main Dam – overview of barge, east abutment, and natural ground north of GHO Tailings Pond, looking northeast. 15 August 2018.

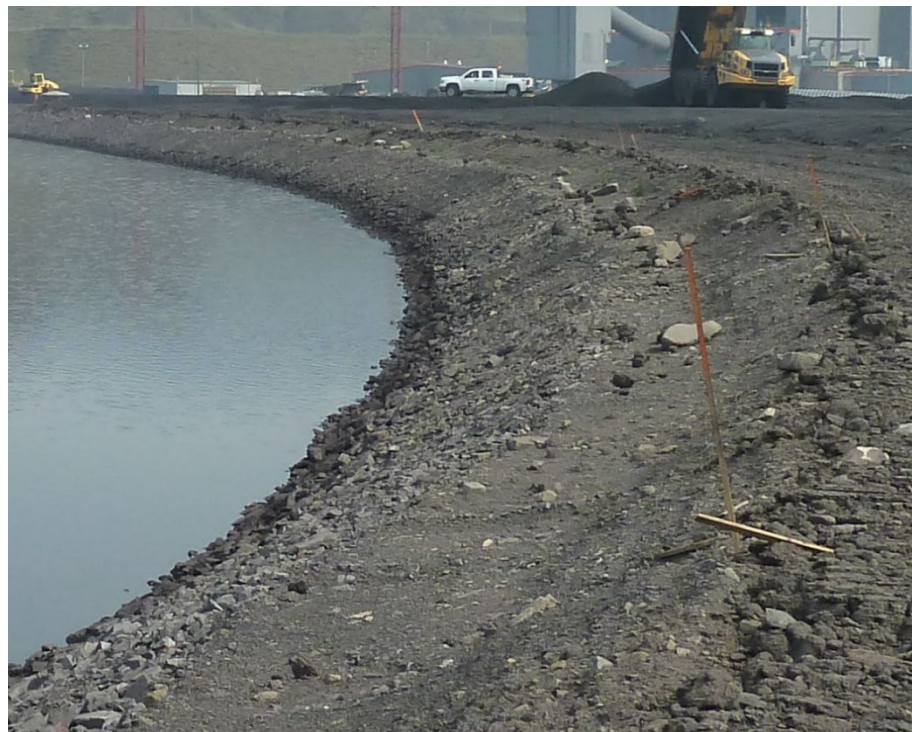
Photograph 6: Main Dam – upstream slope, looking northeast. 15 August 2018

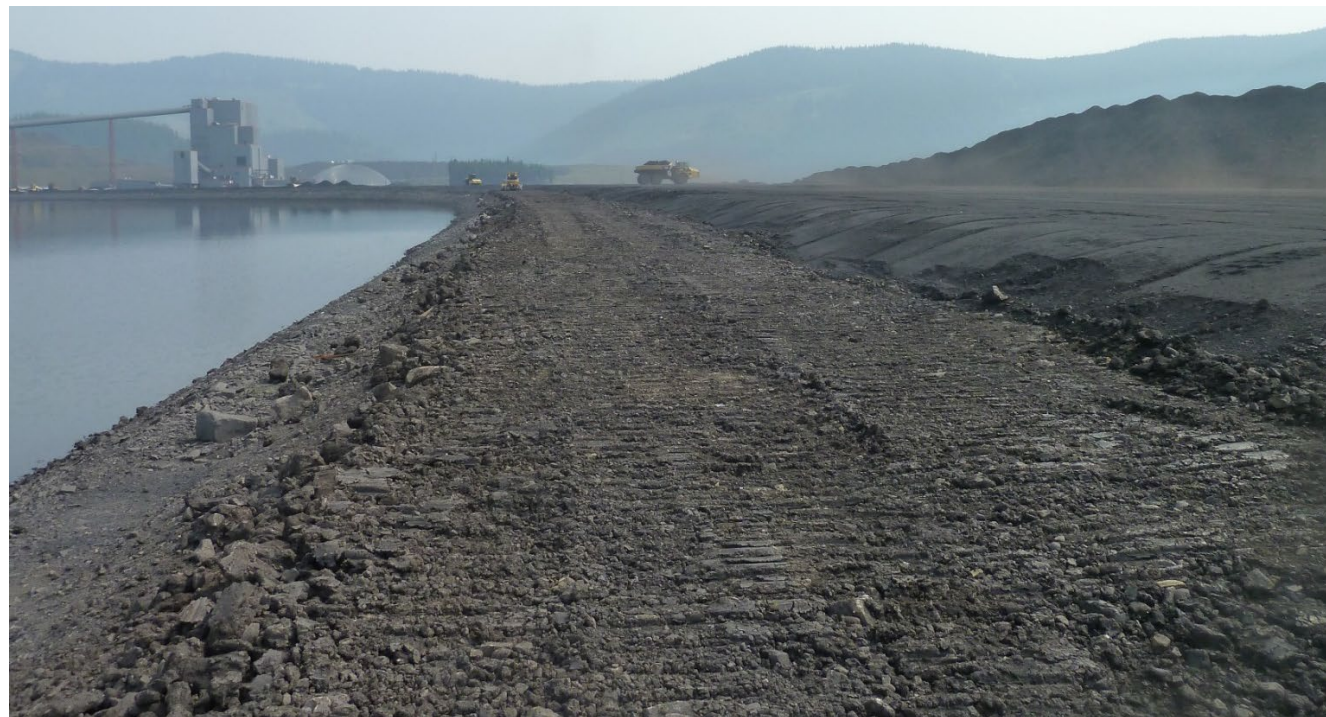
Photograph 8: Main Dam – overview from natural ground above west abutment, looking northeast. 15 August 2018.

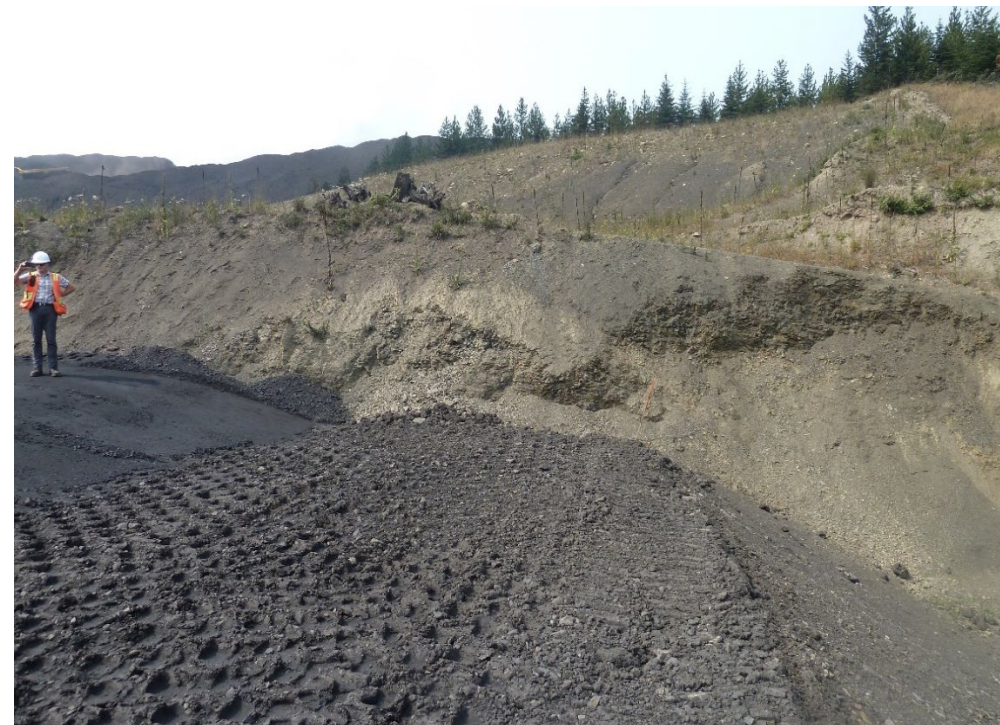
Photograph 9: Main Dam – west abutment, looking west. 15 August 2018.

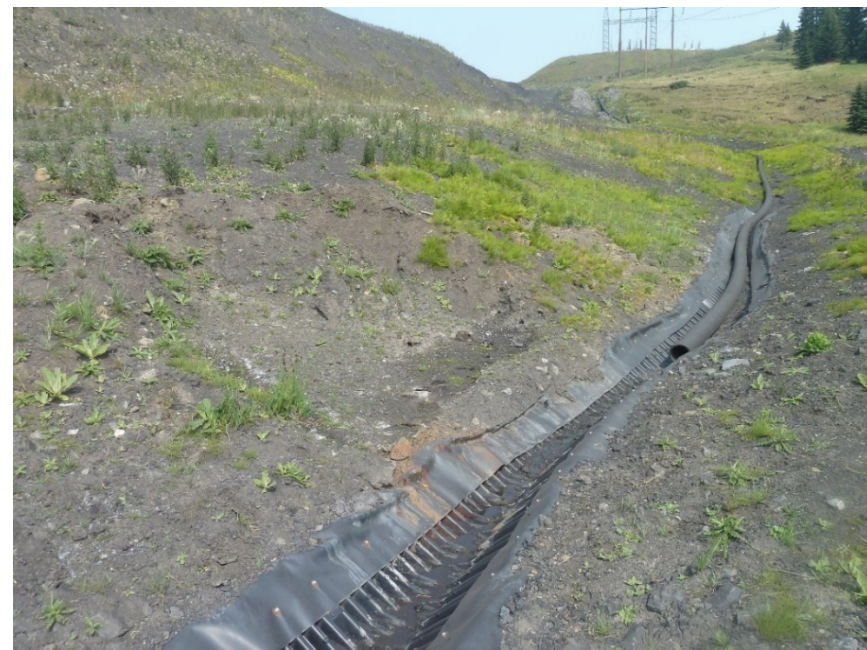
Photograph 11: Site C – view of seepage collection channel. Looking northeast. 15 August 2018.

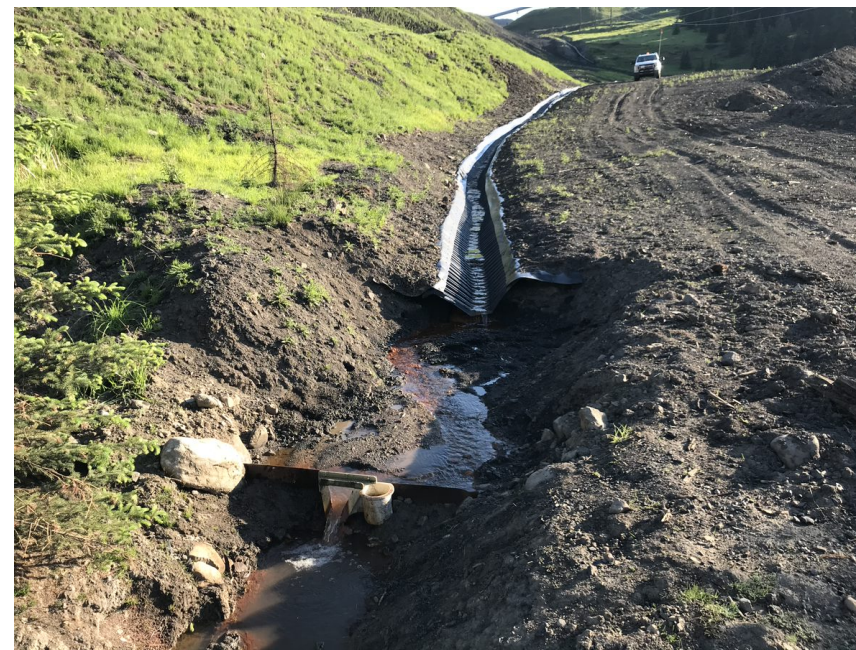
During the site visits, it was observed that the water flowing from the Main Dam rock drains was clear and did not contain visible suspended particles. The water was noted to be causing red-brown staining (Photograph 12a and 12b, Appendix A); which is expected based on the water chemistry. Seepage flow through the V-notch weir installed in the ditch downstream of the West Dam was observed to be clear during the site visits (Photograph 25, Appendix A).

Photograph 12a: Site C – view of seepage collection channel. Looking northeast. 18 June 2018.

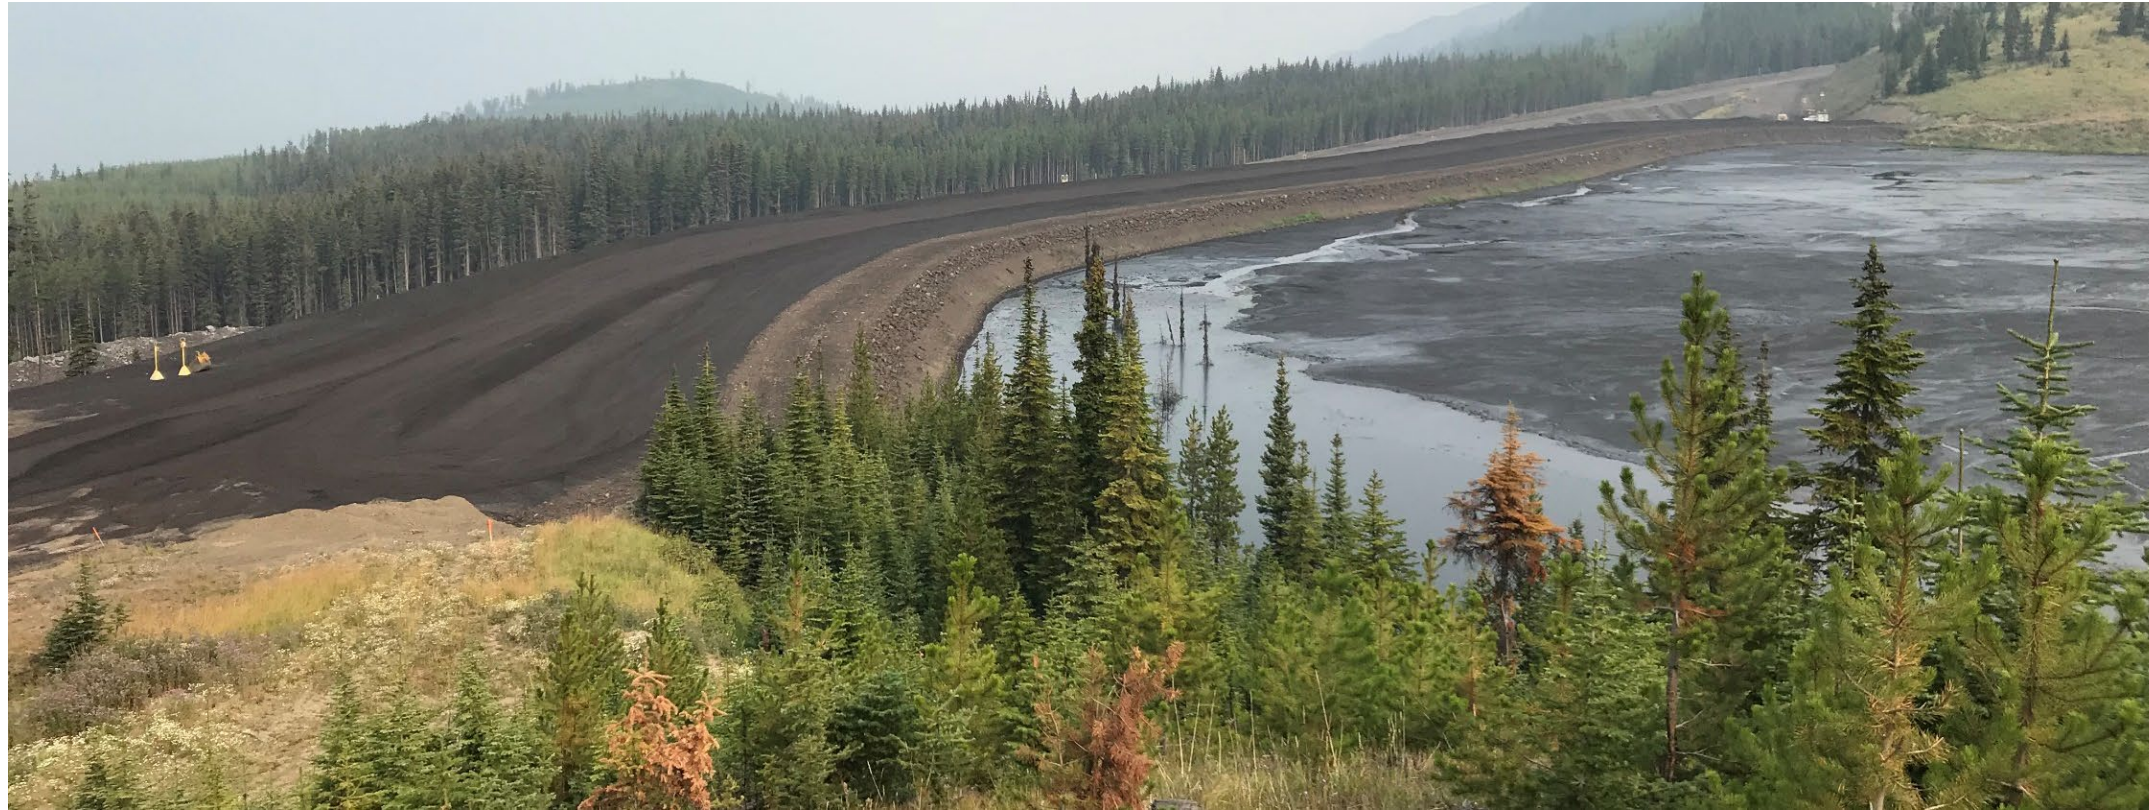
Photograph 16: West Dam – overview of upstream slope, looking northwest. 15 August 2018.

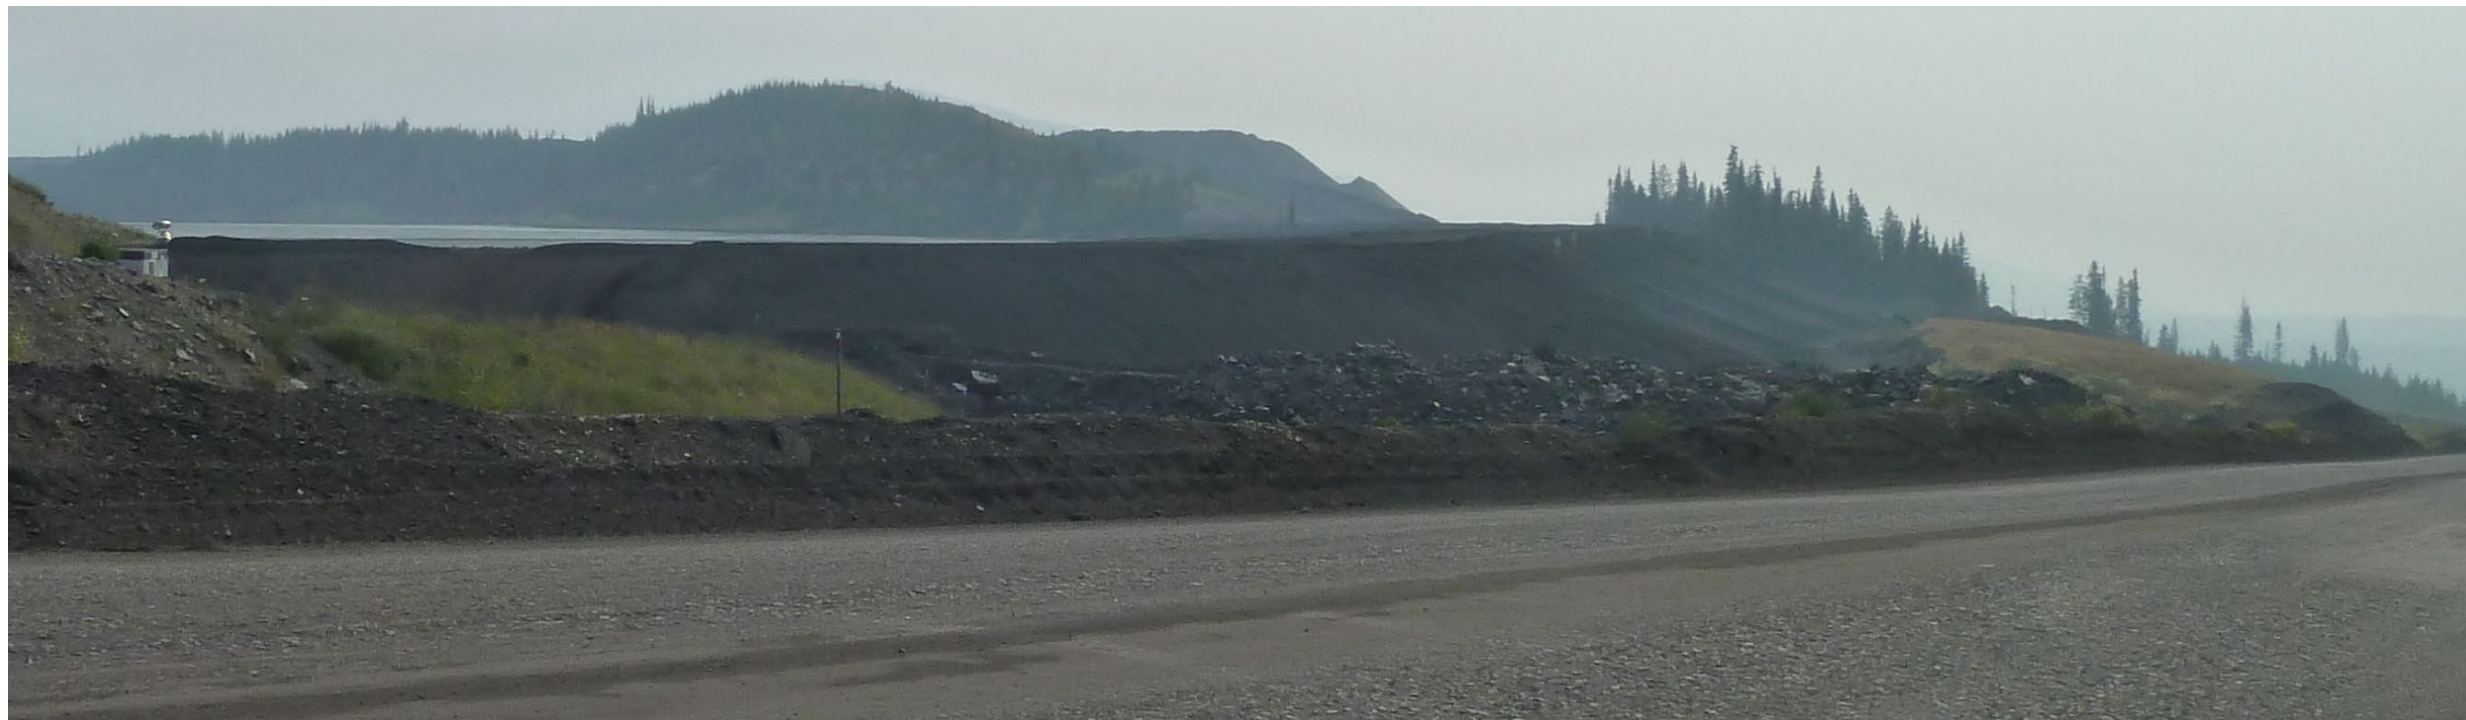
Photograph 17: West Dam – overview of downstream slope, looking south. 15 August 2018.

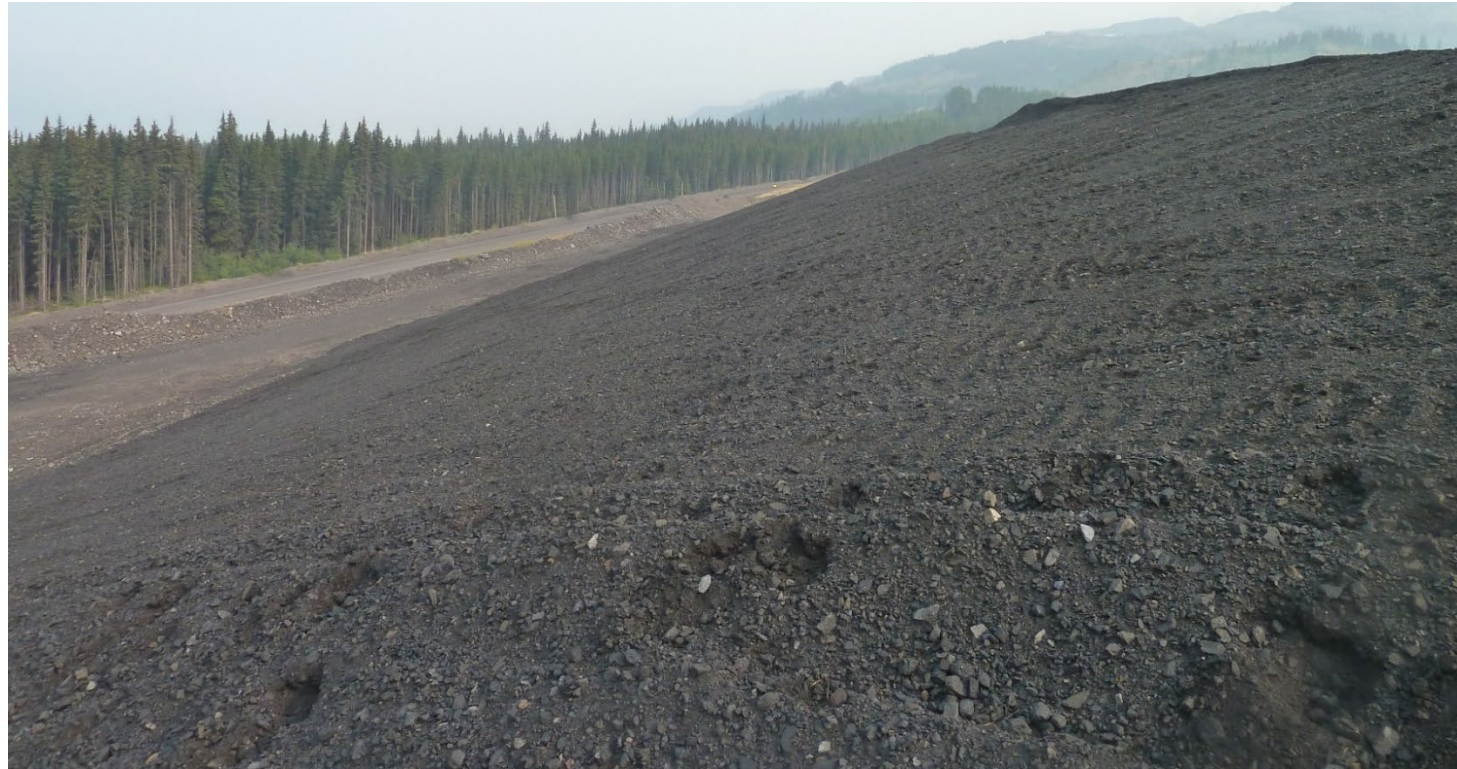
Photograph 18: West Dam – downstream slope, looking north. 15 August 2018.

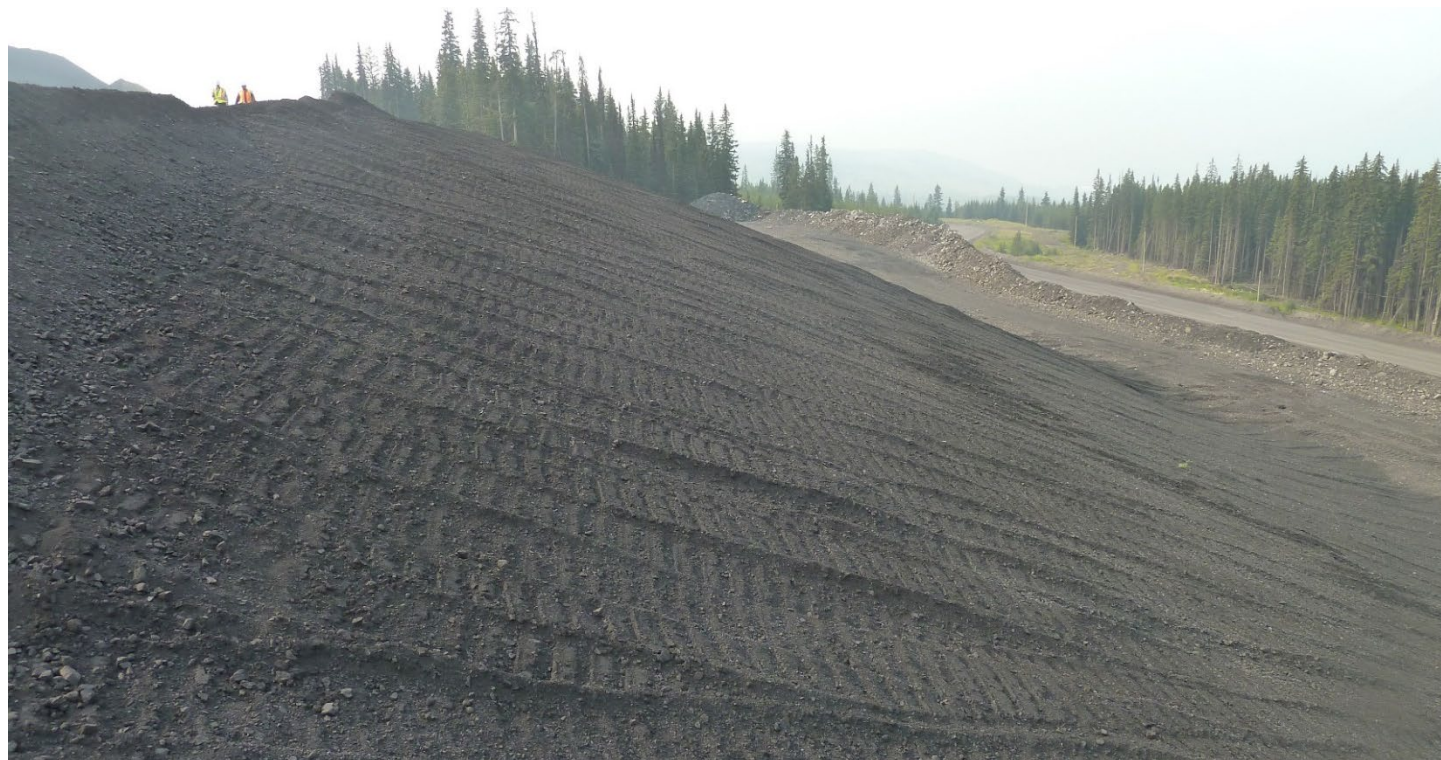
Photograph 19: West Dam – downstream slope, looking south. 15 August 2018.

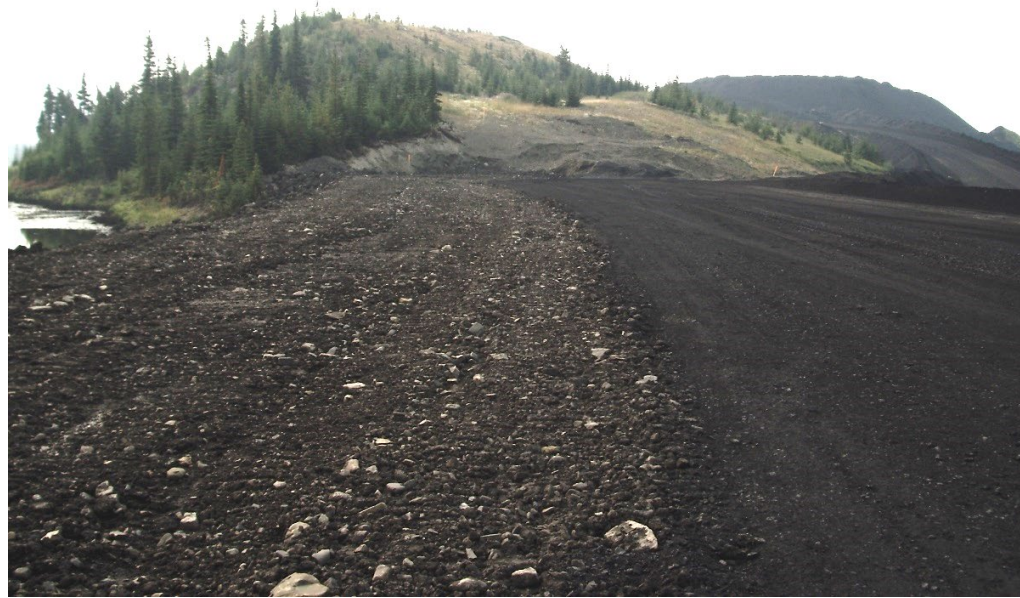
Photograph 20: West Dam – southern abutment, looking south. 15 August 2018.

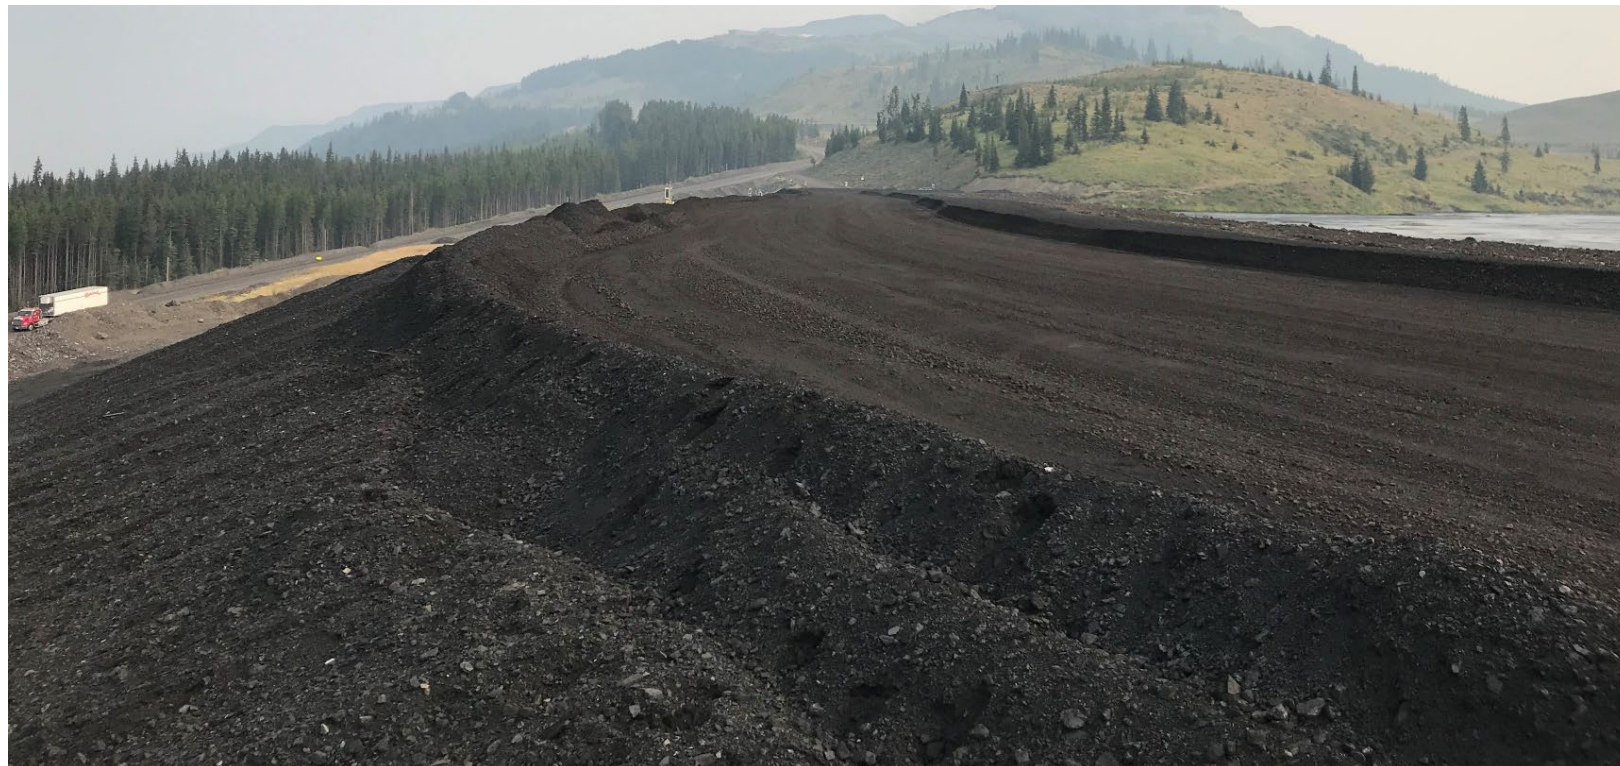
Photograph 21: West Dam – Crest and downstream slope, looking north. 15 August 2018.

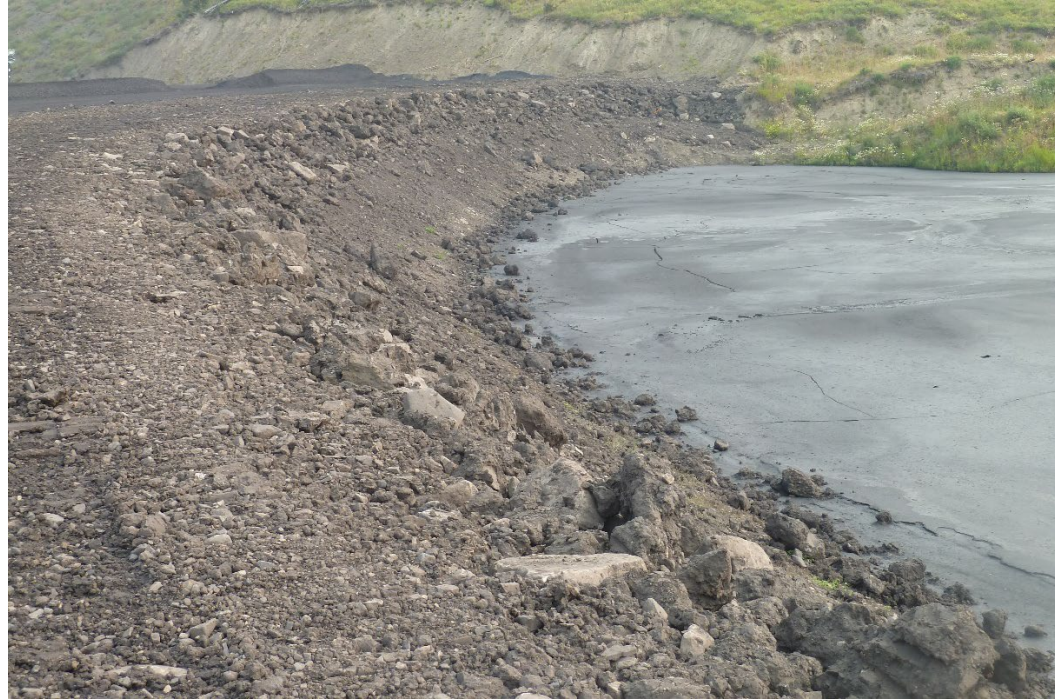
Photograph 22: West Dam – upstream slope and north abutment, looking north. 15 August 2018.

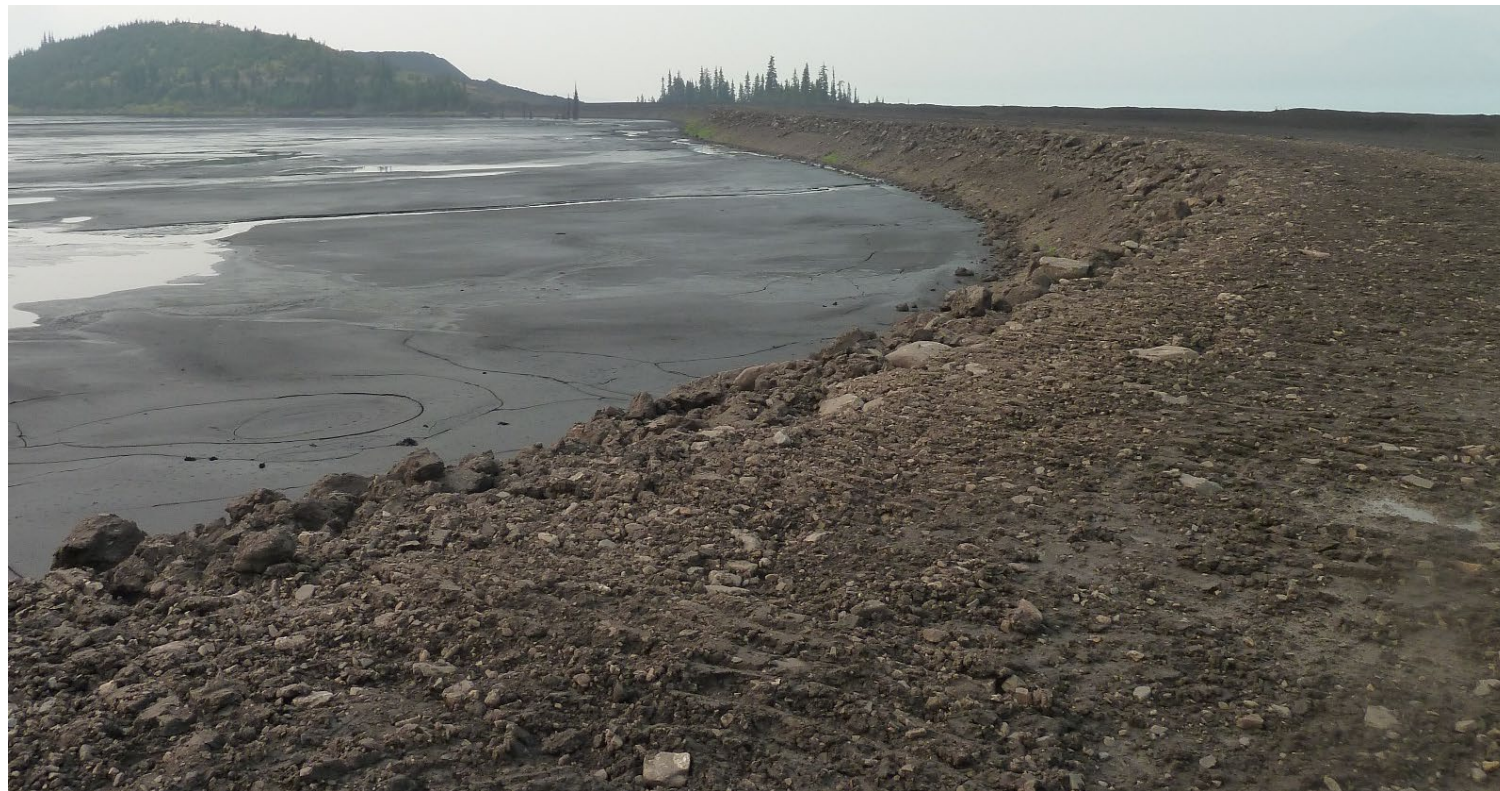
Photograph 213: West Dam – upstream slope and south abutment, looking south. 15 August 2018

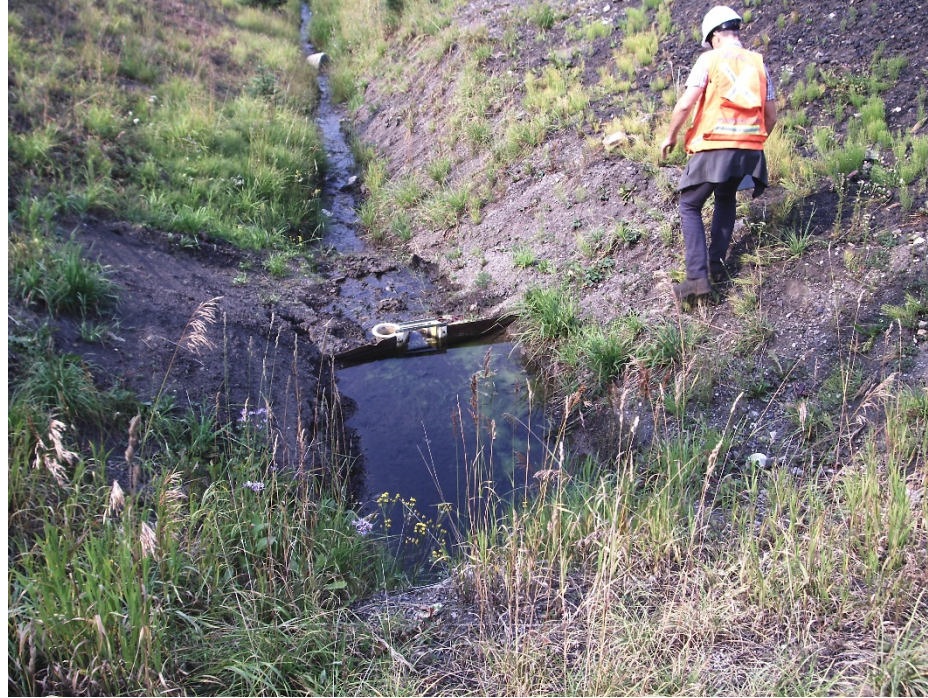
Photograph 224: West Dam – seepage weir downstream of West Dam. 15 August 2018

It is noted that higher than usual flows, which exceeded QPO warning and alarm levels, were recorded by Teck since the weirs were reinstalled (in October 2017 for the West Dam weir, and January 2018 for the Main Dam weir). These readings are suspected to be erroneous based on comparison with readings from previous years (Photograph 1 and 2 in this section). It is therefore recommended that the flow rates from the weirs be checked and calibrated in 2019.

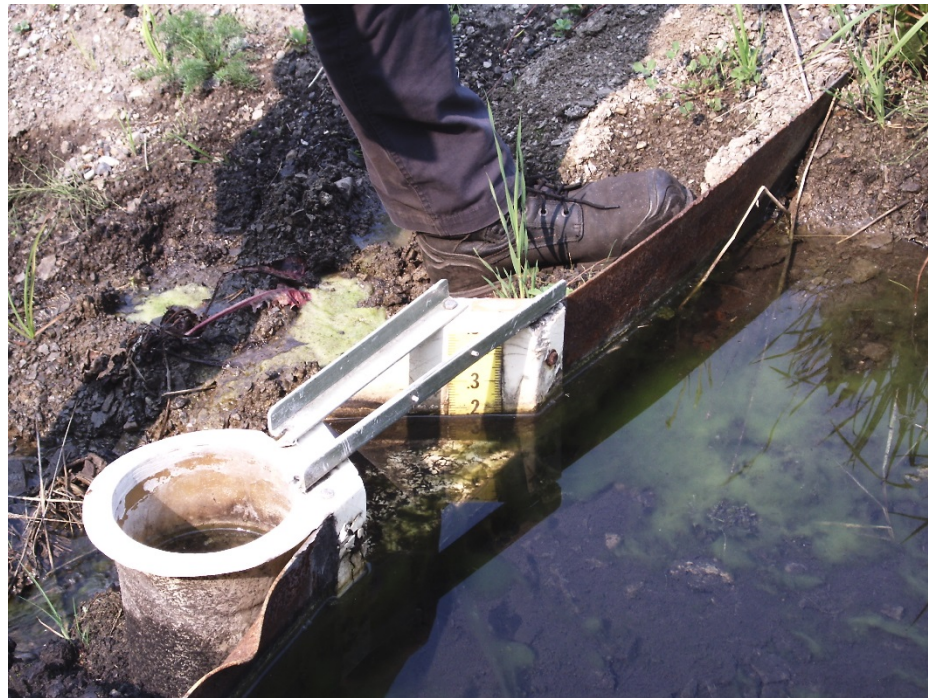
Photograph 235: West Dam – seepage weir downstream of West Dam. 15 August 2018
