# **Teck Highland Valley Copper Partnership**

## **2018 Dam Safety Inspection Report**

### ***Highmont Tailings Storage Facility***

March 2019

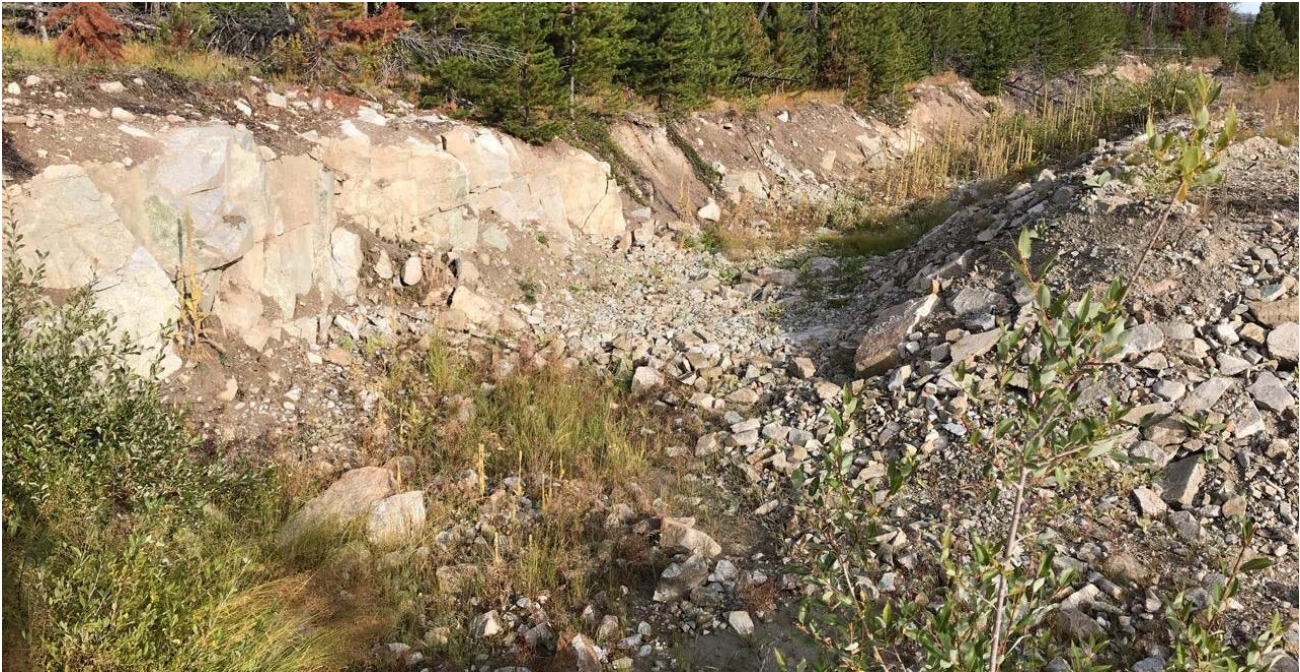
**Photo II-A-21 S2: Highmont spillway; looking north. There is vegetation growth which will be cleared as part of routine maintenance (HGH-2018-13)**

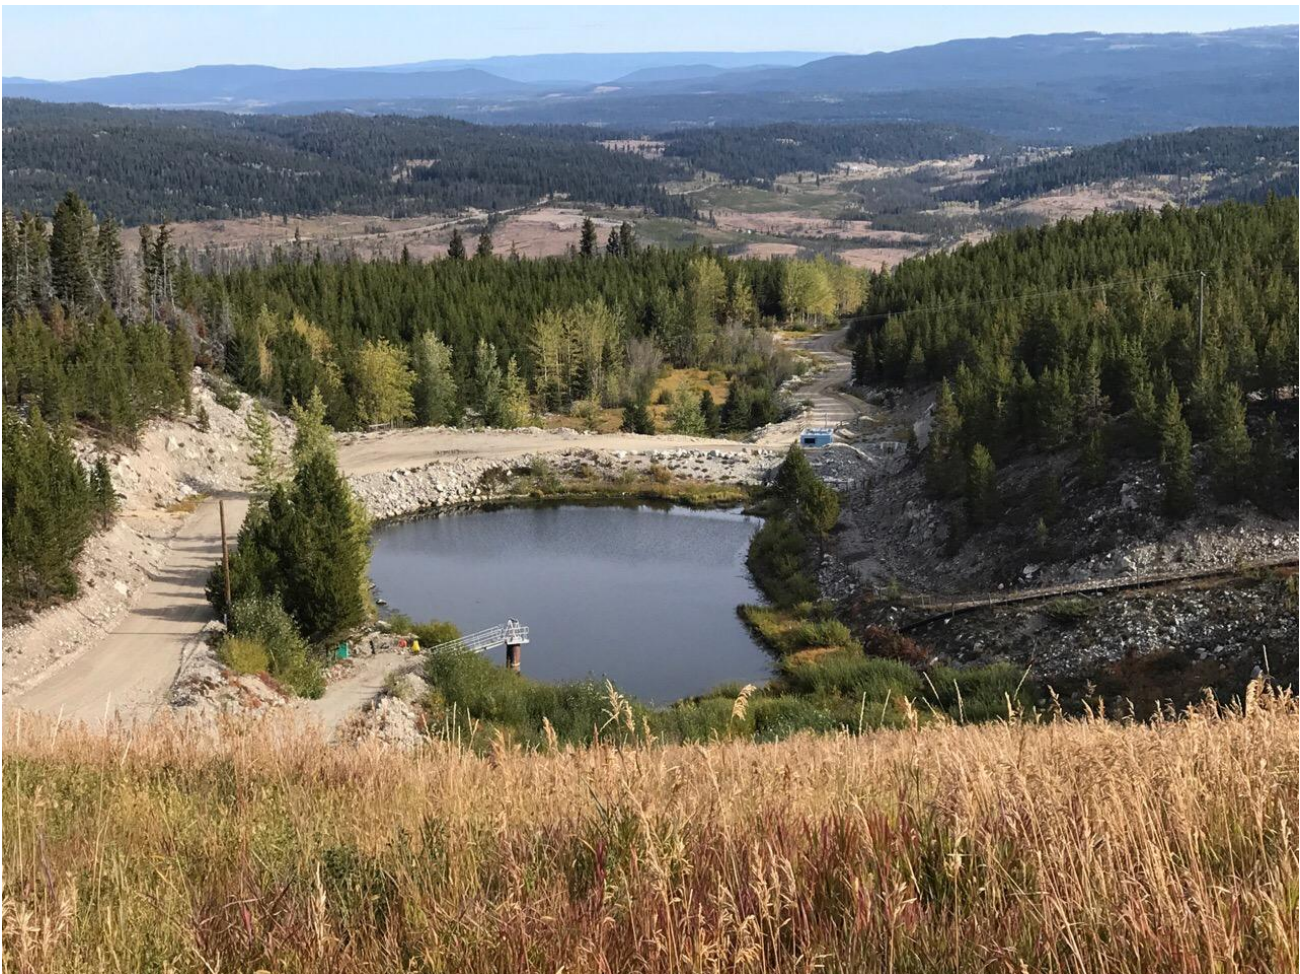
**Photo II-B-1 S1: Overview of pond and upstream slope of dam from Highmont Dam crest.  
(HGH-2018-1)**

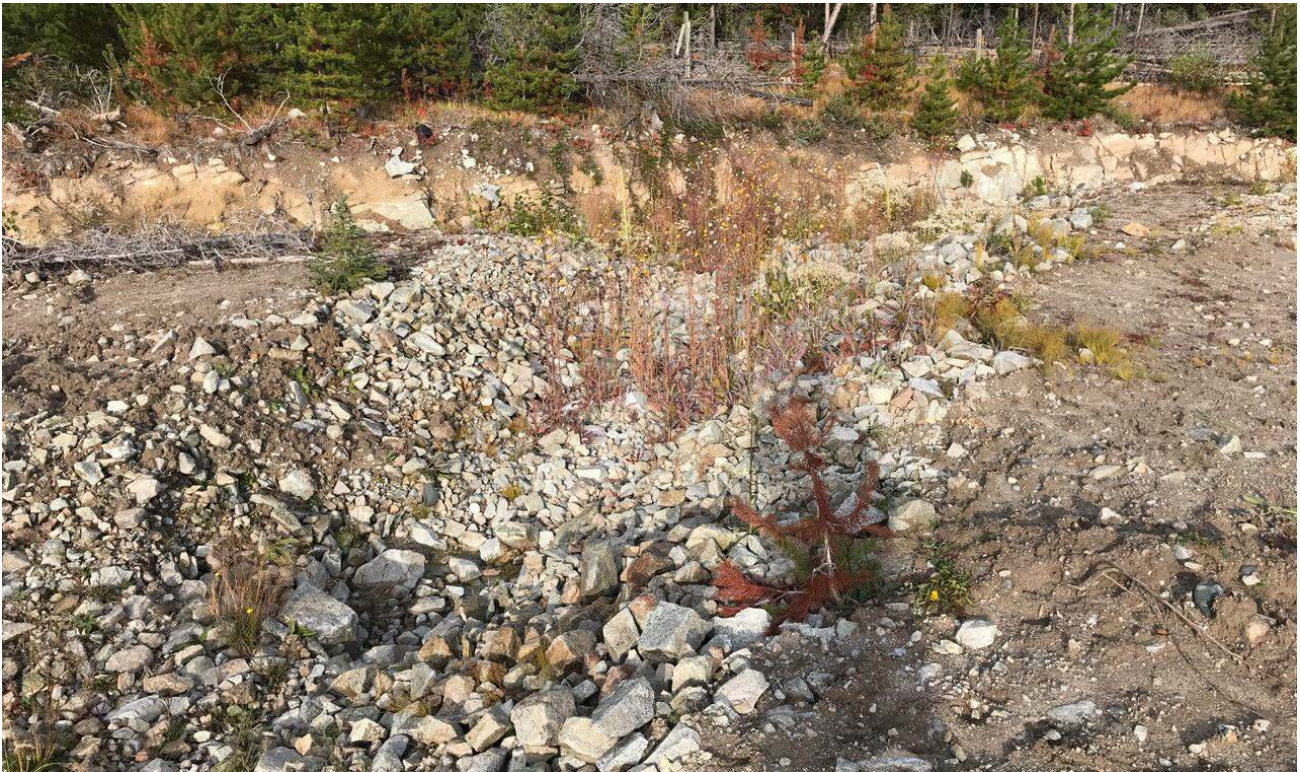
**Photo II-B-10 S2: Spillway invert and channel. (HGH-2018-17)**

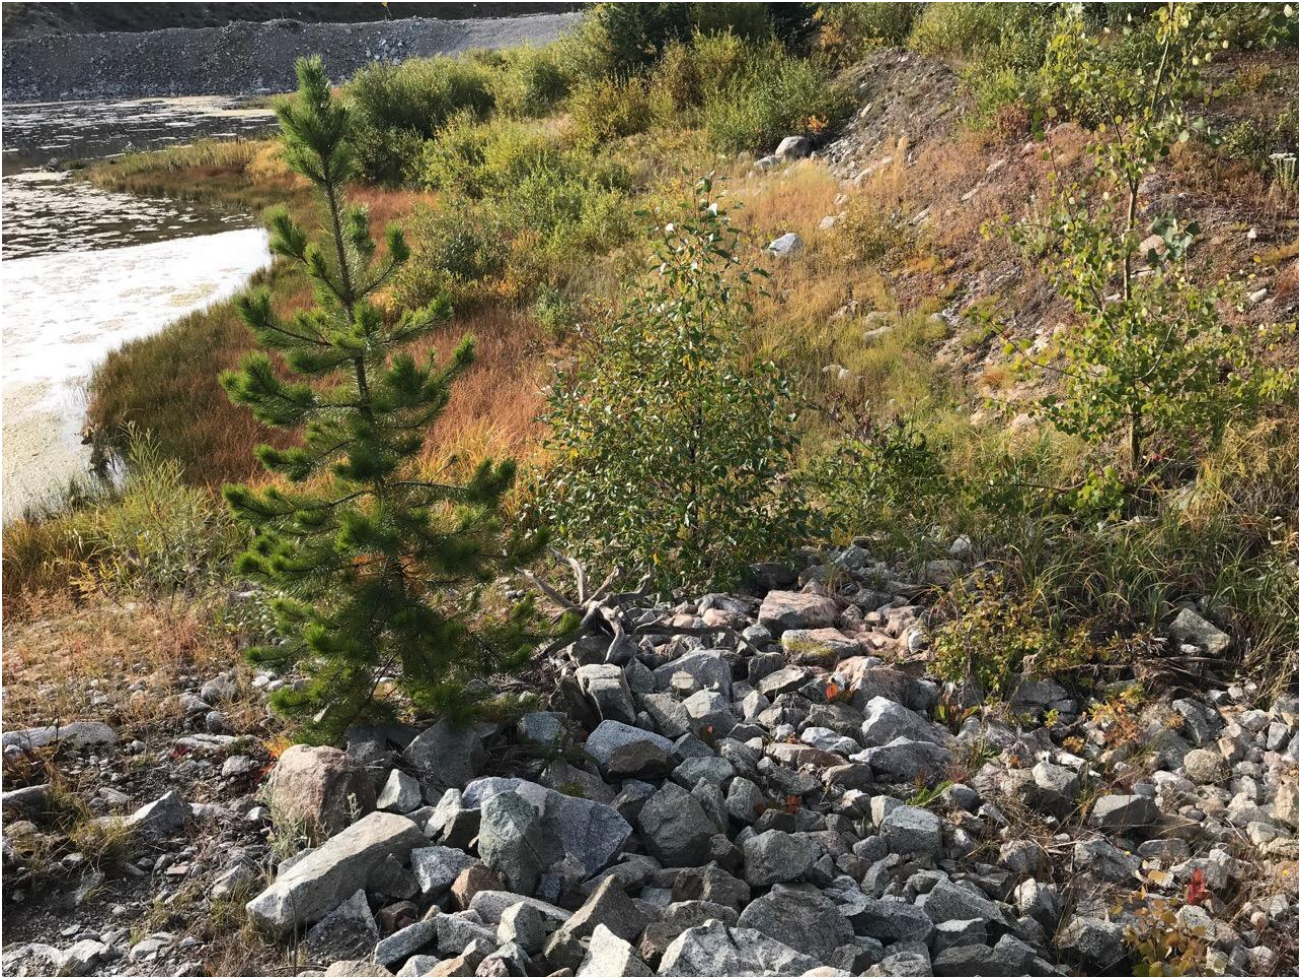
**Photo II-B-11 S2: Spillway outlet. Outlet is vegetated; vegetation should be monitored and removed if reduces the outlet capacity. (HGH-2018-17)**

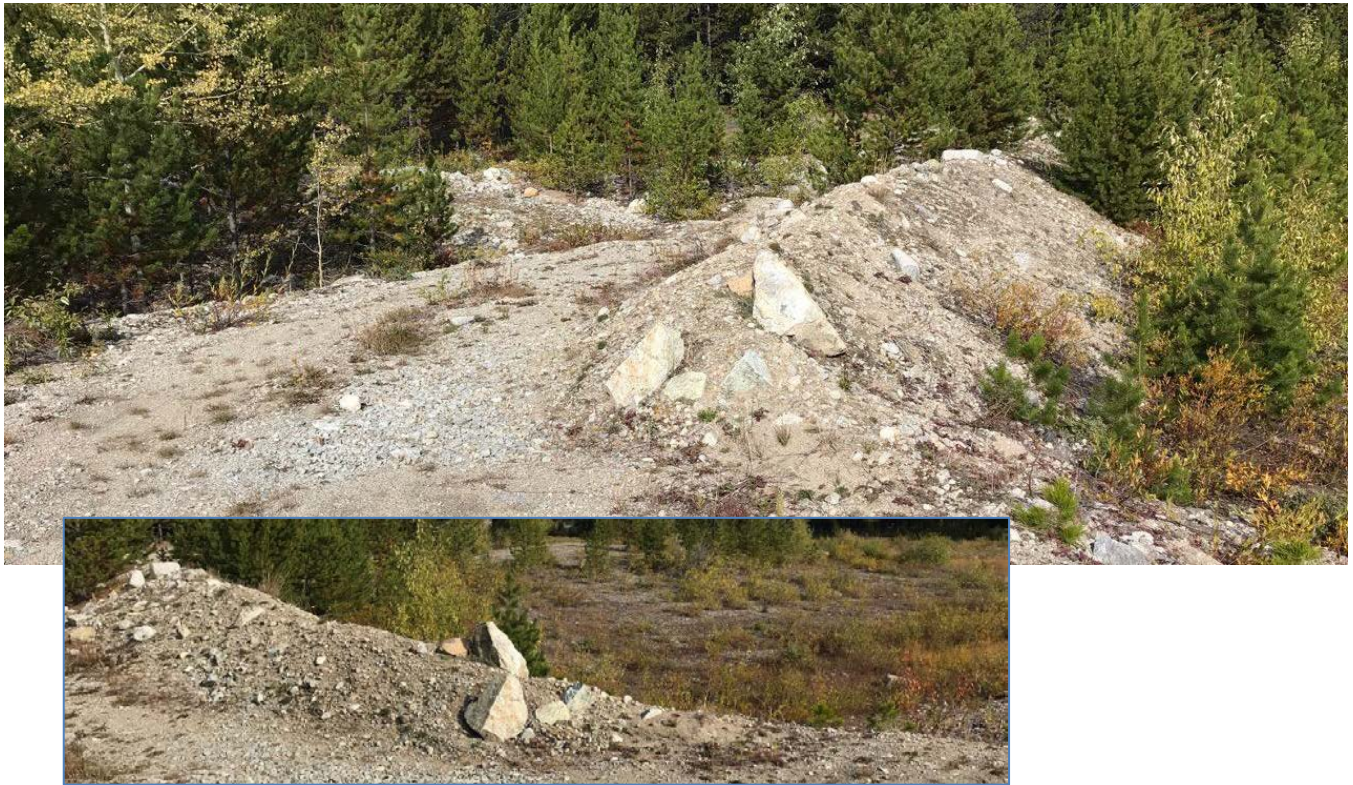
**Photo II-B-19 S3: Spillway intake is blocked (HGH-2018-20)**
