TECK RESOURCES LTD.

Louvicourt Mine Tailings and Polishing Ponds 2018 Dam Safety Inspection

001-18102172-RA-Rev1

March 2019

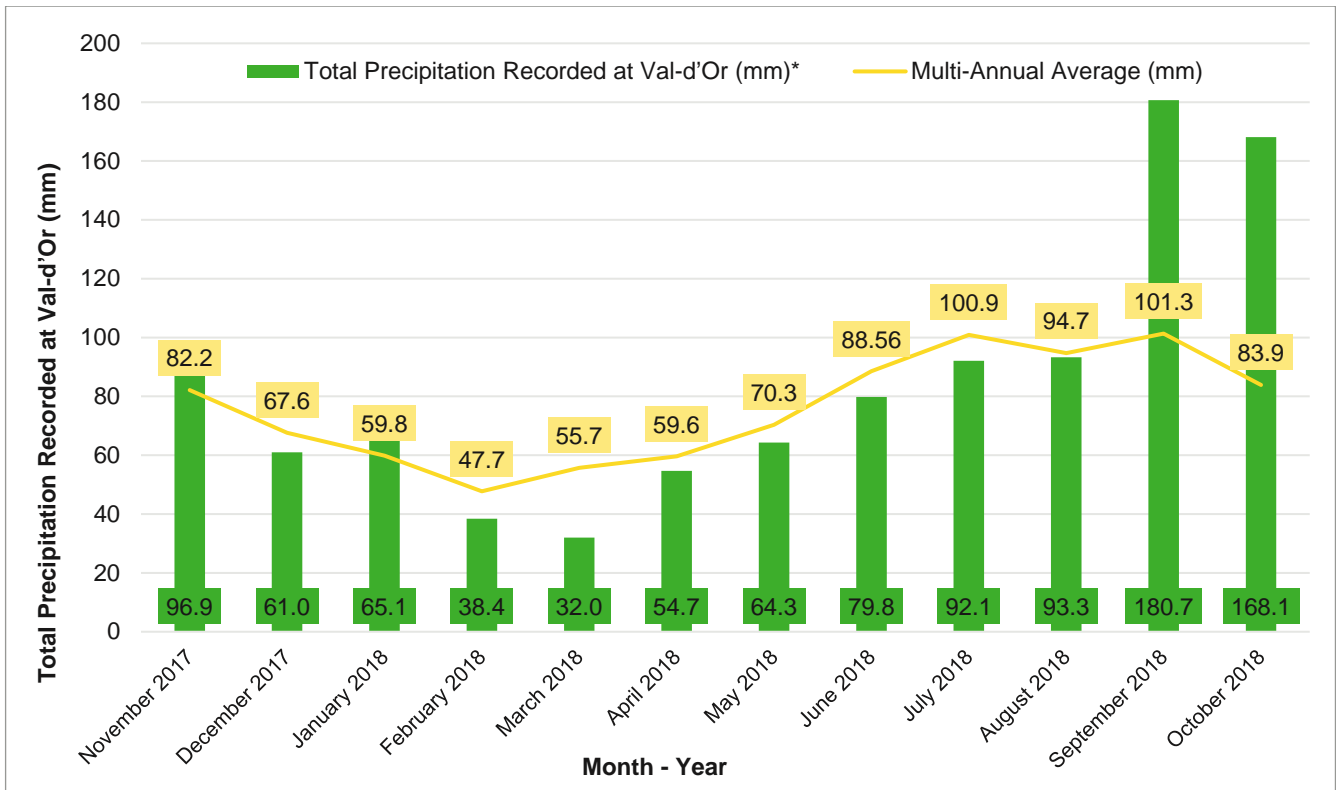
Figure 3: Monthly Precipitation Data from November 2017 to October 2018

Table 2 and Figure 3 summarize the Val-d’Or monthly total precipitation data over the period from November 2017 to October 2018. The data originates from the Environment Canada climate stations (Table 1), which are located about 15 km from the mine site. The available data from the stations presented in Table 1 were combined to form a continuous time series over the period 1951-2018, which was used for the precipitation analysis and water balance presented in this section.

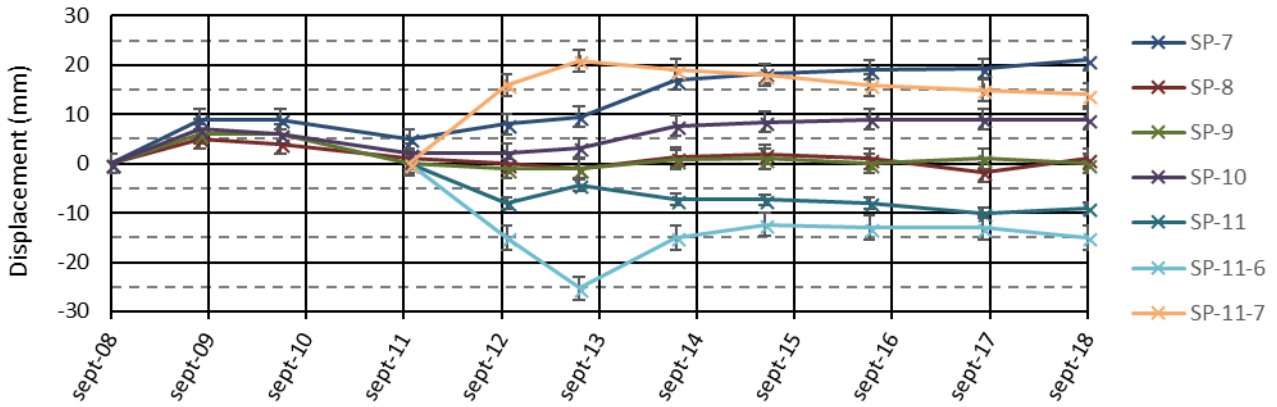
Figure 5: Vertical Displacement of the Survey Monuments at Dam 1

The vertical data shows that 4 monuments indicated upward movements and 11 monuments had settlements of 2 mm or less (which is the stated survey accuracy). Three monuments showed incremental settlements greater than 2 mm (3, 4 and 6 mm). All monuments show total settlement since installation of 25 mm or less. In order to better assess the settlement data, plots of historical settlement have been prepared as Figures 5 to 7.
