# **Teck Metals Ltd.**

## **Pinchi Lake Mine Tailings Storage Facility**

### ***2018 Dam Safety Inspection***

M07728A33.730

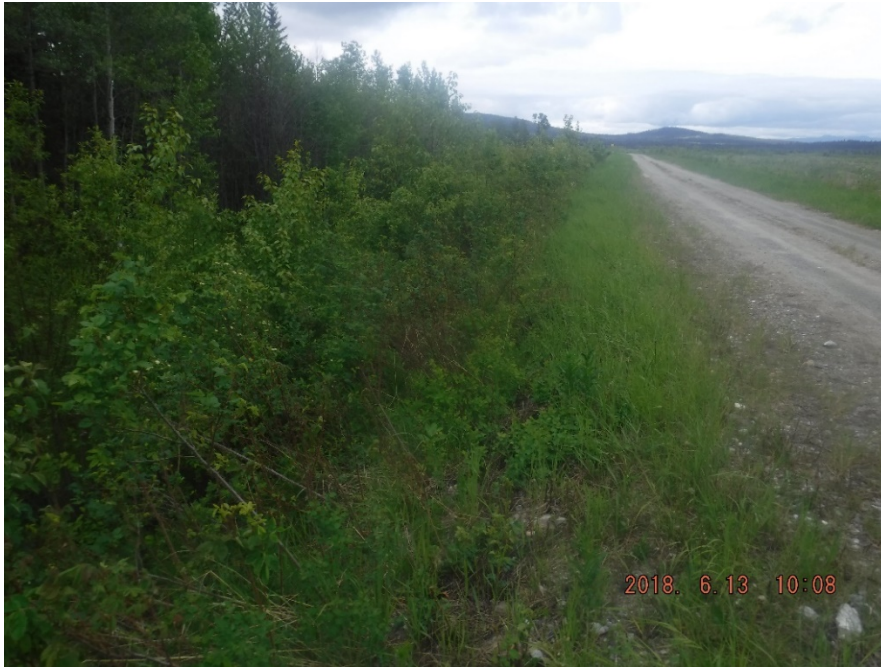
- There is vegetation on the slope of the east leg of the dam, especially on the north section, including trees up to about 3 m tall (Location 8 in Figure 4.1; Photos II-1 to II-4, II-6, and II-8). This vegetation is not currently considered to be a dam safety concern, although it may be prudent to clear it before the trees become more difficult to remove. The vegetation management plan recommends vegetation clearing prior to vegetation exceeding 1.5 m in height (Spectrum 2017).

**Photo II-1 Tailings Dam – east leg, looking south. Note vegetation on dam slope.**

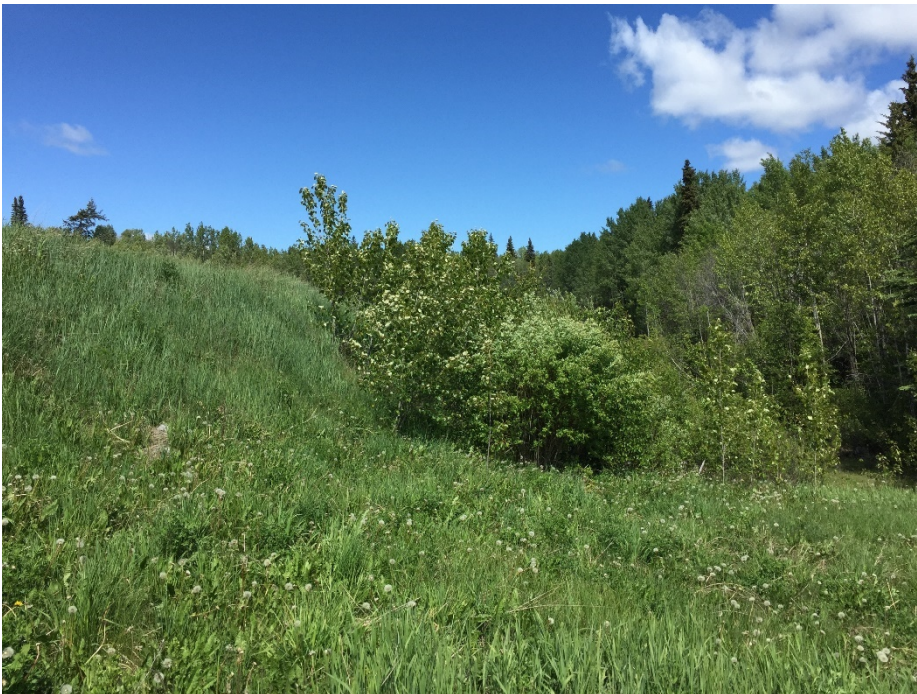
**Photo II-6 Tailings Dam – east leg, looking north. Note vegetation on dam slope.**

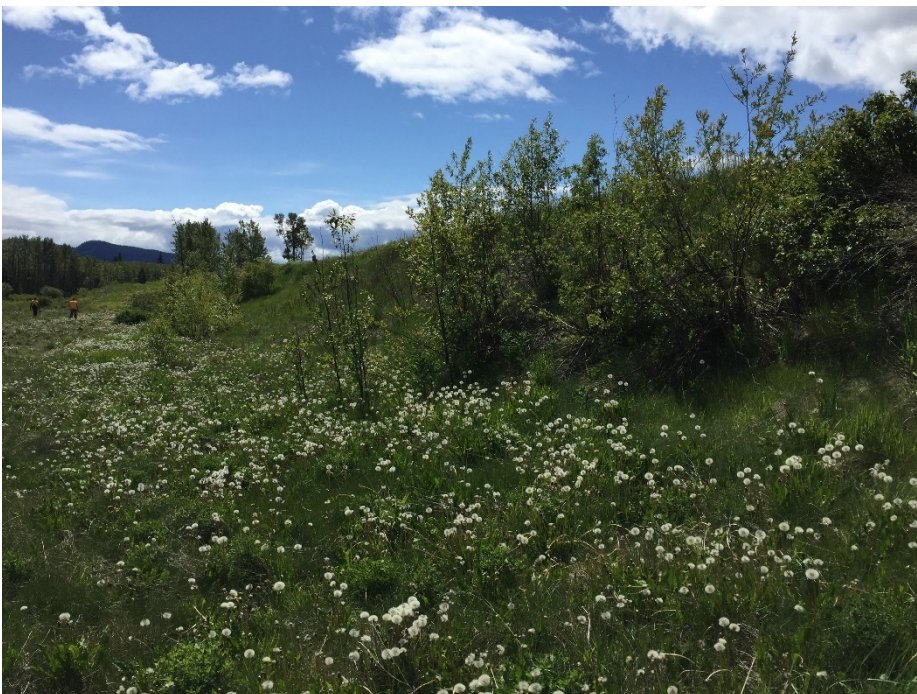
**Photo II-8 Tailings Dam – east leg, looking south. Note vegetation on dam slope.**

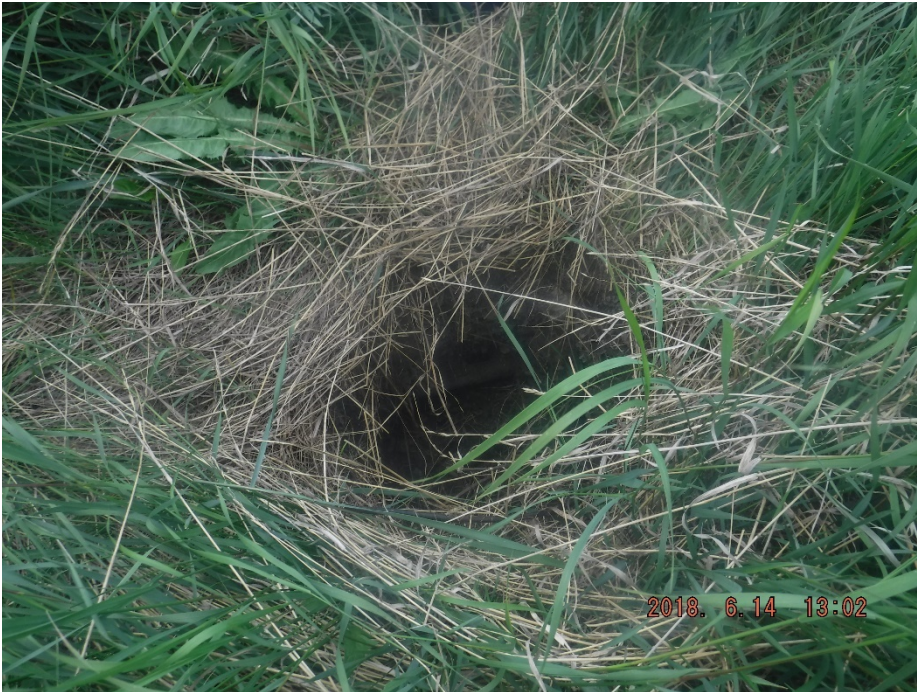
**Photo II-13 Tailings Dam – hole at former survey monument location 1018 on upstream side of crest at south leg.**

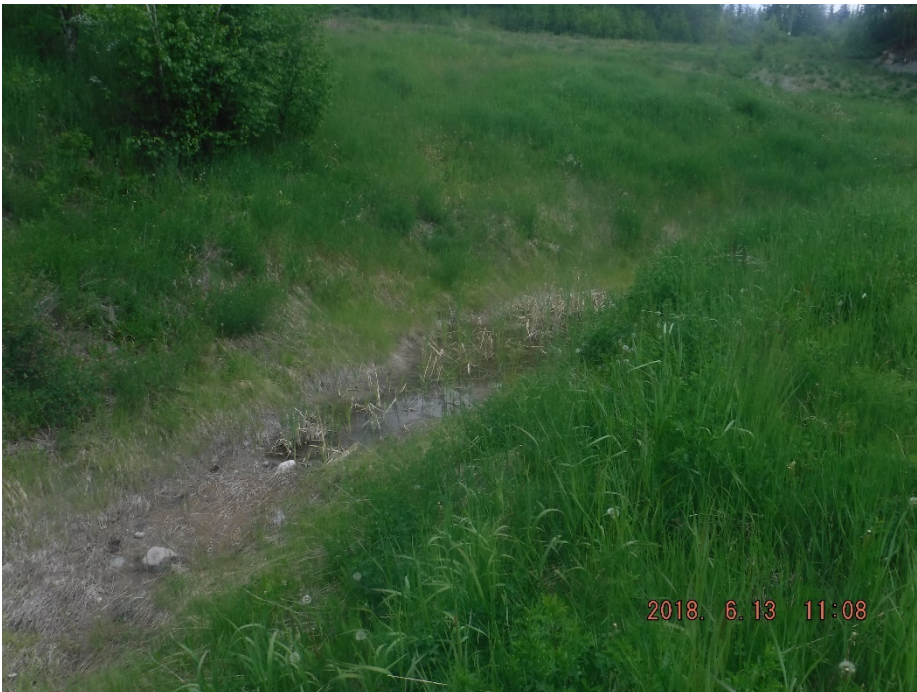
**Photo II-38** West Ditch – looking northeast. Note small pond in base of ditch.

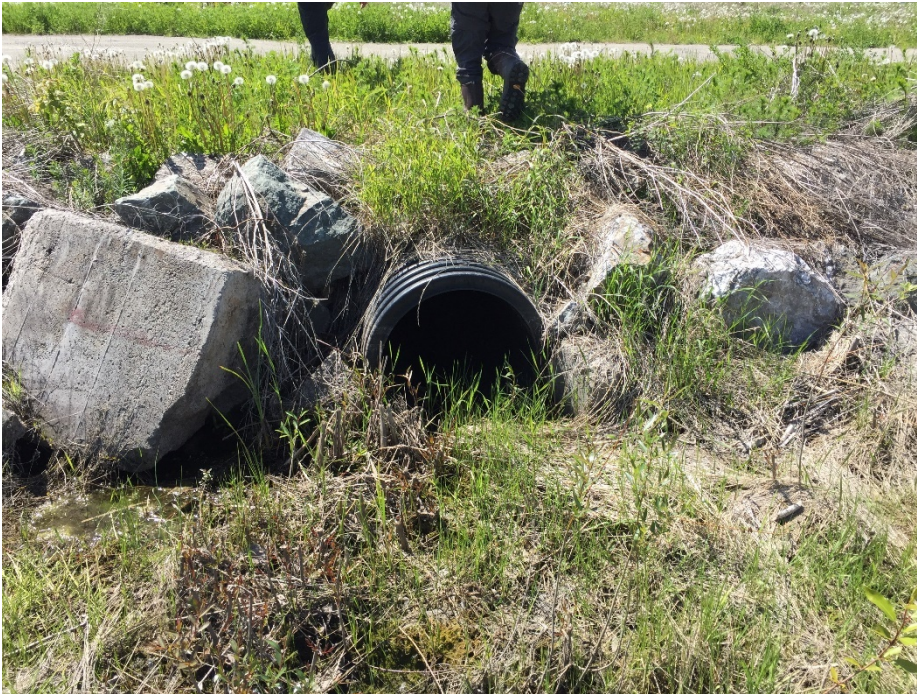
**Photo II-39 Spillway Downstream Channel – inlet to culvert beneath road to former caretaker’s house.**

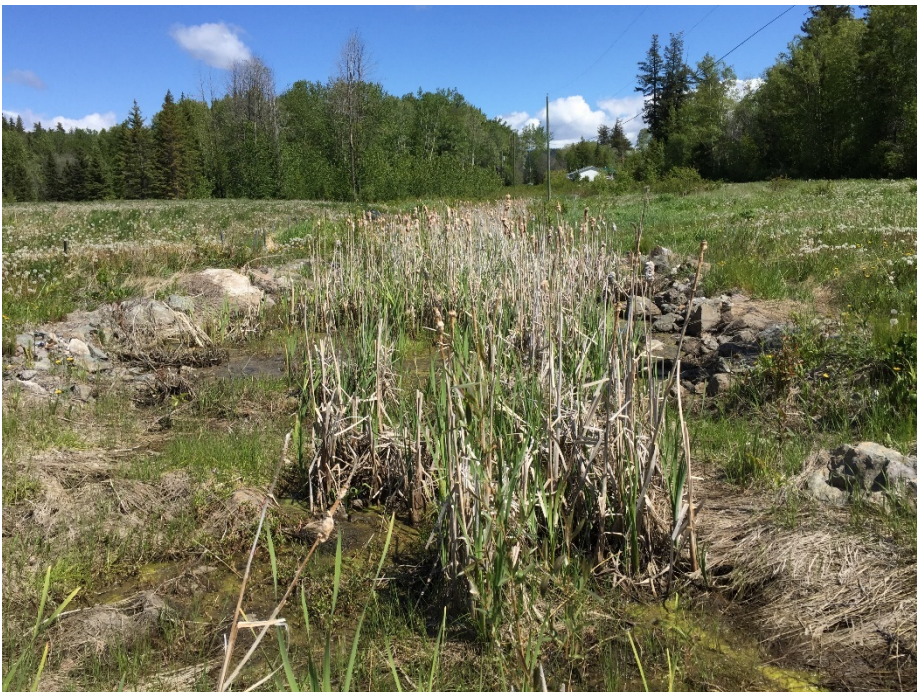
**Photo II-40 Spillway Downstream Channel – Middle Reach, looking upstream from culvert beneath road to former caretaker’s house.**

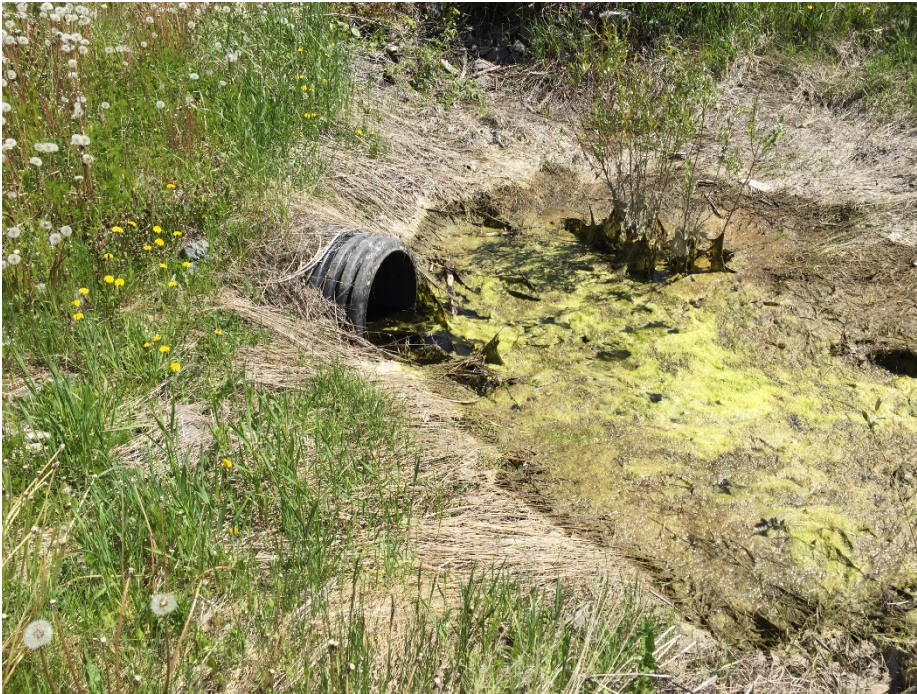
**Photo II-41 Spillway Downstream Channel – outlet of culvert beneath road to former caretaker’s house.**

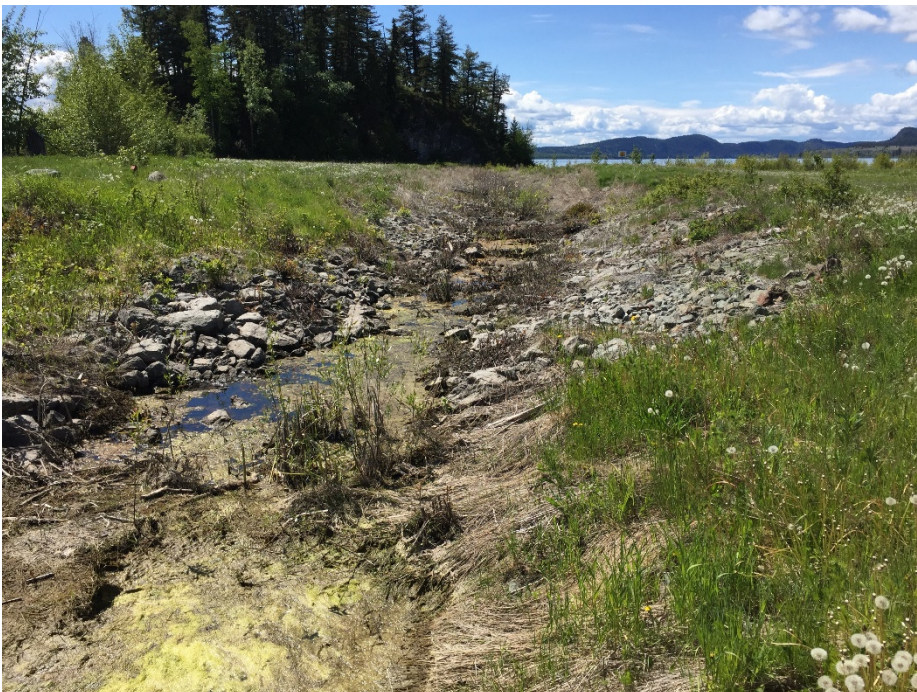
**Photo II-42 Spillway Downstream Channel – Lower Reach, looking downstream from culvert beneath road to former caretaker’s house.**

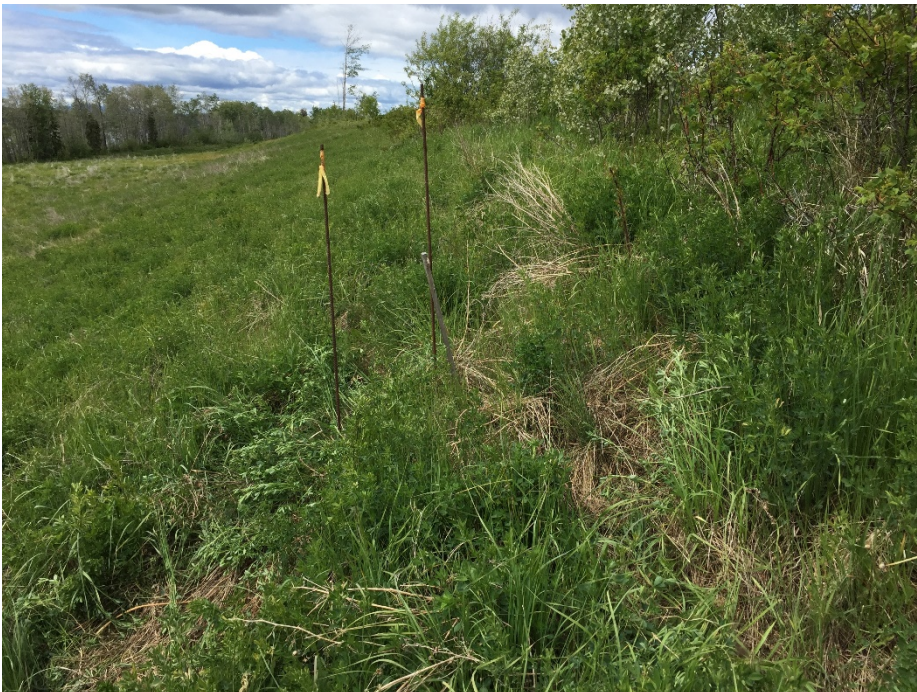
**Photo II-44 Borrow Area A – tension crack monitoring rod location 103.**

- Cracks have been observed on the borrow pit slope since 2013. The cracks have filled in with vegetation and were not clearly visible during the inspection.
- A wet area was observed starting in the northeast corner of the borrow area and continuing 60 m west along the toe of the slope. No flowing water was observed.

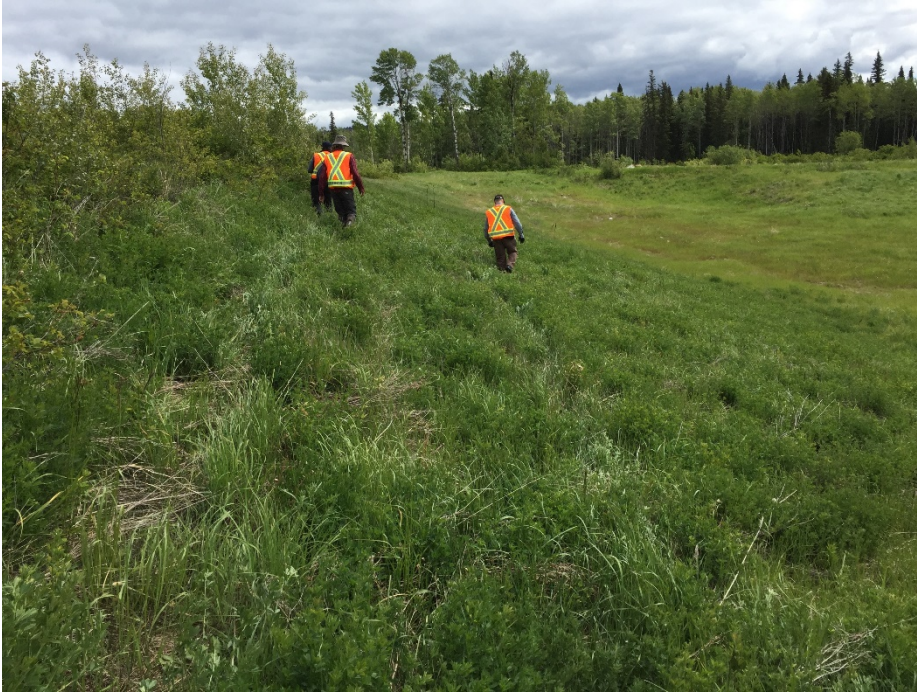
**Photo II-45 Borrow Area A – looking east along the slope.**

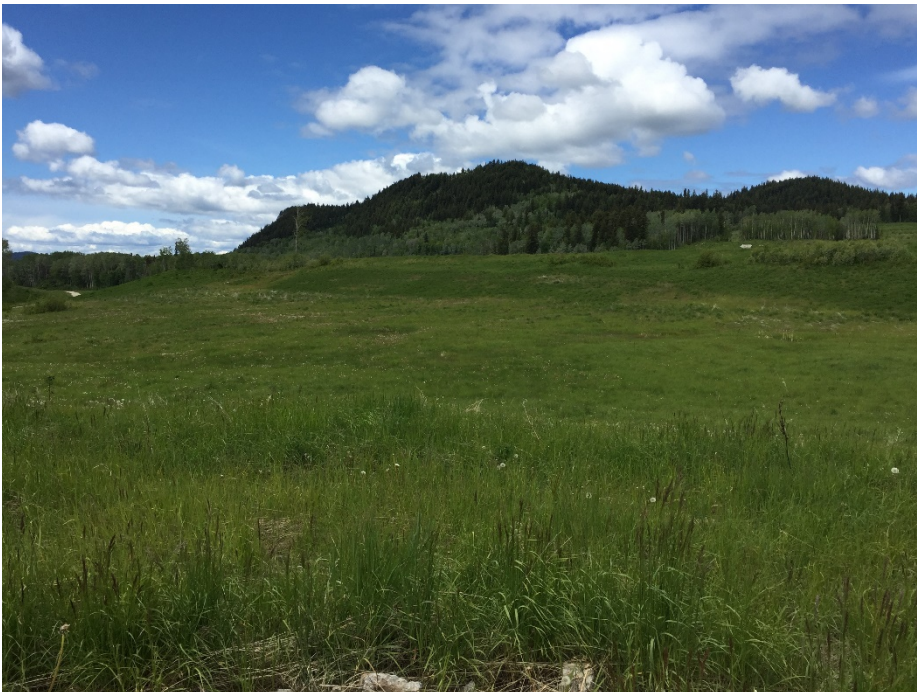
**Photo II-48 Borrow Area A – looking northwest from south end.**

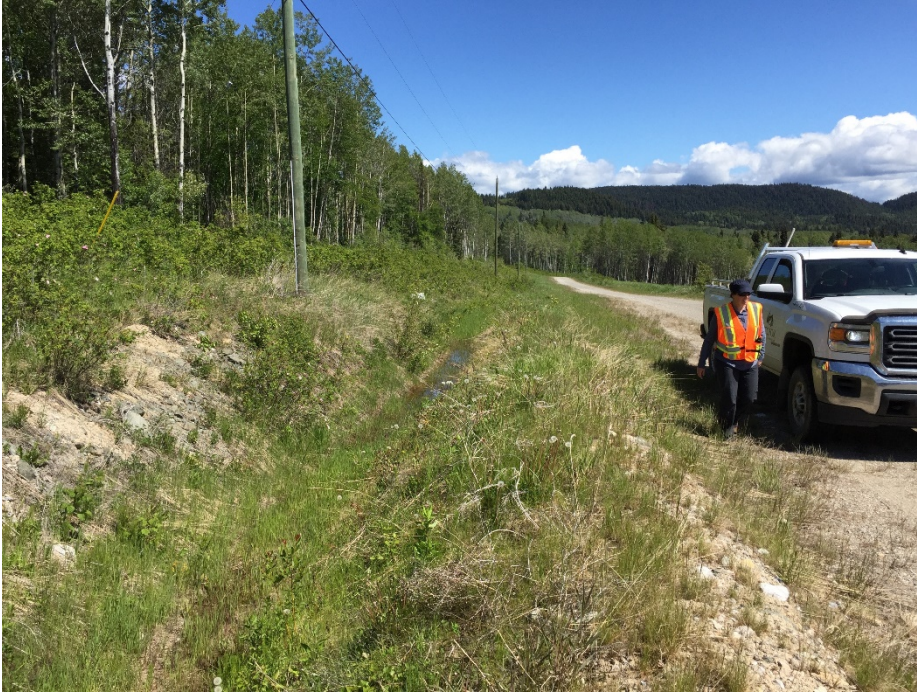
**Photo II-49 Road ditch above tailings impoundment, looking east.**

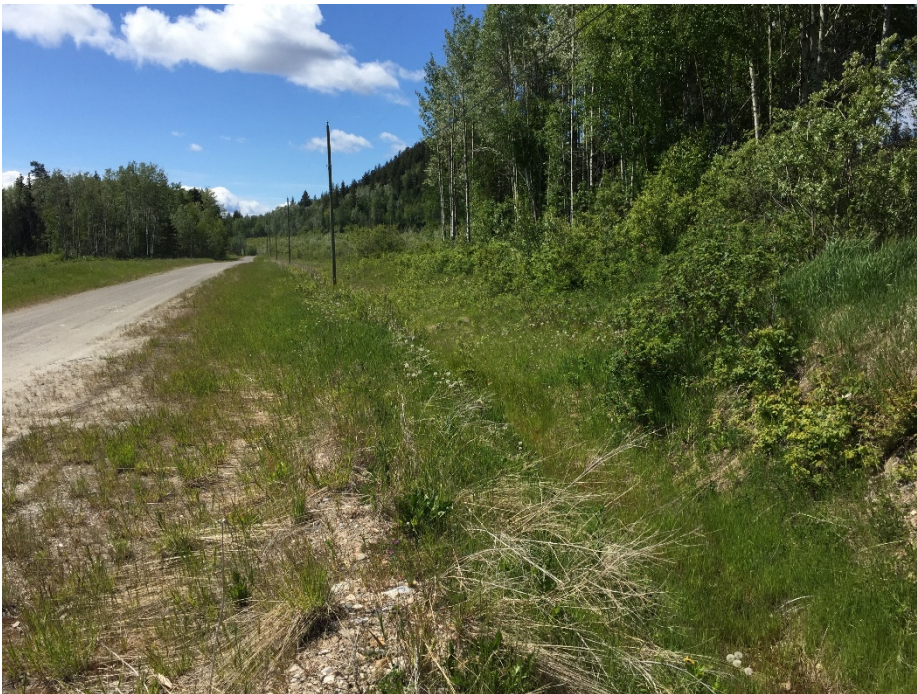
**Photo II-50 Road ditch above tailings impoundment, looking west.**

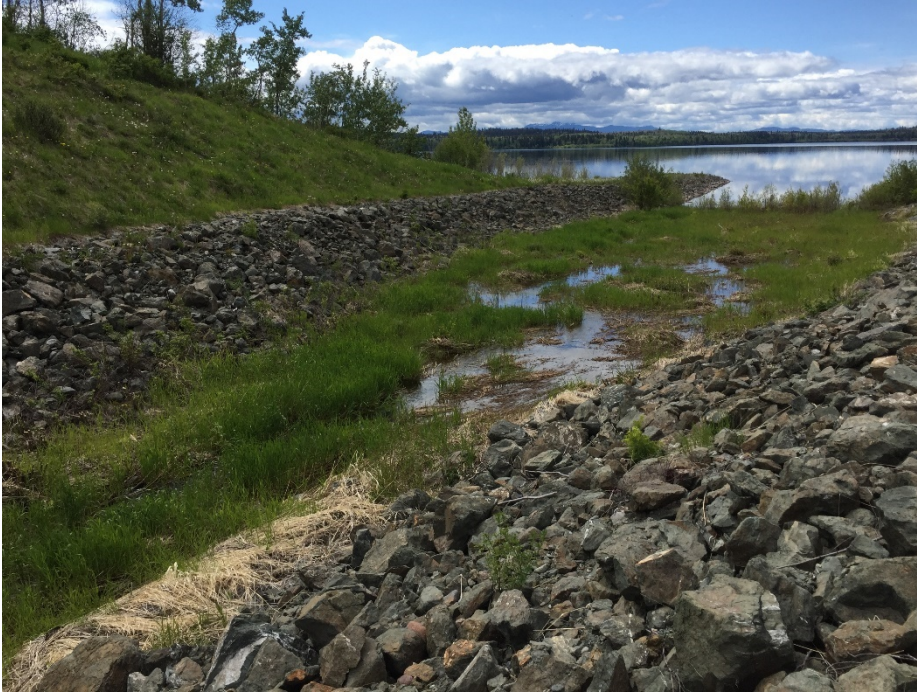
**Photo II-51 Ed Creek Diversion Channel – outlet at Pinchi Lake.**

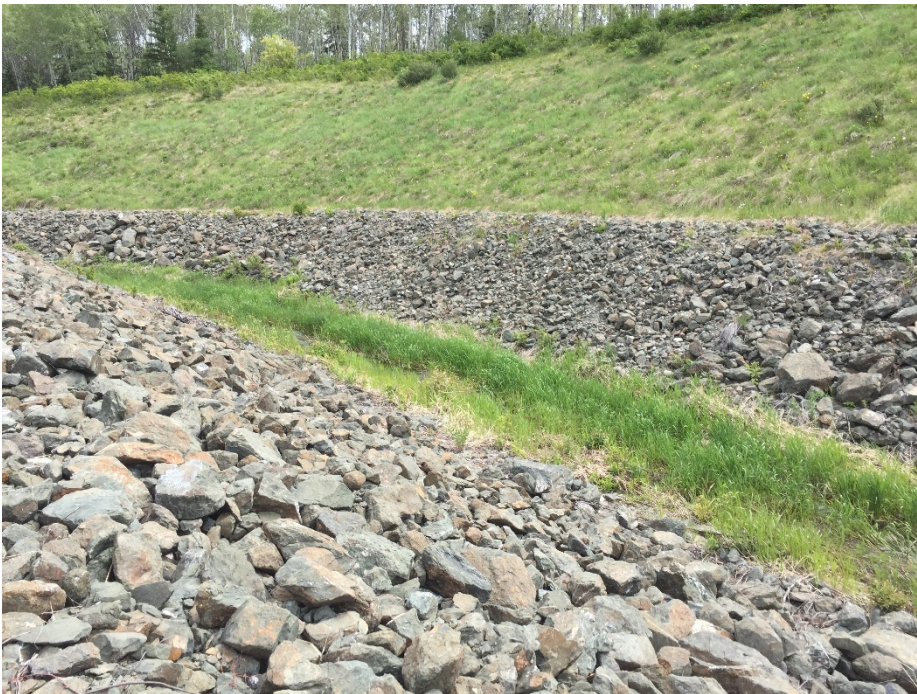
**Photo II-52 Ed Creek Diversion Channel – looking upstream from near outlet.**

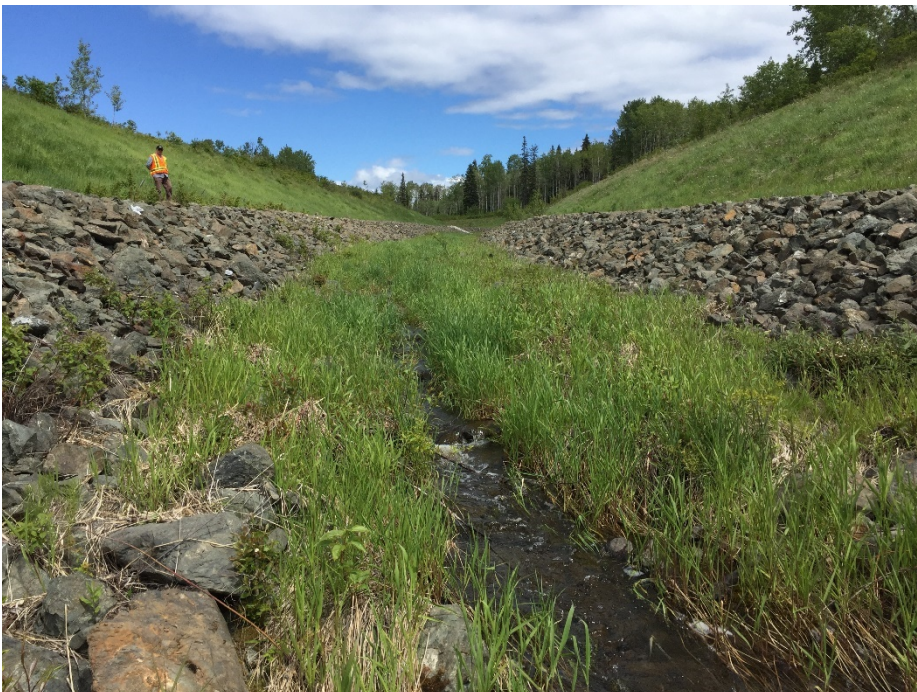
**Photo II-54 Ed Creek Diversion Channel – looking upstream from near third bend. Flow depth in channel is 20 cm.**

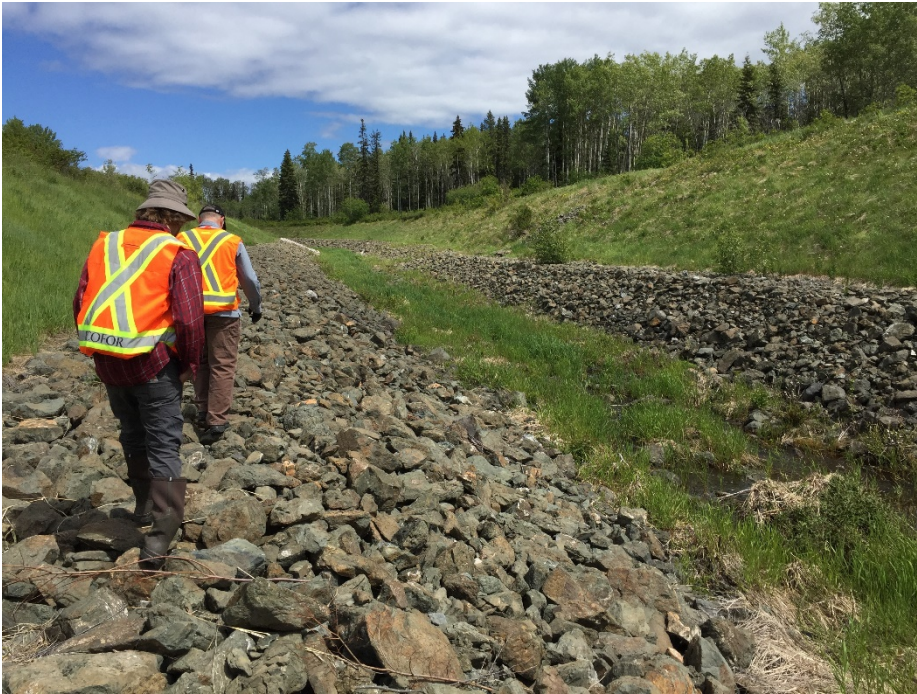
**Photo II-55** Ed Creek Diversion Channel – looking upstream from between second and third bends.

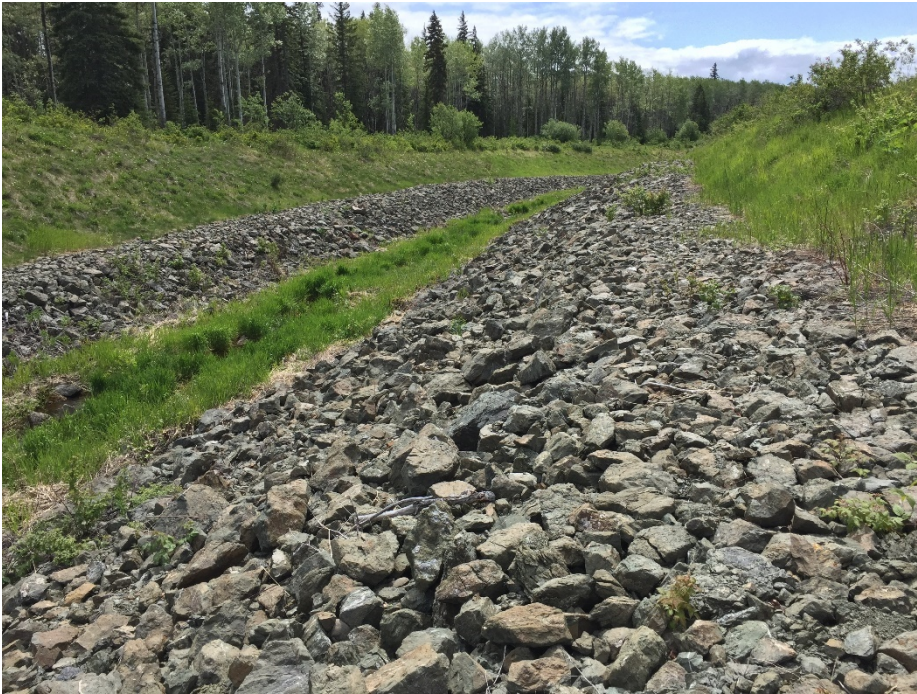
**Photo II-57 Ed Creek Diversion Channel – looking downstream from between first and second bends.**

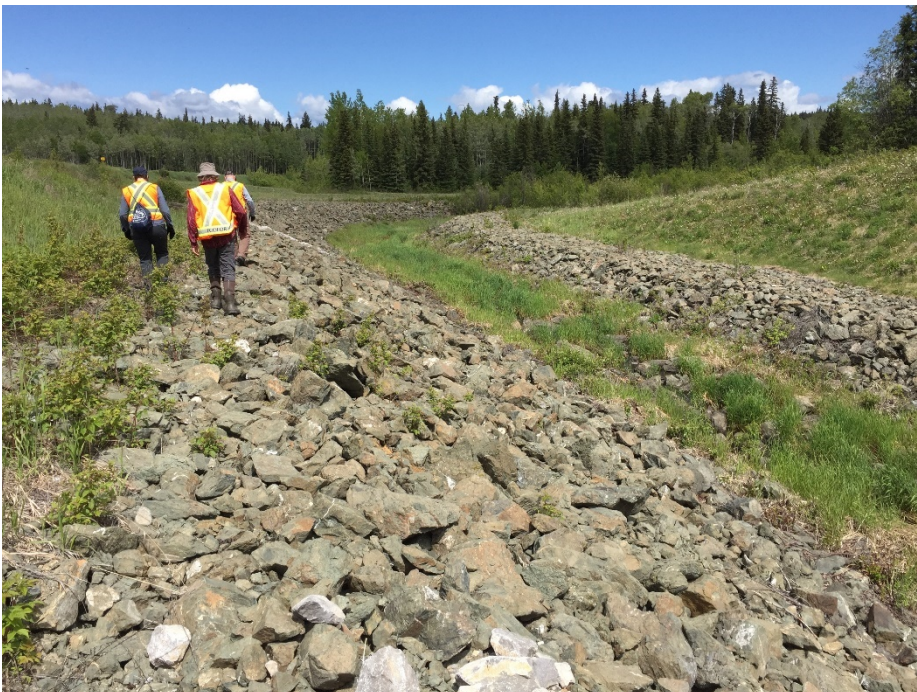
**Photo II-58 Ed Creek Diversion Channel – looking upstream from between first and second bends.**

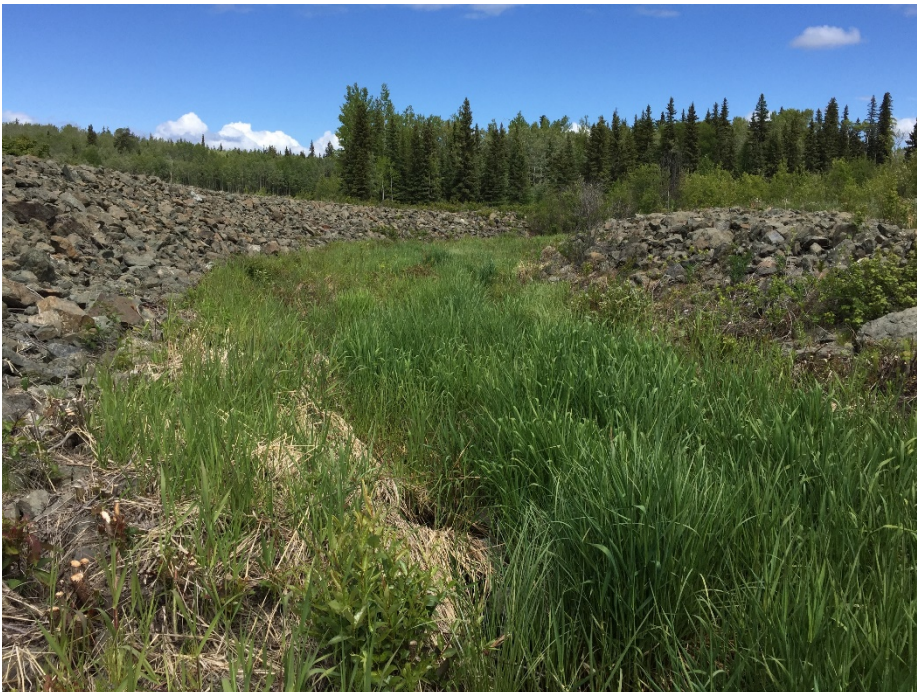
**Photo II-60 Ed Creek Diversion Channel – looking upstream towards first bend.**

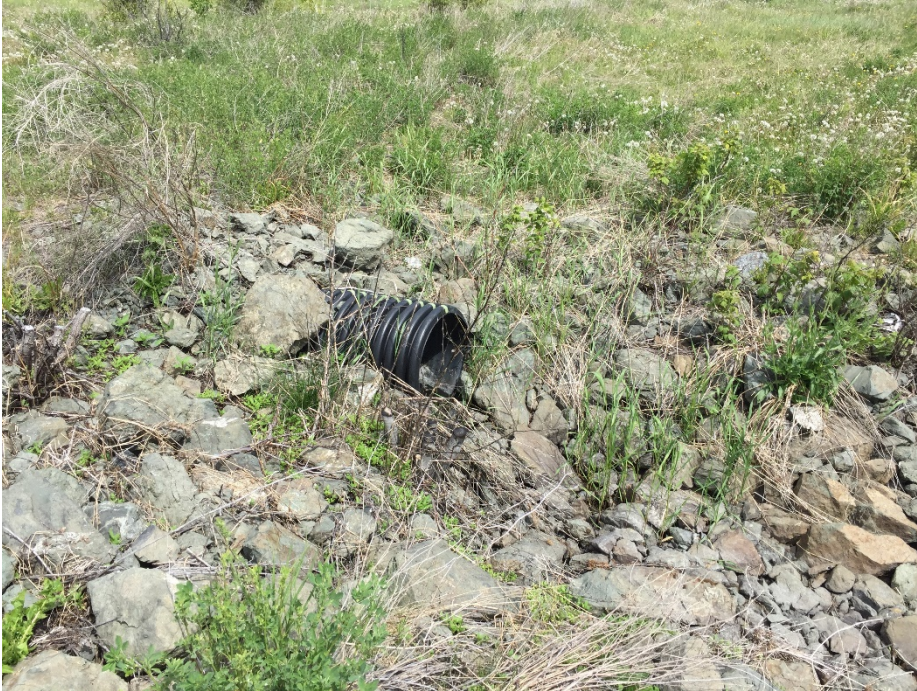
**Photo II-61 Outlet of 460 mm culvert on north bank of Ed Creek Diversion Channel.**

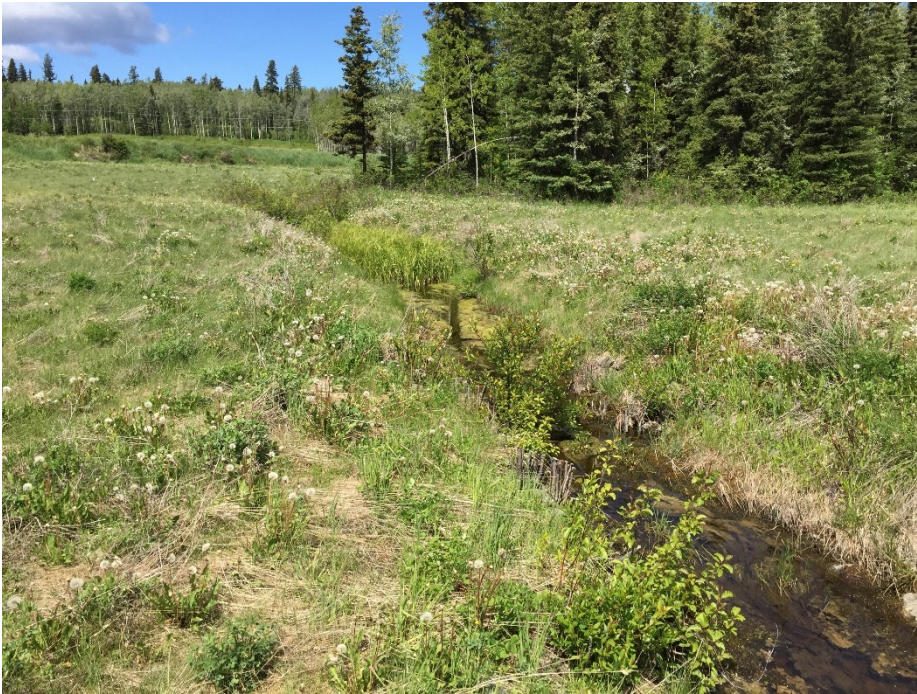
**Photo II-63** Drainage ditch between pond area at the toe of the east leg of the Tailings Dam and Ed Creek Diversion Channel. Looking upstream from culvert shown in Photo II-62.

4. A pond is located near the toe of the east leg of the dam, which drains to the south through a culvert into Ed Creek Diversion Channel. This pond has been observed in previous inspections, and appears to be related to local runoff. No other ponds were observed near the dam toe.
-

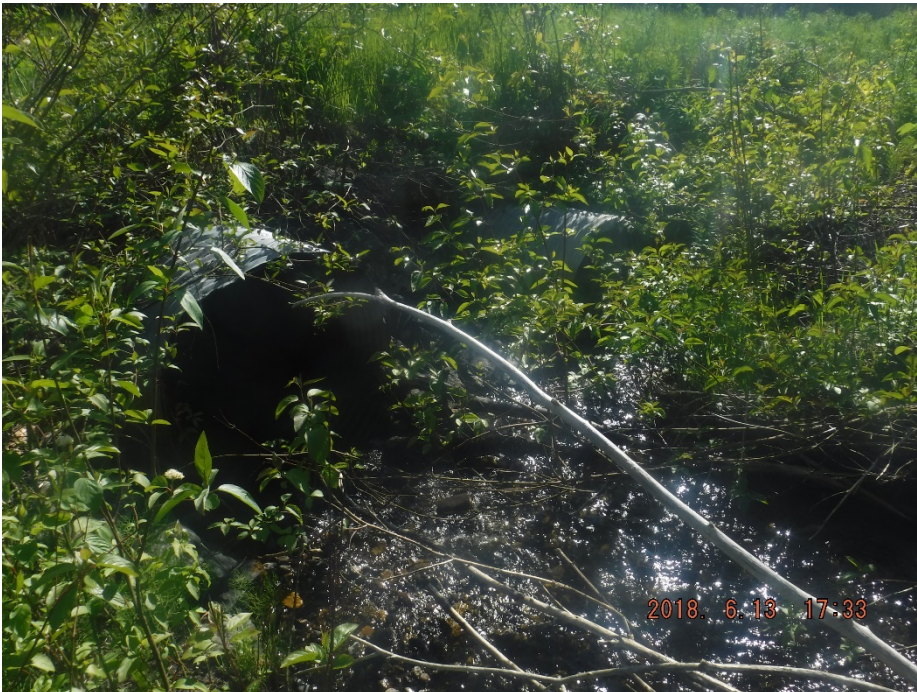
**Photo II-64** Inlets of Ed Creek culverts under Pinchi Lake Road.

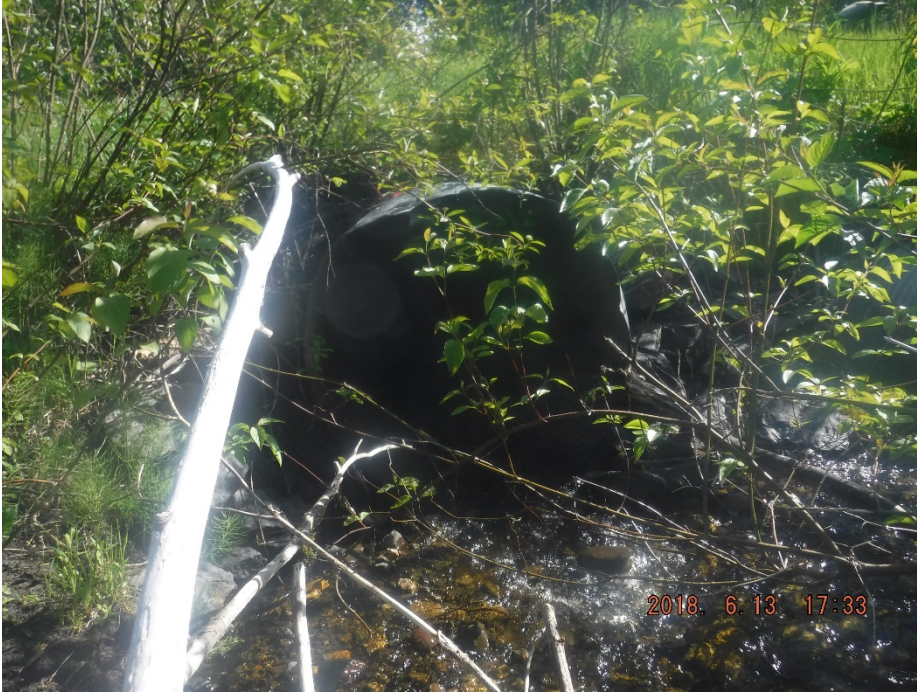
**Photo II-65 Inlet of east culvert under Pinchi Lake Road.**

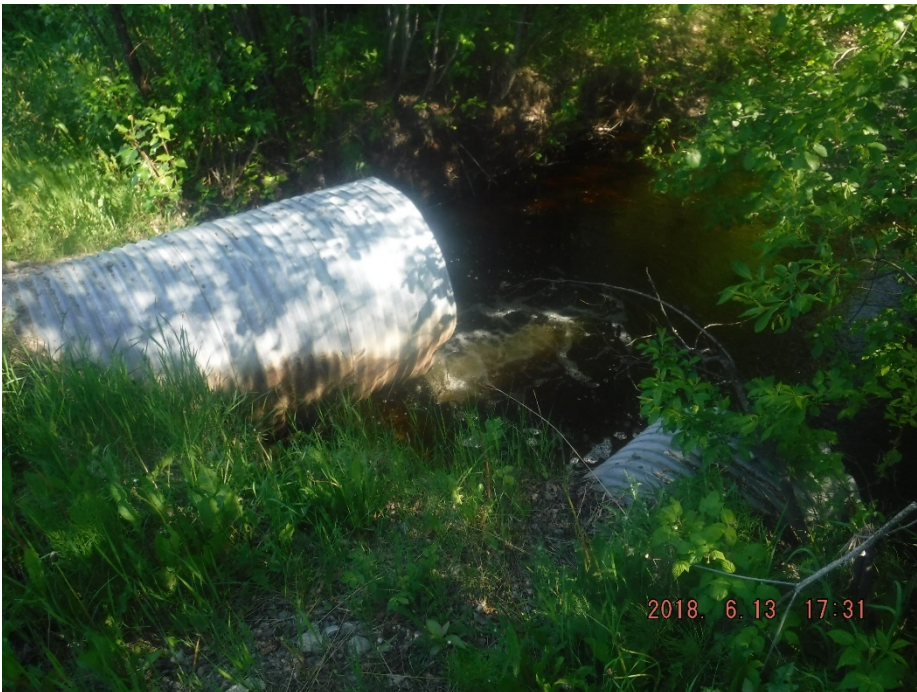
**Photo II-66 Outlets of Ed Creek culverts under Pinchi Lake Road.**
