Teck Coal Limited

Quintette Coal Operations

2018 Dam Safety Inspection

Plantsite Tailings Dam

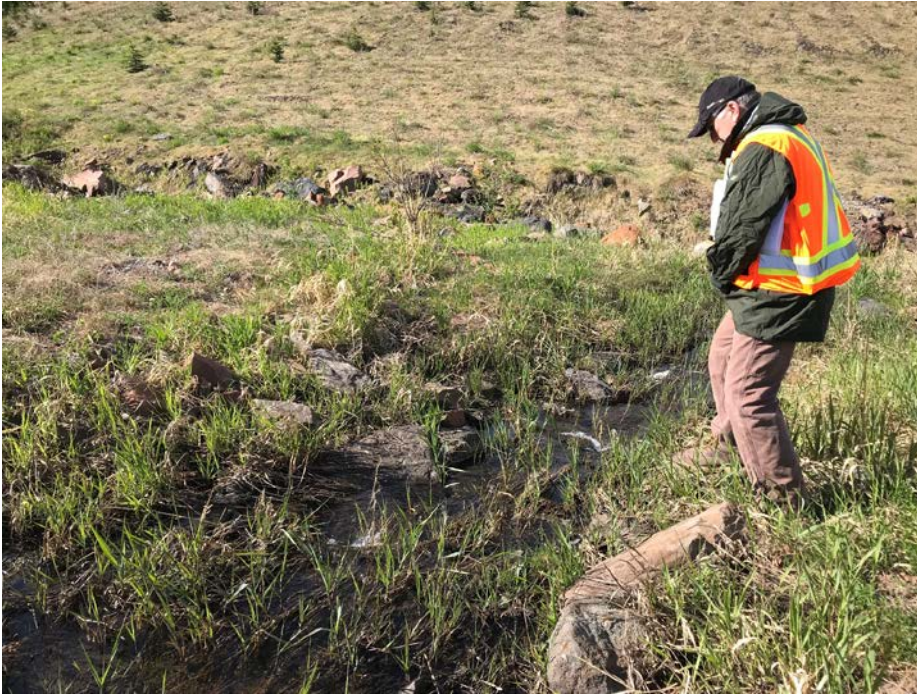
Photo I-5 **Looking south along the M17 Creek. Creek is well vegetated, but not a dam safety concern (PTD-2018-04)**

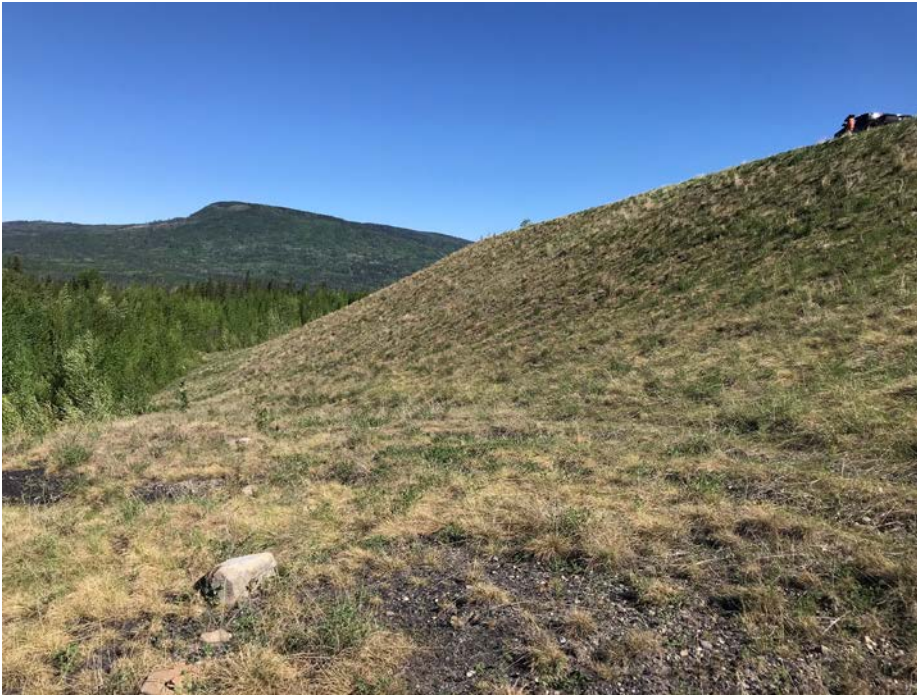
Photo I-9 Small sinkhole located downstream of the dam's toe – suspected to be collapsed animal burrow (PTD-2018-08)

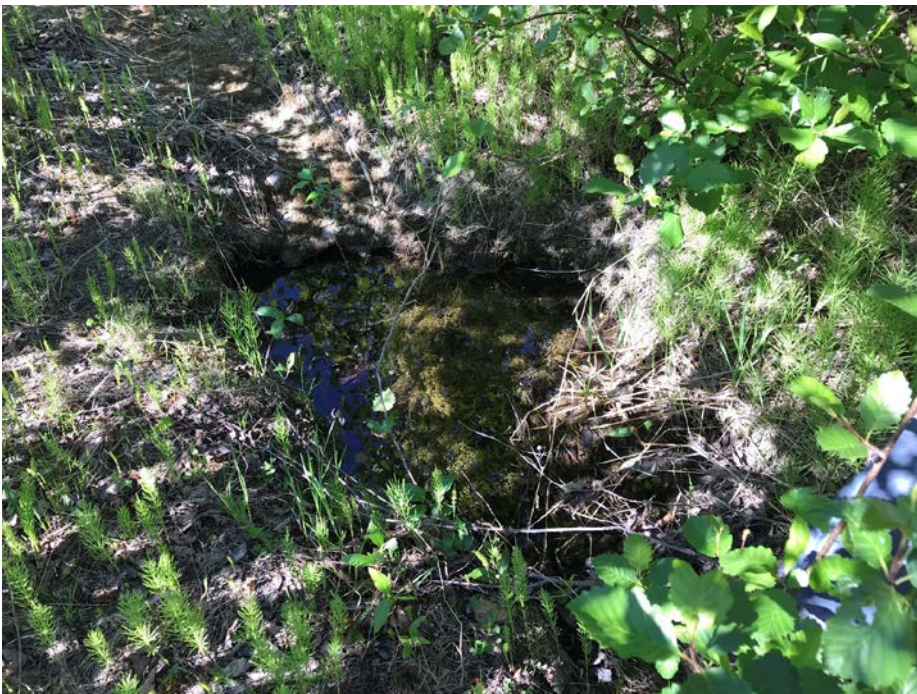
Photo I-10 **Finger drain at PTD toe; area downstream of the finger drain is boggy and well vegetated (PTD-DRAIN-08/09)**

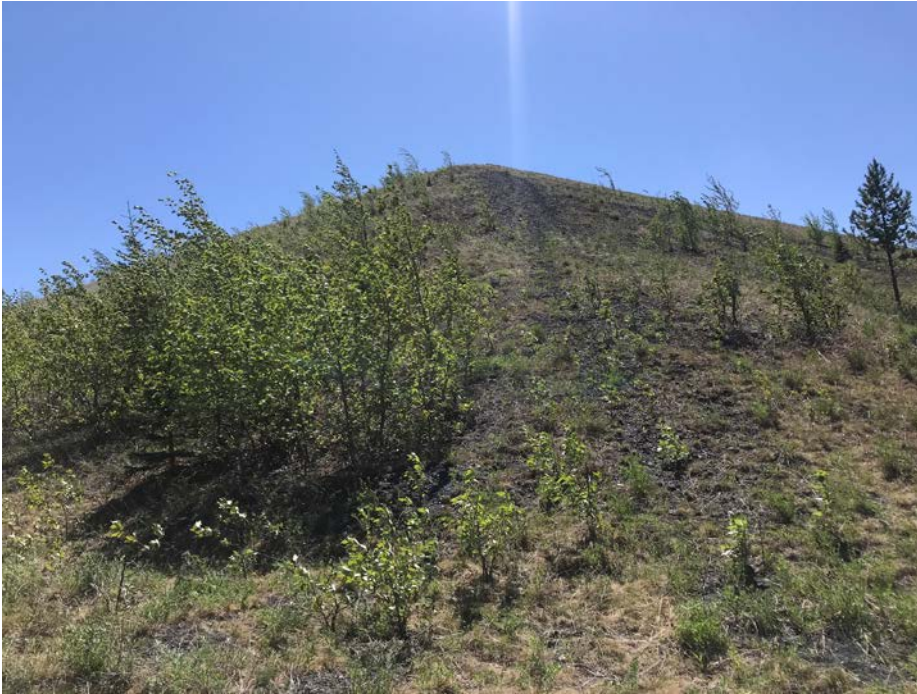
Photo I-22 **Overview of PTD northwest corner - steep scarp near downstream slope ramp – inactive due to the amount of vegetation growth on scarp (PTD-2018-16)**

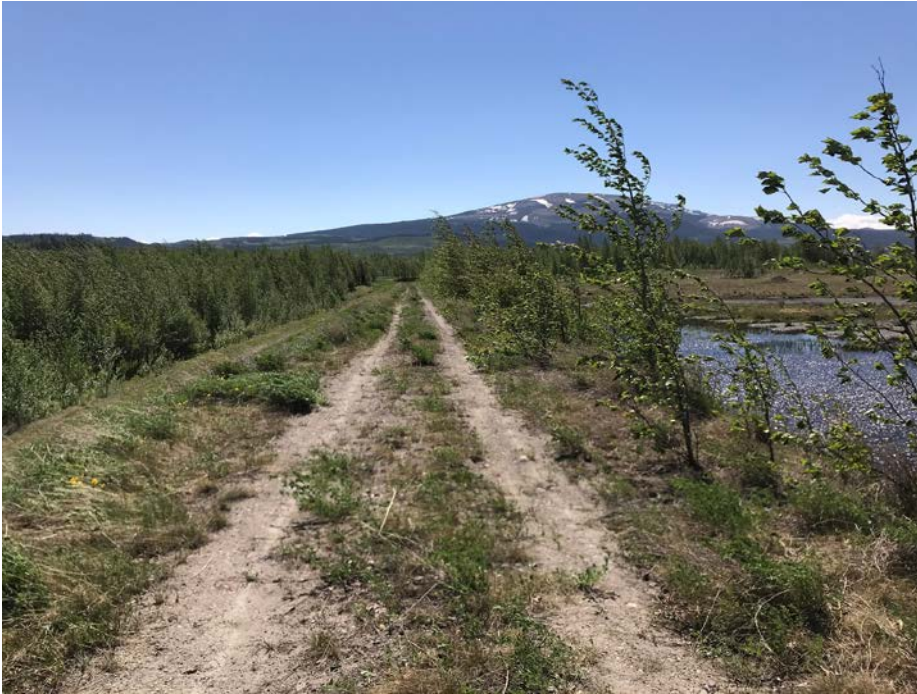
Photo I-30 **Downstream slope of the PTD - looking north at approximately Sta. 2+230 (PTD-2018-20)**

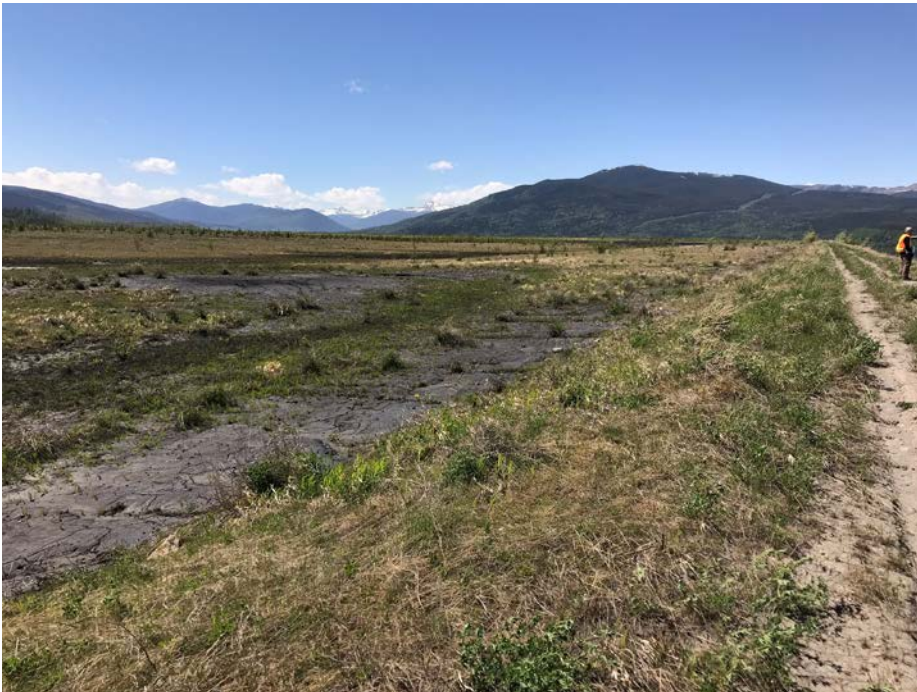
Photo I-33 Downstream slope of the PTD - looking west at approximately Sta. 2+100. No signs of displacement or deformation (PTD-2018-22)

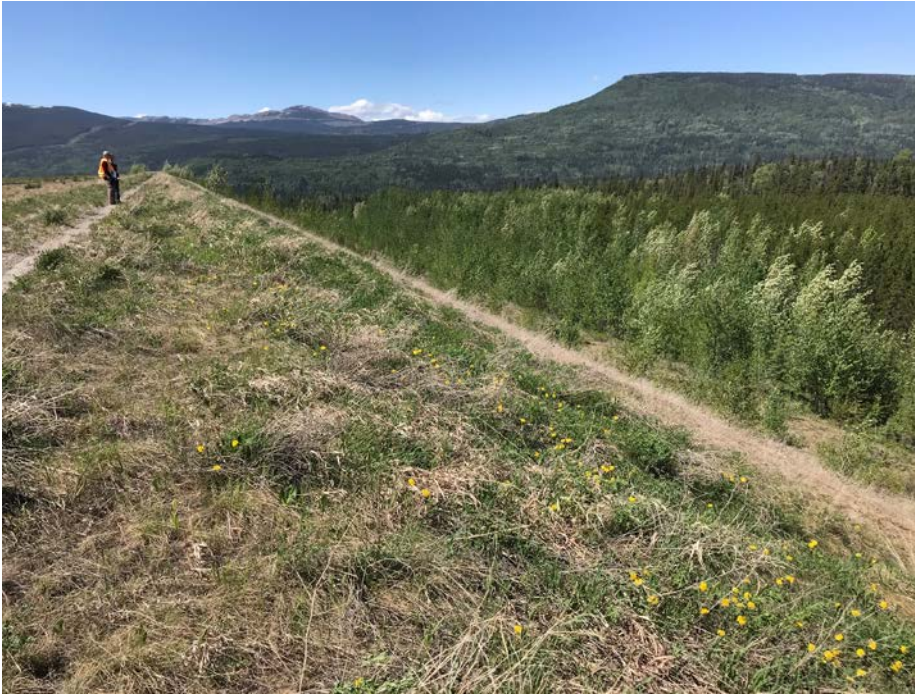
Photo I-34 Upstream slope and tailings beach – no sinkholes or signs of distress. Tailings surface is less than 1 m below the crest; not a dam safety concern (PTD-2018-23)

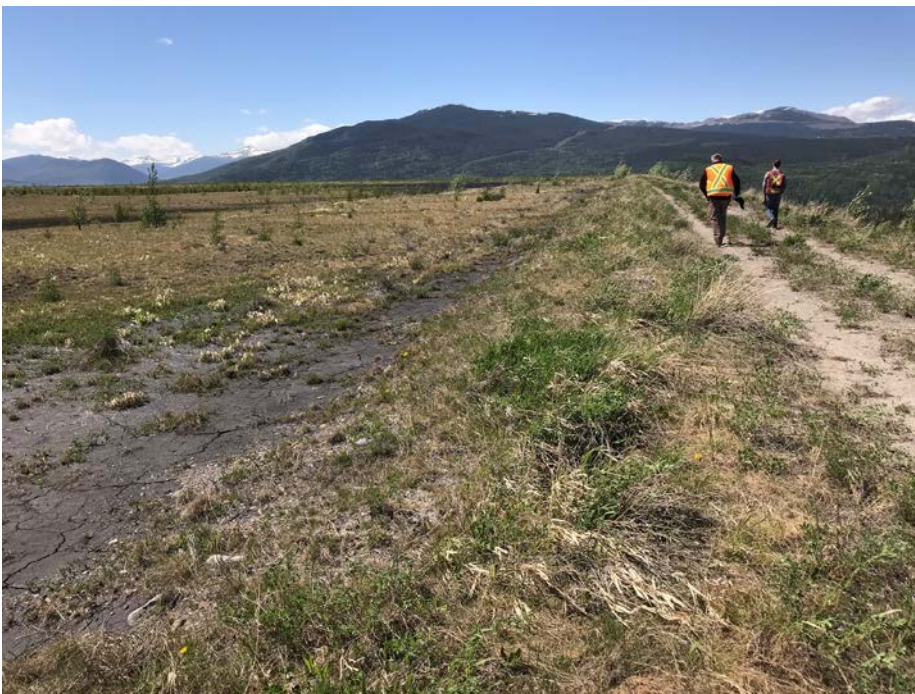
Photo I-35 PTD northwest corner. Poned Area 1 appears to be larger than previous year due to freshet; no dam safety concern (PTD-2018-24)

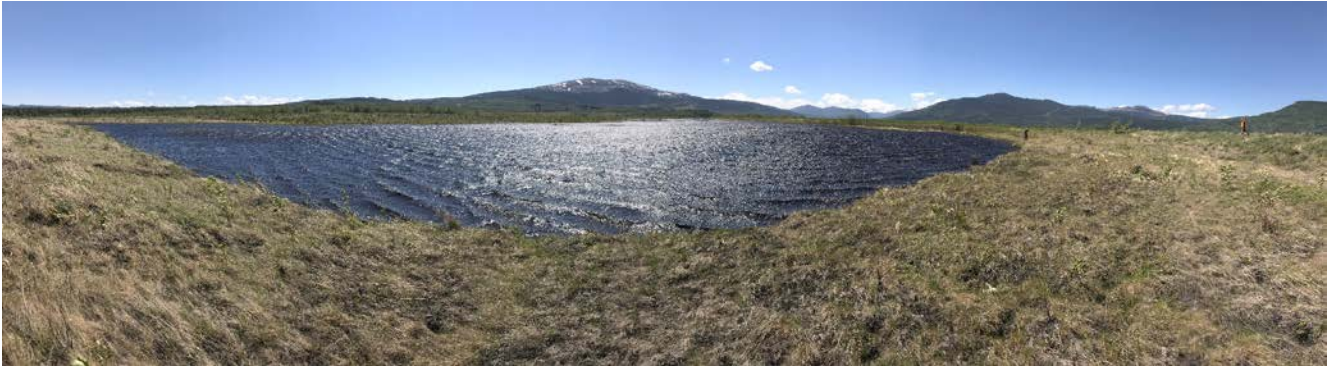
Photo I-36 Temporary stake installed at the ponded area at the northwest corner of the PTD for freeboard monitoring. A permanent staff gauge was installed in July 2018 (PTD-2018-25)

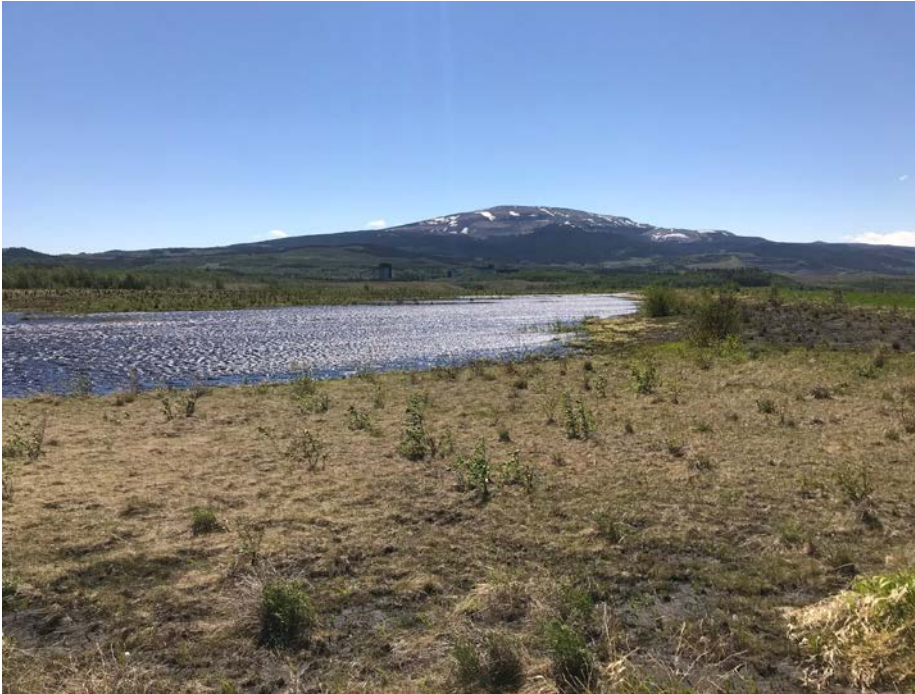
Photo I-38 Standing at the dam's crest at the northwest corner; no signs of distress – looking west (PTD-2018-26)

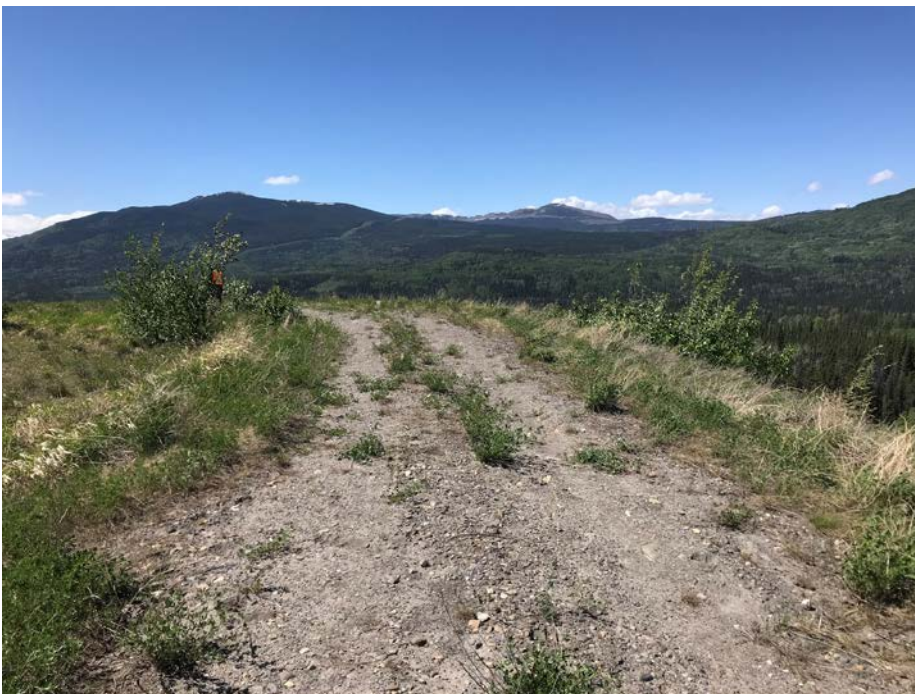
Photo I-39 **Overview of the downstream slope from the dam crest near Sta. 1+640 – looking east. No signs of distress, significant movement or erosion (PTD-2018-26)**

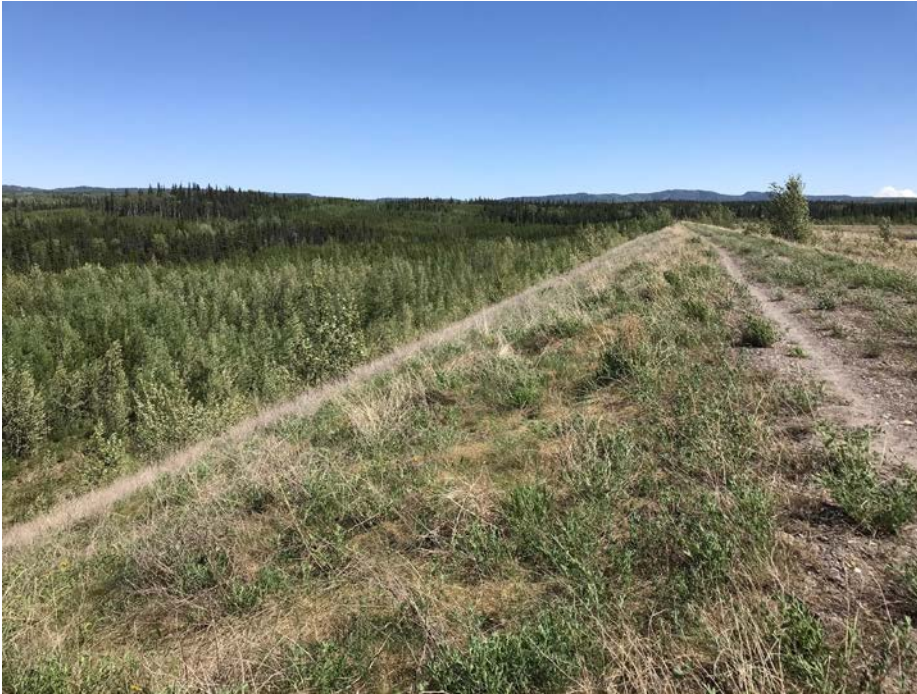
Photo I-40 **Overview of the downstream slope from the dam crest near Sta. 1+230 – looking south. No signs of distress, significant movement or erosion (PTD-2018-27)**

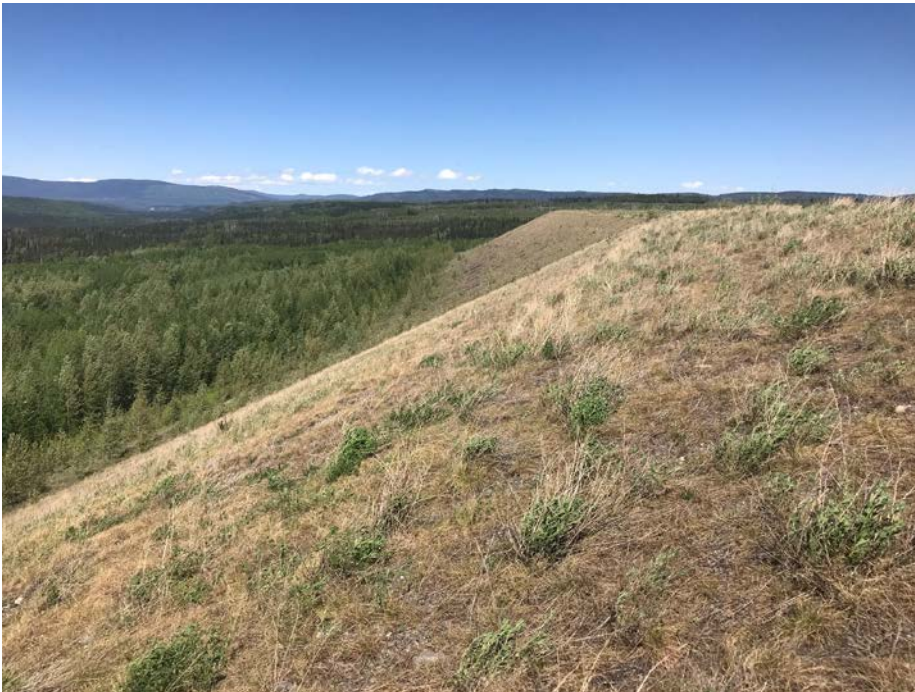
Photo I-43 **Dam upstream slope near Sta. 0+660; no signs of distress – looking south (PTD-2018-30)**

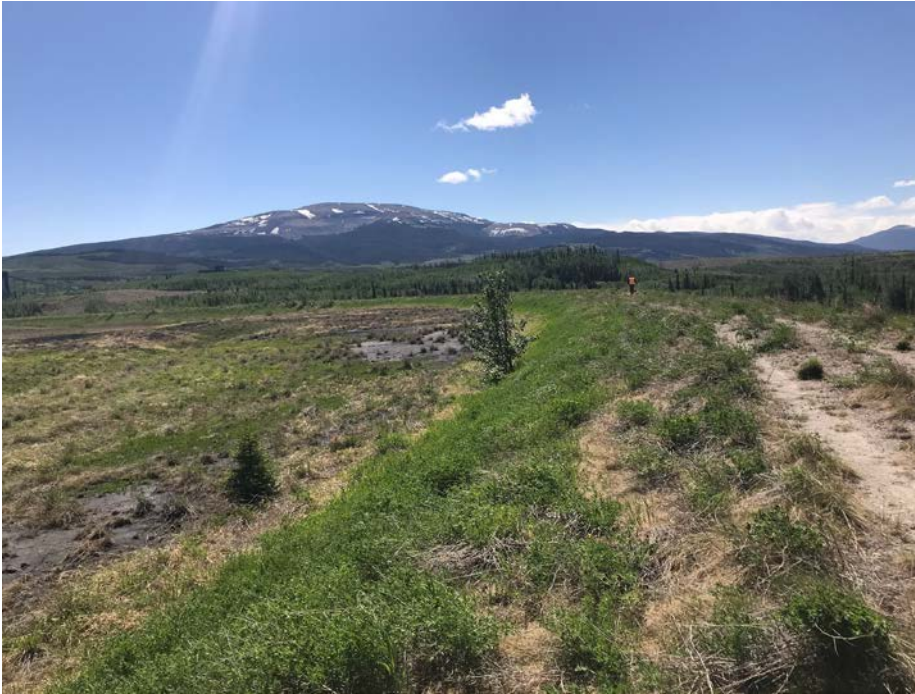
Photo I-44 **From dam crest near Sta. 0+540 looking at the ponded area and the tailings beach; no signs of sinkholes or distress – looking east (PTD-2018-31)**

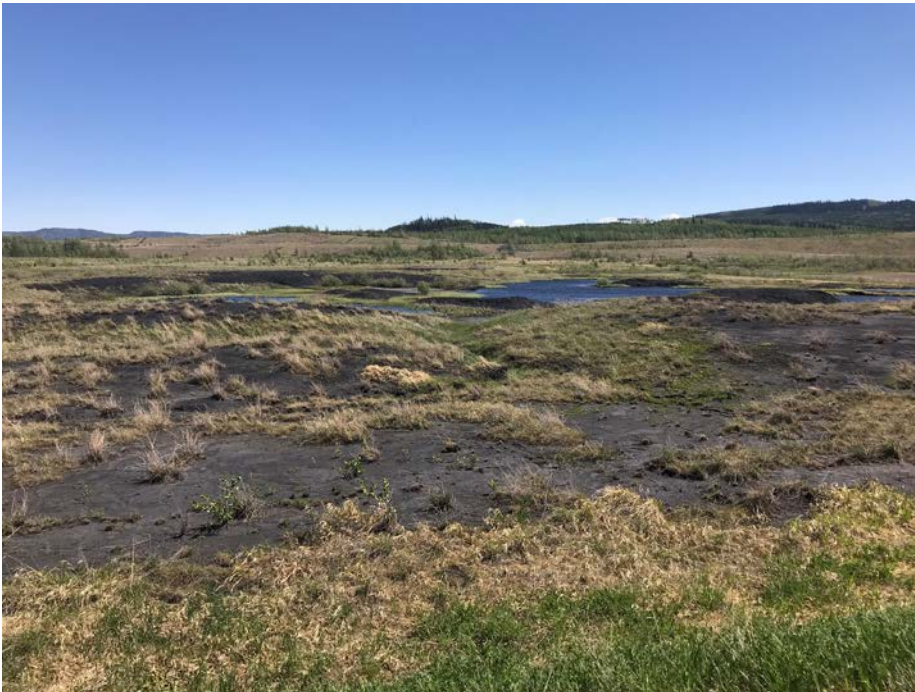
Photo I-45 Pond within depressions (Ponded Area 2) along the tailings beach near Sta. 0+440 – looking east. Pond appears to be the higher than 2017 observation (PTD-2018-32)

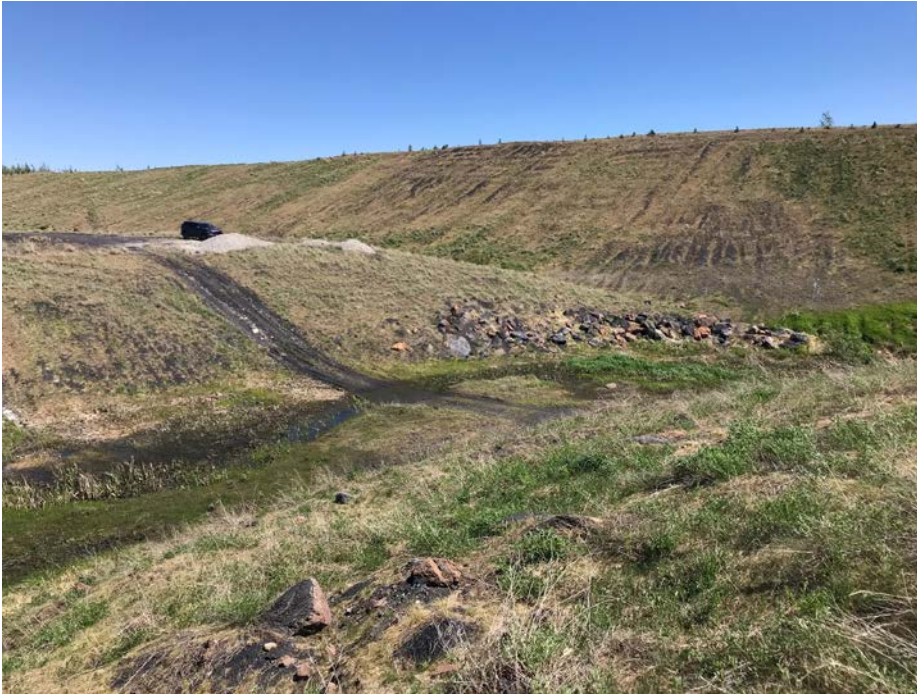
Photo I-50 **Overview of outlet channel – looking south toward discharge point into M17 Creek (PTD-2018-37)**

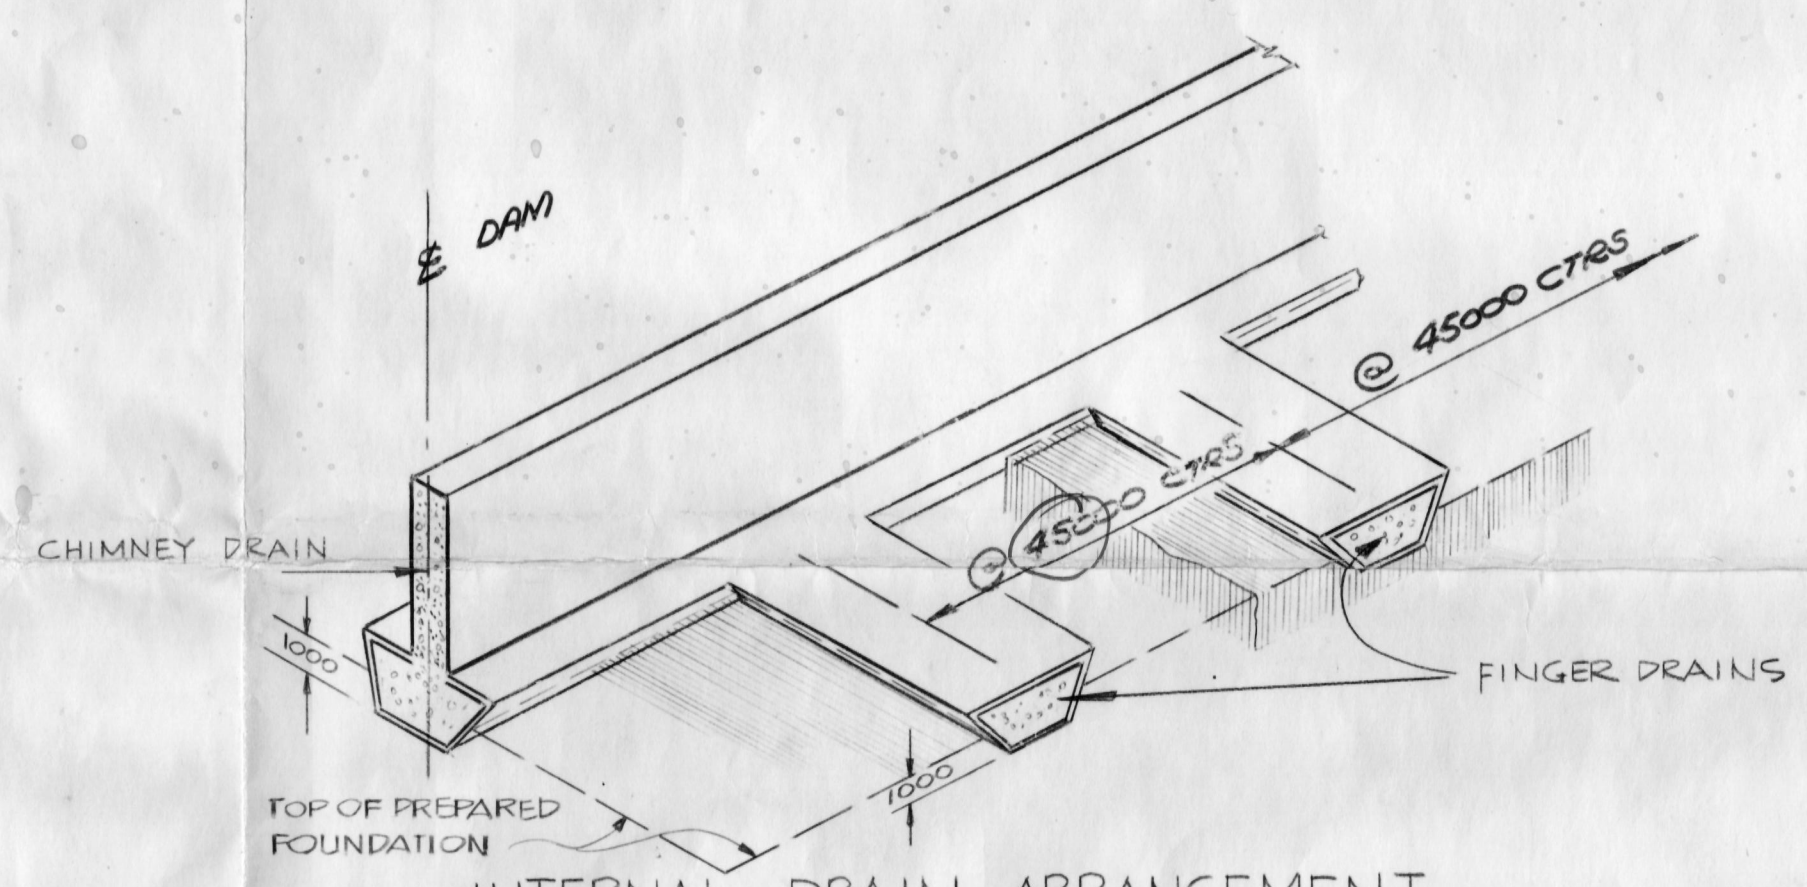
INTERNAL DRAIN ARRANGEMENT
N.T.S.

These conform to spec.

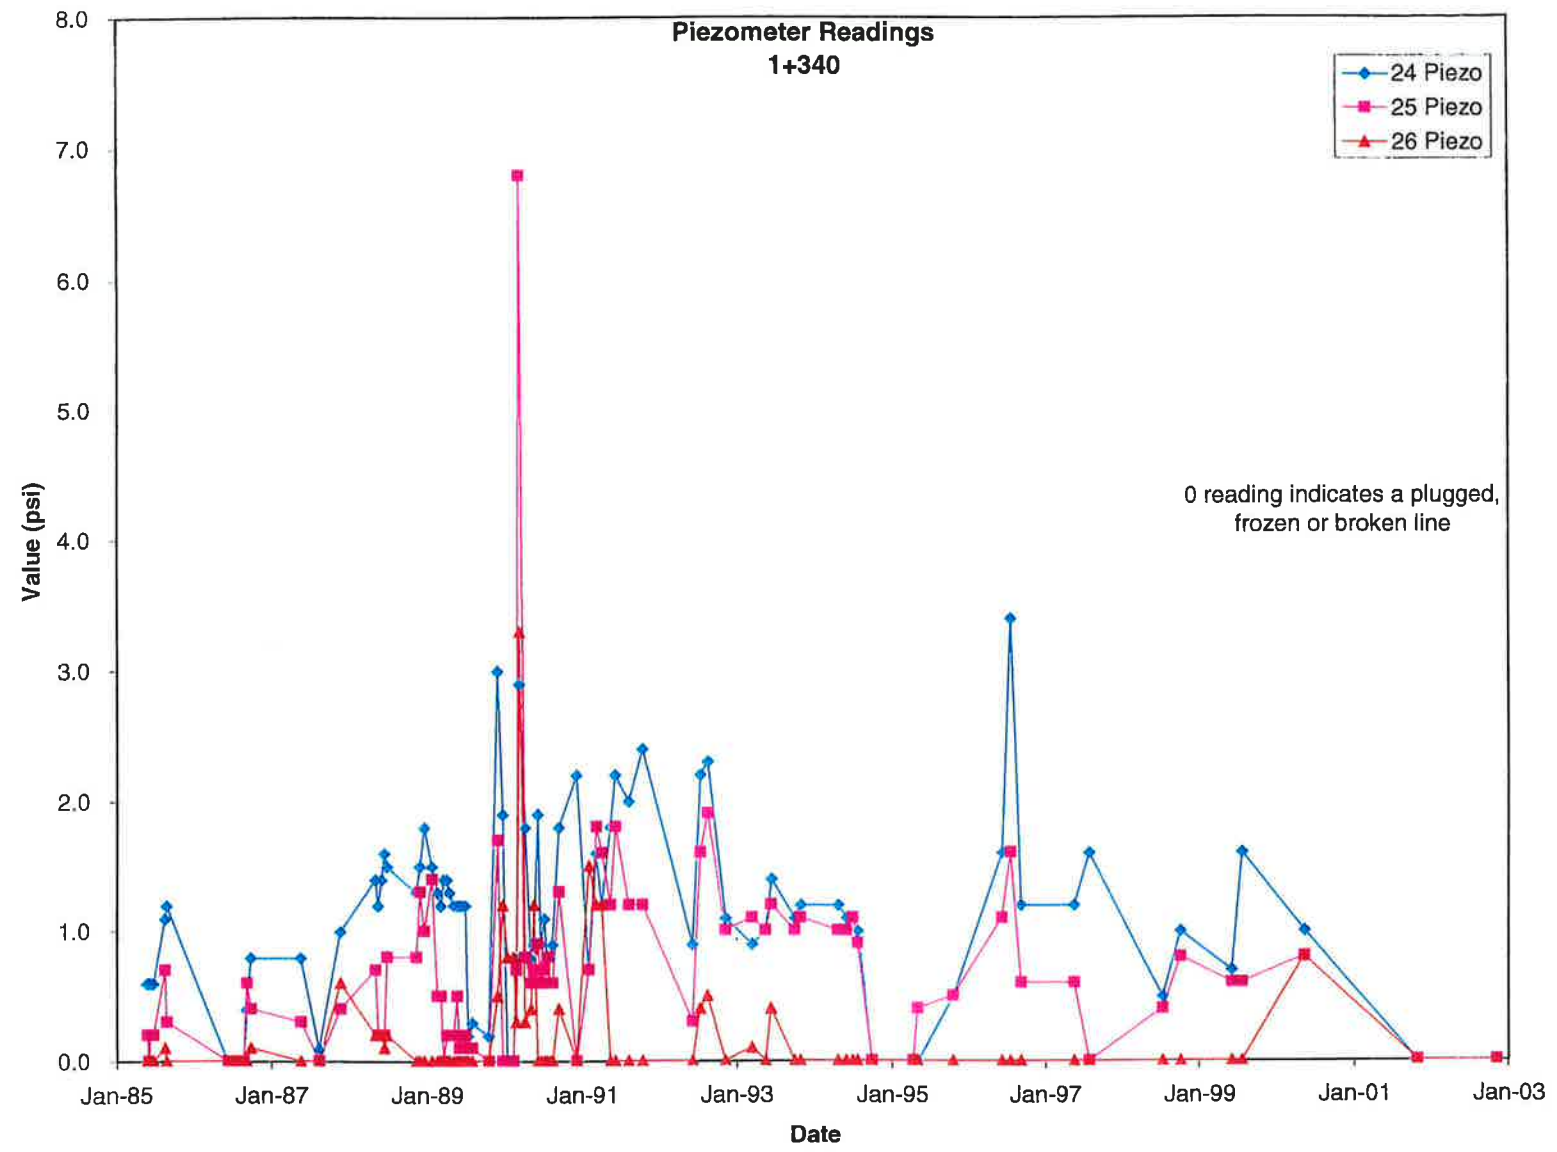
STATION 1+340

Piezometer 26 is located shallow depth below the fill/foundation surface of contact, on the downstream side of the core drain. This piezometer has not been functional for several years.
