# **Teck Coal Limited**

## **Quintette Coal Operations**

### ***2018 Dam Safety Inspection***

### ***Shikano North Tailings Dam***

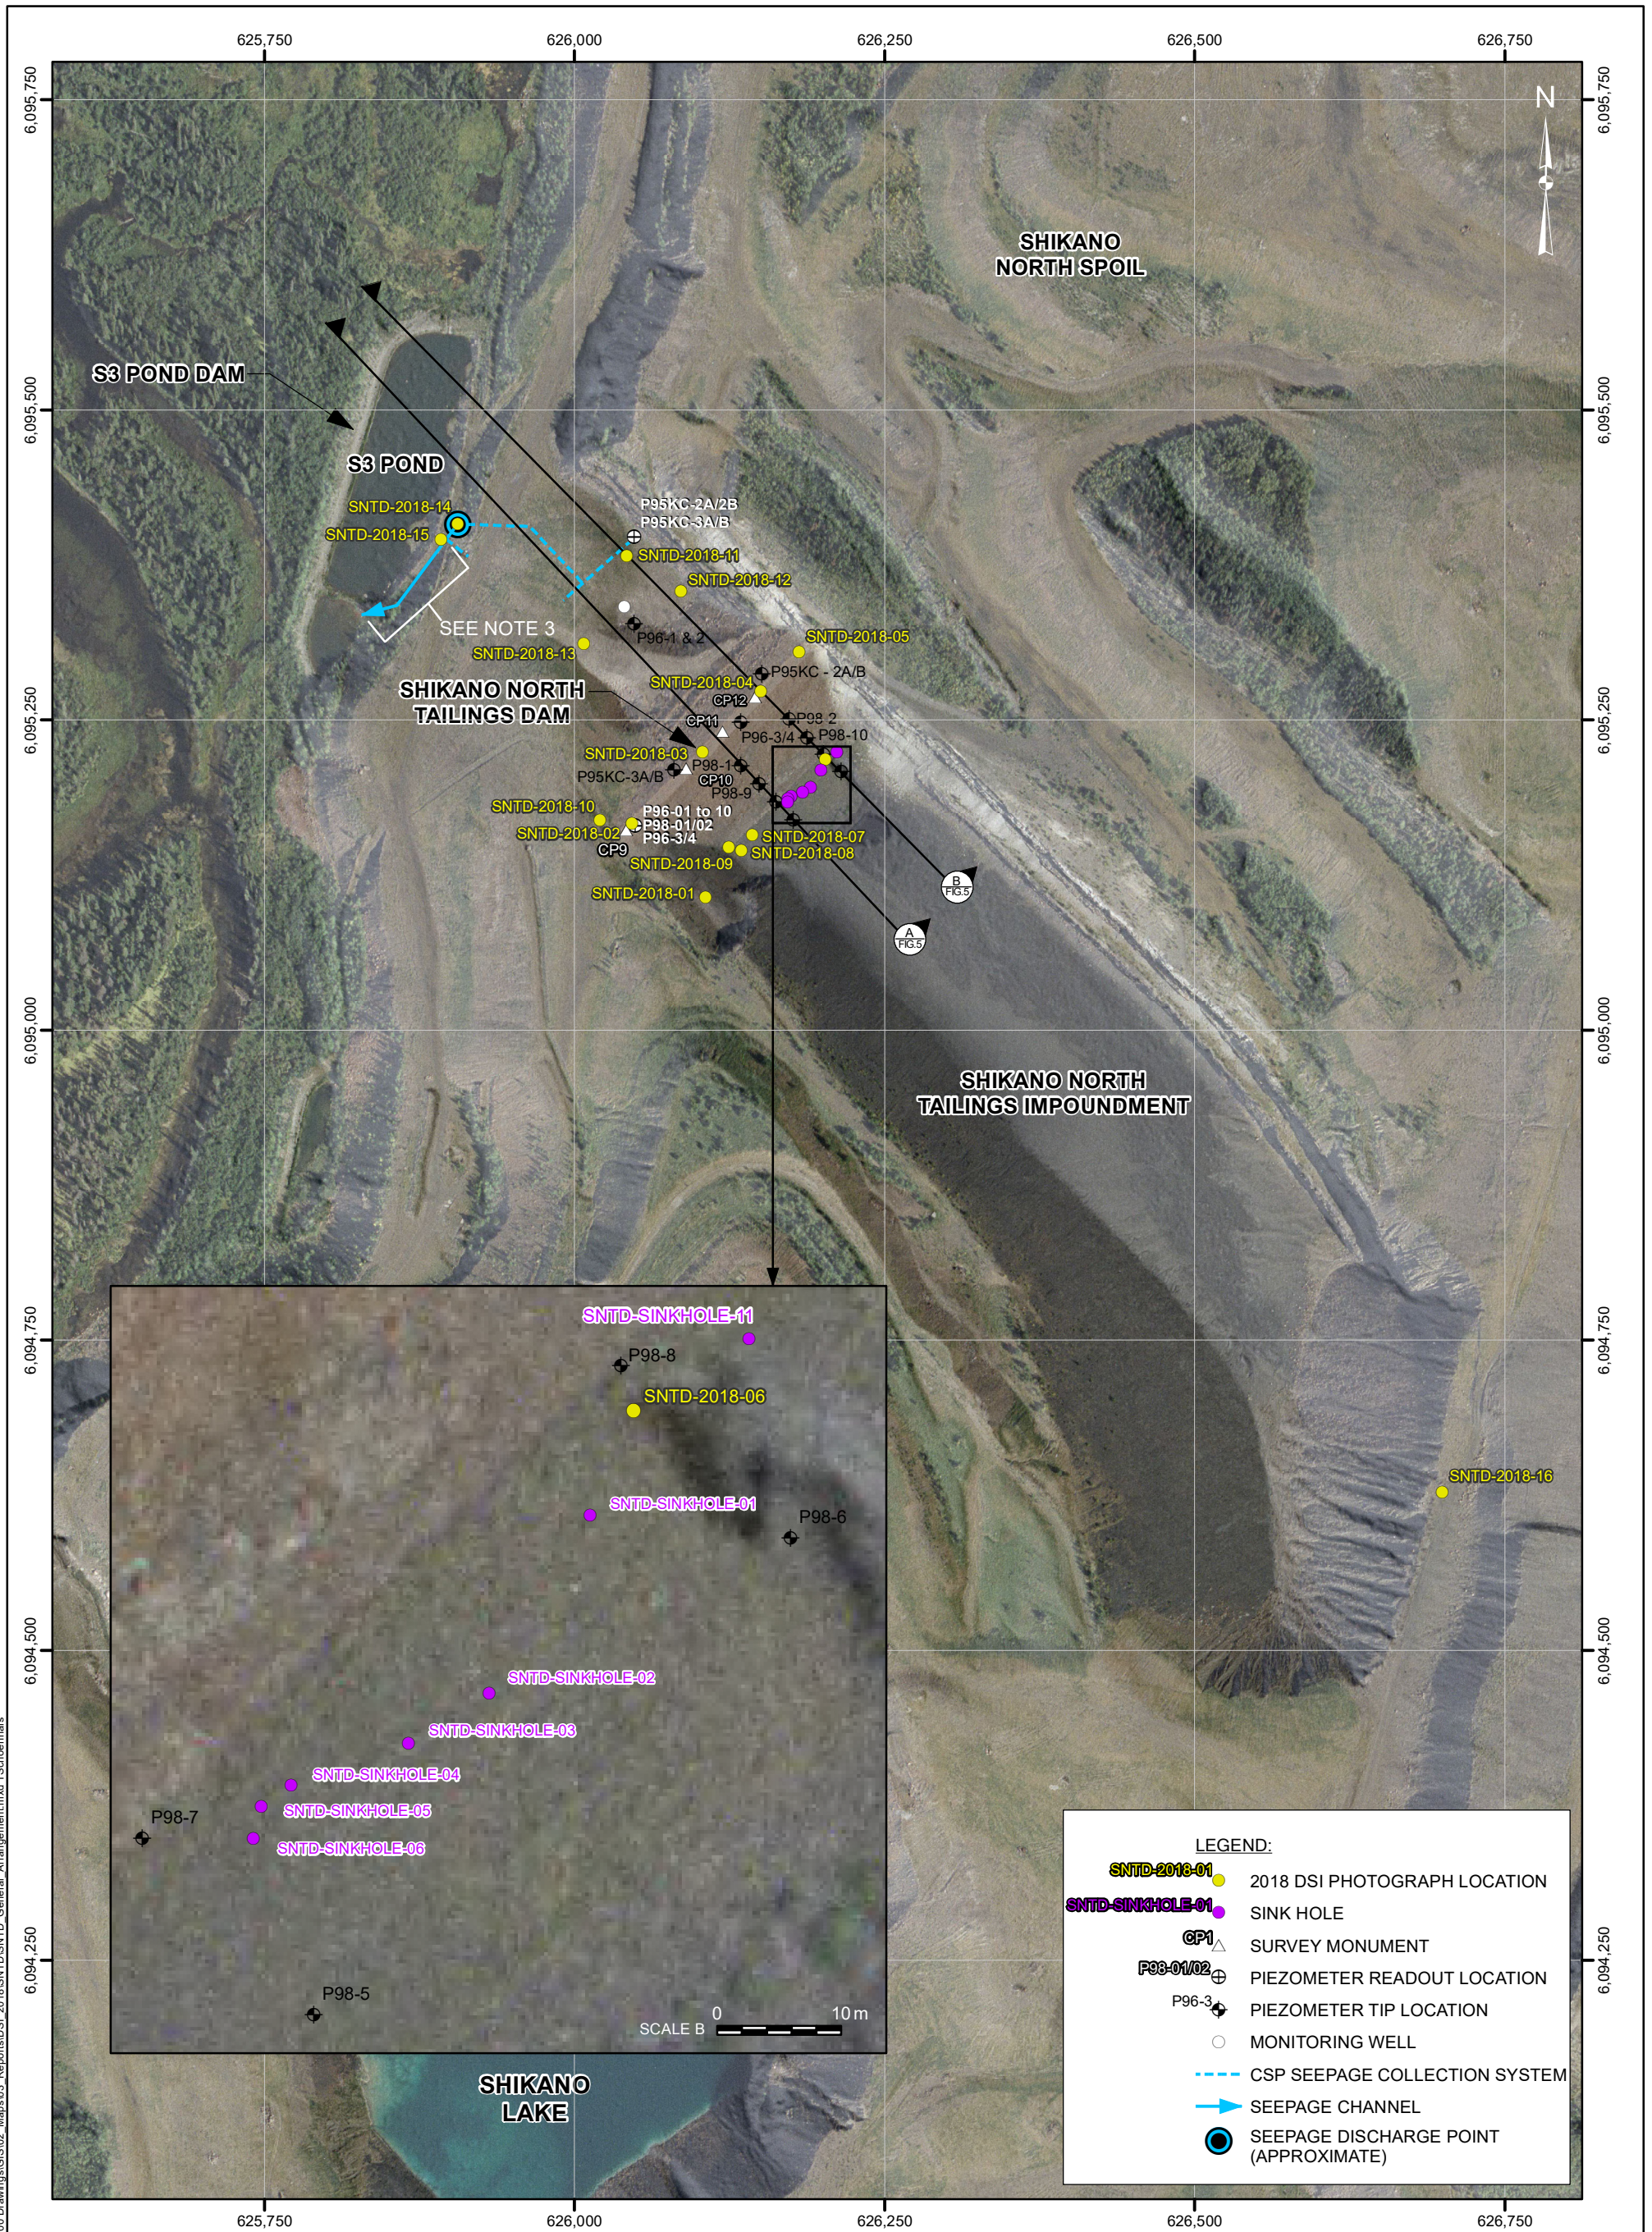
PROJECT		QUINTETTE COAL OPERATIONS 2018 DAM SAFETY INSPECTION	
TITLE		SHIKANO NORTH TAILINGS DAM GENERAL ARRANGEMENT	
PROJECT No.	M09684A15	FIG No.	3

The SNTD was designed as a “flow-through” rockfill dam with internal granular filters and a non-woven geotextile filter fabric to restrict fine coal tailings passing through the dam while allowing seepage through the dam. “Windows” of high permeability gravel, upstream of the filters, were introduced as a design modification during construction to encourage seepage flow through the dam (as per design concept) because the material available for fine filter construction had a permeability lower than expected. Each window was approximately 1 m thick (KC 1997). The seepage discharges to S3 Pond through a culvert in the downstream shell of the dam (Figure 3).

- **Sinkhole Depressions in Tailings Beach:** Refer for Figure 3 and Photo I-8 for sinkholes general location. These features have been noted since 2010 (KCB 2011), but when they started to form is not known. There was a notable increase in size between the 2012 and 2013 inspections, and between 2016 and 2018.

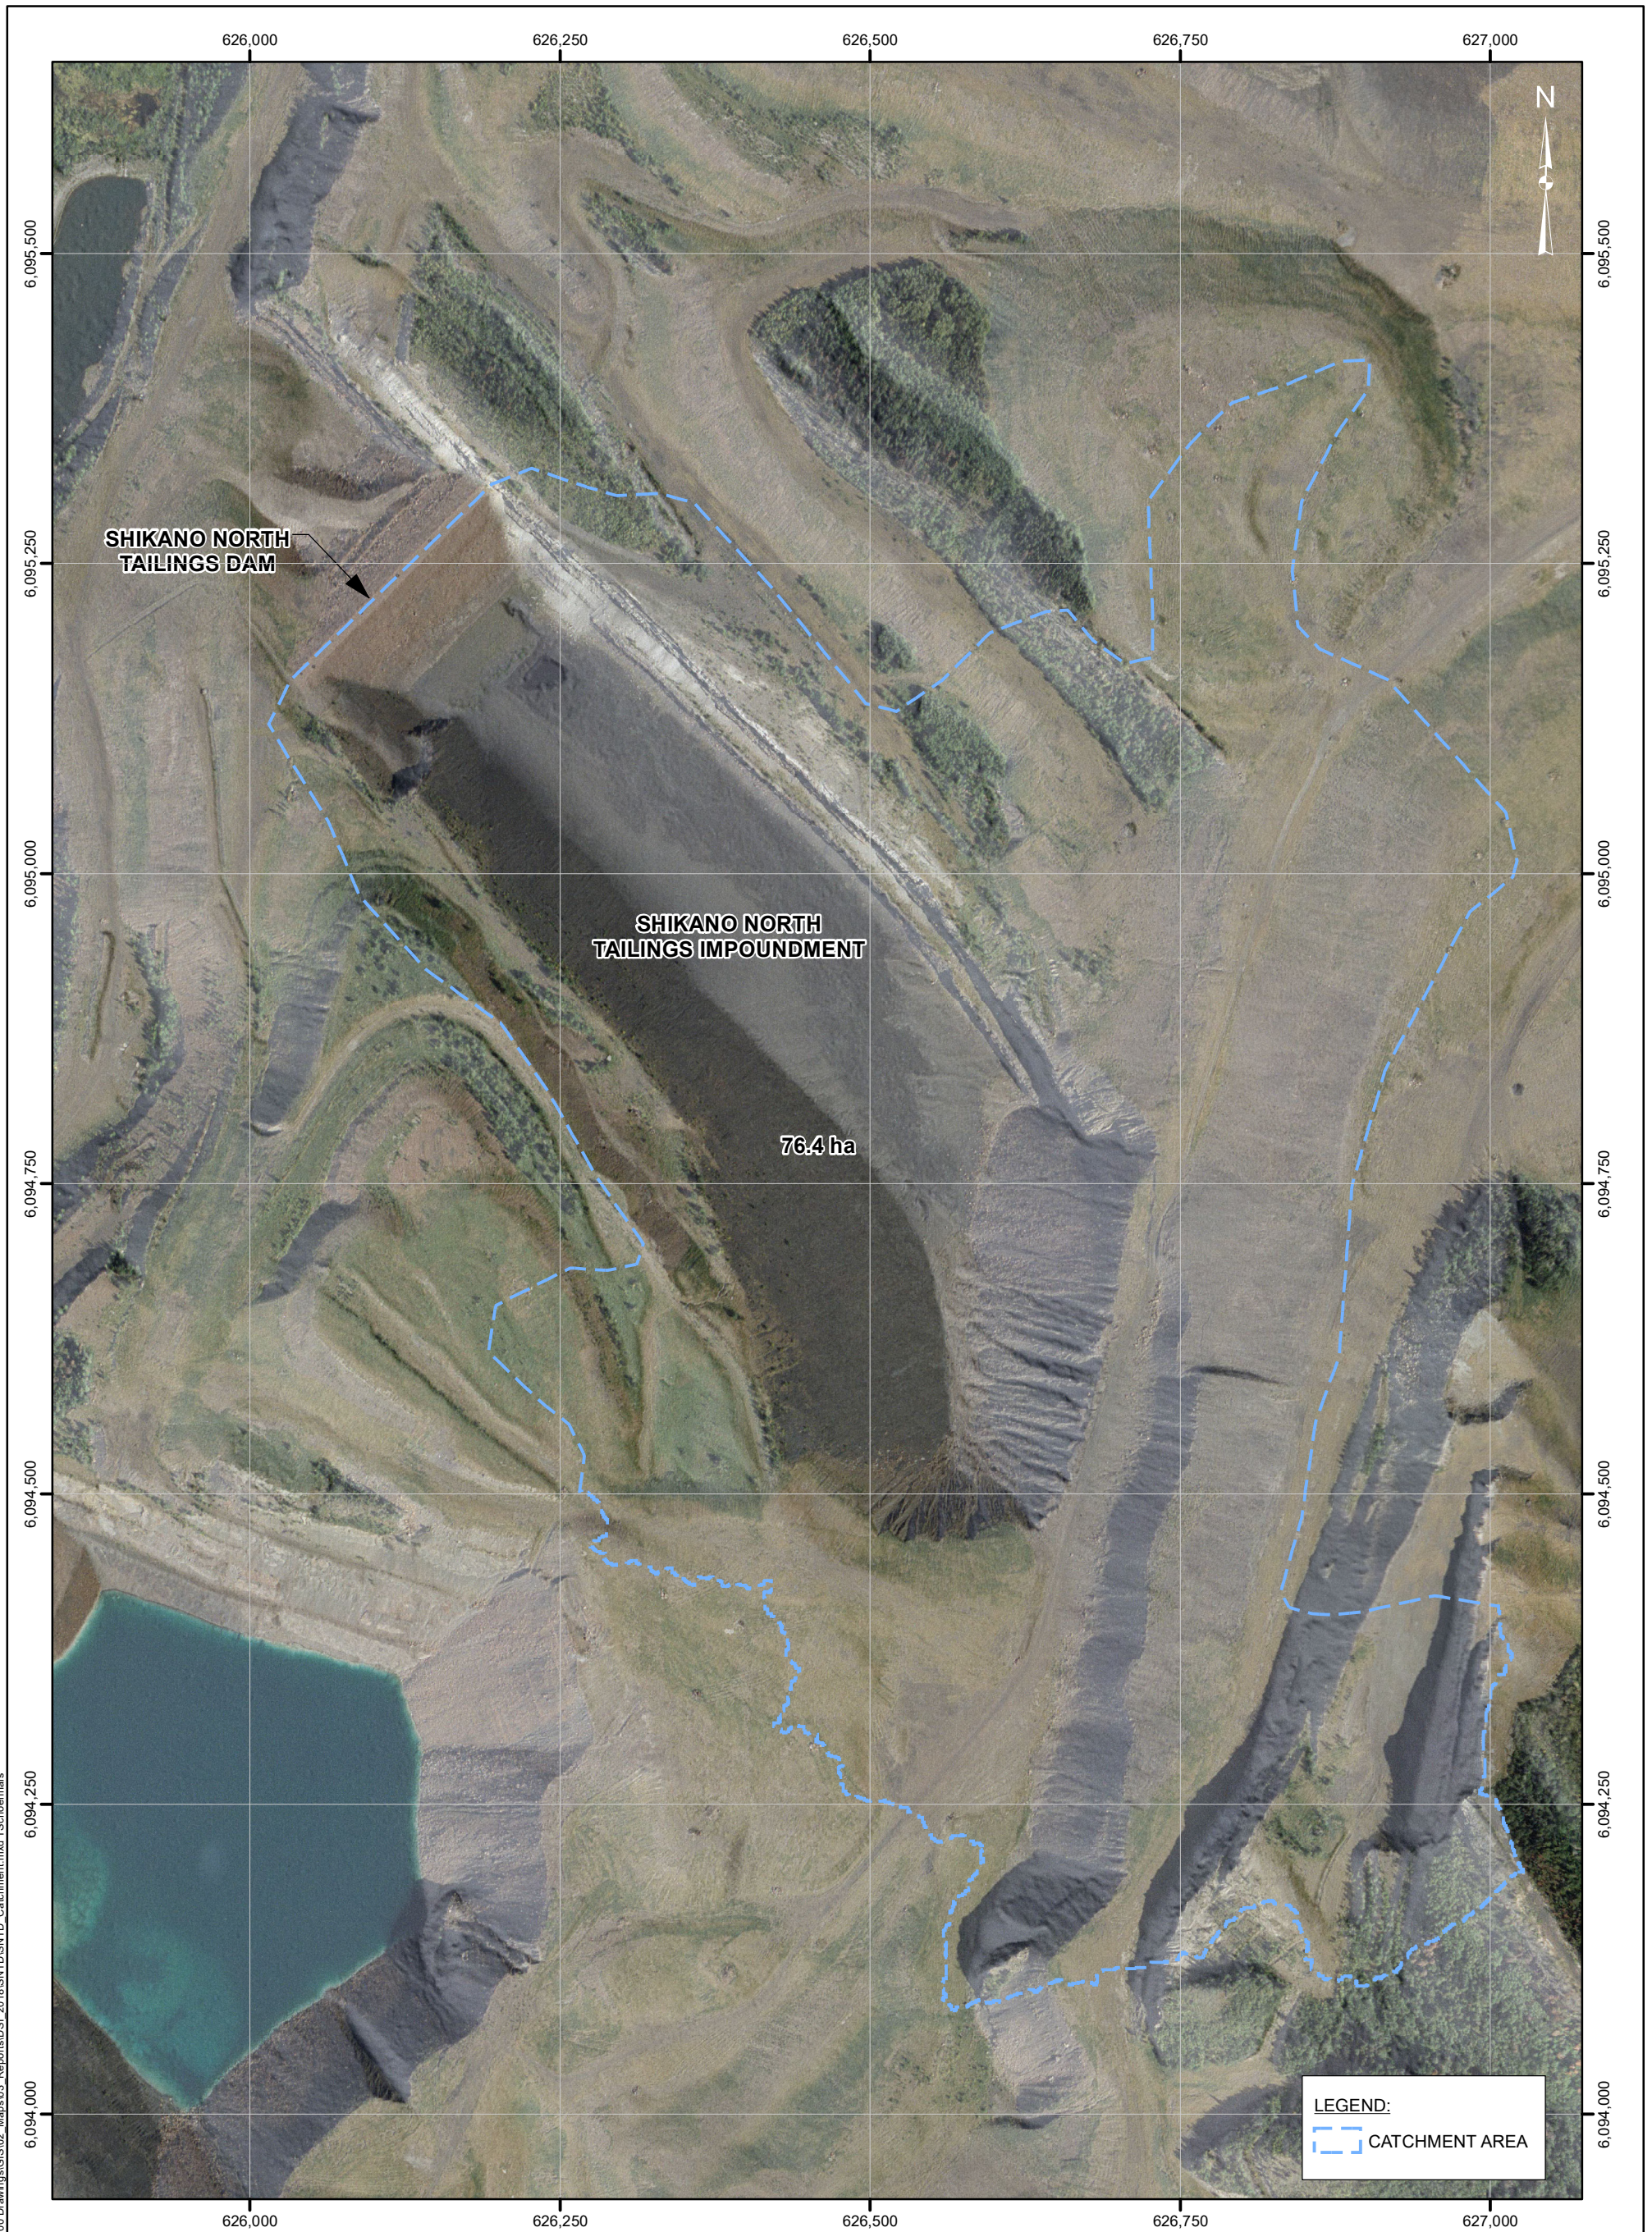
Of the 16 piezometers installed at SNTD, 10 are functional, (refer to Table 4.1 and Figure 3). Annual readings of the functioning pneumatic piezometers are to be taken once a year by Teck's Dam Inspector. 2018 pore pressure readings were collected on May 31. 2018 piezometer readings are plotted in Figures 5 and 6.

- ◆ Teck managed to find P95KC-3B after it has been reported as “not found” in previous DSI reports. The instrument location and its water levels are shown in Figures 5 and 6. P95KC-3B was dry during May 2018 inspection.

The cause of these features is most likely the migration of tailings into the upstream coarse rockfill shell and “windows” of high permeability gravel (Figure 5) which are upstream of the filters. Sinkholes are considered a local condition and not a risk to the SNTD integrity.

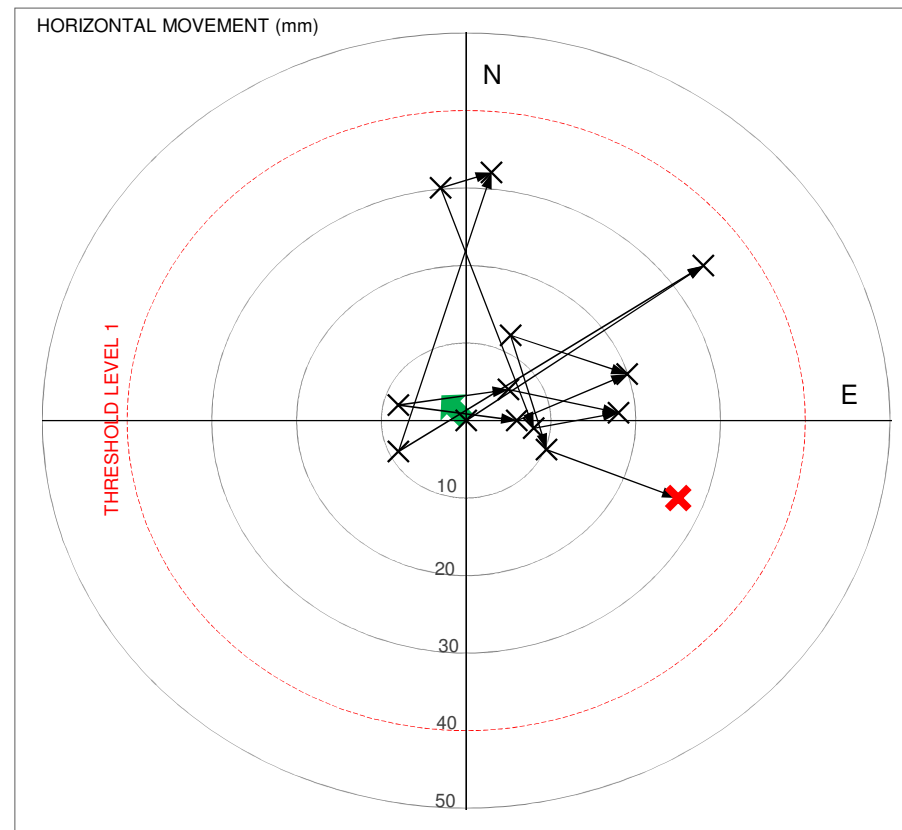
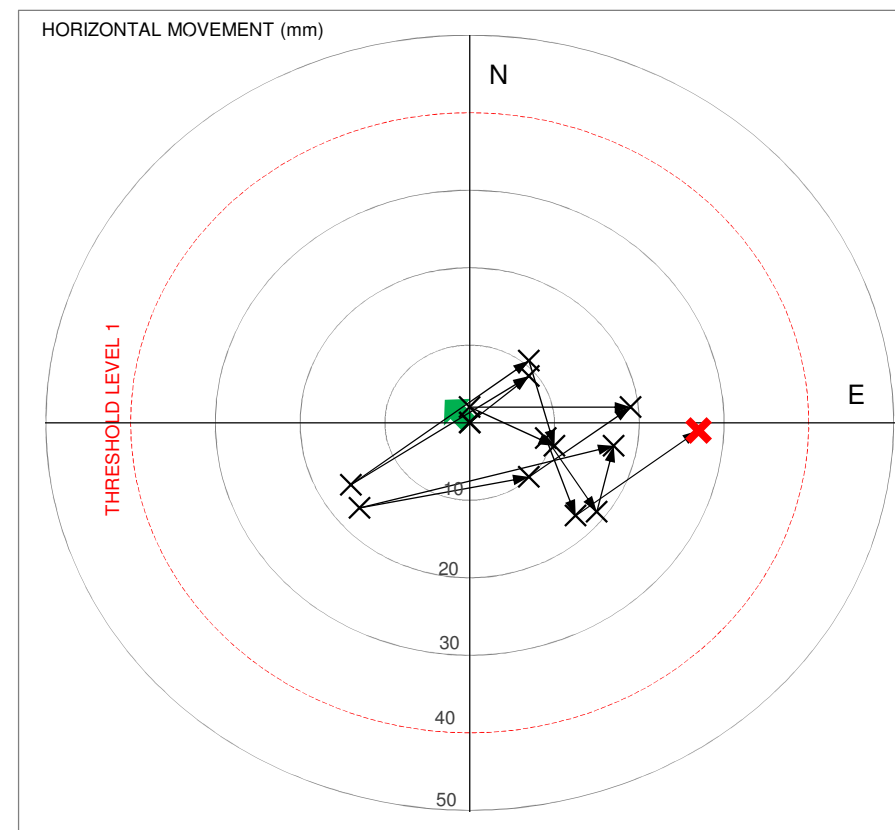
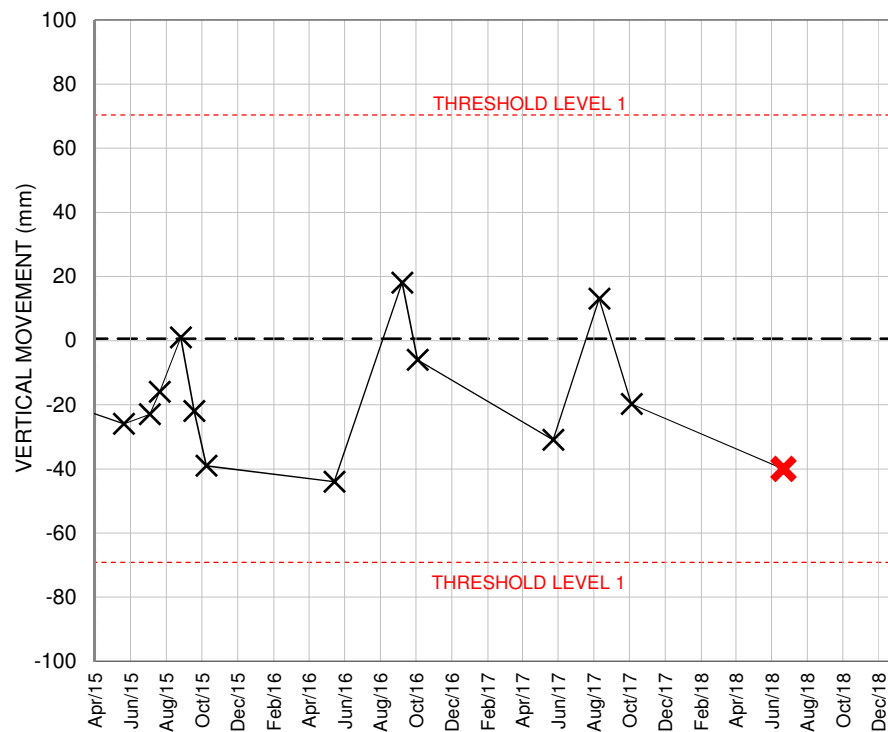
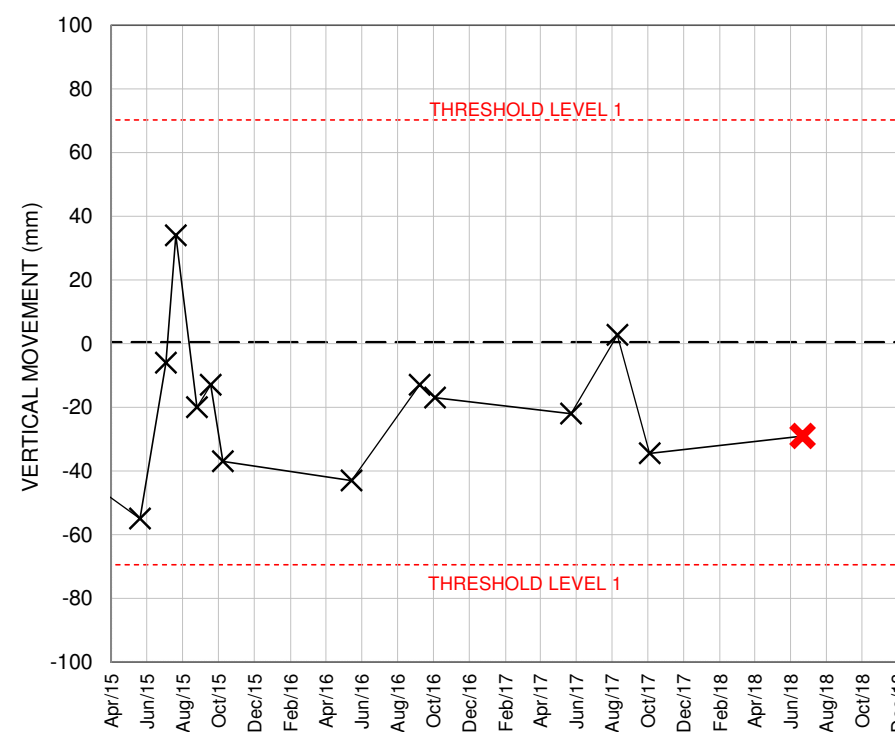
From a review of the available data since 2014, none of the monuments indicates a trend of horizontal movement or significant crest settlement. Incremental movement is more likely attributed to survey accuracy than dam movement. There was no exceedance of thresholds in 2018 (Figures 8 and 9).
