November 5, 2018

Project No. 1895982

**Teck Tailings Main Dam Team**

**2018 ANNUAL PERFORMANCE REPORT FOR TAILINGS MAIN DAM, RED DOG MINE, ALASKA**

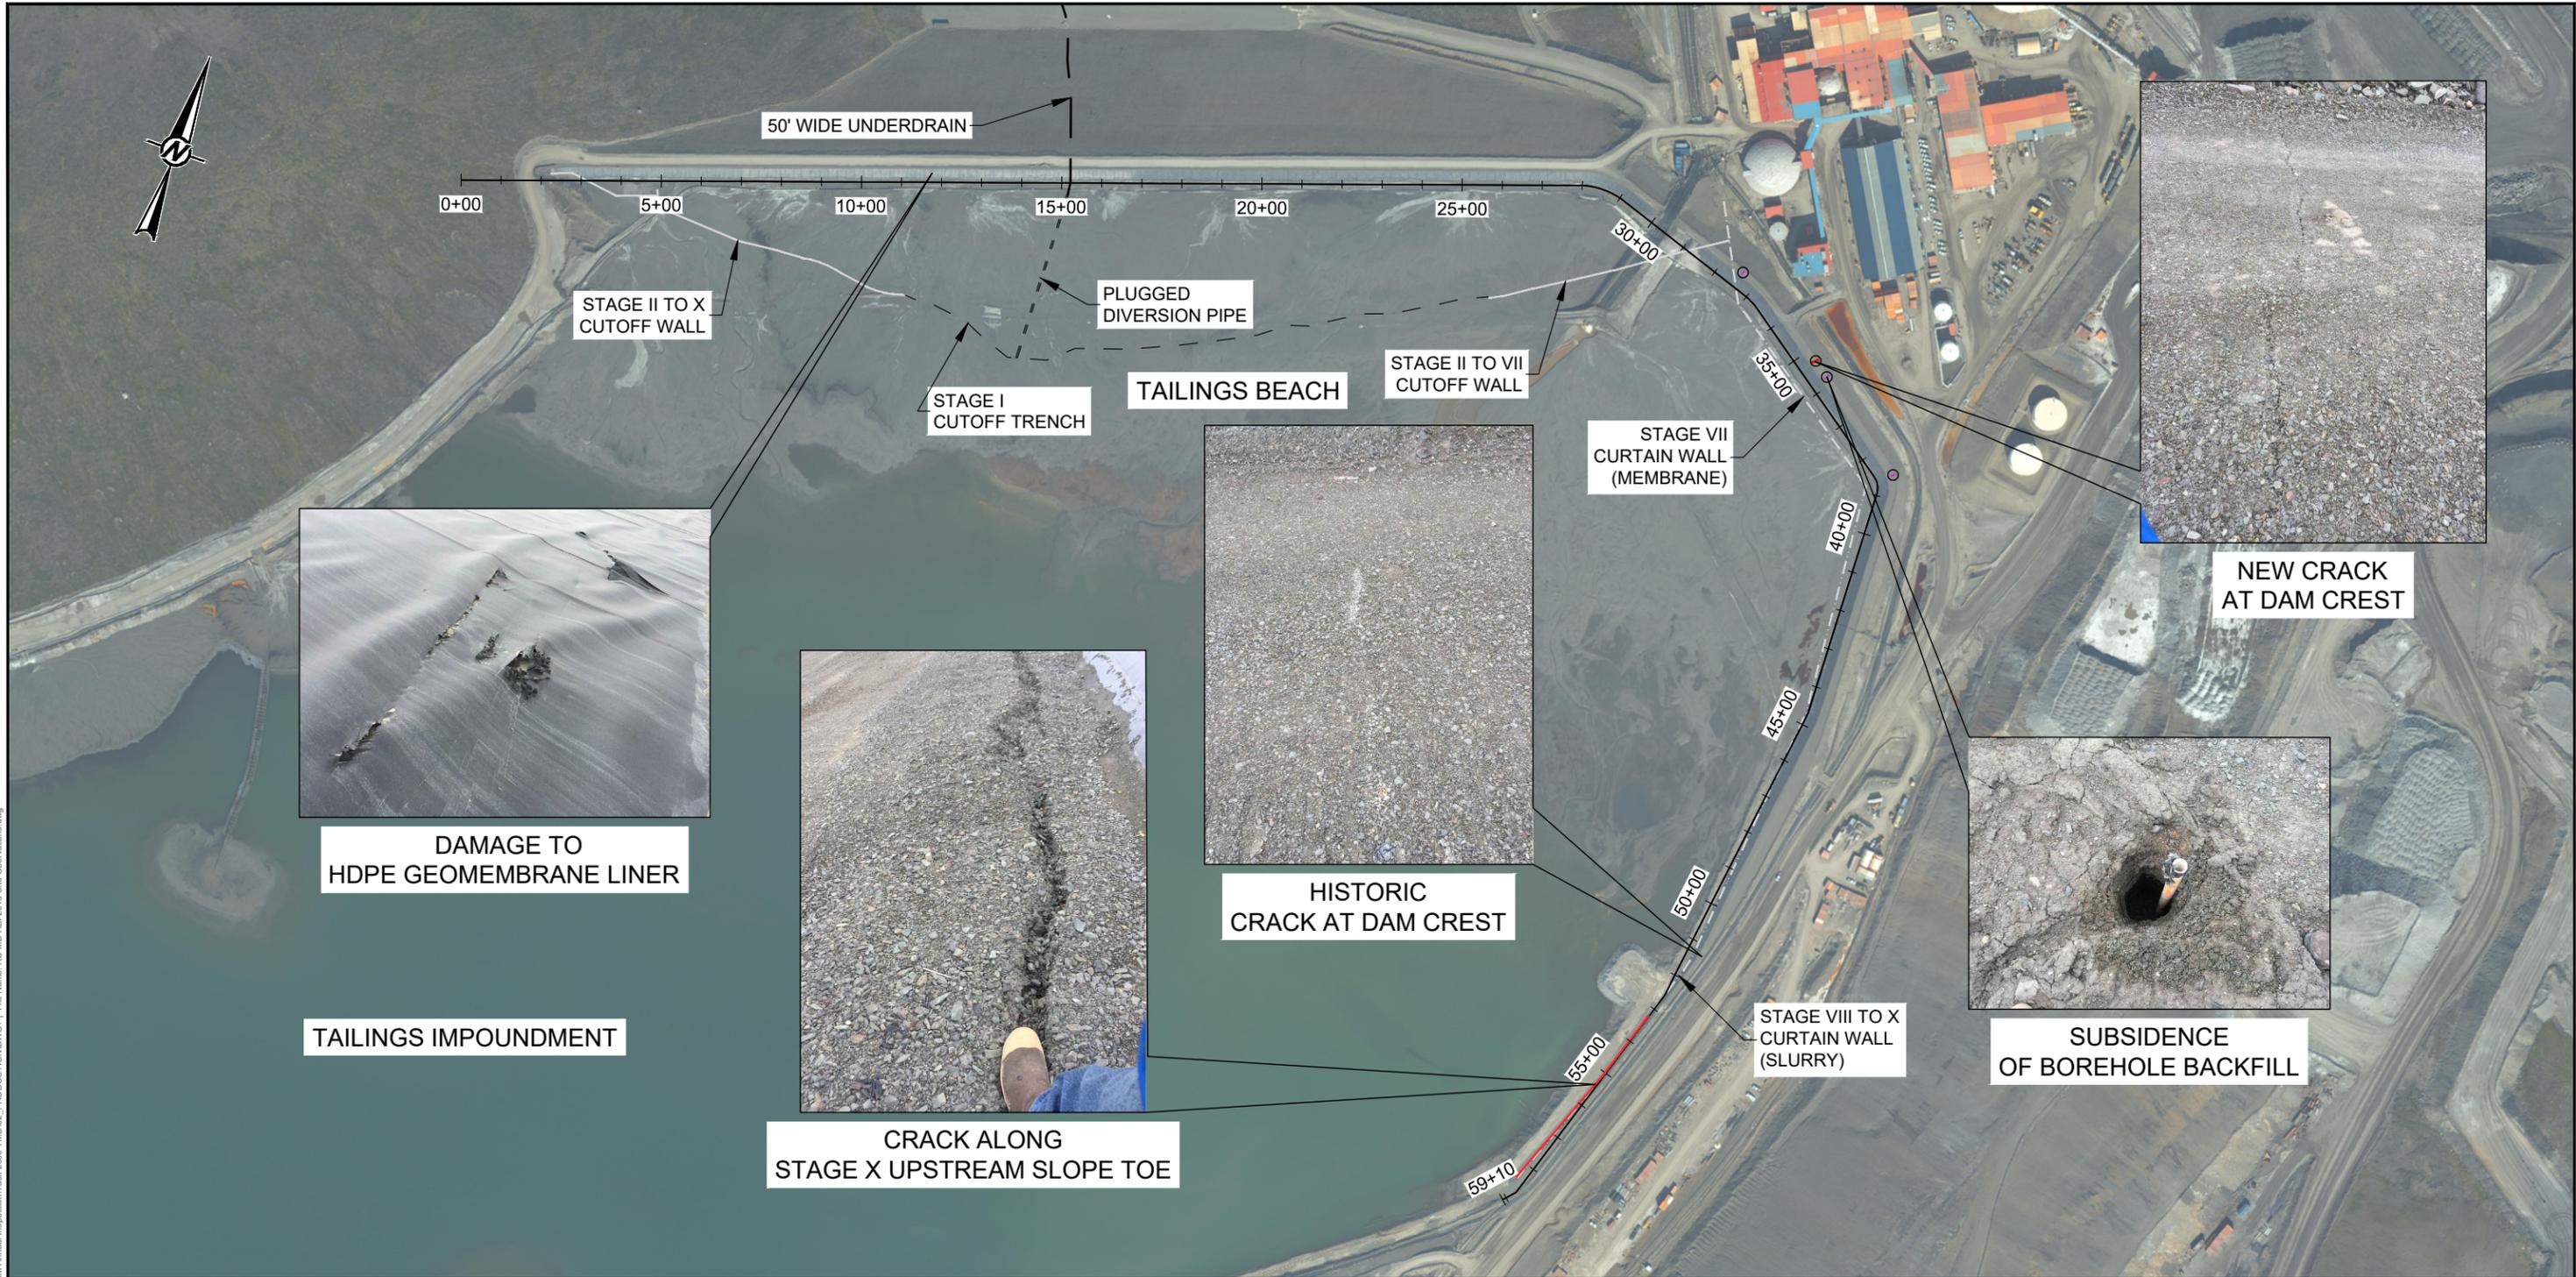
- The upstream and downstream slopes of the TMD Embankment and Wing Wall appeared to be stable with no signs of slumping, seeps, or lateral movements. Lateral cracking was observed along the Wing Wall crest near Station 35+30, as shown in Figure 6 and Photo 10, Appendix B. The crack was about a maximum of ¾ inches wide and less than 6 inches deep based on visual inspection. No signs of distress or instability were noted in the upstream liner or on the downstream slope near the crack. Similar lateral cracking has historically been observed in this area as shown in Figure 6, and they were typically marked with paint and had been surveyed. One such paint-marked lateral crack was observed near Station 51+30 (Figure 6 and Photo 15) that had not been surveyed. These historical lateral cracks were typically very small and seemed to have healed since initially observed based on discussion with Teck. A borehole was drilled at one of these crack locations near Station 35+70, where we observed some subsidence of the annulus backfill materials (Figure 6 and Photo 12). This lateral cracking is thought to be related to thaw consolidation of ice-rich native soils. The lateral nature of the cracks may be related to the orientation and variable ice content of ice-rich

- The exposed upstream liner generally appeared to be in good condition, except for some liner damage observed near Station 11+80 (see Figure 6 and Photos 5 and 6). Teck was aware of this damage and informed us that it occurred last winter from an excavator during manipulation of the tailings discharge pipeline. Teck had already scheduled the repairs and we understand they have been completed before publication of this report. Teck is working to improve procedures during tailings pipeline manipulation to limit or prevent future damage to the upstream geomembrane liner.

SURVEYED CRACKS IN 2018
-

SURVEYED CRACKS IN 2017

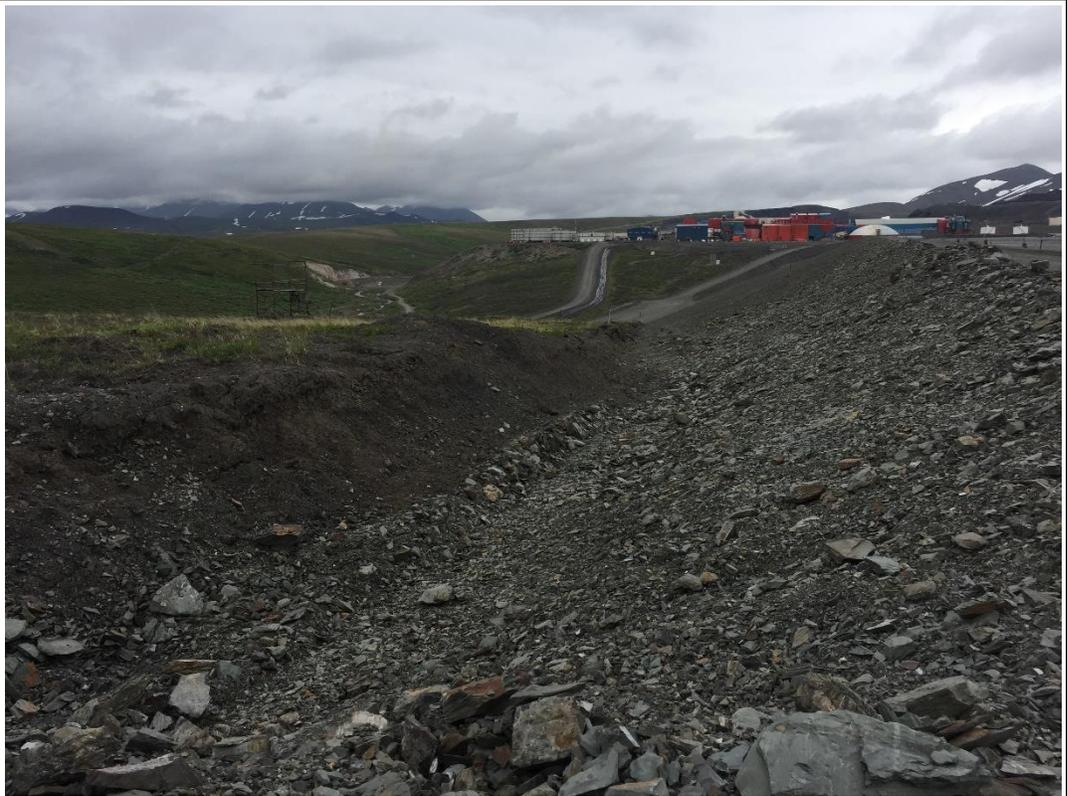
**Appendix B: Photographs****PHOTO 19**

- The downstream abutments of the TMD Embankment were observed and we did not see any signs of instability or seepage (see Photos 19 to 22, Appendix B). We also did not observe any signs of instability for the TMD Embankment buttress, such as cracking, slumps, or indications of lateral movement.

TMD  
EMBANKMENT  
WEST ABUTMENT,  
LOOKING DOWN  
SLOPE FROM  
CREST

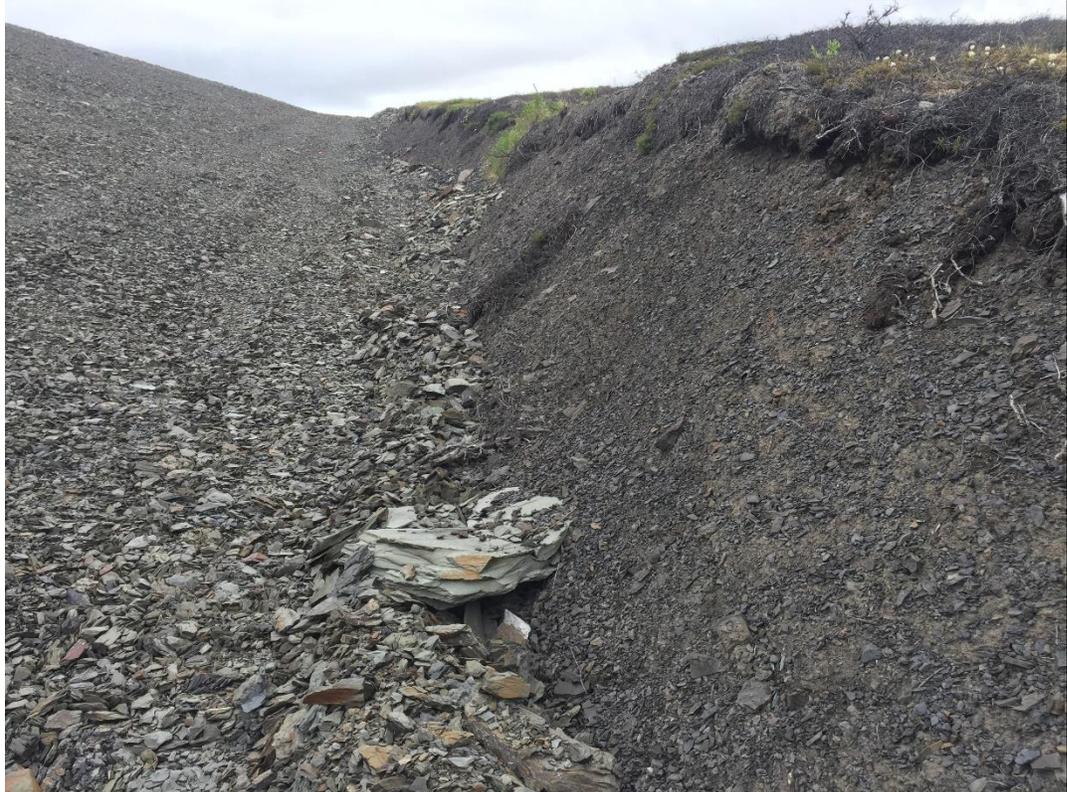
**PHOTO 20**

TMD  
EMBANKMENT  
WEST ABUTMENT,  
LOOKING UP  
SLOPE FROM  
BUTTRESS

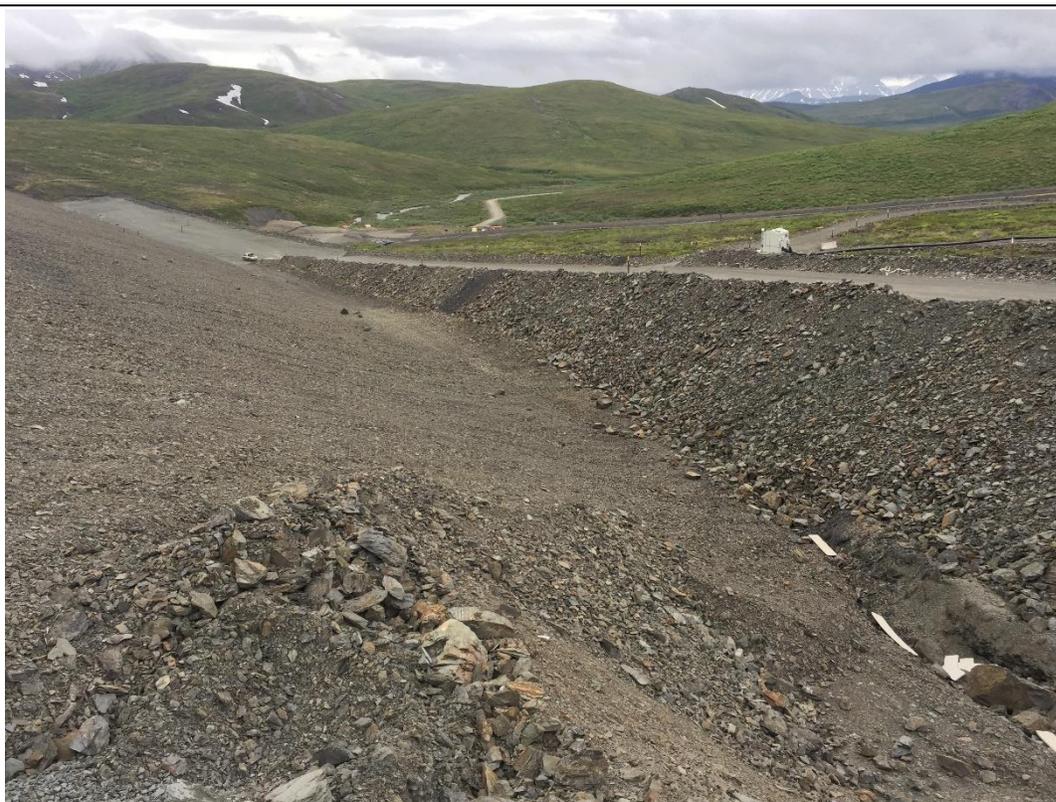
**PHOTO 21**

TMD  
EMBANKMENT  
EAST ABUTMENT,  
LOOKING NW  
DOWN SLOPE

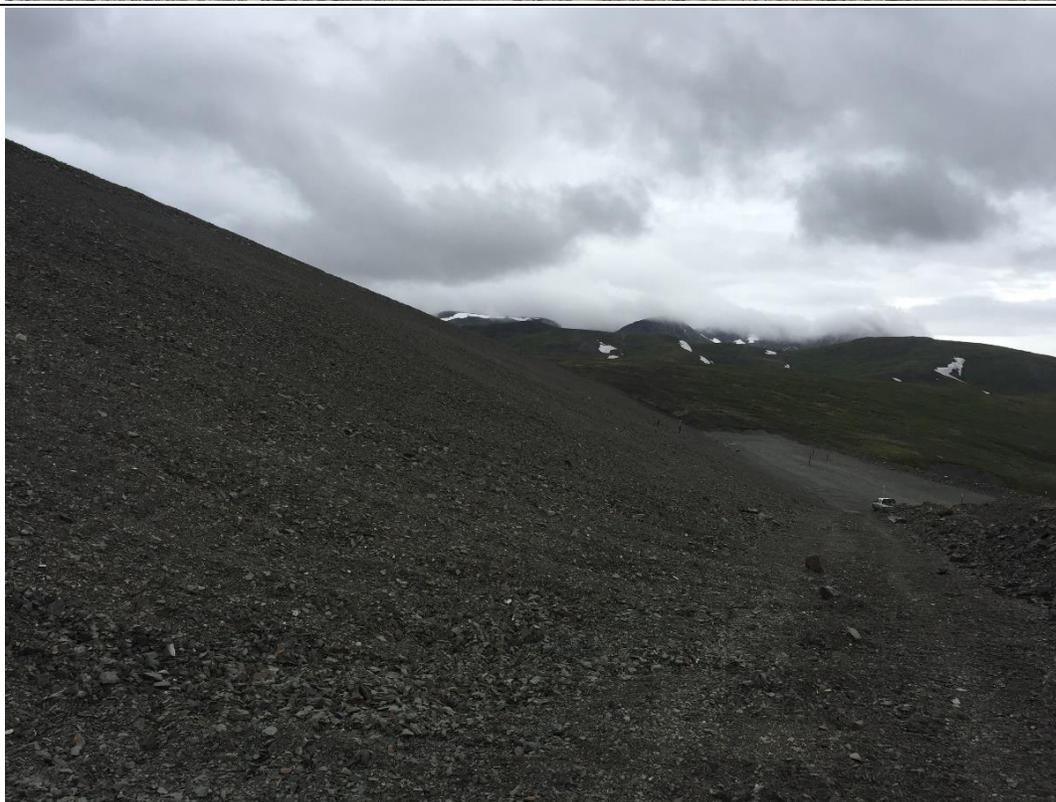
**PHOTO 22**

TMD  
EMBANKMENT  
DOWNSTREAM  
SLOPE FACE,  
LOOKING W

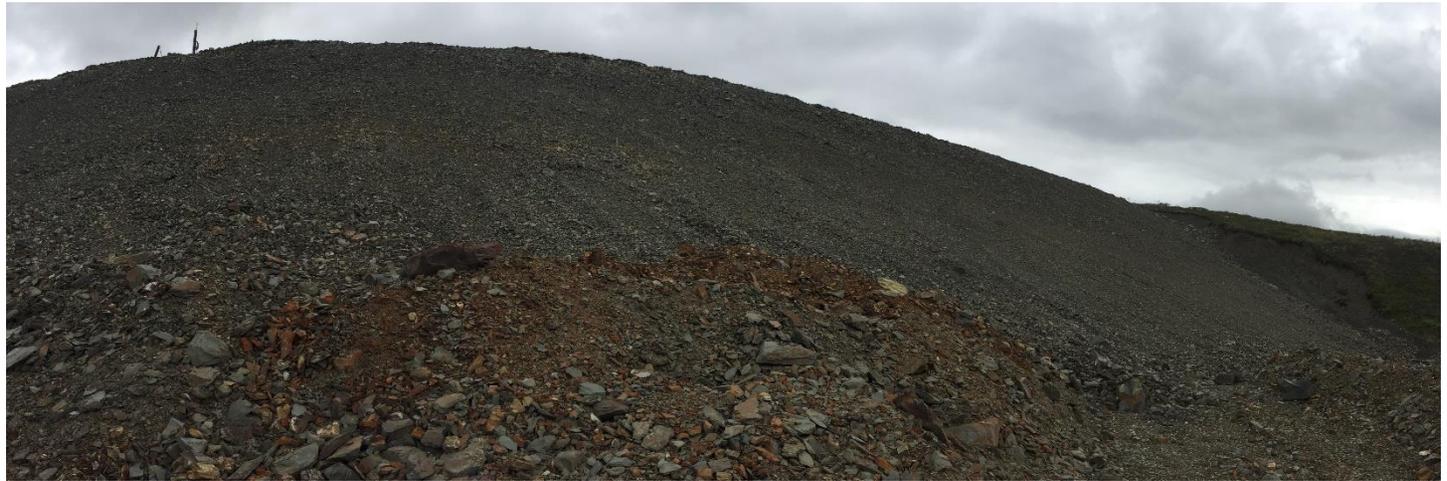
**Appendix B: Photographs****PHOTO 25**

- The SCP was at an elevation of about 789 feet and two of the three pumps were operating during our inspection. These pumps were operating at a combined pumping rate of about 600 gallons per minute (gpm). Some iron staining was observed near the toe of the buttress and around the SCP (see Photos 25 to 27). We understand this iron staining near the buttress toe is related to the rock drain repairs that occurred in 2013 to mitigate formation of ferricrete within the underdrain. We also noted a seep entering the SCP that appeared to be near where the underdrain connects into it (Photo 27).

TMD EMBANKMENT  
DOWNSTREAM BUTTRESS  
SLOPE, LOOKING S

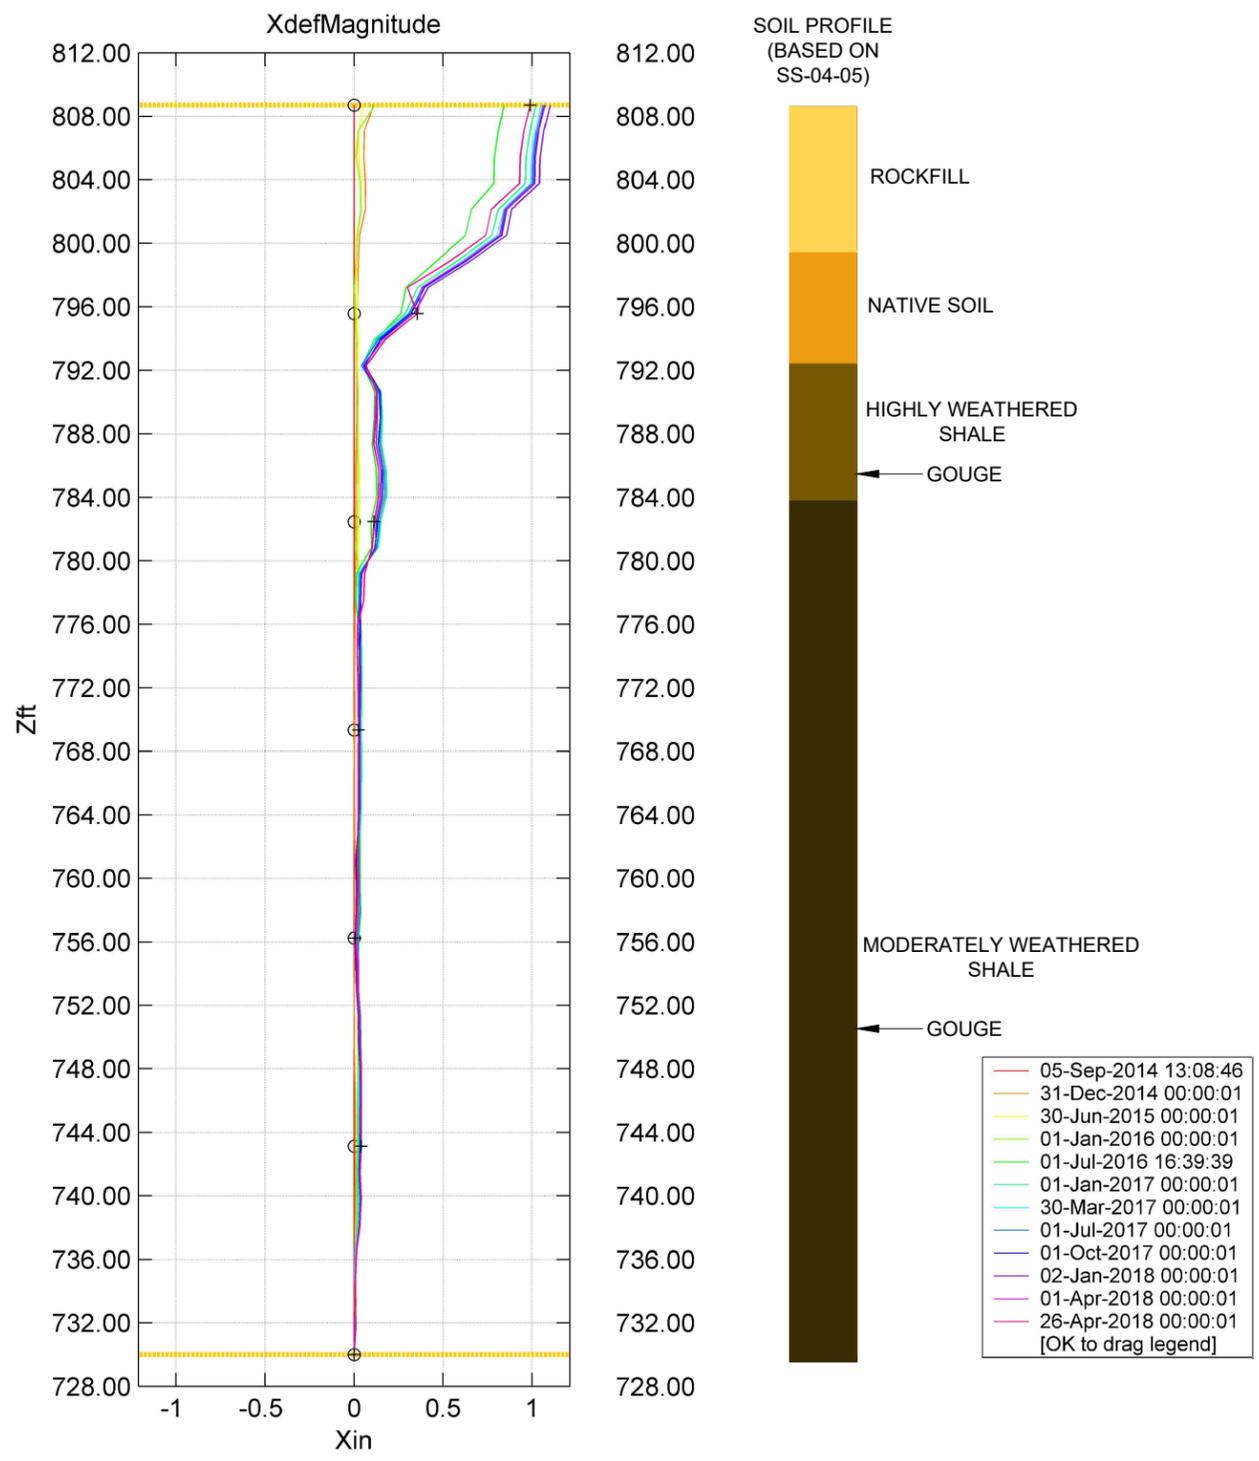
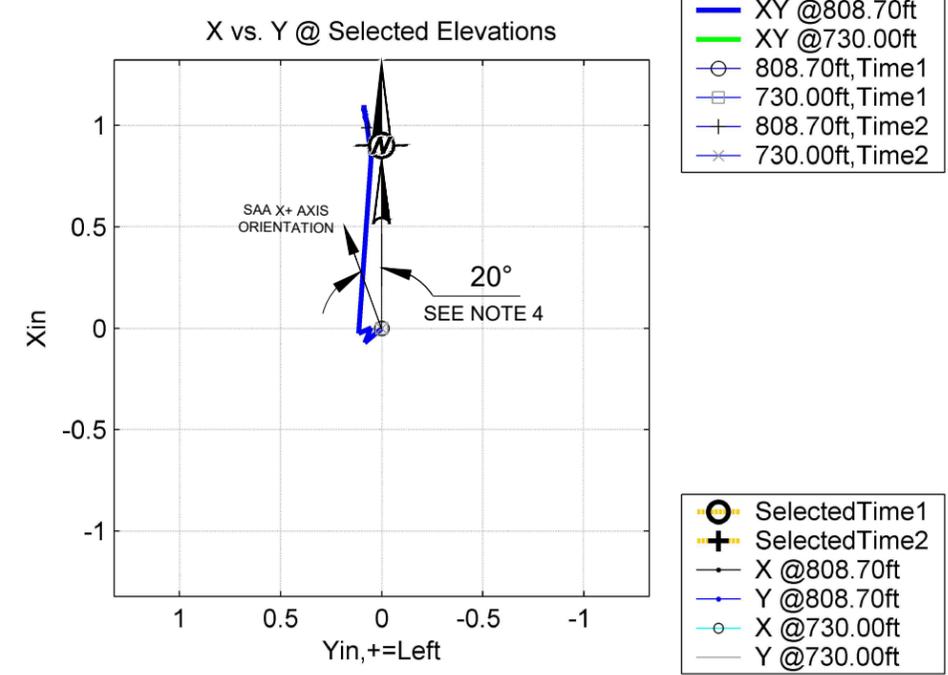
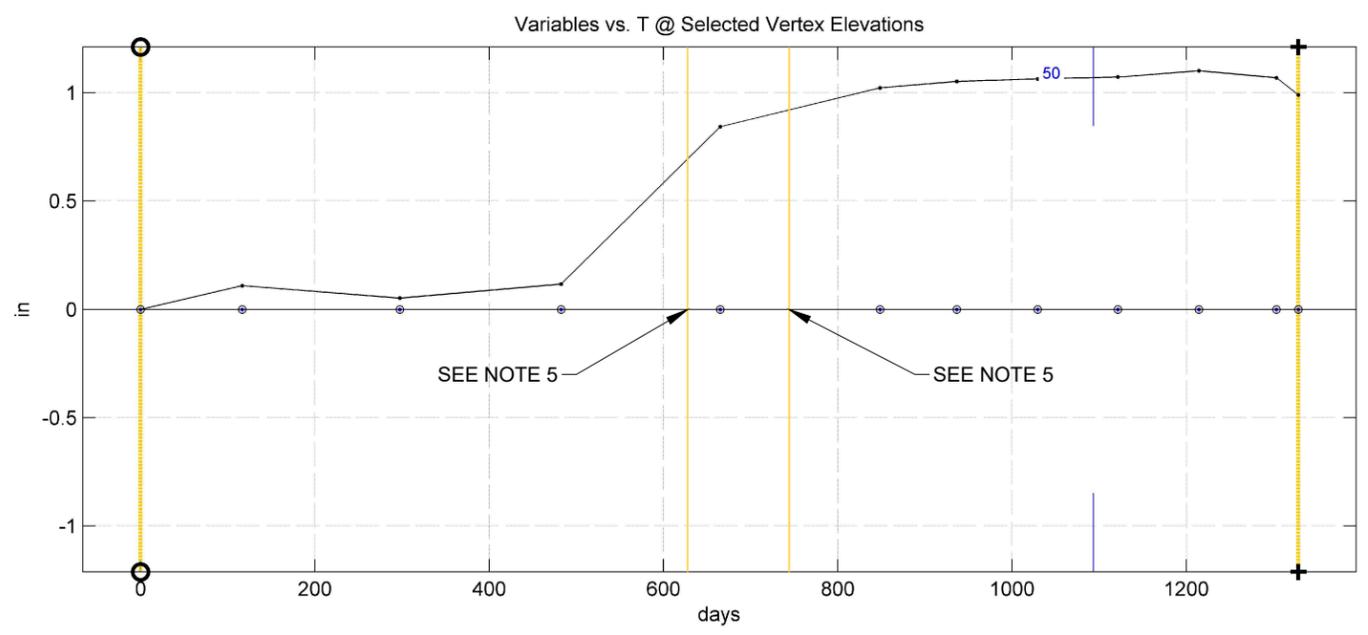
SAA inclinometer data is presented in Figures C-1 through C-3 (Appendix C) for INC-01-13, INC-02-13, and INC-03-14, respectively. These figures present the cumulative magnitude of displacement with depth, the cumulative magnitude of displacement over time presented at the elevation in which the greatest displacement has occurred, and direction of movement with respect to grid-north. A review of the SAA inclinometer data is summarized below with maximum cumulative displacements also depicted in Figure 2.

CUMULATIVE SAA INCLINOMETER DATA COLLECTED FROM SEPTEMBER 2014 BASELINE

- NOTES**
- DISPLACEMENT PLOTTED VERSUS TIME AT LOCATION OF MAXIMUM DISPLACEMENT WITHIN VERTICAL ARRAY.
  - INC-01-13 LIES BURIED UNDERNEATH APPROXIMATELY 25 FEET OF FILL.
  - SENSORIZED INSTRUMENTATION TOLERANCE ERROR AS PER MEASURAND SPECIFICATIONS IS +/- 0.08 INCHES.
  - AZIMUTH ADJUSTMENT OF 20 DEGREES (COUNTER CLOCKWISE) IS ESTIMATED FROM THE URS PHASE II GEOTECHNICAL REPORT THAT STATES THE POSITIVE X-DISPLACEMENT DIRECTION IS NORTH-NORTHWEST
  - APPROXIMATE DATES OF STAGE X BUTTRESS CONSTRUCTION (MAY 15, 2016 TO SEPTEMBER 15, 2016.)

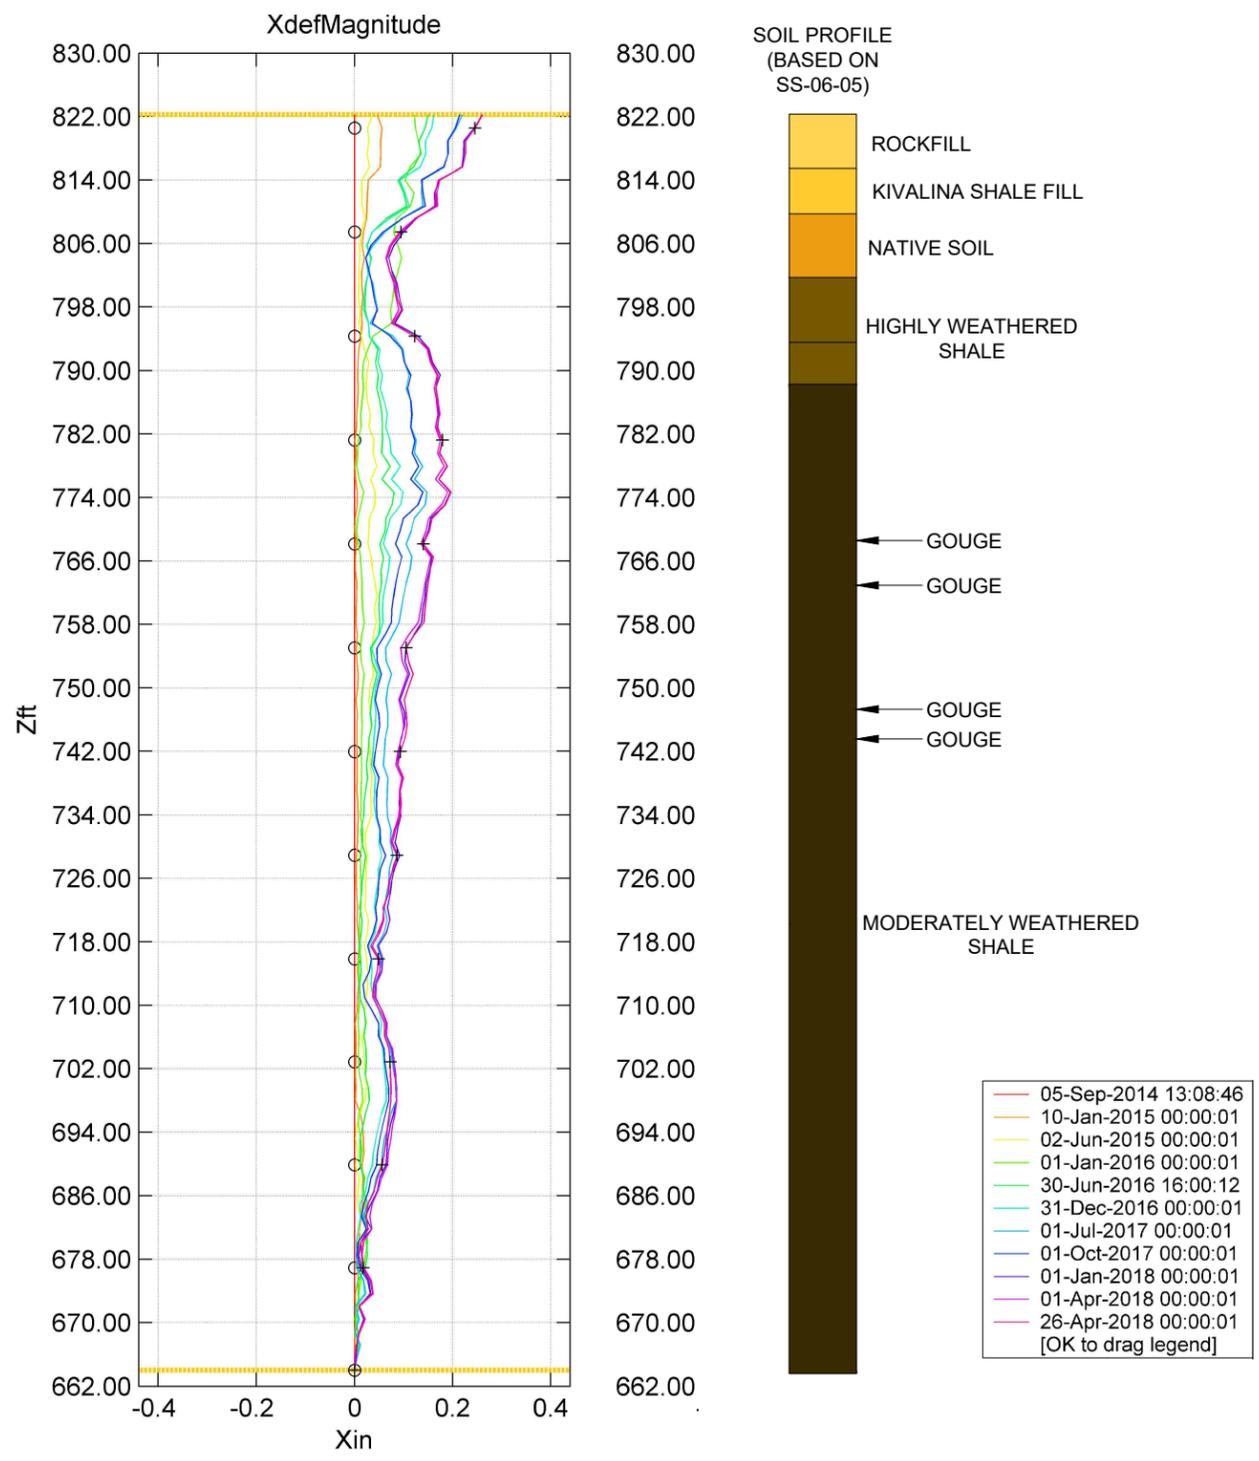
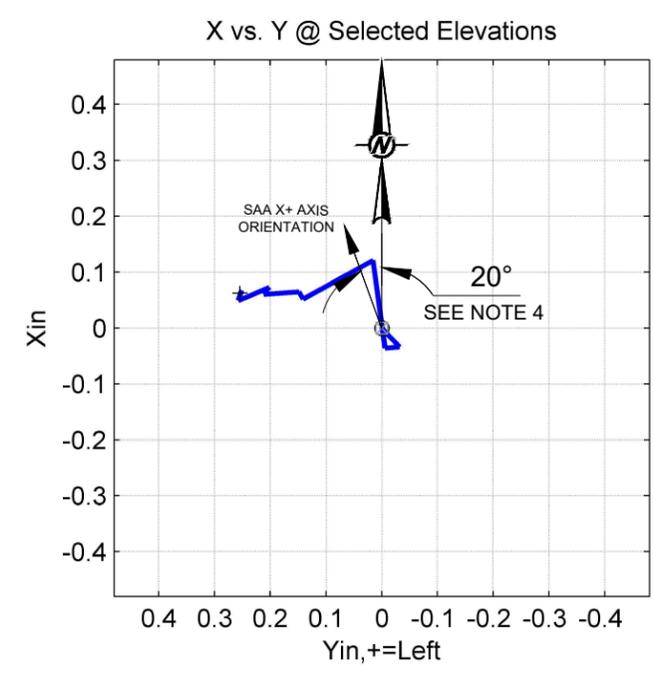
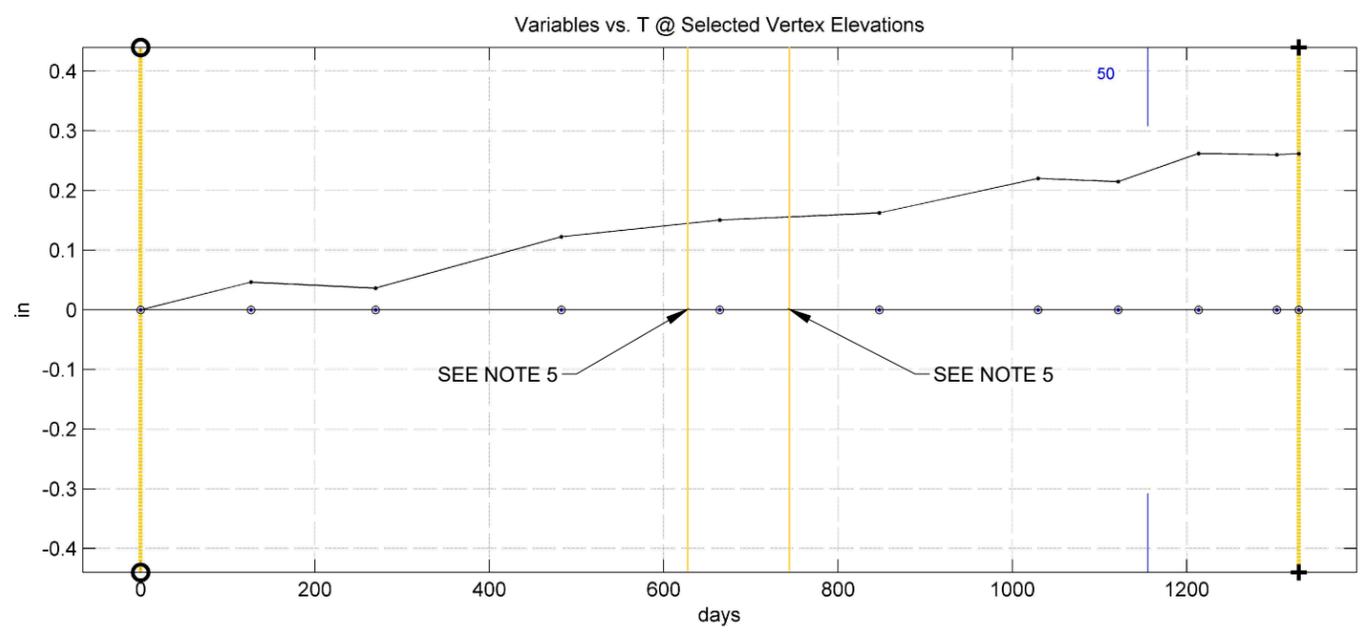
CUMULATIVE SAA INCLINOMETER DATA COLLECTED FROM SEPTEMBER 2014 BASELINE

- NOTES**
- DISPLACEMENT PLOTTED VERSUS TIME AT LOCATION OF MAXIMUM DISPLACEMENT WITHIN VERTICAL ARRAY.
  - INC-02-13 LIES BURIED UNDERNEATH APPROXIMATELY 35+ FEET OF FILL.
  - SENSORIZED INSTRUMENTATION TOLERANCE ERROR AS PER MEASURAND SPECIFICATIONS IS +/- 0.08 INCHES.
  - AZIMUTH ADJUSTMENT OF 20 DEGREES (COUNTER CLOCKWISE) IS ESTIMATED FROM THE URS PHASE II GEOTECHNICAL REPORT THAT STATES THE POSITIVE X-DISPLACEMENT DIRECTION IS NORTH-NORTHWEST
  - APPROXIMATE DATES OF STAGE X BUTTRESS CONSTRUCTION (MAY 15, 2016 TO SEPTEMBER 15, 2016.)

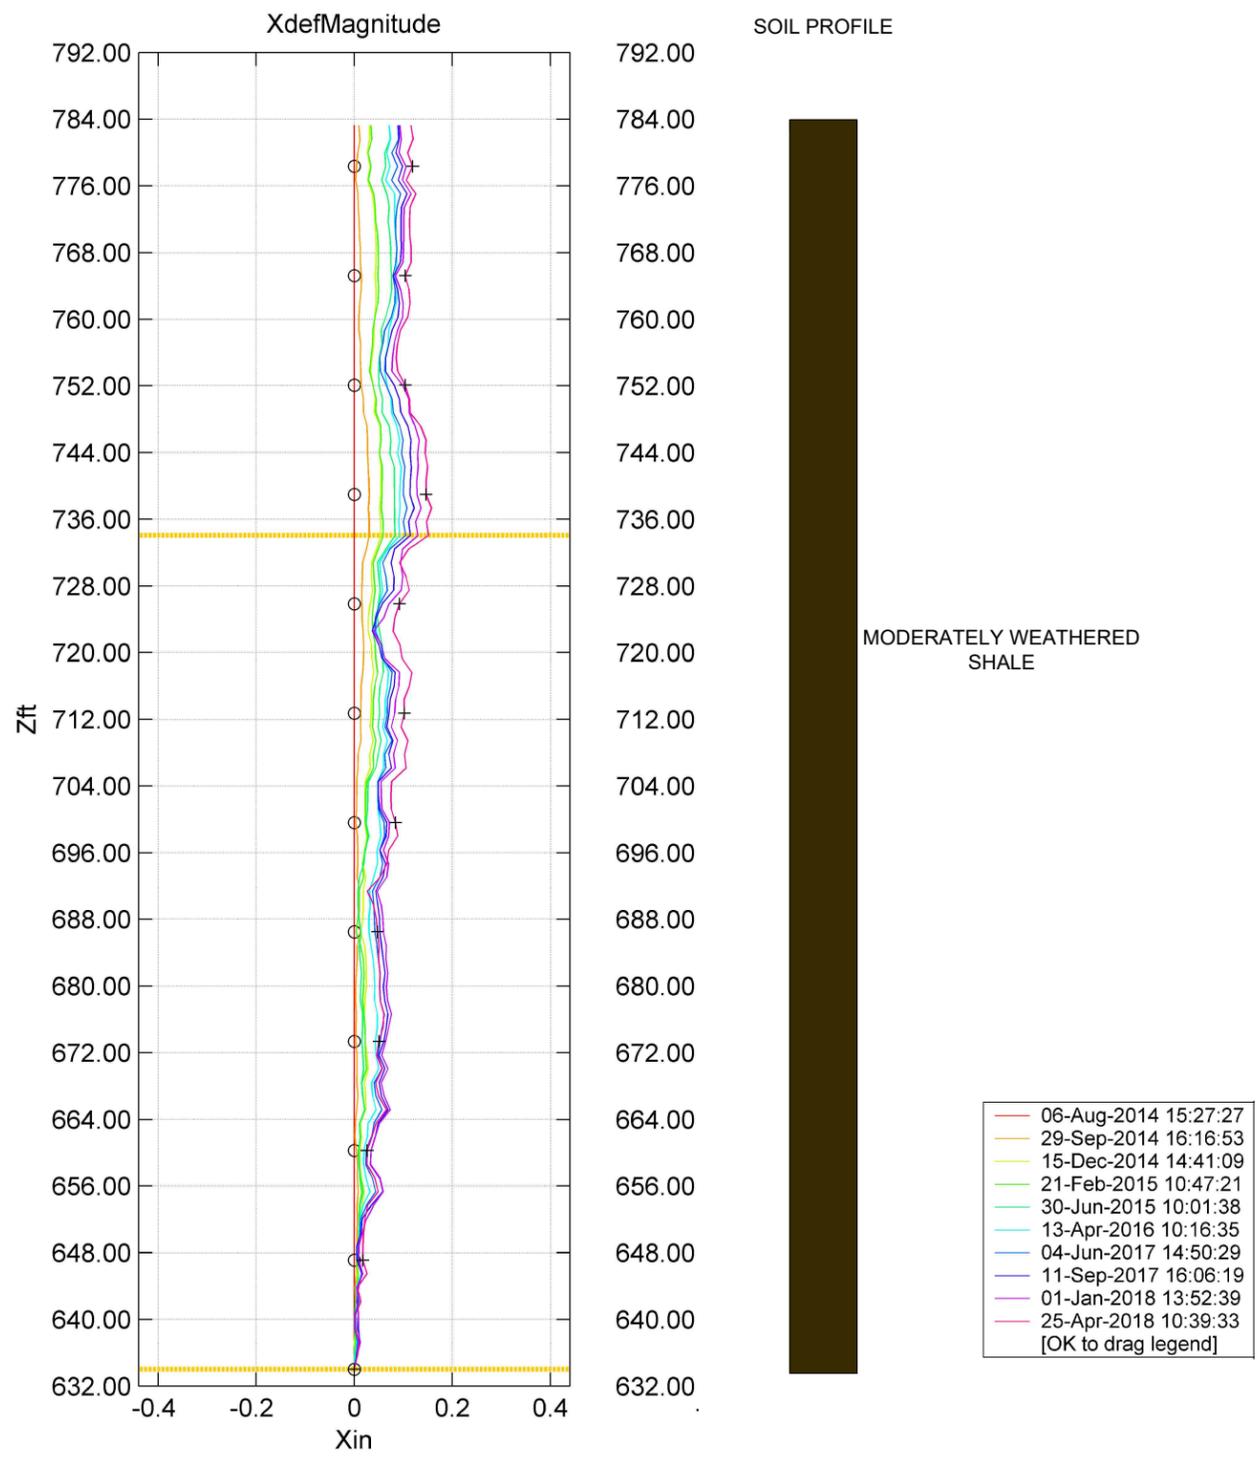
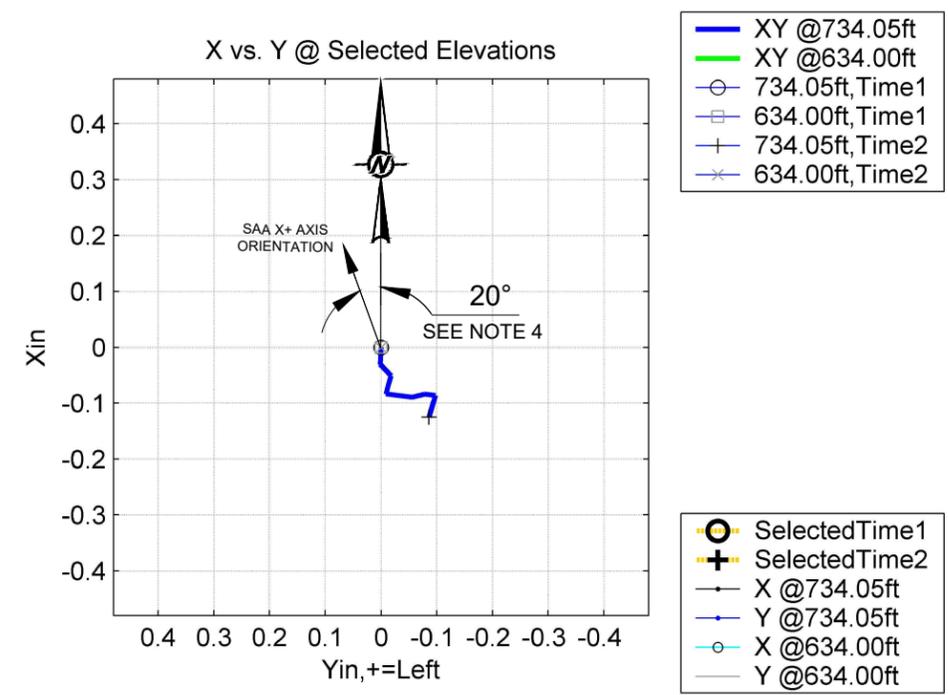
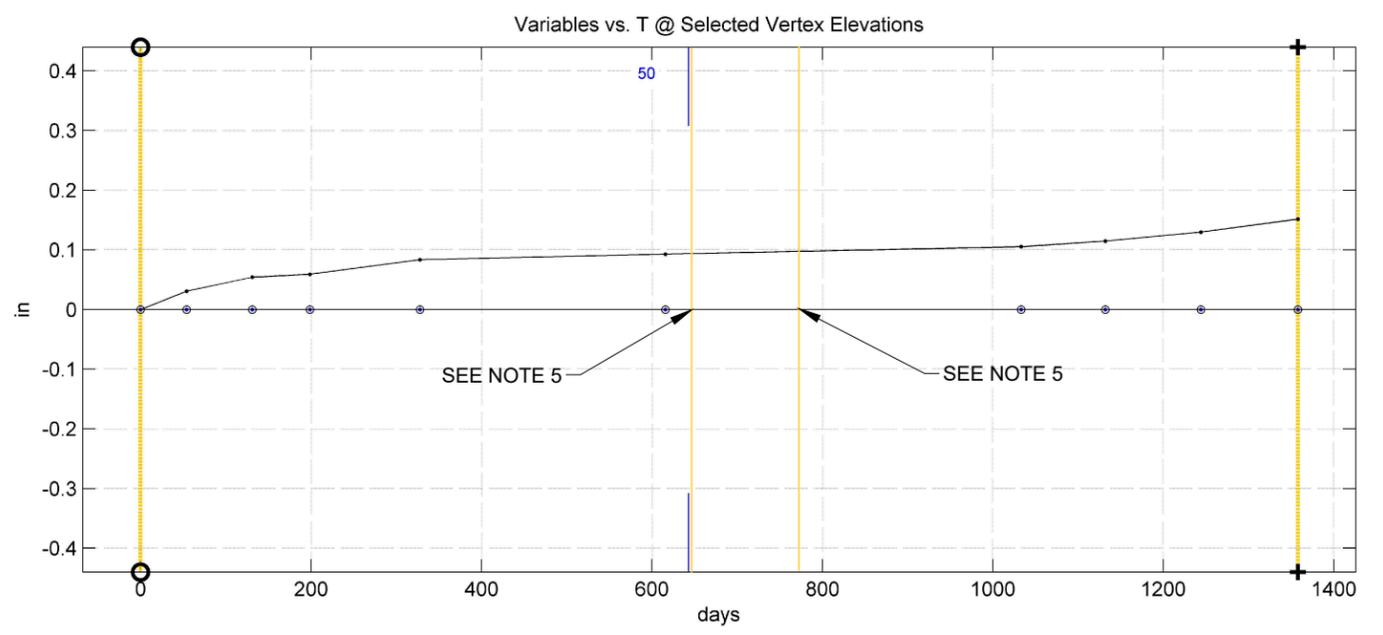
CUMULATIVE SAA INCLINOMETER DATA COLLECTED FROM AUGUST 2014 BASELINE

- NOTES**
- DISPLACEMENT PLOTTED VERSUS TIME AT LOCATION OF MAXIMUM DISPLACEMENT WITHIN VERTICAL ARRAY.
  - INC-03-14 LIES BURIED UNDERNEATH APPROXIMATELY 17 FEET OF FILL.
  - SENSORIZED INSTRUMENTATION TOLERANCE ERROR AS PER MEASURAND SPECIFICATIONS IS +/- 0.08 INCHES.
  - AZIMUTH ADJUSTMENT OF 20 DEGREES (COUNTER CLOCKWISE) IS ESTIMATED FROM THE URS PHASE II GEOTECHNICAL REPORT THAT STATES THE POSITIVE X-DISPLACEMENT DIRECTION IS NORTH-NORTHWEST
  - APPROXIMATE DATES OF STAGE X BUTTRESS CONSTRUCTION (MAY 15, 2016 TO SEPTEMBER 15, 2016.)
