Sä Dena Hes Mine, Yukon Territory 2018 Dam Safety Inspection

SRK Consulting (Canada) Inc.
November 2018

Project No: 1CT008.068

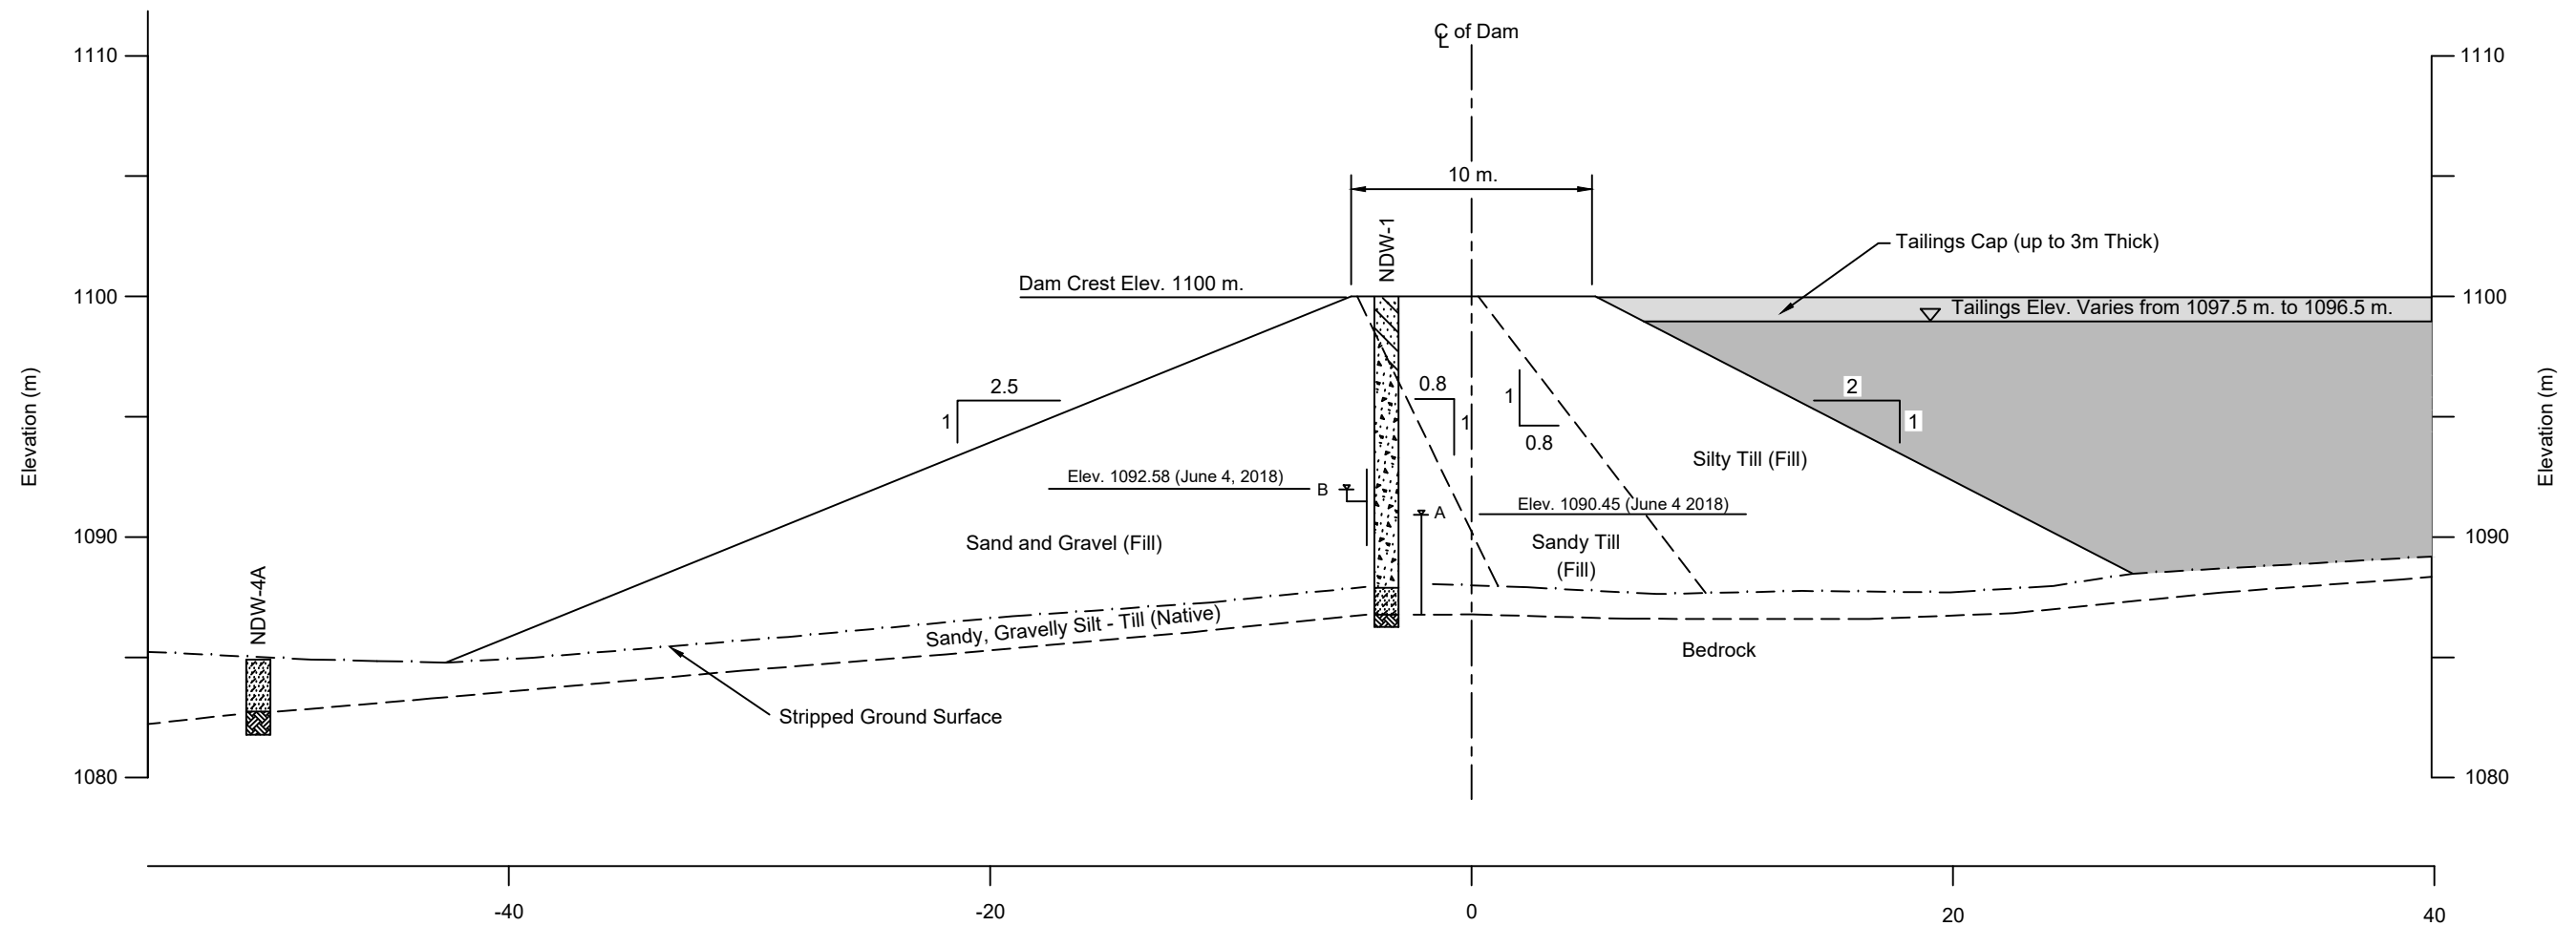
2018 Dam Safety Inspection	
		North Dam Section 0+400	
SRK JOB NO.: 1CT008.068	Sä Dena Hes Project	DATE: September 2018	APPROVED: PMH
FILE NAME: 1CT008_068_fig_04 - North Dam-XS.dwg		FIGURE: 4

DATE	T.O.P.	READING	ELEV.
NDW-1B	June 4, 2018	1100.57	7.99	1092.58
NDW-1A	June 4, 2018	1100.74	10.288	1090.45

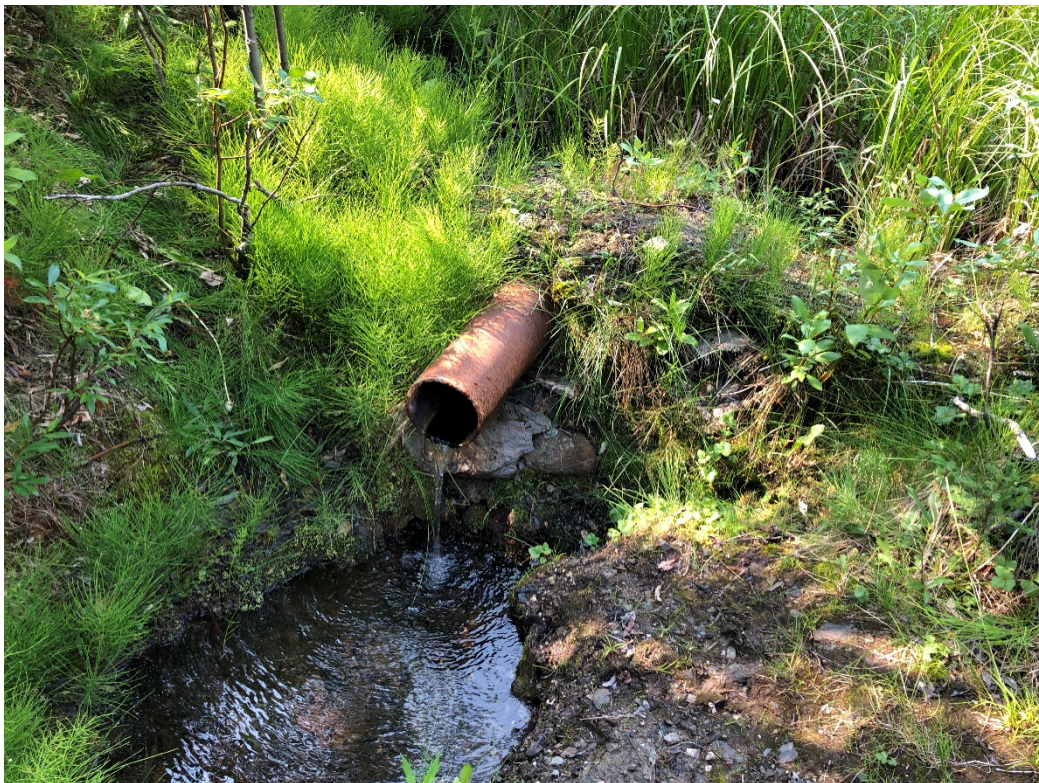
Along the downstream toe of the North Dam there is an 80 m long seepage zone (Photo 7). Seepage from this zone is collected at a monitoring station referred to as MH-02 and is a combination of groundwater discharge from the surrounding hillsides to the west and minimal seepage flow from the impoundment. The monitoring station consists of a 6-inch diameter steel pipe (Photo 8) embedded in sandbags.

Photo 8: Sampling location at Pipe Weir MW-02

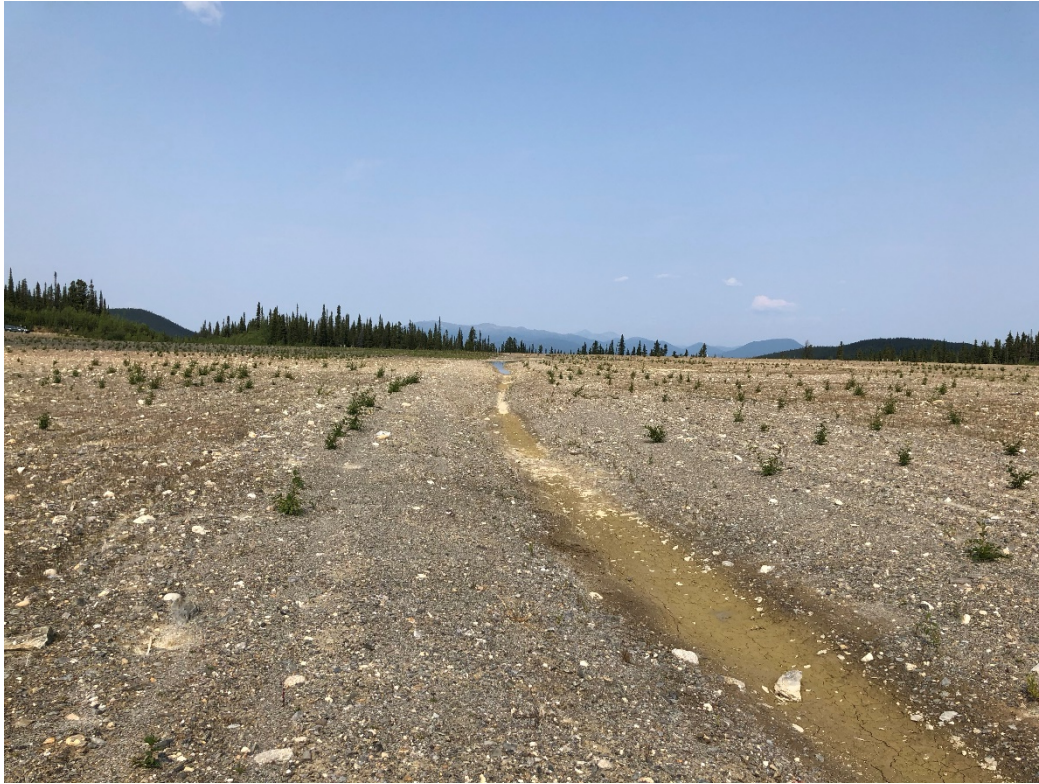
The till tailings cover has an overall gentle downslope gradient away from the North Dam. Photo 9 shows a view looking north of the drainage swale located down the middle of the tailings cover at the north end of the TMA. This swale was constructed to assist in directing runoff away from the crest of the North Dam. The swale was clear of any debris or vegetation and although there was evidence that water has flowed in the swale, at the time of the inspection it was dry except for one pool of water. Photo 10 shows a view of the swale looking south.

Photo 9: View looking north of drainage swale on tailings till cover

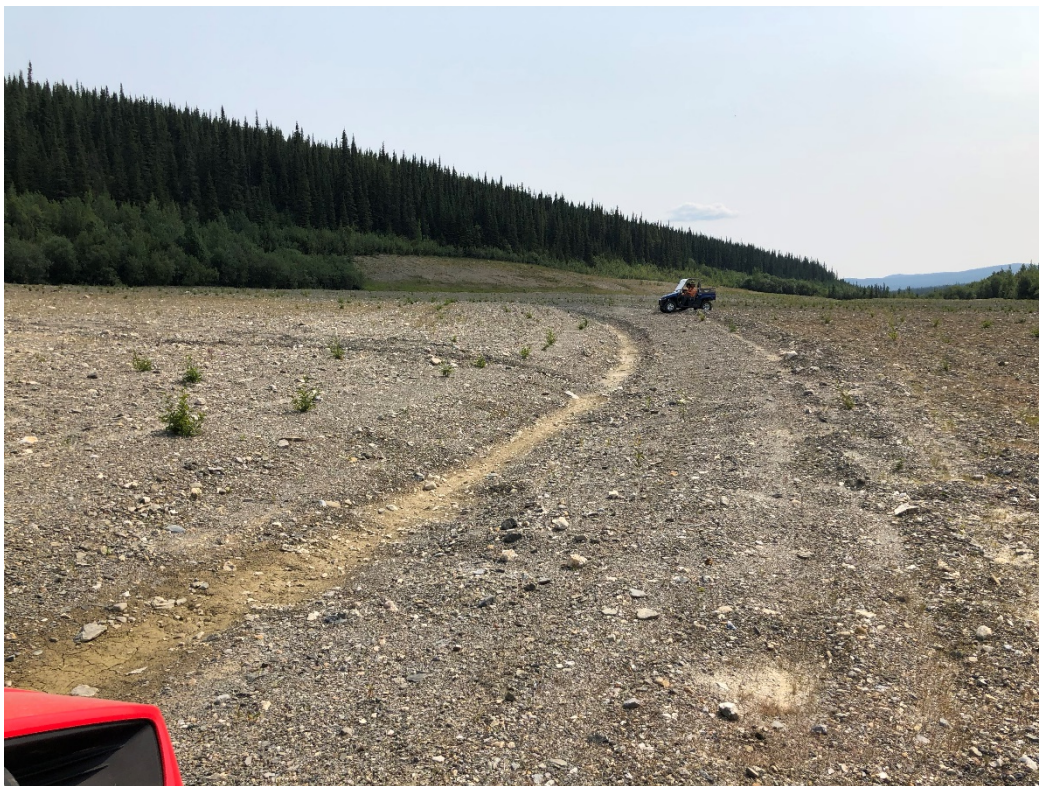
Photo 10: View looking south of drainage swale draining south

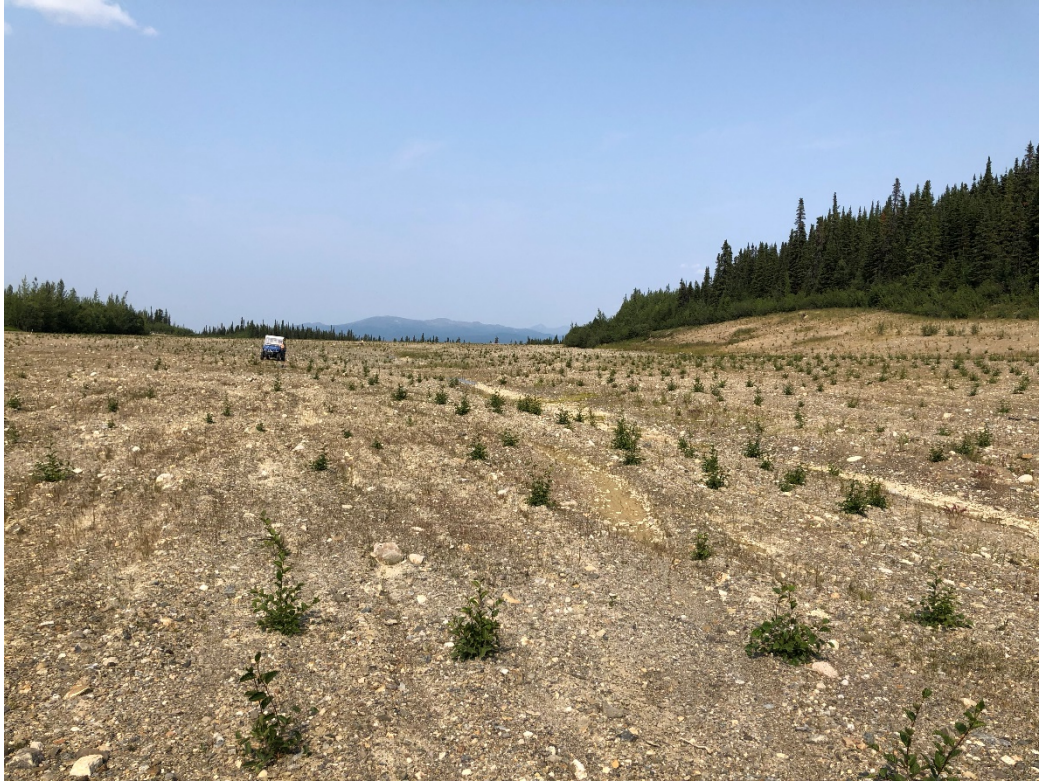
Vegetation is slowly developing over the entire area of the cover as shown in Photo 11.

Photo 11: Vegetation on tailings cover

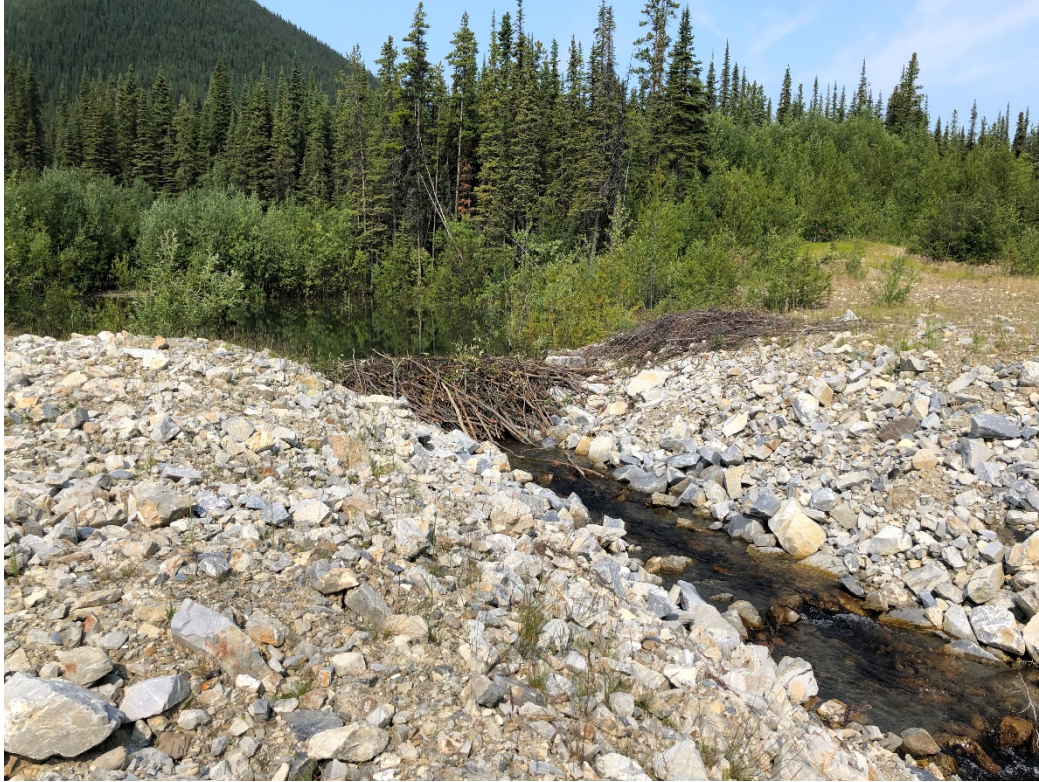
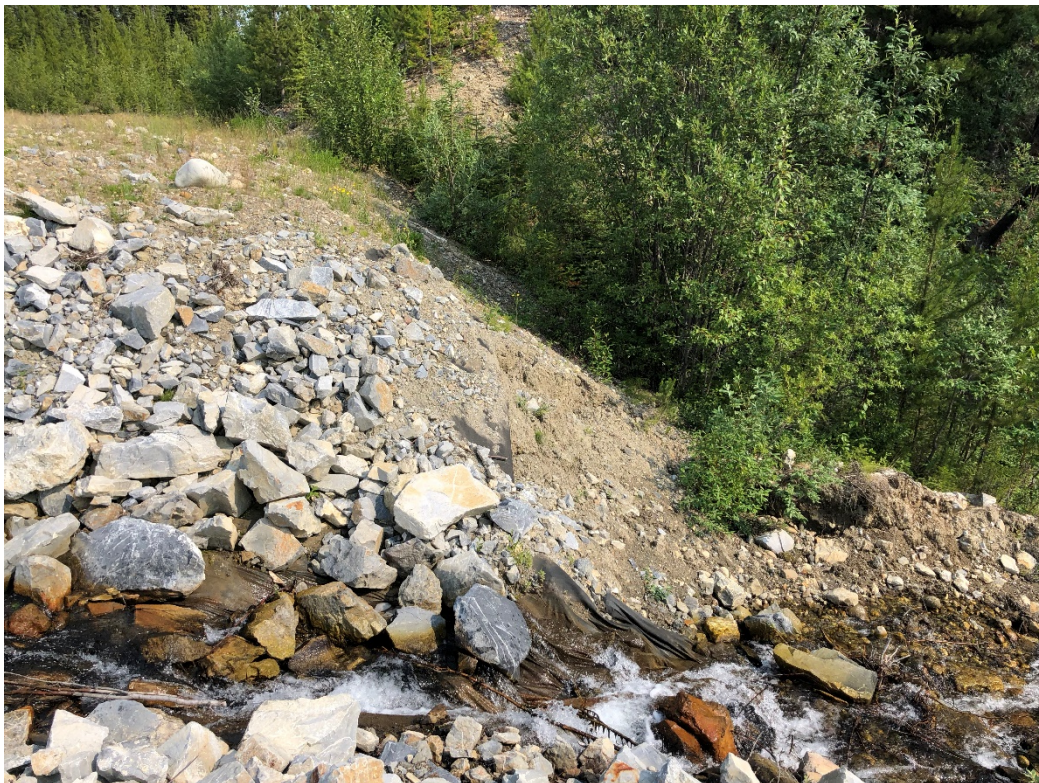
A riprapped channel conveys the North Creek over the original location of the decommissioned North Creek Dyke. It was noted at the inlet of the channel that beavers had again built a dam which was restricting flow (Photo 12). The dam raises the water level of the pond behind the structure and increases the risk of a rapid release of water that could result in erosion of the riprap protection in the channel. The dam was removed in 2018. Best Practice dictates that beaver dams be removed when identified during the routine inspections. Photo 13 shows a view looking upstream of the channel. At the outlet of the channel (Photo 14) some of the riprap had previously been dislodged by the flow, exposing a small area of the underlying filter fabric. There has been no noticeable change to this area since it was observed last year. The channel remains stable and no remediation is required.

Photo 13: North Creek Crossing

Photo 14: Outlet of North Creek crossing

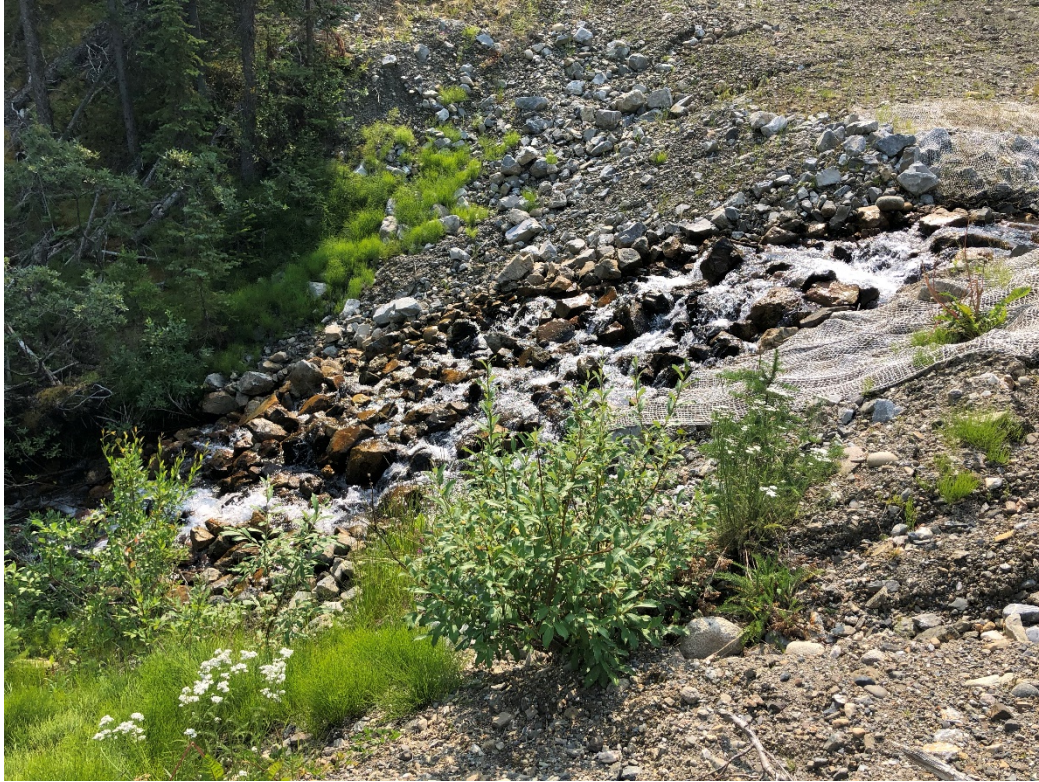
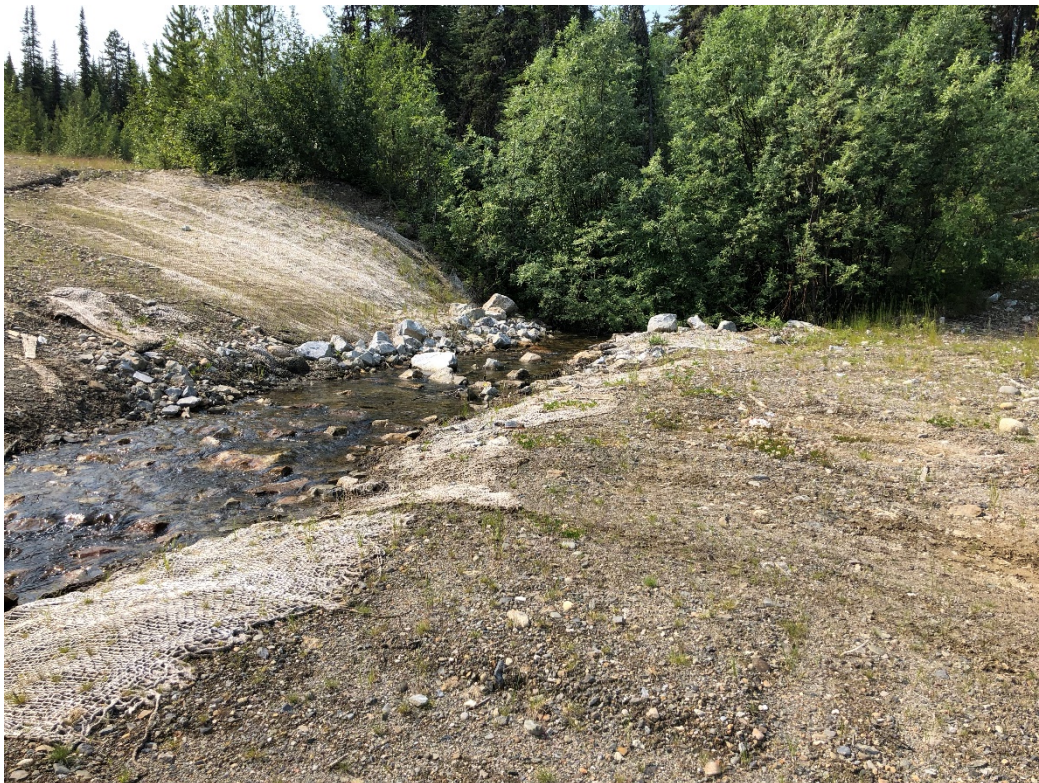
About 150 metres east downstream of the above channel is a second riprapped channel that was reclaimed following the removal of two culverts as part of the site reclamation in 2015 (Photo 15 and 16). The channel is stable and requires no remediation.

Photo 15: Outlet of Second crossing on North Creek

Photo 16: Second Crossing of North Creek

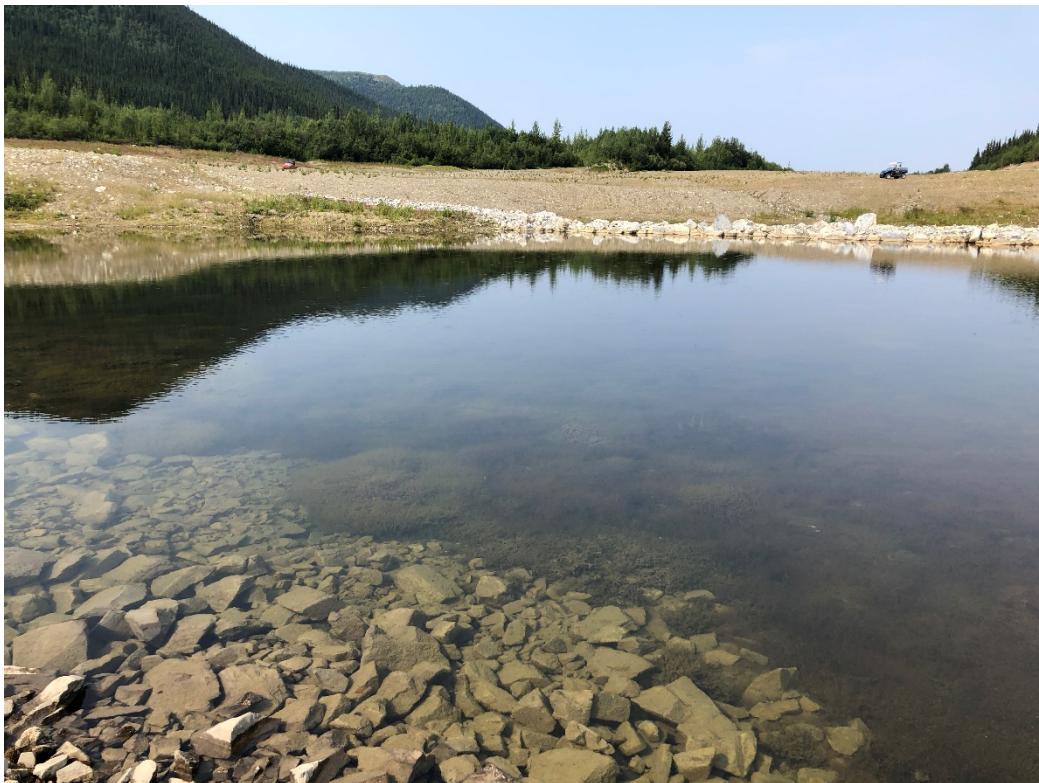
The sedimentation pond was clear at the time of our inspection and there was no evidence of any silt buildup (Photo 18).

Photo 18: Sediment collection pond upstream of SRS

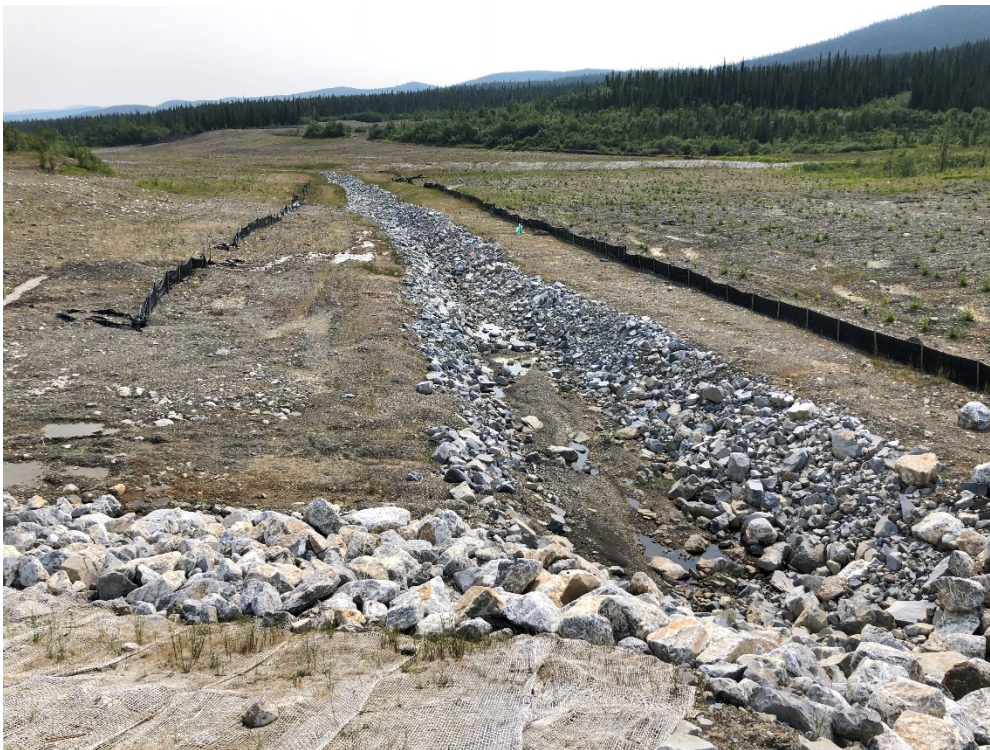
Photo 20 shows the South Channel looking south. Photos 21, 22 and 23 show the North, Camp Creek and South channels. No movement of the riprap or subsidence was evident in any of these channels.

Photo 20: View of the south channel looking south from the SRS Dyke

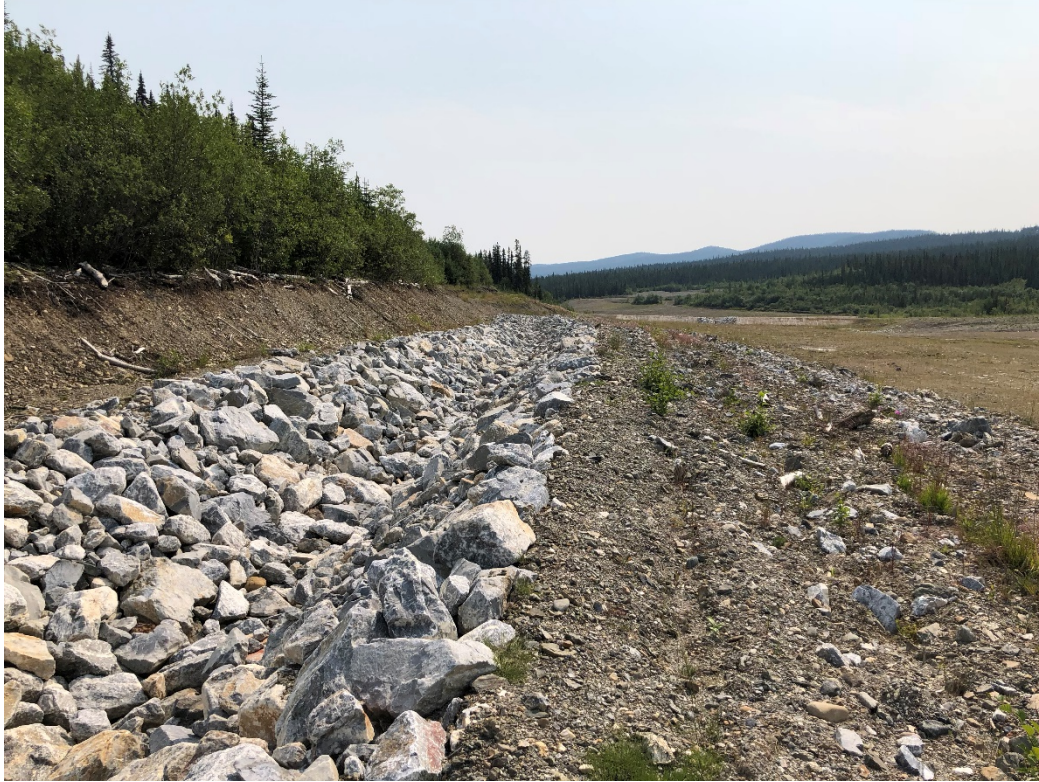
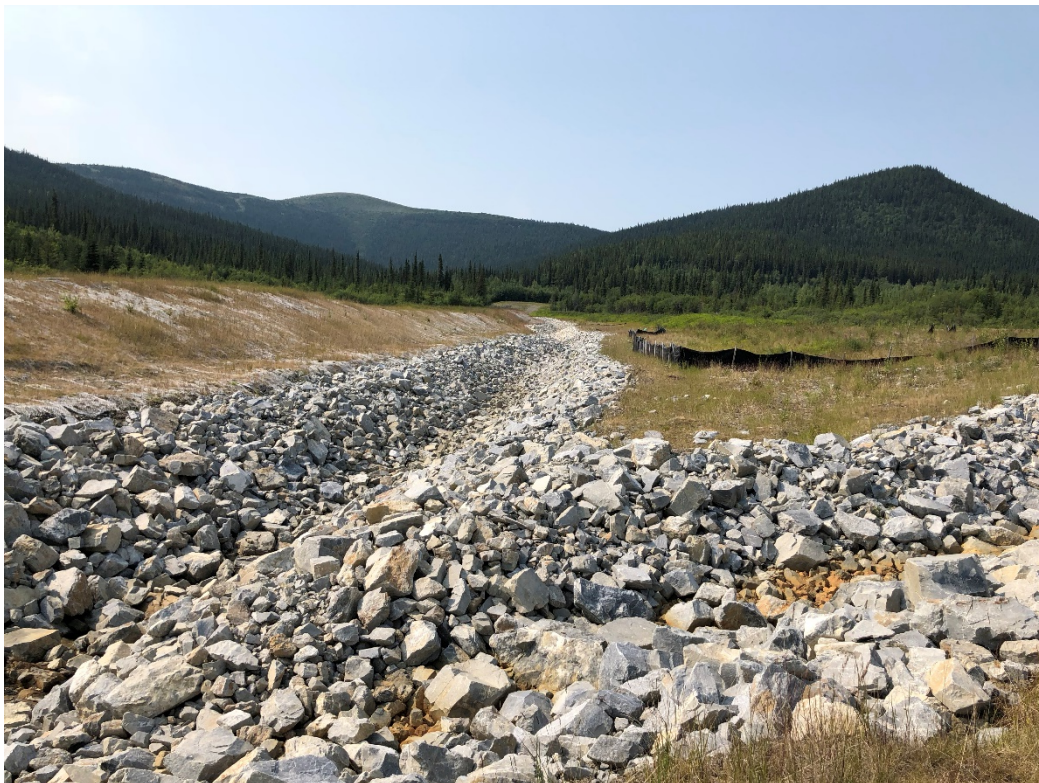
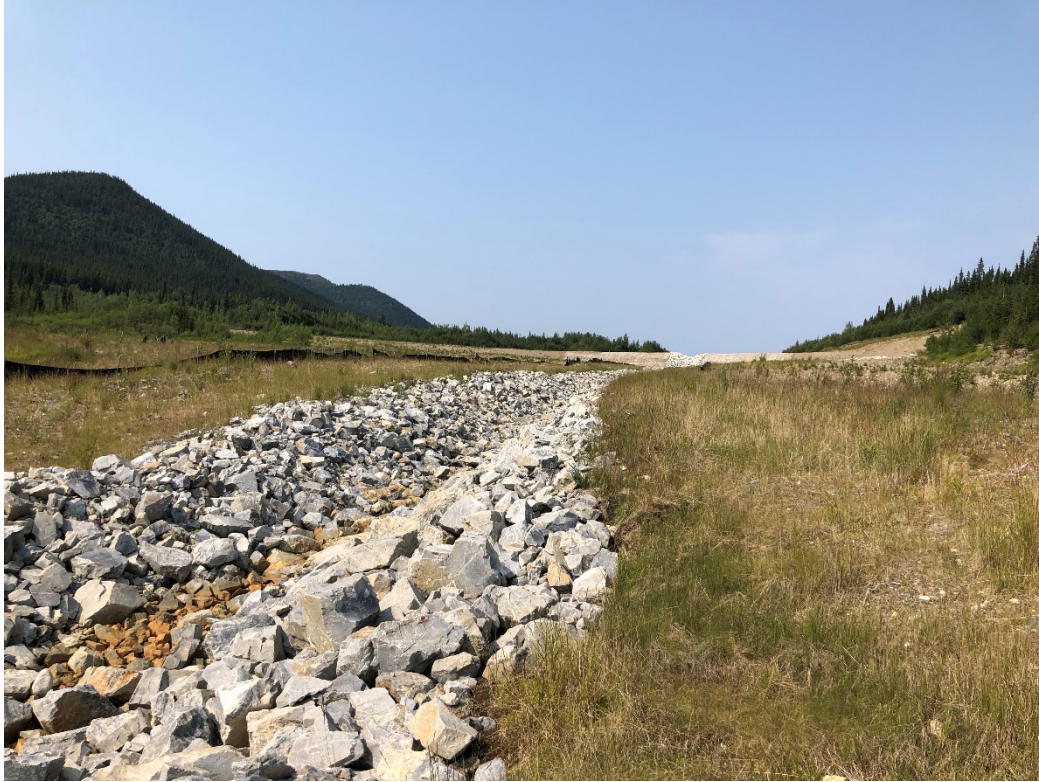
Photo 21: View south of the North Diversion Channel

Photo 22: View upstream of the Camp Creek channel

Photo 23: View north along the South Diversion drainage channel
