**Teck Metals Ltd.**

**Sullivan Mine Tailings Facilities**

***2018 Dam Safety Inspection***

March 2019

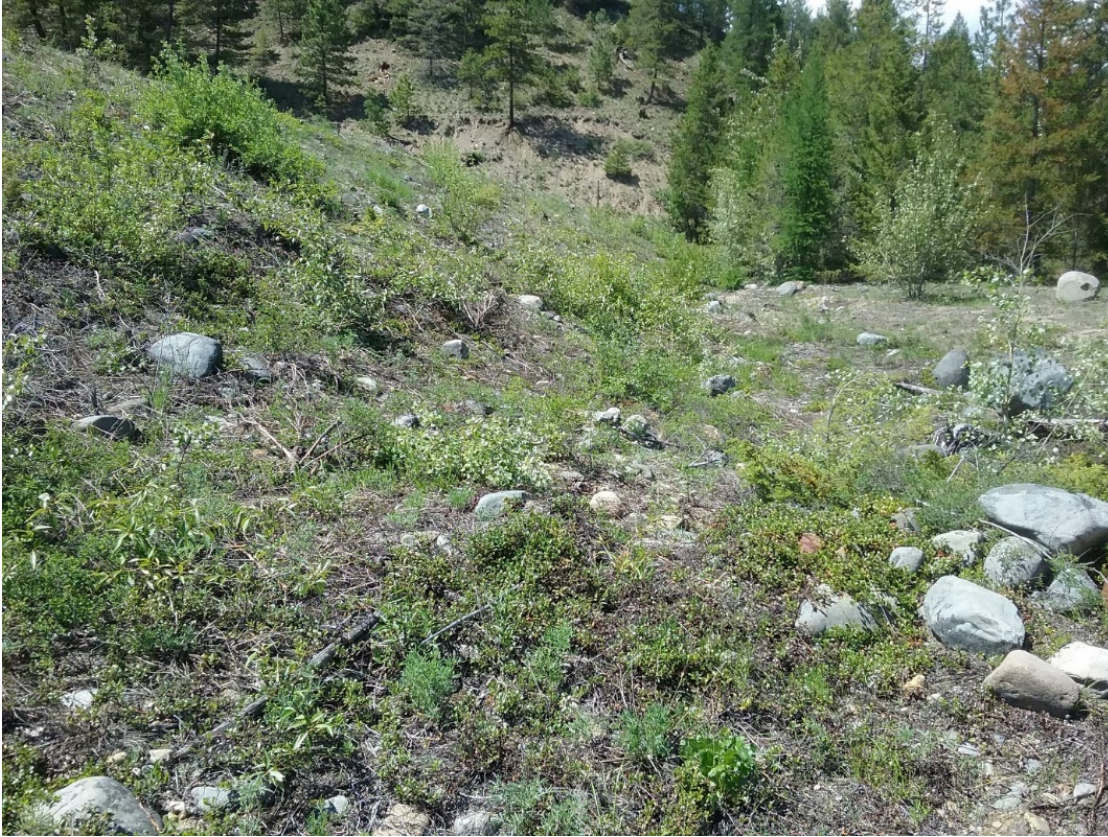
**Photo D.5     Sludge Impoundment North Dike Downstream Slope**

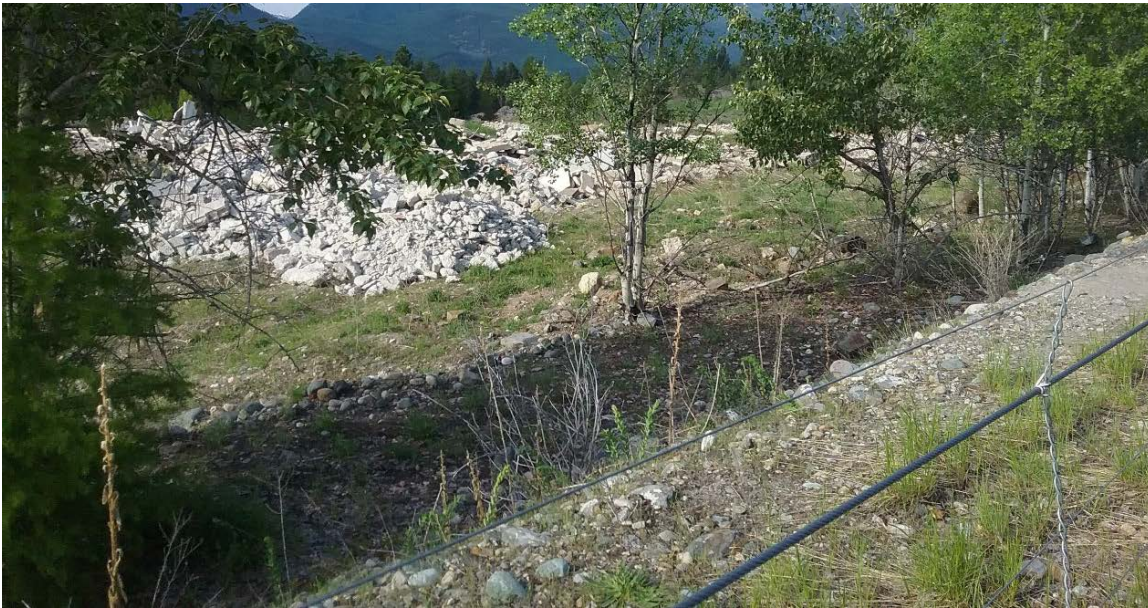
**Photo E.5 Concrete Debris and Landfill Downstream of Calcine TSF**

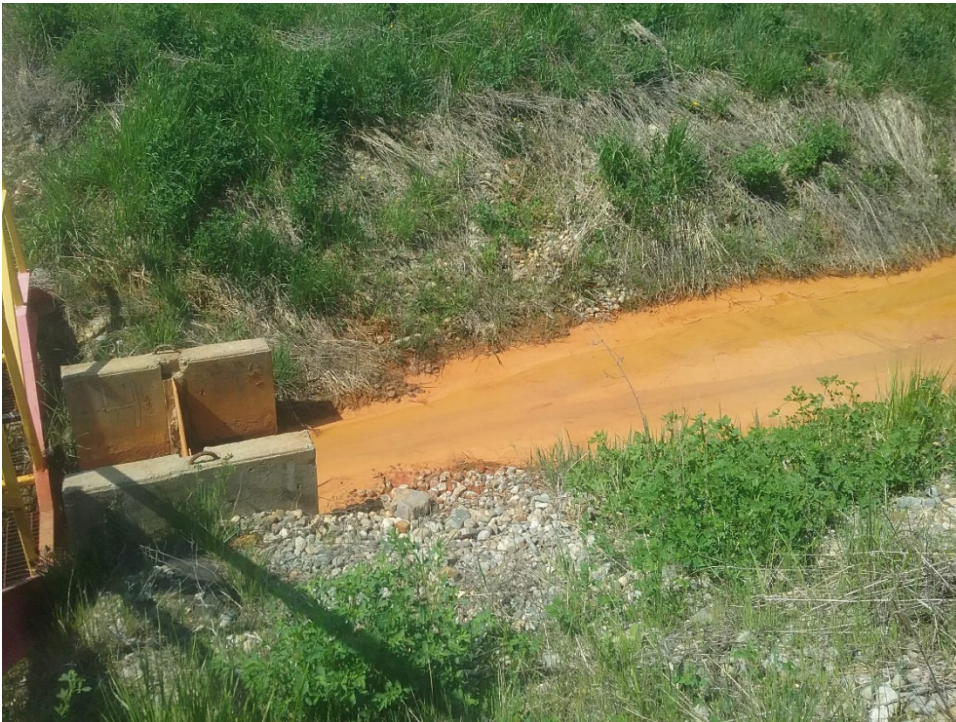
**Photo G.9 Silting of Channel upstream of Weir #4**
