Prepared for  
**Teck Washington Incorporated**  
1382 Pend Oreille Mine Road  
Metaline Falls, Washington  
USA, 99153

**VA101-18/26-1**

## **PEND OREILLE MINE - TAILINGS DISPOSAL FACILITY #3**

# **2019 DAM SAFETY INSPECTION REPORT**

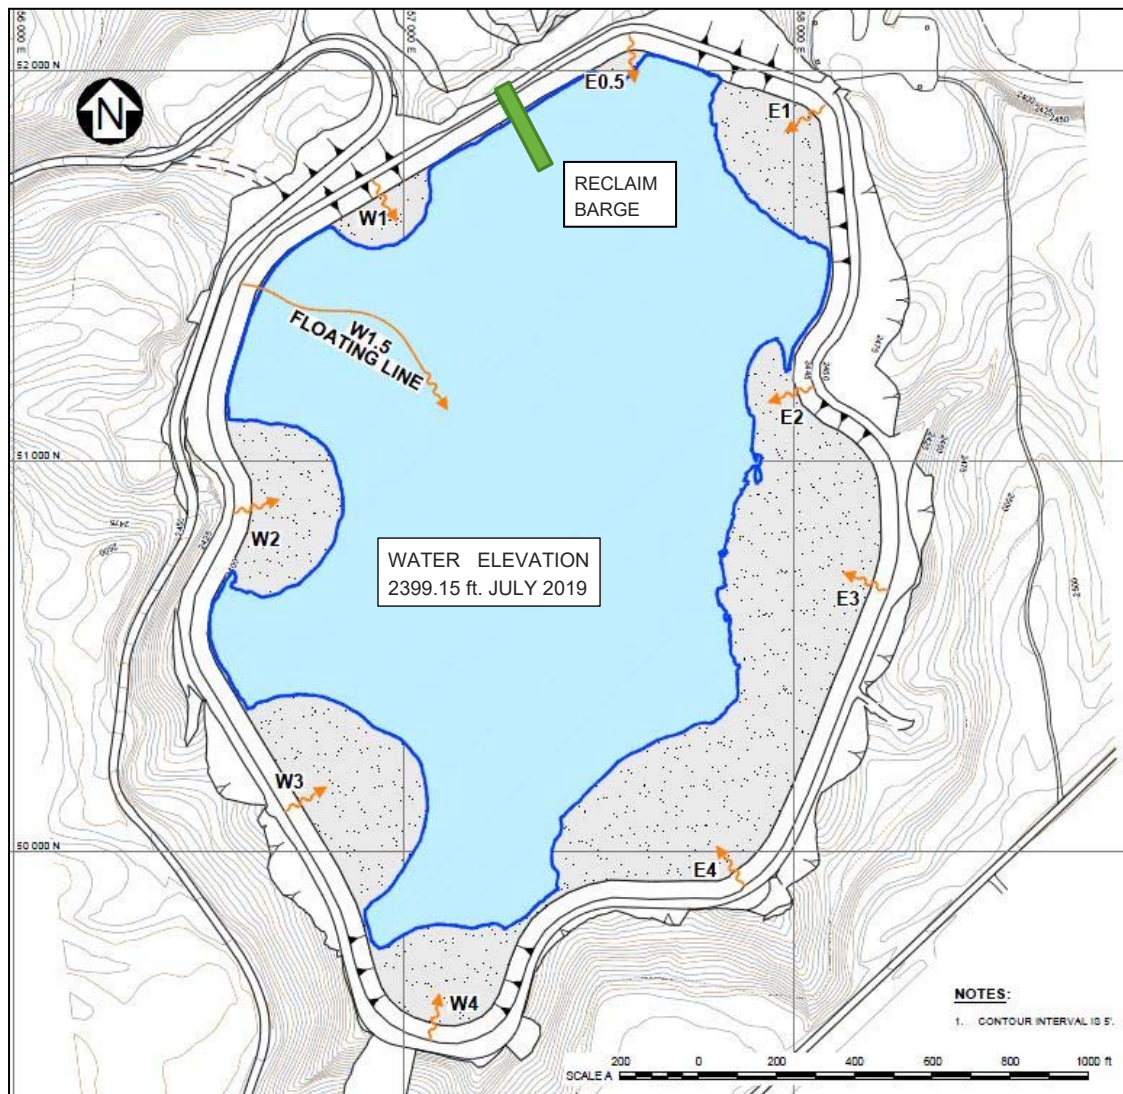
Figure 2.1 Pond and Tailings Beach Schematic

Site inspection forms are provided in Appendix A. A series of photographs collected during the site inspection are provided in Appendix B. Pond and tailings beach configurations at the time of the inspection are shown schematically on Figure 2.1.

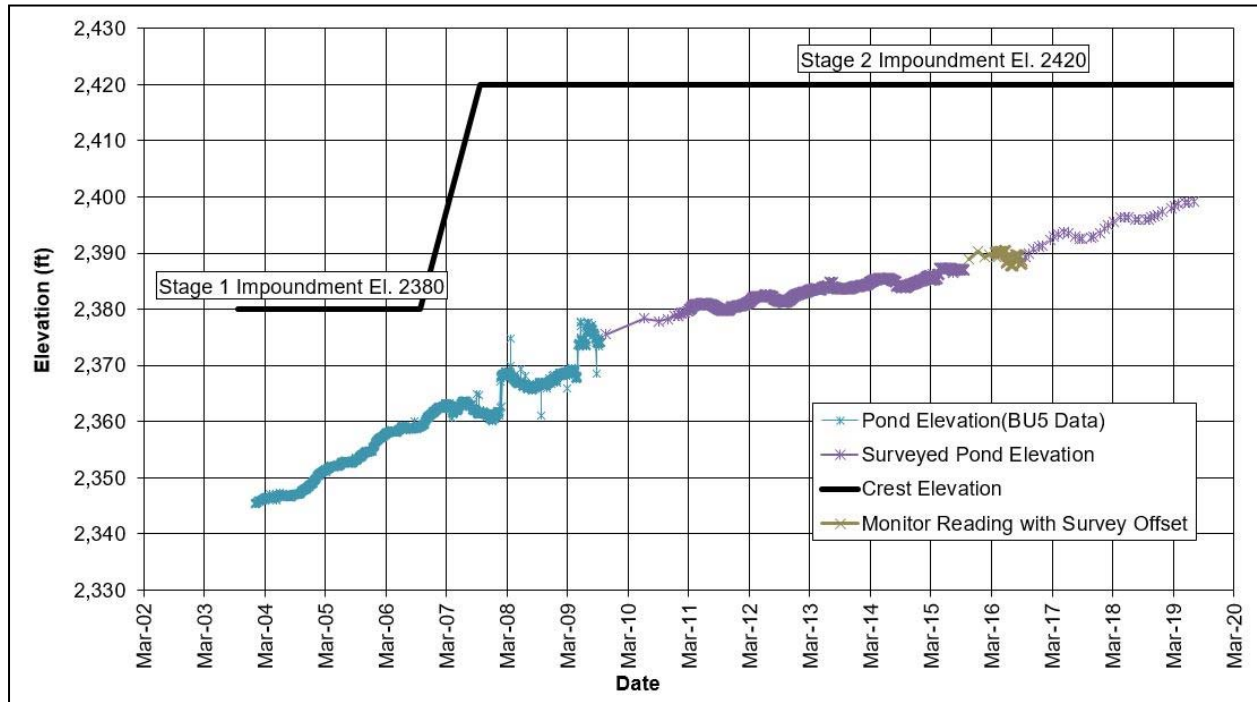
**Figure 2.6 Filling Curve**

Tailings deposition resumed in December 2014 and was halted on August 1, 2019. There is sufficient capacity remaining in the facility for tailings solids and storm water storage based on the updated filling curve on Figure 2.6. Survey measurements have recently been the most reliable source for determining pond elevation.

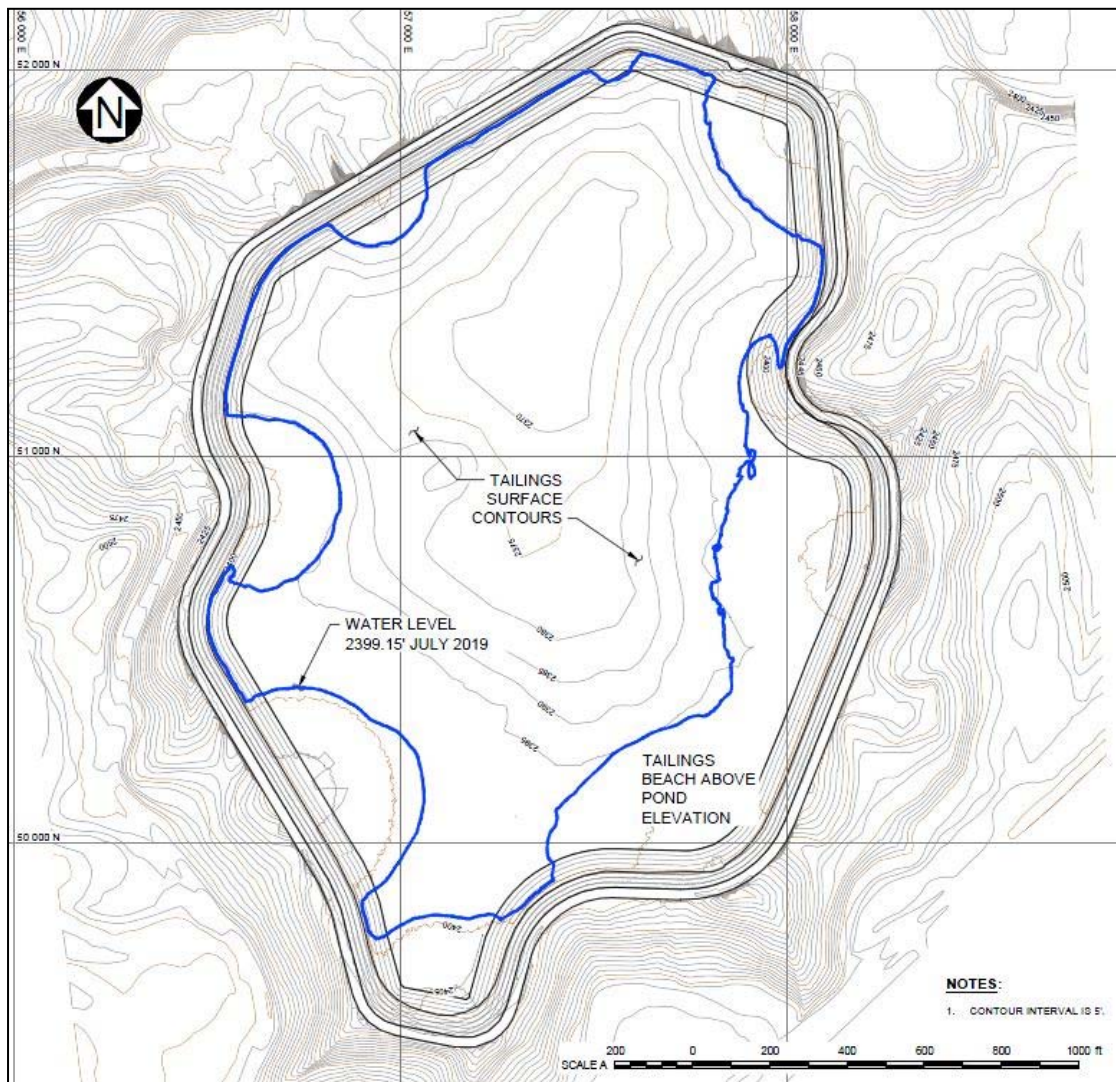
**Figure 2.7 Bathymetric Survey Plan**

TWI completed a bathymetric survey in July 2019 and the volumes for tailings solids and pond water were updated. The tailings solids volume is approximately 101,300,000 ft<sup>3</sup> and the water volume is approximately 24,900,000 ft<sup>3</sup>. The plan view bathymetric survey is shown on Figure 2.7.

Currently 42.4 million cubic feet of storage volume remains between the pond surface water elevation and the freeboard elevation of 2,414 ft. Additional tailings solids storage capacity can be obtained by reducing the pond volume to the targeted operational design volume. The remaining tailings solids storage volume is 59.0 million cubic feet had the pond volume been reduced to the design operational value at the freeboard elevation of 2,414 ft. Reduction of the operational pond volume is a TWI objective during this period of care and maintenance.

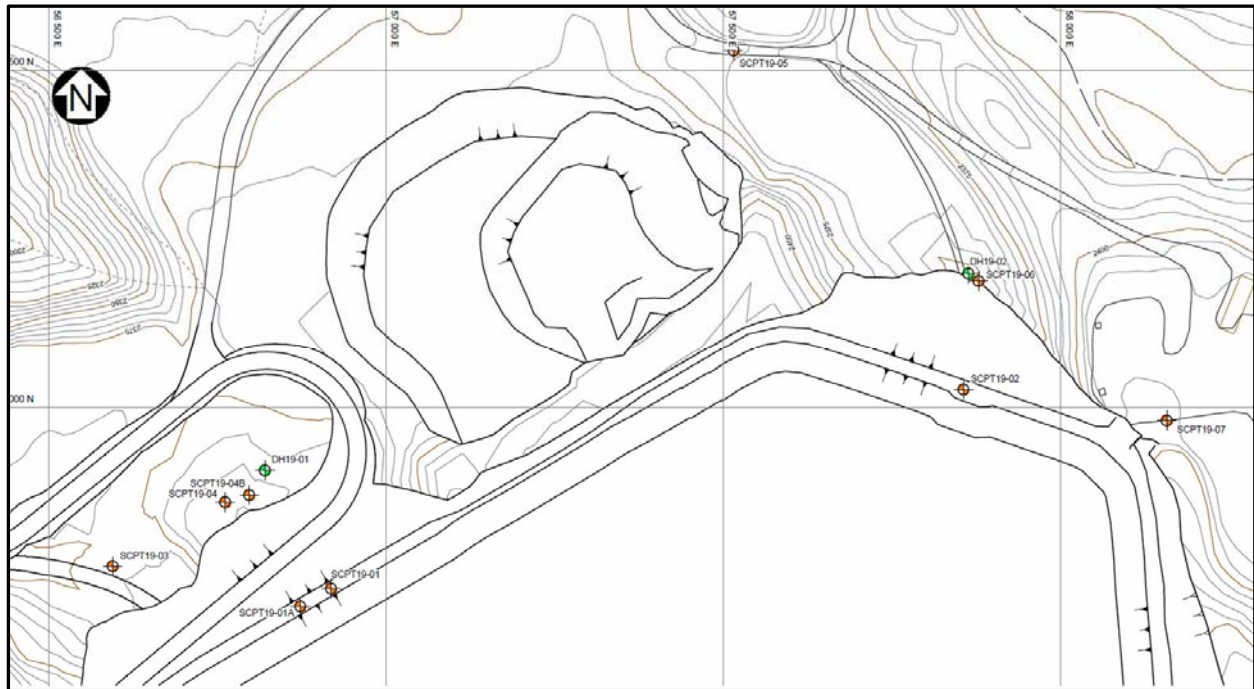
Figure 3.1 2019 TDF #3 Site Investigation Plan

The site investigation plan is shown on Figure 3.1. The results of the SI program indicate the following:

- Data collected through drilling and SCPT methods supports the original characterization that the foundation encountered at the NW and NE Embankments is within the Glaciolacustrine Silt and Sand unit, with some instances of Outwash Sand and Gravel units.

- SCPT results within the foundation suggest that the silt materials are highly stiff with depth and the sand materials are medium dense to dense. Standard Penetration Testing (SPT) results indicate that the foundation material is compact.

- Pore pressure dissipation (PPD) tests performed during the CPT program generally exhibit low to zero pore pressure within the foundation, which are indicative of drained conditions.

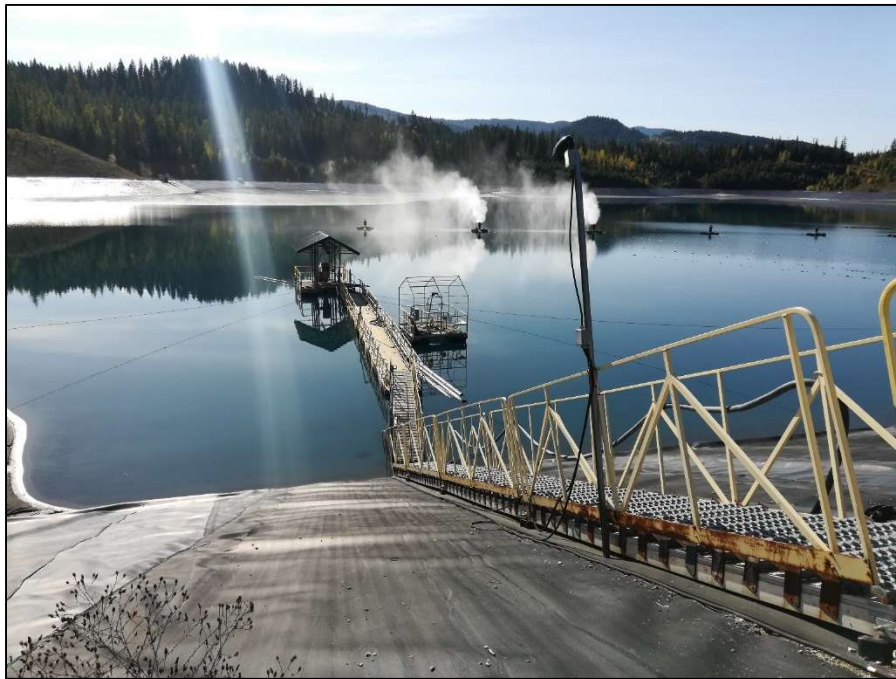
Evaporators generally functioned properly throughout the year, although at the time of inspection, six of eight evaporators were not functioning and required minor maintenance to become operational. Evaporator recommendations are provided in Section 4.

**PHOTO 7** – Reclaim barge, walkway and evaporators.

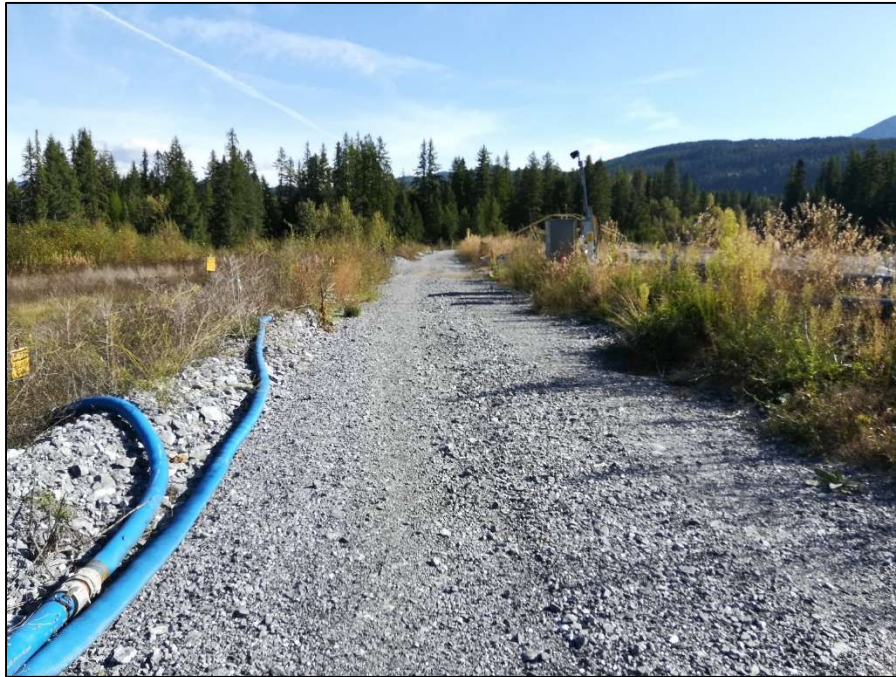
Rockfill was placed along the perimeter road of the TDF in low areas with poor drainage to improve water management and surface water runoff. The minor depression previously referred to as a “sink hole” on the upper slope of the basin, was inspected and no issues were noted. The wildlife fence was inspected, and repairs completed as needed.

**PHOTO 9** – TDF #3 perimeter road connecting northeast and northwest Dams.

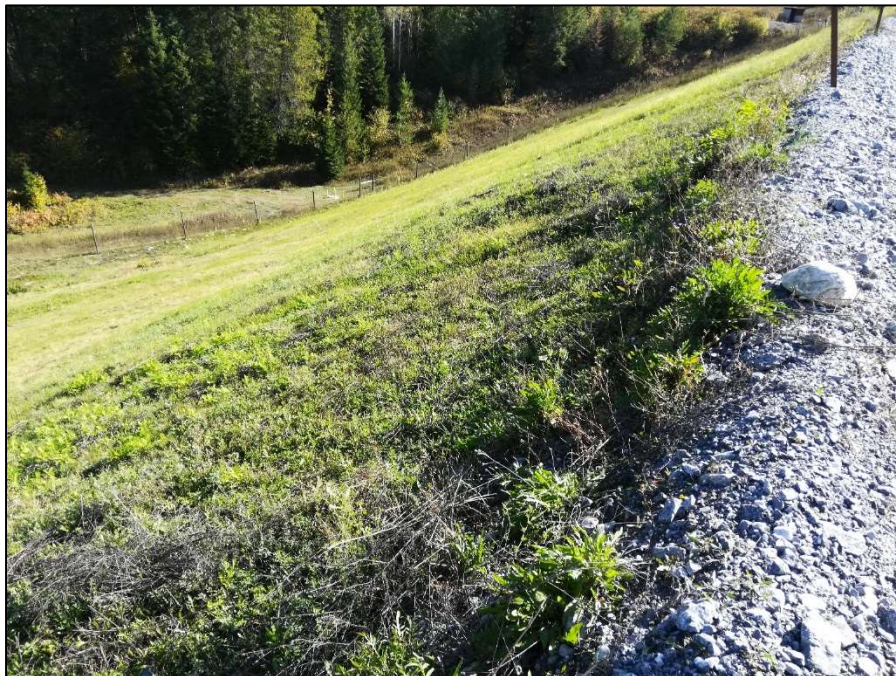
No signs of distress were noted during the inspection of the NE and NW Embankments. No seepage, wet or soft spots were observed on the downstream slopes. The embankment slopes were approximately planar and there was no evidence of cracking, bulging, or slumping in the embankment fill. The embankment crest appeared to be level with no signs of differential settlement or distress. The abutments appear sound with no evidence of erosion, seepage, settlement or cracking. There was some evidence of animal burrowing at the toe of the NE embankment. TWI implements an ongoing pest control program during the summer months, which has proven effective in decreasing the number of animal burrowing incidents. The reclaimed downstream embankment slopes were mowed during the summer as part of the ongoing maintenance of the embankments. Tree growth on the abutments and a removal program are in place for the abutments where past tree growth has occurred. No significant construction activities took place over the course of the year.

**PHOTO 10** – Downstream face of northeast dam from crest.

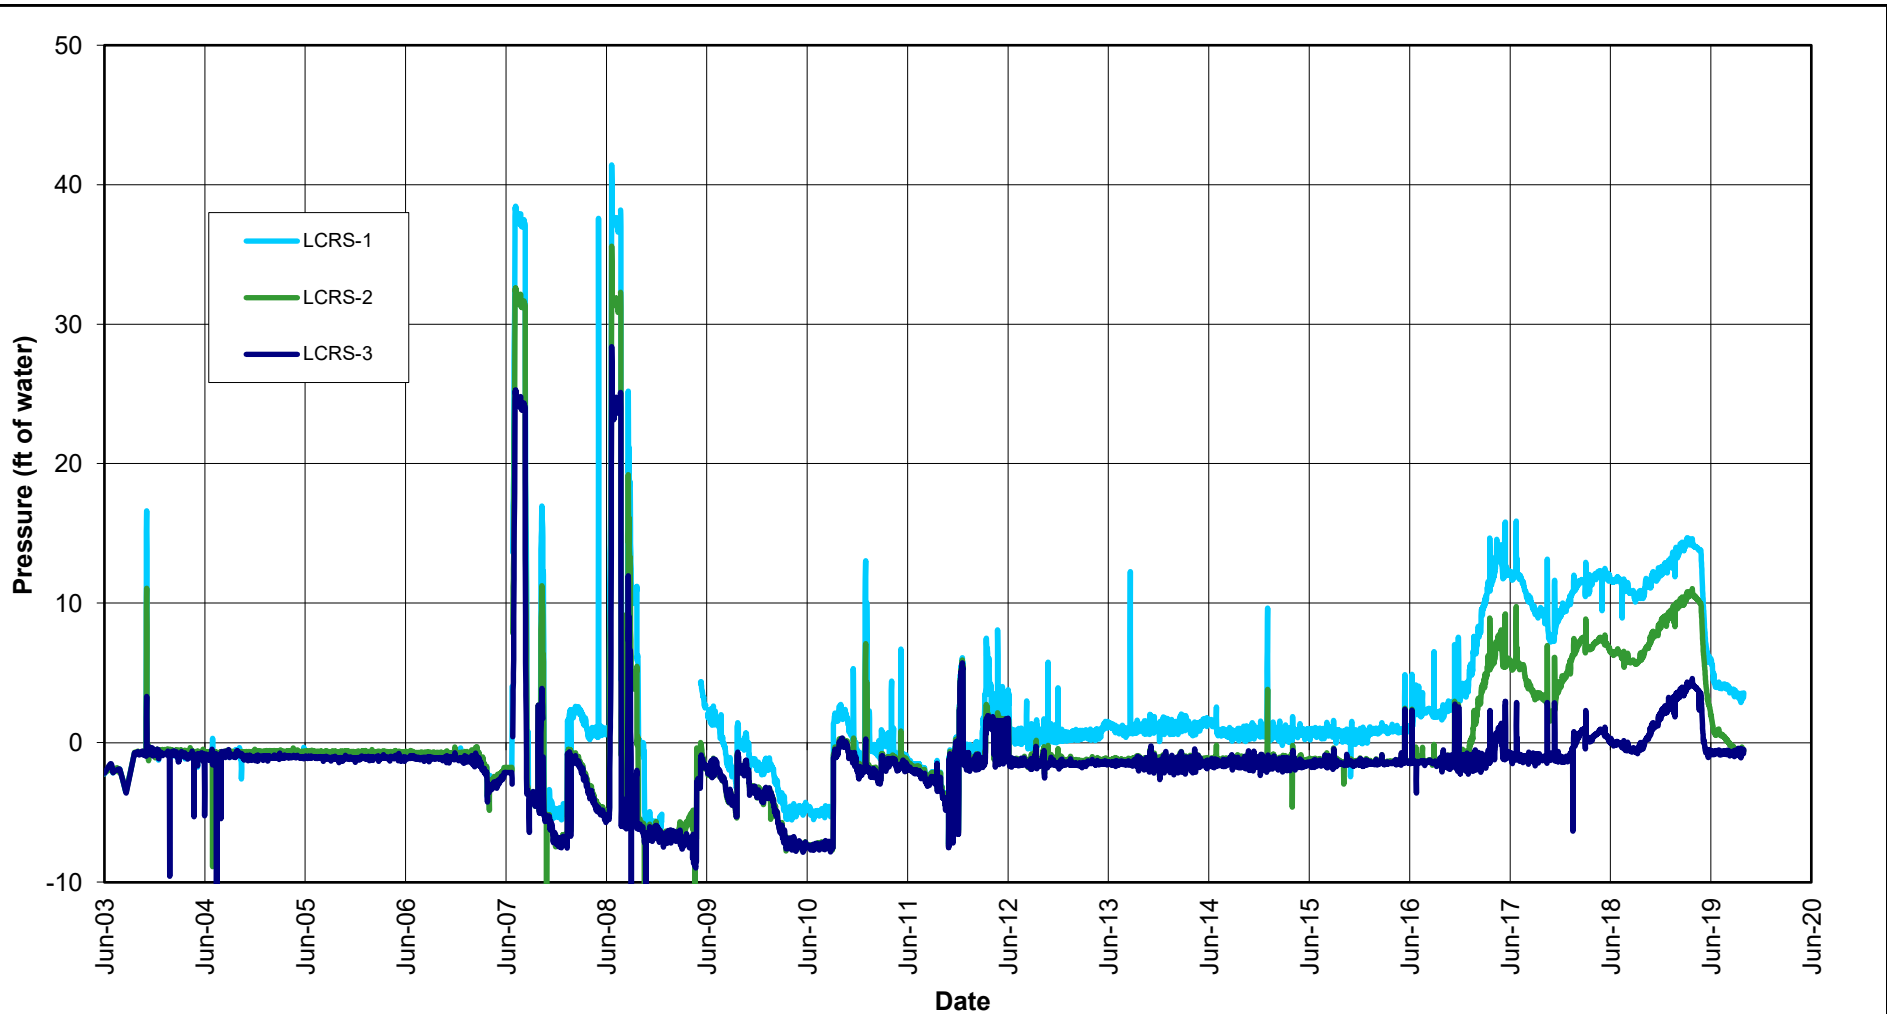
P/A No. VA101-18/26 REF.NO. 1 <b>FIGURE C-8</b> REV 0

TECK WASHINGTON INCORPORATED	
PEND OREILLE MINE	
<b>TAILINGS DISPOSAL FACILITY #3 CALCULATED PRESSURE FOR LCRS PIEZOMETERS</b>

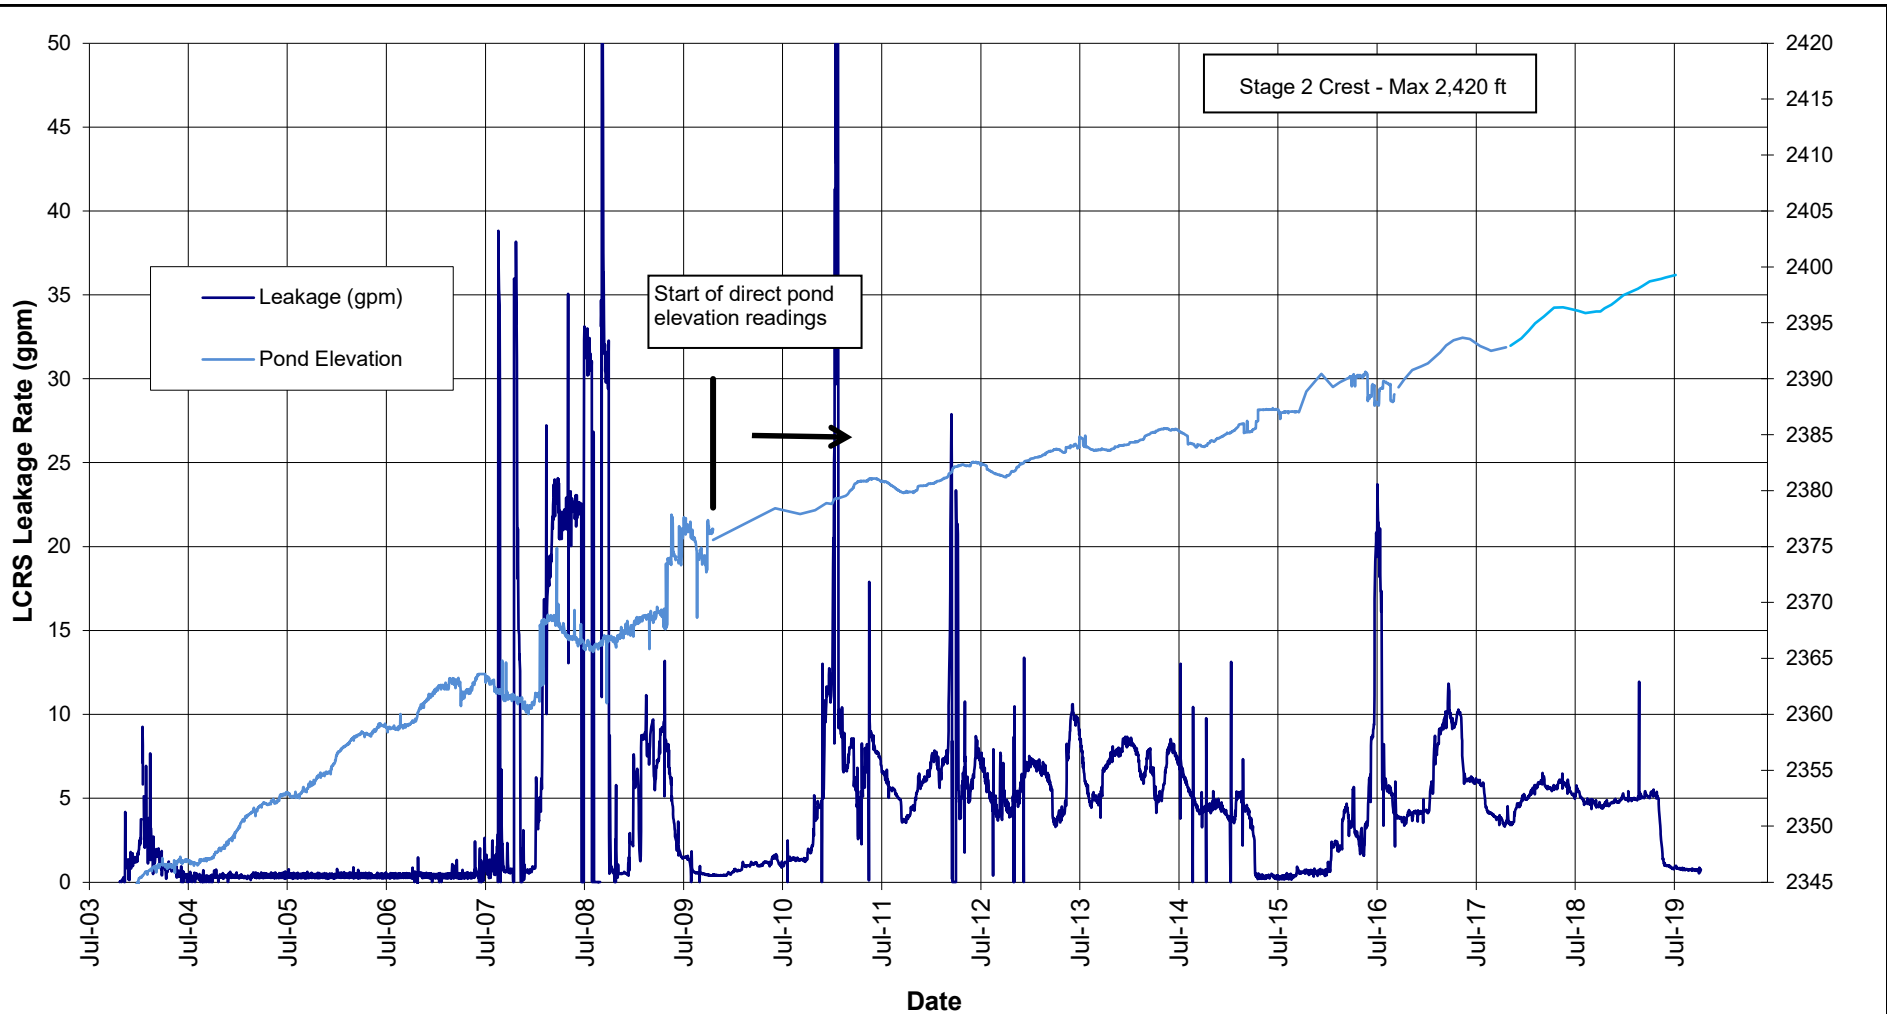
P/A No. VA101-18/26 REF. NO. 1
<b>FIGURE C-9</b>	
REV 0

TECK WASHINGTON INCORPORATED	
PEND OREILLE MINE	
TAILINGS DISPOSAL FACILITY #3 LCRS LEAKAGE RATE

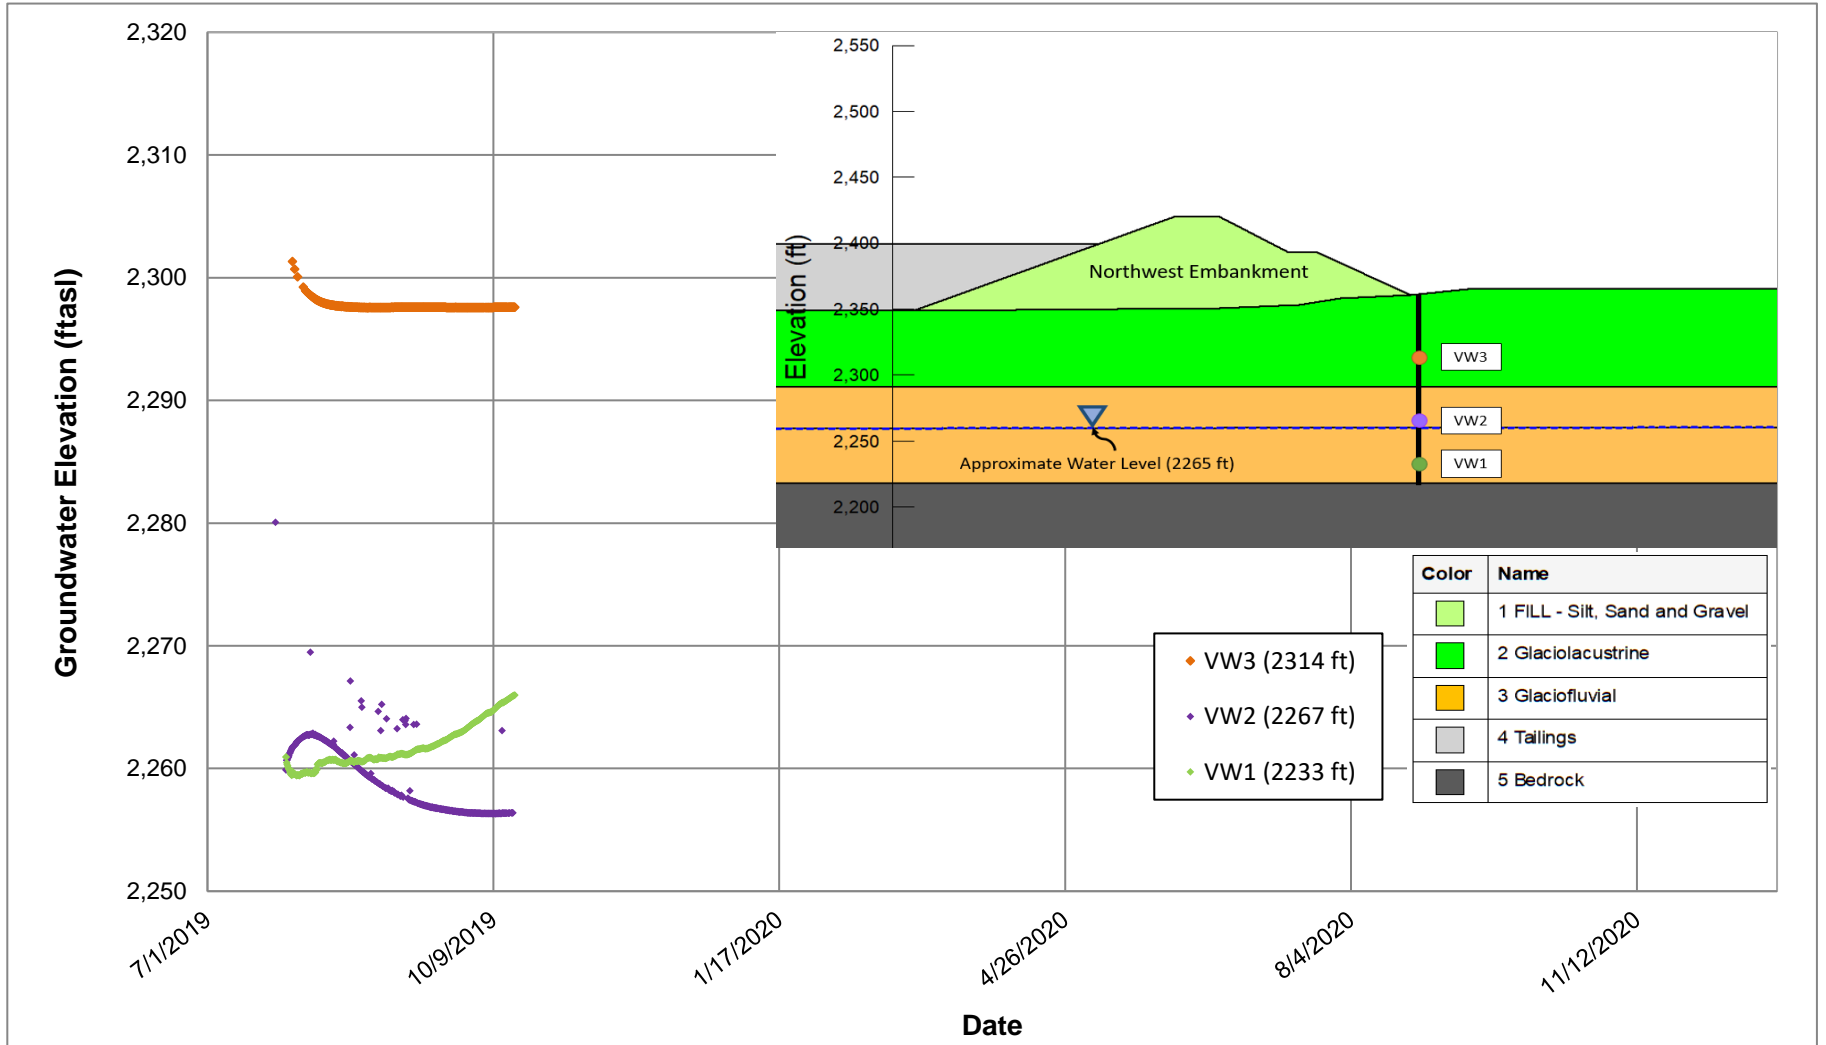
TECK WASHINGTON INC.	
PEND OREILLE MINE	
<b>DH19-01 PIEZOMETER DATA GROUNDWATER ELEVATION</b>	
	P/A NO. VA101-00018/26
	REF. NO 1
<b>FIGURE F-1</b>	
	REV 0

- GROUND ELEVATION IS 2367 ft ABOVE SEA LEVEL.
- SENSOR DEPTHS SHOWN IN LEGEND ARE VERTICAL DEPTHS BELOW GROUND SURFACE.
- VW3 AND VW2 LOCATED ABOVE THE WATER TABLE.
- VW1 = 132 ft BELOW GROUND SURFACE, VW2 = 98 ft BELOW GROUND SURFACE AND VW3 = 51 ft BELOW GROUND SURFACE.

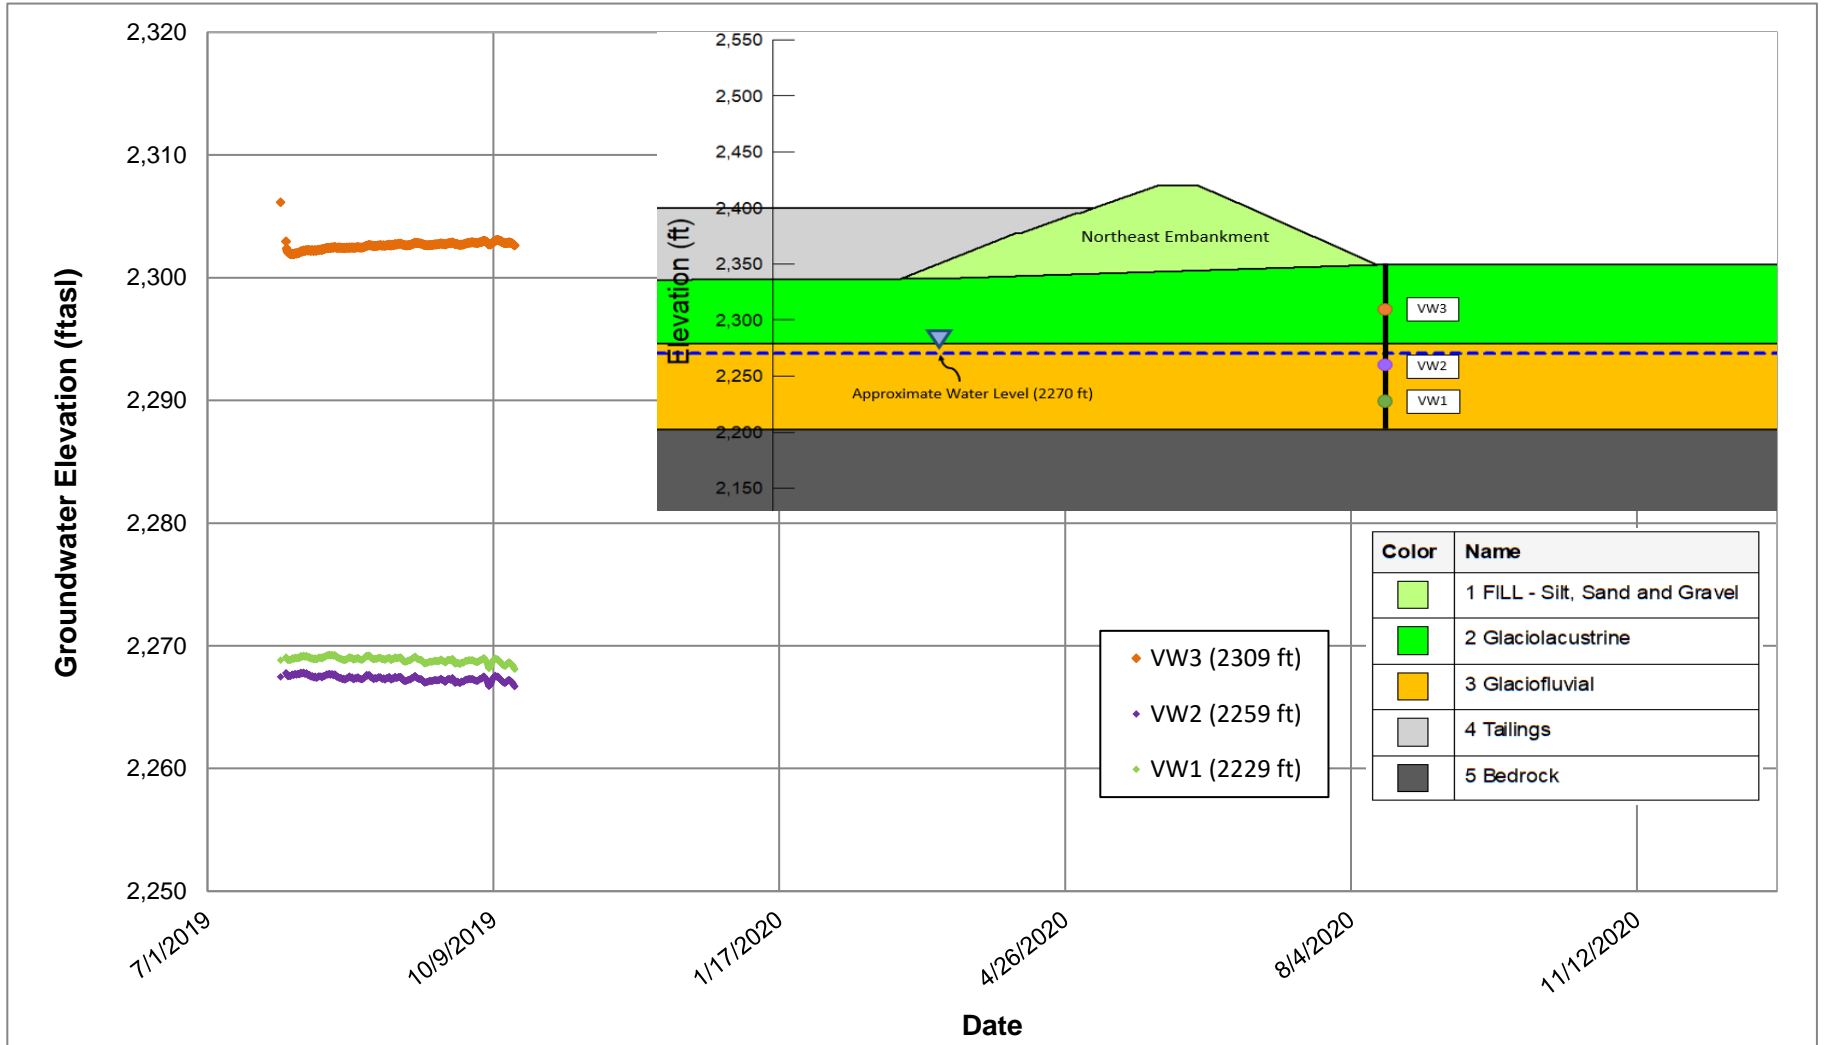
1. GROUND ELEVATION IS 2350 ft ABOVE SEA LEVEL.
2. SENSOR DEPTHS SHOWN IN LEGEND ARE VERTICAL DEPTHS BELOW GROUND SURFACE.
3. VW3 LOCATED ABOVE THE WATER TABL
4. VW1 = 121 ft BELOW GROUND SURFACE, VW2 = 91 ft BELOW GROUND SURFACE AND VW3 = 41 ft BELOW GROUND SURFACE.
