Teck Highland Valley Copper Partnership

2019 Dam Safety Inspection Report

7 Day Pond Tailings Storage Facility

April 2020

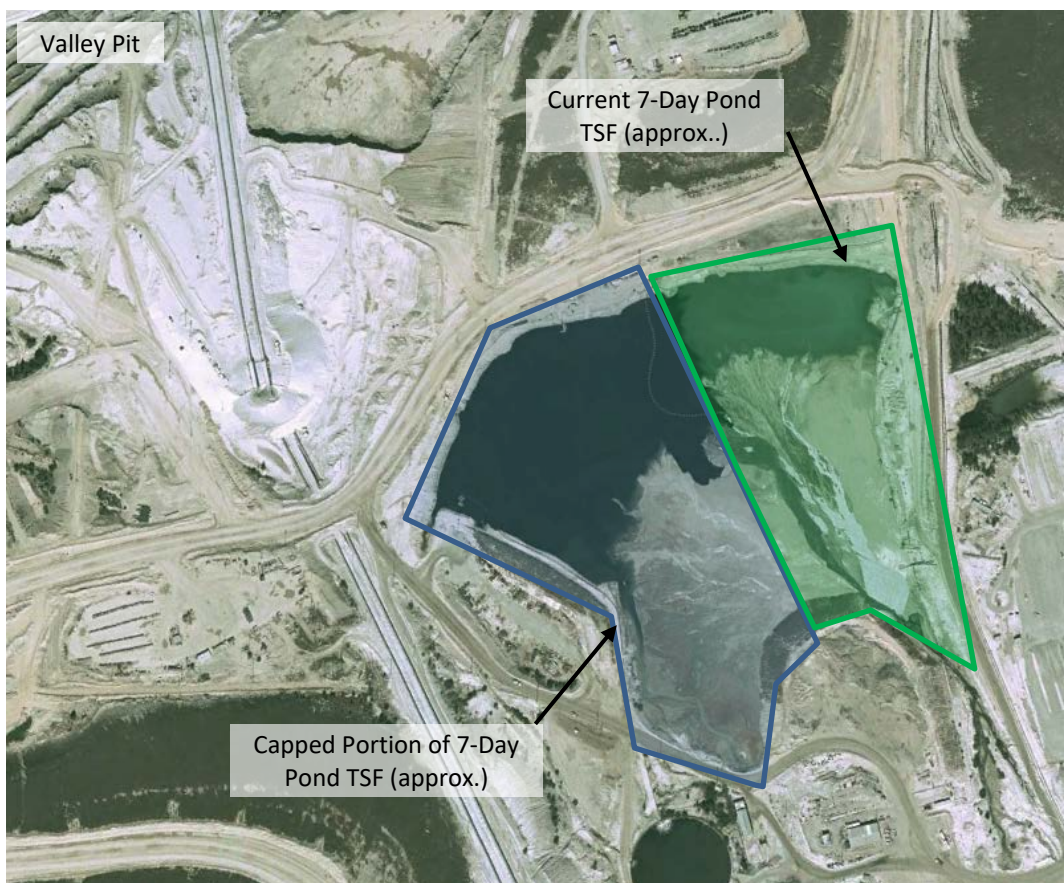
Figure 2.1 Original 7-Day Pond TSF Footprint

In 2013 and 2014 the majority of the 7-Day Pond impoundment area was capped with rockfill from mine waste. The current configuration of the 7-Day Pond is approximately 40% of the original footprint as shown on Figure 2.1. This capping was done to accommodate the alignment of a new ore conveyor to the northwest and did not alter the operation of the facility. The work did reduce the storage capacity of the facility and increased the distance between the ponded water surface and Valley Pit crest.

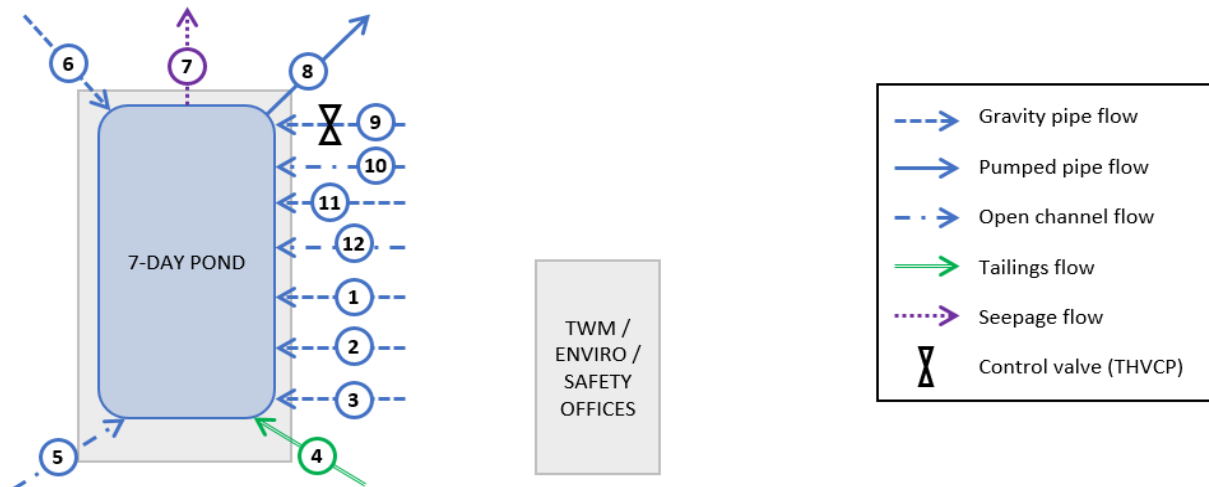
Figure 4.1 Flow Schematic for 7-Day Pond

Figure 4.1 is a simplified water schematic for the pond. Inflows and outflows are not measured. THVCP reviews tailings level annually to define operating and flood levels. Going forward, THVCP will maintain adequate tailings and flood storage through dredging, or some other means, on an as needed basis. The pond levels at the first quarter (Q1) of 2019 was similar to the levels in Q1 2018. However, in Q2 and Q3, the water elevations were higher than historical elevations except in August (refer to Section 5.3).

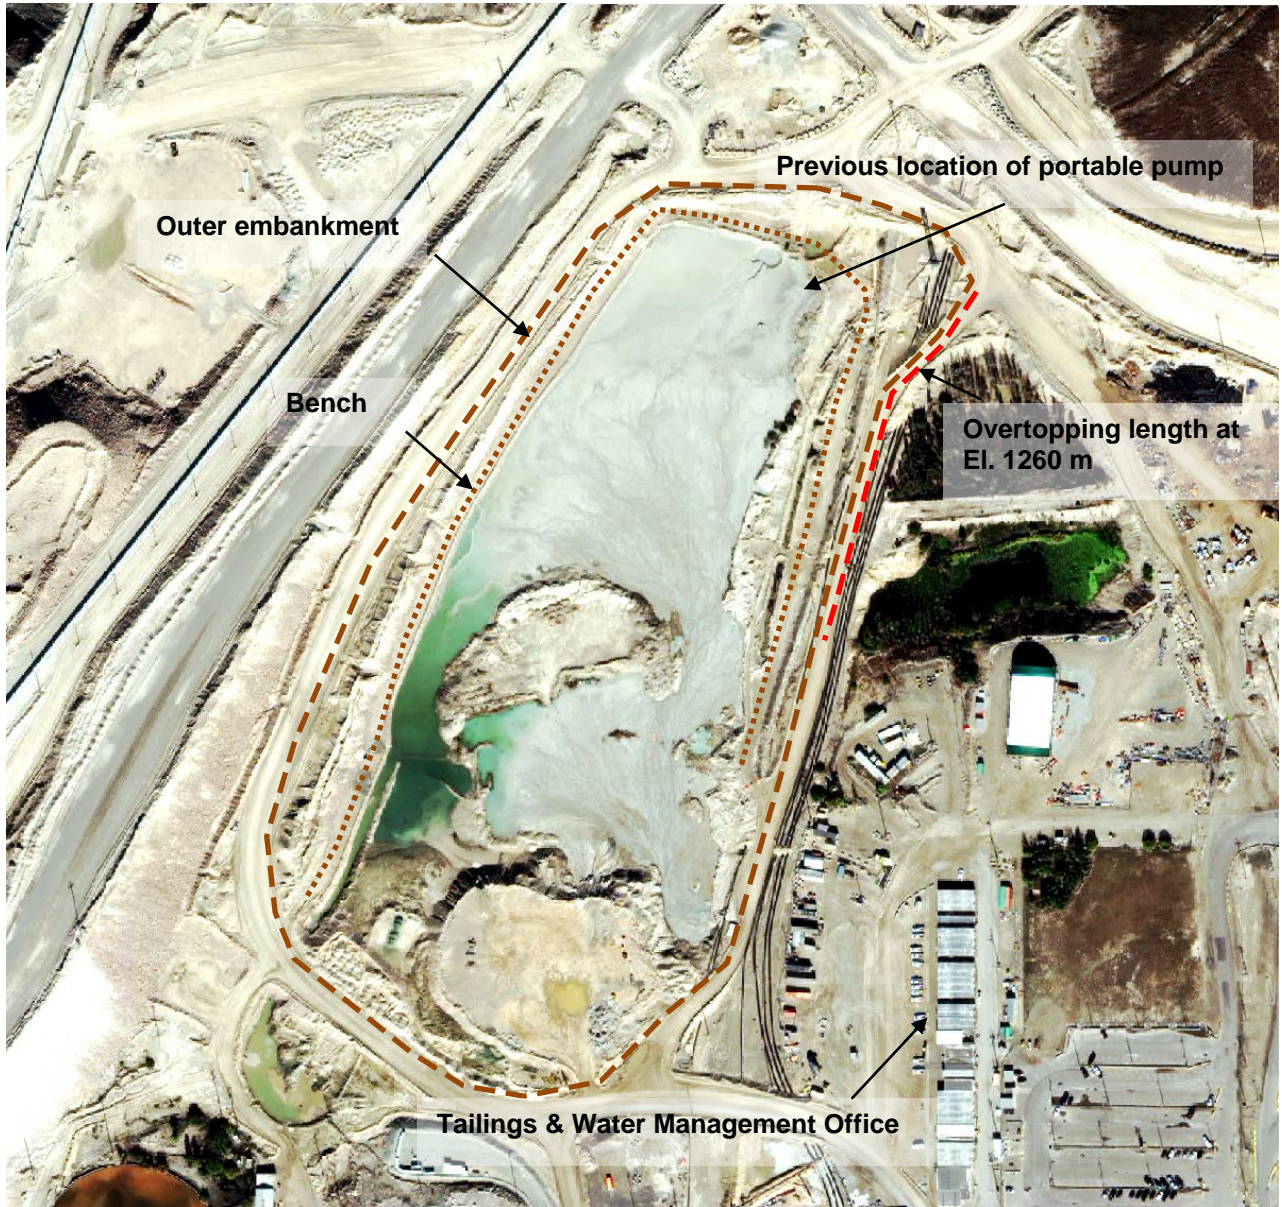
SITE PLAN
(Image provided by THVCP on Dec 03, 2019)

- Interior berm partially dividing TSF. Water can pond u/s of the berm in a corner where no, to little, tailings build up on downstream side
- Storage capacity should be checked to ensure the embankment could store IDF
- What is the discharge plan via pumping?
